FLORIDA DEPARTMENT OF ENVIRONMENTAL PROTECTION  
STRATEGIC MONITORING PROGRAM FIELD SHEET

STORET Station Name: Rocky Creek @ SR51

DEP Form FD 9000-4 Stream/River Habitat Assessment Sketch Sheet

# DEP Form FD 9000-5 Stream/River Habitat Assessment Field Sheet

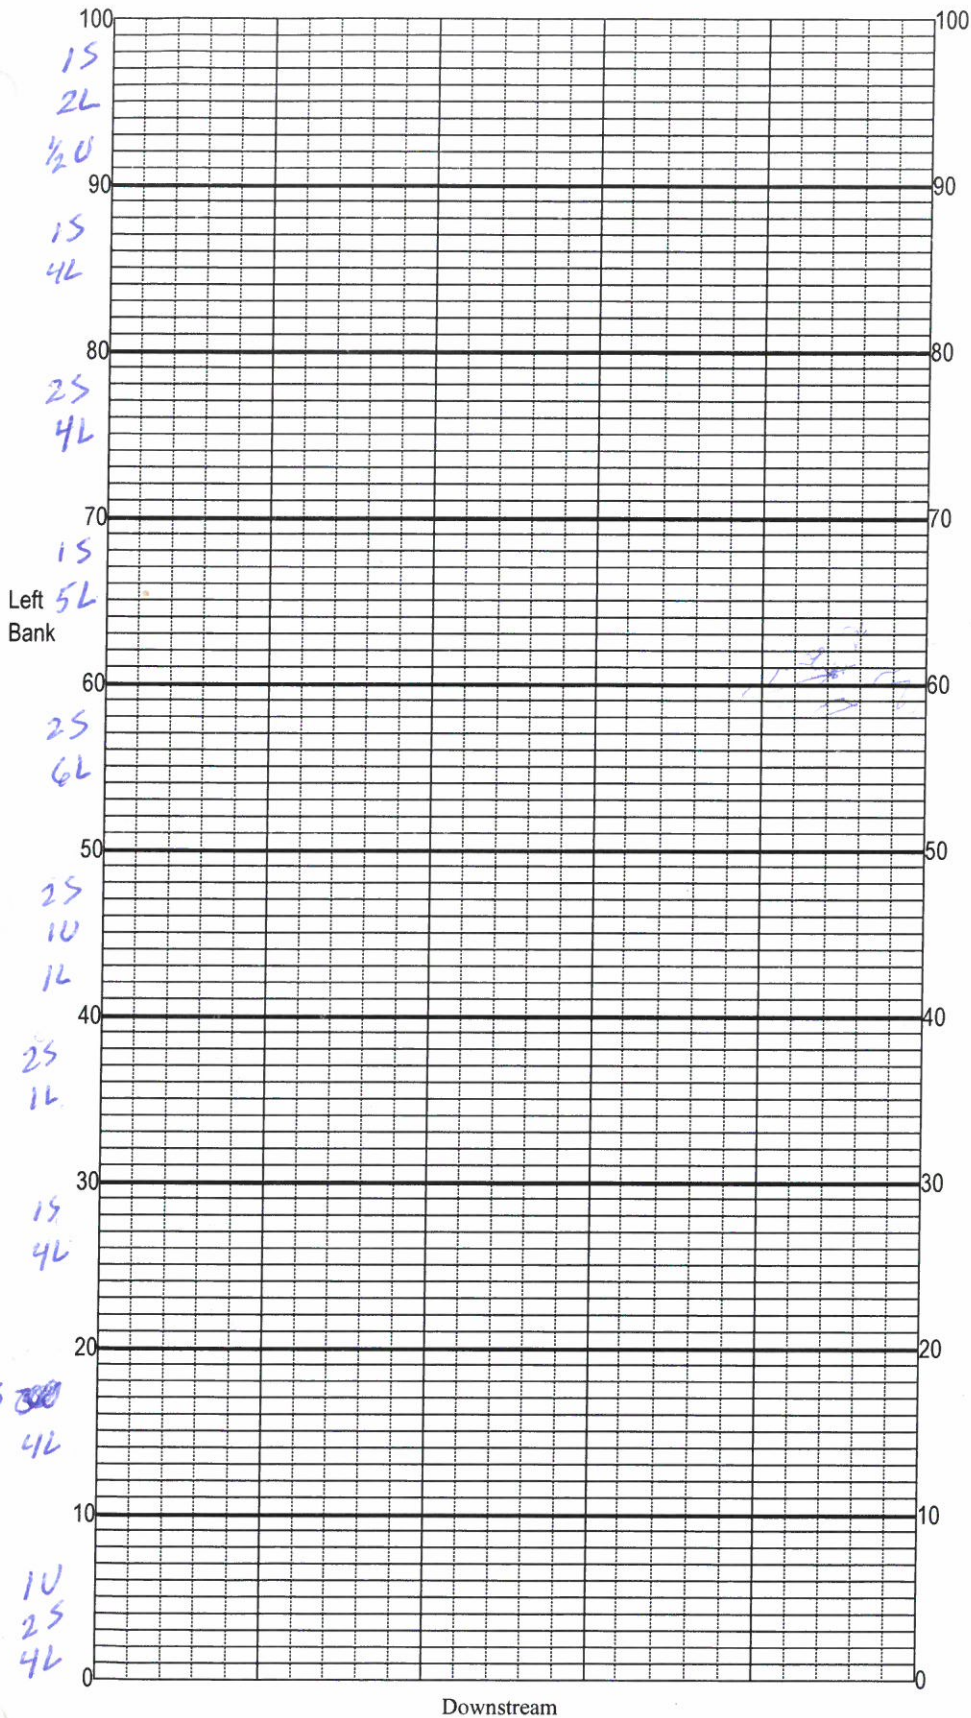
Substrates: Code key, draw proportionate habitat abundance. %

Average width 4 m

Average depth 0.6 m

Velocity measured at 50 meter mark. 3 sec.

WQ & chemistry taken at 50 meter mark.

Habitat Smothering: slight silt  
Note areas (on map) where sand or silt is smothering substrates, limiting habitability.

Bank Stability: good  
Note areas (on map) with unstable, eroding banks.

Riparian Buffer Width: >18m  
Note areas (on map) where natural vegetation is altered or eliminated.

80% of system rock  
river bottom  
bottom

Length of grid represents 100 m of stream (not linear meters).  
(Horizontal scale is double vertical scale, draw proportionately).
