DEP Form FD 9000-5 Stream/River Habitat Assessment Field Sheet

## DEP Form FD 9000-4 Stream/River Habitat Assessment Sketch Sheet

DEP Form FD 9000-3 Physical/Chemical Characterization Field Sheet

# DEP FORM FD 9000-25 Rapid Periphyton Survey Field Sheet

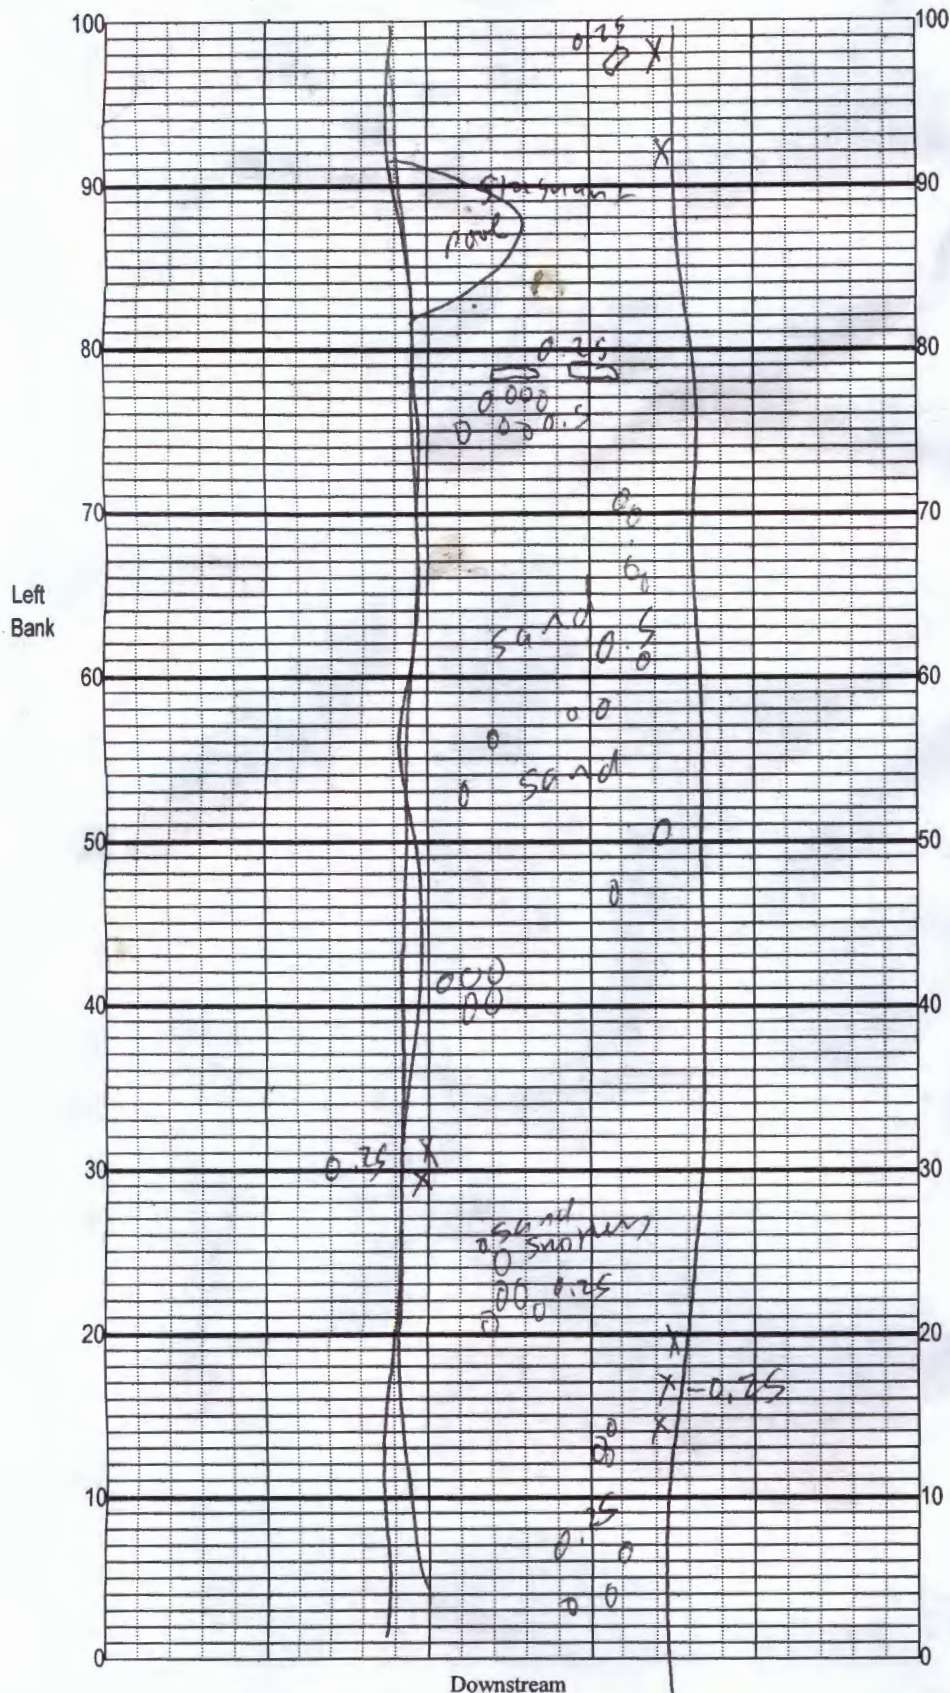
Length of grid represents 100 m of stream (not linear meters).  
(Horizontal scale is double vertical scale, draw proportionately).

Location: Terrapin  
Open Kaye Rd.  
Date: 12/27/17  
Sampler: JP

<2 M of Macrophytes was observed while doing the LVS? YES or NO

0.17 velocity

1.7 wide
