Site Name Elder Springs Run / Six Mile Sample Date 11/19/18  
 WBID 2984 WIN ID G2CE0120 RQ 2018-11-19-44

FLORIDA DEPARTMENT OF ENVIRONMENTAL PROTECTION  
STRATEGIC MONITORING PROGRAM FIELD SHEET

WIN Station Name: Elder Springs Run @ US of Myrtle St

DEP Form FD 9000-4 Stream/River Habitat Assessment Sketch Sheet

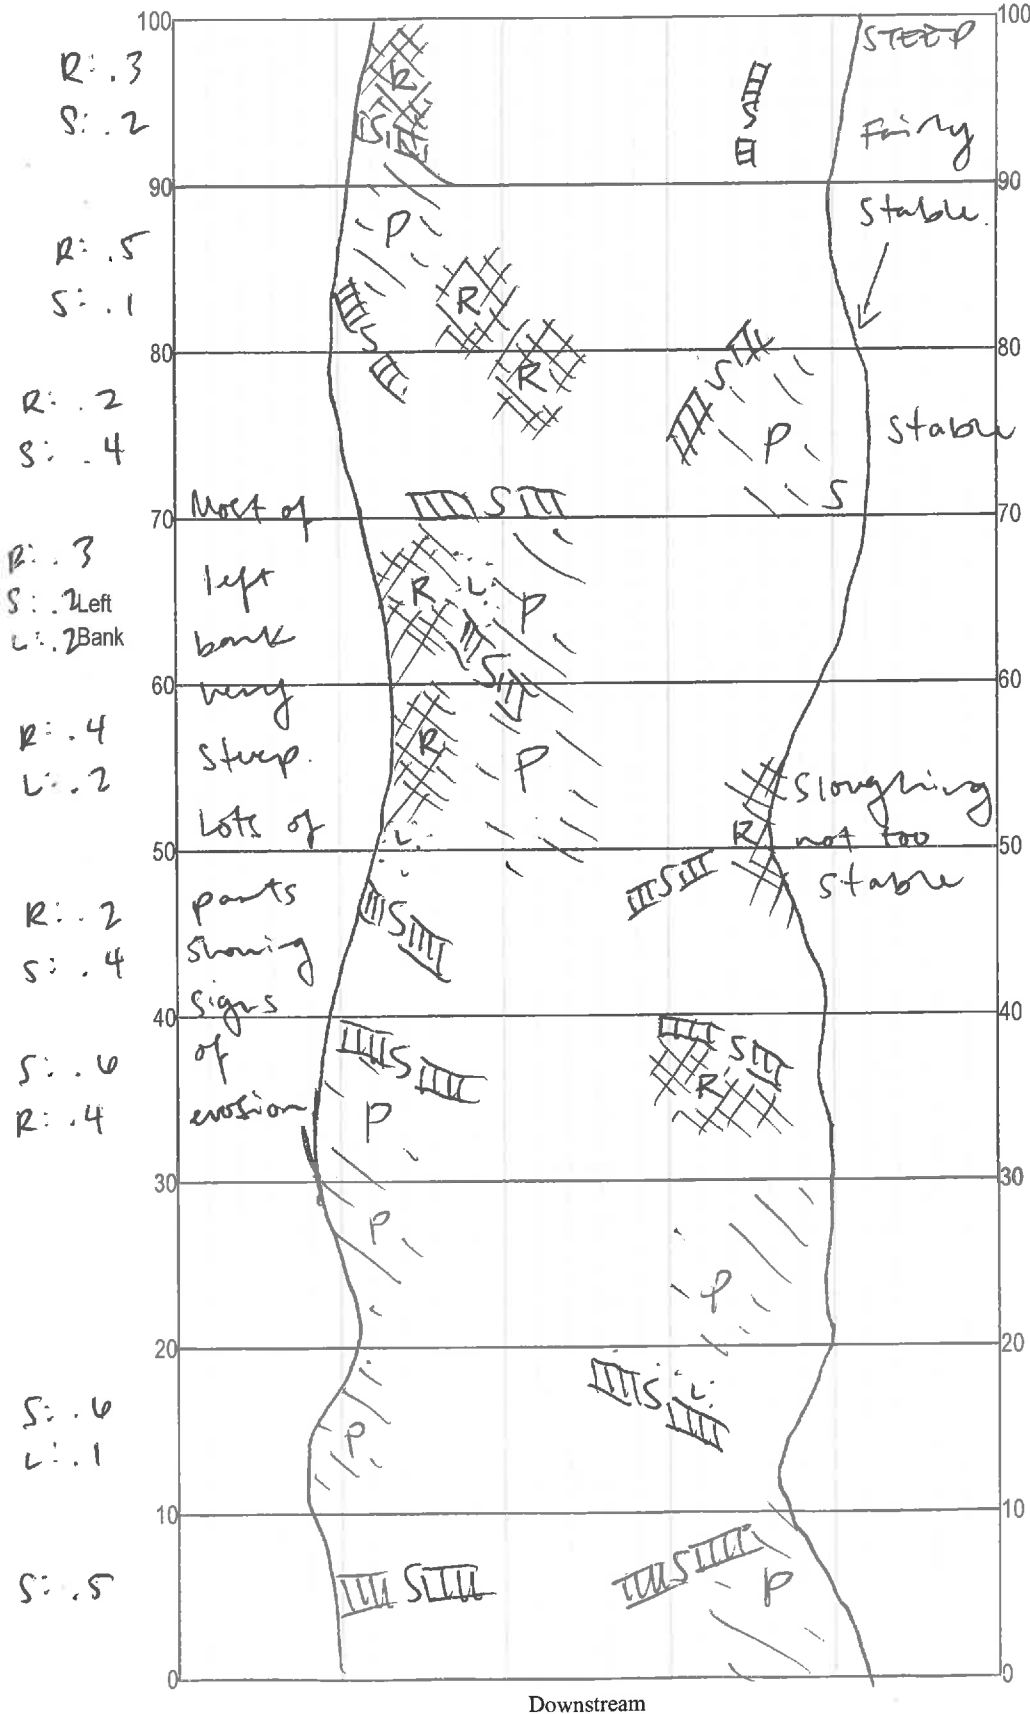
Location: Six Mile Creek @ Myrtle St.  
 Date: 11/19/18  
 Sampler: Leif Bowen, Katie Wood

| Substrates: Code key, draw proportionate habitat abundance. % | |
| Snags | 1.5 |
| Roots/undercut banks | 1.15 |
| Leaf Packs (or mats) | .25 |
| Pools | total # observed = <u>16</u><br># range expected = _____ |
| Average width <u>2</u> m | |

Snags  
 roots  
 minor leaf  
 mats

water level has dropped  
 pools meet required # still
