# FLORIDA DEPARTMENT OF ENVIRONMENTAL PROTECTION STRATEGIC MONITORING PROGRAM FIELD SHEET

WIN Station Name: MCCOYS CR AT LELAND ST

DEP Form FD 9000-5 Stream/River Habitat Assessment Field Sheet

# DEP Form FD 9000-4 Stream/River Habitat Assessment Sketch Sheet

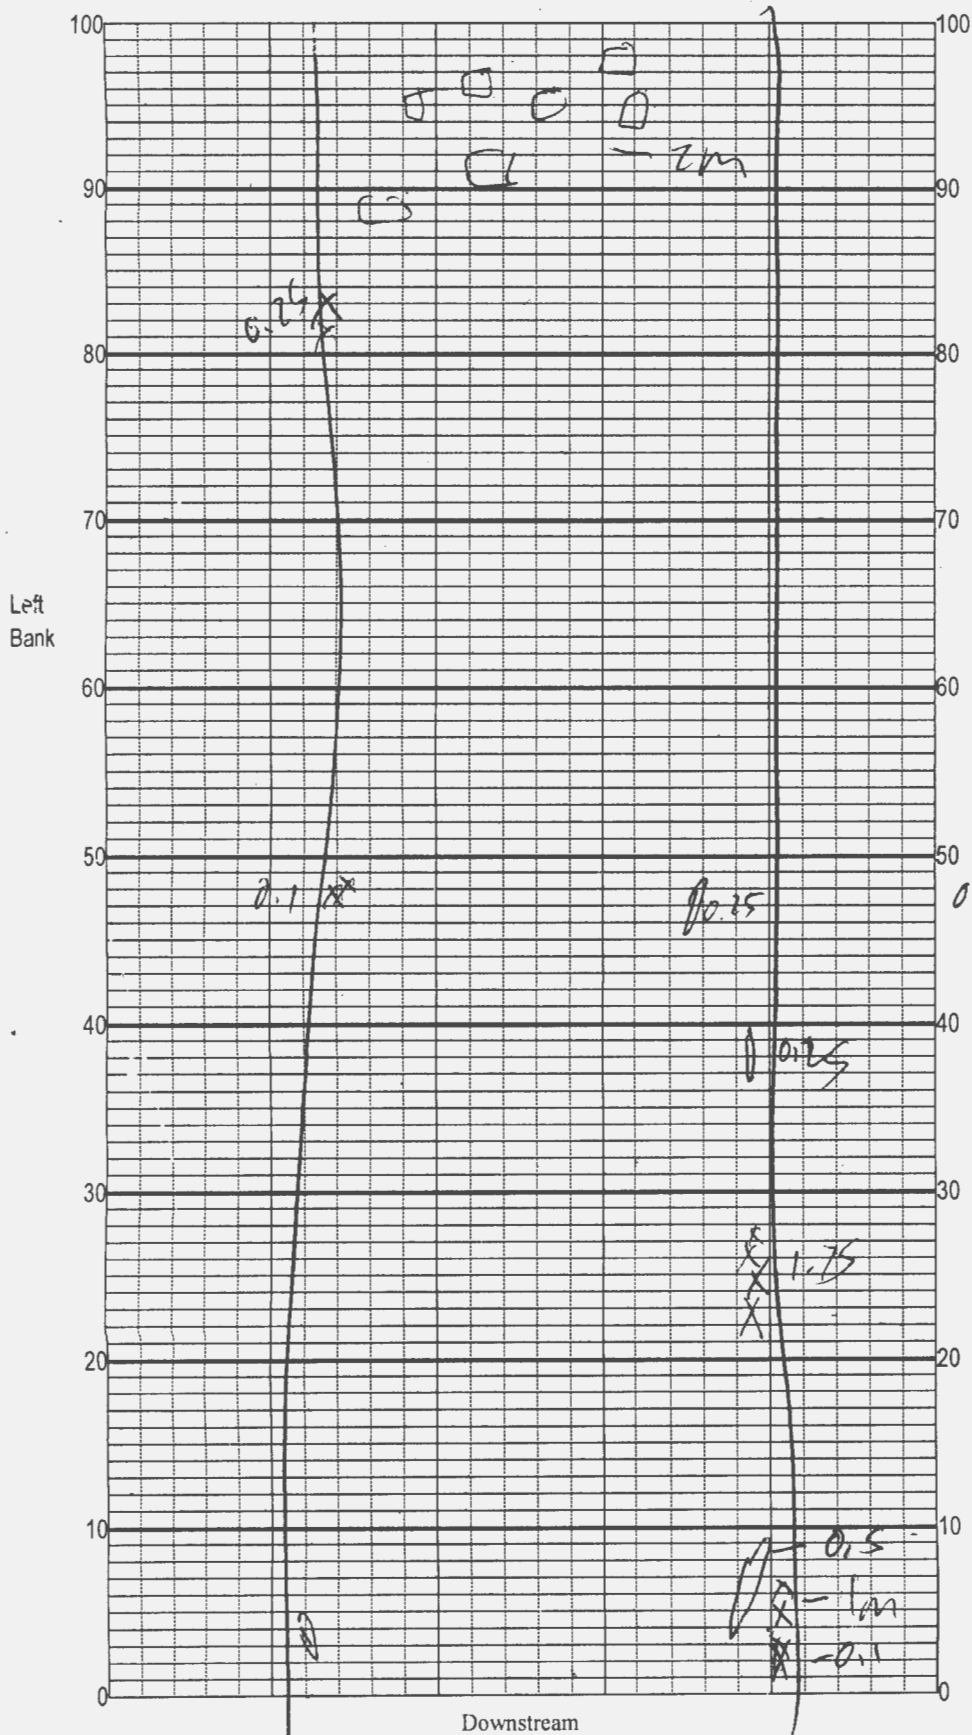
Length of grid represents 100 m of stream (not linear meters).  
(Horizontal scale is double vertical scale, draw proportionately).

Location: McCoy @ Leland
