# FLORIDA DEPARTMENT OF ENVIRONMENTAL PROTECTION STRATEGIC MONITORING PROGRAM FIELD SHEET

WIN Station Name: Stroud Creek @ Easement off Nalle Rd

DEP Form FD 9000-4 Stream/River Habitat Assessment Sketch Sheet

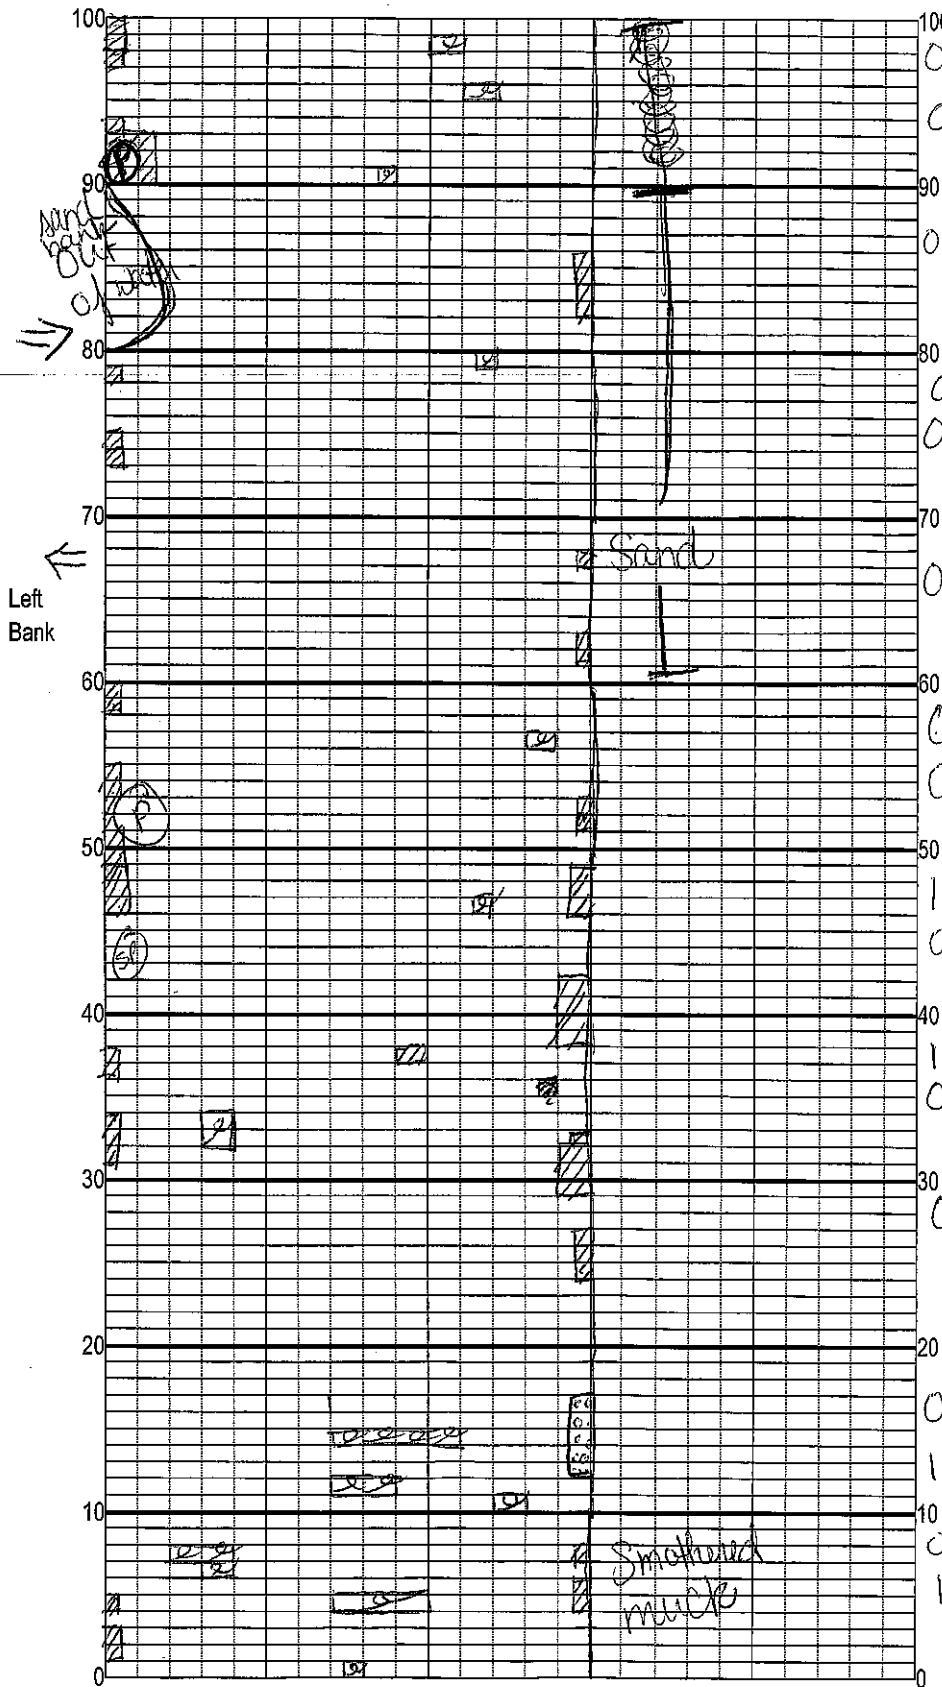
Average width 2.5 m

Average depth 0.2 m

Velocity measured at 0/100 meter mark.

WQ & chemistry taken at 0 meter mark.

Plants observed / other notes: 0m - 25s  
100m - 21s  
23s/m

\*All leaf mats heavily smothered\*

2.5 m Downstream  
Length of grid represents 100 m of stream (not linear meters).  
(Horizontal scale is double vertical scale, draw proportionately).
