Site Name: Gap Creek above 27th Street

## P FORM FD 9000-25 Rapid Periphyton Survey Field SH

## DEP FORM FD 9000-32: LINEAR VEGETATION SURVEY FIELD

## DEP Form FD 9000-3 Physical/Chemical Characterization Field Sheet

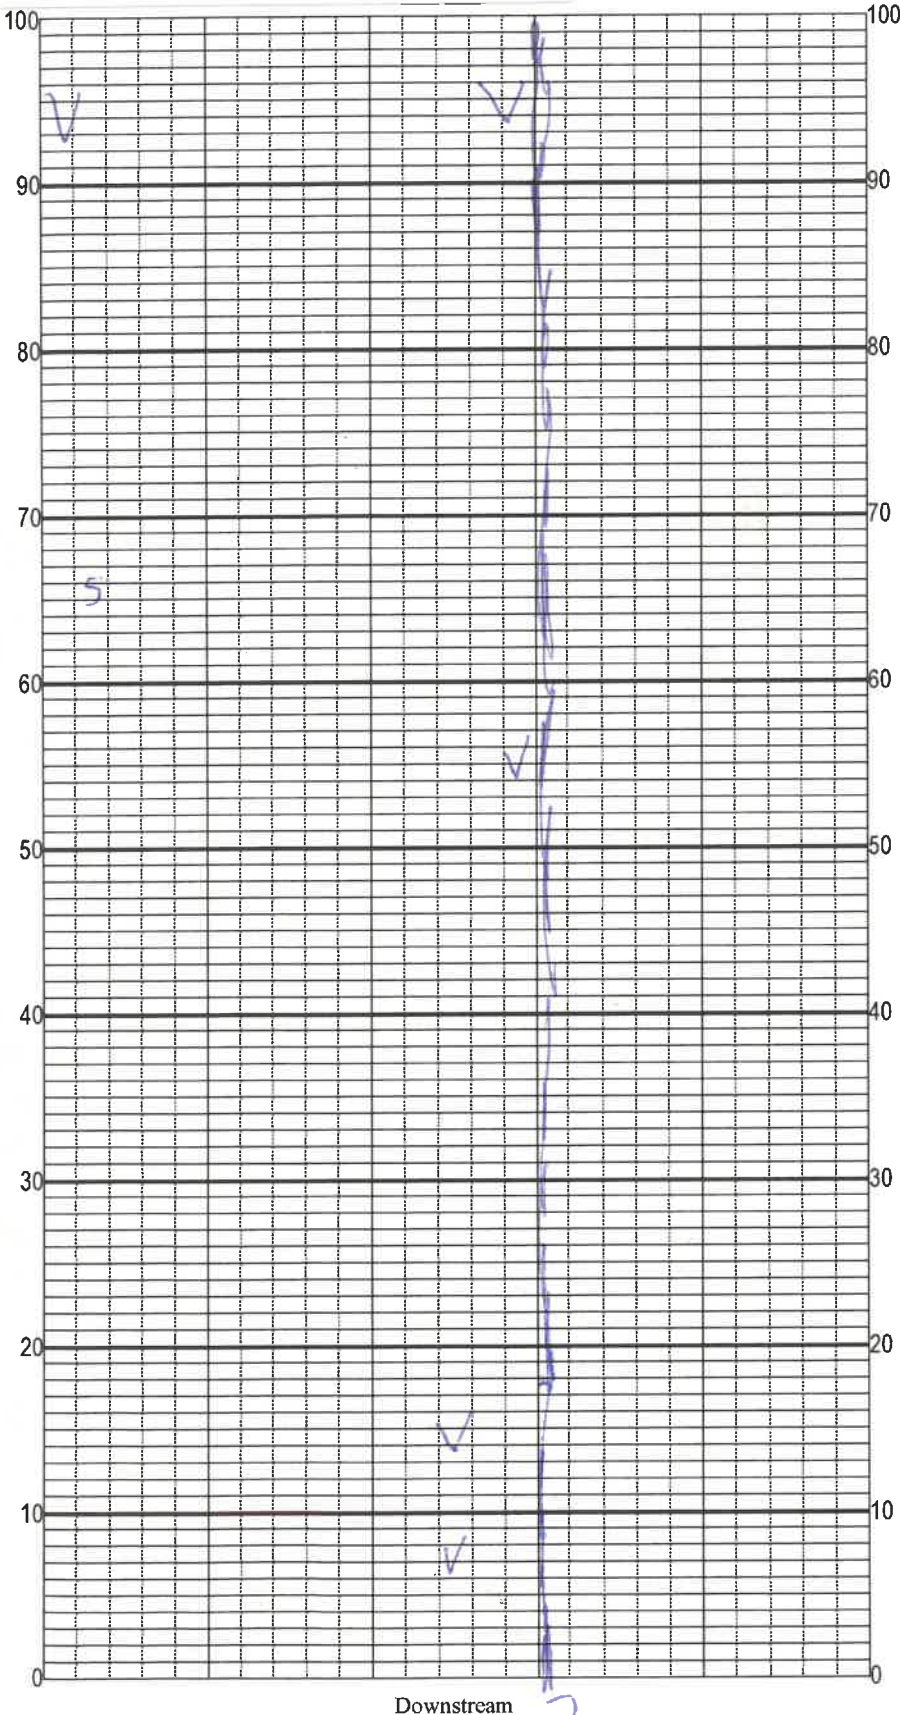
Length of grid represents 100 m of stream (not linear meters).  
(Horizontal scale is double vertical scale, draw proportionately).

| <input checked="" type="checkbox"/> S | Snags <u>few</u> |
| <input checked="" type="checkbox"/> | Aquatic Macrophytes <u>few</u> |
| <input checked="" type="checkbox"/> Pools | total # observed = <u>0</u><br># range expected = <u>3-6</u> |
| Average width <u>3</u> m | |
| Average depth <u>1.5</u> m | |
