**FLORIDA DEPARTMENT OF ENVIRONMENTAL PROTECTION**

## STRATEGIC MONITORING PLAN Field Sheet

| <b>WIN Station Name:</b> | Gamble Creek West Branch @ CR 675 | | | | <b>Sample Date:</b> | 10/24/2022 | |

## DEP Form FD 9000-4 Stream/River Habitat Assessment Sketch Sheet

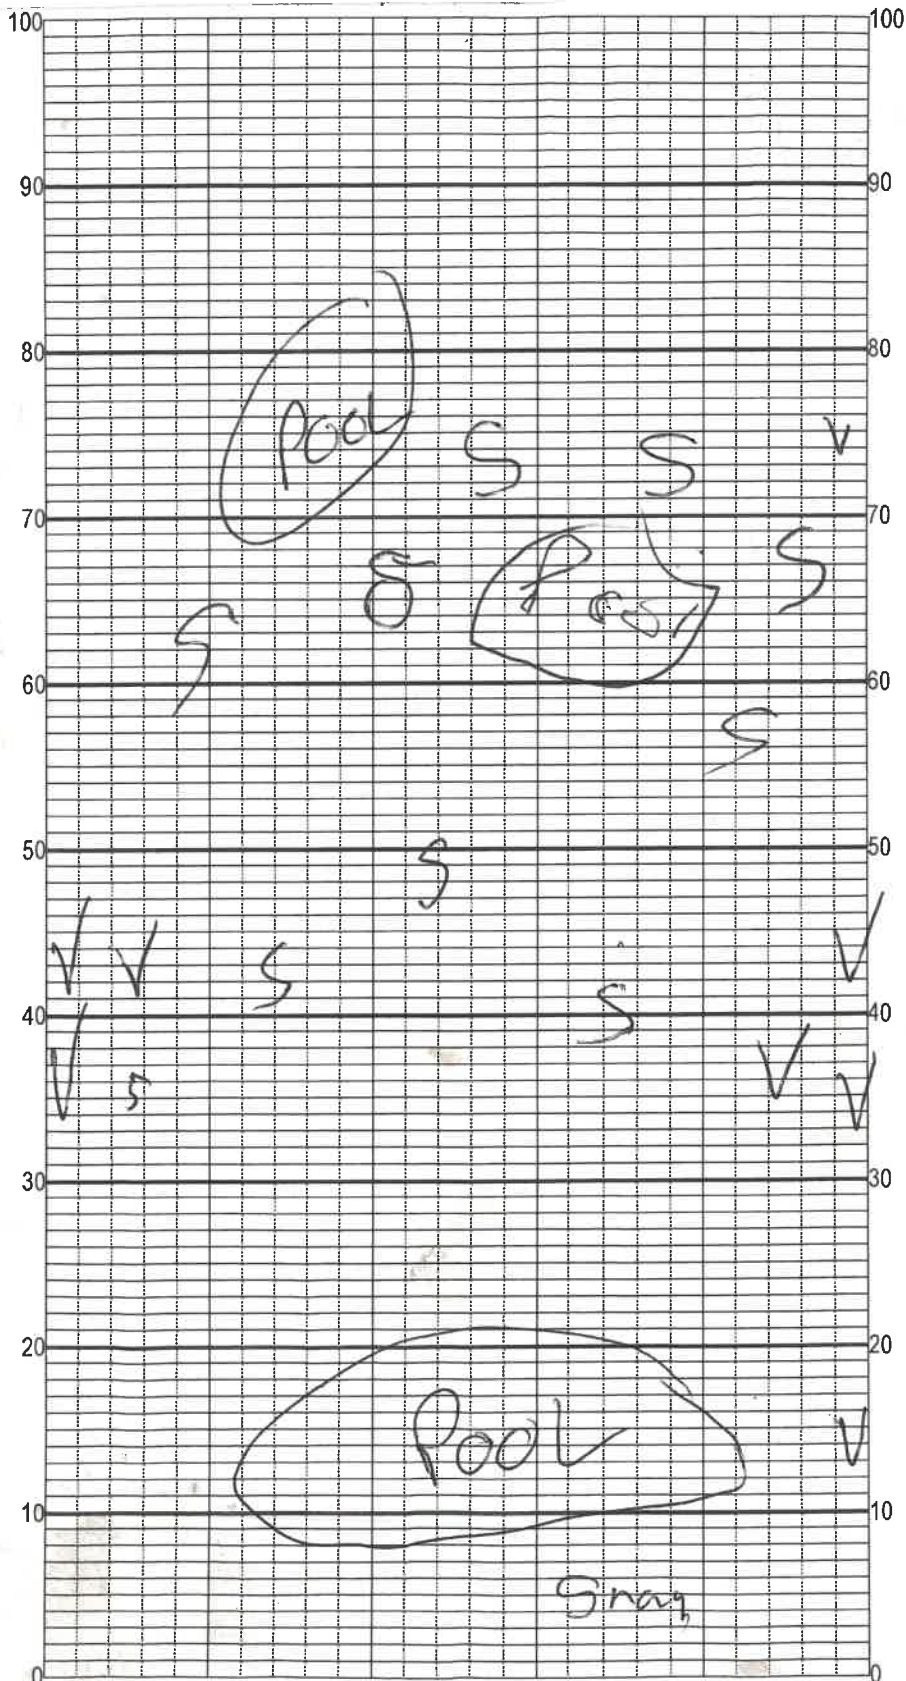
Left Bank

Substrates: Code key, draw proportionate habitat abundance.

| <input checked="" type="checkbox"/> S | Snags | % <u>2.8</u> |
| <input checked="" type="checkbox"/> V | Aquatic Macrophytes | % <u>1.8</u> |
| <input checked="" type="checkbox"/> 3 | Pools | total # observed = <u>3</u><br># range expected = _____ |

Average width 2 m

Average depth .5 m

Velocity measured at 0.50-1.00 meter mark.

WQ & chemistry taken at 100 meter mark.

V = 46  
S = 70

Downstream

Length of grid represents 100 m of stream (not linear meters).  
 (Horizontal scale is double vertical scale, draw proportionately).
