## DEP Form FD 9000-5 Stream/River Habitat Assessment Sheet

**Buffalo Canal @ 54681**STORET STATION  
NUMBER: see stickerSAMPLE TIME: 11/22/22

**FDEP SWROC**RQ: G1SW0135LOCATION:  
see sticker ^COUNTY:  
Manatee

Location: Buffalo CanalDate: 11/22/22Sampler: K. Grace100 m: Latitude 27.588933Longitude -82.479640 m: Latitude 27.589189Longitude -82.480599

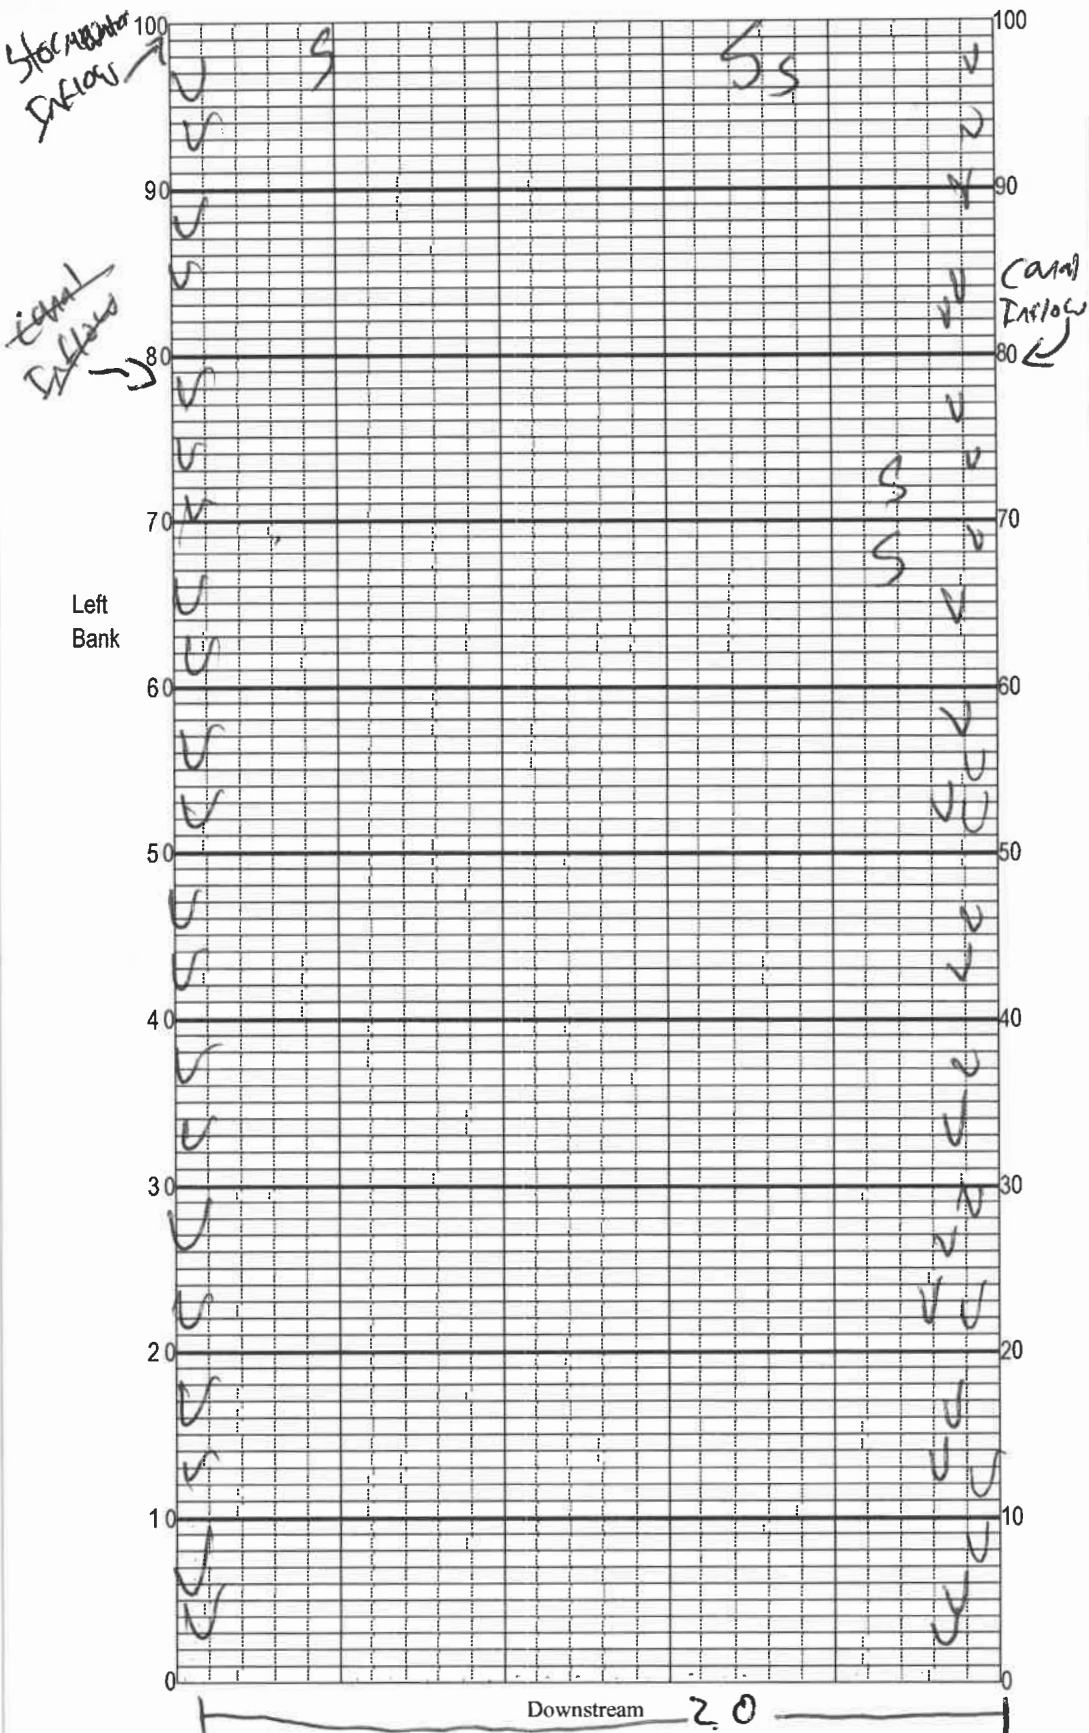
Substrates: Code key, draw proportionate habitat abundance. %

☒ S Snags 2
☐ Roots/undercut banks /
☐ Leaf Packs (or mats) /
☒ Aquatic Macrophytes 22
☐ ROCKS /
☐ /
☐ Pools total # observed = 0  
# range expected = /
Average width 2.0 mAverage depth 0.6 mVelocity measured at 70 meter mark.WQ & chemistry taken at NA meter mark.

Habitat Smothering:  
Note areas (on map) where sand or silt is smothering substrates, limiting habitability.

Bank Stability:  
Note areas (on map) with unstable, eroding banks.

Riparian Buffer Width:  
Note areas (on map) where natural vegetation is altered or eliminated.

Length of grid represents 100 m of stream (not linear meters).  
(Horizontal scale is double vertical scale draw proportionately).
