# Memo

**Date:** May 5, 2025  
**To:** Richard Marcil, PMP. Design Project Manager  
**Organization:** Florida Department of Environmental Protection  
**From:** Amy Daly, Director of Environmental Services  
**Re:** **Ordinary High Water Line Determination – Big Shoals State Park Trail Bridge Replacement**  
**CPH Job No.:** F13637

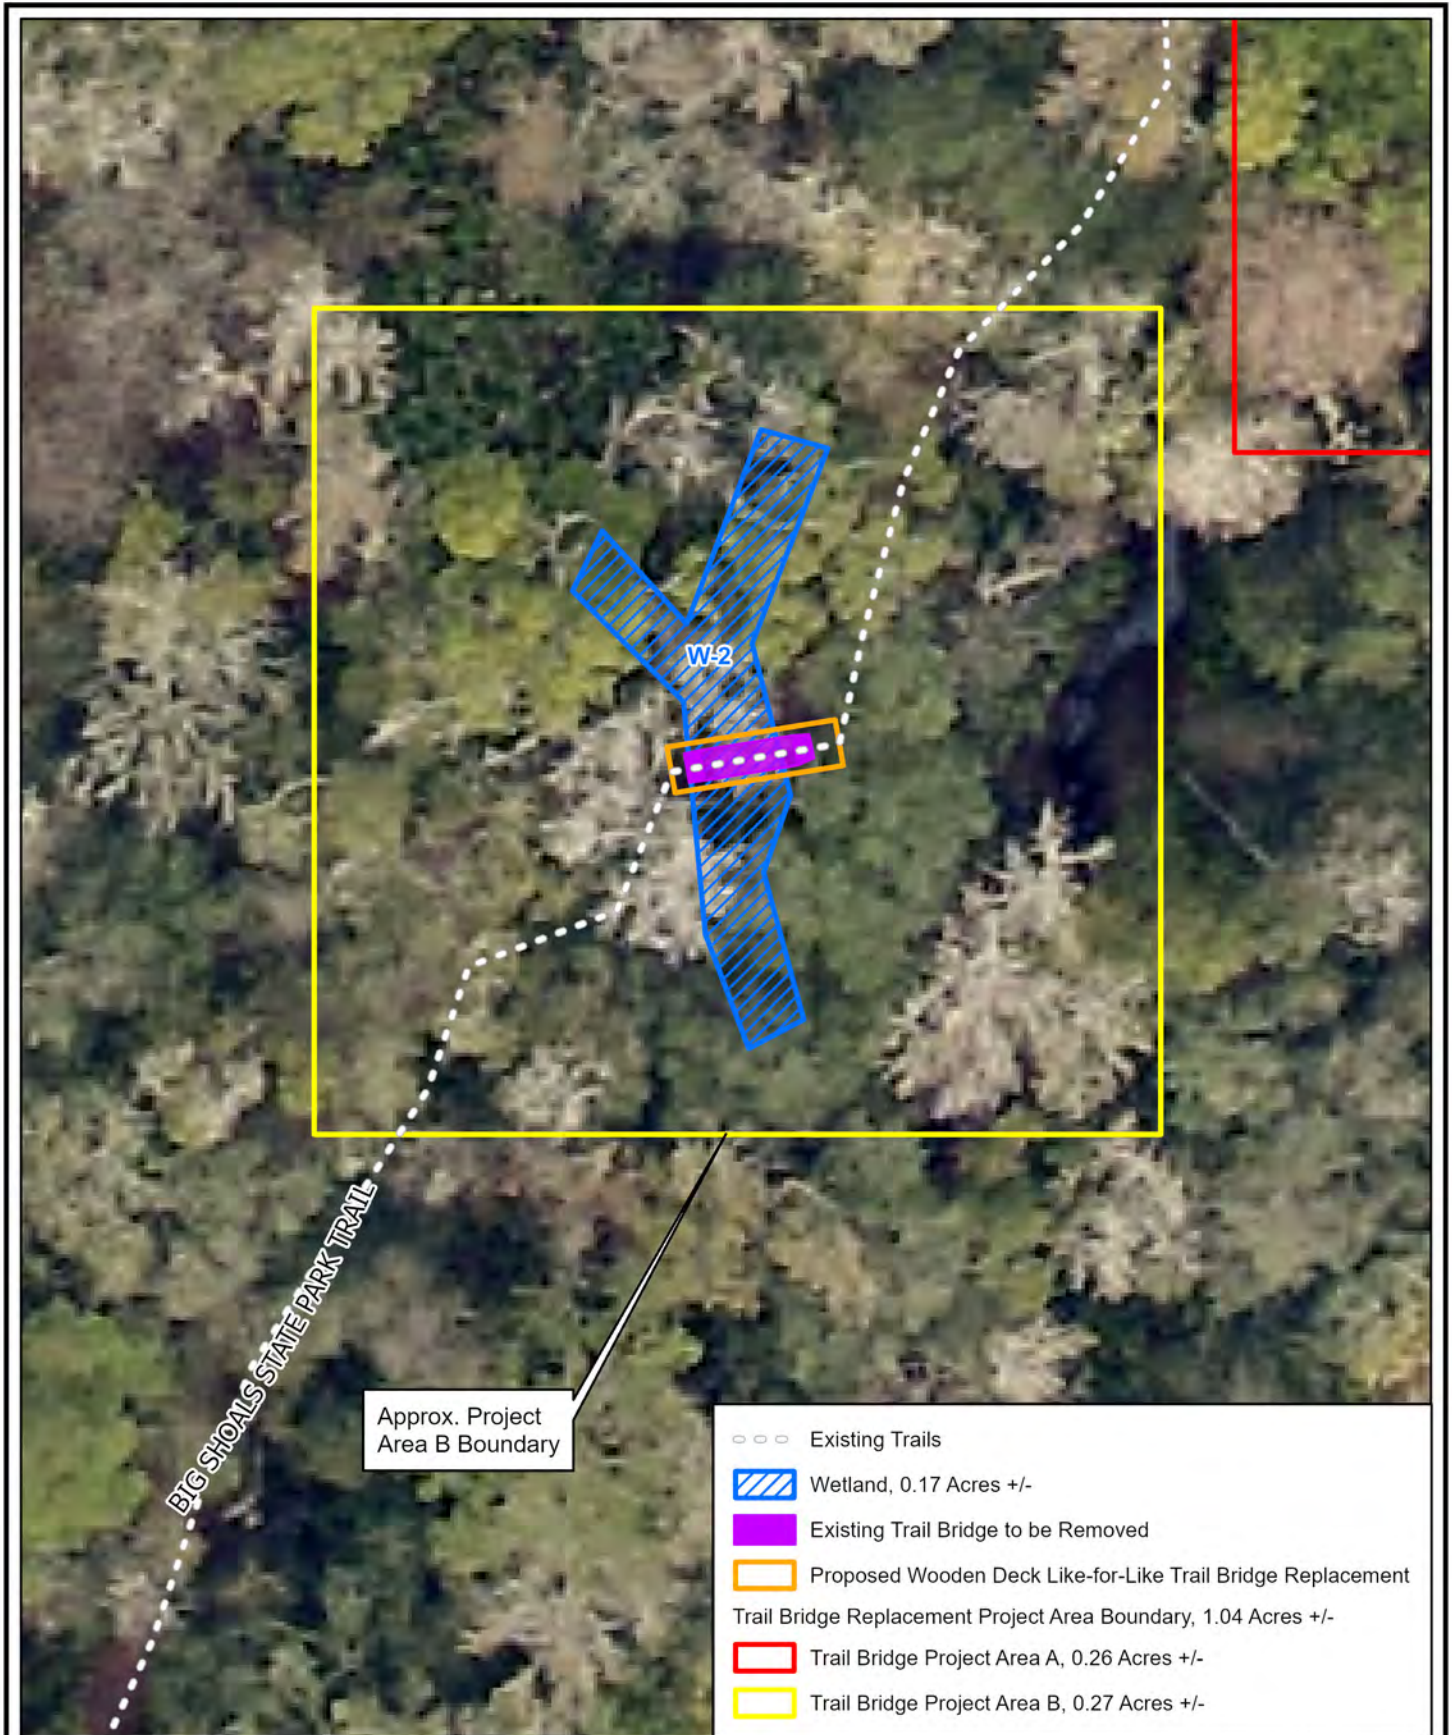
**FIGURE  
7C**

**PROPOSED IWETLAND 2 IMPROVEMENTS MAP**  
 BIG SHOALS STATE PARK TRAIL BRIDGE REPLACEMENT  
 SECTION 35, TOWNSHIP 1 SOUTH, RANGE 16 EAST  
 HAMILTON COUNTY, FLORIDA

**Project Area B** - This intermittent system is narrow and shallow with steep slopes. The location of trail bridge at this wetland area is upslope of the Suwannee River. Water level marks observed on cypress and red maple. The wetland line elevation is at approximately 77.5. Seasonal High Water Elevation (SHWE) set at 76.78. A OHWE is not within this intermittent system due to the nature of the intermittent system.

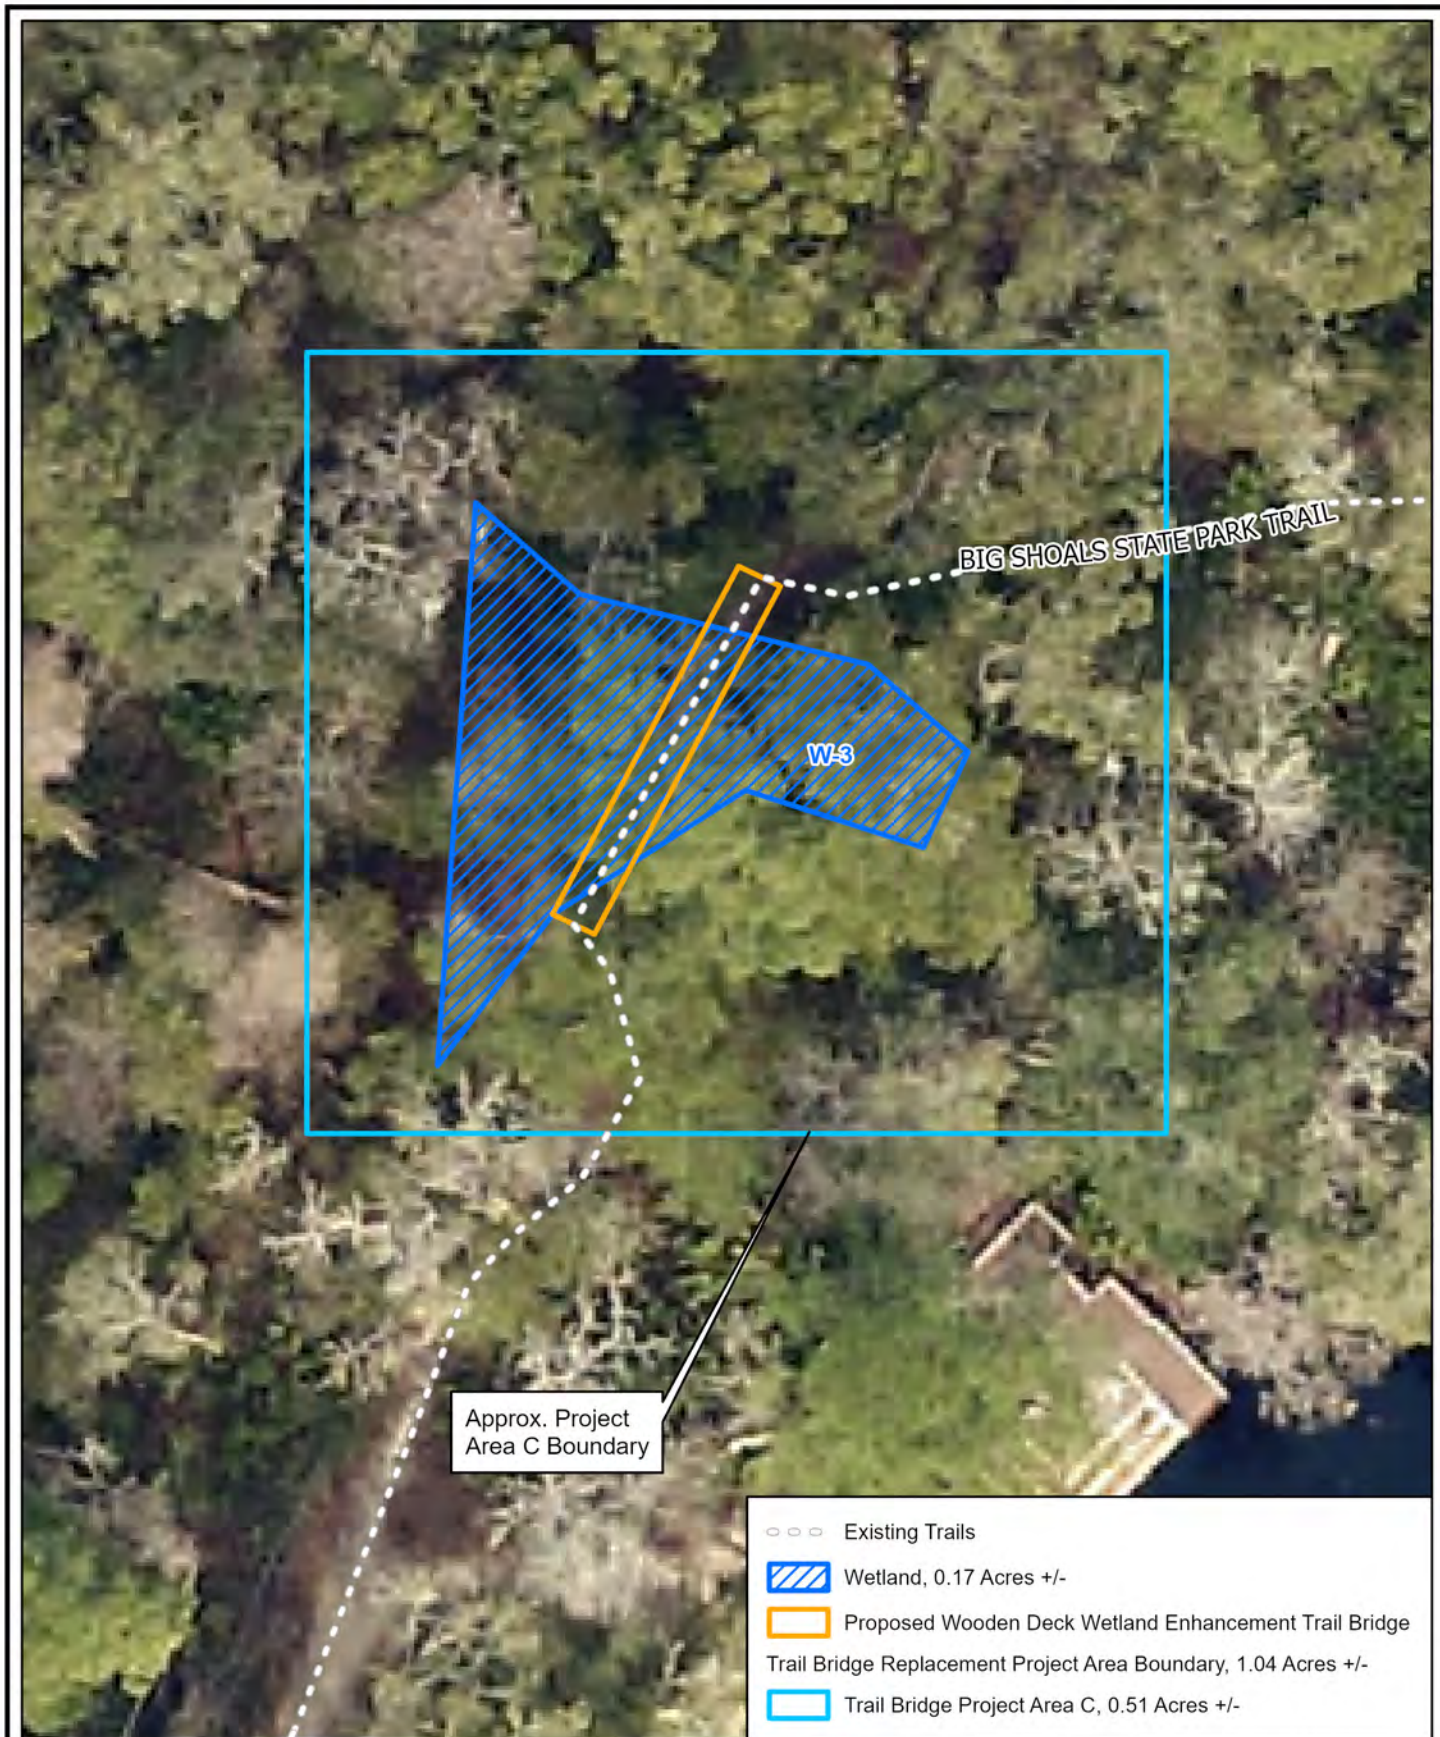
**FIGURE  
7D**

**PROPOSED WETLAND 3 IMPROVEMENTS MAP**  
 BIG SHOALS STATE PARK TRAIL BRIDGE REPLACEMENT  
 SECTION 35, TOWNSHIP 1 SOUTH, RANGE 16 EAST  
 HAMILTON COUNTY, FLORIDA

**Project Area C** – The SWHE was determined during wetland delineation based on topography and limits of hydrologic vegetation. Water level marks were not observed within this narrow intermittent system. The location of trail bridge at this wetland area is upslope of the Suwannee River. Seasonal High Water Elevation (SHWE) set at 80.92. The wetland line elevation is at approximately 82.0. OHWE is not within this intermittent system.
