***Mill View  
Port St. Joe, Gulf County, Florida  
Limited Contamination Assessment Report***

***SIS Report Number 2003-01  
Issued May 2003***

***Authored By:  
Robert Cilek, P.G.***

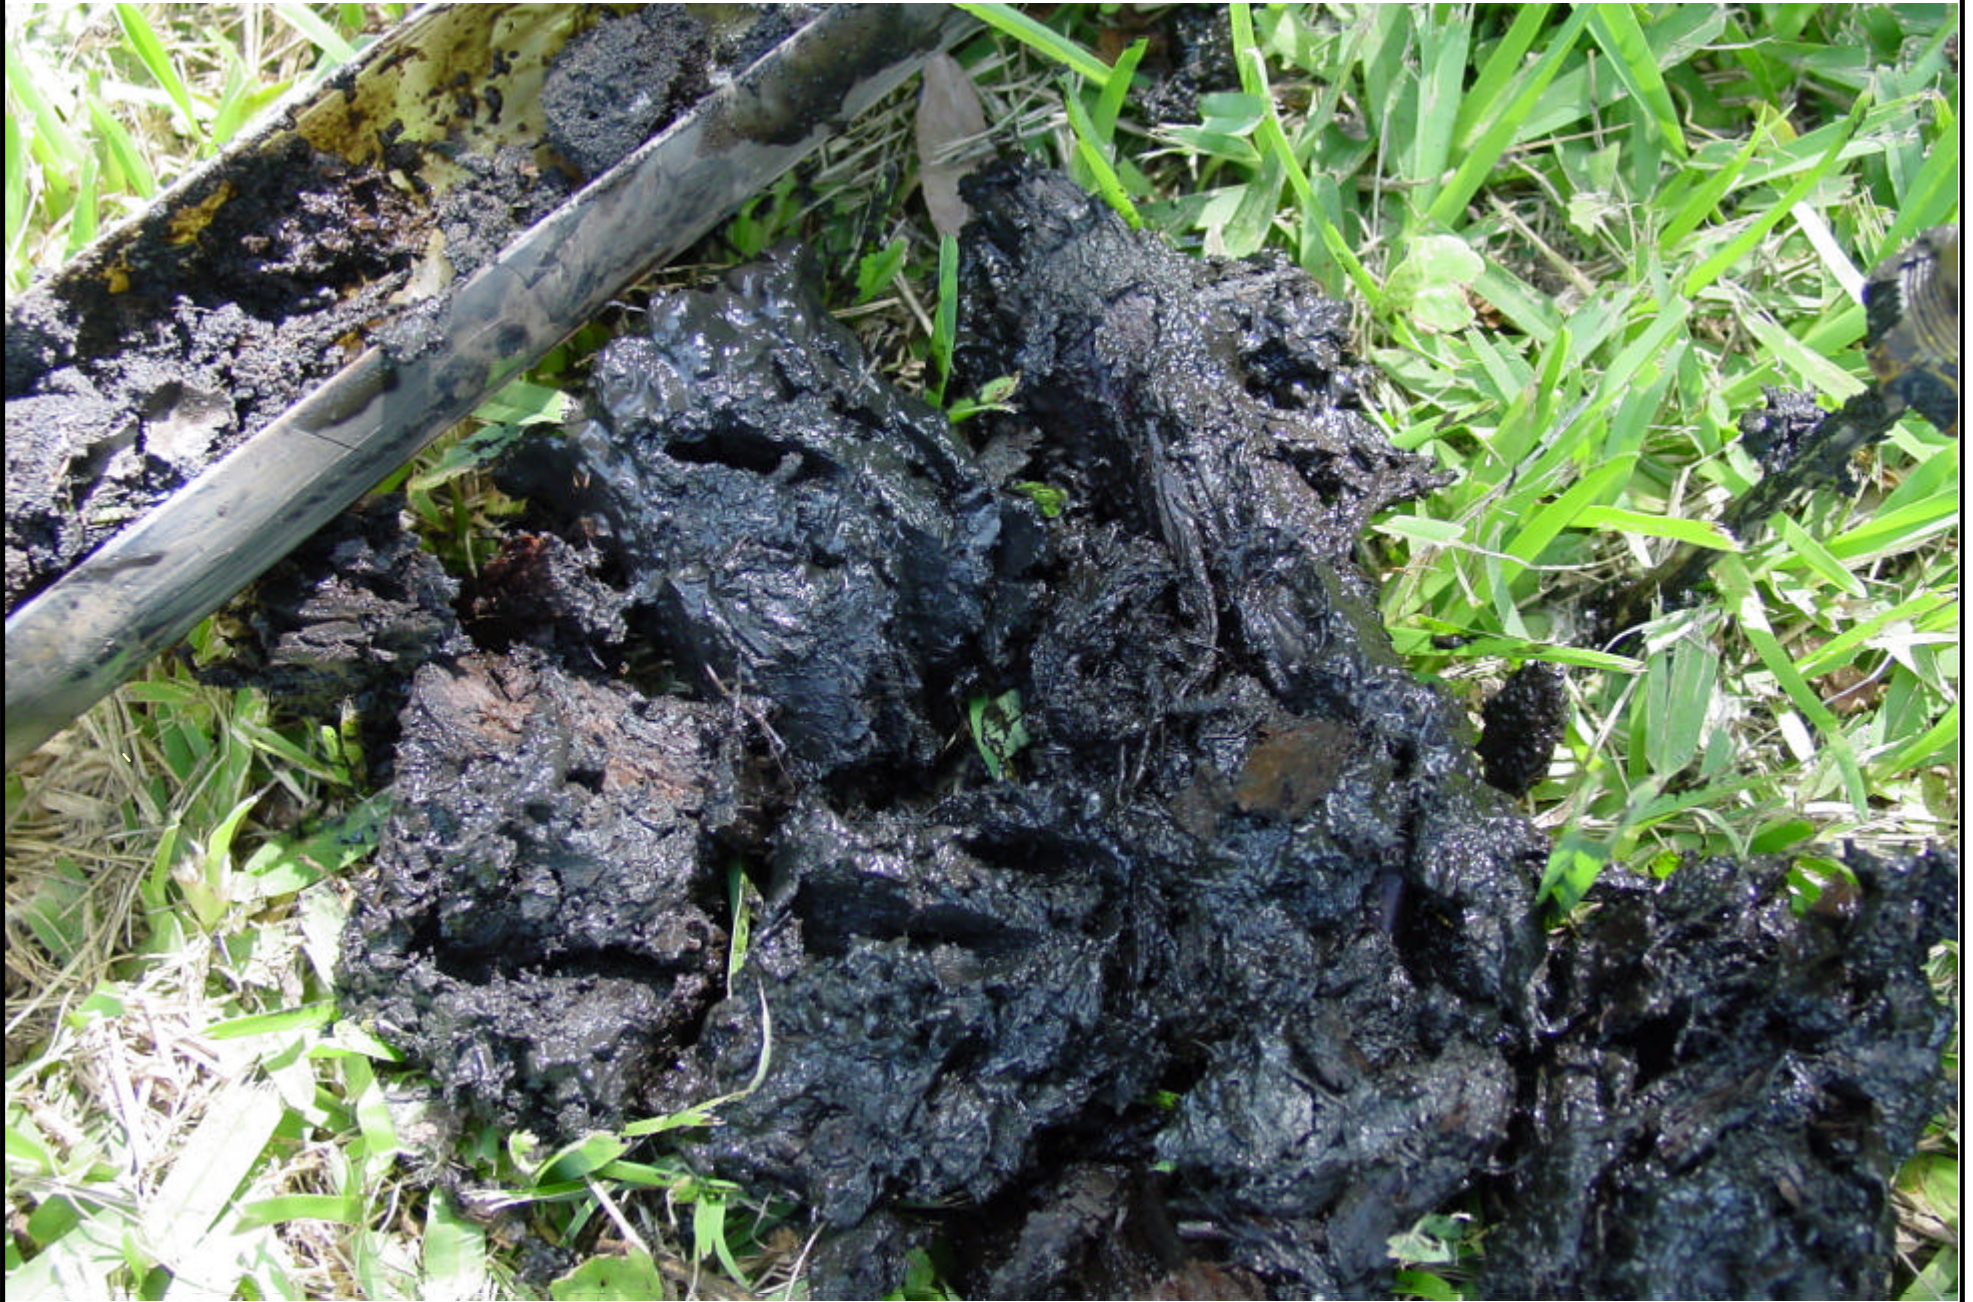
**Photograph 6: Decomposing Wood Chips  
Mill View Subdivision Study Site  
Port St. Joe, Gulf County, Florida**

Within the Mill View #2 sock area where backfilling activities occurred, pine bark chips and wood fiber in various stages of decomposition were observed present in most cores. To a much lesser extent, concrete rubble, broken brick, lime grits, and ash and slag were also present. It appears that the areal extent of backfilling defined by the sock is reasonably accurate although the coverage of landfilling does extend beyond the sock at its western extent at sample point MV8, its eastern measure at MV5, and northern scope at MV28. Limes grits and/or pine bark were observed at these locations. However, no mill waste was observed at sample locations MV22, MV24, MV29, and MV31, which were positioned within the sock.

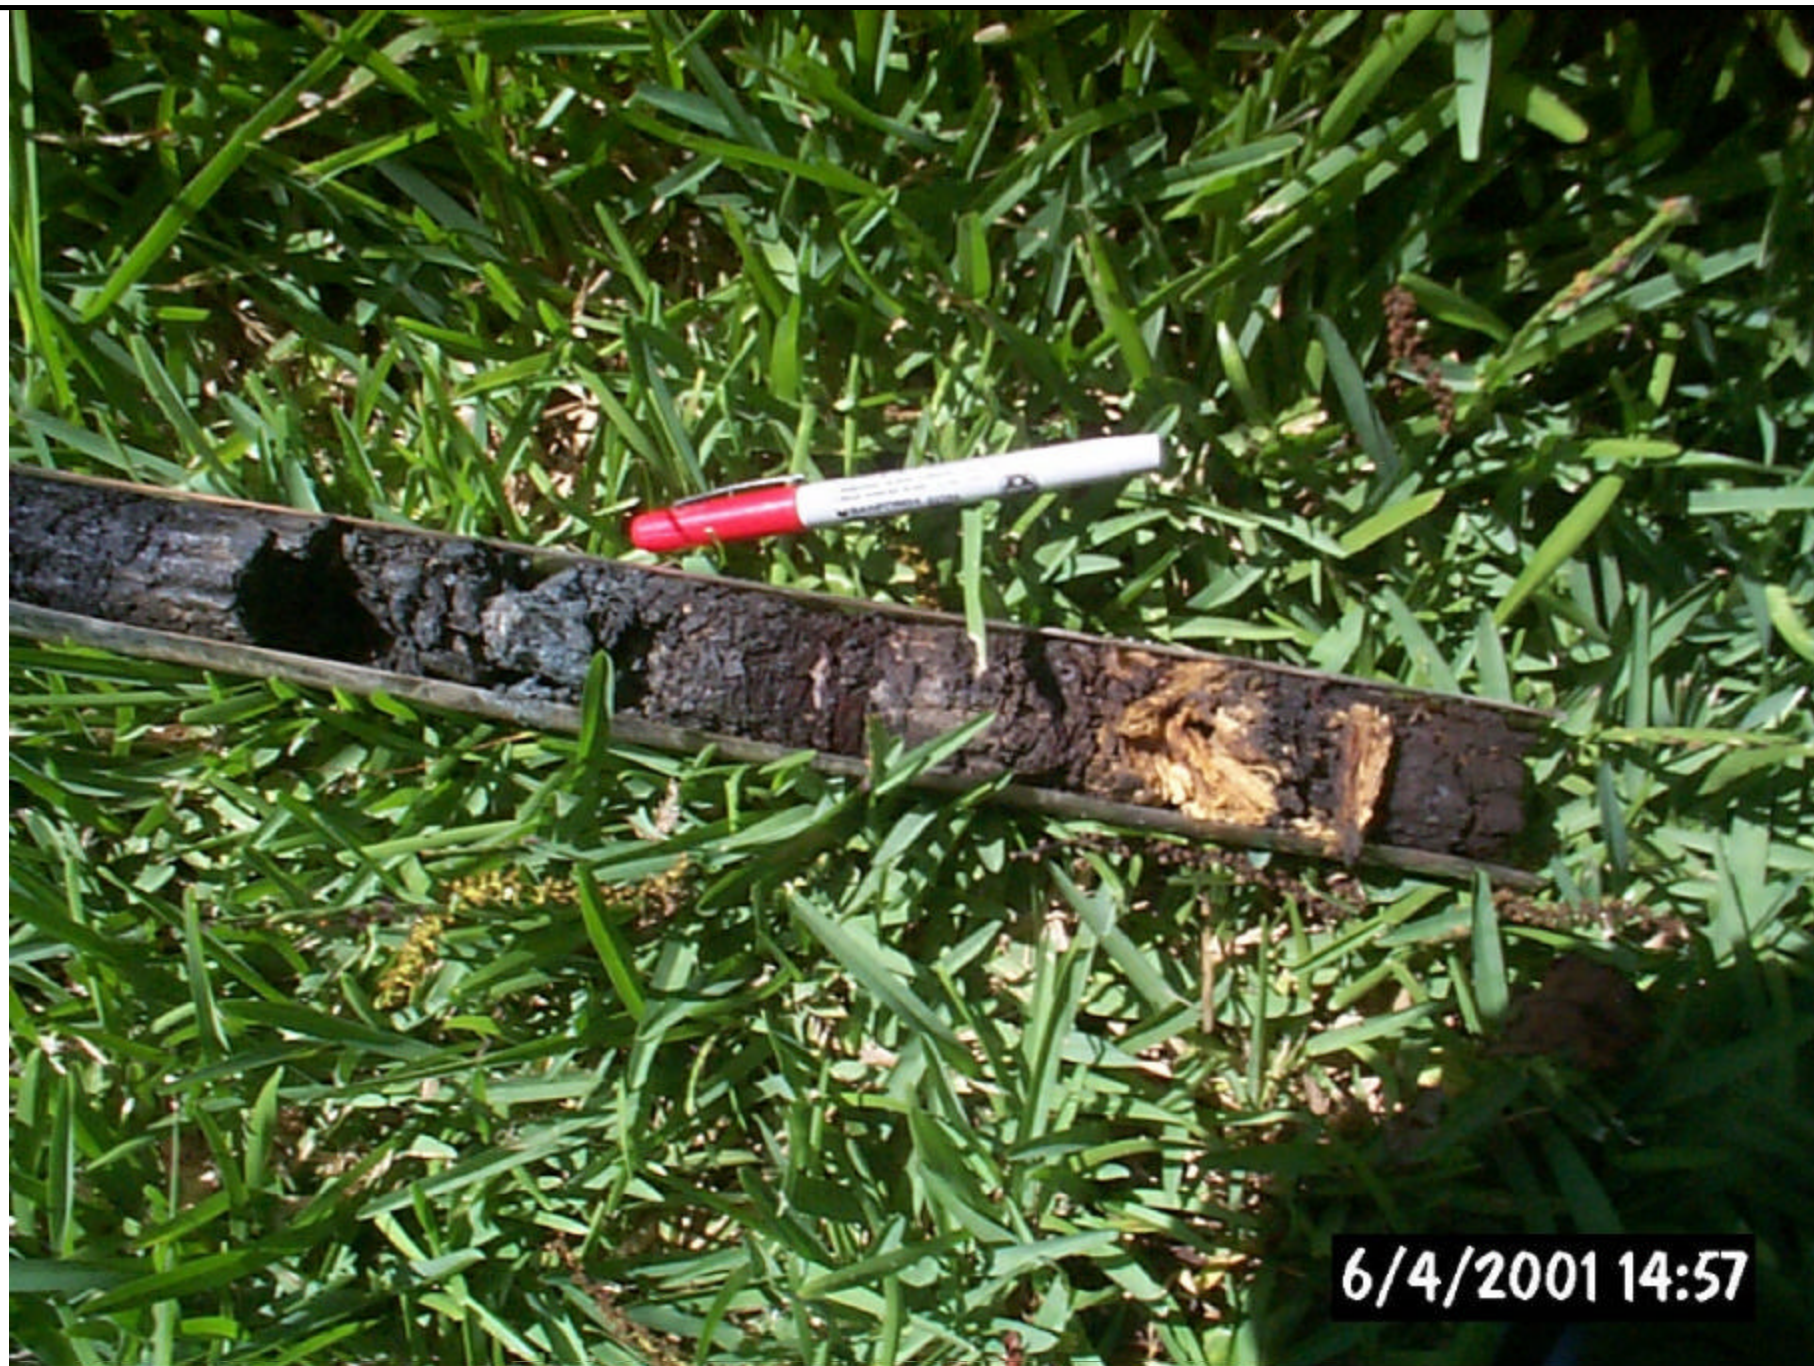
**Photograph 7: Ash/Slag in SIS Core Sample  
Mill View Subdivision Study Site  
Port St. Joe, Gulf County, Florida**

Additionally, lime grits and what appeared to be ash and slag (boiler residue) were identified in some of the collected core samples

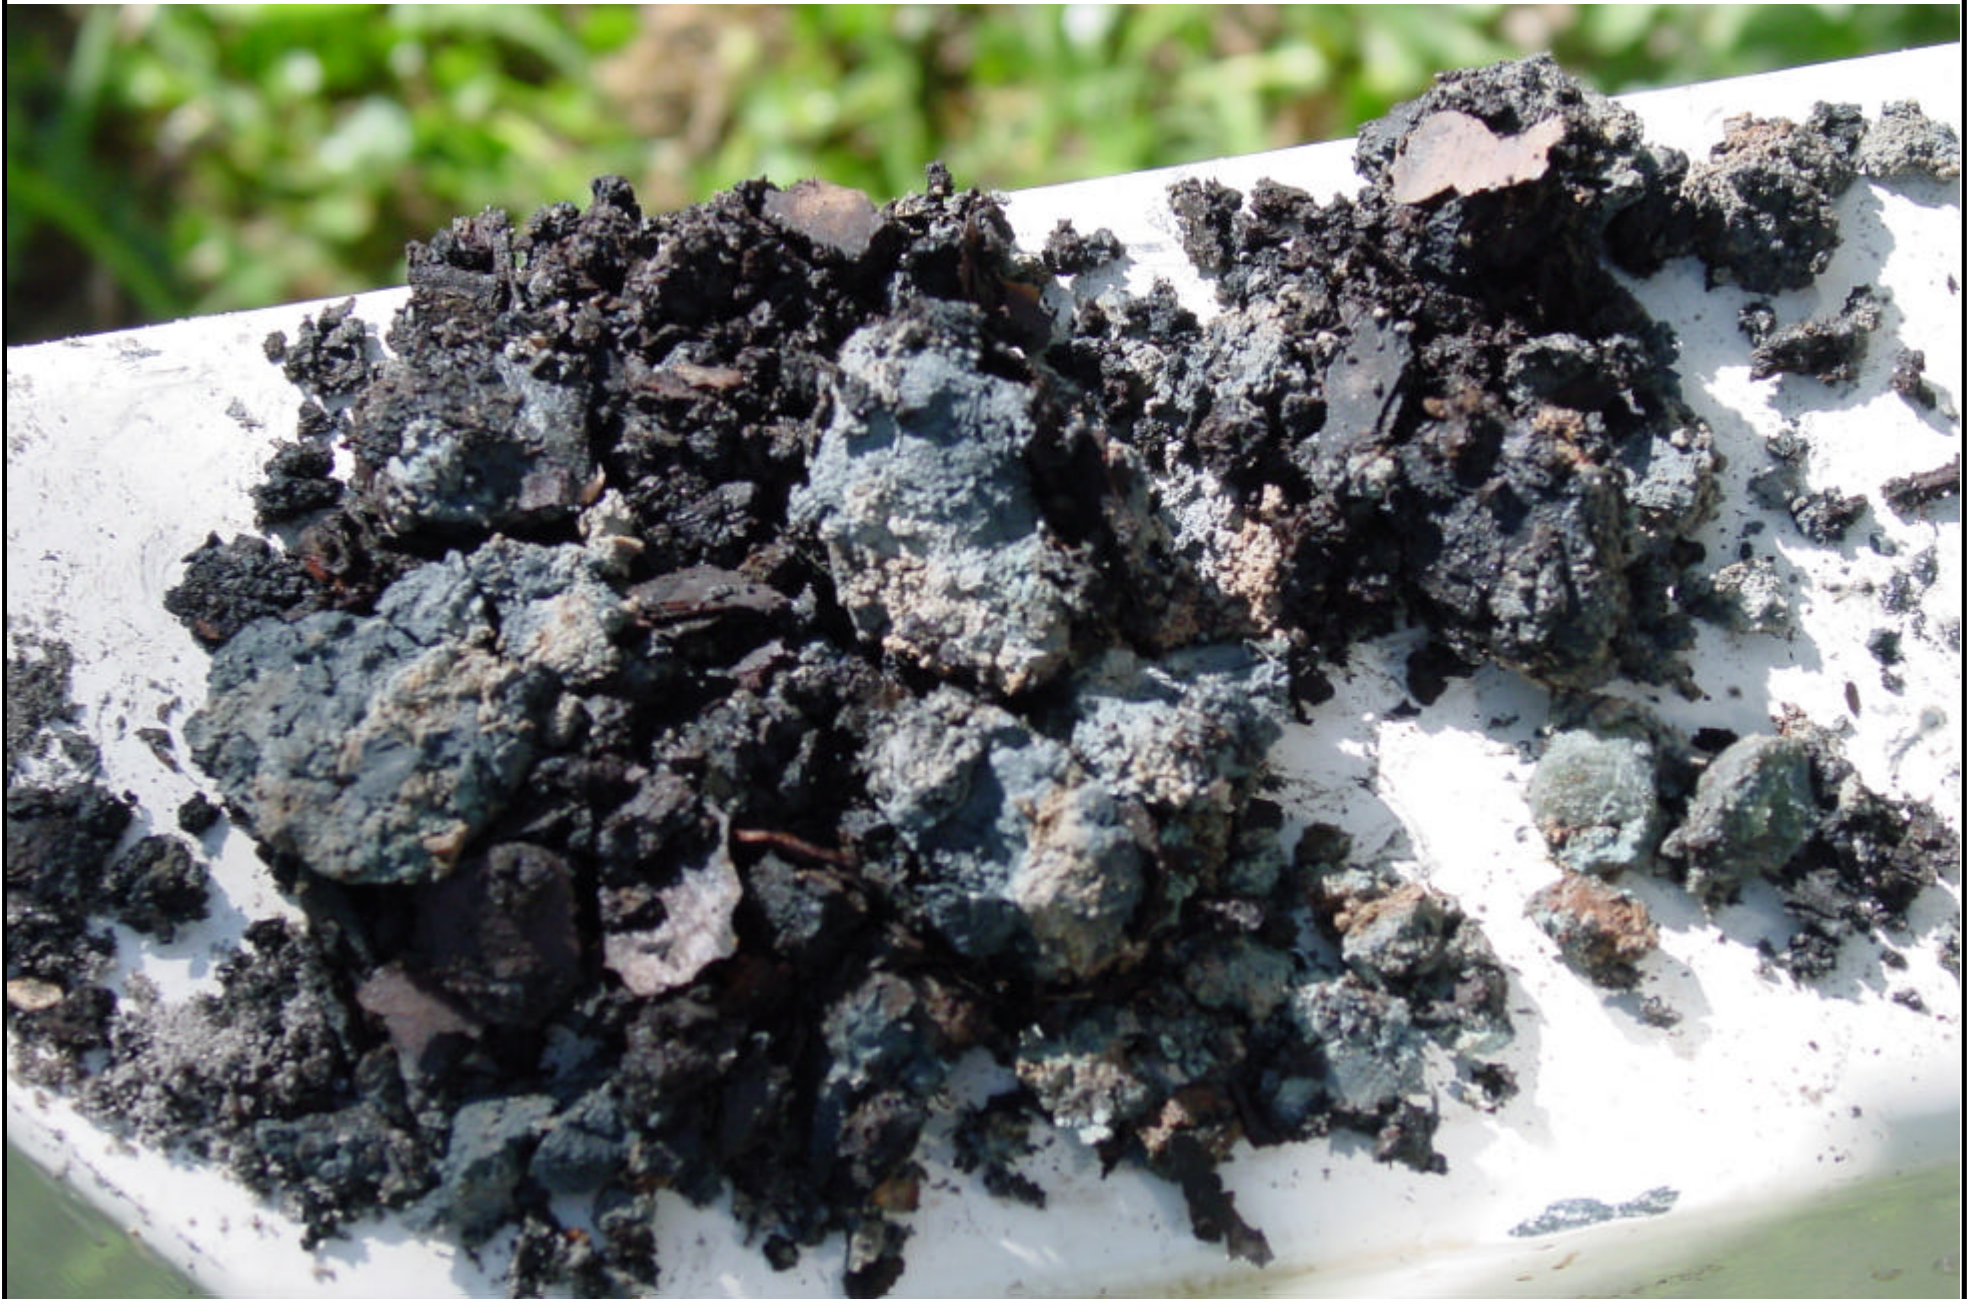
**Photograph 8: Lime Grits in Blue/Green Clayey Matrix**  
Mill View Subdivision Study Site  
Port St. Joe, Gulf County, Florida

In the area along the eastern side of Bay Street and generally extending to the front of the residences, a calcareous clay, most likely lime grit remnants, was routinely found just below land surface. Buried wood chips were also present and were most evident in boreholes alongside and between the homes. The wood chips and calcareous clay were not observed in SIS cores collected adjacent to the service road that parallels Bay Street towards the east. This lane may represent the easternmost extent of filling that occurred within this portion of the neighborhood; conductivity logs collected in Mill View #3 appear to substantiate this aspect (Appendix C).

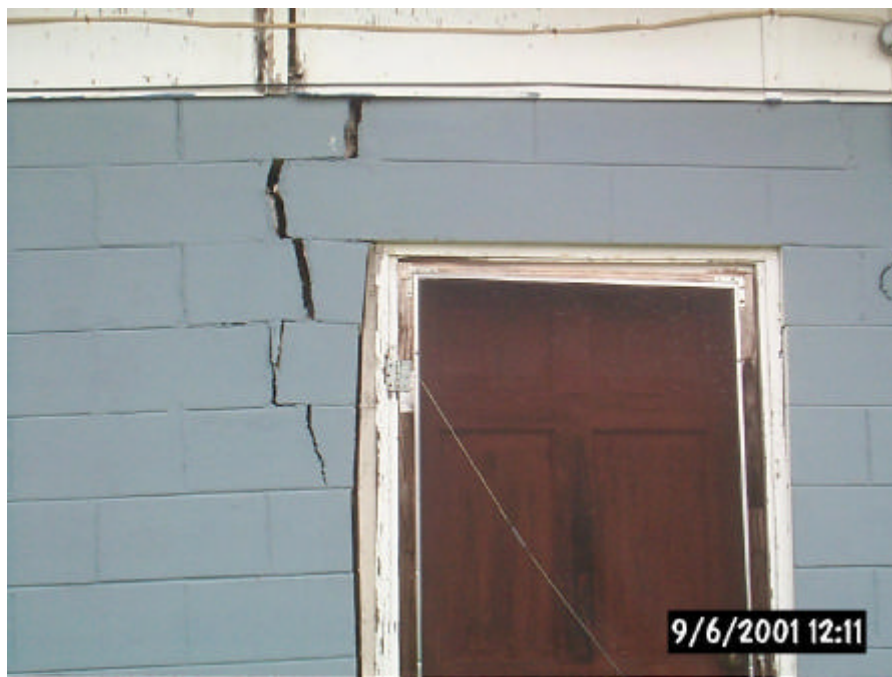
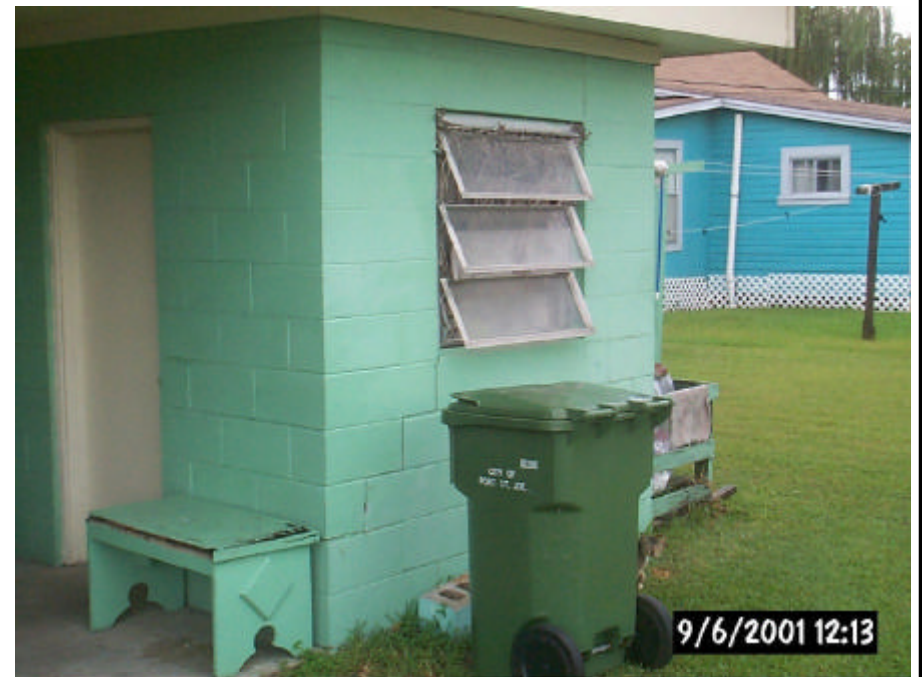
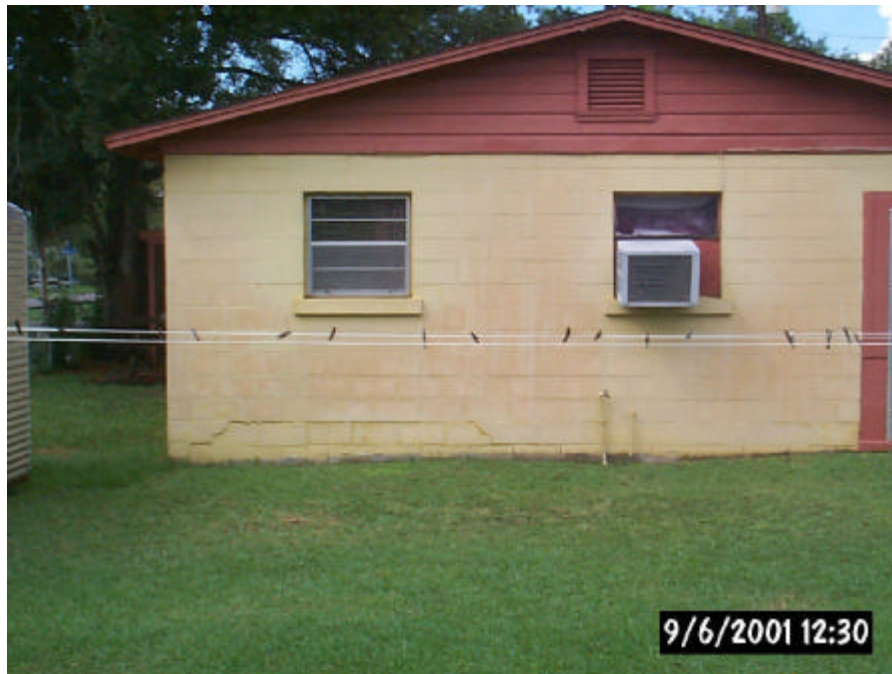
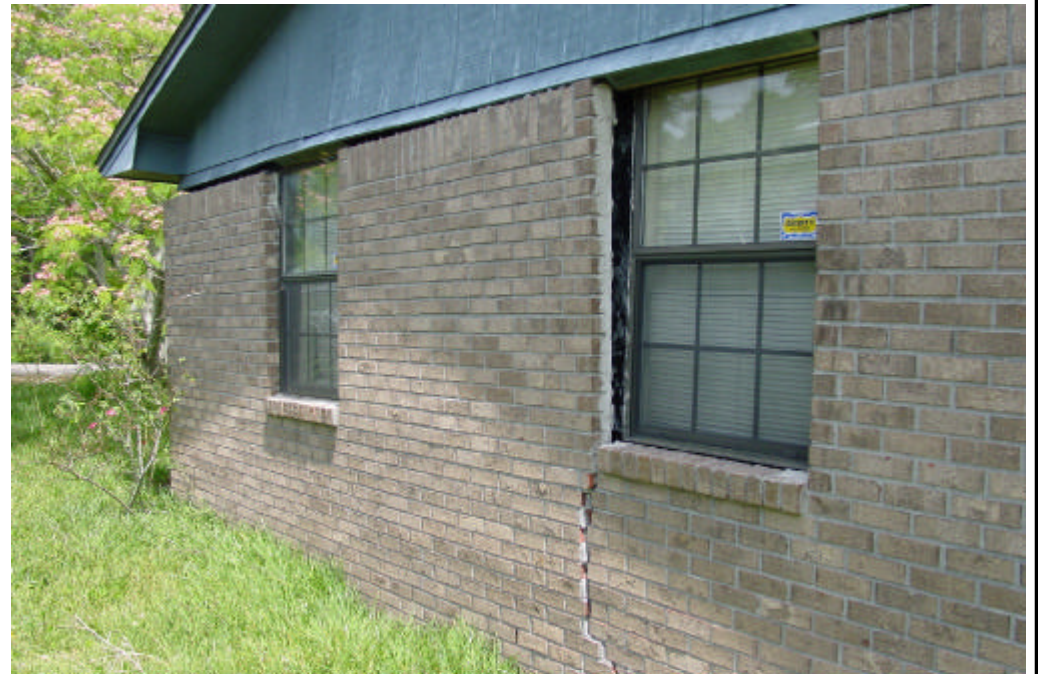
**Photograph 11: Mill View Neighborhood Homes With Visible Cracks**  
**Mill View Subdivision Study Site**  
**Port St. Joe, Gulf County, Florida**

As a consequence of the incomplete compaction of the backfill in Mill View #2 and #3, settling has occurred within the neighborhoods. Several brick and cinder block homes have cracks that appear to have been caused by land subsidence although a geotechnical analysis should be performed to substantiate this assumption (Photograph 11).
