**Contractor Workshop 2016**

**Waste Site Cleanup Section**

**May 24 – 25, 2016**

# **ENGINEERING UPDATE**

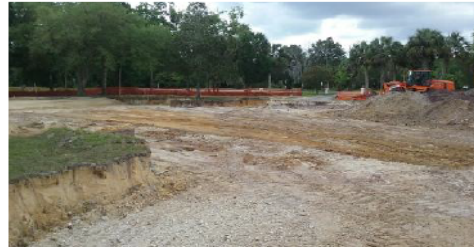
*Excavation looking south-southeast. Orange soil is footprint of former residence*

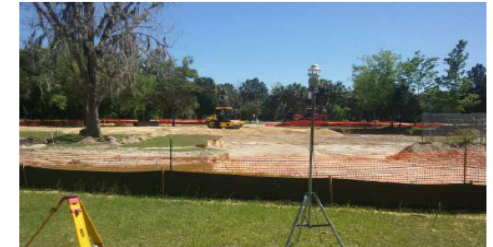
*Backfilling activities. Weather station in forefront*

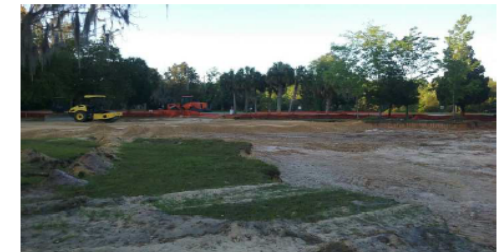
*Excavation looking to southeast*

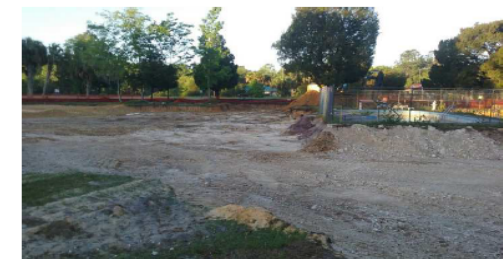
*Excavation looking to south-southwest*

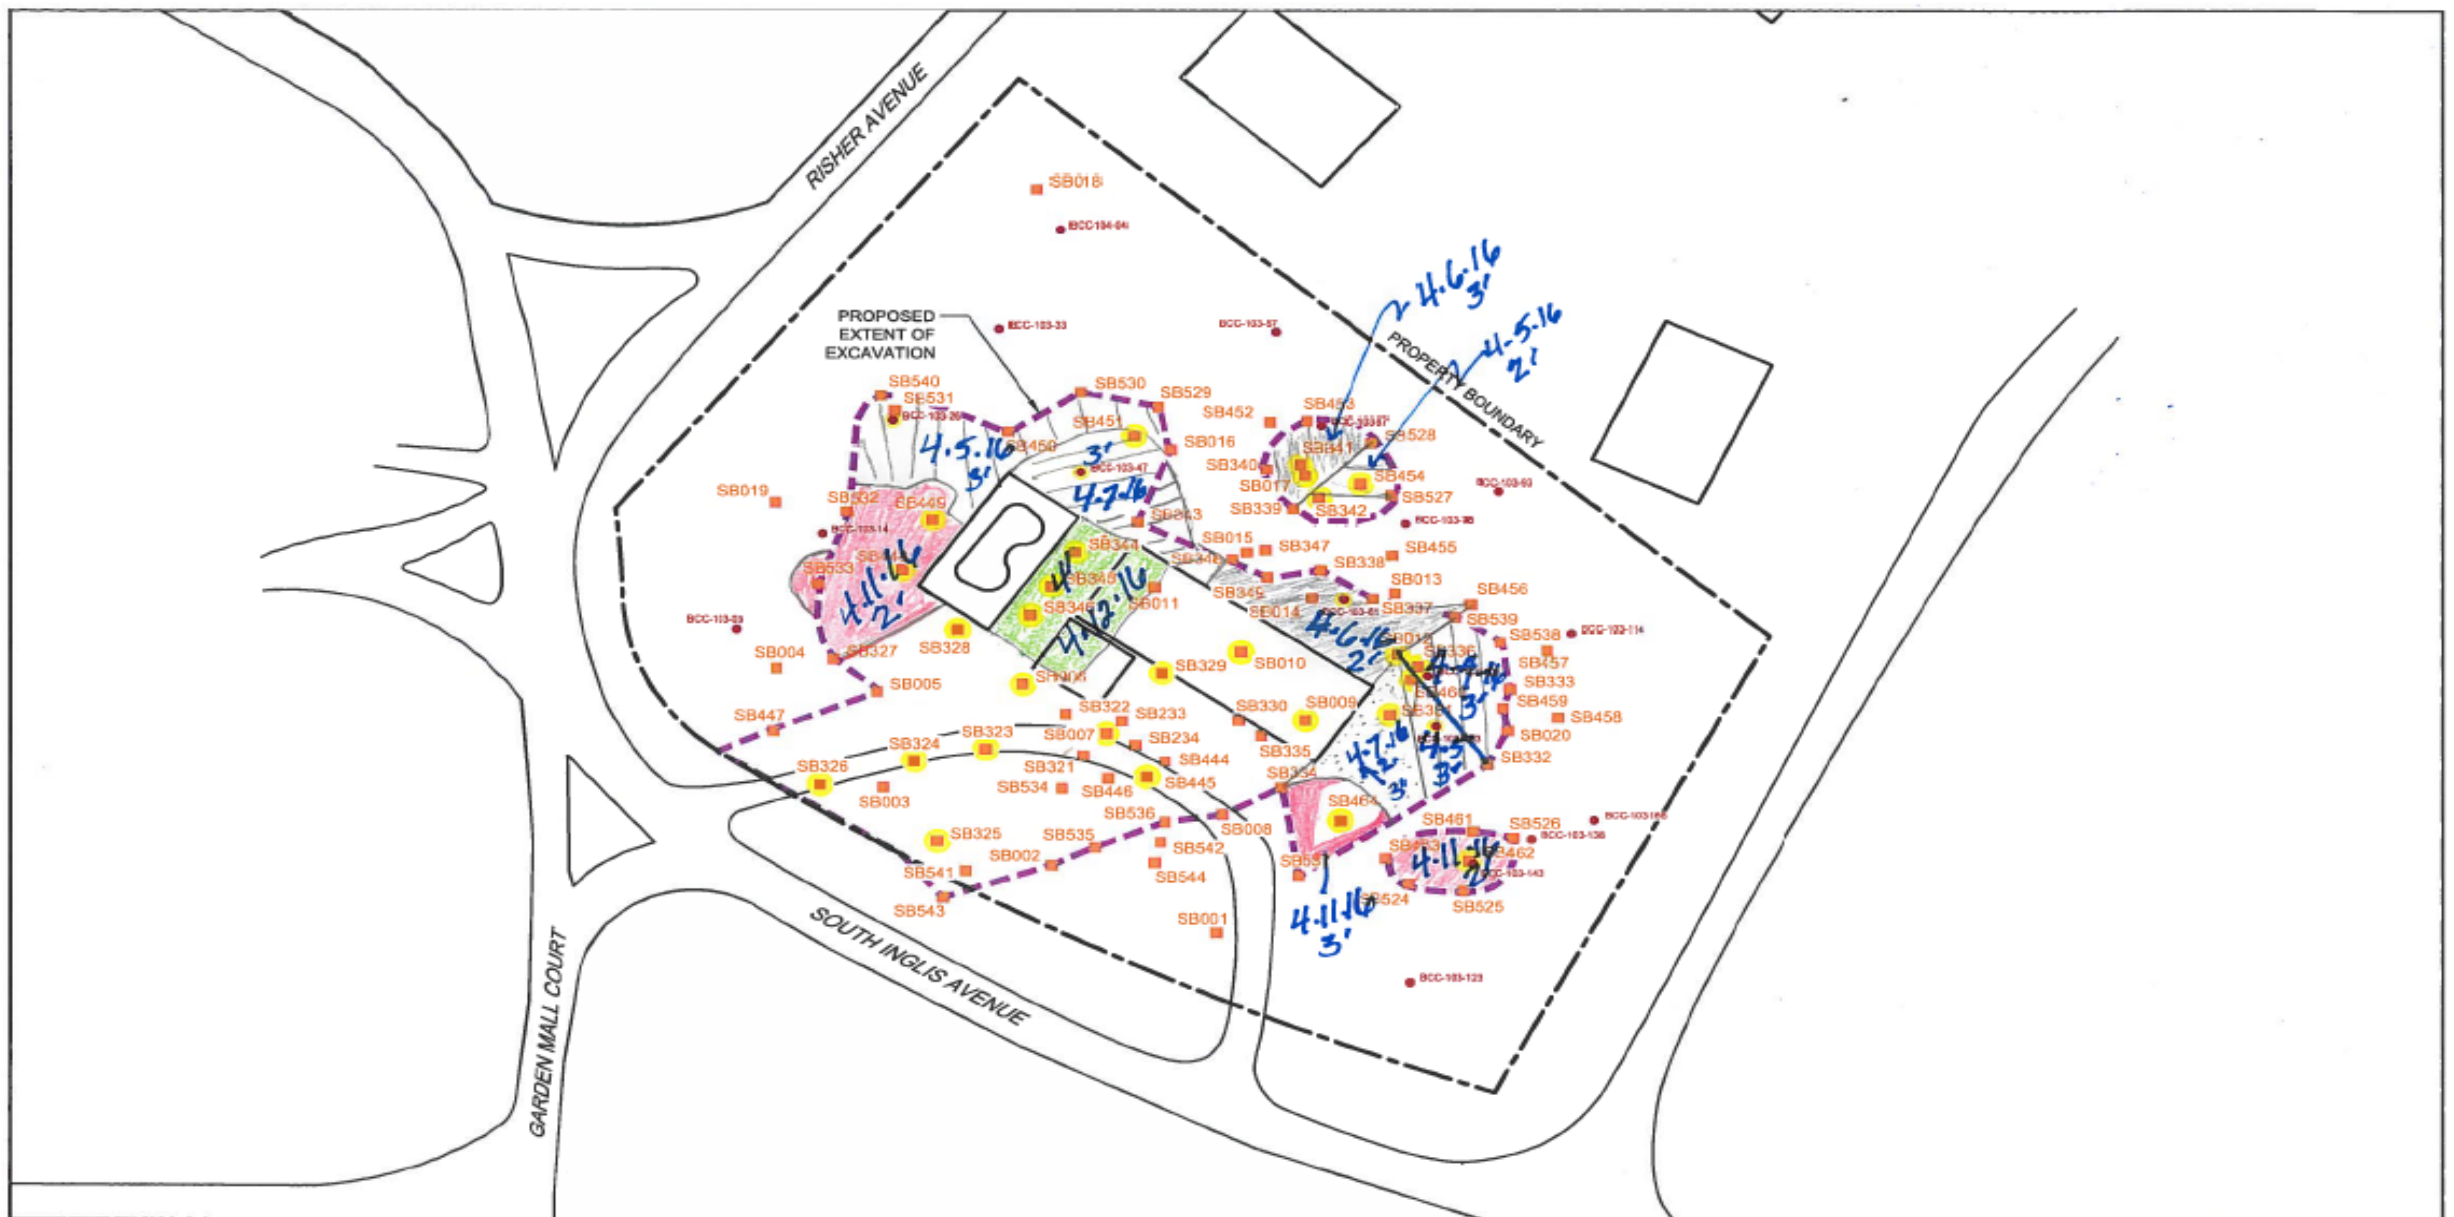
# Site map tracking daily extent of excavation

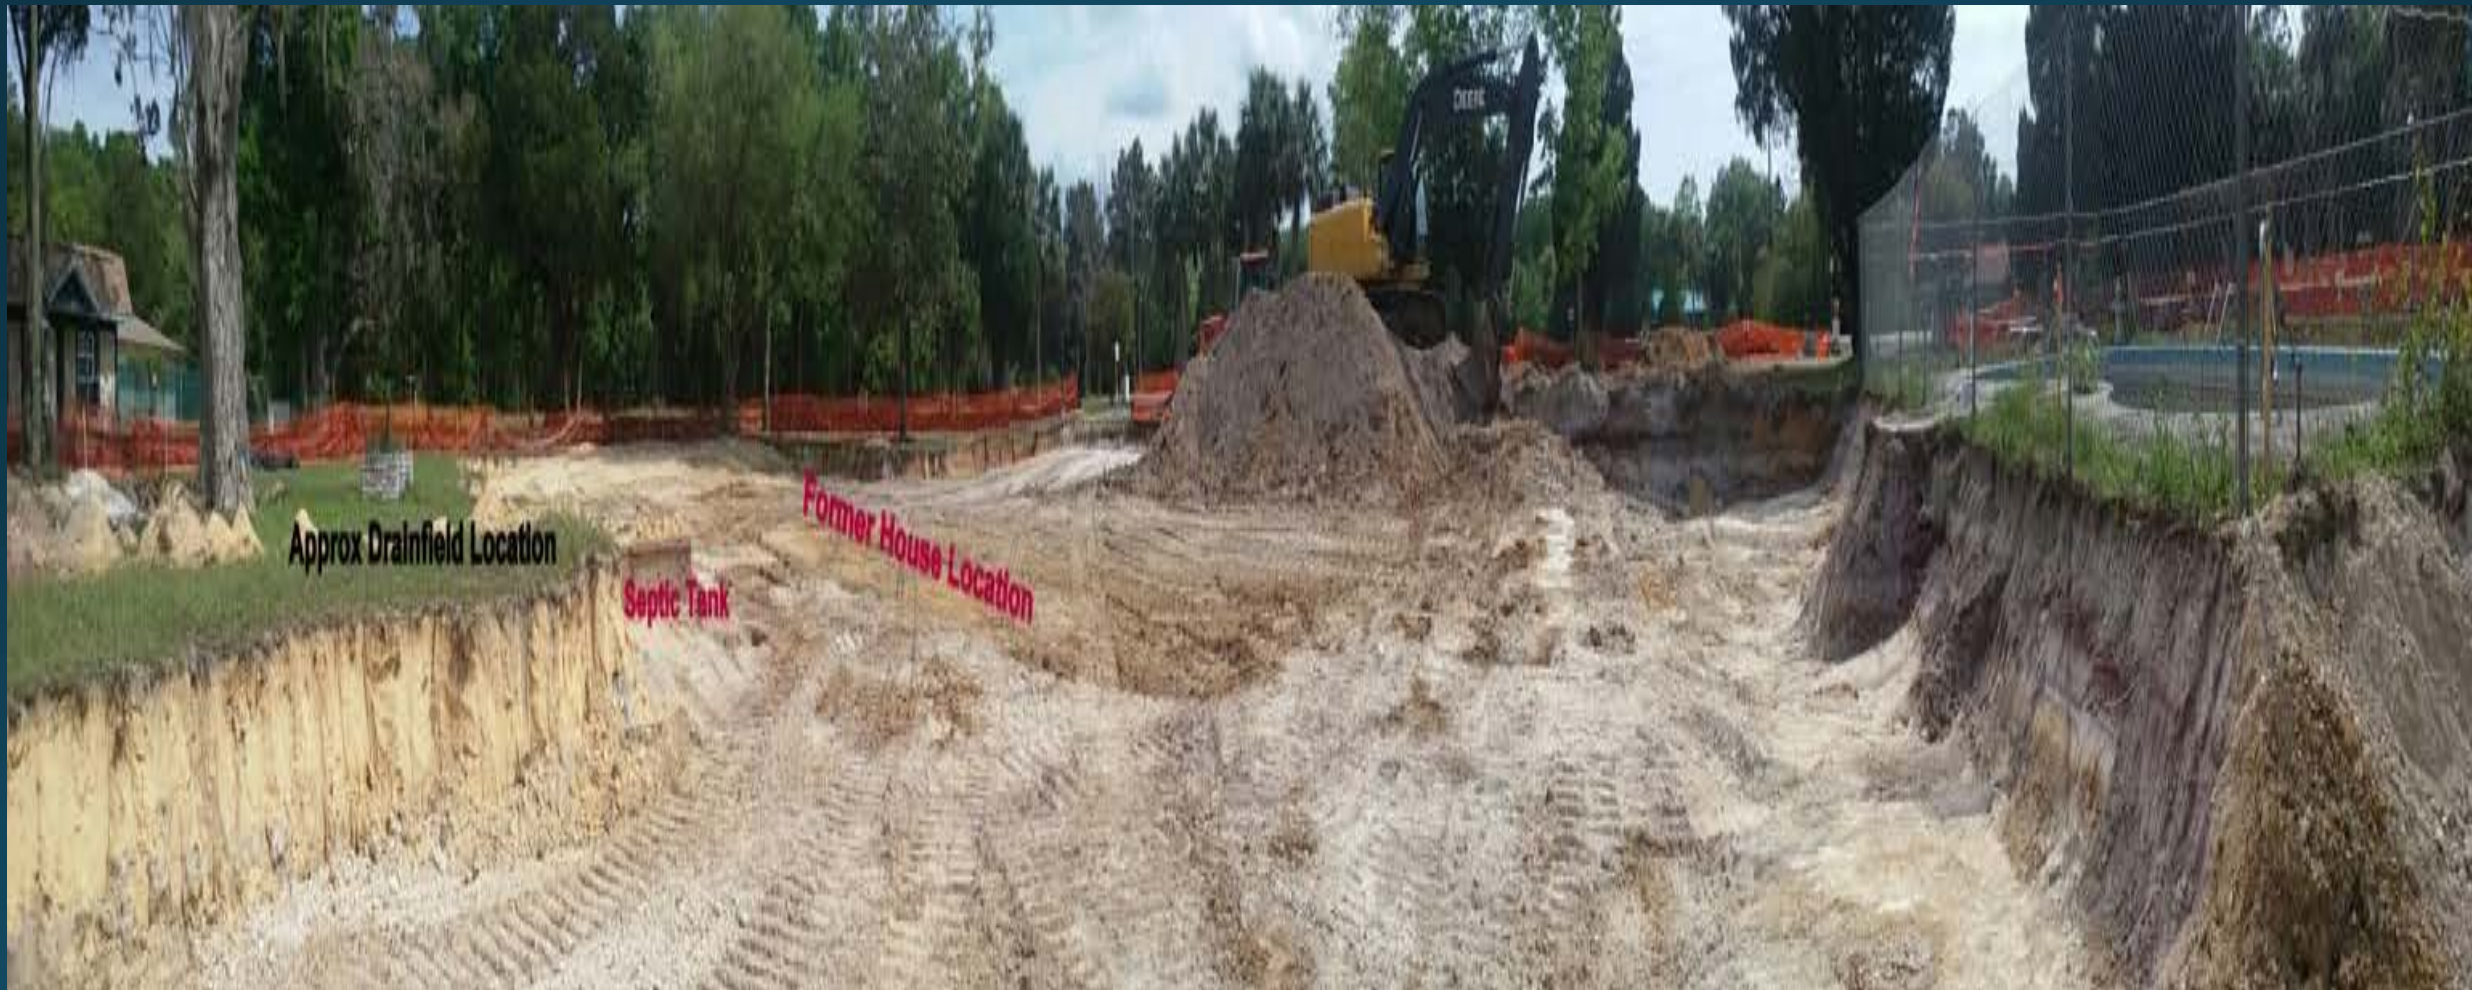
# Panoramic view of ongoing excavation

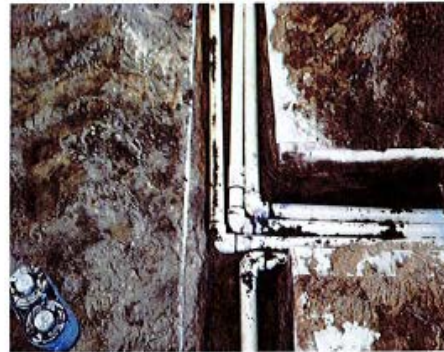
Interior Trenching and Piping.

- Utility locate completed.
- Saw cut and removed Concrete/Asphalt from interior/exterior trench.
- Installed interior/exterior piping and connections to all 4 SVE wells to outside building and capped below ground.
- Completed trench backfill and compaction.
- Poured concrete and restored trenches.

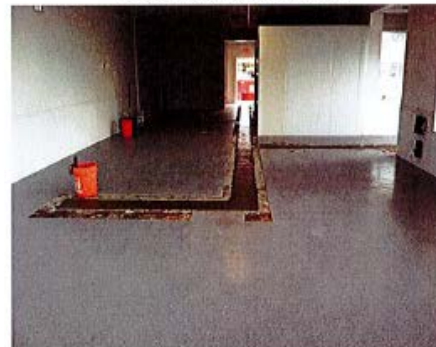
Interior Concrete Restoration.

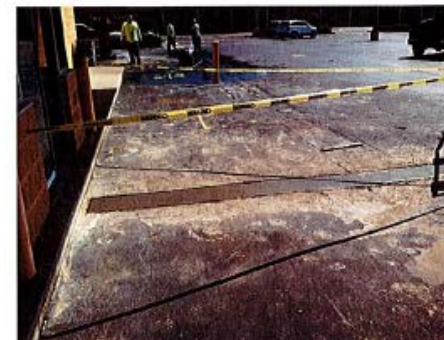
Exterior Concrete Restoration.

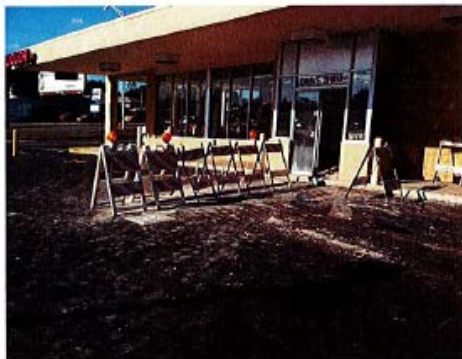
Exterior Trench Extended Beyond Overhang

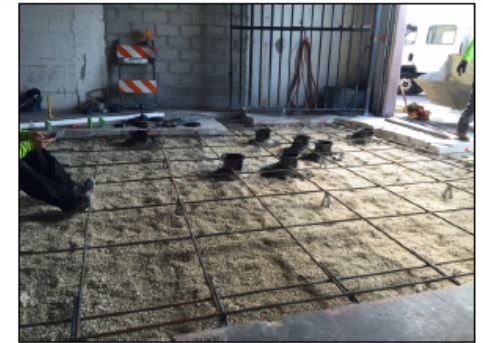
Excavation backfilled. Rebar and new well manholes installed.

- Completed backfilling excavation and trenches
- Repaired well casings for 4 monitor wells that were air sparge wells
- Installed dowel rods and rebar
- Passed M-D County inspection
- Poured concrete

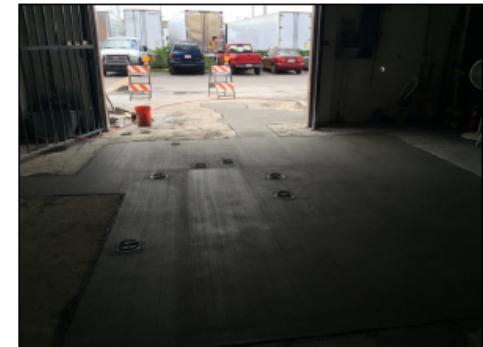
View south from bay. Concrete restored.

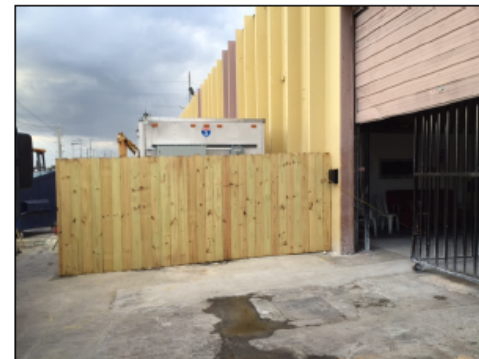
Fence installed around system trailer. Note restored concrete above trench.

- Delivered system trailer to Site
- Installed above grade piping
- Jacked up trailer (per M-D County flood codes) and installed hurricane tie-downs
- Installed fence around trailer compound
- Complete electric hookup and finish VE piping to trailer on 11/16

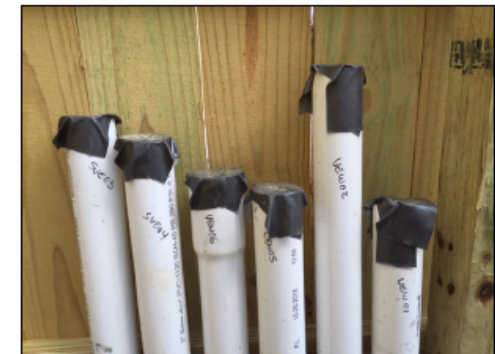
6 SVE lines stubbed up / labeled in system compound.
