**FDEP  
BUREAU OF WASTE SITE  
CLEANUP SECTION  
CONTRACTOR WORKSHOP**

**CASE STUDY: BIOGEOCHEMICAL  
REDUCTIVE DEHALOGENATION  
(BIRD) PILOT STUDY**

**MAY 2016**

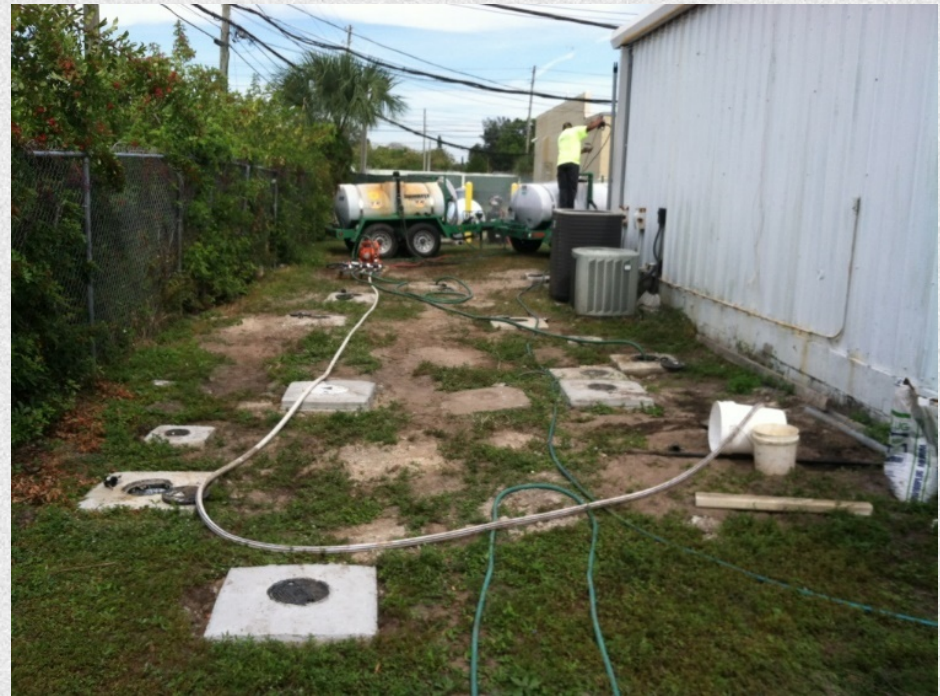
# Injection Layout - PRB1

9 Permanent IW points at each PRB – screened 15 to 30 feet bls

Injection Rate: 0.4 to 6 gpm at pressures of 10 to 65 psi

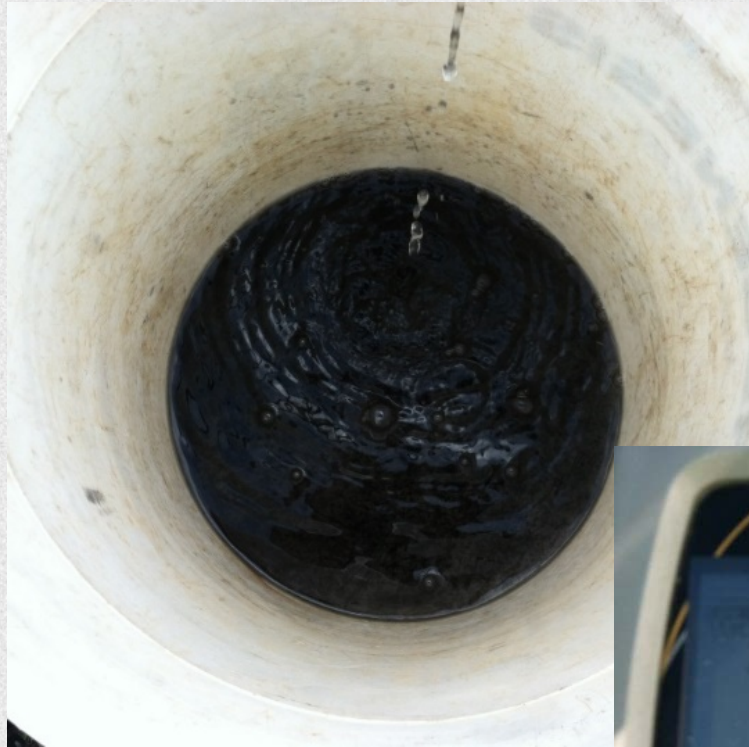
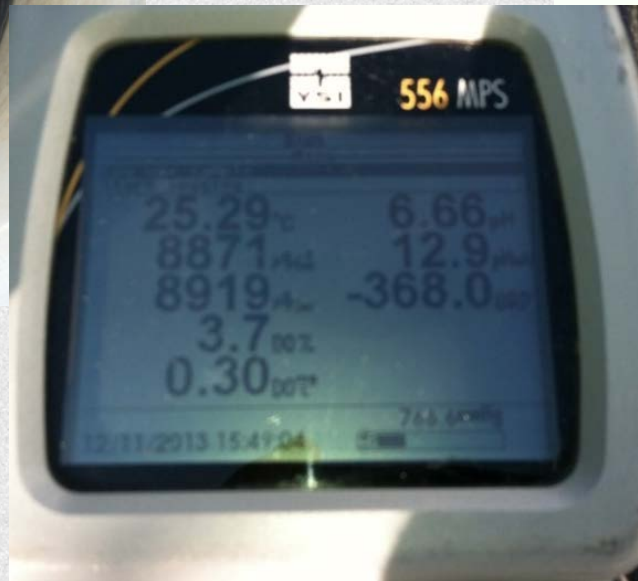
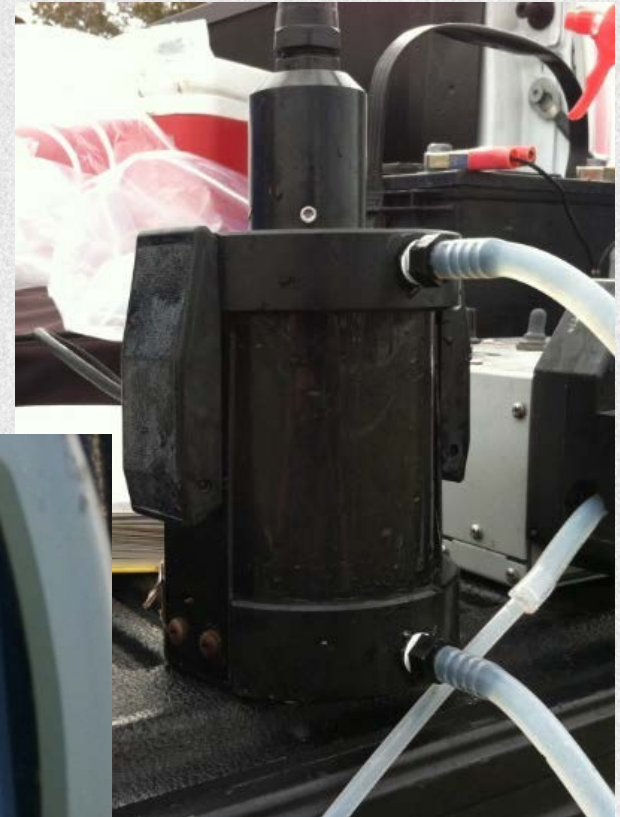
# Black Particulates Formed in Groundwater

- Data suggests biogeochemical reduction (BiRD) is occurring, evidence of the formation of FeS particle in groundwater
- Source area well DMW-02 has significant increase in 1,1-DCA, which is a signature of biogeochemical reduction of 1,1,1-TCA
- Pyrite detected in soil samples analyzed by XRD – pre-injection, this provided an indication that biogeochemical reduction was already occurring.
- ... our job now was to enhance it.
- Post injection, soil samples analyzed by XRD detected iron and sulfur in the soil samples, further suggesting that biogeochemical reduction is occurring.
- Organic soils present at the source areas are sink for the COCs, and back diffusion of COCs are contributing to the groundwater plumes

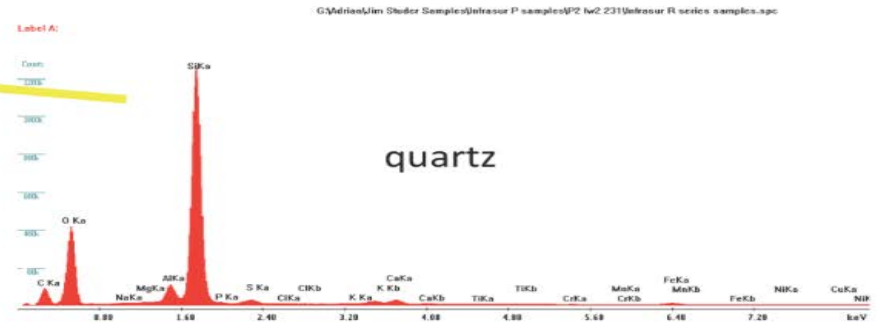
# PRB2 – Pre Injection, XRD – evidence of pyrite!

FOV = 1.764 mm
