# FDEP Waste Cleanup Workshop – Former Technitronics Site & Geophysics

Brian Burke P.G. (Arcadis) & David Harro P.G. – G3 Group

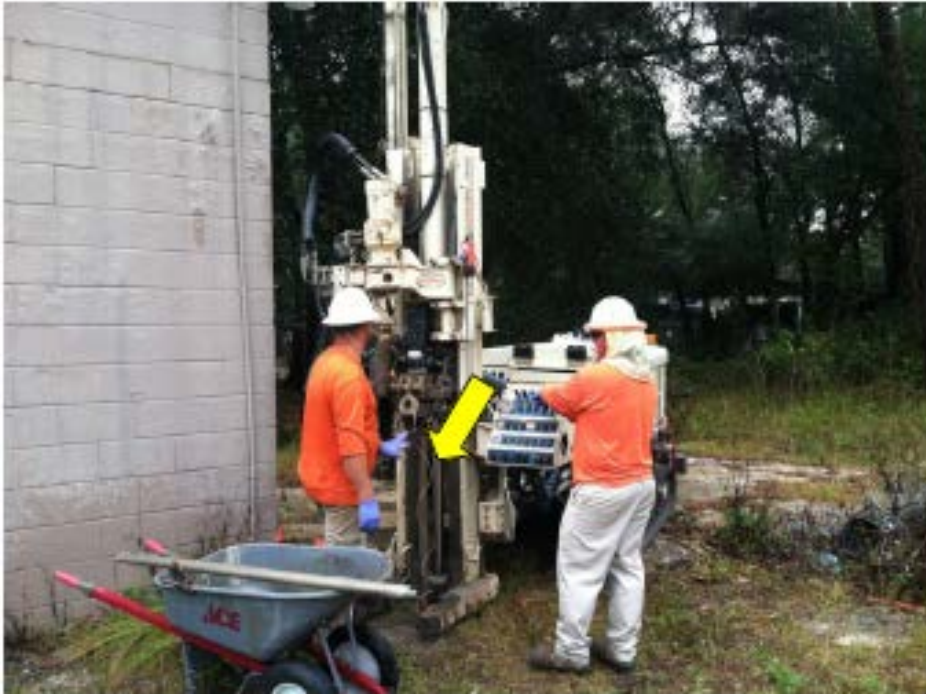
# MERIT Field Implementation

- Array spanning 324 feet
- 28 surface electrodes at 12-foot spacing
- 28 electrodes implanted at 45 feet below ground with DPT at 12-foot spacing
