EcoSummary

BioRecon Report

Rocky Creek above Eglin Road 214/374, Walton County July 18, 2000

BioRecon: A rapid, cost-effective screening mechanism for identification of biological impairment

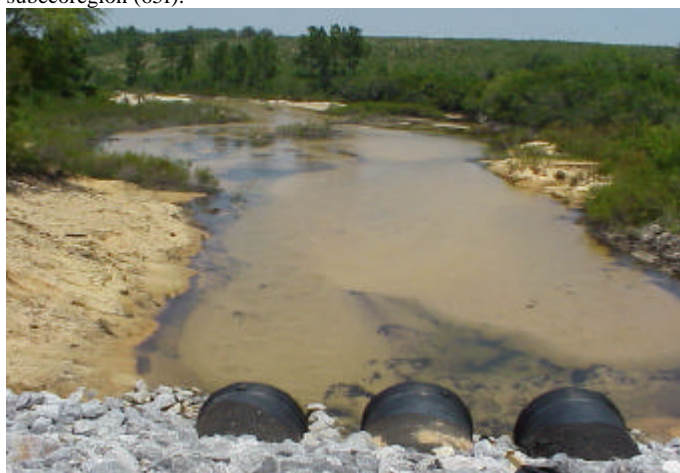
However, sediments have smothered habitat, which limited fish and wildlife productivity in this stream reach. Stream habitats were smothered by sand/silt (99.5%) from weapons test range C-72 runoff (see photo). Road 214/374 culverts and fill material used to span the stream and riparian zone acted as a dam to exacerbate this smothering. Hydrological modifications to Rocky Creek have widened the stream 10 fold. The stream had a width of 35 meters at one point with the average depth of only 0.15 meters. Both stream banks had many raw, unstable eroded areas. Bank erosion had washed away the preexisting riparian vegetated zone. This increased the stream's width/depth ratio leaving sand bar deposits to smother previously vegetated areas. Range personnel eliminated the riparian zone's tree canopy by mechanical/chemical means converting the streamside plant community to St. Johns Wort and forbs. The riparian zone forest cover before human disturbance was an Atlantic white cedar type forest.

Removing road fill and replacing with a bridge spanning Rocky Creek and its floodplain would restore the stream's natural morphological characteristics. Adding habitat such as large woody debris, along with stream bank protection and channel restoration during the stream rehabilitation program for the Okaloosa Darter should enhance fish and wildlife productivity and diversity. Proper placement of large pine logs along the stream bank would enhance riffle/pool habitat (velocity and depth) for the darters and other stream wildlife. Riparian buffer zones greater than 18 meters should be created and maintained. The buffer zones provide the shade, food, habitat (woody debris/leaf fall) and filter runoff necessary for the propagation of Rocky Creek's biota. Restoring the stream's natural hydrology (i.e. increase depth/width ratio) and riparian forests (replanting native Atlantic white cedars, allowing streamside tree growth) buffer zones would benefit the watershed's fish and wildlife including the endangered Okaloosa darter. For more information, contact Donald Ray, FDEP Northwest District, 160 Governmental Center, Pensacola, FL 32501 (850) 595-8300 x1126 or SC 695-8300
