# EcoSummary

BioRecon Report

## Rocky Creek below Eglin Road 214/374, Walton County July 20, 2000

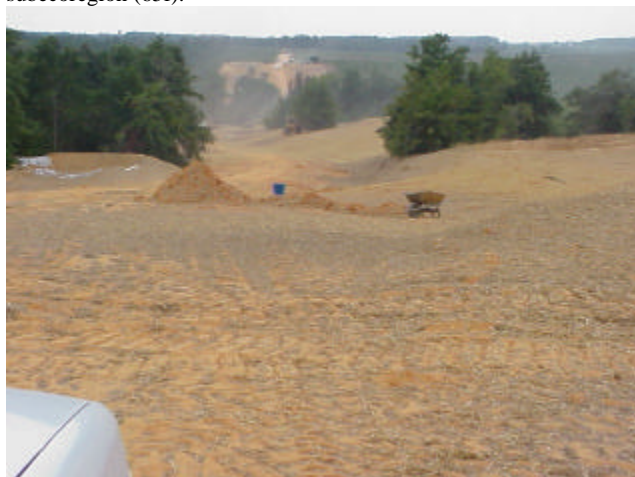
However, sediments have smothered habitat, which limited fish and wildlife productivity in this stream reach. Stream habitats were smothered by sand/gravel (94%) from runoff along the clay filled Eglin Road 626(see photo). Instead of bridge at this site, 3 new culverts and fill dirt were used to span the stream and its riparian zone. The culverts were set too high and created a waterfall barrier to upstream fish migration. Asphalt and concrete pebbles were observed in the stream below the road apparently from previous road washouts. Both stream banks were mostly unstable with many raw eroded areas. The resulting bank sloughing increased the stream's width/depth ratio leaving sand bars smothering previously vegetated areas. Most of the riparian zone vegetation was young with shrubs as the dominant canopy. Atlantic white cedar logs and stumps in the riparian zone indicated the type forest cover before human disturbance.

A bridge spanning Rocky Creek and its floodplain would restore the stream's natural morphological characteristics. Adding habitat such as large woody debris, along with stream bank protection and channel restoration during the stream rehabilitation program for the Okaloosa Darter should enhance fish and wildlife productivity and diversity. Proper placement of large pine logs along the stream bank would enhance riffle/pool habitat (velocity and depth) for the darters and other stream wildlife. Riparian buffer zones greater than 18 meters should be maintained. The buffer zones provide the shade, food, habitat (woody debris/leaf fall) and filter runoff necessary for the propagation of Rocky Creek's biota. Restoration of the stream's natural hydrology (i.e. increase depth/width ratio) and riparian forests (replanting native Atlantic white cedars) buffer zones would benefit the watershed's fish and wildlife including the endangered Okaloosa darter. **For more information, contact Donald Ray, FDEP Northwest District, 160 Governmental Center, Pensacola, FL 32501 (850) 595-8300 x1126 or SC 695-8300**
