Southeast District  
Assessment and Monitoring Program  
**Ecosummary**

## Chandler Hammock Slough

Okeechobee County

September 1999

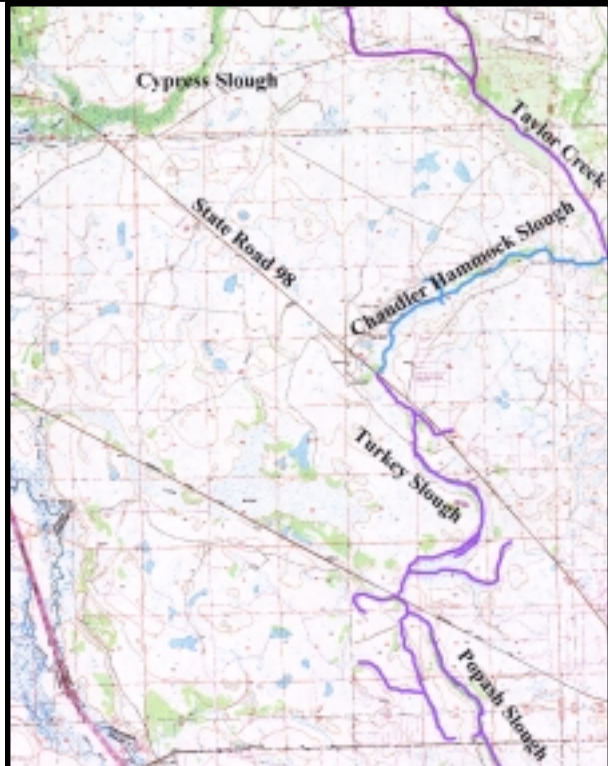
*Chandler Hammock Slough is but one of an interconnecting network of sloughs, low areas, natural creeks and man-made canals that drain to the Kissimmee River and Lake Okeechobee.*

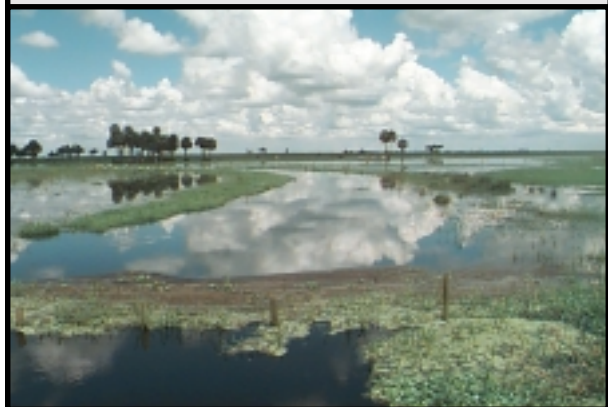
*Chandler Hammock Slough during high water flows to the Kissimmee River and Lake Okeechobee.*

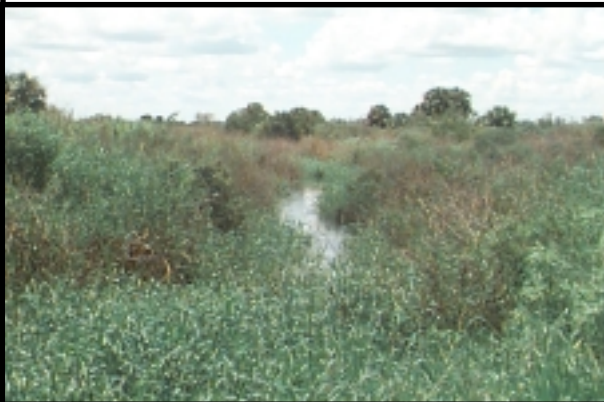
*Chandler Hammock Slough on its way towards the Kissimmee River during August, 1999.*

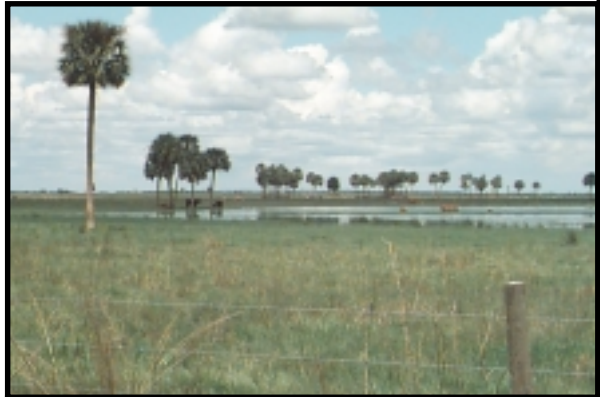
*Chandler Hammock Slough contains one of the highest observed concentrations of both nitrogen and phosphorus nutrient in the basin.*
