Southeast District
Assessment and Monitoring Program
Ecosummary

Myrtle Slough

Martin County

September 1999

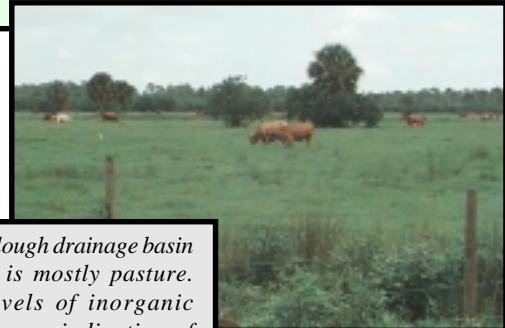
Myrtle Slough drainage basin landuse is mostly pasture. High levels of inorganic nitrogen are indicative of runoff containing animal waste.
