# **CENTRAL AND SOUTHERN FLORIDA PROJECT COMPREHENSIVE EVERGLADES RESTORATION PLAN**

## **FINAL TECHNICAL DATA REPORT**

### **COMPREHENSIVE EVERGLADES RESTORATION PLAN AQUIFER STORAGE AND RECOVERY PILOT PROJECT**

**December 2013**

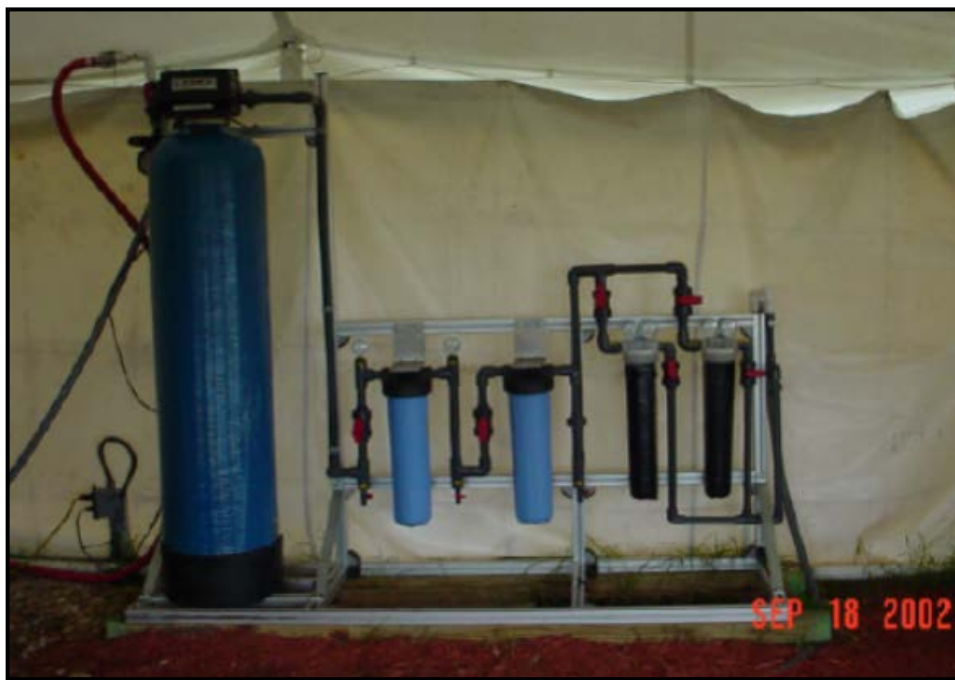
**Figure 4-6 -- Photo showing Ionics serial filtration system with 20-, 5-, 1-, and 0.45- $\mu$ m cartridge filters (left to right).**

The SF unit operated for 625 hours, or for 77 percent of the test duration. The unit was down approximately 205 hours during testing. Approximately 85 of those down hours were the result of the power outages and plumbing repairs resulting from storm activity. The remaining 120 hours of downtime were due to technical difficulties regarding the filter cartridges clogging rapidly during normal filtration. Specifically, the 0.45- $\mu$ m cartridge would become completely blocked within 20 minutes at a flow rate of 10 GPM. When clogging occurred, pressure build-up across the system reduced water flow to 5 GPM or less. After the first week of testing, the 0.45- $\mu$ m cartridge was bypassed making the 1- $\mu$ m cartridge the final filter in the serial system. Flow rate through the 1- $\mu$ m cartridge was difficult to stabilize. Flow rate greater than 10 GPM was rarely maintained, as the gauge pressure would increase sometimes by 15 psi within two hours before backwashing the 20- $\mu$ m filter. Optimal serial filter throughput occurred at flows less than 6 GPM with a total daily backwash time of about 30 minutes. These conditions yielded about 49,000 gallons of filtrate over 150 hours of operation before cartridge replacement was required (HSA, 2003).

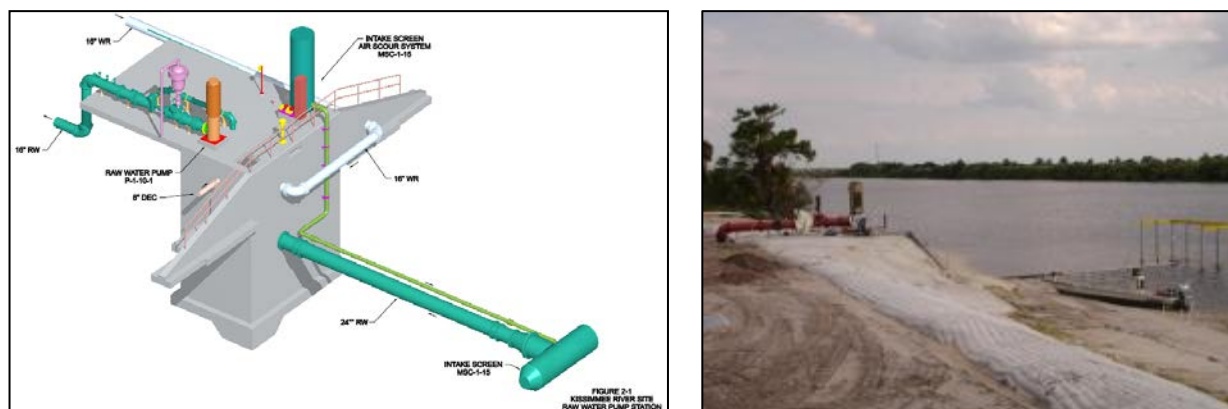
An air scour system cleans the intake screen by bursting air from a 280-gallon compressed air tank through a 6-in pipe that ends with an internally mounted manifold (**Figure 6-2**). Air burst pressure is 175 psig that lasts about 2 to 3 seconds. A pneumatic-actuated check butterfly valve on the air holding tank rapidly discharges air through the pipe. The air scour system has three modes of operation: pre-set head loss set point, pre-set timer, and manual. Specific information on the source water intake components is presented in **Table 6-1**. The process and instrumentation diagrams for the intake are also shown on sheets 1-G-10, 1-G-11, 1-G-12 and 1-I-2 in **Appendix C**.

Figure 6-2 -- Intake design layout (left), and intake structure under construction (right).

The intake system consists of a submerged intake structure and pump station that delivers surface water to the treatment components. The pump station is constructed of cast-in-place concrete comprising of a wet well, intake portal, and top slab. The pump station equipment includes an intake screen, intake screen air scour system and recharge pump. The intake structure is designed to prevent fish larvae and debris from entering the system. It consists of a 48-in diameter T-shaped cylindrical passive intake screen (Hendrick Screen, Owensboro, KY) that is located about 60-ft from the pump station concrete wall. The screen grid mesh size is 1-mm, and was designed for a flow velocity of 0.25 ft/sec in compliance with the USFWS requirements to prevent larval entrainment. The screen blockage factor is 30 percent. The intake design depth is at least 2.5-ft below the Kissimmee River water level to prevent pump cavitation. Water is conveyed through a 24-in ductile iron pipe to the pump station.

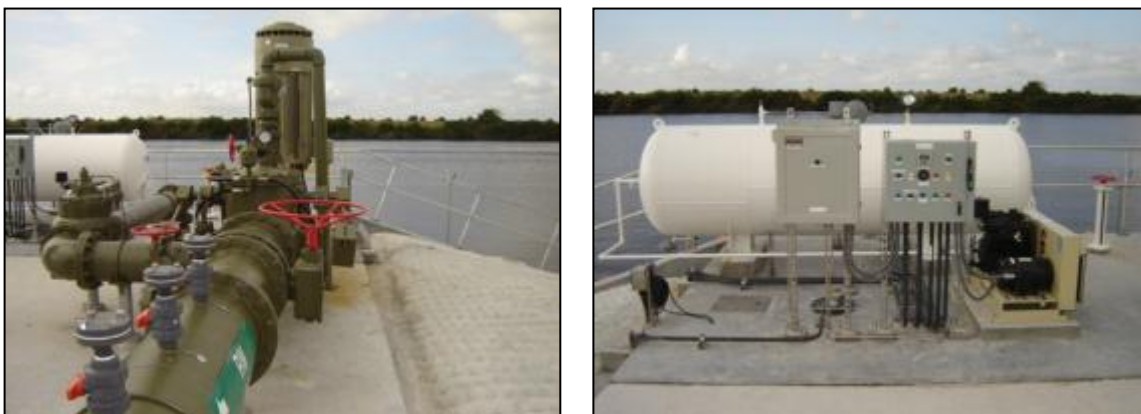
The recharge pump (Weir Floway, Inc., Fresno CA) is a 350-HP vertical turbine pump with 4,000 GPM capacity at 235-ft total dynamic head (TDH). The pump pressurizes water to pass through the filters, UV disinfection system, and into the aquifer. This recharge pump was selected to account for minimum water level, maximum back-pressure at the ASR well, and head loss in piping and treatment facilities. Additional pump capacity is provided to allow for higher flow or for future higher pressure rating of the ASR well. Discharge pressure is monitored locally by a pressure gauge. The low and high water levels are monitored by a float in the wet well to automatically shut down pumping at water levels beyond design criteria. A pressure relief valve and the associated piping are designed for surge and pressure relief control. Pressure relief piping directs the flow from the pump back into the wet well. The pump station and air compressor are shown in Figure 6-3. The pressure relief valve also provides additional protection in the event of power loss or if the pressure exceeds the valve set point (150 psi) (R2T, Inc., 2011).

Figure 6-3 -- Recharge pump at intake (left) and air compressor (right).

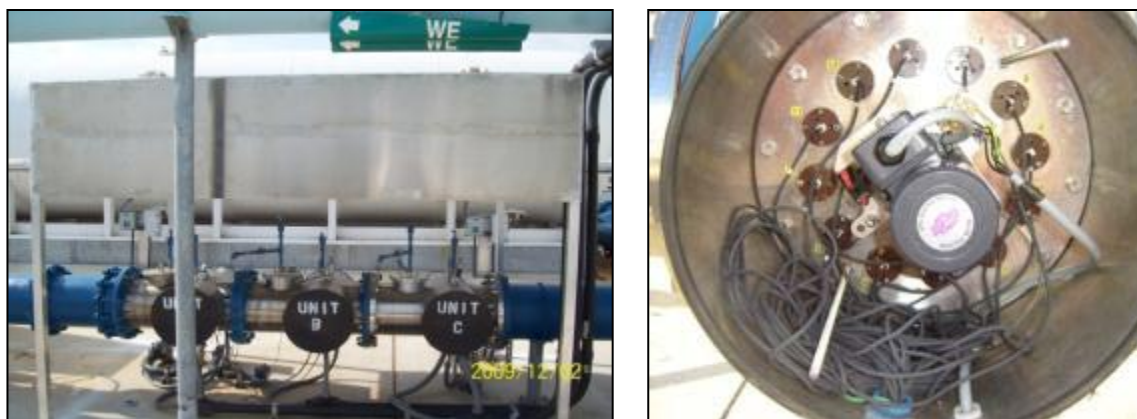
**Figure 6-6 -- The UV disinfection units.** Units are arranged in series (left), and a cross-section view of a single unit showing 12 UV lamps oriented perpendicular to flow direction (right).

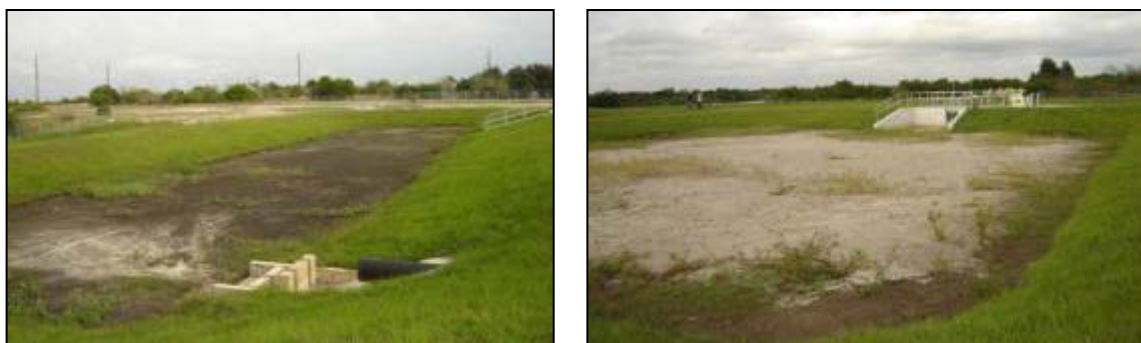
The backwash equalization and solids storage ponds were constructed to manage filter backwash and turbid “first flush” water from the ASR well at the onset of the recovery phase. The backwash equalization pond receives backwash water from the filters and first flush water from the ASR well. The solids storage pond receives water from the backwash equalization pond at a constant flow rate that allows settling as shown in Figure 6-8.

Figure 6-8 -- The backwash equalization pond (left), and solids storage pond (right).

The technical specifications of the backwash equalization pond, solids storage pond and the decant pumps are listed in **Table 6-6**. The process and instrumentation diagram is also shown on sheet 1-I-5 in **Appendix C**.

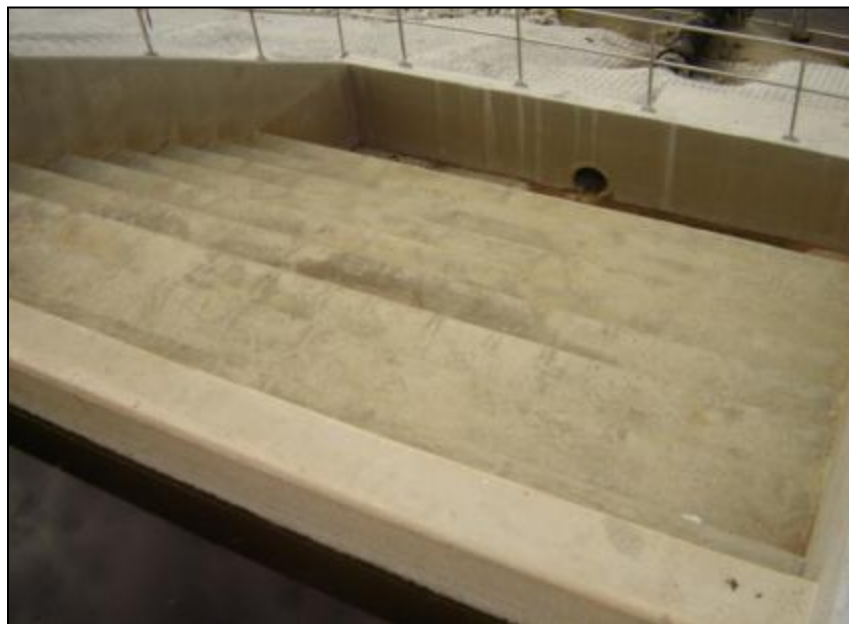
The native and recovered groundwater in the FAS is anoxic, so dissolved oxygen (DO) concentrations must be increased in recovered water prior to release into the Kissimmee River. Recovered water is oxygenated by passage over a cascade aerator (Figure 6-10) to meet the 7 mg/L target DO concentration.

Figure 6-10 -- The spill structure and cascade aerator.

A cascade aerator is a simple and effective way to increase DO concentration. The splashing of water down a series of designed steps entrains oxygen from the atmosphere. The number of steps and height of a cascade aerator is dependent upon the required oxygen residual (R2T, Inc., 2011). The specifications of the KRASR cascade aerator are presented in Table 6-7.

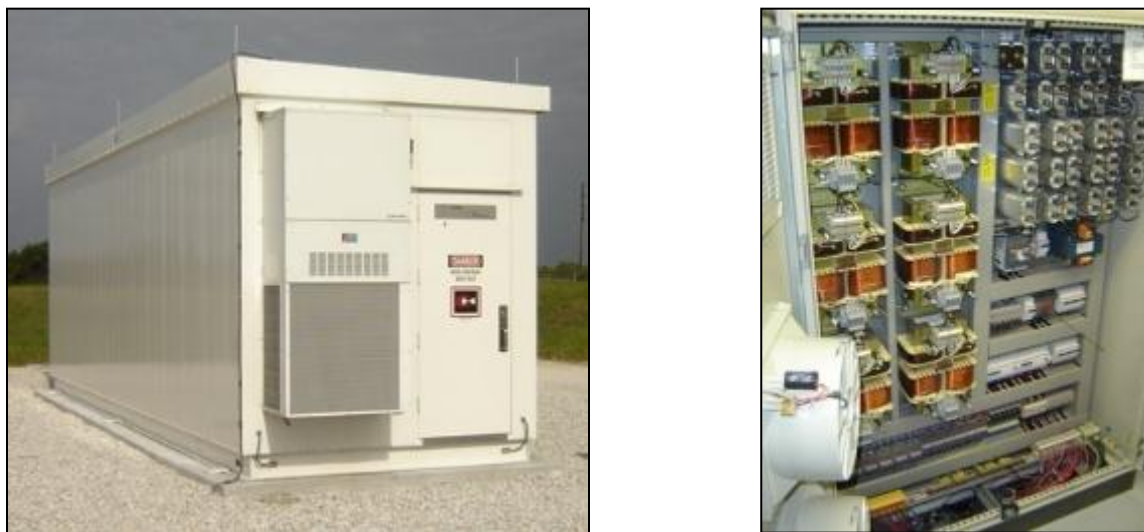
**Figure 6-12 -- The electrical and motor control center enclosure (left); and UV disinfection system control unit box (right).**

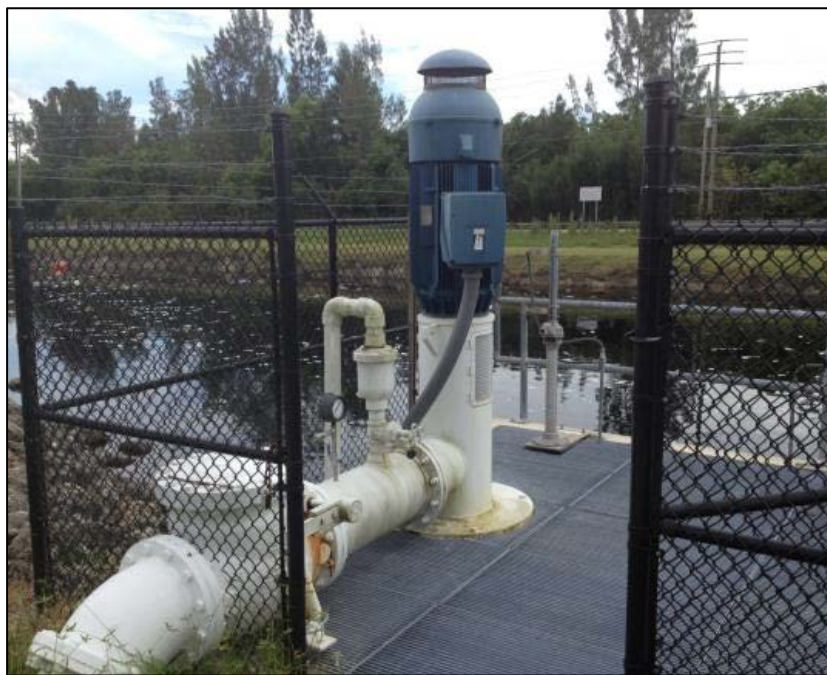
**Figure 6-14 -- Recharge pump at the intake structure.**

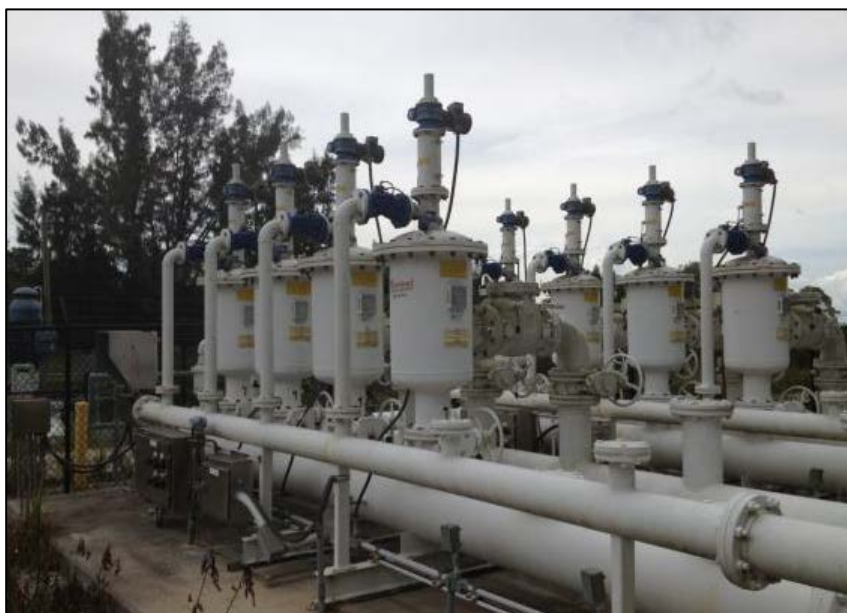
Filtration at HASR is accomplished by the use of automatic screen-type filters (Amiad Water Systems, Ltd., Galil Elyon, Israel; Figure 6-15). The filtration system consists of eight screen filters (14-in diameter), though the skid has been constructed to accommodate four additional units if needed in the future. Multiple filter units were used with 30- $\mu\text{m}$  internal screens initially. The size of the screens was increased to 80- $\mu\text{m}$  after early tests showed filter clogging. The filters are backwashed when the pressure differential across the screens exceeds 6- to 7-psi. For the purpose of the filter design, it was assumed that two filters would backwash simultaneously at 150-GPM each. However, the filters at HASR are set to backwash based on interval or demand conditions that are input directly into the unit controls and are not continuously backwashed. The filter units are installed together and arranged so that they can filter both influent source water from the canal and effluent water from the ASR well prior to discharge. These flows are divided uniformly across the eight units of the filtration system. The number of filter units was determined by the manufacturer and the design engineer, and was based on flow and water quality test results and experience from other Amiad filtration system installations. All of the filter units are identical with interchangeable screens and are rated for the anticipated maximum recharge process flow of 5.7-MGD (Figure 6-15; PBS&J, 2005).

Figure 6-15 -- Amiad filtration system.

For improved source water filtration, the tee-screen described in Figure 6-13 was selected for use in pre-filtration screening. The tee-screen filters suspended solids, and then the Amiad filtration manifold filters smaller particles (PBS&J, 2005). However, due to the small size of most particles in the source water ( $\leq 1\text{-}\mu\text{m}$ ), the filtration system at the HASR was not able to reduce the concentration of those colloidal-sized particles. The original instrumentation diagram for the filter system is located on Sheet I-2 of **Appendix D**.

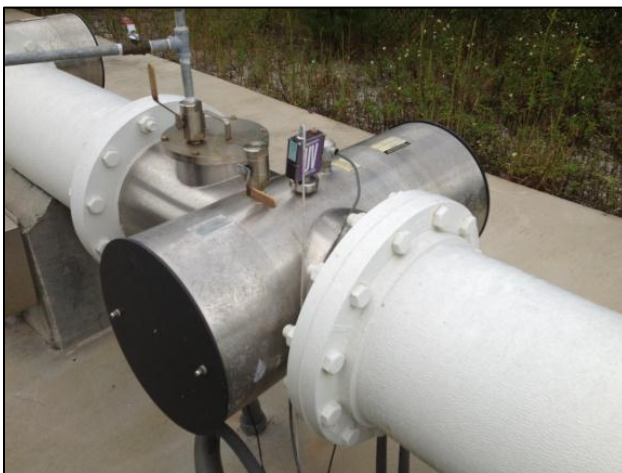
Disinfection of the canal water prior to aquifer storage is performed by UV radiation. The UV system (model Inline 7500; Aquionics Inc., Erlanger, KY; **Figure 6-16**) consists of two single units in series. The system was constructed so that an additional unit can be added if microbial inactivation is not effective. The two units connect in the process pipeline between the flowmeter and the well via 14-in flanged connections. Two units were selected to ensure maximum coliform inactivation at the design dosage ( $40 \text{ mJ/cm}^2$ ). During cycle test 1, the system performed as anticipated, achieving slightly above a 2-log (99 percent) inactivation rate. During cycle tests 2 and 3, the units were not effective for microbe inactivation. Additional discussion of UV disinfection system issues is found in **Section 6.3.1**.

**Figure 6-16 -- A single chamber of the UV disinfection unit.**

Reducing biofilm growth within the Aquionics 7500 unit is critical for effective microbe inactivation. This model has an automatic cleaning mechanism (wiper assembly) that cleans the silicate sleeve for maximum UV transmittance. Each unit also has a separate power and control module cabinet. Each cabinet is a floor-mounted enclosure approximately 7-ft tall by 2.5-ft<sup>2</sup> housing the power supply and controls. Each unit has an adjustable power level feature, so that it functions at low, medium, or high lamp power. The electrical requirements for each unit are 480-V, 3-phase with a power consumption of 45-kilowatts at the highest power level. Each unit has 12 bulbs that have a service life of 5000 hours. The control cabinets are epoxy coated steel, and both cabinets are housed in the control building, along with other electrical project components (PBS&J, 2005).

The UV system can be operated automatically by the PLC or manually. Besides the three power settings, UV sensors control flow into the ASR well. When the UV dose transmitted to the flow diminishes to a specific setting, a butterfly valve closes to reduce flow. These two components are interlocked with the UV sensor for safety, as interlocking prevents untreated water from recharging the aquifer. Other safety

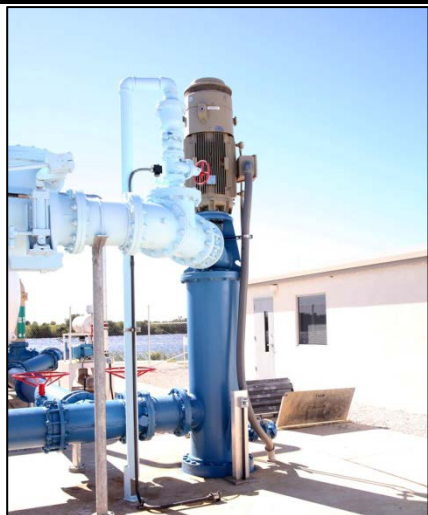
The recovery pump (14x16RGLC; Goulds, City of Industry, CA, **Figure 6-17**) is a 3-stage, vertical turbine similar to the recharge pump with the same manufacturer, model number, and horsepower. Use of similar pumps with identical model numbers and horsepower requirements streamlines the operation and maintenance efficiency for both pump systems. The recovery pump design point is 4500-GPM at 146-ft TDH. The pump is powered by a vertically mounted Siemens, 250-HP, 480-V, 1800-rpm, 3- phase motor at a pump efficiency of 73 percent and a motor efficiency of 94 percent, using a 9.6-in diameter impeller. The pump is located 155.5-ft deep within the ASR well and has 3 bowls (Goulds O&M Manual, 2006).

Figure 6-17 -- ASR well recovery pump.

During recovery, this pump delivers groundwater to the intake/discharge structure for aeration and final discharge to the Hillsboro Canal. The flow is modulated by a check valve that protects the pump from water hammer by closing slowly. This valve also serves to prevent motor overloading due to low head requirements as it has a control arm with weights that permits adjustment to ensure a minimum head. Finally, it closes during reverse flow conditions so it prevents loss of stored water by the artesian flow from the FAS. The pump has both high and low level alarms. The water level is measured by a titanium mechanical sensor and at a specified (low) level, the pump initiates shut down. Redundancy to the ultrasonic sensor is provided with a water level float switch. The ASR well water level and pump pressure can be monitored manually at the wellhead and at the control panel. The original design for the recovery pump process and instrumentation diagram is shown on sheet I-4 in **Appendix D**.

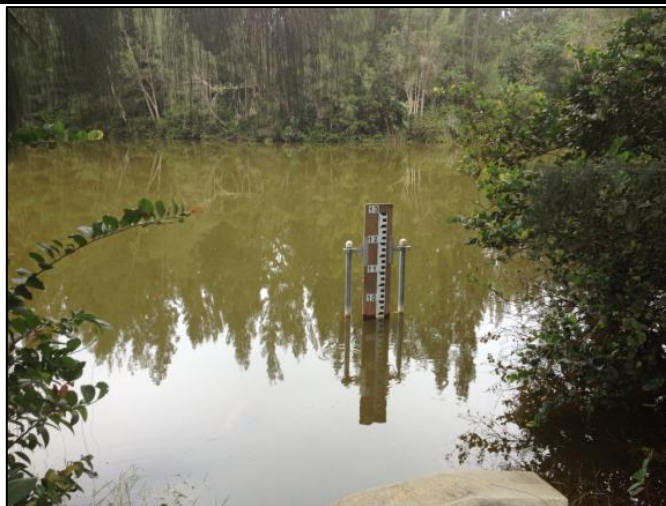
Figure 6-18 -- Backwash quarry pit.

Turbid groundwater and backwash from the filtration system flow into a quarry pit located adjacent to the ASR system on the Site 1 impoundment footprint (**Figure 6-18**). The filter backwash line has a 3-in diameter, and extends from the filters and connects to a 6-in diameter backwash line that leads to the quarry pit. The backwash discharge pipe is installed below grade with a minimum 30-in cover, and terminates at a concrete headwall at the edge of the quarry pit. During test operation, backwash flows were as needed or set to specific intervals using local controls on the Amiad filtration system. Backwash flow rates were estimated to be 50- to 100-GPM. The original design instrumentation diagram including the quarry pit is located on sheet I-3 in **Appendix D**.

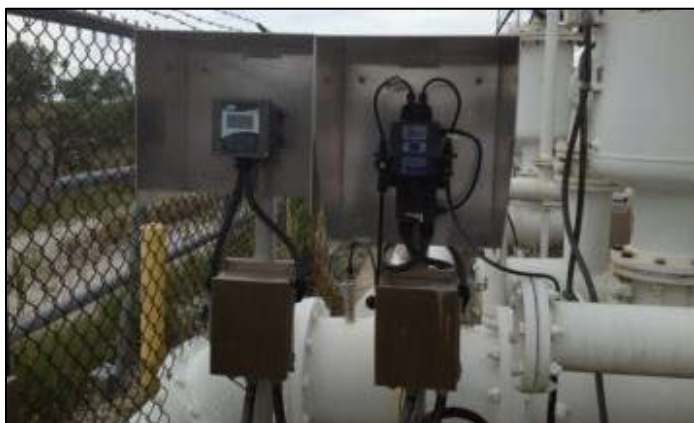
**Water Quality Sensors.** Water quality sensors have been installed in this facility to monitor specific attributes including dissolved oxygen concentrations, specific conductance, and turbidity. The specific conductance and turbidity sensors were installed to monitor water quality and compare data between pre-filter and post-filter water within the facility as well as data at the facility discharge. An example meter is shown below in **Figure 6-19**. These meters currently do not communicate with remote operations but can be monitored locally.

**Figure 6-19 -- Water quality monitoring components.**

A dissolved oxygen (DO) sensor is located inside the stilling well where the re-oxygenated water is held before being discharged into the Hillsboro Canal. DO monitoring is performed confirm that target concentration is being met in the effluent. If effluent DO concentration is below 5 mg/L, then the effluent can be redirected into the quarry pit instead of Hillsboro Canal (PBS&J, 2005). The DO sensors currently do not have remote telemetry included but can be monitored locally.

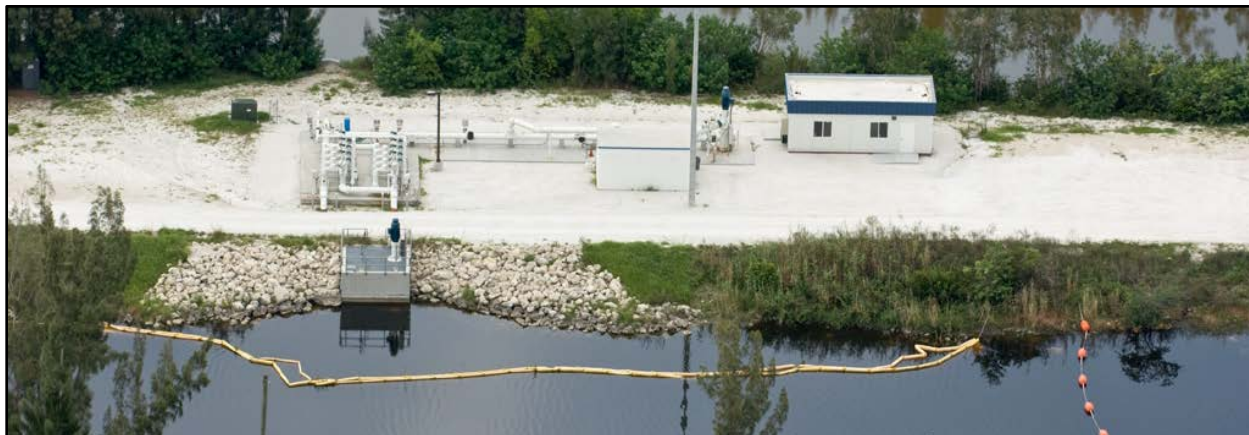
The HASR surface facility consists of appurtenances, an electrical control building, a modular personnel building, filtration and UV disinfection systems, and an intake/discharge feature that includes aeration (**Figure 6-20**). The surface facility is surrounded by a 6-ft tall chain link perimeter fence and a double 10-ft gate (20-ft clear opening) allowing vehicle access for equipment maintenance and repair. Should the motors or pumps need to be temporarily removed for repair, a small hydraulic boom crane can easily accomplish the required tasks, operating either inside the fenced compound or over the perimeter fencing. A gravel parking area has been built at this location as well. A small non-potable water supply well has been installed in the southeastern corner of the fenced compound. This well supplies water via a small hydro-pneumatic tank. A small swale has been installed to direct stormwater runoff around the site to be discharged into the quarry pit (PBS&J, 2005).

**Figure 6-20 -- Aerial photograph showing the surface facility at HASR.**

**Electrical Control Building.** A precast concrete electrical control building houses the electrical controls, starters, switchgear, water quality monitoring, and telemetry equipment. The building is a set-in-place type of structure, fully wired with light fixtures and constructed with double louvered doors (no windows). A wall vent (instead of the originally designed exhaust fan) is installed in the control building. The building size is 10-ft by 20-ft. The concrete floor of the electrical control building was poured in place in the field following installation of conduit to facilitate and simplify the installation and placement of conduit as well as provide a secure building foundation on a pre-prepared gravel base (PBS&J, 2005).

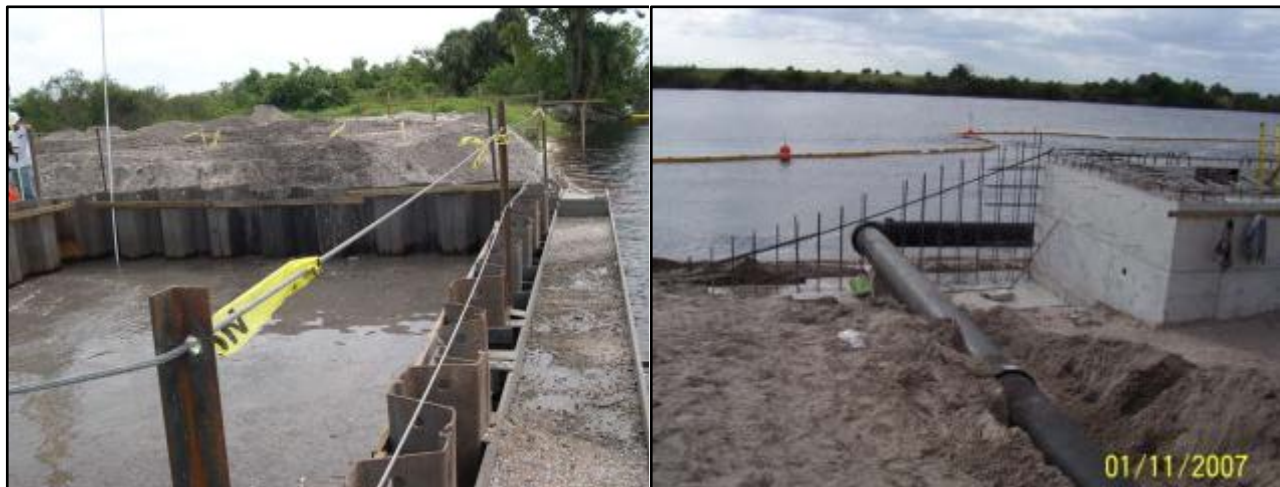
A. Cofferdam for wet well construction.  
inlet pipe.

B. Wet well, wing wall, and raw water

**Figure 8-1 (A through F)** -- Photographs showing the KRASR pilot system under construction.

Construction was initiated in July 2006, commencing with clearing and grubbing, and grading the site to ensure that surface runoff would not enter the Kissimmee River. The ASR system construction began at the river, with the intake (wet well, wing walls, bulkhead, intake piping, and intake structure (**Figure 8-2 A, B**) and outflow features (cascade aerator and piping). Simultaneously, the subsurface plumbing of the ASR system (intake to filter to ASR well) was installed. With great effort, the pressure filter (Tonka’s largest) was installed on the surface facility pad (**Figure 8-2 C, D**).

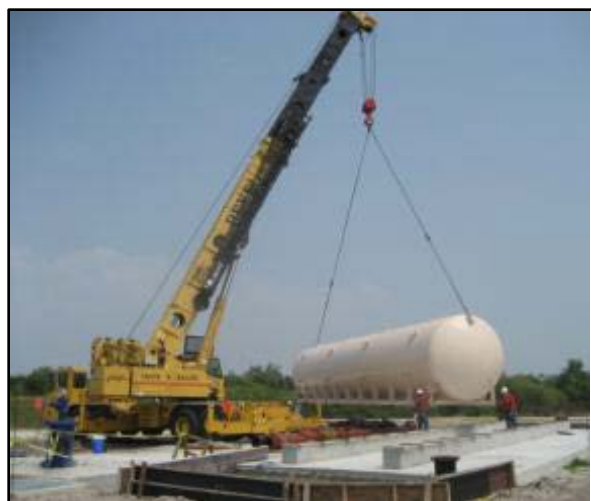
C. Installing the pressure filter.

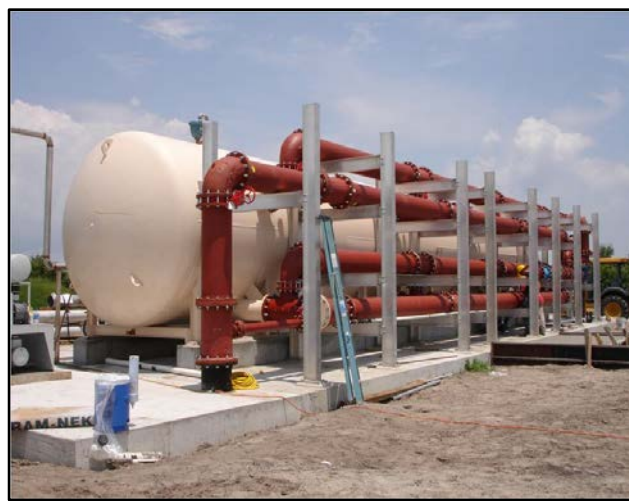
D. Influent and effluent pipes on pressure filter.

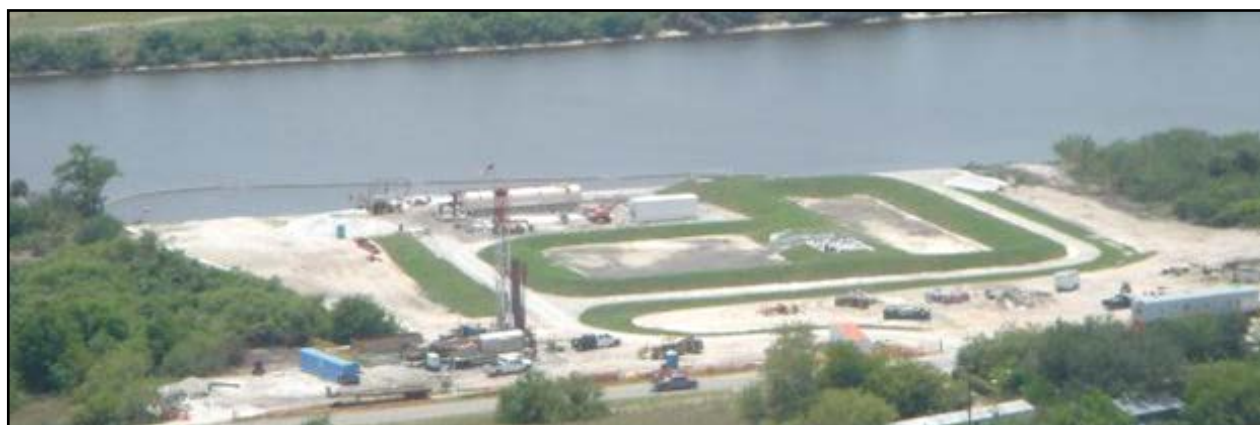
E. ASR system construction in progress – June 2007. Drill rig in lower left is constructing the 350-ft SZMW.

After a significant portion of intake and outflow plumbing was constructed, grading and construction of berms around the flow equalization and solid settling ponds, and the final access road were initiated (**Figure 8-2 E**). The backwash decant pump station, to transfer effluent between these ponds also was completed. As these features were established, the working areas of the site were developed. The working areas include foundation, pads, structures and conduit for electrical and operations buildings, and all of the water treatment components of the surface facility. The progress of construction went well due to the solid team work of USACE and our Contractor (**Figure 8-2 F**). However, it might have been helpful to have the design engineer of record (CH2M Hill) available through separate contract to provide oversight that the facility was constructed as designed. Construction duration was 437 days (1.2 years) from NTP to acceptance. **Figure 8-3** shows the sequence of major construction tasks and their estimated durations.

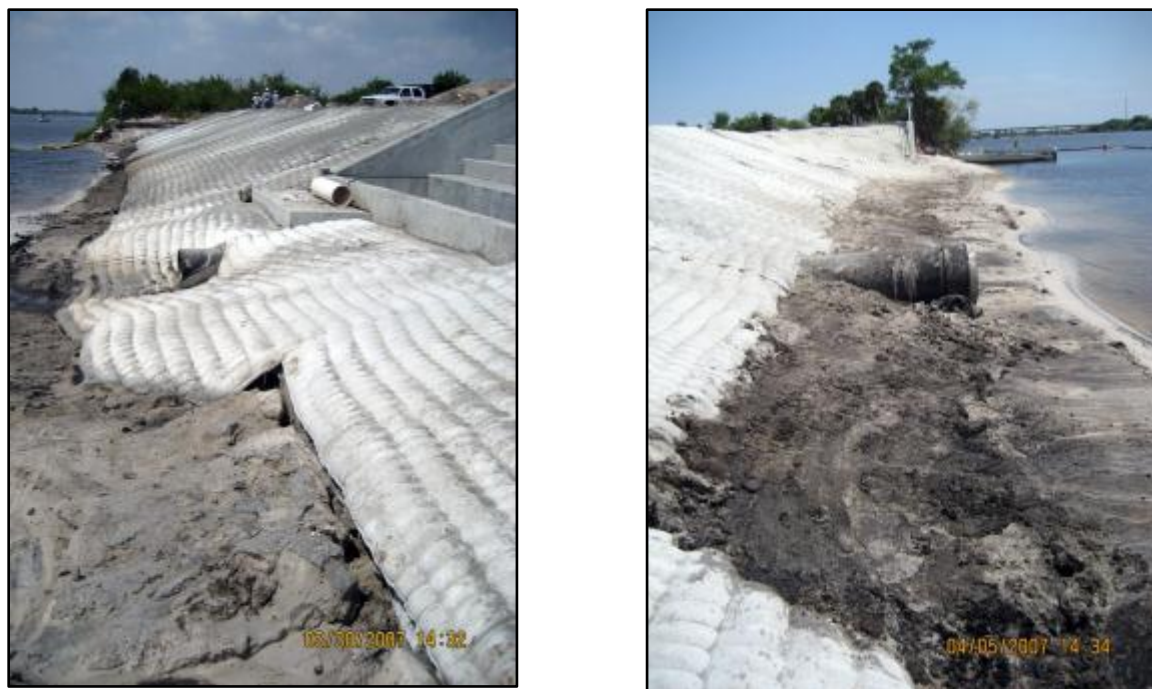
Erosion along swales that drain the site became apparent in late spring 2007 (**Figure 8-4**). As part of a cumulative repair to control erosion of sands in along the toe of the embankment and also along the drainage swales, Harry Pepper Associates was retained after the site was accepted, to perform additional repair tasks. Work during 2008 extended the fabriform apron to the 8-ft NGVD29 elevation. The fabriform was also extended around along the base of the drainage swales, where surface runoff discharges into the Kissimmee River. Swales were partially filled with #57 stone for stability and to reduce runoff flow velocity. By October 2008, river levels rose to the range of design stage, the toe of the embankment became vegetated, a fence bounding the river was installed. The drainage swales became vegetated and stabilized. No piping was observed on the site foundation, and no further disruption of the fabriform apron has been observed throughout the project duration.

Figure 8-4 -- Embankment erosion control before (left) and after (right).

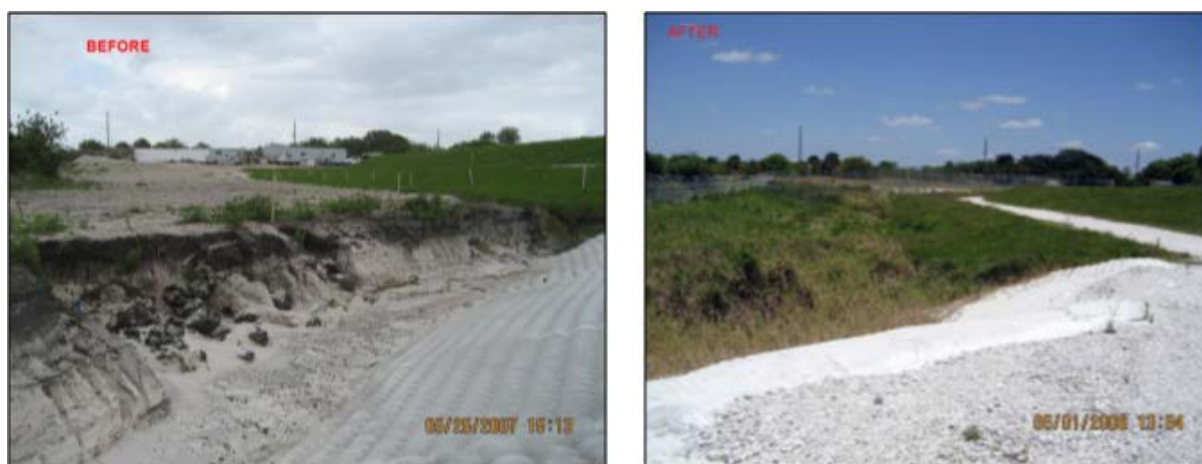
In August 2006, the Contractor submitted Request for Information (RFI) #0008 requesting clarification on the extent of the fabriform (“grout bag”) apron that protects the Kissimmee River bank from erosion. In the plans, the fabriform apron was designed for a normal water elevation of 14 ft NGVD29, with low water at 10.7 ft and high water at about 18 ft. At this time, Kissimmee River and Lake Okeechobee water levels were approaching a historical low, at 8.79 ft NGVD29, exposing the toe of the fabriform apron. Subsequently, cavities appeared beneath the toe so there was a concern that piping could develop if significant erosion occurred beneath the apron. The remedy was to infill the eroded margin with silt, and vegetate the area (**Figure 8-5**).

Figure 8-5 -- Erosion control along drainage swales, before (left) and after (right).

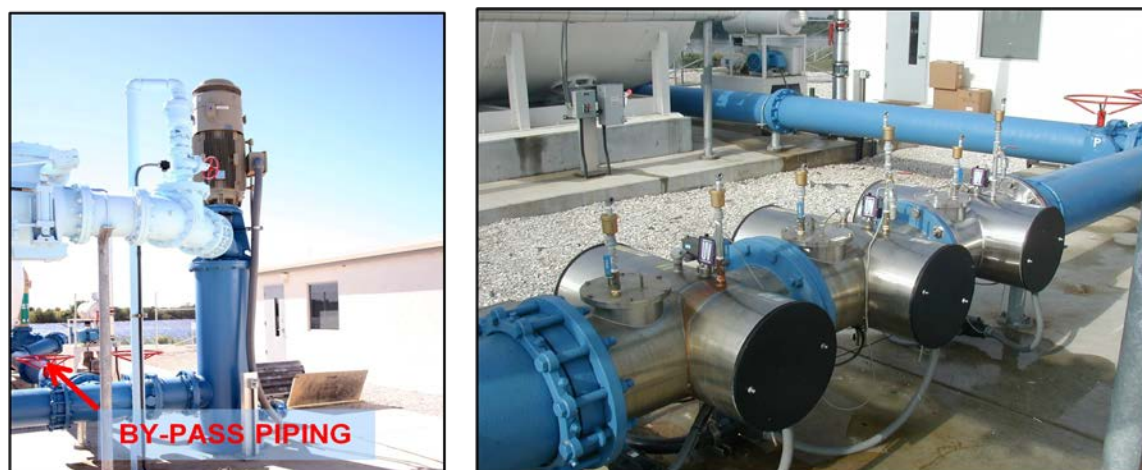
**Figure 8-6 -- Completed by-pass piping (left), completion of 3-unit, in-line UV disinfection system (right).**

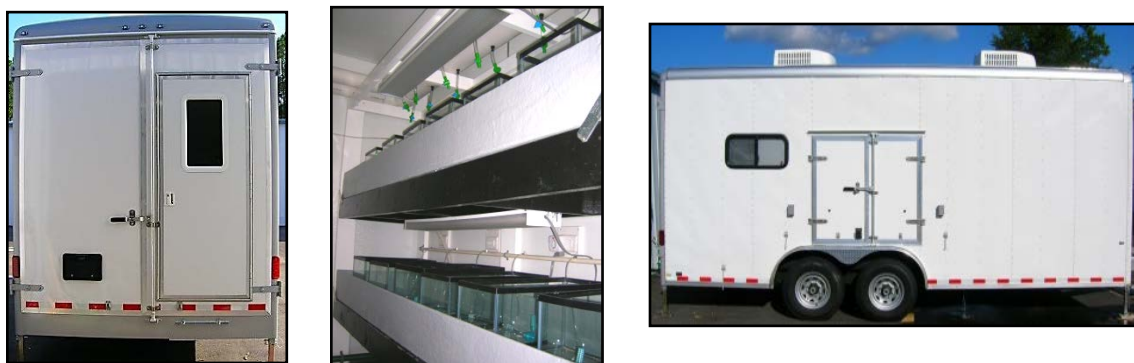
A mobile bioconcentration laboratory was designed and built by Golder for the SFWMD (**Figure 10-1**). The laboratory was designed to conduct bioconcentration studies onsite at the ASR sites using recovered and source waters. The 20-ft trailer has two air conditioners mounted on the roof to control temperature. The laboratory also has external side access for the water pumps.

**Figure 10-1 -- Mobile bioconcentration laboratory at KRASR**

Left, exterior back access door. Center, bioconcentration gallery. Right, exterior side view.

The water distribution system in the laboratory is flow-through. The head tank water bath is connected to a chiller/heater and pump with a temperature control range of 60 to 80 degrees Fahrenheit (°F). This head tank holds two 20-gallon aquaria that feed the source and/or recovered water to the test chambers. Each water type is pumped from the head tank into a 6-inch PVC channel that distributes water to up to 12 different test chambers. These 10-gallon test aquaria are located on either side of the trailer on two levels, six above and six below. Test water is gravity-fed to the aquaria from a 4-inch head of water to ensure equal flow rates. Each aquarium has a stand pipe that maintains the tank volume to approximately 8 gallons. The flow rate of the system allows for a minimum of five tank replacements per day.

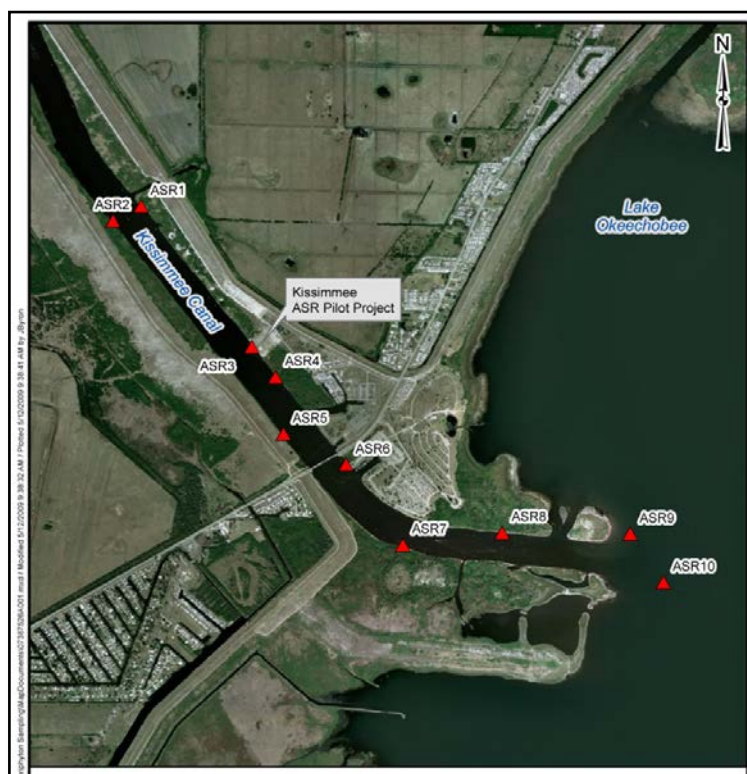
Figure 10-4 -- Location of periphytometer stations in the Kissimmee River in the vicinity of the KRASR system.

On January 13, 2009, 10 periphytometers were deployed in the Kissimmee River concurrent with the KRASR recharge period. **Figure 10-5** shows the stations which were located from the vicinity of the flow control structure, approximately 4,000-ft up-river from the KRASR system, to the mouth of the Kissimmee River approximately 1.5-miles down-river from the KRASR system.

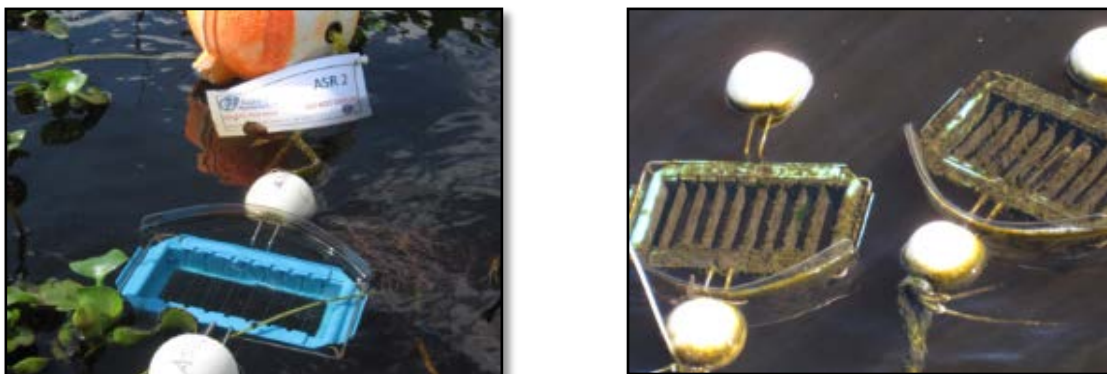
Figure 10-5 – Examples of periphytometers during initial deployment (left), and after a 28-day deployment (right).

Periphyton baseline field studies were included in the ecotoxicology program in order to include plant communities in the assessment of potential risks and/or benefits of ASR implementation. Periphyton is attached algae that grow on submerged surfaces in aquatic ecosystems, and this community can be a valuable indicator of water quality. Periphyton communities were sampled using periphytometers (**Figure 10-4**; Wildlife Supply Company, Yulee FL, model 156-D30) according to FDEP standard operating procedure (SOP) FS7000. A periphytometer consists of a buoyant frame that holds eight glass slides that provide a clean surface for periphyton to colonize. Periphytometers were deployed for a 28-day period.

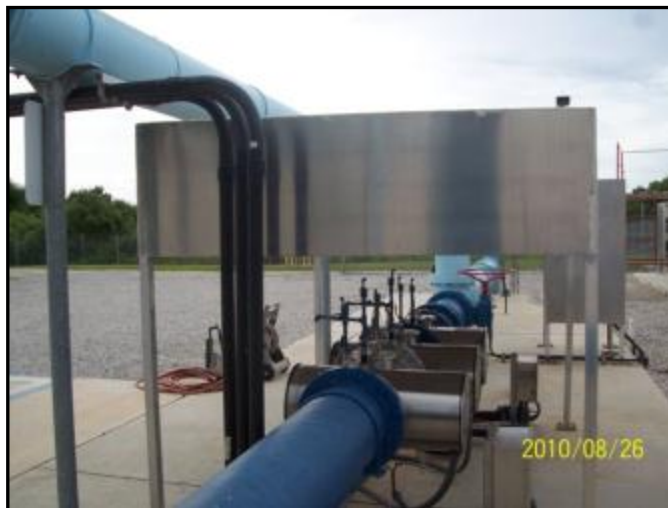
To ensure reliable operation of the UV disinfection system, proper material selection and weather rating of equipment was essential. The UV unit's intensity meter, UVector, is mounted on top of the UV units (**Figure 12-1 --** ) and is essential for proper operation of the exposed units (R2T, Inc., 2011).

**Figure 12-1 -- The UV disinfection system enclosure.**

Since the UVectors were not waterproof or rated for outdoor service, the units failed or misread the intensity settings, resulting in frequent alarms and system shut downs. This problem was solved by providing a metal enclosure on top of the UV units at a minimal cost (**Figure 12-1**). Since the addition of the enclosures, the UVector intensity meters have operated adequately.
