# The Conservation and Preservation of Coquina

## A Symposium on Historic Building Material in the Coastal Southeast

Held January 24-26, 2000  
at St. Augustine, Florida

Division of Historical Resources  
Florida Department of State

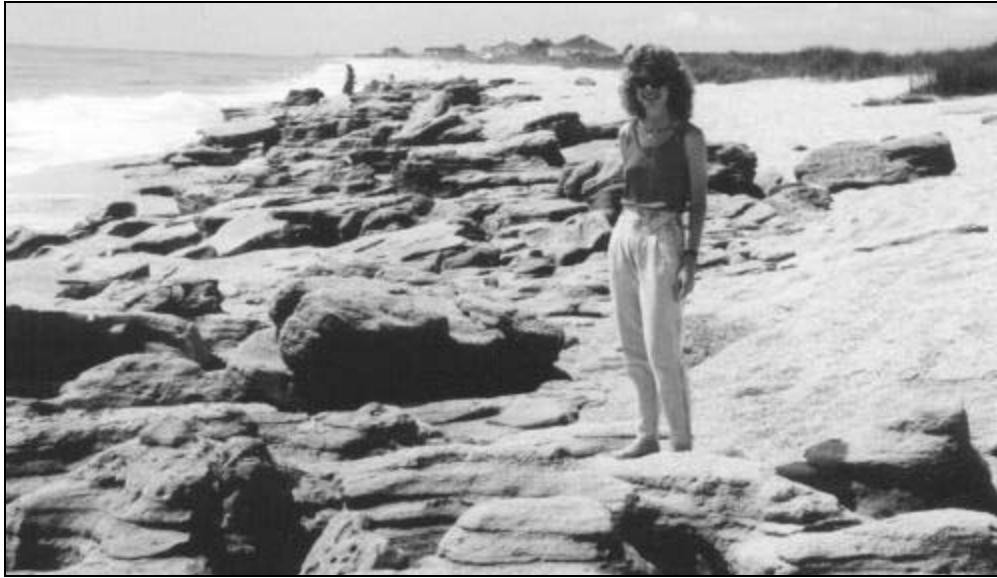
Figure 2. Anastasia Formation coquina exposed at “The Rocks” in Washington Oaks State Park

The Anastasia Formation is exposed in a number of places along the east coast. The best and most impressive places to see the Anastasia Formation naturally exposed along the coast are at Washington Oaks State Park (The Rocks, Flagler County) (Figure 2), Gilbert's Bar House of Refuge, Hutchinson Island (Martin County) (Figure 3) and the Nature Conservancy's Blowing Rocks (Palm Beach County). The House of Refuge site in Martin County is the most spectacular with as much as 10 feet of coquina exposed. The exposures of coquina along the beaches vary in size and shape. At times sand piles up around the outcrops, covering much of the exposure. Following storms, more rock is often exposed.

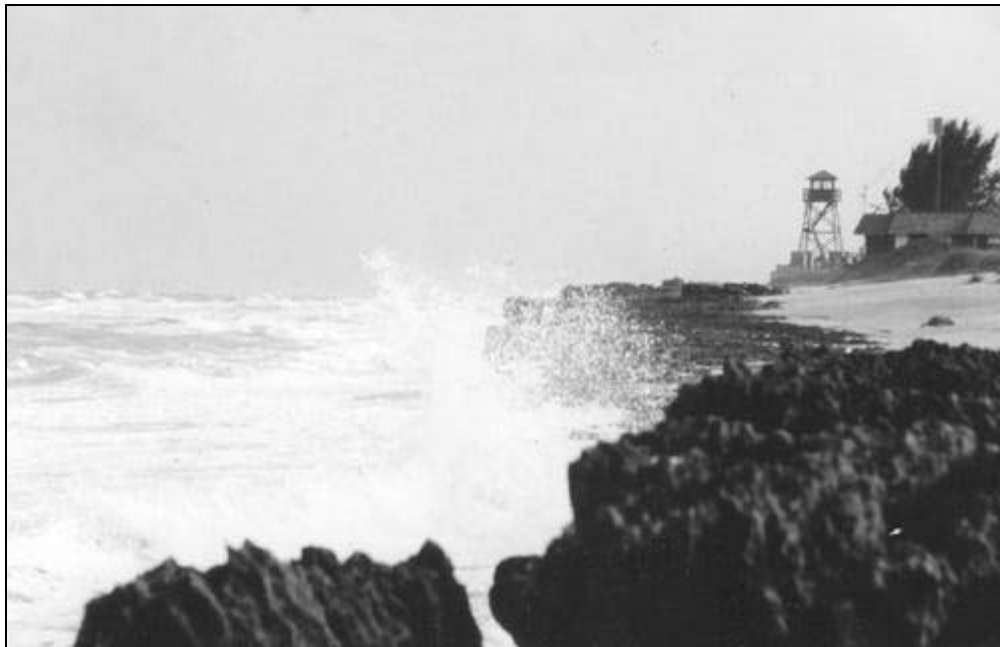
Figure 3. Anastasia Formation exposed at Gilbert’s House of Refuge, Hutchinson Island, Martin County

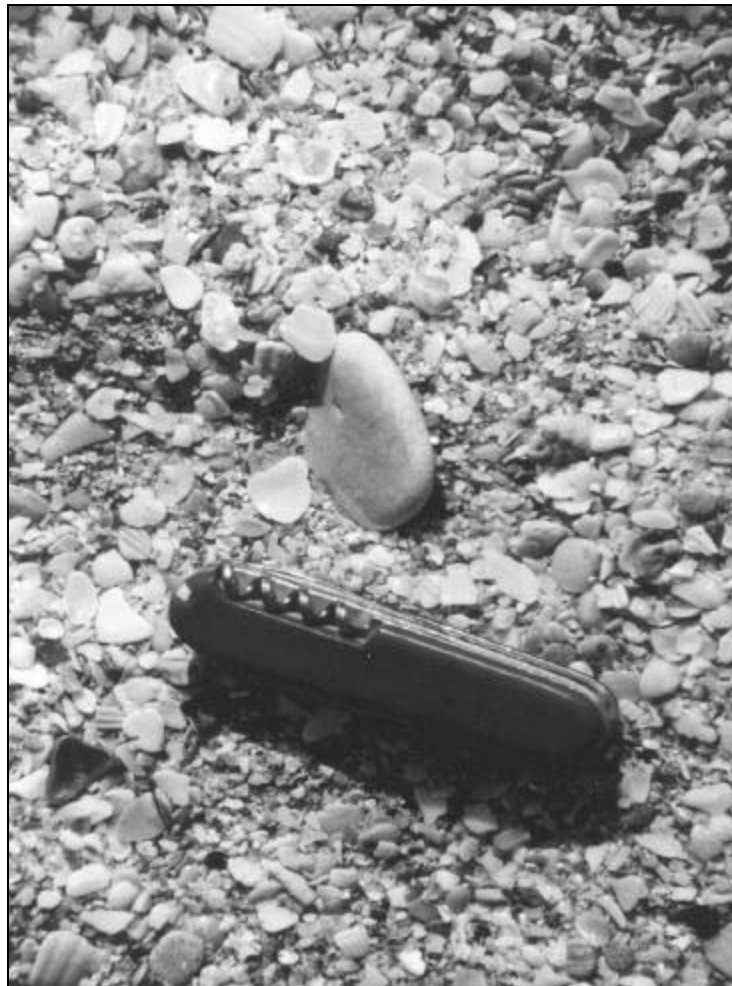
Figure 5. Loose sediment composed of shell debris and quartz sand

Coquina forms as the result of sediment deposition on beaches by waves and currents. Mollusk shells, from organisms living in the near-shore zone, are moved on to the beach and mixed with quartz sand (Figure 5). The quartz sand is the result of the weathering and erosion of older rocks and sediments. The sand is transported into the marine environment by streams and rivers then moved by currents and waves along the coastline. Wave and current action deposits shell and sand forming beaches and barrier islands that are common along Florida's coasts. When sea level dropped, shell-bearing sediments were influenced by rainwater soaking into them as the surficial aquifer system was recharged. Rainwater is naturally acidic and as the water seeps through the organic matter on the ground it becomes more acidic. The shell material is composed of calcium carbonate so acidic groundwater dissolves it until the water becomes saturated with calcium carbonate. Once the water is saturated with calcium carbonate, calcite can be deposited cementing the sand and shell together creating coquina (Figure 6). The coquina is weakly cemented or indurated with calcite.

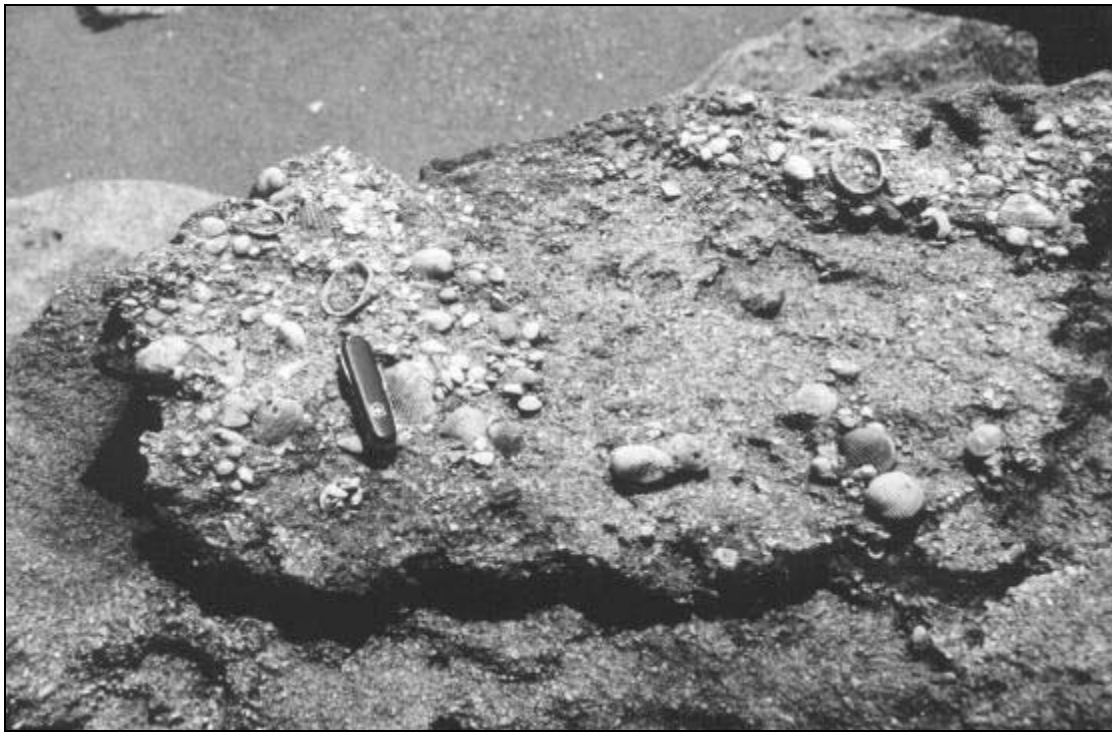
Figure 6. Anastasia Formation coquina

The Anastasia Formation coquina lithologies exhibit significant variation in both a vertical (deeper underground) and lateral (north to south) sense. The sediment characteristics vary from a rock composed of poorly cemented shell material with minor sand to more cemented quartz sand with little to no shell. There are layers within the formation that consist of loose, uncemented sand and shell. There is a general trend of the coquina containing more shell from St. Augustine

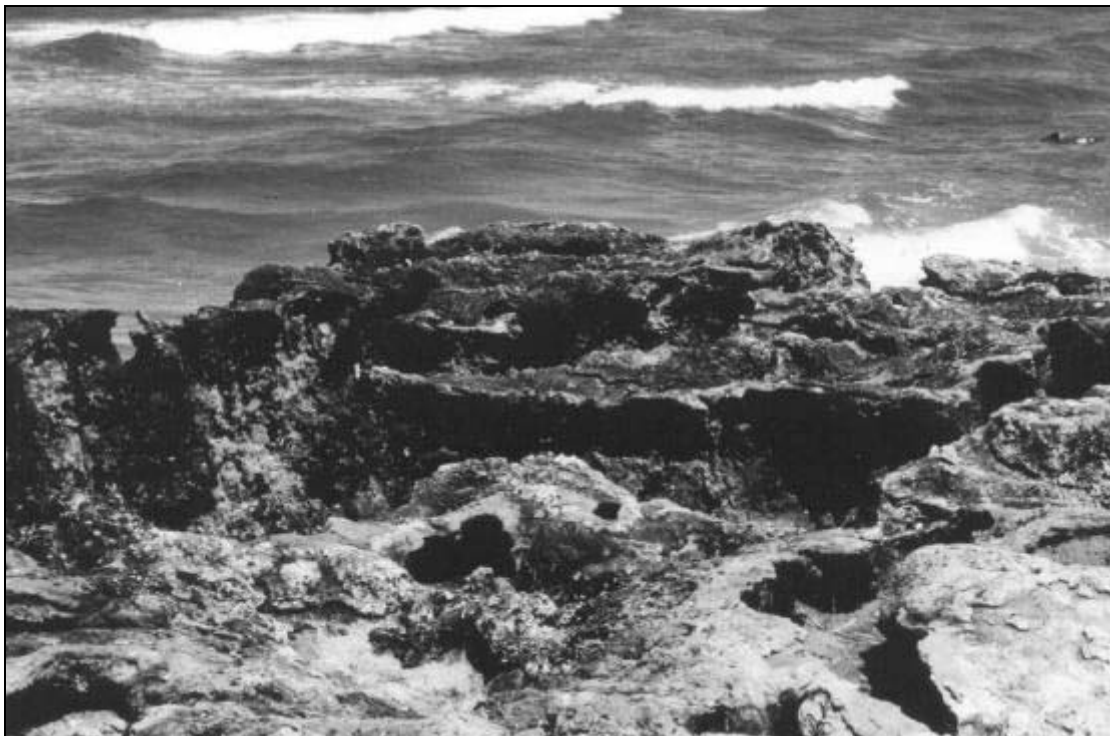
Figure 7. Exposure of features on top of the Anastasia Formation, Martin County

Anastasia Formation outcrops reveal some interesting and intriguing features. Cross beds of sand and shell (beds dipping at an angle to horizontal) are a common feature of the formation. Fossilized burrows of marine organisms are frequently encountered. One of the most intriguing features is the bowl-shaped depressions on the upper surface of the coquina (Figure 7). These features are formed by cabbage palms that grew on the surface of the coquina. The cabbage palm roots dissolve the coquina forming the bowl. Occasionally, there will be calcified root structures associated with the depression.

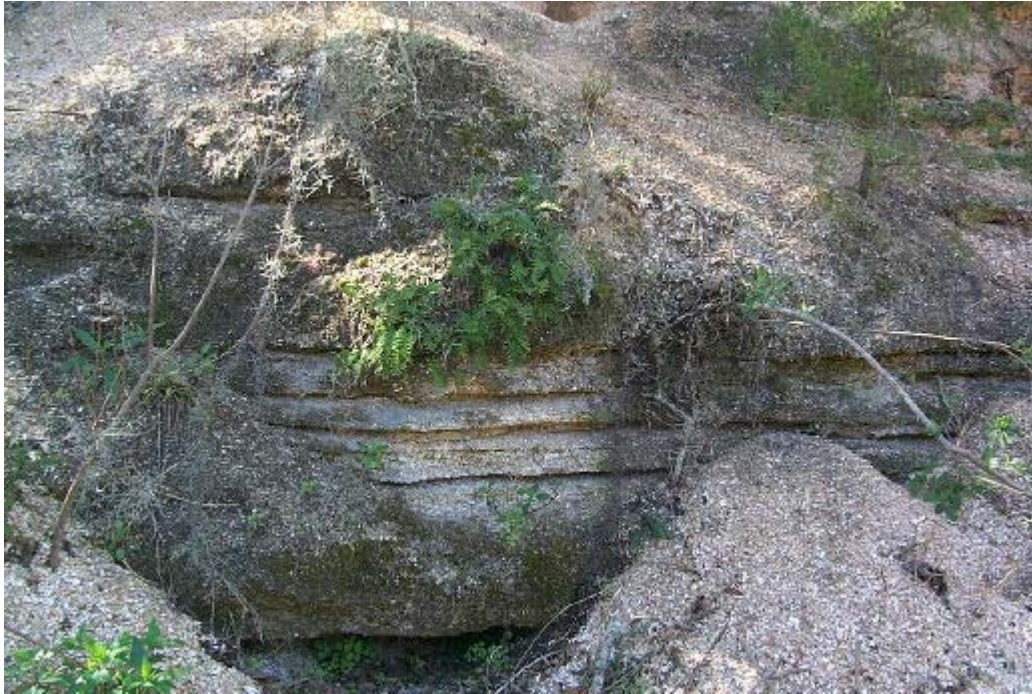
Figure 1. Anastasia Island coquina quarry. (Photo courtesy of the author.)

It is easy to quarry and is done so wet. Once quarried, it is allowed to season by leaving it outdoors for a period of time before use. During the seasoning process, it is washed free of any soluble salts from the marine environment and becomes hard as it is allowed to dry and age. Because its physical structure and density are quite varied, it can be found in a variety of grades, from very fragile material that crumbles easily, to a denser more durable stone. The lowest grade material is crushed and used in road beds, while the finer grade is used for veneers and construction. A nice example of an outcropping of coquina can be found at Anastasia Island quarry, the source of the coquina from the Castillo de San Marcos can be seen in Figure 1.

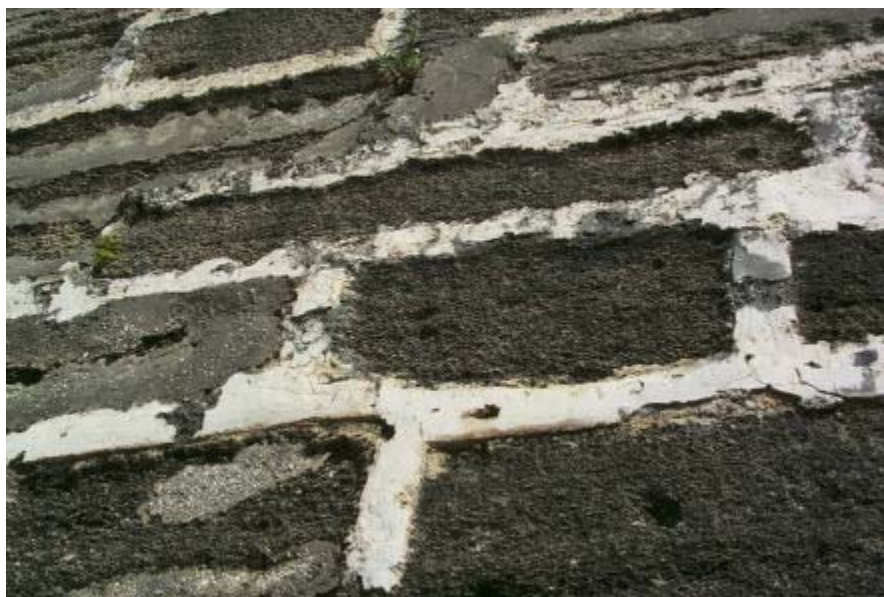
Figure 9. Erosion of surface of coquina stones. (Photo courtesy of the author.)

Because the products from this reaction are either water soluble or gaseous, their formation by reaction of coquina with acidic materials results in loss of material from the surface of the stone and, over time, can cause serious erosion and surface losses. An example of such losses from erosion can be seen in Figures 8 and 9. Figure 8 shows the circular eddies or the “river and tributary” pattern of erosion of coquina.

Problems with inappropriate mortars are not limited to the materials used historically in the original structure, but can arise from poor quality repairs or restoration efforts. For example, in Figure 9, we see the use of Portland cement mortar in the joints. (These joints can be seen to extend out from the surface of the coquina stones.) These early restoration efforts were probably done in the 1950's. In fairness to these early restorers, the use of the very strong Portland cement predates systematic and solid conservation decision-making. Today it is well established by the conservation profession that a repair should be weaker in strength than the original structure so as to not induce any stresses that can lead to damage to the historic fabric.

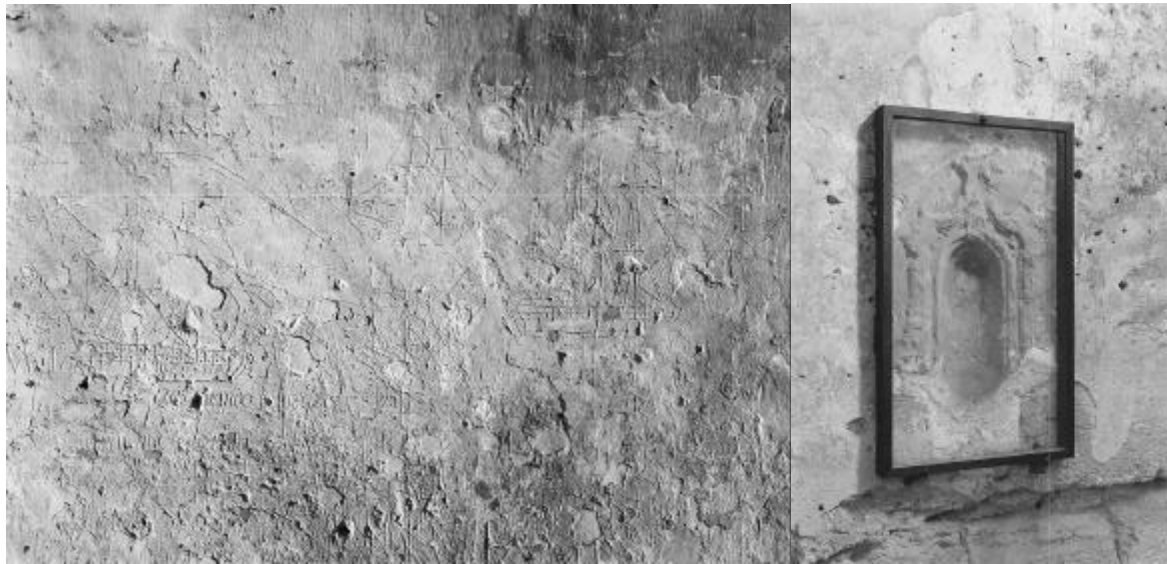
Figure 12. Images of ships scratched into the wall in the gunner's room and the niche in St. Mark's chapel at the Castillo de San Marcos National Monument. (Photos courtesy of the NPS Photo Archives.)

itself and access has been limited by cordoning off some areas that are particularly vulnerable to damage such as the wall on which has been scratched images of ships and the case around the niche in the chapel, as seen in Figure 12.

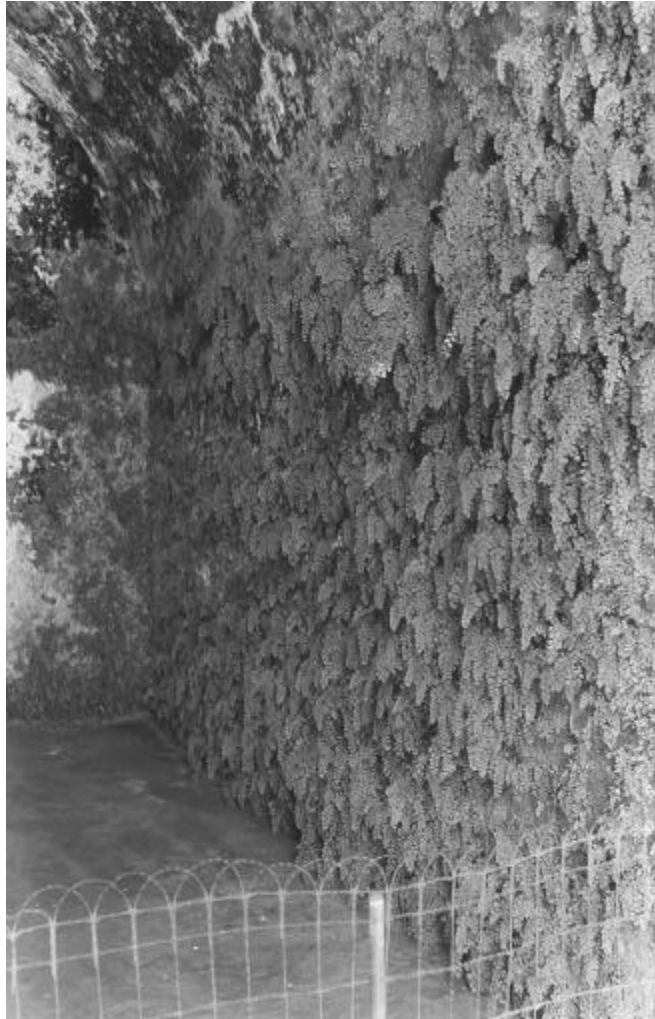
**Figure 13. Historic “fern room” at the Castillo de San Marcos. (Photo courtesy of National Park Service-Harper’s Ferry Center Photo Archives.)**

The tropical climate of the Florida coastal areas is an ideal environment for the growth of a huge array of biological organisms from microorganisms such as slime molds and bacteria to larger vegetation. Some of these organisms are benign, that is, they rest on the surface of the structure but exert no adverse effects on that surface. However, organisms such as algae, bacteria, fungi, lichens and mosses are capable of causing deterioration and discoloration. They can trap dirt and moisture, leading to accelerated soiling and aiding in the establishment of higher plants, which increase water retention. Moreover, many lichens produce and secrete acidic substances that may react with the alkaline components of coquina and may darken, damage and disfigure the exterior surfaces of buildings. (Jones 1985; Lloyd 1971). In the past, such growths were encouraged, since they gave a desired mature appearance to a building, as illustrated in Figure 13; however, their presence is now known to be destructive, and therefore is a preservation concern.
