# Initial Inventory of Karst Features in the Chassahowitzka Swamp and Vicinity

November 2005

KARST  
UNDERWATER RESEARCH, INC.

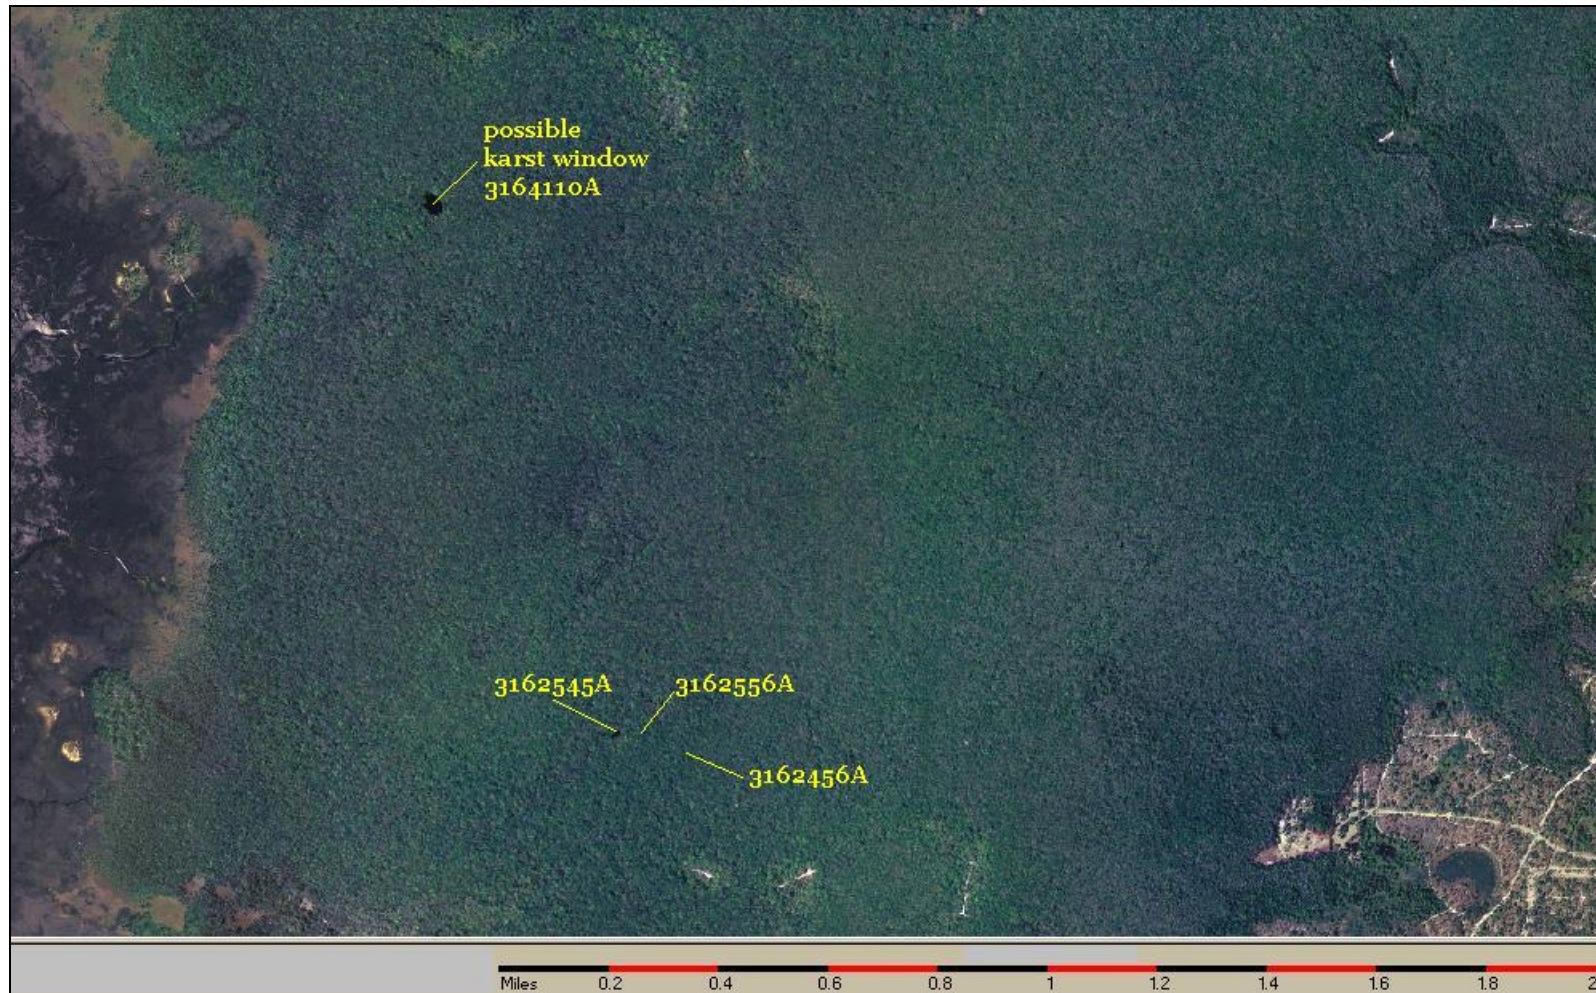
## Figure 9 – Sawmill Island Array

A few ponds were reported by local hunters. Investigation to date has identified two ponds. Since the saltwater interface is much closer to the surface where these springs have been found, it was surprising to observe them discharging freshwater.

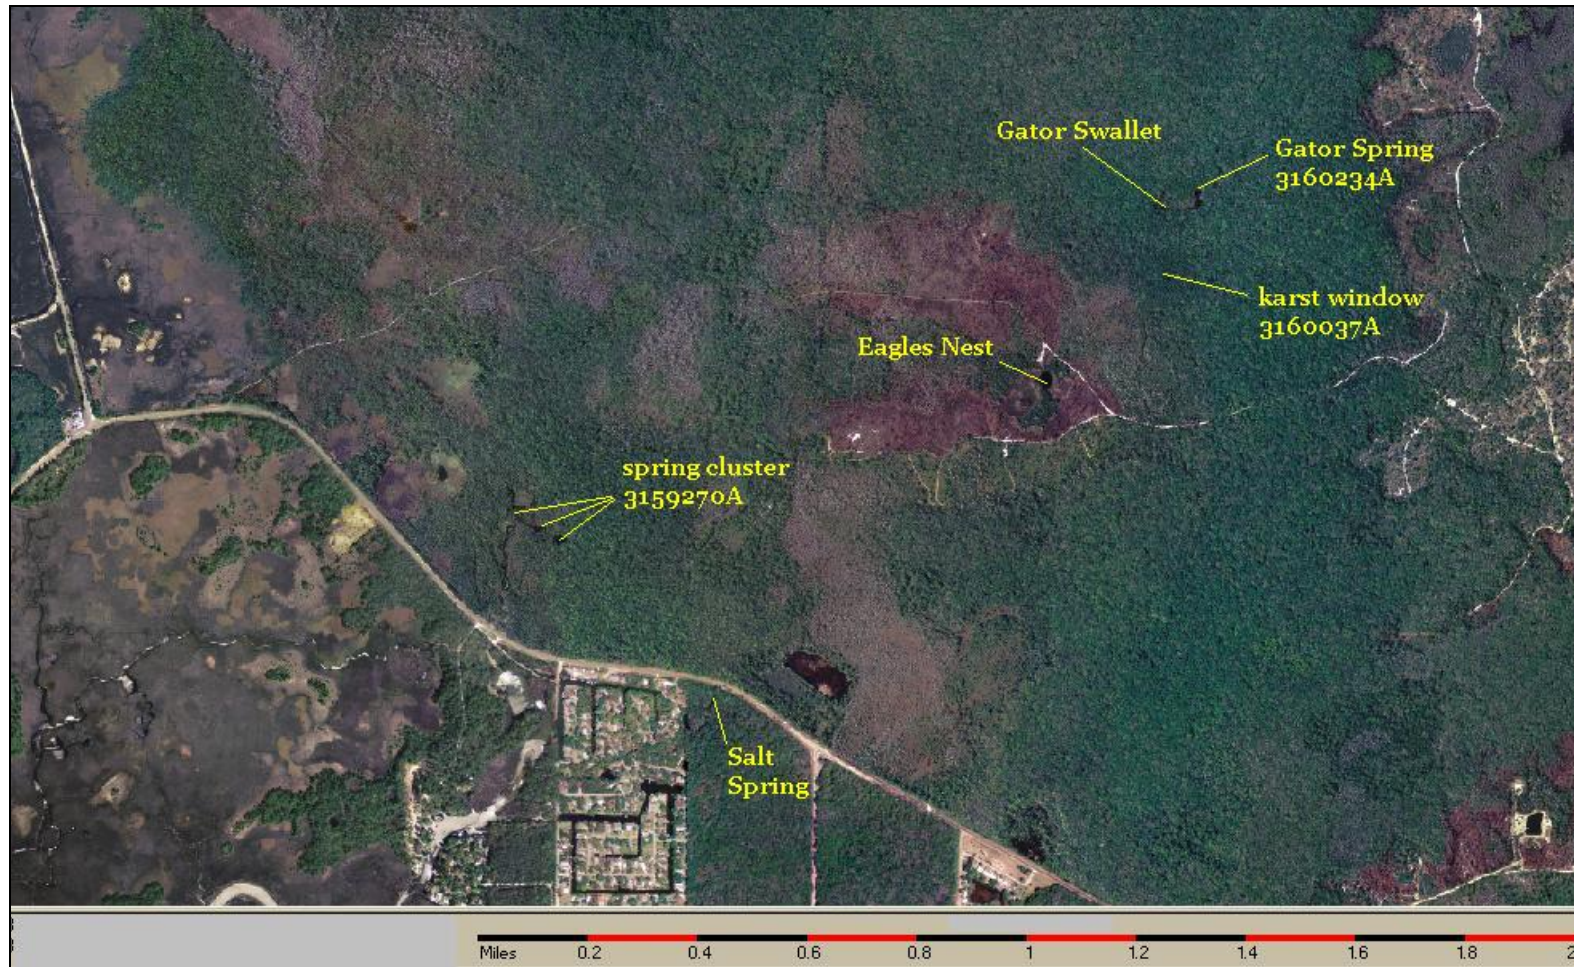
**Figure 10 – Eagles Nest Array – selected points of interest**

The brief surface stream created at Gator Spring (3160234A) returns underground and, via conduit, feeds into the large "upstream" tunnel in Eagles Nest. Several different "vents" have been identified that feed into the upstream Eagles Nest tunnel. These vents appear to have different sources based on the variations in the comparative water quality.

It is presumed that the karst window (3160037A) intersects the conduit leading from Gator swallet to Eagles Nest. Further exploration is expected to resolve this question.
