# Leon County Lakes Ecology

## Lake Iamonia

### 4.3: Lake Iamonia

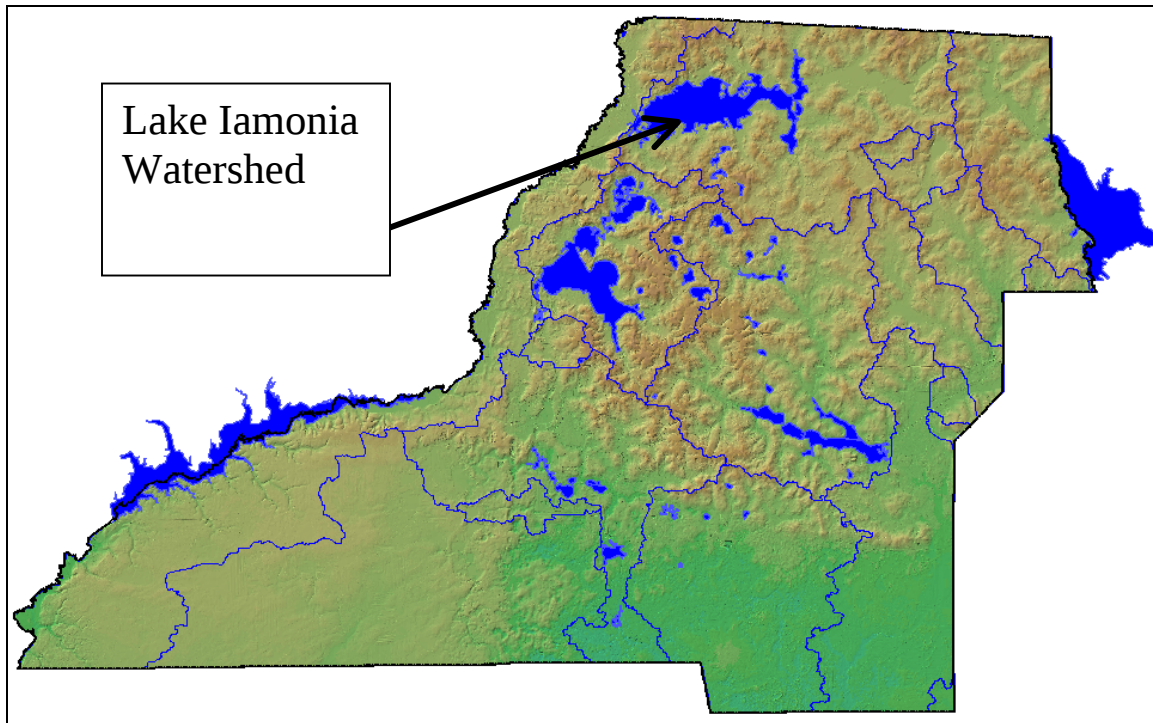
**Figure 4.3.2:** The Lake Iamonia Watershed is connected to the Ochlockonee River Watershed at high water through the slough system at River Ridge Plantation. Water passes under the Meridian Road Bridges and periodically fills Lake Iamonia. Map by Greg Mauldin, Tallahassee-Leon County GIS

Early management of the lake basin emphasized agricultural usage. A dam was built across the sloughs connecting Lake Iamonia with the Ochlockonee River in 1910 to keep the river water out so that the lakebed would be dry (Sellards, 1914). The sloughs were also restricted to flowing beneath two small bridges (separated by 1850 feet of fill) under Meridian Road. These dams were built in order to keep the lake basin dry for agriculture.

Agricultural water usage in Georgia consumes a lot of water in the Ochlocknee River Drainage Basin during the growing season. There is also evidence that the slough system connecting Lake Iamonia with the Ochlocknee River may be altered by an access road for the pipeline. There are only three small culverts under this road allowing exchange of water at moderate flows on the Ochlocknee River. The diameter of the slough is still constricted at the Meridian Road bridges.

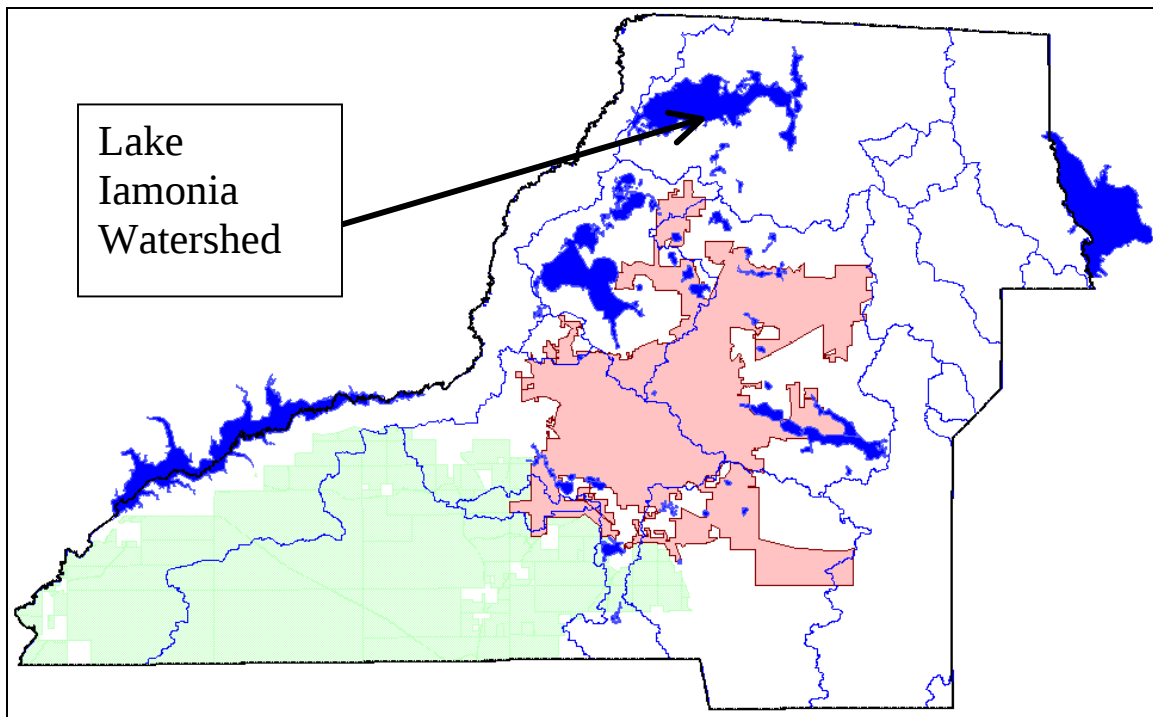
**Figure 4.3.3:** The Lake Iamonia Watershed is one of the few that received little stormwater from the City of Tallahassee. Map by Greg Mauldin, Tallahassee-Leon County GIS

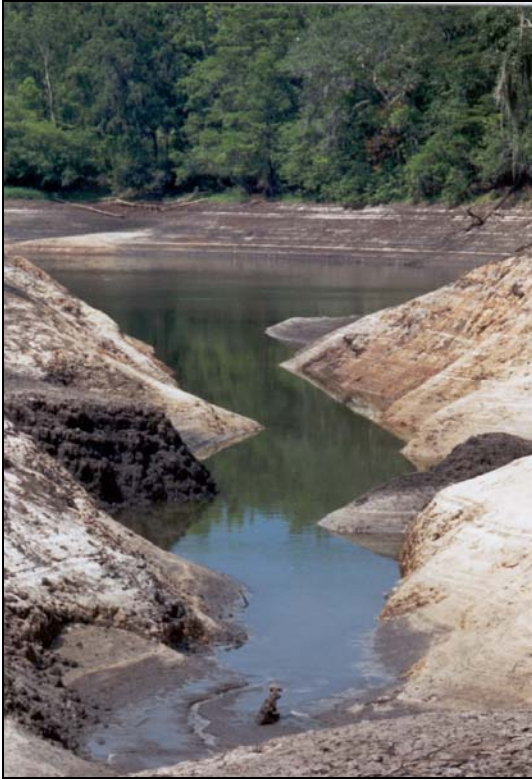
**Figure 4.3.5:** Iamonia Sink as lake Iamonia is draining (2000).

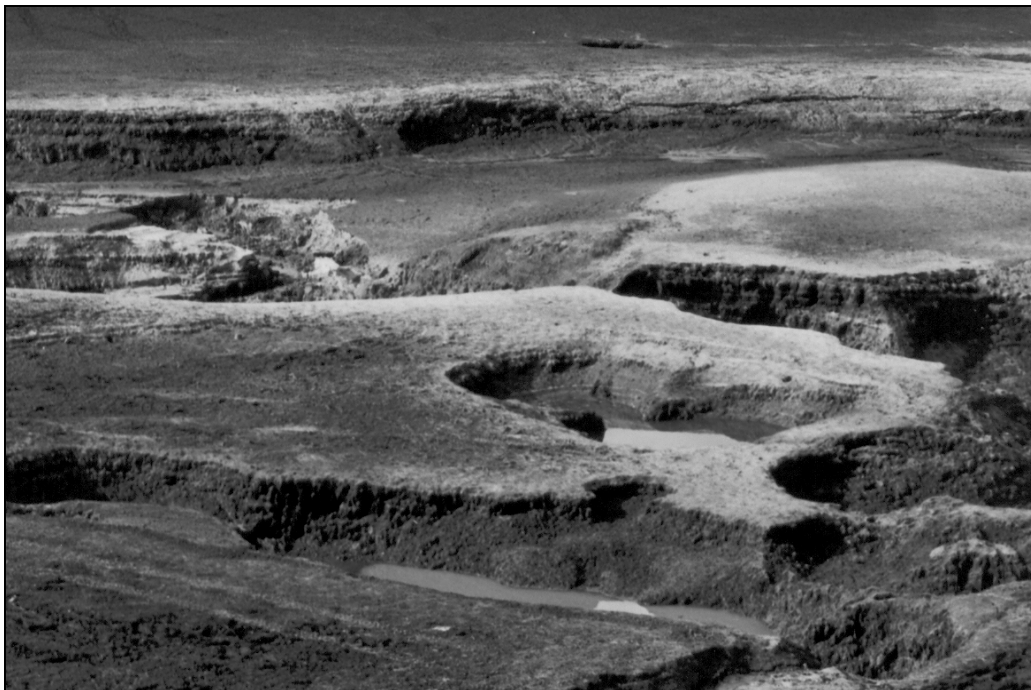
**Figure 4.3.7:** View of the karst depressions after Iamonia Sink went totally dry in August 2000. There were 32 different places where water was draining into the ground.

The Sink Basin has a surface area of 19.52 acres at 95 ft NGVD, and a maximum depth of 40 feet. The basin is located on the northern shore of Lake Iamonia. The control structure is now open all of the time. In 1999, during the drought Lake Iamonia remained full while lakes Lafayette and Jackson drained. Doubt that the sink was not taking in water and that declining lake levels were due to evapotranspiration led to an experimental closing of the gates to the Sink Basin in May 2000 by Michael Hill and Sean McGlynn. The water level in the Sink Basin rapidly declined when the gates were closed, evidence that the sink was actively taking water. The acceptance rate of the Sink was measured at 9.9 cfs. This was slightly higher than previous flow measurements made in 1981; 6.2, 7.4, 3.4 and 9.5 cfs (Wagner and Musgrove, 1983). It was concluded that if the sinkhole were the only means of drawing down the lake, it would take 2.5 years of extremely dry weather to achieve a 5.0 ft decline (Wagner and Musgrove, 1983). This represents a loss of 19.6 acre-ft/day, or 0.04 inches/day. Seepage was estimated at 1 acre-ft/day, of 0.5 cfs. Evapotranspiration was estimated at 132.5 acre-ft/day (66.8 cfs or 0.276 inches/day). Evapotranspiration accounts for three times as much water loss as the sink.

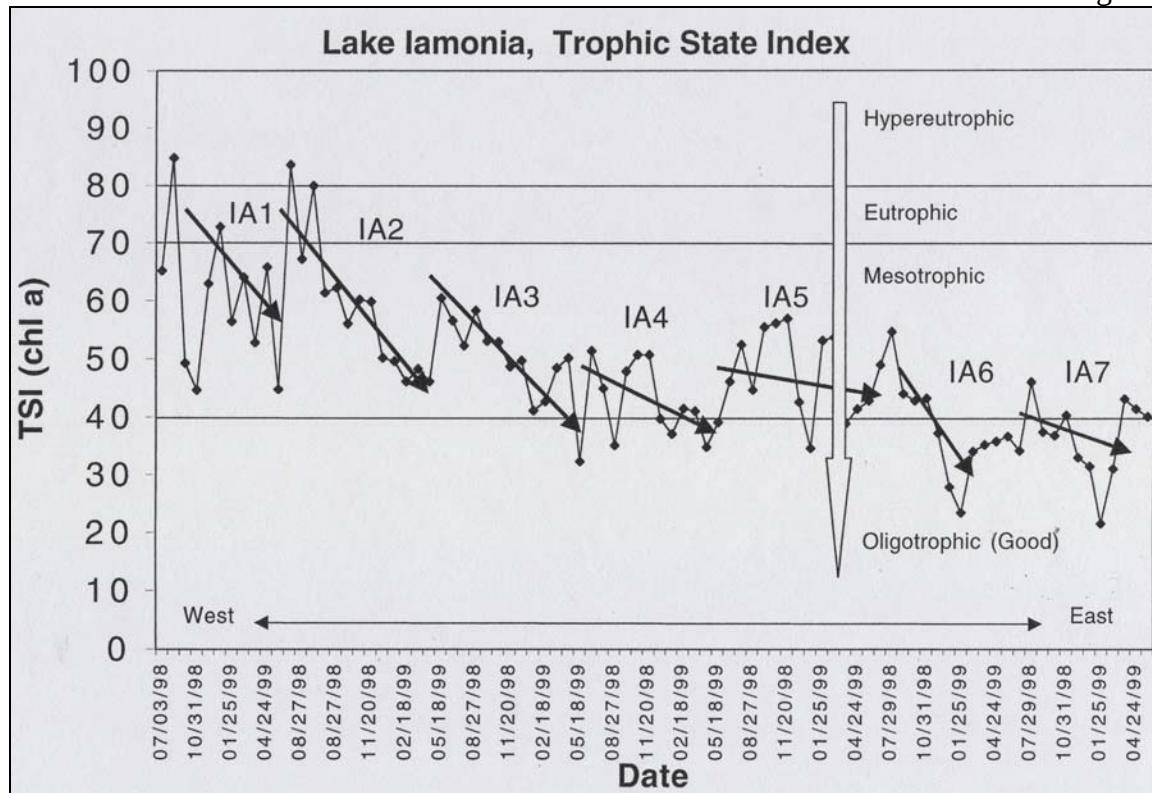
**Figure 4.3.8:** This graphic from before the drought shows that Lake Iamonia is quite clean on its eastern side (near Thomasville Road), with a good low trophic state index. It is borderline oligotrophic, and on that side one of the cleanest lakes in Leon County. However, the western side of Lake Iamonia, the side closest to the Ochlockonee River, is borderline Eutrophic and considered as poor water quality. This depicts the influence of the Ochlockonee River on Lake Iamonia. The Ochlockonee River normally spills into Lake Iamonia through a series of sloughs at the western end of the lake about twice a year, during tropical or later winter storms.

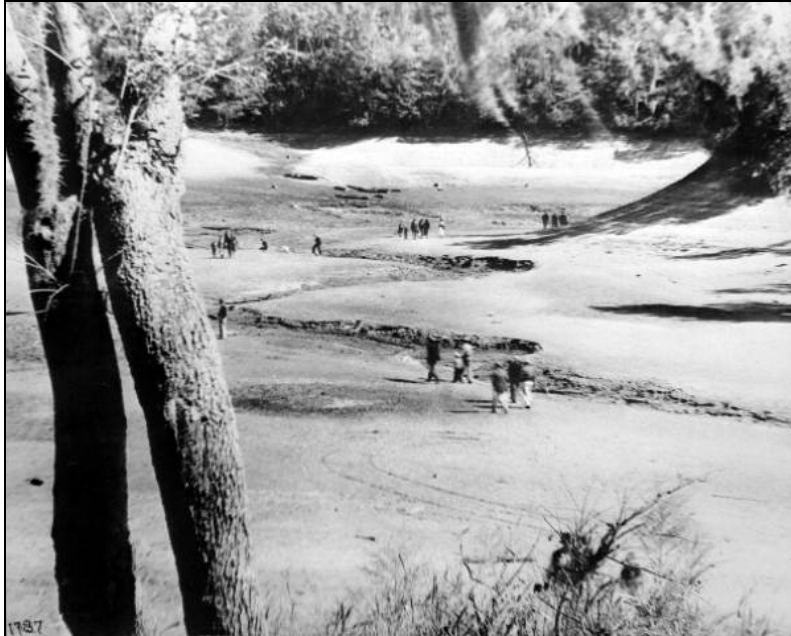
**Figure 4.3.9:** An early view of the Iamonia Sink basin (November 1934, Herman Gunter). The sink basin still looked like this in 2000 when Lake Iamonia went dry again.

Later management of the lake basin shifted to recreational usage such as boating, fishing, and duck hunting. In 1940 an earthen dike was built around the sink basin to keep water in Lake Iamonia. It was 1150 feet long, 150 feet broad at the base, 12 feet wide at the top, and 20 feet high. A concrete spillway was constructed as an overflow. 60-inch metal pipes with sluice gates were built into the earthen dikes at the sink. Sometime before 1950 additional earthen dams were built across Cromartie and Strickland Arms. The purpose of these dams was to keep water in Cromartie and Strickland Arms for the plantations.

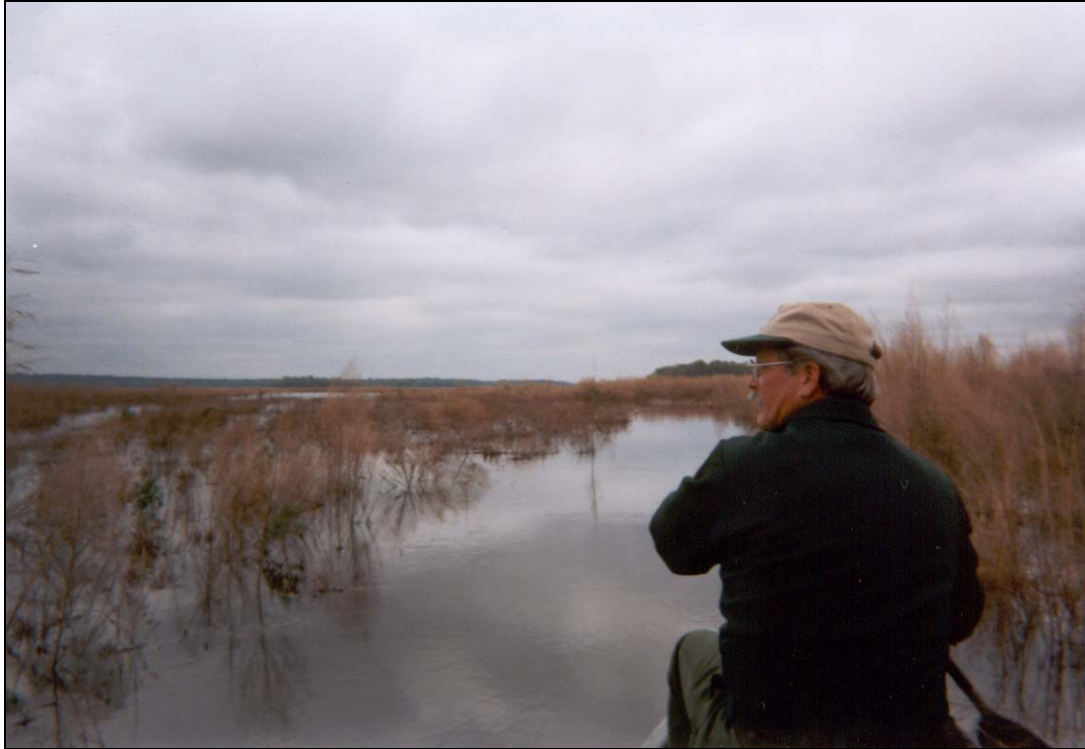
**Figure 4.3.11:** Lake Iamonia did eventually go dry during the drought that began in 1999. The deep central valley in Lake Iamonia remained full of water due to a berm in the channel at the dam at the sinkhole. The purpose of this berm was to keep a minimal amount of water in Lake Iamonia for fish populations so that the lake would not need restocking. This berm may have also retained enough water in Lake Iamonia during the drought to allow the aquatic plants to survive as well.

both the Meridian Road bridges and the Sink Basin (Wagner and Musgrove, 1983). The weirs and gates built to control the flow of the Ochlockonee into Lake Iamonia failed repeatedly and were removed by 1980. Attempts to draw Lake Iamonia down failed until the recent drought, and Lake Iamonia finally went dry in August 2000. Extensive cypress growth along the dam around the sinkhole caused the Northwest Florida Water Management District to condemn the structure, which had become unstable because of the tree roots penetrating it. Regulators determined that it might collapse during high water. The two sluice gates on the control structure are now welded open. The sink now drains continuously, just as it did before all these structures were built. However, the sink basin is still surrounded by the dams and flow through the sloughs is restricted.

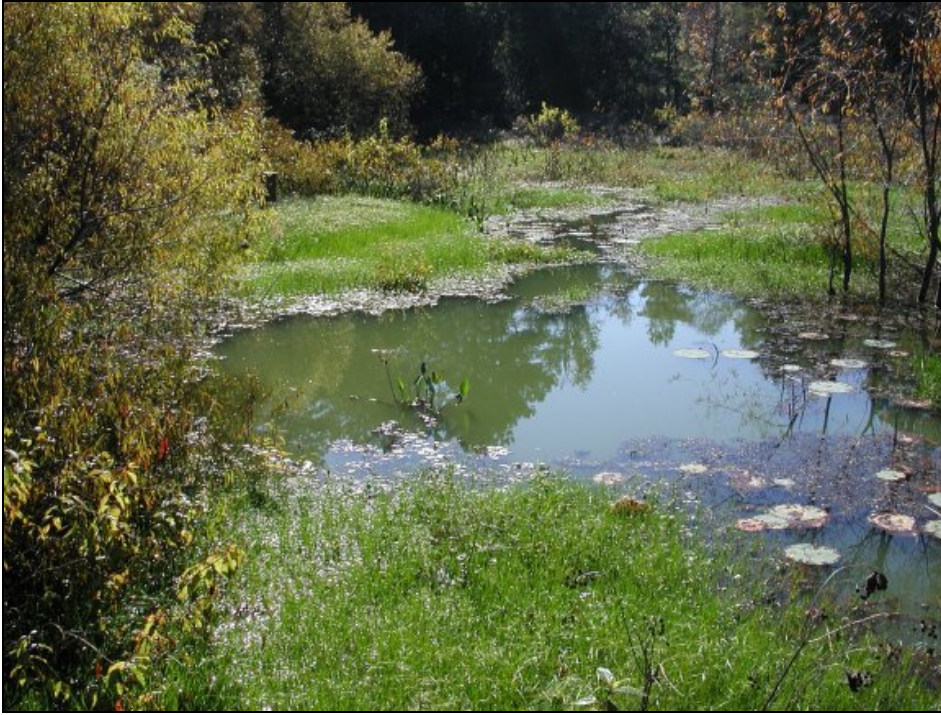
**Figure 4.3.12:** An algal bloom in Lester Creek inlet in Lake Iamonia (photo by Michael Hill, 11/03)

During these rains many of the septic tanks in the Killearn Lakes subdivision were found to be failing. Lester Creek, which drains the Killearn chain of lakes, has long been known to contribute pollutants to Lake Iamonia. Algal blooms occurred in Lester Cove.

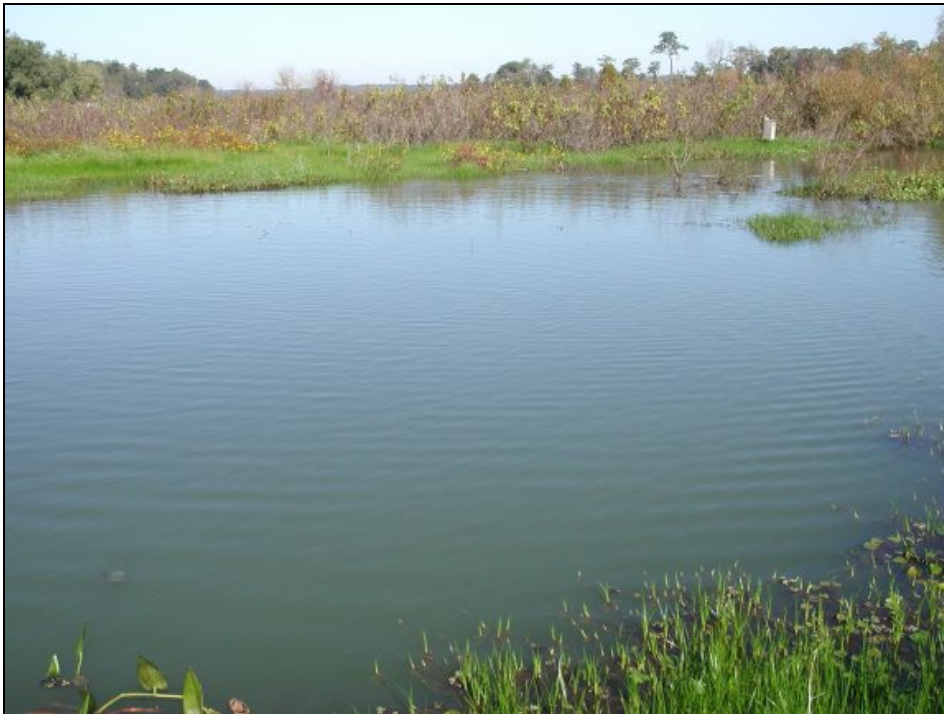
**Figure 4.3.13:** The same algal bloom further into lake Iamonia in Lester Cove (photo by Michael Hill, 11/03)

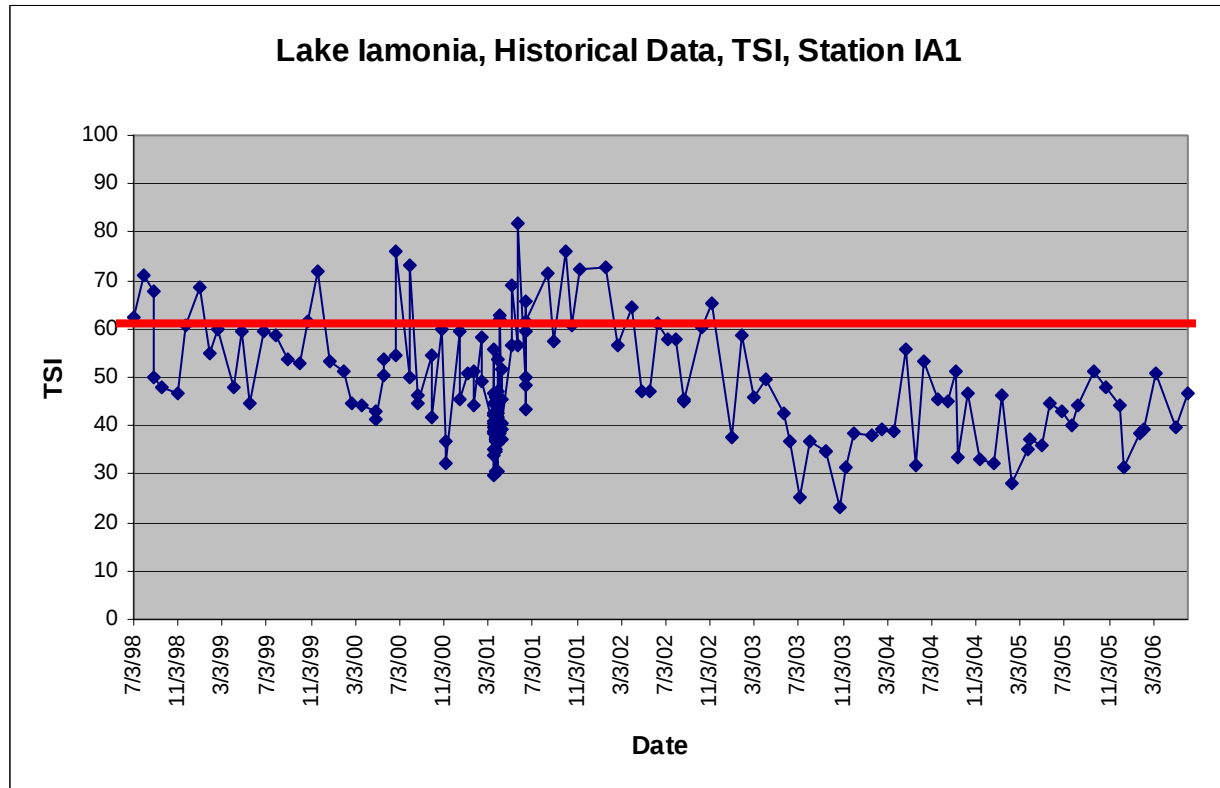
**Figure 4.3.14:** Lake Iamonia, Station IA1, at the slough connecting the lake to the Ochlockonee River, Tannic lake, According to FDEP criteria this lake would be impaired at TSIs greater than 60 units, Data source LCL Data (McGlynn Laboratories Inc). Data duration: 07/98-09/04

**\* Result: not impaired and stable.**

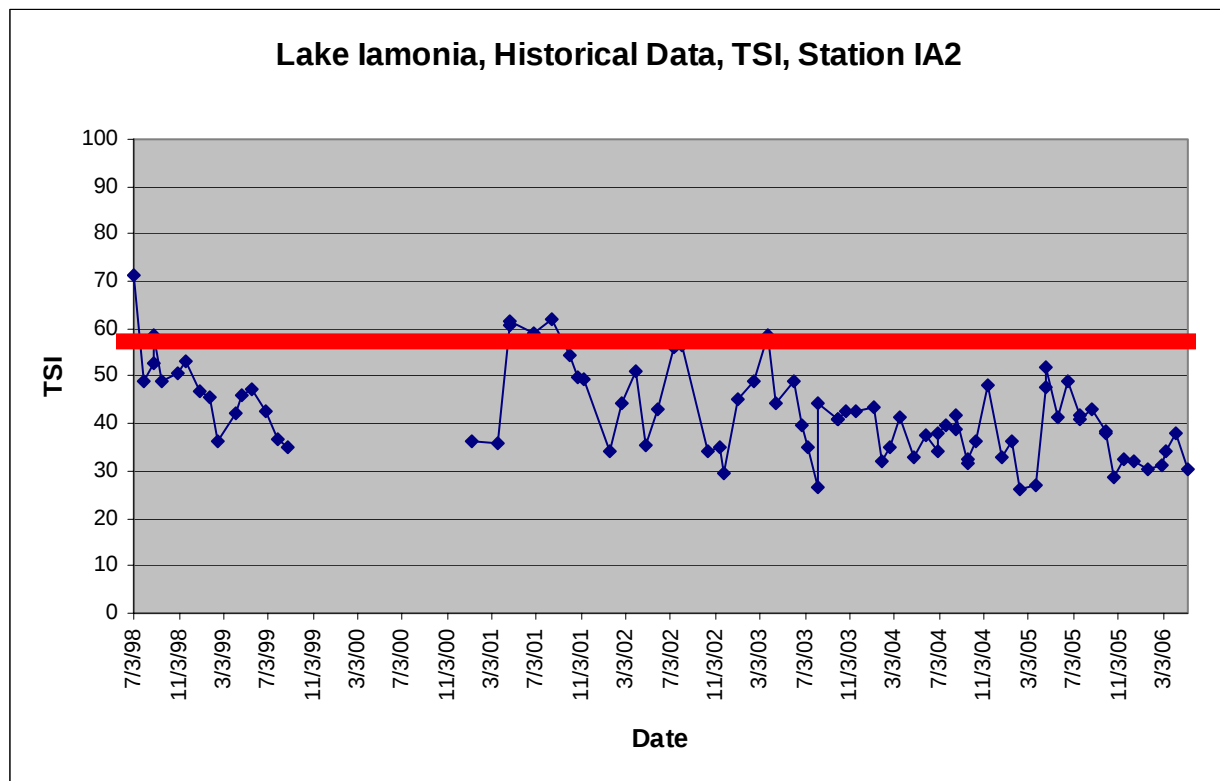
**Figure 4.3.15:** Lake Iamonia, Station IA2

Tannic lake,

According to FDEP this lake would be impaired at TSIs greater than 60 units,

**\* Result: not impaired and improving.**

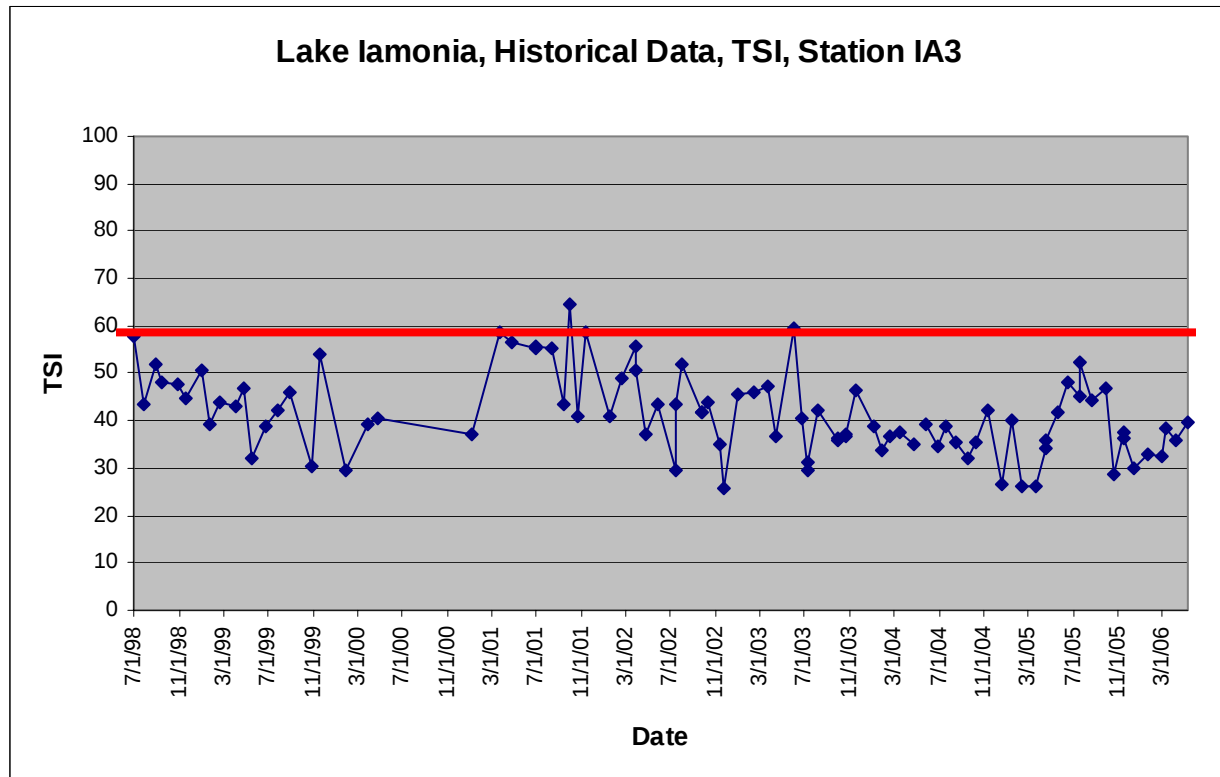
**Figure 4.3.16:** Lake Iamonia, Station IA3, near Bull Headly

Tannic lake,

According to FDEP criteria this lake would be impaired at TSIs greater than 60 units,

**\* Result: not impaired and stable.**

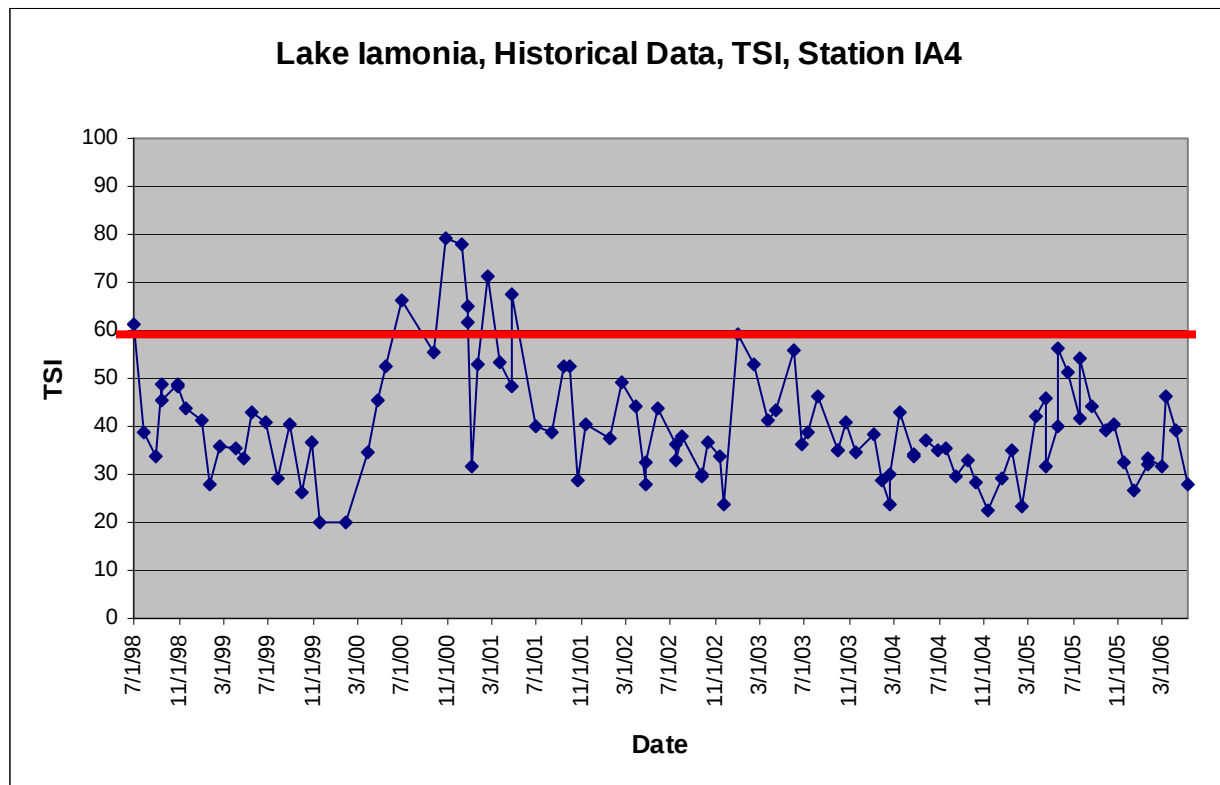
**Figure 4.3.17:** Lake Iamonia, Station IA4, Anders Flat, Tannic lake,  
According to FDEP criteria this lake would be impaired at TSIs greater than 60 units,  
Data source LCL Data (McGlynn Laboratories Inc).  
Data duration: 07/98-09/04

**\* Result: not impaired and improving (note drought effects, 2000-2001).**

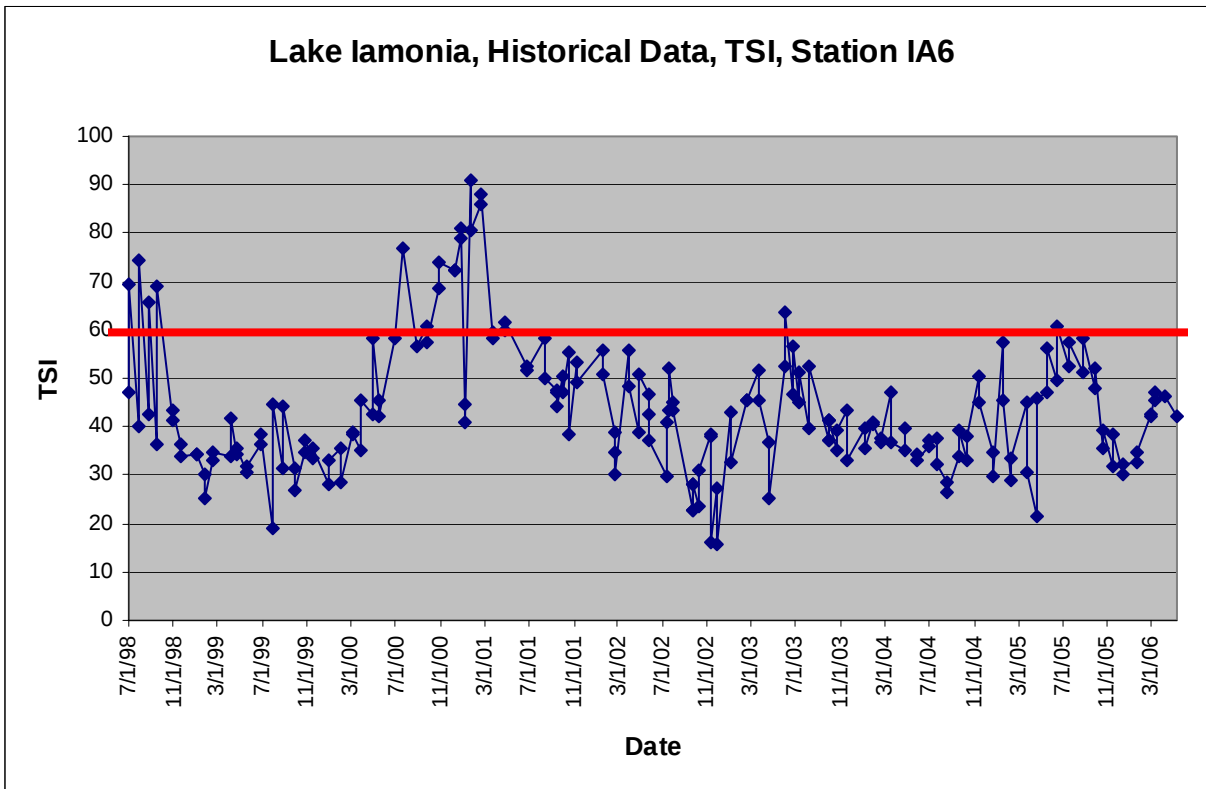
**Figure 4.3.19:** Lake Iamonia Station IA6, near Tall Timbers Research Station, Tannic lake,  
According to FDEP this lake would be impaired at TSIs greater than 60 units,  
Data source LCL Data (McGlynn Laboratories Inc).  
Data duration: 07/98-09/04

**\* Result: not impaired and improving (note drought effects, 2000-2001).**

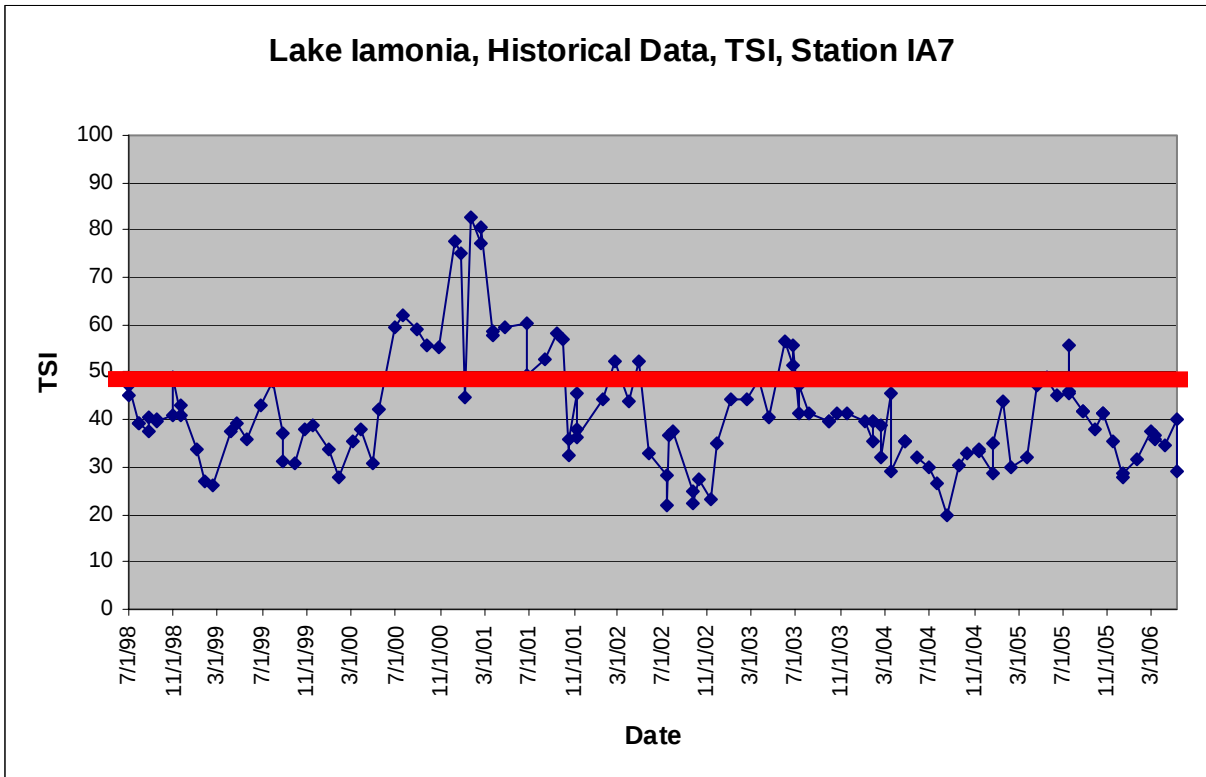
**Figure 4.3.20:** Eastern Lake Iamonia, Station IA7, at the eastern end Tannic lake, According to FDEP criteria this lake would be impaired at TSIs greater than 60 units, Data source LCL Data (McGlynn Laboratories Inc).

**\* Result: not impaired and improving (note drought effects, 2000-2001).**
