# The 1999 Draining of Lake Jackson - Photos and Bathymetric Map

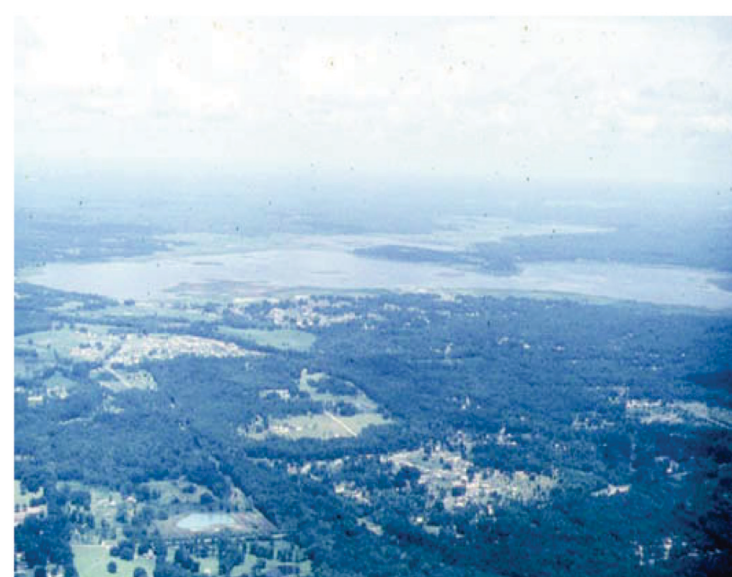
Aerial view of Lake Jackson containing water (Walt Schmidt).

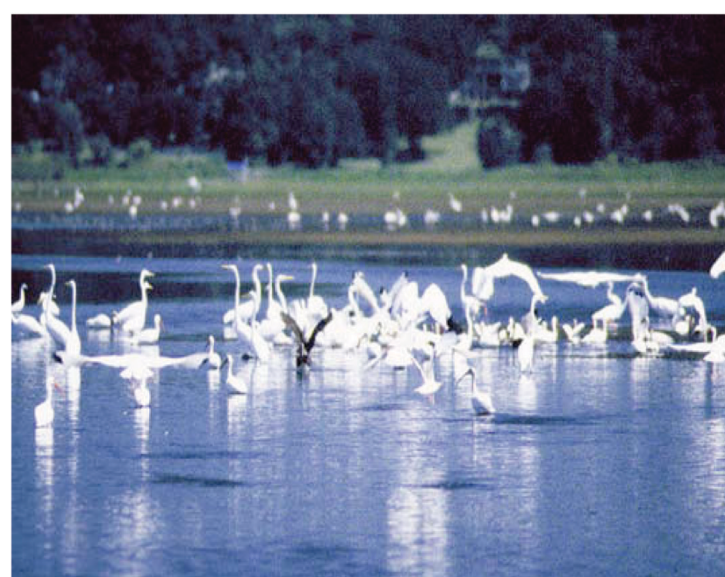
As the lake began to drain in September, 1999, flocks of birds gathered to feed on fish trapped in shallow pools by the receding water (Tom Scott).

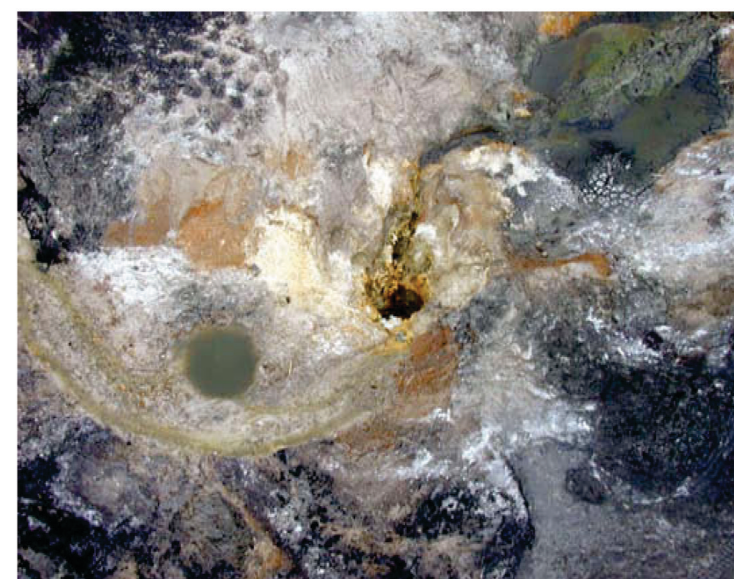
Aerial view of Porter Hole Sink (dark hole) through which the lake drained (Tom Scott).

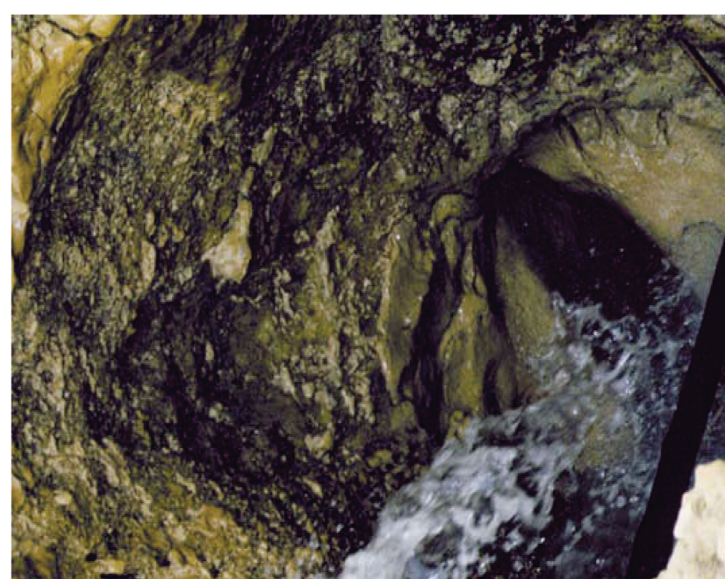
Close-up of water cascading into Porter Hole Sink (Tom Scott).

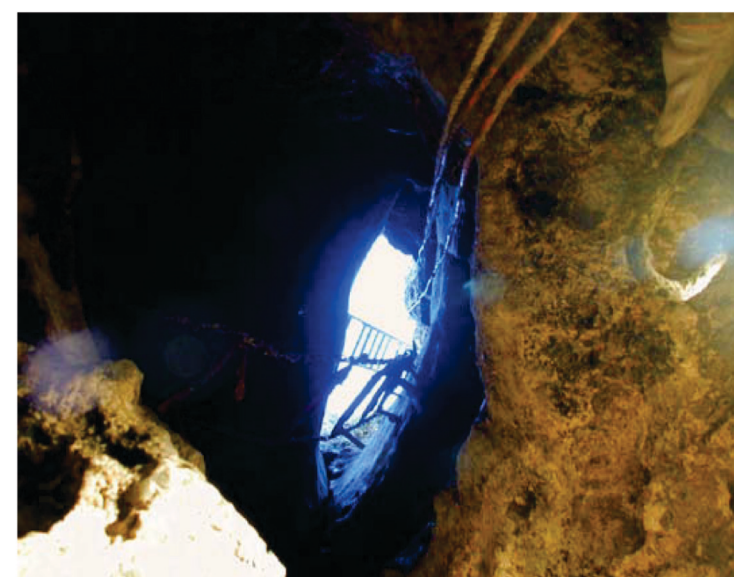
After the lake drained geologists entered Porter Hole Sink by ladder. This view is taken from a cavern at the base of the sink, looking up at the slit-like opening to the surface (Tom Scott).

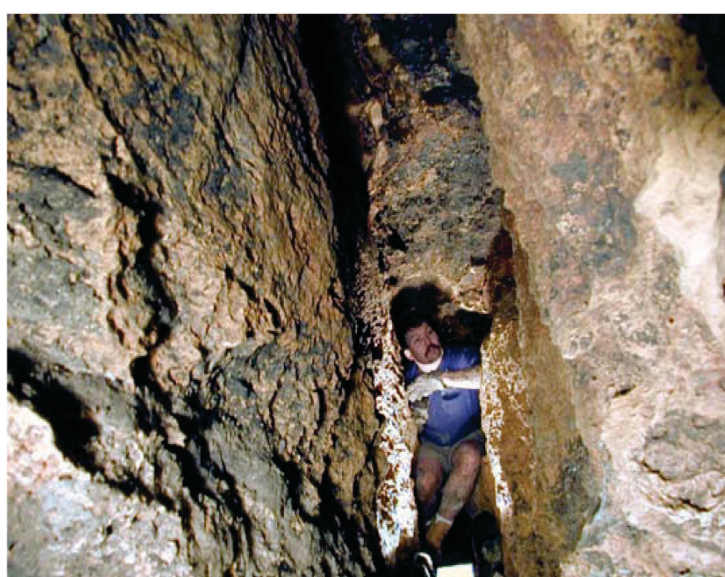
Geologist standing in the narrow passage leading from the cavity beneath Porter Sink towards a nearby plugged sink (Tom Scott).

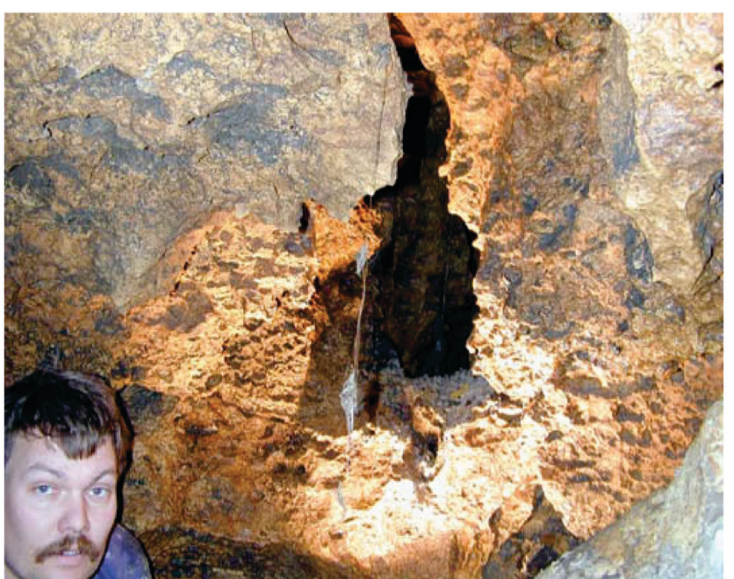
A cavity at the end of the cave passage where clay, boulders, and monofilament fishing line (hanging in center of picture) from the lake have slumped into the cave from an adjacent sink.

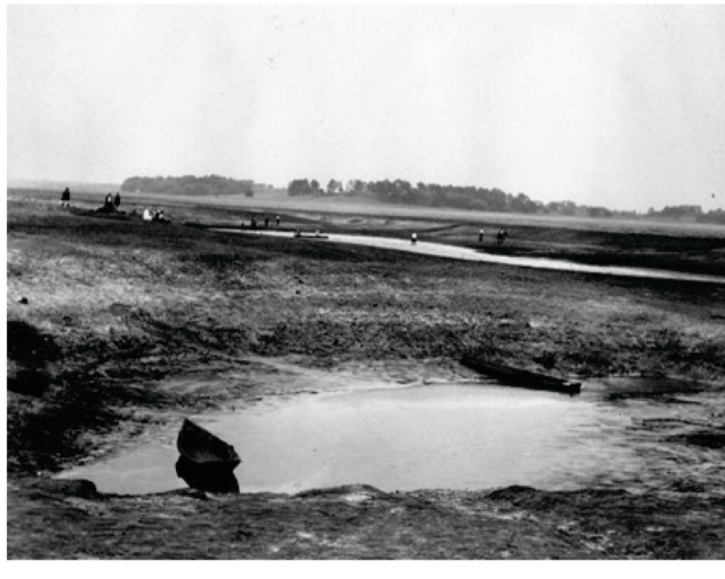
Drainage events are not a recent phenomenon. A photo from 1907 showing the dry lakebed after a June drought (Herman Gunter).
