# First Magnitude Springs of Florida

FLORIDA GEOLOGICAL SURVEY  
OPEN FILE REPORT NO. 85

**FIRST MAGNITUDE SPRINGS OF FLORIDA**

Thomas M. Scott, Guy H. Means,  
Ryan C. Means, and Rebecca P. Meegan

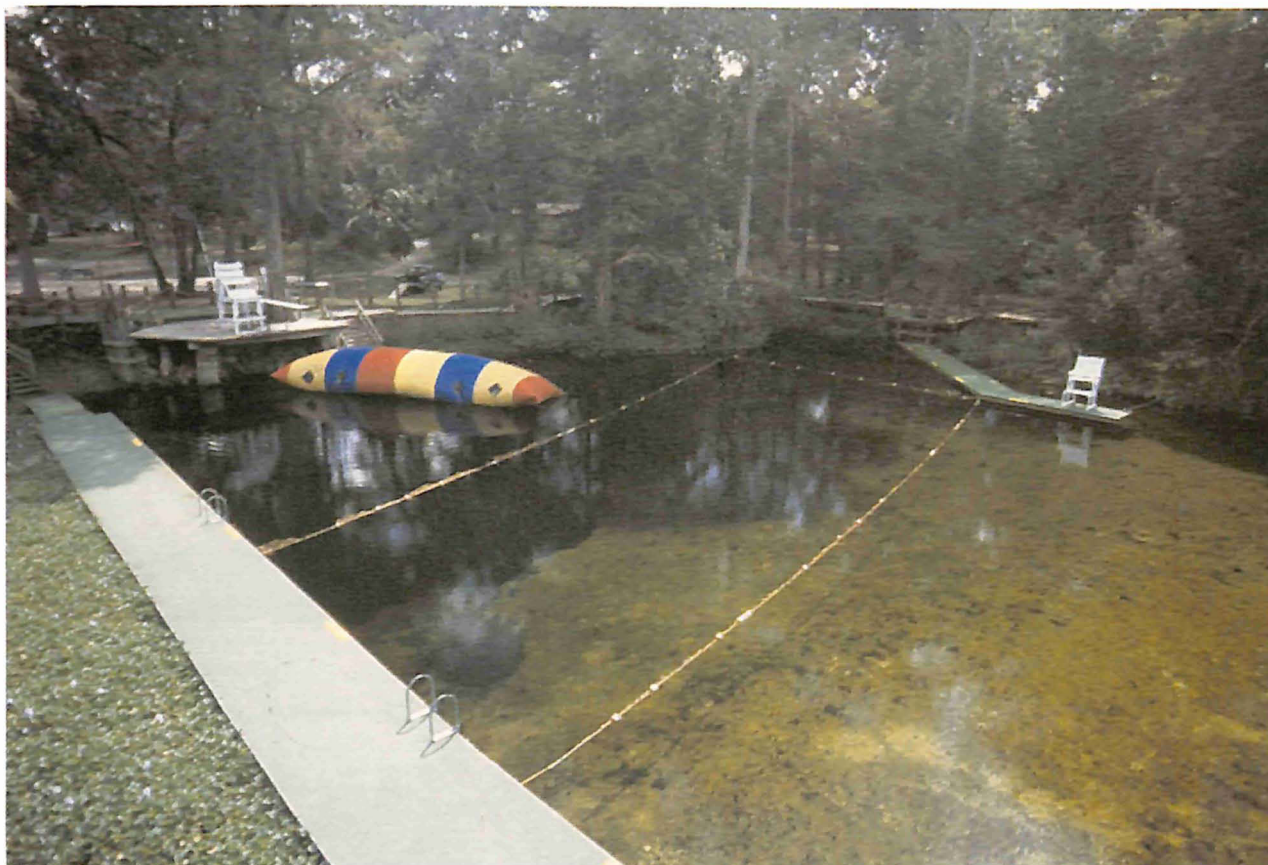
Figure 9. Hornsby Spring (photo by T. Scott).

**Description** - Hornsby Spring has a circular spring pool measuring 155 ft (48 m) north to south and 147 ft (45 m) east to west. Its depth is 34.5 ft (10.6 m). The water is clear and slightly greenish blue. The spring has an underwater limestone ledge on the north side under a floating walkway. Algae patches are growing on limestone substrates. The spring run flows generally westward into the Santa Fe River. A small spring boil is visible near the wooden walkway. This spring is situated on the edge of the lowland floodplain of the Santa Fe River. The floodplain is forested with cypress, gum, and maple. High ground on the east side of the spring rises steeply to 6 ft (2 m) above water level, then gently rises to approximately 15 ft (4.5 m) and is a rolling sandhills terrain. The uplands are open and grassy.

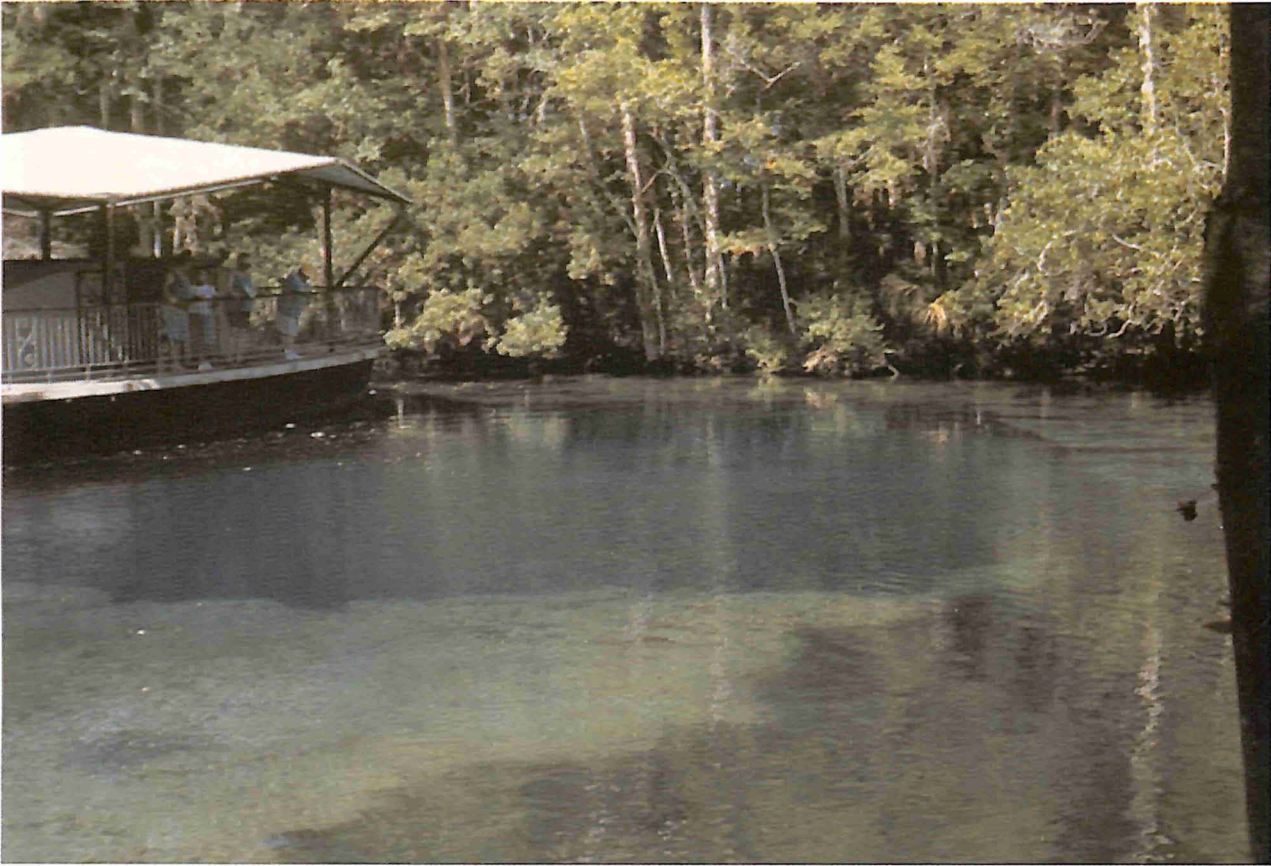
Figure 17. Homosassa Springs Group (photo by J. Stevenson).

HOMOSASSA SPRINGS NOS. 1, 2, and 3 - All three vents issue out of the same spring pool. The pool measures 189 ft (58 m) north to south and 285 ft (89 m) east to west. Depth for each of the vents is 67, 65, and 62 ft (20.4, 19.8, and 18.8 m) for spring nos. 1, 2, and 3, respectively. The springs issue from a conical depression with limestone outcropped along the sides and bottom of the spring pool. Pool is teeming with saltwater and freshwater fishes. Water is clear and light blue. There is a large boil in center of pool. Surrounding land is Gulf Coastal Lowlands with thick hardwood-palm forest cover. Approximately 1000 ft (305 m) downstream, a fence spans across the river to keep boats out of the spring pool.

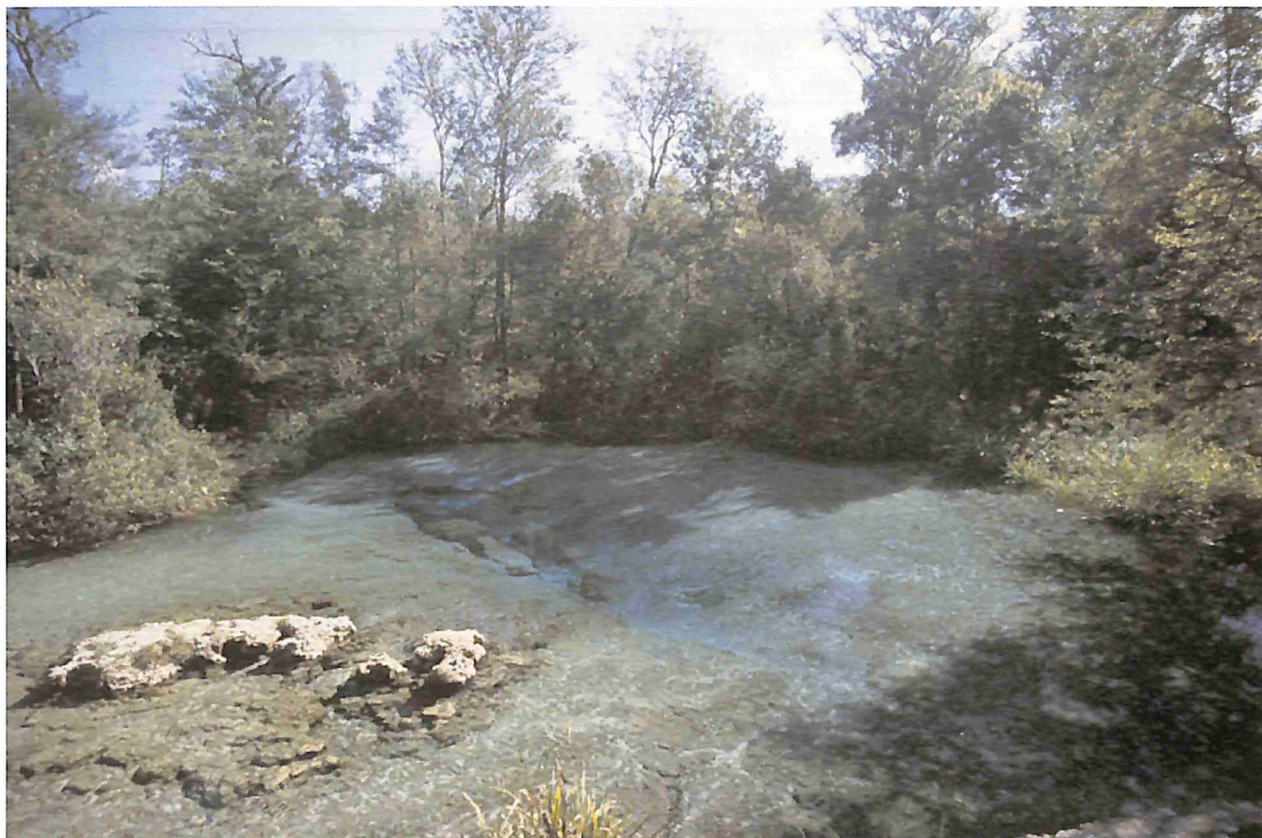
Figure 24. Ichetucknee Springs Group, Ichetucknee Head Spring (photo by T. Scott).

ICHETUCKNEE HEAD SPRING - Lat. 29° 59' 03.1" N, Long. 82° 45' 42.7" (SE/NE/NE/sec. 12, T. 6 S, R. 15 E). This spring forms the head of the Itchetucknee River. The spring pool measures 102 ft (31 m) east to west and 87 ft (27 m) north to south. Depth measures 17 ft (5m) over the vent. Water is clear and sky blue and issues vertically from a crack in the bedrock limestone forming a visible boil. A thin, transparent layer of algae carpets most of the bottom of the spring. Spring has sandy and rocky bottom with little or no aquatic vegetation. North and east shorelines have thick emergent grass and shrubs, west shore is near high ground sloping to approximately 15 ft (4.5 m) above water. All surrounding land is densely forested. Restroom facilities are about 200 ft (61 m) west. This spring is easily accessed by a path and is a well used swimming hole.

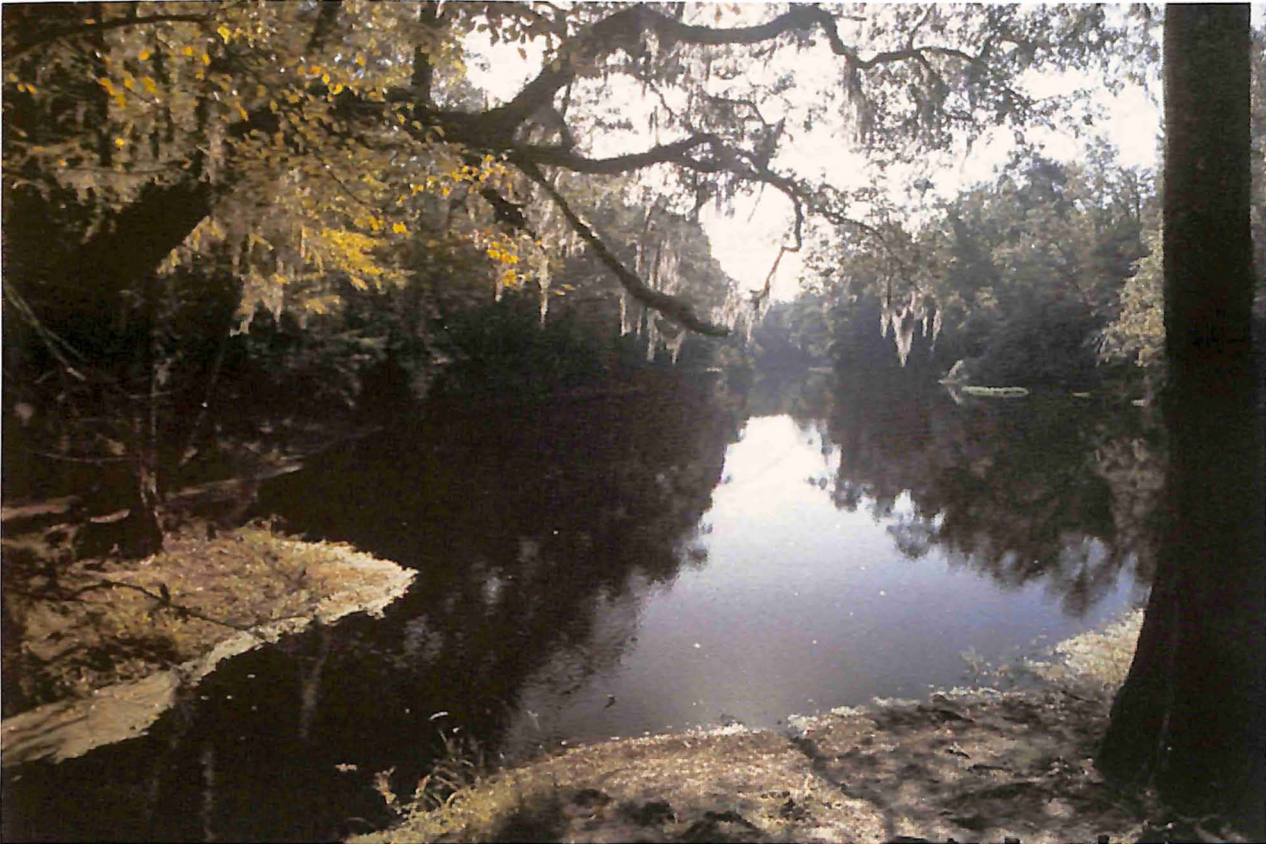
Figure 27. Santa Fe River Rise (photo by T. Scott).

**Description** - Santa Fe Rise is the re-emergence of the underground Santa Fe River. The spring pool measures 175 ft (53 m) east to west and 165 ft (50 m) north to south. There is a vertical limestone ledge on the northeast side of the pool, and the depth just south measures 49 ft (15m). The water color is typically that of the Santa Fe River, which may be tannic or clear depending mainly on rainfall. No boil was observed during the October 2001 visit. The river flows southward from the vent and is approximately as wide (east to west) as the spring pool. There is a narrow band of cypress growing around pool perimeter. There are patches of duckweed around the periphery of the pool, and no aquatic vegetation could be seen through the tannic water. Several hundred yards of the Santa Fe River below Santa Fe Rise is choked with water hyacinth, and boat access to the rise is nearly impossible. Land around the river rise quickly rises to approximately 8 ft (2.5 m) above water level and levels off into a flat mesic hardwood hammock.

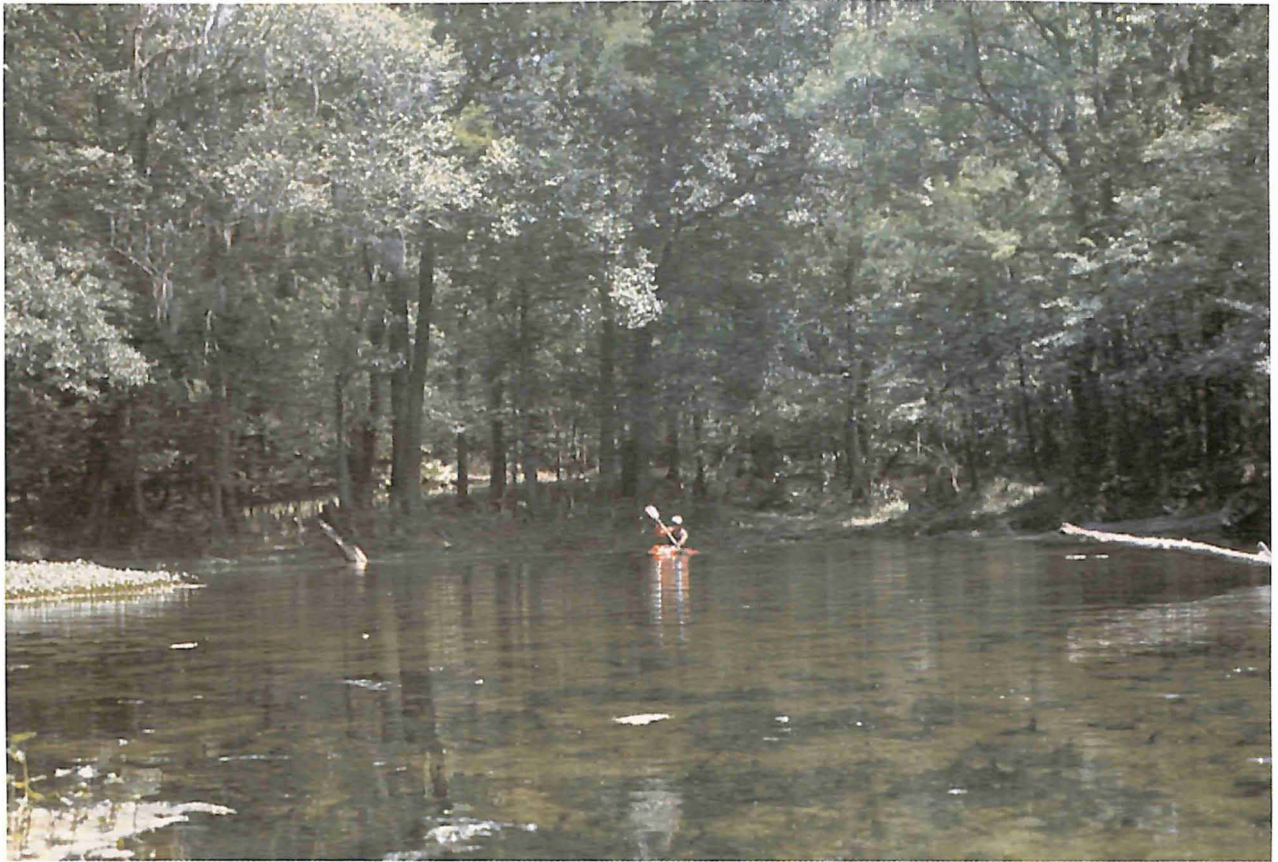
Figure 29. Treehouse Spring (photo by J. Stevenson).

**Description** - Treehouse Spring is in a circular cove on the east side of the Santa Fe River. The spring discharges westward into the adjacent river. Spring pool diameter measures 125 ft (38 m) north to south and 175 ft (53 m) east to west. Pool depth is 31 ft (9.4 m). Water color was tannic, and there was no spring boil during October 2001. Water hyacinth was the only non native plant species observed in the spring pool. No other vegetation could be seen through the dark water. Land adjacent to this spring is a forested lowland flood plain. The nearest high ground is approximately 150 ft (46 m) to the east, and it rises 10-12 ft (3-4 m) higher than the flood plain and is forested with mixed hardwoods and pines.

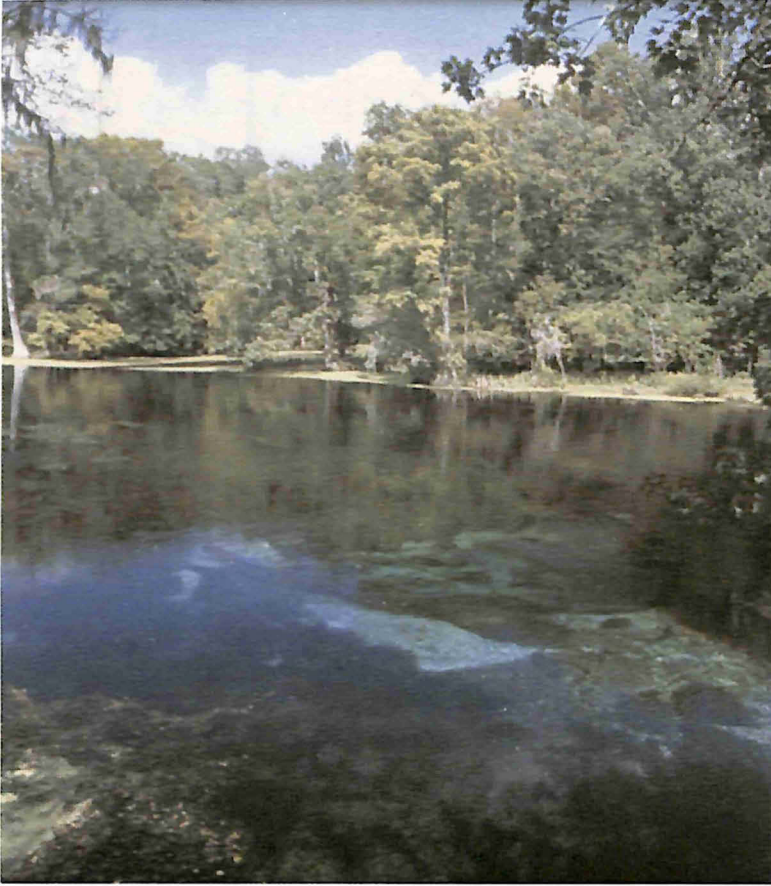
Figure 31. Devil's Ear Spring (photo by H. Means).

of a 375 ft (114 m) long spring run that enters into the Santa Fe River from the south trending side. It is an elongated limestone fissure that discharges directly into the adjacent Santa Fe River. Dark water from the river contrasts distinctly with clear bluish water issuing along the side of the river. There is a large boil over the spring vent. The spring pool measures approximately 105 ft (32 m) east to west and 60 ft (18 m) north to south. The vent is an oval shaped opening in bedrock limestone with steep sides leading down to a depth of 34 ft (10.5 m). Native aquatic grasses are common around the vent opening, and some algae are on grass blades and limestone walls. The banks on the south trending side of the river (and therefore the spring) rise steeply to approximately 3 ft (1 m) above water level, then levels off. On top of the bank, a mesic hardwood forest with interspersed clearings is present.

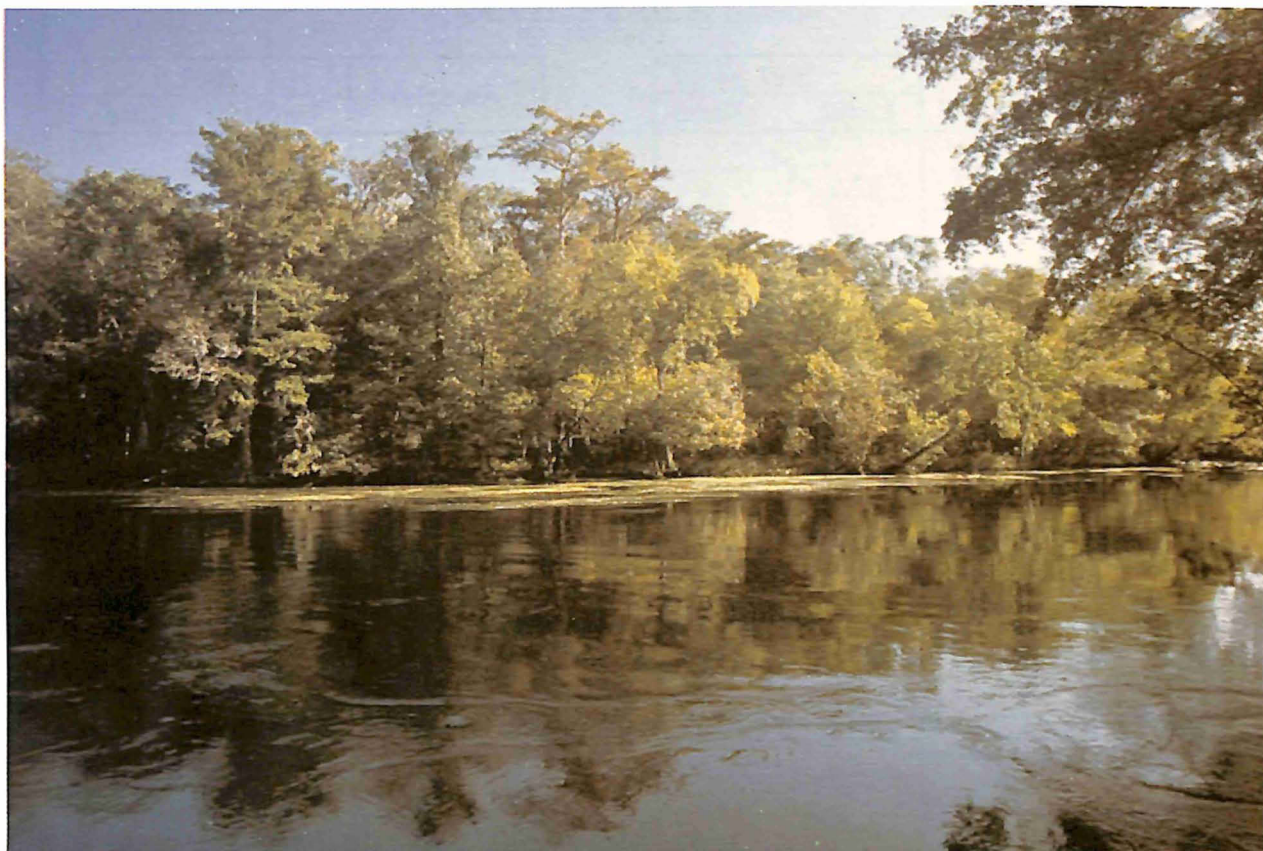
**Figure 33. Siphon Creek Rise (photo by T. Scott).**

**Location** - Lat. 29° 51' 22.3" N, Long. 82° 43' 59.0" W (SW/SW / SE/sec. 20, T. 7 S, R. 16 E). The rise is approximately 4 miles (6.4 k'm) south of Fort White on the Santa Fe River. Take SR 47 south from Fort White to the boat launch on the Santa Fe River. River rise is upstream approximately 1 mile (1.2 km). The creek rise is boiling up on the south trending side of the river at the mouth of Siphon Creek.

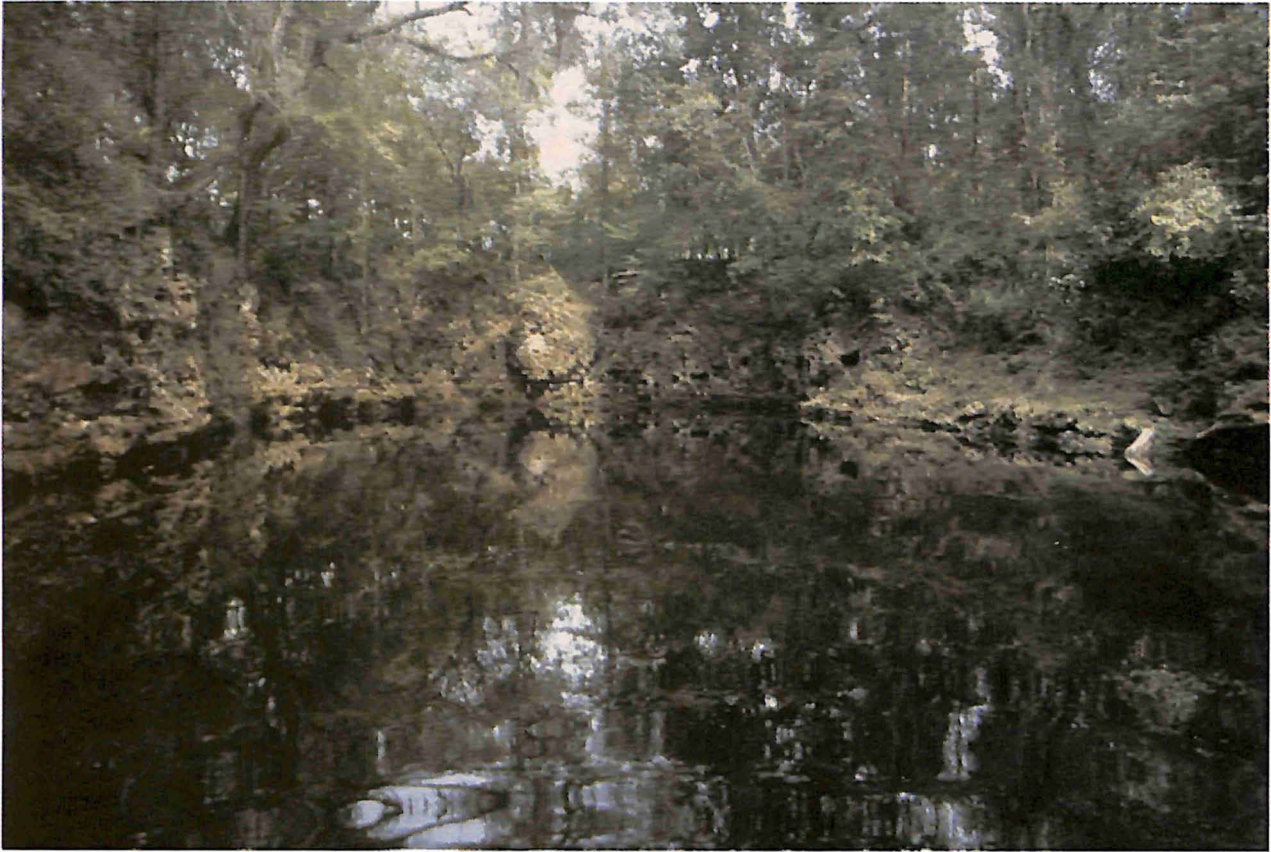
Figure 35. Alapaha River Rise (photo by T. Scott).

**Location** - Lat. 30° 26' 20.3" N, Long. 83° 05' 22.4" W (NW/SW/SE/sec. 35, T. 1 N, R. 12 E). The river rise is approximately 19 miles (31 km) southeast of Madison on the north side of the Suwannee River. Drive 8.7 miles (14 km) east of the Withlacoochee River on SR 6. Turn south and drive 2.8 miles (4.5 km), then 1 mi (1.6 km) east across the Alapaha River and 1 mile (1.6 km) southwest of a park and boat launching area on the Suwannee River. The spring is approximately .3 miles (.5 km) east.

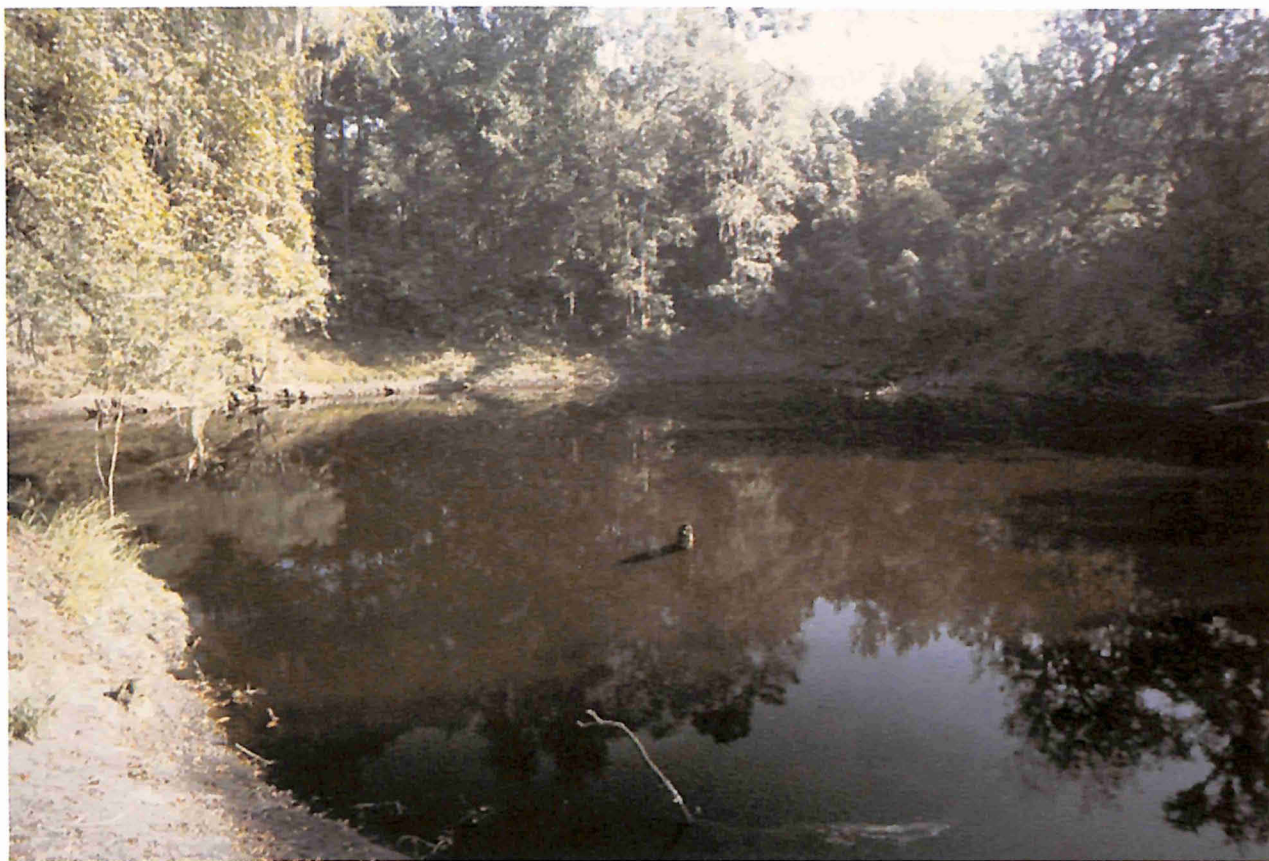
Figure 37. Holton Creek Rise (photo by T. Scott).

**Location** - Lat. 30° 26' 16.5" N, Long. 83° 03' 27.4" W (NW/SE/SW/sec. 31, T. 1 N, R. 13 E). The river rise is 11 miles (17 km) northwest of Live Oak on SRWMD land. From Live Oak, drive northwest on CR 751 (Noble's Ferry Rd.). Take the second right on a graded road after crossing over the Suwannee River. Follow SRWMD signs to Holton Creek. The spring is at the head of the creek.

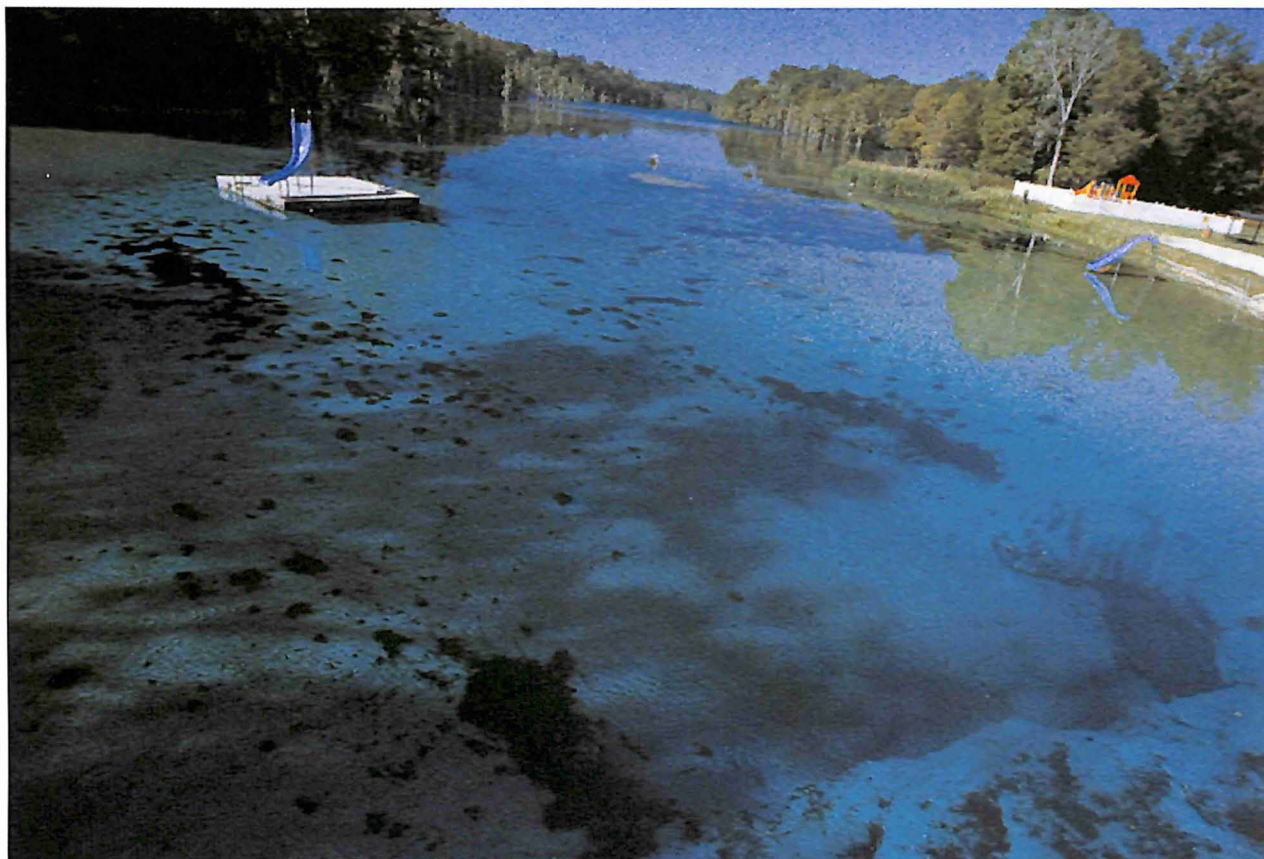
**Figure 41. Jackson Blue Spring (photo by T. Scott).**

**Description** - Numerous springs feed Merritts Mill Pond. Jackson Blue Spring is the main spring at the head of the pond. It is situated about 10 ft (3 m) west of the diving board platform. Clear bluish water issues vertically from a conical depression. Maximum depth over the vent is 16.5 ft (5 m). Vent diameter is about 5 ft (1.5 m). Limestone is exposed near the vent, and it bears back-hoe scars. Spring pool diameter is approximately 240 ft (73 m) southwest to northeast and 233 ft (71 m) northwest to southeast. The boil is slightly visible at the surface. There is approximately 40% algae coverage on the pool bottom and very little aquatic or emergent vegetation. The spring pool is a designated swimming area separated from the rest of Merritts Mill Pond by a chain link fence across the channel approximately 100 yds (92 m) downstream. The southern shore of the spring pool meets a lowland cypress-gum forest. The northern half of the pool is bordered by high ground sloping upward to nearly 20 ft (7 m) above water level. Most of the high ground is cleared and grassy. All nearby uplands are developed with numerous buildings, concrete retaining wall near shore, slides, diving board, picnic tables, and parking area.

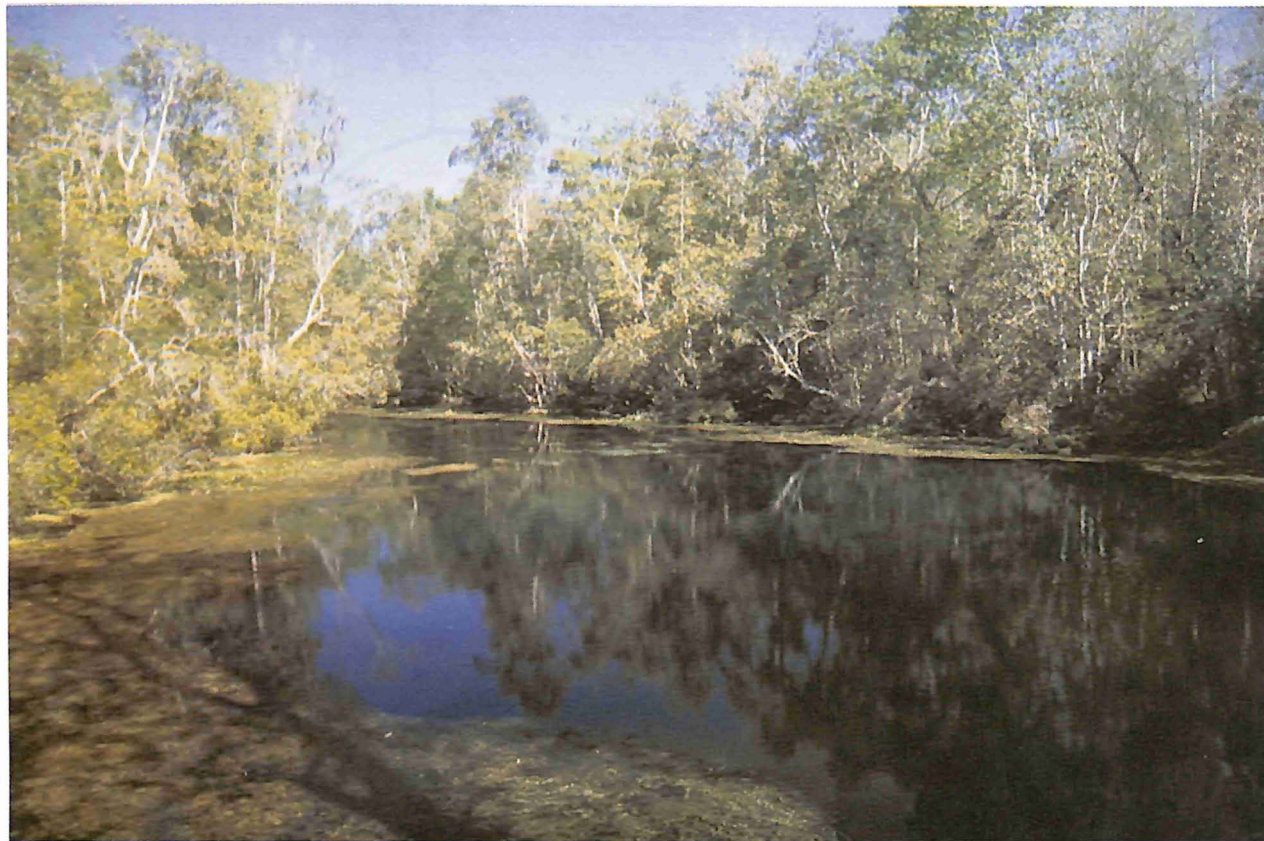
Figure 43. Wacissa Springs Group, Big Spring (Big Blue Spring) (photo by R. Means).

**Group Location** - Lat. 30° 20' N, Long. 83° 59' W (Sections 2 and 12, T. 2 S, R. 3 E). The Wacissa Springs are approximately 19 miles (30 km) southwest of Tallahassee and 1.2 miles (2 km) south of the town of Wacissa. SR 59 runs south out of Wacissa and turns sharply to the west after less than 1 mile (1.2 km). At this sharp right turn, a paved county road continues straight and ends 0.6 miles (0.9 km) beyond at a county park and boat ramp adjoining the head of the Wacissa River on the east side.

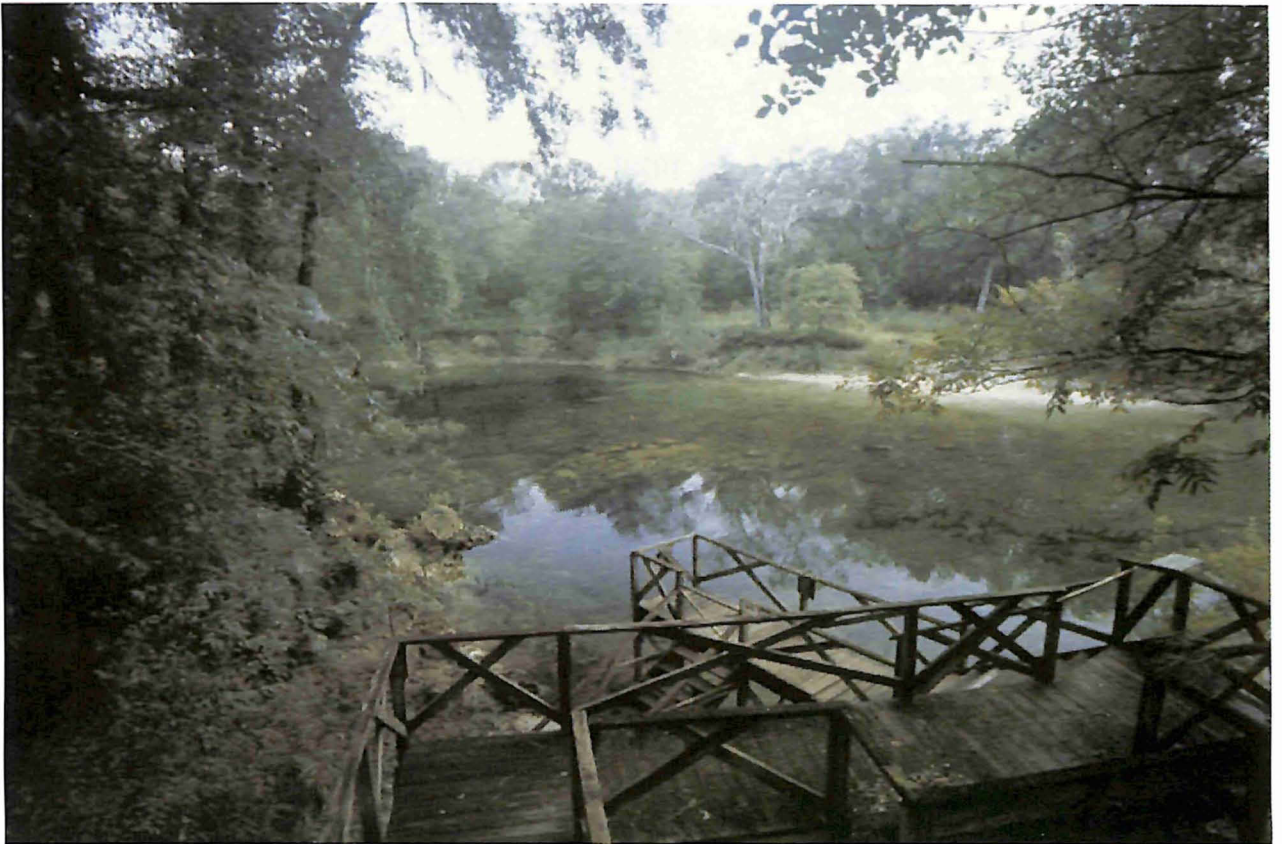
Figure 47. Troy Spring (photo by T. Scott).

**Location** - Lat. 30° 00' 21.7" N, Long. 82° 59' 51.0" W (NW/NE/SE/sec. 34, T. 5 S, R. 13 E). Troy Spring is located 5.5 miles (8.5 km) northwest of Branford and flows into the Suwannee River. From the intersection of US 129 and US 27 in Branford, travel northwest on US 27 for 5.3 miles (8.5 km). Turn right on a paved road across highway from white house and go north 1.3 miles (2 km). As the paved road curves left, there is a small green house trailer on the right. Turn onto the dirt road that runs between the trailer and a fence line, and travel 0.6 miles (1 km) to the spring.

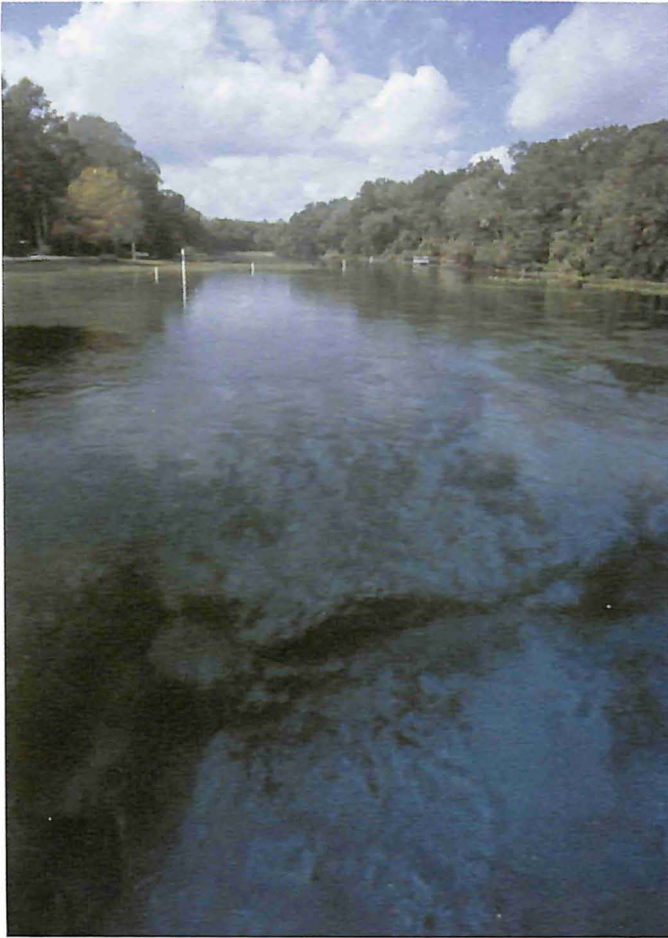
Figure 49. Alexander Spring (photo by T. Scott).

**Location** - Lat. 29° 04' 52.7" N, Long. 81° 34' 33.2" W (Levy Grant 39, T. 16 S, R. 27 E). Alexander Spring is approximately 17 miles (27.5 km) northwest of Deland in the Ocala National Forest. Travel west on SR 40 from Ocala. Turn right on CR 445A just before the town of Astor. Follow 445A past the sharp turn to the east. Entrance to Alexander Springs Recreation Area will be on the right. Follow signs to parking area.

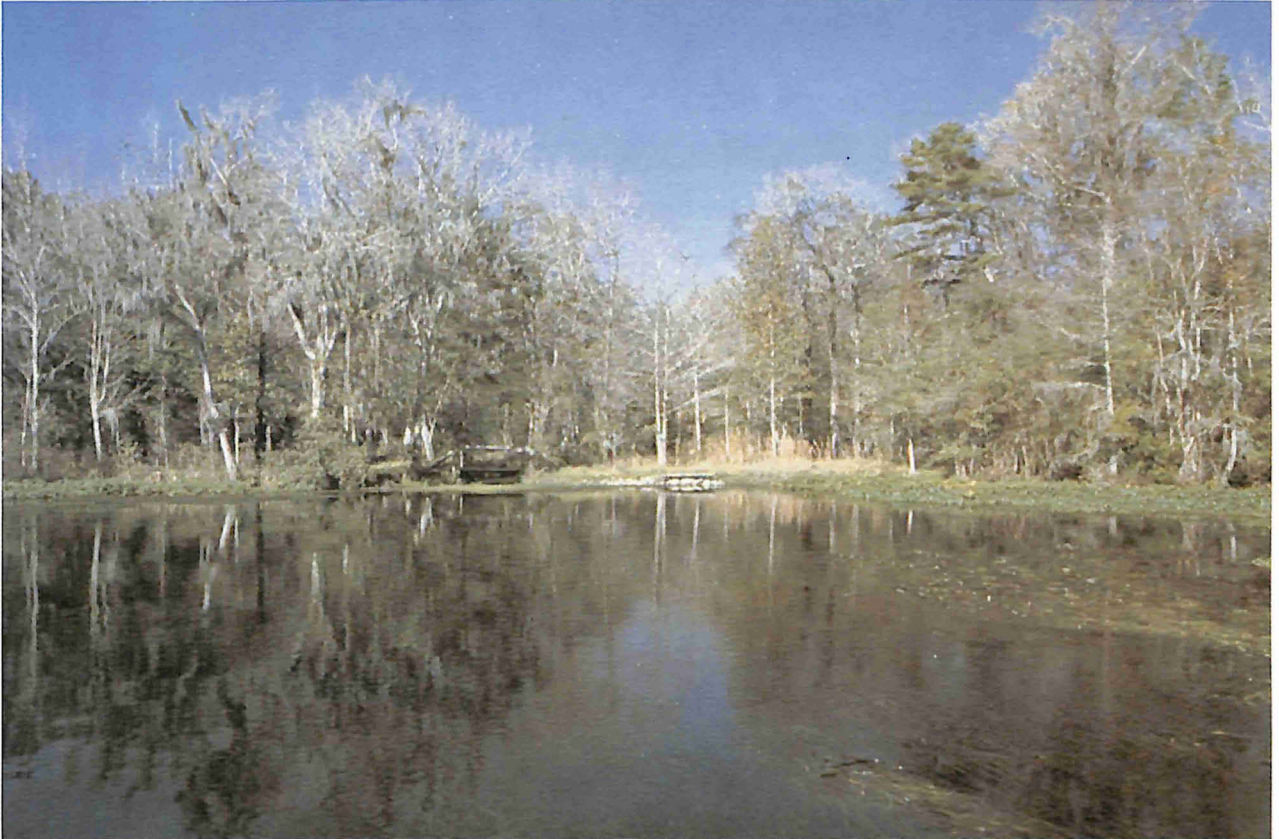
Figure 51. St. Marks River Rise (photo by H. Means).

**Location** - Lat. 30° 16' 33.8" N, Long. 84° 08' 56.2" W (NE/SW/SE/sec. 29, T. 2 S, R. 2 E). St. Marks River Rise is located 0.6 miles (0.9 km) south of Natural Bridge Battlefield Park. The River Rise is on private property but can be accessed by small boat. From the intersection of SR 267, drive east on US 98 to the public boat ramp sign on the east side of the St. Marks River. St. Marks River Rise is 6.5 miles (10.5 km) upstream from the boat ramp.

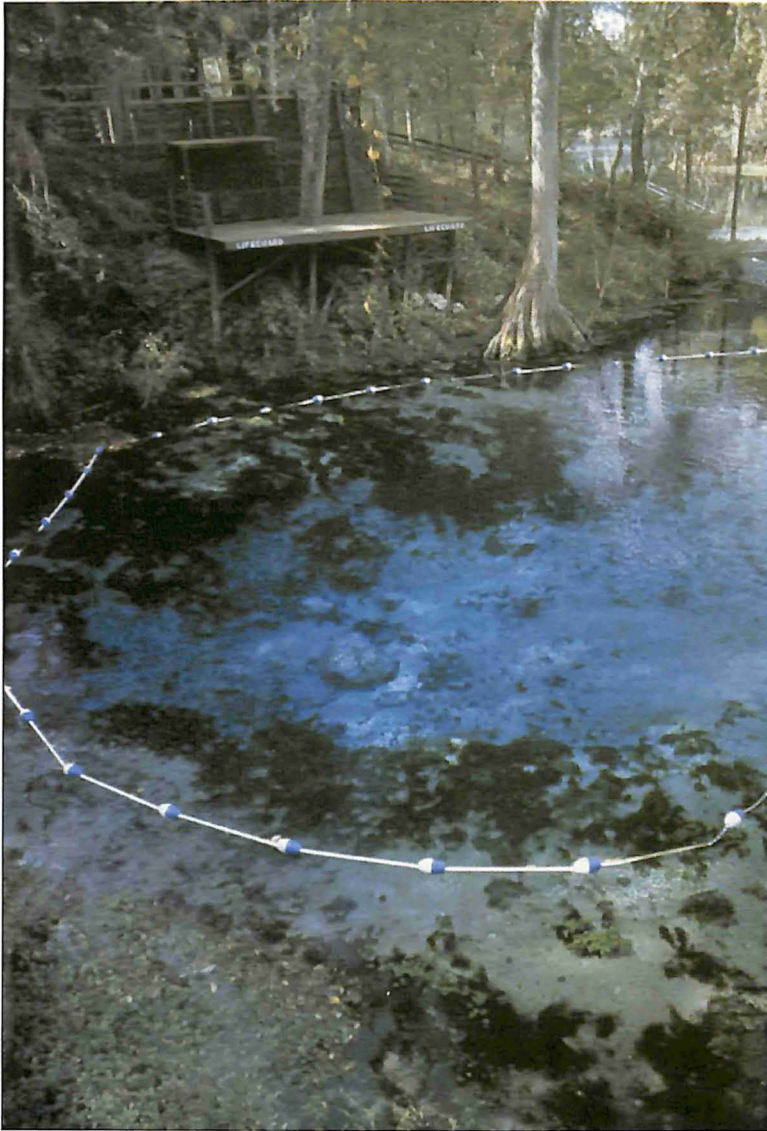
Figure 53. Fanning Spring (photo by H. Means).

**Location** - Lat. 29° 35' 15.3" N, Long. 82° 56' 07.1" W (SW/NE/NW/sec. 29, T. 10 S, R. 14 E). Fanning Springs is located in Fanning Springs Park in the town of Fanning Springs. Park entrance is located on the east side of the Suwannee River on US 98/19/27. Follow access road to parking lot. Spring vent is southwest of parking area.

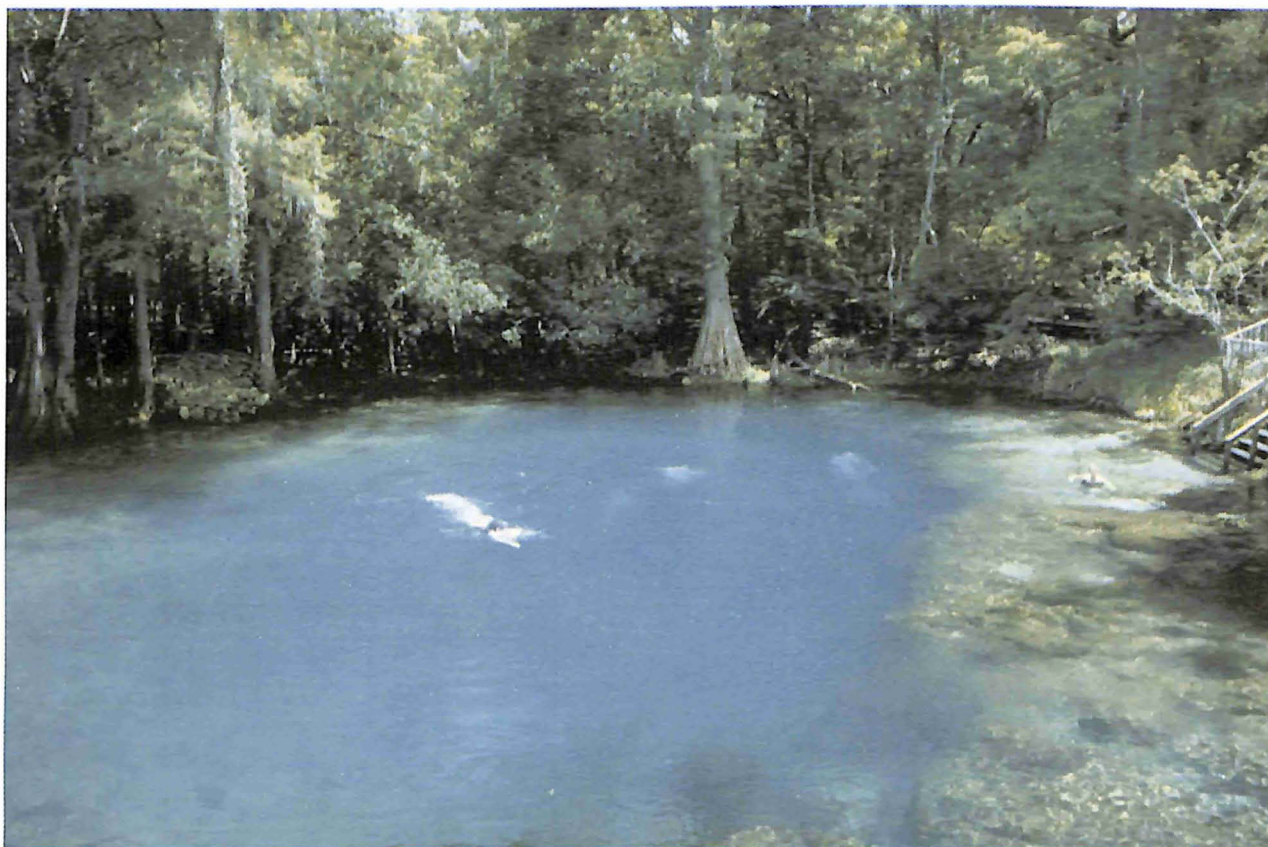
Figure 55. Manatee Springs main spring (photo by T. Scott).

**Description** - Manatee Springs and its issuing spring run are on the east side of the Suwannee River within the densely wooded, lowland floodplain. The spring discharges vertically in a conical sink depression. The spring pool measures 60 ft (18 m) north to south and 75 ft (23 m) east to west. The depth of the spring pool is 17 ft (7.7 m). There is a tremendous boil associated with this spring. Divers report that entry into the vent against the current is very difficult. The bottom of the spring pool is sandy with numerous submerged logs. There is a limestone ledge 3 ft (1 m) below the water surface and vertical cliff on the south side of the spring pool where wooden steps lead down into the water for swimming access. Thick algae covers approximately 75% of the inundated limestone ledge and cliff face. The water is sky blue. Native aquatic grasses inhabit the spring run. There are many cypress trees and knees on the north and east shores of the spring pool. The spring run flows southward to the Suwannee River approximately 1200 ft (365 m). Uplands on the south side of the spring rise to approximately 15 ft (4.5 m) above the water level and are developed into a swimming and recreation area underneath a thick canopy of live oak and pine. There are numerous walkways and a rock wall along the south shore of the spring pool. The north shore is relatively pristine and wooded.

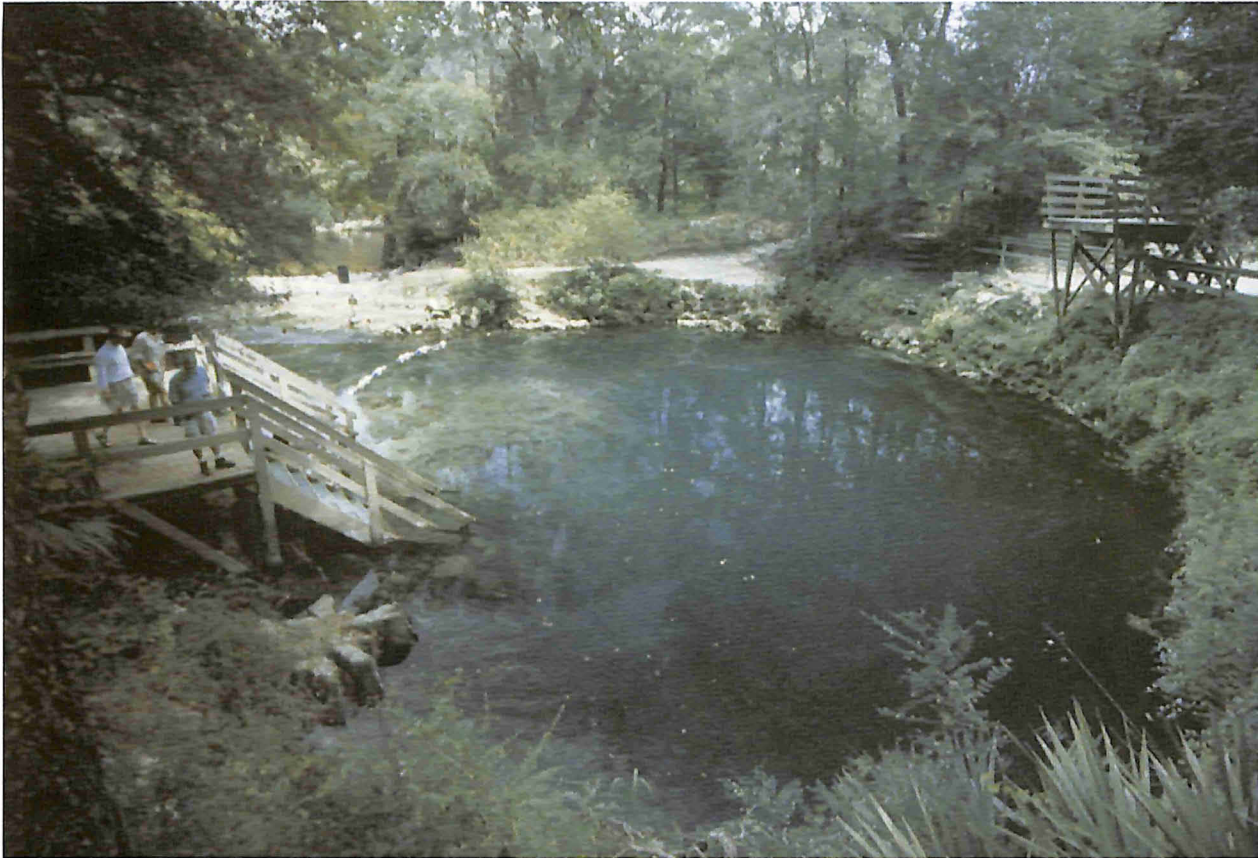
Figure 57. Madison Blue Spring (photo by T. Scott).

**Location** - Lat. 30° 28' 49.6" N, Long. 83° 14' 39.7" W (SW / SE / SW / sec. 17, T. 1 N, R. 11 E). Madison Blue Spring is approximately 10 miles (16 km) east of Madison on the west bank of the Withlacoochee River. From Madison, drive east on SR 6 to the Withlacoochee River. Turn south on the west side of the bridge at the park sign. Spring is 525 ft (160 m) south of the highway.

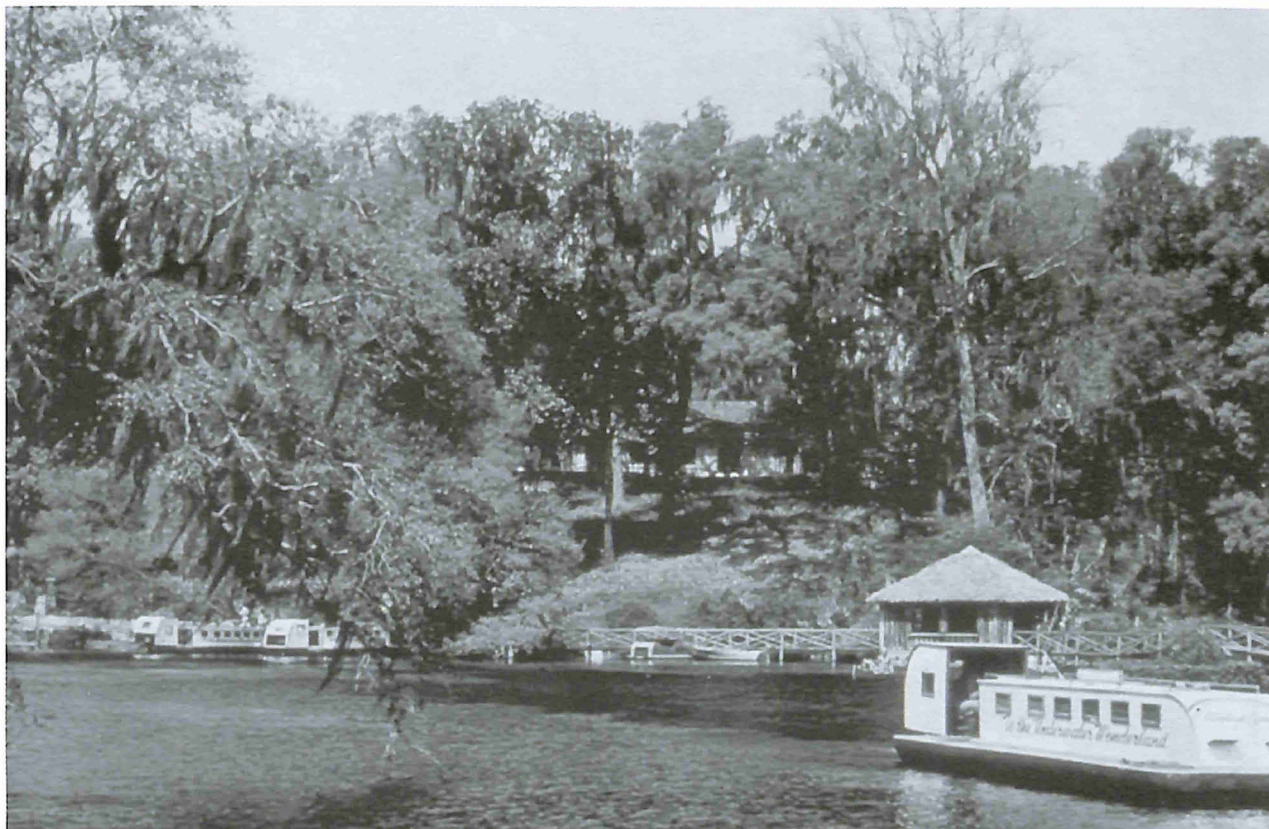
Figure 59. Rainbow Springs Group (photo from J. Stevenson).

**Group Location** - Lat. 29° 06' N, Long. 82° 26' W (sections 7, 12, and 18, T. 16 S, R. 18 E). The springs group is approximately 3.5 miles (5 km) north of Dunnellon on the Rainbow River. Drive north on US 41 from Dunnellon 3.8 miles (6.1 km) to a large sign on the east side of the road indicating the entrance to the Rainbow Springs State Park. Turn east (right) onto access road and continue 0.8 miles (1.3 km) to the parking area near the head of the Rainbow River. The springs are scattered alongside and on the bottom of the river for most of its length.
