# First Magnitude Springs of Florida

FLORIDA GEOLOGICAL SURVEY  
OPEN FILE REPORT NO. 85

**FIRST MAGNITUDE SPRINGS OF FLORIDA**

Thomas M. Scott, Guy H. Means,  
Ryan C. Means, and Rebecca P. Meegan

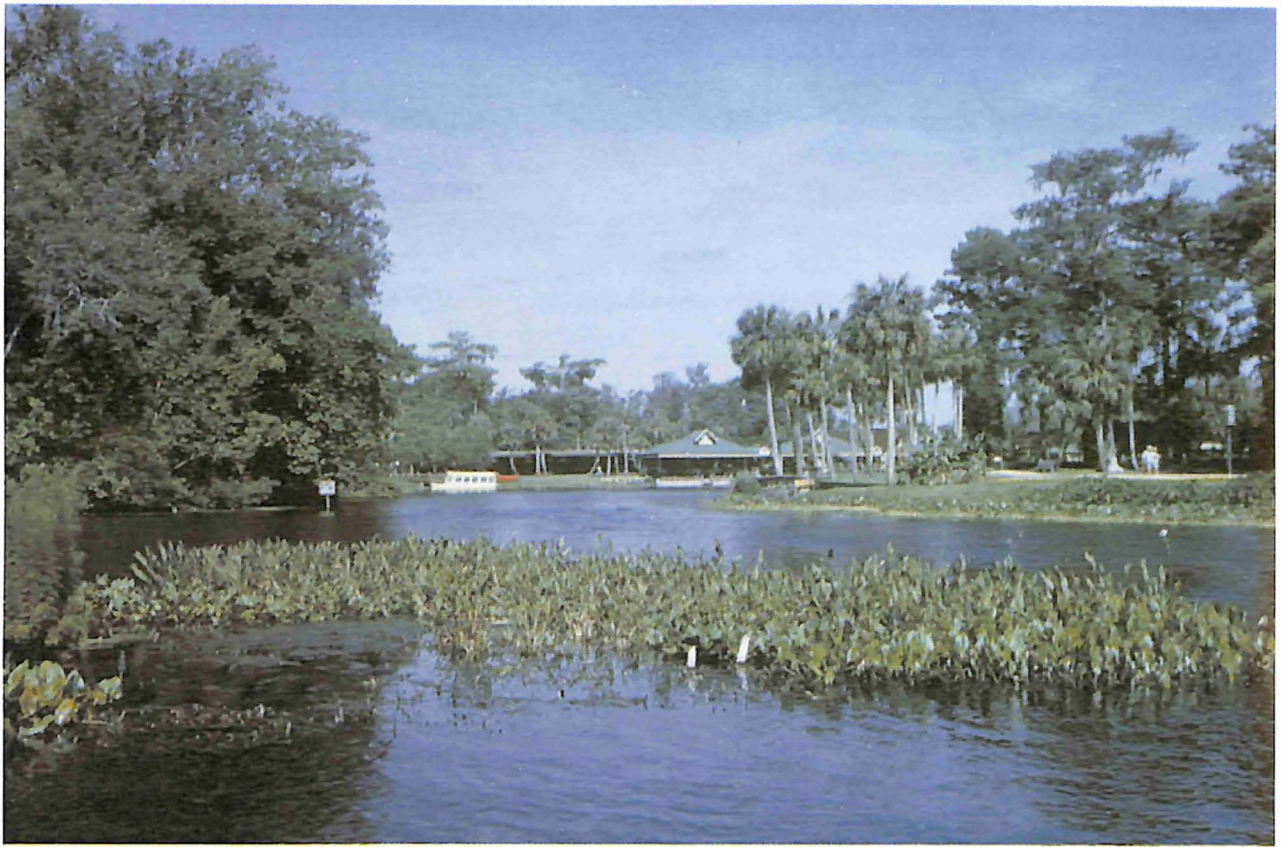
Figure 63. Silver Springs Group (photo by J. Stevenson).

**MAIN SPRING** - Lat.  $29^{\circ} 12' 58.3'' N$ , Long.  $82^{\circ} 03' 09.5'' W$  (SW1/4, SW1/4, NW1/4 sec. 6, T. 15 S, R. 23 E). The main spring is approximately 200 ft (61 m) northeast of the glass-bottom boat launch area. This is the head spring of the Silver River and the largest spring of the group. The spring pool measures 300 ft (91.4 m) north to south and 195 ft (59.4 m) east to west. Depth measured over the vent opening is 33 ft (10 m). The water is clear and sky blue. Aquatic vegetation is abundant across the spring bottom, and a layer of algae covers most substrates.

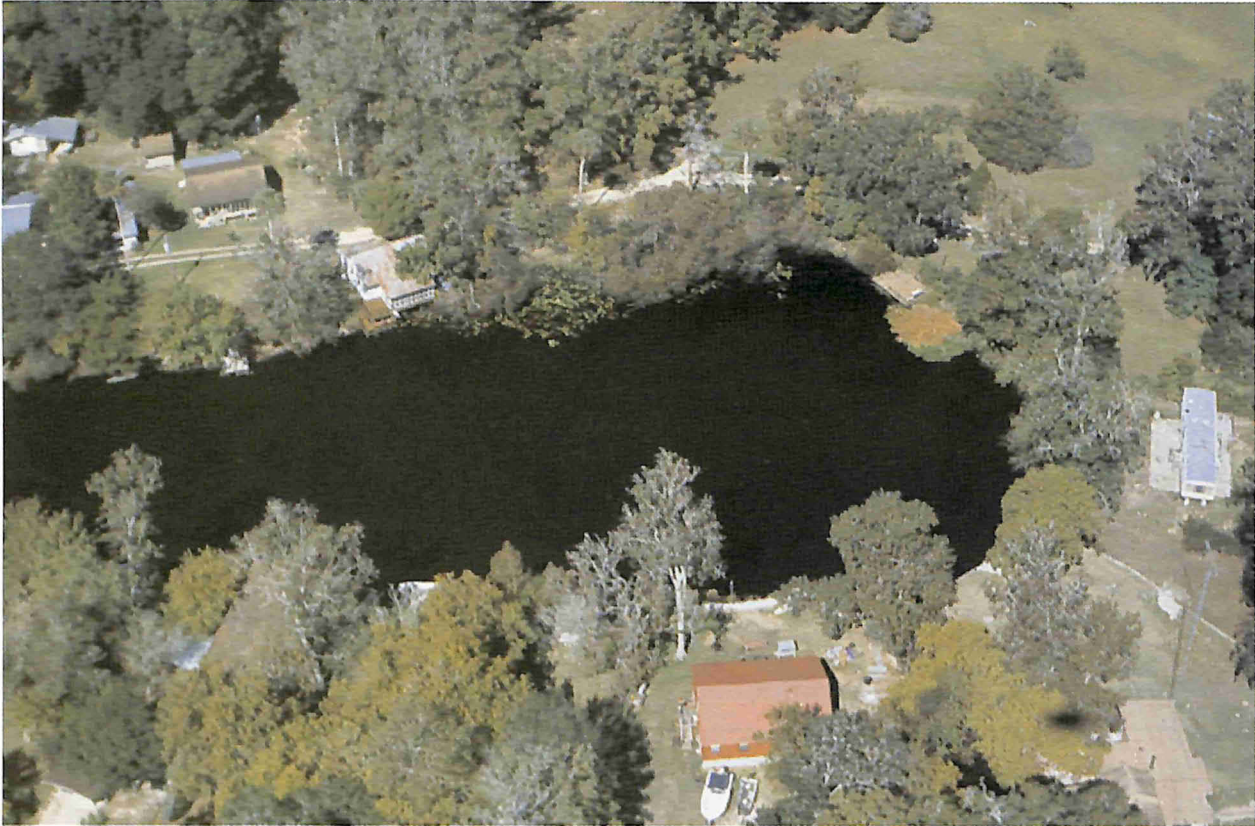
Figure 66. Nutall Rise (photo by J. Stevenson).

**Location** - Lat. 30° 09' 01.7" N, Long. 83° 57' 47.8" W (NE/NE/SE/sec. 7, T. 4 S, R. 4 E). Nutall River Rise is located on the Aucilla River approximately 28 miles (45 km) southeast of Tallahassee. The river rise is on private property and is best accessed from a public boat access off US 98. From the intersection with SR 363 (Woodville Hwy), turn east on US 98. Immediately after crossing the Aucilla River, turn north on dirt road marked by a boat ramp sign. The river rise is located approximately 0.6 miles (1 km) upstream from the boat ramp.

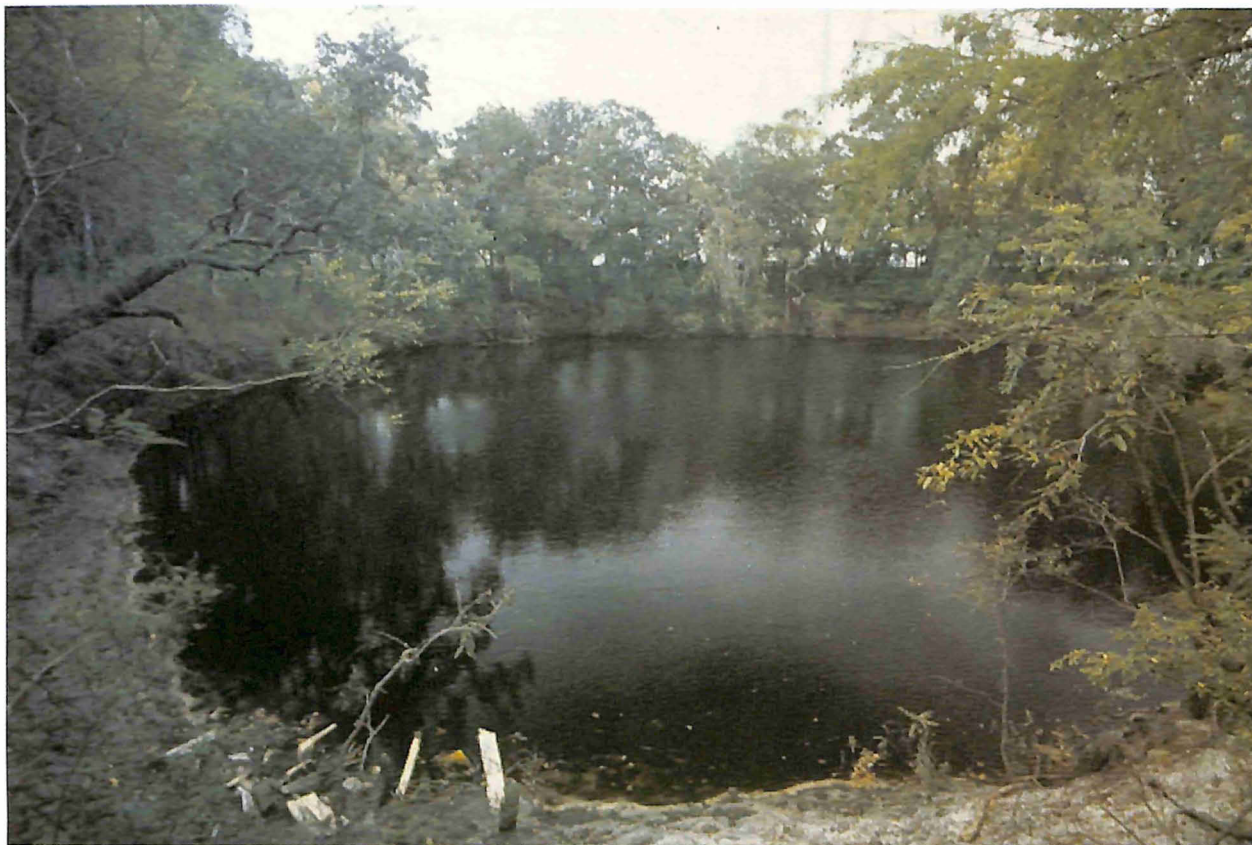
Figure 70. Santa Fe Spring (photo by T. Scott).

**Location** - Lat. 29° 56' 05.3" N, Long. 82° 31' 49.5" W (NW/SE/SE/sec. 29, T. 6 S, R. 18 E). Santa Fe Spring is located approximately 8 miles (13 km) northeast of High Springs on the west bank of the Santa Fe River. The spring is 2 miles (3.5 km) upstream from the I-75 bridge over the river. At this point, a narrow spring run comes in from the north. The spring is approximately 90 ft (27 m) up the spring run at the head.

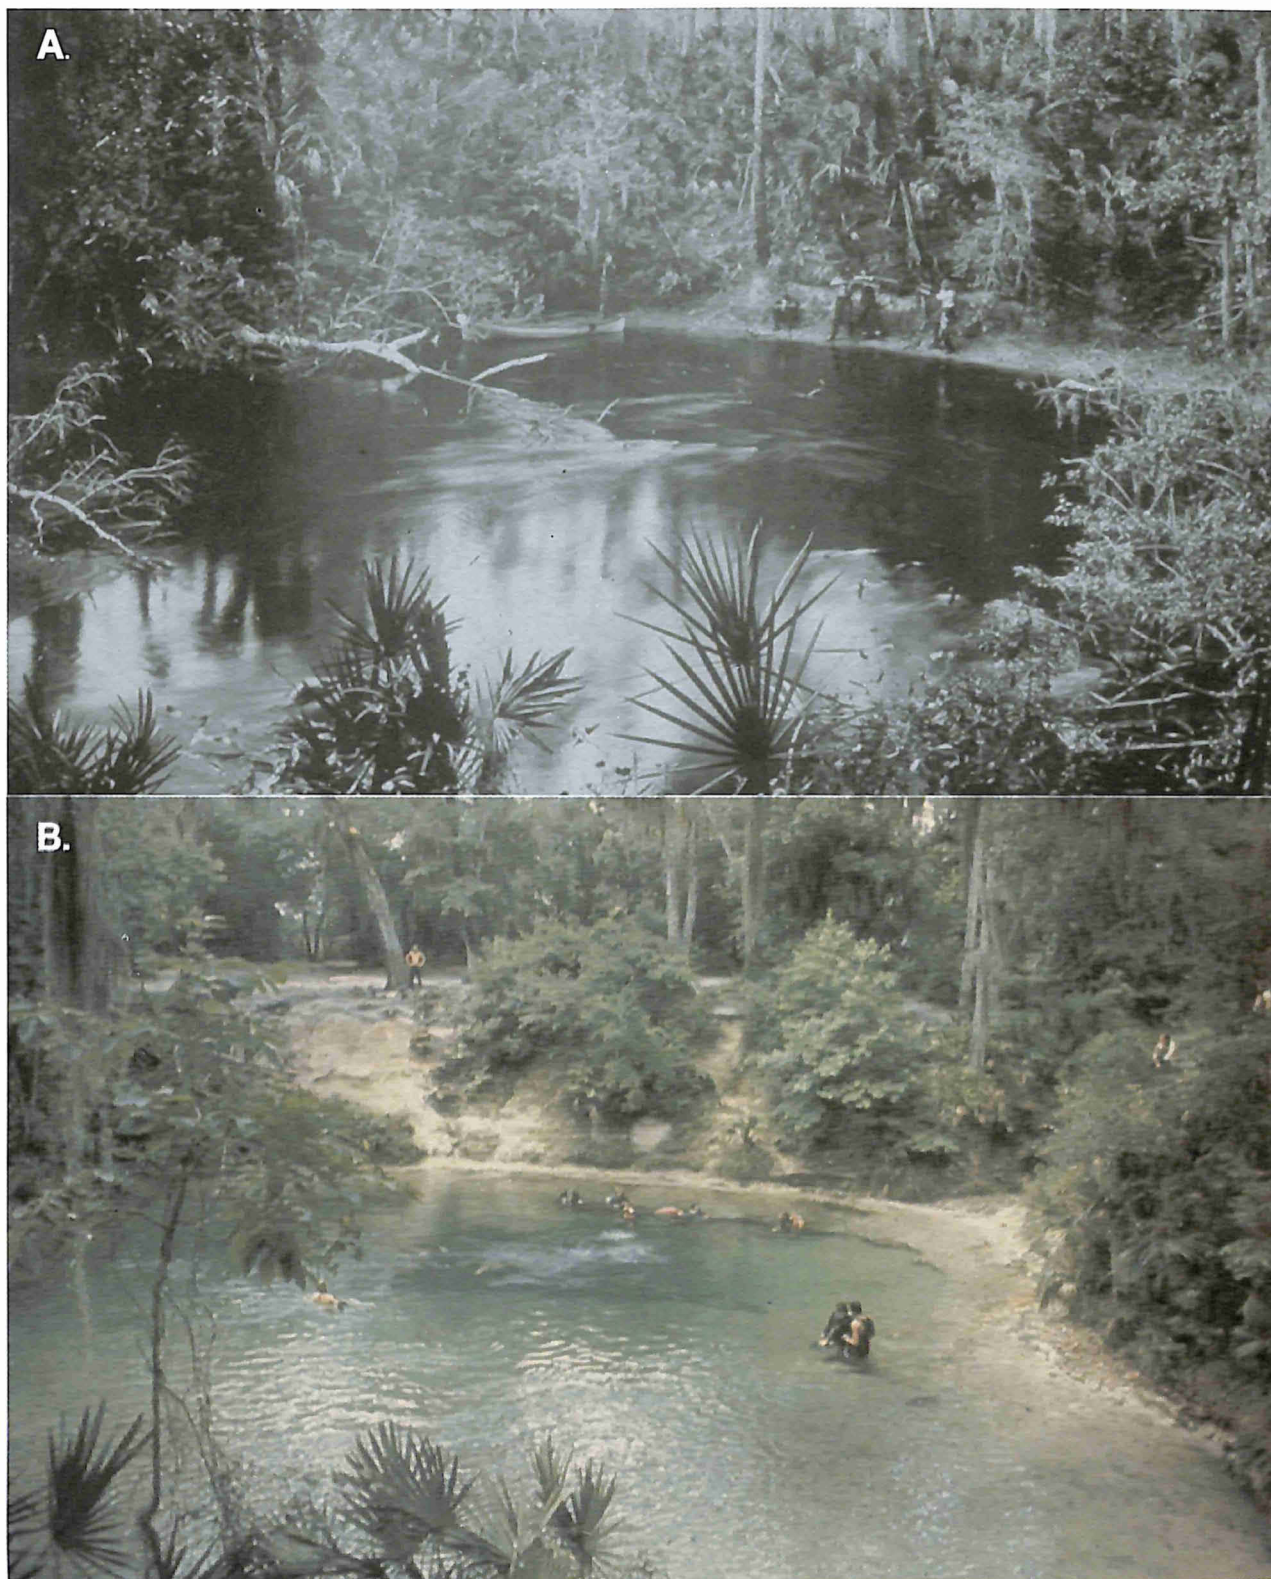
Figure 72. Volusia Blue Spring: A - Old Photo around 1900;  
B - 1970s photo (courtesy of Florida State Parks)

**Location** - Lat. 28° 56' 51.0" N, Long. 81° 20' 22.5" W (NW / NW / NE / sec. 8, T. 18 S, R 30 E). Volusia Blue Spring is 6 miles (10 km) southwest of Deland in Blue Spring State Park. From Deland, drive south on US 17. Turn west on CR 4142 in Orange City and continue 3.25 miles (5.2 km) to Blue Spring State Park. The spring is at the head of Blue Run about .25 miles (0.4 km) north of the parking area and is reached by a wooden boardwalk trail on the east bank of the spring run.

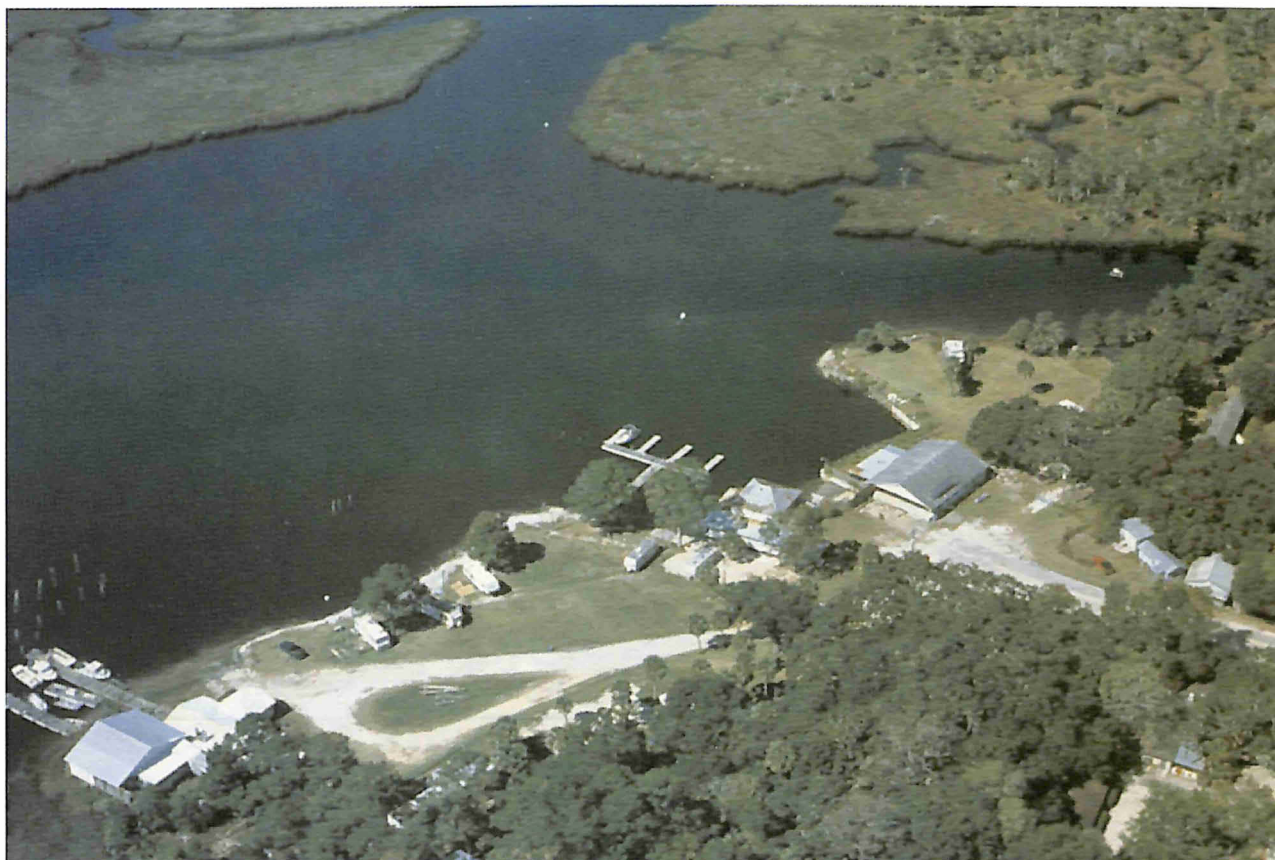
Figure 74. Spring Creek Springs Group (photo by J. Stevenson).

**SPRING CREEK NO. 1** - Lat. 30° 04' 48.6" N, Long. 84° 19' 47.3" W. This spring has a voluminous boil that discharges from a 30 ft (9.1 m) wide cavern in limestone against a sea wall northwest of the old Spear's Seafood and adjacent to the dock of the ice house. The spring pool measures 153 ft (46.6 m) north to south and 150 ft (45.7 m) east to west. Depth meas-

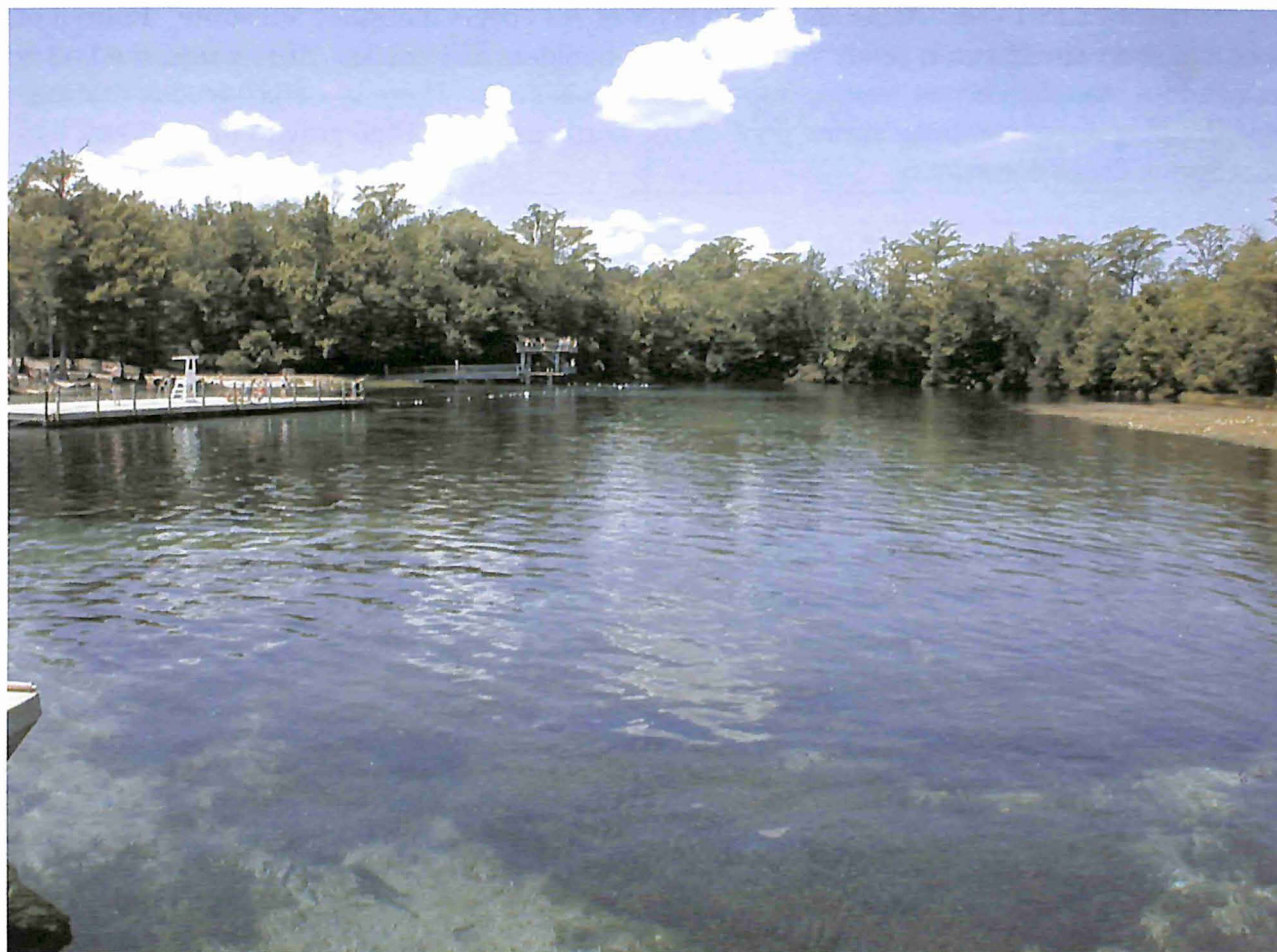
Figure 76. Wakulla Spring (photo by T. Scott).

**Description** - Wakulla Spring is one of the largest and most dramatic of Florida's springs. Spring pool is roughly circular with a diameter of 315 ft (96 m) north to south. Pool depth is 185 ft (56.4 m). The vent opening is a horizontal ellipse along the south side of the pool bottom and is estimated to measure 50 ft by 82 ft (15 m by 25 m). Along with a few smaller springs nearby, including Sally Ward Spring, Wakulla Spring gives rise to the clear Wakulla River. Water clarity of the spring in October 2001 was exceptional and colored bluish. *Hydrilla* once covered much of the spring pool and adjacent river bottom, but divers have recently removed large amounts. The Wakulla River remains choked with this exotic invasive plant species. Many other aquatic and emergent plant species also are present in the spring pool and river. A mixed hardwood, cabbage palm, and cypress forest inhabits lowlands along the north and east shores of the spring and along the river. Uplands along the western shore of the spring are developed into a state park lodge and facilities. Also, there are hardwoods and large loblolly pines scattered about.
