JACKSON COUNTY

Figure 74. Springs visited by FGS in Jackson County.

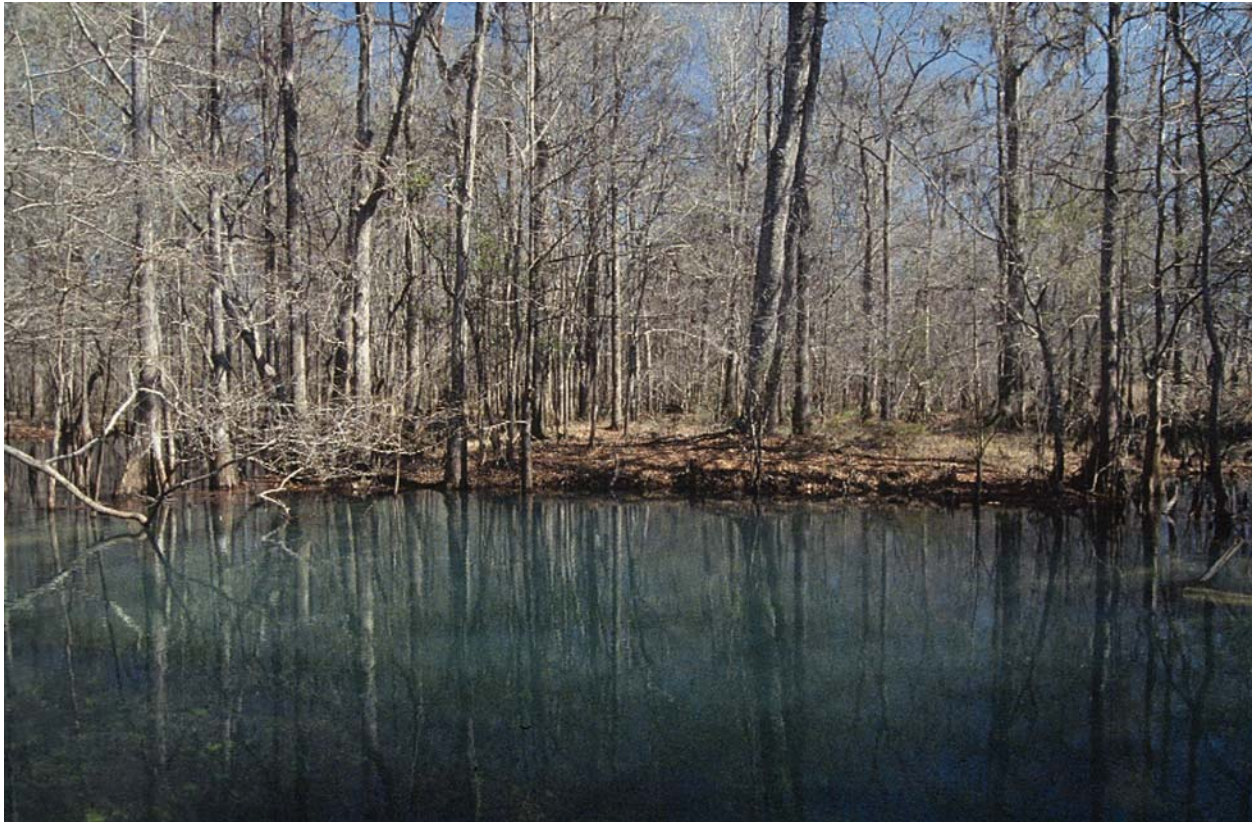
**Figure 75. Baltzell Spring (photo by R. Means).**

**Description** – Baltzell Spring is also referred to as Bosel or Bozel Spring. The spring pool measures 75 ft (22.9 m) north to south and 54 ft (16.5 m) east to west. The depth of the spring over the vent measures 14.0 ft (4.3 m). The water is light blue-green with a slight murkiness. Limestone is exposed near the vent and a slight boil is present on the pool surface. There is an old collapsed dock on the east shore of the spring. A small spring run enters the spring pool from the north, and the combined flow from both exits to the south. The spring and its run support rich native aquatic vegetation. Baltzell Spring run flows south, then east for a total distance of approximately 800 ft (243.8 m) (Rosenau et al., 1977), before entering the Chipola River from the east. To the east, the ground rises to approximately 12 ft (4 m) above the water surface. An old house and cleared pasture are visible a short distance to the east. Land west of the spring is comprised of the river and its flood-plain swamp forest. There are at least three other springs in close proximity to Baltzell Spring that maybe collectively referred to as the Baltzell Springs Group.

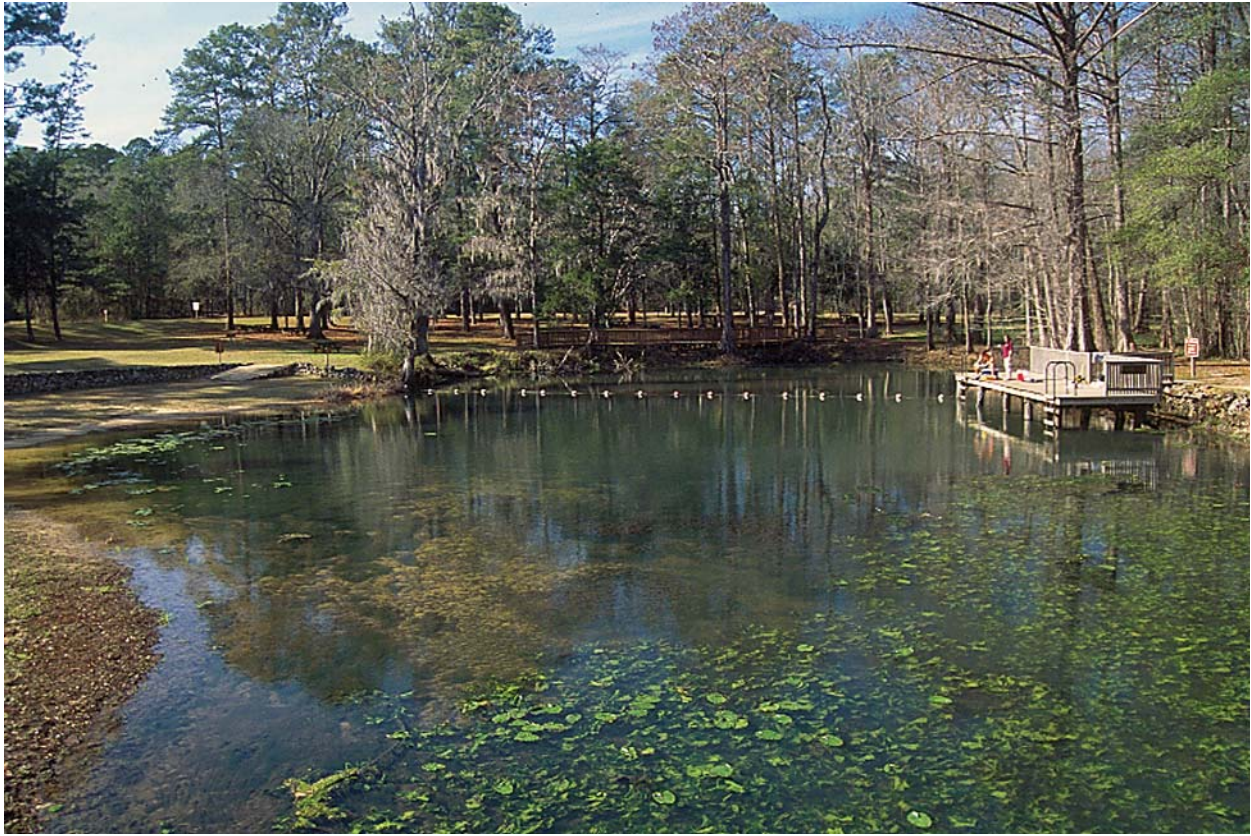
Figure 76. Blue Hole (photo by R. Means).

**Description** – Blue Hole Spring pool is elongated and measures 159 ft (48.5 m) east to west and 258 ft (78.6 m) northwest to southeast. The depth of the spring pool is variable and measures up to 26 ft (7.9 m) (Rosenau et al., 1977). The spring has a sand bottom. Thick patches of filamentous green algae cover about half of the spring bottom. The water color is greenish and murky. No boil was visible on the water surface in June 2002. Water lettuce is abundant in the southeast portion of the pool. The west side of the pool has a limestone boulder wall with stairs leading down to a sandy swimming area. The south side of the spring has a wooden footbridge over the outflow channel. The east side has a limestone boulder wall and a wooden swimming dock. On the north side of the main pool, there is another much smaller pool that is separated from the main pool by a narrow land bridge. During the January 2002 visit, the water in the small pool was crystal clear and light blue, contrasting with the murky greenish water of the main spring pool. There is a wooden walkway that leads over the land bridge. The spring run discharges south approximately 1.6

miles (2.6 km) into the Chipola River through a heavily forested lowland. All immediate surroundings are landscaped with grassy lawns, scattered tall pines, picnic tables, restroom facilities, and parking area. The ground rises gently away from the spring on the west side to approximately 10 ft (3 m) above water level. Blue Hole Spring may be a river rise of an underground channel of the nearby Chipola River. During the January 2002 visit, the physical characteristics of both spring and river water were similar (relatively high DO, low temperature, and similar color).

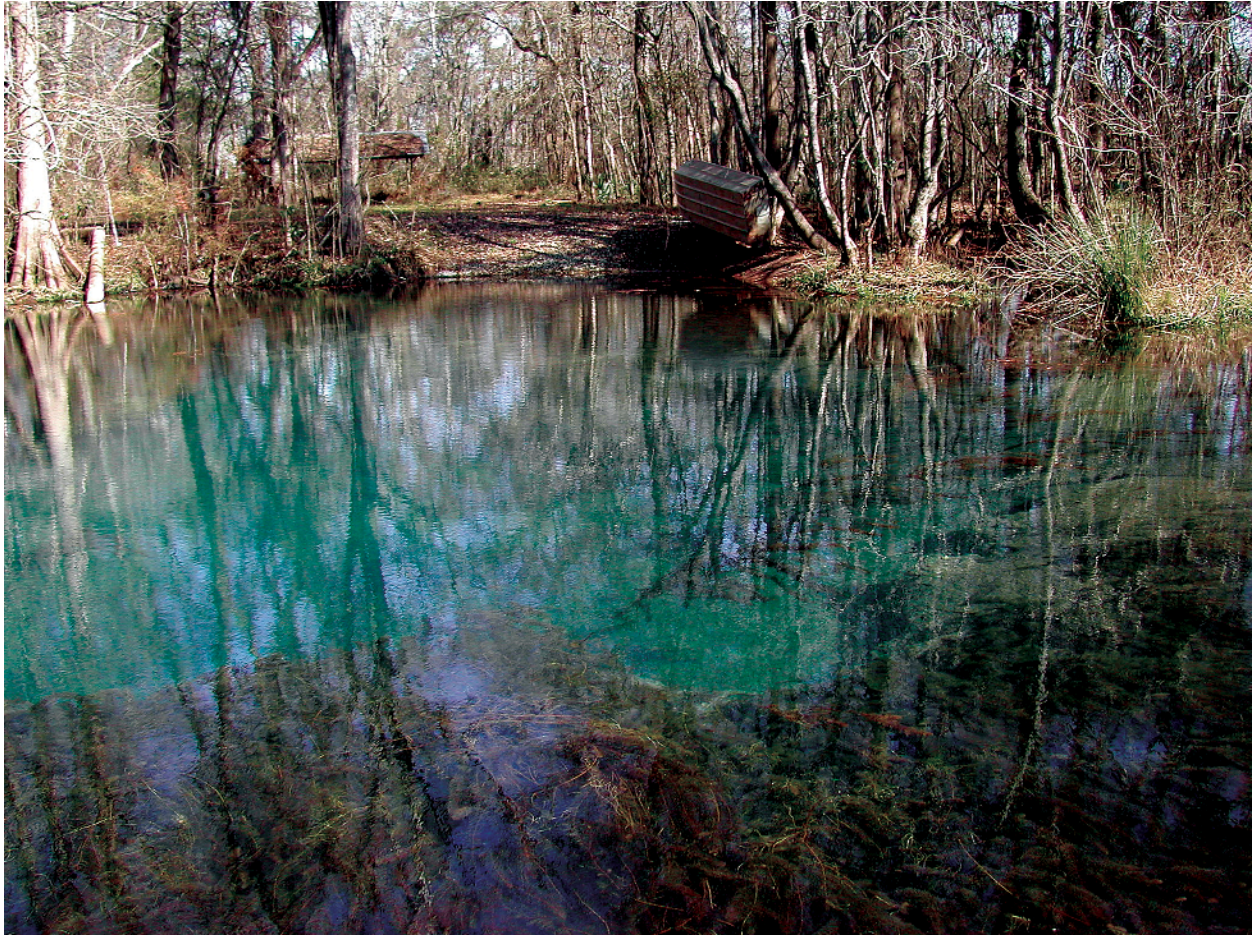
**Figure 77. Hays Spring (photo by R. Means).**

**Description** – Hays Spring pool measures 75 ft (22.9 m) north to south and 100 ft (30.5 m) east to west. Spring bathymetry is dramatic, with limestone cliffs and overhangs near the vent. The spring pool is shallow, except over the elongated vent opening, where depths reach 14.9 ft (4.5 m). Rosenau et al. (1977) report that the bottom is soft and muddy. Hays Spring is bluish and slightly murky. Water lettuce and exotic aquatic vegetation are present. There was no visible boil over the spring during the February 2003 sampling visit. A creek channel comes in on the northwest side of the spring pool. Hays Spring Run exits the pool to the southwest. The upper section of the spring run is approximately 0.5 mi (0.8 km) long and 100 ft (30.5 m) wide. Thereafter, the spring run narrows, is often multi-chan-

neled, and runs for a total length of approximately 2.8 mi (4.5 km) southwestward into the Chipola River. A pipe leads into the Hays Spring from the northeast bank. The northeast side also has a pavilion and cleared boat launch area. The immediate surroundings are forested, with cleared farmland visible through the trees to the east.

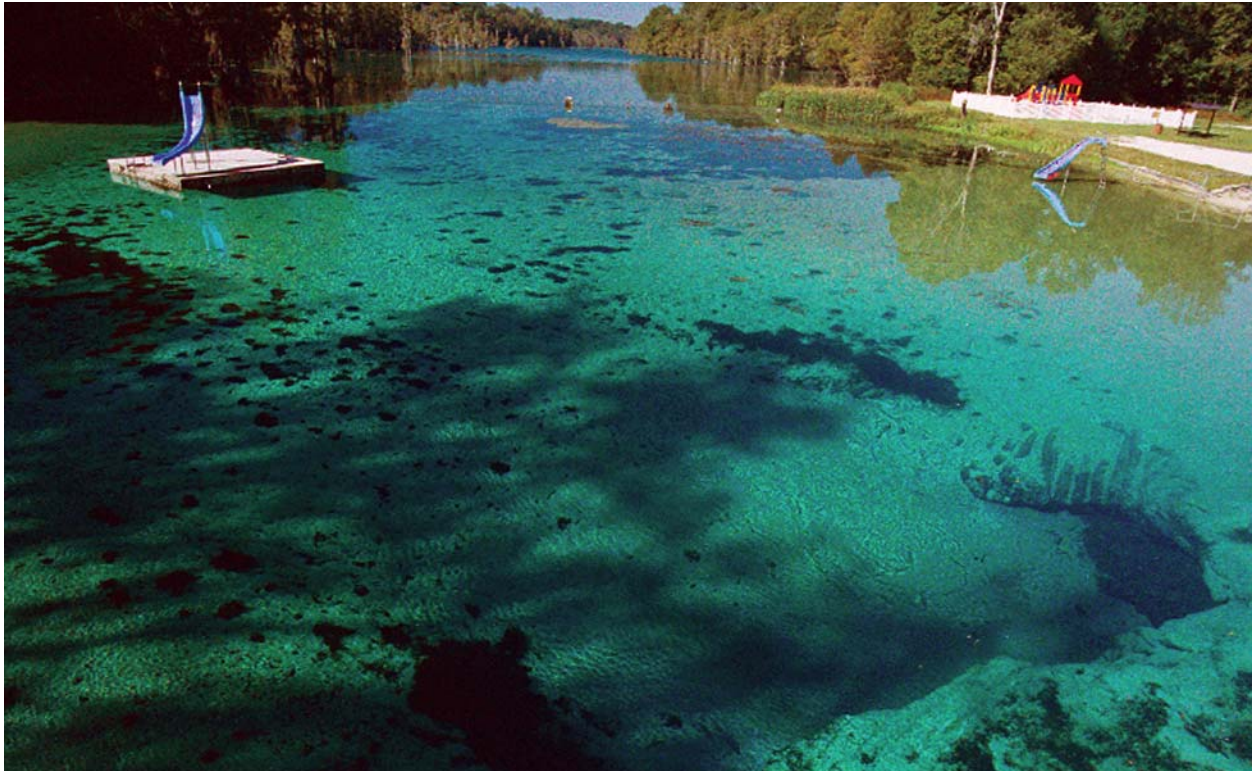
Figure 78. Jackson Blue Spring (photo by T. Scott).

**Description**—Numerous springs feed Merritts Mill Pond. Jackson Blue Spring is the main spring at the head of the pond. It is situated about 10 ft (3 m) west of the diving platform. Spring pool diameter is approximately 240 ft (73.2 m) southwest to northeast and 233 ft (71 m) northwest to southeast. Maximum depth over the vent is 16.5 ft (5 m). The vent is elliptical and approximately 5 ft (1.5 m) high and 25 feet (7.6 m) wide. Limestone is exposed near the vent, and it bears backhoe scars. Clear bluish water issues from the vent. A boil is slightly visible at the surface. There is approximately 40% algae coverage on the pool bottom and very little aquatic or emergent vegetation. The spring pool is a designated swimming area separated from the rest of Merritts Mill Pond by a chain link fence across the channel approximately 300 ft (91.4 m) downstream. The southern shore of the spring pool meets a lowland cypress-gum forest. The northern half of the pool is bordered by high ground sloping upward to nearly 20 ft (6.1 m) above water level. Most of the high ground is cleared and grassy. All nearby uplands are developed. There are buildings and a parking

area constructed on the uplands. Surrounding the spring, are a concrete retaining wall near shore, slides, a diving board, and picnic tables. An extensive underwater cave system has been mapped at Jackson Blue Spring.

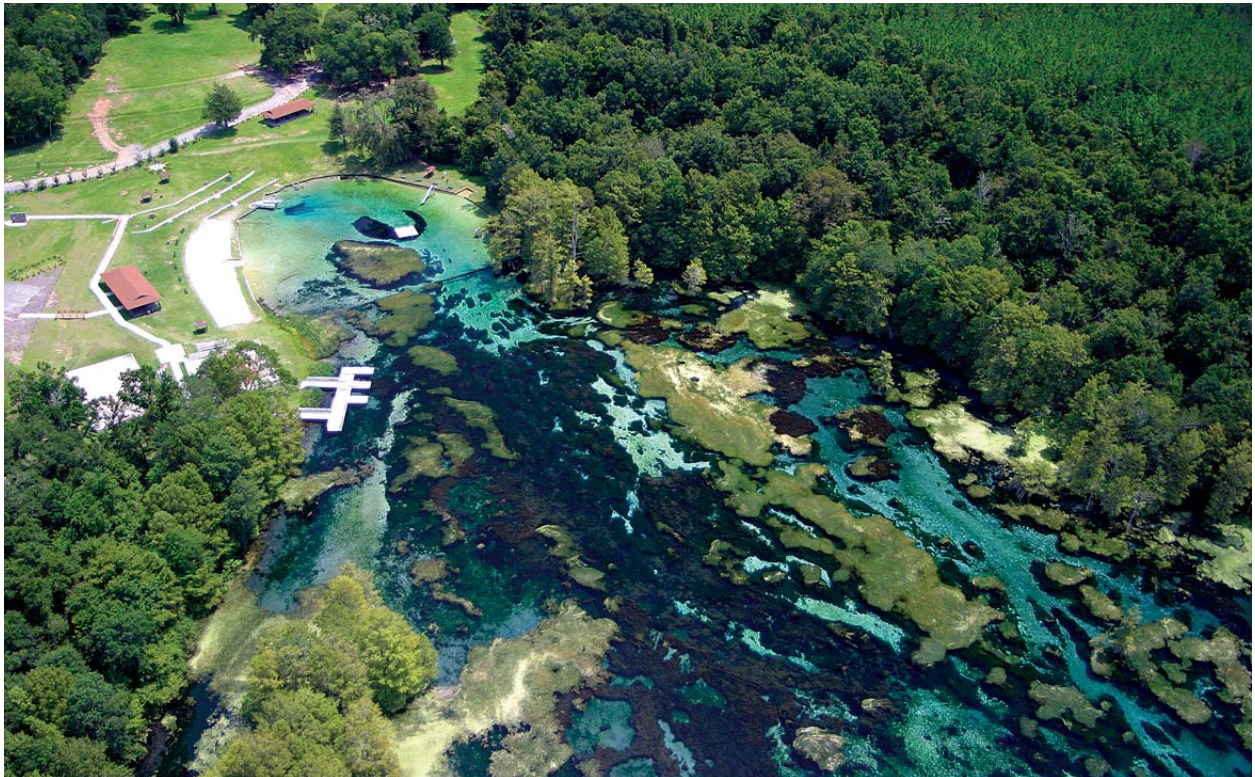
Figure 79. Jackson Blue Spring aerial photo (photo by T. Scott).

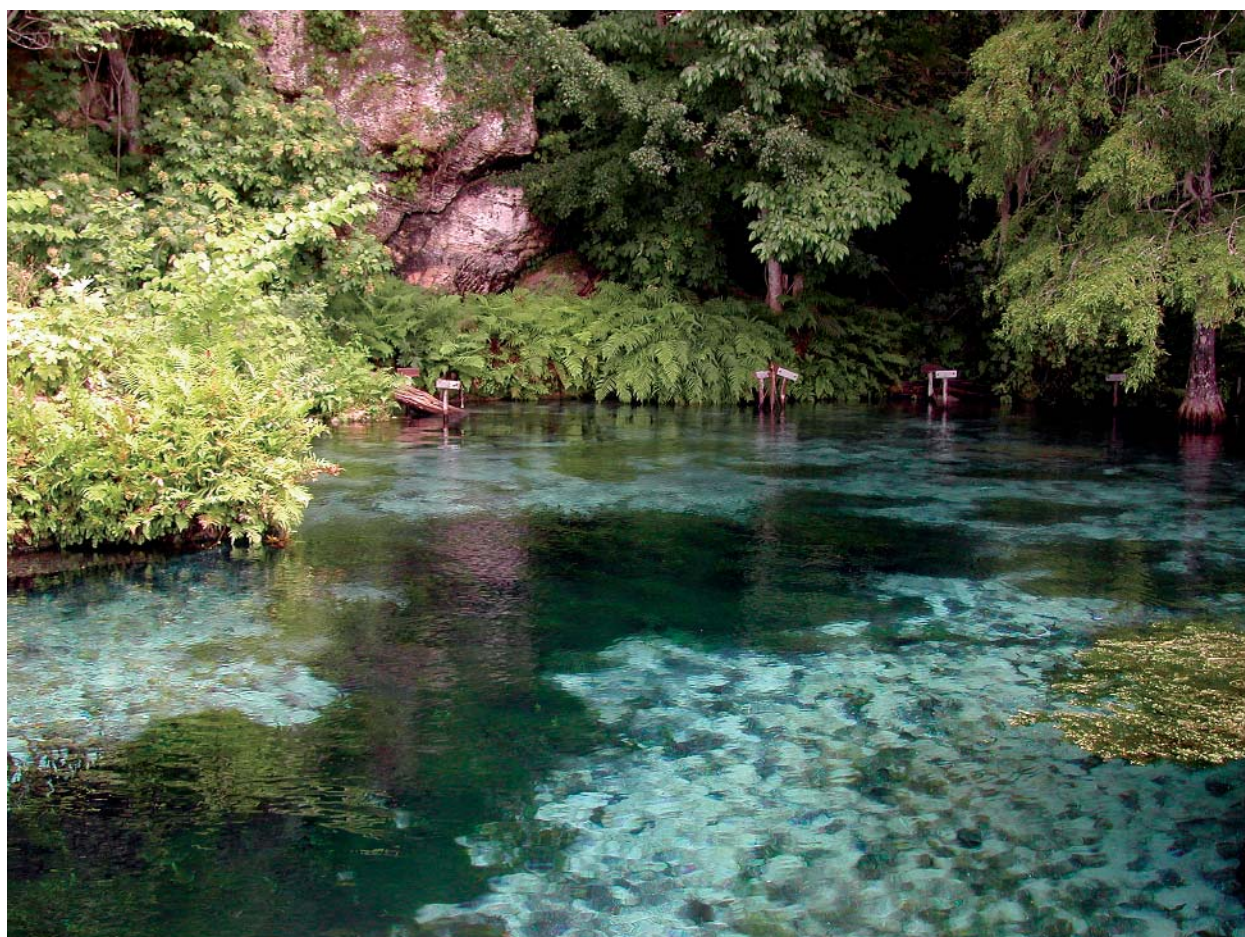
Figure 80. Shangri-La Springs (photo by R. Means).

**Description** – Shangri-La Springs is situated between a large boulder and a 20 ft (6.1 m) high vertical limestone bluff on the west side of Merritts Mill Pond and forms a 40 ft (12.2 ft) diameter spring cove with native aquatic vegetation and little algae. Shangri-La Springs vent is 7 ft (2.1 m) deep and sand-bottomed with exposed limestone. Another vent is situat-

ed in a limestone fissure 50 ft (15.2 m) to the east. The water is light blue and clear. A prominent boil is seen over the vent near the bluff. A lone scraggly cypress tree stands in the open waters of the mill pond, 100 ft (30.5 m) southeast of the main vent. The bluff face, boulder, and surrounding area are lush with ferns and other vegetation. Merritts Mill Pond is a 5 mile (8 km) long impounded spring run. Several springs feed into the pond along the edges or directly from the pond bottom. Jackson Blue Spring forms the headwaters of Merritt's Mill Pond.

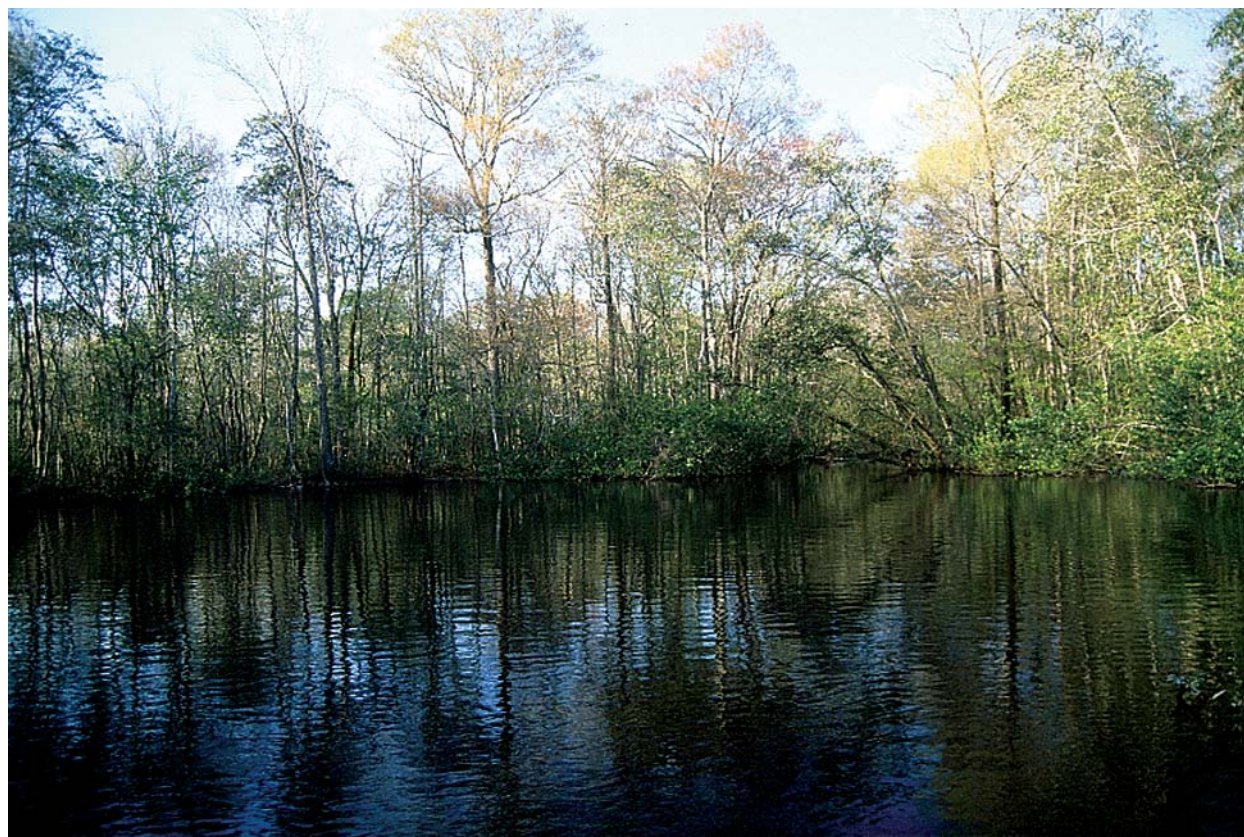
Figure 81. Black Spring (photo by R. Means).

**Description** – Black Spring is also known as Black Hole (Rosenau et al., 1977). The spring pool is nearly circular, steep-sided, and deep. It measures 150 ft (45.7 m) in diameter, and is 49.1 ft (15.0 m) deep northeast of the pool's center. Approximately 20 ft (6.1 m) below the surface on the northeast side, a 25 ft (7.6 m) vertical limestone wall leads down to the spring vent. The water is clear to slightly tannic but appears very dark. Black Spring derives its name from its tendency to issue tannic water during times when all other springs associated with Spring Lake may be discharging clear water. This was the case during the March 2002 sampling visit; however, the water of Black Spring was clear and bluish two months later. Abundant aquatic vegetation, including water lettuce, exotic aquatic vegetation and algae, covers the shallow areas around the perimeter of the spring pool. No boil was visible in March 2002. Black Spring flows through three separate stream channels. The main channel flows north, another northeast, and the other east, all under a swamp forest canopy and into Spring Lake. The north-flowing channel is approximately 150 ft (45.7 m) long, the northeast-flowing and smallest channel is approximately 300 ft (91.4 m), and the east-flowing run approximately 350 ft (106.7 m). The runs are up to 50 ft (15.2 m) wide and 5 ft (1.5 m) deep. All immediate surroundings are low-lying with dense hardwood and cypress

swamp forest. The nearest high ground is approximately 150 ft (45.7 m) south and gently rises to a height of about 12 ft (3.7 m) above the lowlands.

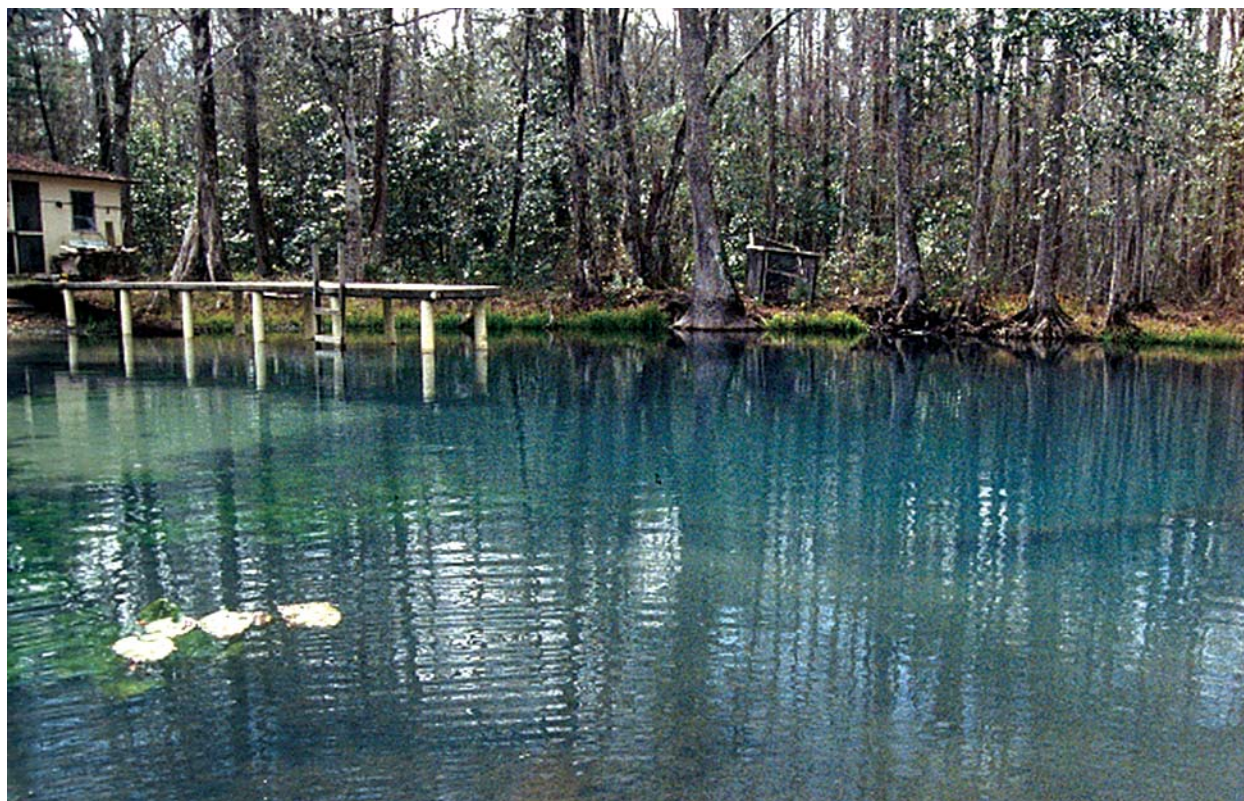
**Figure 82. Double Spring (photo by R. Means).**

**Description** – Double Spring, a karst window, is composed of a spring, a short run, and a siphon, all on the south side of Spring Lake. Double Spring is nearly circular and sits in a bowl-shaped depression measuring 87 ft (26.5 m) in diameter. The depth of the spring pool is 18.0 ft (5.5 m), and the water is somewhat murky with a bluish hue. Limestone can be

found near the vent and siphon, but the rest of the spring, siphon and run has a soft sand bottom. A moderate boil is present on the water surface. There are large, thick mats of filamentous algae scattered about the pool among native aquatic vegetation with some exotic invasive aquatic plants. The spring discharges through a run as wide as the spring and flows for approximately 75 ft (22.9 m), where it splits into two channels, one flowing north and one flowing east. The majority of flow travels eastward approximately 200 ft (61 m) into a siphon that is estimated to have a depth of 15 ft (4.6 m). The northward run flows through a narrow channel a short distance into Spring Lake. Higher ground on the south side of the spring rises gently to approximately 8 ft (2.4 m) above the water. There is a wooden dock on the south side of the pool, and a private residence can be seen to the southwest on the higher ground. The area around the spring is within in a dense hardwood and cypress swamp forest.

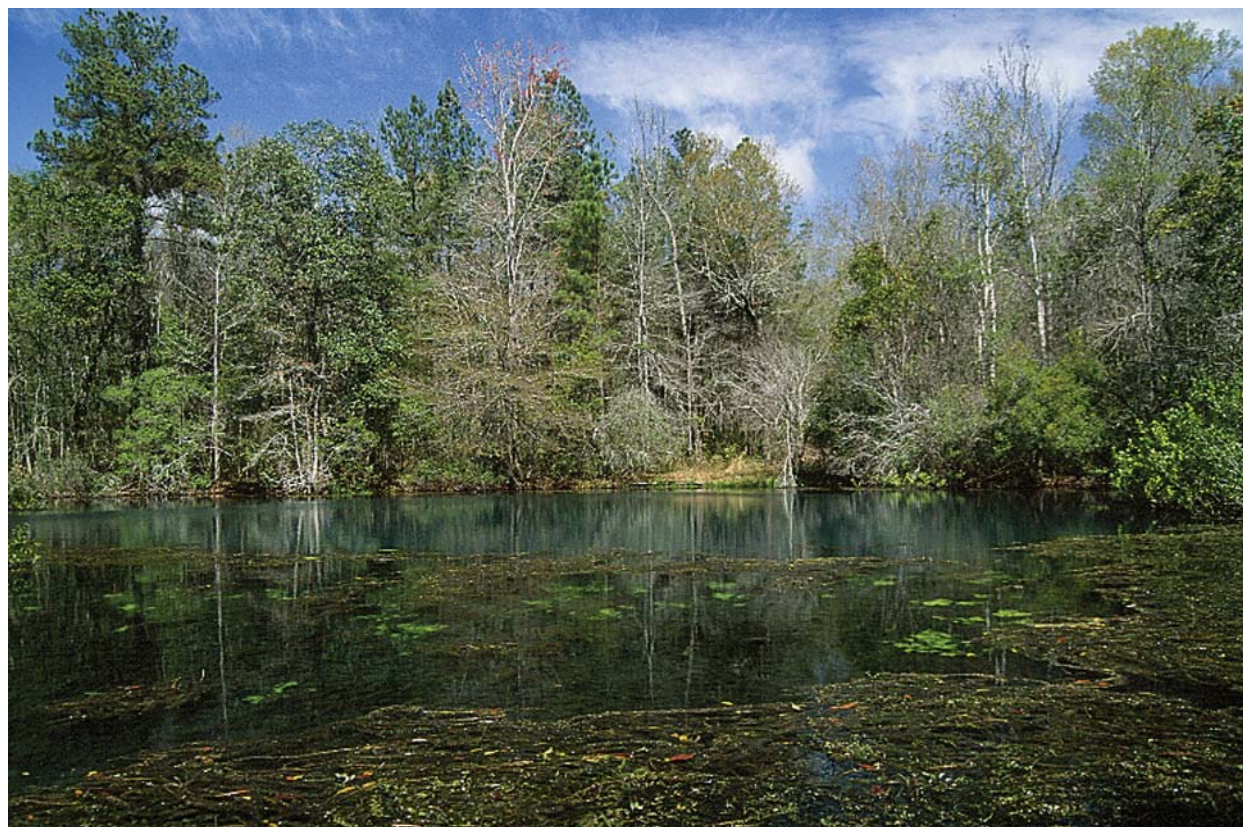
**Figure 83. Gadsen Spring (photo by R. Means).**

**Description** – Gadsen Spring occupies a deep, conical, nearly circular to oval depression 120 ft (36.6 m) north to south and 141 ft (43 m) east to west. The depth of the spring pool measured over the vent is 43 ft (13.1m). The vent is located beneath a vertical limestone ledge that is slightly north of the pool's center. The water is slightly murky with a greenish blue color. No boil on the pool surface was observed in March 2002. There is abundant native aquatic vegetation with some thick algae mats. Gadsen Spring discharges south 75 ft (22.9 m) through a narrow run that is shallow, approximately 1-3 ft (0.3-0.9 m) deep. The run then widens to about 100 ft (30.5 m) forming a pool that is approximately 150 ft (45.7 m) long and has dense aquatic vegetation. This pool is reported to be a sinkhole that takes some of the water (Rosenau et al., 1977). Continuing downstream southward, the run again narrows and flows swiftly for approximately 800 ft (243.8 m) through low-lying swamp forest until entering Spring Lake. A mowed grassy track accesses the spring on the north side. To the north, land rises very gently to a height of about 10 ft (3.1 m) above the lowlands. There is a small water-filled sinkhole to the north a short distance. All surrounding lands are forested.

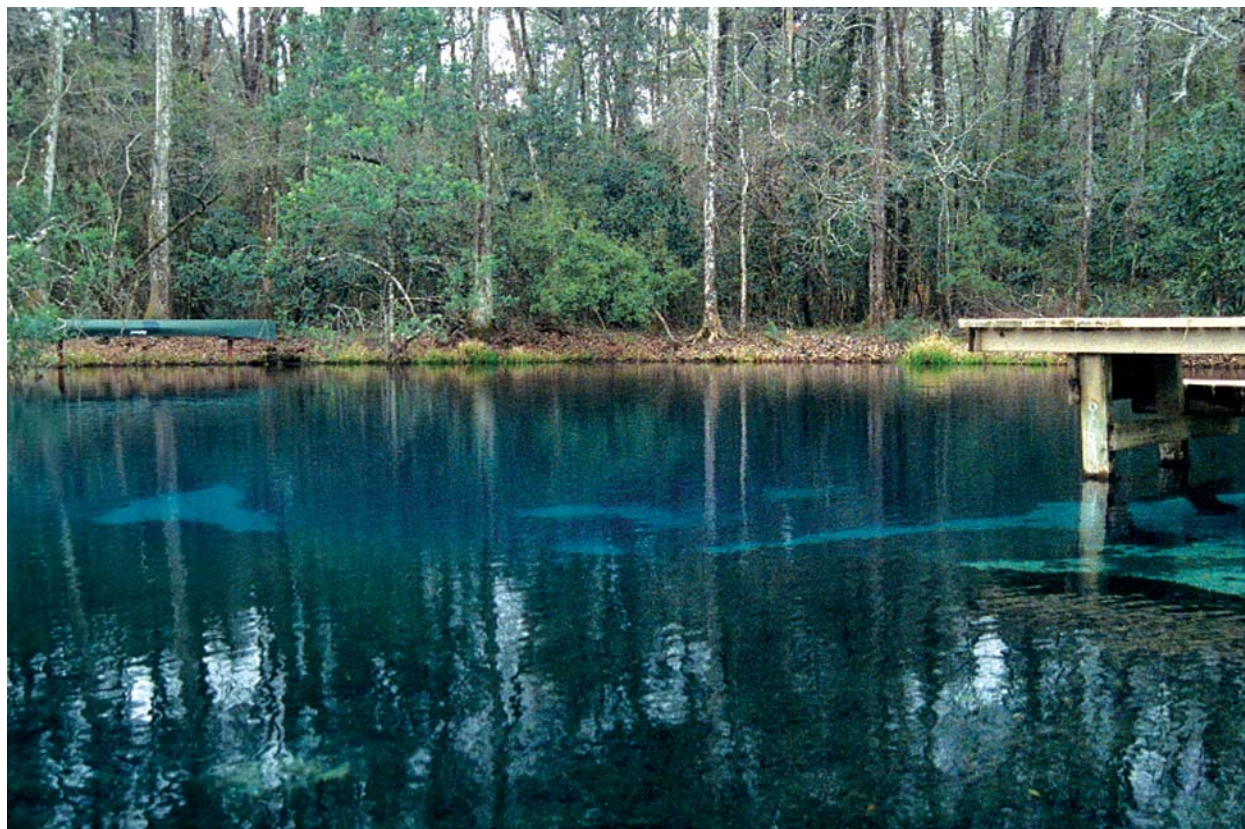
Figure 84. Mill Pond Spring (photo by R. Means).

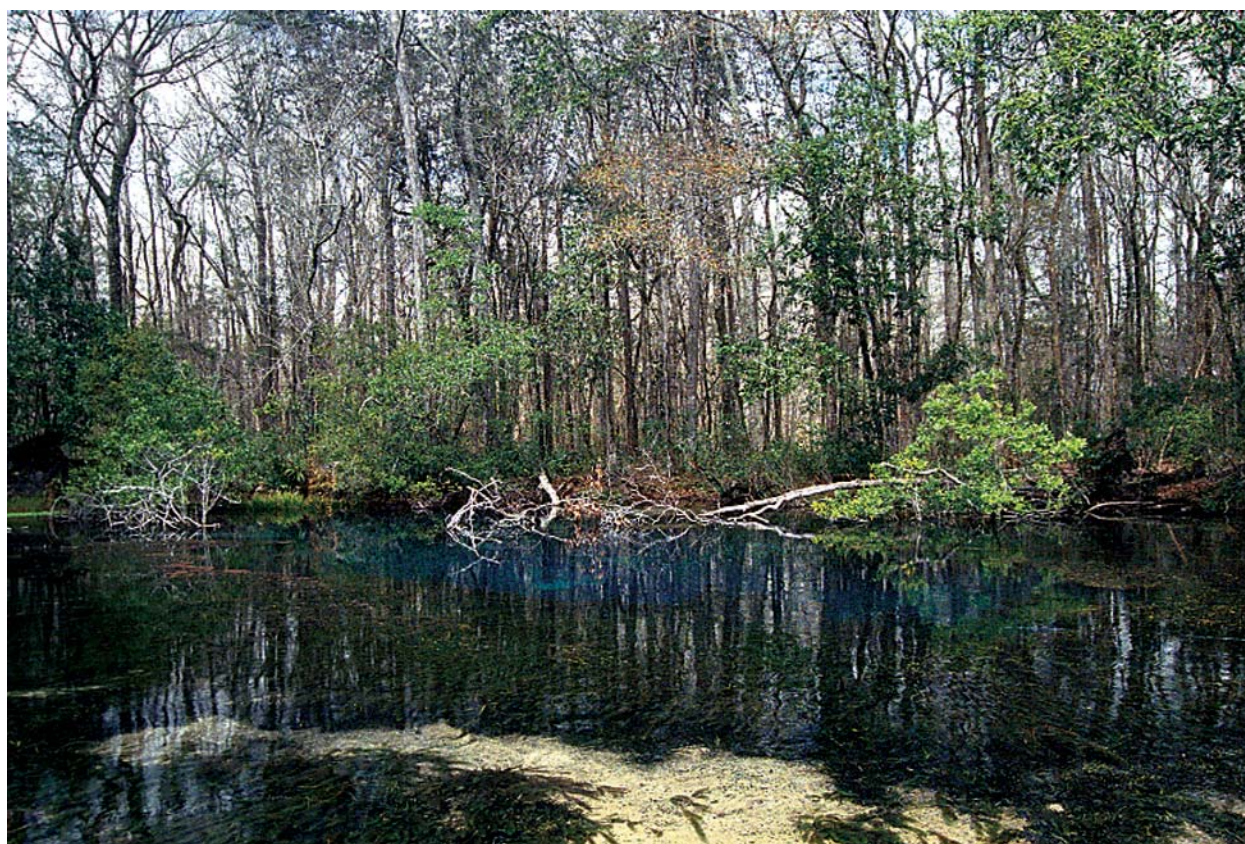
Figure 85. Springboard Spring (photo by R. Means).

**Description** – Springboard Spring pool measures 78 ft (23.8 m) north to south and 60 ft (18.3 m) east to west. The spring issues from a deep crack in limestone near the center of the spring pool and is 18.4 ft (5.6 m) deep. Its water is clear and bluish. Aquatic vegetation including exotic aquatic vegetation and algae are abundant. A very slight boil was present in March 2002. It has two spring runs, one flowing southwest, and one flowing southeast. The southwest run, approximately 1,000 ft (304.8 m) long, is narrow, averages 2 ft (0.6 m) deep, and merges with Mill Pond Spring run to form upper Spring Lake. The southeast-flowing run is approximately 125 ft (38.1 m) wide and averages less than 1 ft (0.3 m) deep. It has a soft sand and detritus-covered bottom with rich aquatic vegetation and freshwater mollusks. Approximately 800 ft (243.8 m) downstream, half of the southeast run flows into a swirling siphon approximately 50 ft (15.2 m) in diameter. The other half flows southward a short distance from the first siphon into another. During higher water levels, water flows past the siphons via an ephemeral stream channel southward to the northwest portion of Spring Lake. This intermittent channel was dry in March 2002. The immediate lands to the north of the spring are all low-lying and densely forested with mixed hardwoods and cypress.
