# Strategic Approach and Case Studies

- Issue in Florida
- Project Areas
- Development of Two Approaches / Tools
- Decision-Support Tool
- Identification of Sources using Weight-of-Evidence Approach
- Case Studies

**Hillsborough River Watershed**

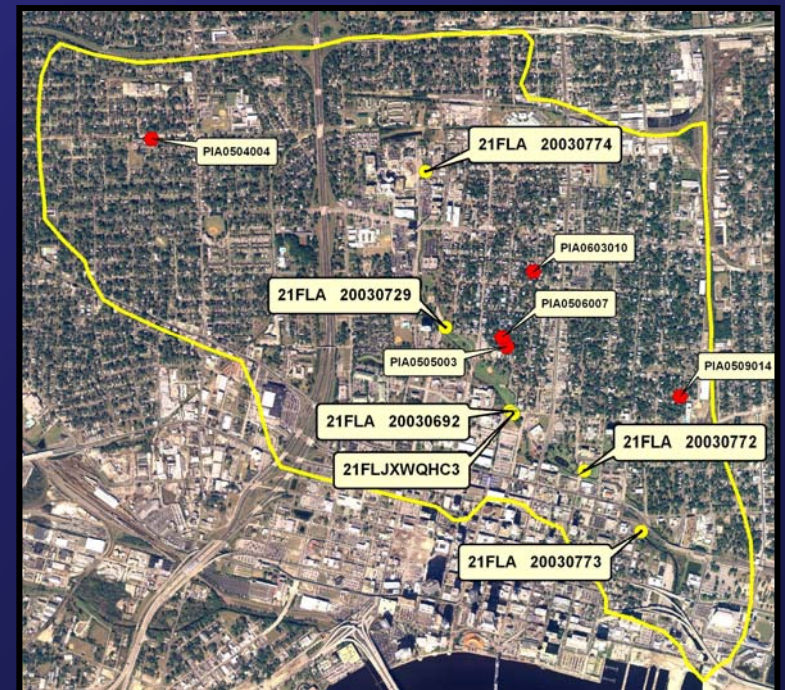
## 2. Compilation and evaluation of GIS data

- Land use
- Soil type
- Long-term monitoring stations
- Red line properties (prone to flooding)
- Landfills
- Infrastructure
  - Stormwater
  - Septic Tanks
  - Sanitary Sewer
- Potential illicit discharges
- Septic tank repair permits
- Sanitary Sewer Overflows
- Permitted discharges

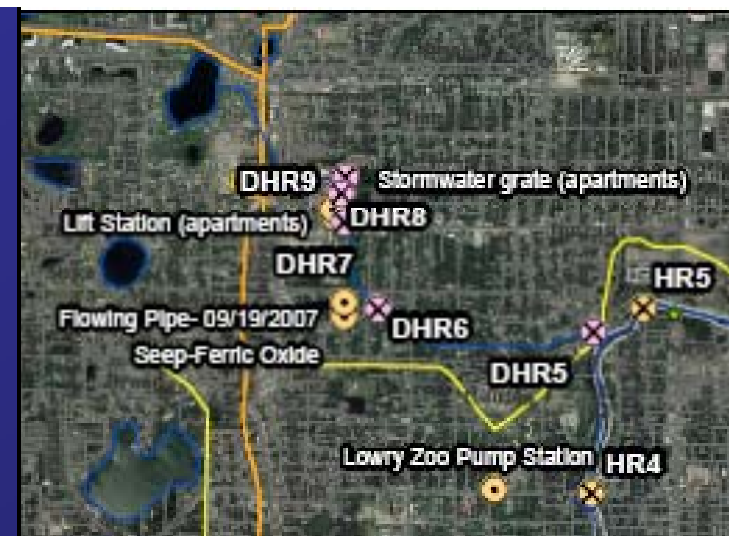
# Kirby Creek at Hillsborough River

**Mixture of MST markers but land use information suggests human sources throughout Kirby Creek**

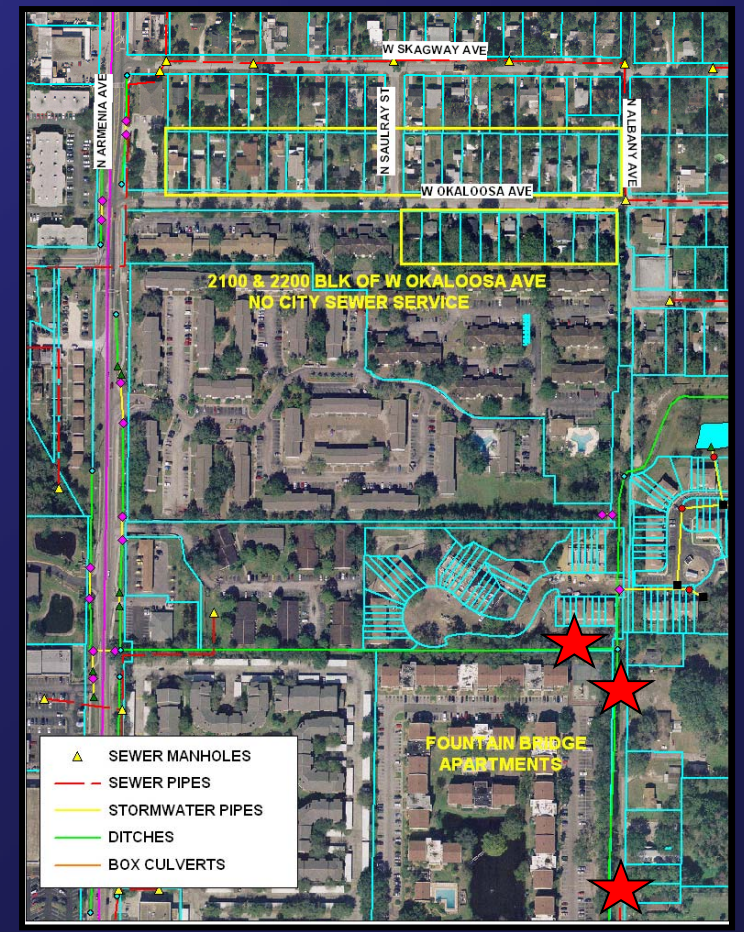
# COT Investigation of Upper Kirby Creek

- Drainage system investigated upstream of DHR7 on Feb. 11, 2008
  - Flow in connecting ditch system after ~2 weeks with no appreciable rainfall
  - Stormwater grate (DHR10) full but no evidence of odor or sewage
  - Onsite retention pond appeared normal
- Redline properties identified
- Parcels within COT limits that do not have sewer accounts upstream of DHR8 (outlined in yellow)

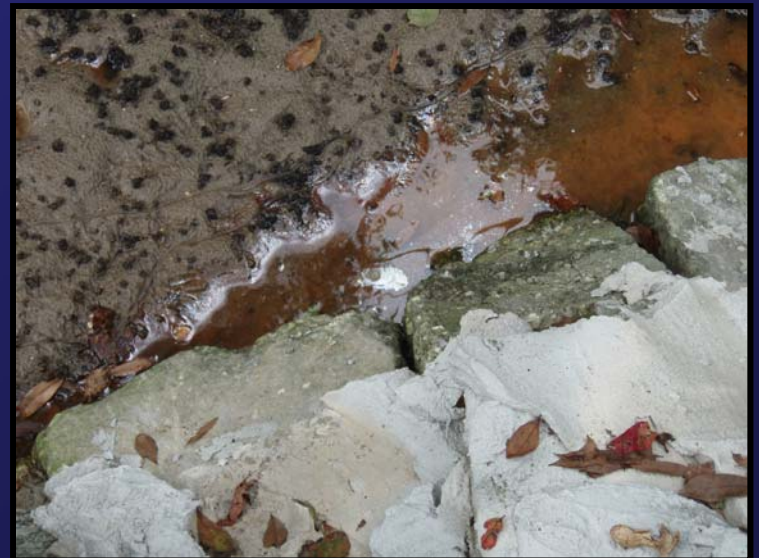
# Additional COT Investigations of Midstream Kirby Creek

- Flowing pipe connected to water softener-letter sent to resident
- Pond overflow pipe identified and left as is
- Groundwater seep identified in ditch
  - Ferric oxide where bottom of ditch interfaces with groundwater

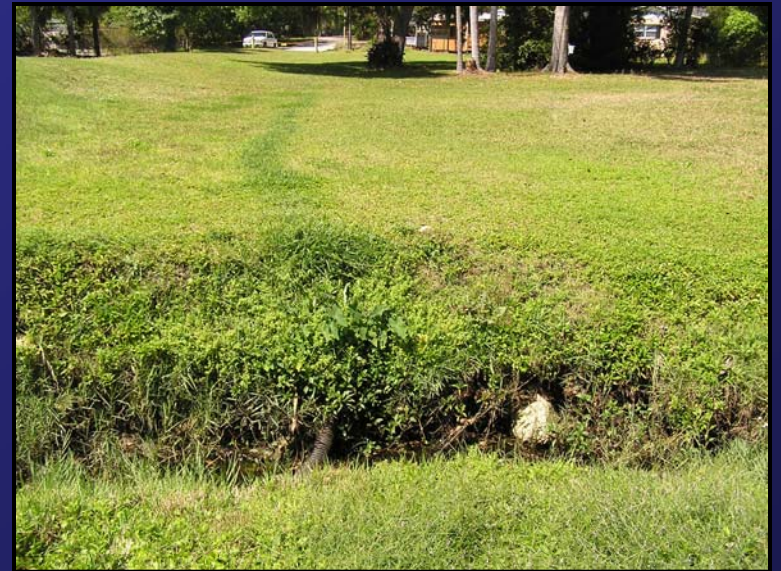
# HCHD and EPCHC Investigation

- Black corrugated pipe observed upstream between HR3 and DHR4A (March 25, 2008) by EPCHC
- Line of dark green grass led to residence and an area of the yard that was “soft and spongy”
- Samples downstream of pipe showed fecal coliform and enterococci exceedances
- HCHD found no evidence of sanitary nuisance (April 4, 2008)
  - Will attempt to contact owner about mandatory sewer connection due to proximity of available infrastructure

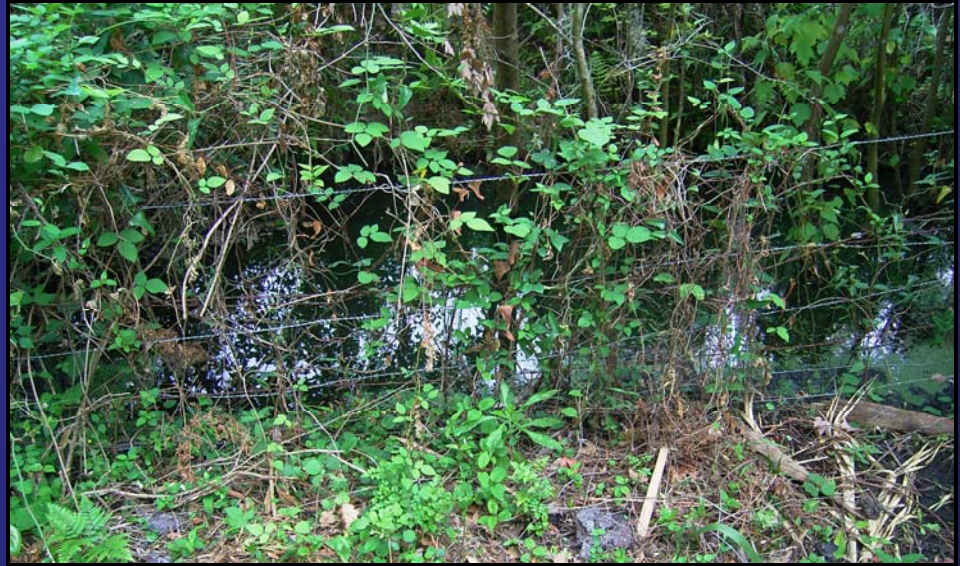
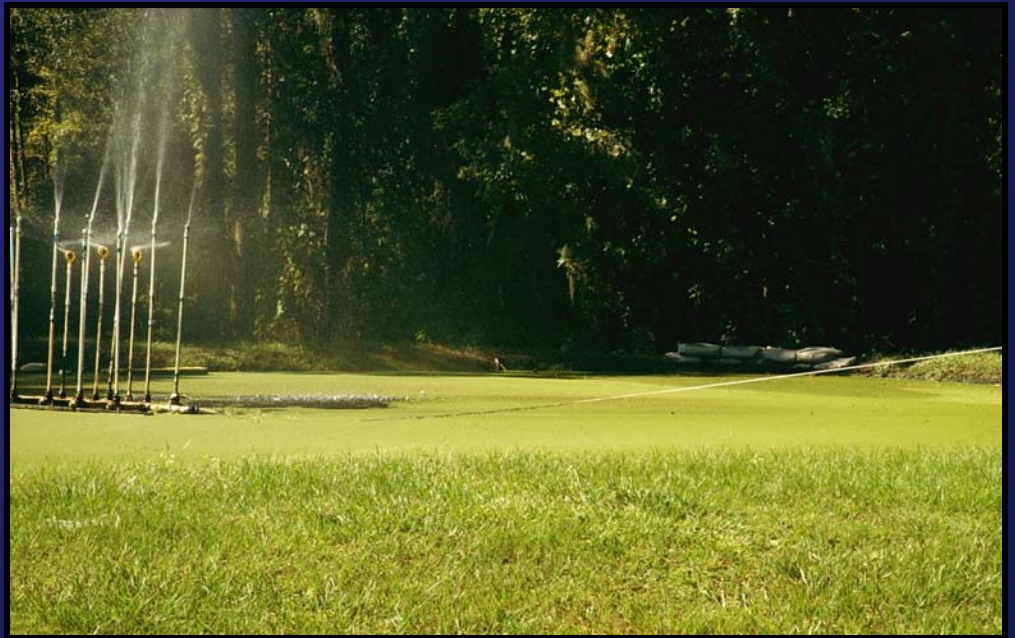
# DEP/EPCHC Investigation

- Facility currently undergoing re-permitting for new 5-year cycle (including new temporary pond)
- Using temporary pond to gain freeboard; little freeboard observed still
  - May continue to be an issue in rainy season

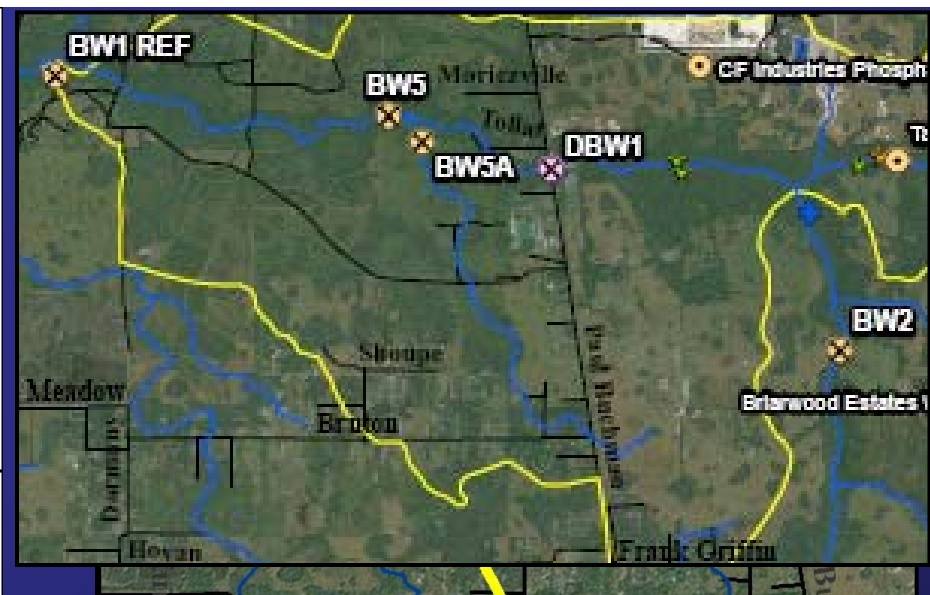
**Episodic exceedances at BW1**

**All 3 human markers at BW1; not associated with highest levels but during times of flow**

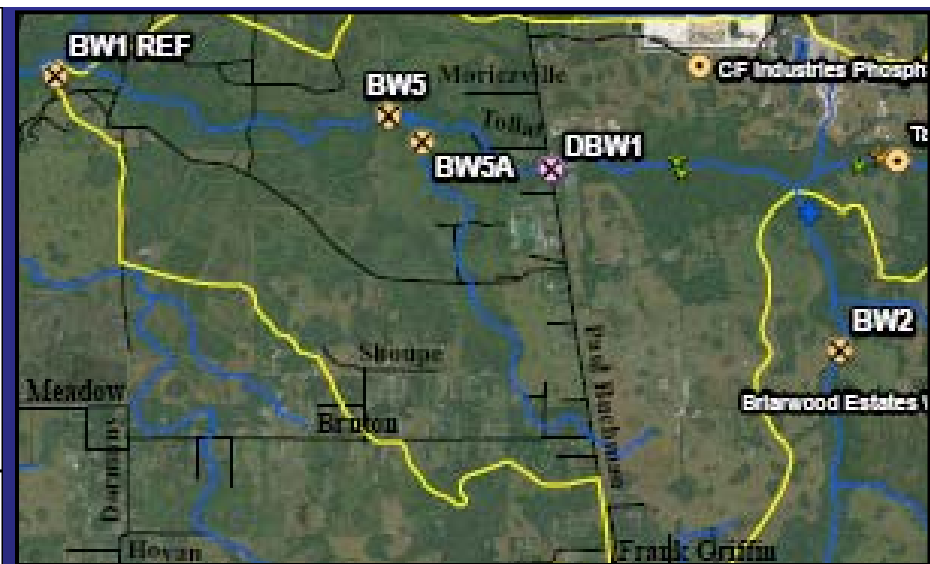
**Exceedances likely due to upstream human source**
