# Observable signs of small sewage leaks

Anita Nash

8-27-19

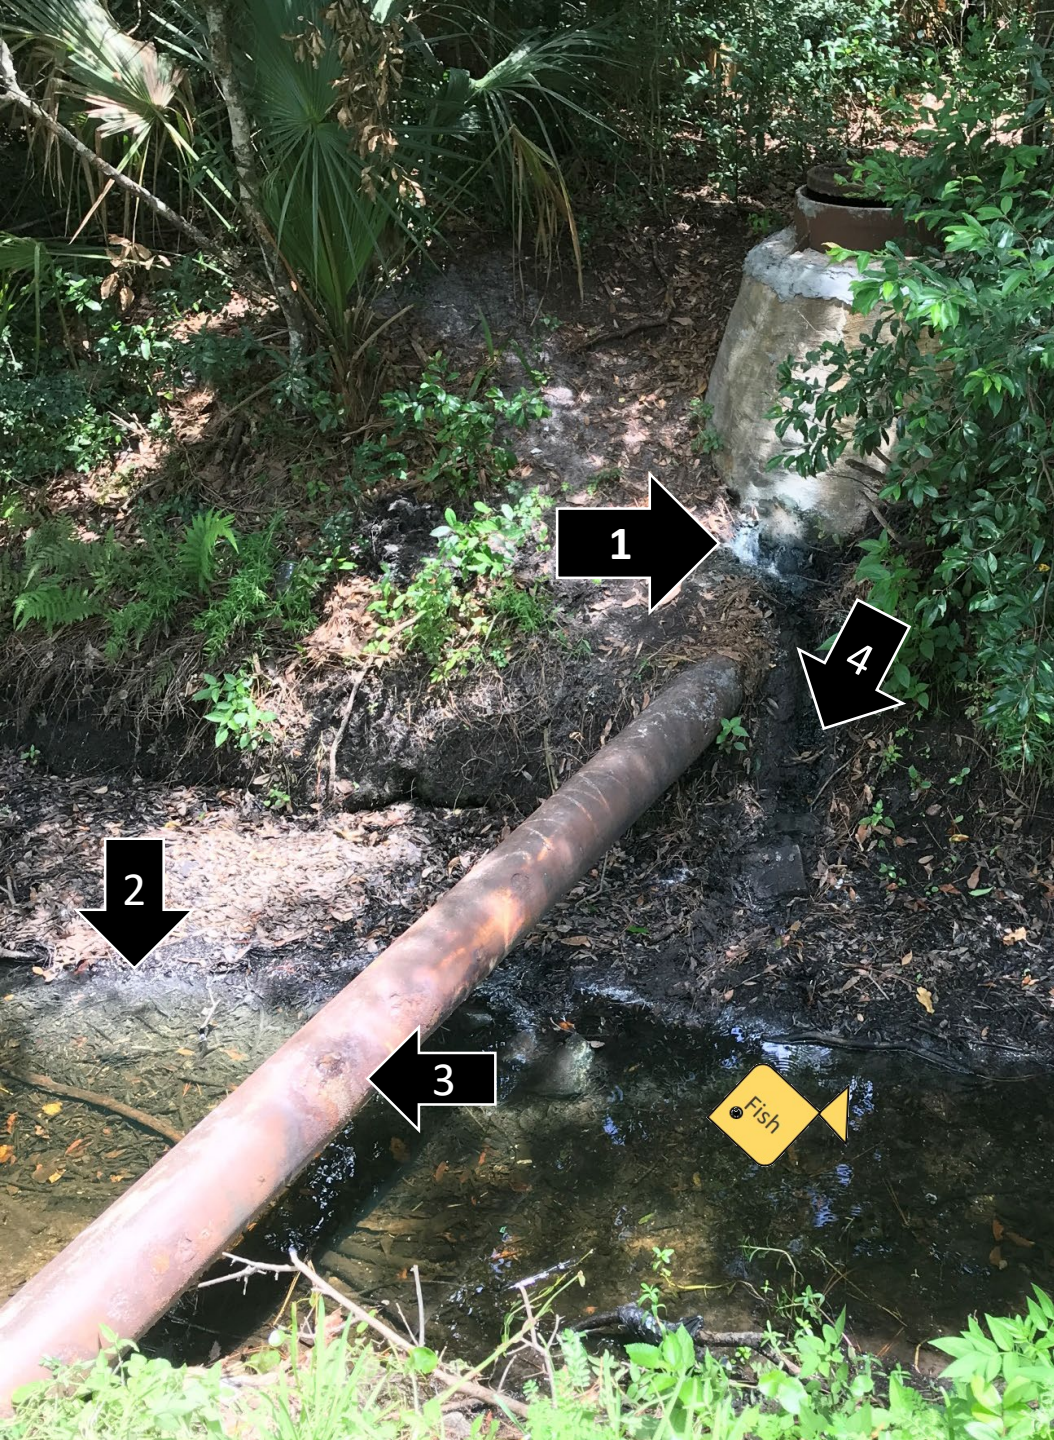
# Four observable signs of problems

- This is a metal sewer line crossing the creek. On the other side is a raised manhole.
- White sulfur bacteria is growing:
  - at the base of the concrete (1) supporting the top of the manhole.
  - And in the creek along the slow moving edges (2) and was visible a long way downstream.
- The pipe is “tuberculated” meaning, rusted through from corrosive sewage gasses, and dripping into the creek (3).
- And a seep runs down the bank from the base of the sewer manhole (4).
- Presence of minnows is not a sign all is clear.

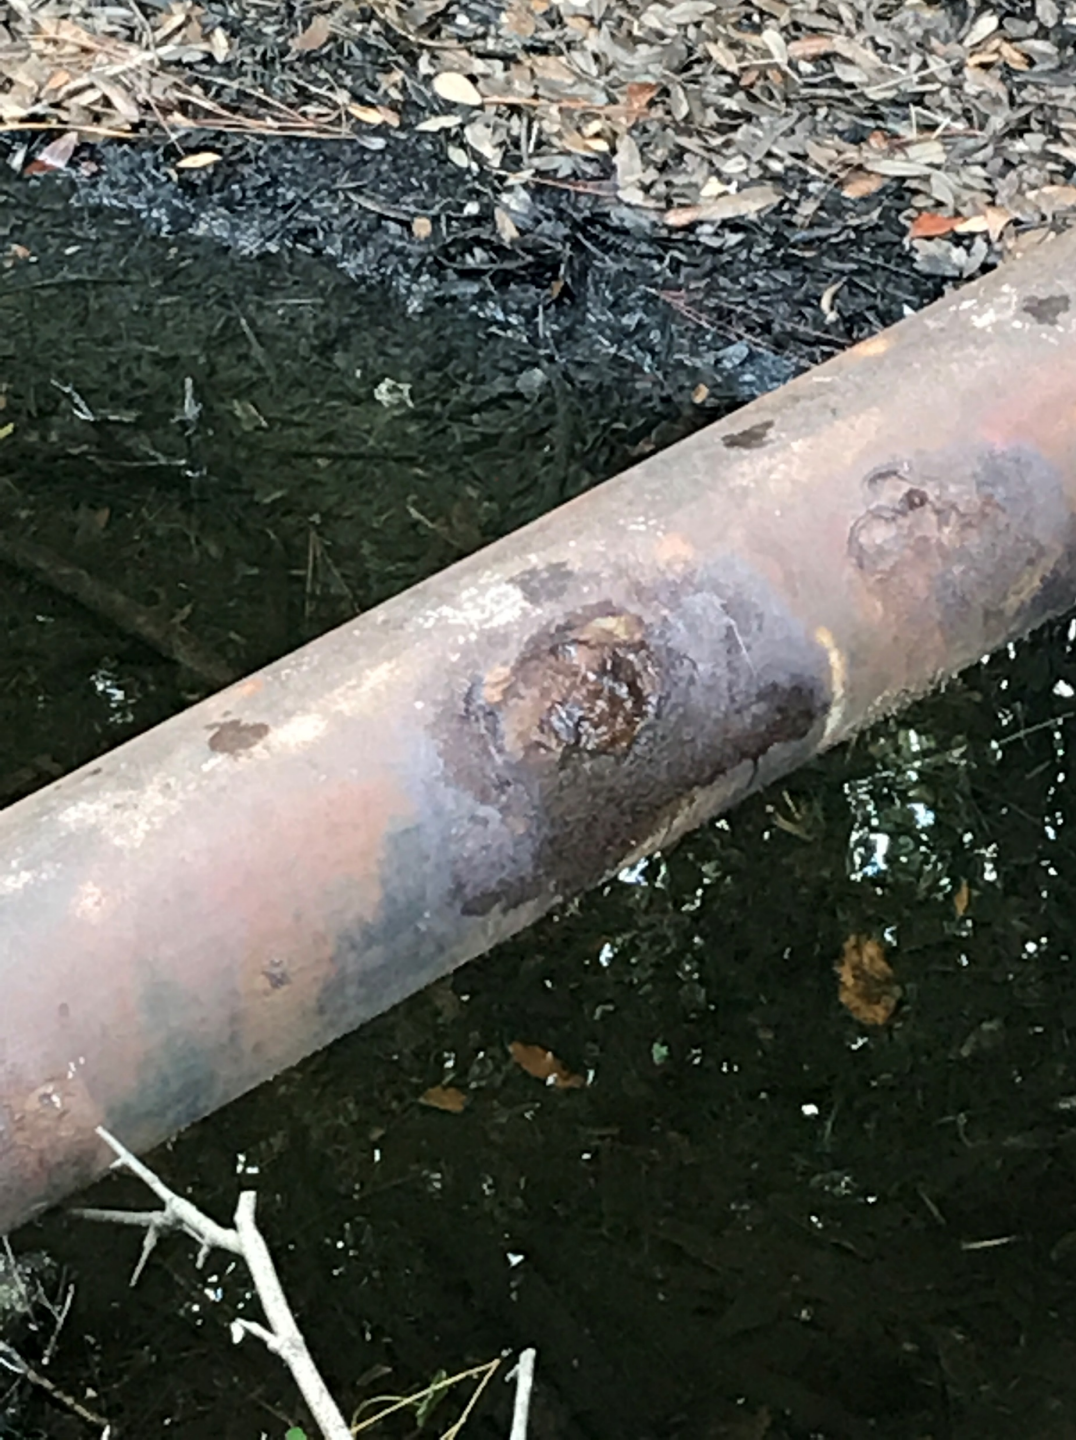
# Leaking tuberculated pipe

A close up of the pipe where it is “tuberculated” meaning, rusted through from corrosive sewage gasses, and dripping into the creek (3).

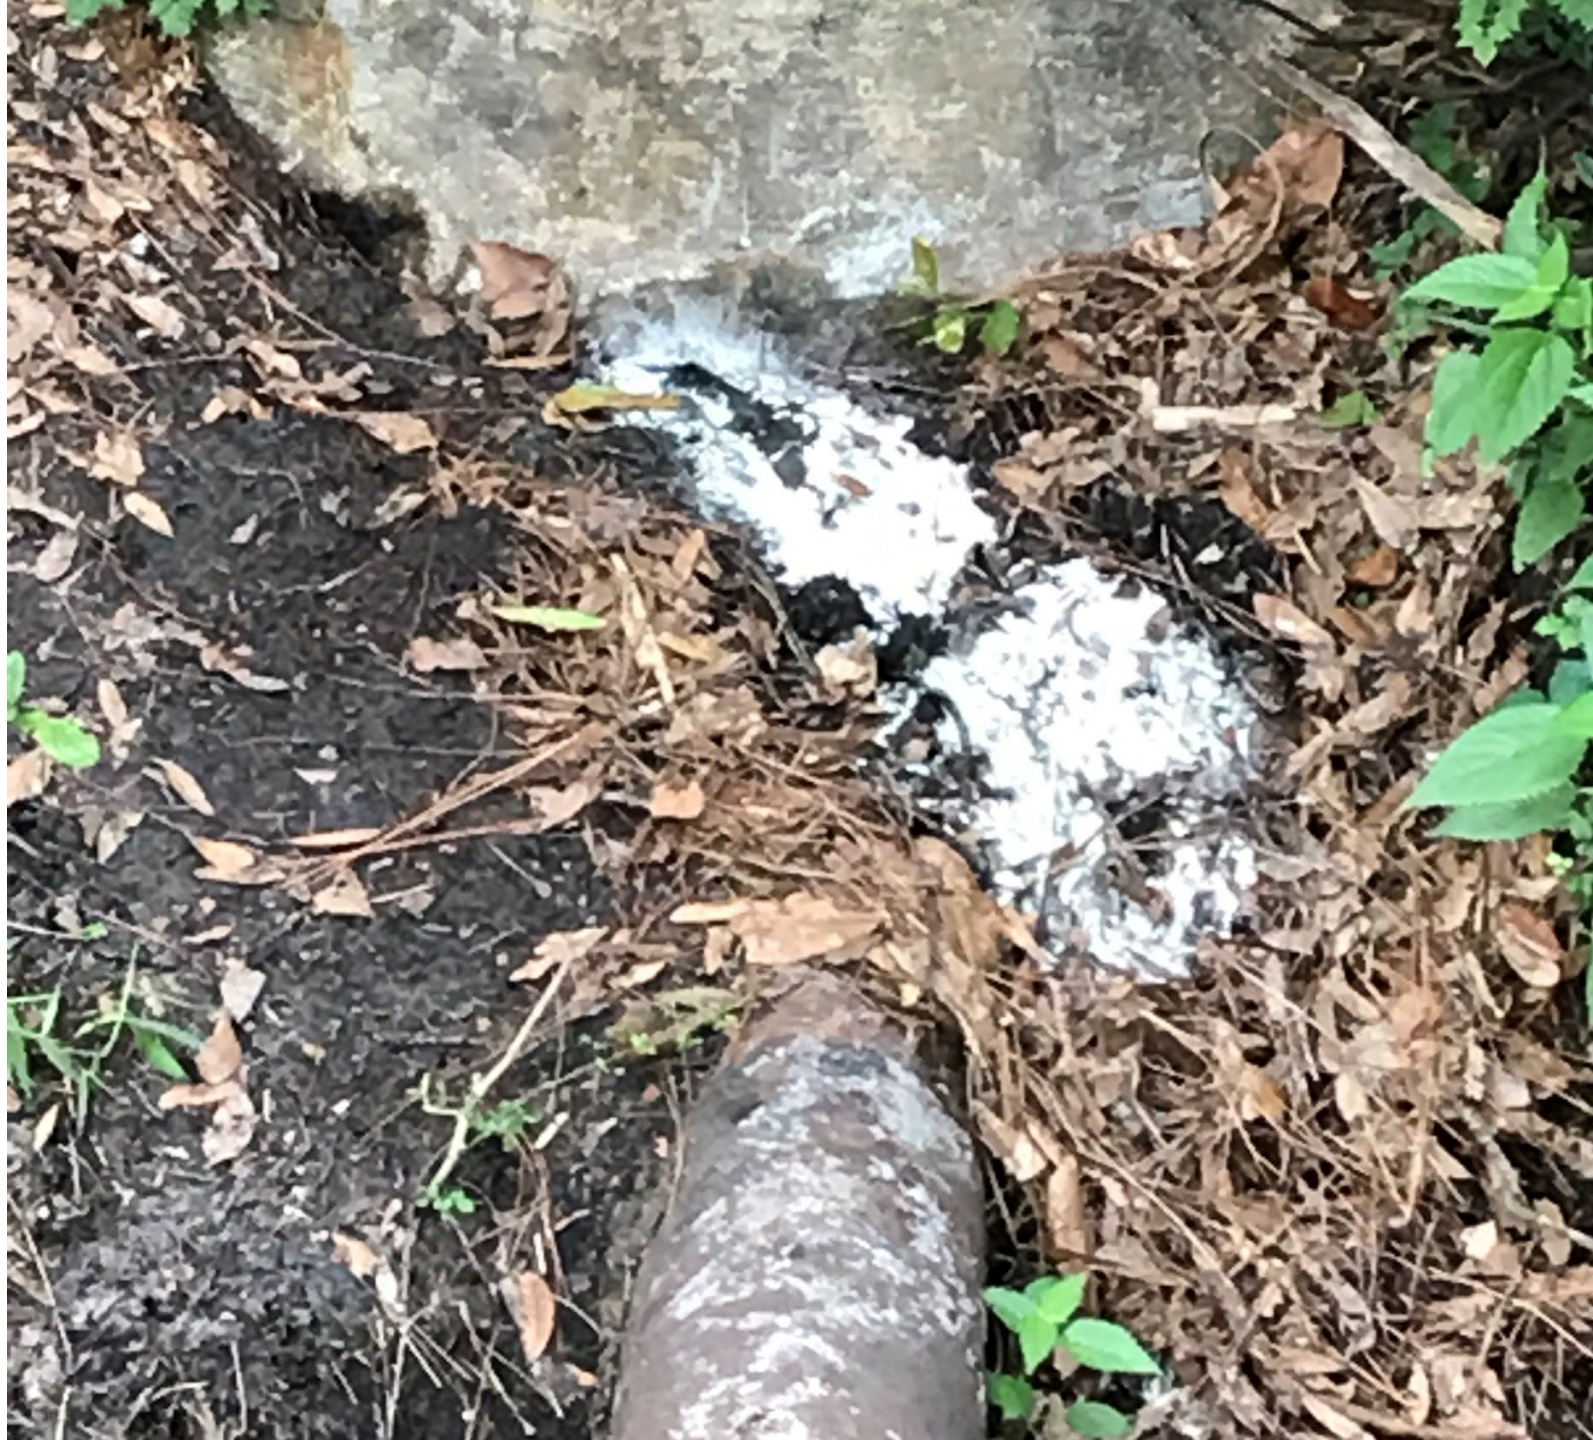
# Is that snow?

- Close up of the white sulfur bacteria growing at the base of the concrete (1) supporting the top of the manhole

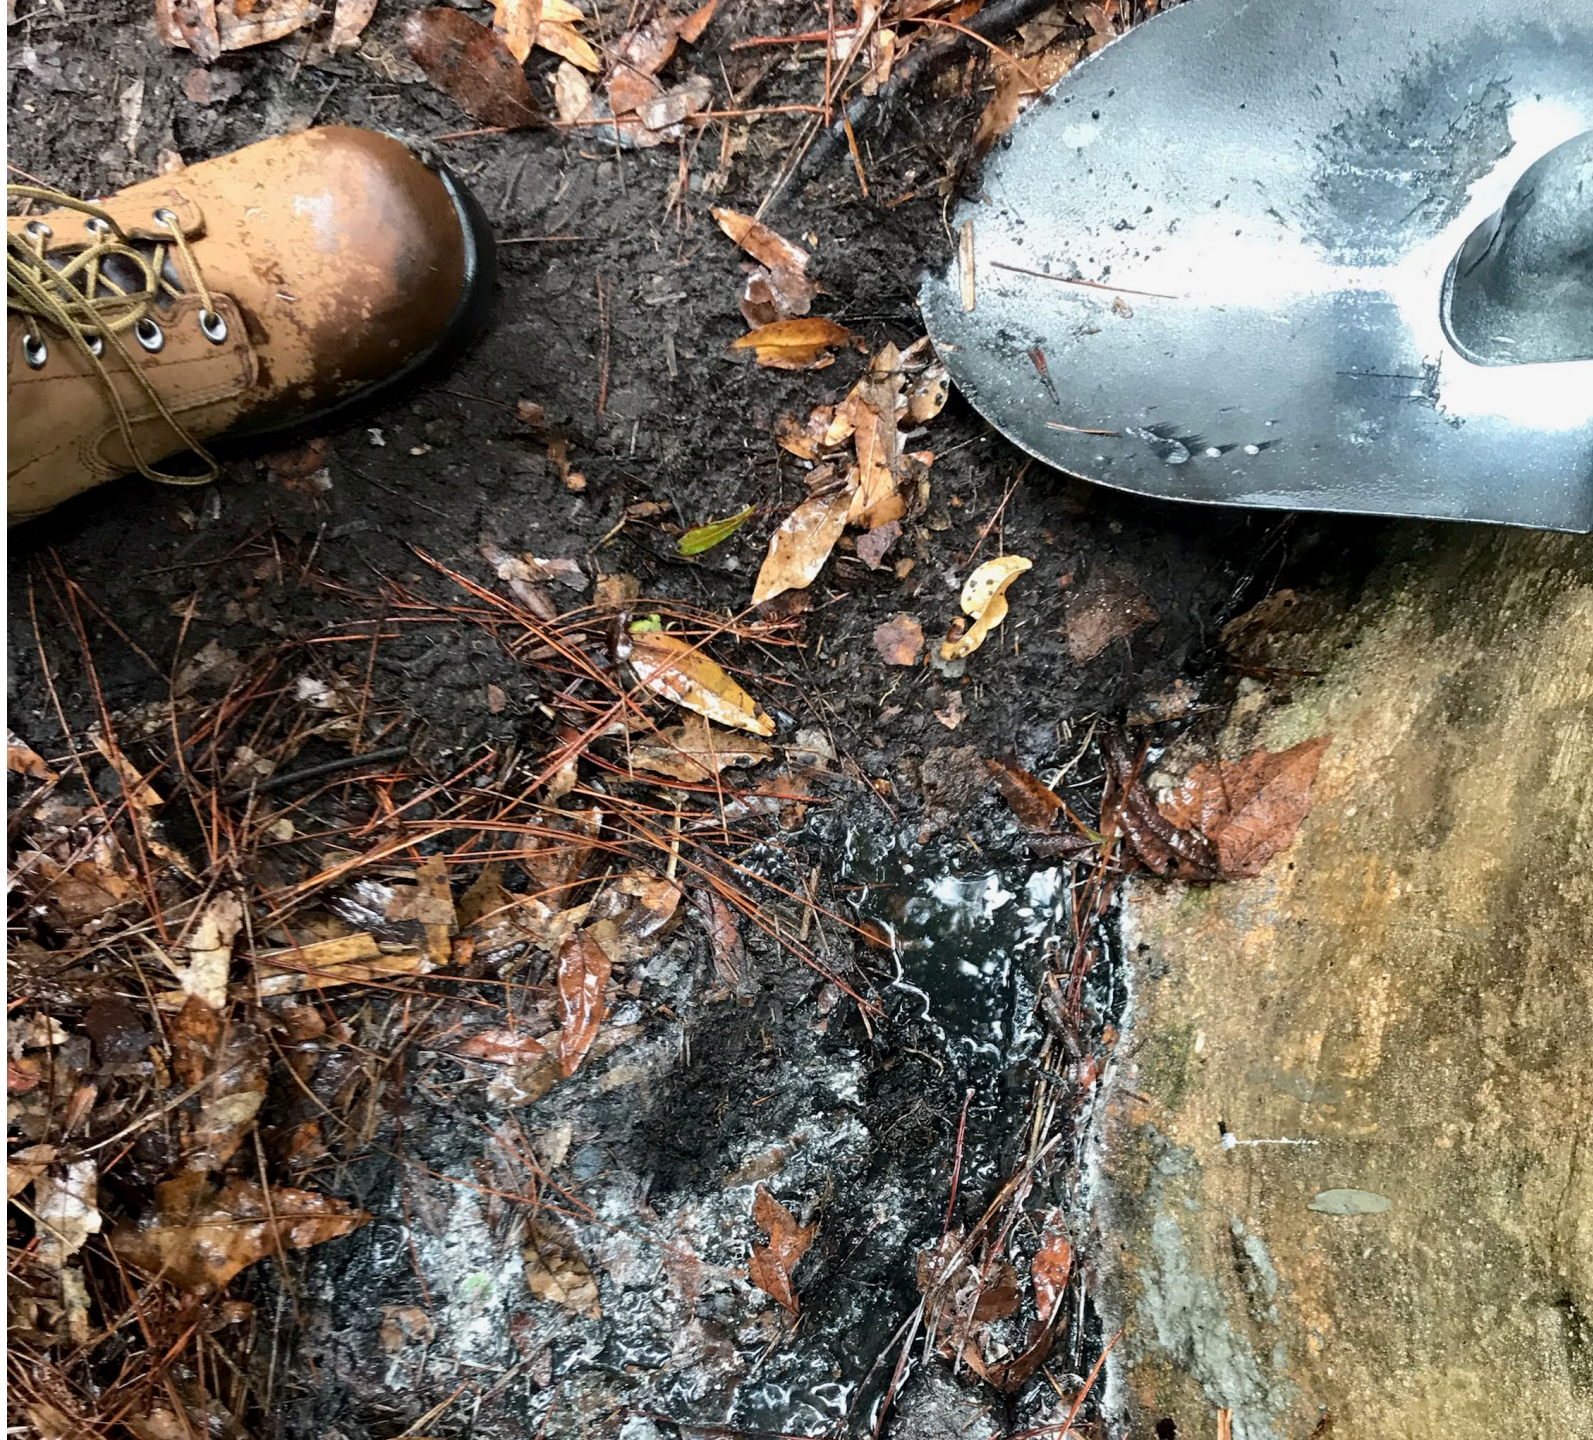
# A closer inspection

- Close-up of sewage leaking at base of concrete.

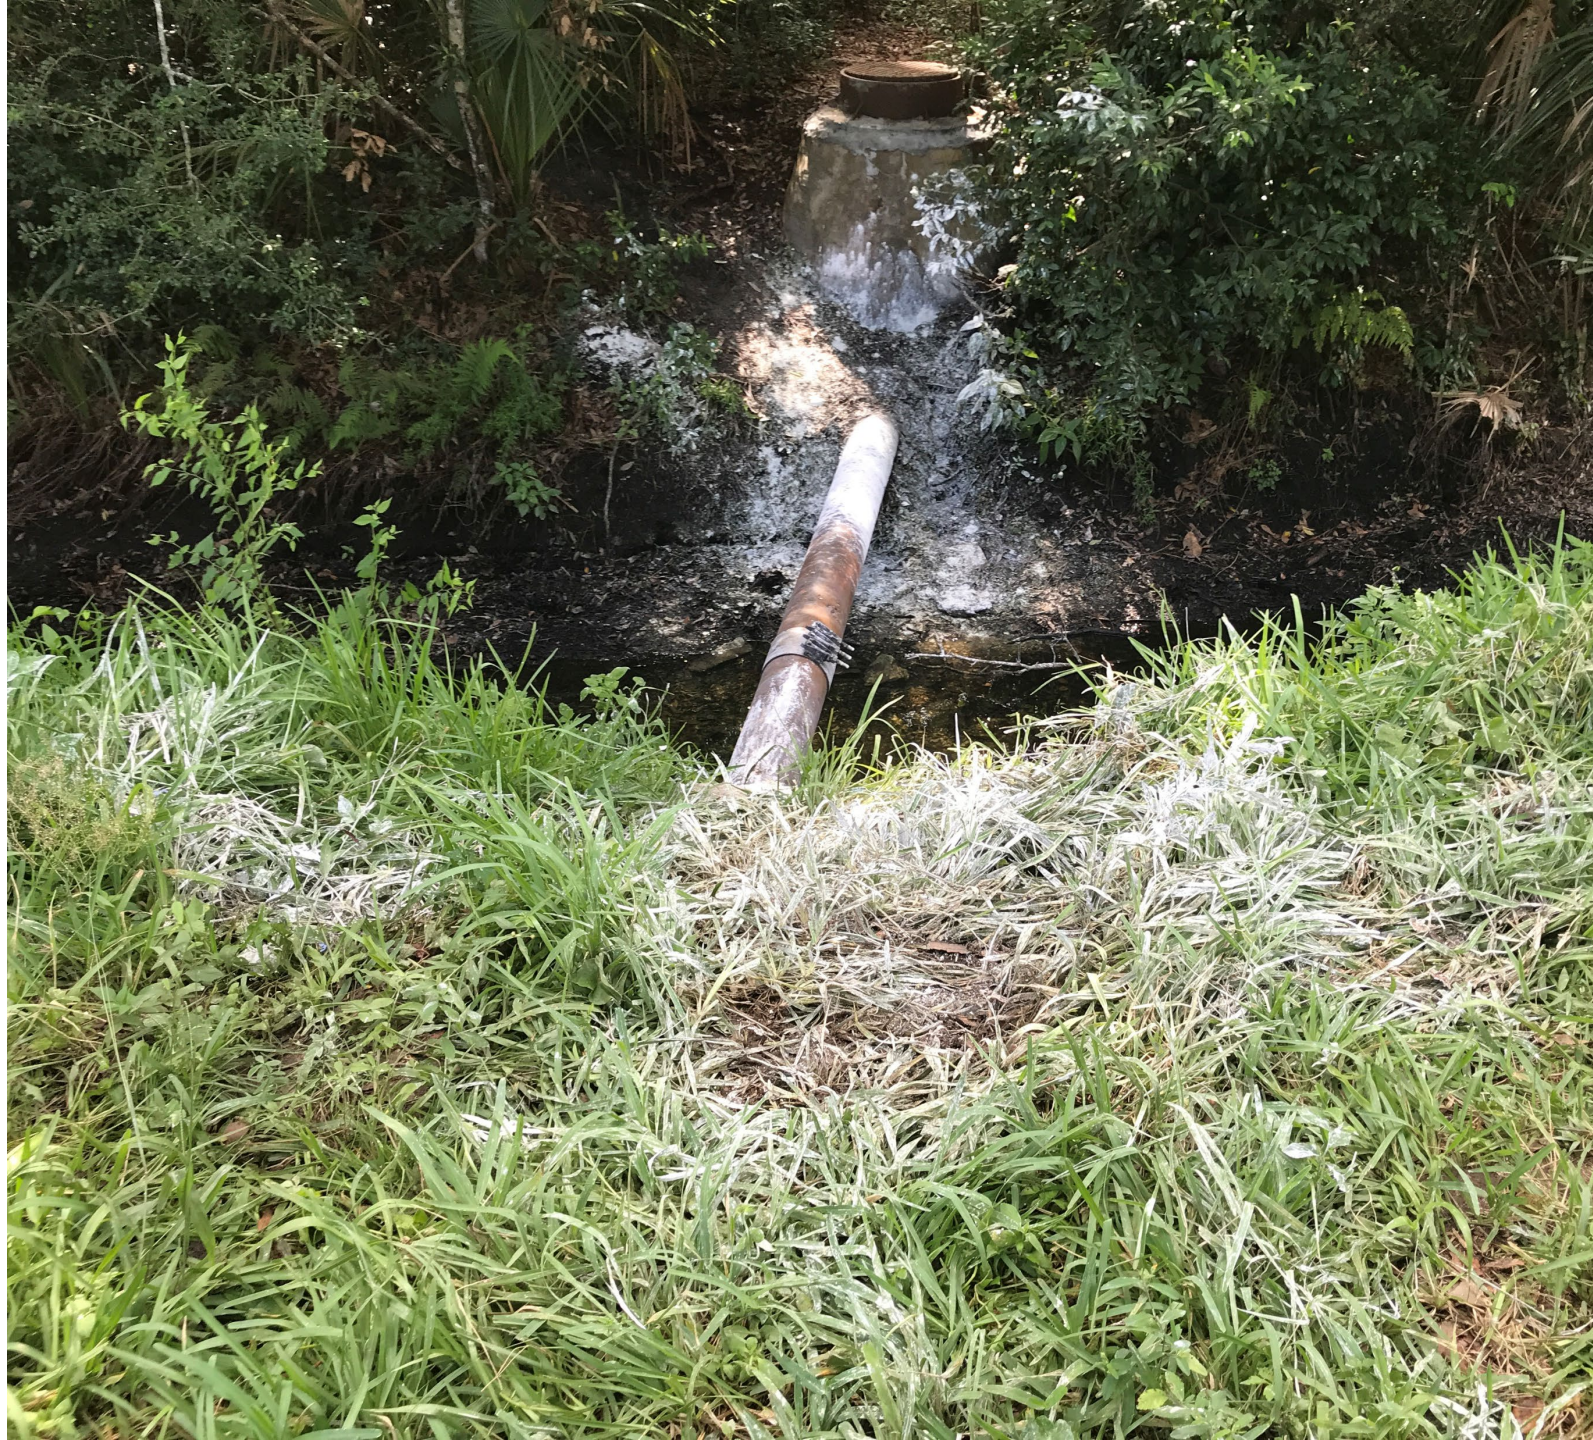
# Fixed

- White lime sprinkled all over the area where sewage was on the ground. (1)
- Clamp on pipe to seal off the hole until the pipe can be replaced or lined. (2)
- The manhole filled up and leaked out because there was a blockage of the pipe downstream. Obstruction was removed.
