Site Name: McDonald Branch @ Thompson Rd

P Form FD 9000-4 Stream/River Habitat Assessment Sketch Sheet

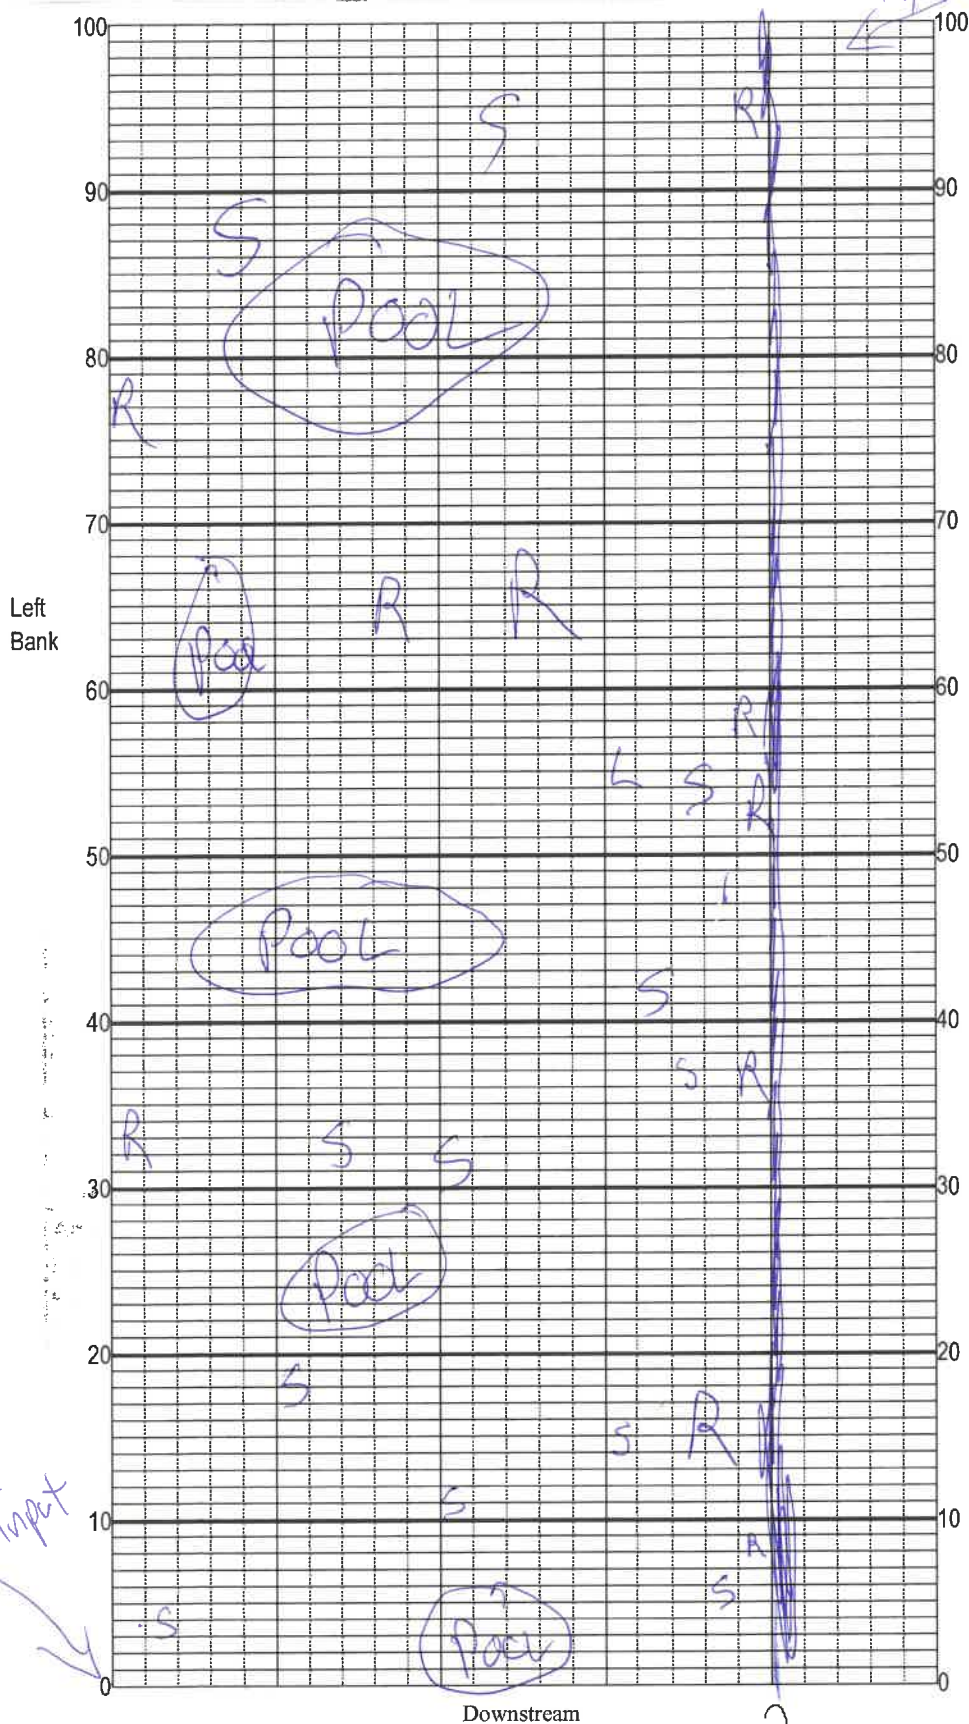
Substrates: Code key, draw proportionate habitat abundance. %

| S | Snags | 1.9 |

| R | Roots/undercut banks | 2.3 |

| L | Leaf Packs (or mats) | few |

| P | Pools | total # observed = 5 |
| | | # range expected = 4-8 |

Average width 2 m

Average depth 1.5 m

Velocity measured at 50, 100 meter mark.

WQ &amp; chemistry taken at 100 meter mark.

S 38  
R 46

Length of grid represents 100 m of stream (not linear meters).  
(Horizontal scale is double vertical scale, draw proportionately).
