# R-52-T PROFILES

FRANKLIN  
PROGRAM SUPPORT GIS  
DIVISION OF WATER RESOURCE MANAGEMENT  
FLORIDA DEPARTMENT OF ENVIRONMENTAL PROTECTION

RANGE: R-52-T  
EST DATE: FEB1980  
SURVEY DATE: 16MAY19  
AZIMUTH: 150.0

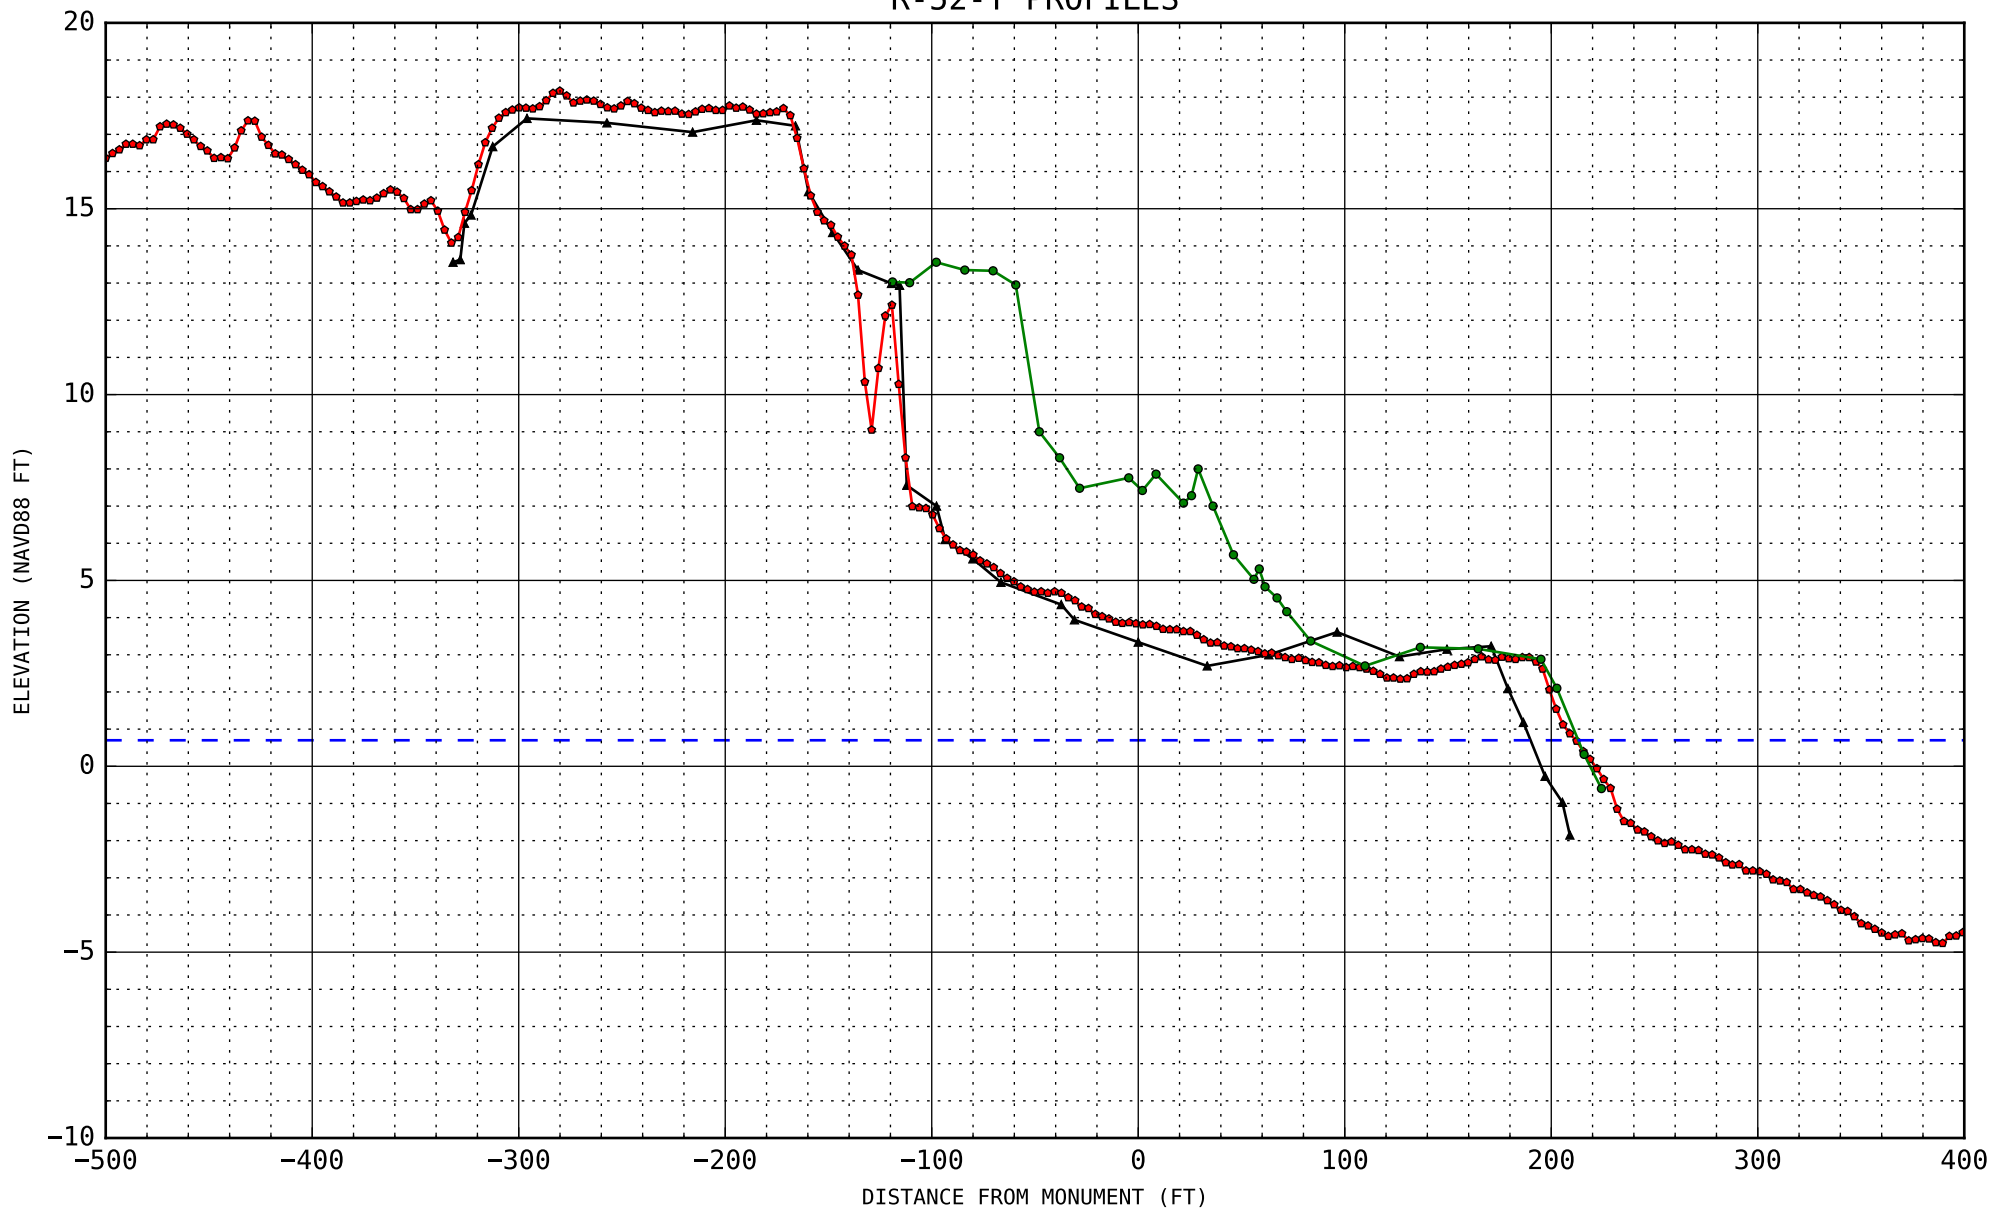
- ▲ 2019-MAY CONDITION BY DEP
- 2018-OCT MONITORING BY USACE-LIDAR
- 2017-FEB MONITORING BY DEP
- - - MHW CONTOUR (0.7 FT)

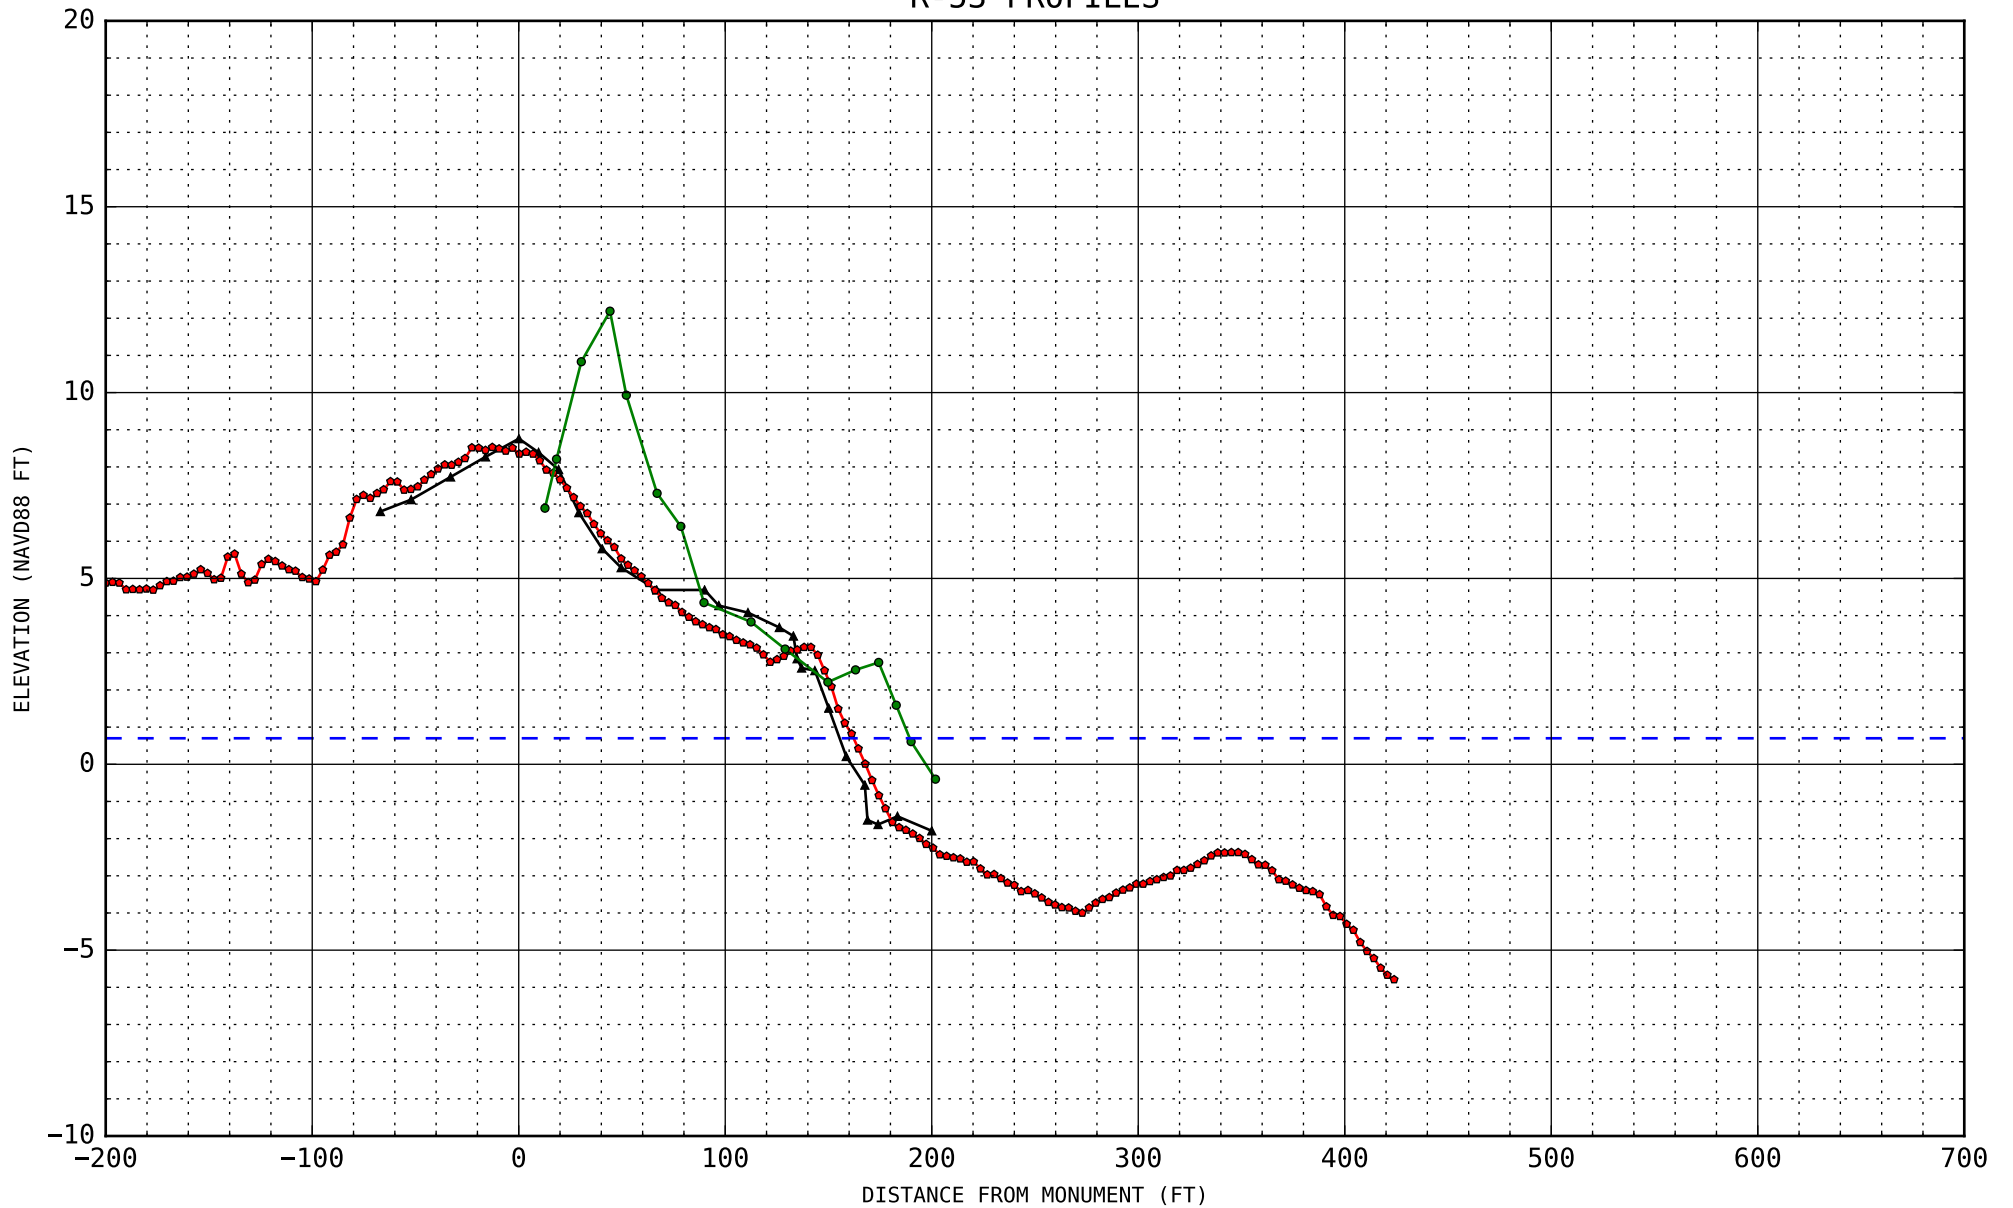
# R-53 PROFILES

- ▲ 2019-MAY CONDITION BY DEP
- 2018-OCT MONITORING BY USACE-LIDAR
- 2017-FEB MONITORING BY DEP
- - - MHW CONTOUR (0.7 FT)

RANGE: R-53  
EST DATE: JUL1996  
SURVEY DATE: 16MAY19  
AZIMUTH: 150.0

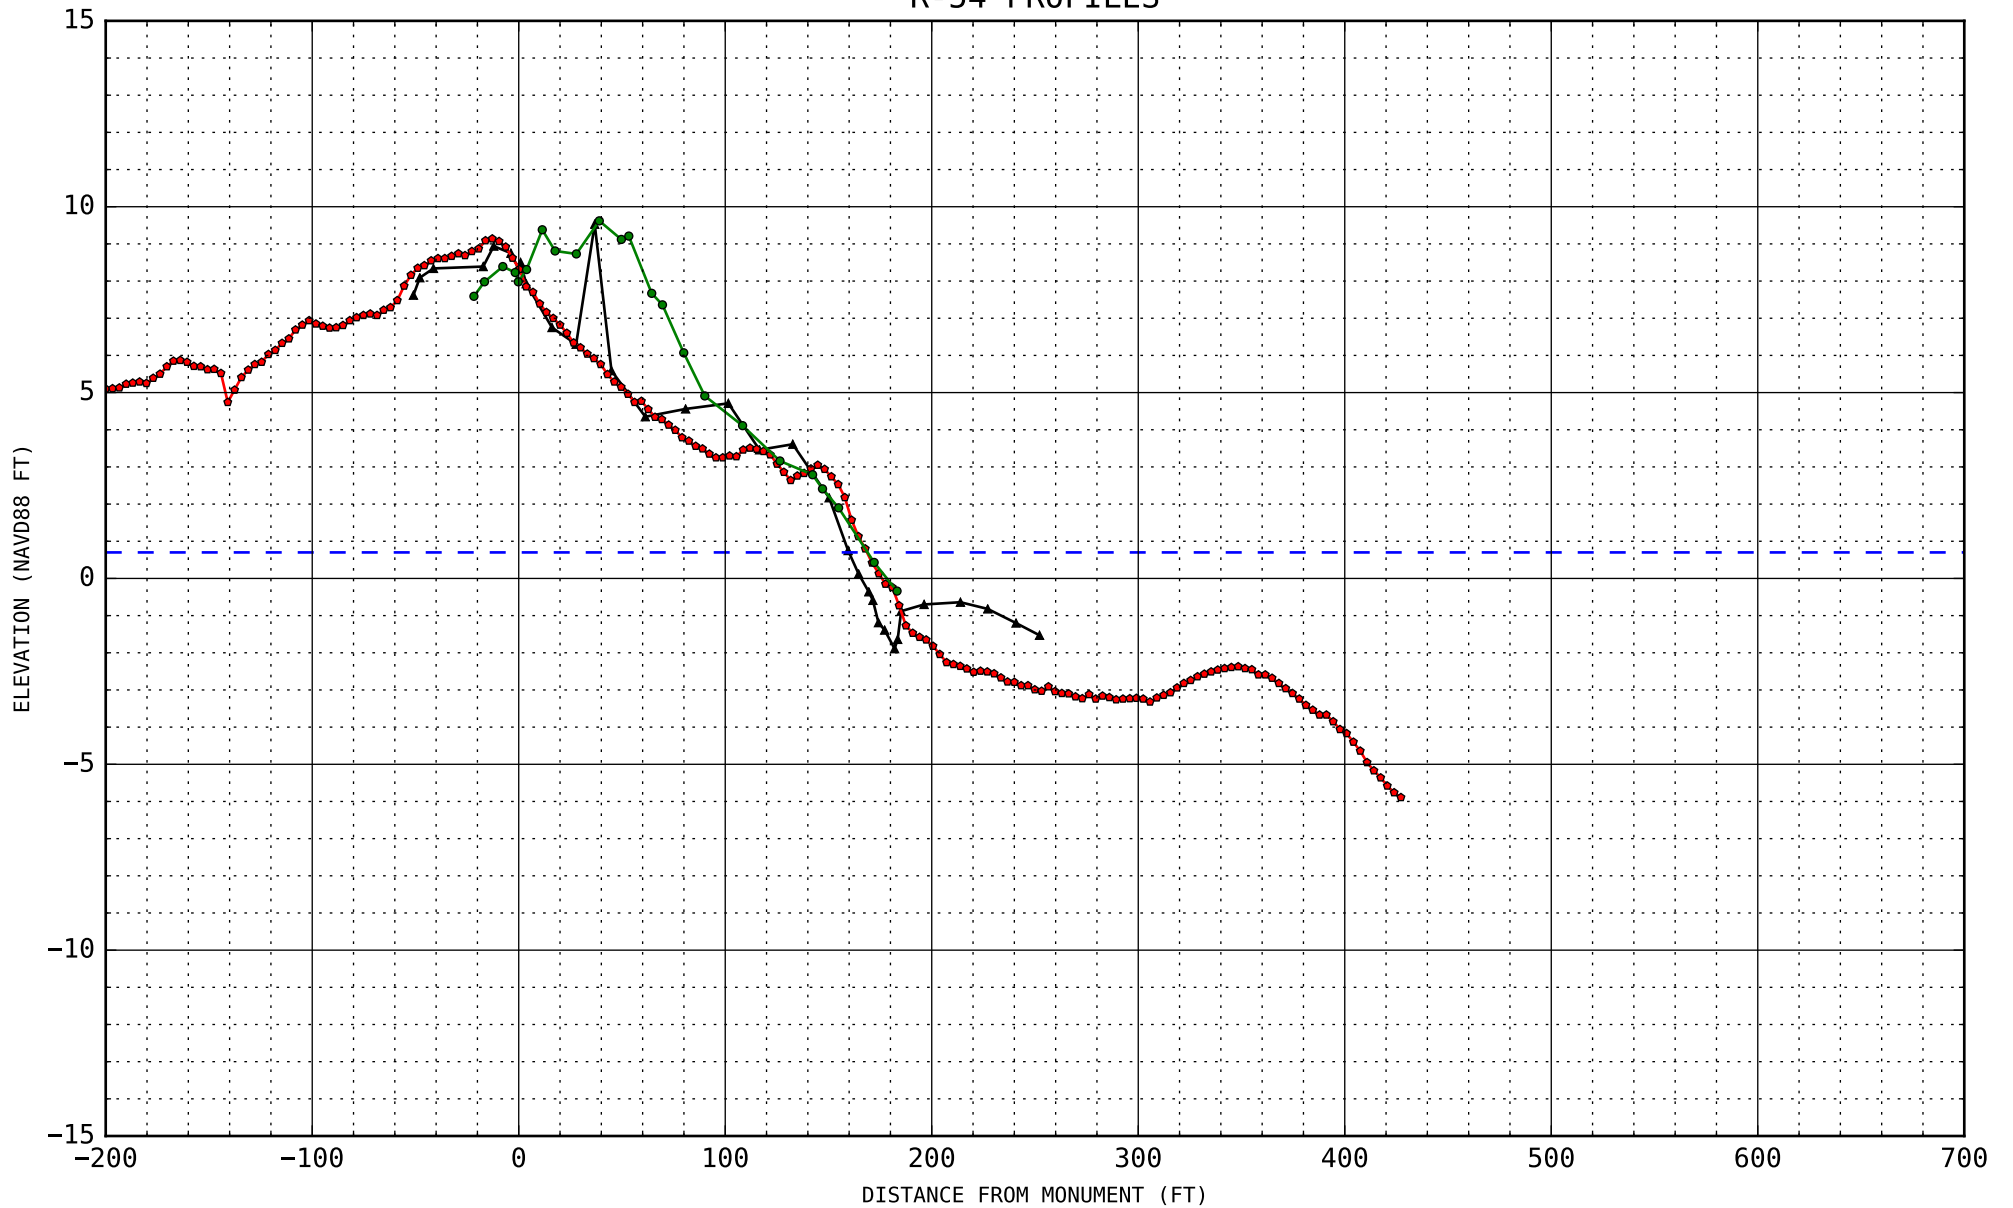
# R-54 PROFILES

- ▲ 2019-MAY CONDITION BY DEP
- 2018-OCT MONITORING BY USACE-LIDAR
- 2017-FEB MONITORING BY DEP
- - - MHW CONTOUR (0.7 FT)

RANGE: R-54  
EST DATE: JUL1996  
SURVEY DATE: 16MAY19  
AZIMUTH: 150.0

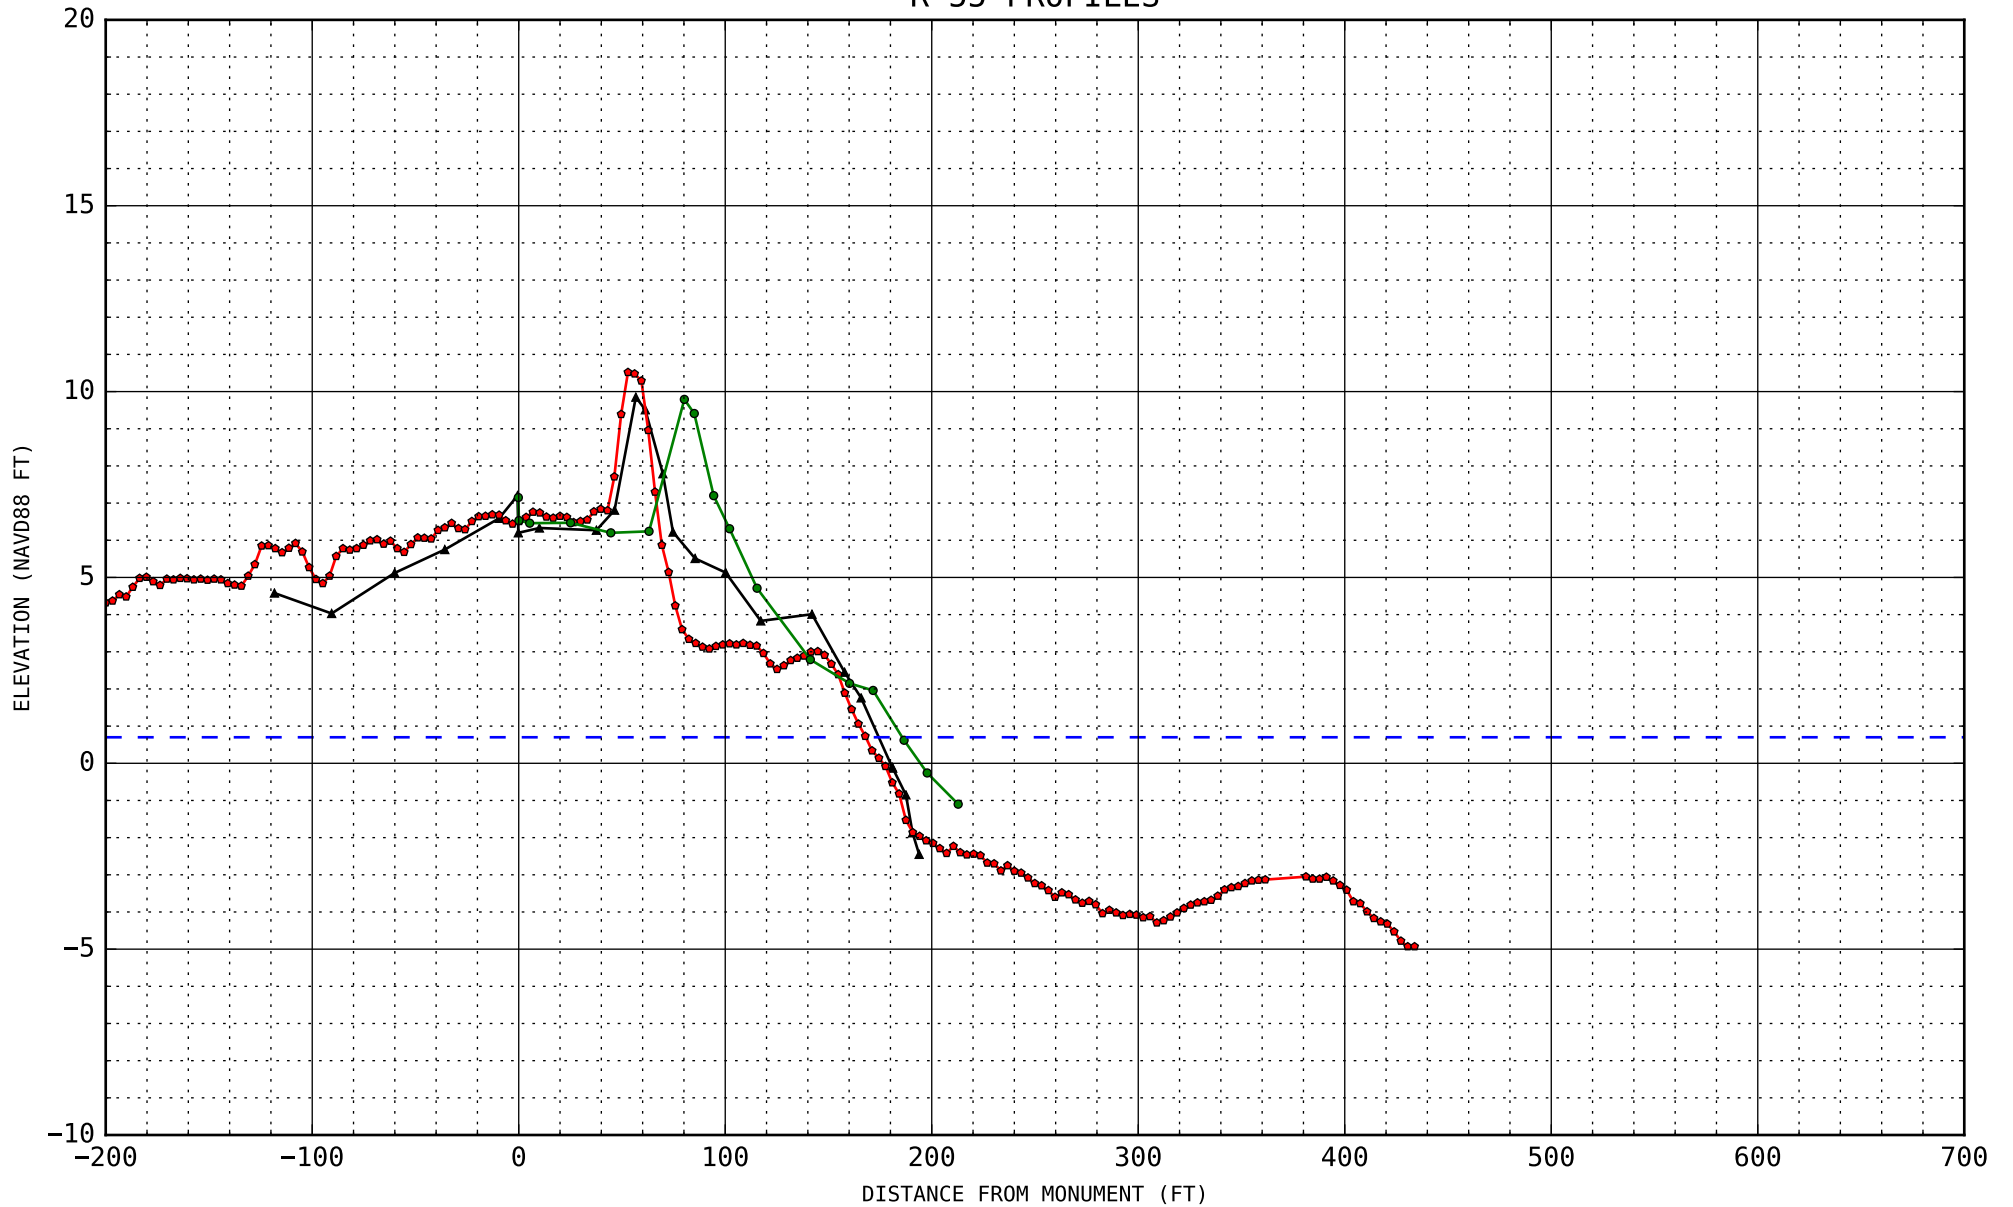
# R-55 PROFILES

- ▲ 2019-MAY CONDITION BY DEP
- 2018-OCT MONITORING BY USACE-LIDAR
- 2017-FEB MONITORING BY DEP
- - - MHW CONTOUR (0.7 FT)

RANGE: R-55  
 EST DATE: JUL1996  
 SURVEY DATE: 16MAY19  
 AZIMUTH: 150.0

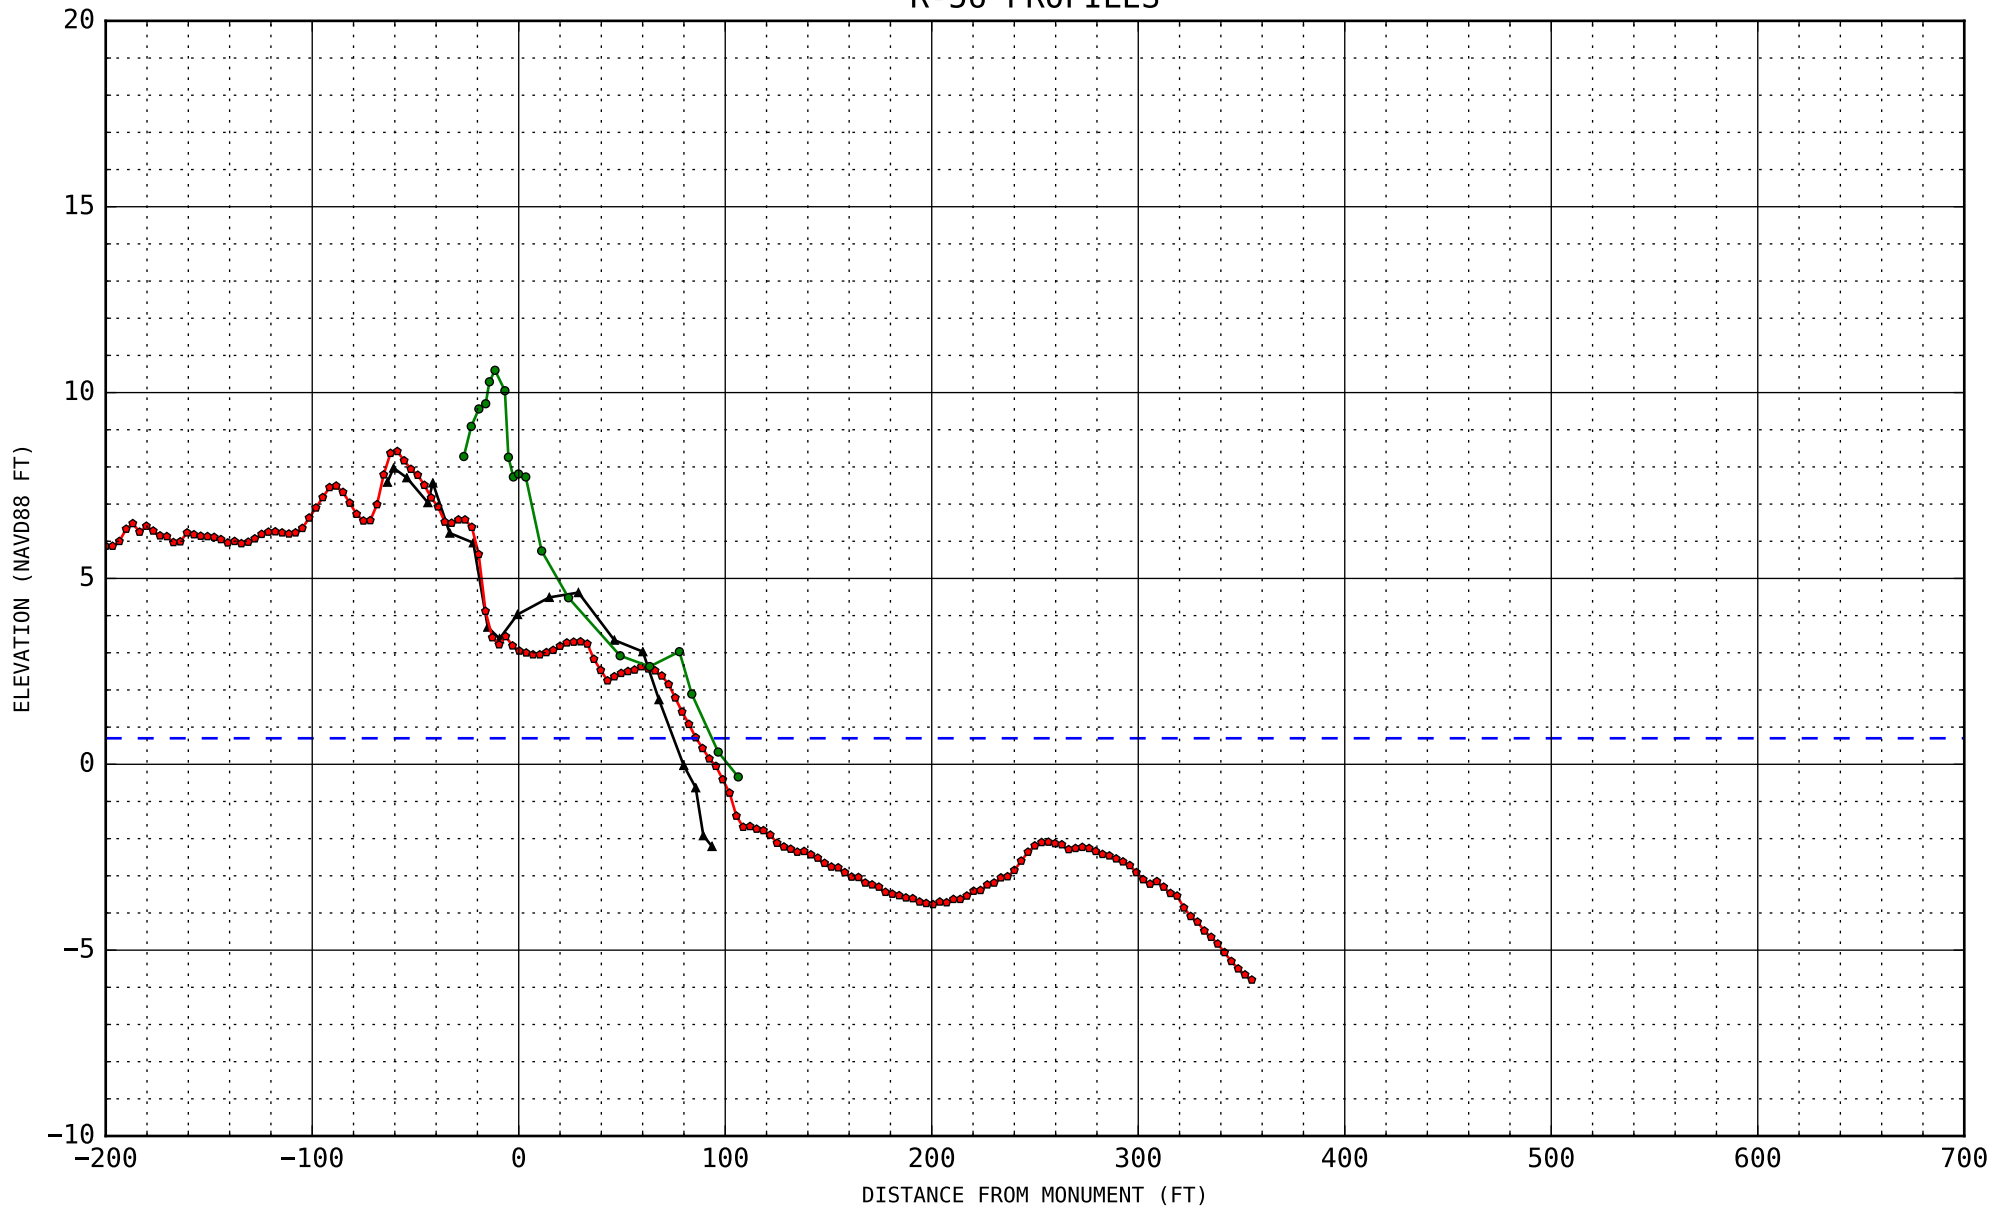
# R-56 PROFILES

- ▲ 2019-MAY CONDITION BY DEP
- 2018-OCT MONITORING BY USACE-LIDAR
- 2017-FEB MONITORING BY DEP
- - - MHW CONTOUR (0.7 FT)

RANGE: R-56  
 EST DATE: JUL1996  
 SURVEY DATE: 16MAY19  
 AZIMUTH: 150.0

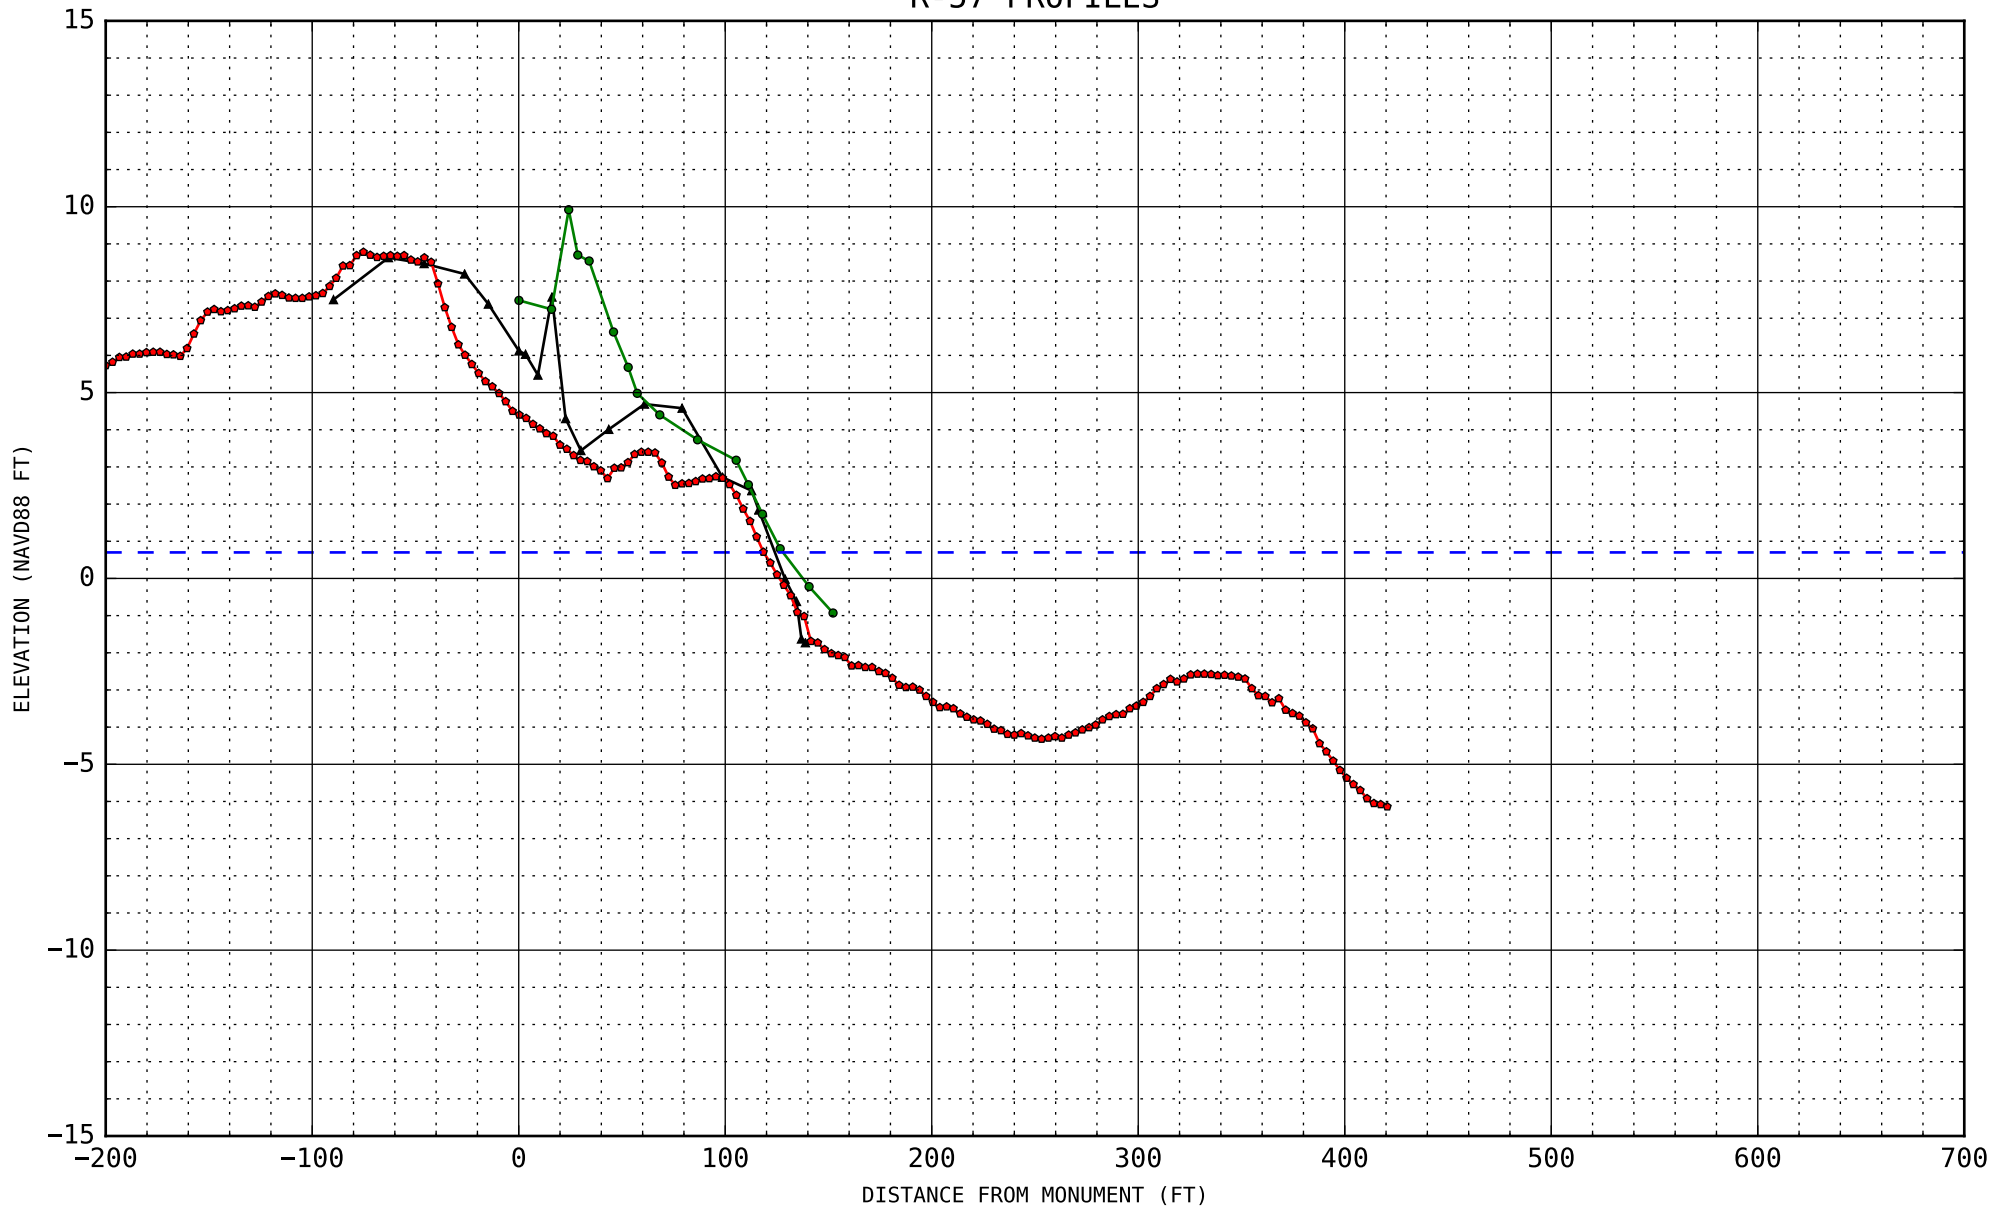
# R-57 PROFILES

- ▲ 2019-MAY CONDITION BY DEP
- 2018-OCT MONITORING BY USACE-LIDAR
- 2017-FEB MONITORING BY DEP
- - - MHW CONTOUR (0.7 FT)

RANGE: R-57  
 EST DATE: JUL1996  
 SURVEY DATE: 16MAY19  
 AZIMUTH: 150.0

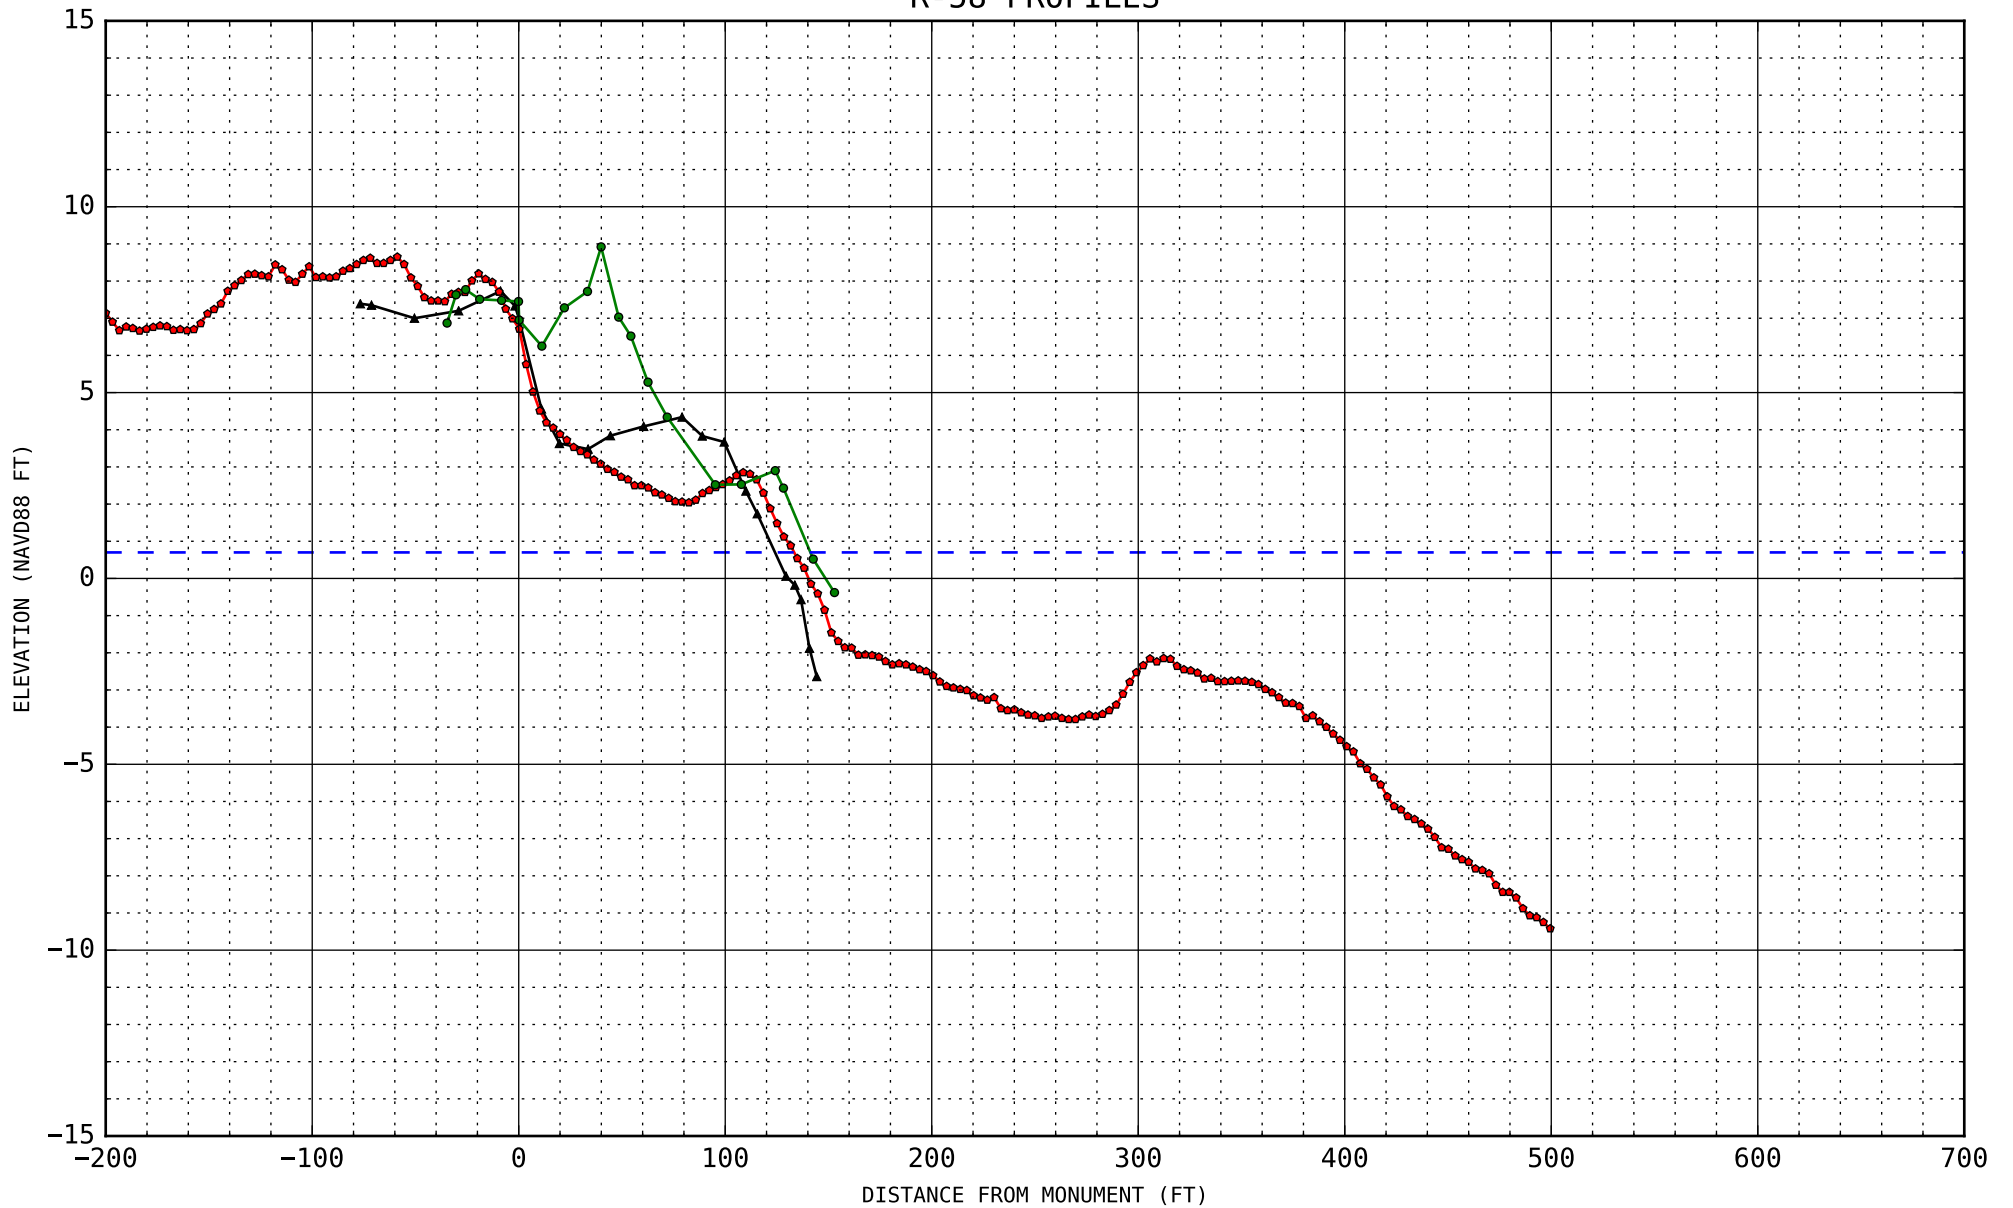
# R-58 PROFILES

- ▲ 2019-MAY CONDITION BY DEP
- 2018-OCT MONITORING BY USACE-LIDAR
- 2017-FEB MONITORING BY DEP
- - - MHW CONTOUR (0.7 FT)

RANGE: R-58  
 EST DATE: JUL1996  
 SURVEY DATE: 16MAY19  
 AZIMUTH: 150.0

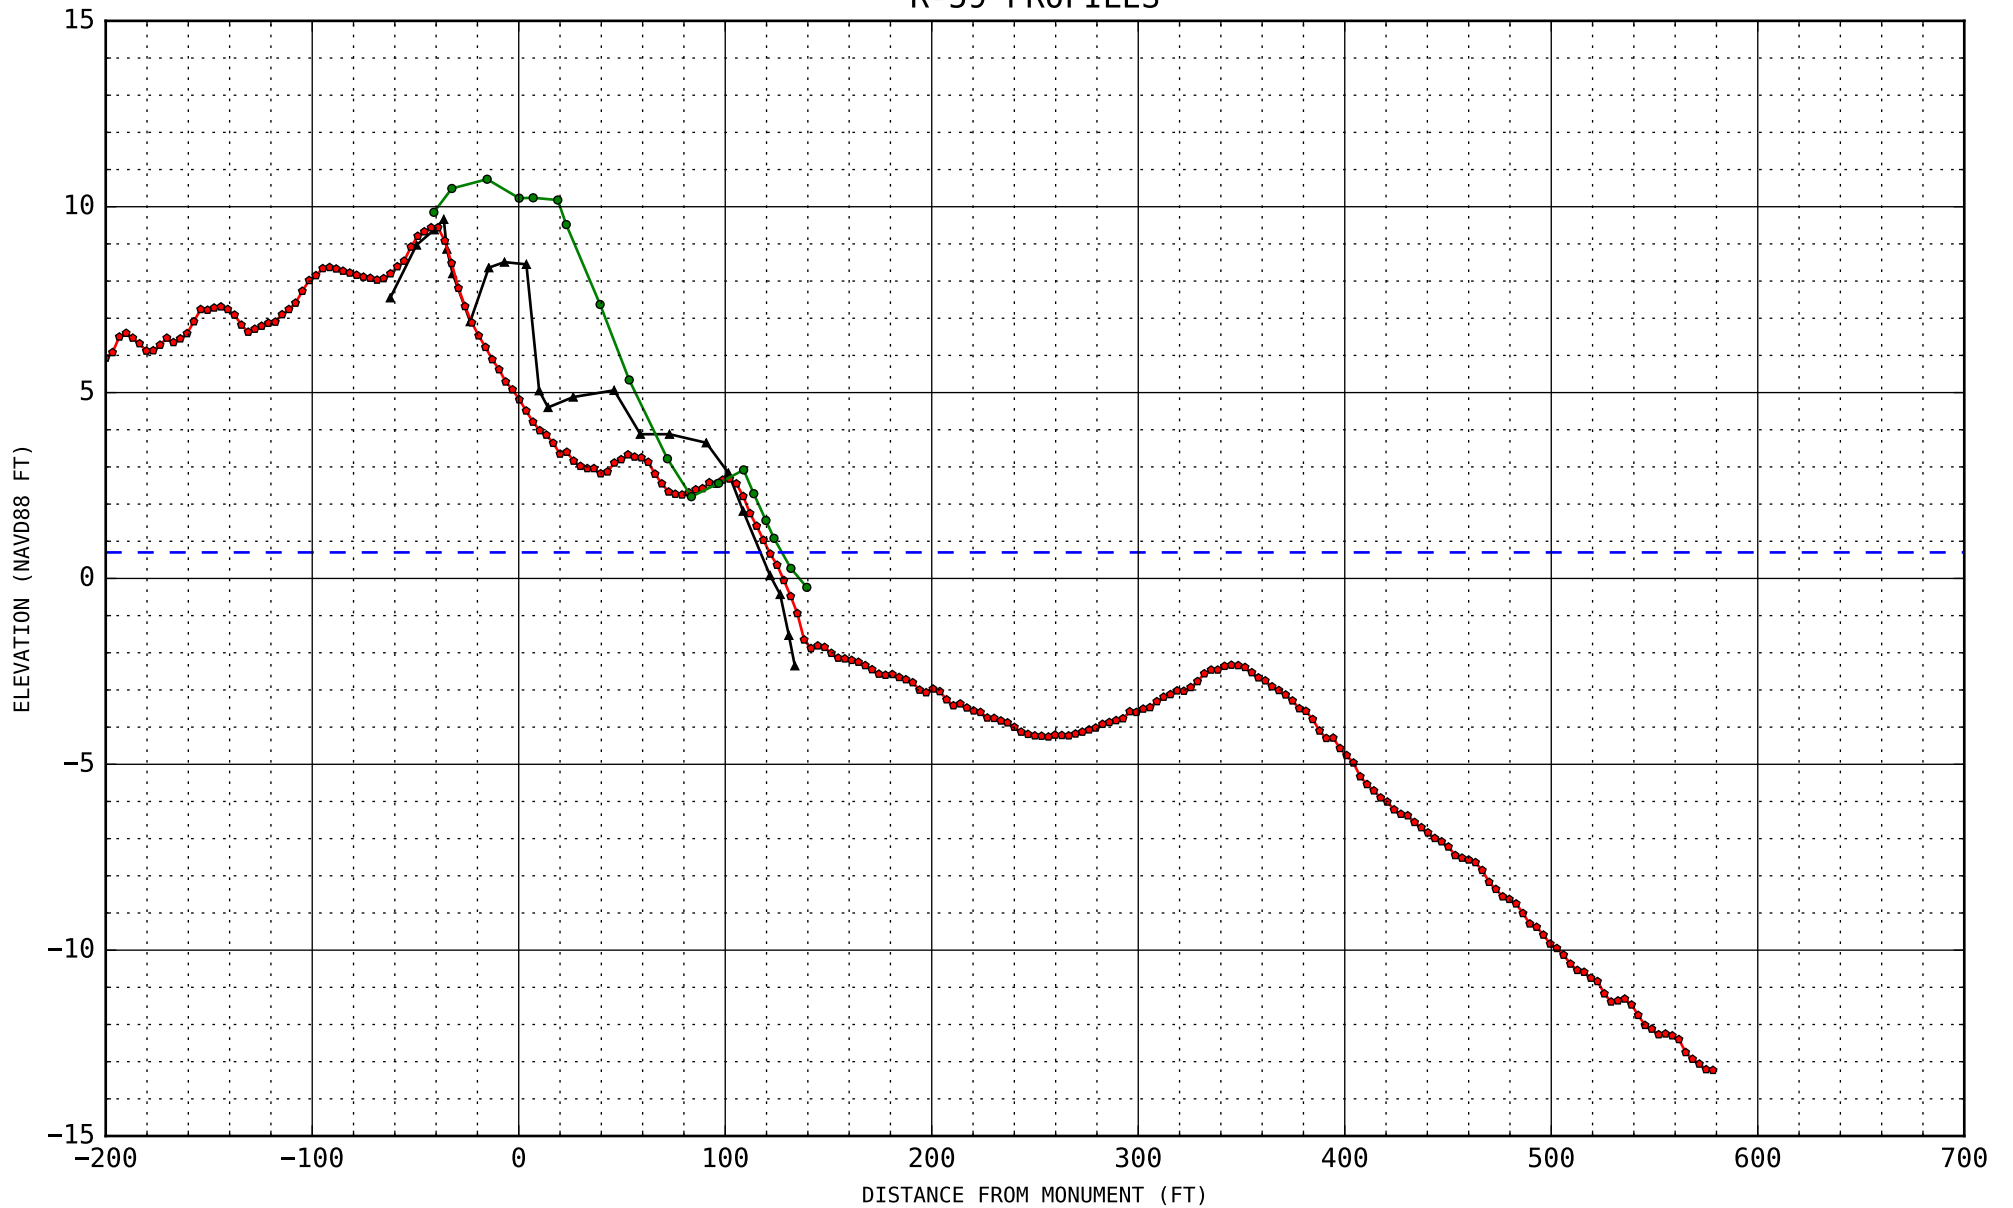
# R-59 PROFILES

- ▲ 2019-MAY CONDITION BY DEP
- 2018-OCT MONITORING BY USACE-LIDAR
- 2017-FEB MONITORING BY DEP
- - - MHW CONTOUR (0.7 FT)

RANGE: R-59  
 EST DATE: JUL1996  
 SURVEY DATE: 16MAY19  
 AZIMUTH: 150.0

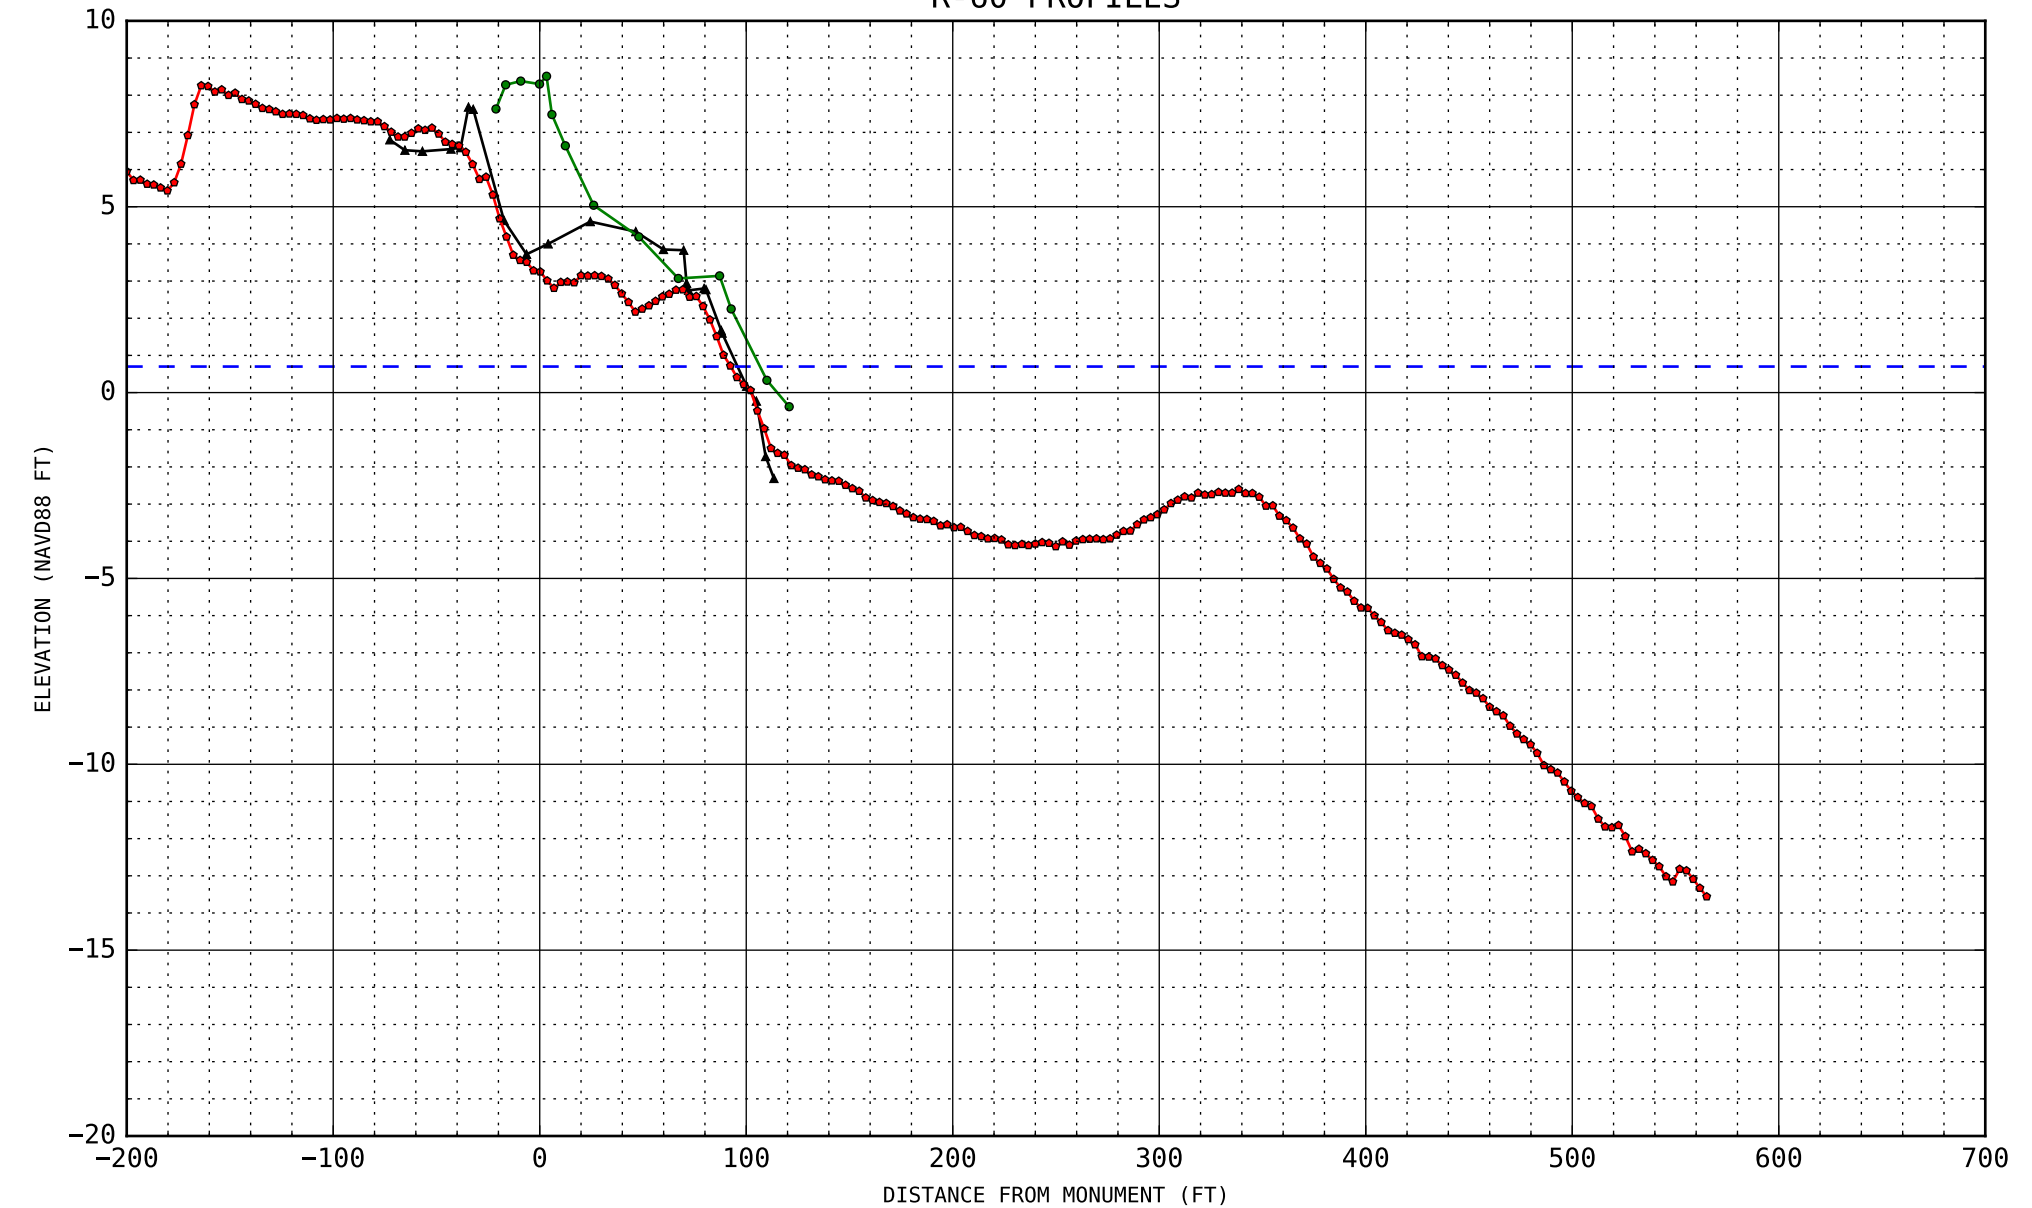
# R-60 PROFILES

- ▲ 2019-MAY CONDITION BY DEP
- 2018-OCT MONITORING BY USACE-LIDAR
- 2017-FEB MONITORING BY DEP
- - - MHW CONTOUR (0.7 FT)

RANGE: R-60  
EST DATE: JUL1996  
SURVEY DATE: 16MAY19  
AZIMUTH: 150.0
