# R-52-T PROFILES

FRANKLIN  
PROGRAM SUPPORT GIS  
DIVISION OF WATER RESOURCE MANAGEMENT  
FLORIDA DEPARTMENT OF ENVIRONMENTAL PROTECTION

RANGE: R-52-T  
EST DATE: FEB1980  
SURVEY DATE: 16MAY19  
AZIMUTH: 150.0

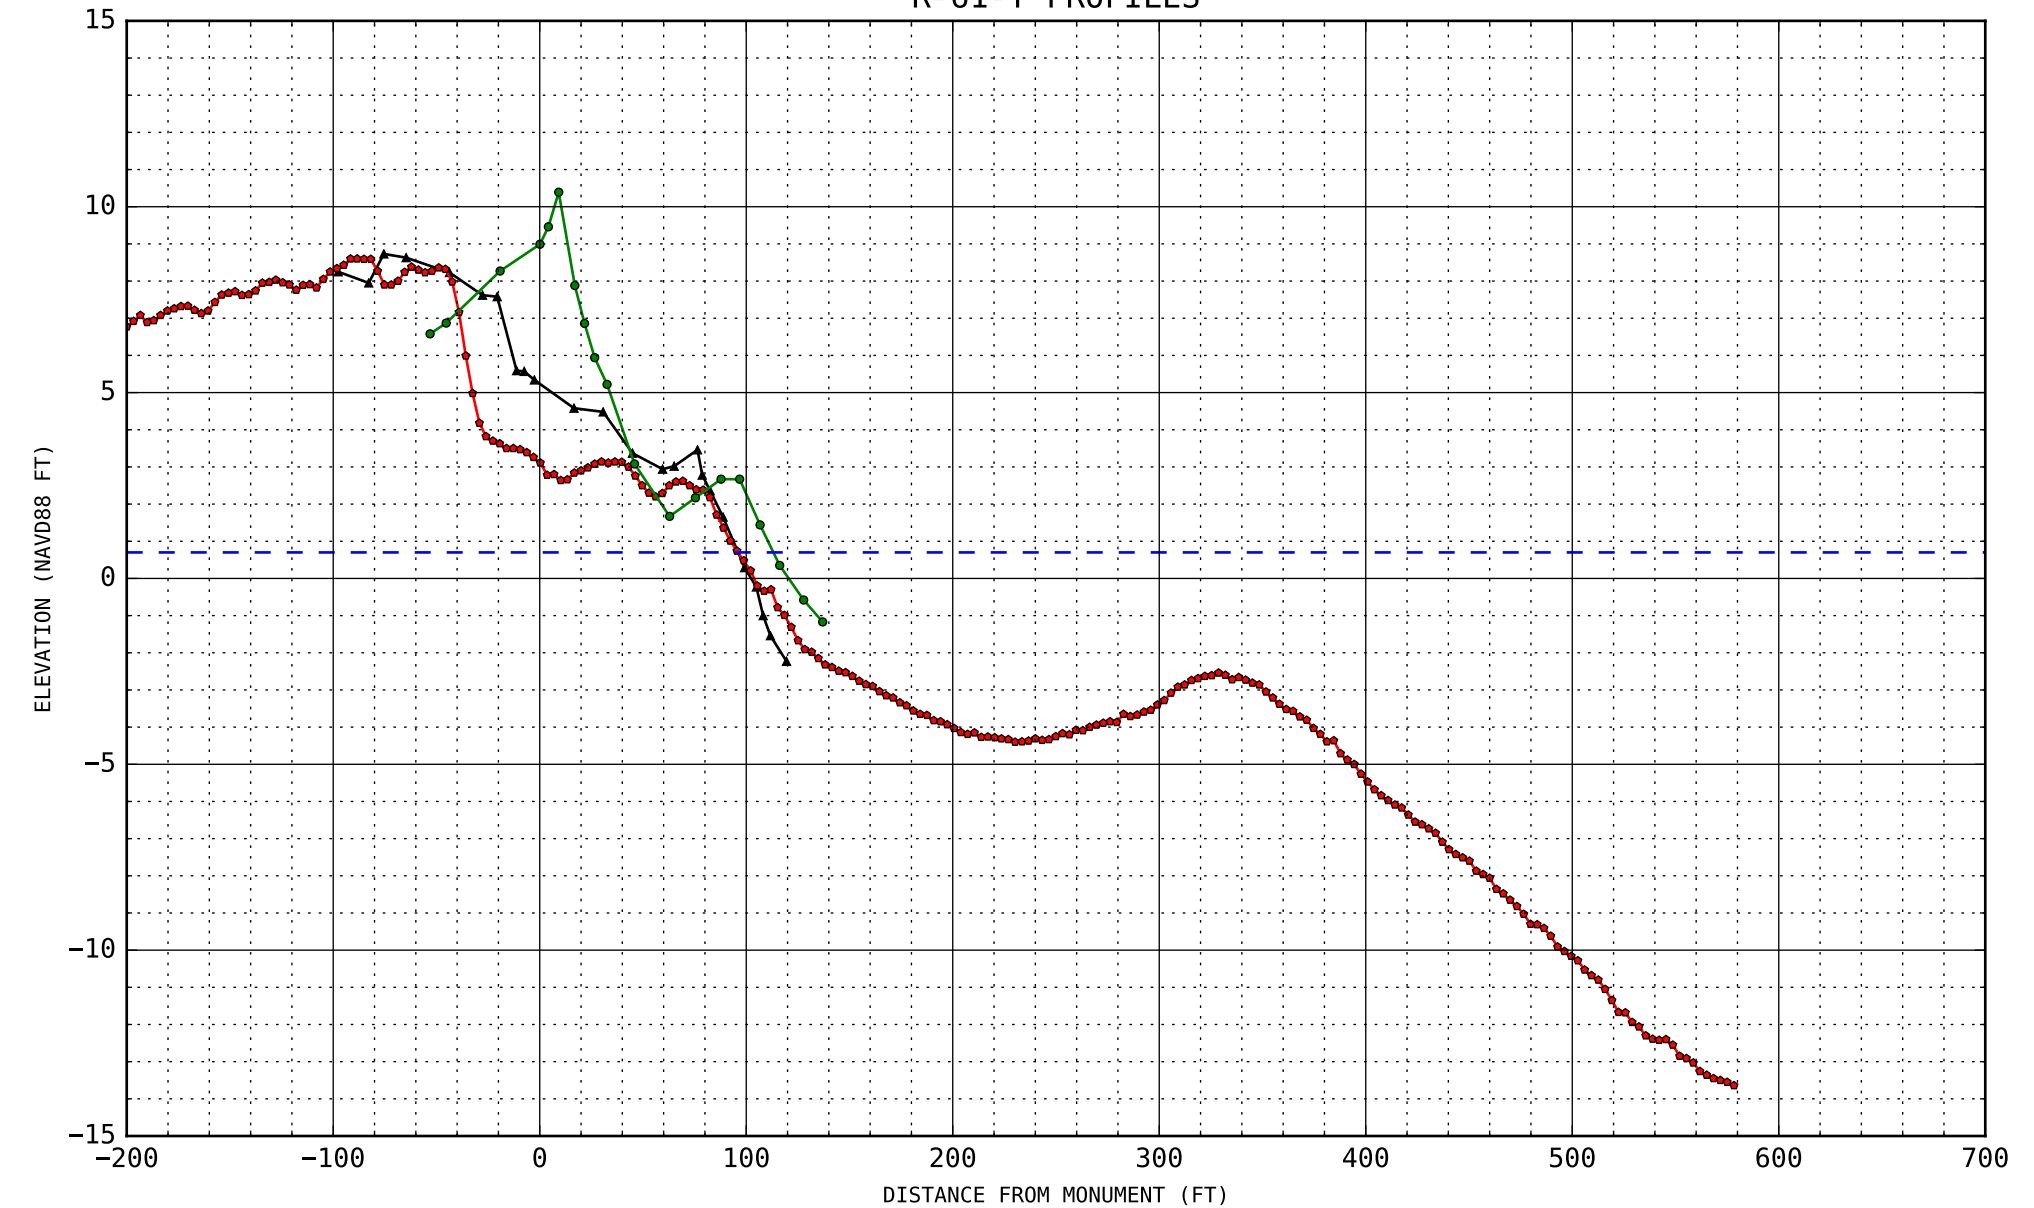
# R-61-T PROFILES

- ▲ 2019-MAY CONDITION BY DEP
- 2018-OCT MONITORING BY USACE-LIDAR
- 2017-FEB MONITORING BY DEP
- - - MHW CONTOUR (0.7 FT)

RANGE: R-61-T  
EST DATE: FEB1980  
SURVEY DATE: 16MAY19  
AZIMUTH: 150.0

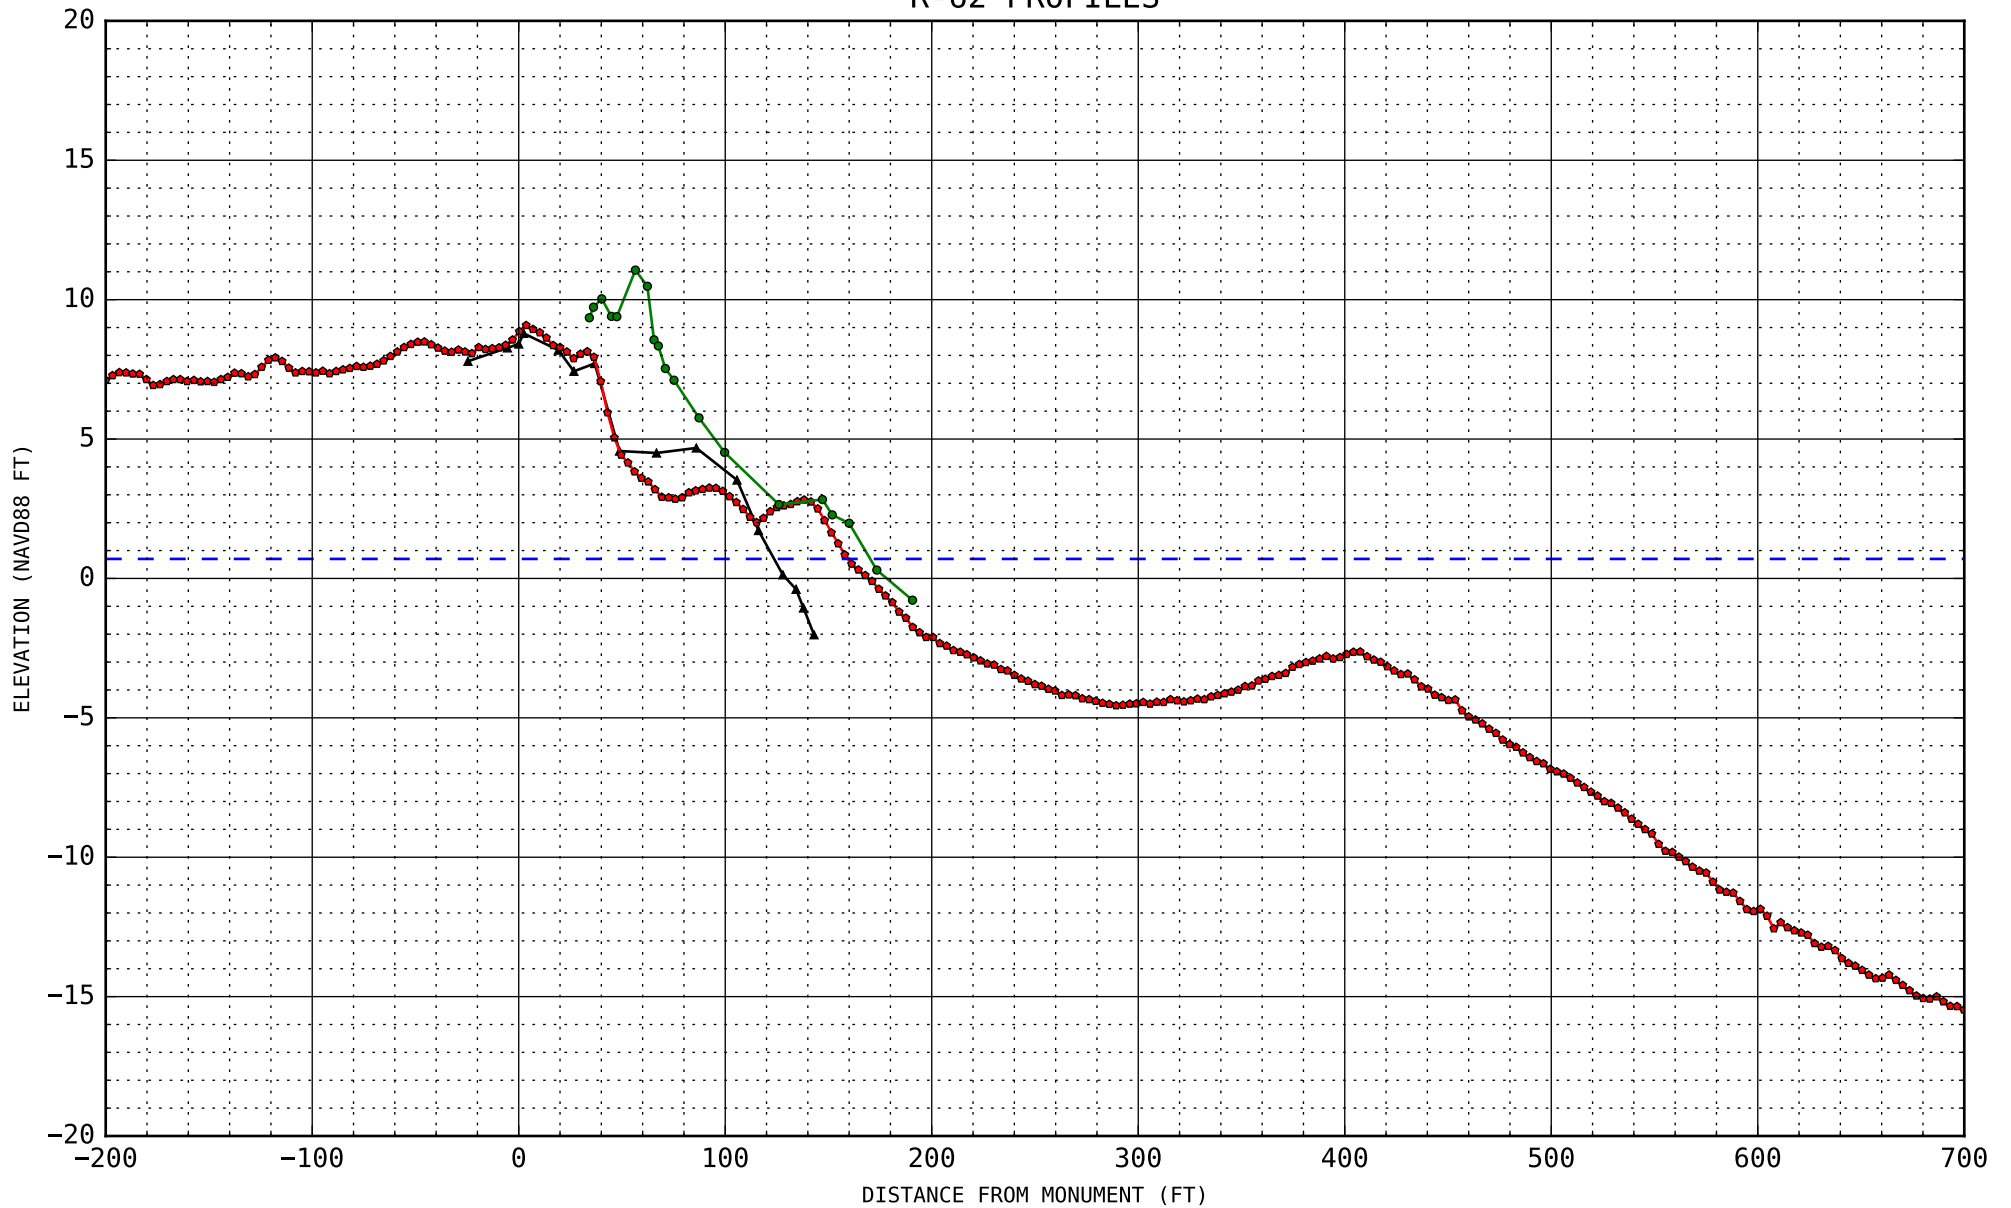
# R-62 PROFILES

- ▲ 2019-MAY CONDITION BY DEP
- 2018-OCT MONITORING BY USACE-LIDAR
- 2017-FEB MONITORING BY DEP
- - - MHW CONTOUR (0.7 FT)

RANGE: R-62  
EST DATE: JUL1996  
SURVEY DATE: 16MAY19  
AZIMUTH: 150.0

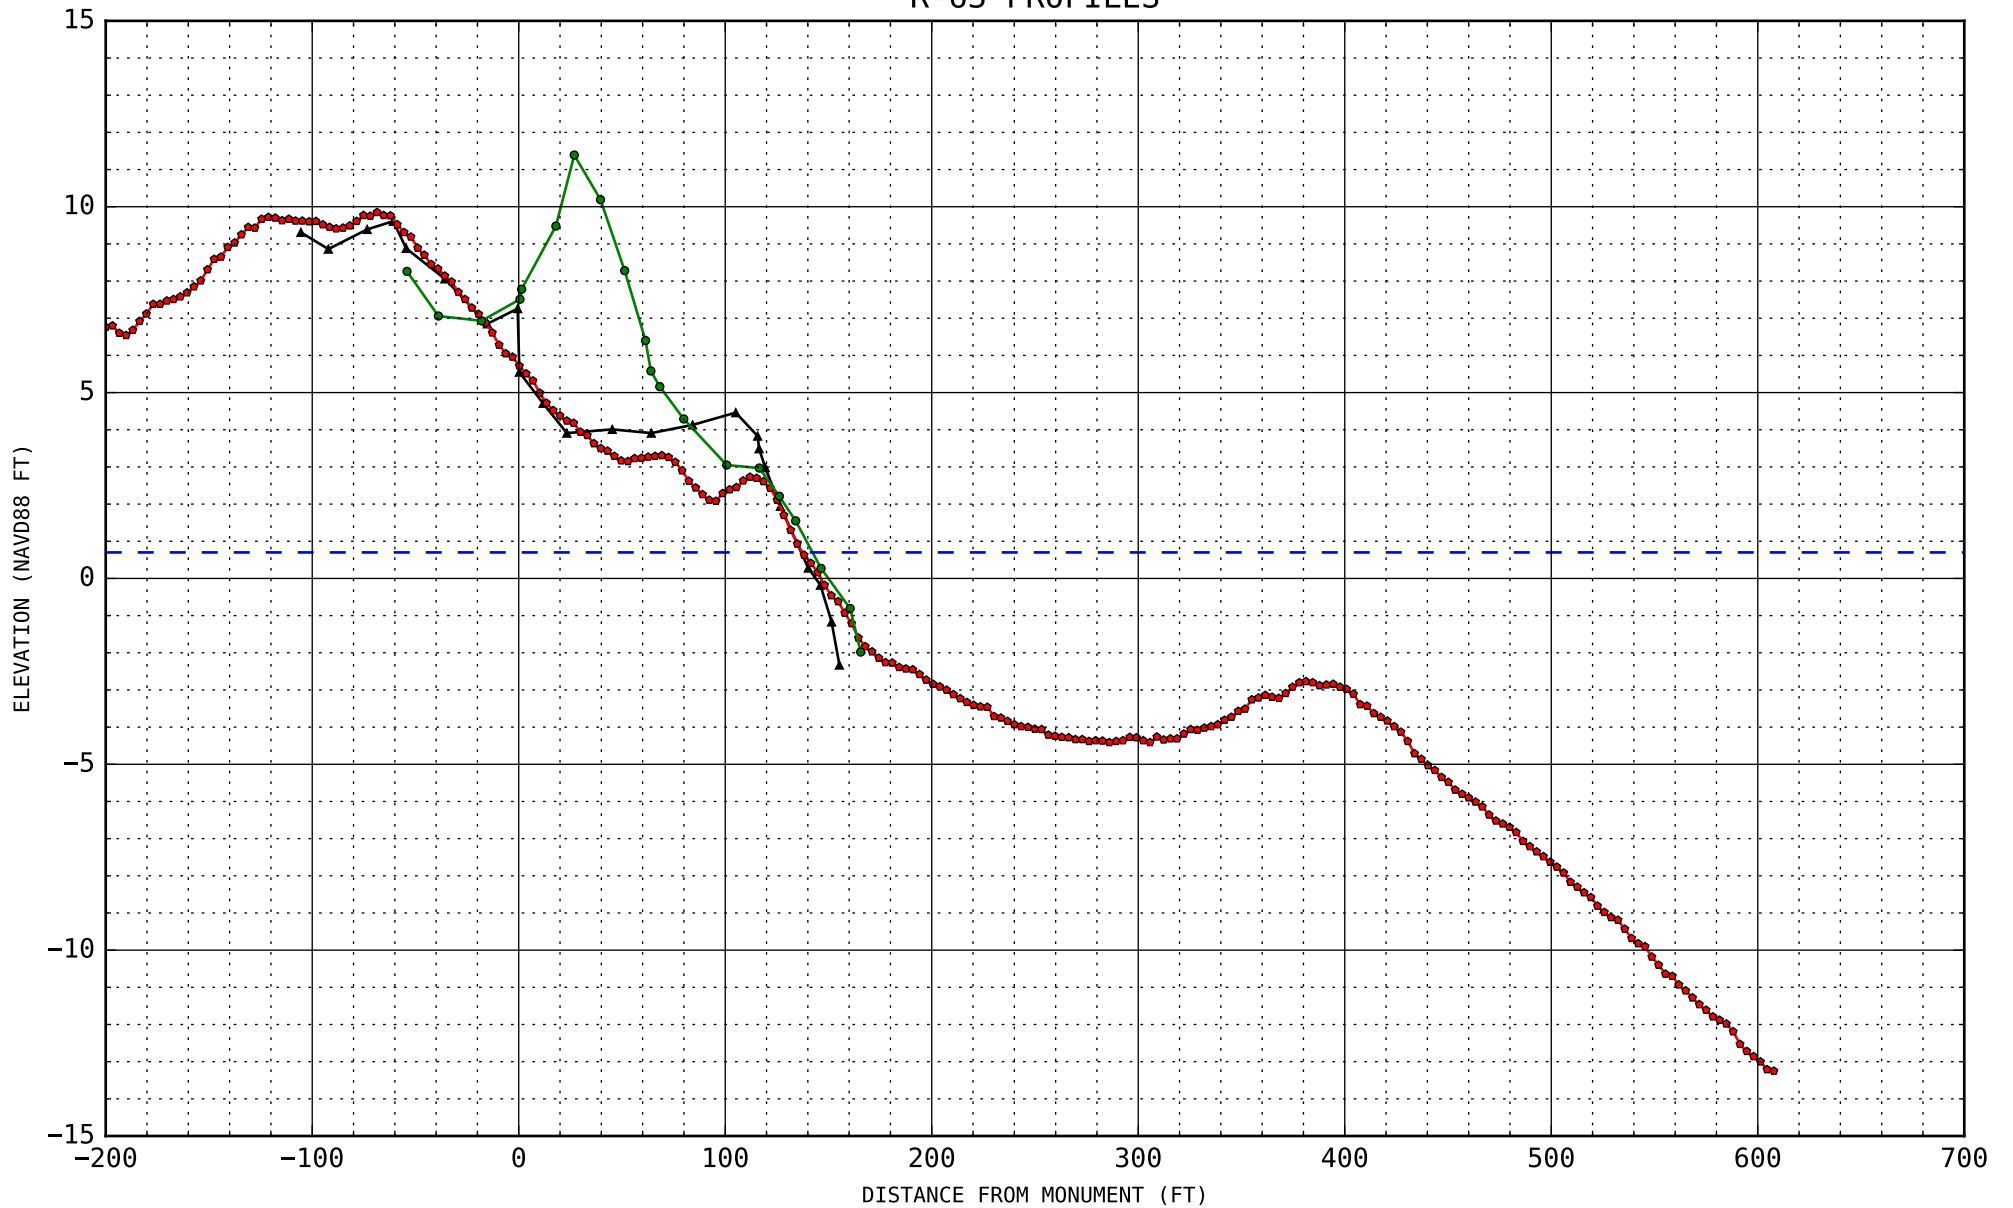
# R-63 PROFILES

- ▲ 2019-MAY CONDITION BY DEP
- 2018-OCT MONITORING BY USACE-LIDAR
- 2017-FEB MONITORING BY DEP
- - - MHW CONTOUR (0.7 FT)

RANGE: R-63  
 EST DATE: JUL1996  
 SURVEY DATE: 16MAY19  
 AZIMUTH: 150.0

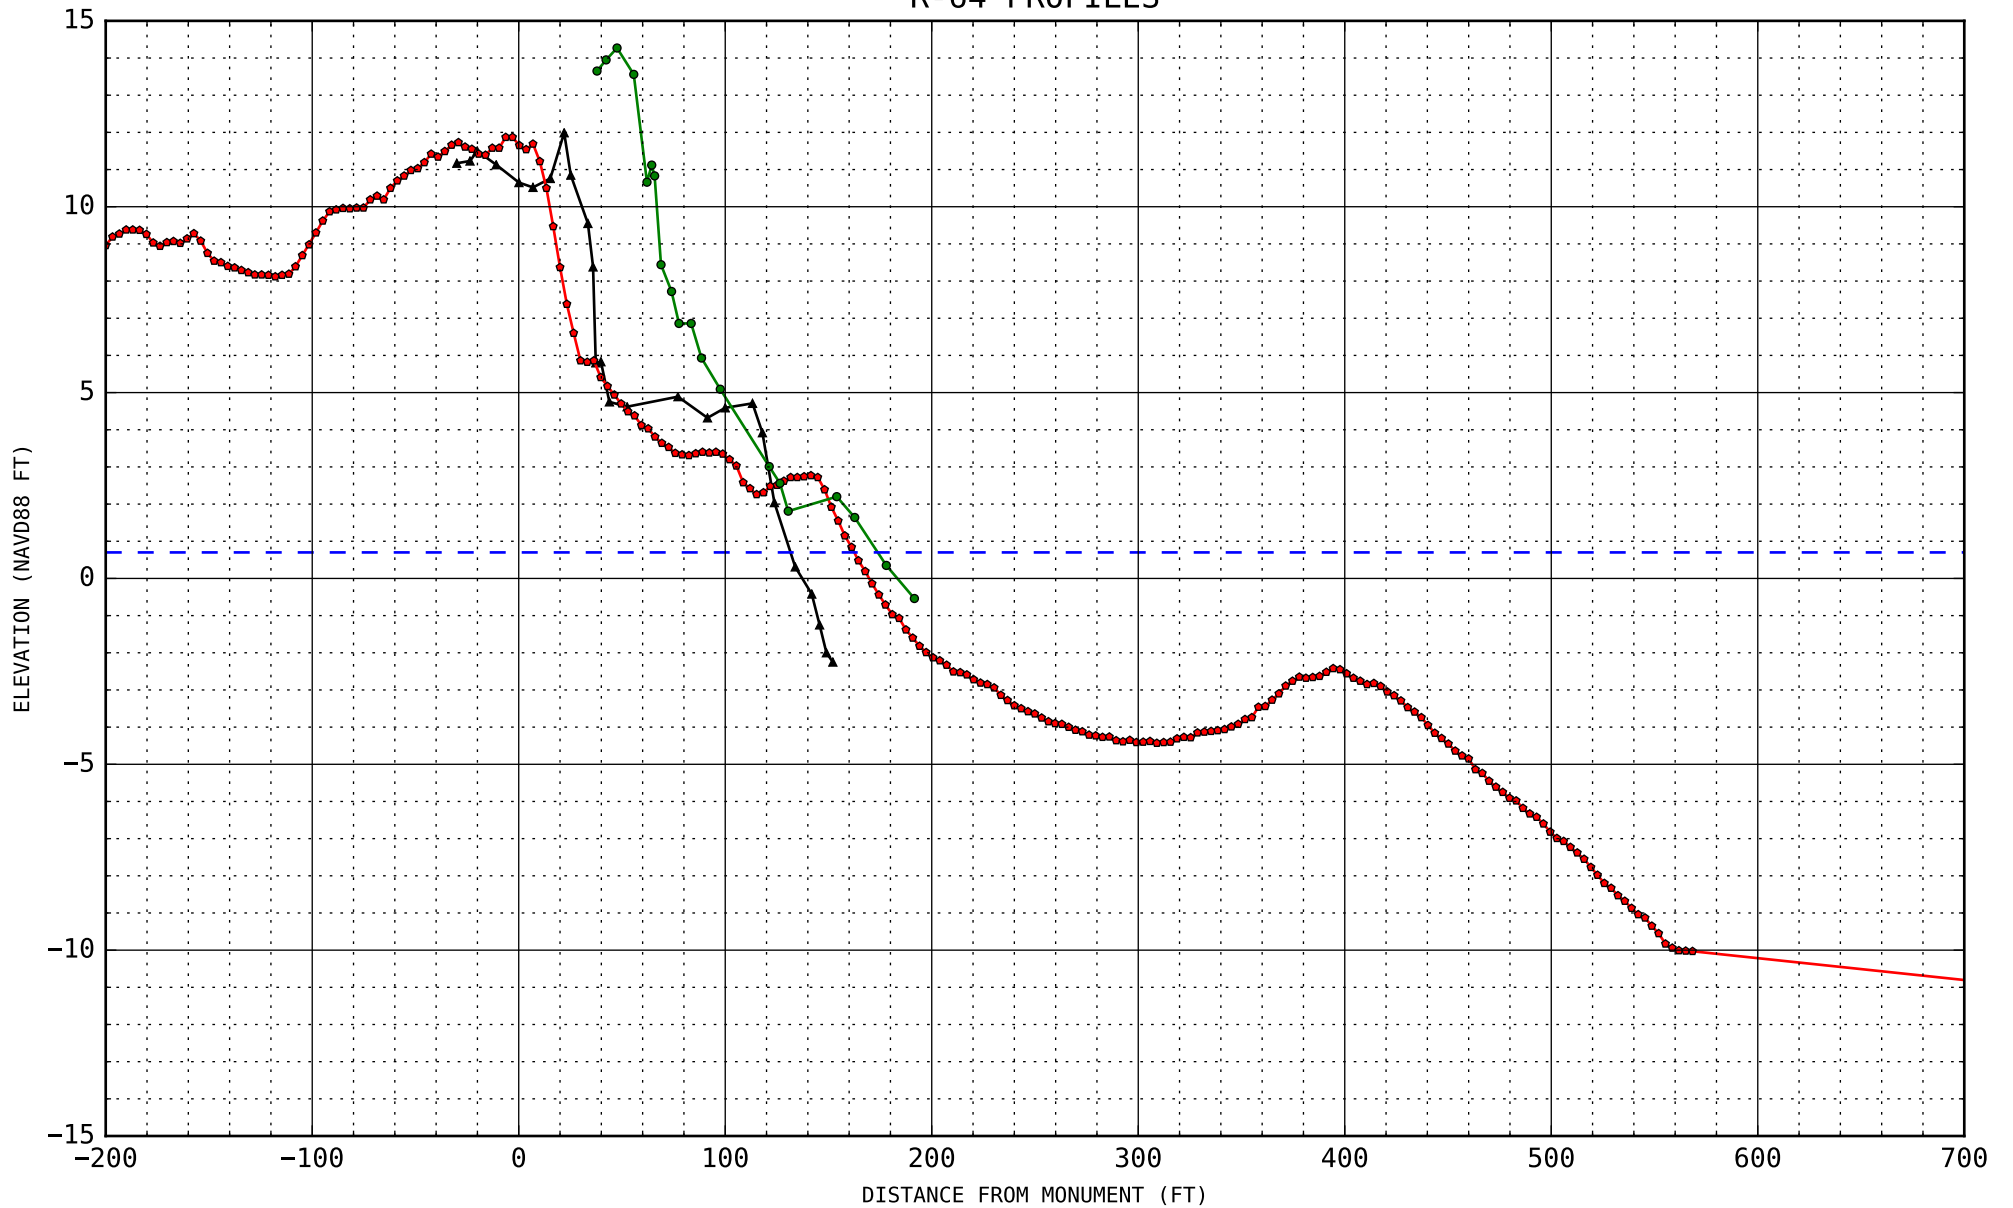
# R-64 PROFILES

- ▲ 2019-MAY CONDITION BY DEP
- 2018-OCT MONITORING BY USACE-LIDAR
- 2017-FEB MONITORING BY DEP
- - - MHW CONTOUR (0.7 FT)

RANGE: R-64  
 EST DATE: JUL1996  
 SURVEY DATE: 16MAY19  
 AZIMUTH: 150.0

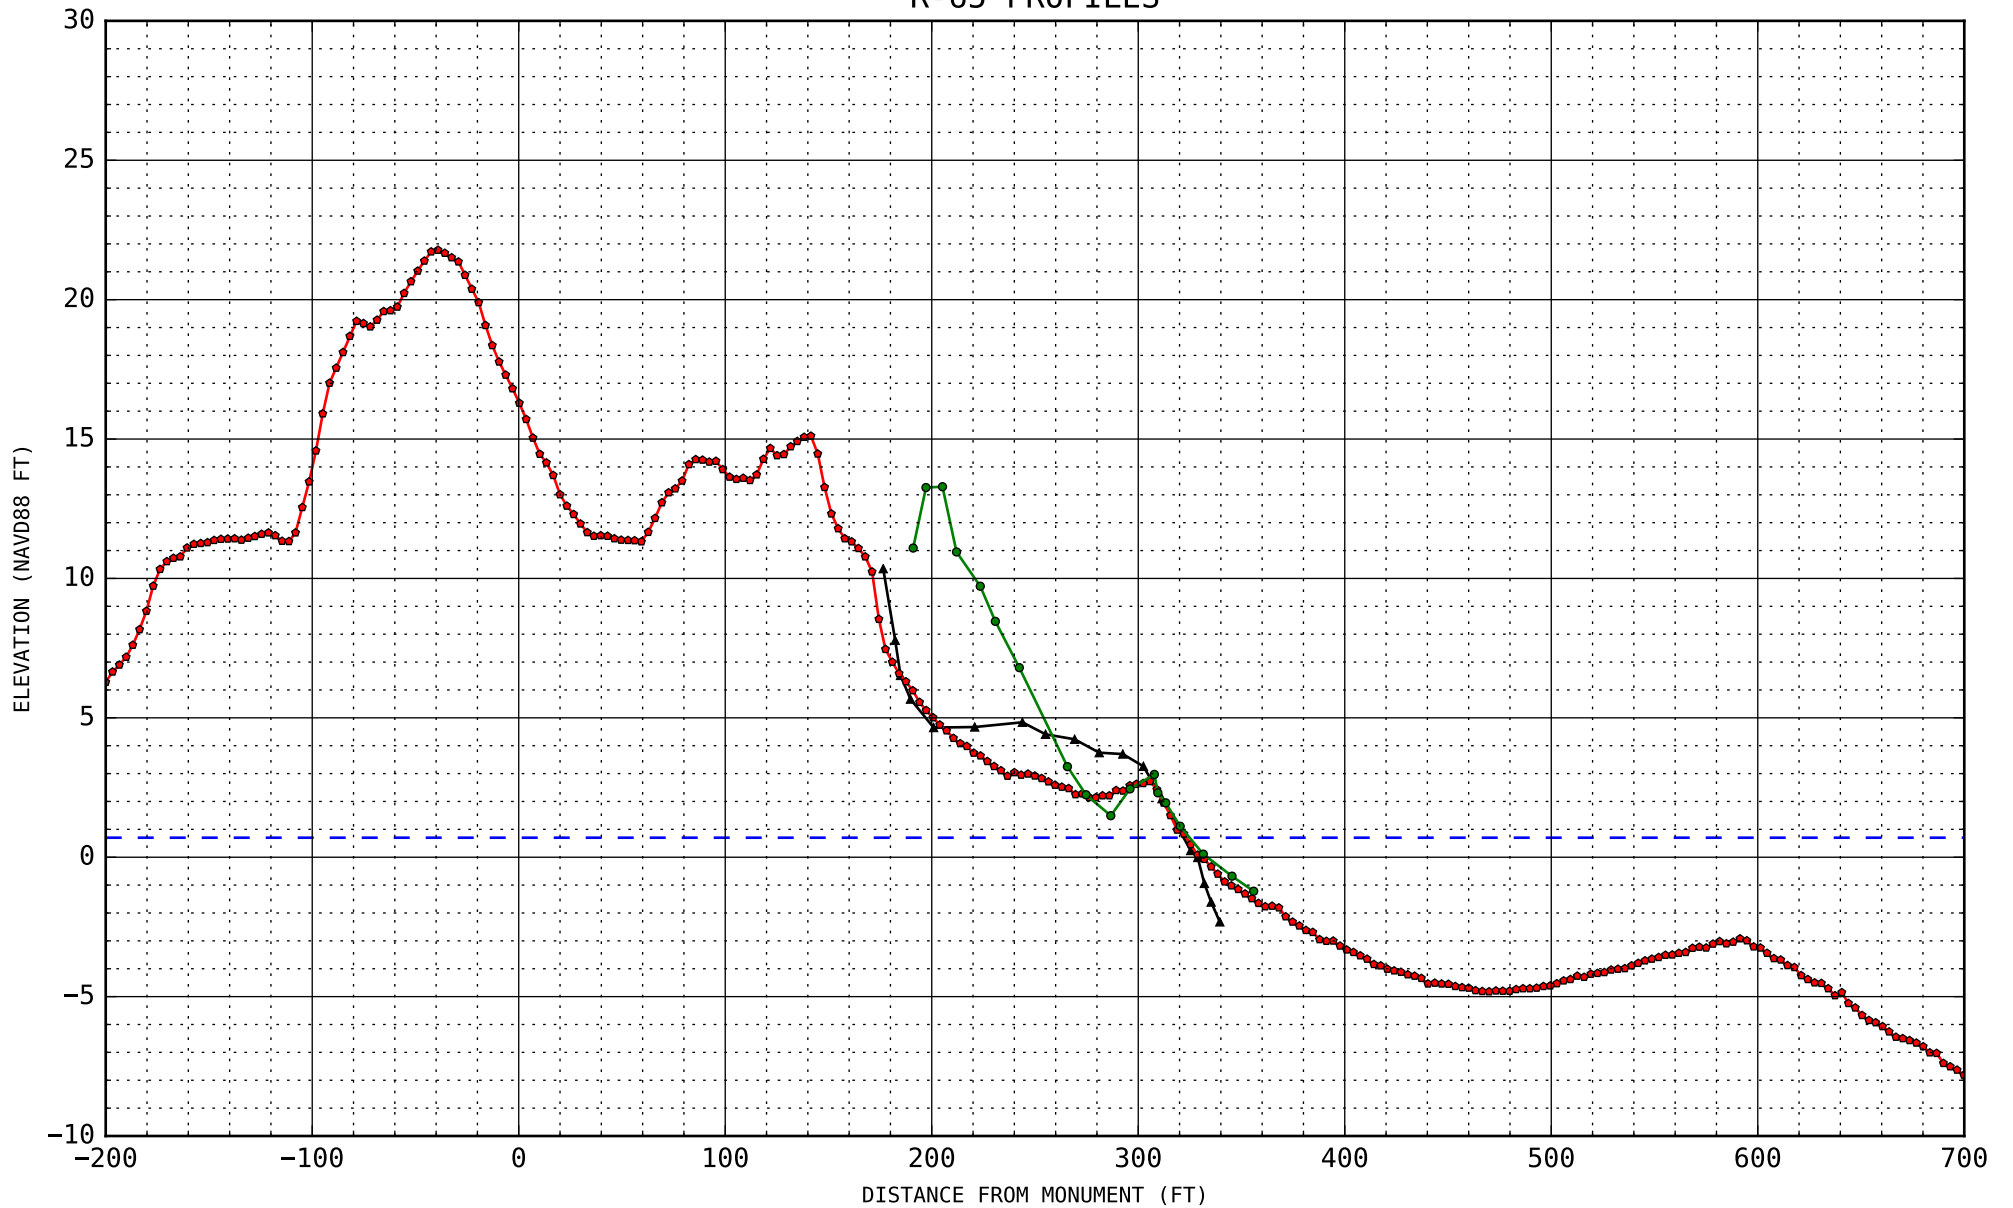
# R-65 PROFILES

- ▲ 2019-MAY CONDITION BY DEP
- 2018-OCT MONITORING BY USACE-LIDAR
- 2017-FEB MONITORING BY DEP
- - - MHW CONTOUR (0.7 FT)

RANGE: R-65  
EST DATE: JUL1996  
SURVEY DATE: 16MAY19  
AZIMUTH: 150.0

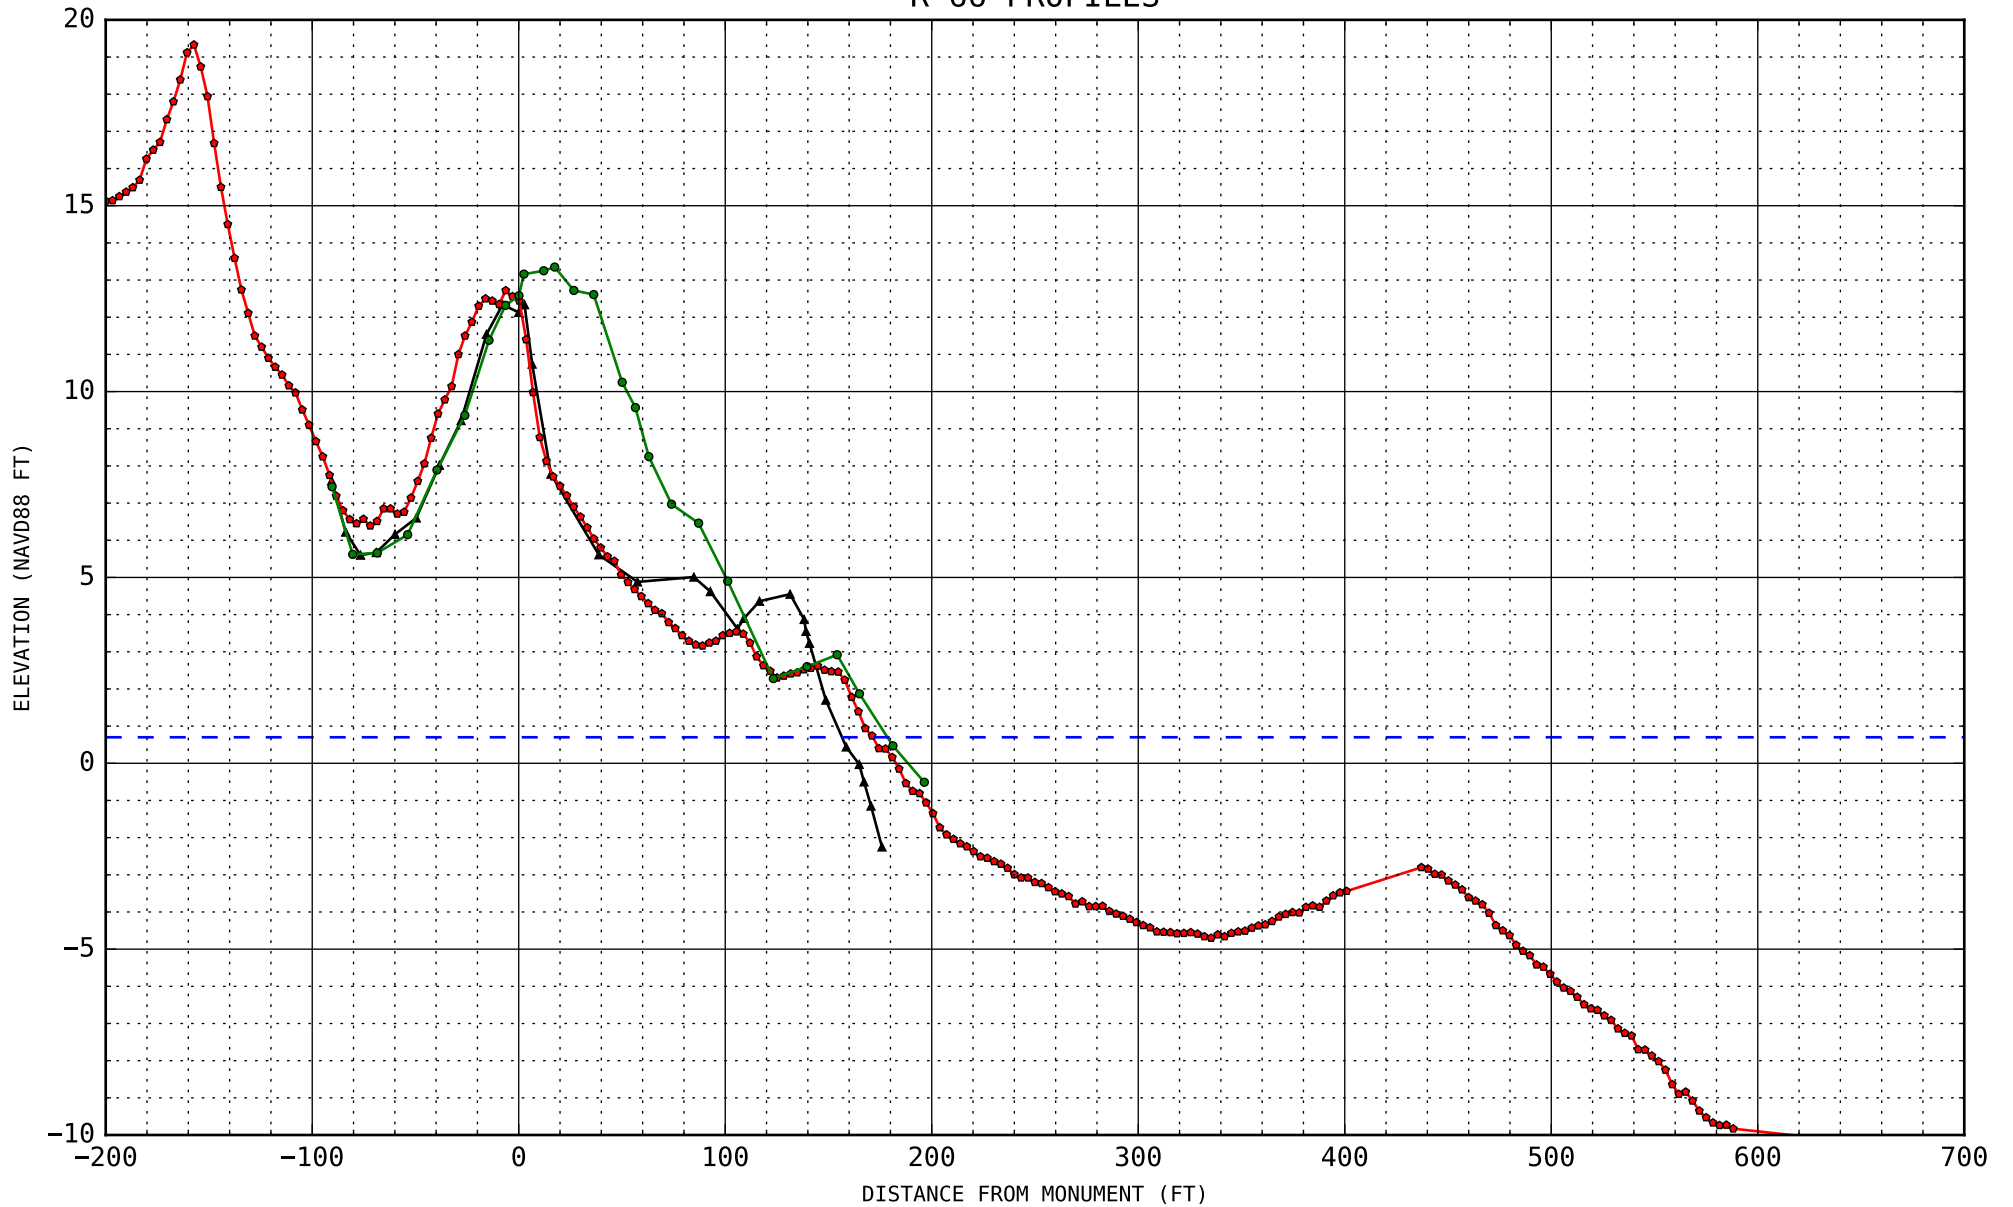
# R-66 PROFILES

- ▲ 2019-MAY CONDITION BY DEP
- 2018-OCT MONITORING BY USACE-LIDAR
- 2017-FEB MONITORING BY DEP
- - - MHW CONTOUR (0.7 FT)

RANGE: R-66  
EST DATE: JUL1996  
SURVEY DATE: 16MAY19  
AZIMUTH: 150.0

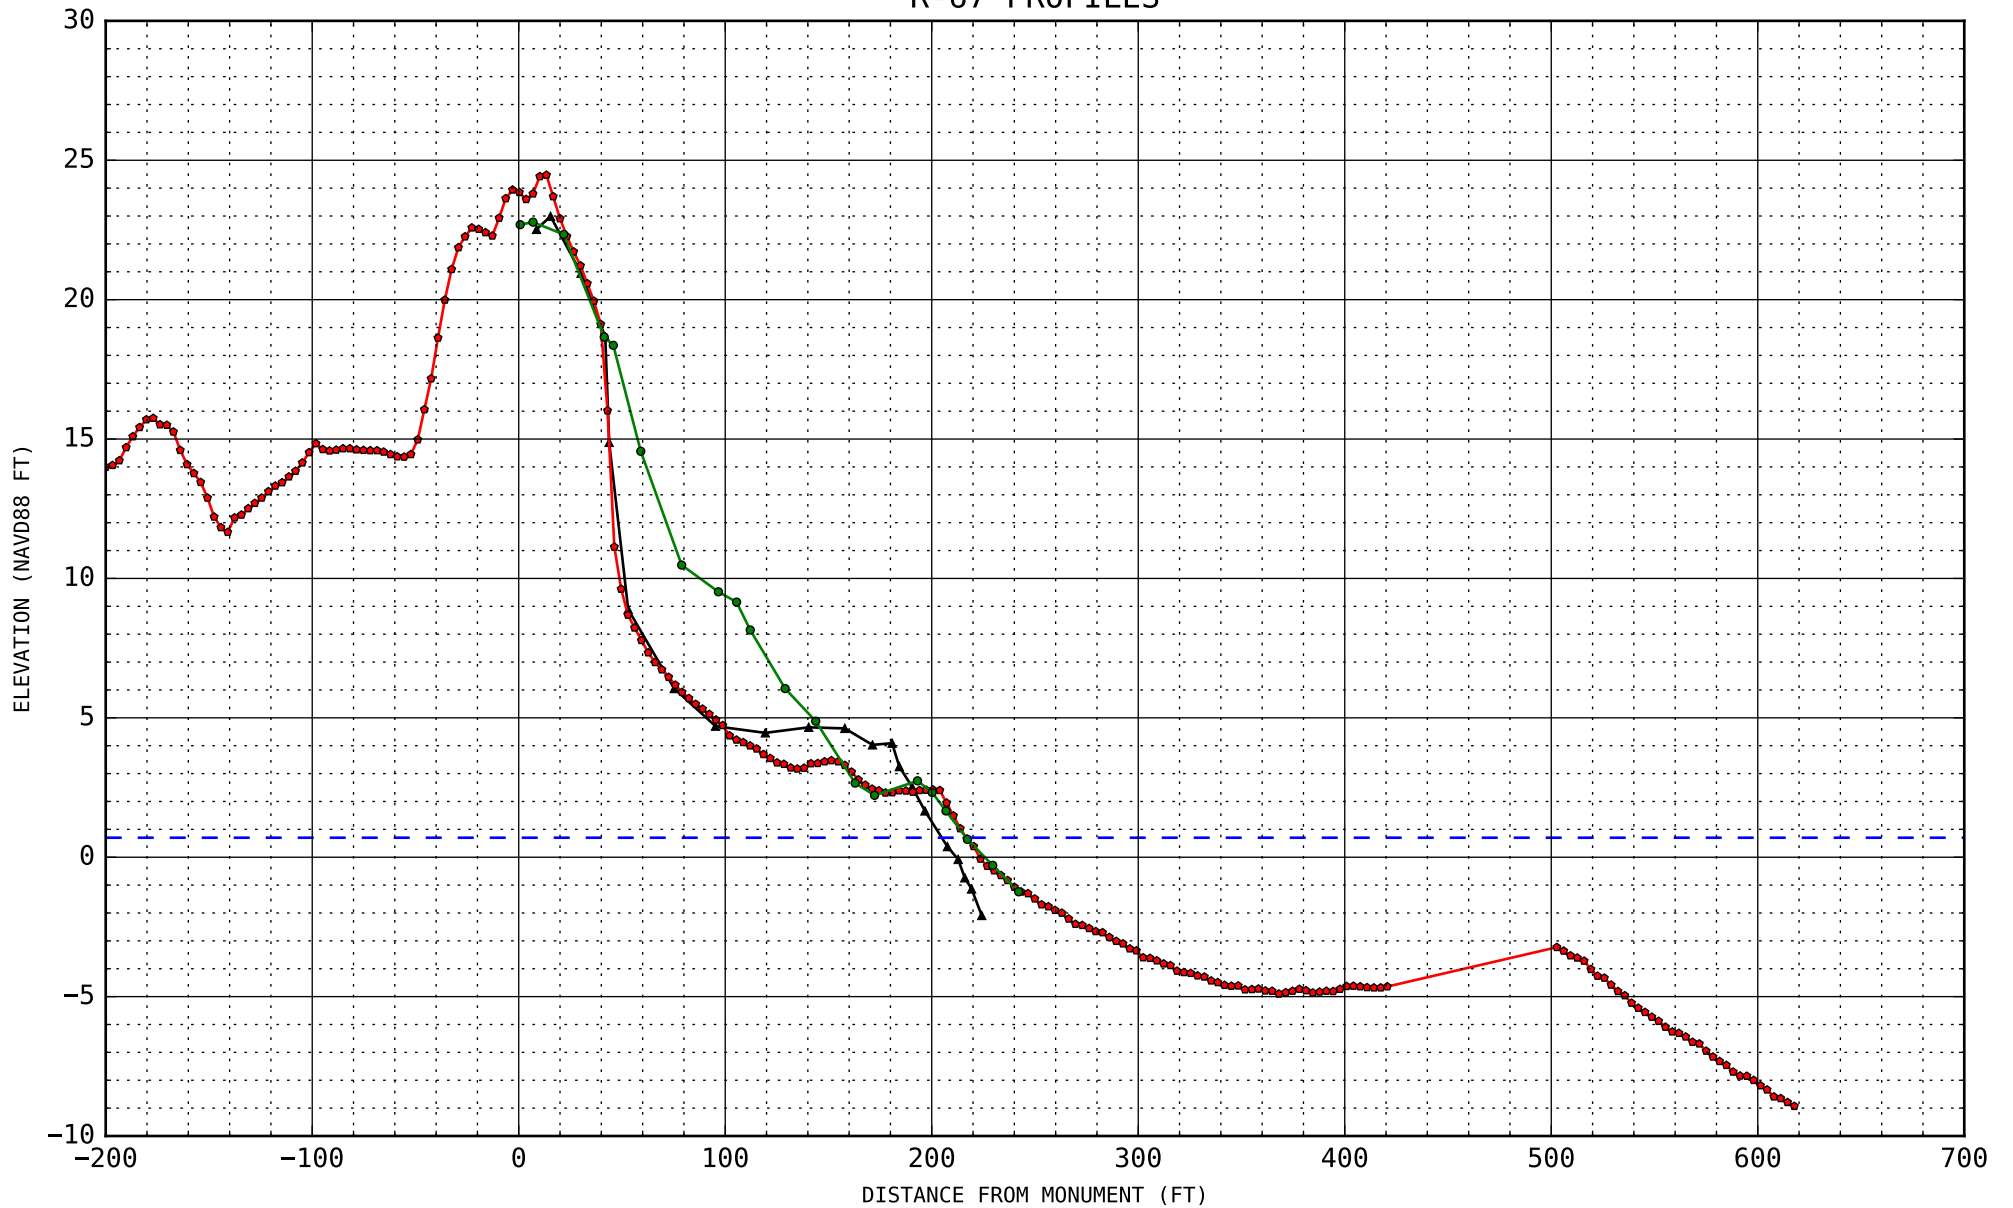
# R-67 PROFILES

- ▲ 2019-MAY CONDITION BY DEP
- 2018-OCT MONITORING BY USACE-LIDAR
- 2017-FEB MONITORING BY DEP
- - - MHW CONTOUR (0.7 FT)

RANGE: R-67  
 EST DATE: JUL1996  
 SURVEY DATE: 16MAY19  
 AZIMUTH: 150.0

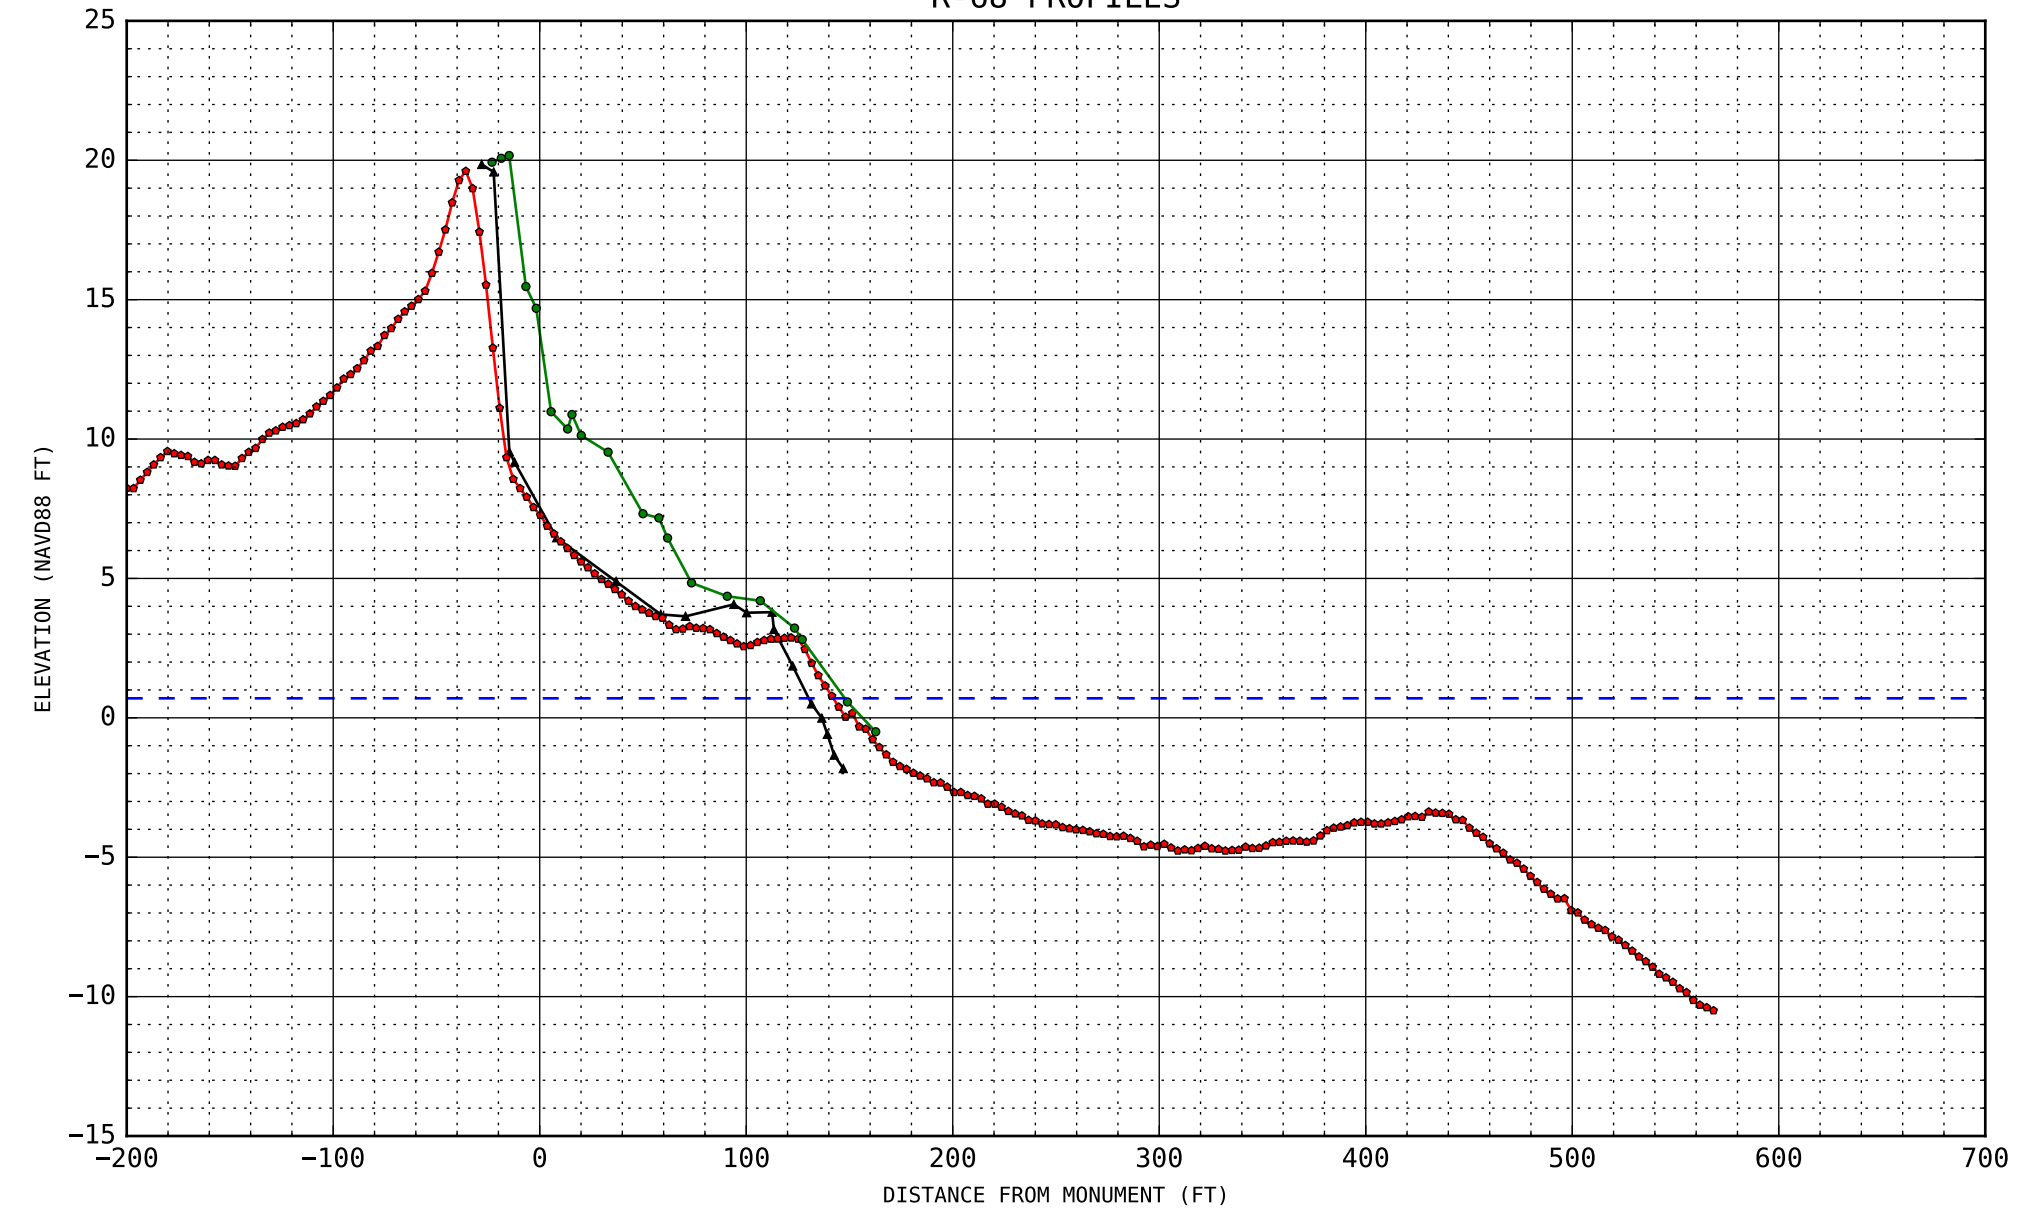
# R-68 PROFILES

- ▲ 2019-MAY CONDITION BY DEP
- 2018-OCT MONITORING BY USACE-LIDAR
- 2017-FEB MONITORING BY DEP
- - - MHW CONTOUR (0.7 FT)

RANGE: R-68  
EST DATE: JUL1996  
SURVEY DATE: 16MAY19  
AZIMUTH: 150.0

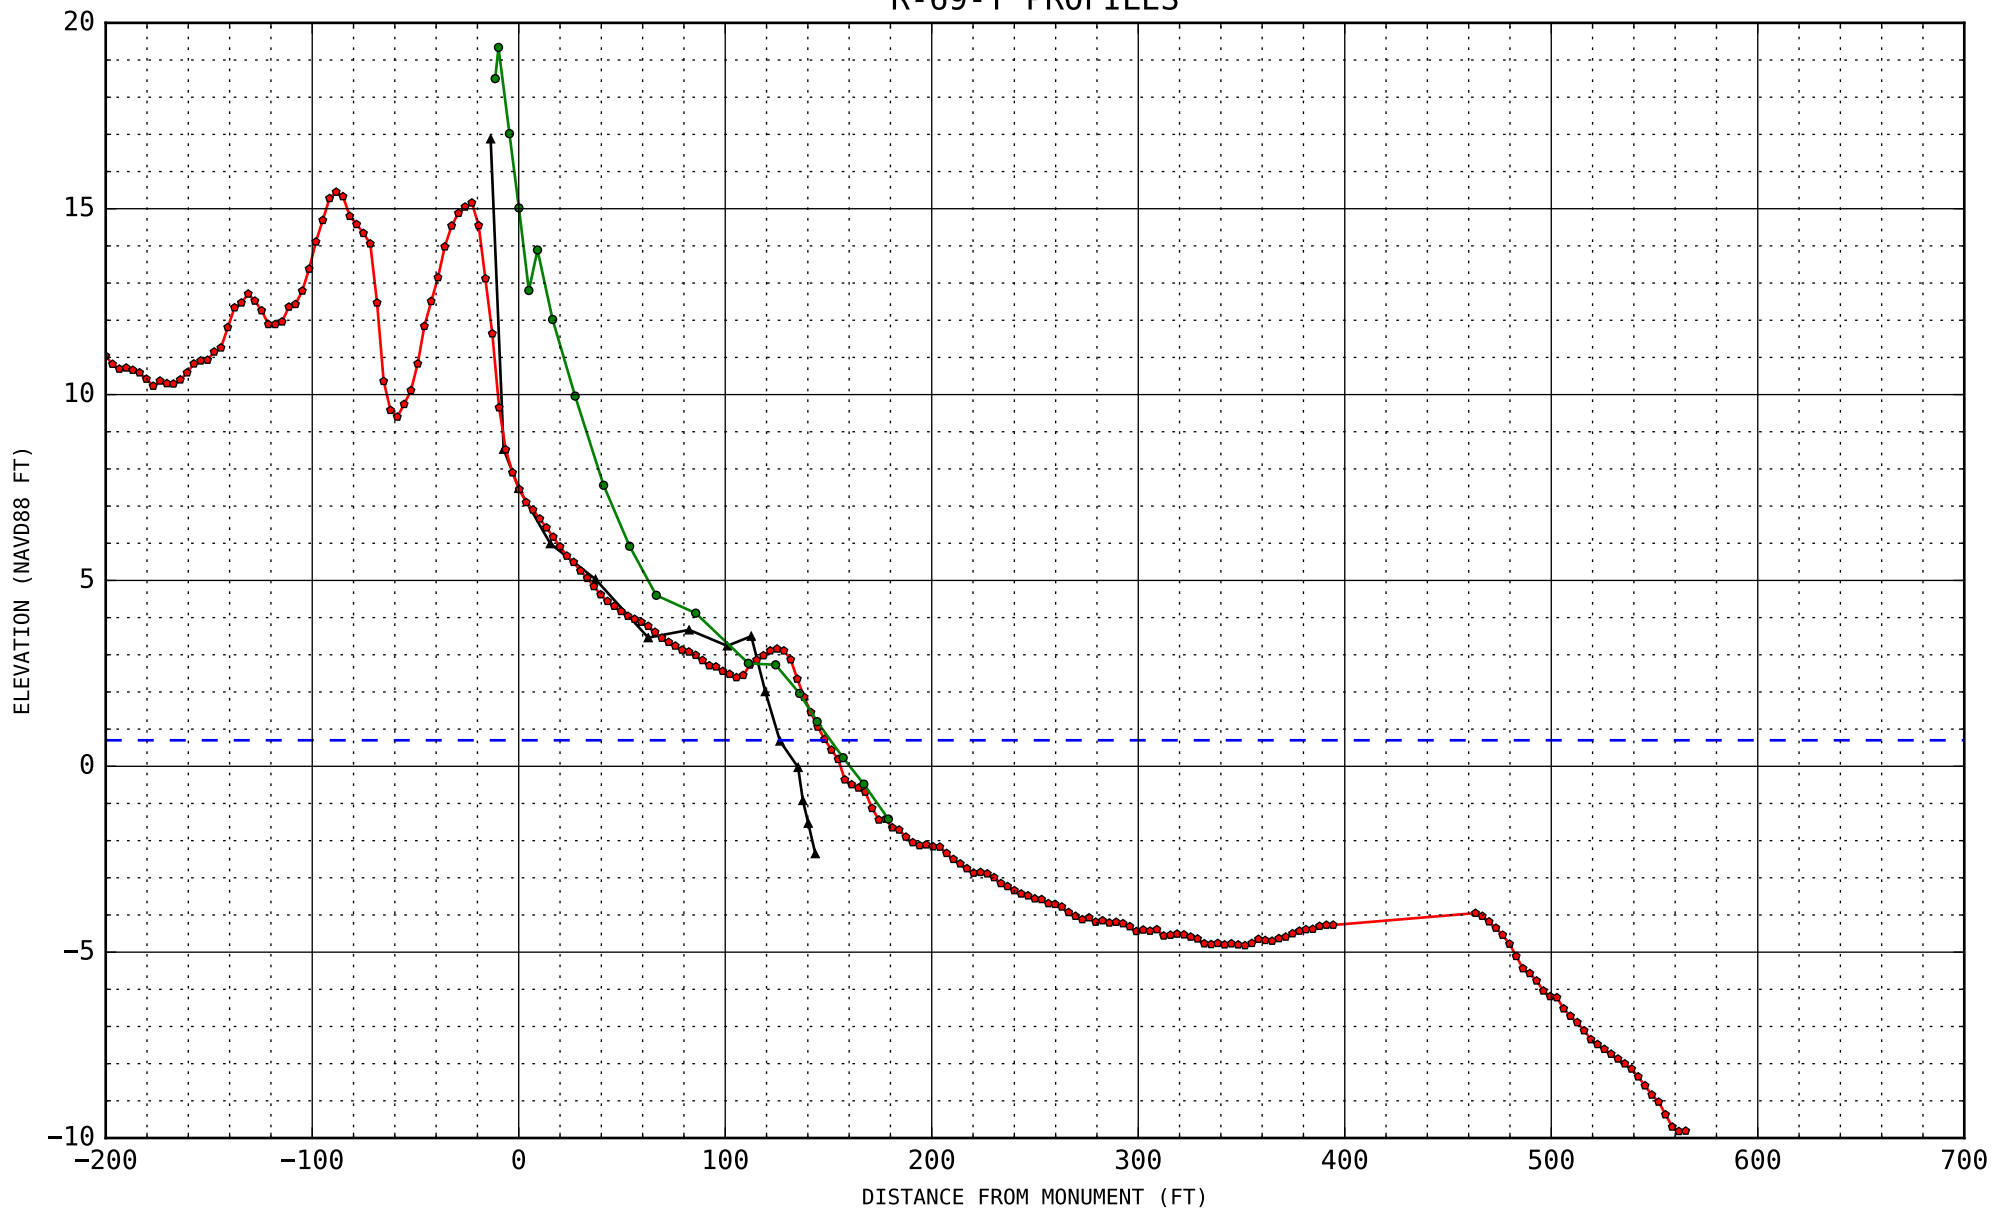
# R-69-T PROFILES

- ▲ 2019-MAY CONDITION BY DEP
- 2018-OCT MONITORING BY USACE-LIDAR
- 2017-FEB MONITORING BY DEP
- - - MHW CONTOUR (0.7 FT)

RANGE: R-69-T  
EST DATE: FEB1980  
SURVEY DATE: 16MAY19  
AZIMUTH: 150.0
