# R-52-T PROFILES

FRANKLIN  
PROGRAM SUPPORT GIS  
DIVISION OF WATER RESOURCE MANAGEMENT  
FLORIDA DEPARTMENT OF ENVIRONMENTAL PROTECTION

RANGE: R-52-T  
EST DATE: FEB1980  
SURVEY DATE: 16MAY19  
AZIMUTH: 150.0

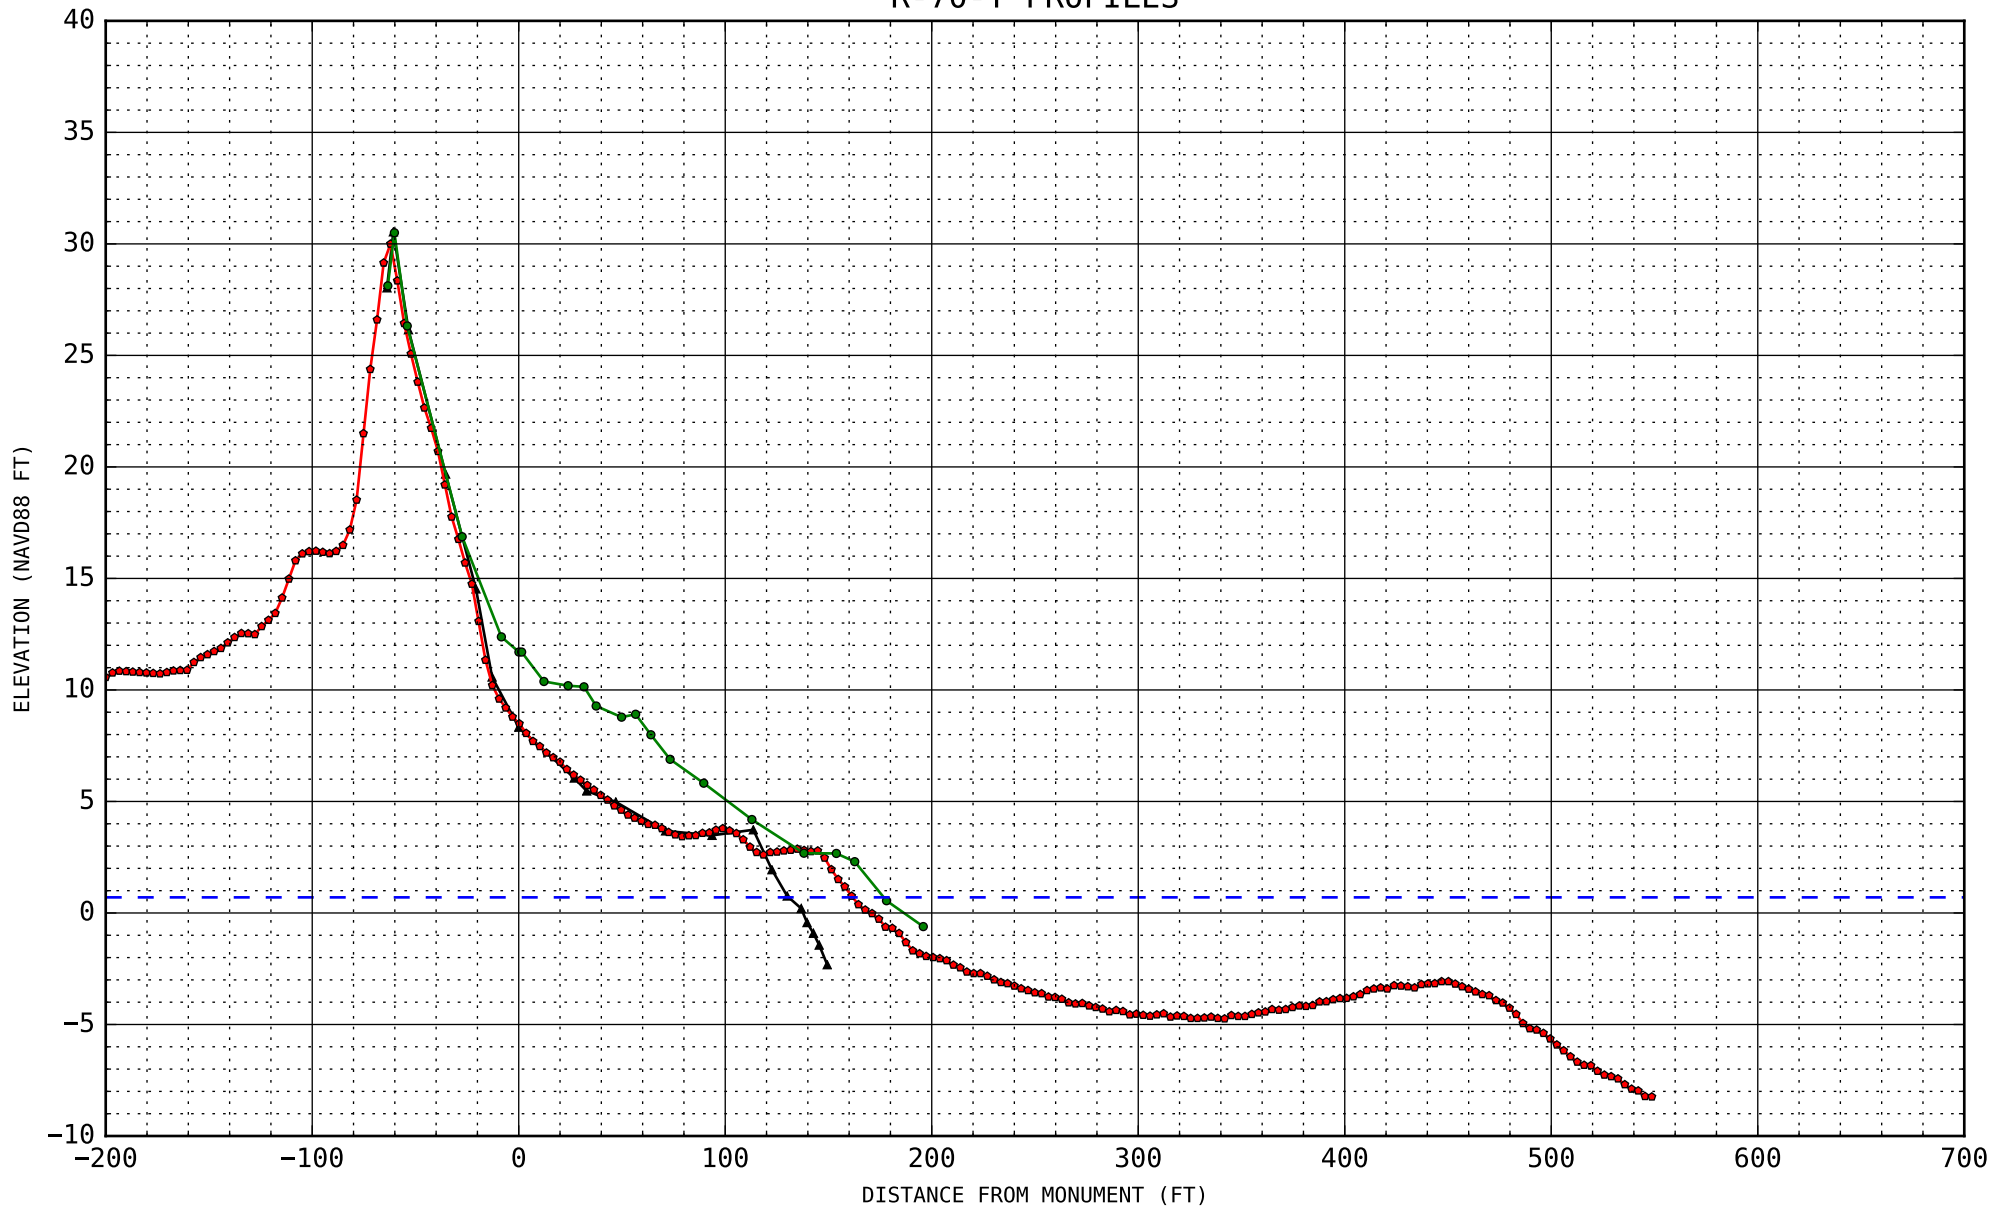
# R-70-T PROFILES

- ▲ 2019-MAY CONDITION BY DEP
- 2018-OCT MONITORING BY USACE-LIDAR
- 2017-FEB MONITORING BY DEP
- - - MHW CONTOUR (0.7 FT)

RANGE: R-70-T  
EST DATE: FEB1980  
SURVEY DATE: 16MAY19  
AZIMUTH: 150.0

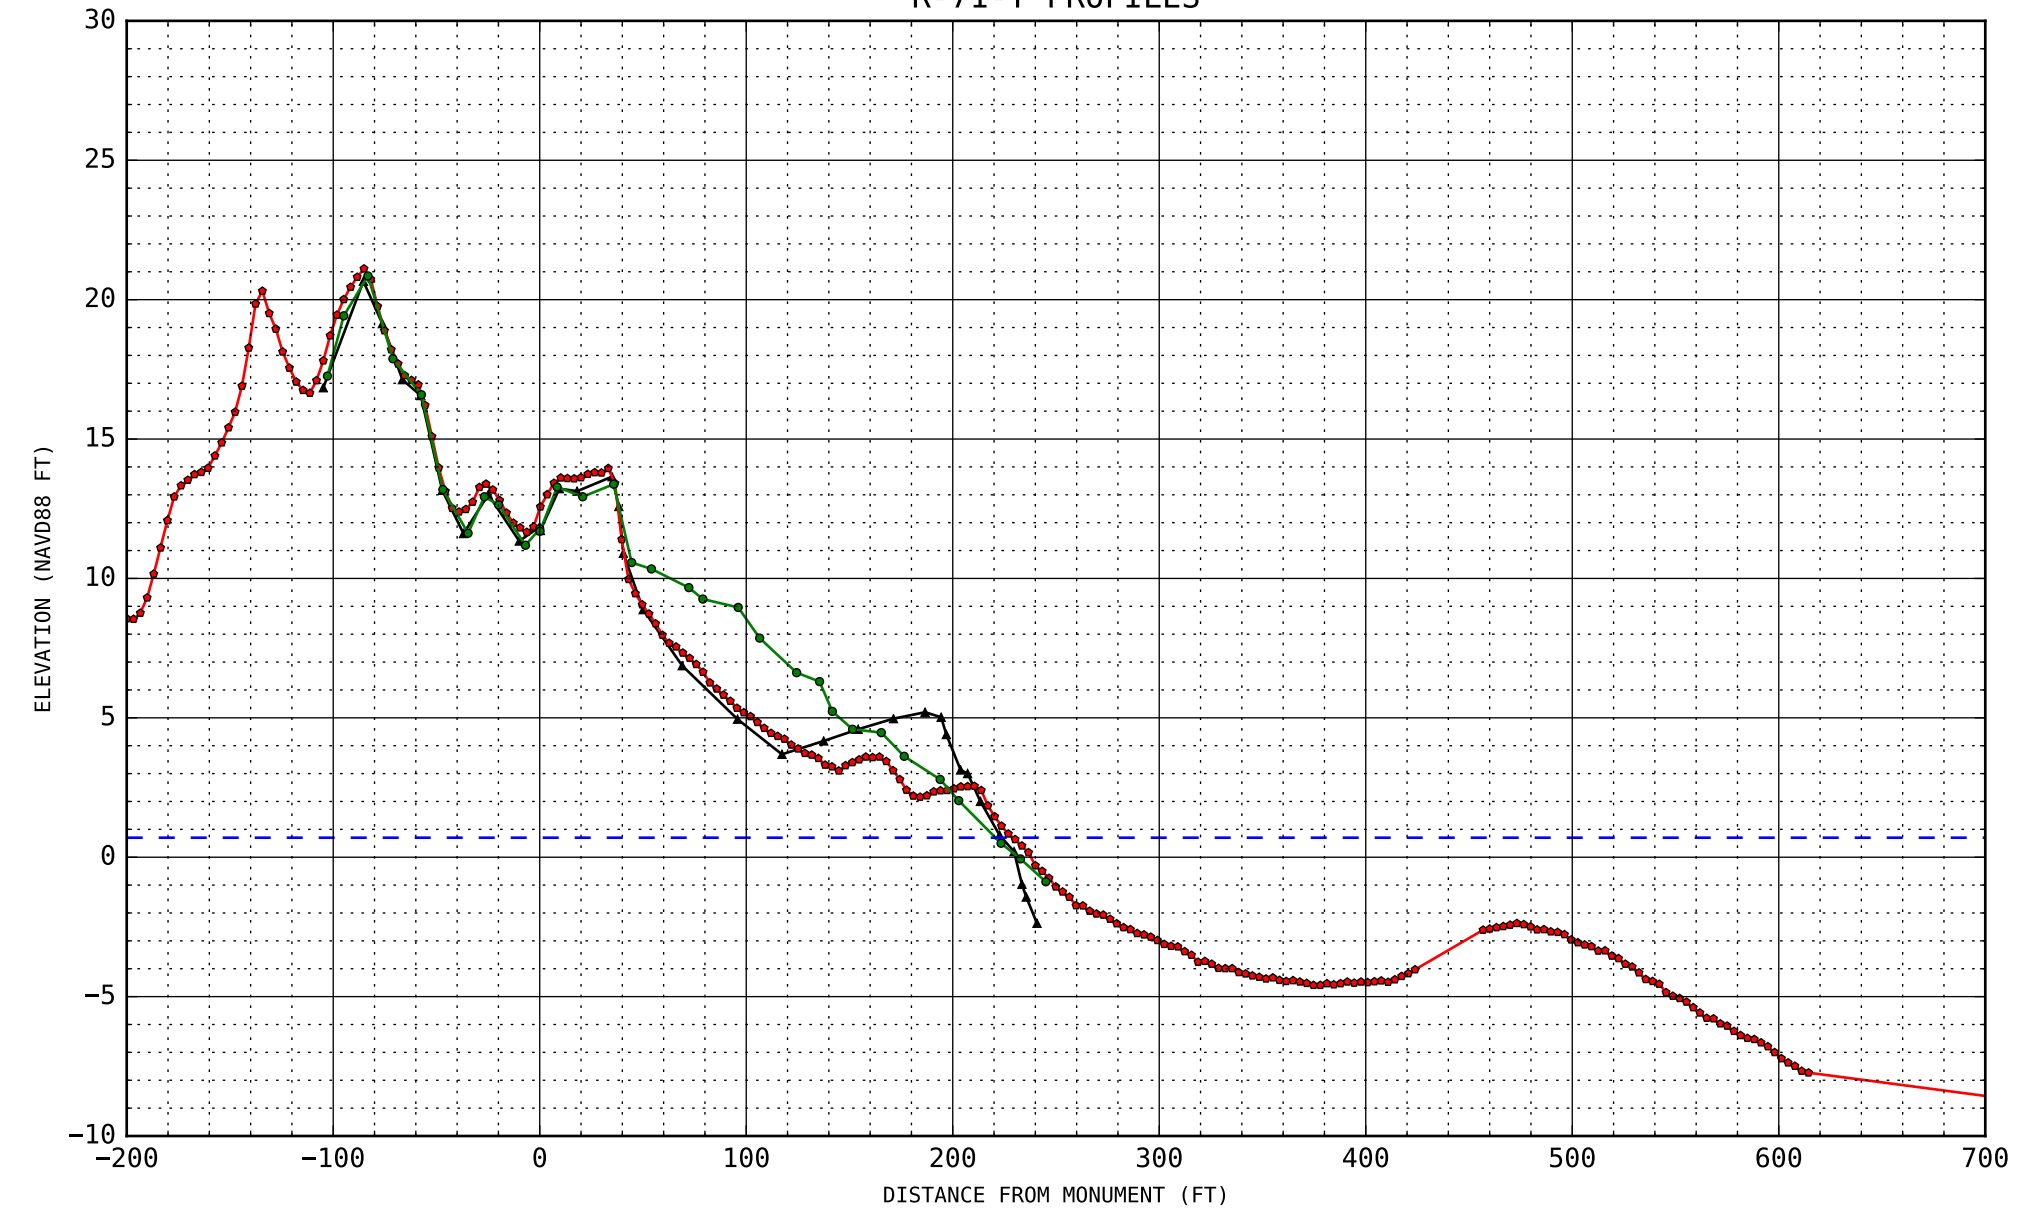
# R-71-T PROFILES

- 2019-MAY CONDITION BY DEP
- 2018-OCT MONITORING BY USACE-LIDAR
- 2017-FEB MONITORING BY DEP
- MHW CONTOUR (0.7 FT)

RANGE: R-71-T  
EST DATE: JUL1996  
SURVEY DATE: 16MAY19  
AZIMUTH: 150.0

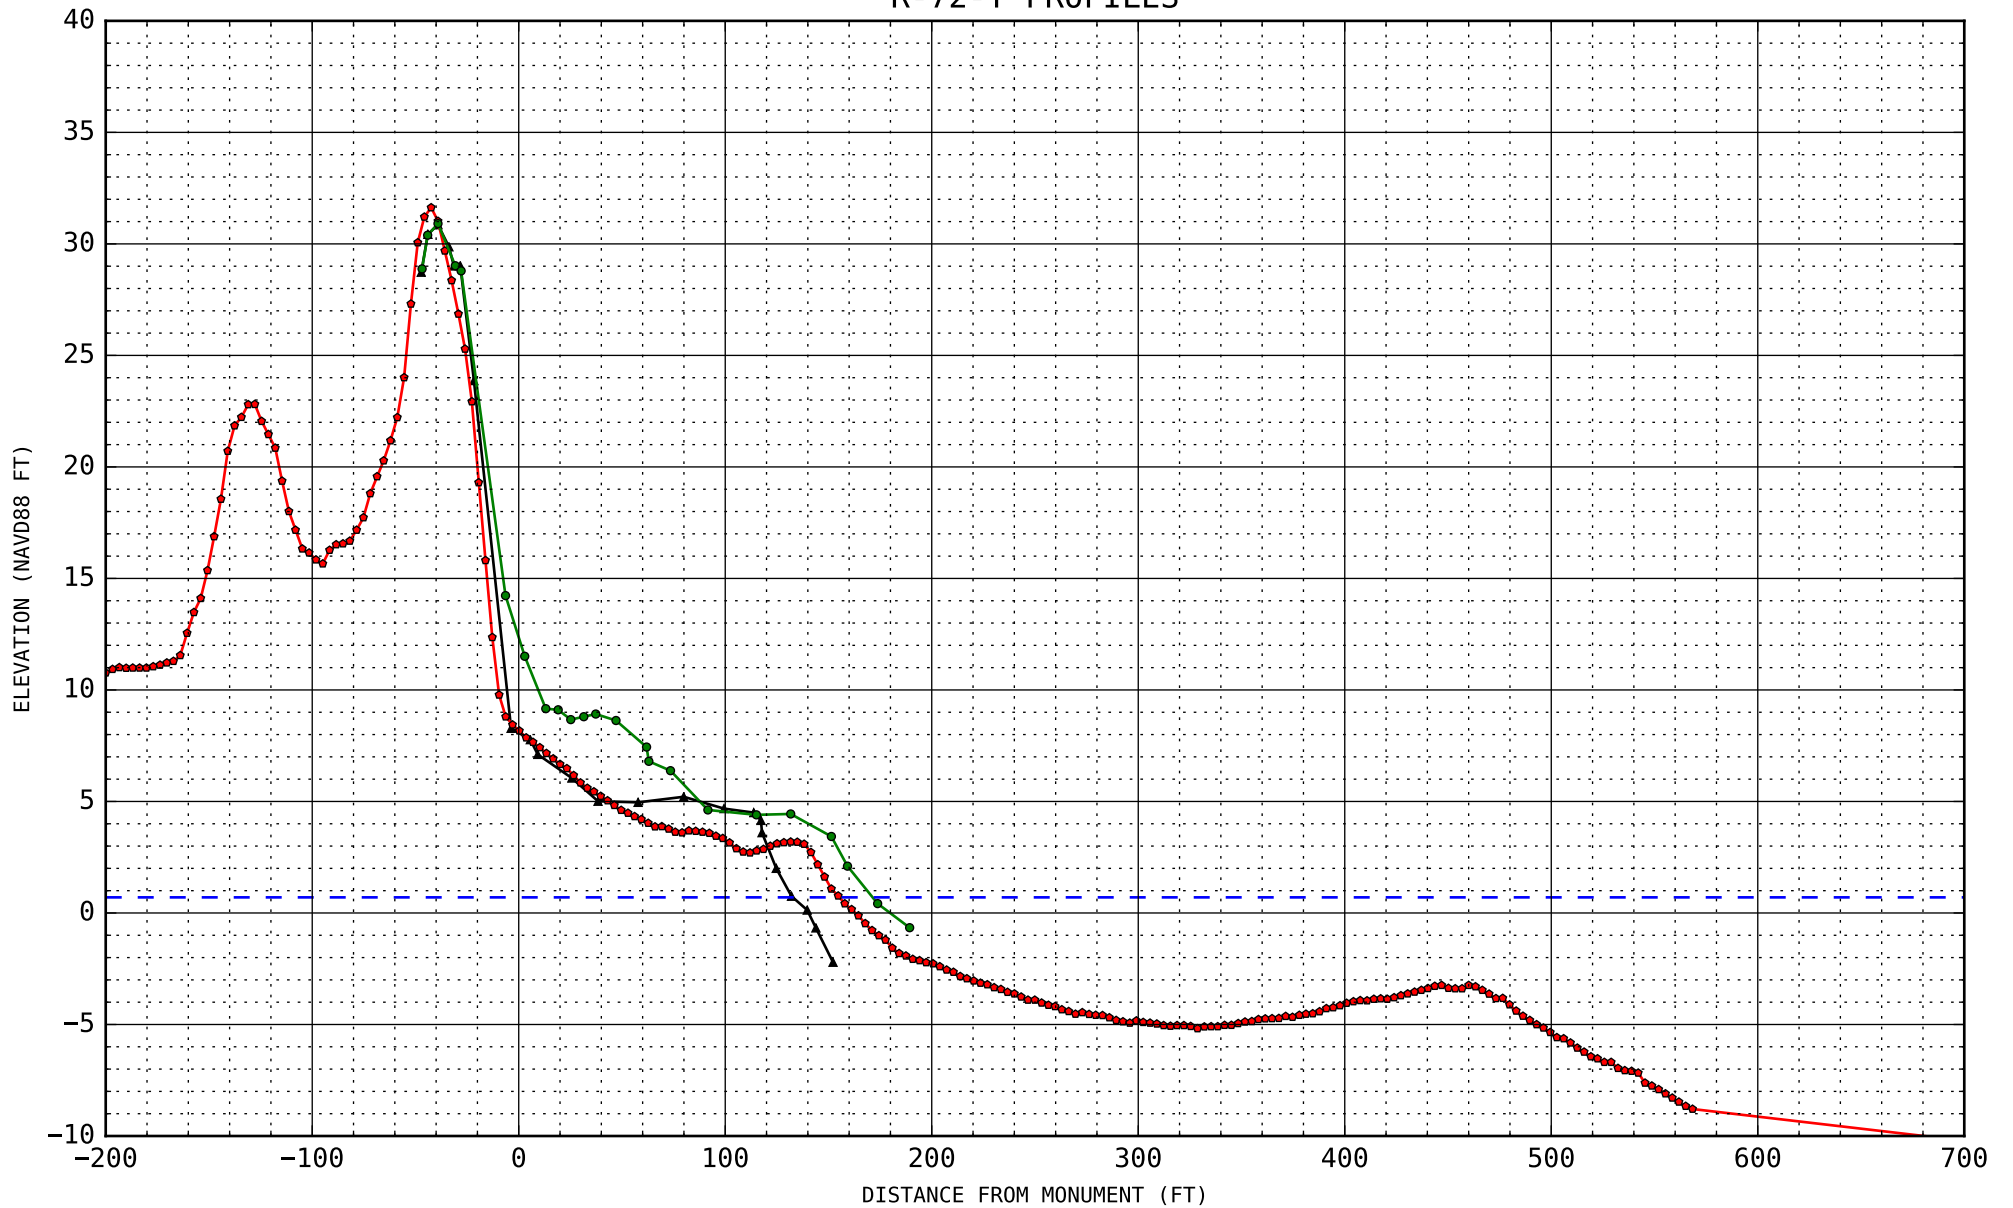
# R-72-T PROFILES

- ▲ 2019-MAY CONDITION BY DEP
- 2018-OCT MONITORING BY USACE-LIDAR
- 2017-FEB MONITORING BY DEP
- - - MHW CONTOUR (0.7 FT)

RANGE: R-72-T  
EST DATE: FEB1980  
SURVEY DATE: 16MAY19  
AZIMUTH: 150.0

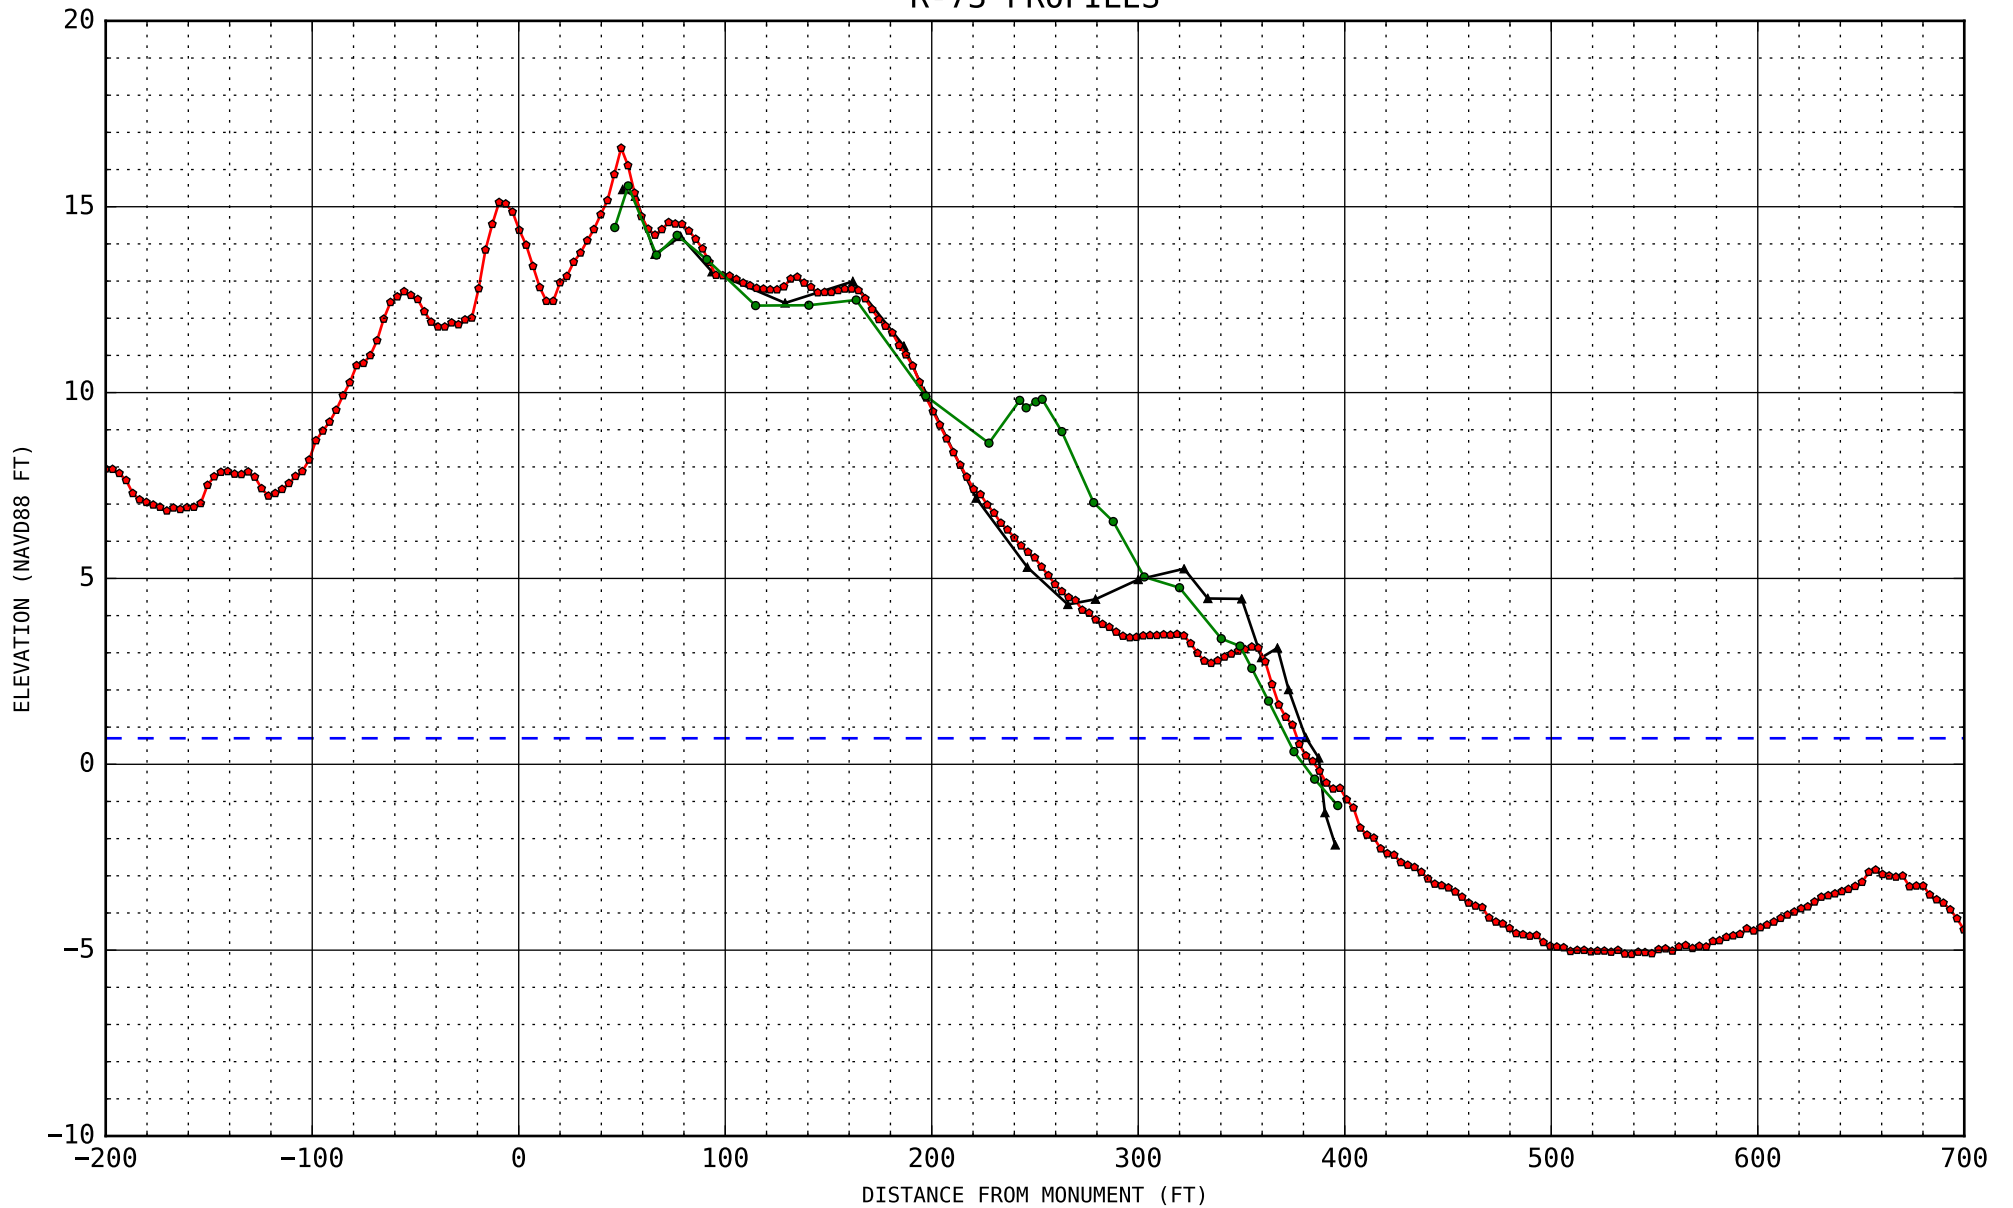
# R-73 PROFILES

- ▲ 2019-MAY CONDITION BY DEP
- 2018-OCT MONITORING BY USACE-LIDAR
- 2017-FEB MONITORING BY DEP
- - - MHW CONTOUR (0.7 FT)

RANGE: R-73  
 EST DATE: JUL1996  
 SURVEY DATE: 16MAY19  
 AZIMUTH: 150.0

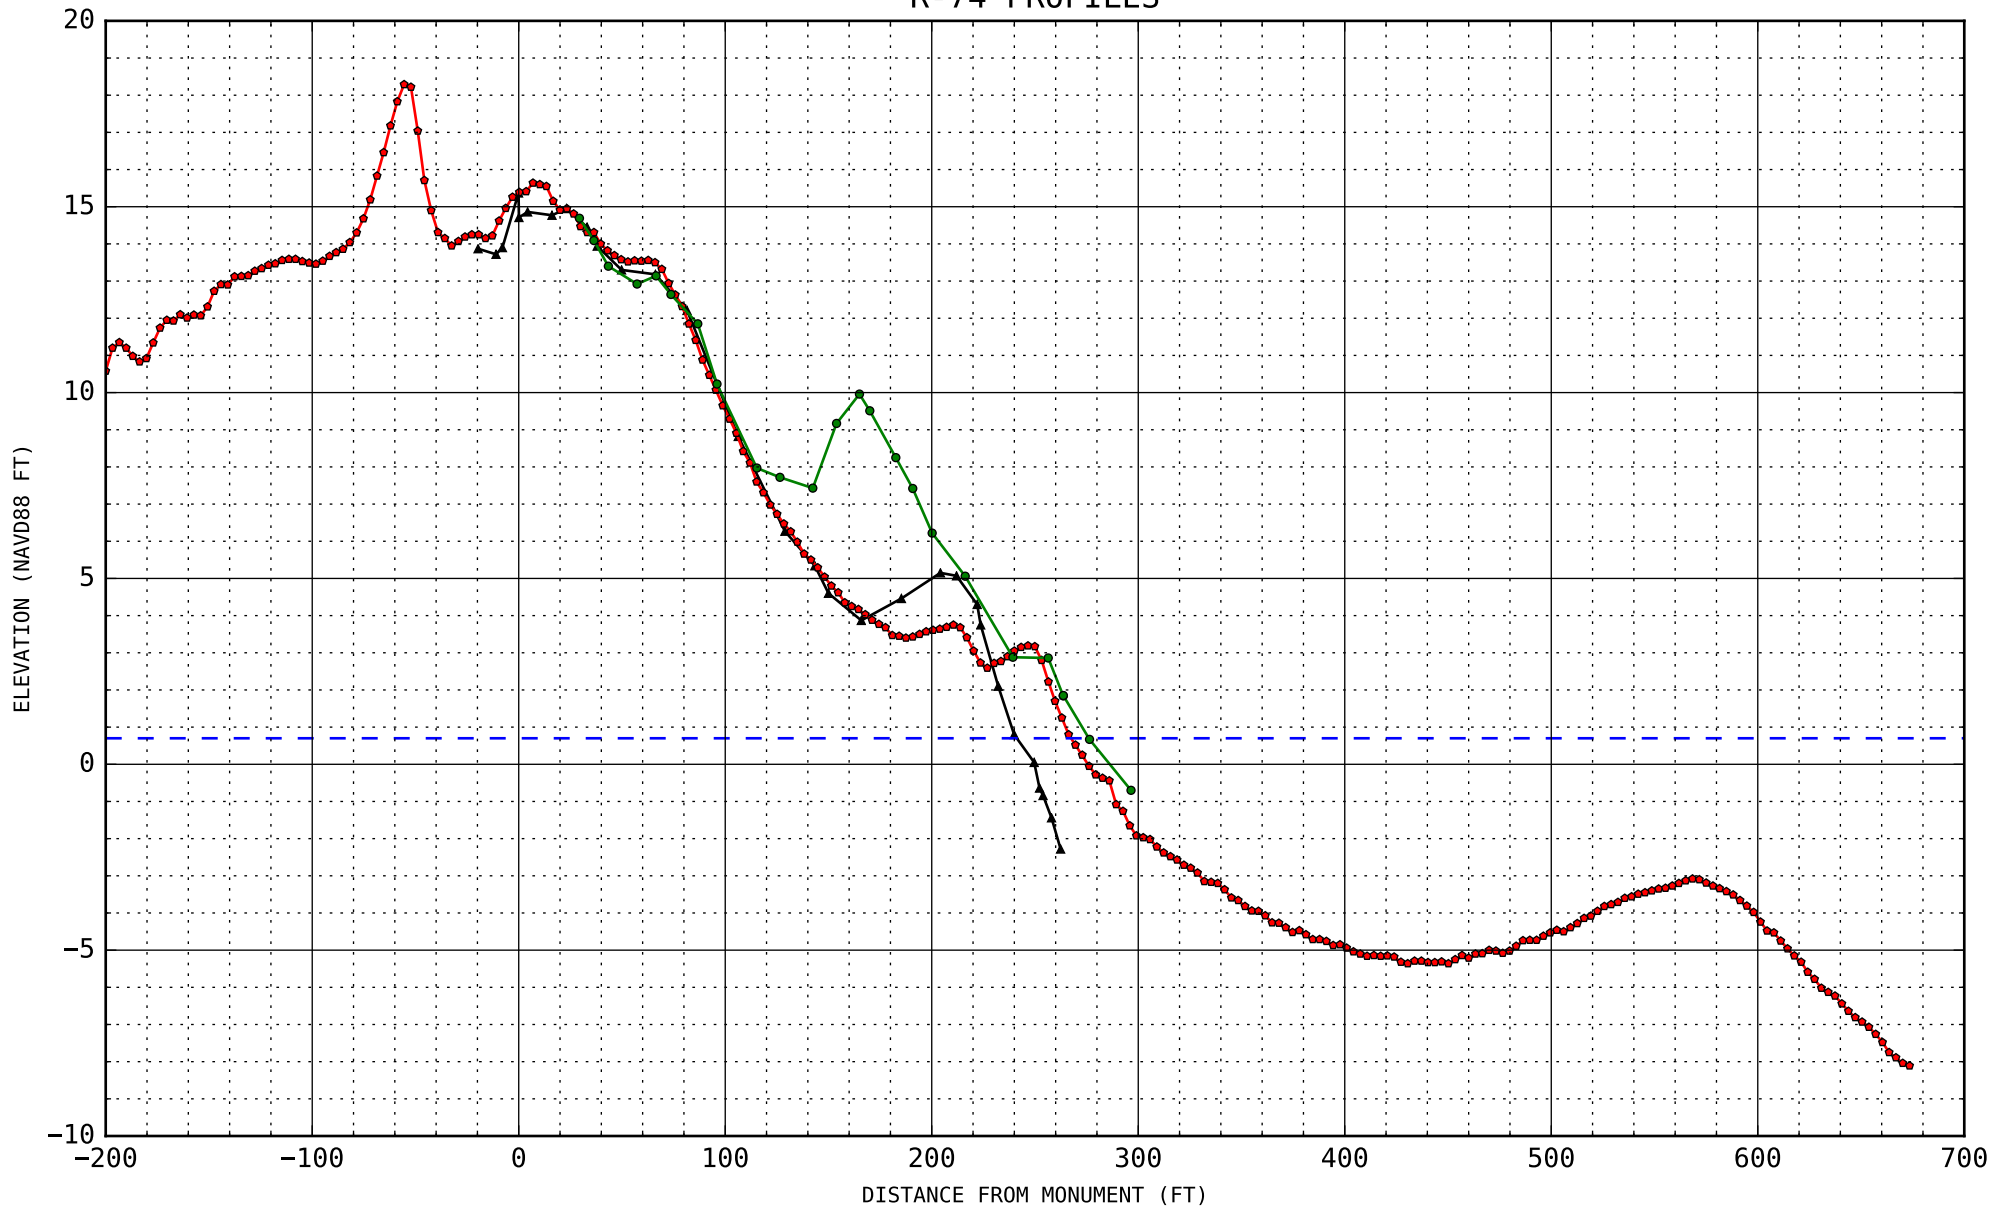
# R-74 PROFILES

- ▲ 2019-MAY CONDITION BY DEP
- 2018-OCT MONITORING BY USACE-LIDAR
- 2017-FEB MONITORING BY DEP
- - - MHW CONTOUR (0.7 FT)

RANGE: R-74  
EST DATE: JUL1996  
SURVEY DATE: 16MAY19  
AZIMUTH: 150.0

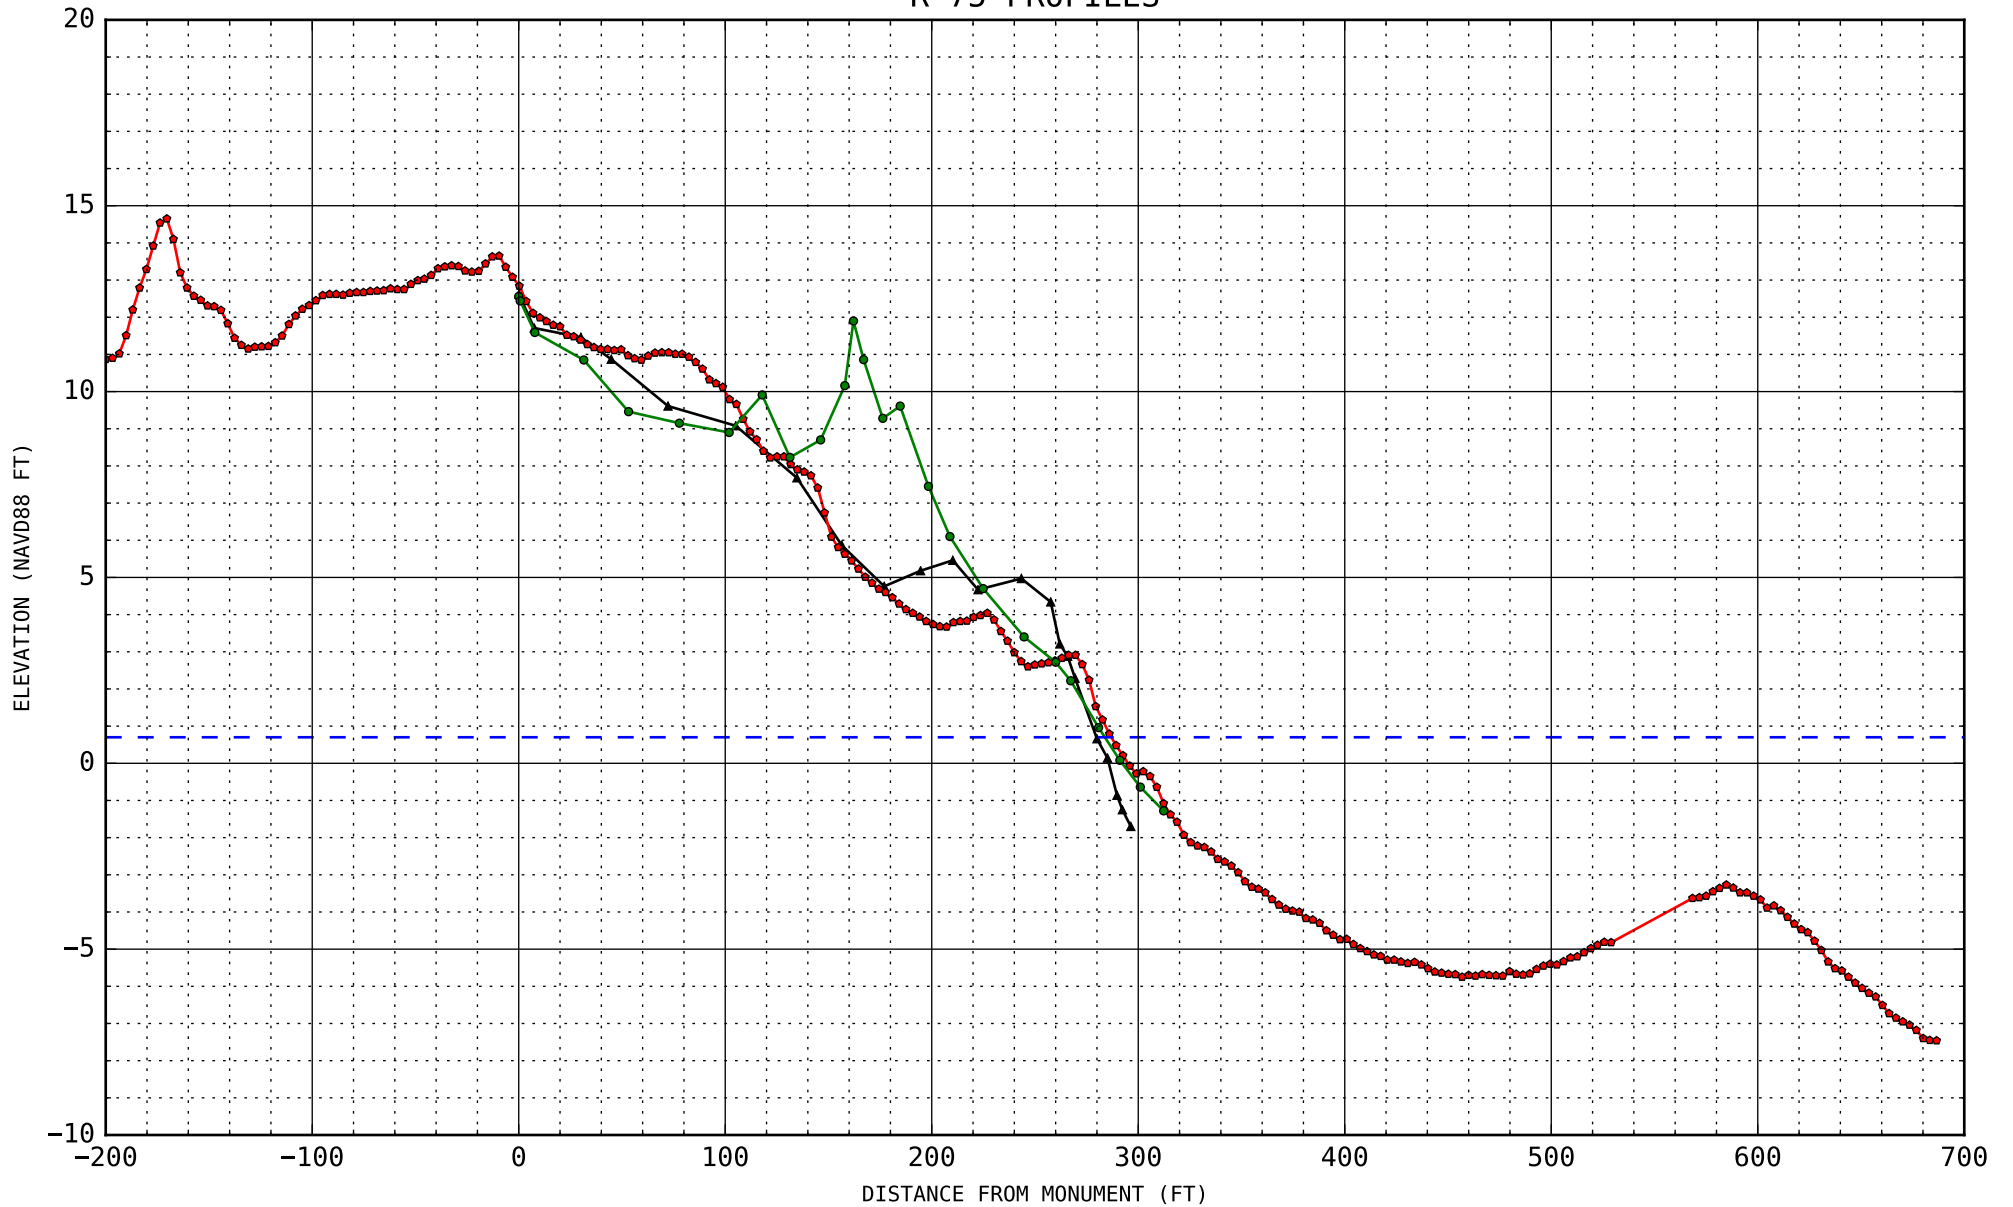
# R-75 PROFILES

- ▲ 2019-MAY CONDITION BY DEP
- 2018-OCT MONITORING BY USACE-LIDAR
- 2017-FEB MONITORING BY DEP
- - - MHW CONTOUR (0.7 FT)

RANGE: R-75  
EST DATE: MAY1973  
SURVEY DATE: 16MAY19  
AZIMUTH: 150.0

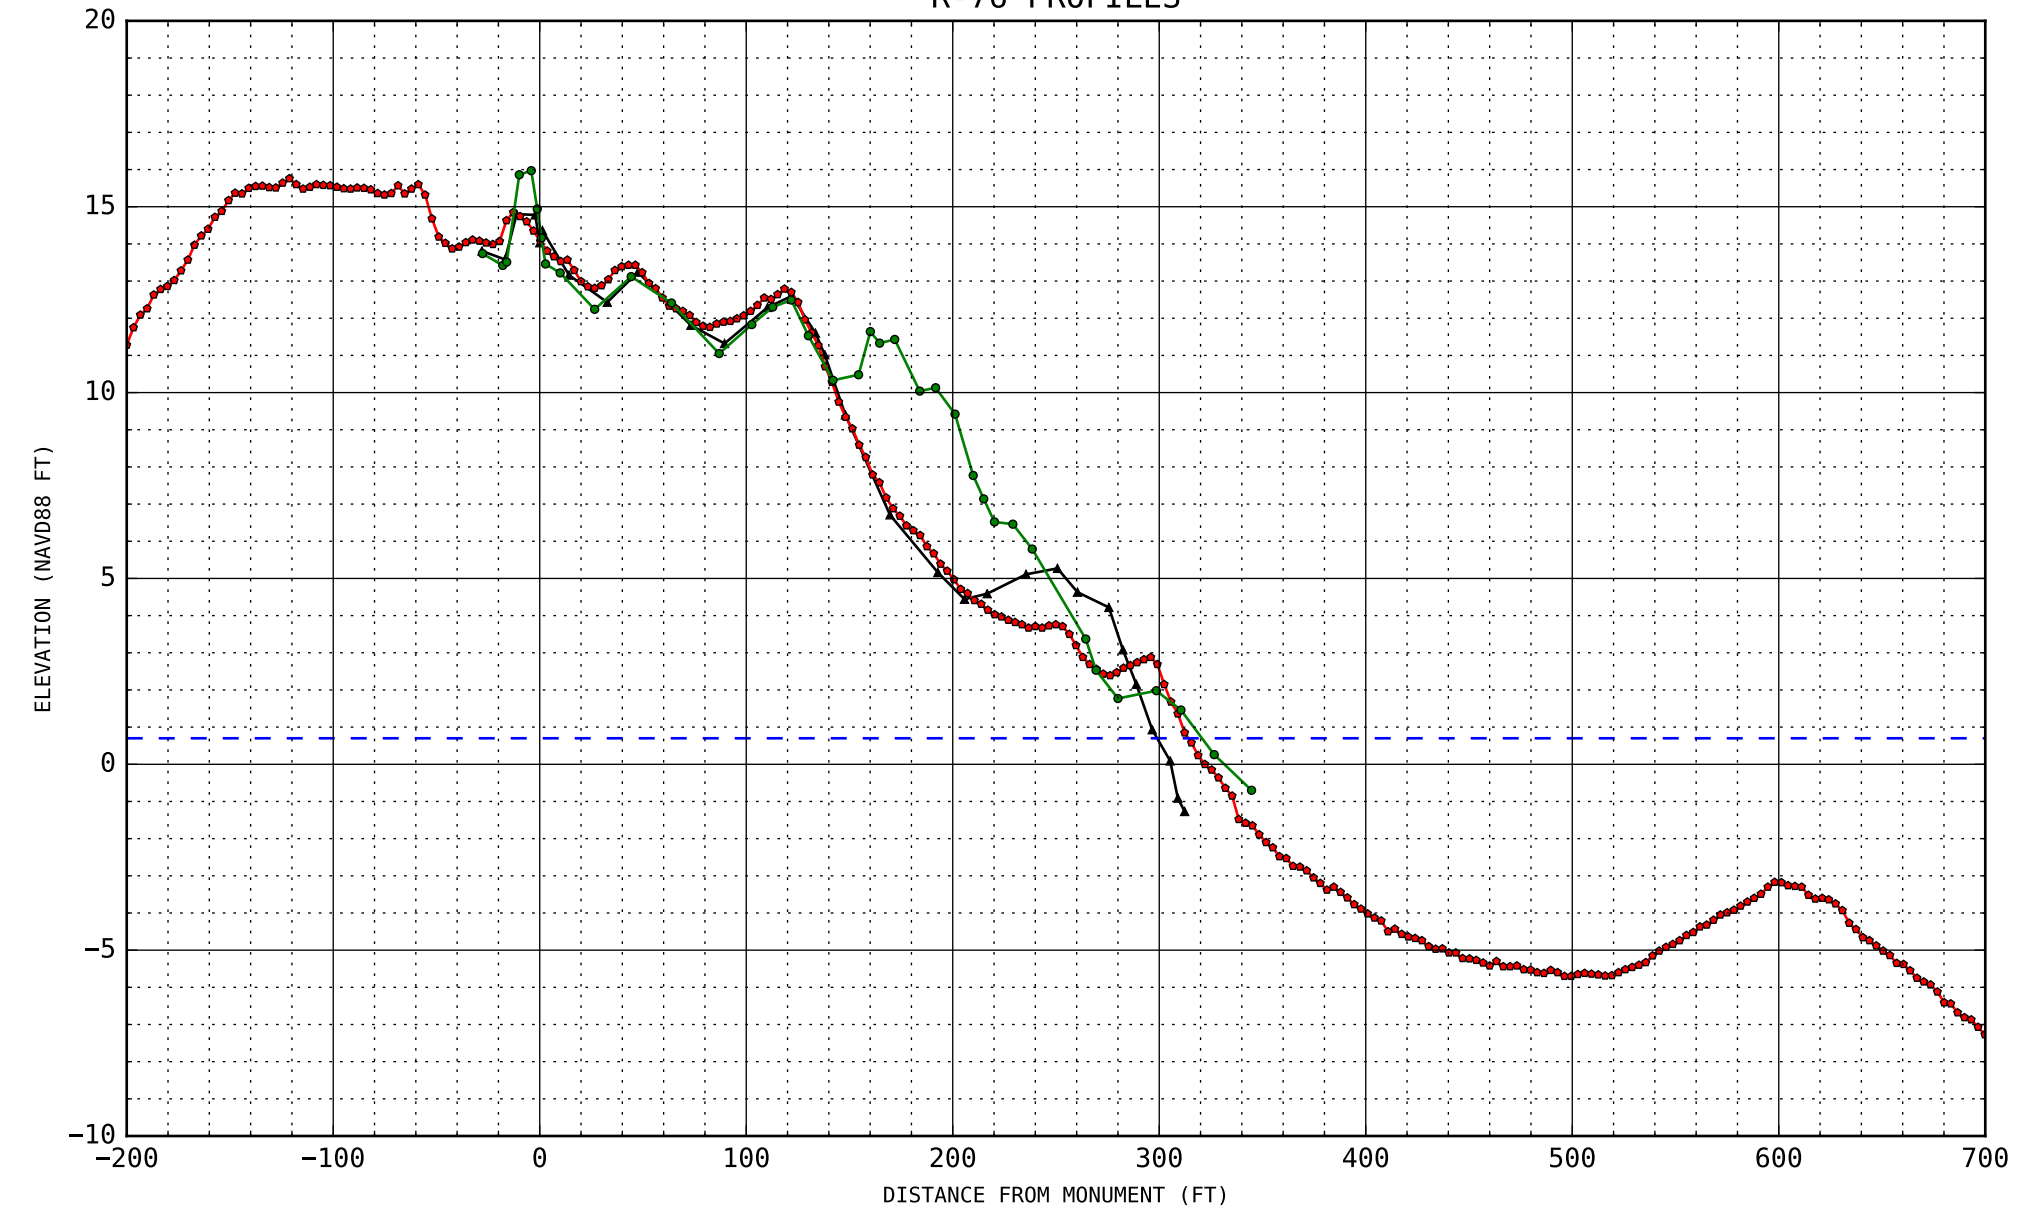
# R-76 PROFILES

- ▲ 2019-MAY CONDITION BY DEP
- 2018-OCT MONITORING BY USACE-LIDAR
- 2017-FEB MONITORING BY DEP
- - - MHW CONTOUR (0.7 FT)

RANGE: R-76  
EST DATE: NOV1987  
SURVEY DATE: 16MAY19  
AZIMUTH: 150.0

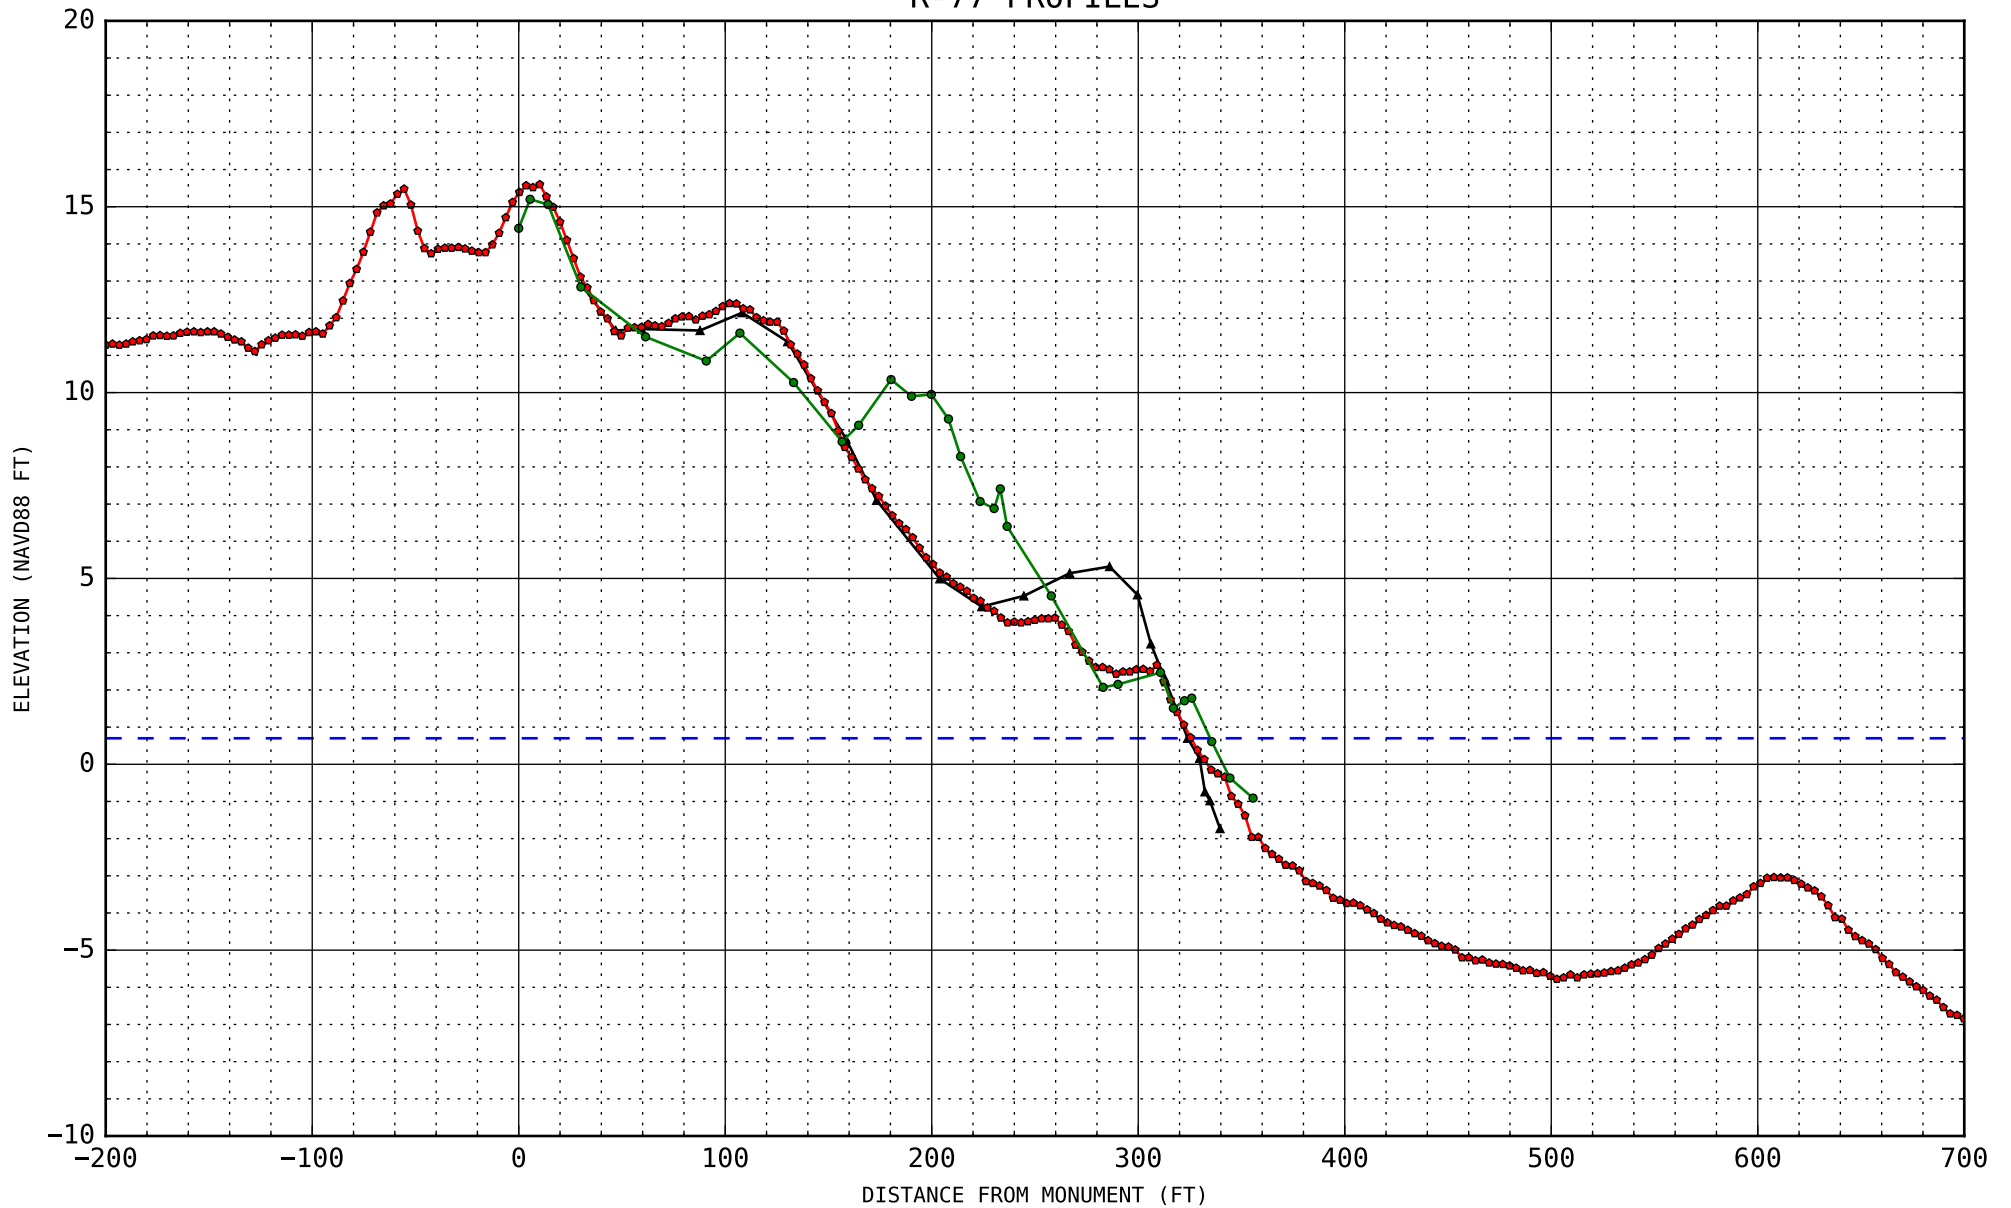
# R-77 PROFILES

- ▲ 2019-MAY CONDITION BY DEP
- 2018-OCT MONITORING BY USACE-LIDAR
- 2017-FEB MONITORING BY DEP
- - - MHW CONTOUR (0.7 FT)

RANGE: R-77  
 EST DATE: NOV1987  
 SURVEY DATE: 16MAY19  
 AZIMUTH: 150.0

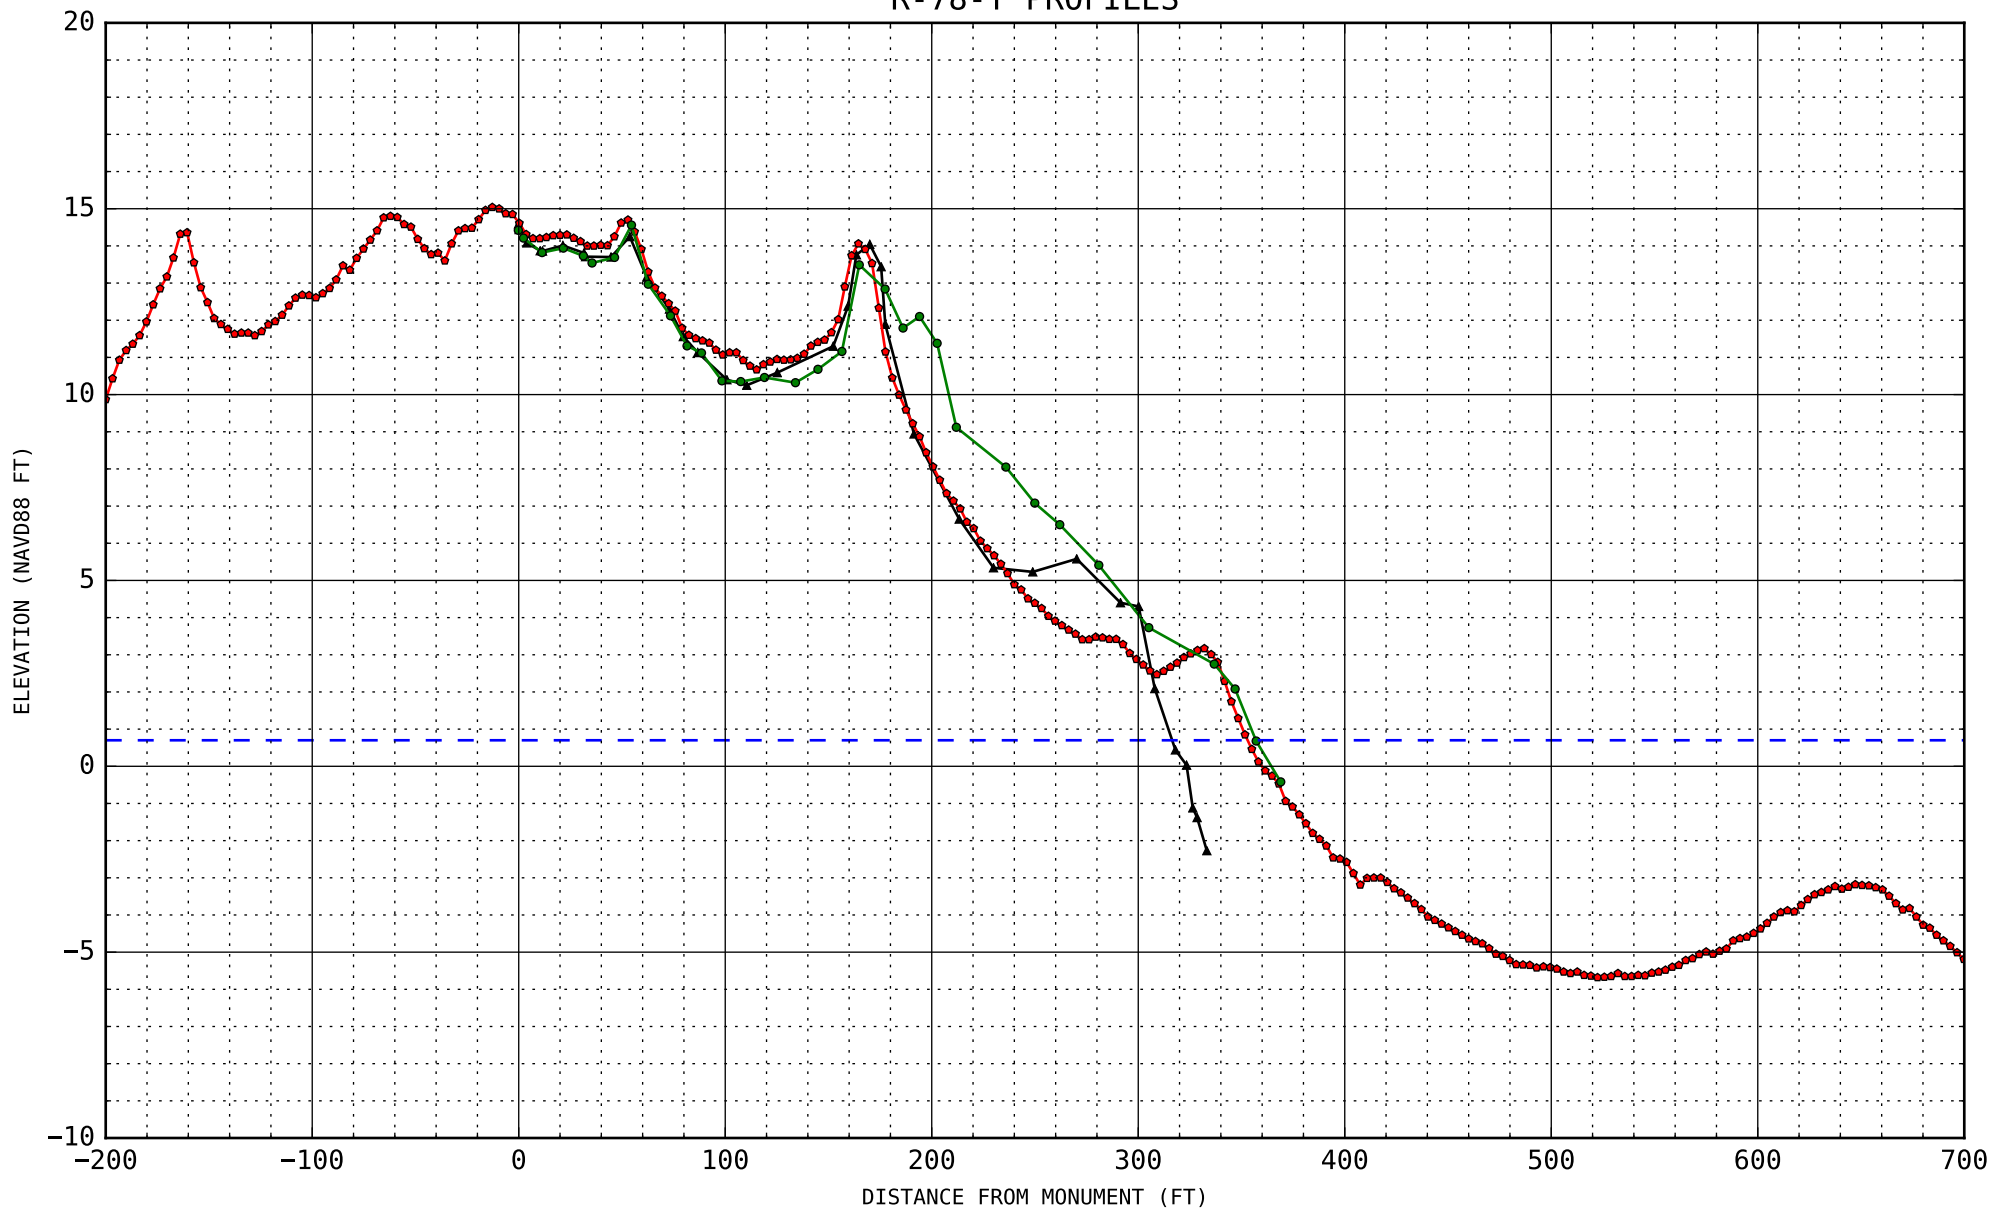
# R-78-T PROFILES

- ▲ 2019-MAY CONDITION BY DEP
- 2018-OCT MONITORING BY USACE-LIDAR
- 2017-FEB MONITORING BY DEP
- - - MHW CONTOUR (0.7 FT)

RANGE: R-78-T  
EST DATE: FEB1980  
SURVEY DATE: 16MAY19  
AZIMUTH: 150.0
