# R-52-T PROFILES

FRANKLIN  
PROGRAM SUPPORT GIS  
DIVISION OF WATER RESOURCE MANAGEMENT  
FLORIDA DEPARTMENT OF ENVIRONMENTAL PROTECTION

RANGE: R-52-T  
EST DATE: FEB1980  
SURVEY DATE: 16MAY19  
AZIMUTH: 150.0

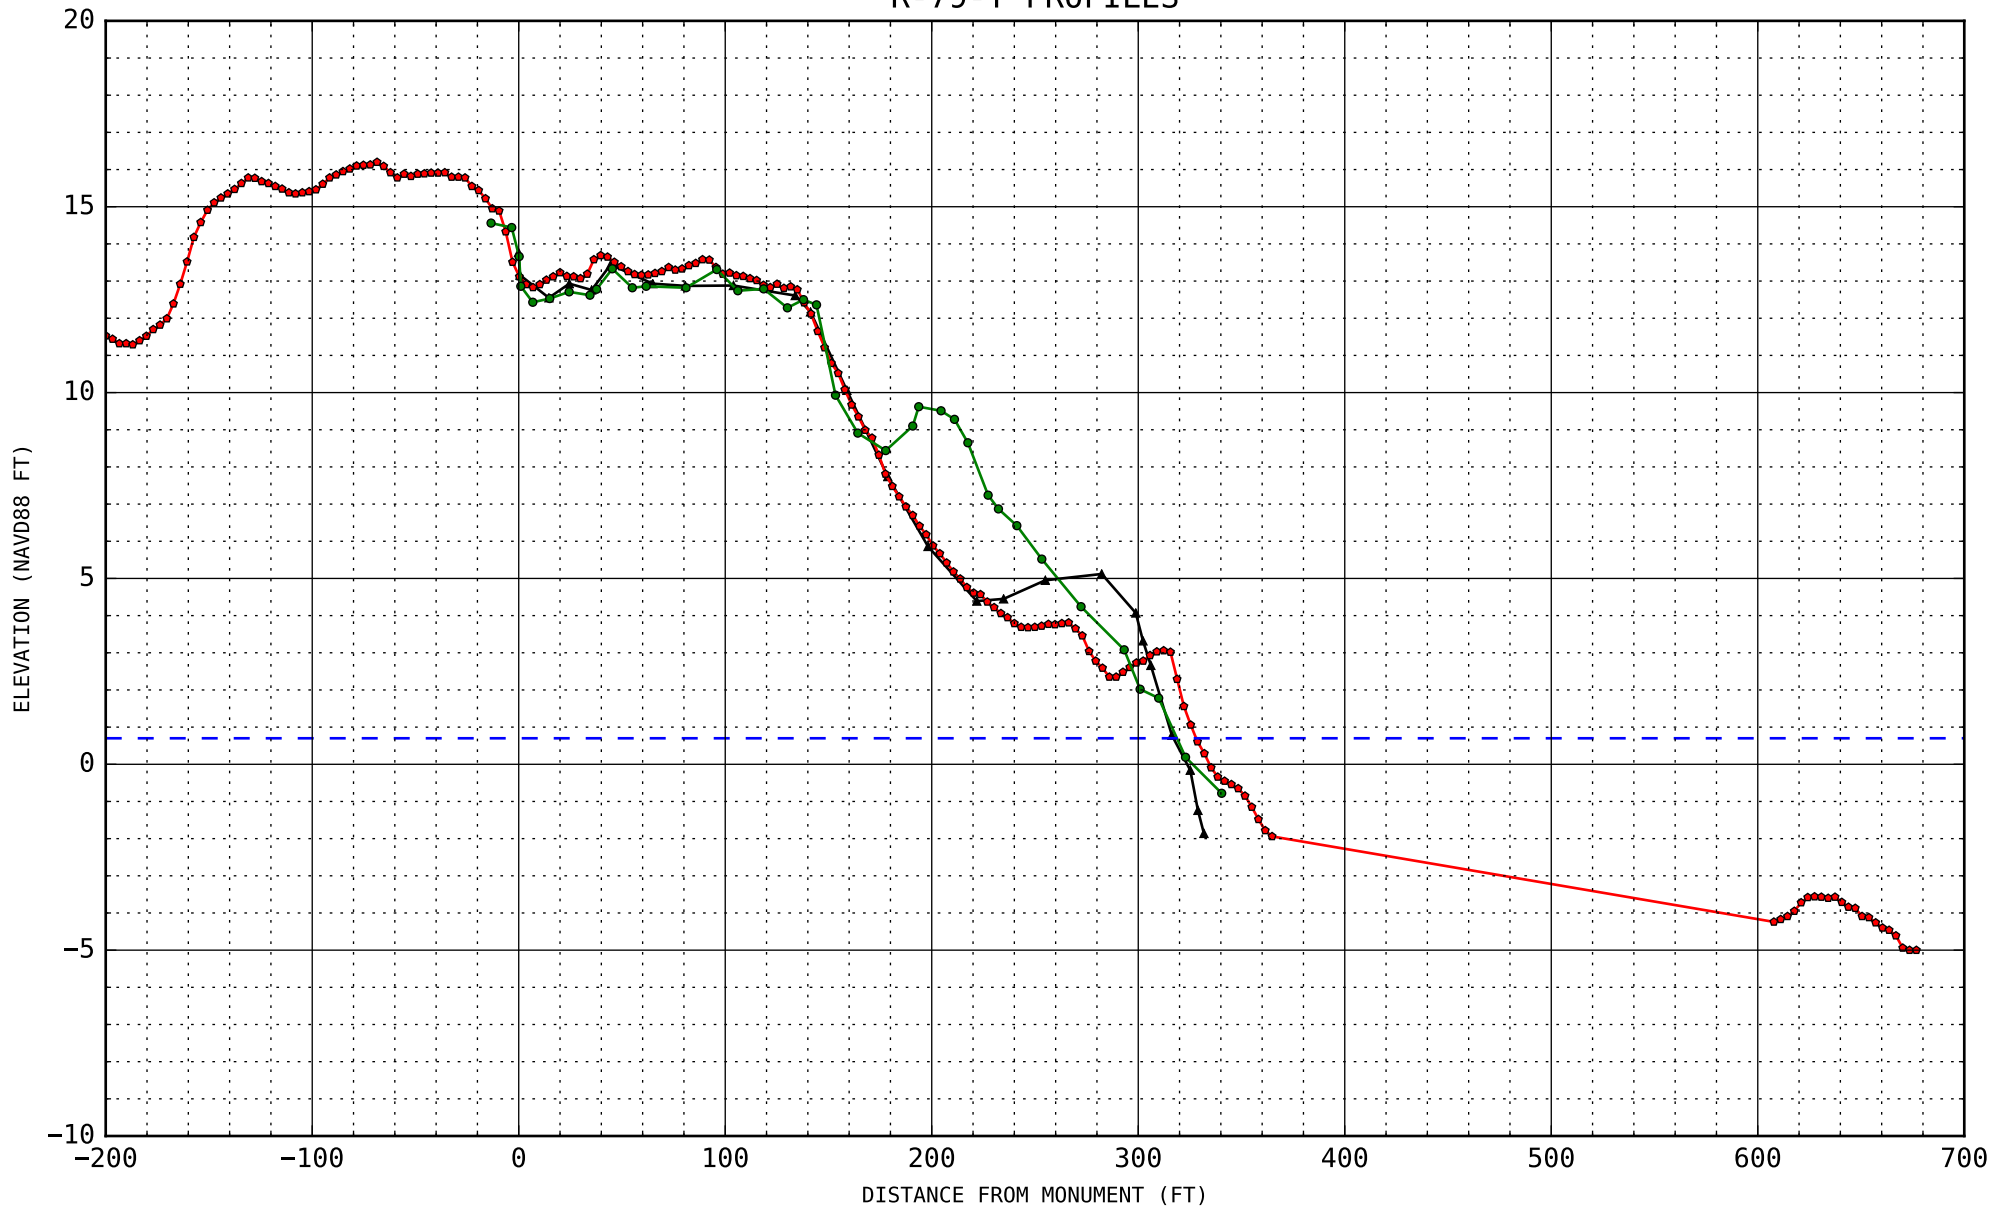
# R-79-T PROFILES

- ▲ 2019-MAY CONDITION BY DEP
- 2018-OCT MONITORING BY USACE-LIDAR
- 2017-FEB MONITORING BY DEP
- - - MHW CONTOUR (0.7 FT)

RANGE: R-79-T  
EST DATE: NOV1987  
SURVEY DATE: 16MAY19  
AZIMUTH: 150.0

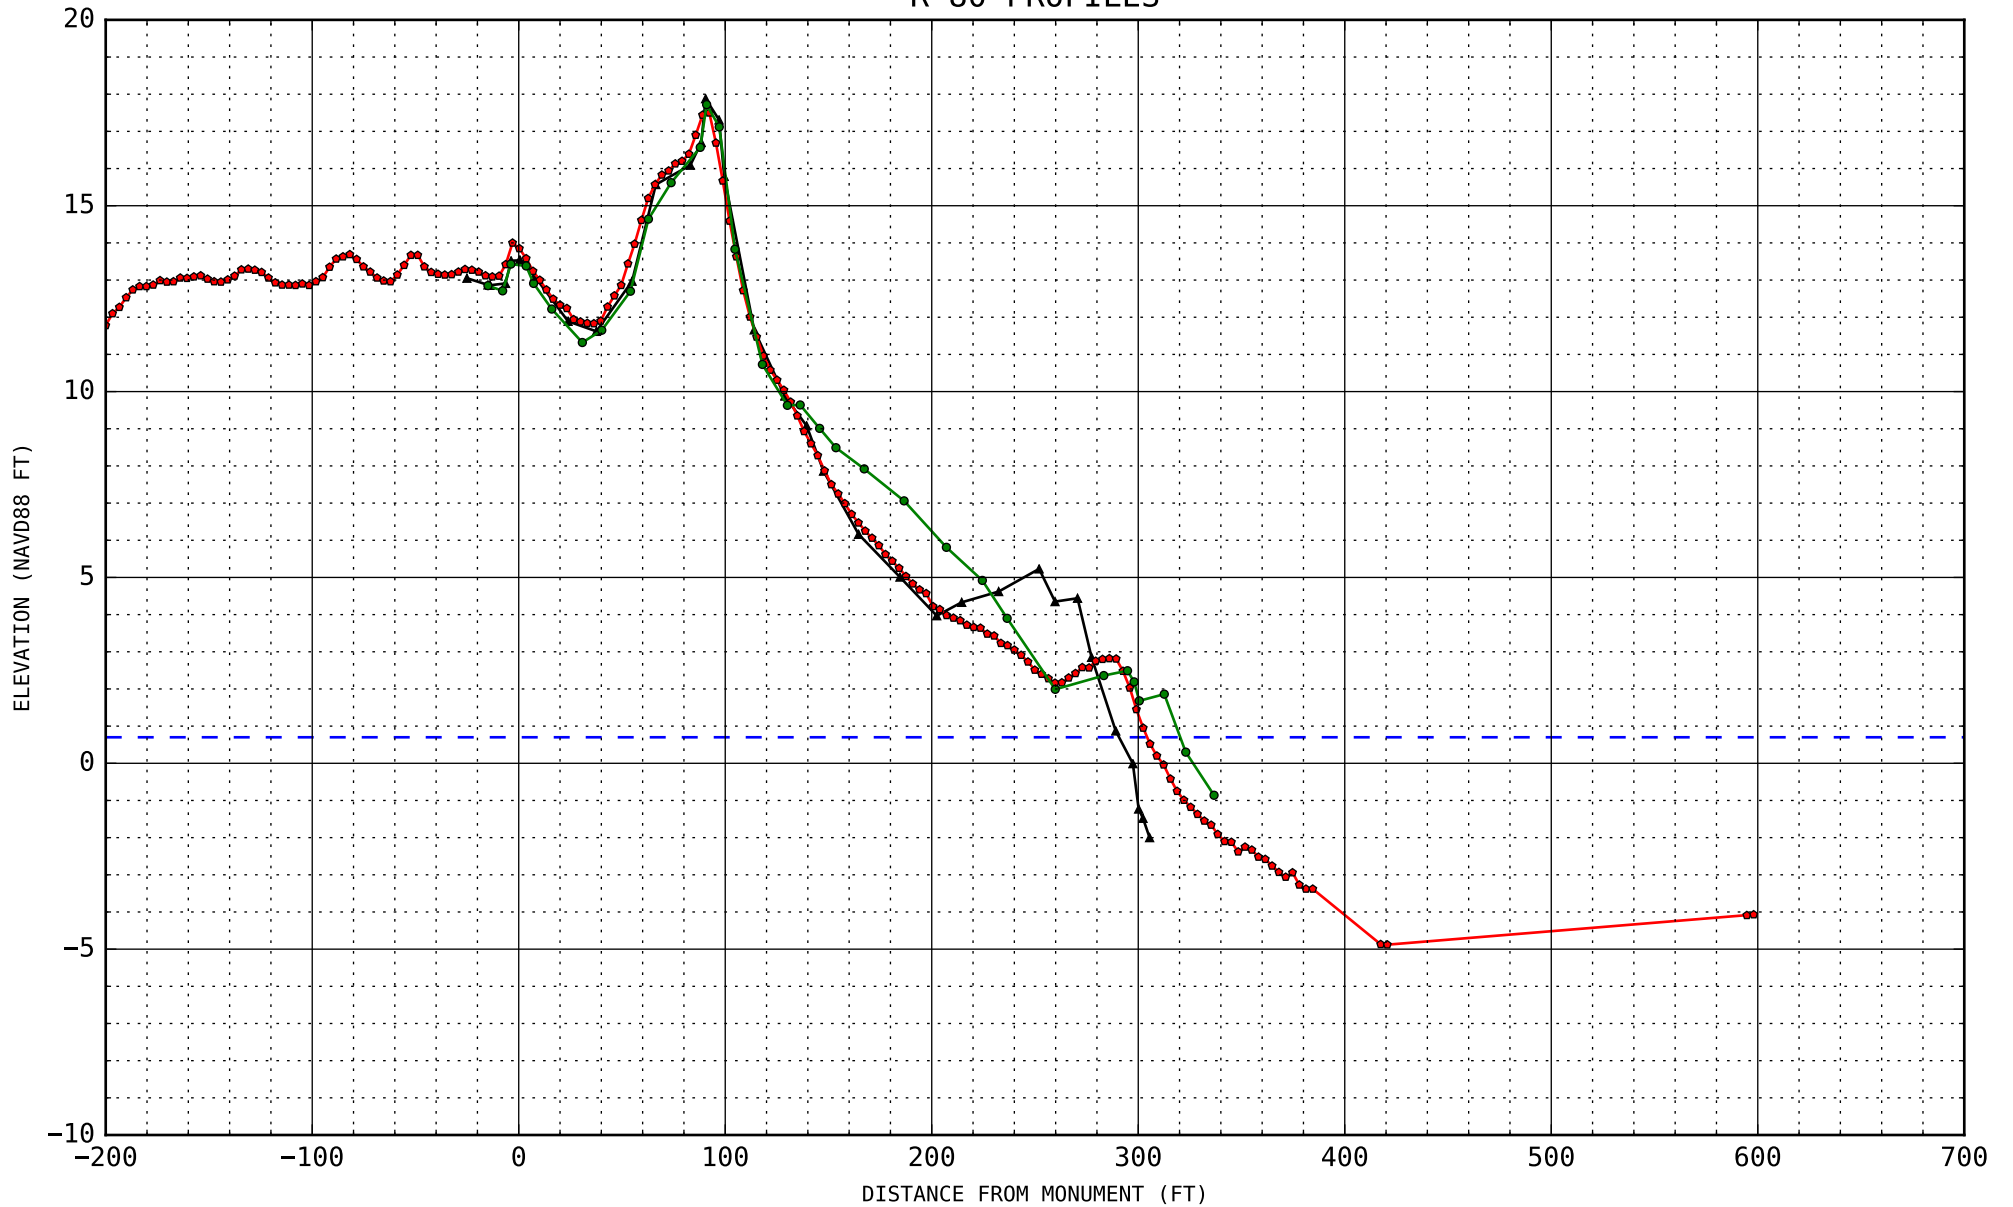
# R-80 PROFILES

- ▲ 2019-MAY CONDITION BY DEP
- 2018-OCT MONITORING BY USACE-LIDAR
- 2017-FEB MONITORING BY DEP
- - - MHW CONTOUR (0.7 FT)

RANGE: R-80  
 EST DATE: MAY1973  
 SURVEY DATE: 16MAY19  
 AZIMUTH: 150.0

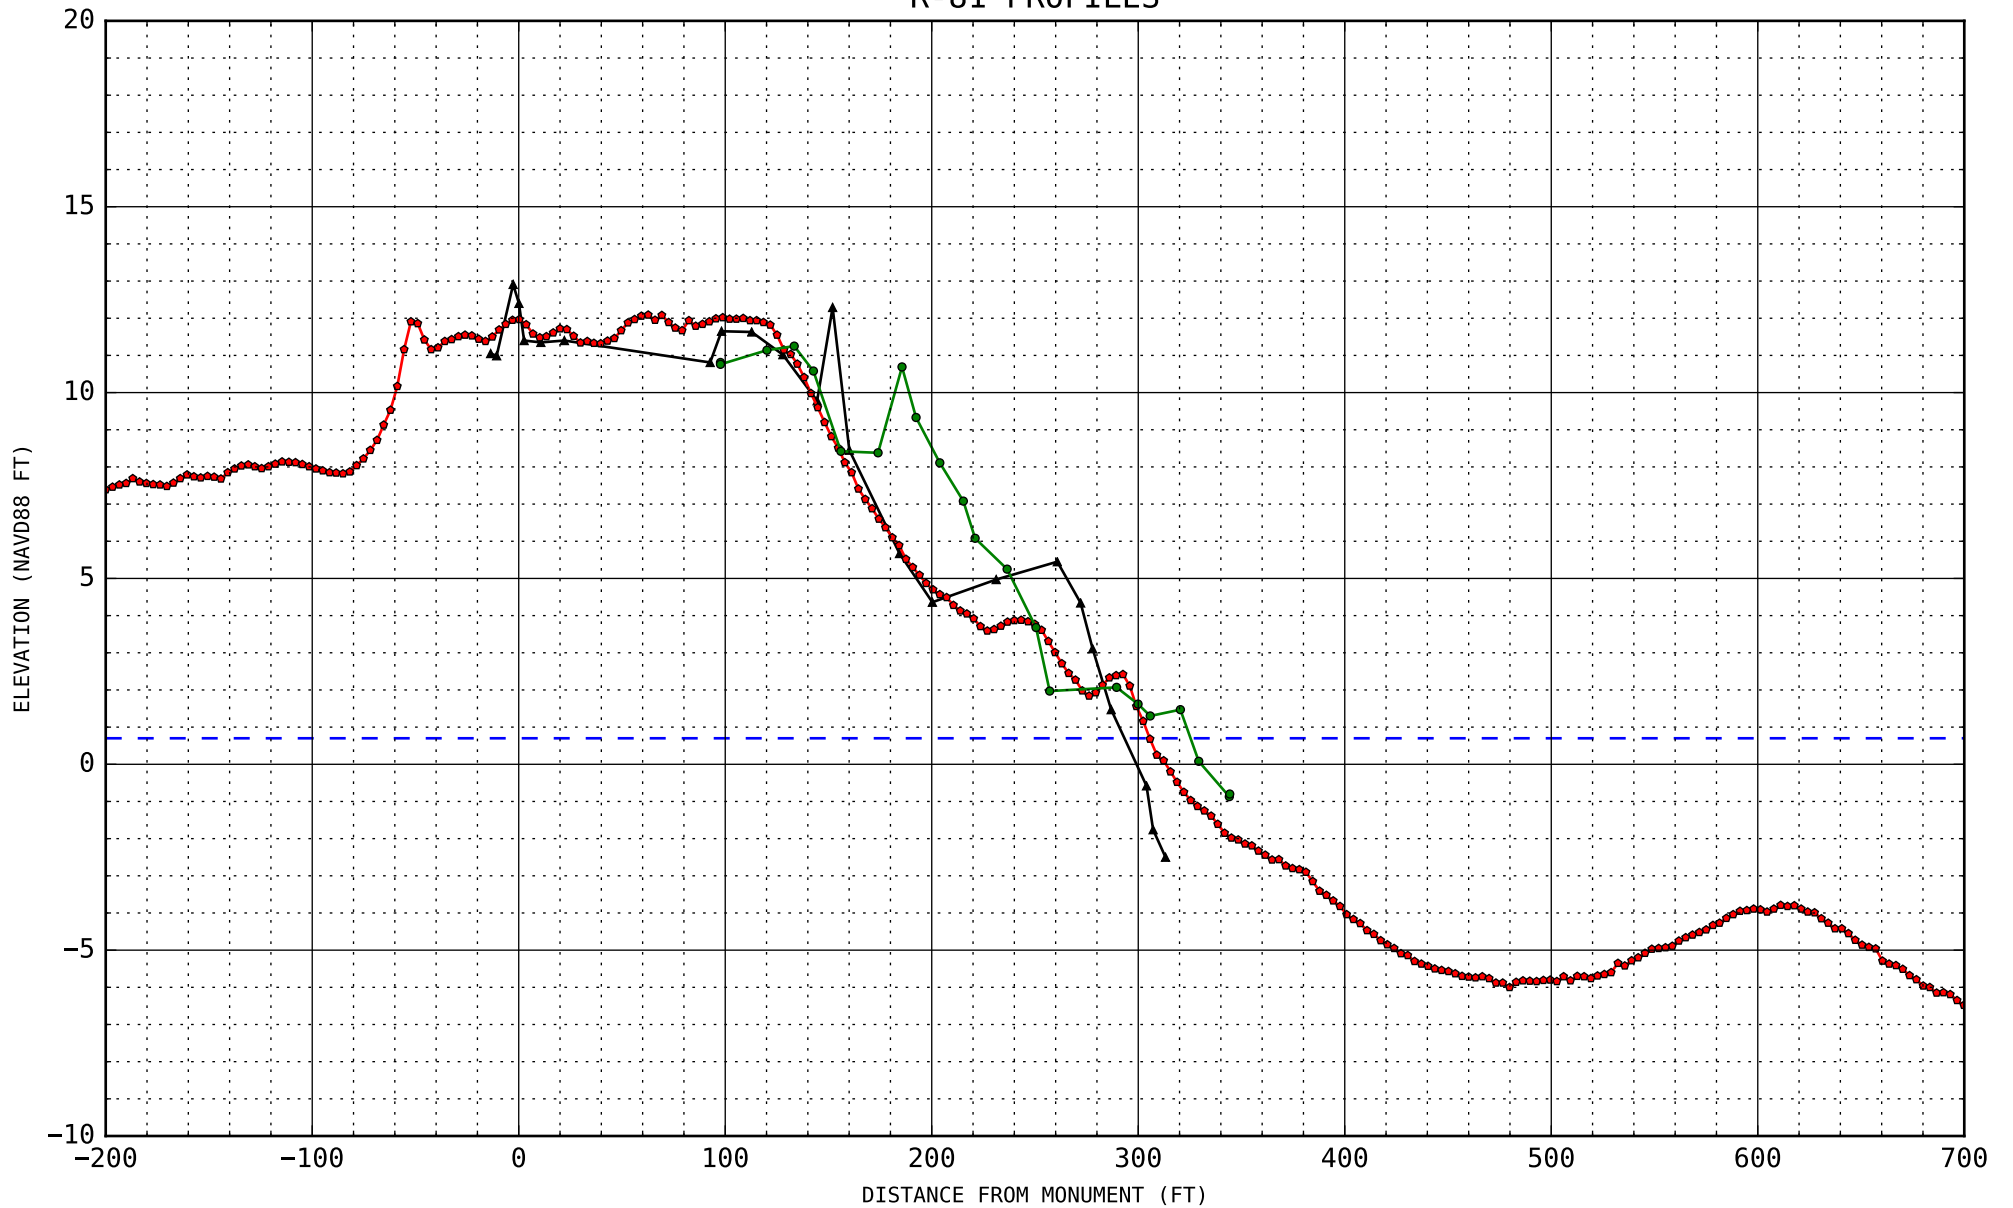
# R-81 PROFILES

- ▲ 2019-MAY CONDITION BY DEP
- 2018-OCT MONITORING BY USACE-LIDAR
- 2017-FEB MONITORING BY DEP
- - - MHW CONTOUR (0.7 FT)

RANGE: R-81  
EST DATE: MAY1973  
SURVEY DATE: 17MAY19  
AZIMUTH: 150.0

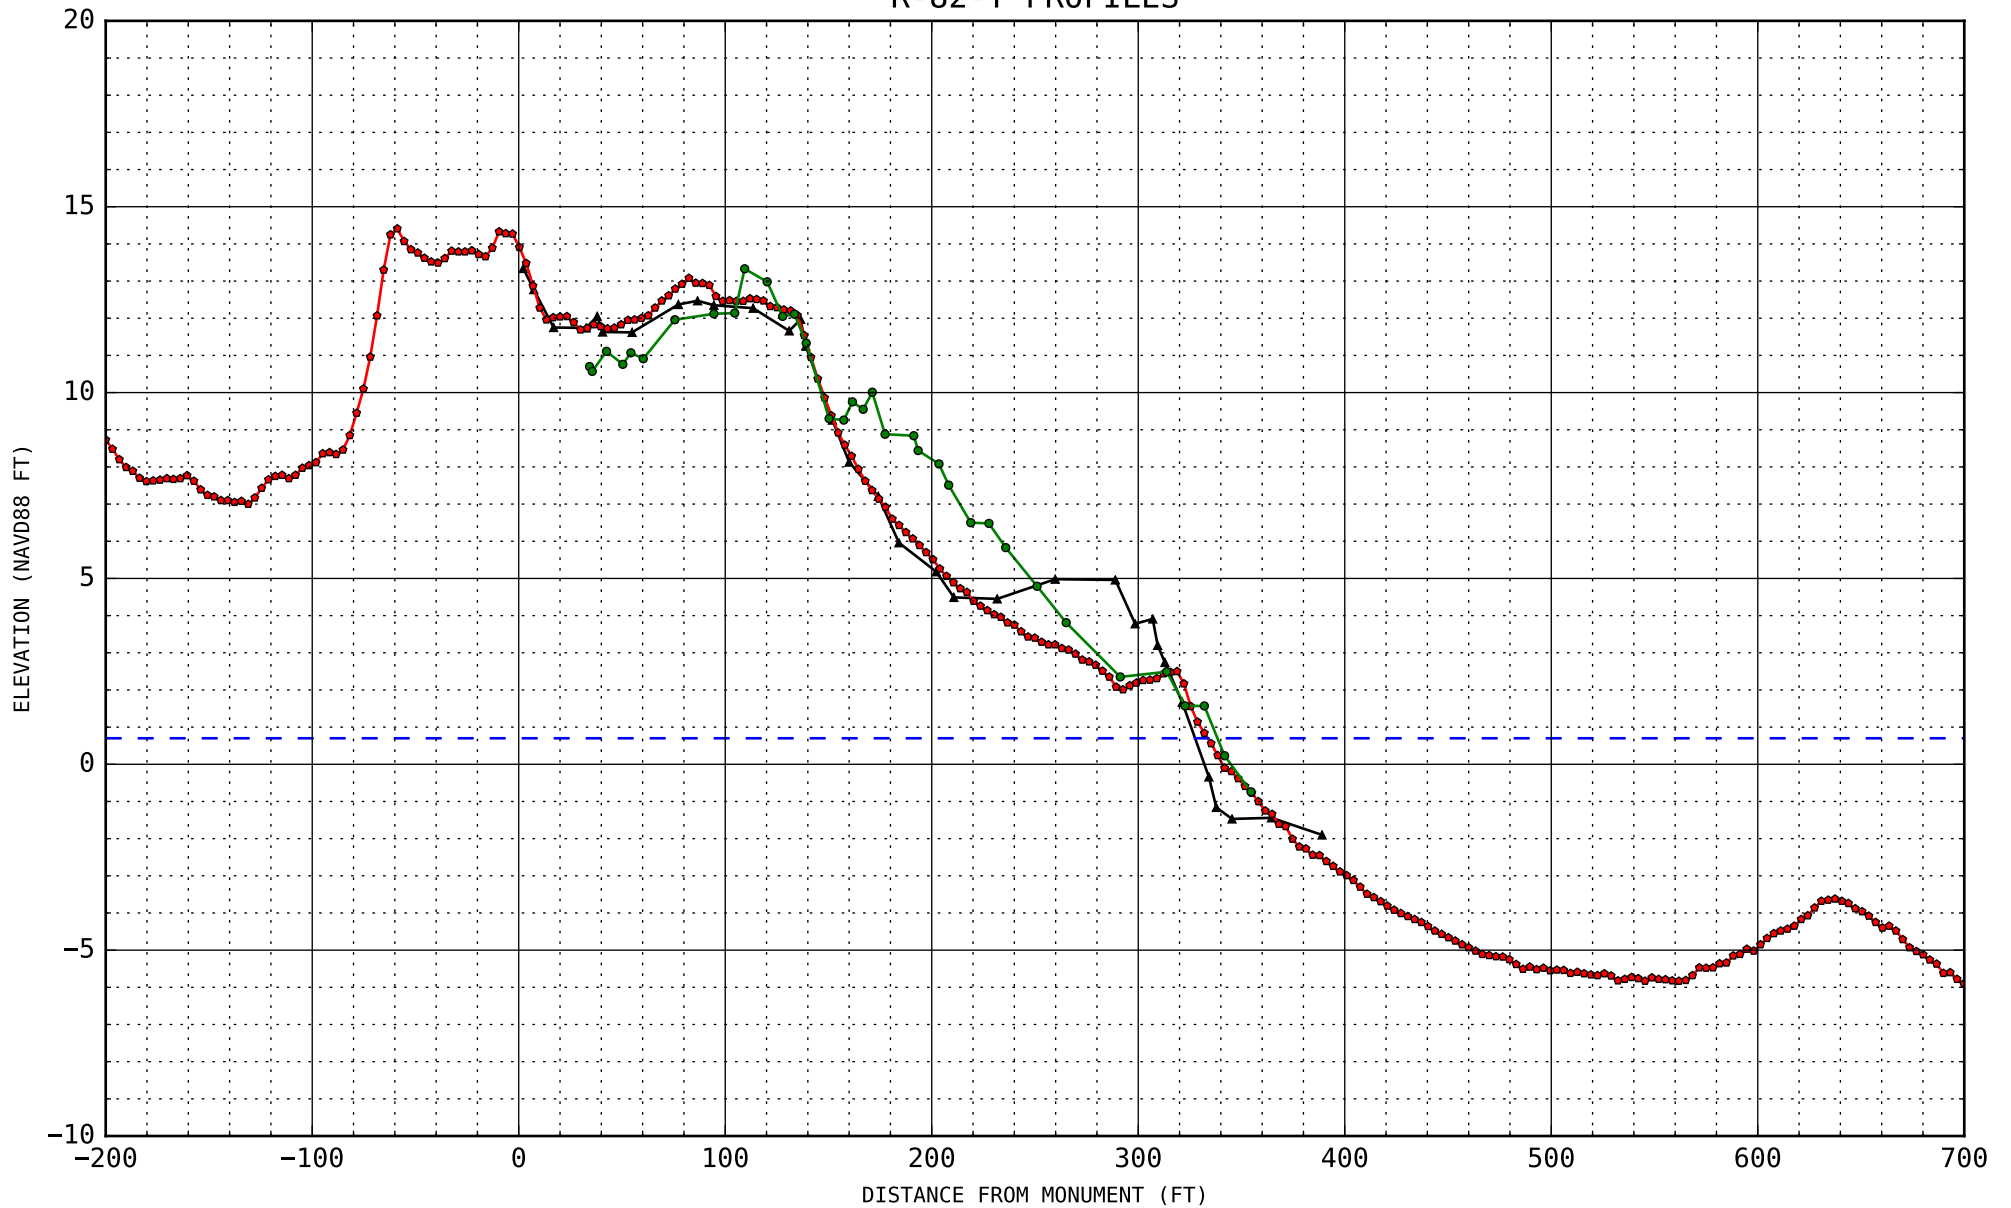
# R-82-T PROFILES

- ▲ 2019-MAY CONDITION BY DEP
- 2018-OCT MONITORING BY USACE-LIDAR
- 2017-FEB MONITORING BY DEP
- - - MHW CONTOUR (0.7 FT)

RANGE: R-82-T  
 EST DATE: FEB1980  
 SURVEY DATE: 17MAY19  
 AZIMUTH: 150.0

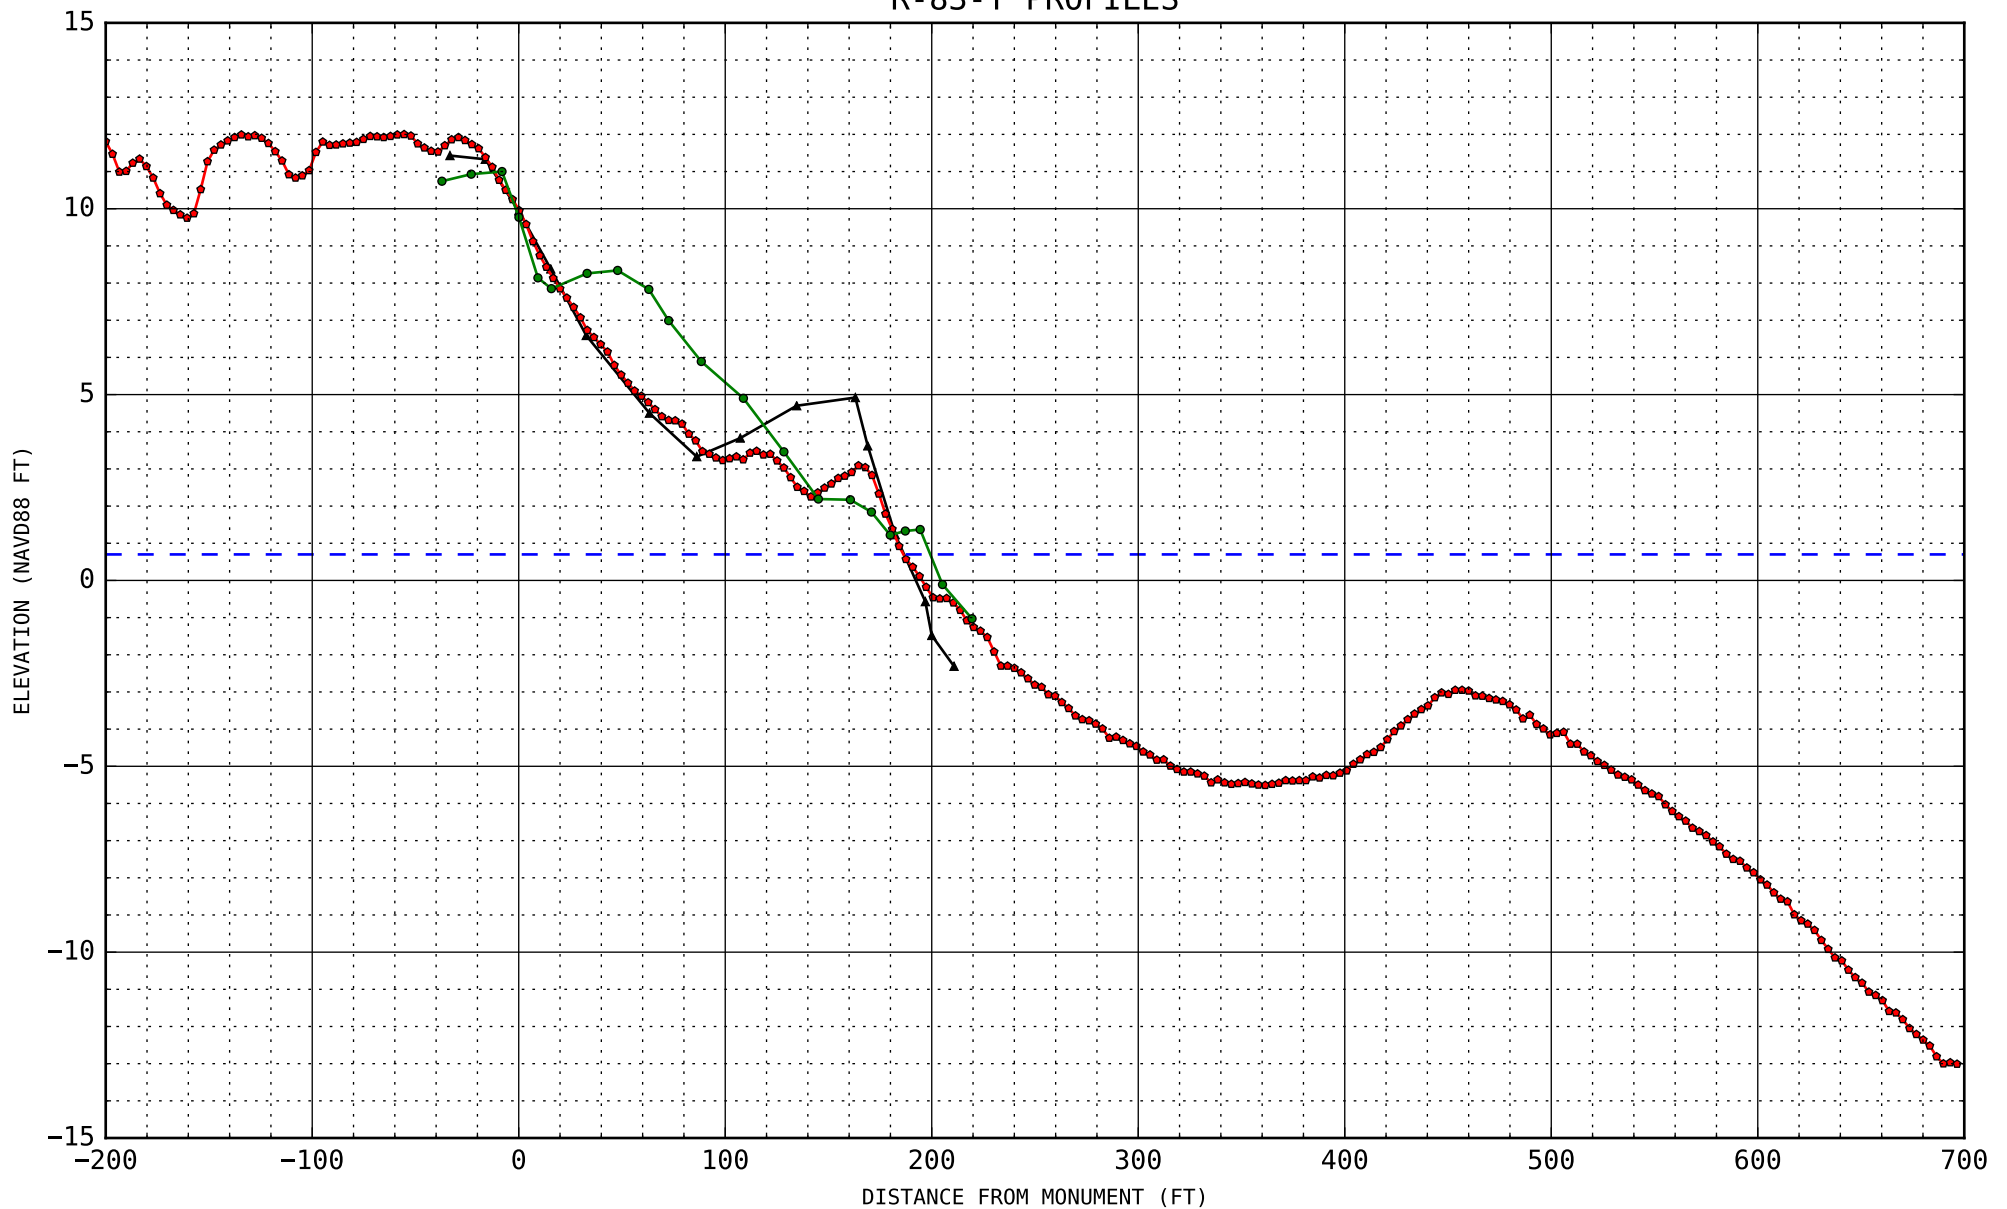
# R-83-T PROFILES

- ▲ 2019-MAY CONDITION BY DEP
- 2018-OCT MONITORING BY USACE-LIDAR
- 2017-FEB MONITORING BY DEP
- - - MHW CONTOUR (0.7 FT)

RANGE: R-83-T  
 EST DATE: FEB1980  
 SURVEY DATE: 17MAY19  
 AZIMUTH: 150.0

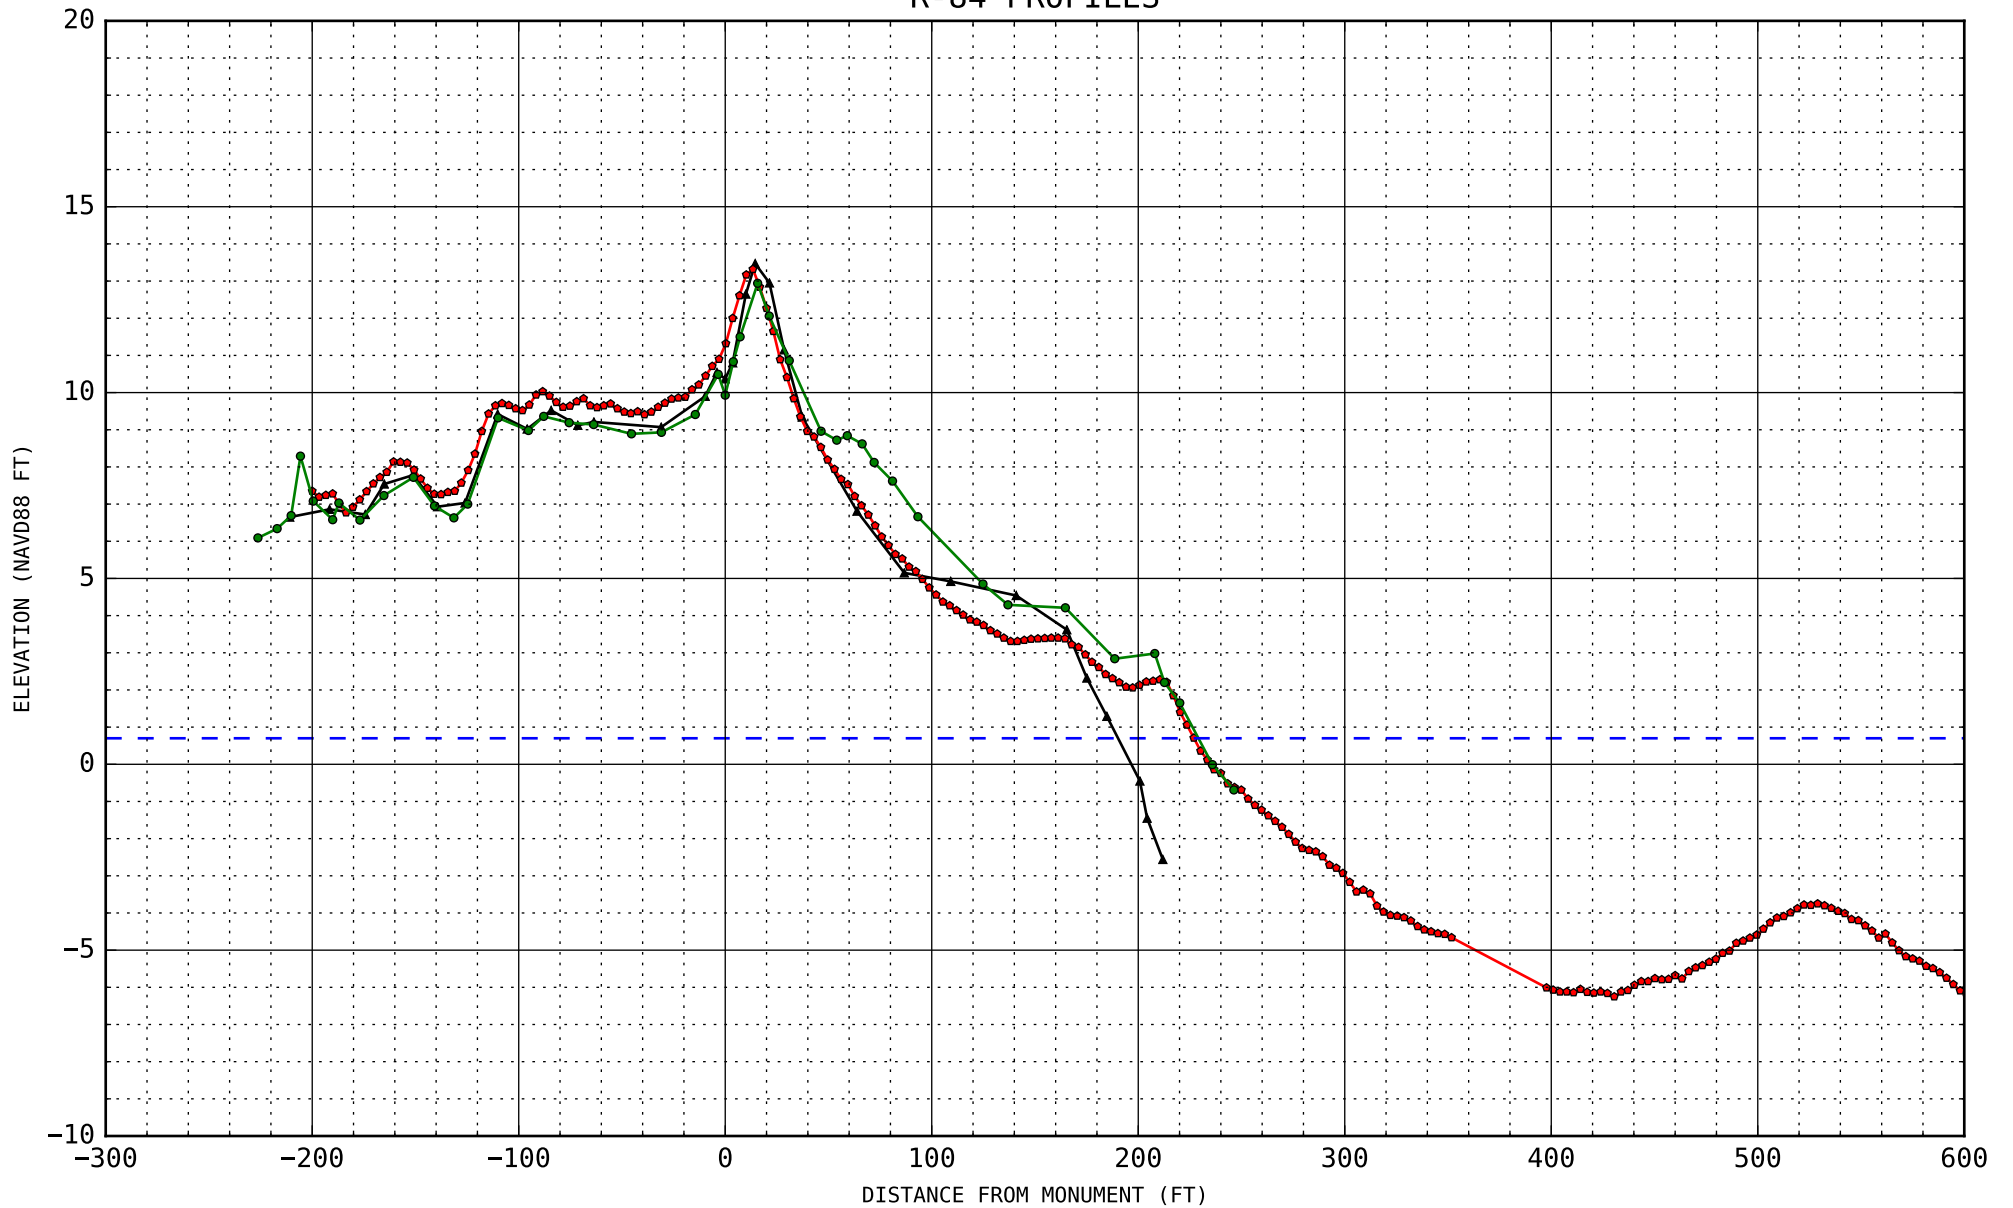
# R-84 PROFILES

- ▲ 2019-MAY CONDITION BY DEP
- 2018-OCT MONITORING BY USACE-LIDAR
- 2017-FEB MONITORING BY DEP
- - - MHW CONTOUR (0.7 FT)

RANGE: R-84  
EST DATE: MAY1973  
SURVEY DATE: 17MAY19  
AZIMUTH: 150.0

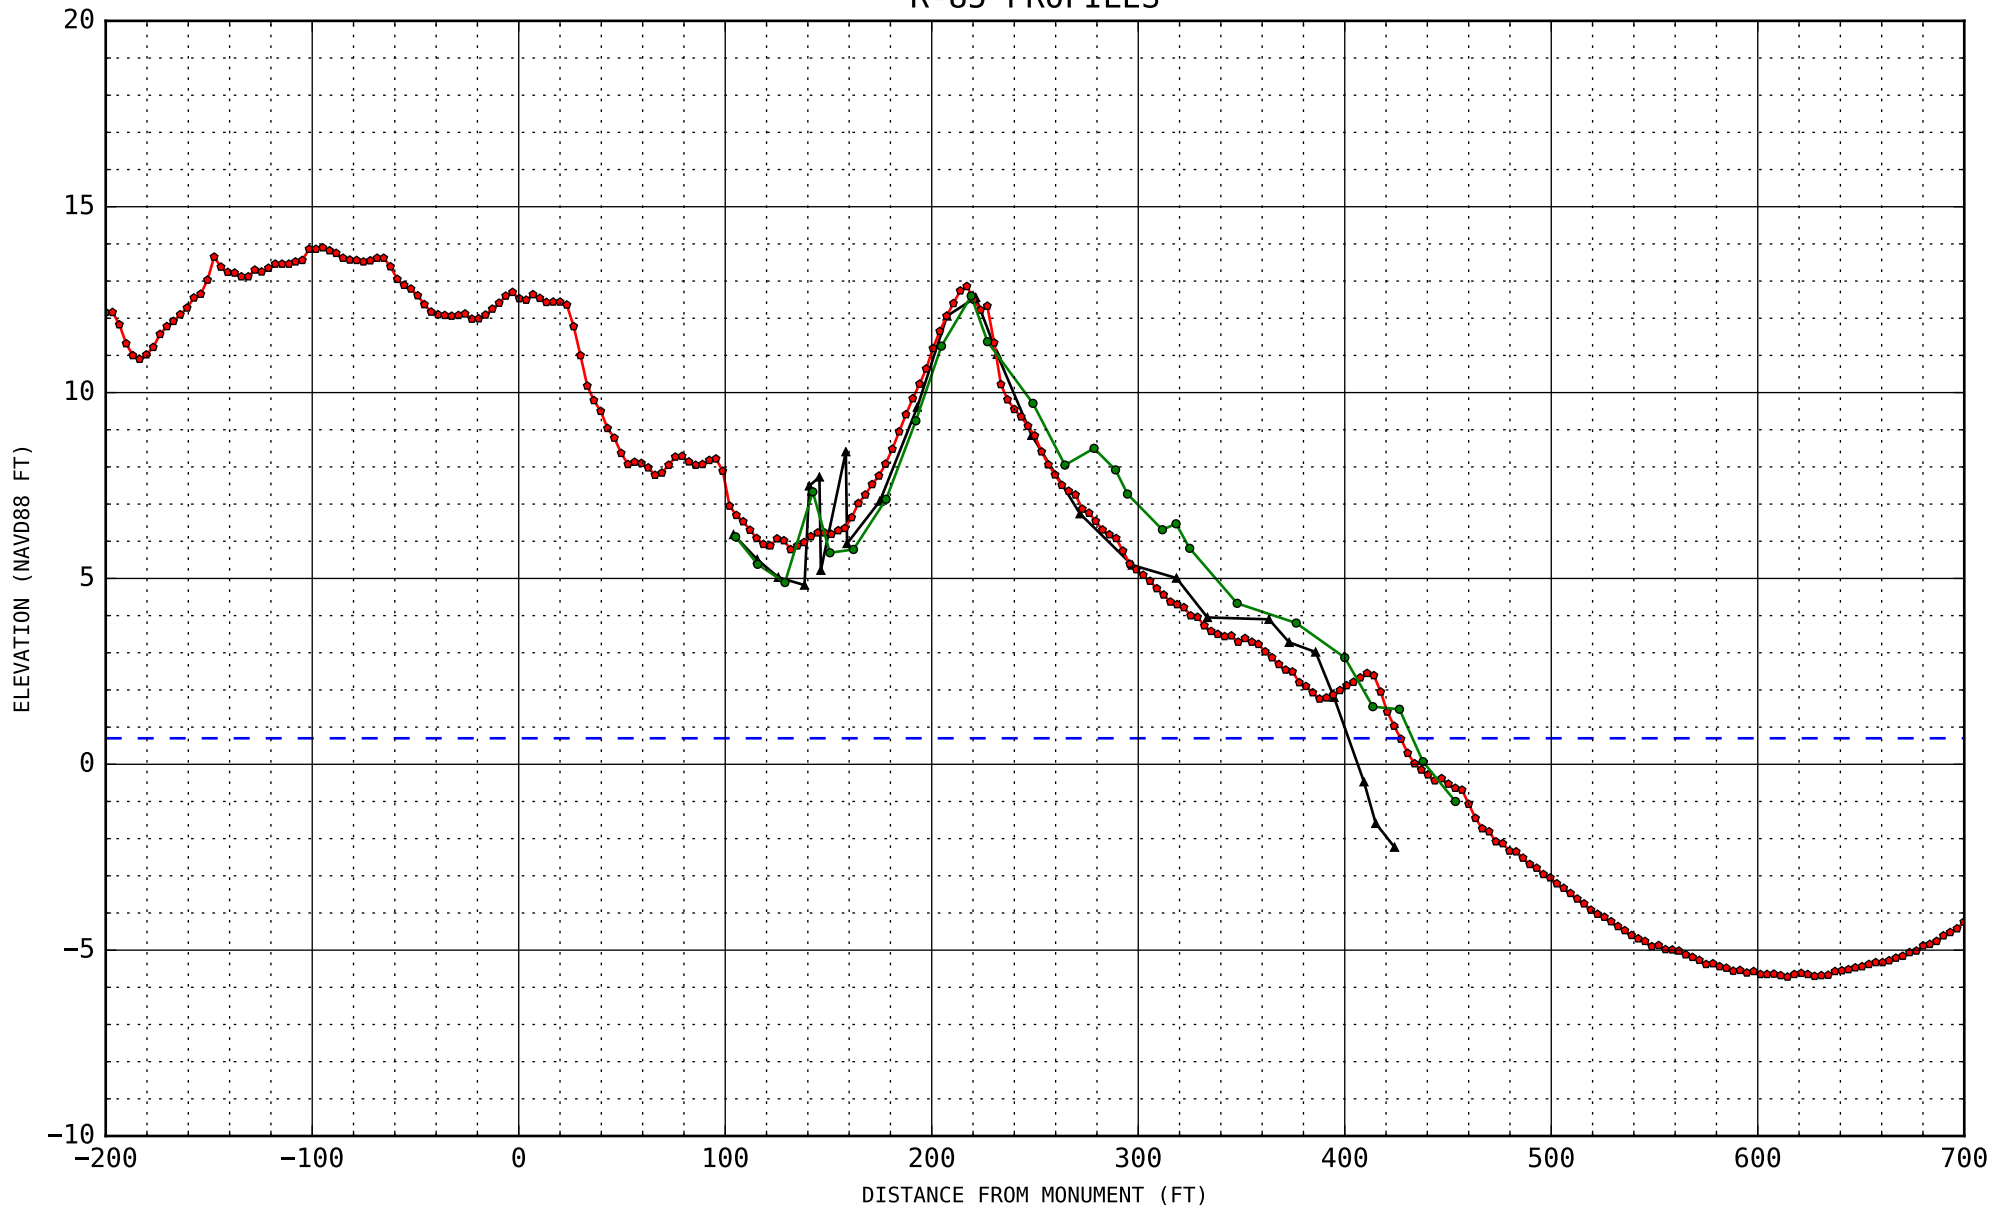
# R-85 PROFILES

- ▲ 2019-MAY CONDITION BY DEP
- 2018-OCT MONITORING BY USACE-LIDAR
- 2017-FEB MONITORING BY DEP
- - - MHW CONTOUR (0.7 FT)

RANGE: R-85  
EST DATE: JUL1996  
SURVEY DATE: 17MAY19  
AZIMUTH: 150.0

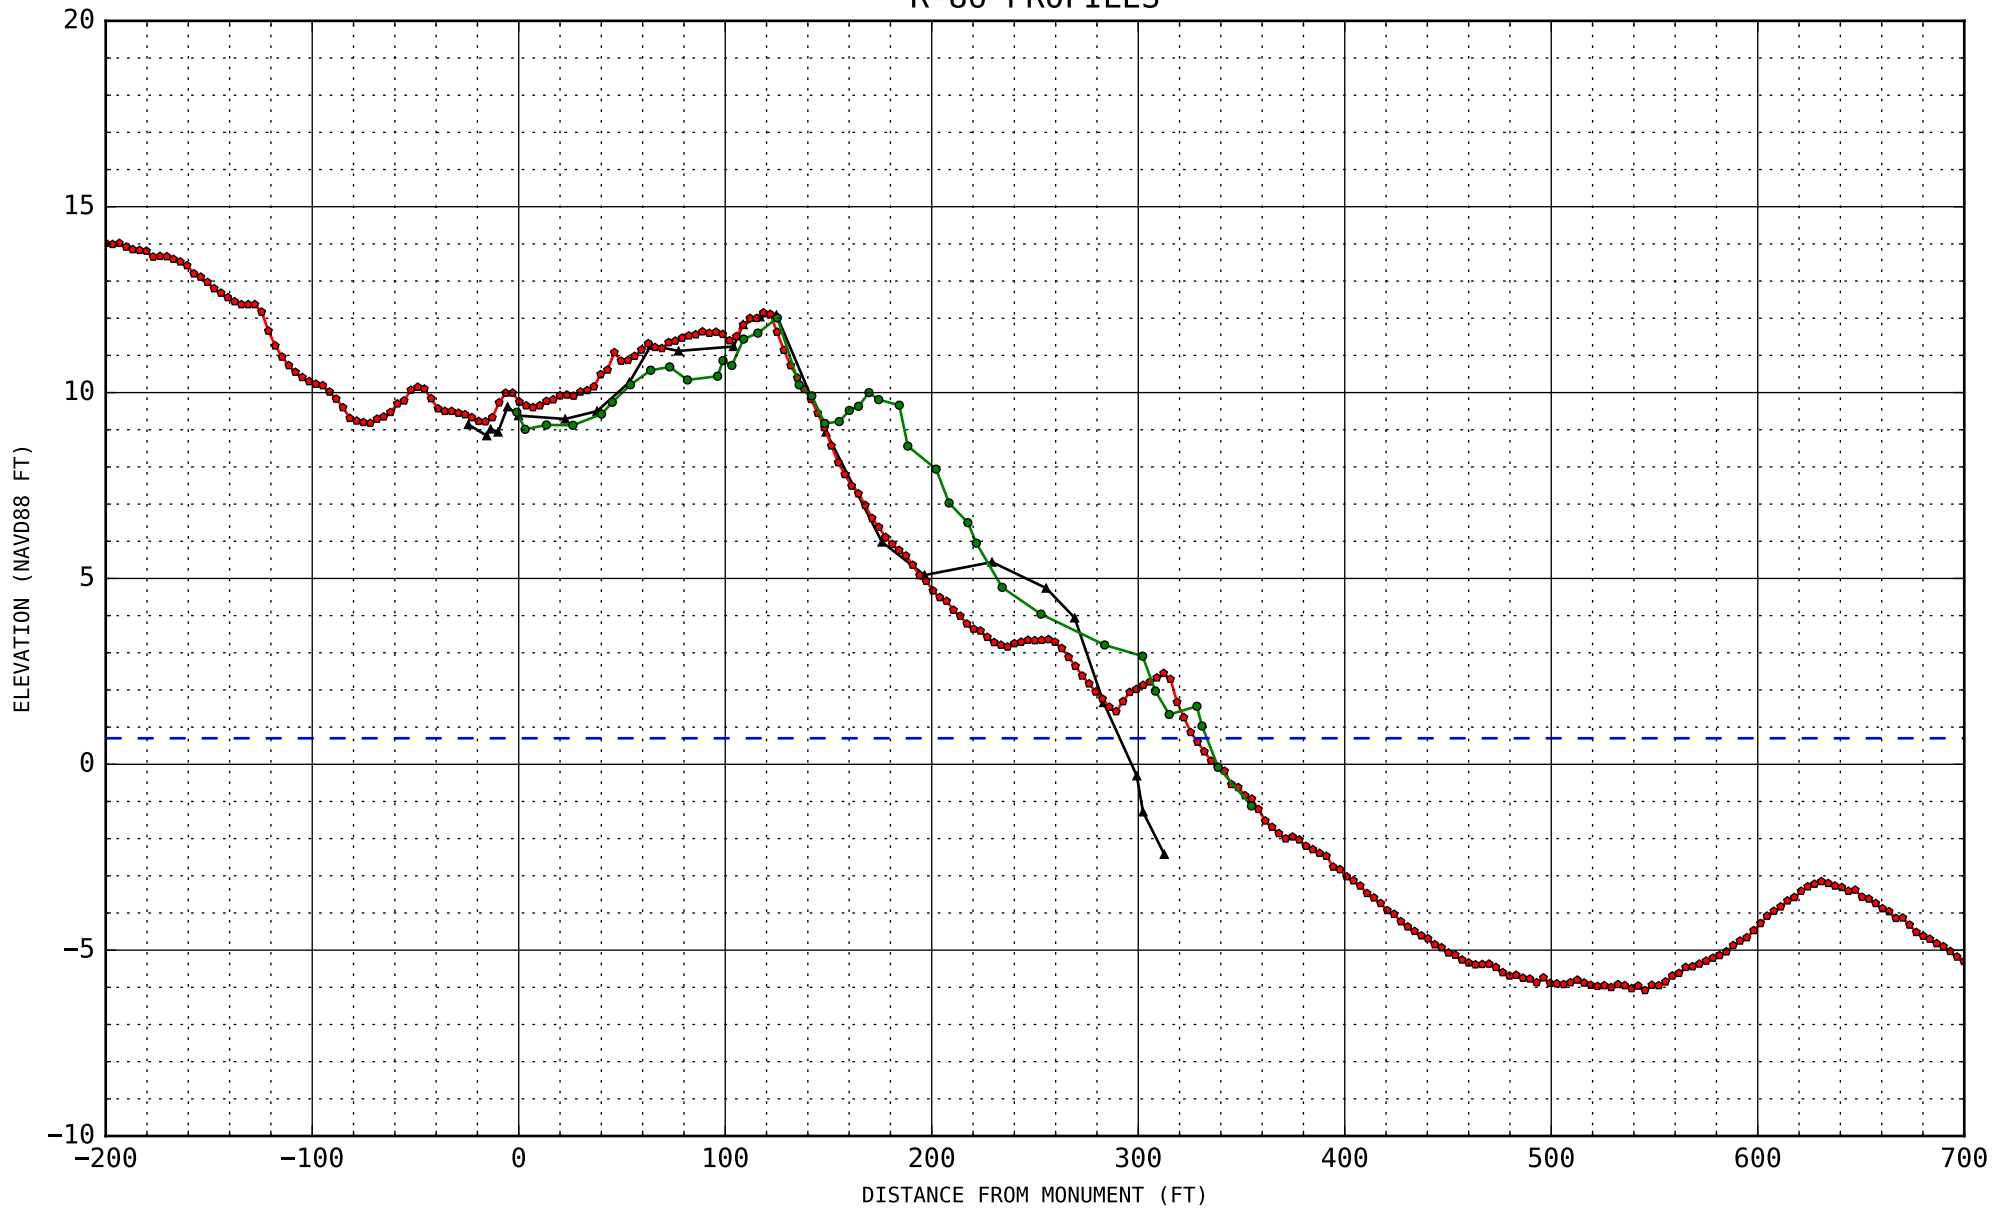
# R-86 PROFILES

- ▲ 2019-MAY CONDITION BY DEP
- 2018-OCT MONITORING BY USACE-LIDAR
- 2017-FEB MONITORING BY DEP
- - - MHW CONTOUR (0.7 FT)

RANGE: R-86  
 EST DATE: MAY1973  
 SURVEY DATE: 17MAY19  
 AZIMUTH: 150.0

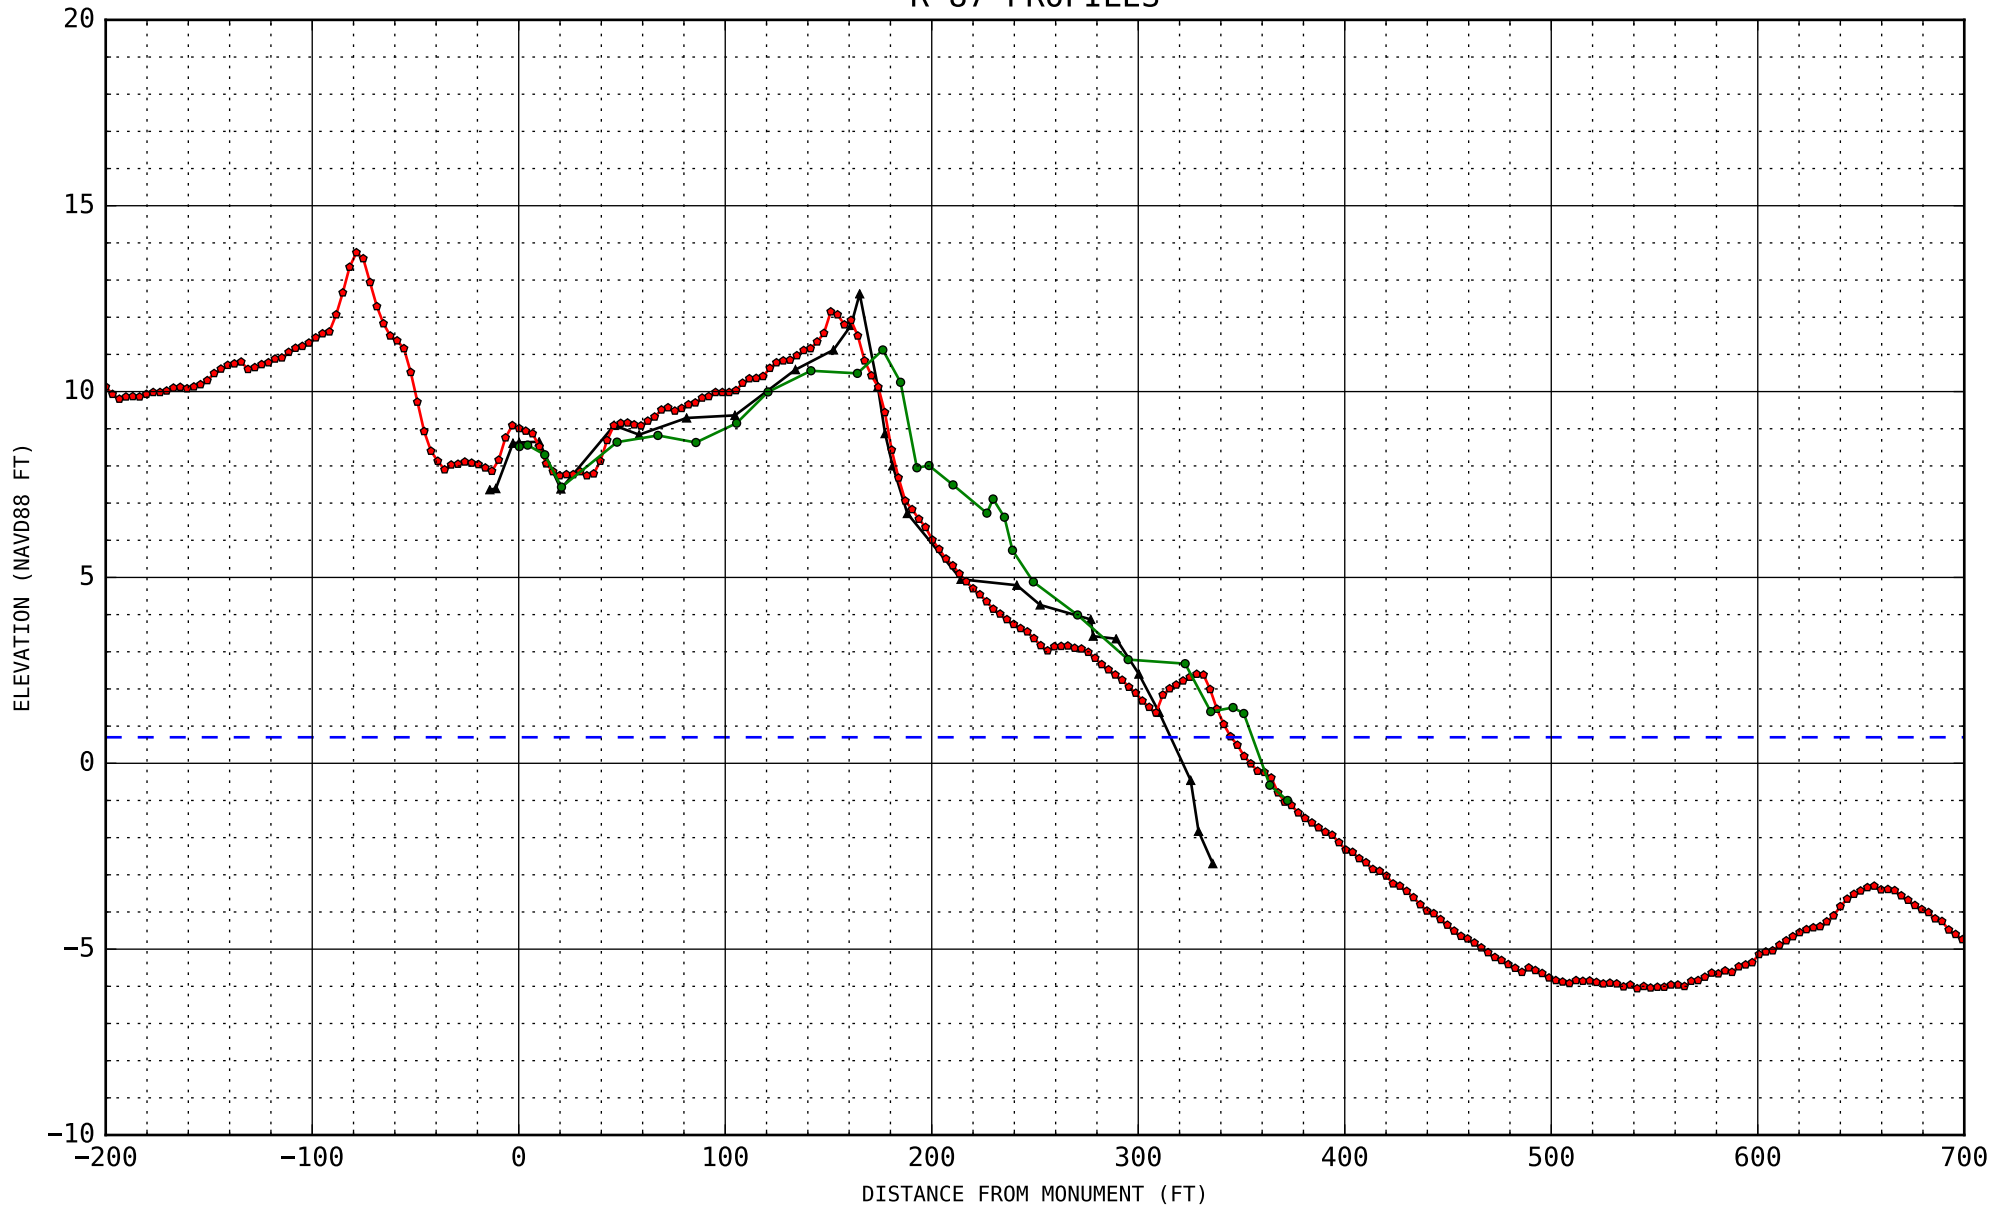
# R-87 PROFILES

- ▲ 2019-MAY CONDITION BY DEP
- 2018-OCT MONITORING BY USACE-LIDAR
- 2017-FEB MONITORING BY DEP
- - - MHW CONTOUR (0.7 FT)

RANGE: R-87  
EST DATE: JUL1996  
SURVEY DATE: 17MAY19  
AZIMUTH: 160.0
