# R-52-T PROFILES

FRANKLIN  
PROGRAM SUPPORT GIS  
DIVISION OF WATER RESOURCE MANAGEMENT  
FLORIDA DEPARTMENT OF ENVIRONMENTAL PROTECTION

RANGE: R-52-T  
EST DATE: FEB1980  
SURVEY DATE: 16MAY19  
AZIMUTH: 150.0

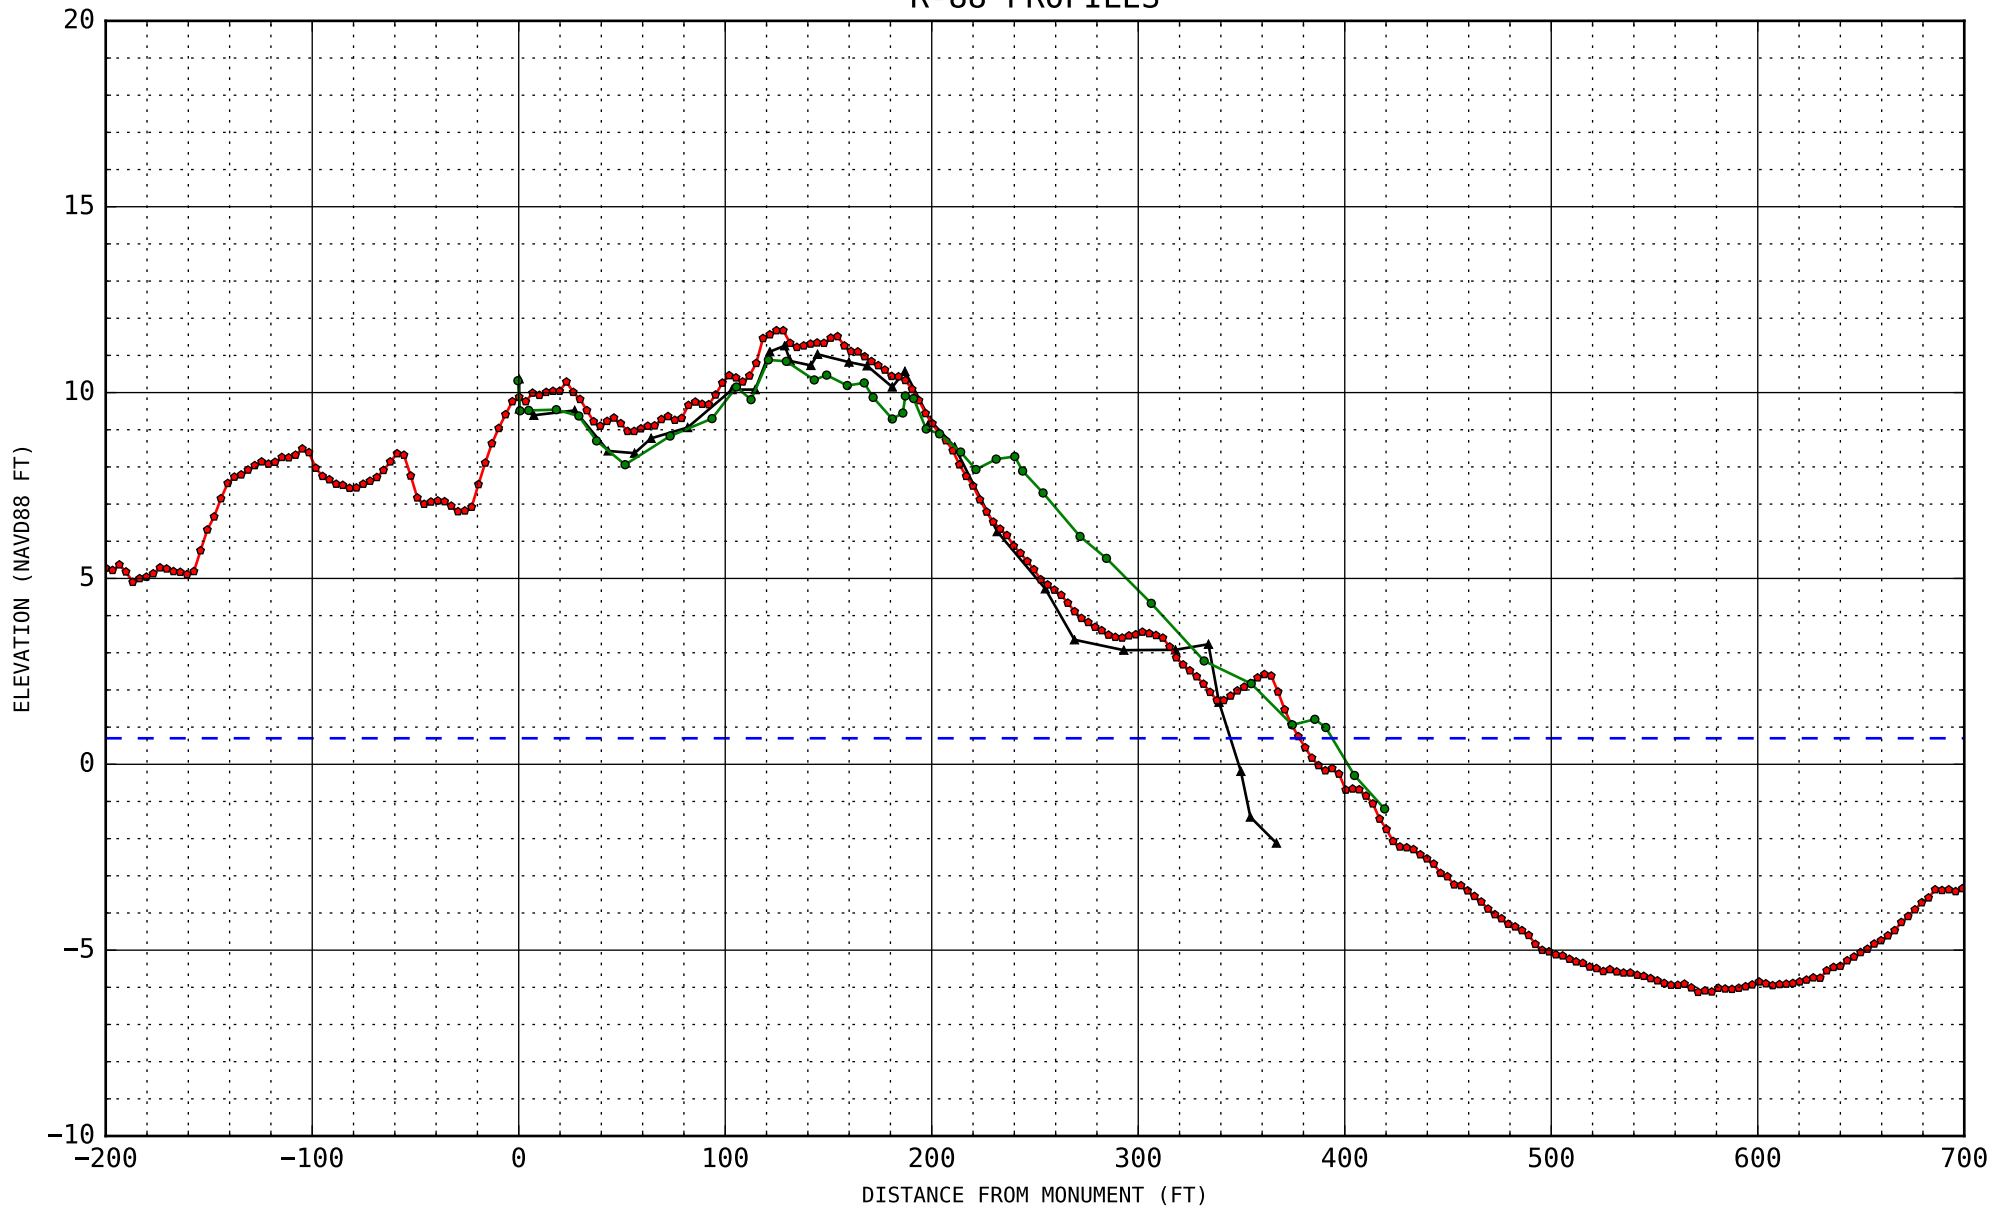
# R-88 PROFILES

- ▲ 2019-MAY CONDITION BY DEP
- 2018-OCT MONITORING BY USACE-LIDAR
- 2017-FEB MONITORING BY DEP
- - - MHW CONTOUR (0.7 FT)

RANGE: R-88  
EST DATE: MAY1973  
SURVEY DATE: 17MAY19  
AZIMUTH: 160.0

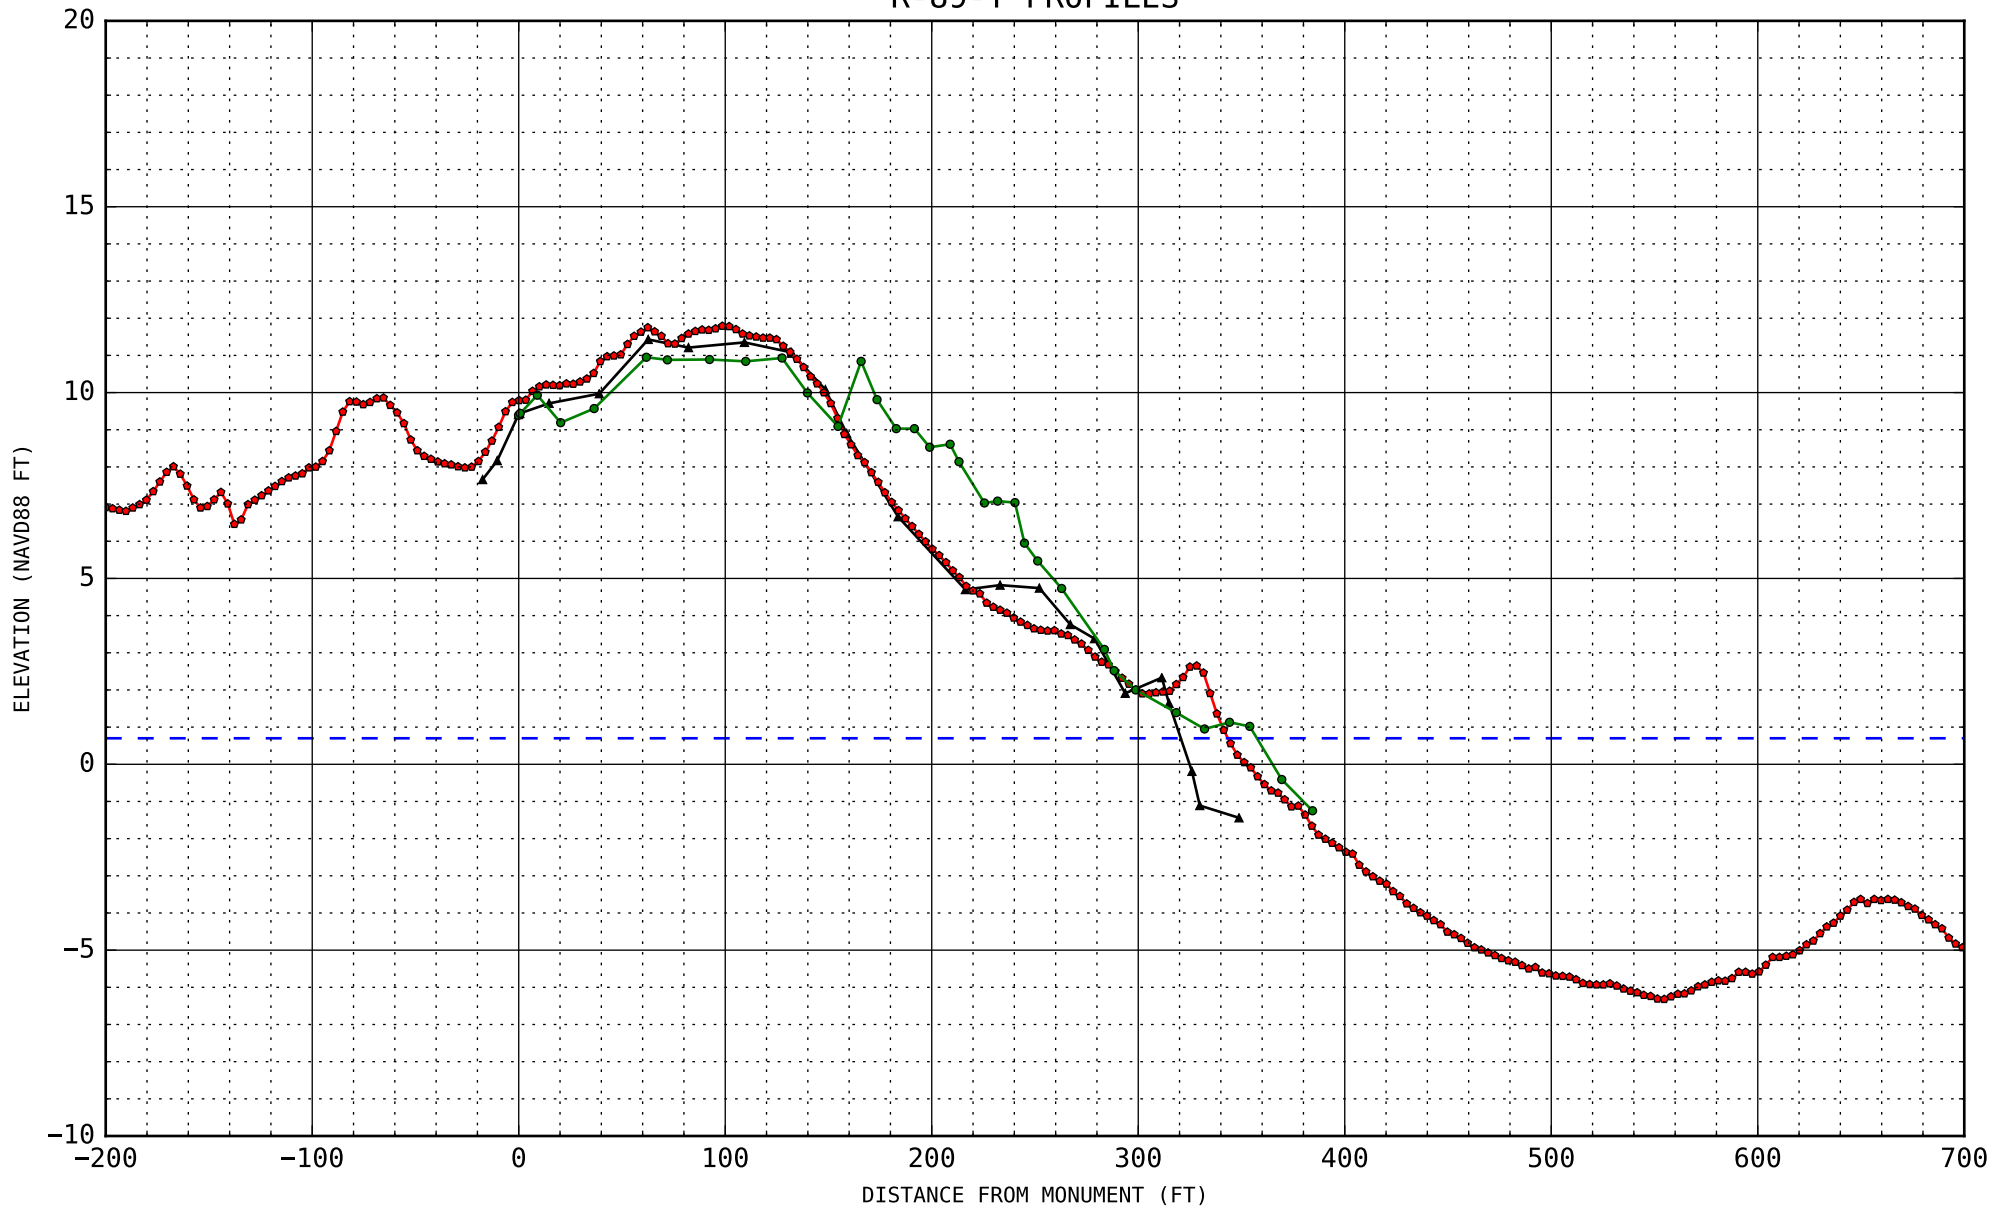
# R-89-T PROFILES

- ▲ 2019-MAY CONDITION BY DEP
- 2018-OCT MONITORING BY USACE-LIDAR
- 2017-FEB MONITORING BY DEP
- - - MHW CONTOUR (0.7 FT)

RANGE: R-89-T  
EST DATE: FEB1980  
SURVEY DATE: 17MAY19  
AZIMUTH: 160.0

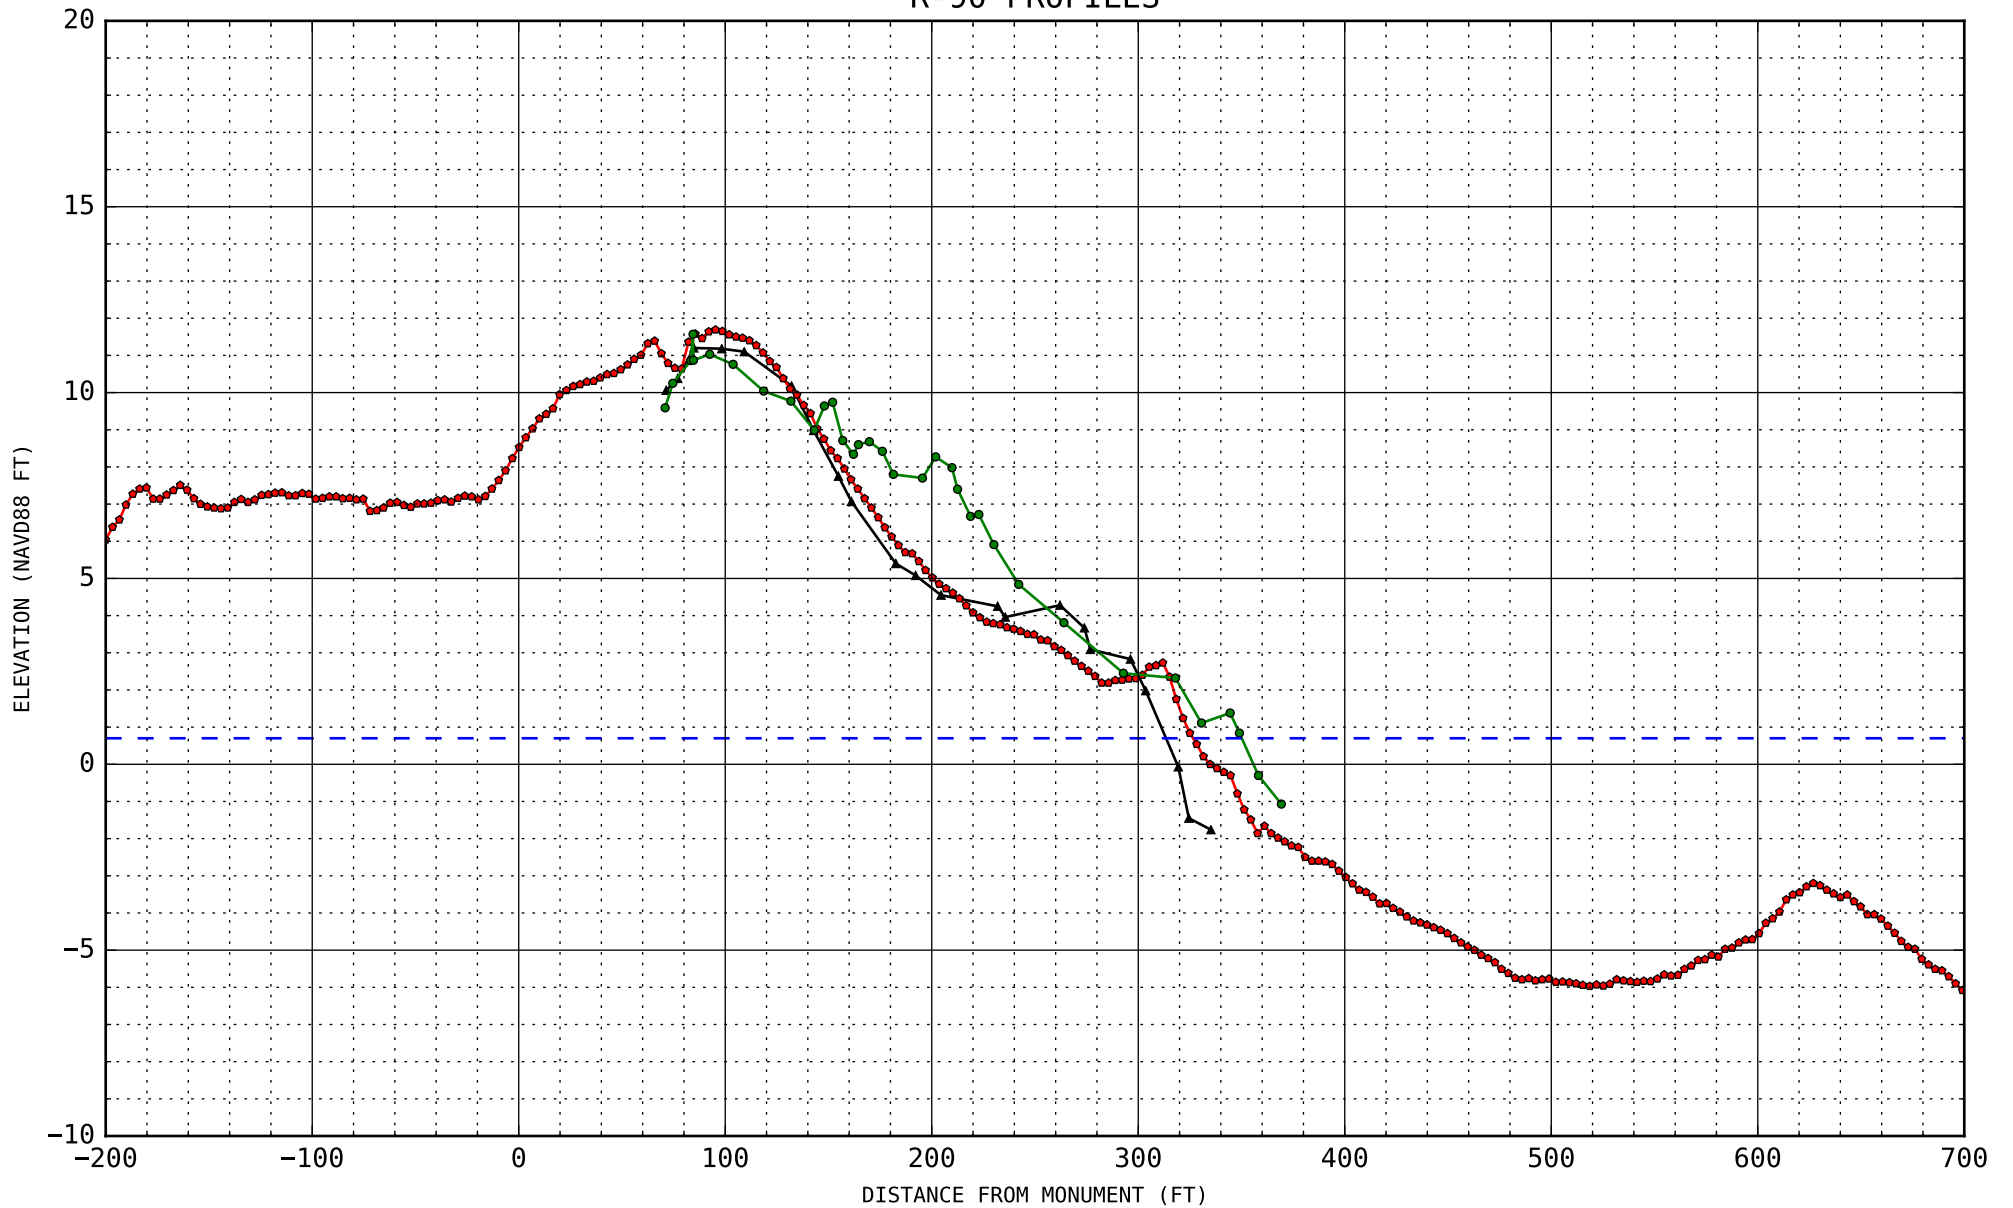
# R-90 PROFILES

- ▲ 2019-MAY CONDITION BY DEP
- 2018-OCT MONITORING BY USACE-LIDAR
- 2017-FEB MONITORING BY DEP
- - - MHW CONTOUR (0.7 FT)

RANGE: R-90  
EST DATE: JUL1996  
SURVEY DATE: 17MAY19  
AZIMUTH: 160.0

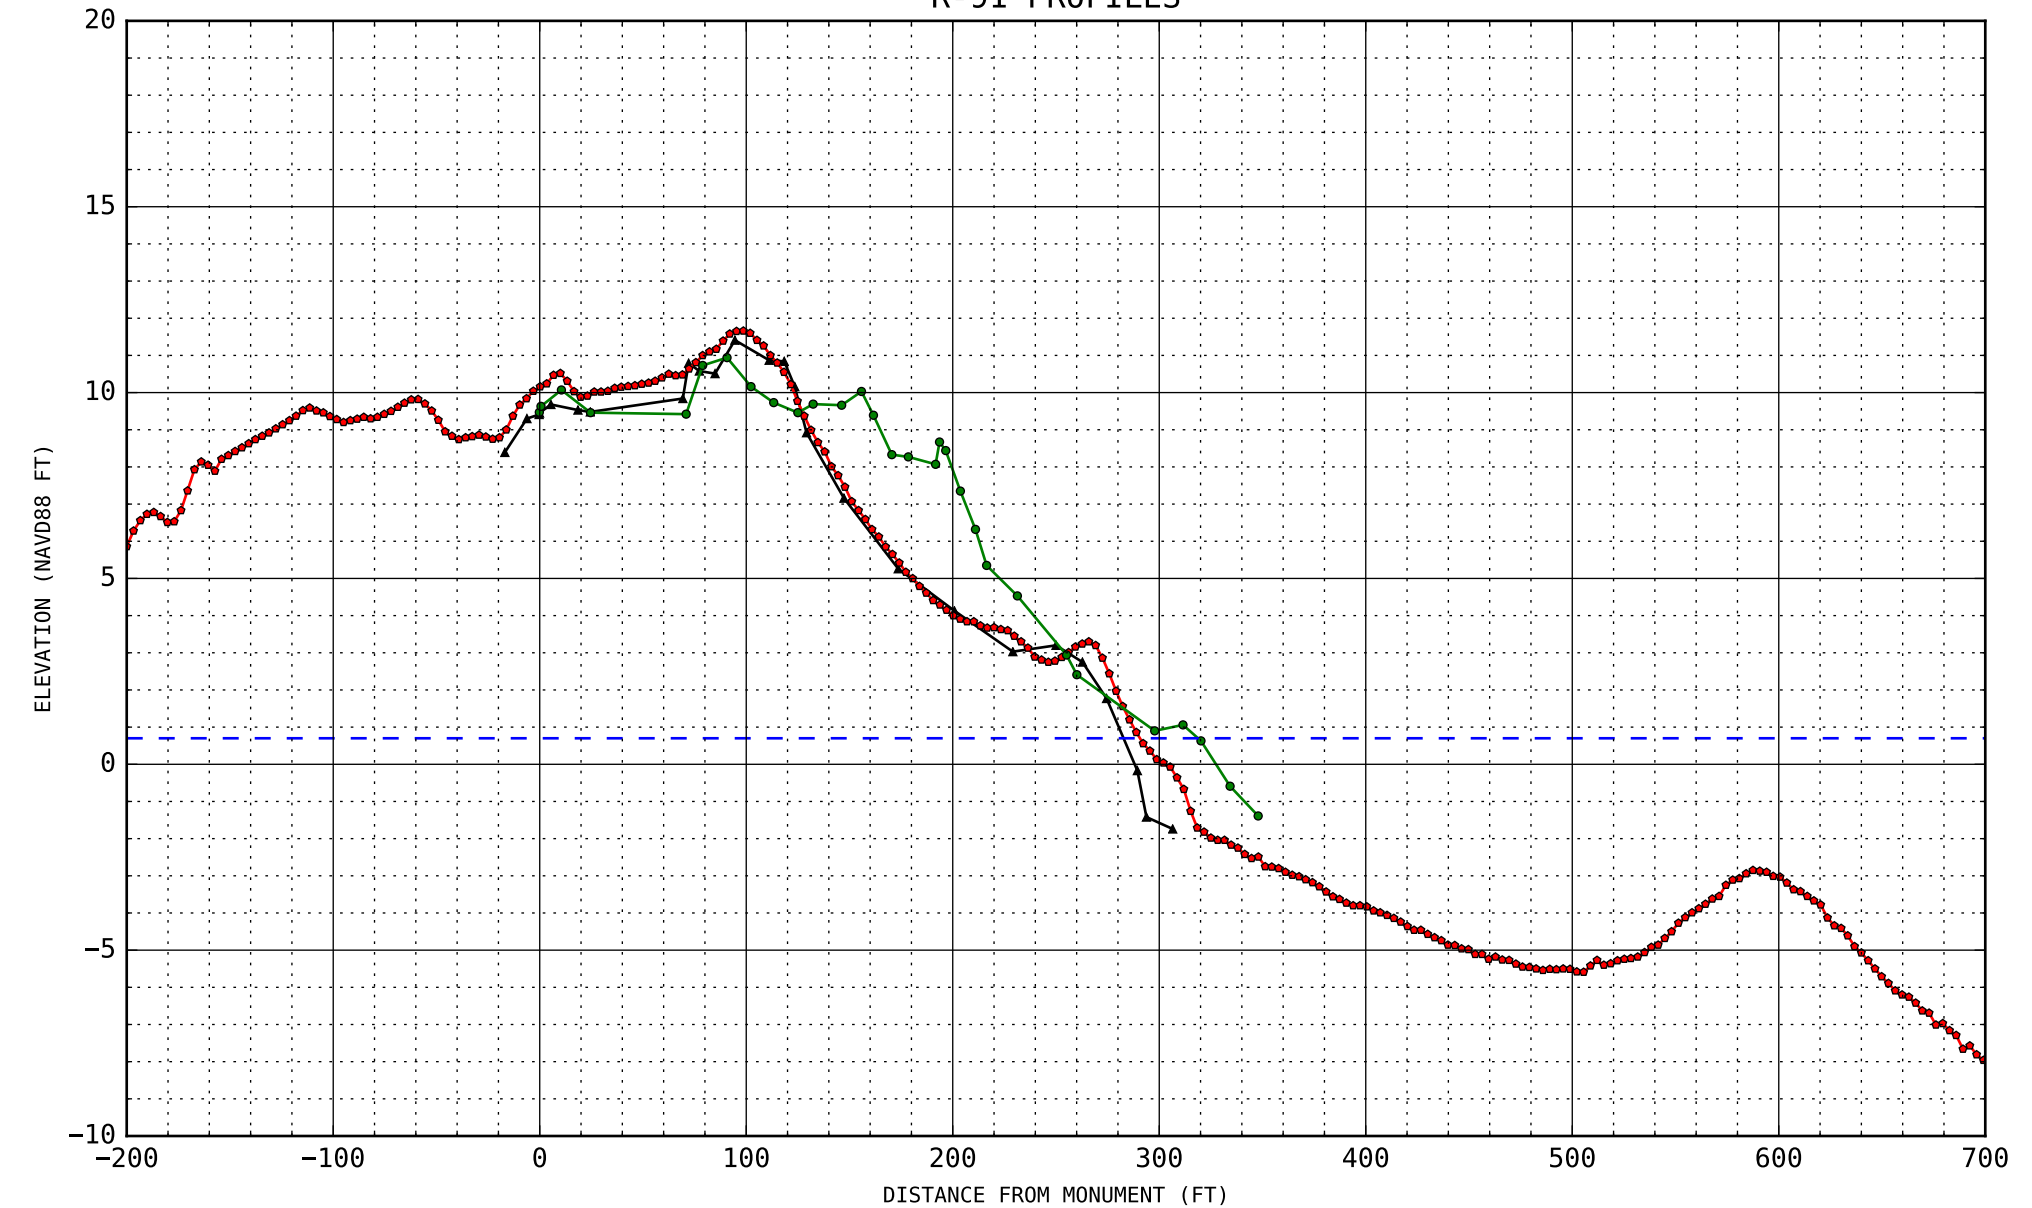
# R-91 PROFILES

- ▲ 2019-MAY CONDITION BY DEP
- 2018-OCT MONITORING BY USACE-LIDAR
- 2017-FEB MONITORING BY DEP
- - - MHW CONTOUR (0.7 FT)

RANGE: R-91  
EST DATE: NOV1987  
SURVEY DATE: 17MAY19  
AZIMUTH: 160.0

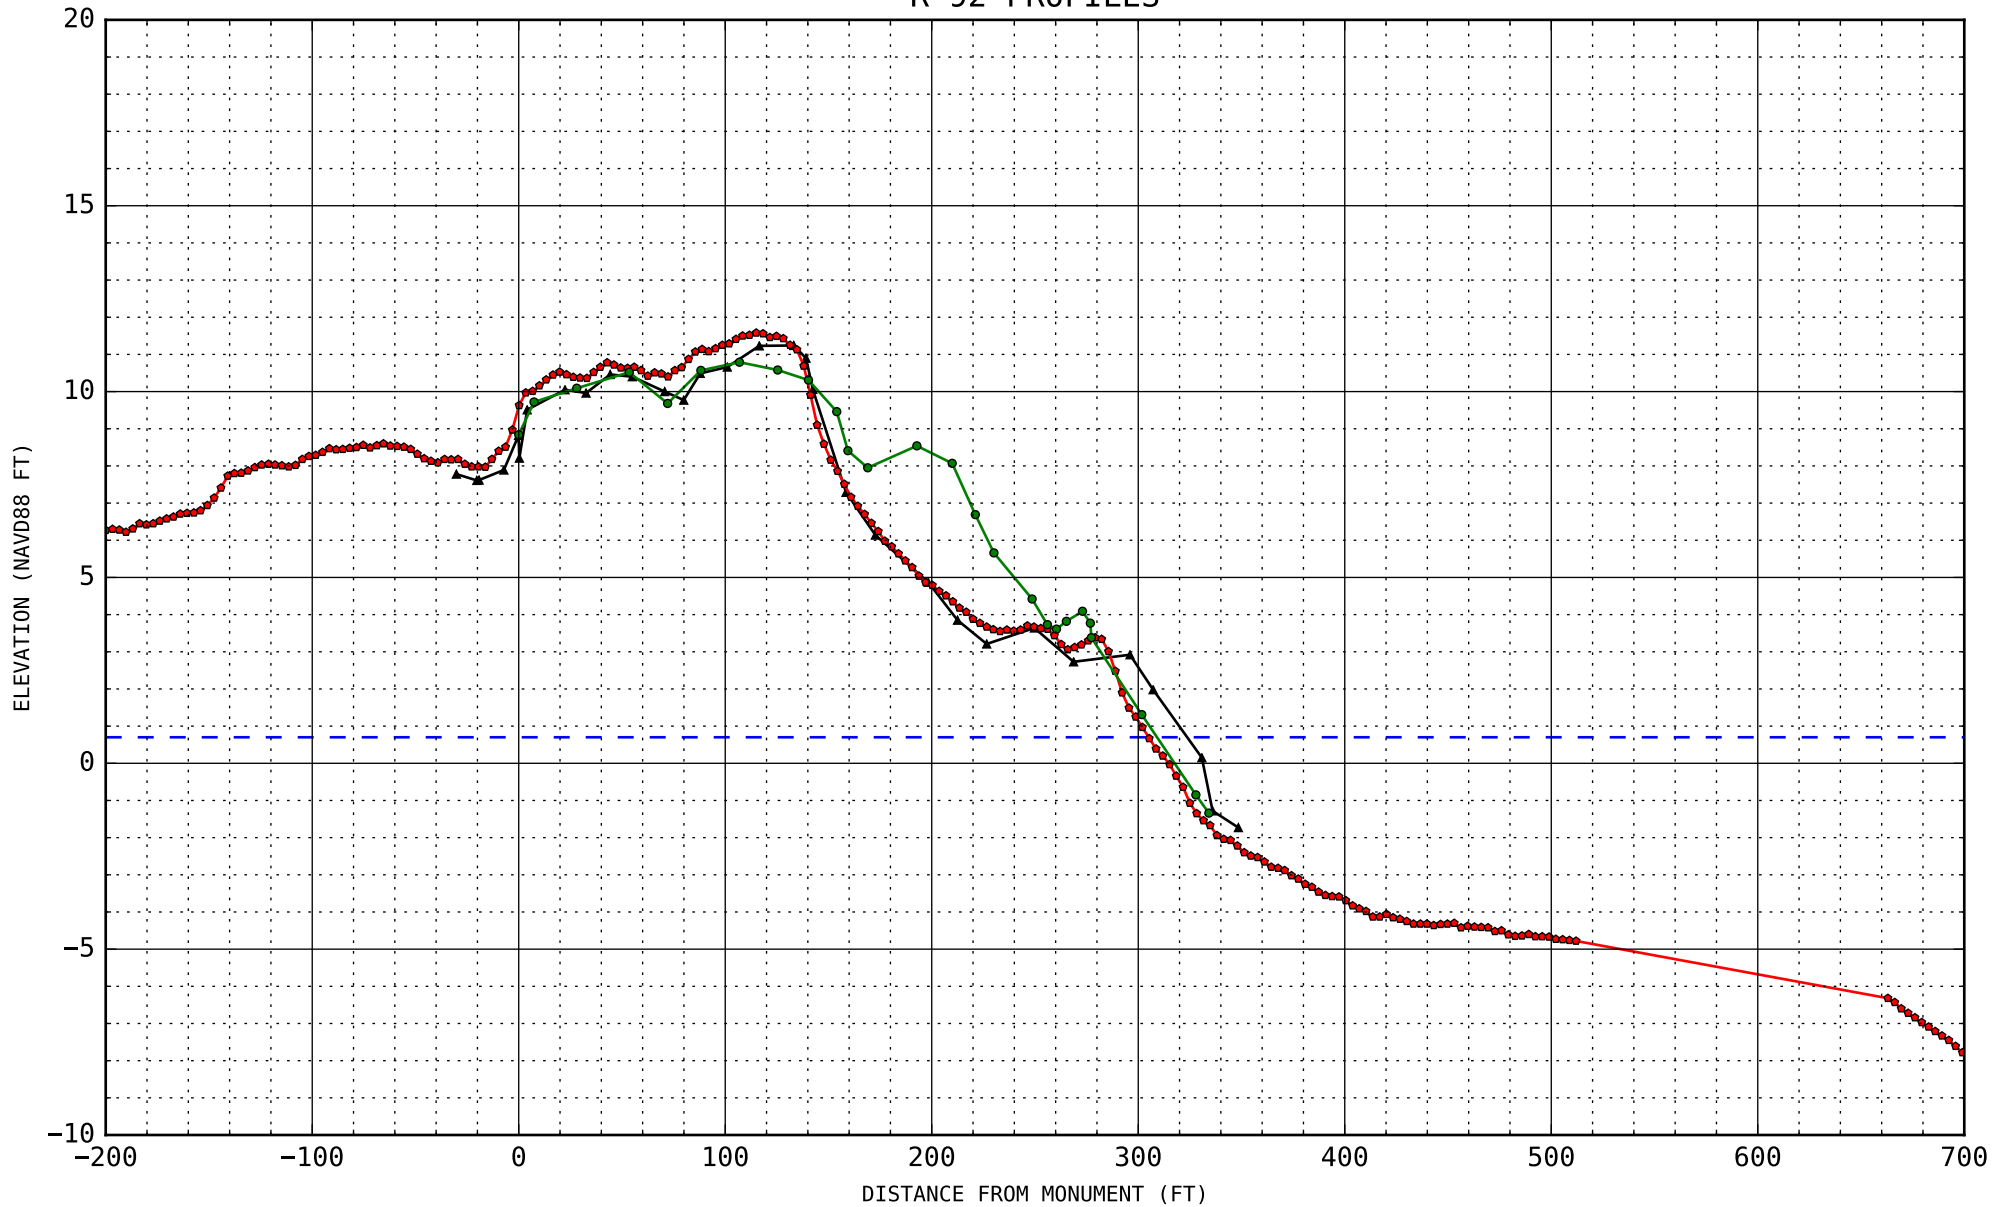
# R-92 PROFILES

- ▲ 2019-MAY CONDITION BY DEP
- 2018-OCT MONITORING BY USACE-LIDAR
- 2017-FEB MONITORING BY DEP
- - - MHW CONTOUR (0.7 FT)

RANGE: R-92  
EST DATE: MAY1973  
SURVEY DATE: 17MAY19  
AZIMUTH: 160.0

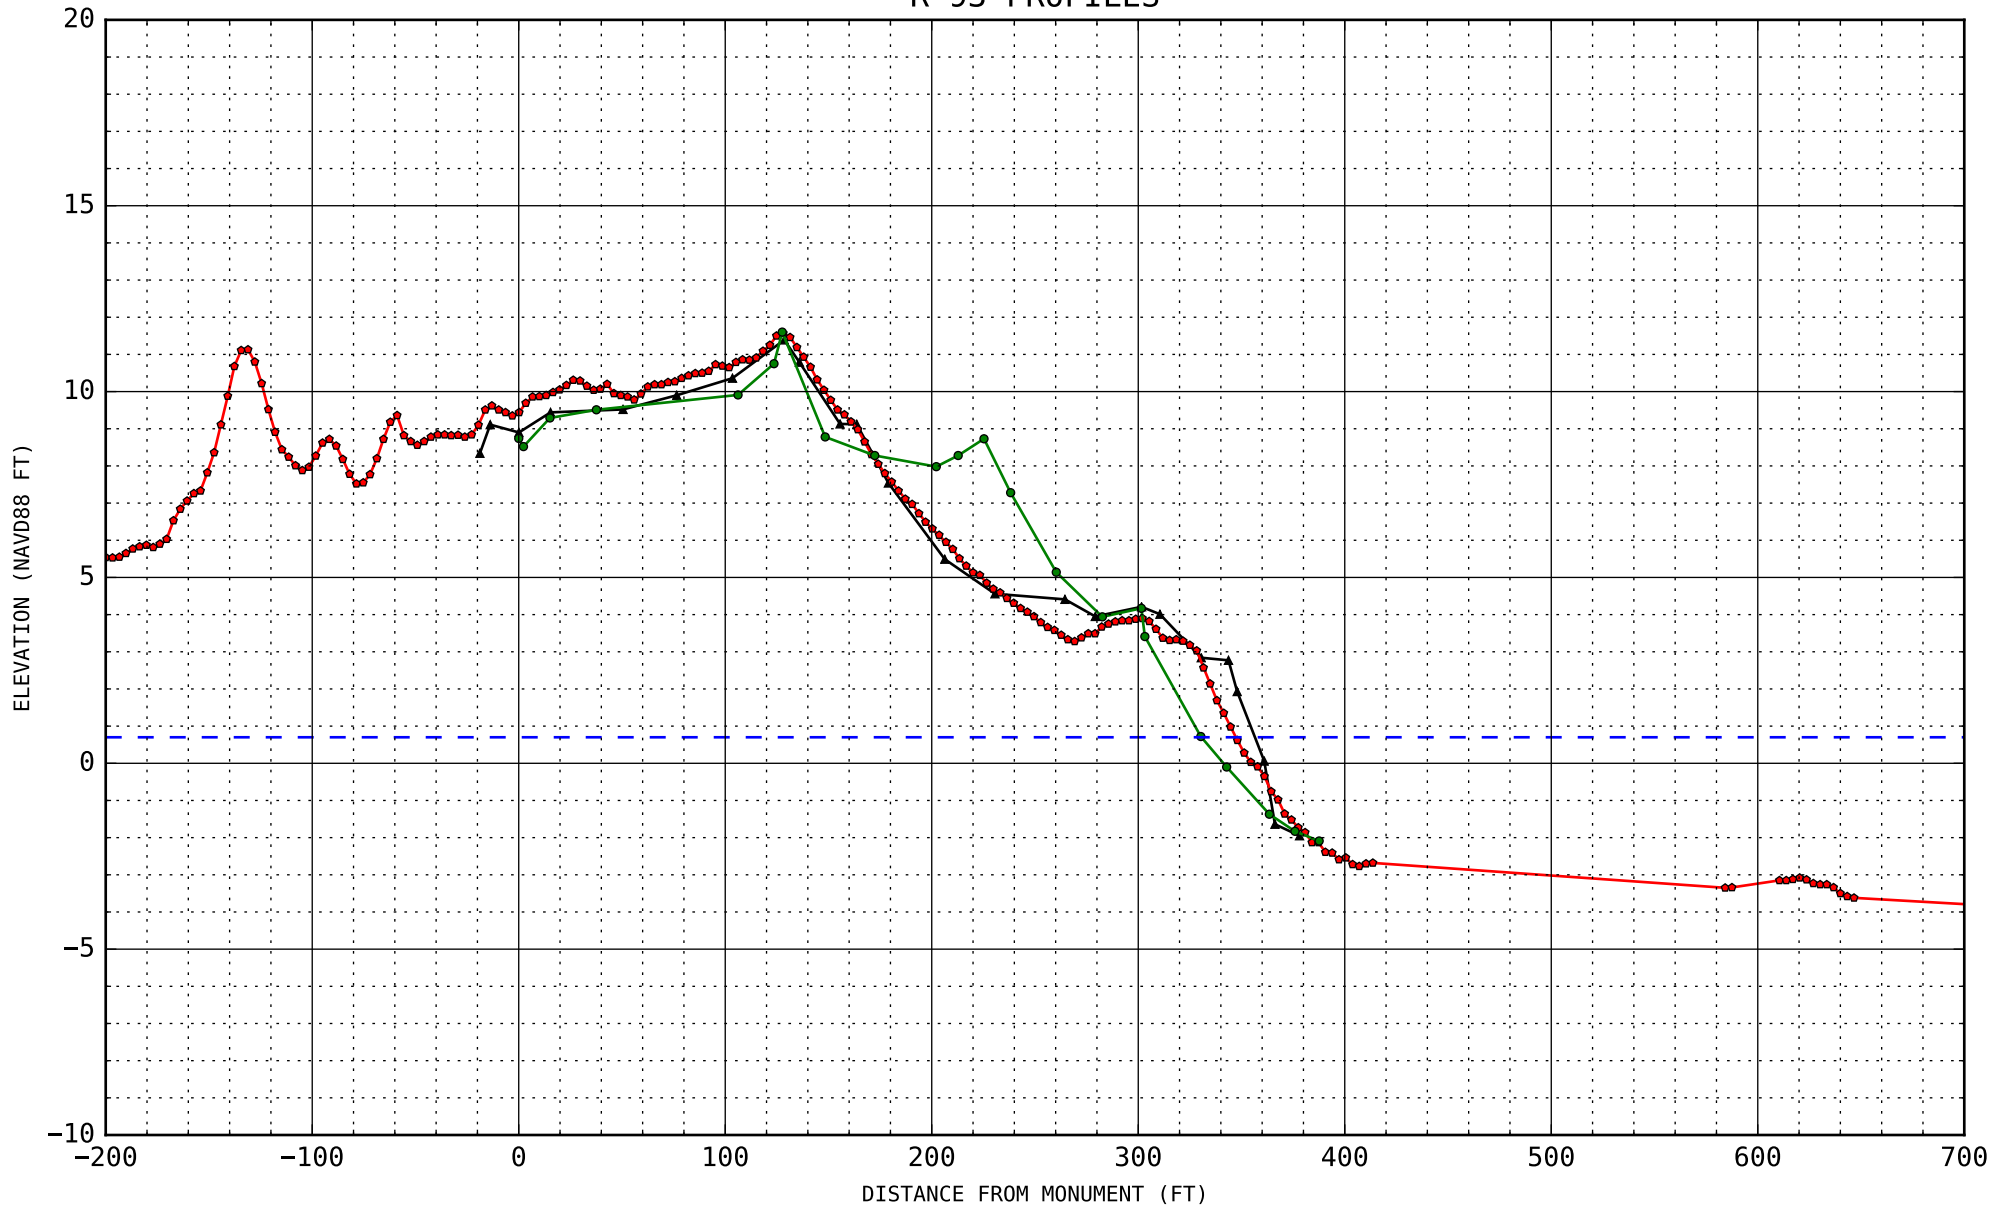
# R-93 PROFILES

- ▲ 2019-MAY CONDITION BY DEP
- 2018-OCT MONITORING BY USACE-LIDAR
- 2017-FEB MONITORING BY DEP
- - - MHW CONTOUR (0.7 FT)

RANGE: R-93  
 EST DATE: MAY1973  
 SURVEY DATE: 17MAY19  
 AZIMUTH: 160.0

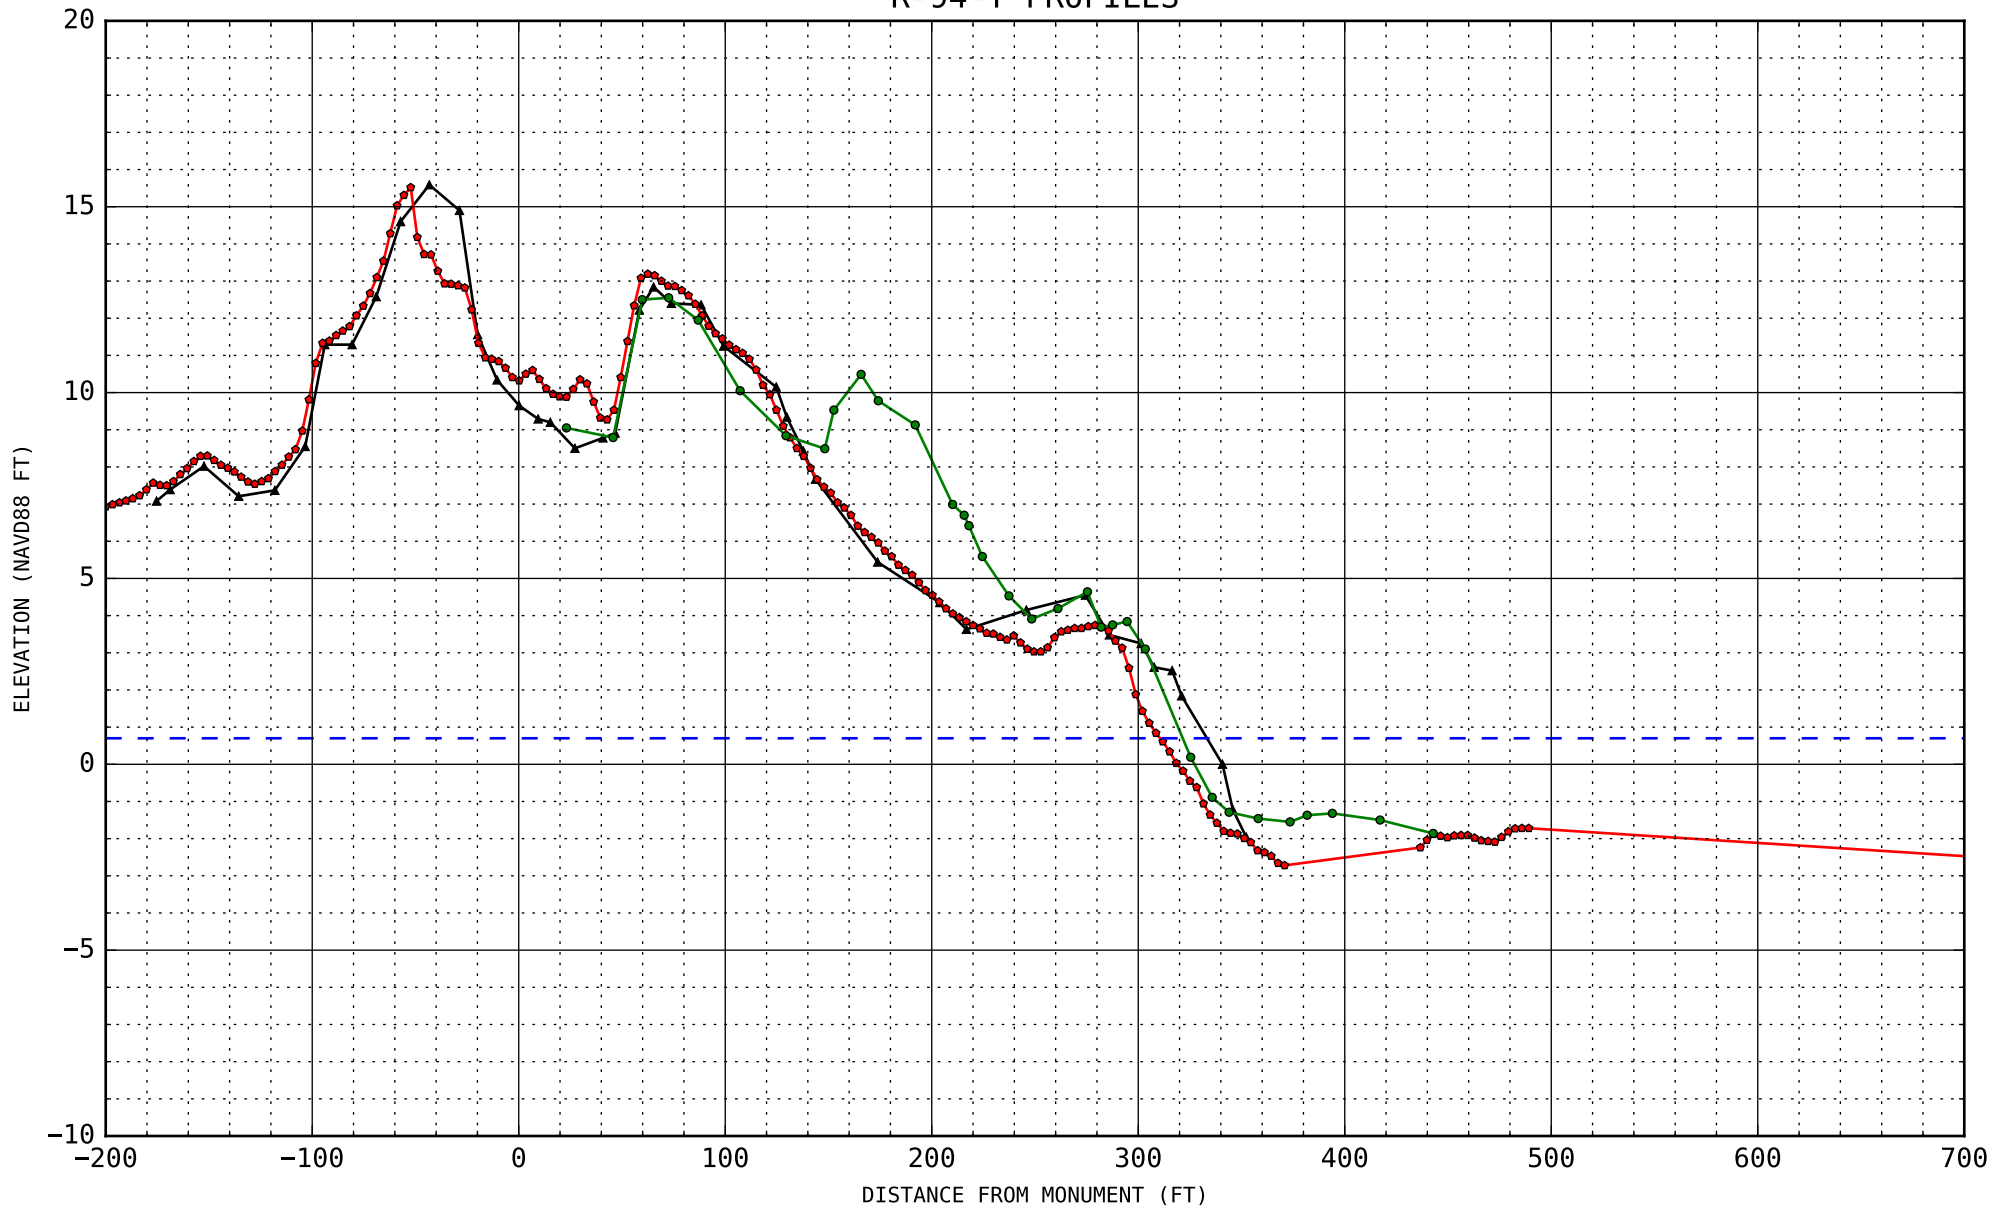
# R-94-T PROFILES

- ▲ 2019-MAY CONDITION BY DEP
- 2018-OCT MONITORING BY USACE-LIDAR
- 2017-FEB MONITORING BY DEP
- - - MHW CONTOUR (0.7 FT)

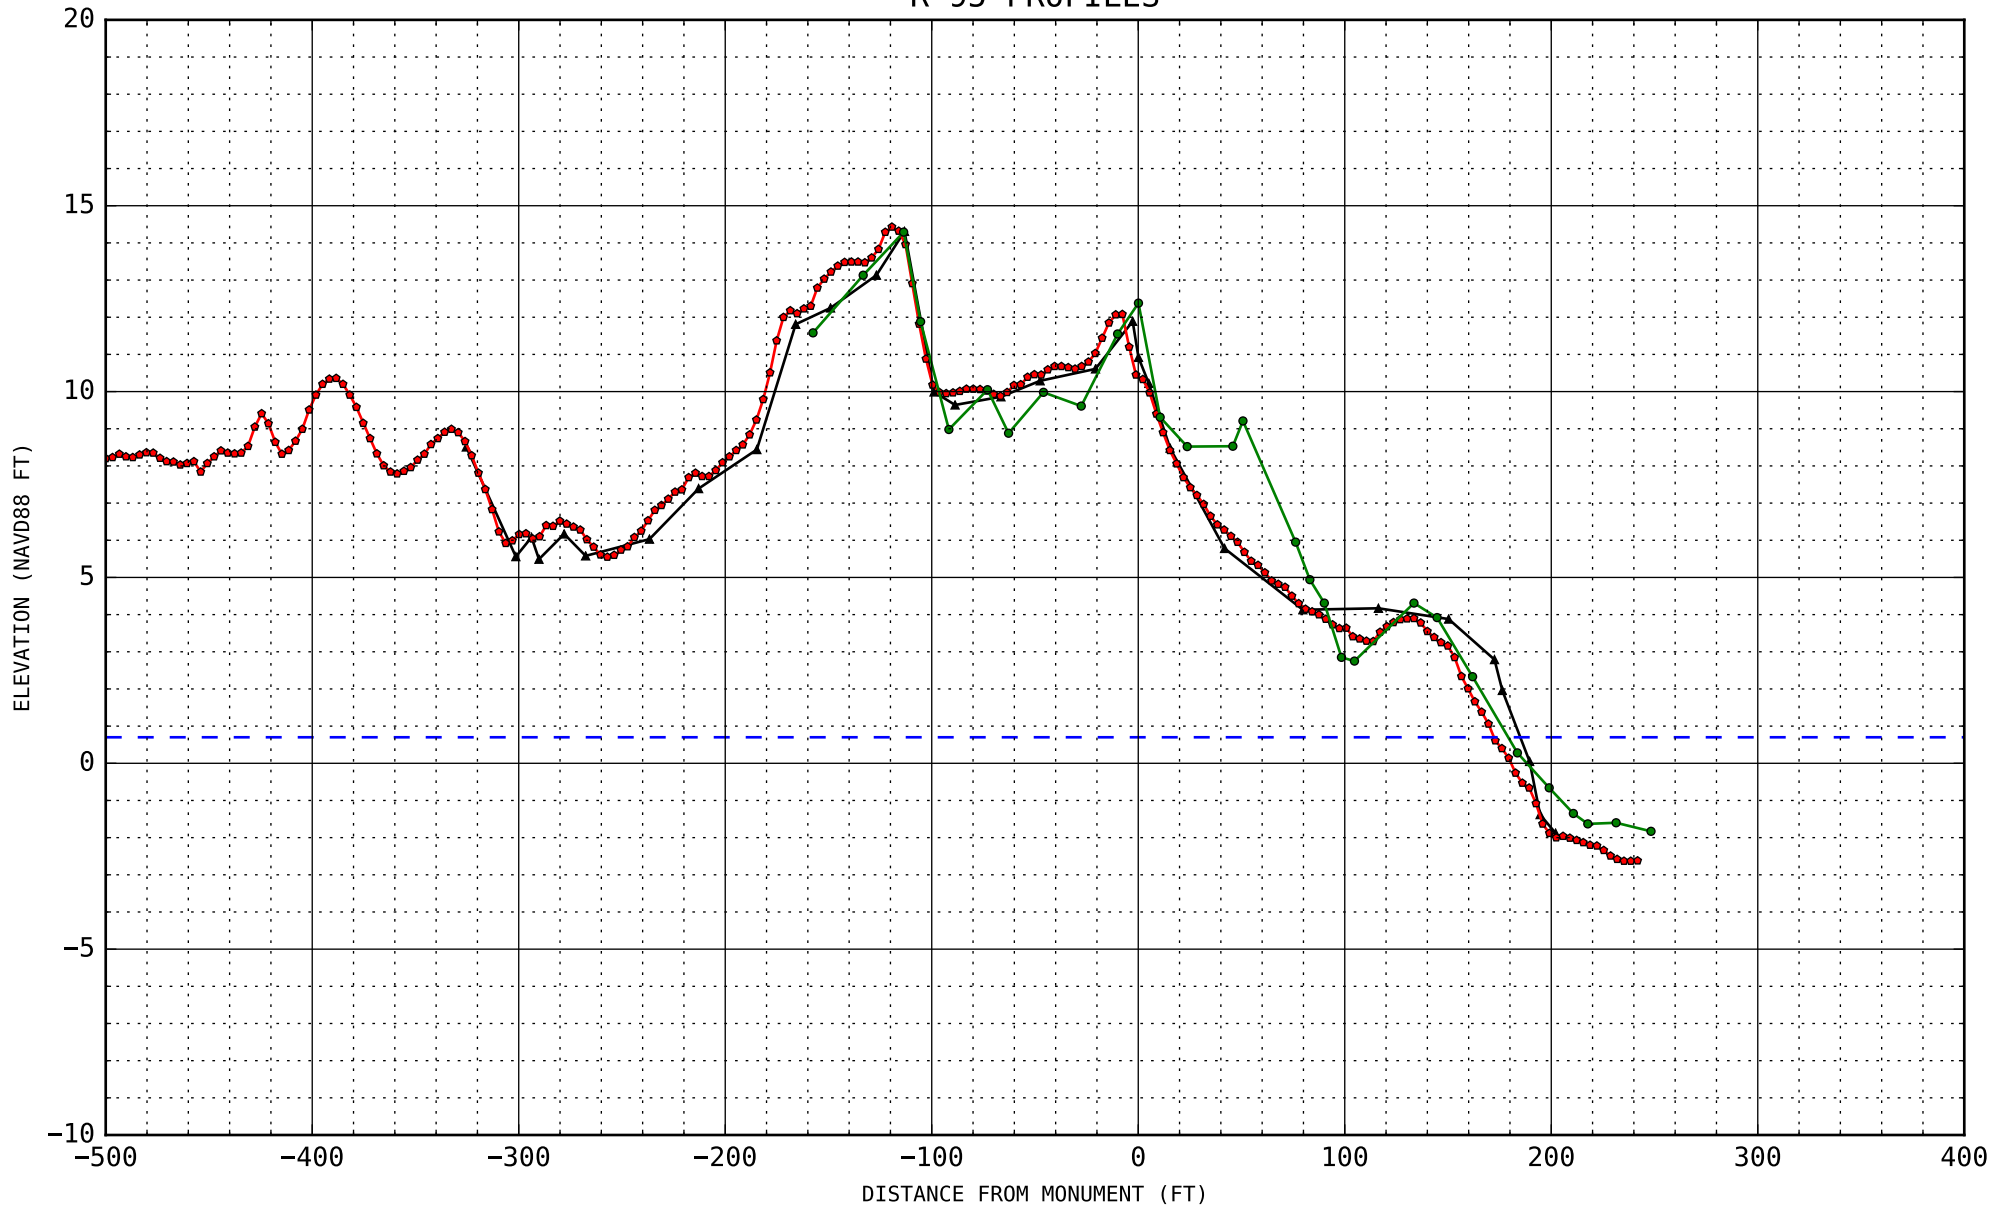
# R-95 PROFILES

- ▲ 2019-MAY CONDITION BY DEP
- 2018-OCT MONITORING BY USACE-LIDAR
- 2017-FEB MONITORING BY DEP
- - - MHW CONTOUR (0.7 FT)

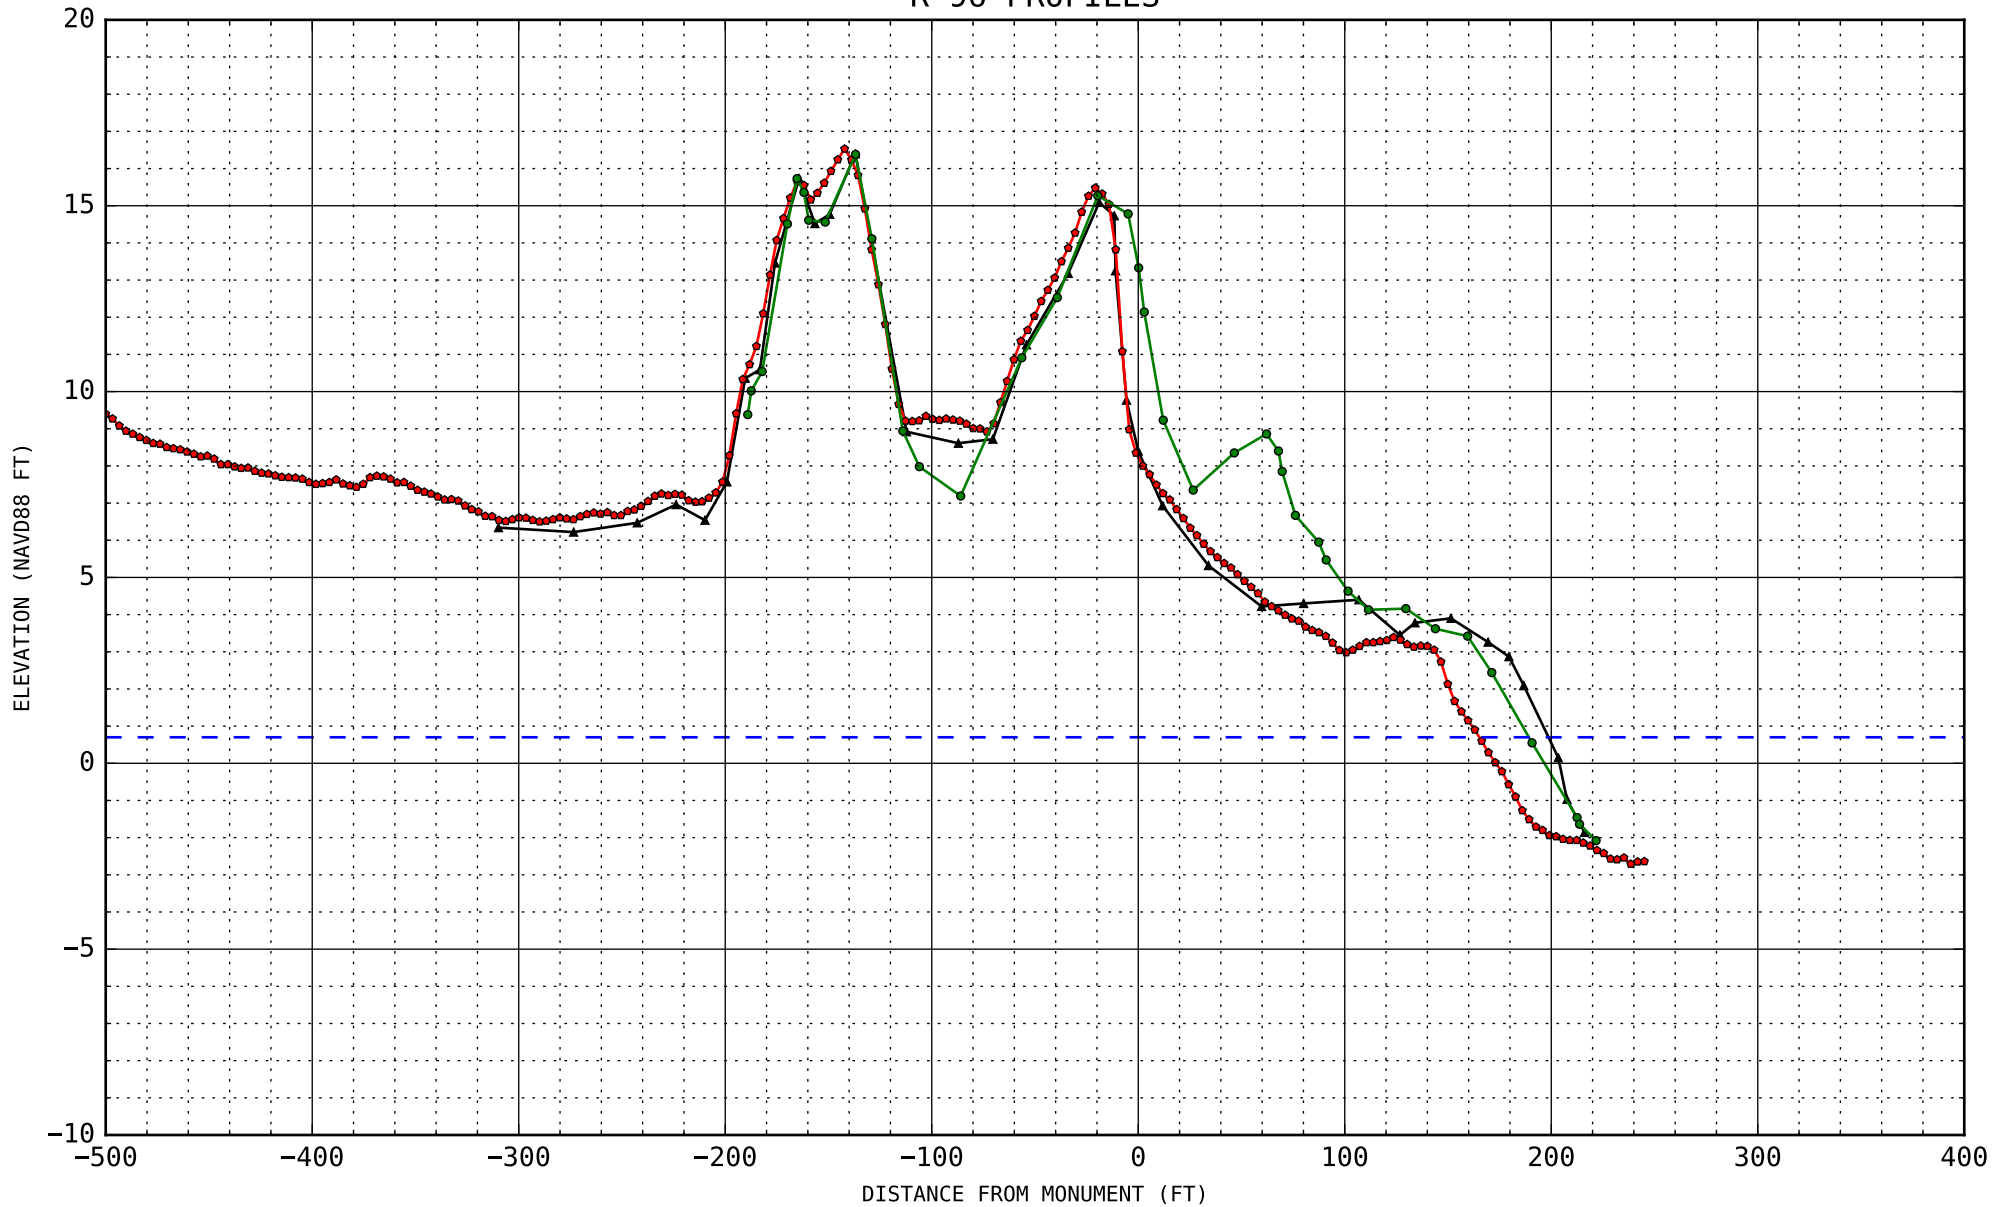
# R-96 PROFILES

- ▲ 2019-MAY CONDITION BY DEP
- 2018-OCT MONITORING BY USACE-LIDAR
- 2017-FEB MONITORING BY DEP
- - - MHW CONTOUR (0.7 FT)
