# R-52-T PROFILES

FRANKLIN  
PROGRAM SUPPORT GIS  
DIVISION OF WATER RESOURCE MANAGEMENT  
FLORIDA DEPARTMENT OF ENVIRONMENTAL PROTECTION

RANGE: R-52-T  
EST DATE: FEB1980  
SURVEY DATE: 16MAY19  
AZIMUTH: 150.0

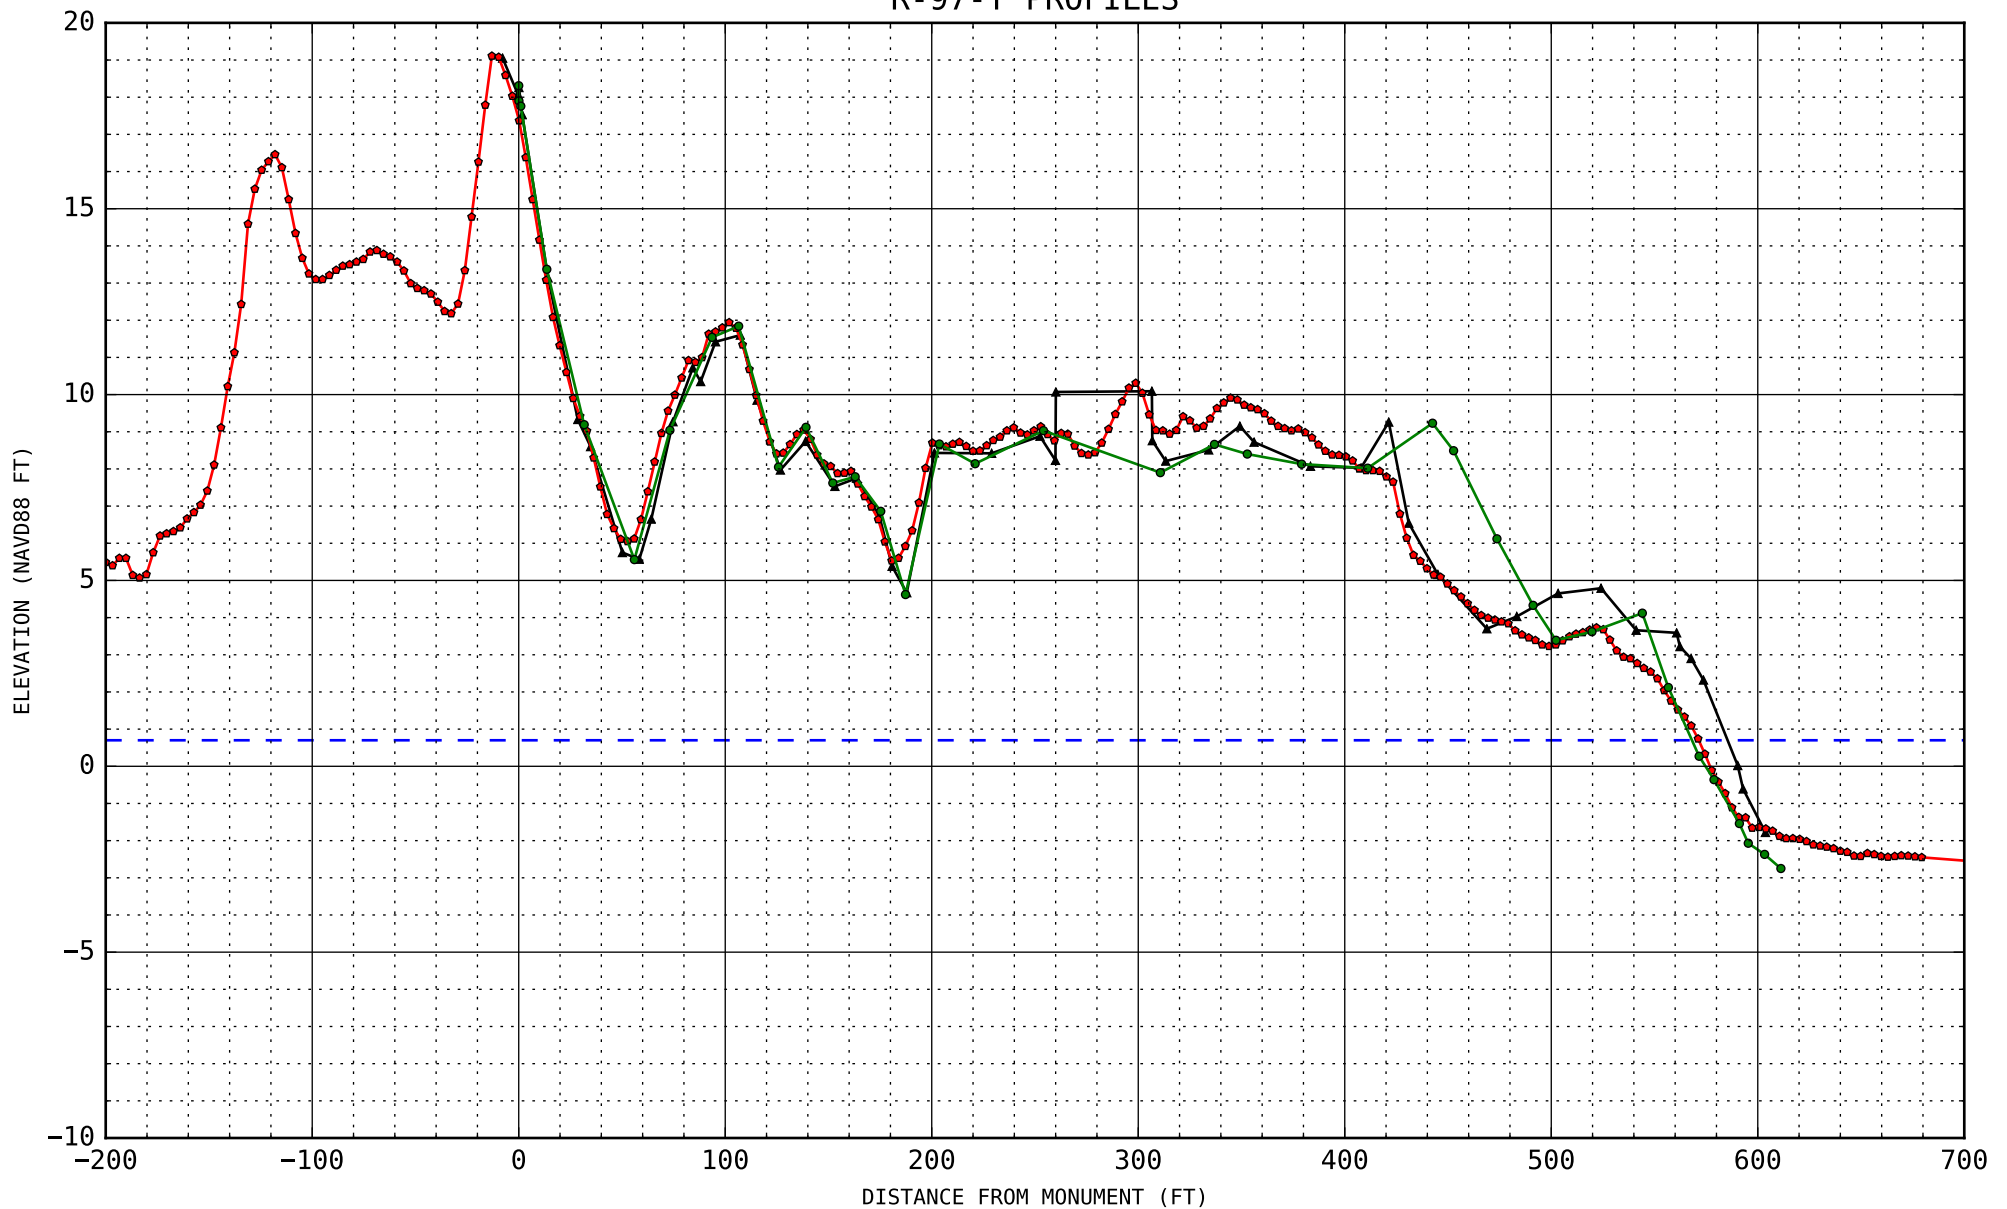
# R-97-T PROFILES

- ▲ 2019-MAY CONDITION BY DEP
- 2018-OCT MONITORING BY USACE-LIDAR
- 2017-FEB MONITORING BY DEP
- - - MHW CONTOUR (0.7 FT)

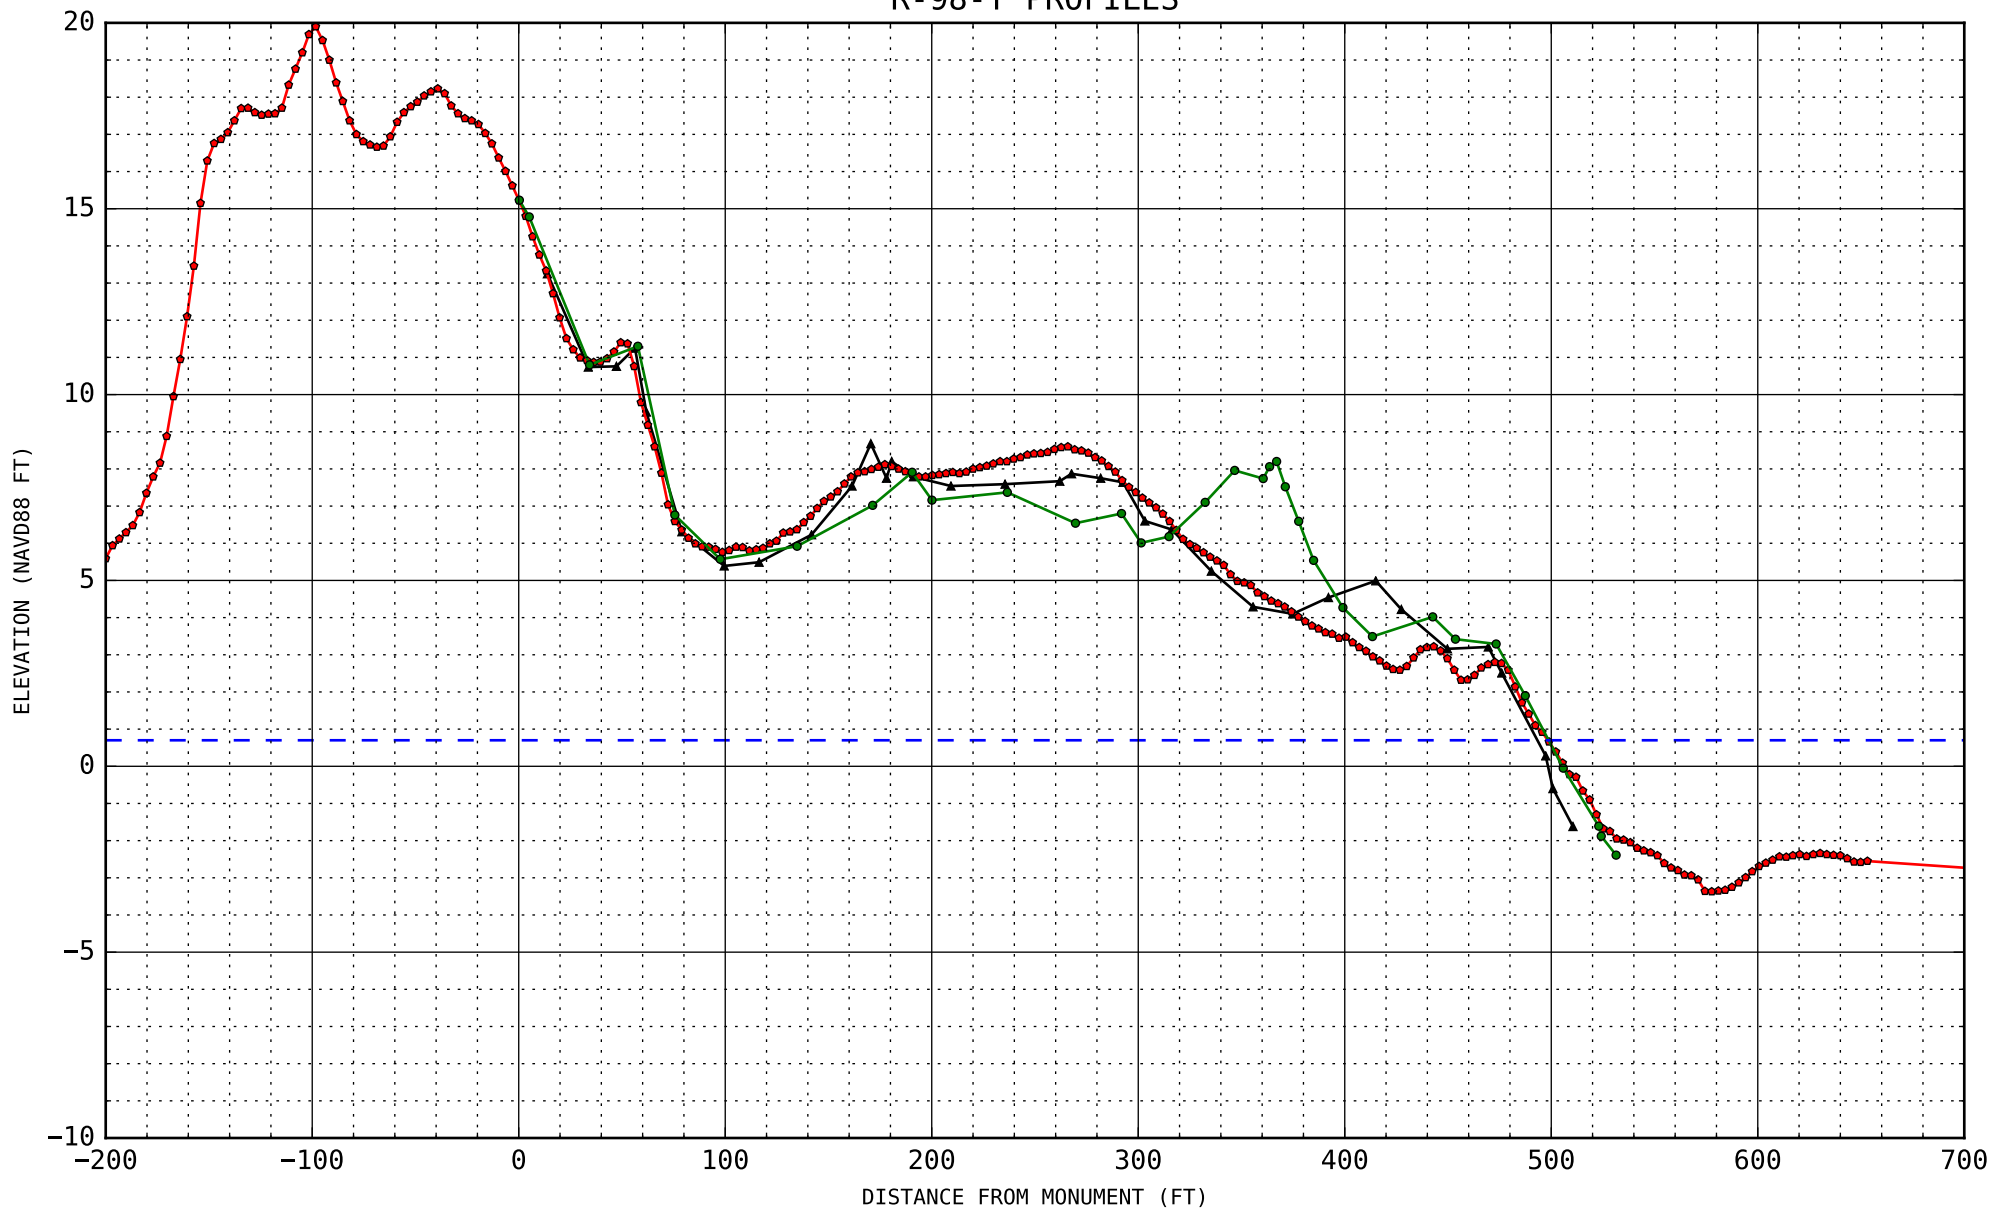
# R-98-T PROFILES

- ▲ 2019-MAY CONDITION BY DEP
- 2018-OCT MONITORING BY USACE-LIDAR
- 2017-FEB MONITORING BY DEP
- - - MHW CONTOUR (0.7 FT)

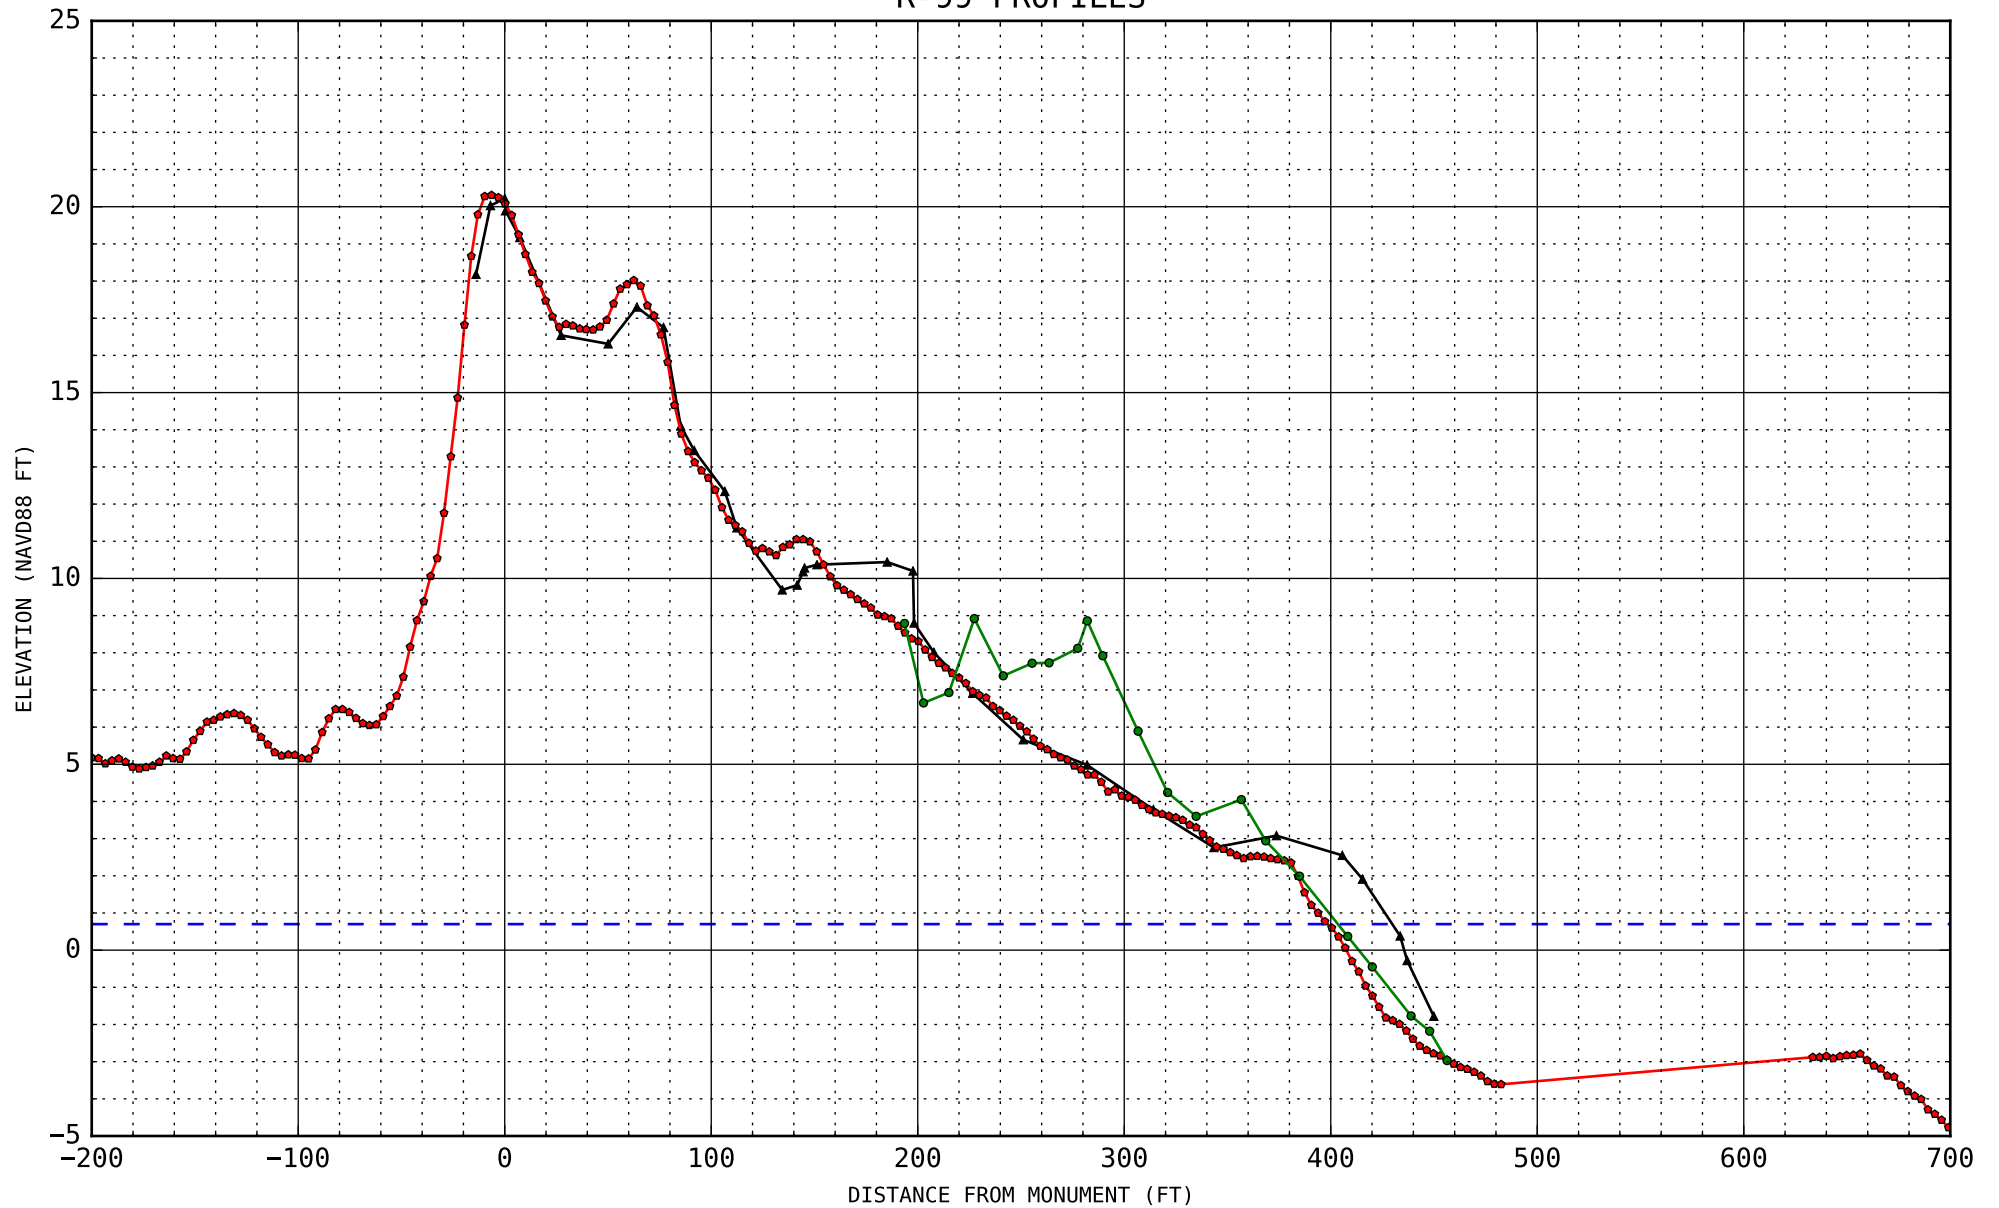
# R-99 PROFILES

- ▲ 2019-MAY CONDITION BY DEP
- 2018-OCT MONITORING BY USACE-LIDAR
- 2017-FEB MONITORING BY DEP
- - - MHW CONTOUR (0.7 FT)

RANGE: R-99  
EST DATE: JUL1996  
SURVEY DATE: 17MAY19  
AZIMUTH: 160.0

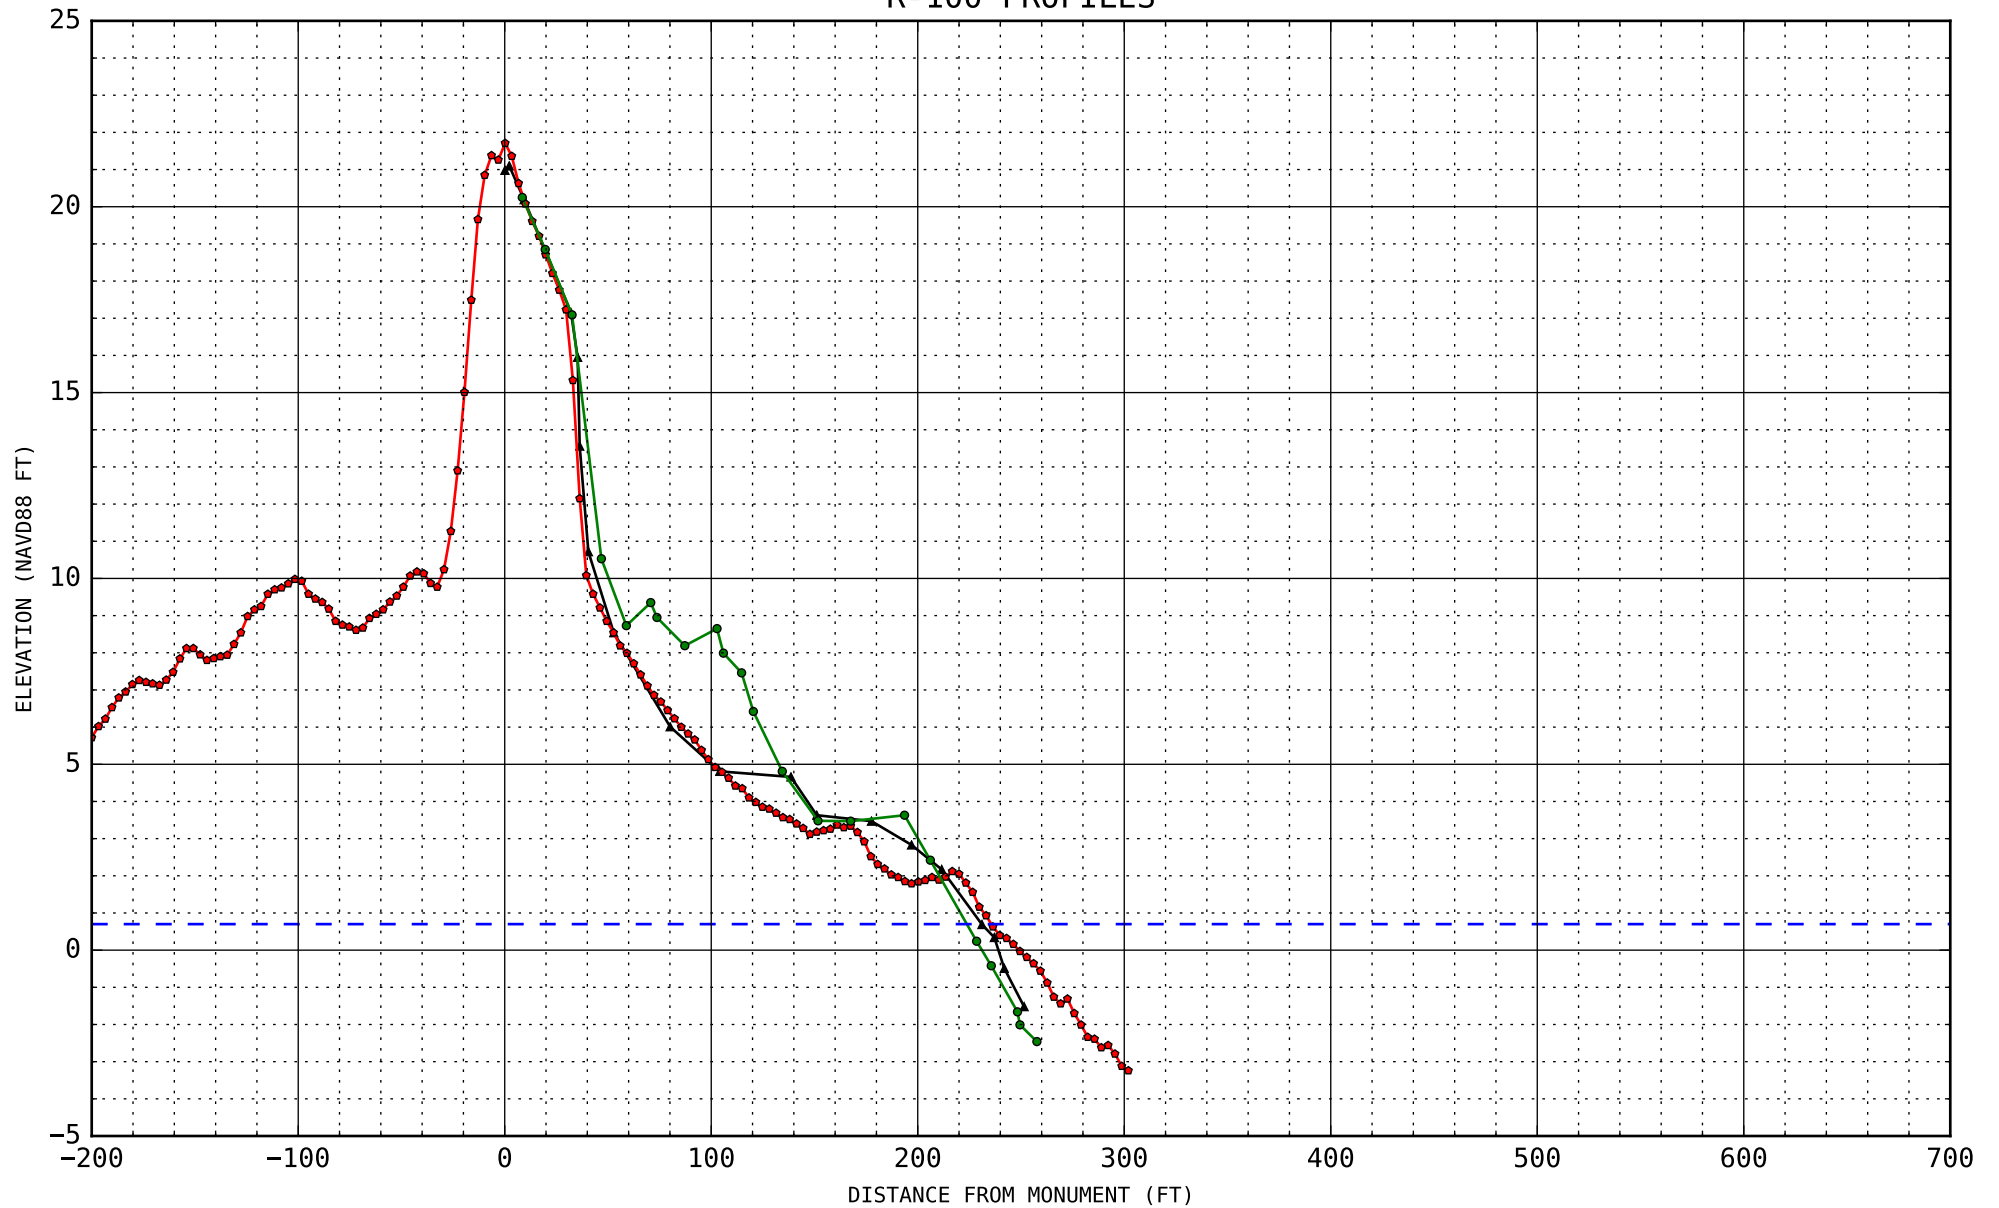
# R-100 PROFILES

- ▲ 2019-MAY CONDITION BY DEP
- 2018-OCT MONITORING BY USACE-LIDAR
- 2017-FEB MONITORING BY DEP
- - - MHW CONTOUR (0.7 FT)

RANGE: R-100  
 EST DATE: JUL1996  
 SURVEY DATE: 17MAY19  
 AZIMUTH: 160.0

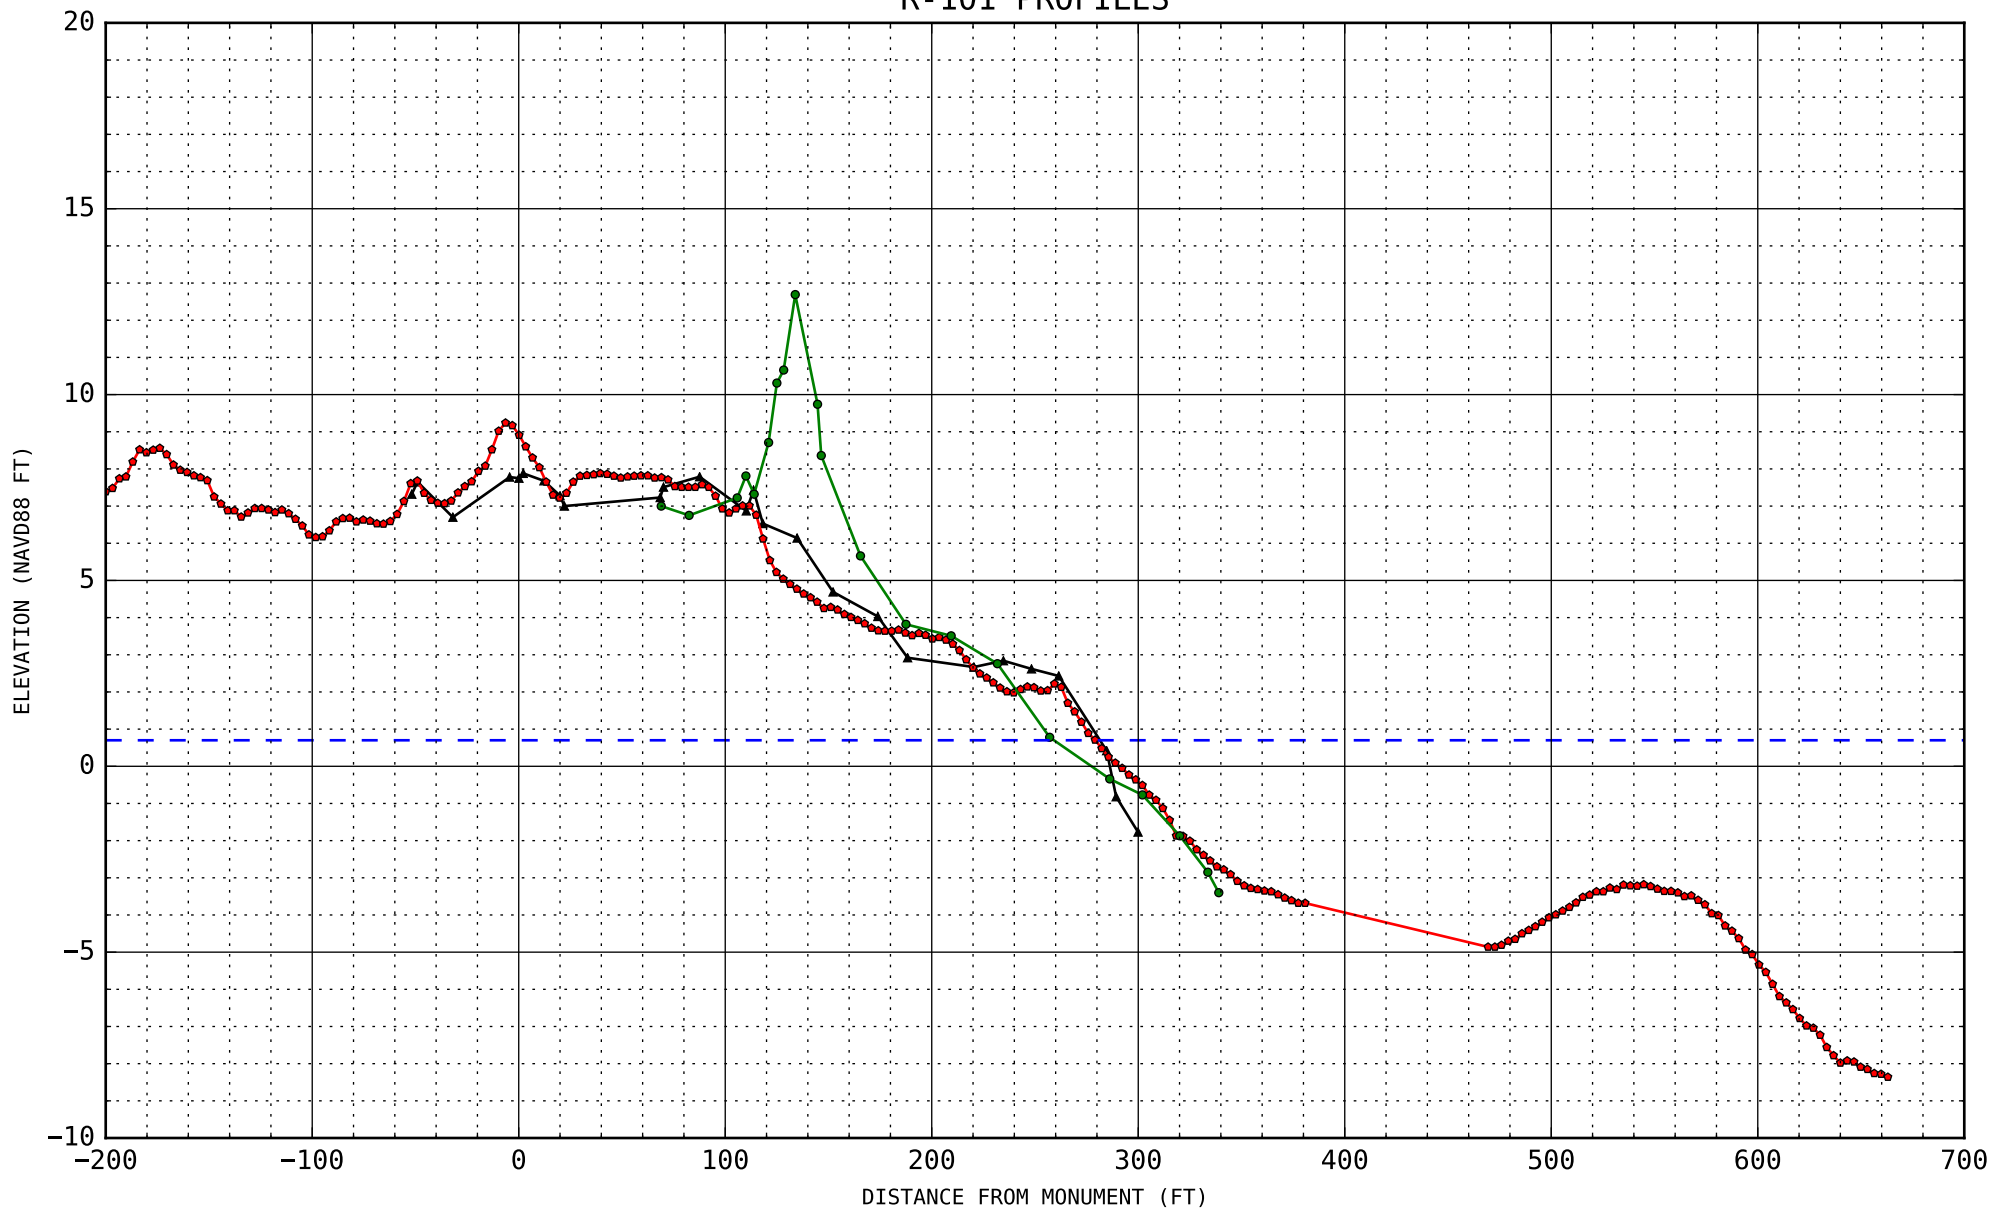
# R-101 PROFILES

- ▲ 2019-MAY CONDITION BY DEP
- 2018-OCT MONITORING BY USACE-LIDAR
- 2017-FEB MONITORING BY DEP
- - - MHW CONTOUR (0.7 FT)

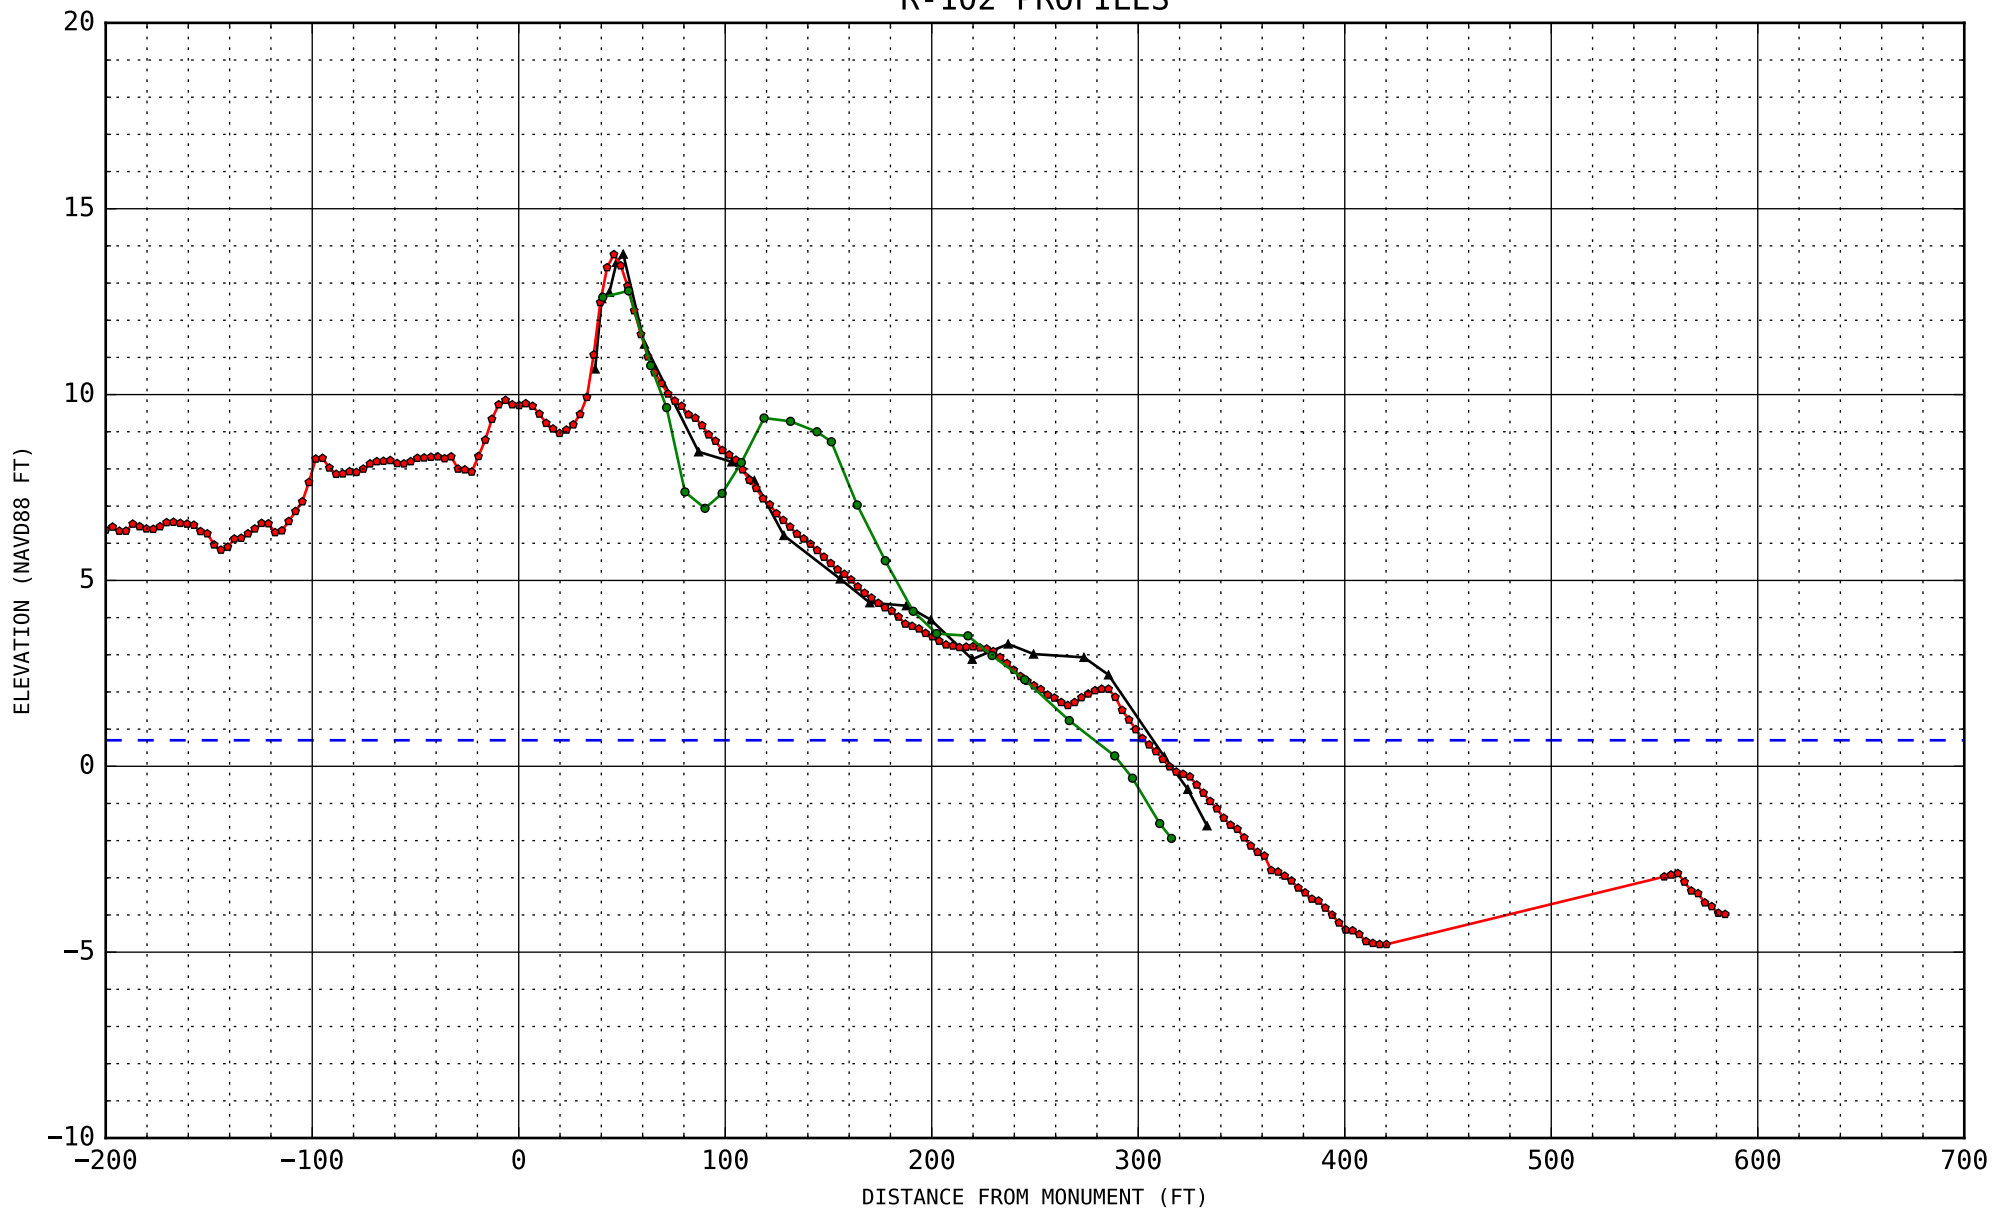
# R-102 PROFILES

- ▲ 2019-MAY CONDITION BY DEP
- 2018-OCT MONITORING BY USACE-LIDAR
- 2017-FEB MONITORING BY DEP
- - - MHW CONTOUR (0.7 FT)

RANGE: R-102  
 EST DATE: JUL1996  
 SURVEY DATE: 17MAY19  
 AZIMUTH: 160.0

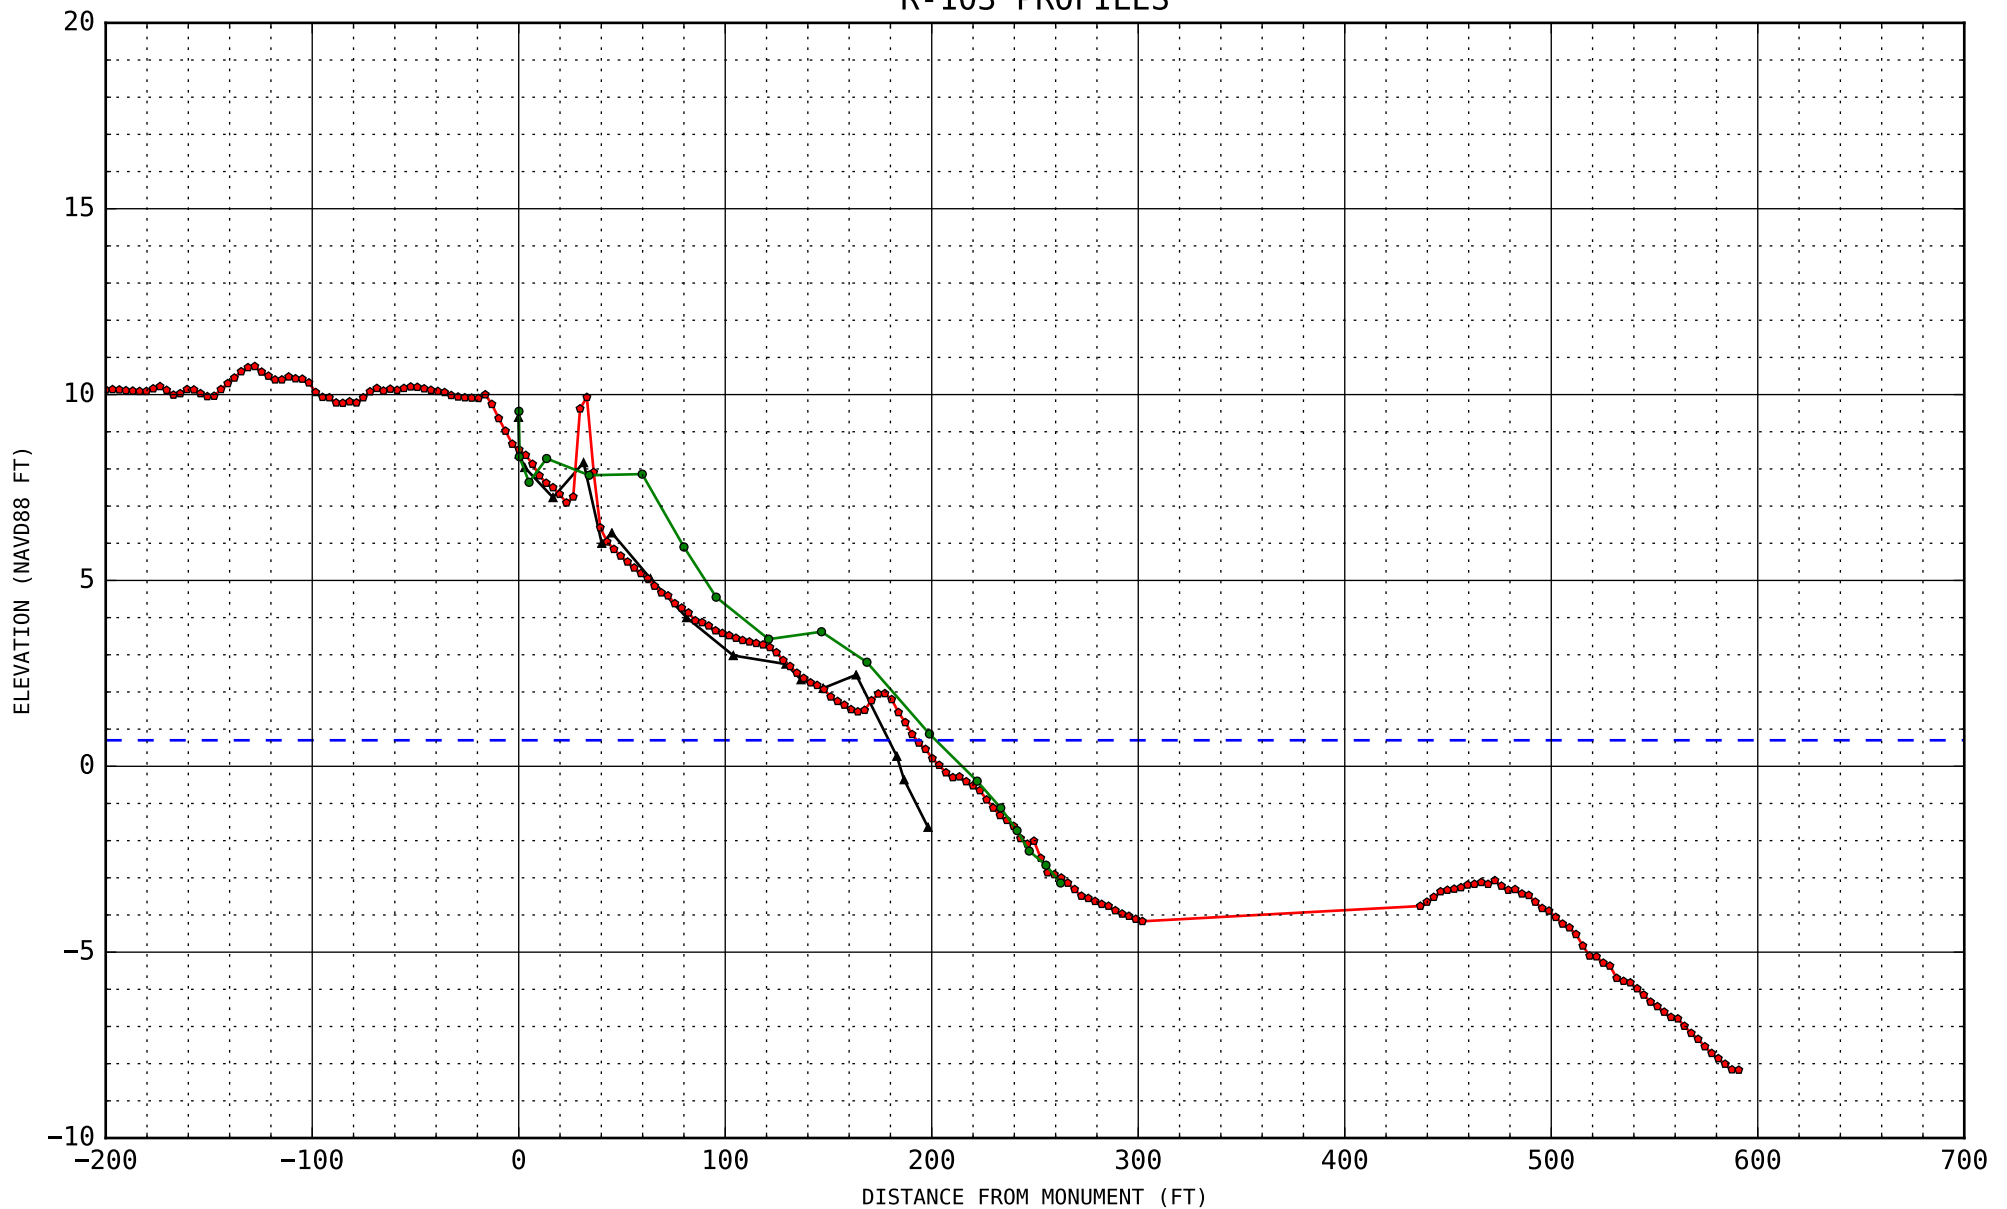
# R-103 PROFILES

- ▲ 2019-MAY CONDITION BY DEP
- 2018-OCT MONITORING BY USACE-LIDAR
- 2017-FEB MONITORING BY DEP
- - - MHW CONTOUR (0.7 FT)

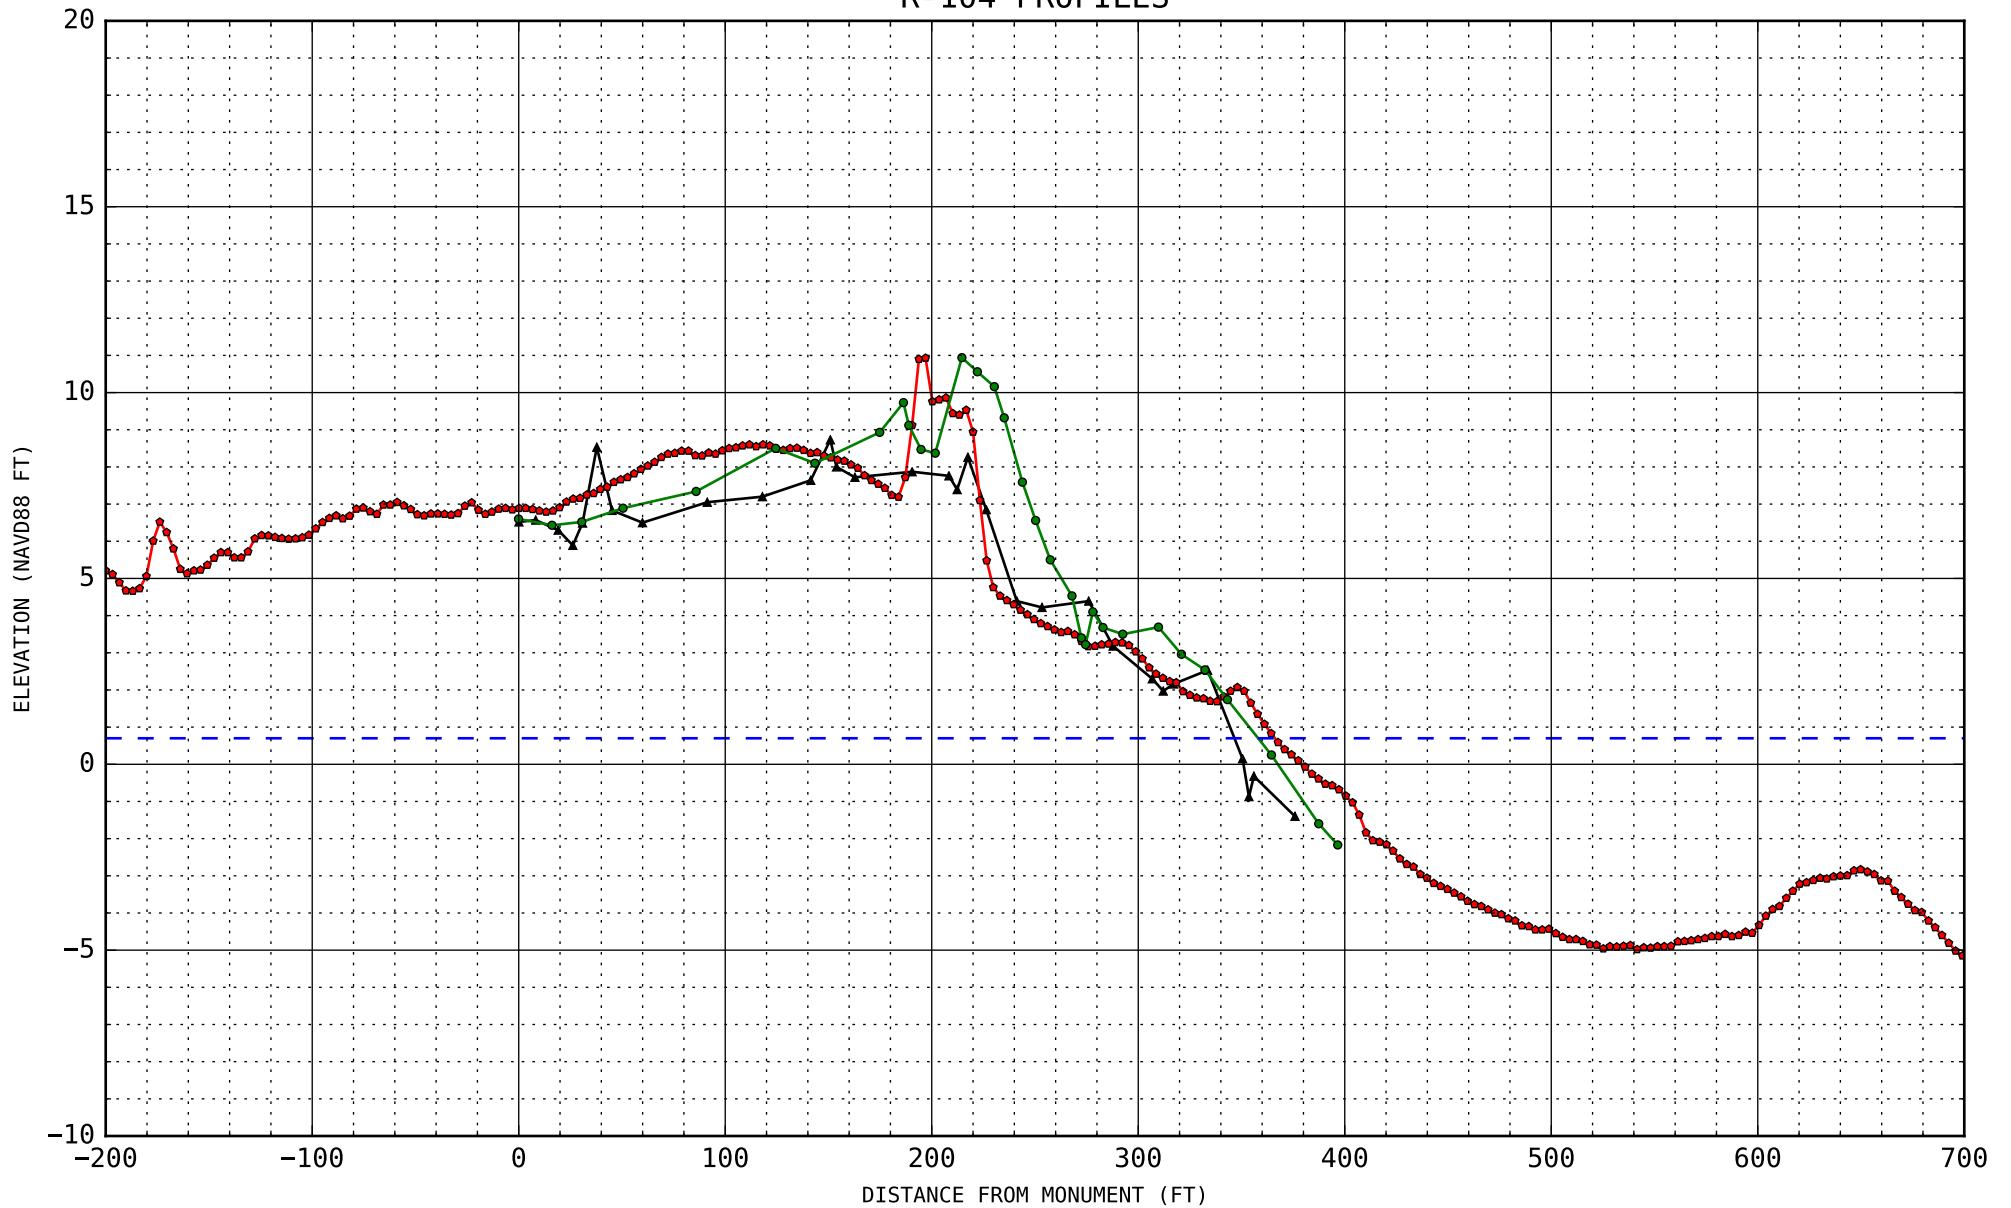
# R-104 PROFILES

- ▲ 2019-MAY CONDITION BY DEP
- 2018-OCT MONITORING BY USACE-LIDAR
- 2017-FEB MONITORING BY DEP
- - - MHW CONTOUR (0.7 FT)

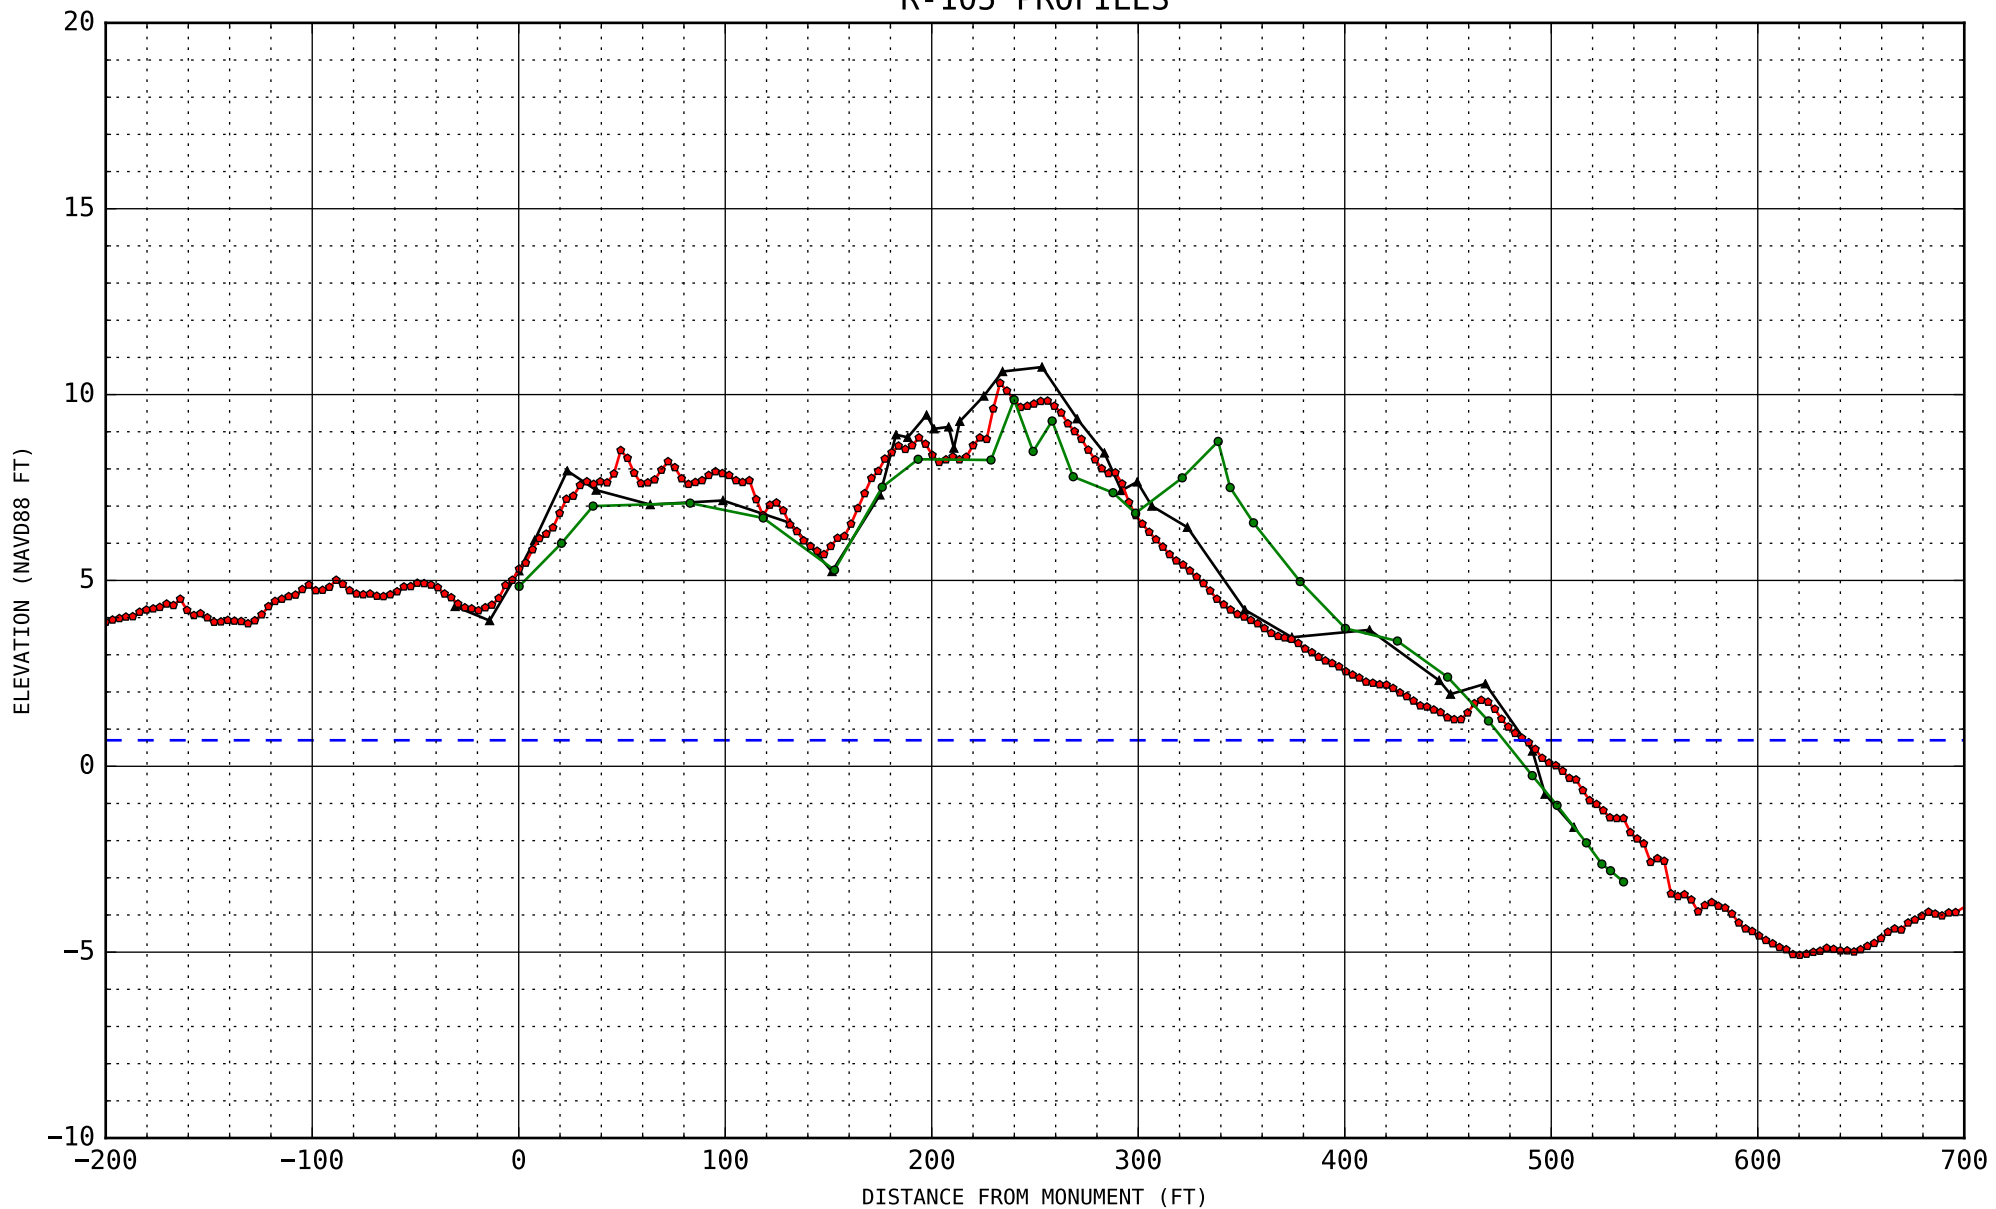
# R-105 PROFILES

- ▲ 2019-MAY CONDITION BY DEP
- 2018-OCT MONITORING BY USACE-LIDAR
- 2017-FEB MONITORING BY DEP
- - - MHW CONTOUR (0.7 FT)
