# R-52-T PROFILES

FRANKLIN  
PROGRAM SUPPORT GIS  
DIVISION OF WATER RESOURCE MANAGEMENT  
FLORIDA DEPARTMENT OF ENVIRONMENTAL PROTECTION

RANGE: R-52-T  
EST DATE: FEB1980  
SURVEY DATE: 16MAY19  
AZIMUTH: 150.0

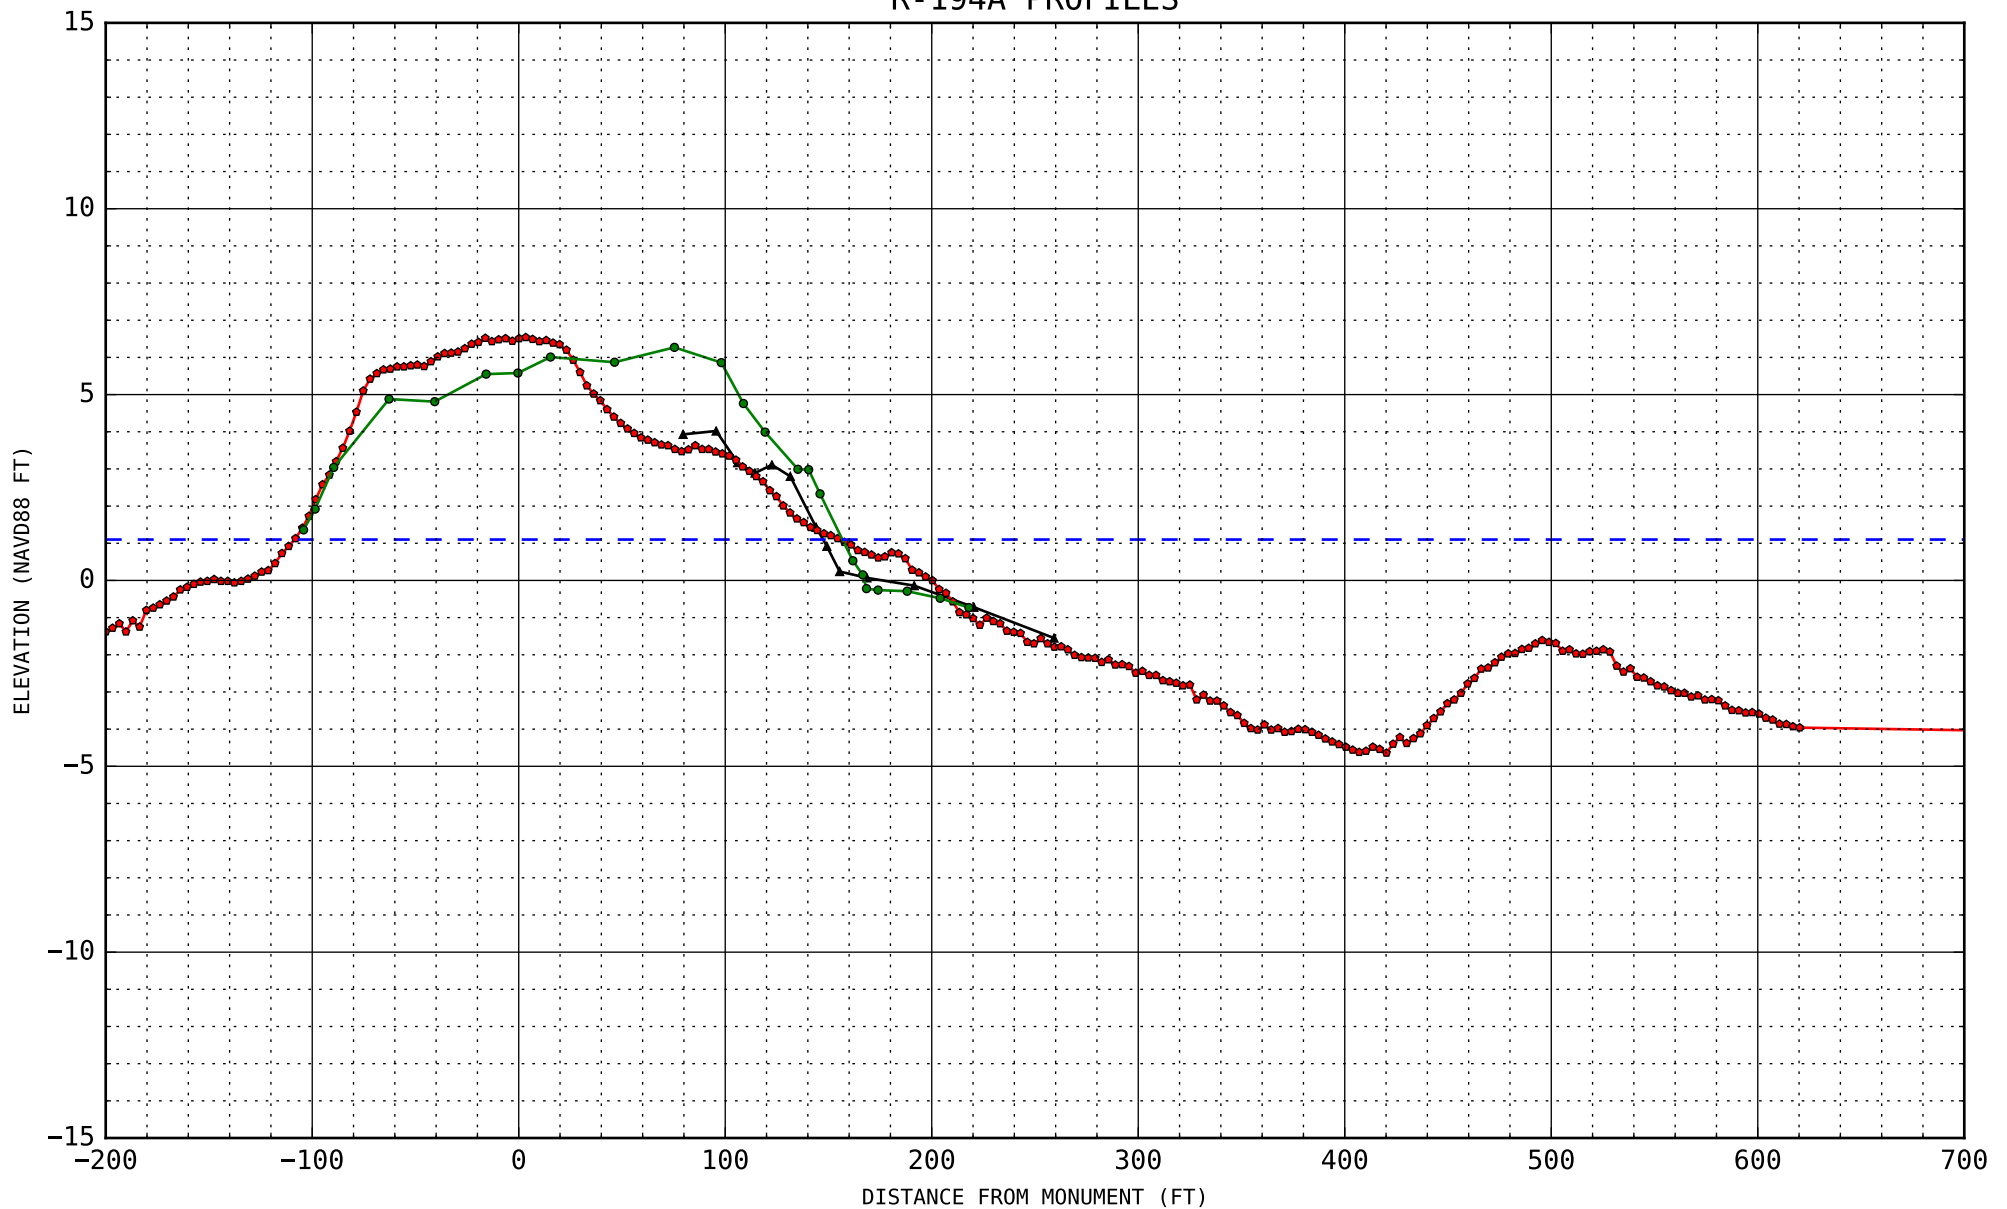
# R-194A PROFILES

- 2019-MAY CONDITION BY DEP
- 2018-OCT MONITORING BY USACE-LIDAR
- 2017-FEB MONITORING BY DEP
- MHW CONTOUR (1.1 FT)

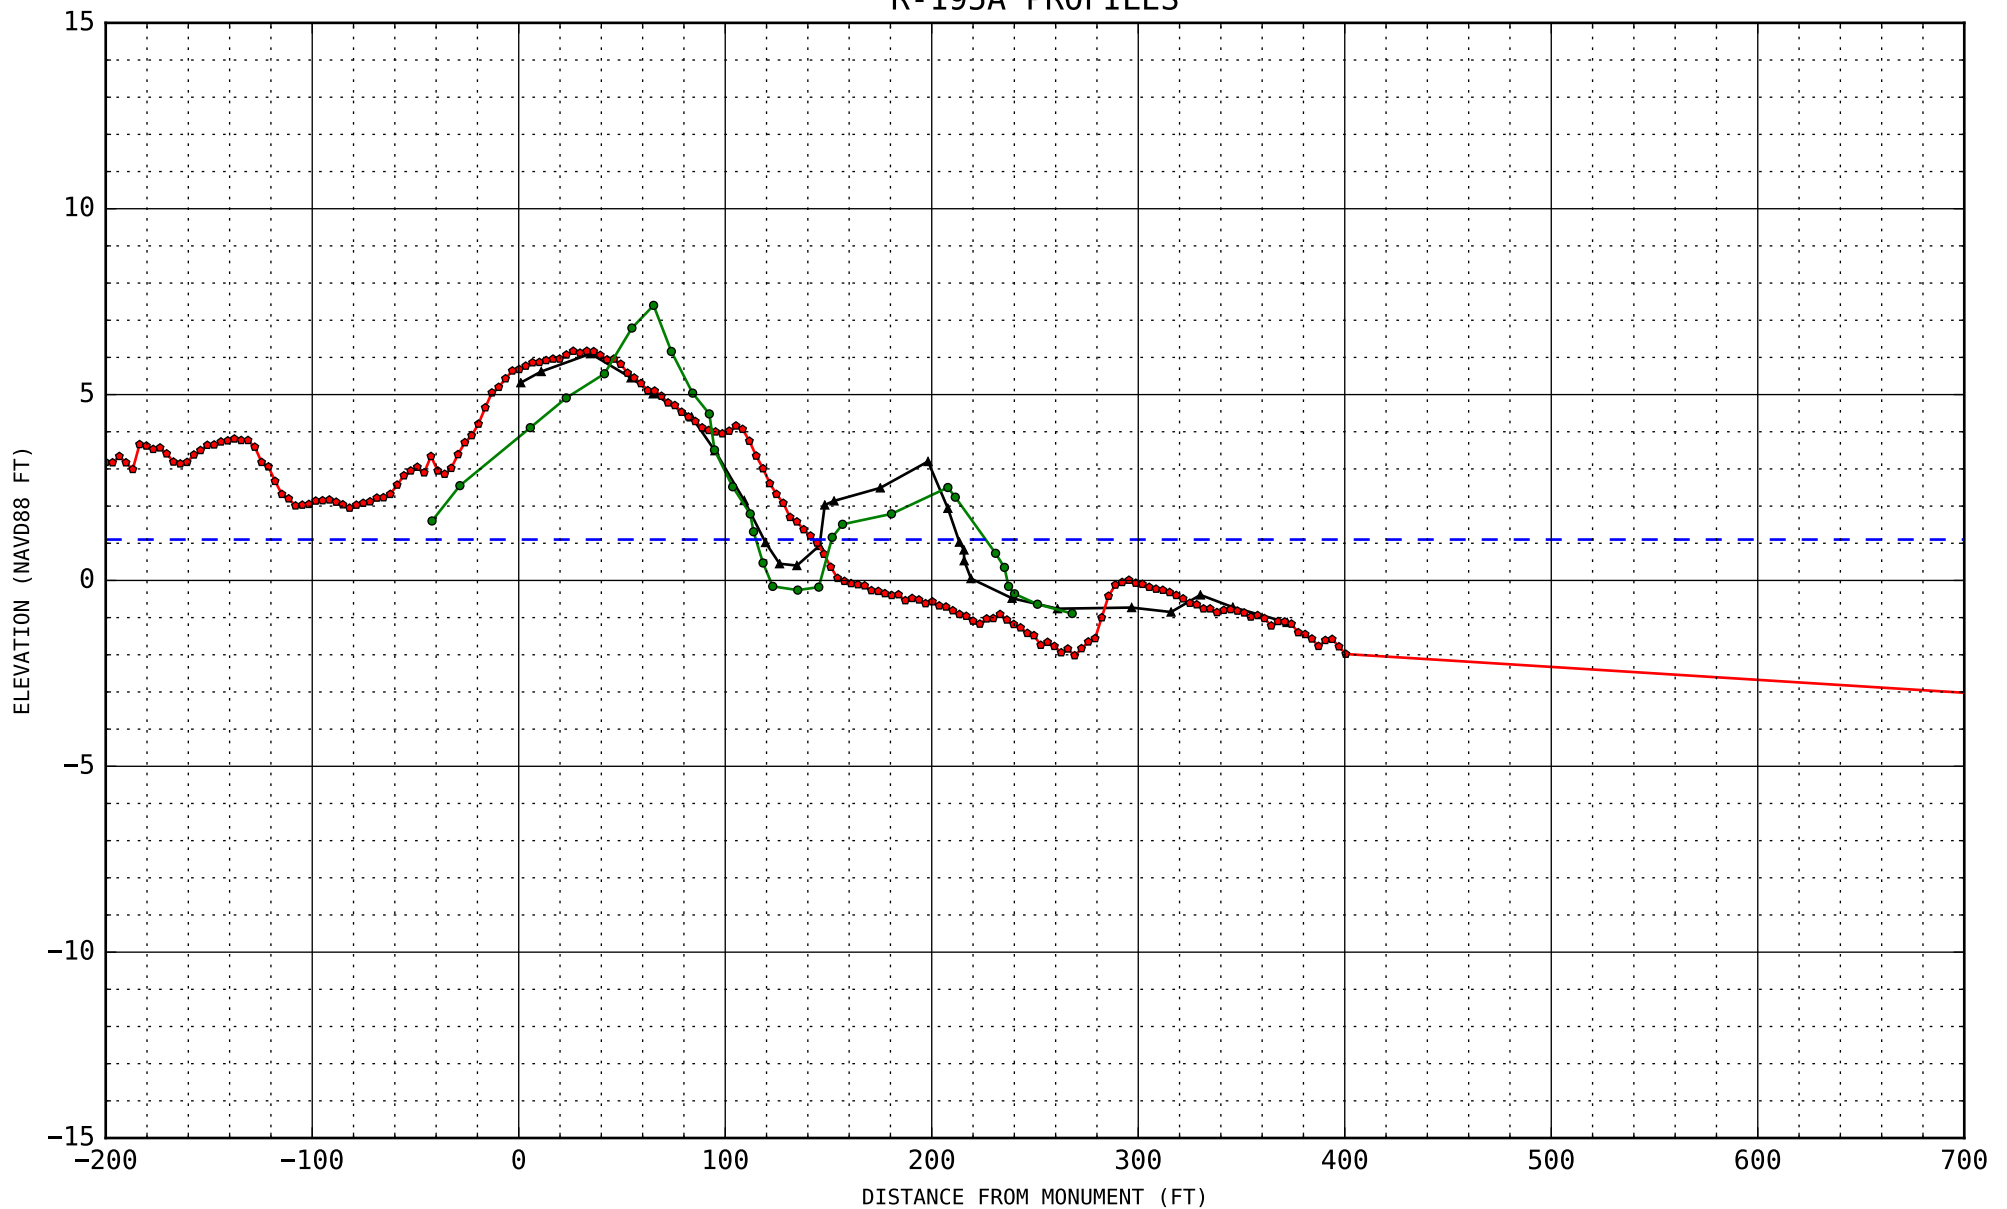
# R-195A PROFILES

- ▲ 2019-MAY CONDITION BY DEP
- 2018-OCT MONITORING BY USACE-LIDAR
- 2017-FEB MONITORING BY DEP
- - - MHW CONTOUR (1.1 FT)

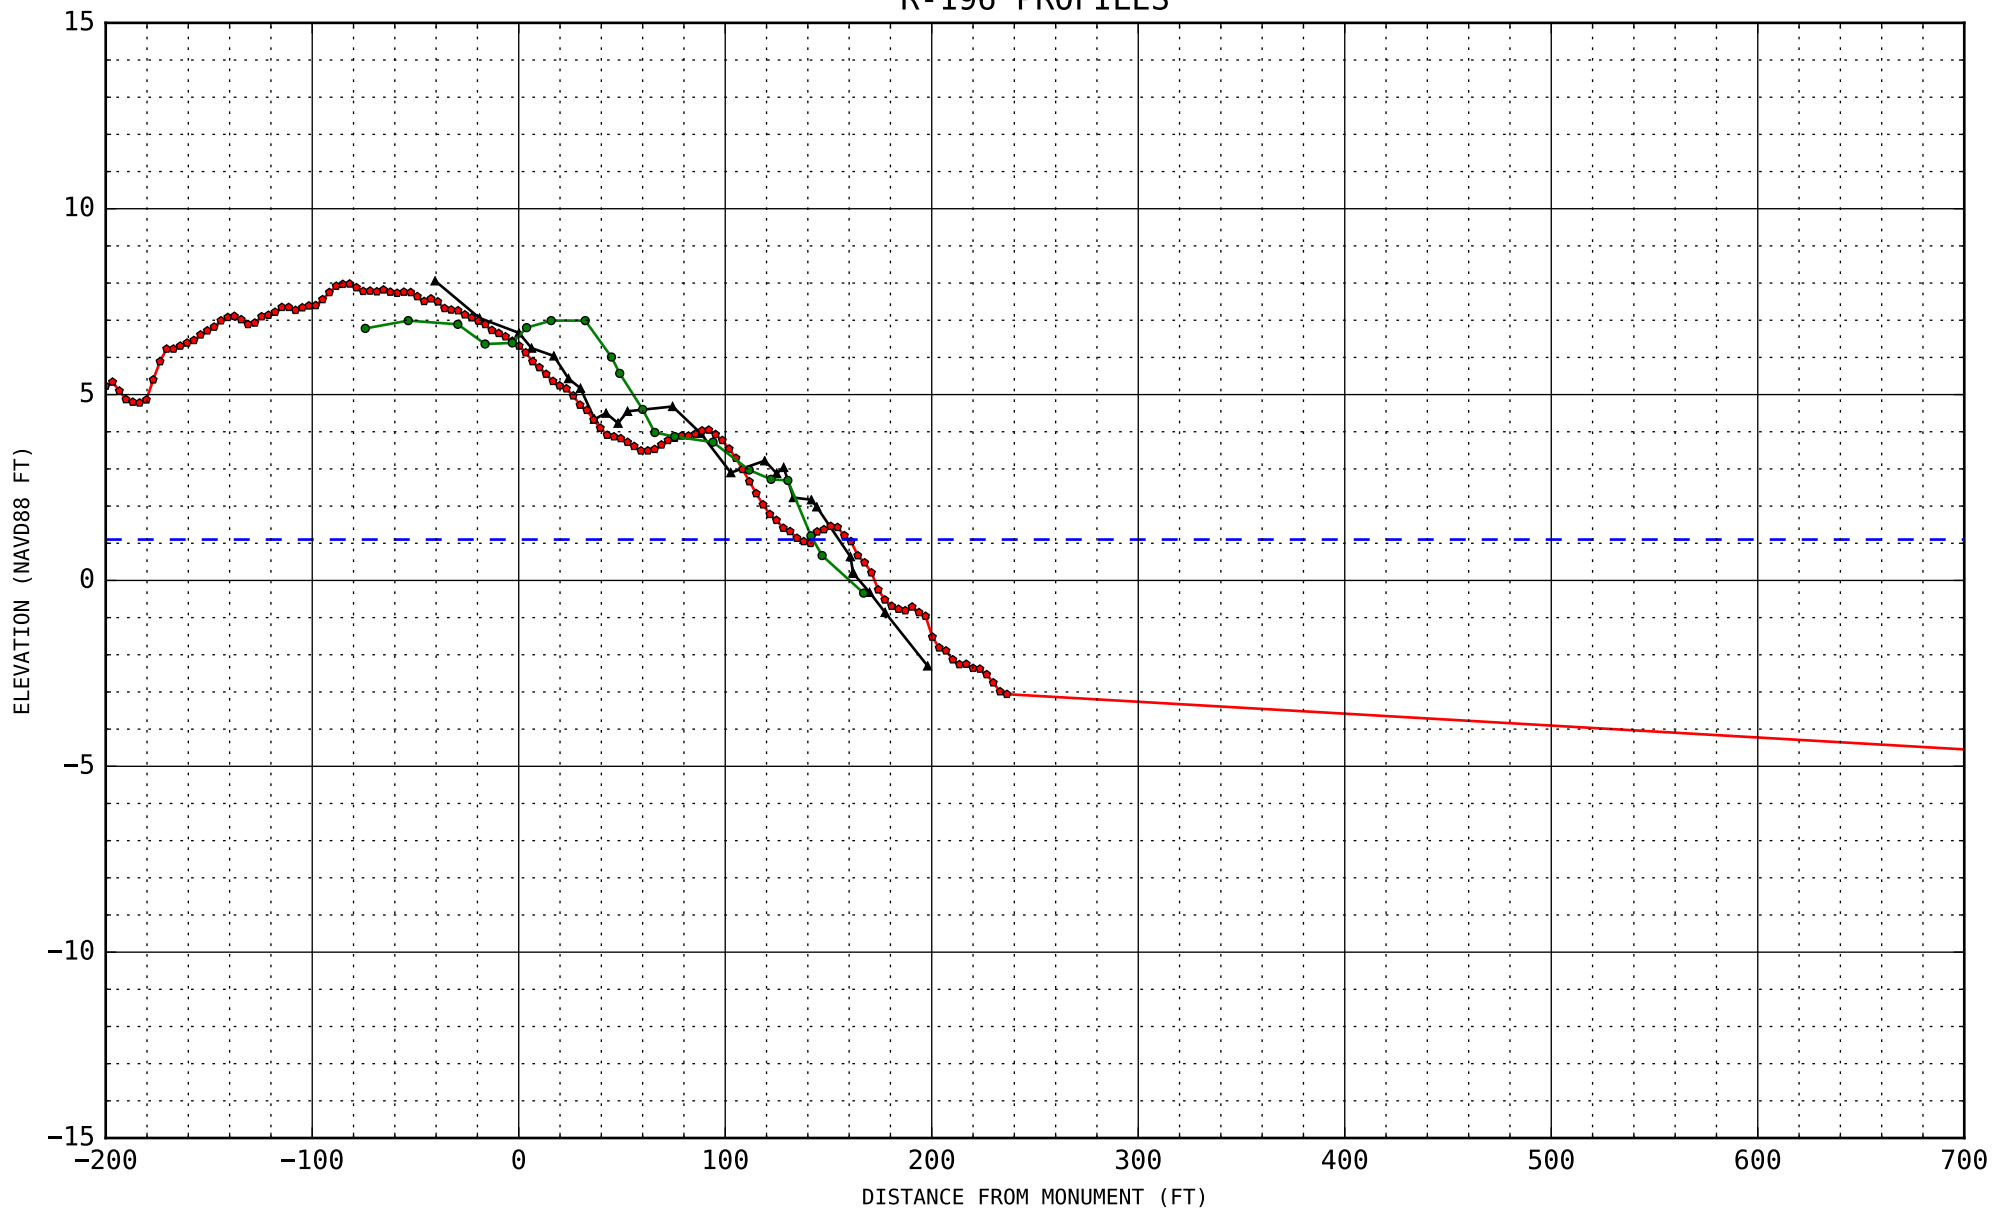
# R-196 PROFILES

- ▲ 2019-MAY CONDITION BY DEP
- 2018-OCT MONITORING BY USACE-LIDAR
- 2017-FEB MONITORING BY DEP
- - - MHW CONTOUR (1.1 FT)

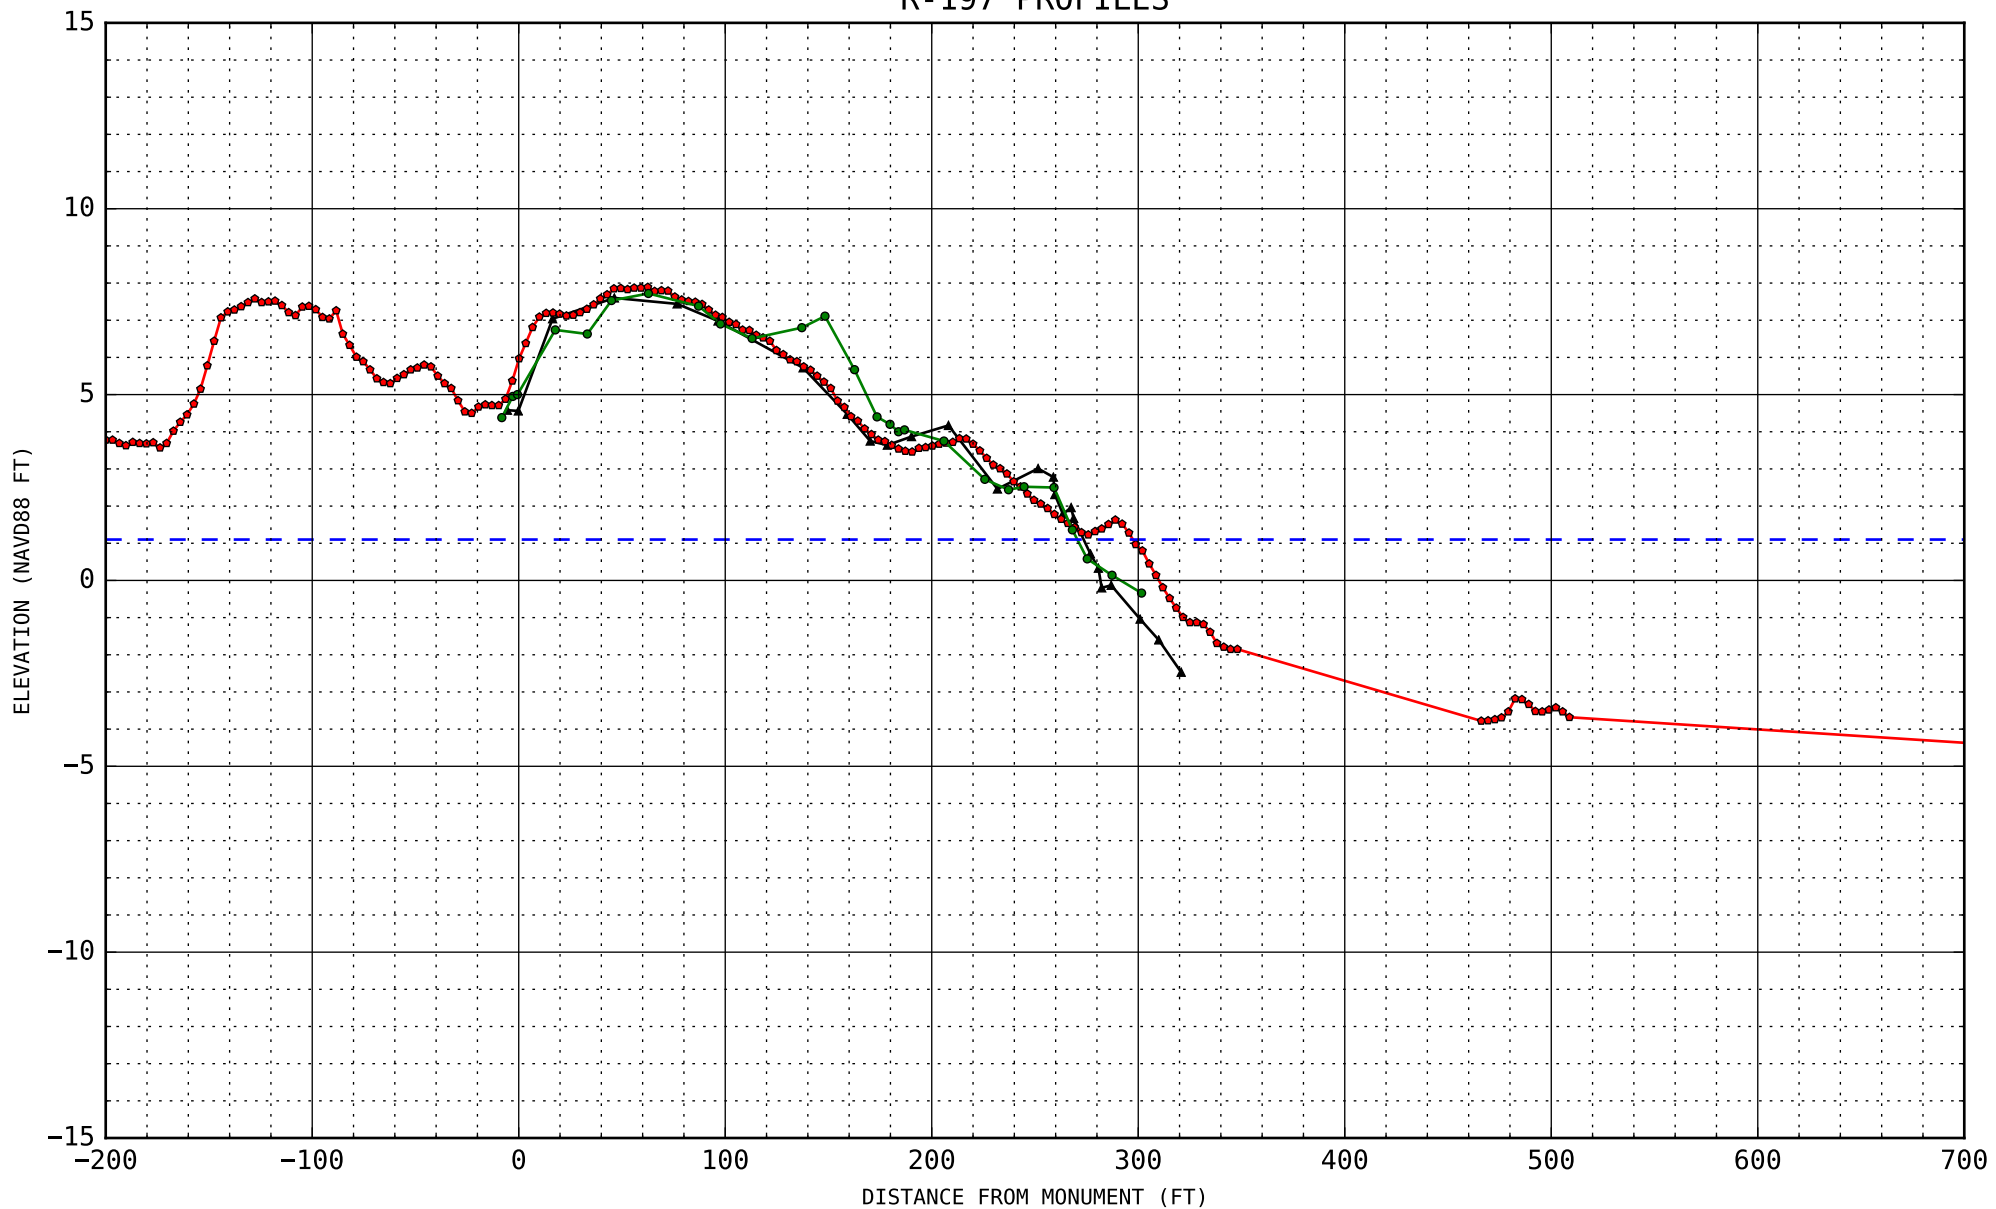
# R-197 PROFILES

- ▲ 2019-MAY CONDITION BY DEP
- 2018-OCT MONITORING BY USACE-LIDAR
- 2017-FEB MONITORING BY DEP
- - - MHW CONTOUR (1.1 FT)

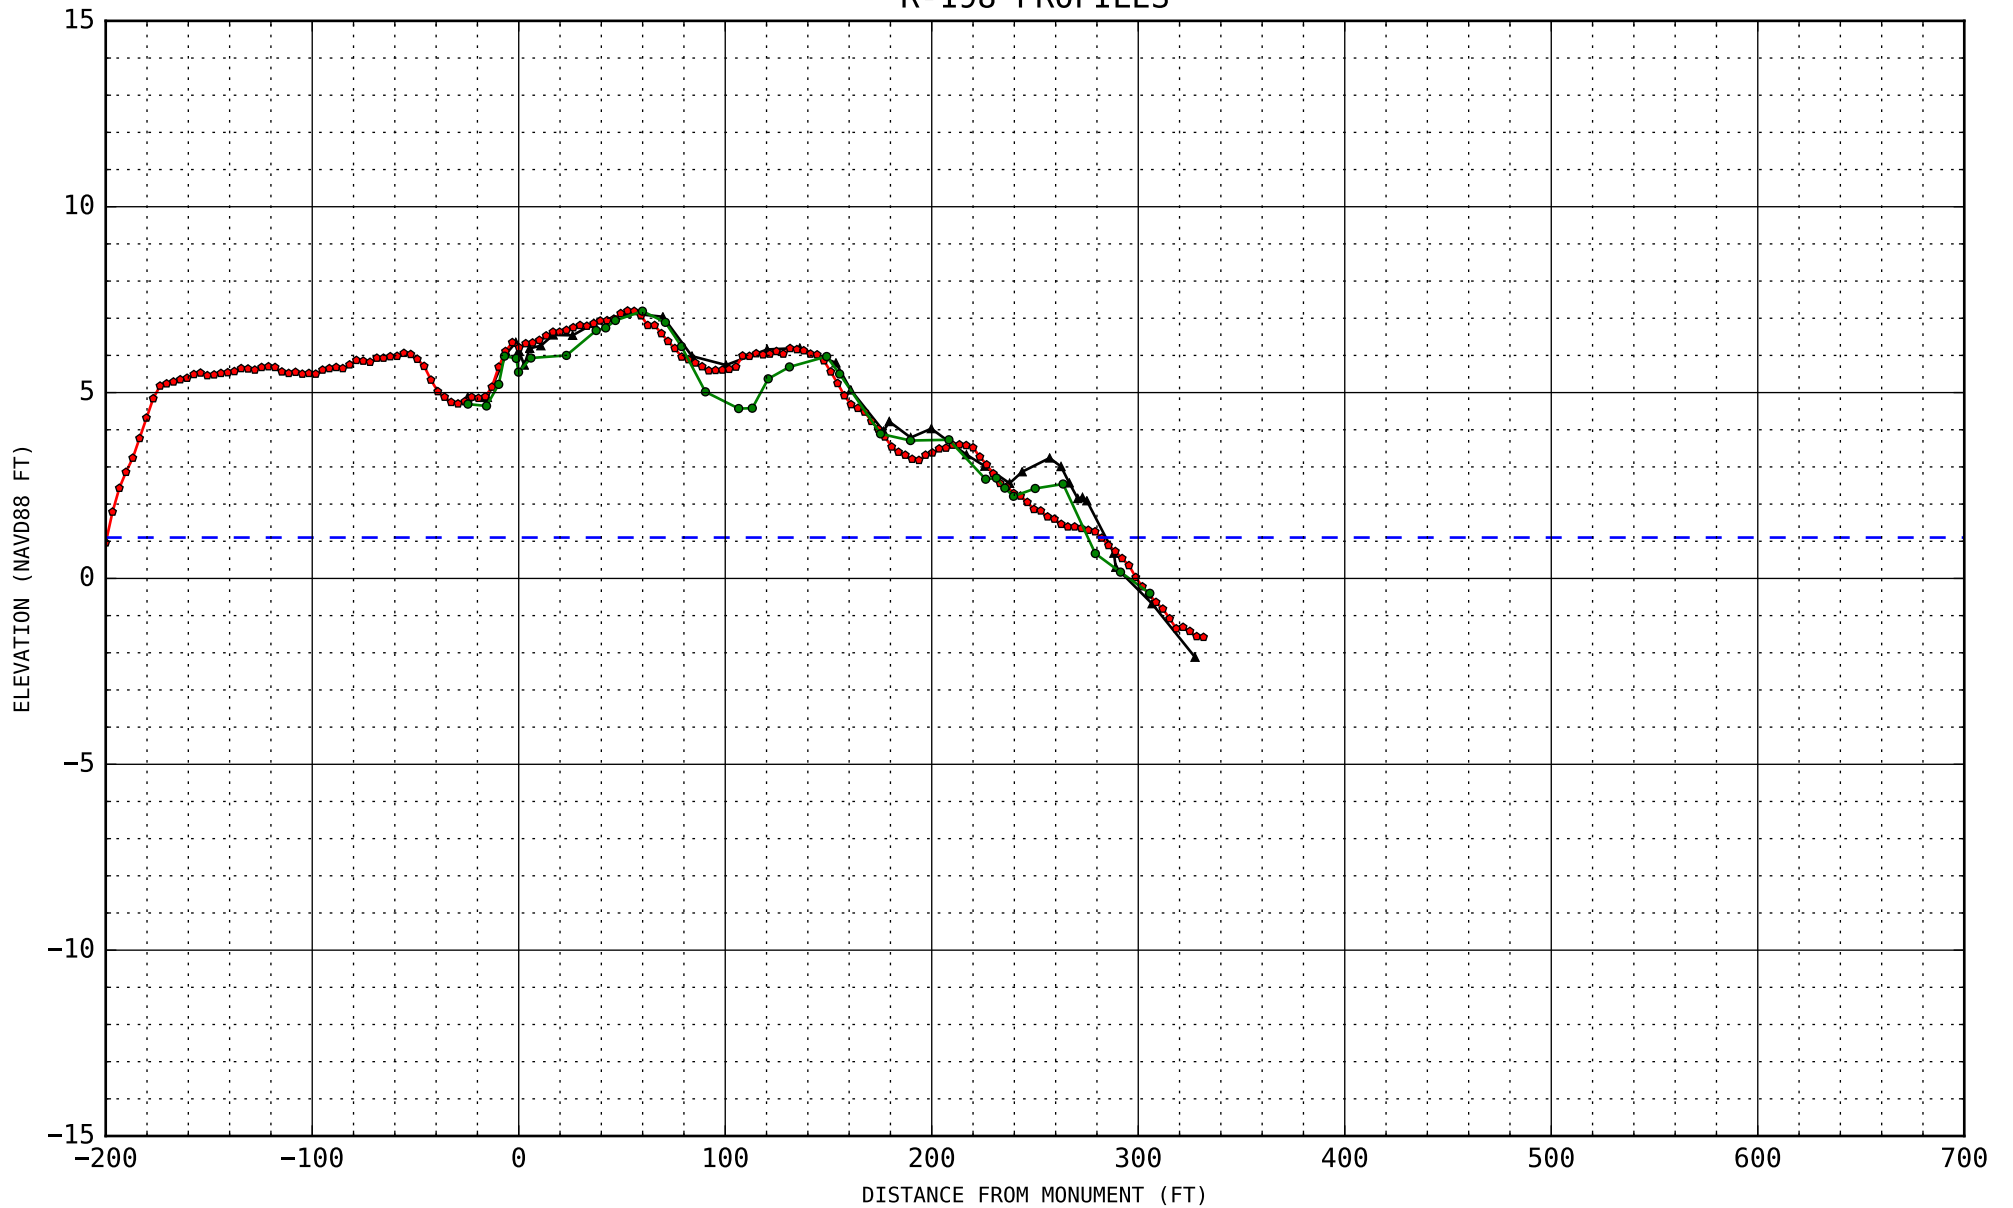
# R-198 PROFILES

- ▲ 2019-MAY CONDITION BY DEP
- 2018-OCT MONITORING BY USACE-LIDAR
- 2017-FEB MONITORING BY DEP
- - - MHW CONTOUR (1.1 FT)

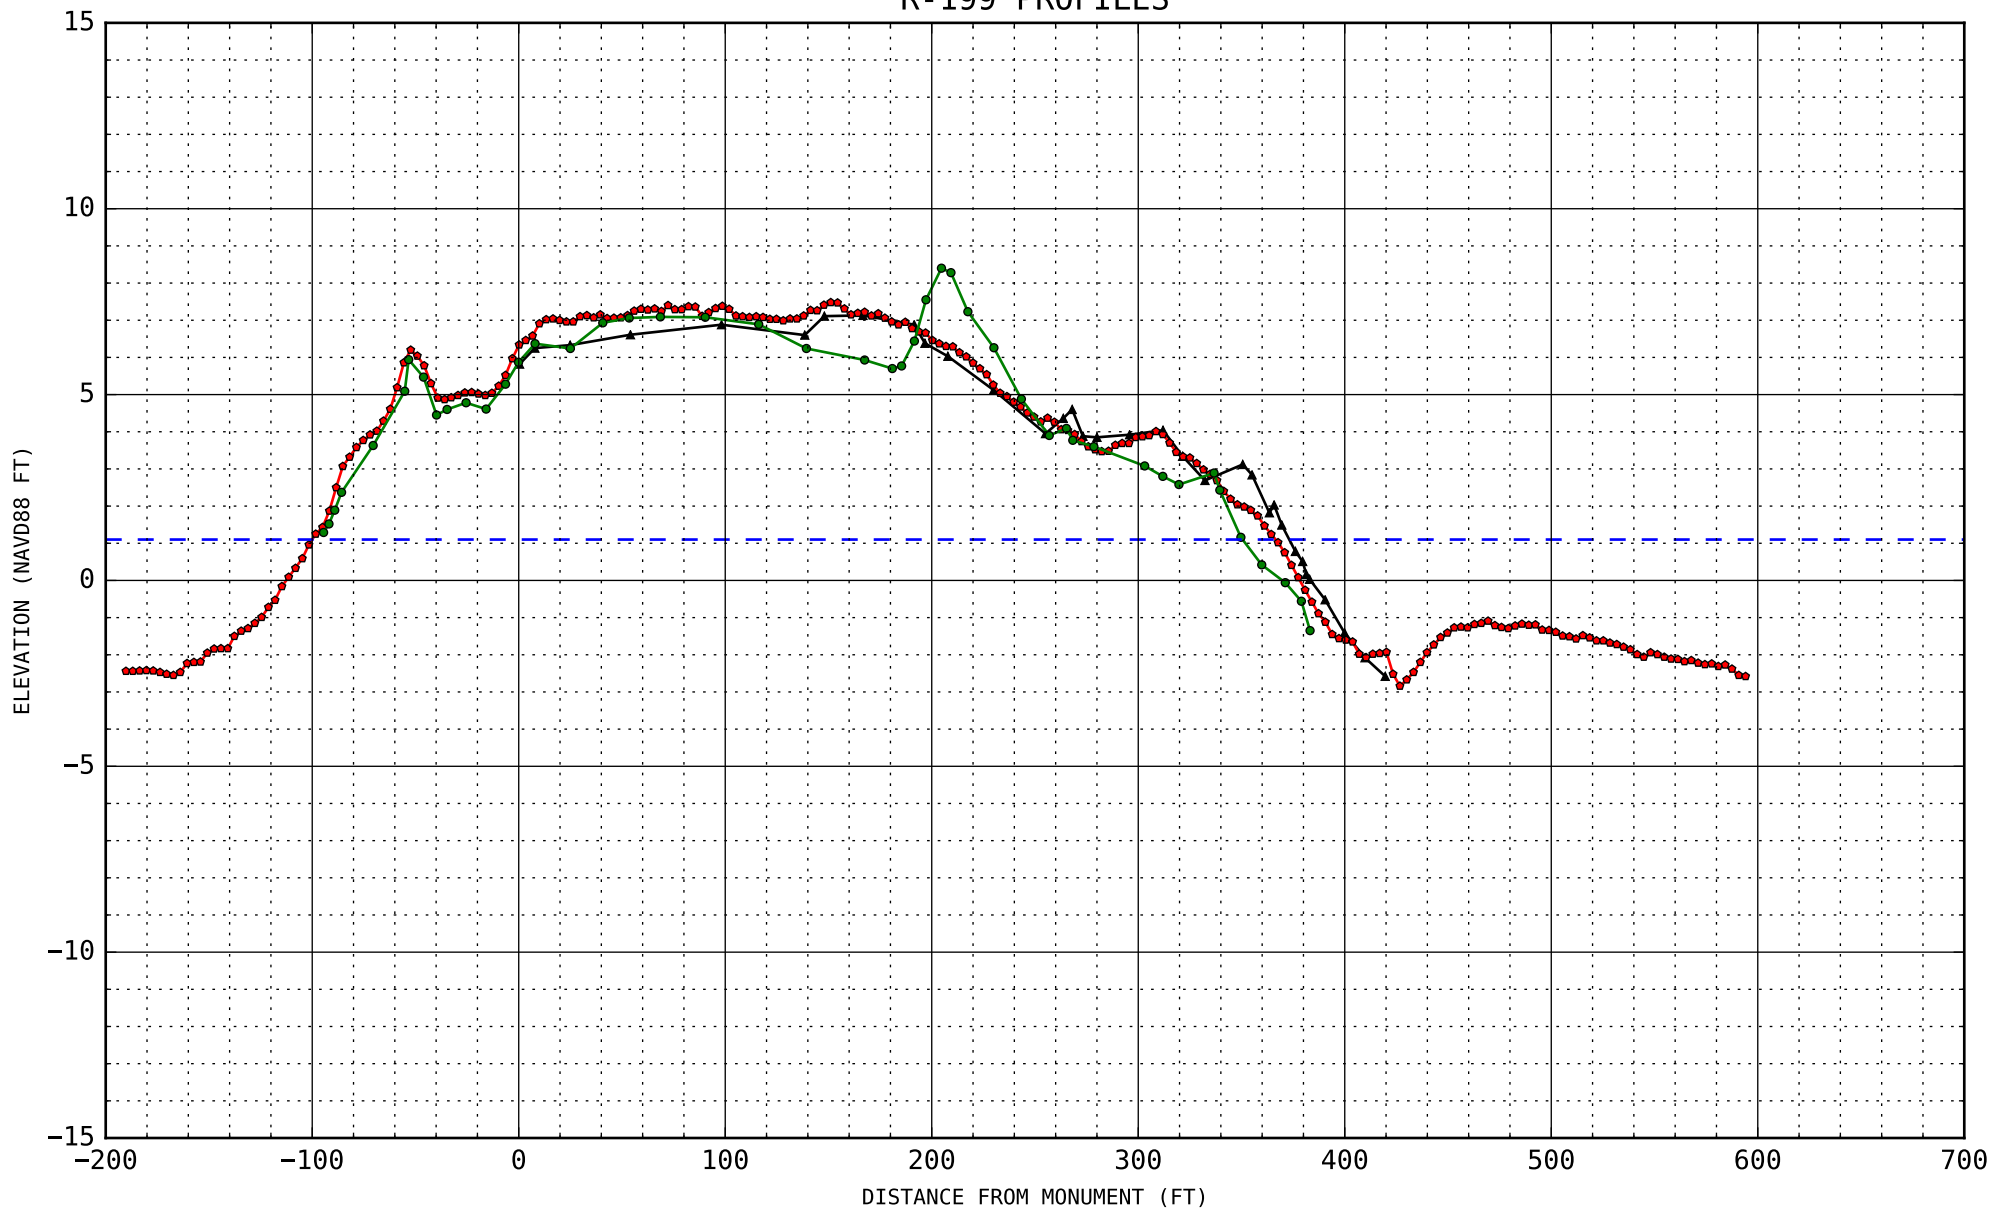
# R-199 PROFILES

- ▲ 2019-MAY CONDITION BY DEP
- 2018-OCT MONITORING BY USACE-LIDAR
- 2017-FEB MONITORING BY DEP
- - - MHW CONTOUR (1.1 FT)

RANGE: R-199  
EST DATE: JUL1996  
SURVEY DATE: 28MAY19  
AZIMUTH: 185.0

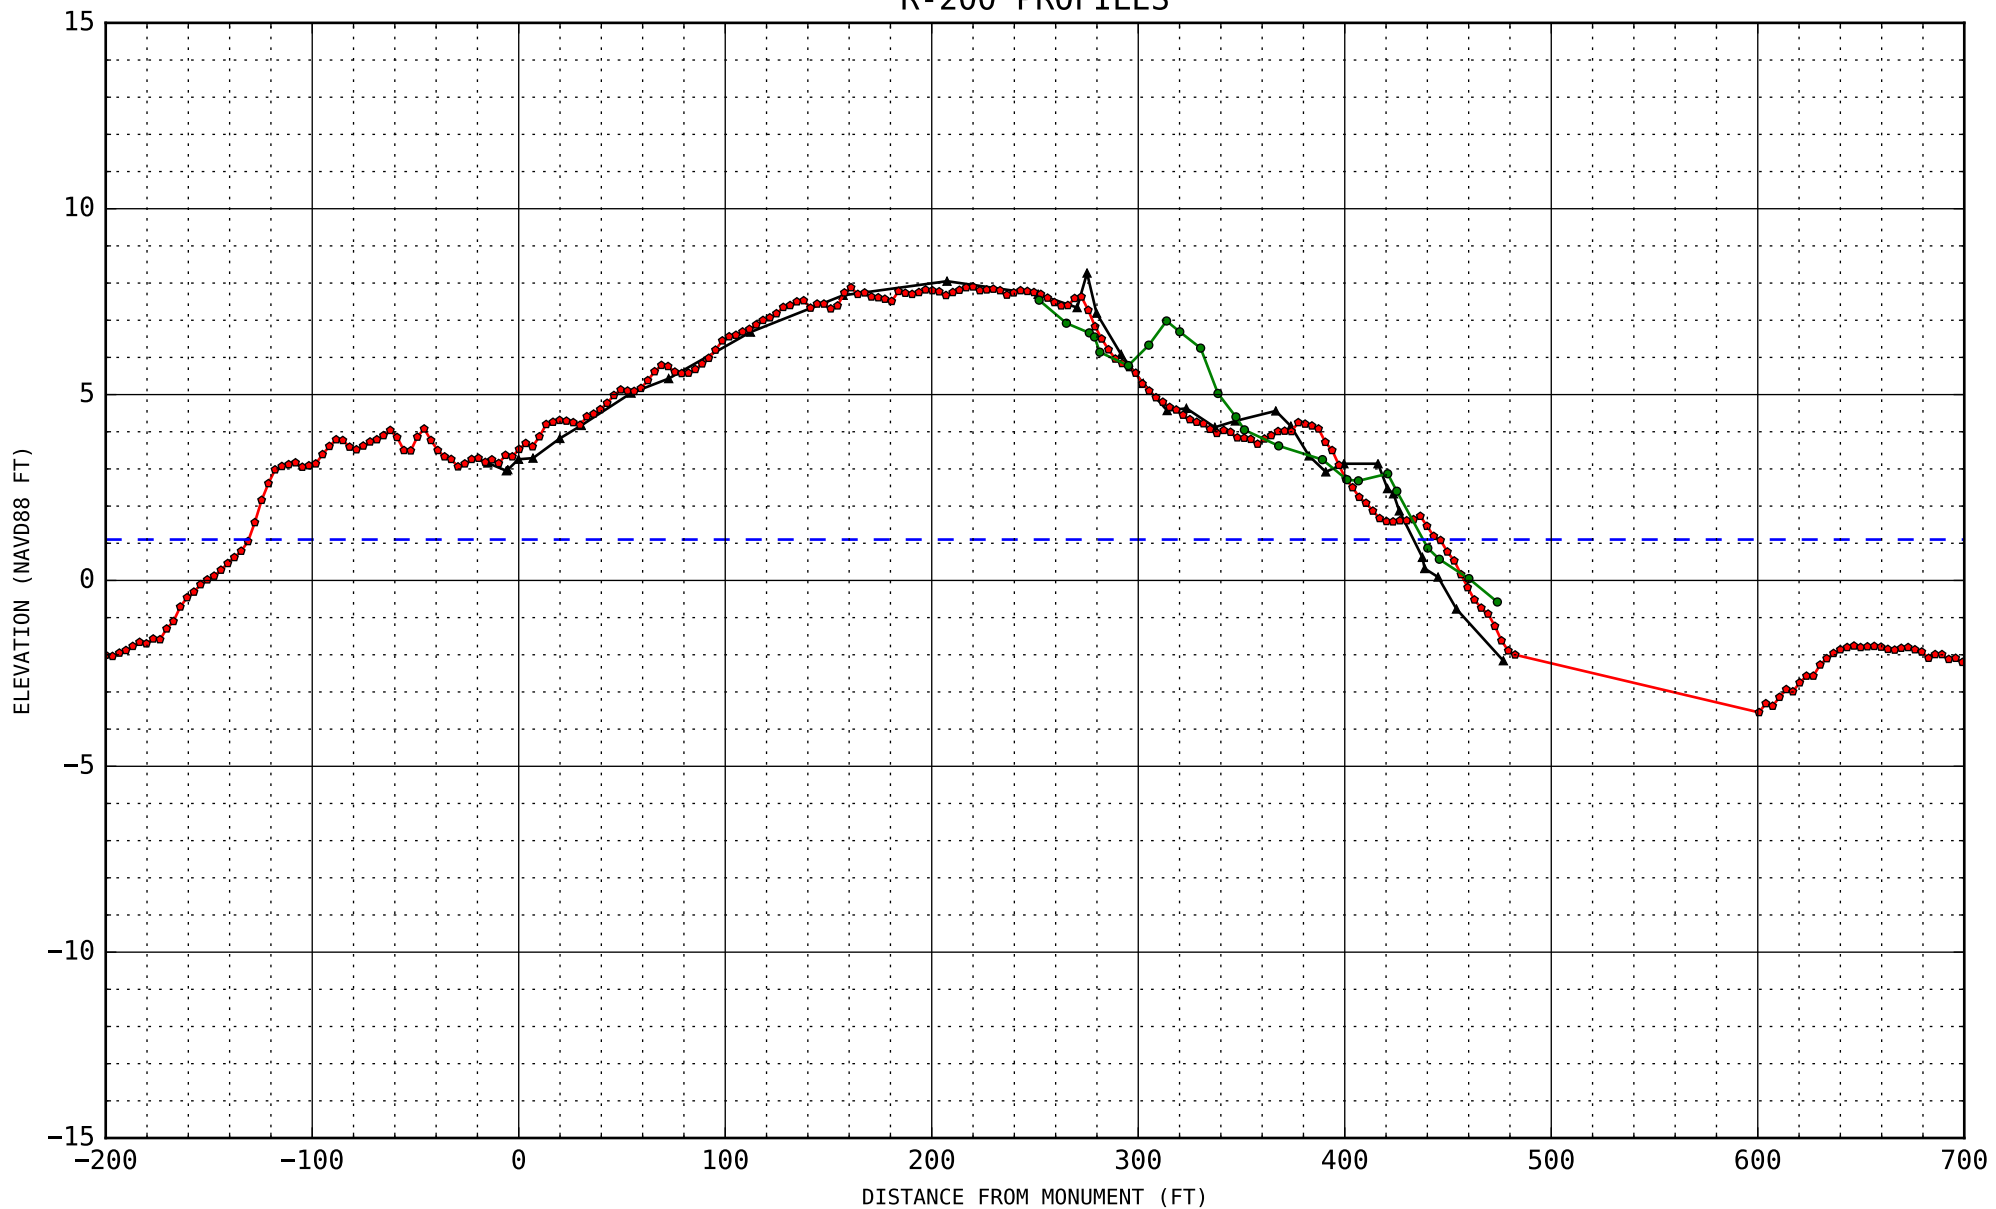
# R-200 PROFILES

- ▲ 2019-MAY CONDITION BY DEP
- 2018-OCT MONITORING BY USACE-LIDAR
- 2017-FEB MONITORING BY DEP
- - - MHW CONTOUR (1.1 FT)

RANGE: R-200  
 EST DATE: JUL1996  
 SURVEY DATE: 28MAY19  
 AZIMUTH: 190.0

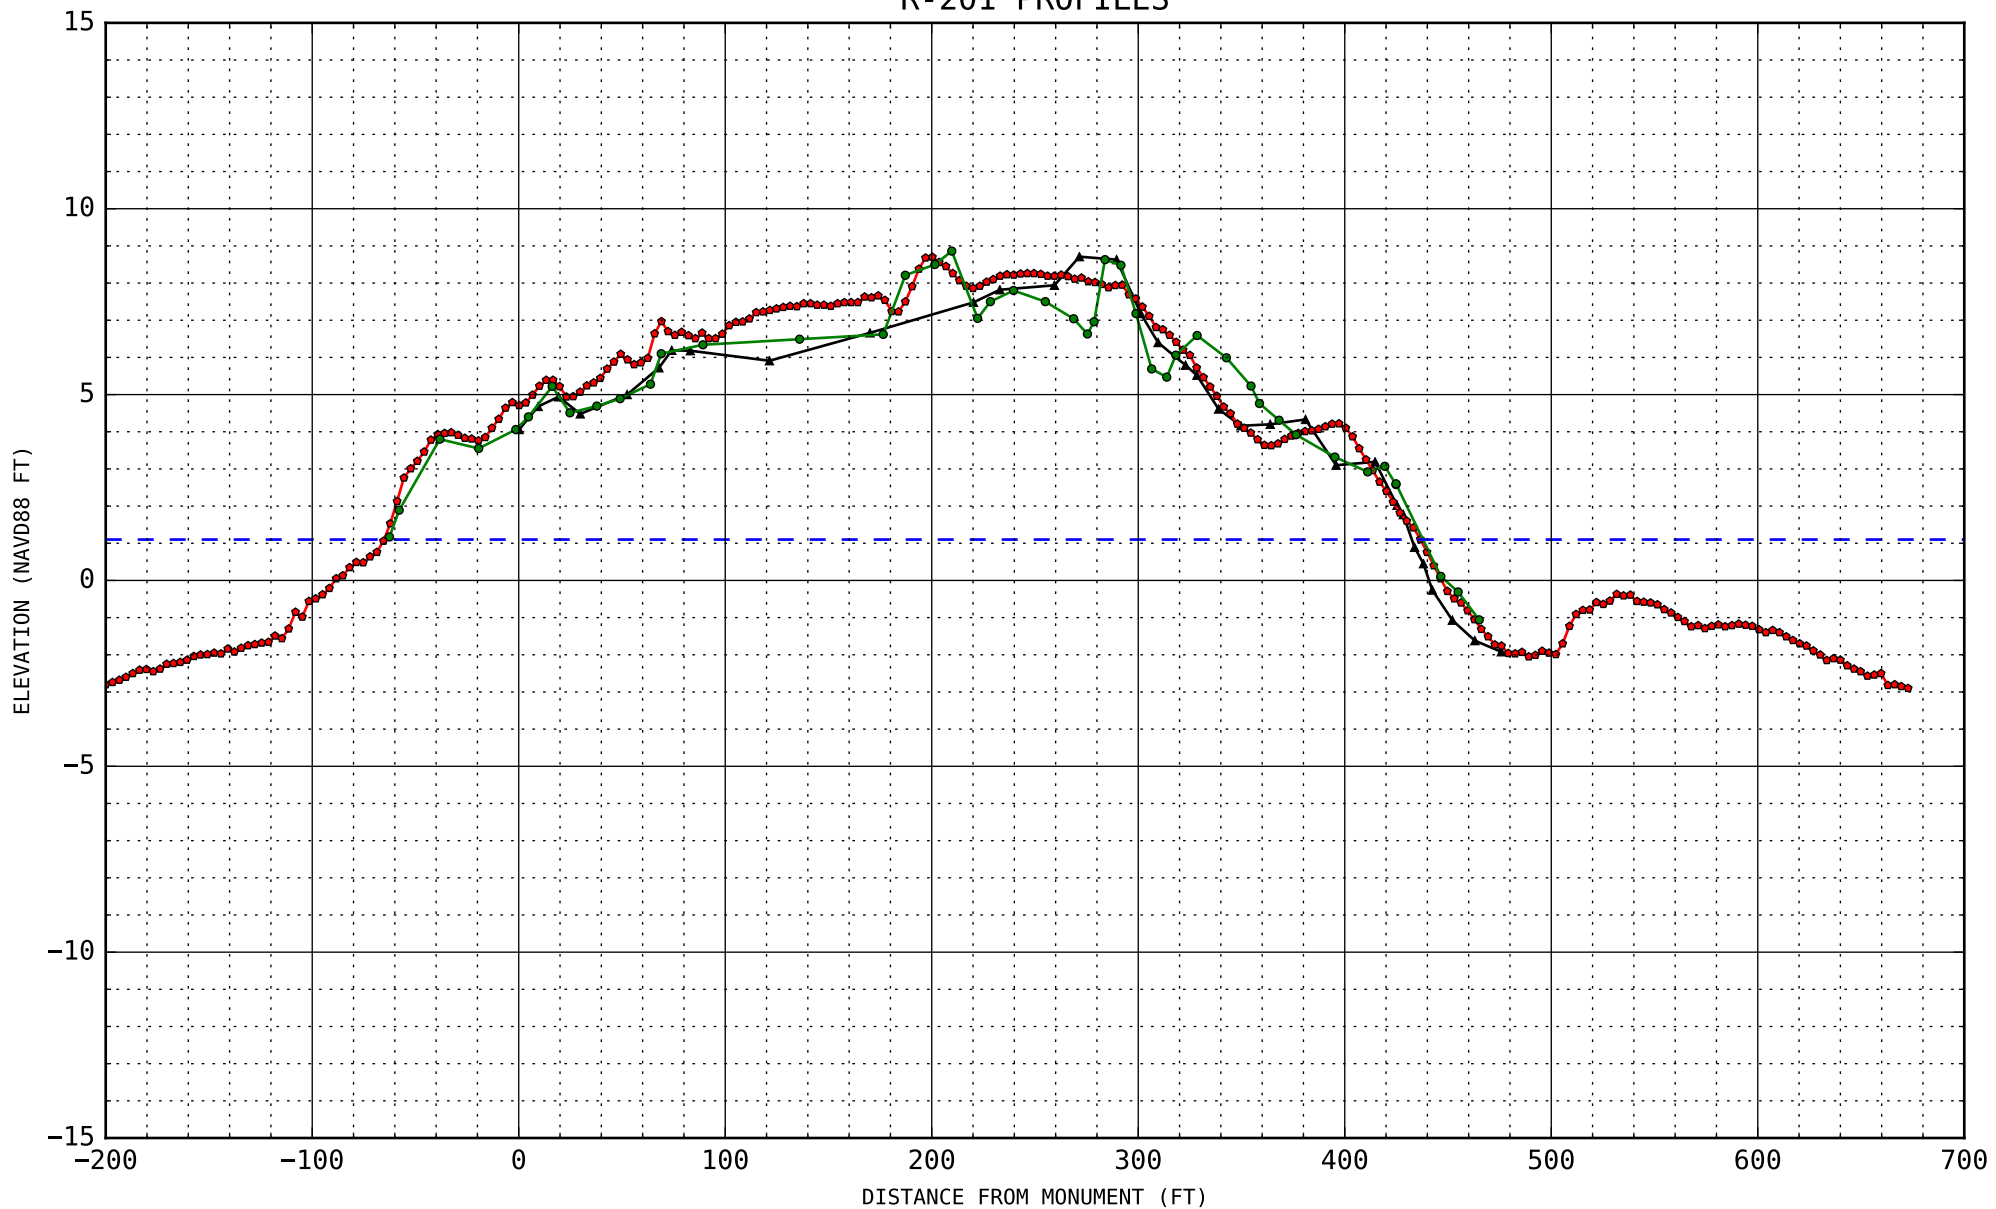
# R-201 PROFILES

- ▲ 2019-MAY CONDITION BY DEP
- 2018-OCT MONITORING BY USACE-LIDAR
- 2017-FEB MONITORING BY DEP
- - - MHW CONTOUR (1.1 FT)

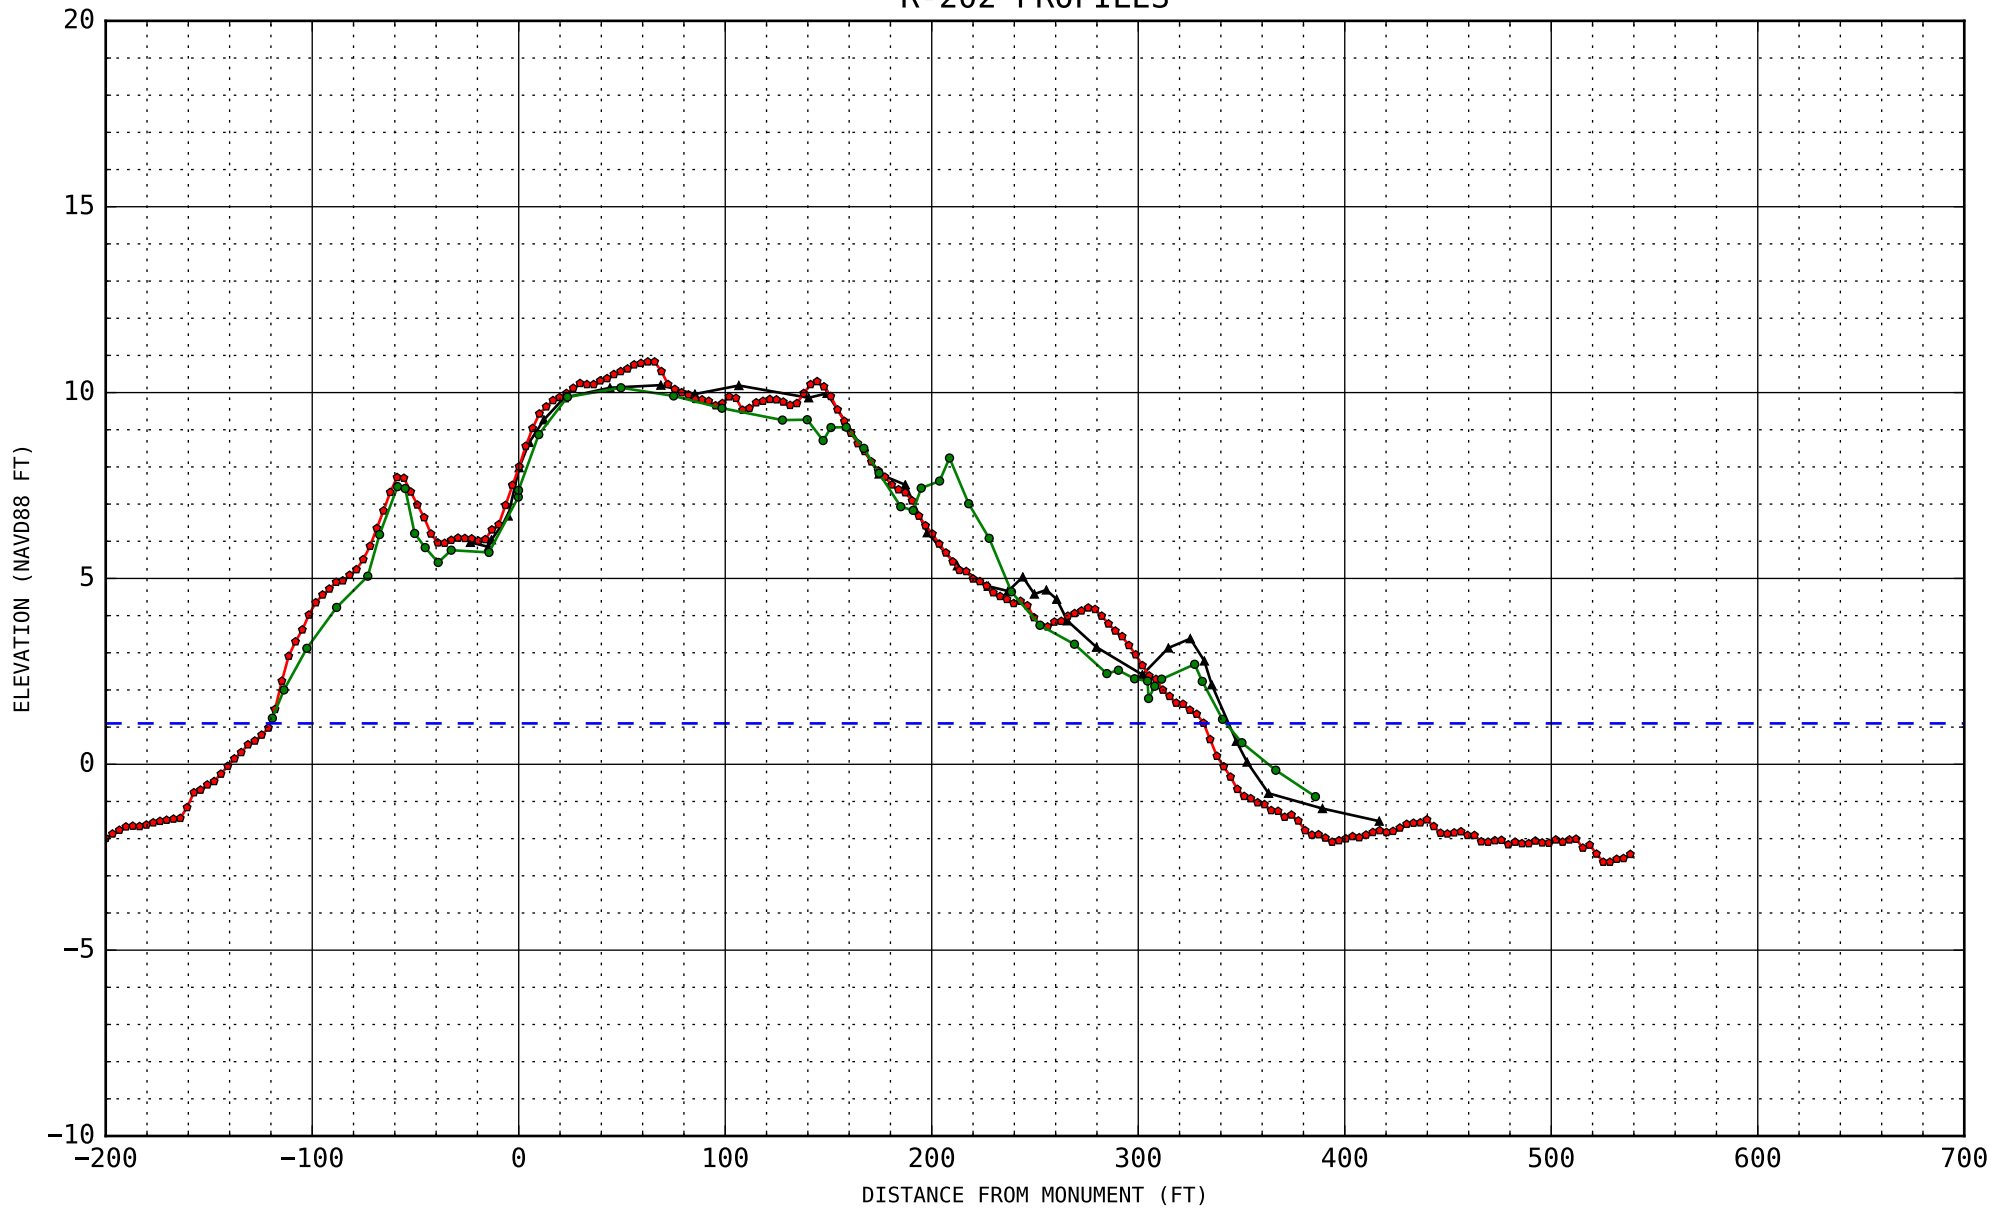
# R-202 PROFILES

- ▲ 2019-MAY CONDITION BY DEP
- 2018-OCT MONITORING BY USACE-LIDAR
- 2017-FEB MONITORING BY DEP
- - - MHW CONTOUR (1.1 FT)
