# R-52-T PROFILES

FRANKLIN  
PROGRAM SUPPORT GIS  
DIVISION OF WATER RESOURCE MANAGEMENT  
FLORIDA DEPARTMENT OF ENVIRONMENTAL PROTECTION

RANGE: R-52-T  
EST DATE: FEB1980  
SURVEY DATE: 16MAY19  
AZIMUTH: 150.0

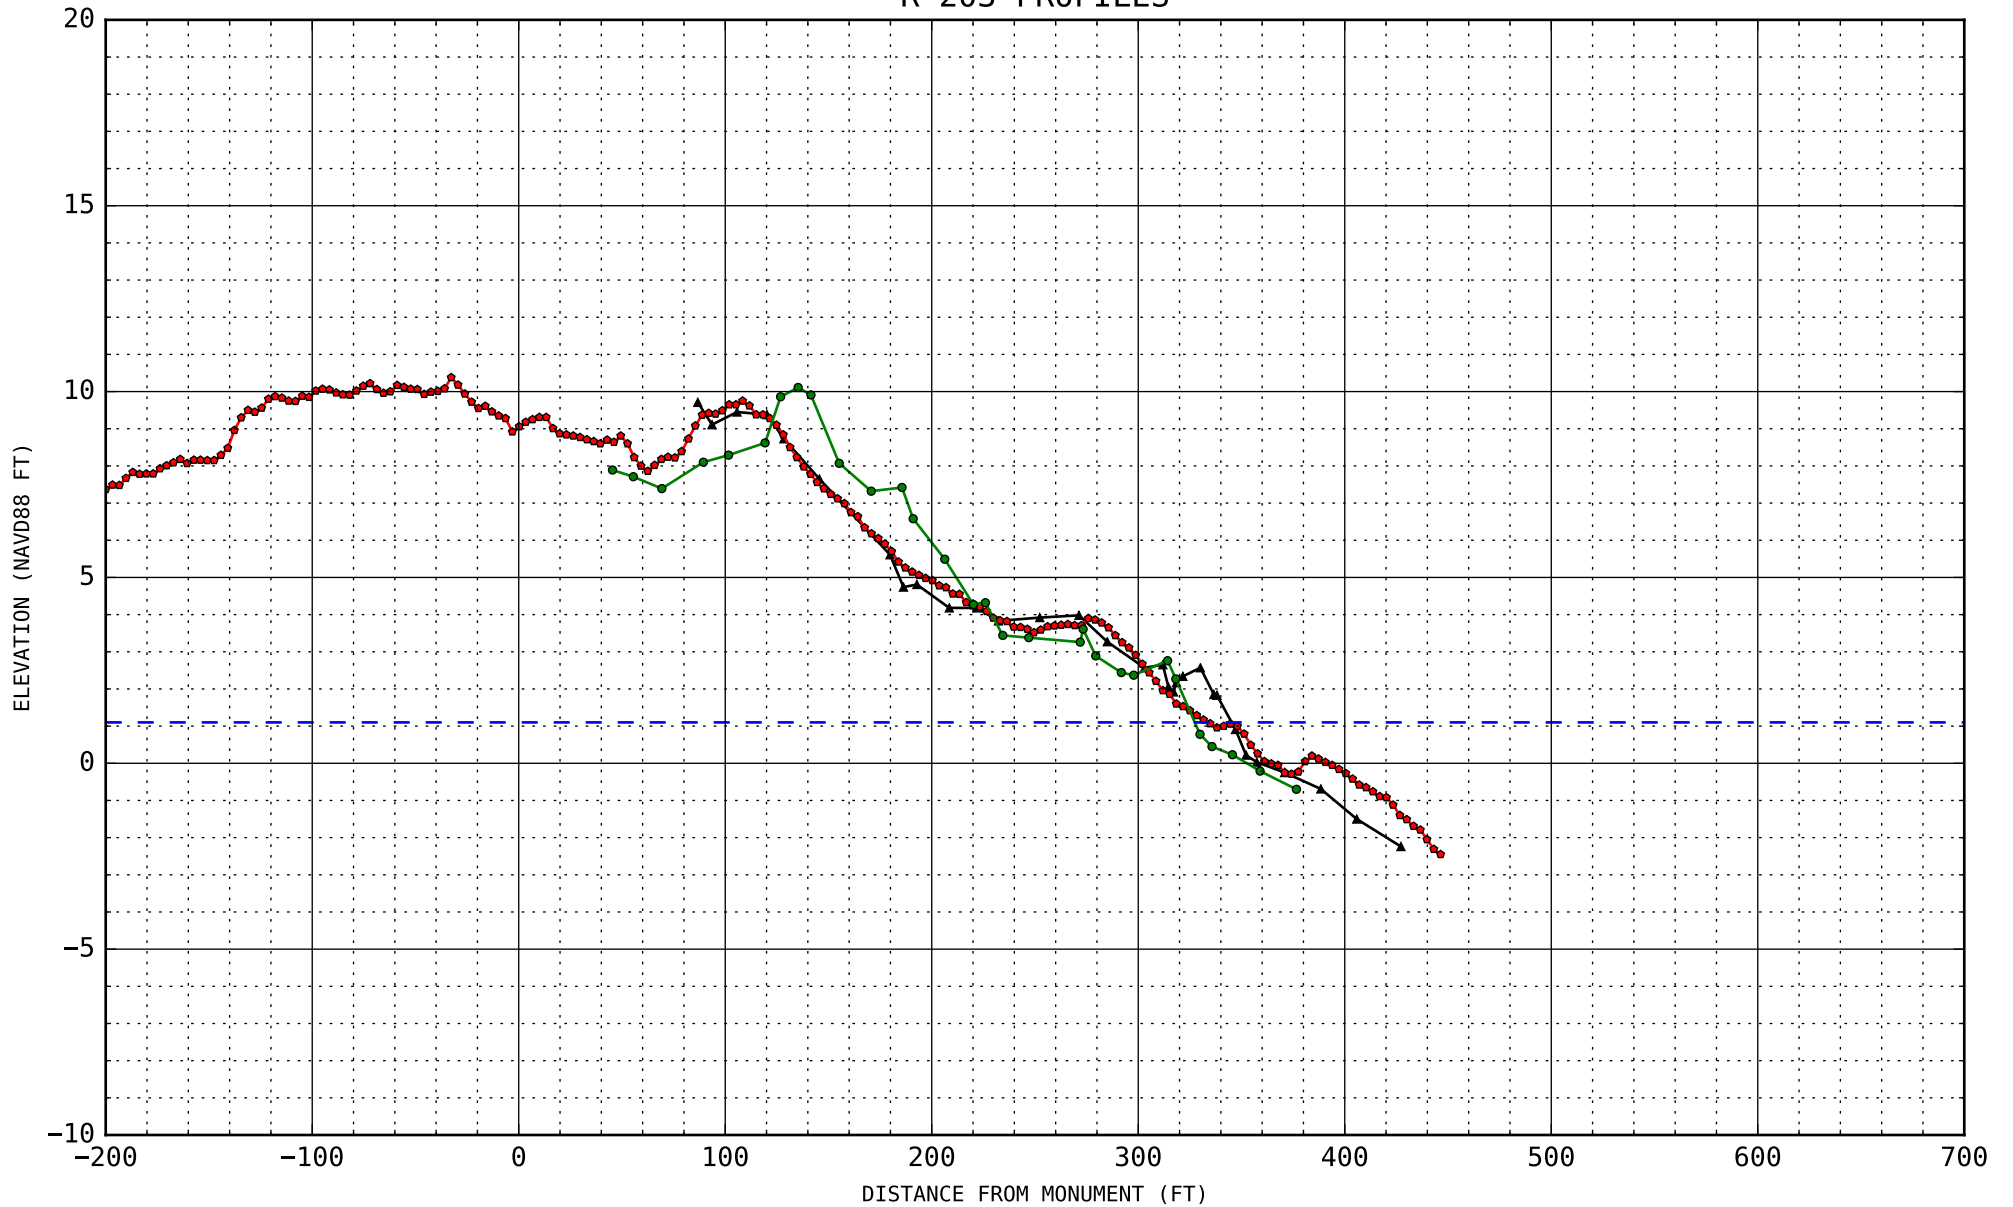
# R-203 PROFILES

- ▲ 2019-MAY CONDITION BY DEP
- 2018-OCT MONITORING BY USACE-LIDAR
- 2017-FEB MONITORING BY DEP
- - - MHW CONTOUR (1.1 FT)

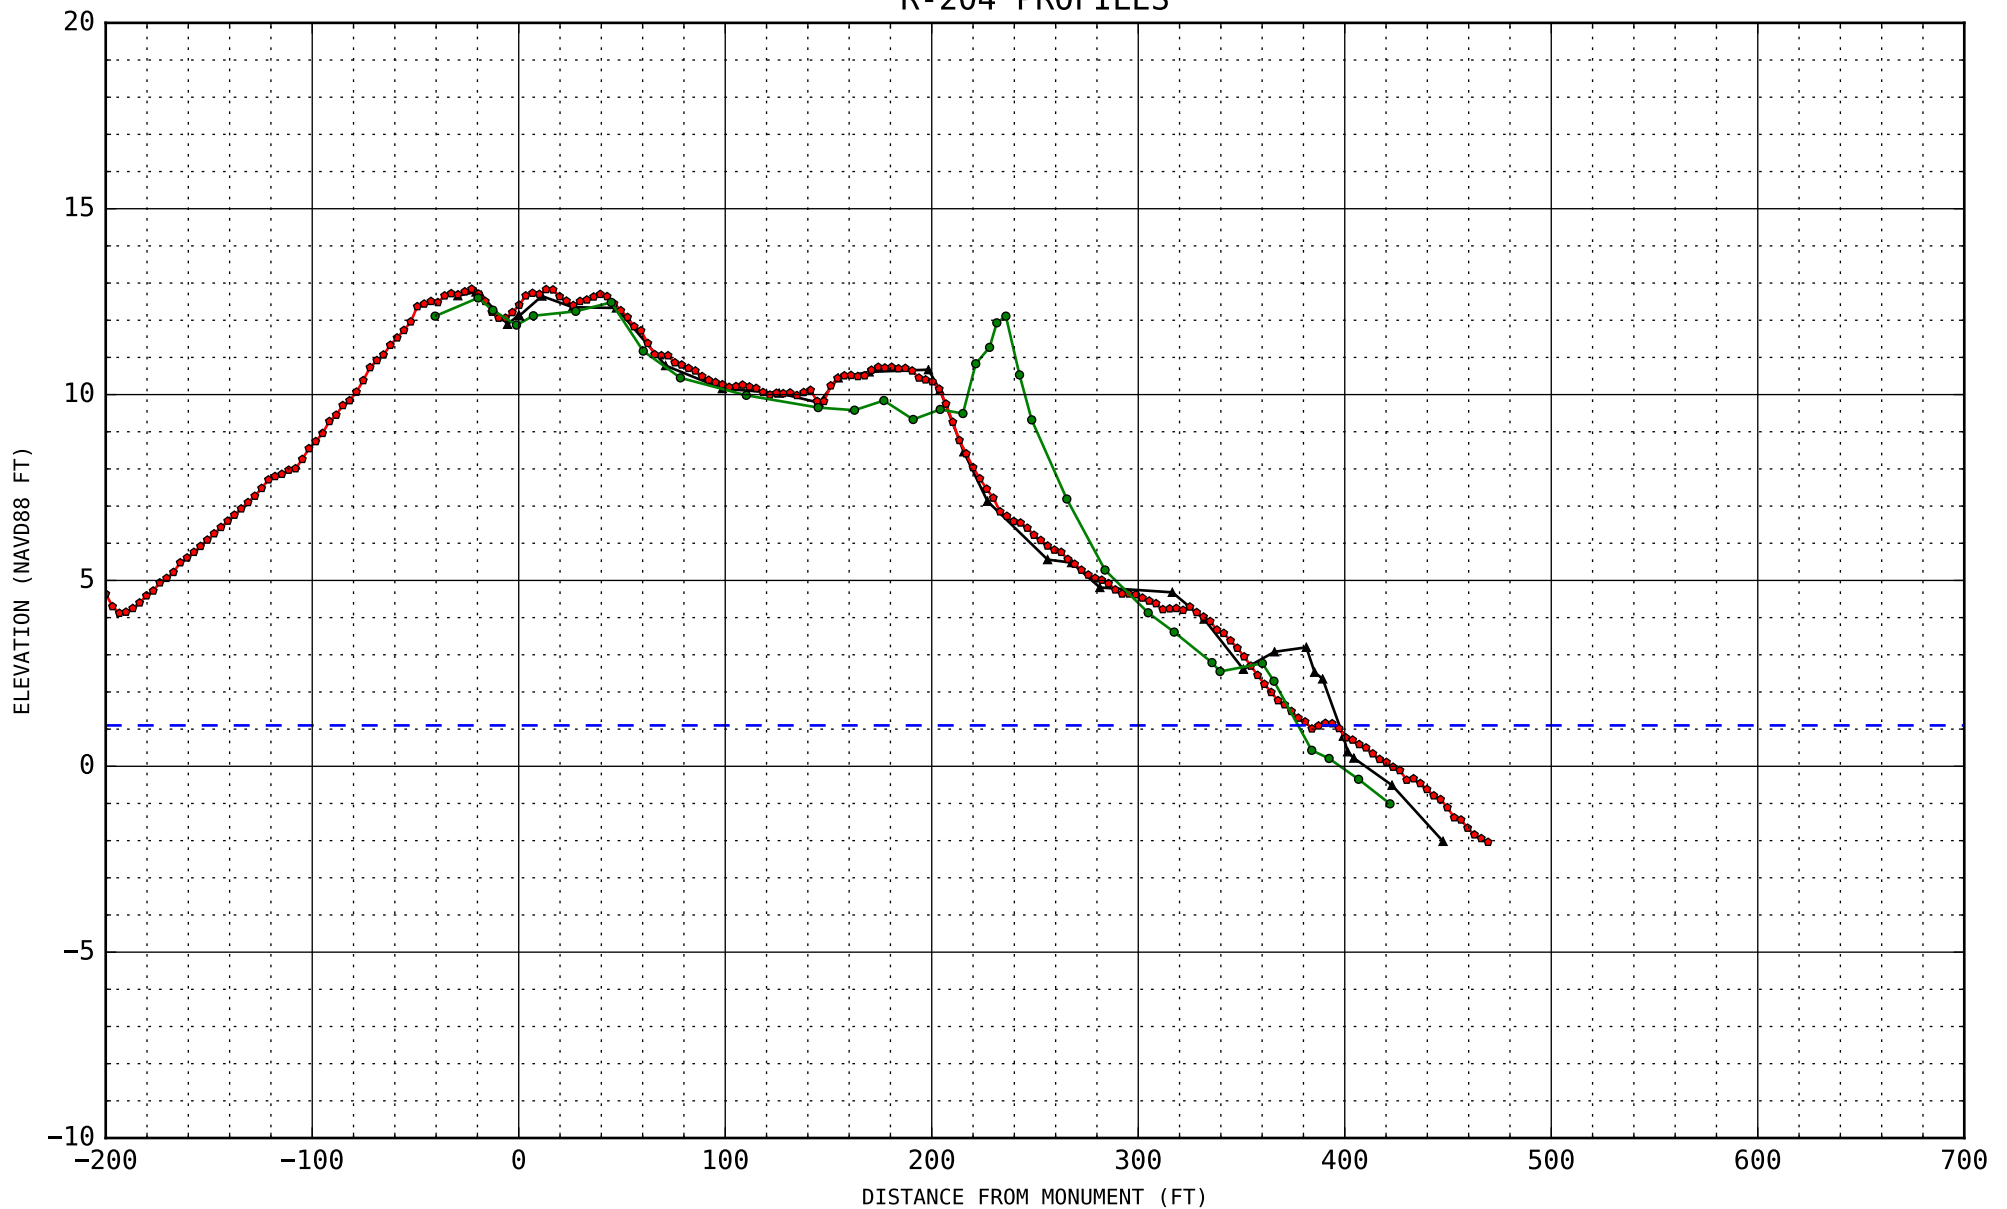
# R-204 PROFILES

- ▲ 2019-MAY CONDITION BY DEP
- 2018-OCT MONITORING BY USACE-LIDAR
- 2017-FEB MONITORING BY DEP
- - - MHW CONTOUR (1.1 FT)

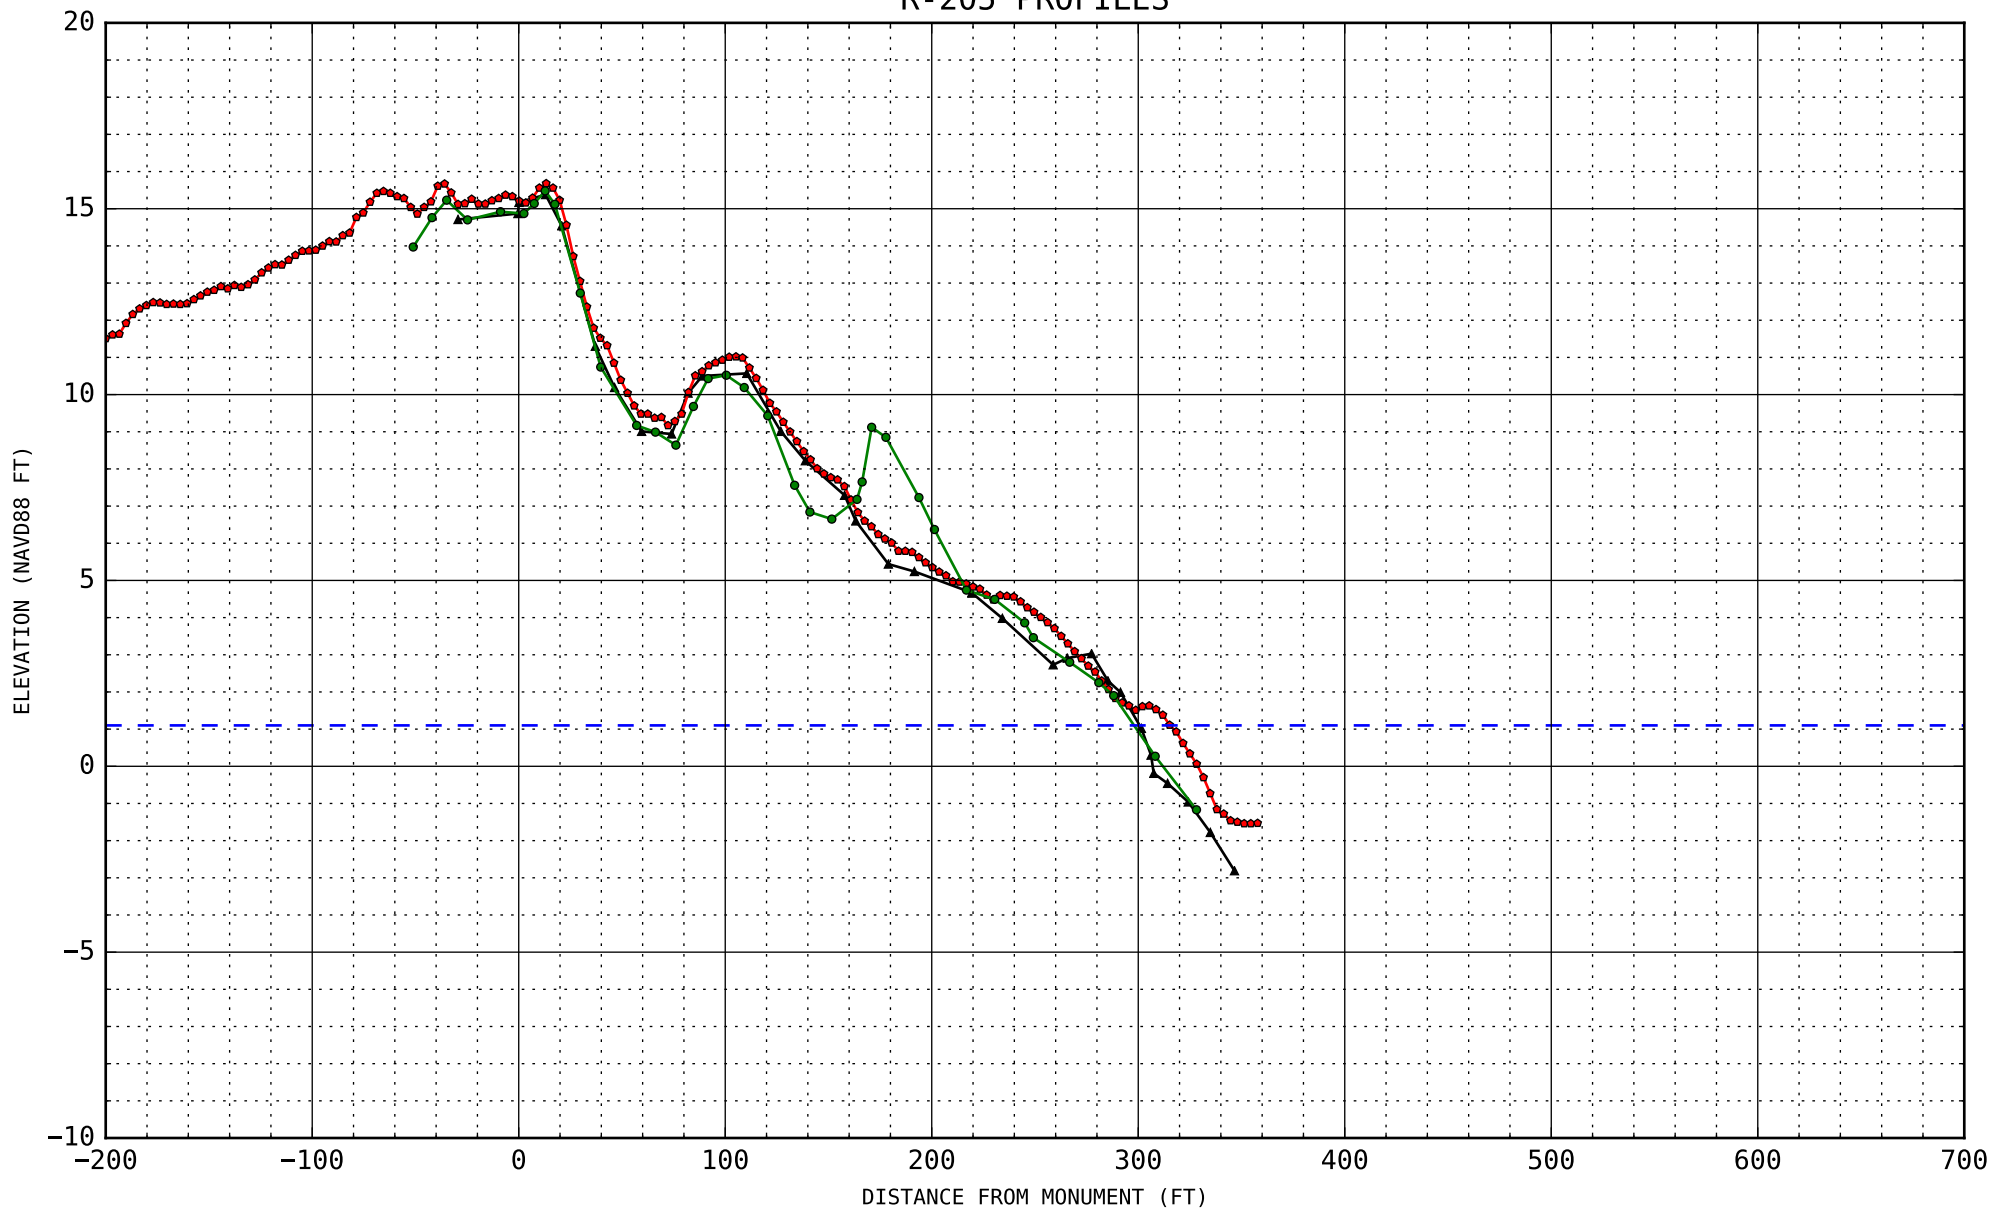
# R-205 PROFILES

- ▲ 2019-MAY CONDITION BY DEP
- 2018-OCT MONITORING BY USACE-LIDAR
- 2017-FEB MONITORING BY DEP
- - - MHW CONTOUR (1.1 FT)

RANGE: R-205  
 EST DATE: MMM1974  
 SURVEY DATE: 28MAY19  
 AZIMUTH: 200.0

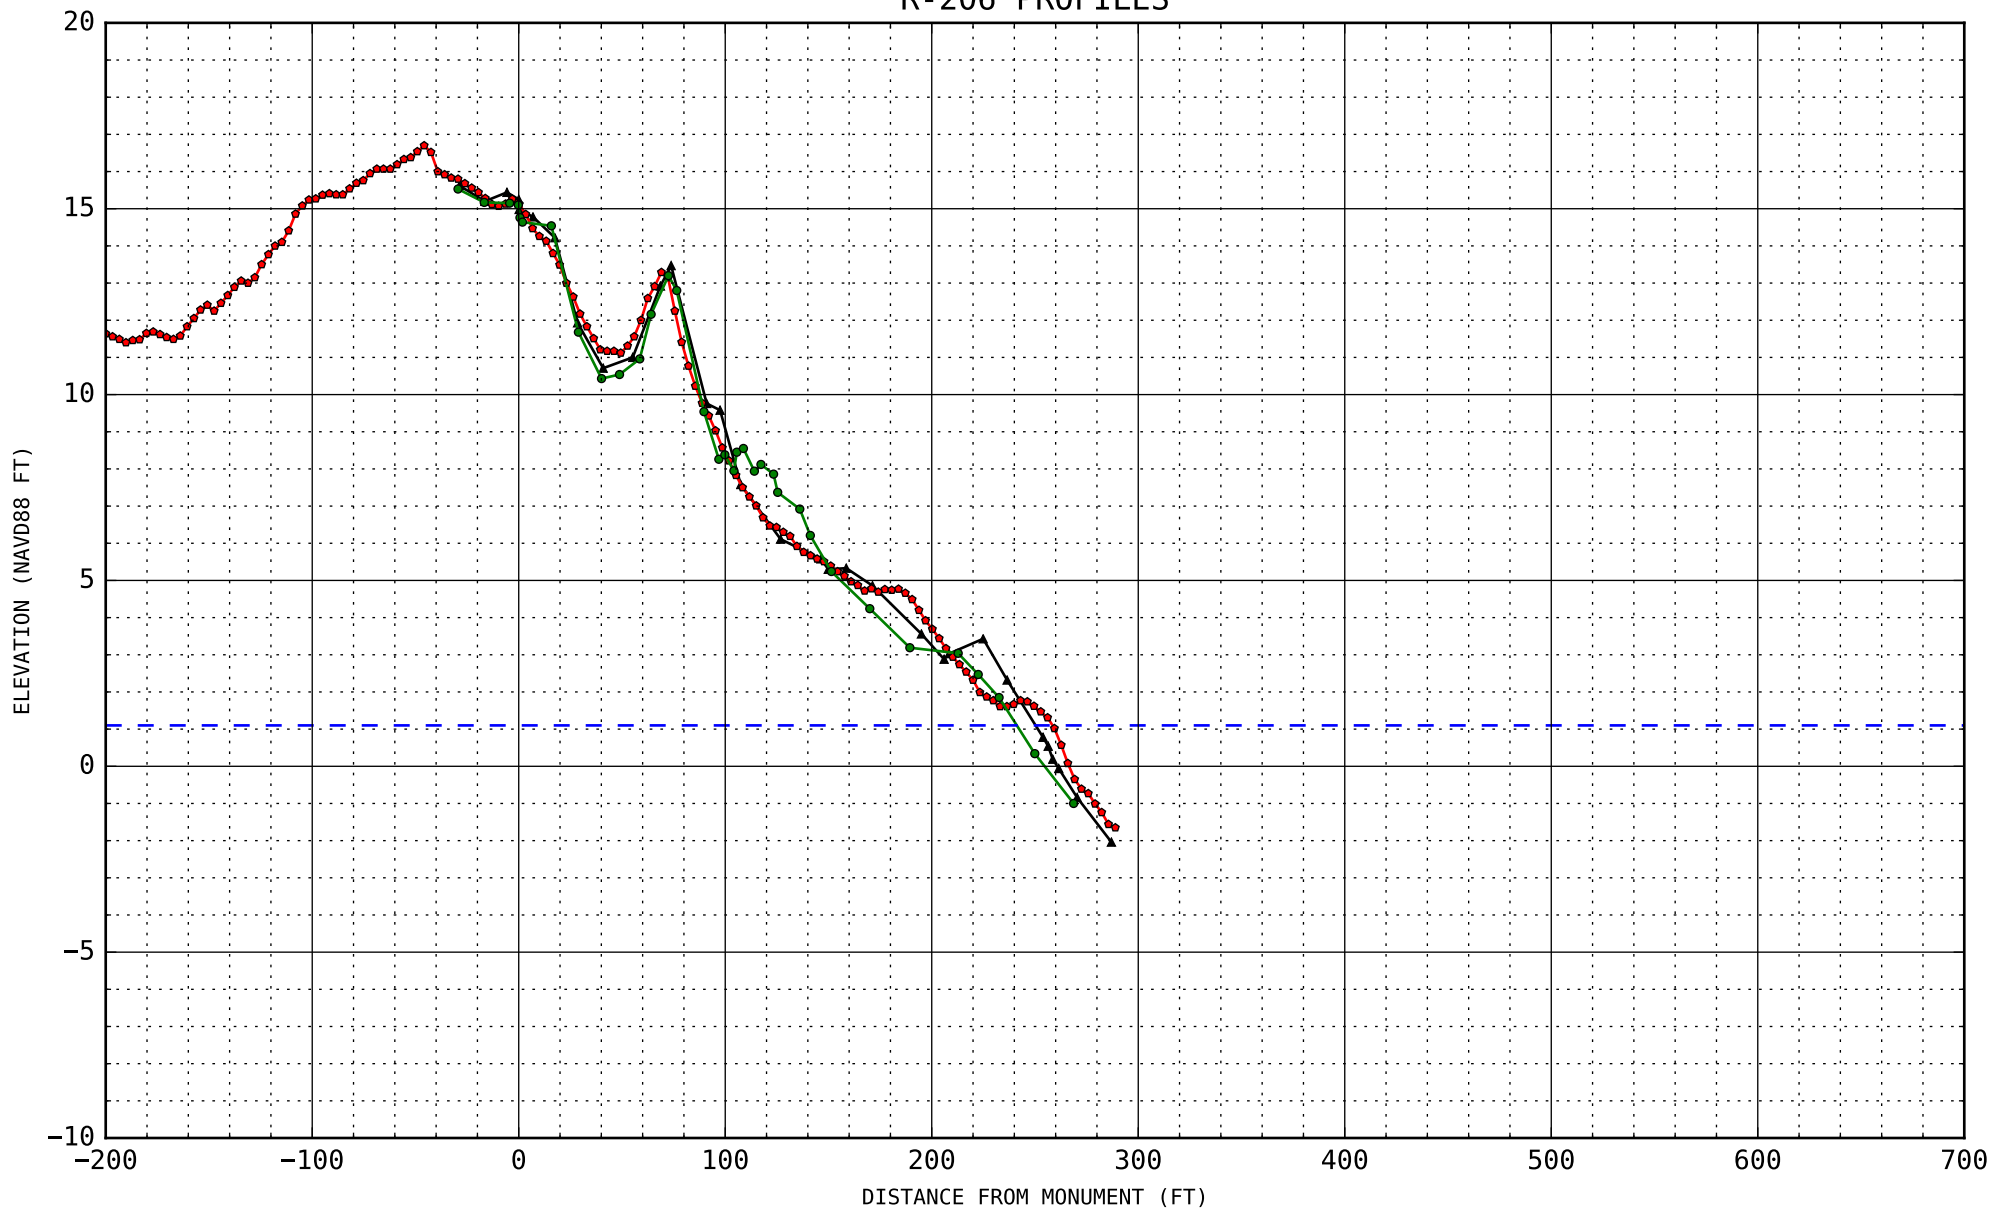
# R-206 PROFILES

- ▲ 2019-MAY CONDITION BY DEP
- 2018-OCT MONITORING BY USACE-LIDAR
- 2017-FEB MONITORING BY DEP
- - - MHW CONTOUR (1.1 FT)

RANGE: R-206  
EST DATE: MMM1974  
SURVEY DATE: 28MAY19  
AZIMUTH: 200.0

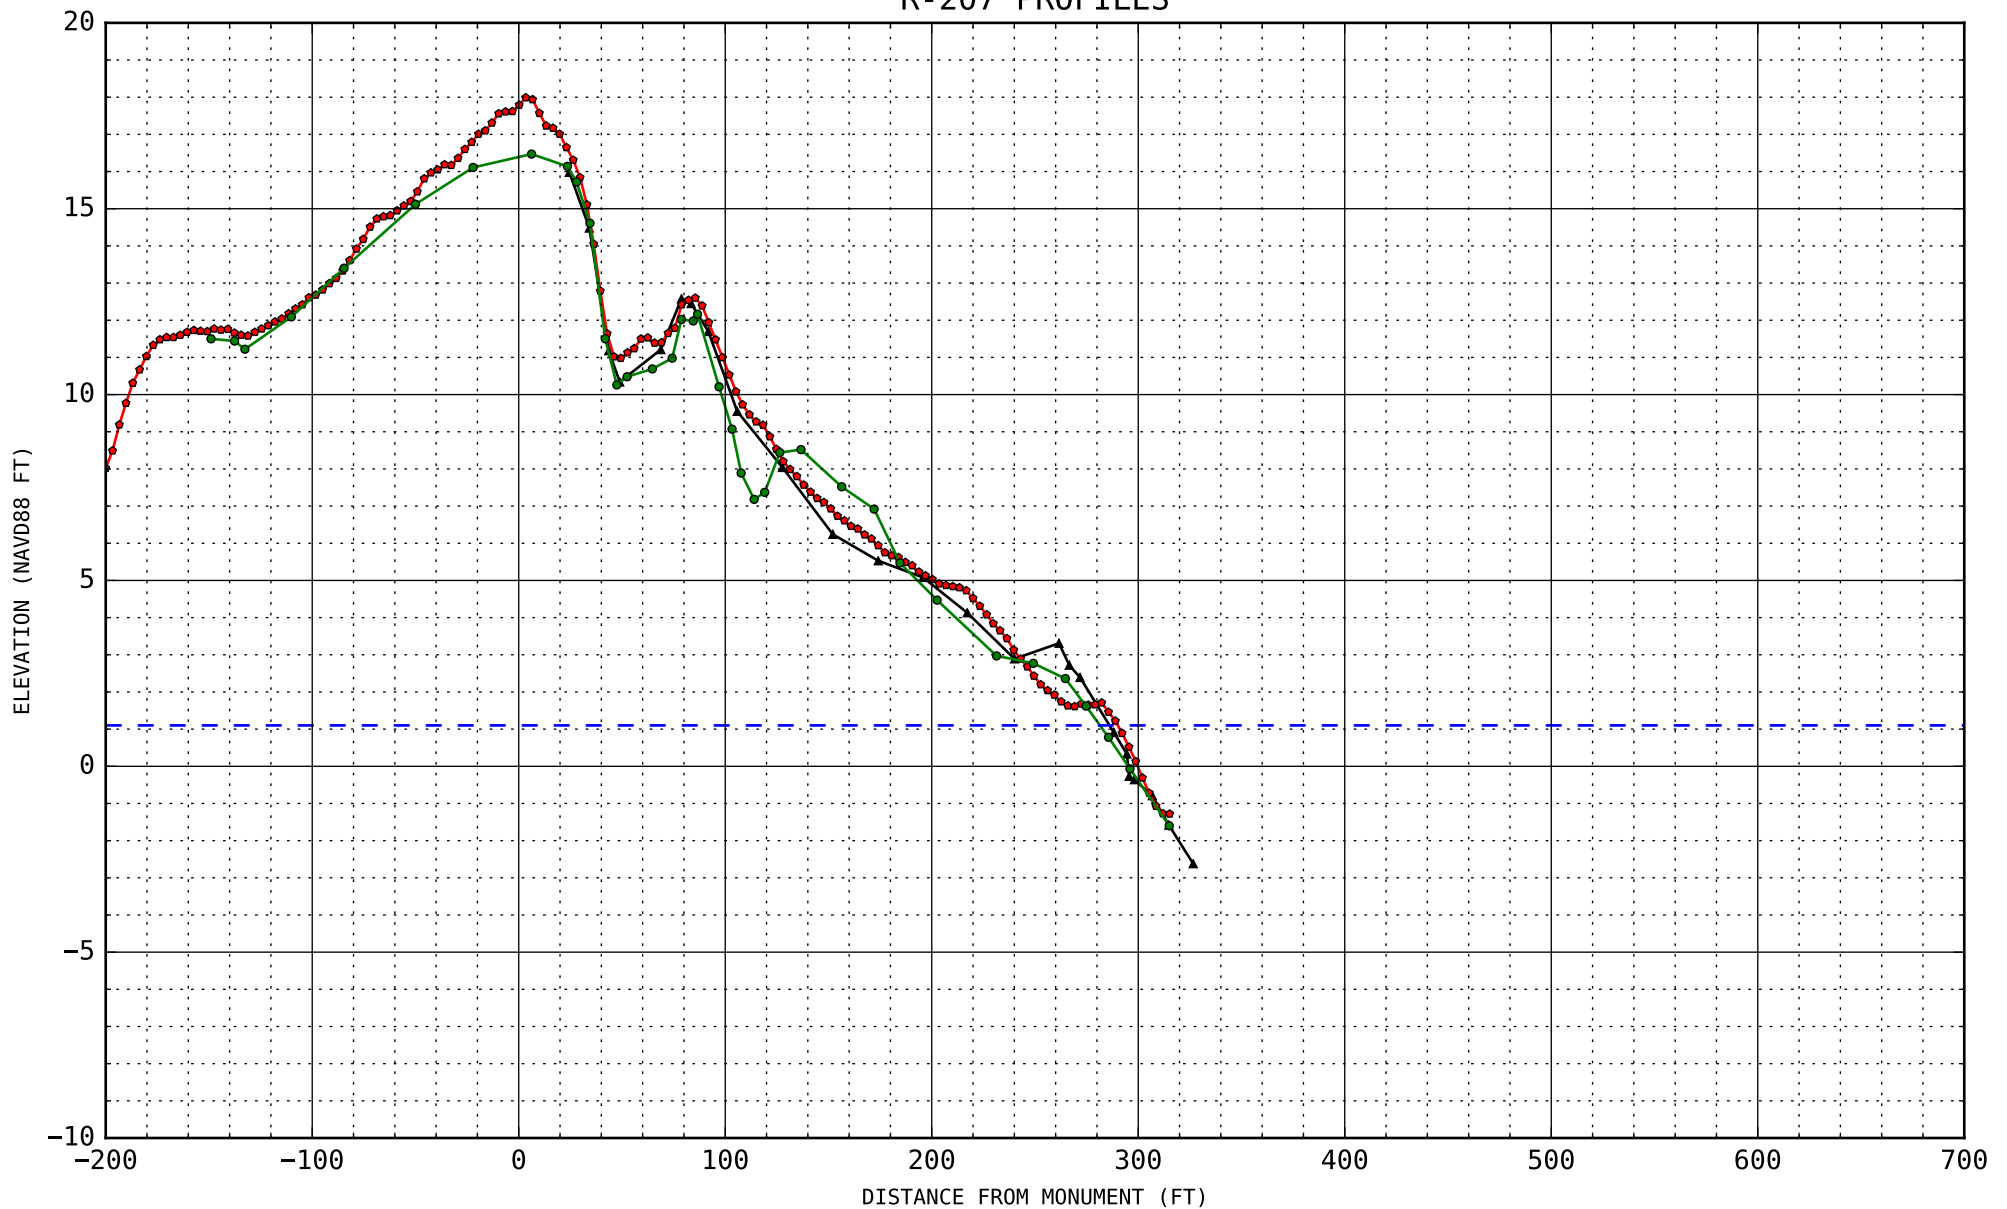
# R-207 PROFILES

- ▲ 2019-MAY CONDITION BY DEP
- 2018-OCT MONITORING BY USACE-LIDAR
- 2017-FEB MONITORING BY DEP
- - - MHW CONTOUR (1.1 FT)

RANGE: R-207  
EST DATE: MMM1974  
SURVEY DATE: 28MAY19  
AZIMUTH: 200.0

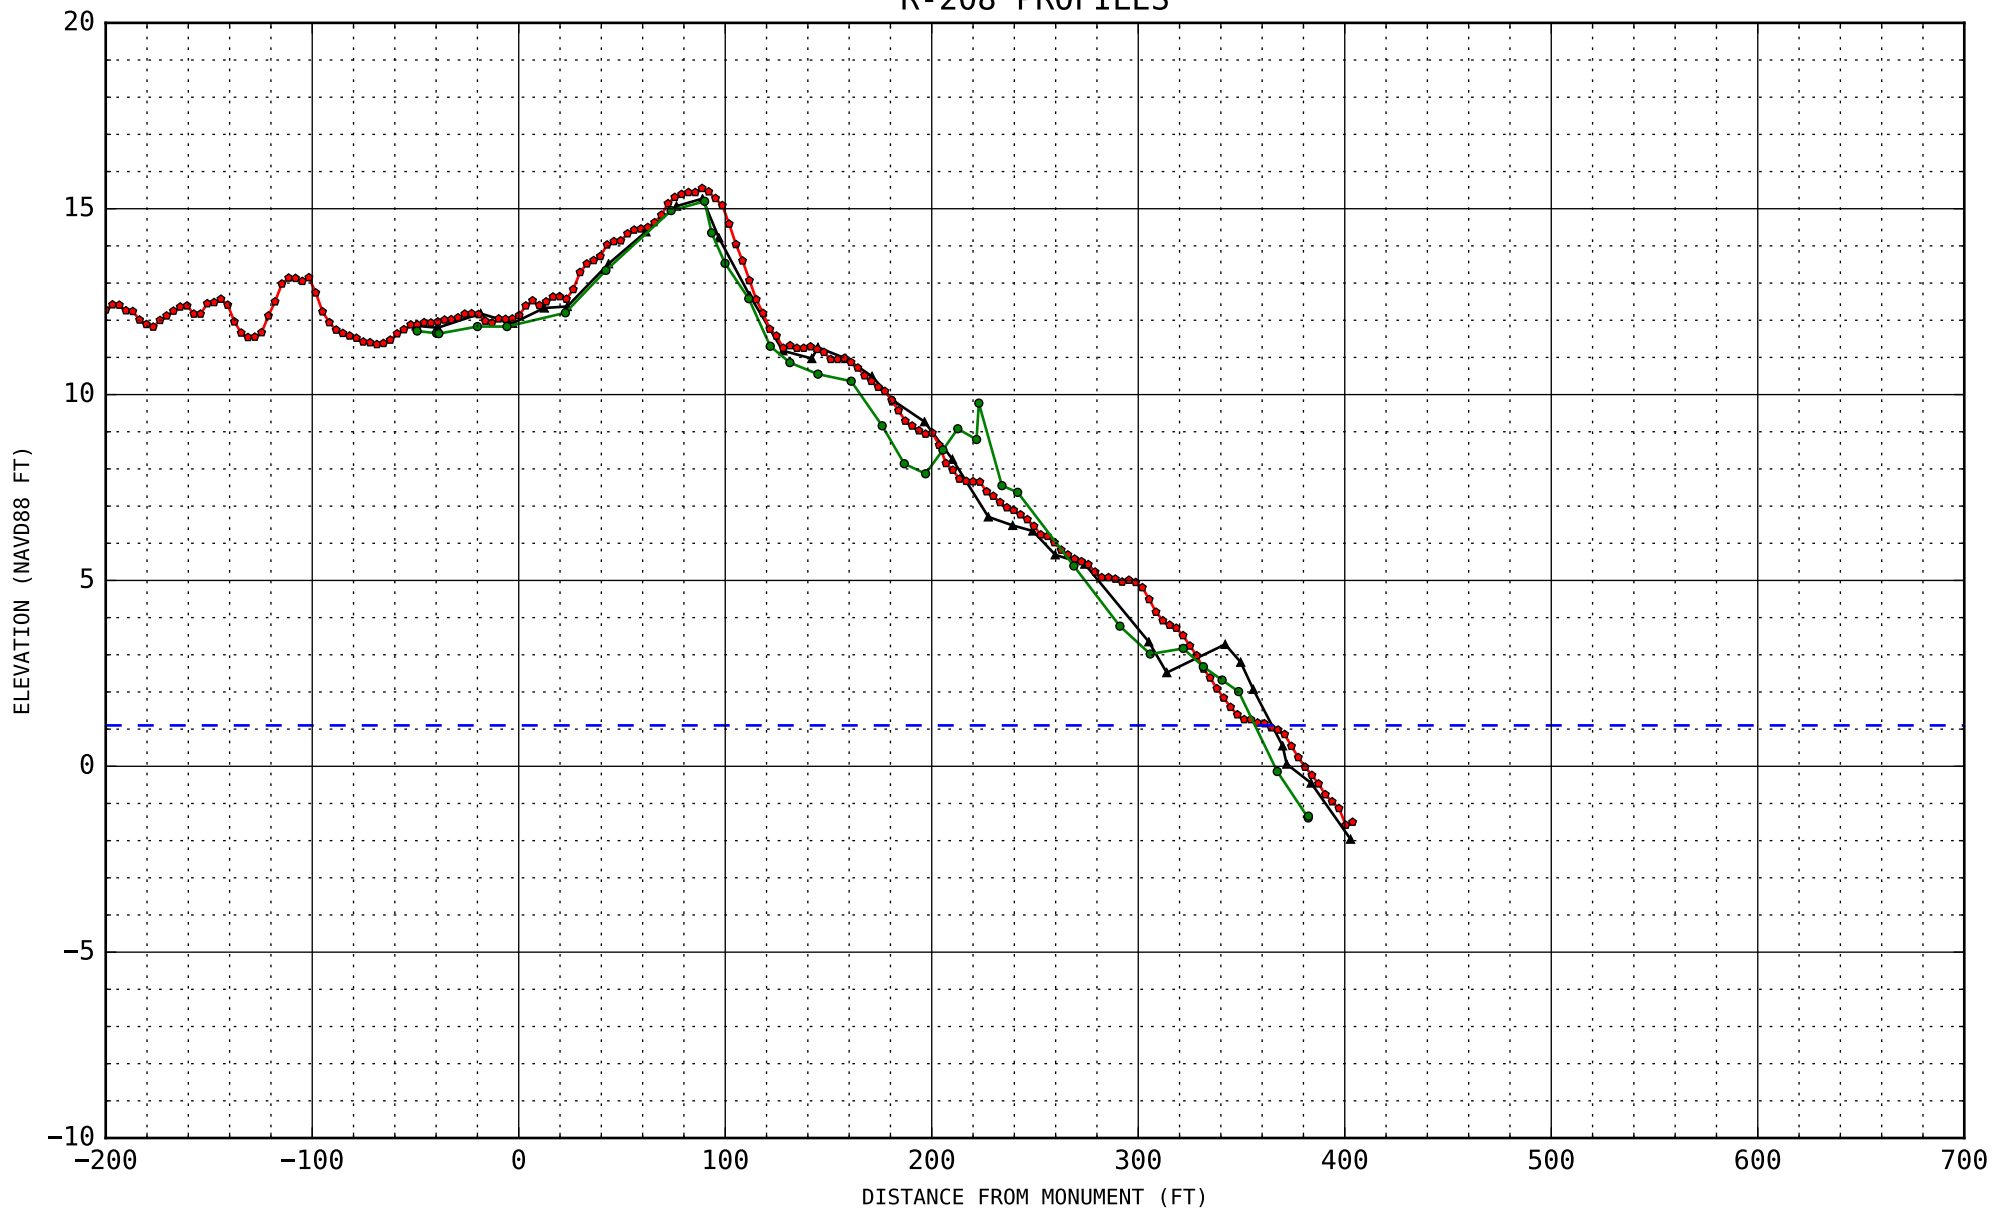
# R-208 PROFILES

- ▲ 2019-MAY CONDITION BY DEP
- 2018-OCT MONITORING BY USACE-LIDAR
- 2017-FEB MONITORING BY DEP
- - - MHW CONTOUR (1.1 FT)

RANGE: R-208  
 EST DATE: MMM1974  
 SURVEY DATE: 28MAY19  
 AZIMUTH: 205.0

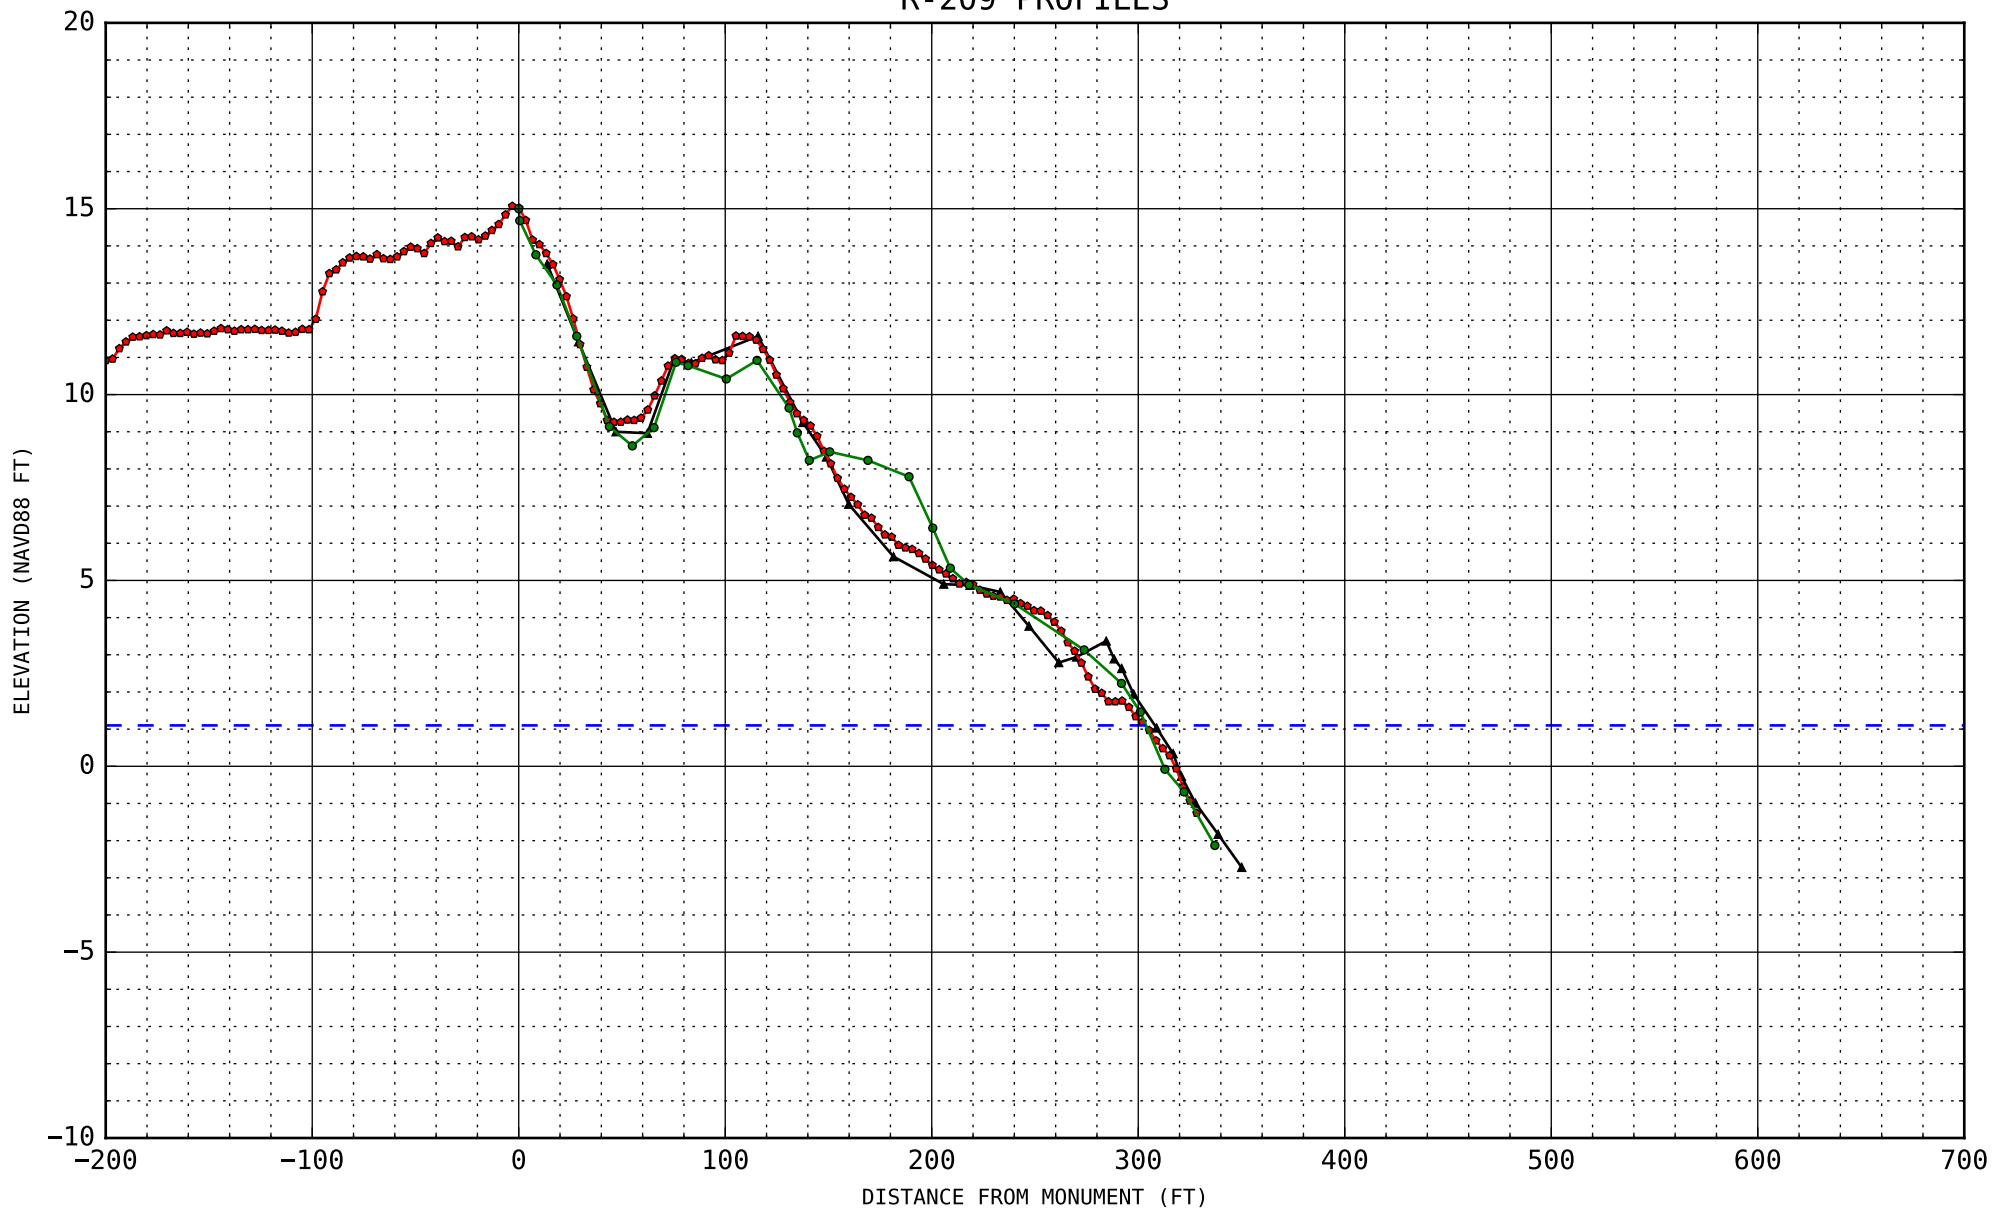
# R-209 PROFILES

- ▲ 2019-MAY CONDITION BY DEP
- 2018-OCT MONITORING BY USACE-LIDAR
- 2017-FEB MONITORING BY DEP
- - - MHW CONTOUR (1.1 FT)

RANGE: R-209  
EST DATE: MMM1974  
SURVEY DATE: 28MAY19  
AZIMUTH: 205.0

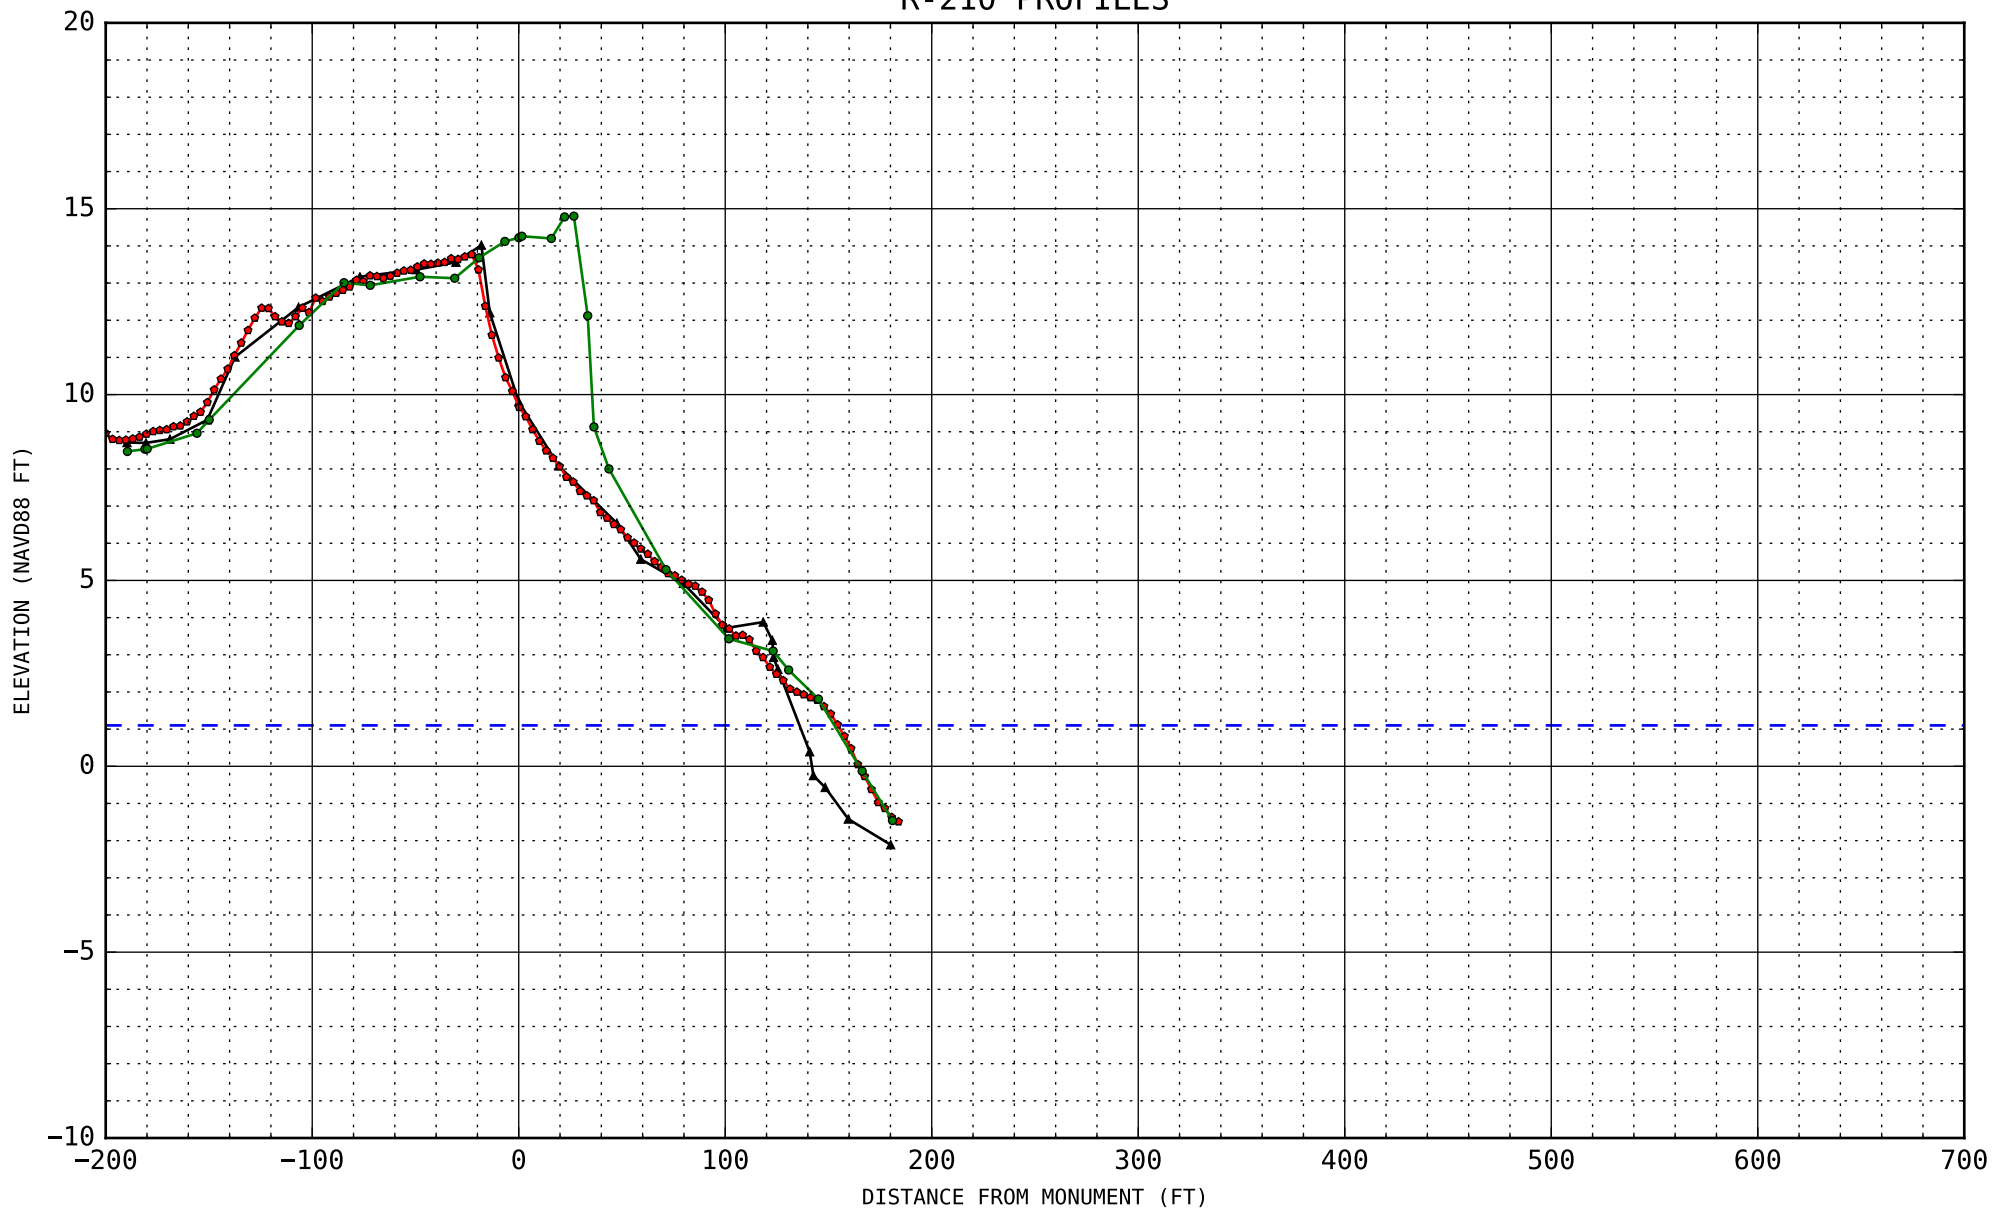
# R-210 PROFILES

- ▲ 2019-MAY CONDITION BY DEP
- 2018-OCT MONITORING BY USACE-LIDAR
- 2017-FEB MONITORING BY DEP
- - - MHW CONTOUR (1.1 FT)

RANGE: R-210  
 EST DATE: MMM1974  
 SURVEY DATE: 28MAY19  
 AZIMUTH: 205.0

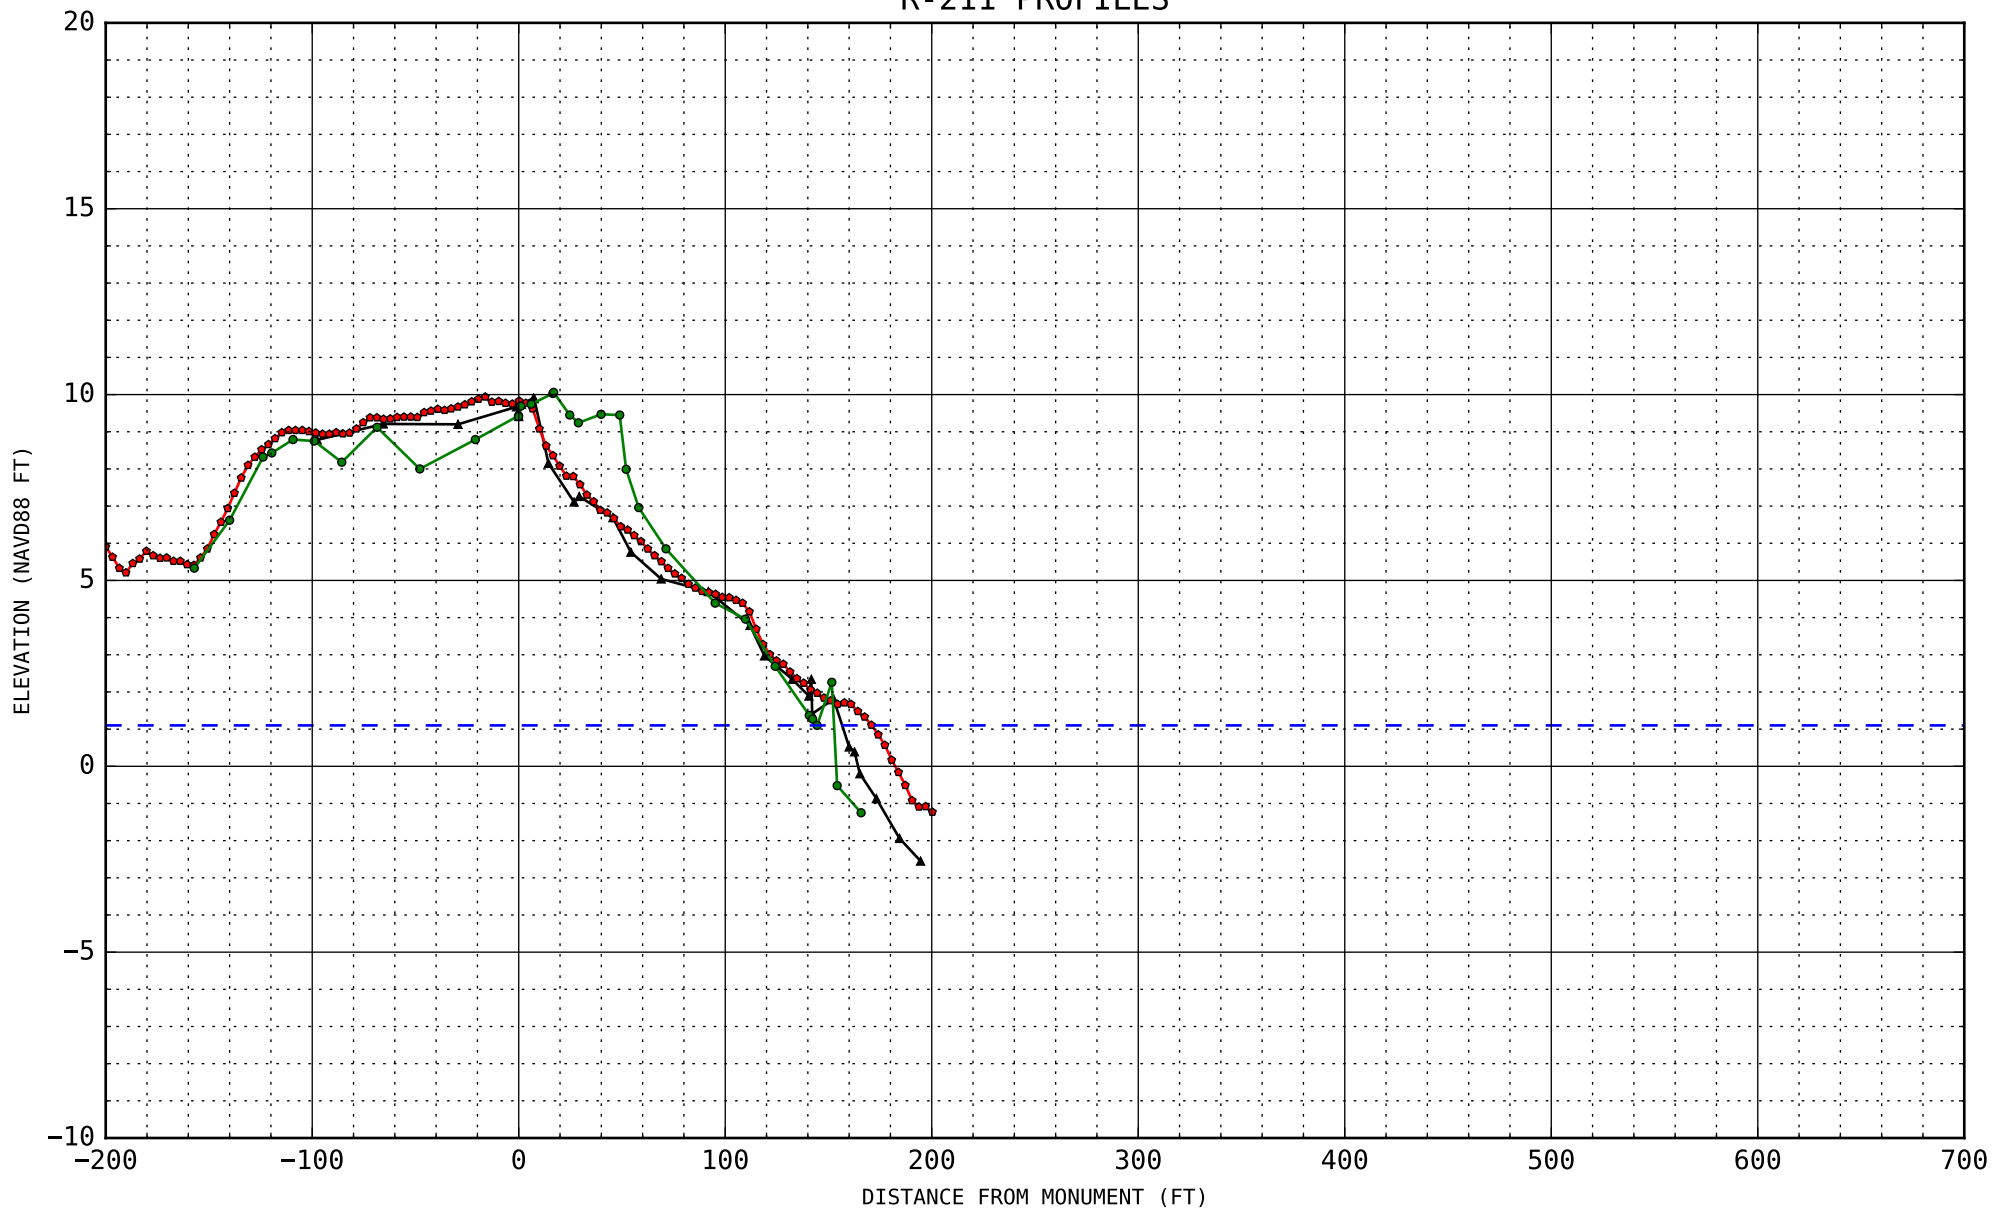
# R-211 PROFILES

- ▲ 2019-MAY CONDITION BY DEP
- 2018-OCT MONITORING BY USACE-LIDAR
- 2017-FEB MONITORING BY DEP
- - - MHW CONTOUR (1.1 FT)
