# R-52-T PROFILES

FRANKLIN  
PROGRAM SUPPORT GIS  
DIVISION OF WATER RESOURCE MANAGEMENT  
FLORIDA DEPARTMENT OF ENVIRONMENTAL PROTECTION

RANGE: R-52-T  
EST DATE: FEB1980  
SURVEY DATE: 16MAY19  
AZIMUTH: 150.0

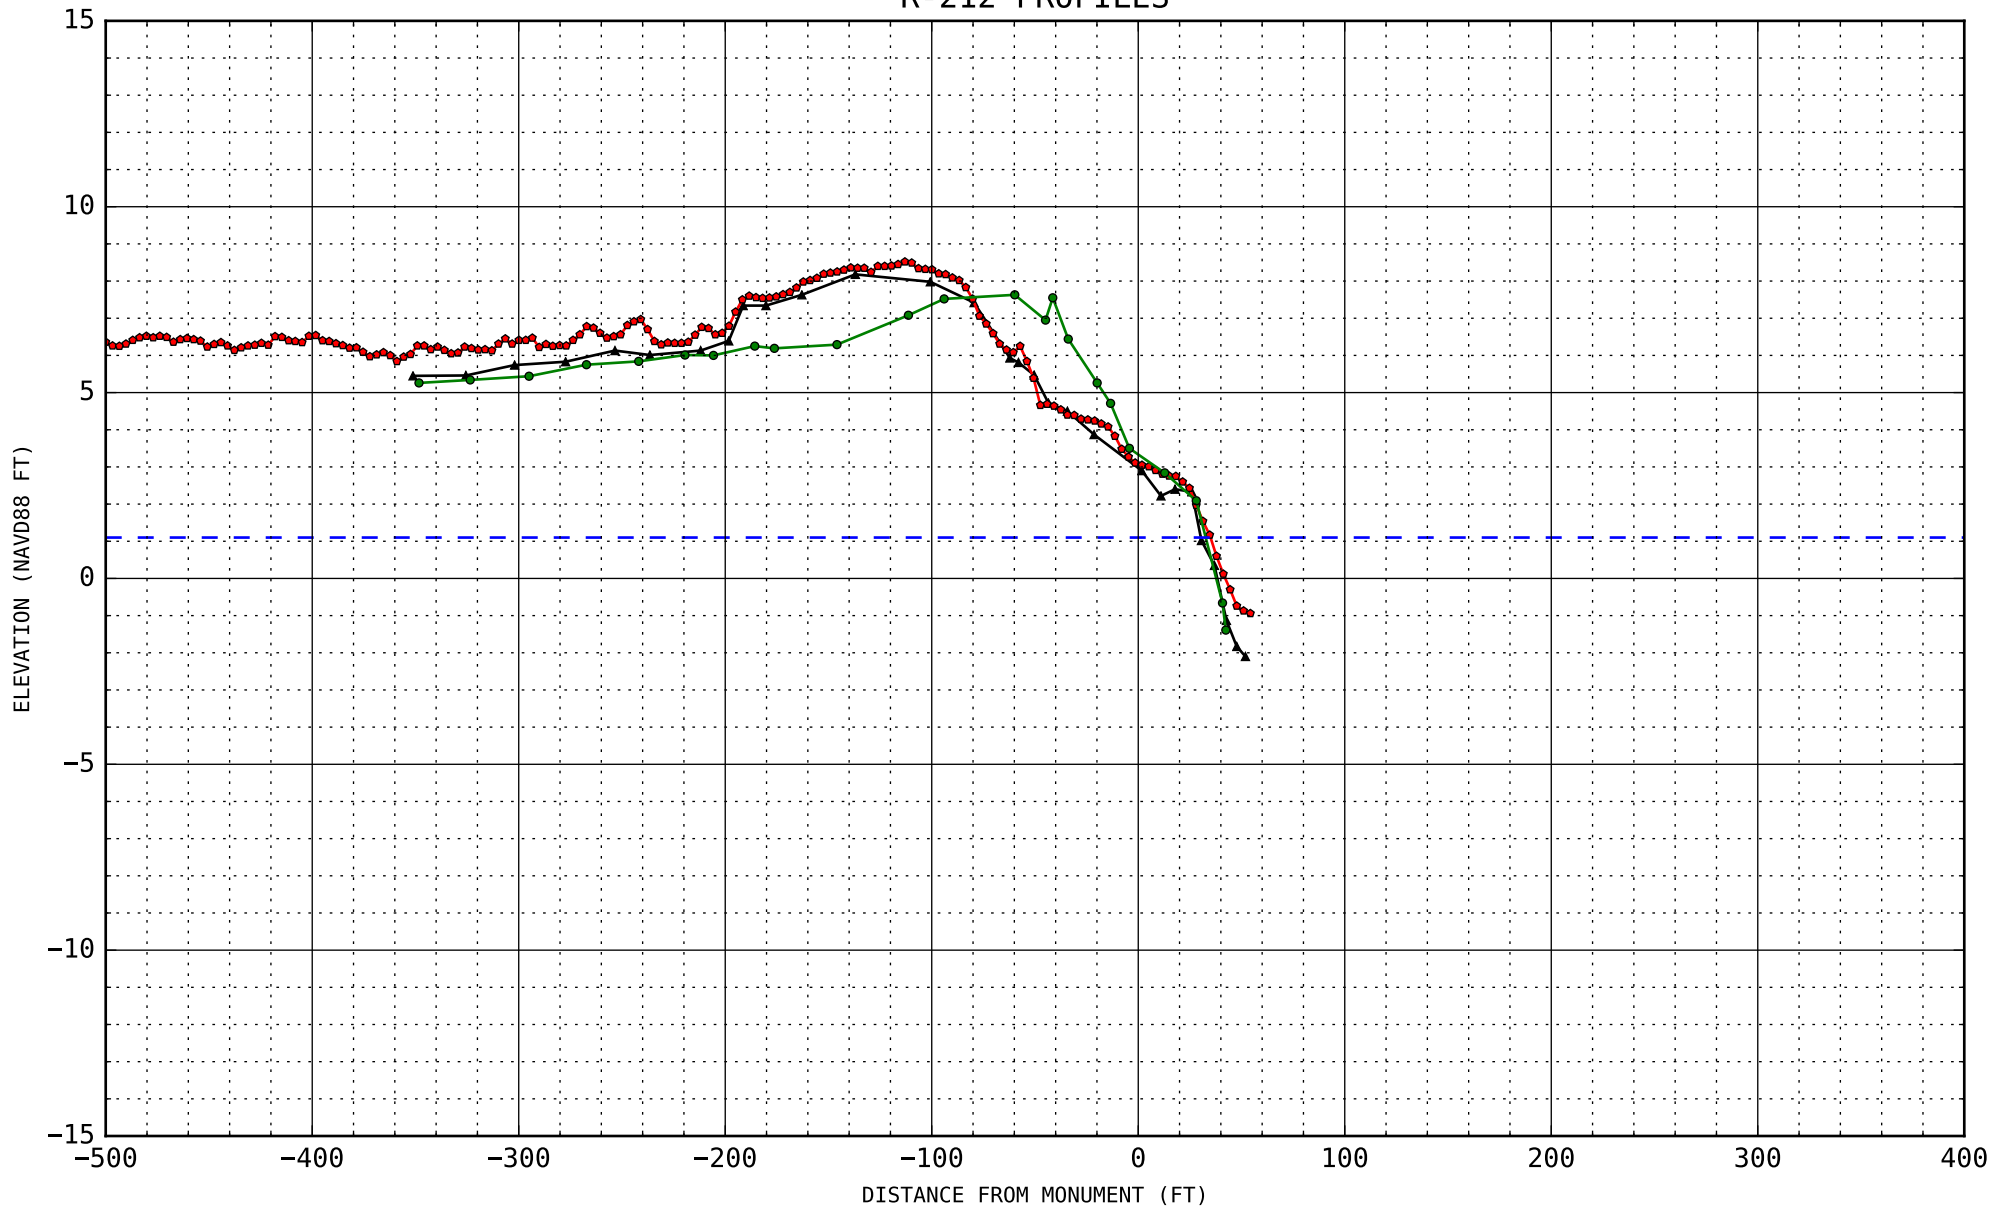
# R-212 PROFILES

- ▲ 2019-MAY CONDITION BY DEP
- 2018-OCT MONITORING BY USACE-LIDAR
- 2017-FEB MONITORING BY DEP
- - - MHW CONTOUR (1.1 FT)

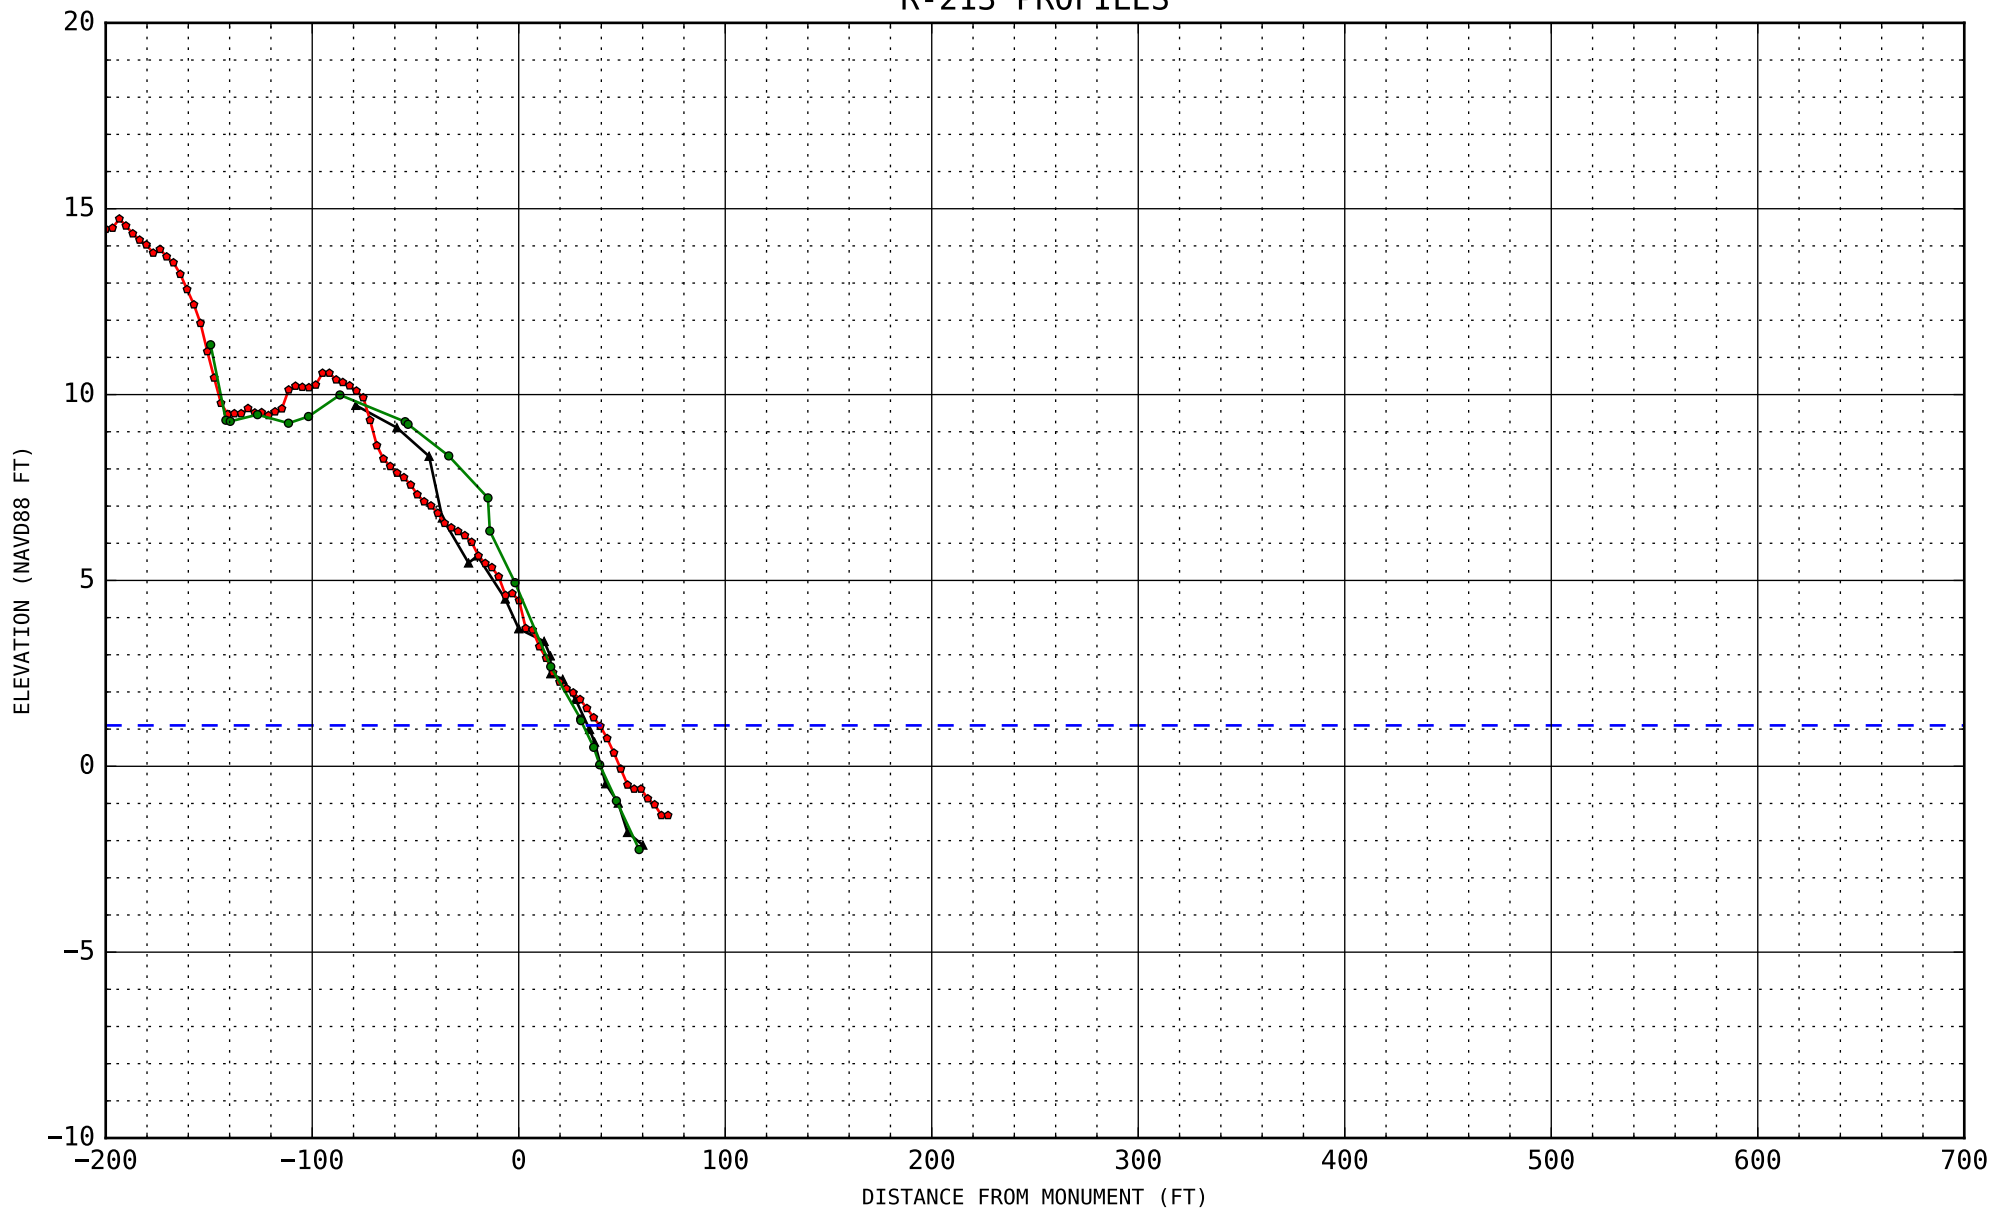
# R-213 PROFILES

- ▲ 2019-MAY CONDITION BY DEP
- 2018-OCT MONITORING BY USACE-LIDAR
- 2017-FEB MONITORING BY DEP
- - - MHW CONTOUR (1.1 FT)

RANGE: R-213  
 EST DATE: MMM1974  
 SURVEY DATE: 28MAY19  
 AZIMUTH: 170.0

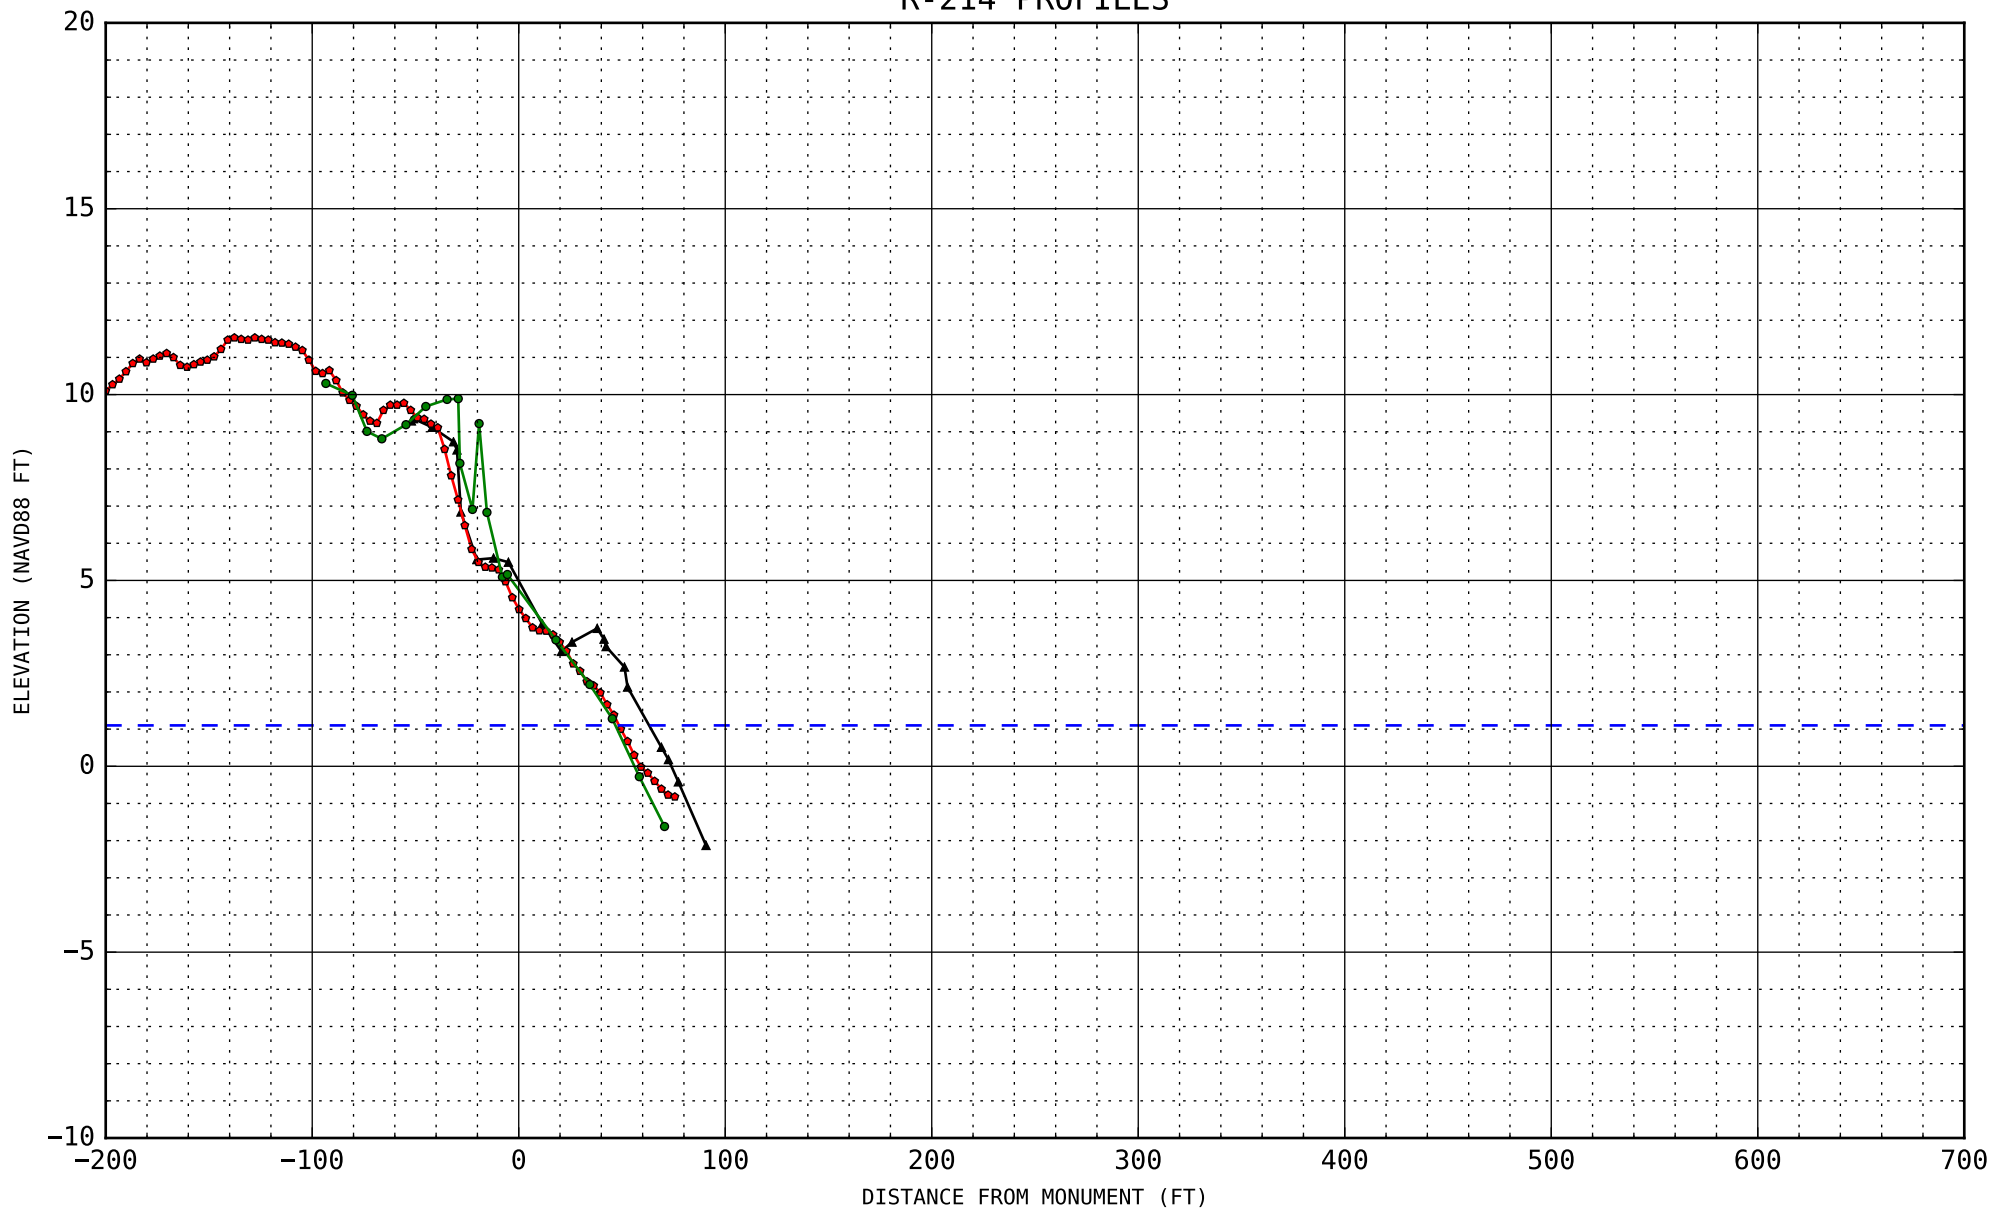
# R-214 PROFILES

- ▲ 2019-MAY CONDITION BY DEP
- 2018-OCT MONITORING BY USACE-LIDAR
- 2017-FEB MONITORING BY DEP
- - - MHW CONTOUR (1.1 FT)

RANGE: R-214  
EST DATE: MMM1974  
SURVEY DATE: 28MAY19  
AZIMUTH: 165.0

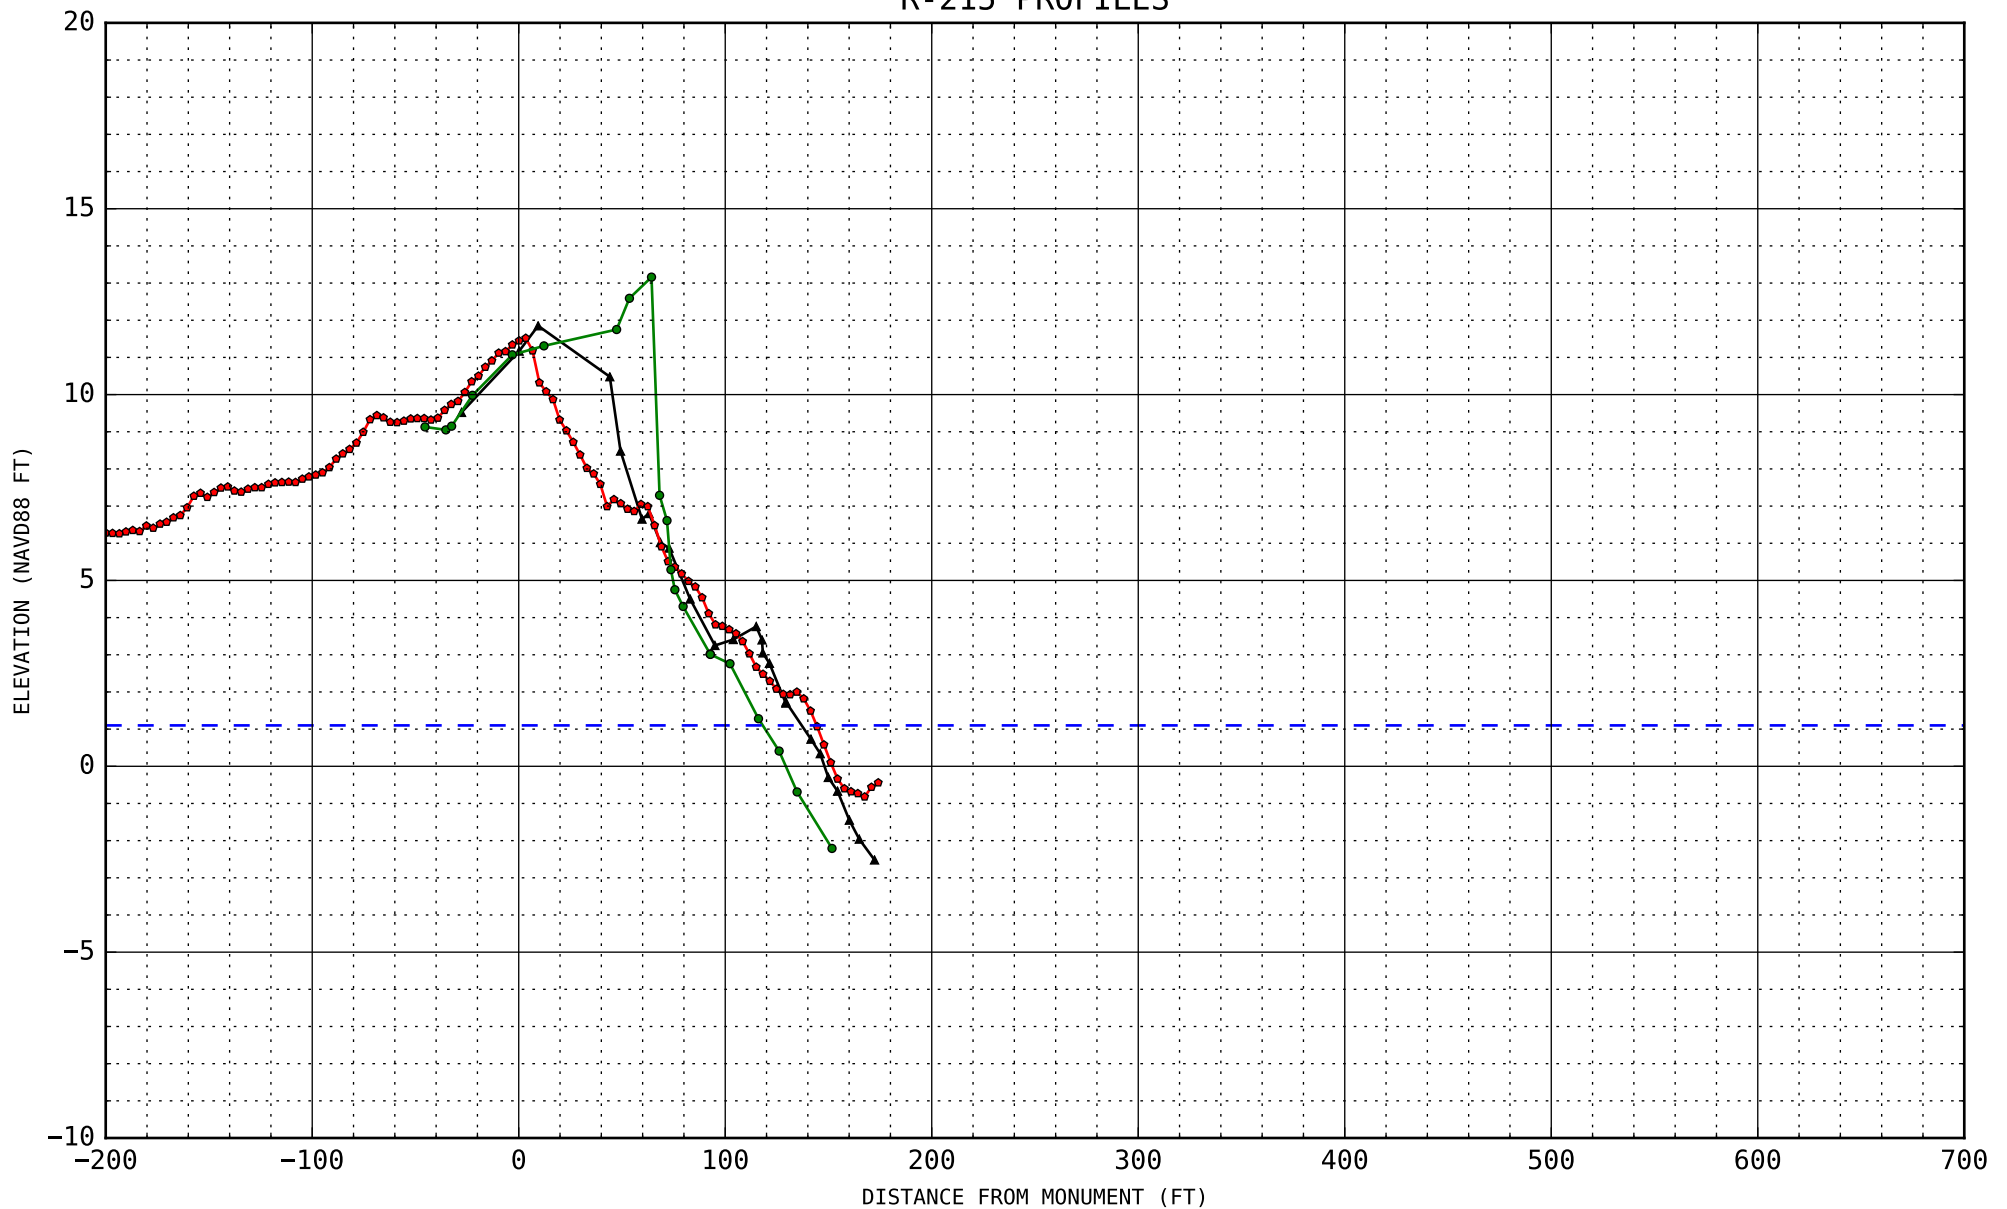
# R-215 PROFILES

| <p> 2019-MAY CONDITION BY DEP<br/> 2018-OCT MONITORING BY USACE-LIDAR<br/> 2017-FEB MONITORING BY DEP<br/> MHW CONTOUR (1.1 FT) </p> | <p> FRANKLIN<br/> PROGRAM SUPPORT GIS<br/> DIVISION OF WATER RESOURCE MANAGEMENT<br/> FLORIDA DEPARTMENT OF ENVIRONMENTAL PROTECTION </p> | <p> RANGE: R-215<br/> EST DATE: MMM1974<br/> SURVEY DATE: 28MAY19<br/> AZIMUTH: 170.0 </p> |

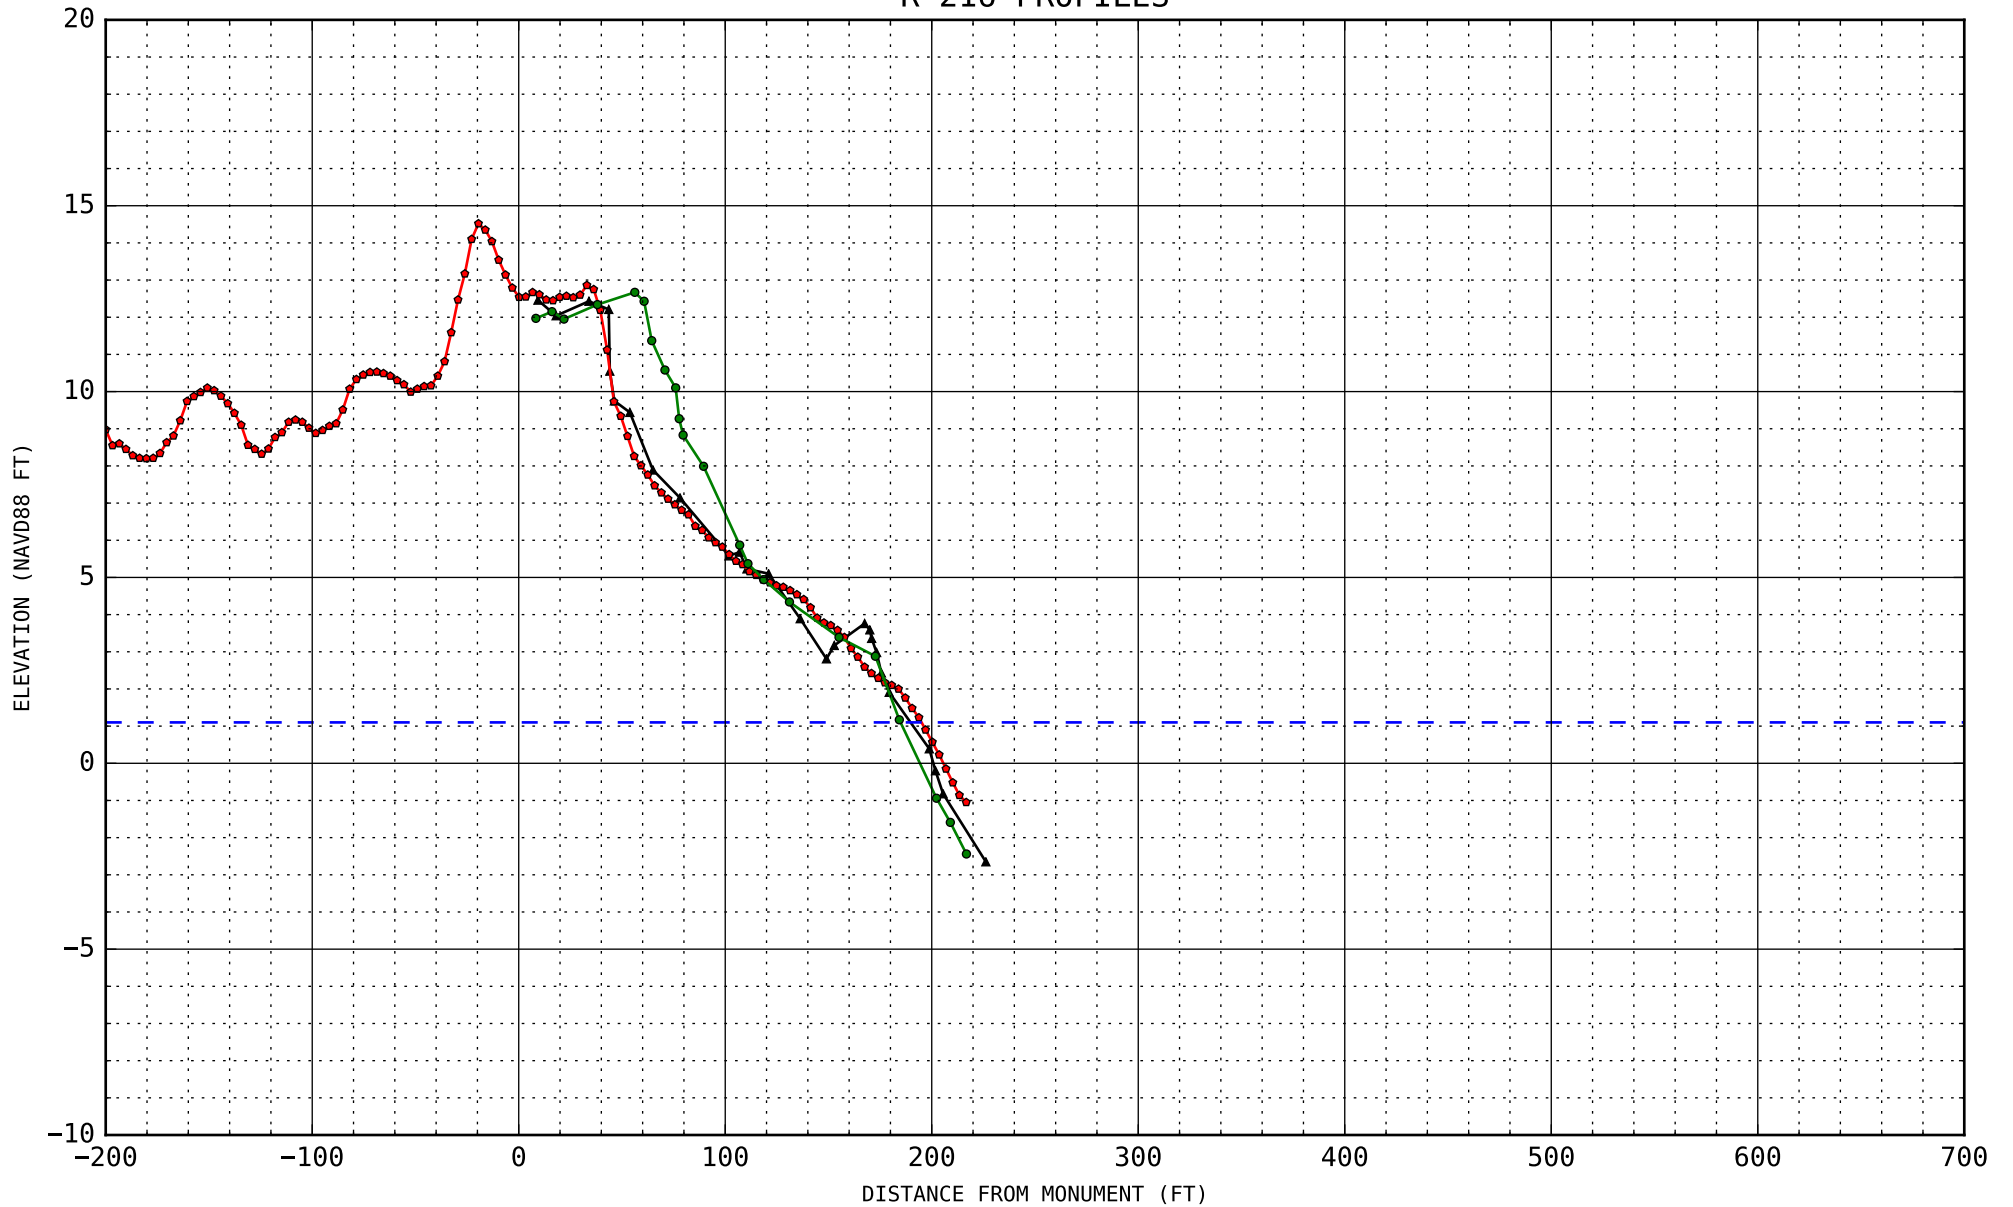
# R-216 PROFILES

- ▲ 2019-MAY CONDITION BY DEP
- 2018-OCT MONITORING BY USACE-LIDAR
- 2017-FEB MONITORING BY DEP
- - - MHW CONTOUR (1.1 FT)

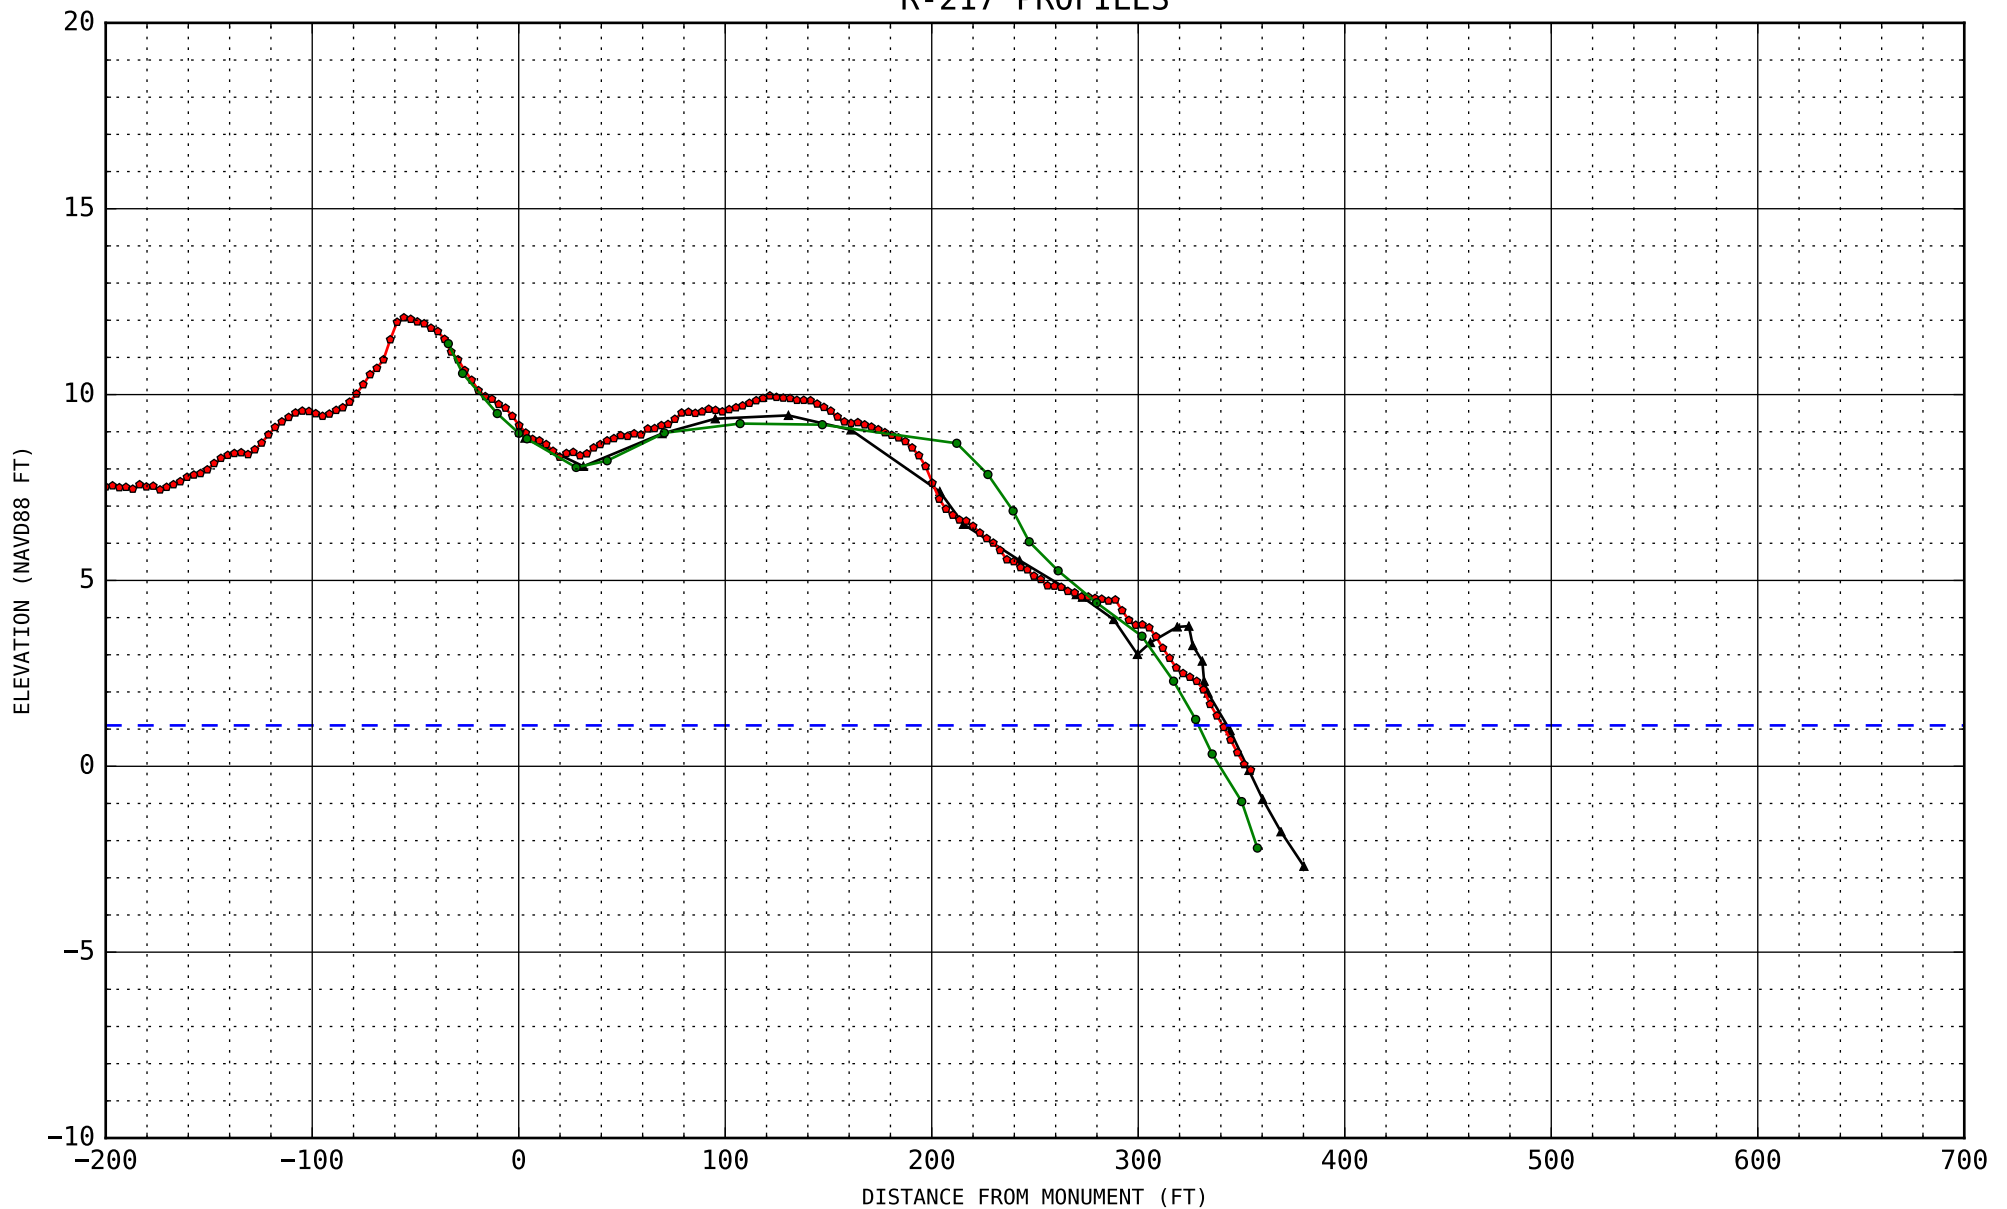
# R-217 PROFILES

- ▲ 2019-MAY CONDITION BY DEP
- 2018-OCT MONITORING BY USACE-LIDAR
- 2017-FEB MONITORING BY DEP
- - - MHW CONTOUR (1.1 FT)

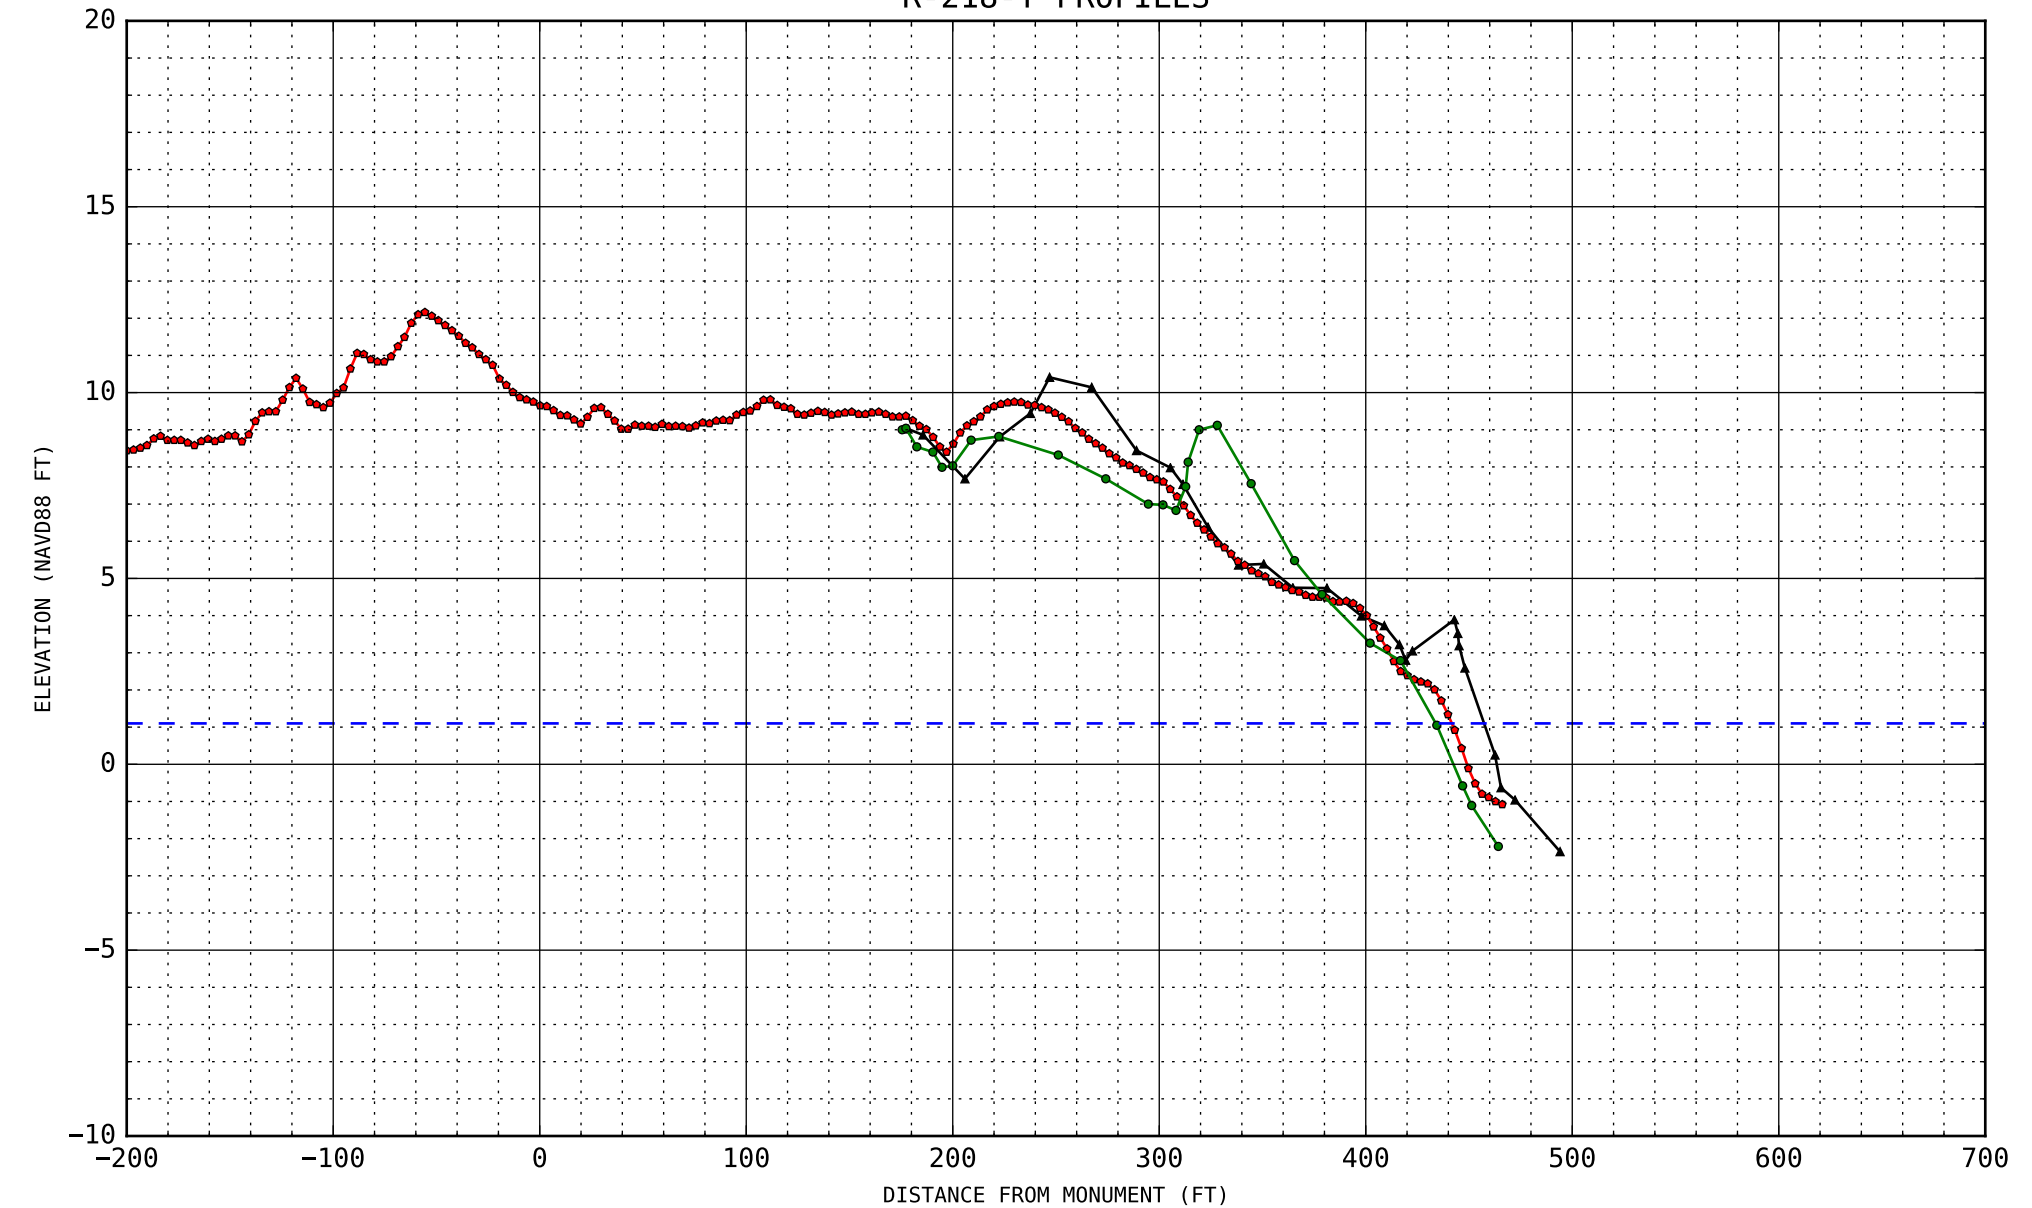
# R-218-T PROFILES

- ▲ 2019-MAY CONDITION BY DEP
- 2018-OCT MONITORING BY USACE-LIDAR
- 2017-FEB MONITORING BY DEP
- - - MHW CONTOUR (1.1 FT)

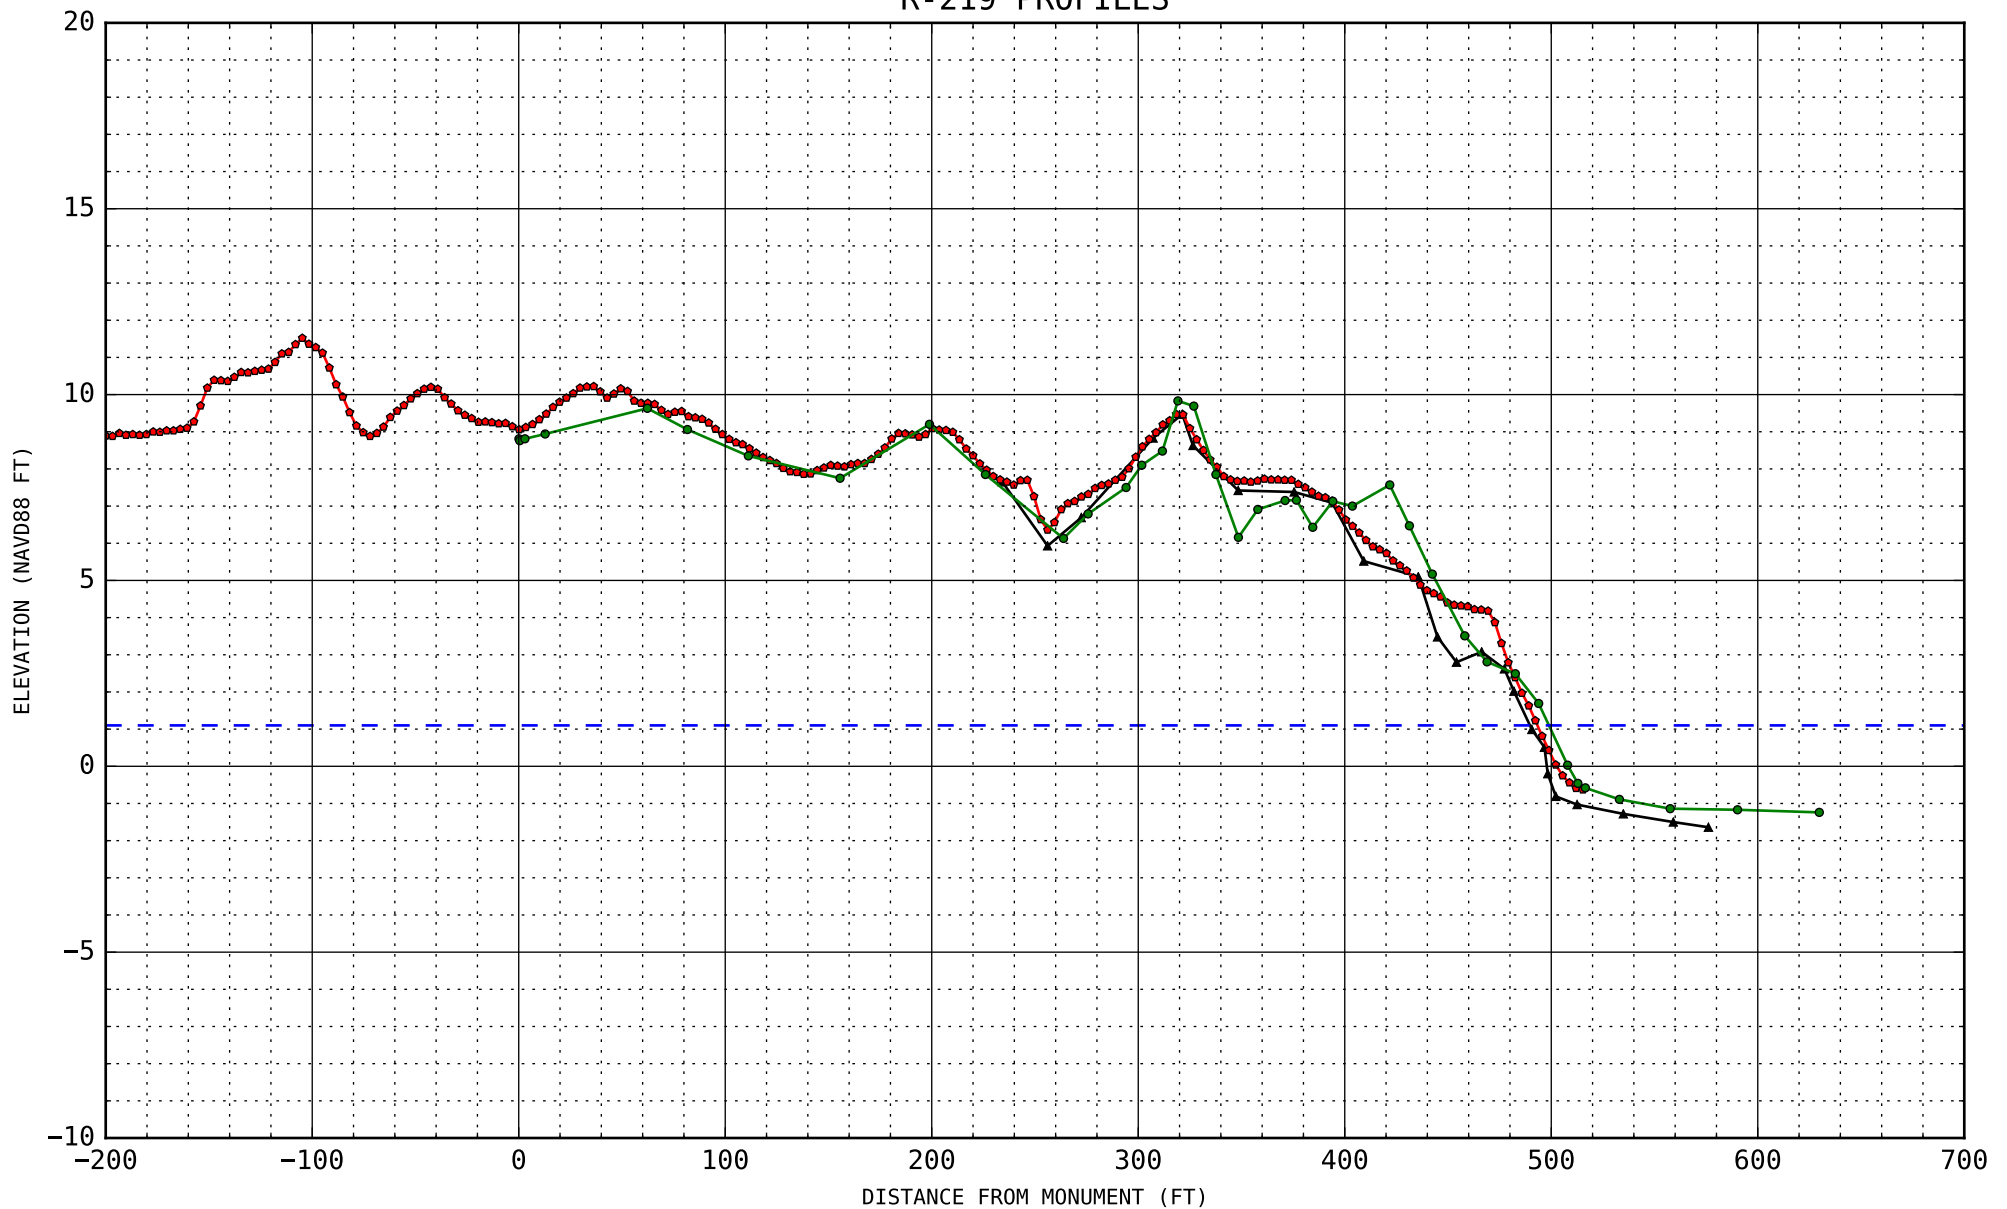
# R-219 PROFILES

- ▲ 2019-MAY CONDITION BY DEP
- 2018-OCT MONITORING BY USACE-LIDAR
- 2017-FEB MONITORING BY DEP
- - - MHW CONTOUR (1.1 FT)

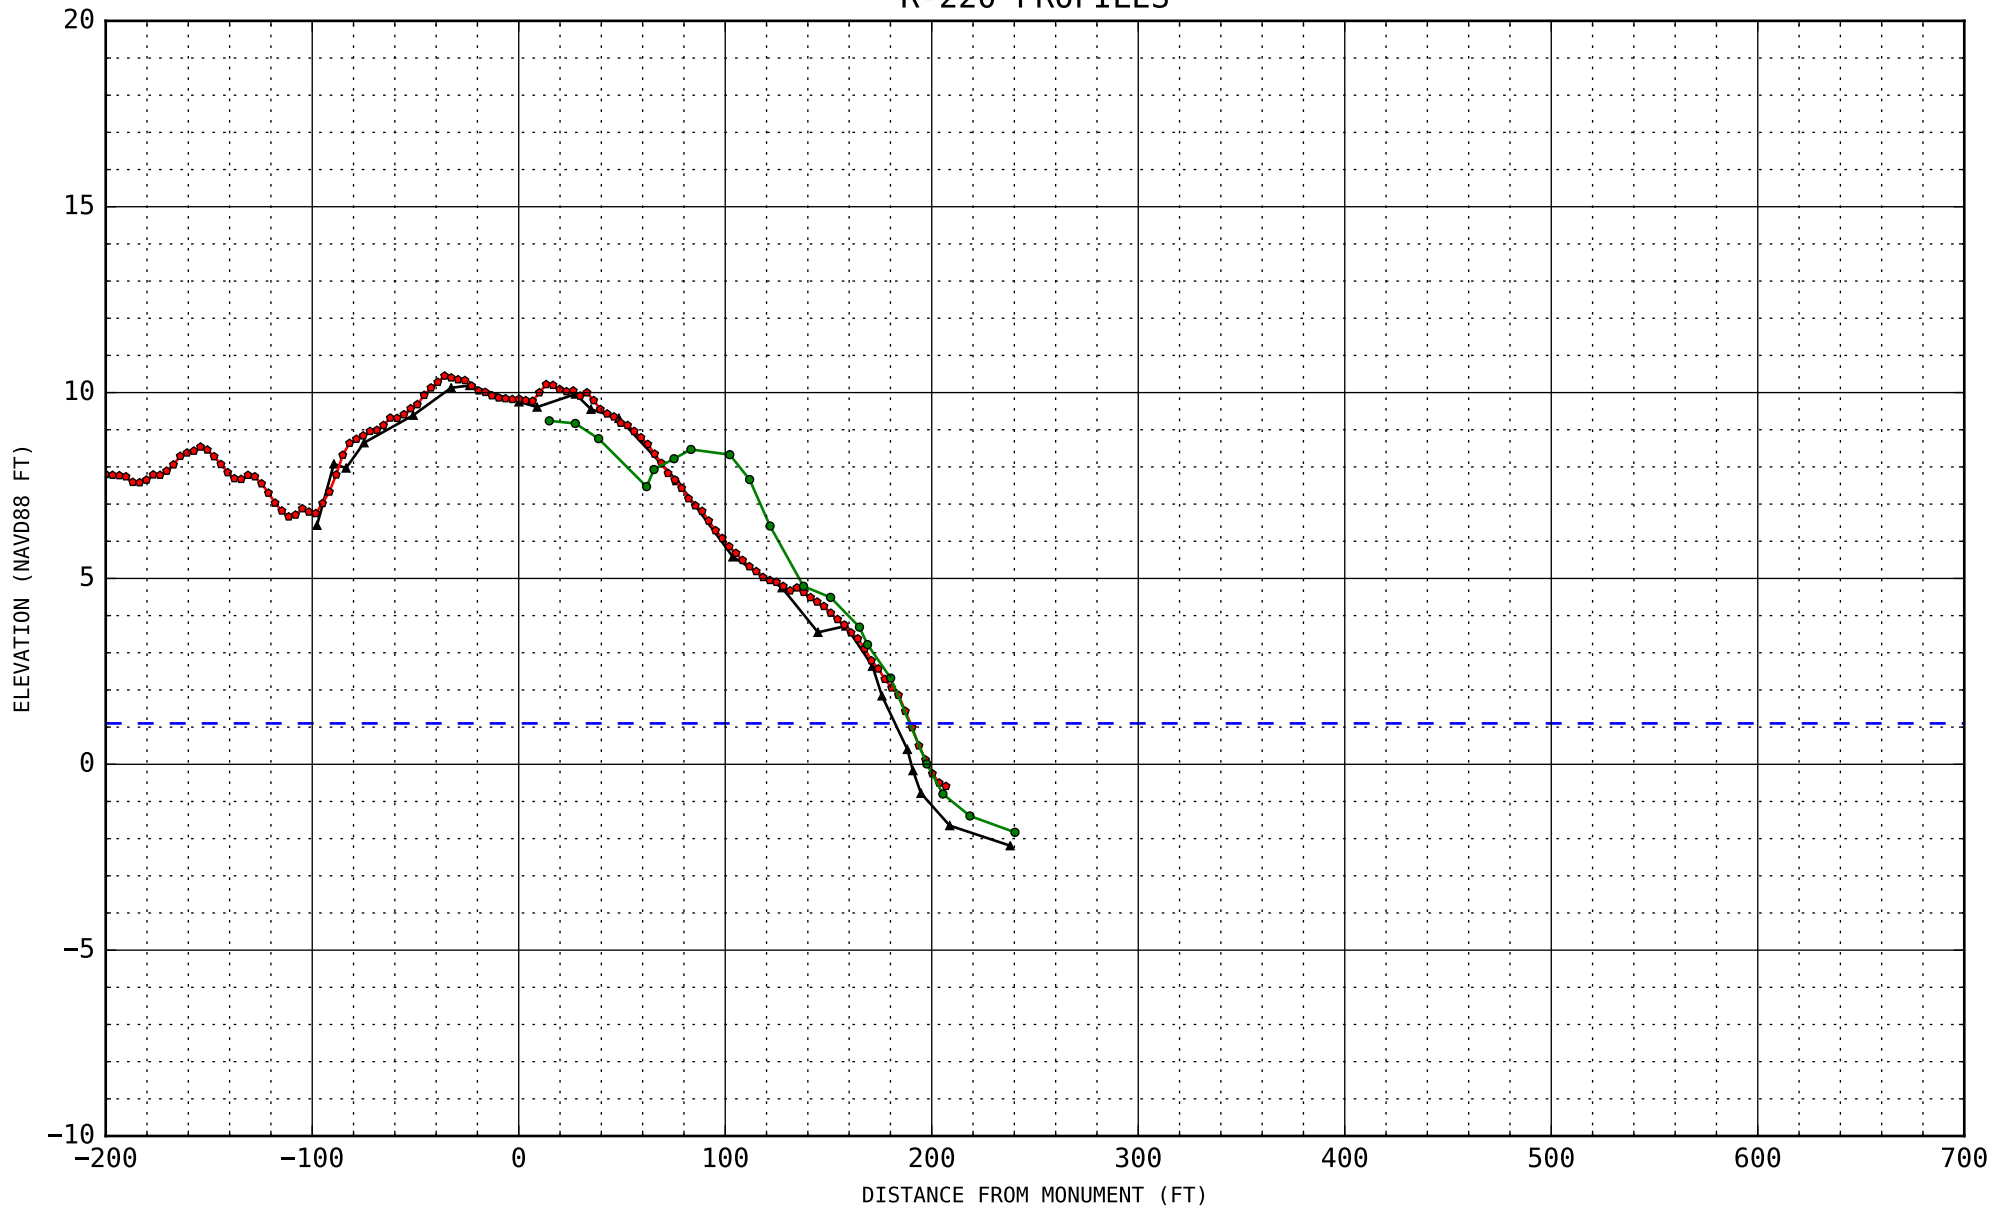
# R-220 PROFILES

- ▲ 2019-MAY CONDITION BY DEP
- 2018-OCT MONITORING BY USACE-LIDAR
- 2017-FEB MONITORING BY DEP
- - - MHW CONTOUR (1.1 FT)
