# R-52-T PROFILES

FRANKLIN  
PROGRAM SUPPORT GIS  
DIVISION OF WATER RESOURCE MANAGEMENT  
FLORIDA DEPARTMENT OF ENVIRONMENTAL PROTECTION

RANGE: R-52-T  
EST DATE: FEB1980  
SURVEY DATE: 16MAY19  
AZIMUTH: 150.0

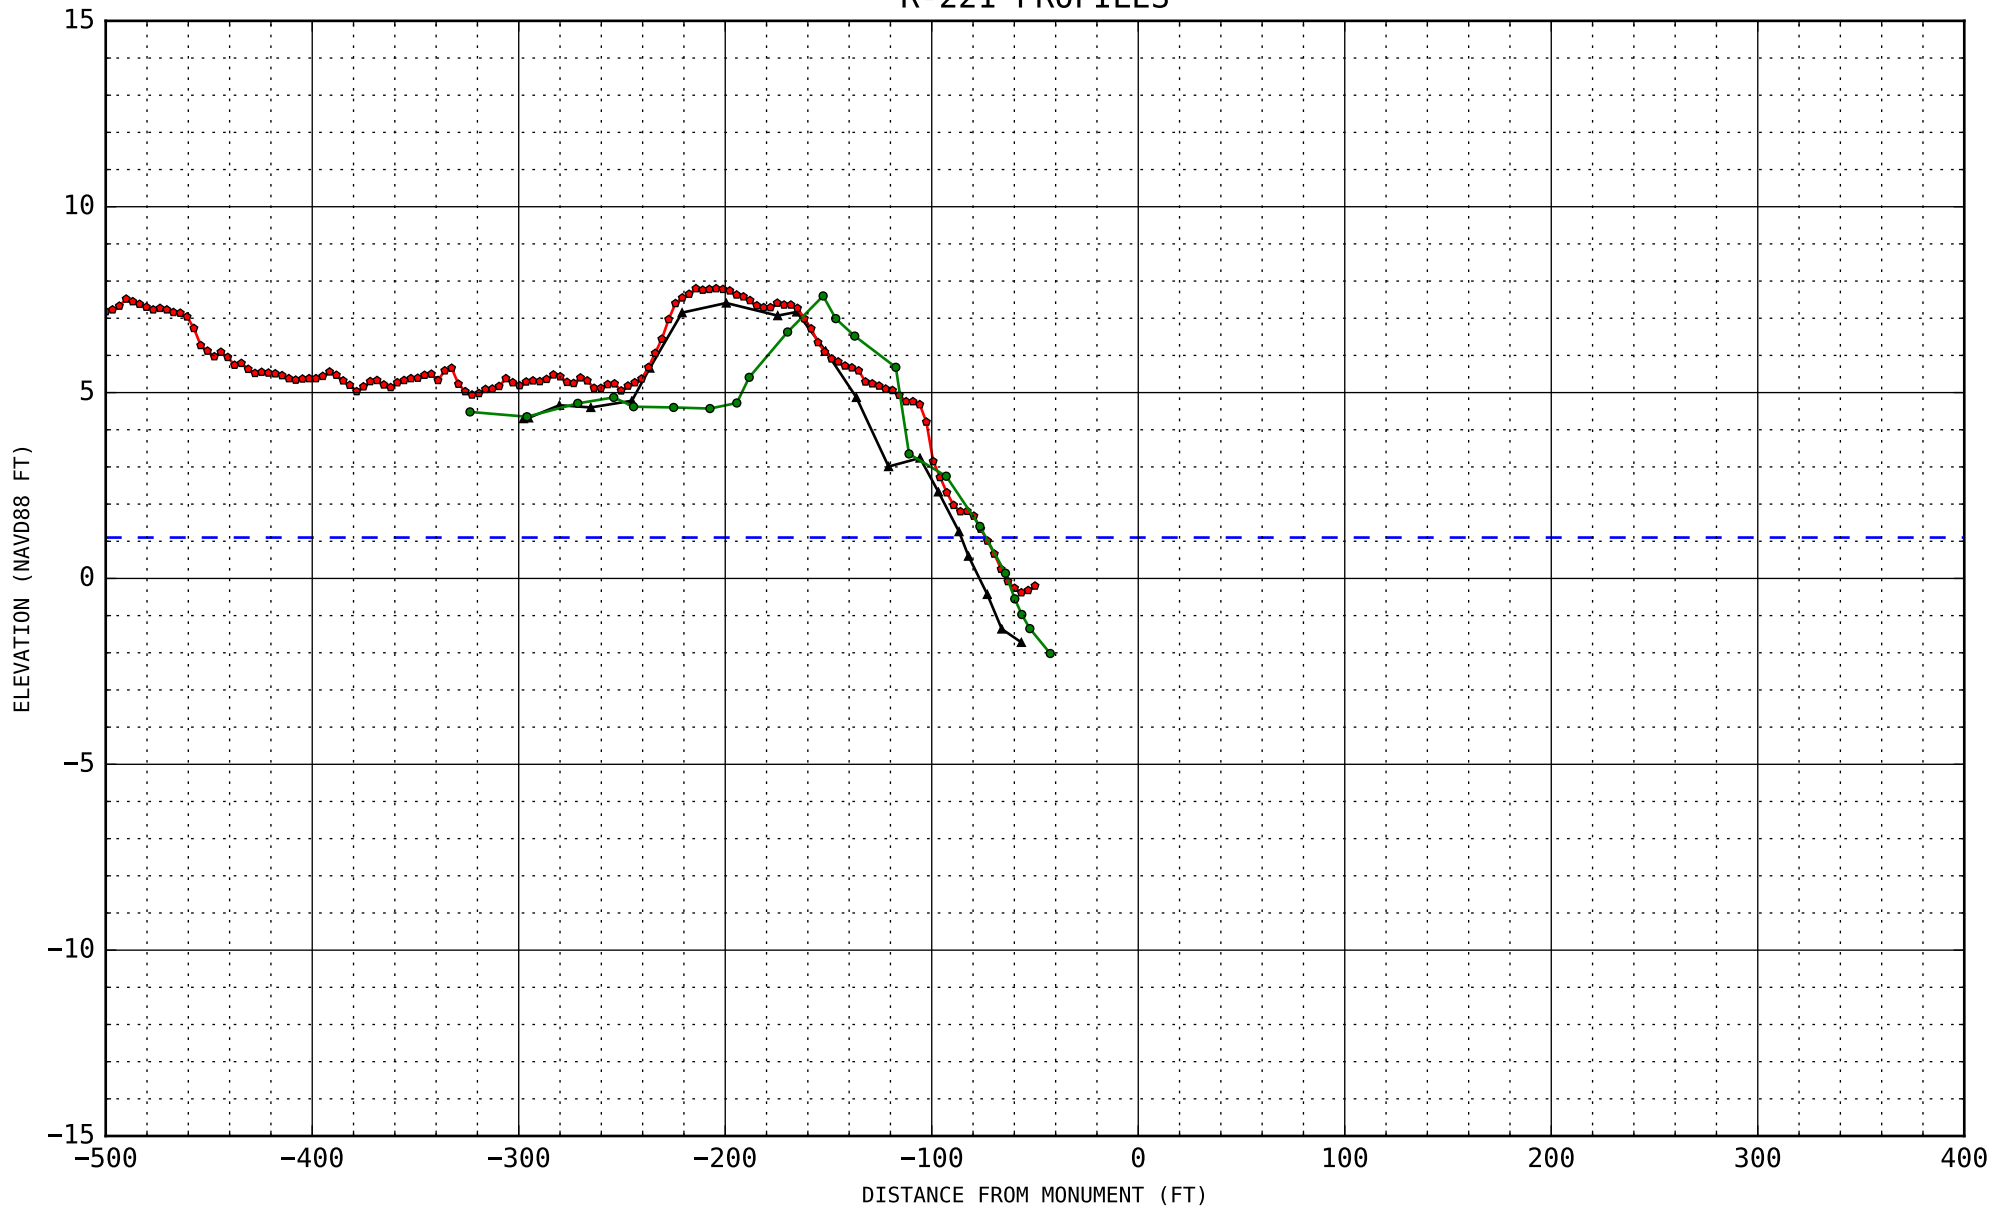
# R-221 PROFILES

- ▲ 2019-MAY CONDITION BY DEP
- 2018-OCT MONITORING BY USACE-LIDAR
- 2017-FEB MONITORING BY DEP
- - - MHW CONTOUR (1.1 FT)

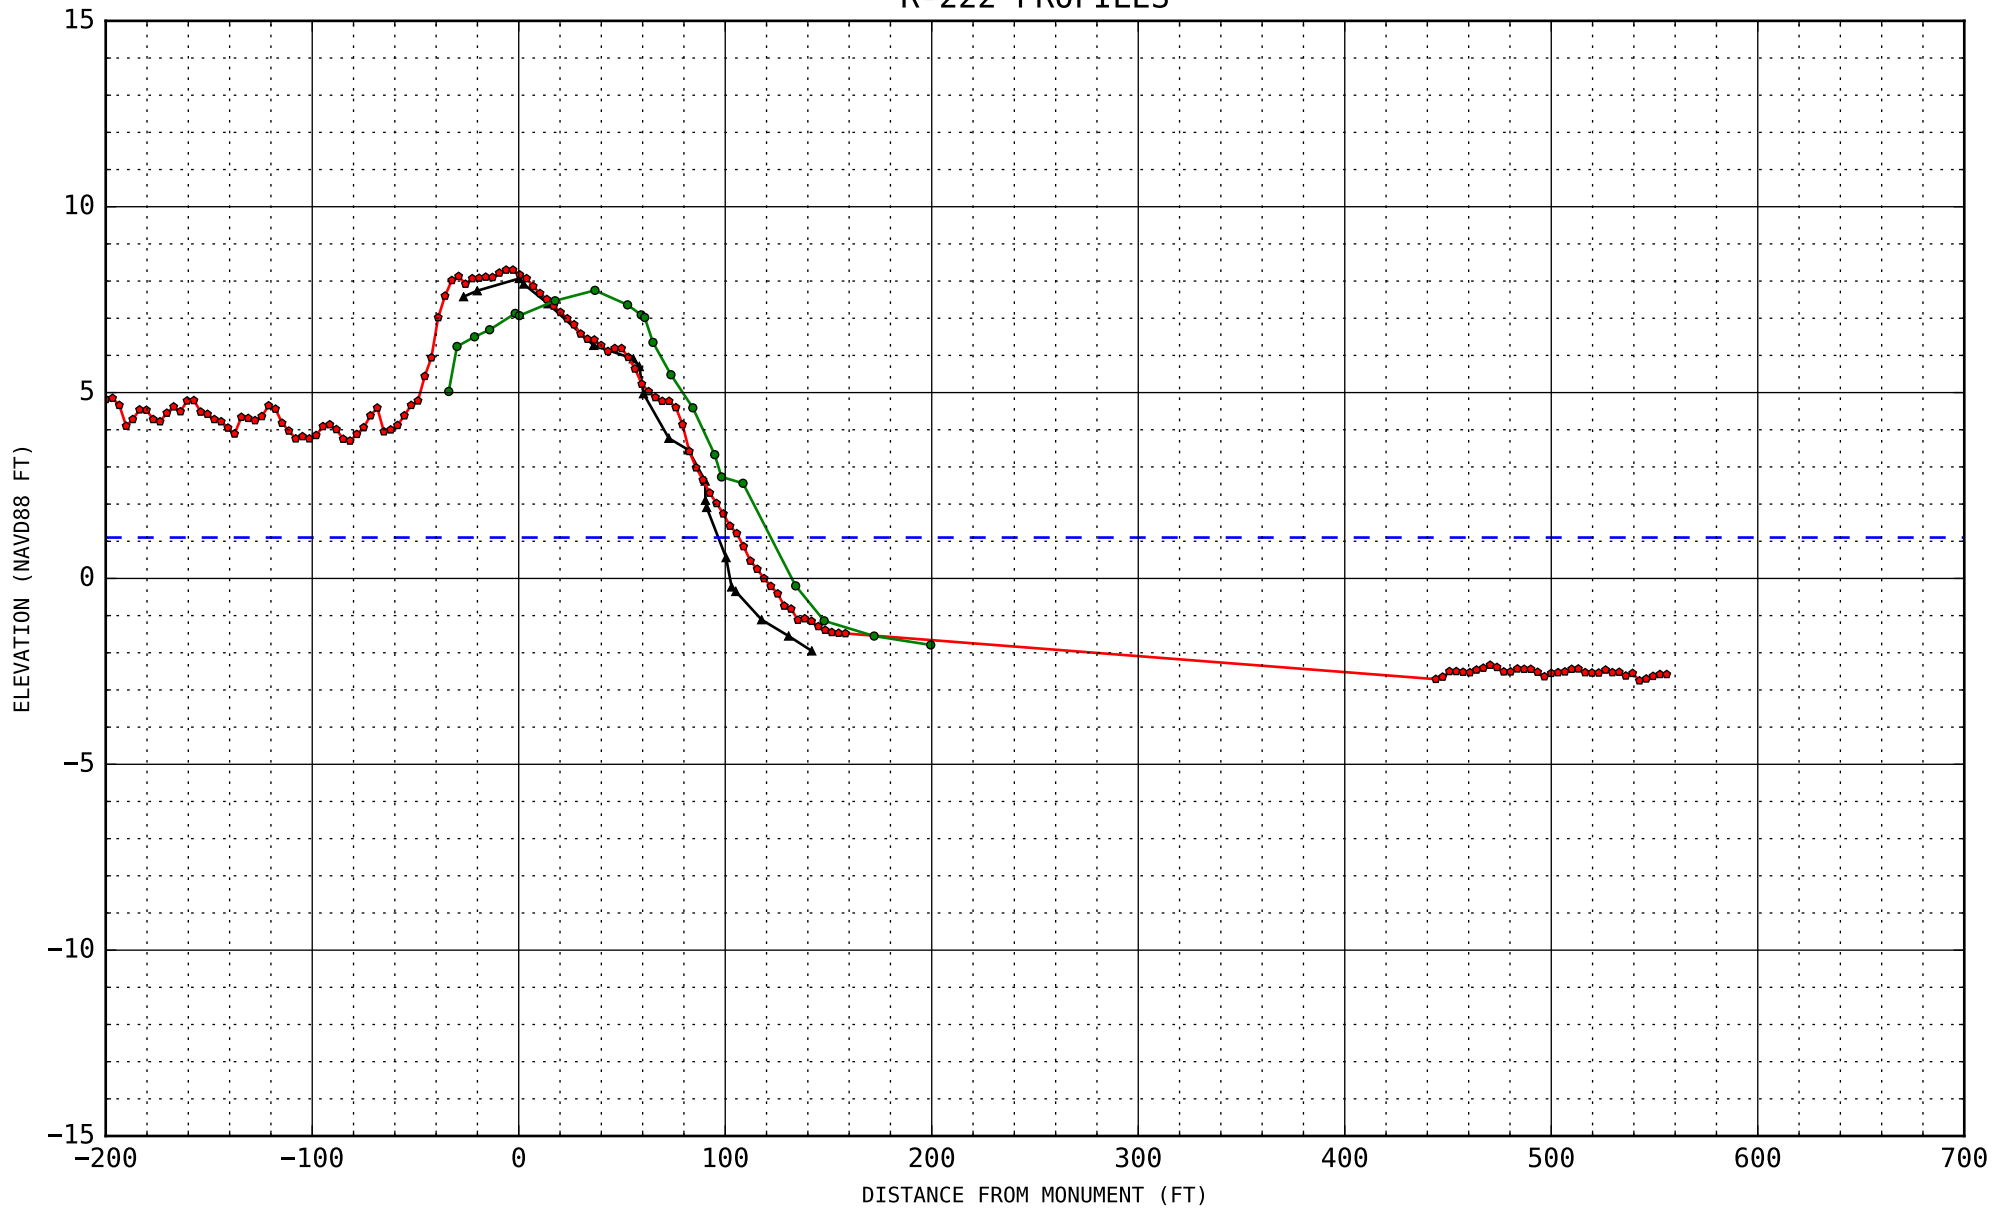
# R-222 PROFILES

- ▲ 2019-MAY CONDITION BY DEP
- 2018-OCT MONITORING BY USACE-LIDAR
- 2017-FEB MONITORING BY DEP
- - - MHW CONTOUR (1.1 FT)

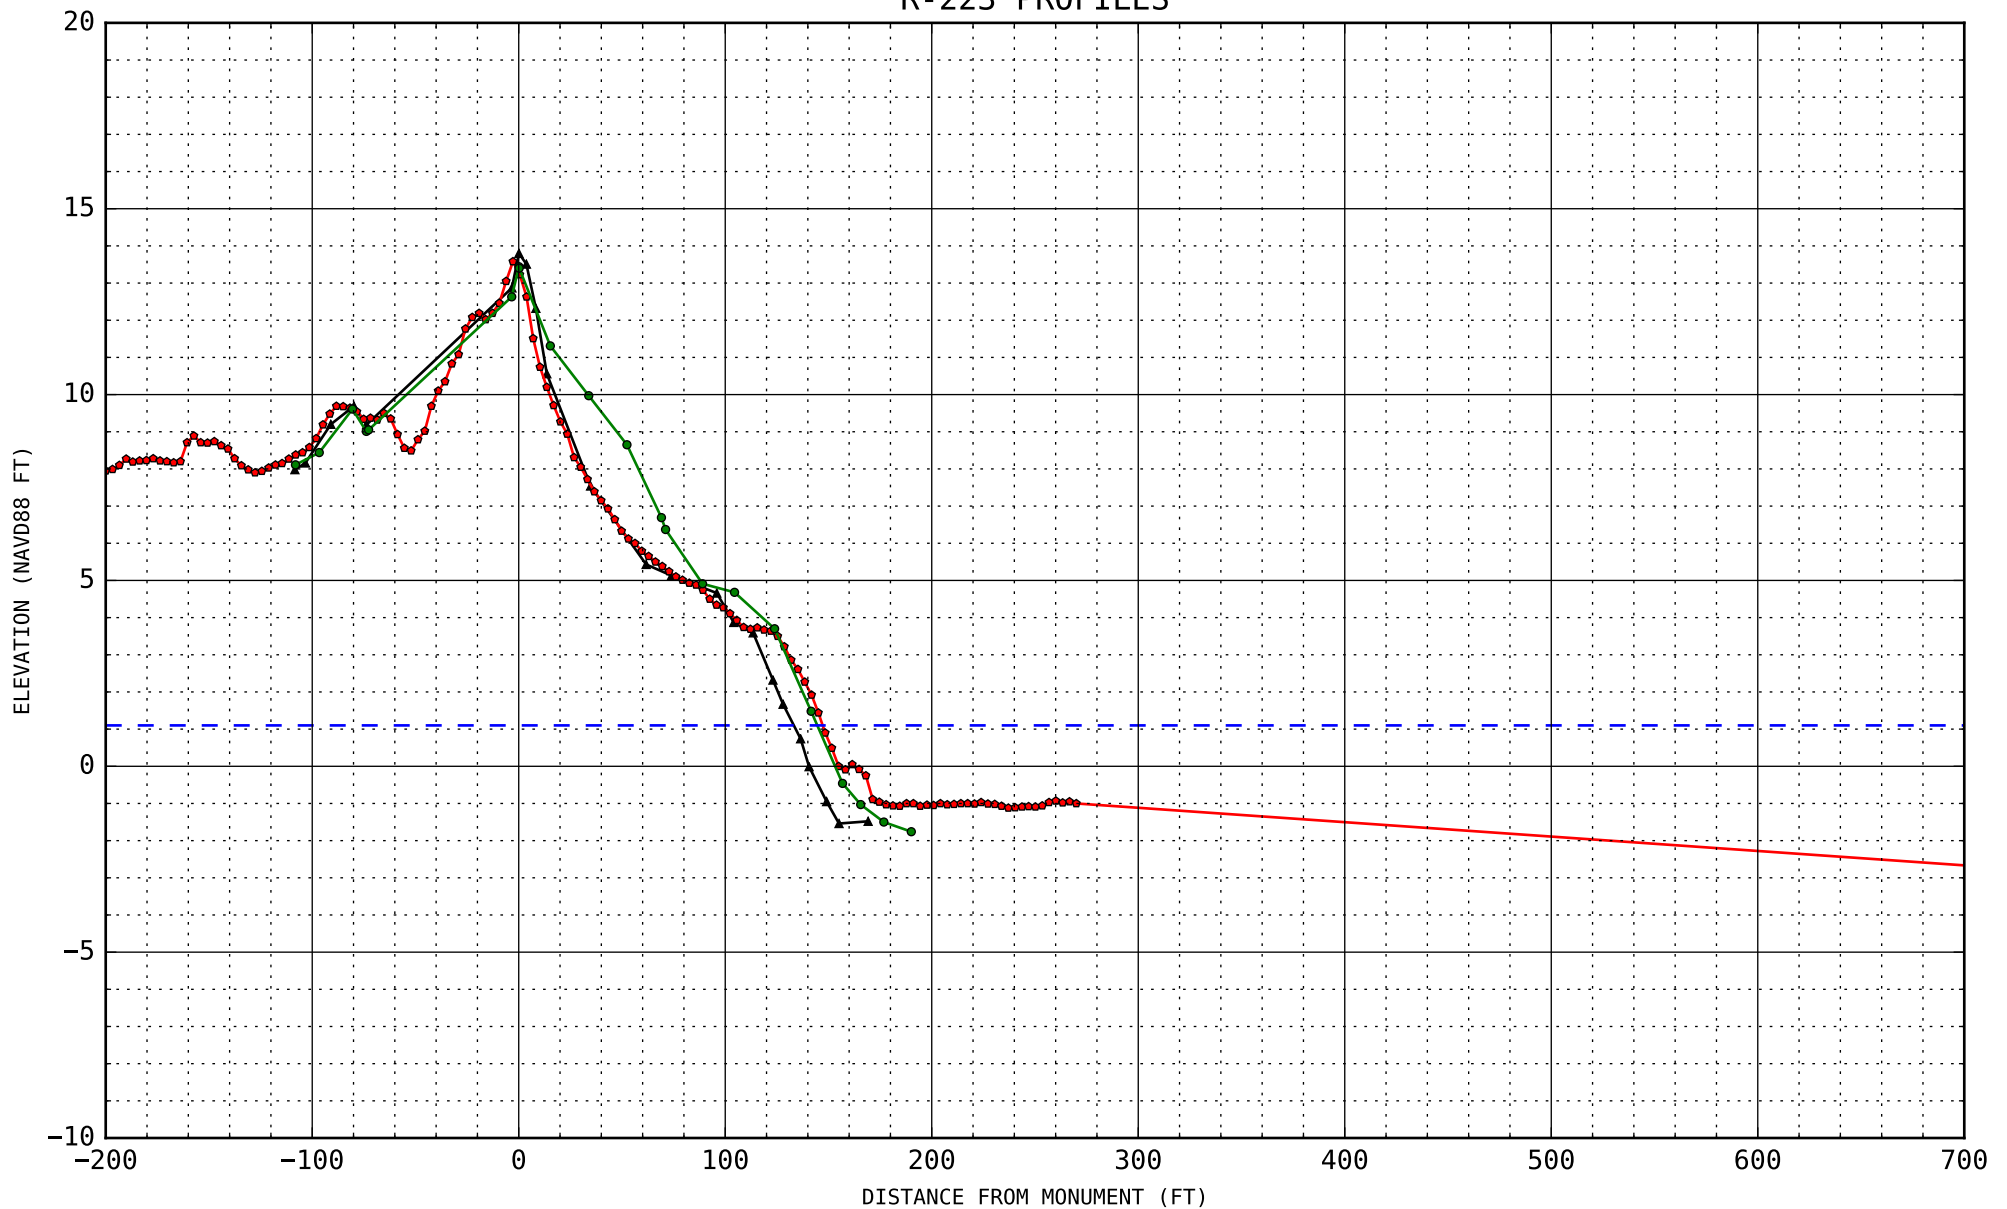
# R-223 PROFILES

- ▲ 2019-MAY CONDITION BY DEP
- 2018-OCT MONITORING BY USACE-LIDAR
- 2017-FEB MONITORING BY DEP
- - - MHW CONTOUR (1.1 FT)

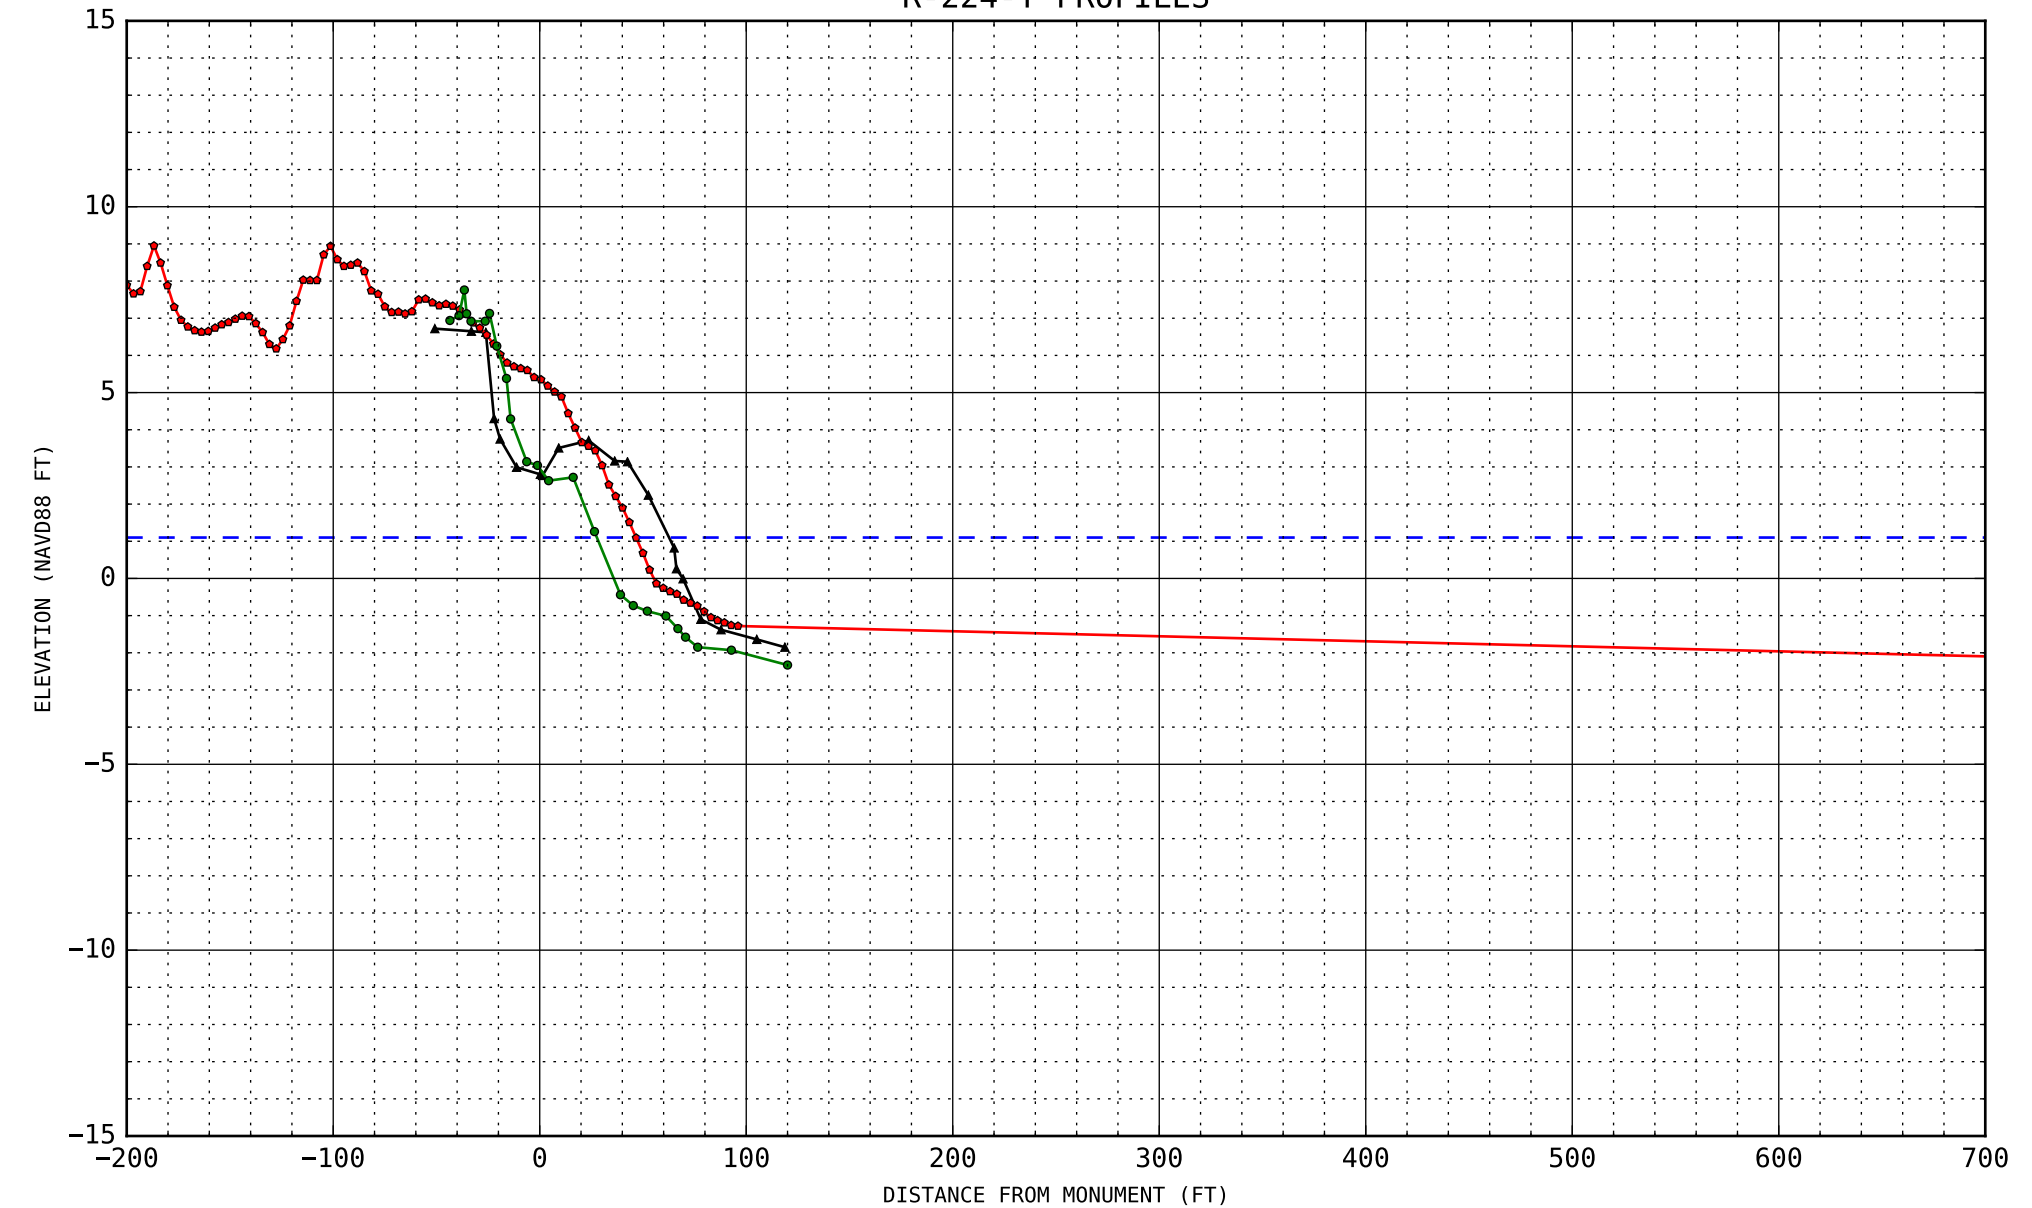
# R-224-T PROFILES

- ▲ 2019-MAY CONDITION BY DEP
- 2018-OCT MONITORING BY USACE-LIDAR
- 2017-FEB MONITORING BY DEP
- - - MHW CONTOUR (1.1 FT)

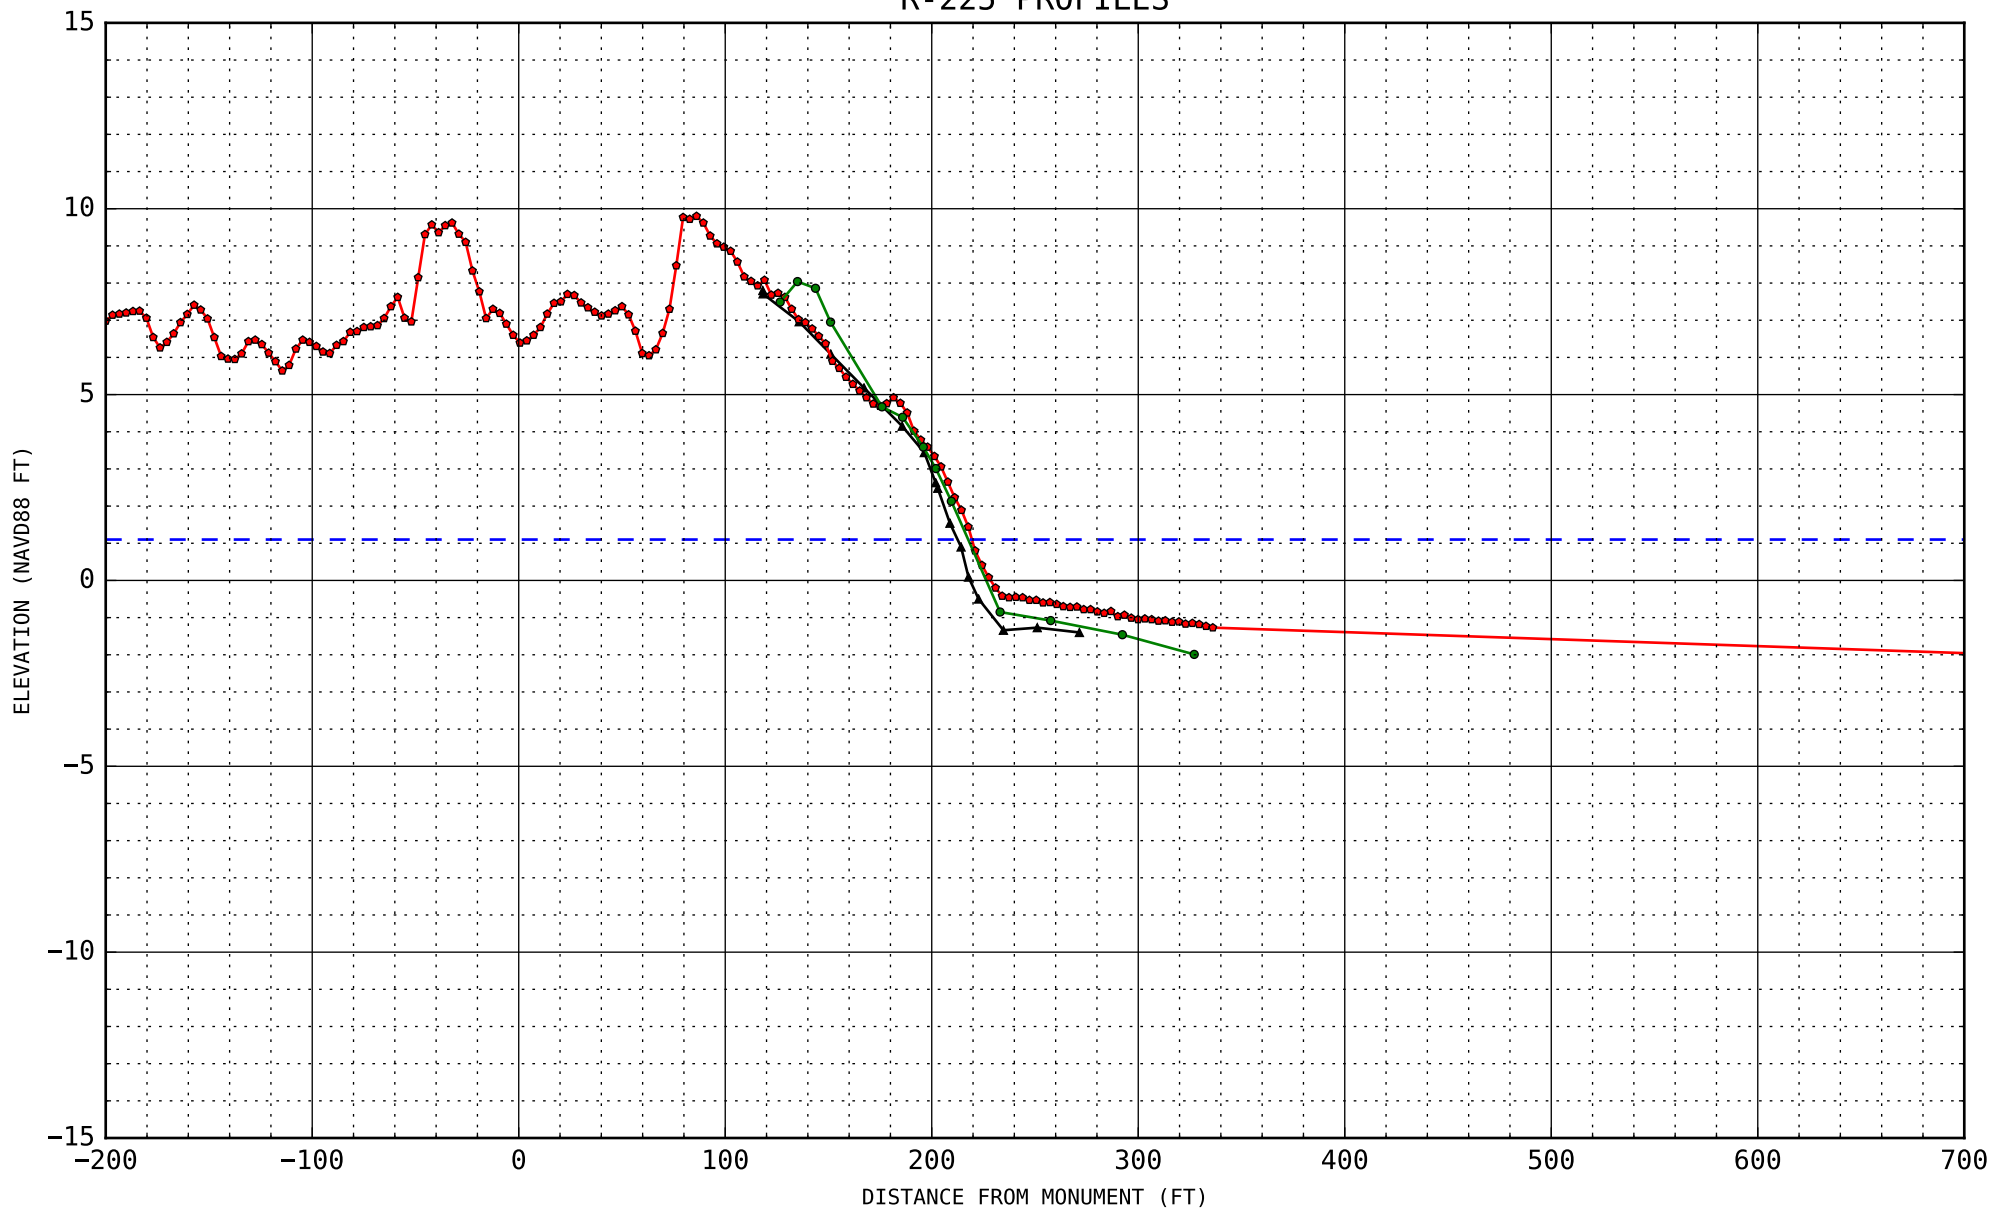
# R-225 PROFILES

- ▲ 2019-MAY CONDITION BY DEP
- 2018-OCT MONITORING BY USACE-LIDAR
- 2017-FEB MONITORING BY DEP
- - - MHW CONTOUR (1.1 FT)

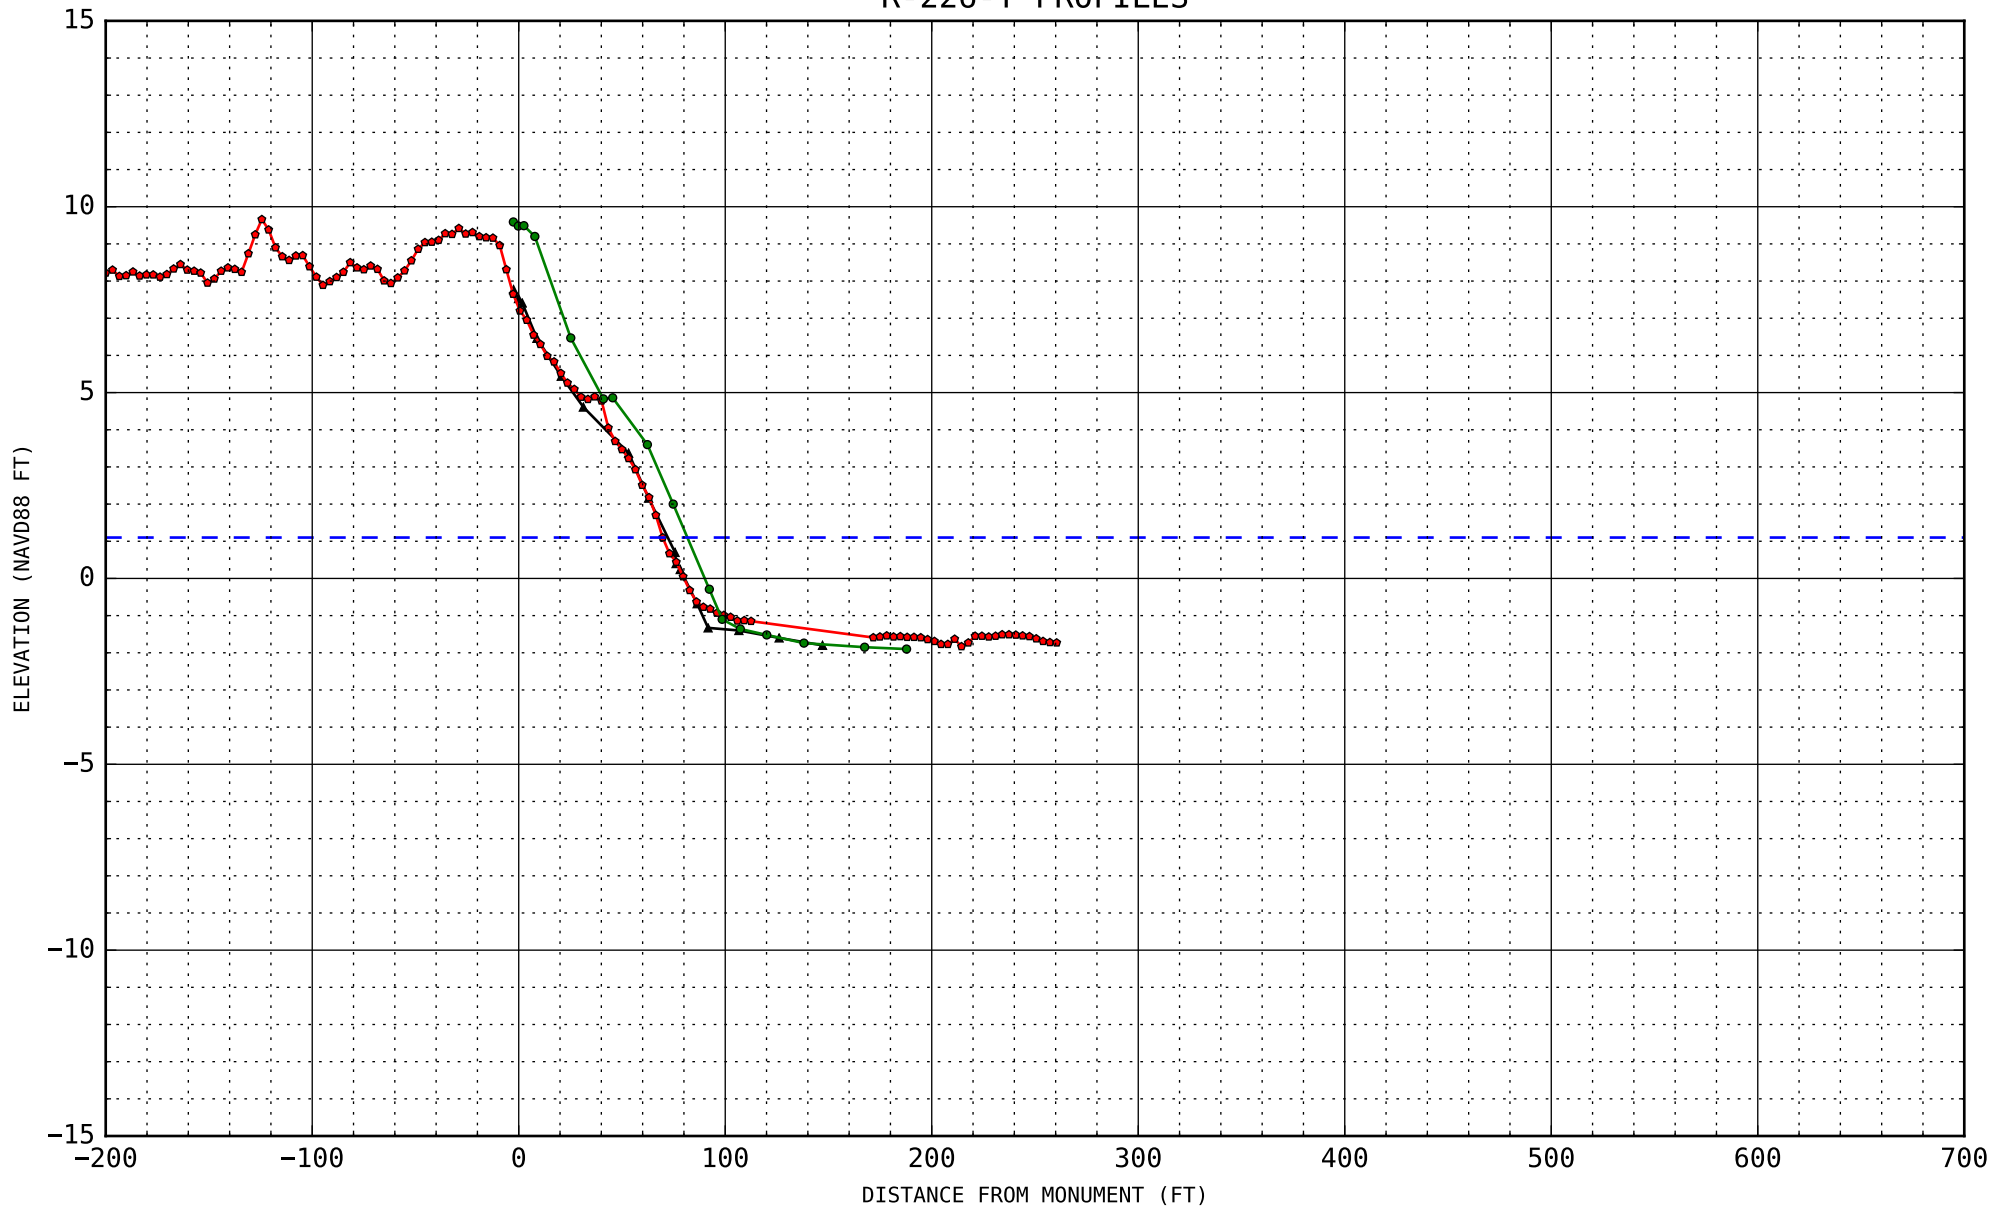
# R-226-T PROFILES

- ▲ 2019-MAY CONDITION BY DEP
- 2018-OCT MONITORING BY USACE-LIDAR
- 2017-FEB MONITORING BY DEP
- - - MHW CONTOUR (1.1 FT)

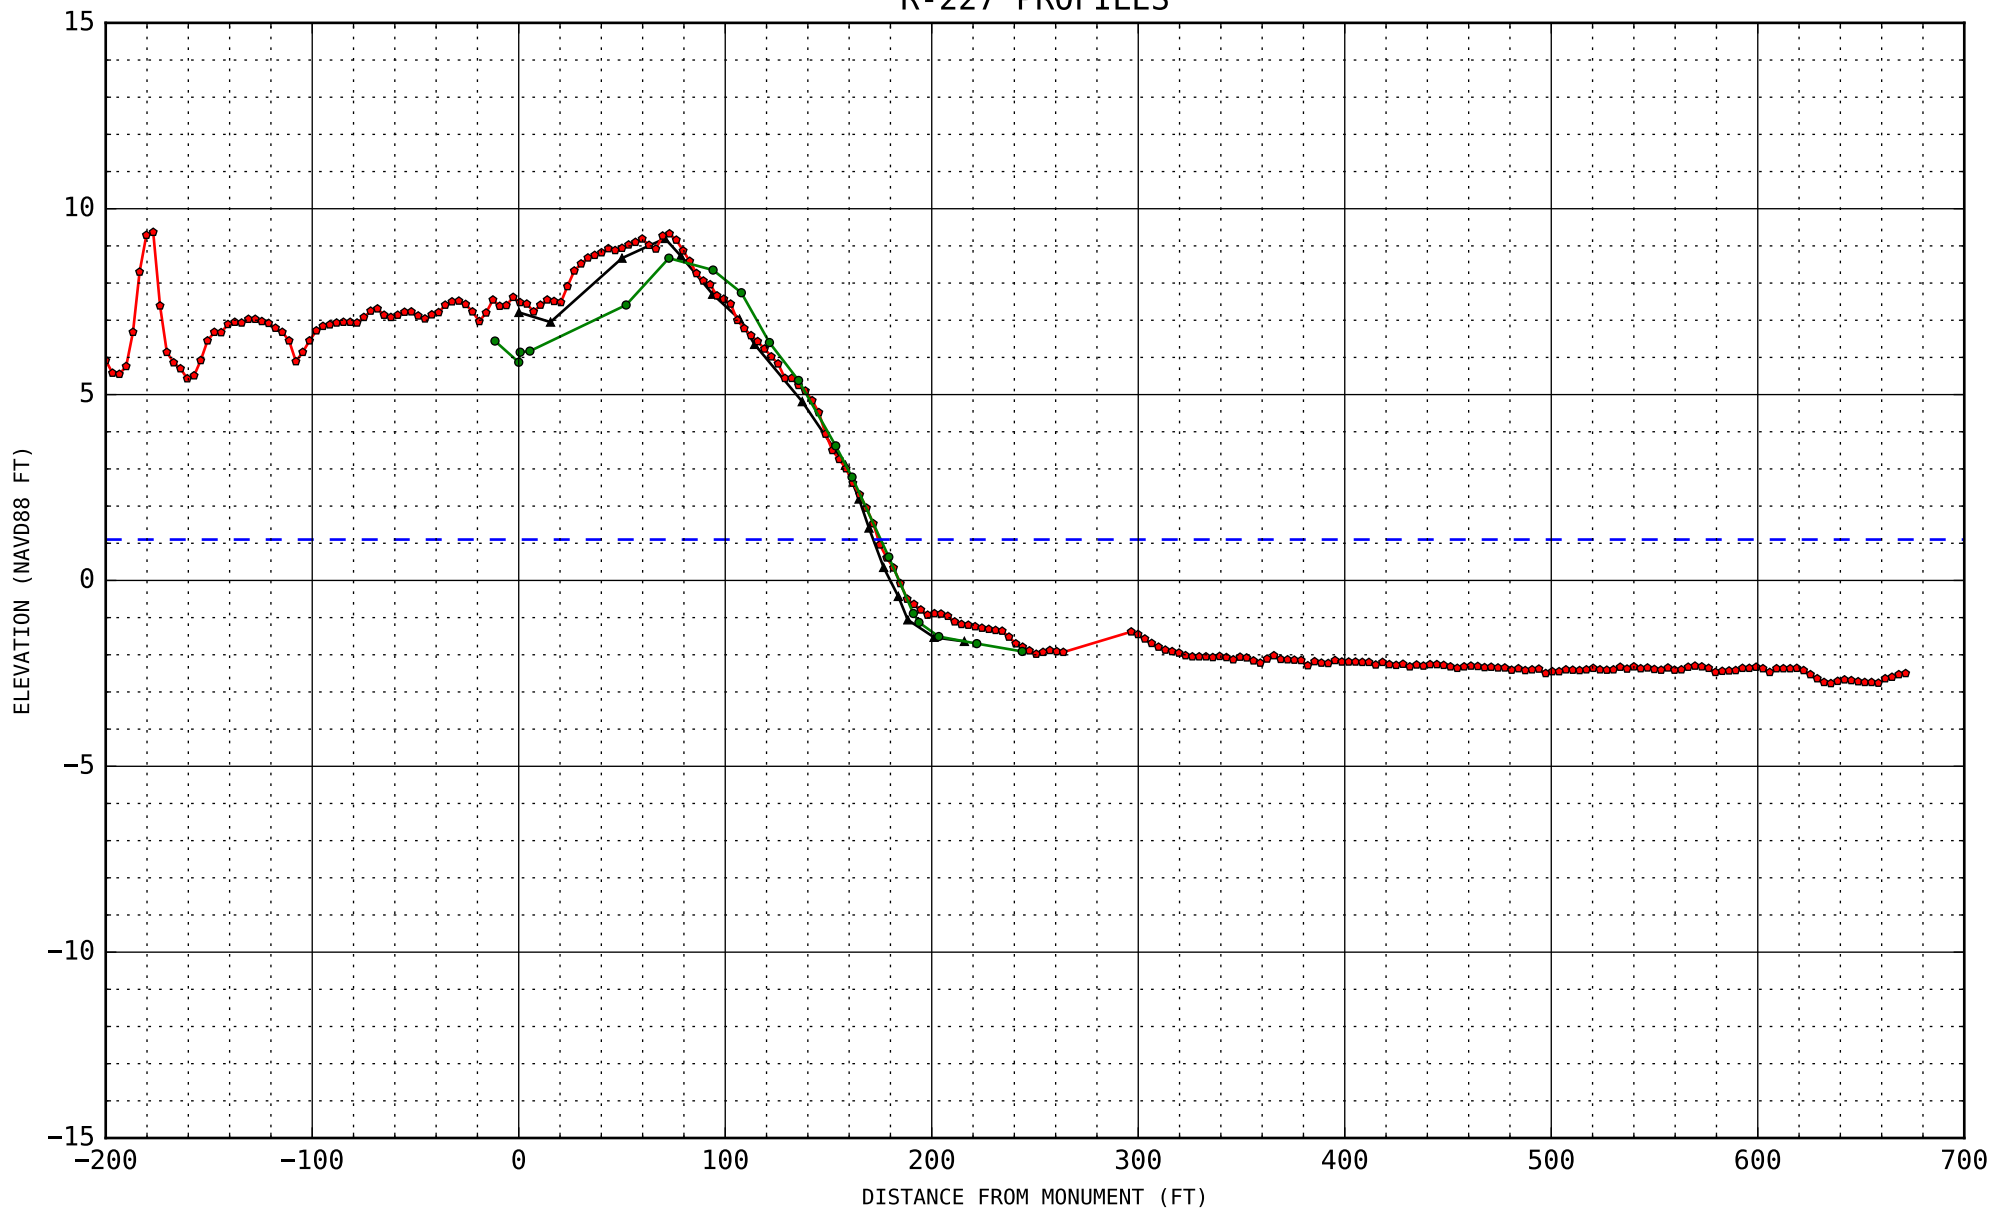
# R-227 PROFILES

- ▲ 2019-MAY CONDITION BY DEP
- 2018-OCT MONITORING BY USACE-LIDAR
- 2017-FEB MONITORING BY DEP
- - - MHW CONTOUR (1.1 FT)

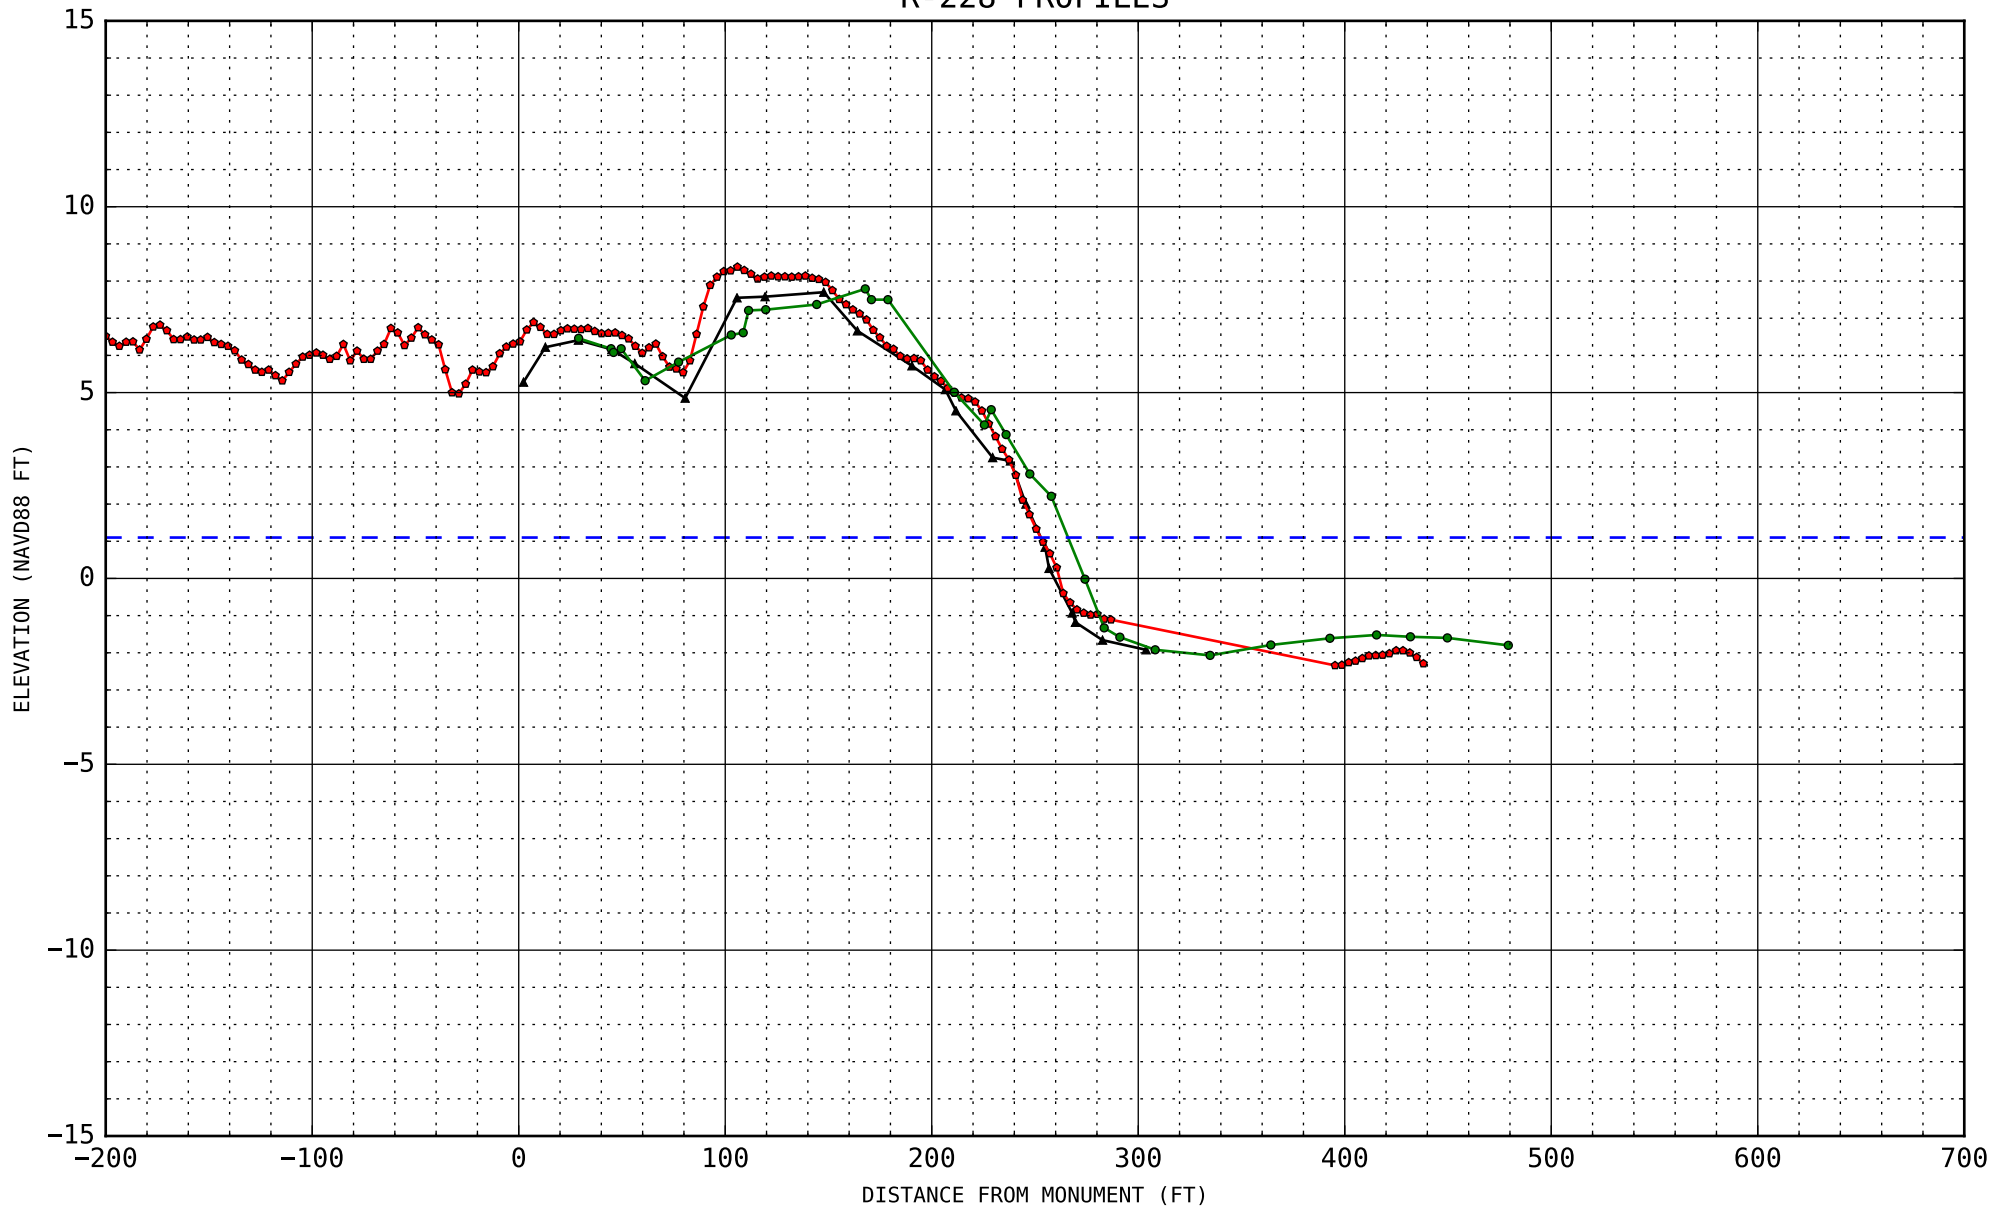
# R-228 PROFILES

- ▲ 2019-MAY CONDITION BY DEP
- 2018-OCT MONITORING BY USACE-LIDAR
- 2017-FEB MONITORING BY DEP
- - - MHW CONTOUR (1.1 FT)

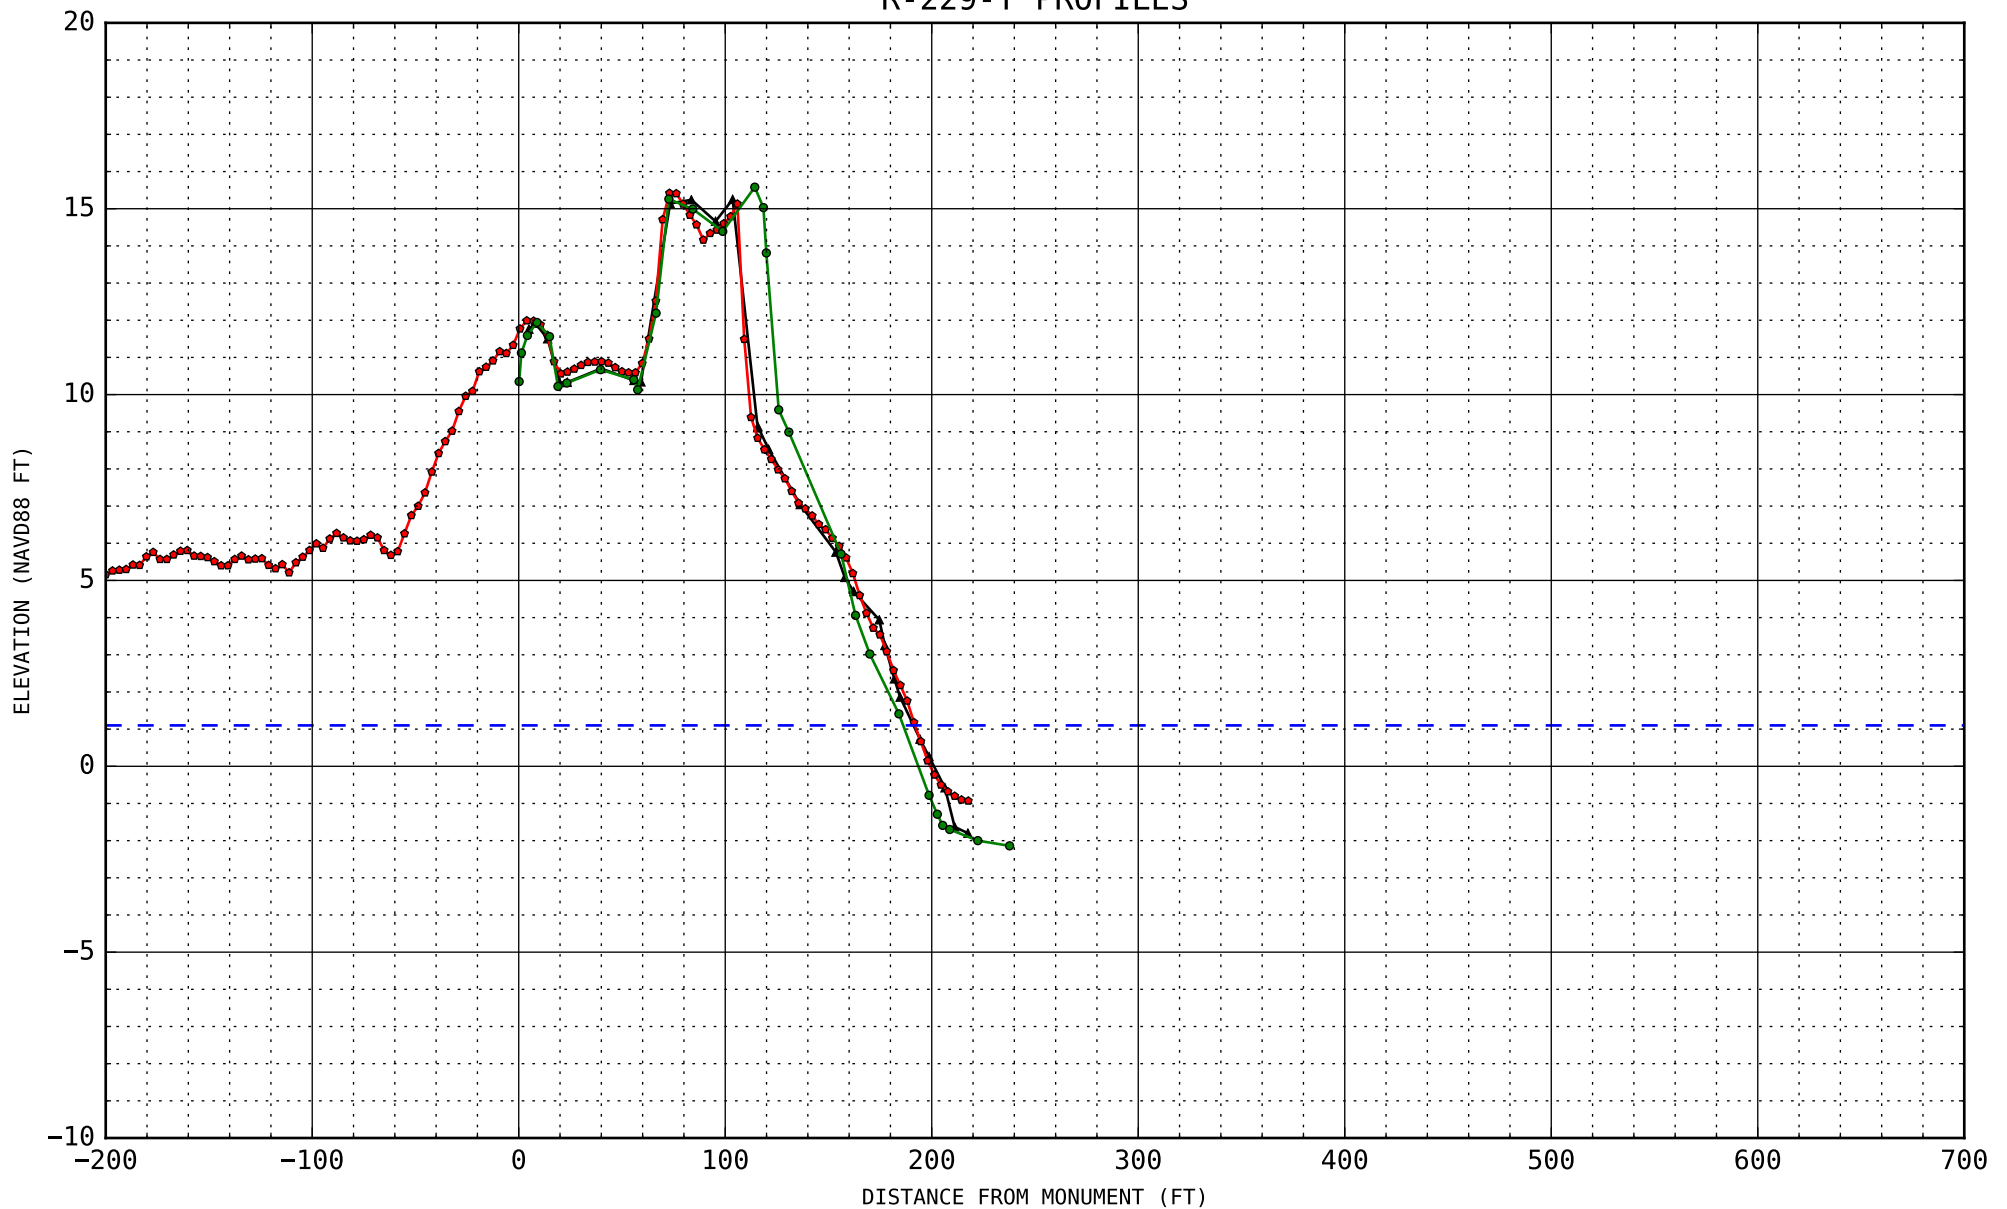
# R-229-T PROFILES

- ▲ 2019-MAY CONDITION BY DEP
- 2018-OCT MONITORING BY USACE-LIDAR
- 2017-FEB MONITORING BY DEP
- - - MHW CONTOUR (1.1 FT)

RANGE: R-229-T  
 EST DATE: MAR1976  
 SURVEY DATE: 29MAY19  
 AZIMUTH: 105.0
