# R-52-T PROFILES

FRANKLIN  
PROGRAM SUPPORT GIS  
DIVISION OF WATER RESOURCE MANAGEMENT  
FLORIDA DEPARTMENT OF ENVIRONMENTAL PROTECTION

RANGE: R-52-T  
EST DATE: FEB1980  
SURVEY DATE: 16MAY19  
AZIMUTH: 150.0

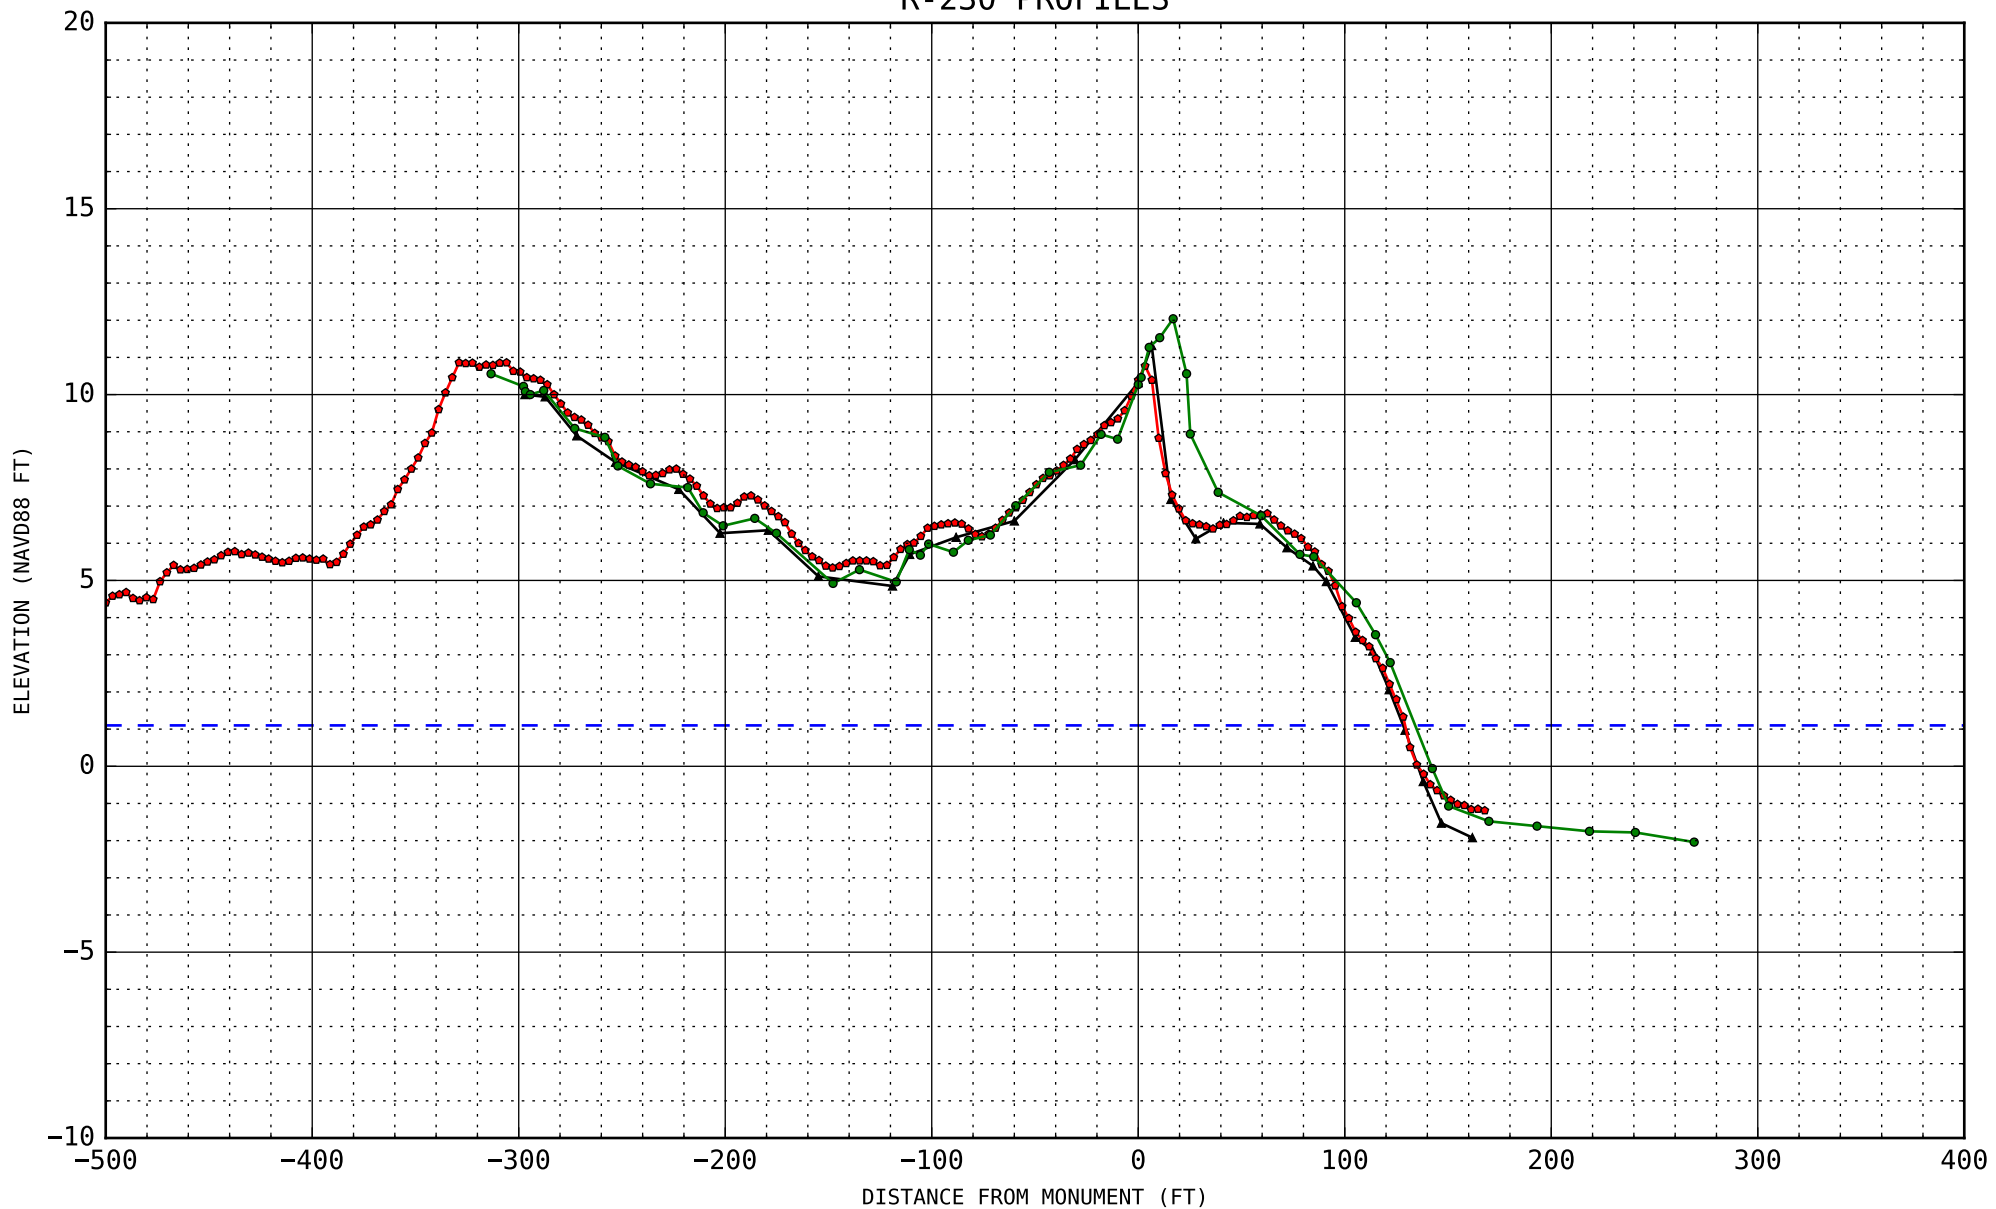
# R-230 PROFILES

- ▲ 2019-MAY CONDITION BY DEP
- 2018-OCT MONITORING BY USACE-LIDAR
- 2017-FEB MONITORING BY DEP
- - - MHW CONTOUR (1.1 FT)

RANGE: R-230  
EST DATE: MMM1974  
SURVEY DATE: 29MAY19  
AZIMUTH: 95.0

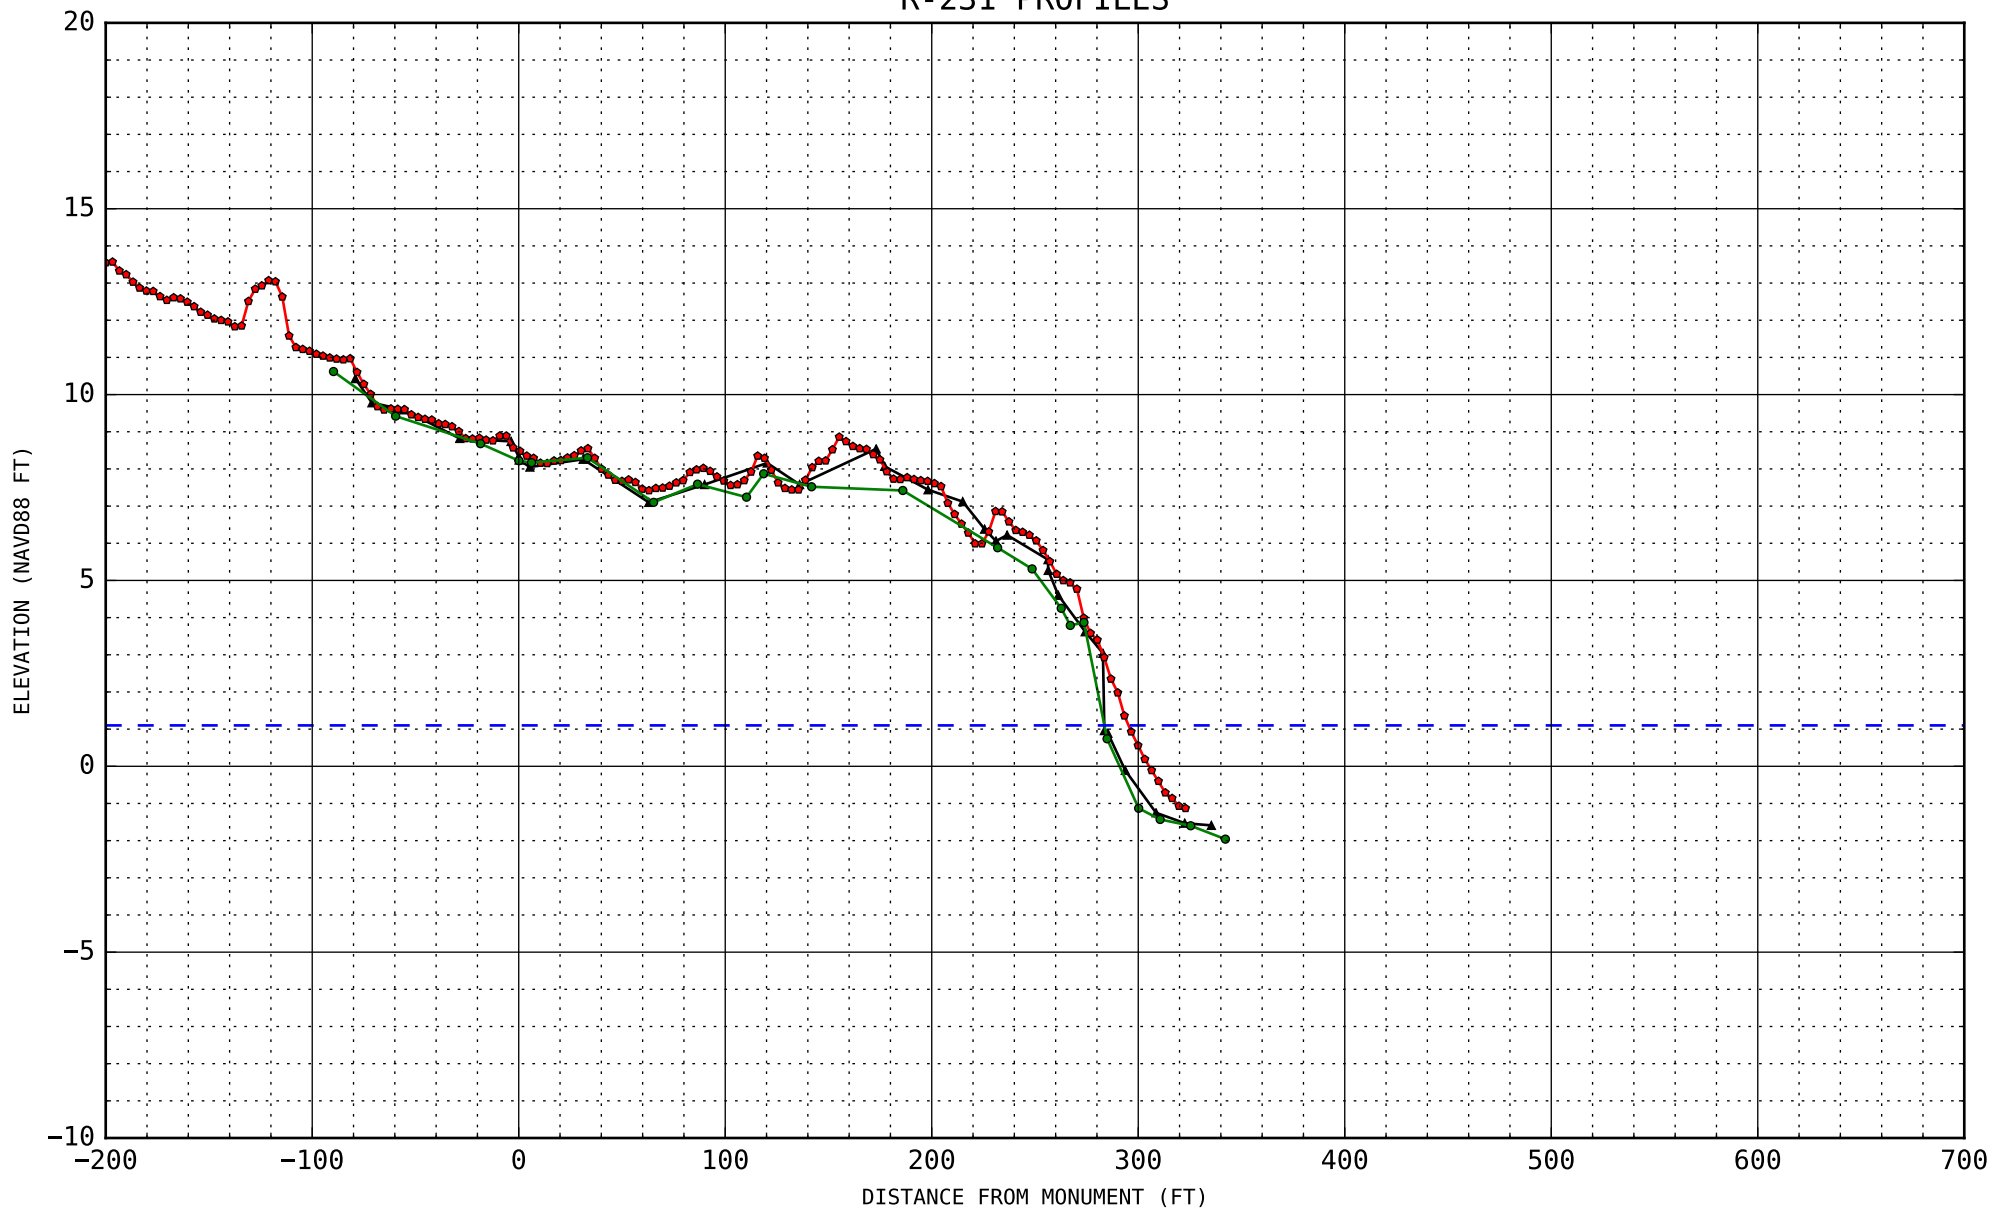
# R-231 PROFILES

- ▲ 2019-MAY CONDITION BY DEP
- 2018-OCT MONITORING BY USACE-LIDAR
- 2017-FEB MONITORING BY DEP
- - - MHW CONTOUR (1.1 FT)

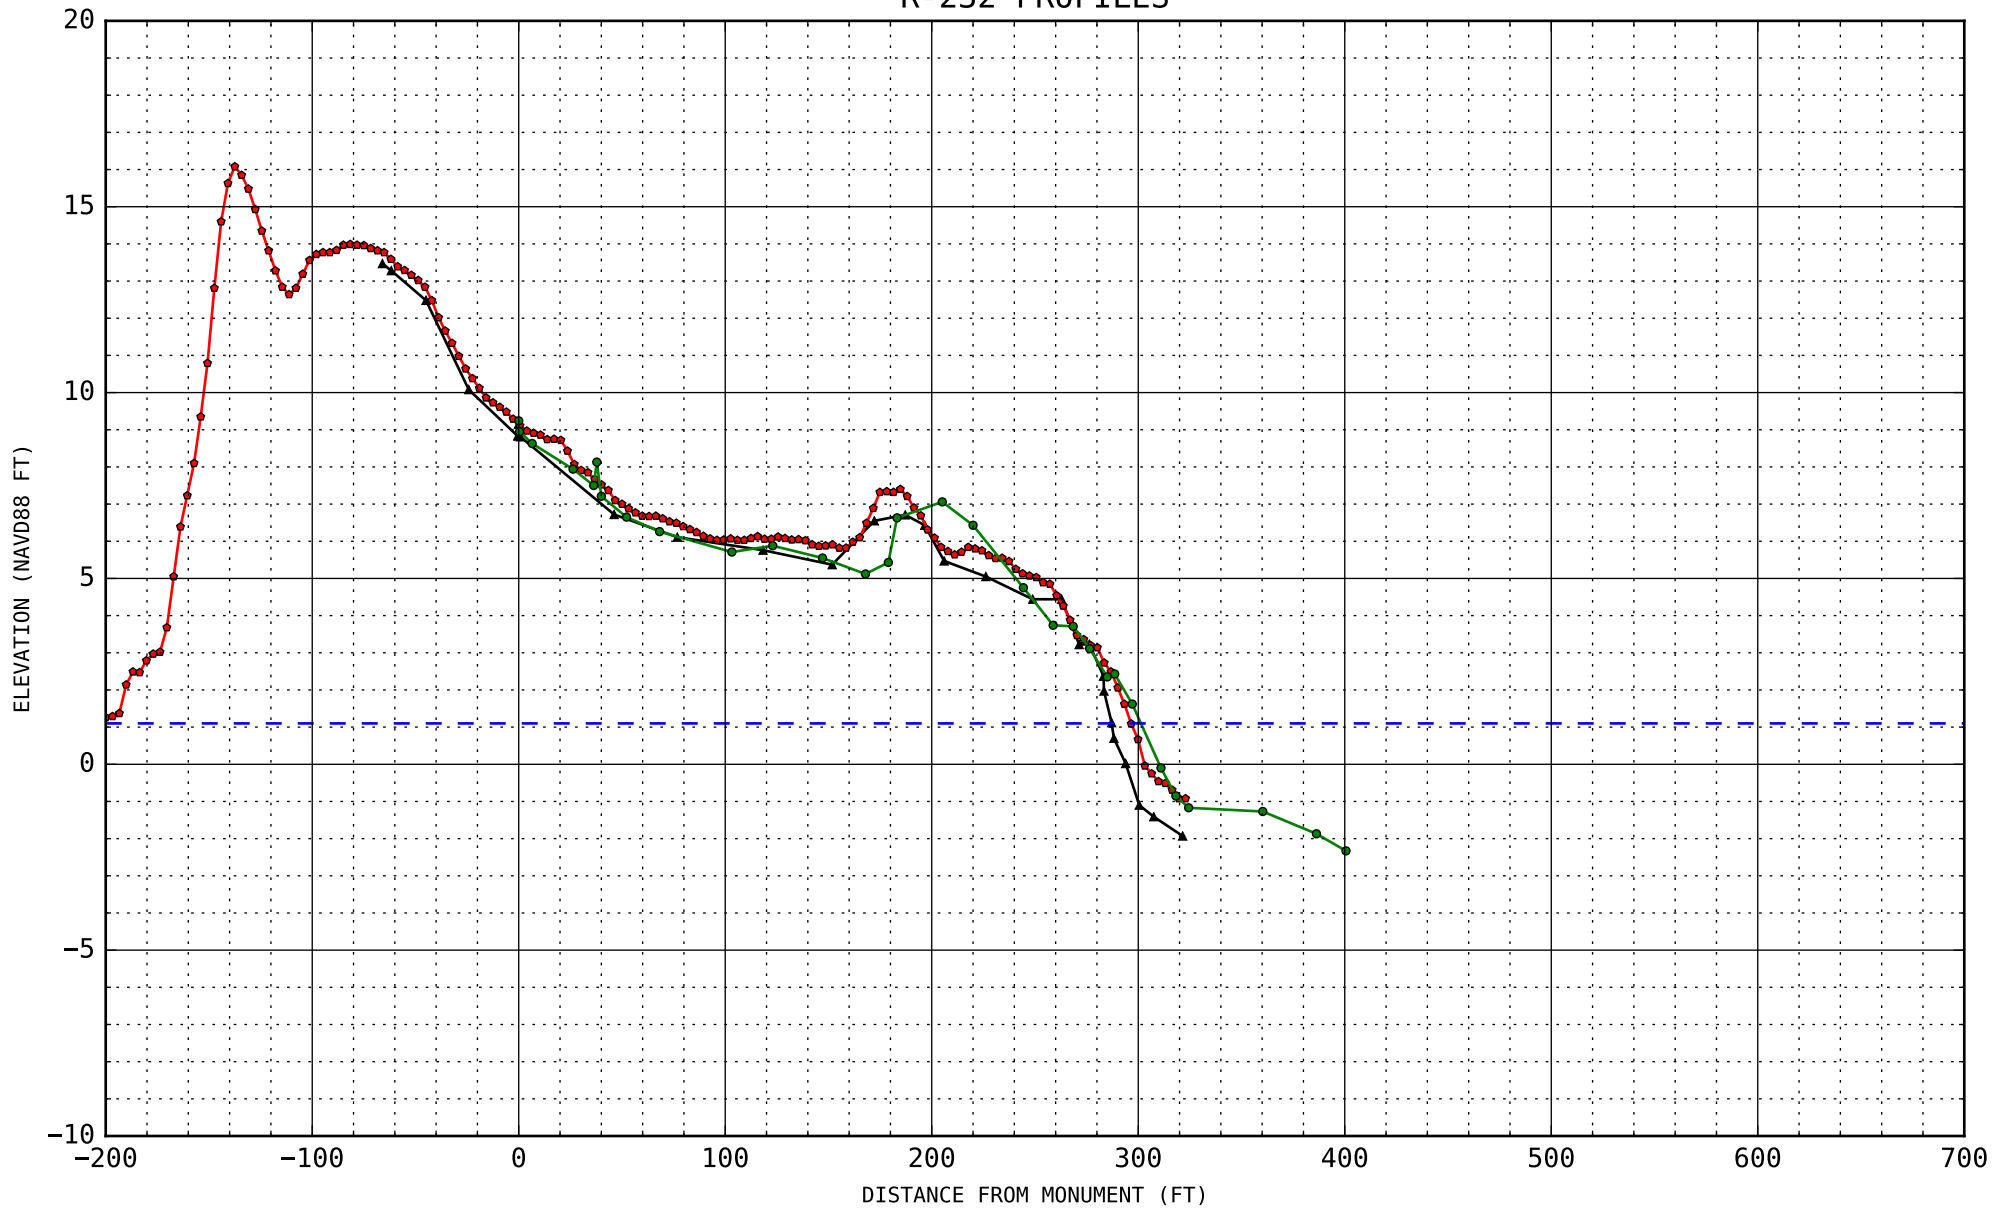
# R-232 PROFILES

- ▲ 2019-MAY CONDITION BY DEP
- 2018-OCT MONITORING BY USACE-LIDAR
- 2017-FEB MONITORING BY DEP
- - - MHW CONTOUR (1.1 FT)

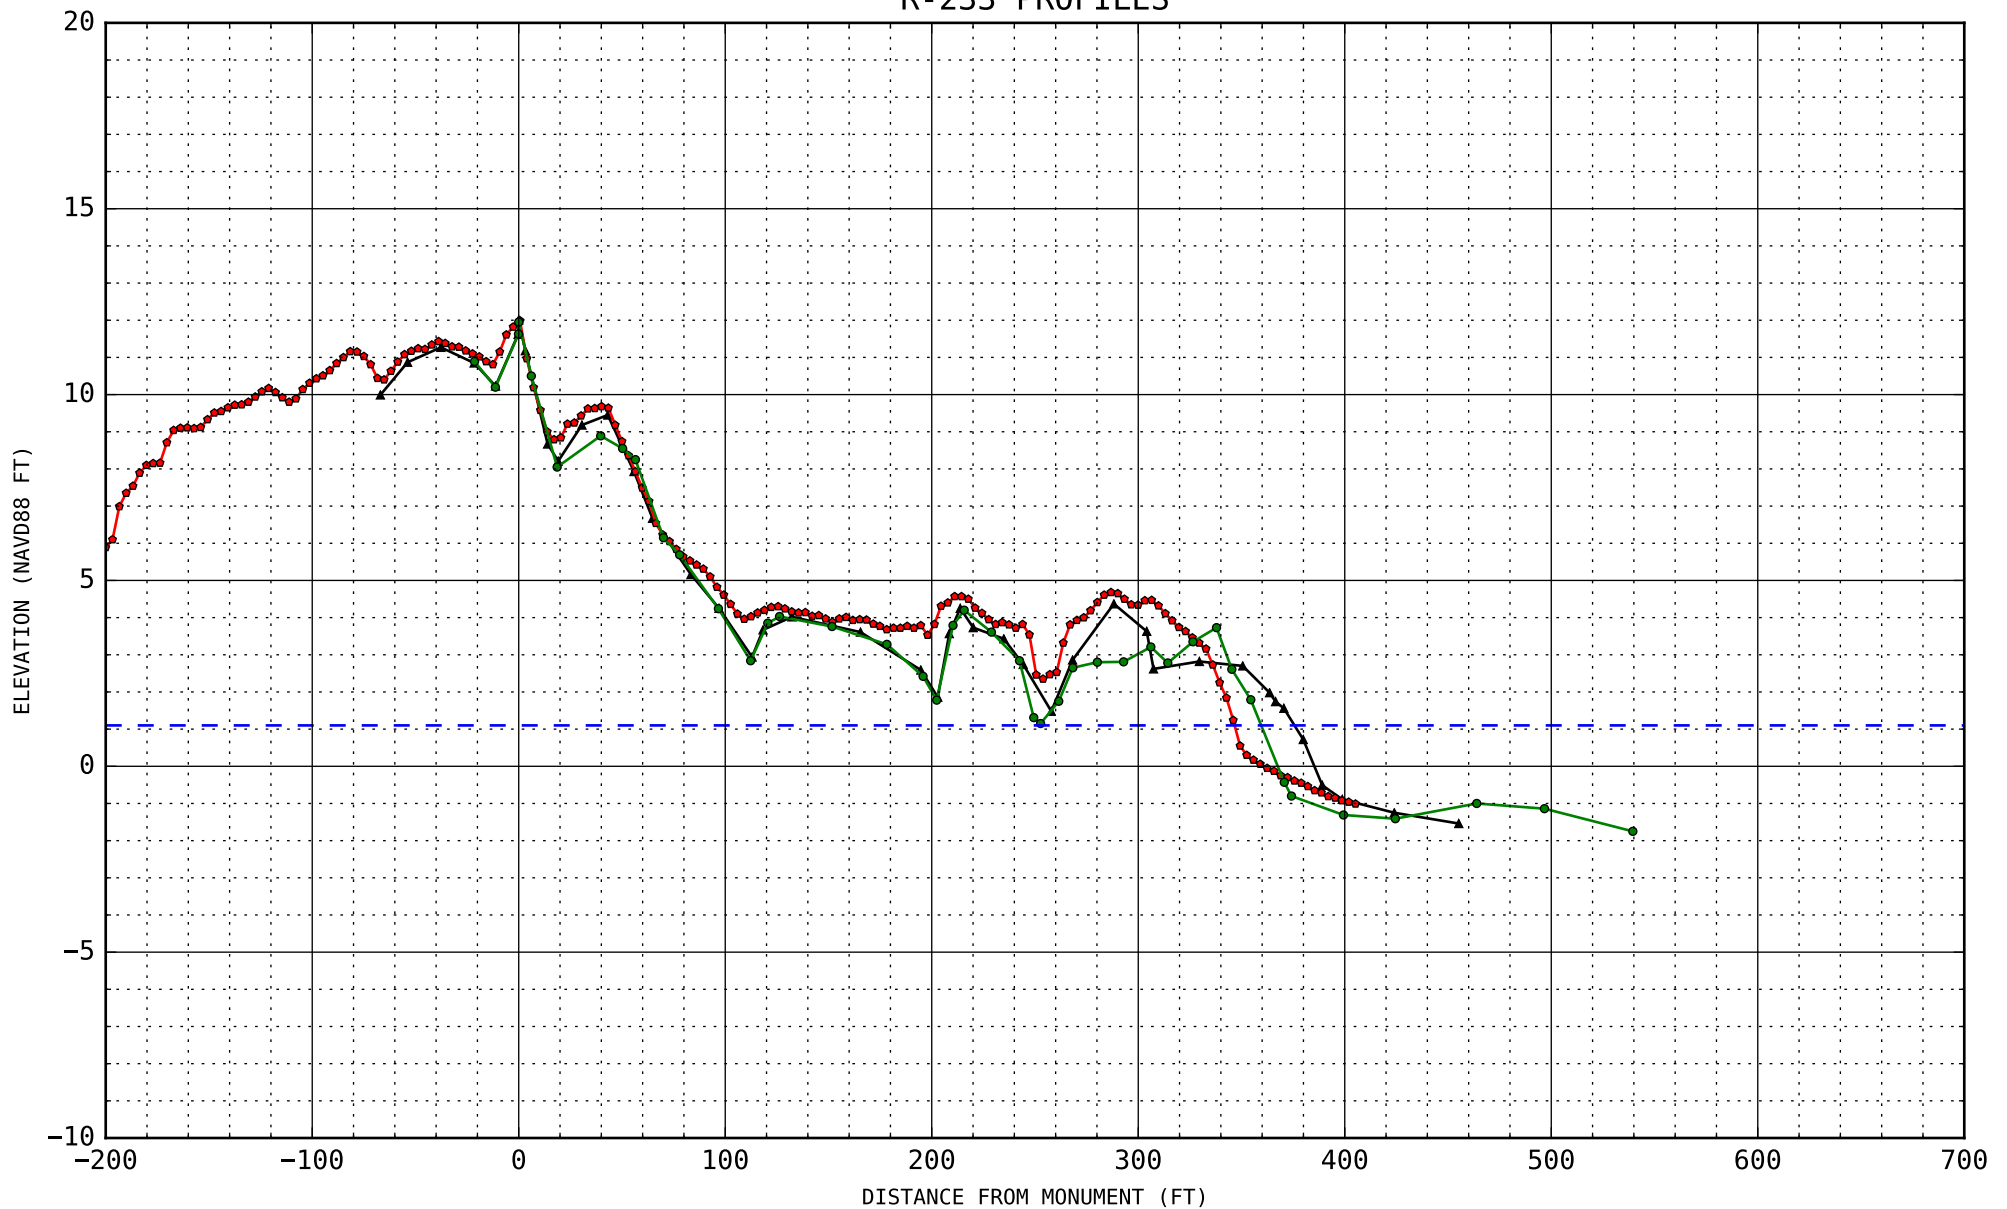
# R-233 PROFILES

- ▲ 2019-MAY CONDITION BY DEP
- 2018-OCT MONITORING BY USACE-LIDAR
- 2017-FEB MONITORING BY DEP
- - - MHW CONTOUR (1.1 FT)

RANGE: R-233  
EST DATE: MMM1974  
SURVEY DATE: 29MAY19  
AZIMUTH: 80.0

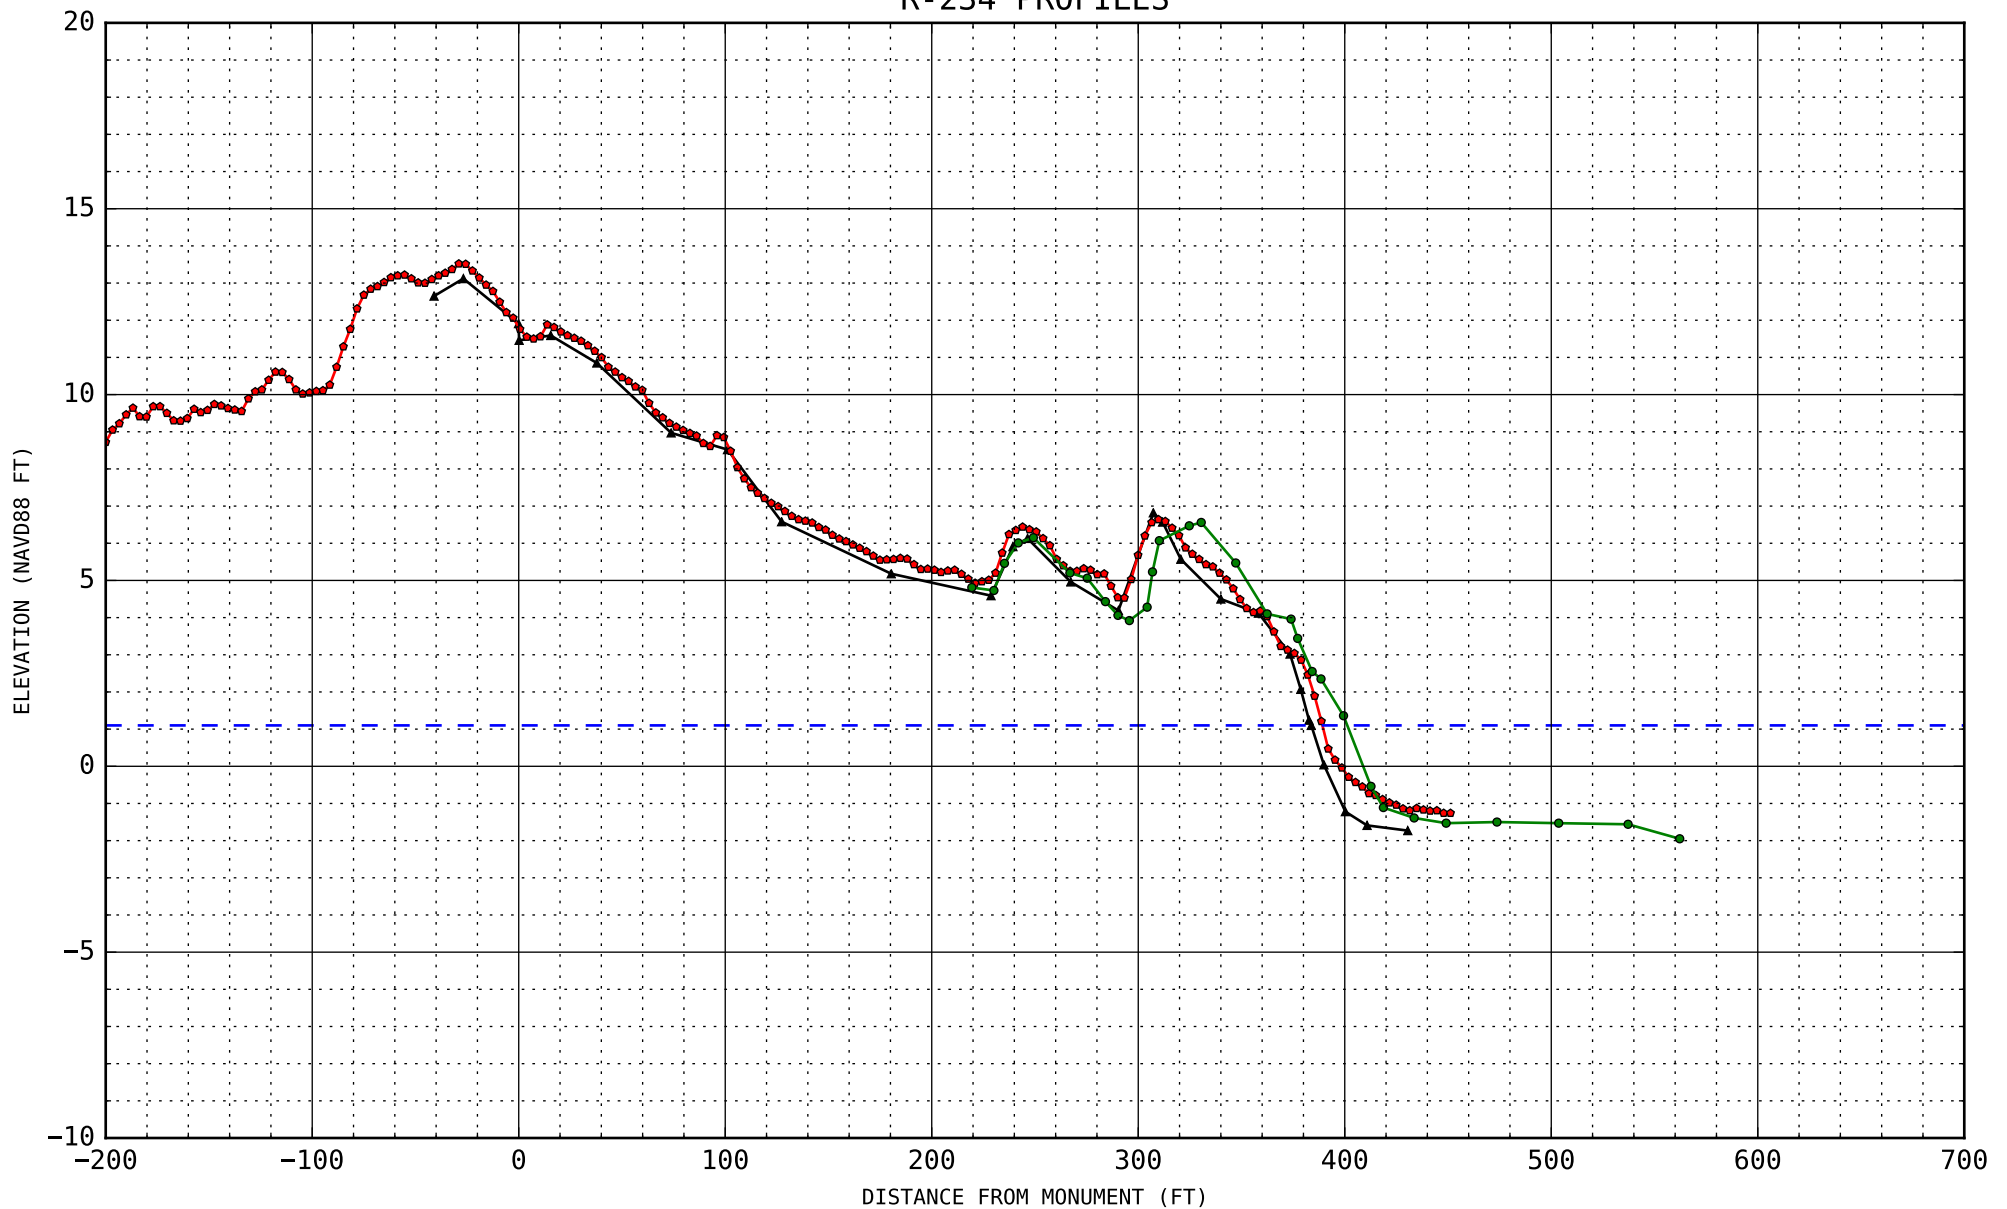
# R-234 PROFILES

- ▲ 2019-MAY CONDITION BY DEP
- 2018-OCT MONITORING BY USACE-LIDAR
- 2017-FEB MONITORING BY DEP
- - - MHW CONTOUR (1.1 FT)

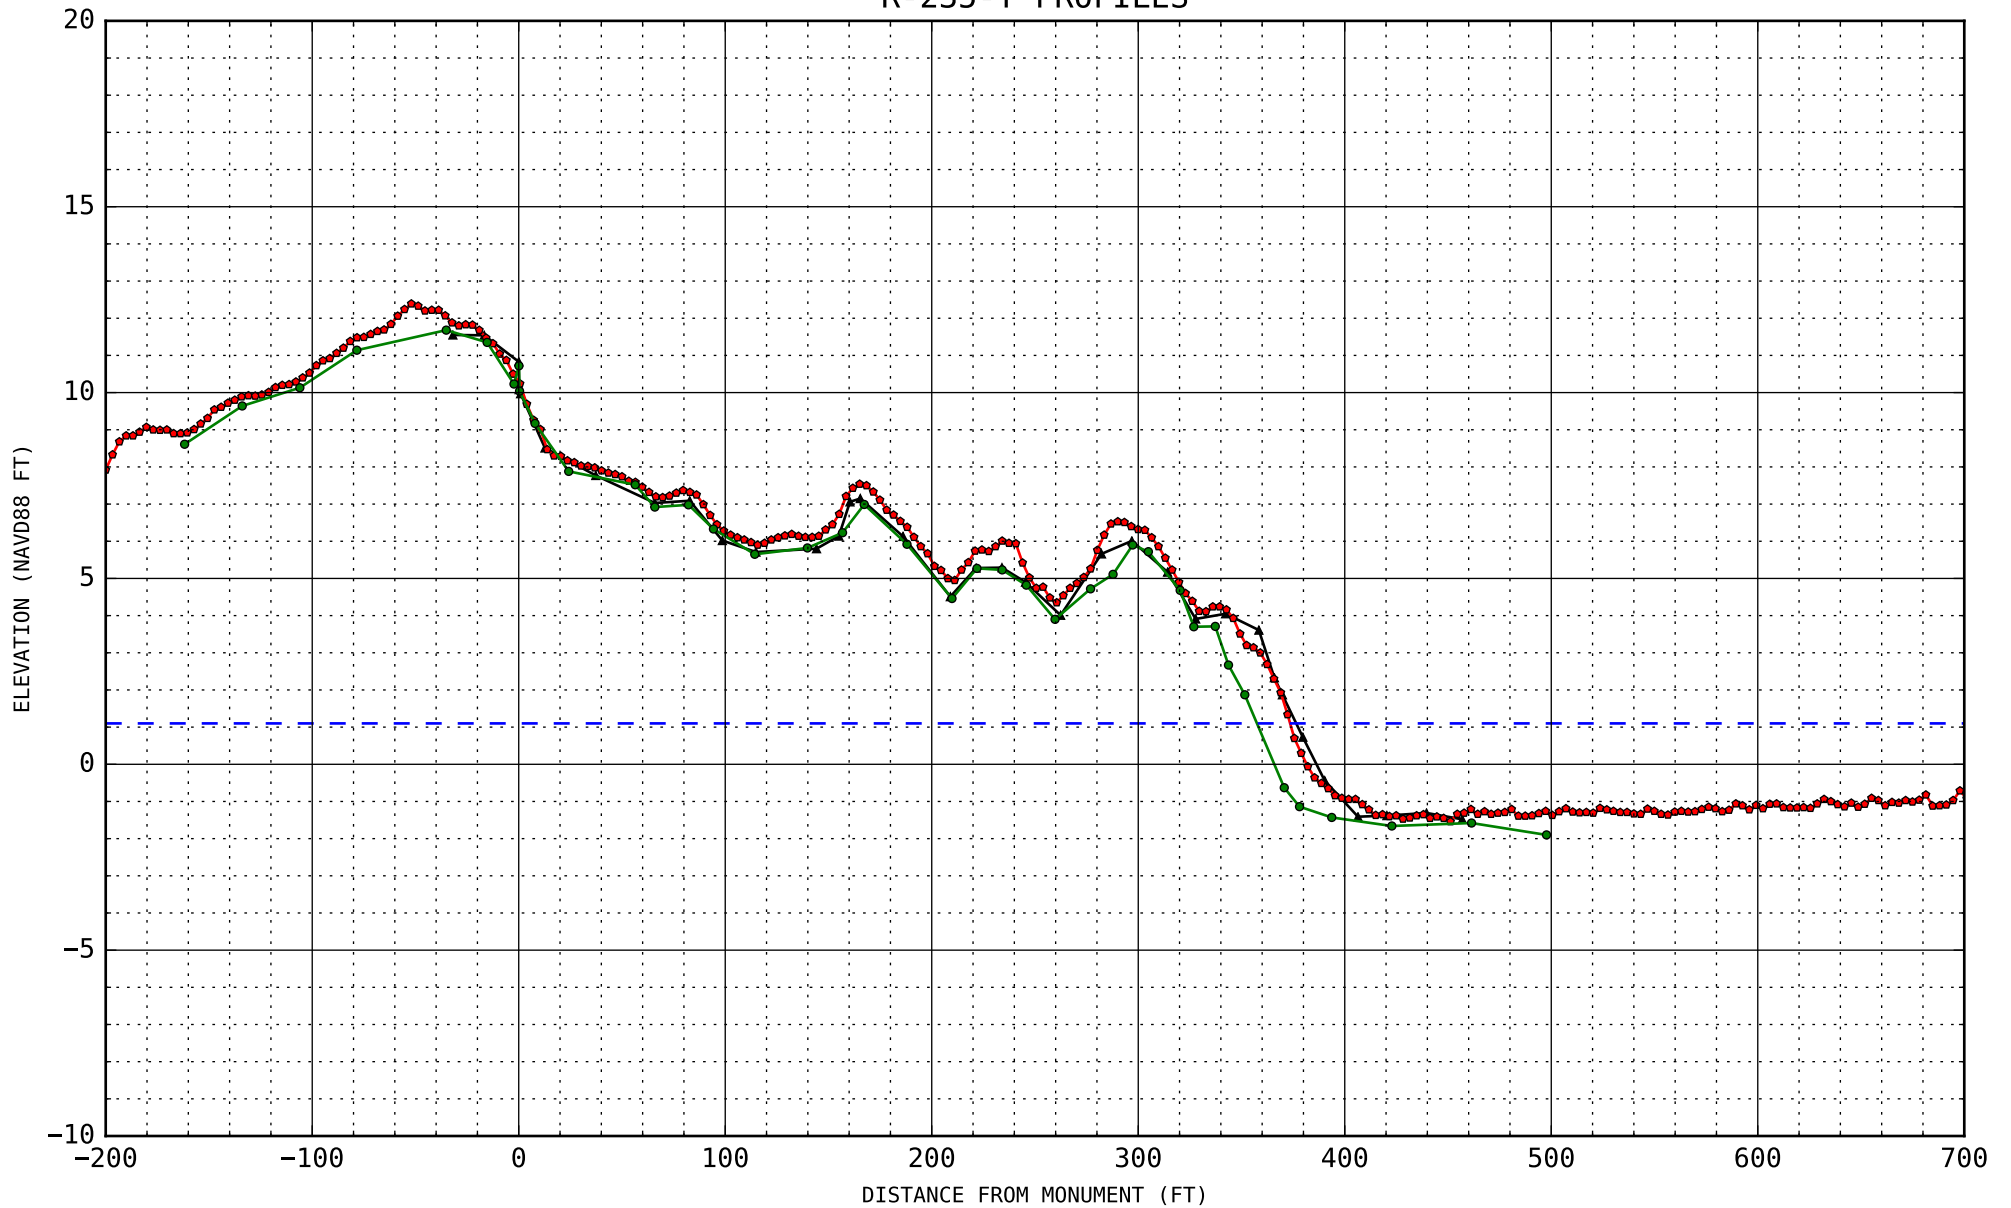
# R-235-T PROFILES

- ▲ 2019-MAY CONDITION BY DEP
- 2018-OCT MONITORING BY USACE-LIDAR
- 2017-FEB MONITORING BY DEP
- - - MHW CONTOUR (1.1 FT)

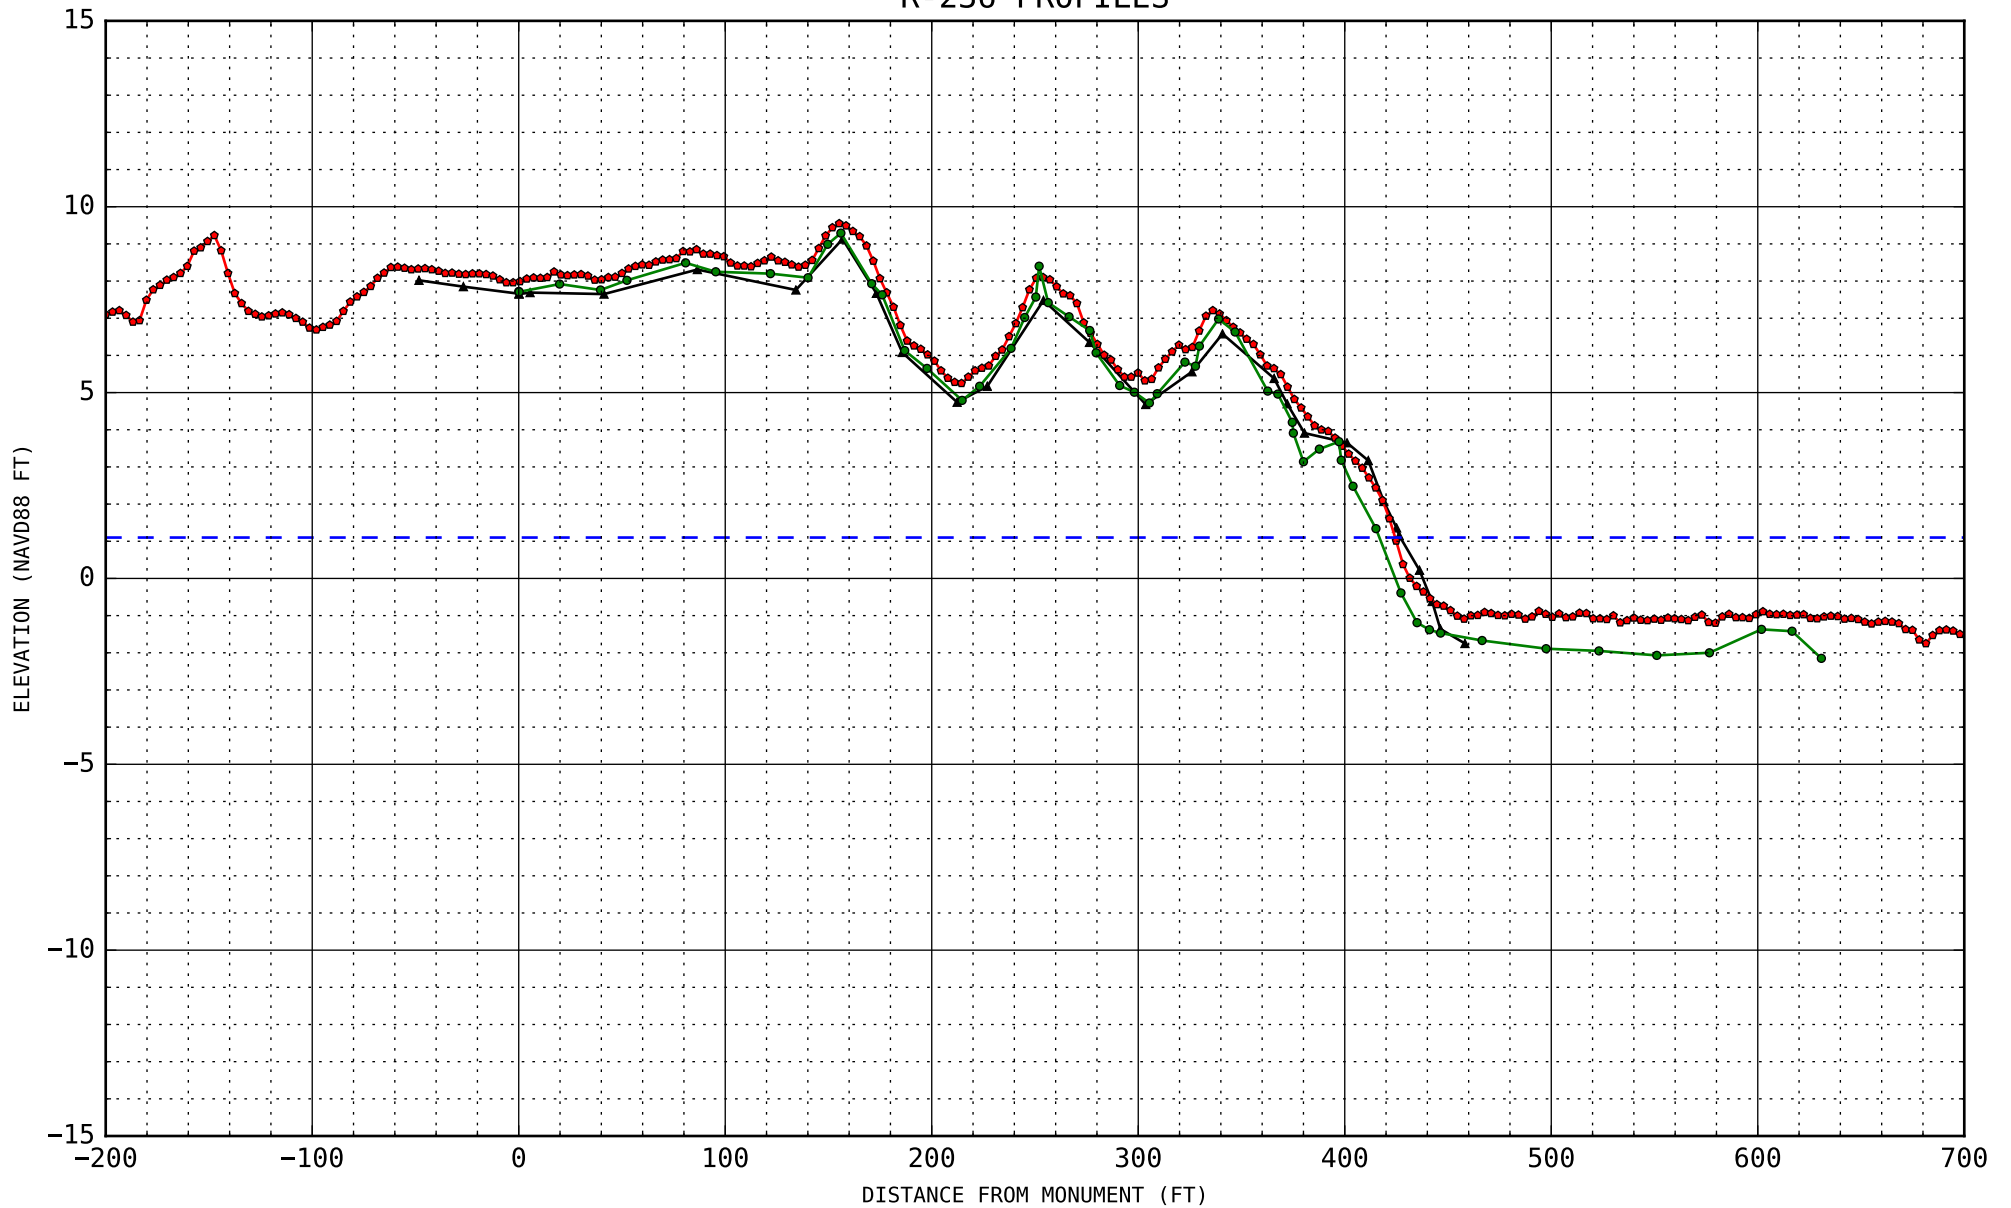
# R-236 PROFILES

- ▲ 2019-MAY CONDITION BY DEP
- 2018-OCT MONITORING BY USACE-LIDAR
- 2017-FEB MONITORING BY DEP
- - - MHW CONTOUR (1.1 FT)

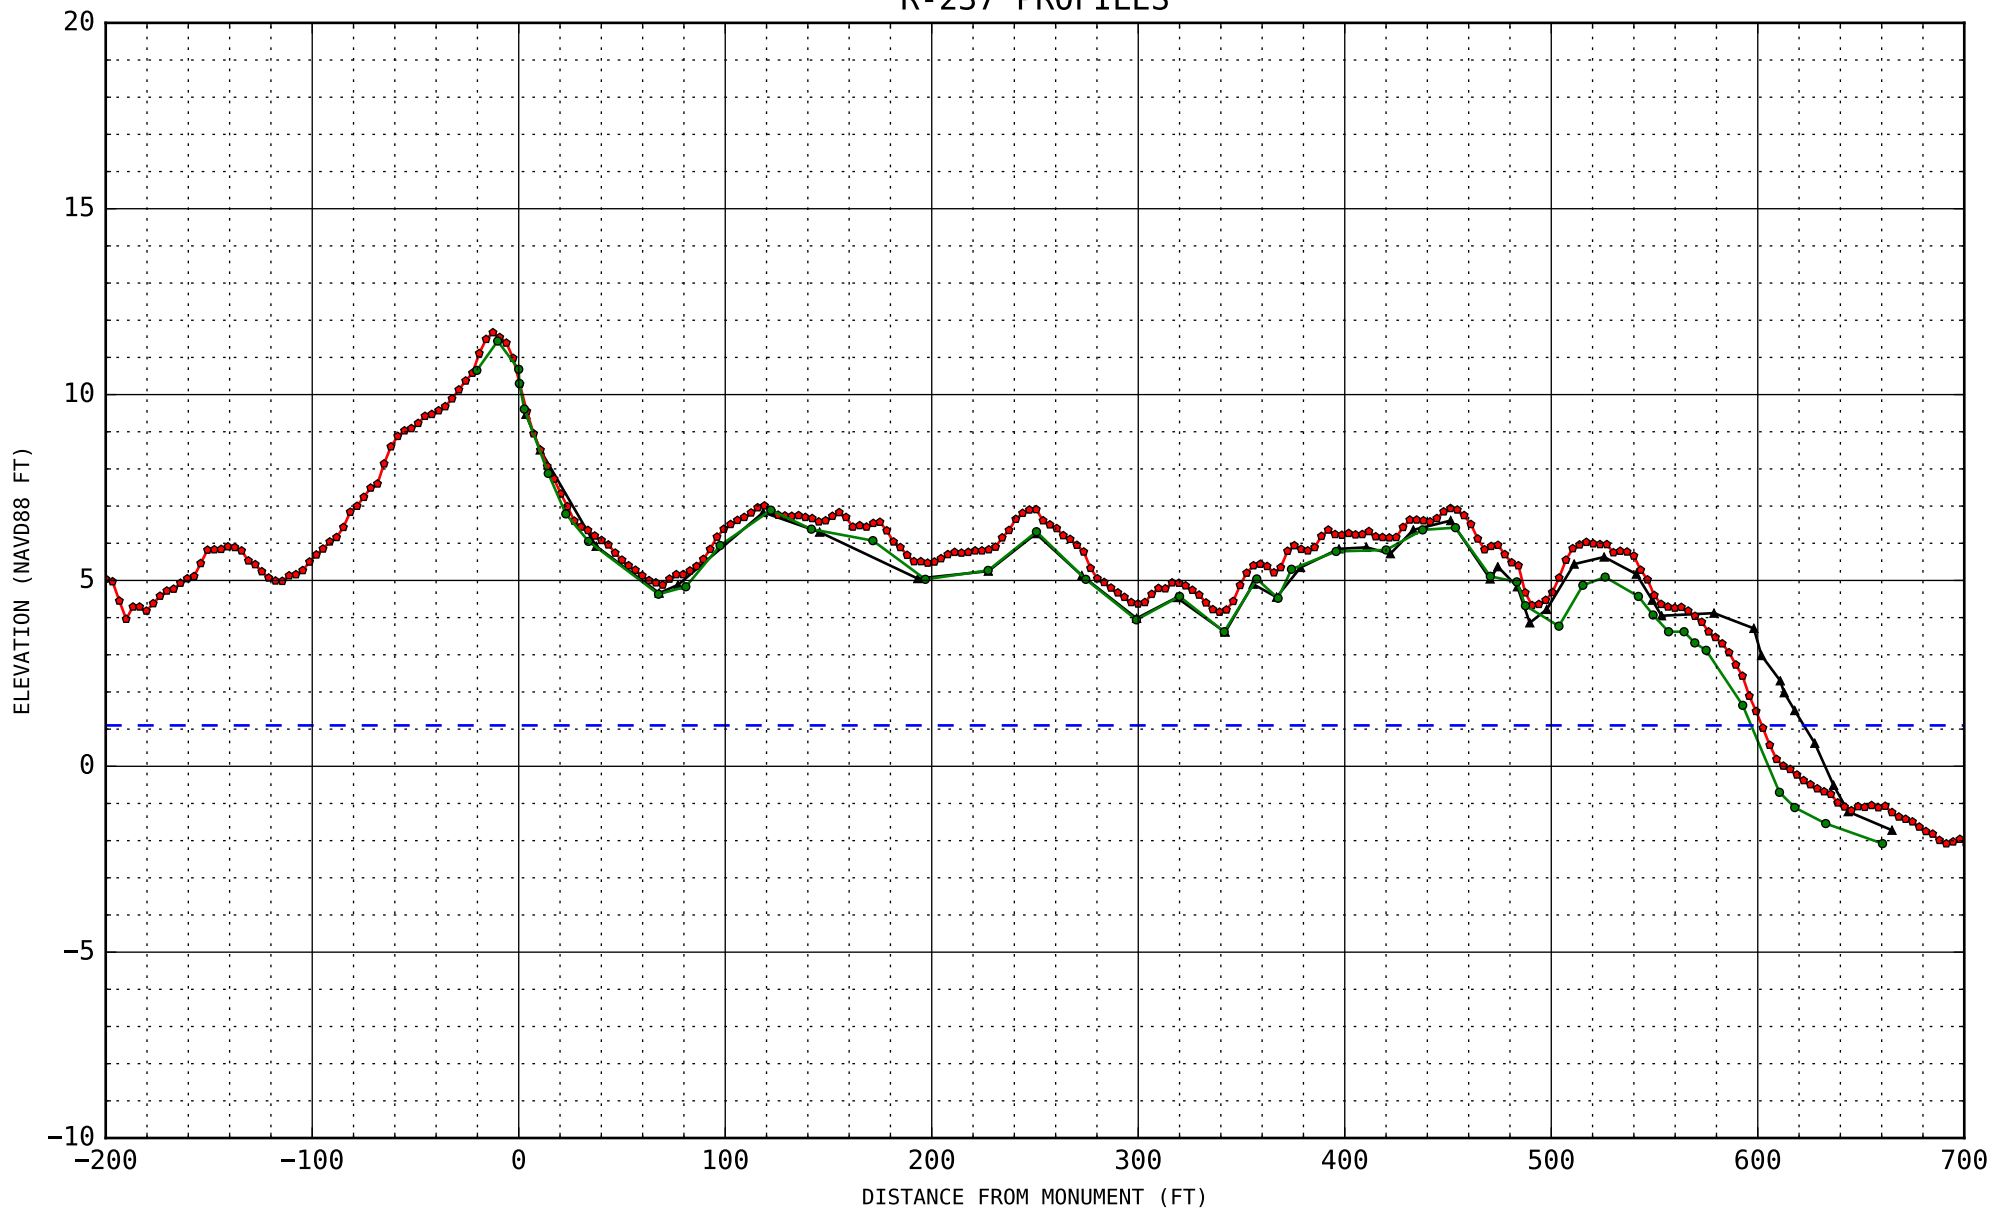
# R-237 PROFILES

- ▲ 2019-MAY CONDITION BY DEP
- 2018-OCT MONITORING BY USACE-LIDAR
- 2017-FEB MONITORING BY DEP
- - - MHW CONTOUR (1.1 FT)

RANGE: R-237  
EST DATE: MMM1974  
SURVEY DATE: 29MAY19  
AZIMUTH: 70.0

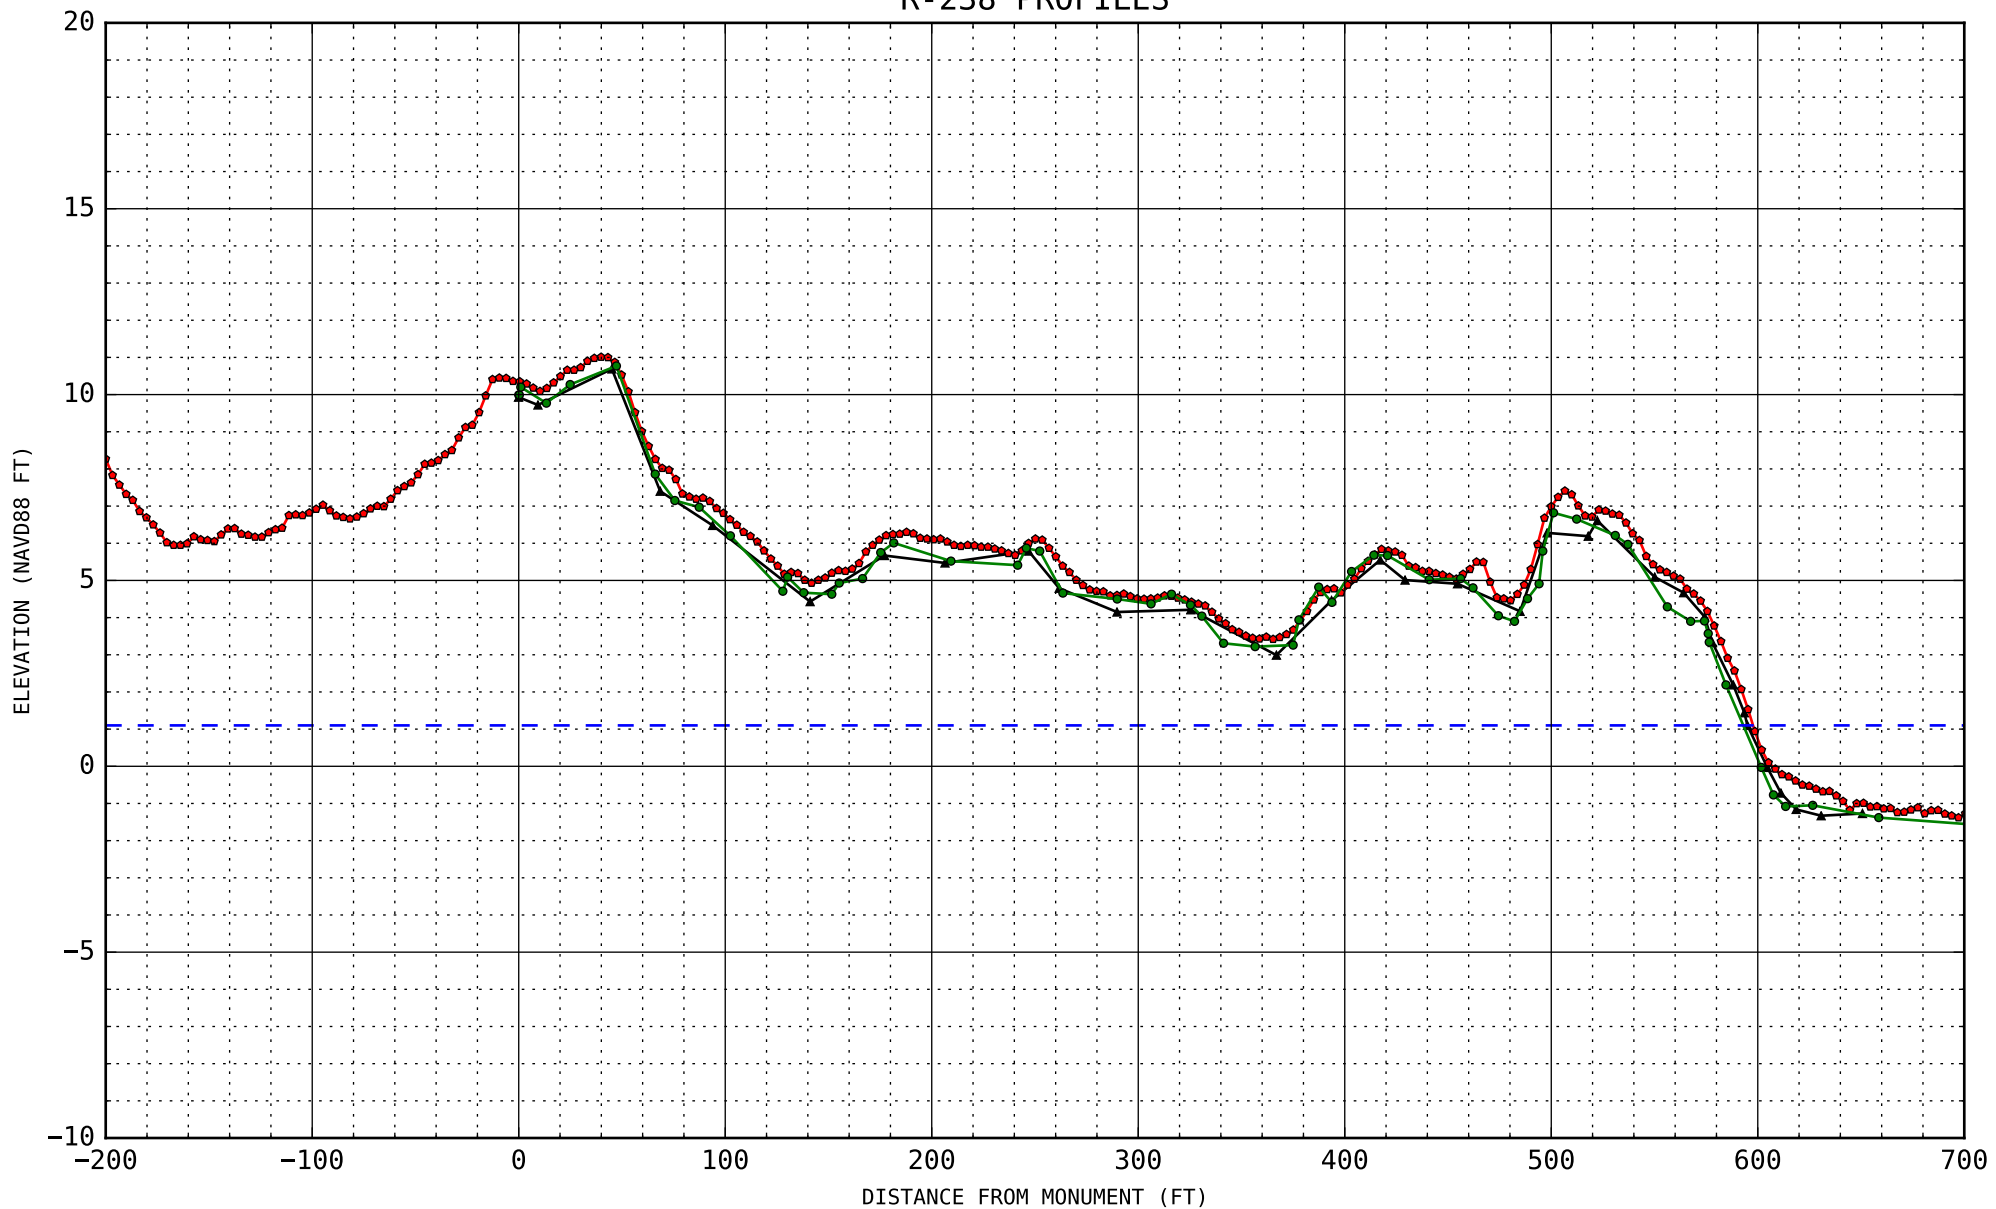
# R-238 PROFILES

- ▲ 2019-MAY CONDITION BY DEP
- 2018-OCT MONITORING BY USACE-LIDAR
- 2017-FEB MONITORING BY DEP
- - - MHW CONTOUR (1.1 FT)
