# R-52-T PROFILES

FRANKLIN  
PROGRAM SUPPORT GIS  
DIVISION OF WATER RESOURCE MANAGEMENT  
FLORIDA DEPARTMENT OF ENVIRONMENTAL PROTECTION

RANGE: R-52-T  
EST DATE: FEB1980  
SURVEY DATE: 16MAY19  
AZIMUTH: 150.0

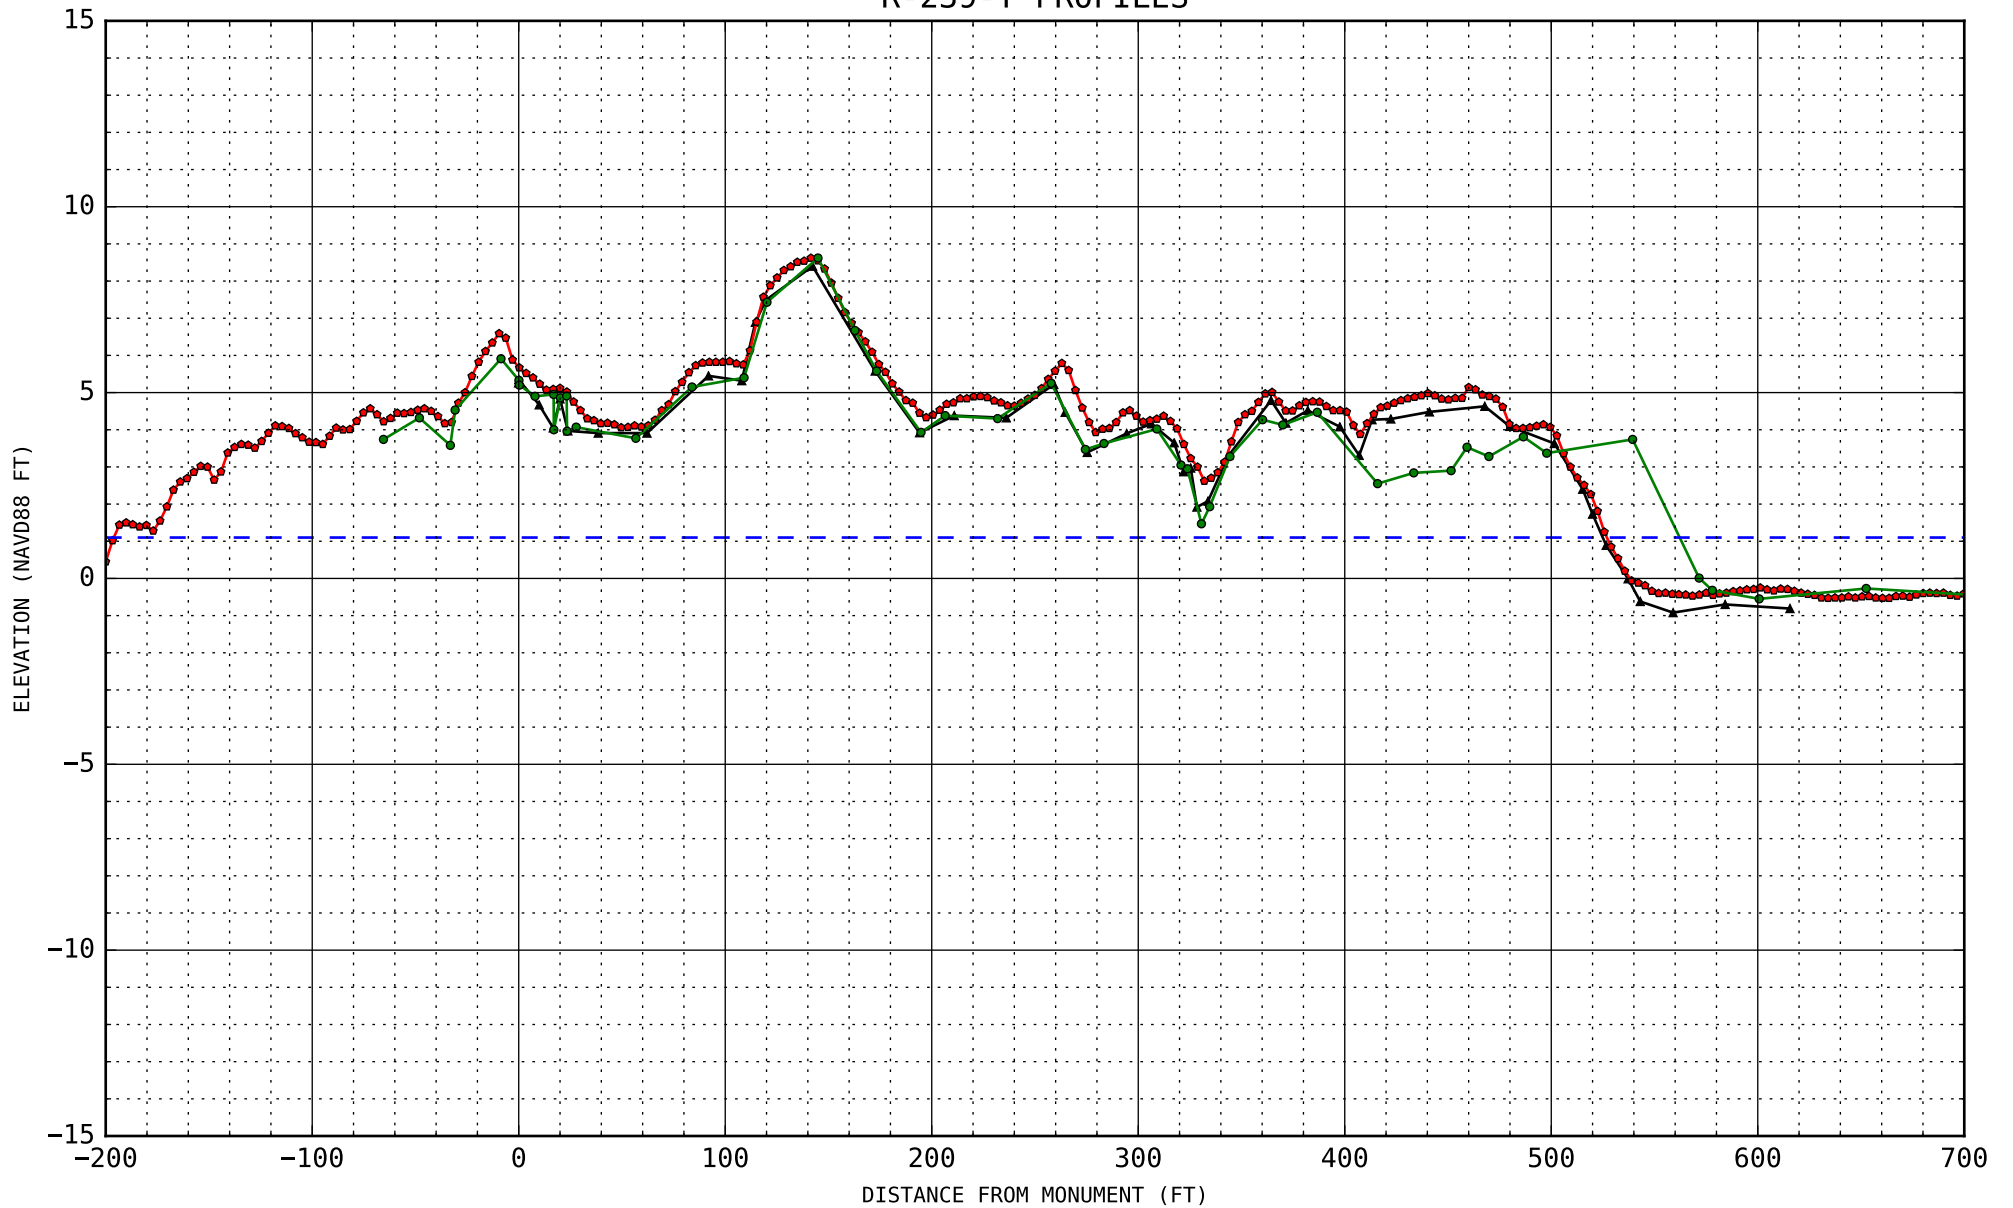
# R-239-T PROFILES

- ▲ 2019-MAY CONDITION BY DEP
- 2018-OCT MONITORING BY USACE-LIDAR
- 2017-FEB MONITORING BY DEP
- - - MHW CONTOUR (1.1 FT)
