# R-1 PROFILES

WALTON  
PROGRAM SUPPORT GIS  
DIVISION OF WATER RESOURCE MANAGEMENT  
FLORIDA DEPARTMENT OF ENVIRONMENTAL PROTECTION

RANGE: R-1  
EST DATE: NOV1980  
SURVEY DATE: 04APR19  
AZIMUTH: 190.0

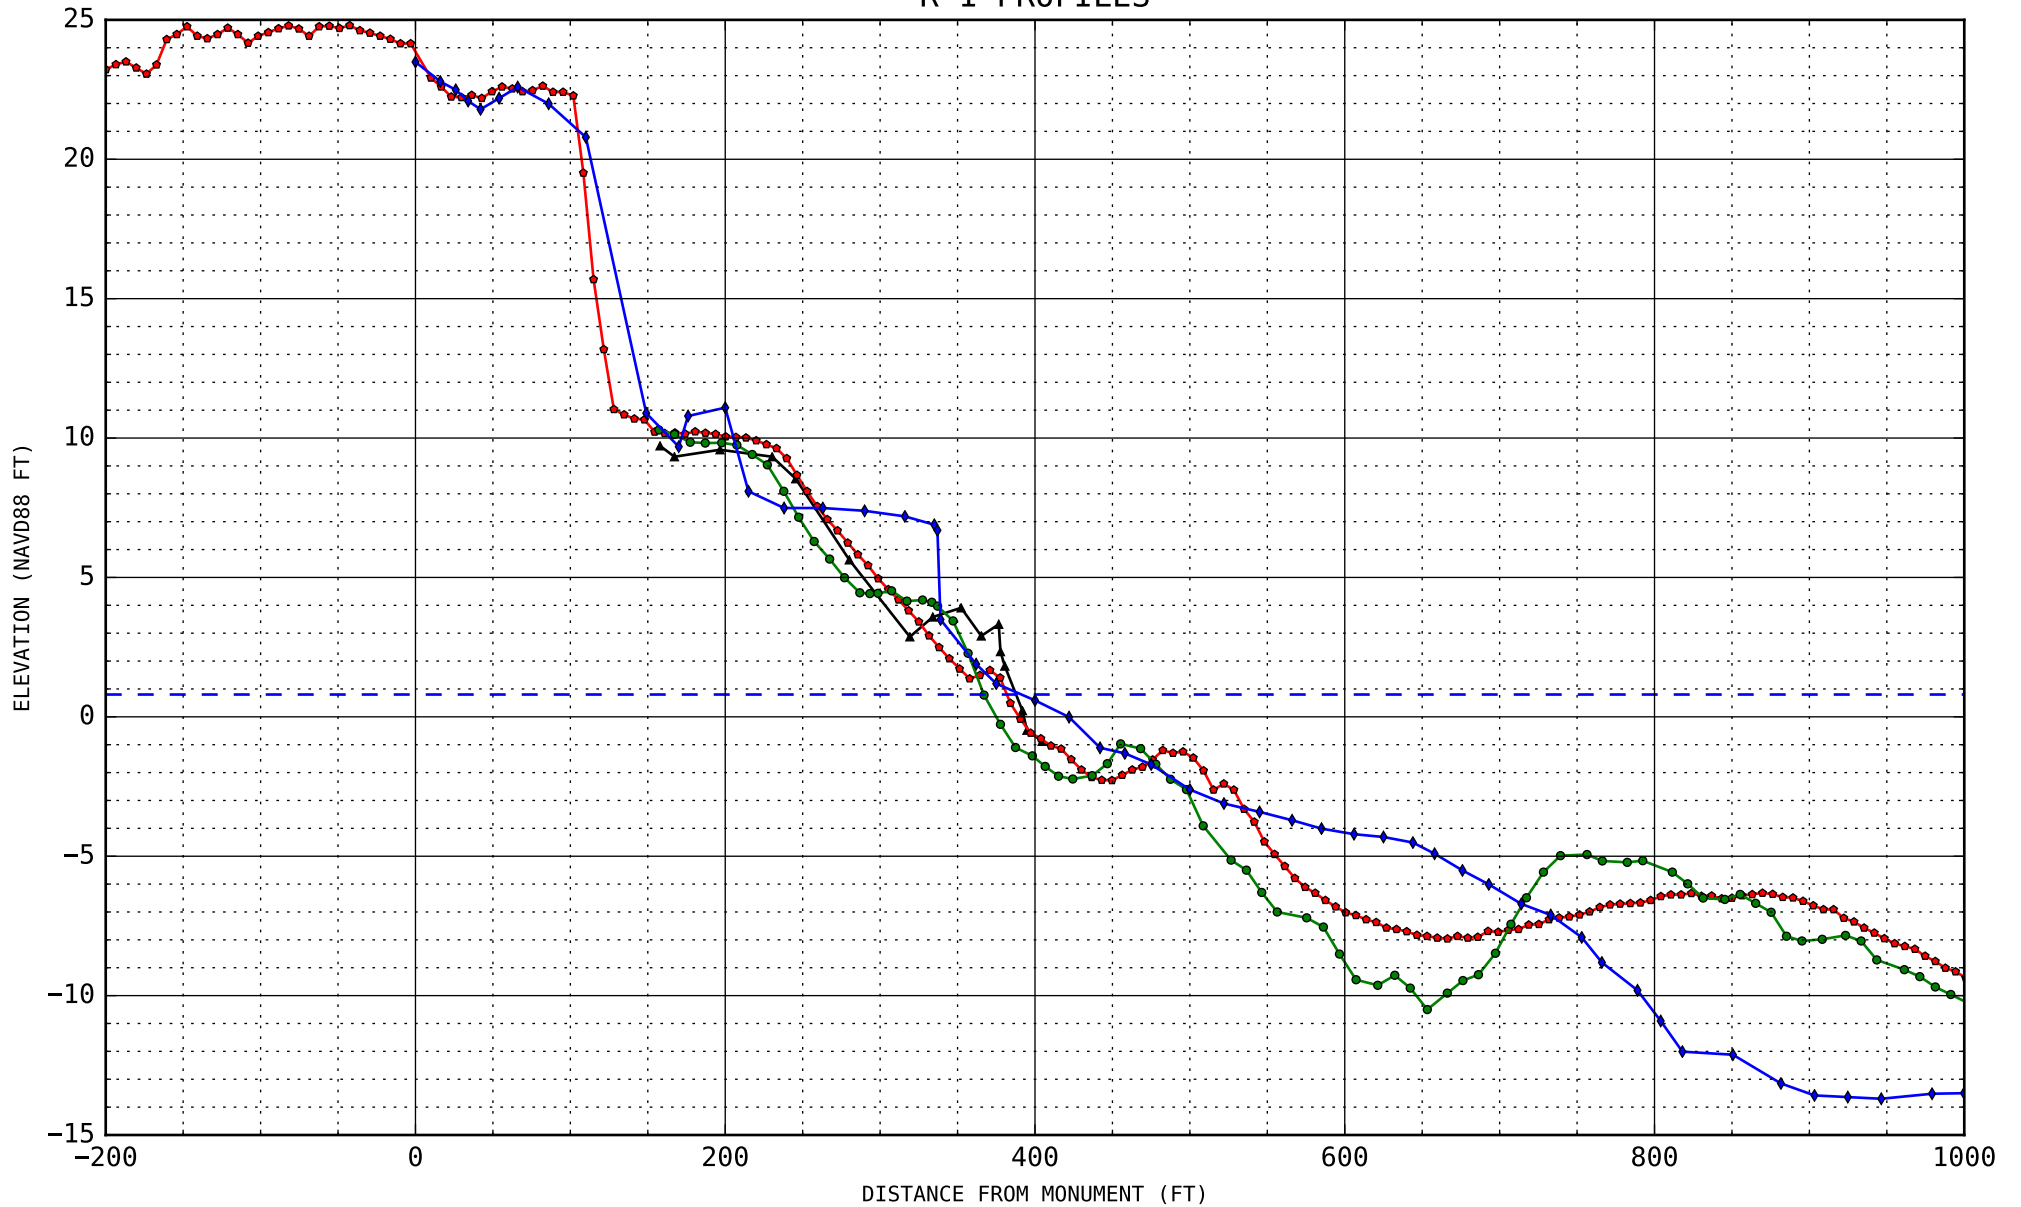
- ▲ 2019-APR CONDITION BY DEP
- 2018-OCT MONITORING BY USACE-LIDAR
- 2013-SEP MONITORING BY USACE
- ◆ 2007-FEB MONITORING BY MAE
- - - MHW CONTOUR (0.8 FT)

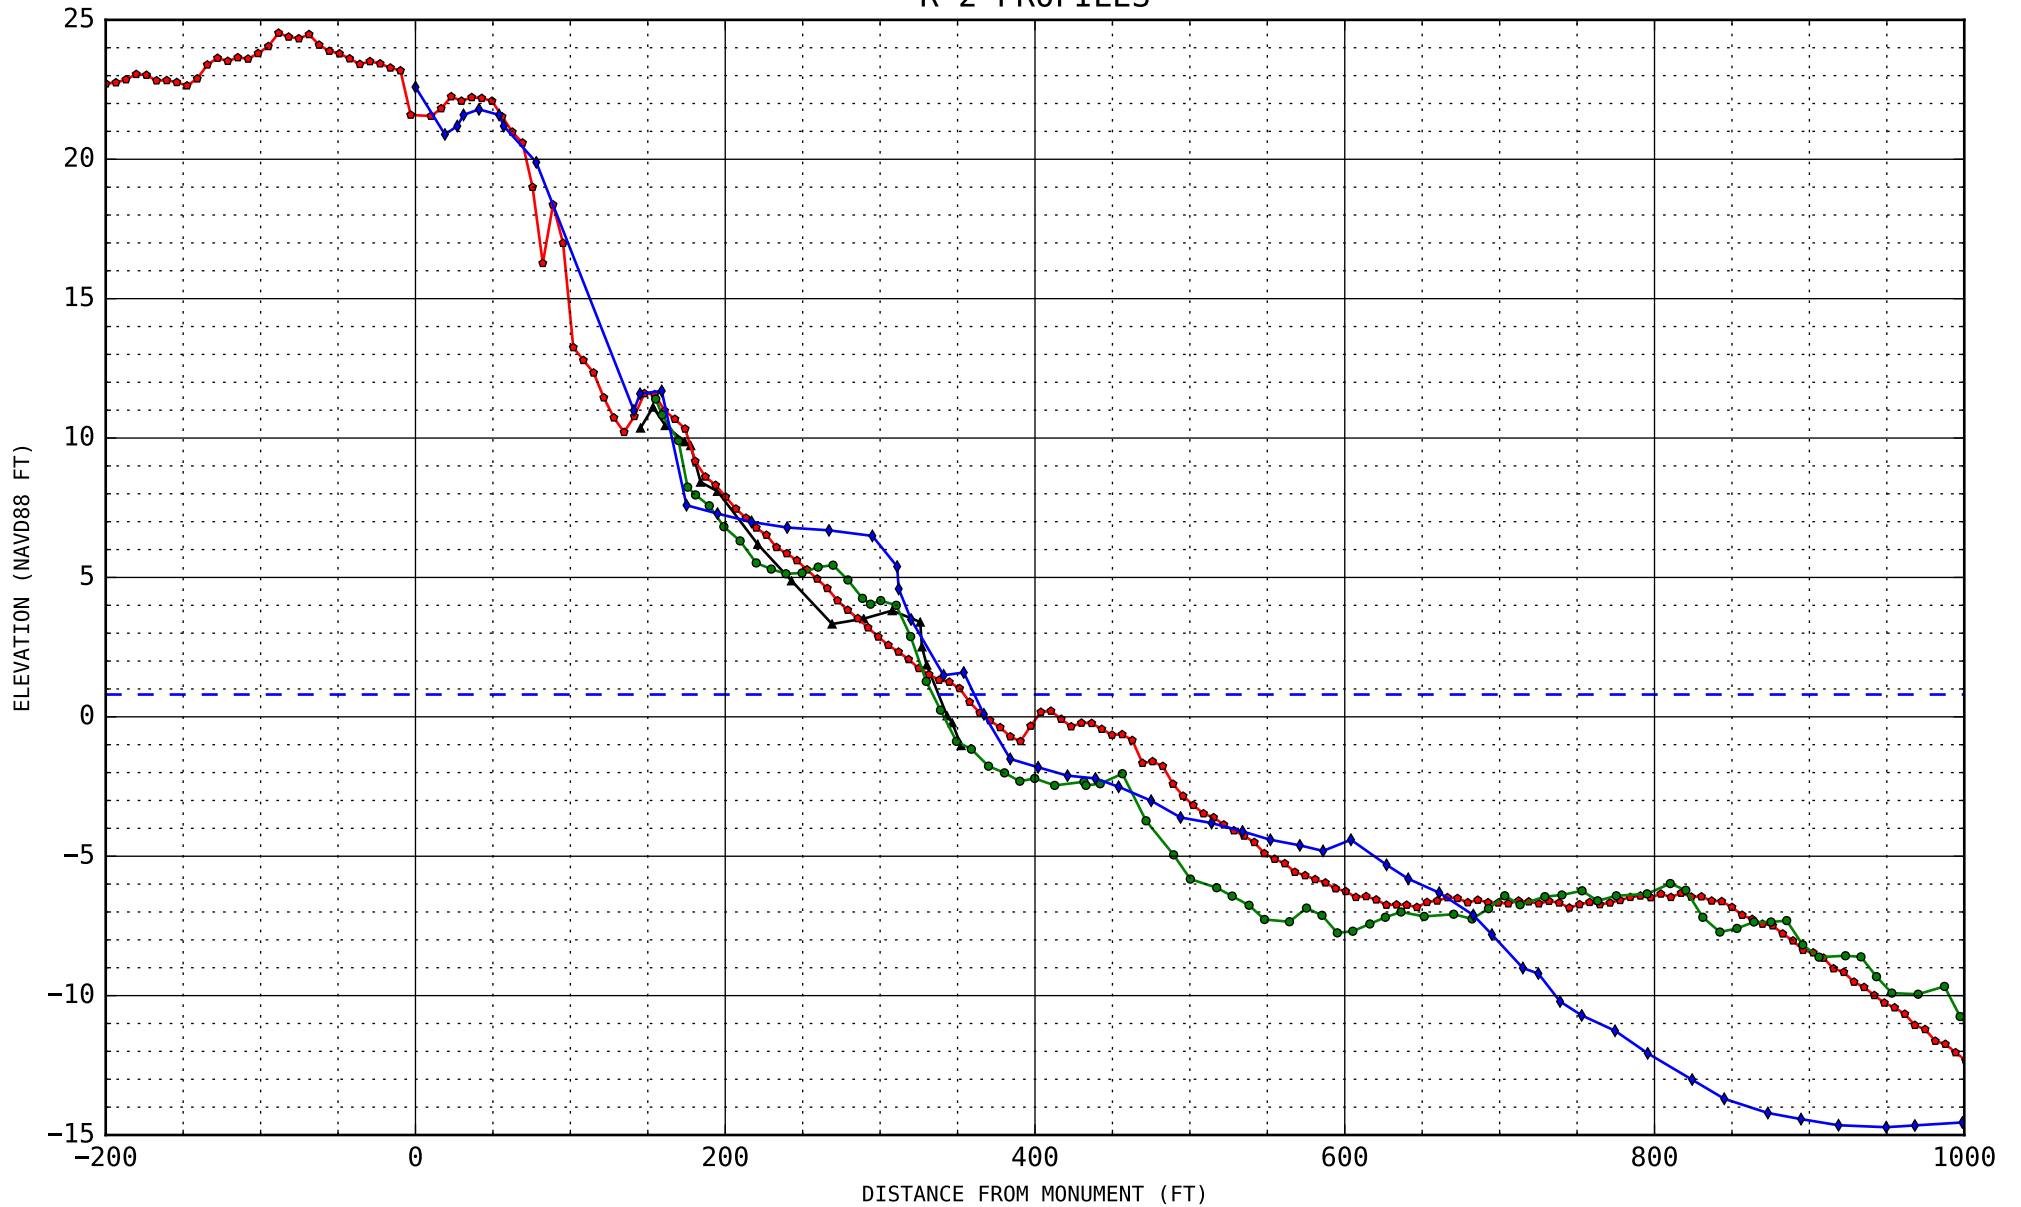
# R-2 PROFILES

- ▲ 2019-APR CONDITION BY DEP
- 2018-OCT MONITORING BY USACE-LIDAR
- 2013-SEP MONITORING BY USACE
- ◆ 2007-FEB MONITORING BY MAE
- - - MHW CONTOUR (0.8 FT)

RANGE: R-2  
EST DATE: OCT1994  
SURVEY DATE: 04APR19  
AZIMUTH: 190.0

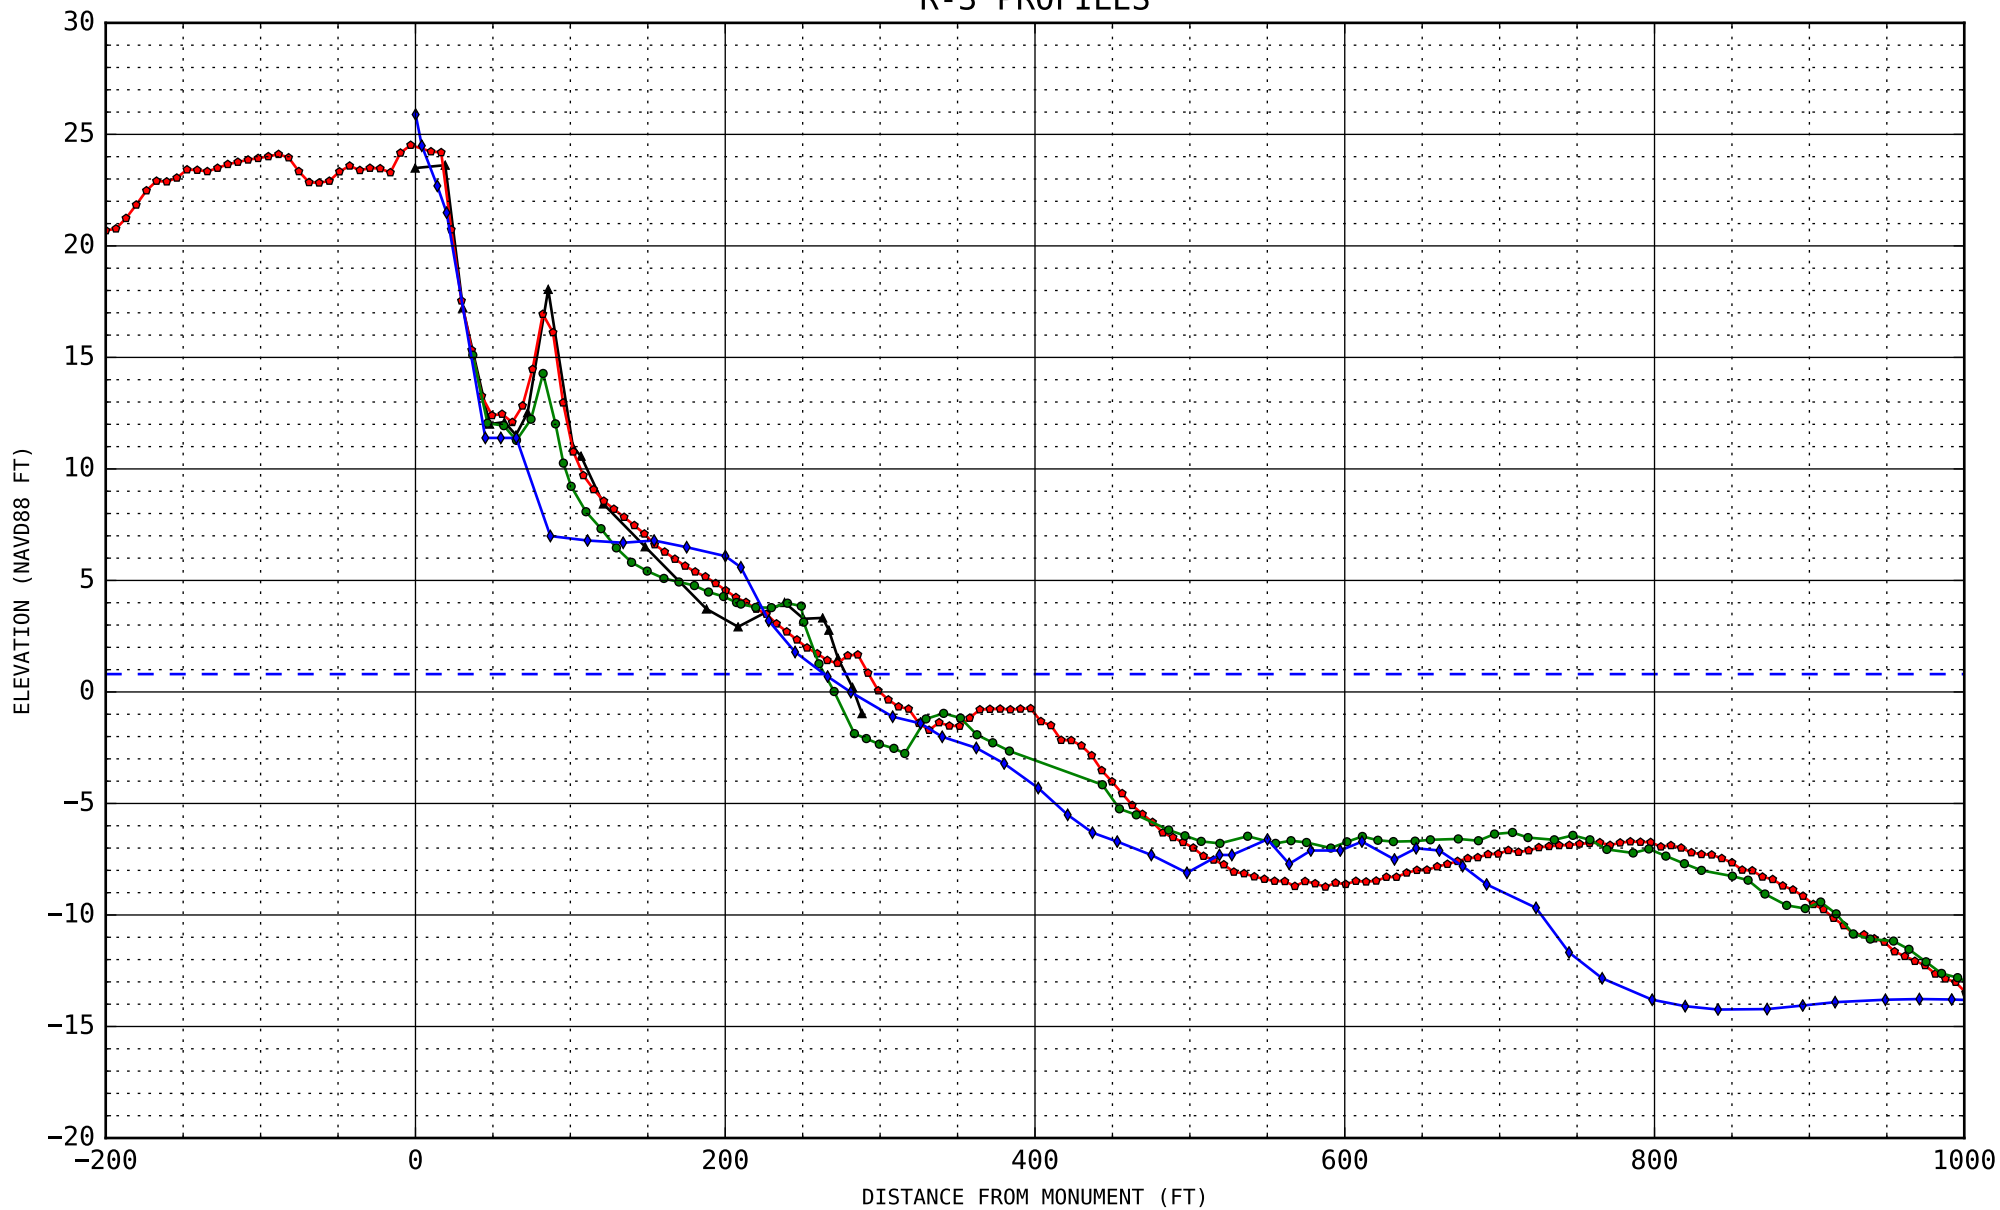
# R-3 PROFILES

- ▲ 2019-APR CONDITION BY DEP
- 2018-OCT MONITORING BY USACE-LIDAR
- 2013-SEP MONITORING BY USACE
- ◆ 2007-FEB MONITORING BY MAE
- - - MHW CONTOUR (0.8 FT)

RANGE: R-3  
EST DATE: OCT1994  
SURVEY DATE: 04APR19  
AZIMUTH: 190.0

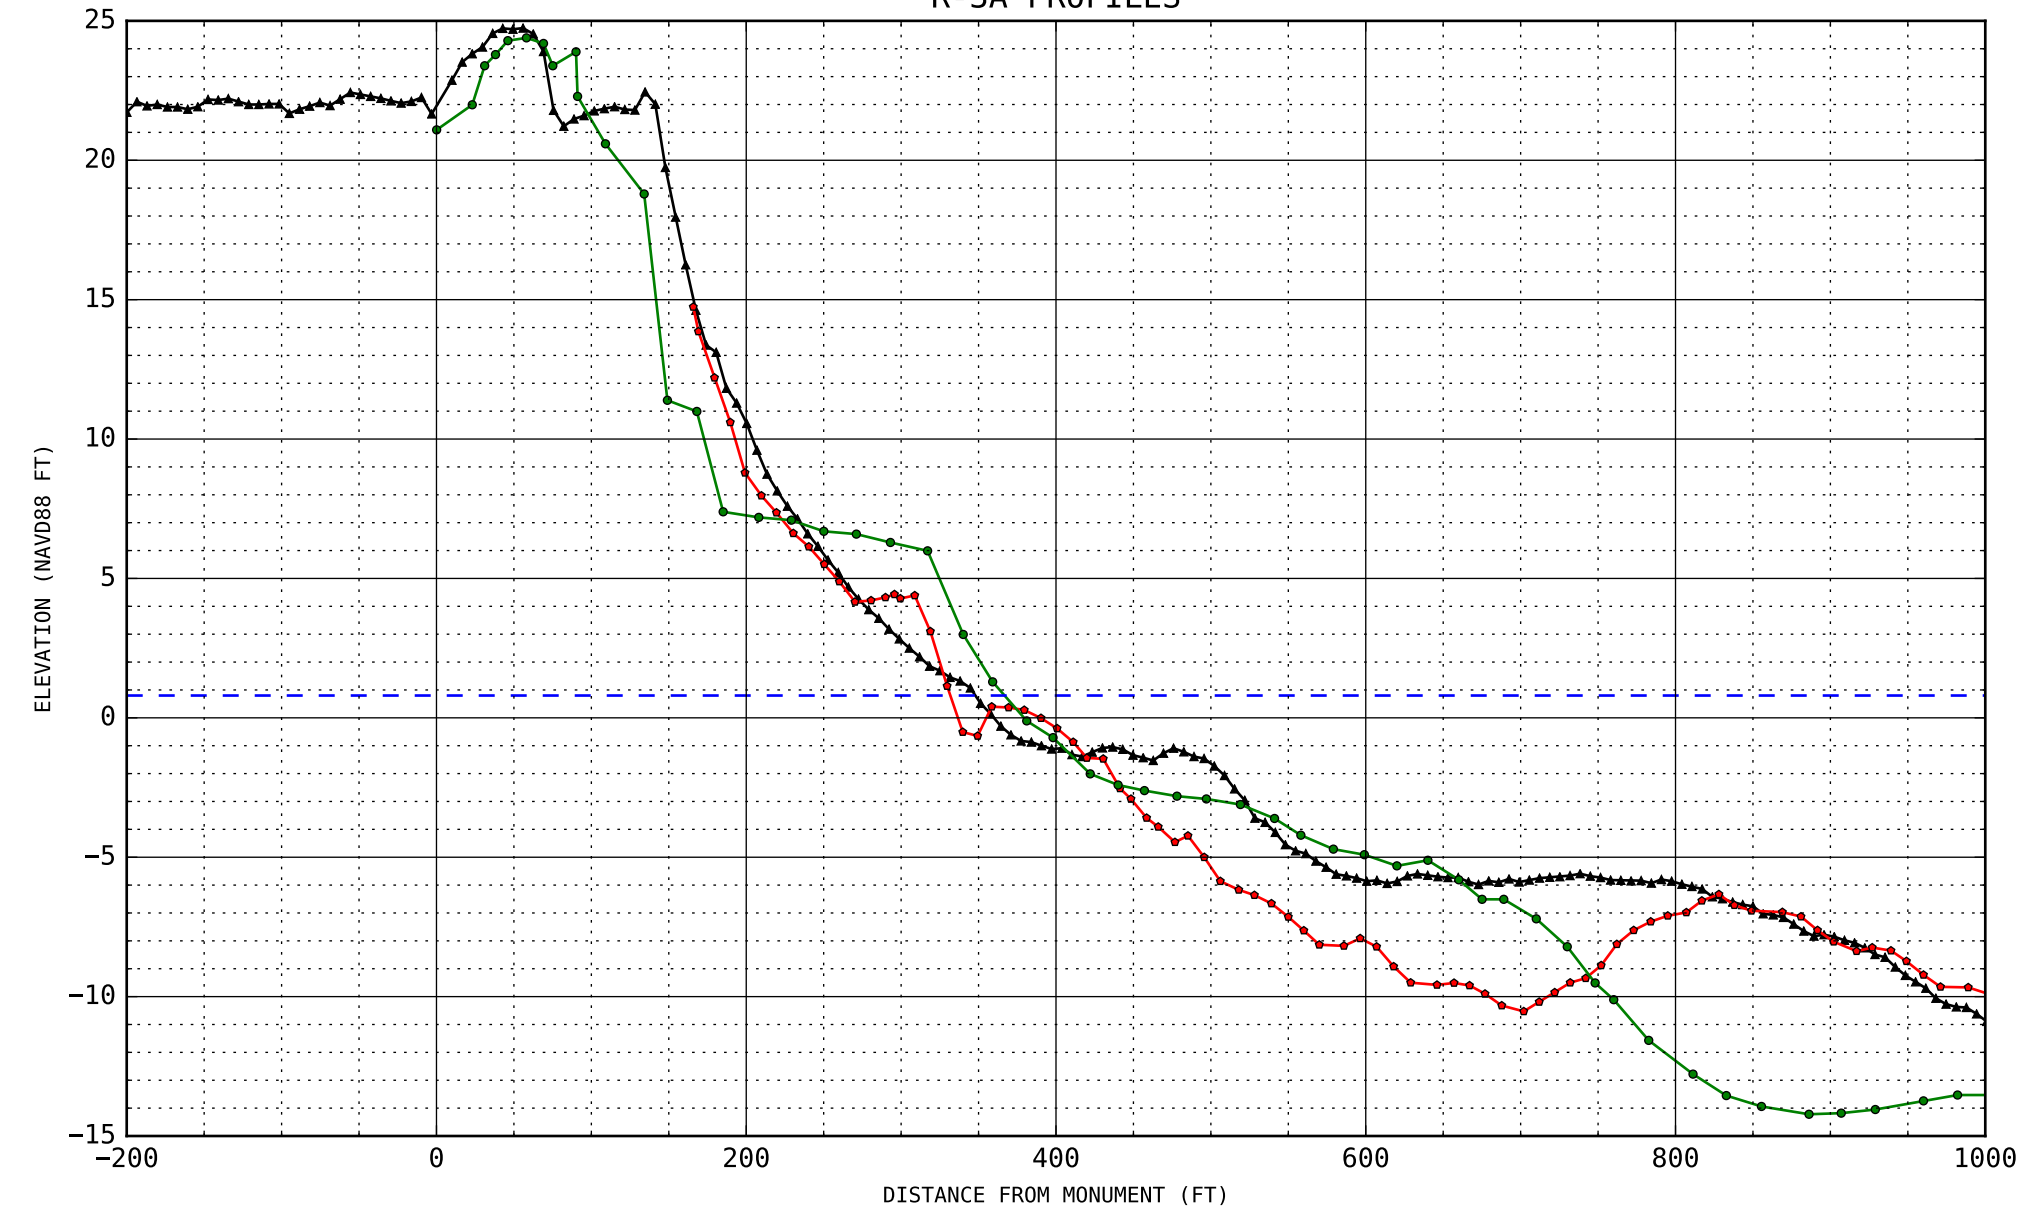
# R-3A PROFILES

▲ 2018-OCT MONITORING BY USACE-LIDAR  
 ● 2013-SEP MONITORING BY USACE  
 ● 2007-FEB MONITORING BY MAE  
 - - - MHW CONTOUR (0.8 FT)

RANGE: R-3A  
 EST DATE: OCT1994  
 SURVEY DATE: 27OCT18  
 AZIMUTH: 190.0

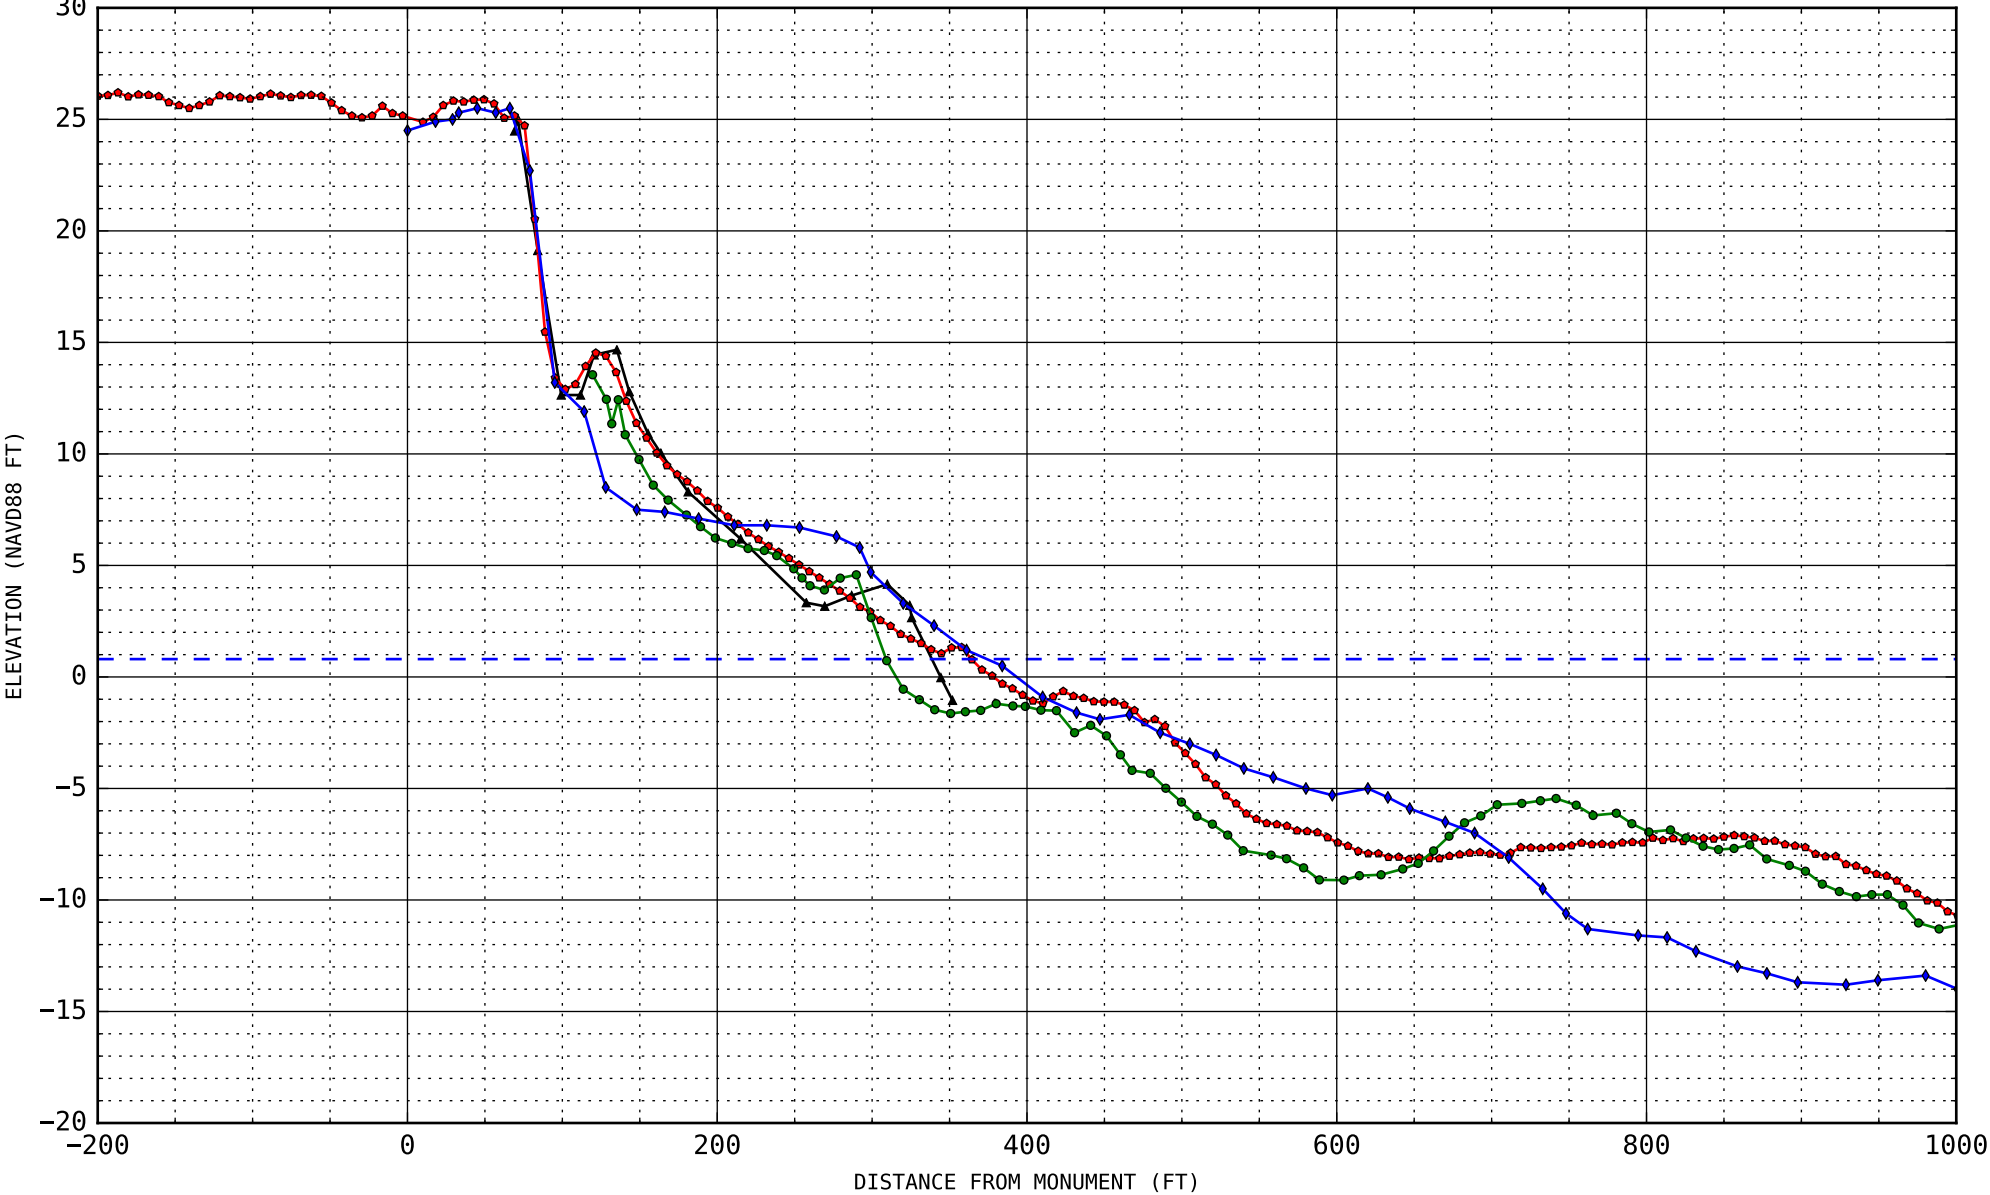
R-4 PROFILES

- 2019-APR CONDITION BY DEP
- 2018-OCT MONITORING BY USACE-LIDAR
- 2013-SEP MONITORING BY USACE
- 2007-FEB MONITORING BY MAE
- MHW CONTOUR (0.8 FT)

RANGE: R-4  
EST DATE: OCT1995  
SURVEY DATE: 04APR19  
AZIMUTH: 190.0

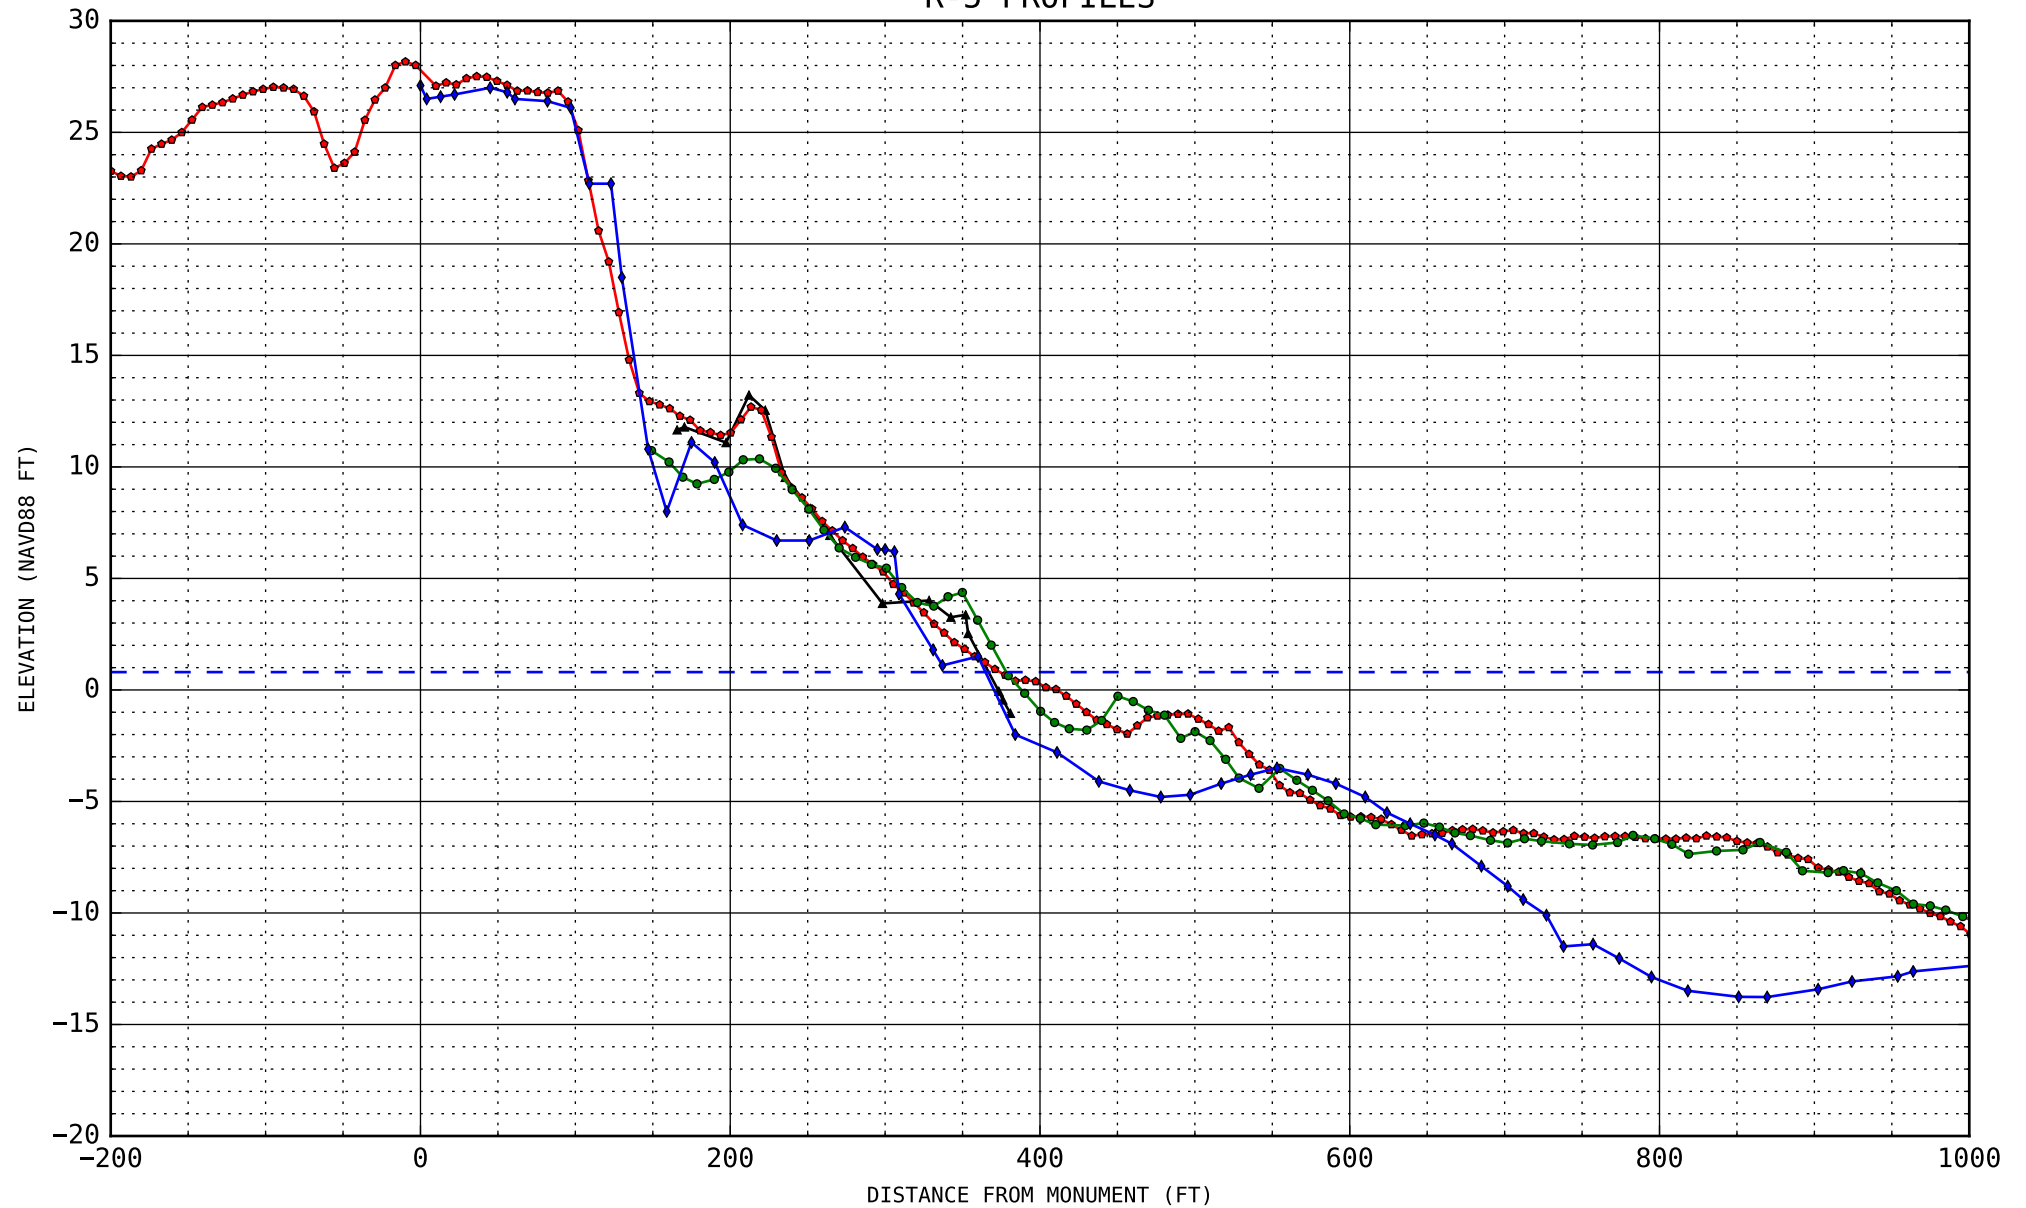
# R-5 PROFILES

RANGE: R-5  
EST DATE: NOV1980  
SURVEY DATE: 04APR19  
AZIMUTH: 190.0

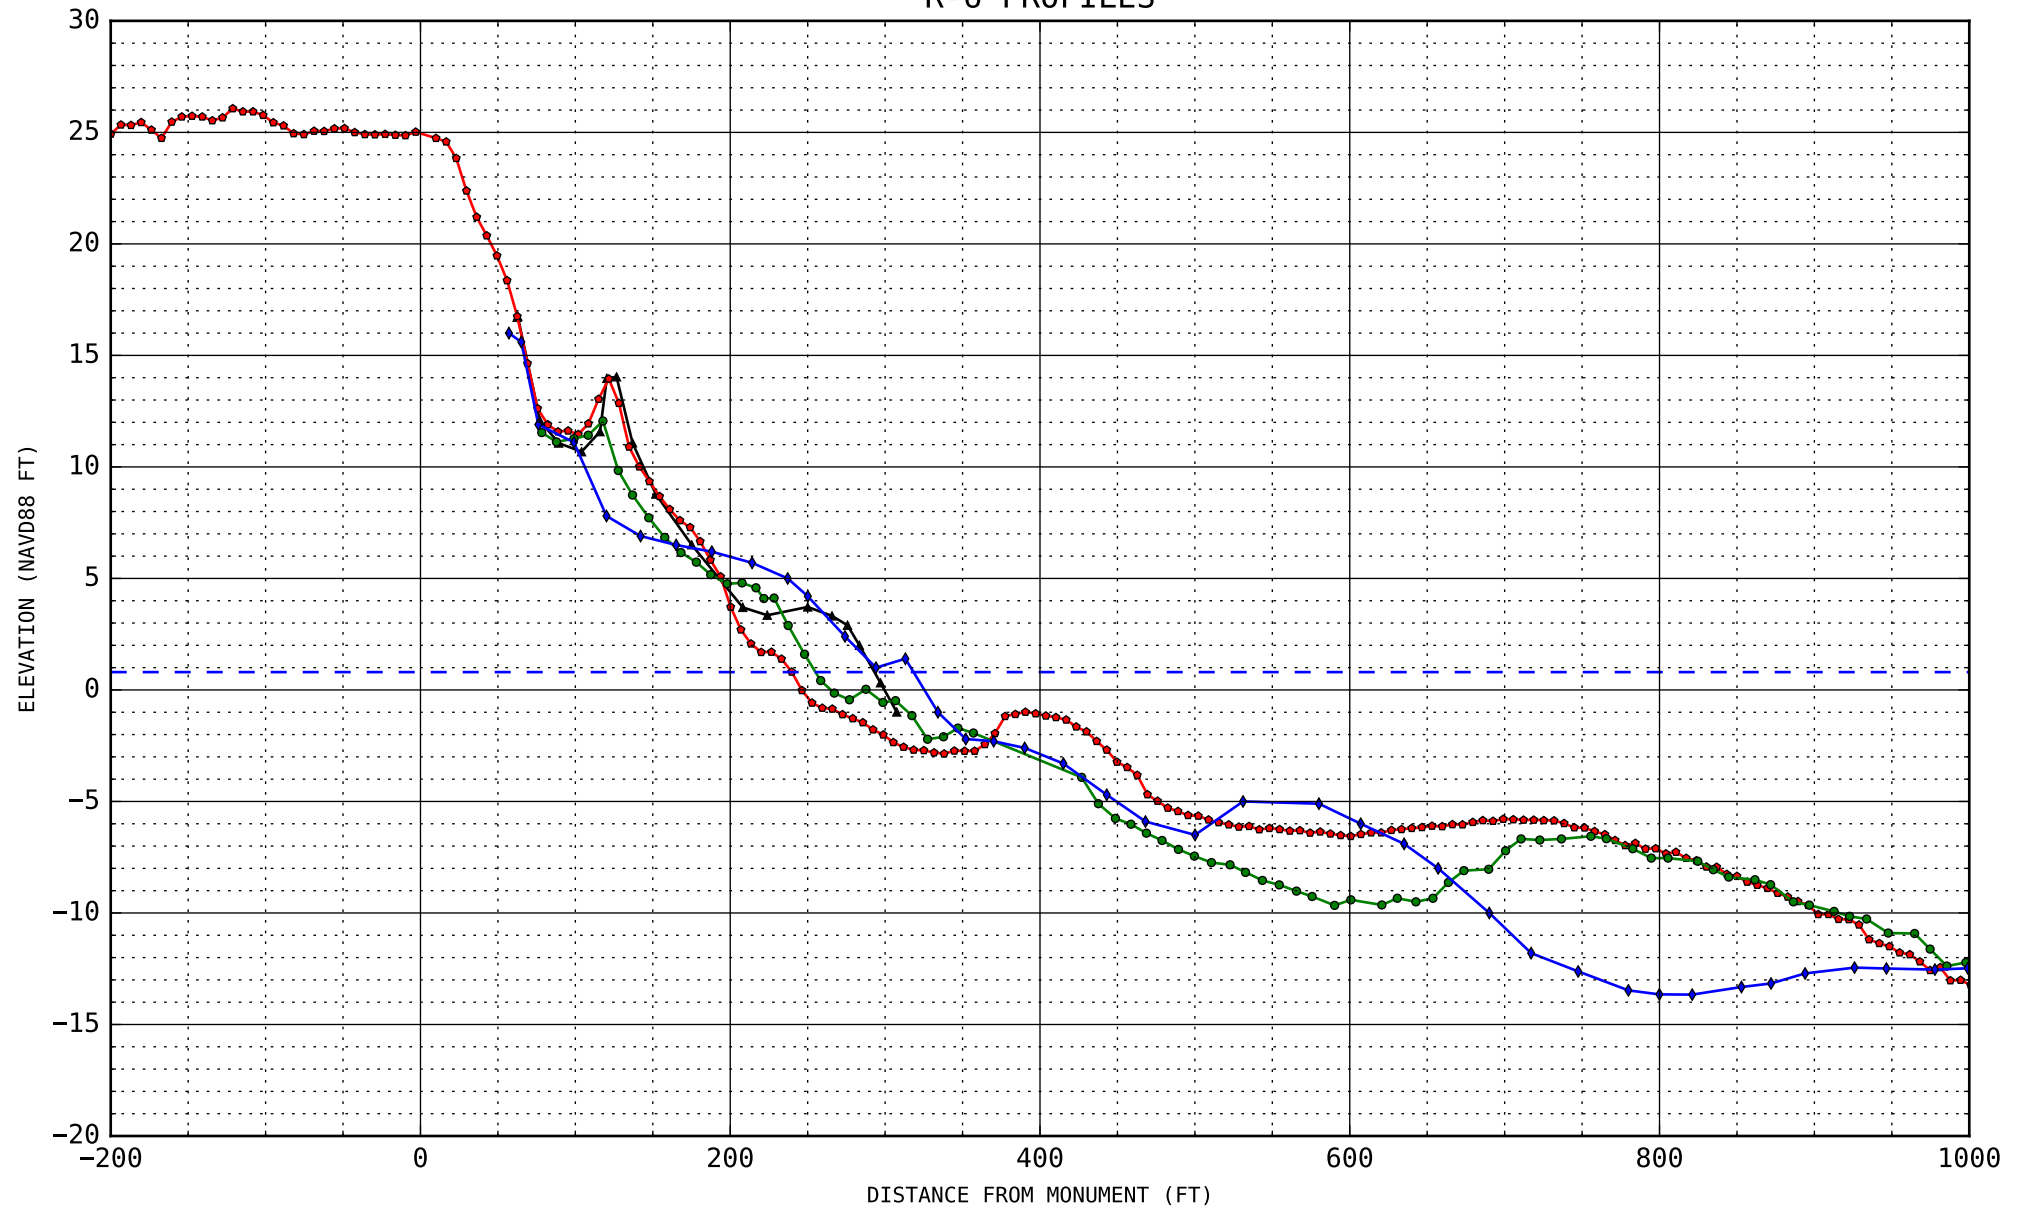
# R-6 PROFILES

RANGE: R-6  
 EST DATE: NOV1980  
 SURVEY DATE: 04APR19  
 AZIMUTH: 190.0

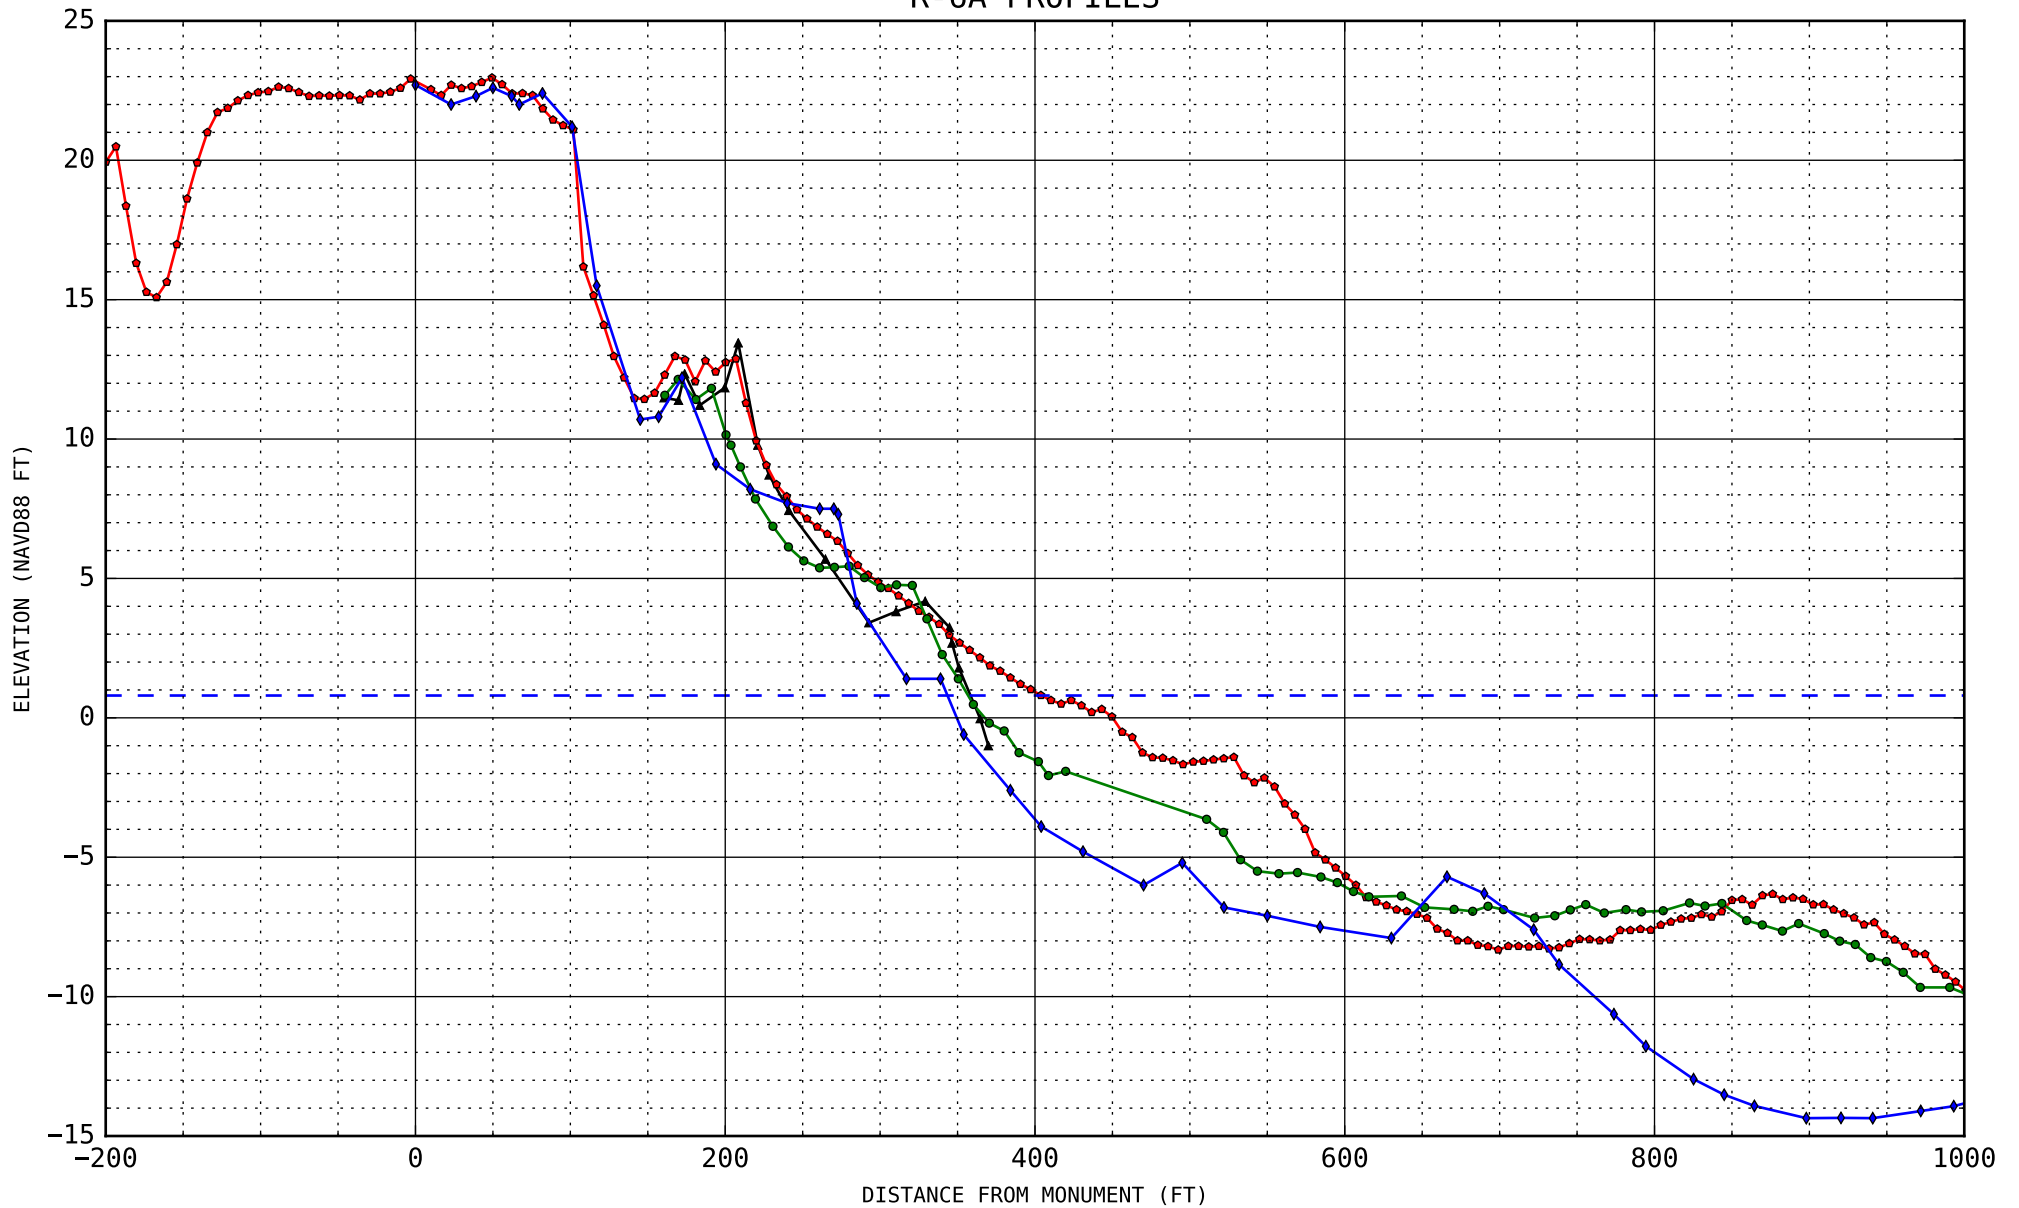
# R-6A PROFILES

- ▲ 2019-APR CONDITION BY DEP
- 2018-OCT MONITORING BY USACE-LIDAR
- 2013-SEP MONITORING BY USACE
- ◆ 2007-FEB MONITORING BY MAE
- - - MHW CONTOUR (0.8 FT)

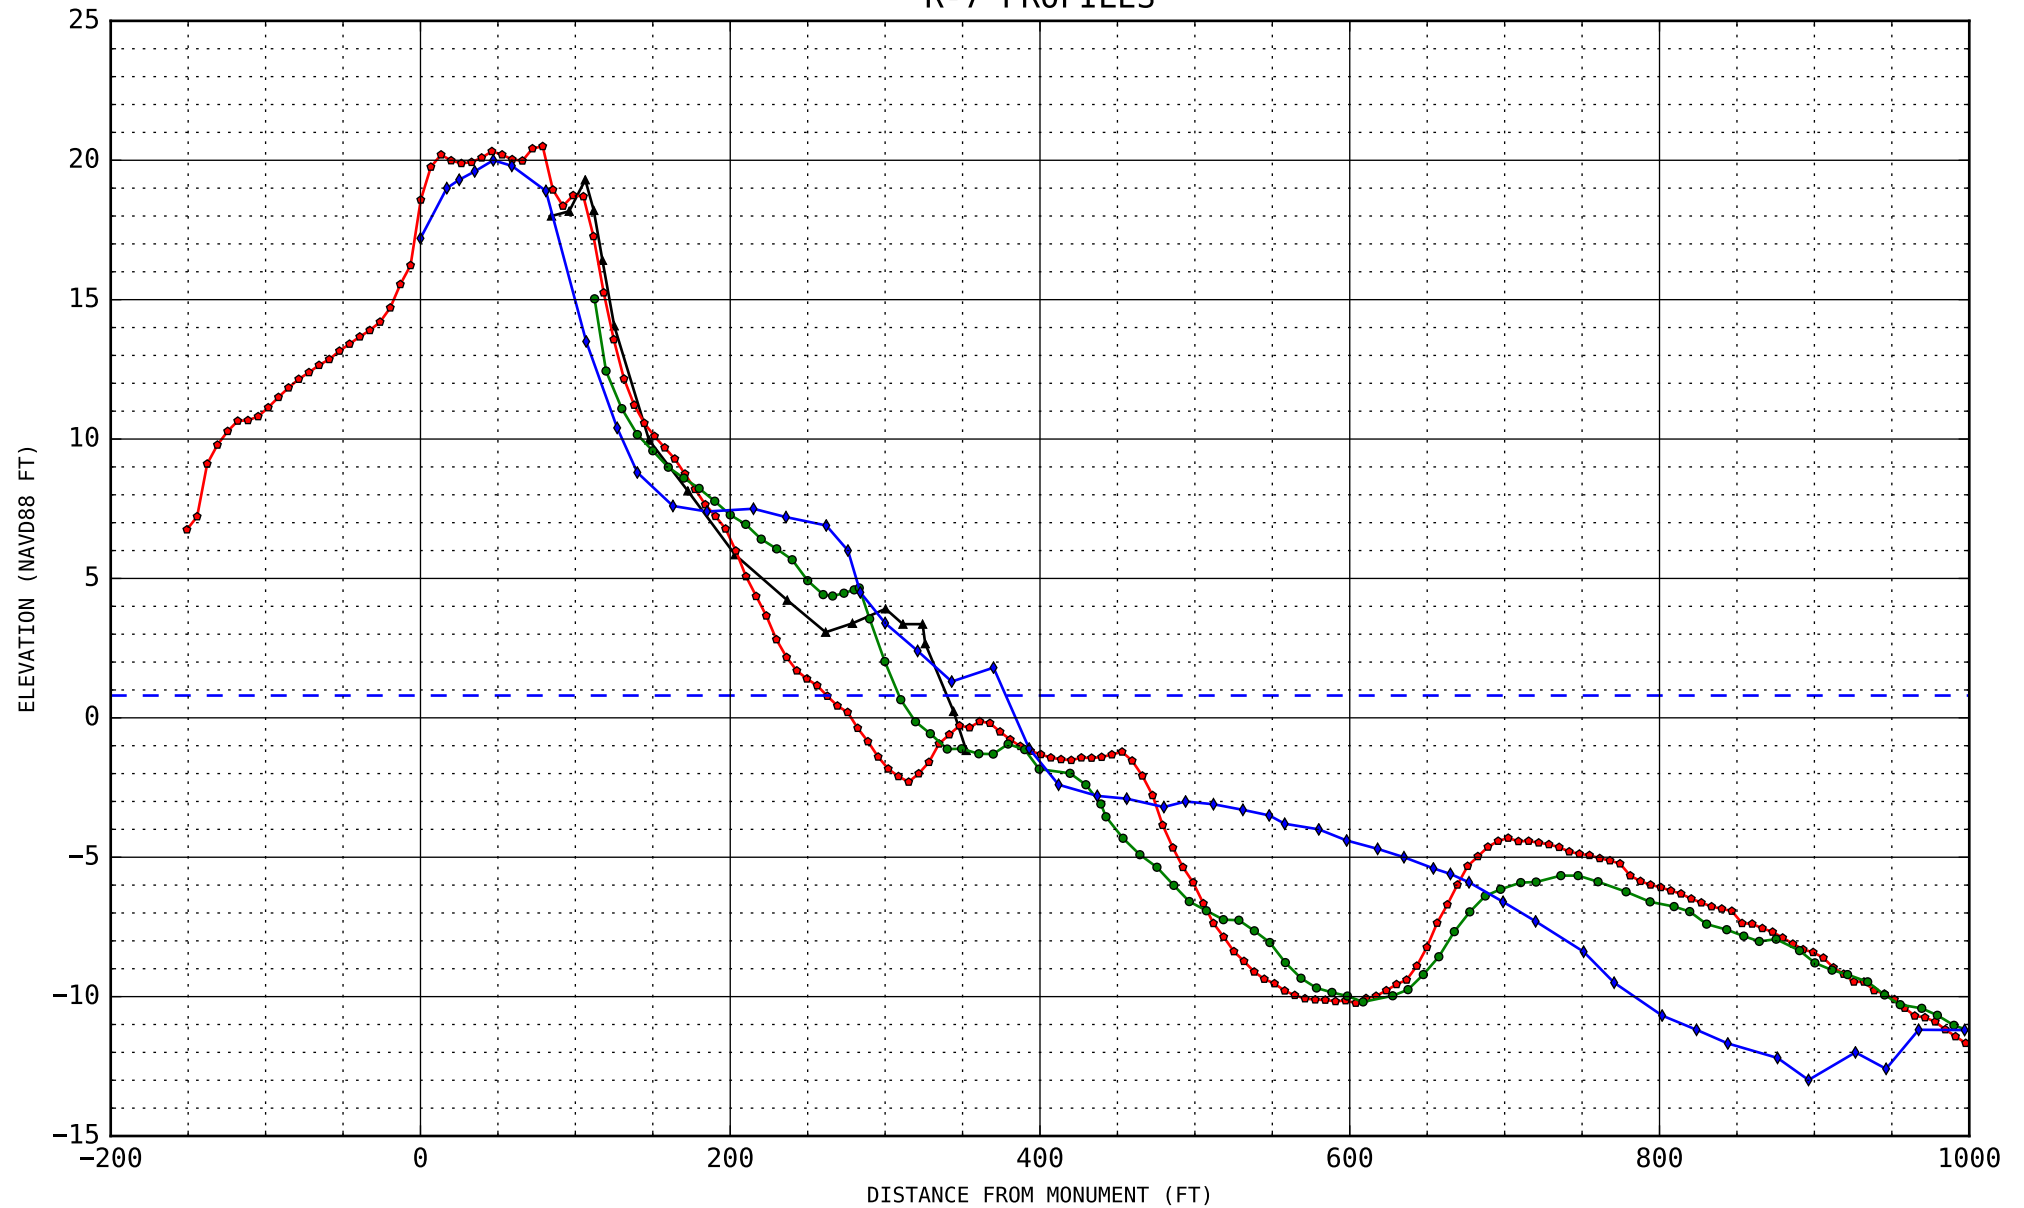
# R-7 PROFILES

- ▲ 2019-APR CONDITION BY DEP
- 2018-OCT MONITORING BY USACE-LIDAR
- 2013-SEP MONITORING BY USACE
- ◆ 2007-FEB MONITORING BY MAE
- - - MHW CONTOUR (0.8 FT)
