# R-1 PROFILES

WALTON  
PROGRAM SUPPORT GIS  
DIVISION OF WATER RESOURCE MANAGEMENT  
FLORIDA DEPARTMENT OF ENVIRONMENTAL PROTECTION

RANGE: R-1  
EST DATE: NOV1980  
SURVEY DATE: 04APR19  
AZIMUTH: 190.0

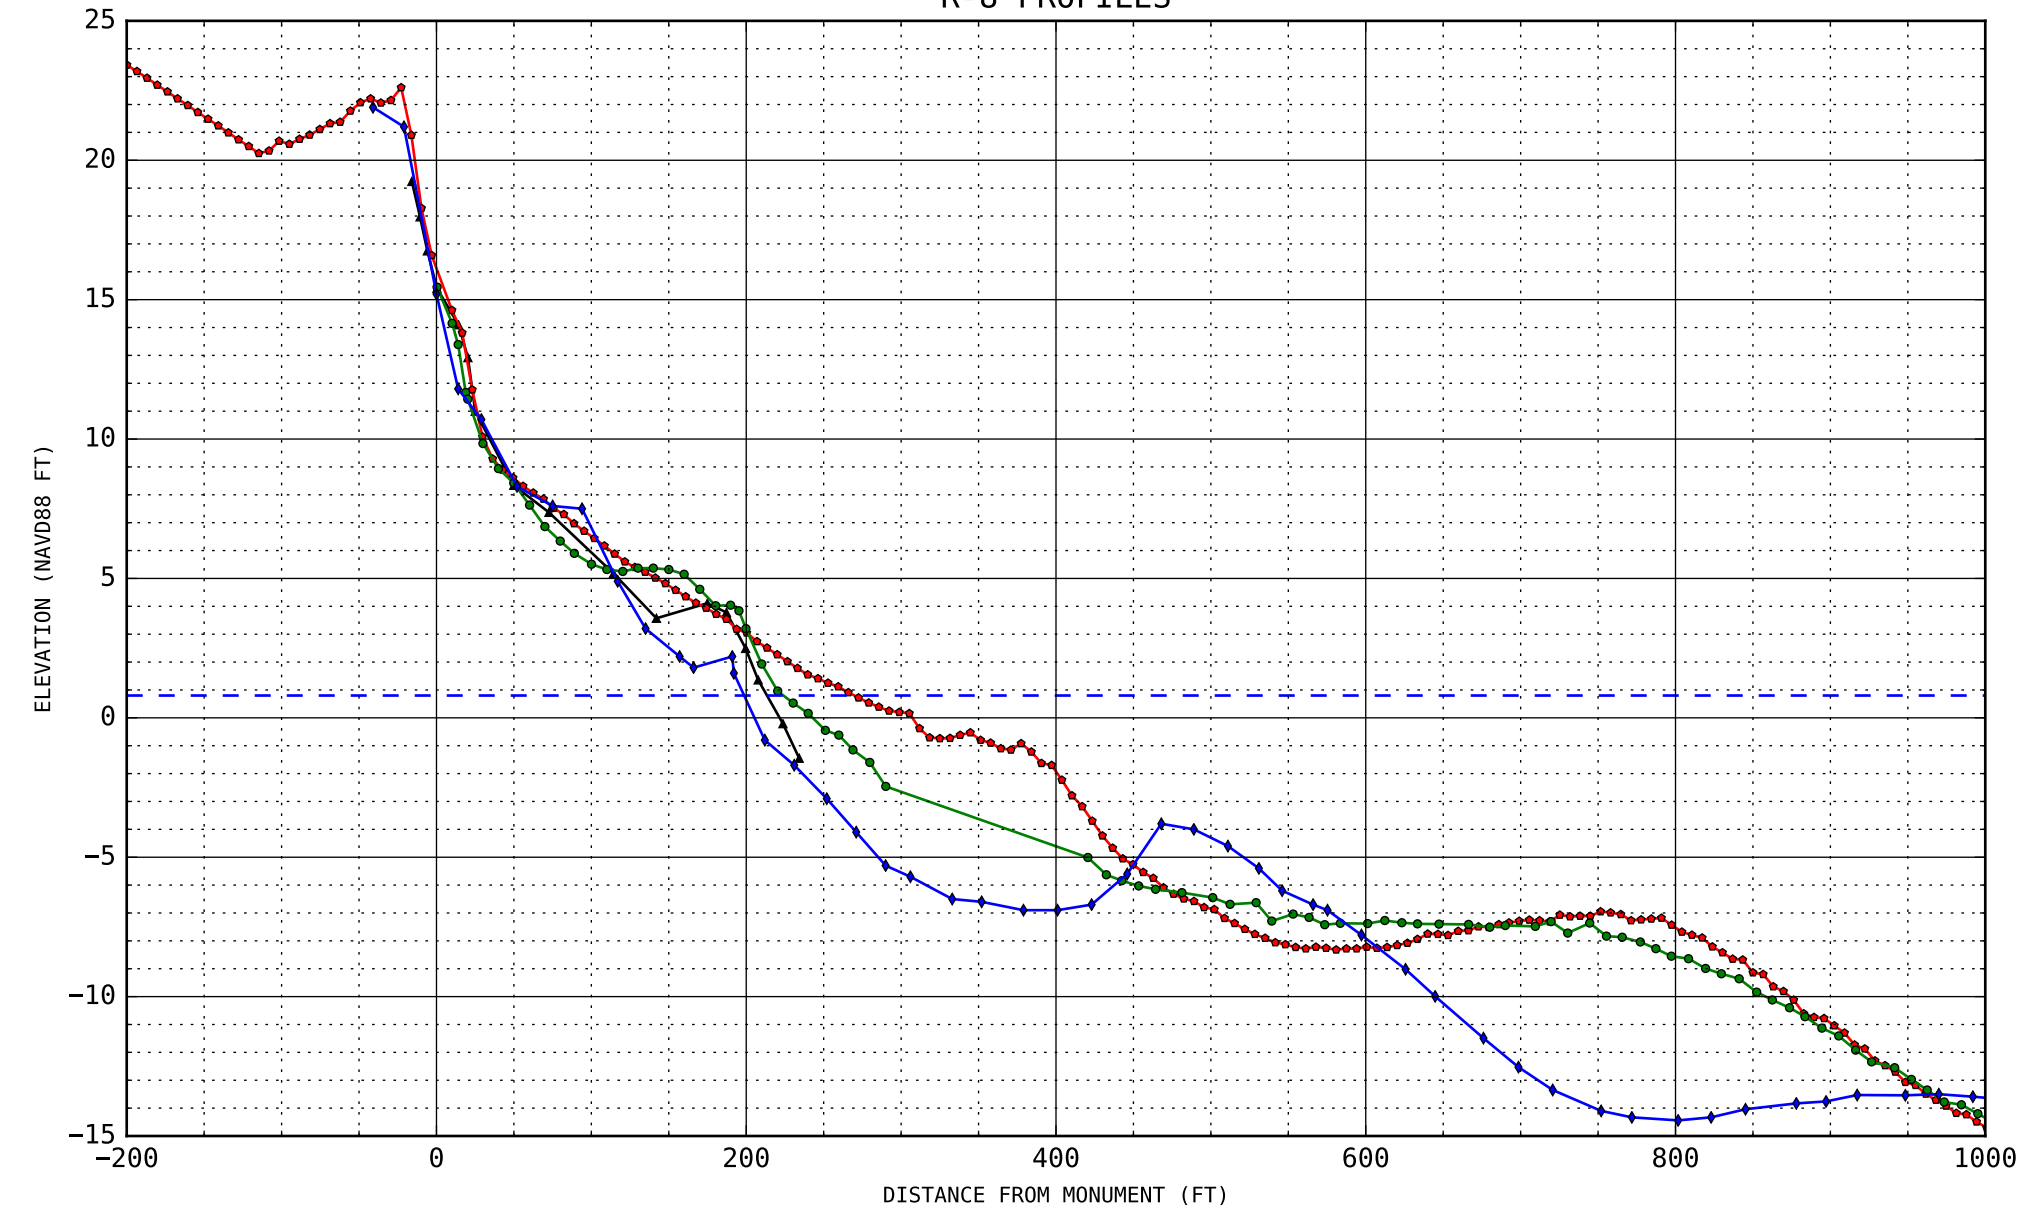
# R-8 PROFILES

- ▲ 2019-APR CONDITION BY DEP
- 2018-OCT MONITORING BY USACE-LIDAR
- 2013-SEP MONITORING BY USACE
- ◆ 2007-FEB MONITORING BY MAE
- - - MHW CONTOUR (0.8 FT)

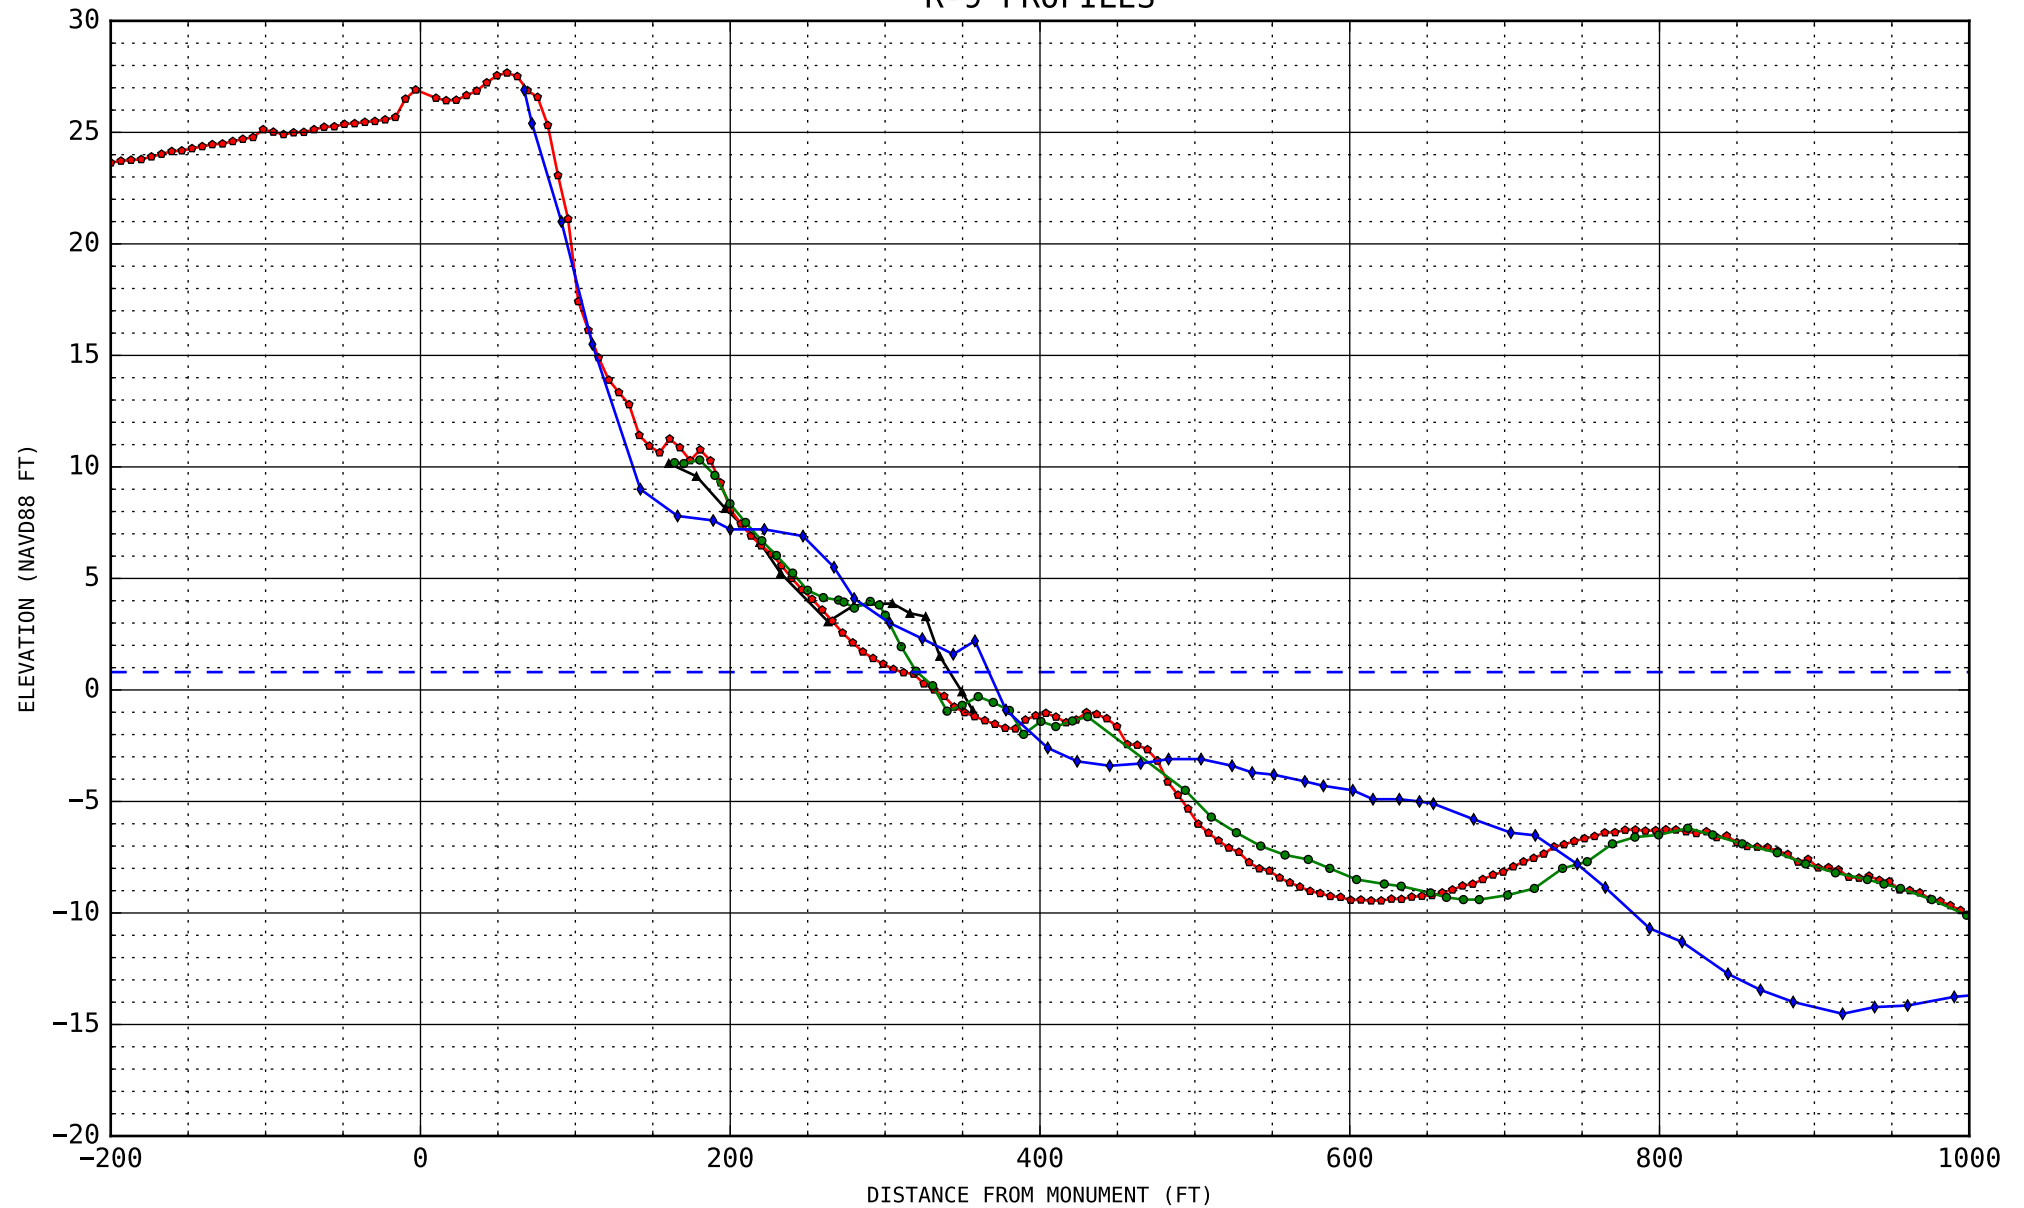
# R-9 PROFILES

- ▲ 2019-APR CONDITION BY DEP
- 2018-OCT MONITORING BY USACE-LIDAR
- 2013-SEP MONITORING BY USACE
- ◆ 2007-FEB MONITORING BY MAE
- - - MHW CONTOUR (0.8 FT)

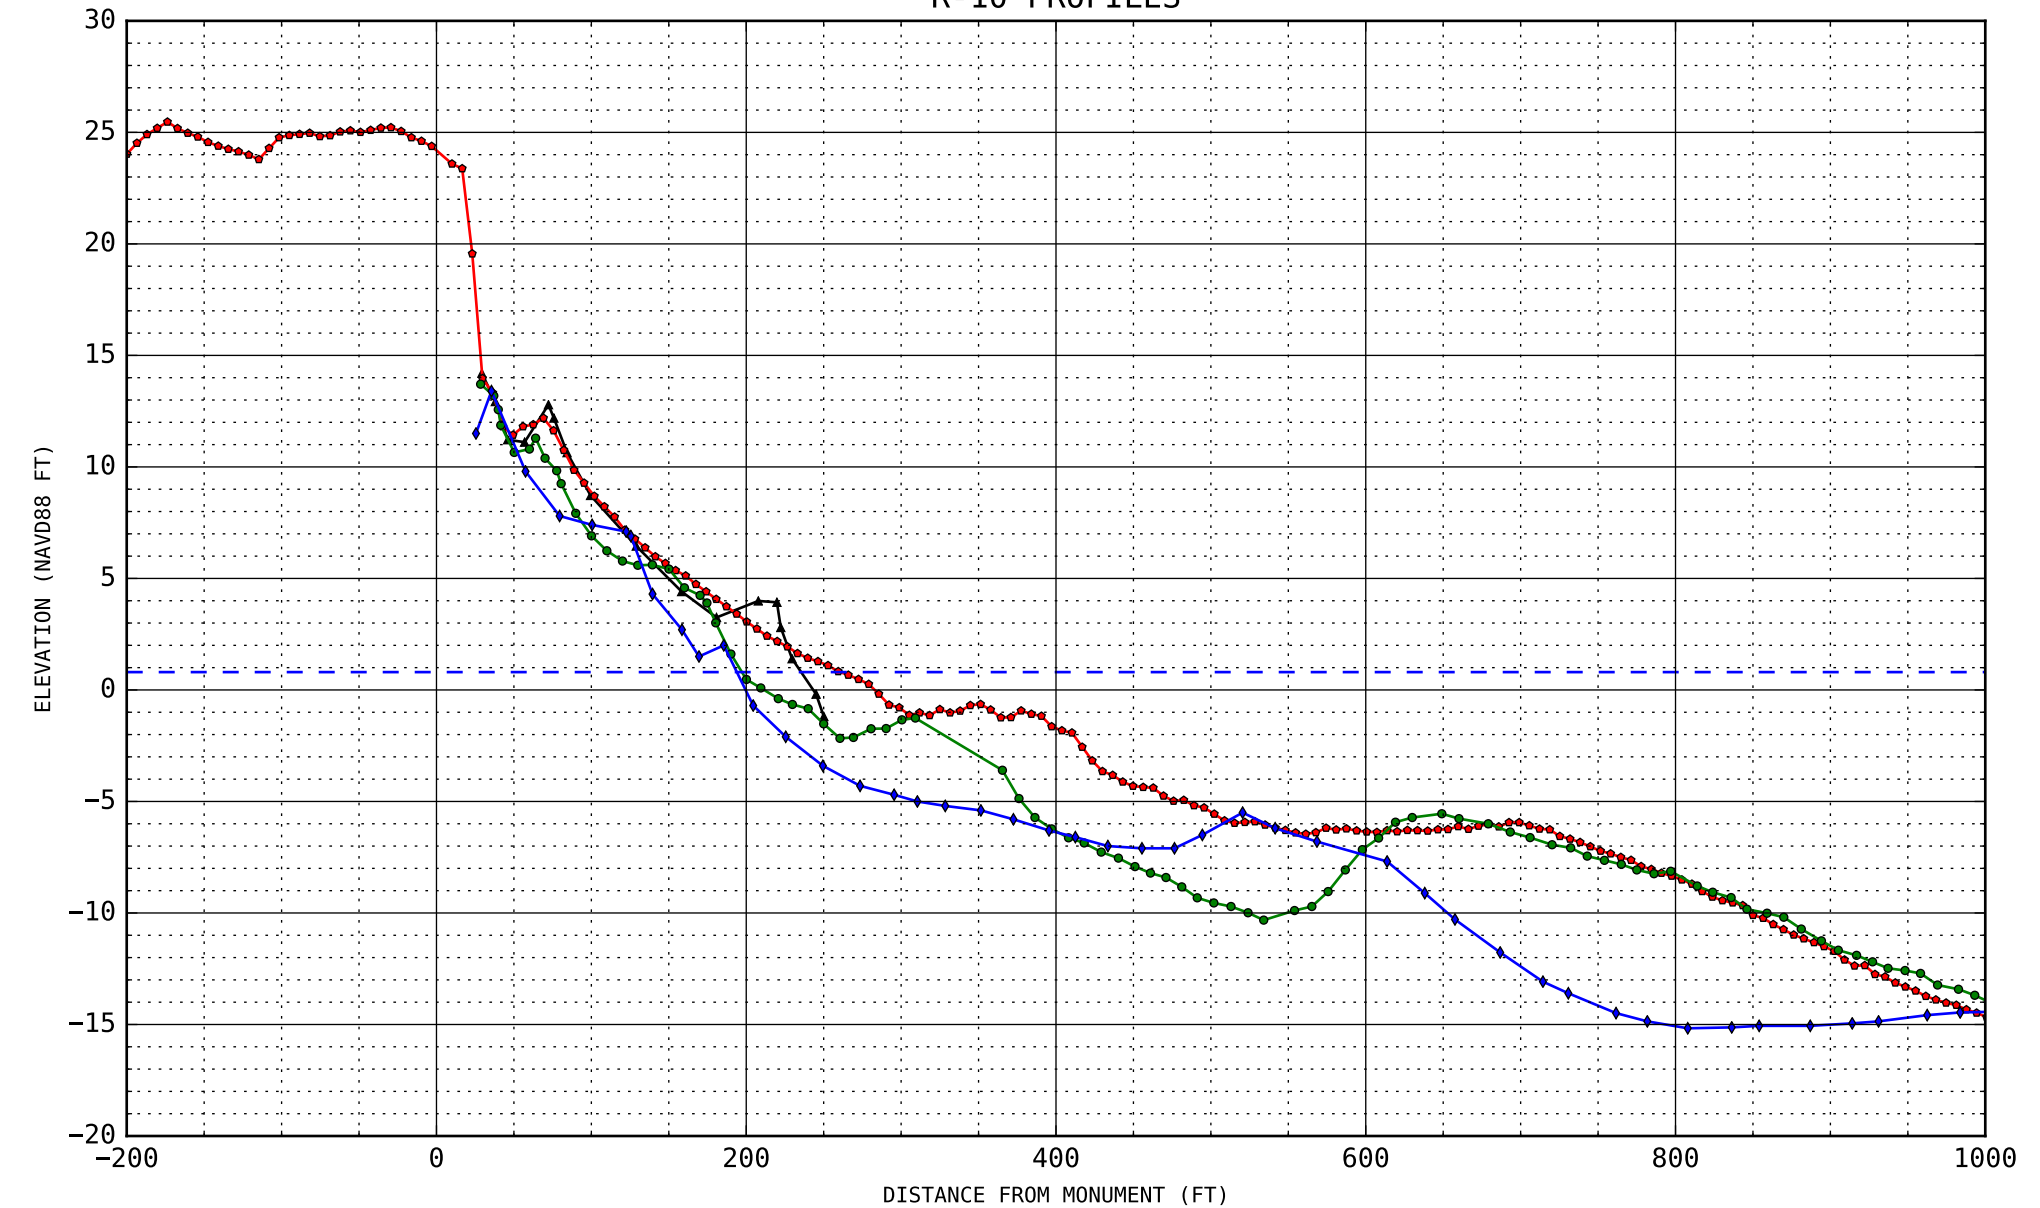
# R-10 PROFILES

- 2019-APR CONDITION BY DEP
- 2018-OCT MONITORING BY USACE-LIDAR
- 2013-SEP MONITORING BY USACE
- 2007-FEB MONITORING BY MAE
- MHW CONTOUR (0.8 FT)

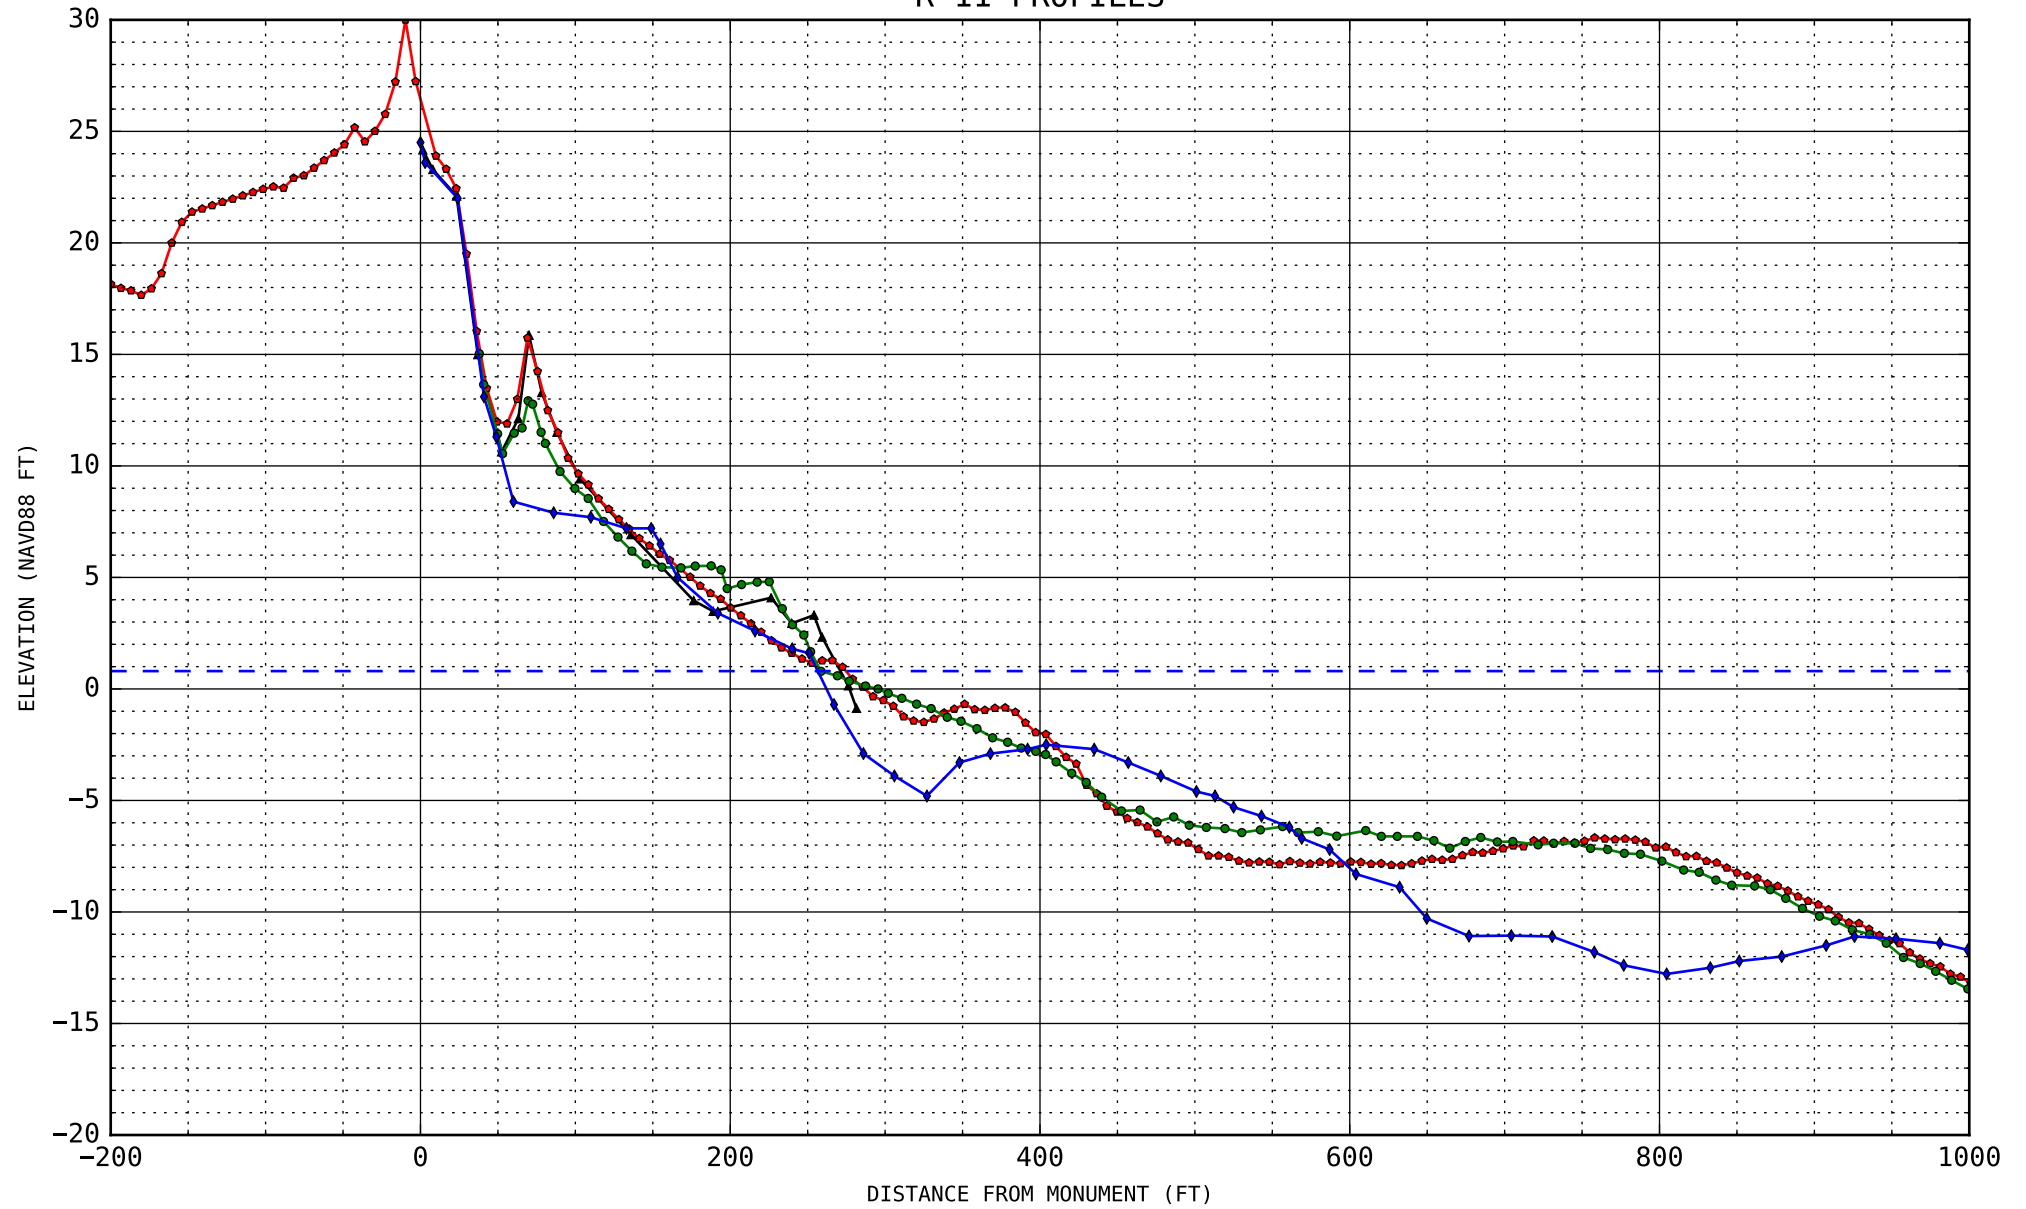
# R-11 PROFILES

- ▲ 2019-APR CONDITION BY DEP
- 2018-OCT MONITORING BY USACE-LIDAR
- 2013-SEP MONITORING BY USACE
- ◆ 2007-FEB MONITORING BY MAE
- - - MHW CONTOUR (0.8 FT)

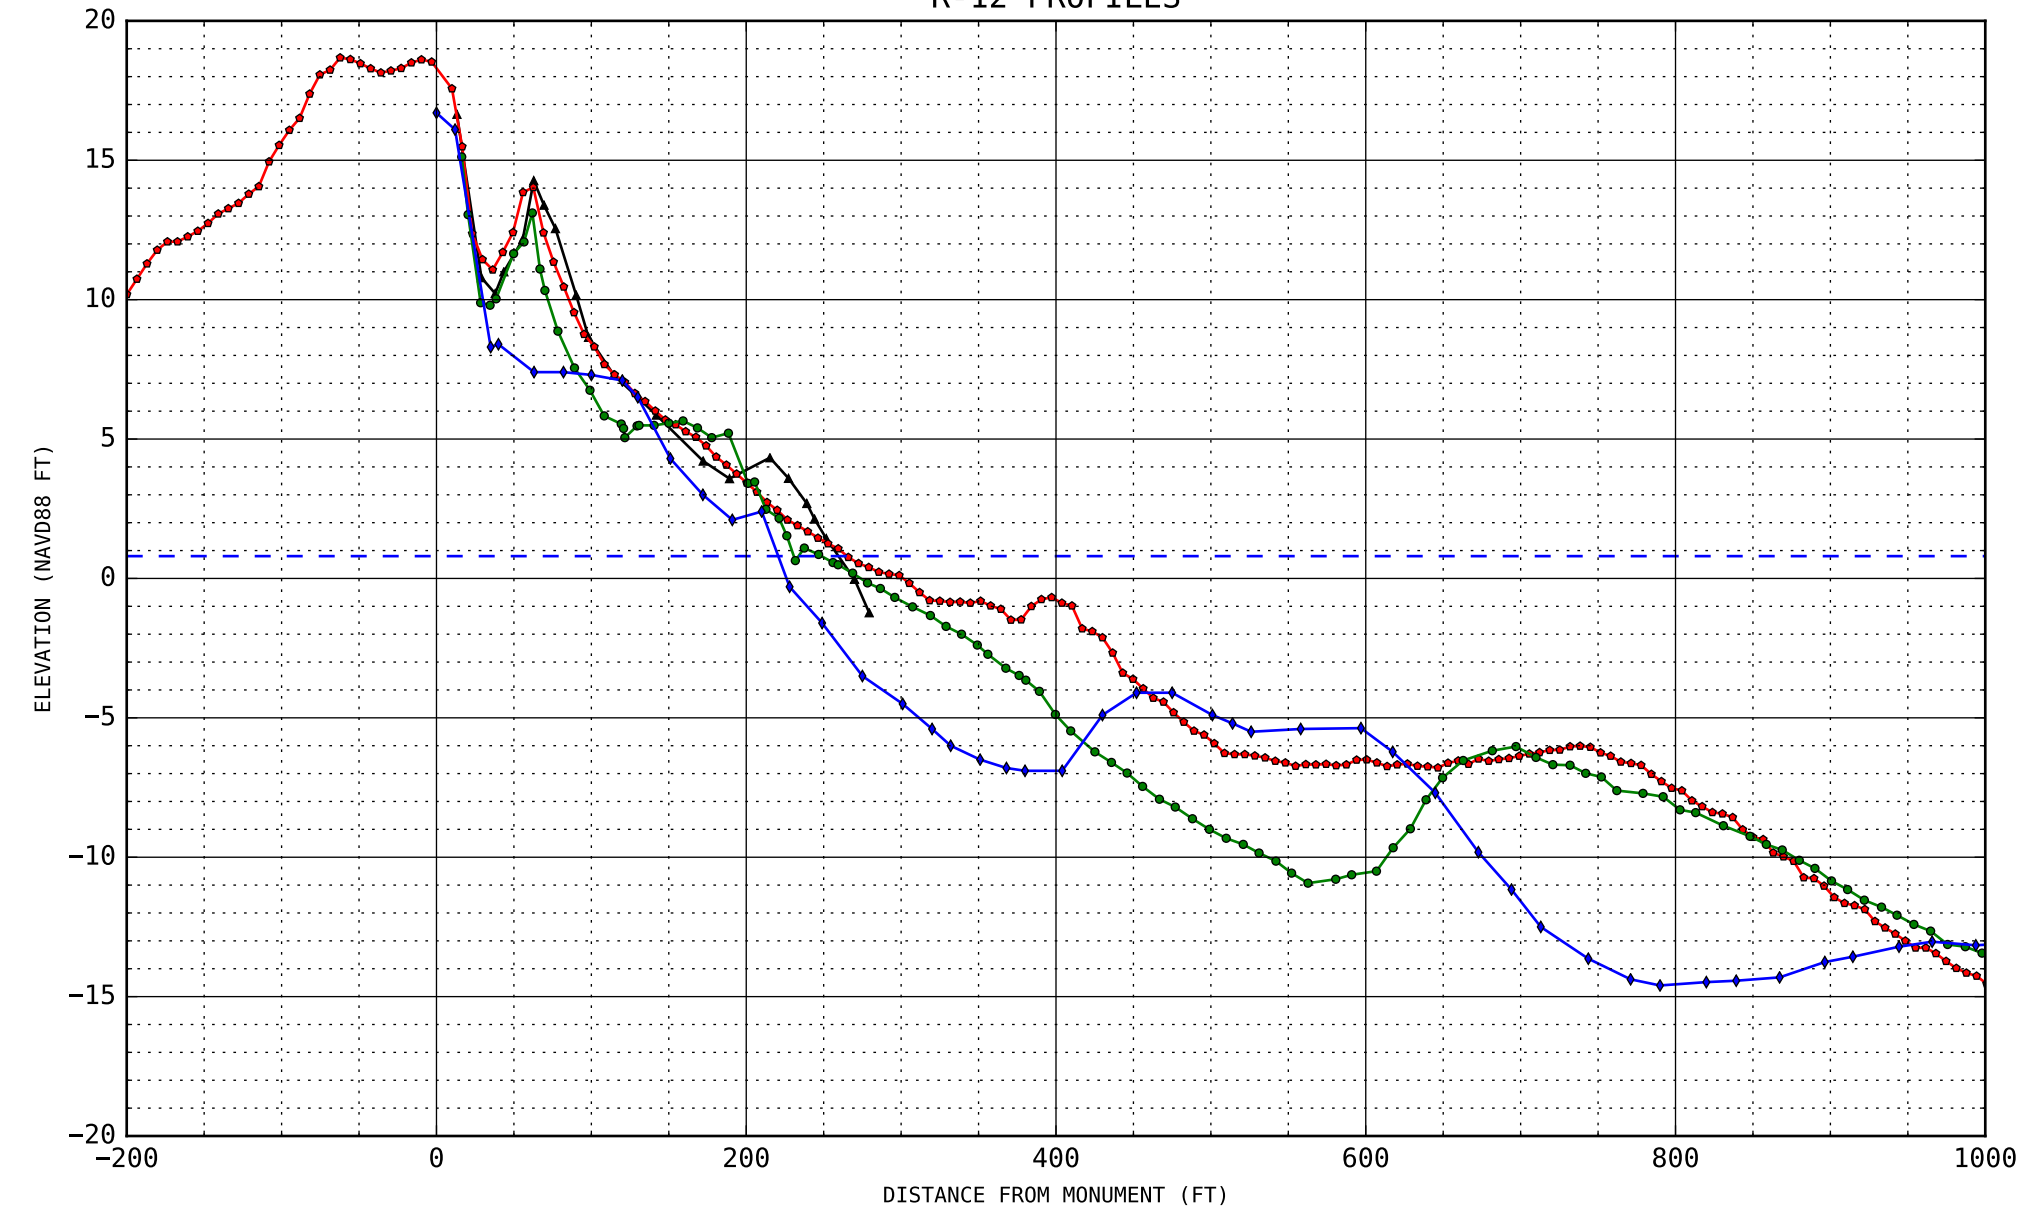
# R-12 PROFILES

- ▲ 2019-APR CONDITION BY DEP
- 2018-OCT MONITORING BY USACE-LIDAR
- 2013-SEP MONITORING BY USACE
- ◆ 2007-FEB MONITORING BY MAE
- - - MHW CONTOUR (0.8 FT)

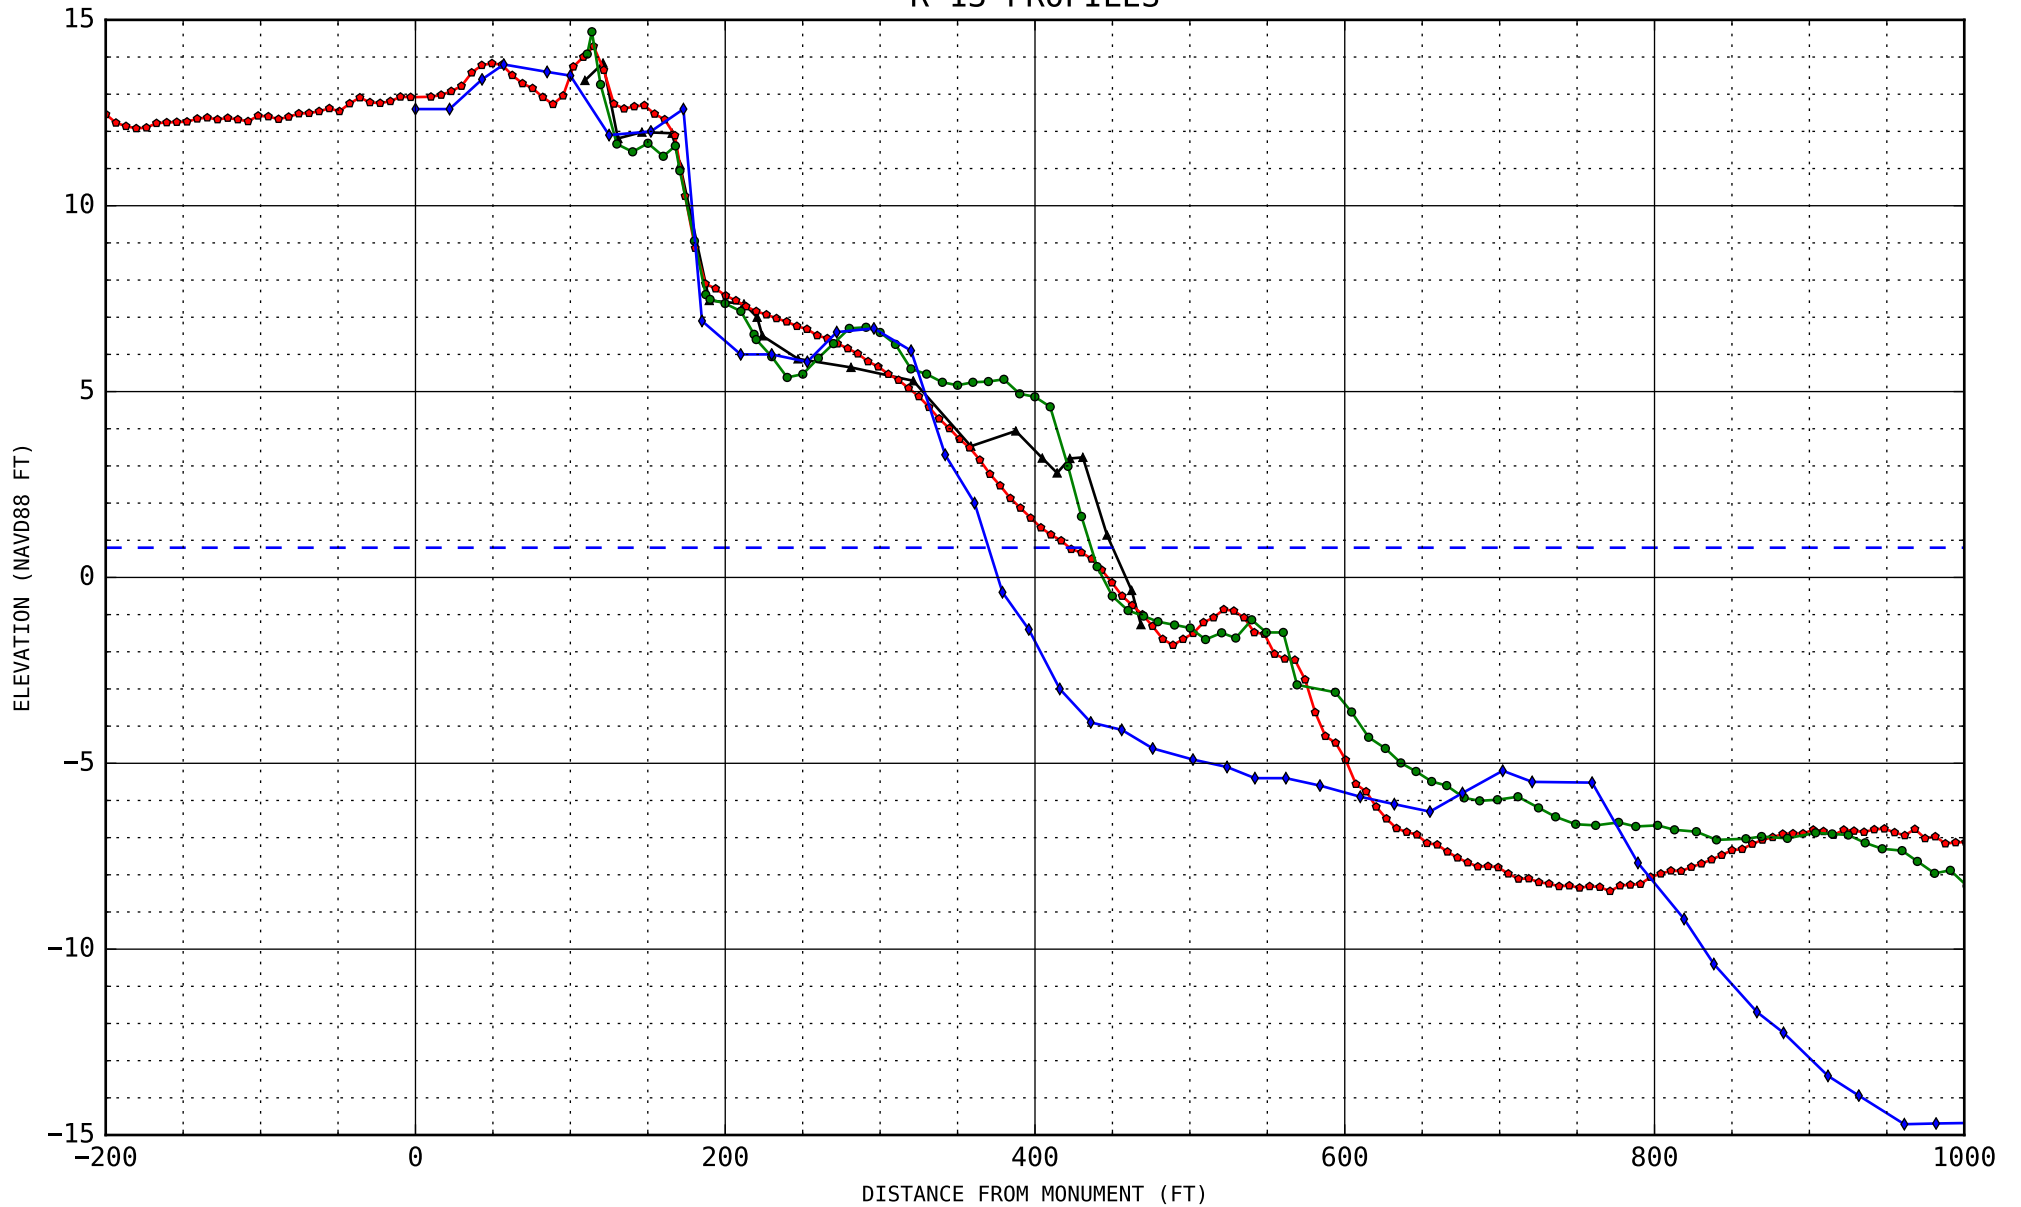
# R-13 PROFILES

- ▲ 2019-APR CONDITION BY DEP
- 2018-OCT MONITORING BY USACE-LIDAR
- 2013-SEP MONITORING BY USACE
- ◆ 2007-FEB MONITORING BY MAE
- - - MHW CONTOUR (0.8 FT)

RANGE: R-13  
EST DATE: M&E1997  
SURVEY DATE: 04APR19  
AZIMUTH: 190.0

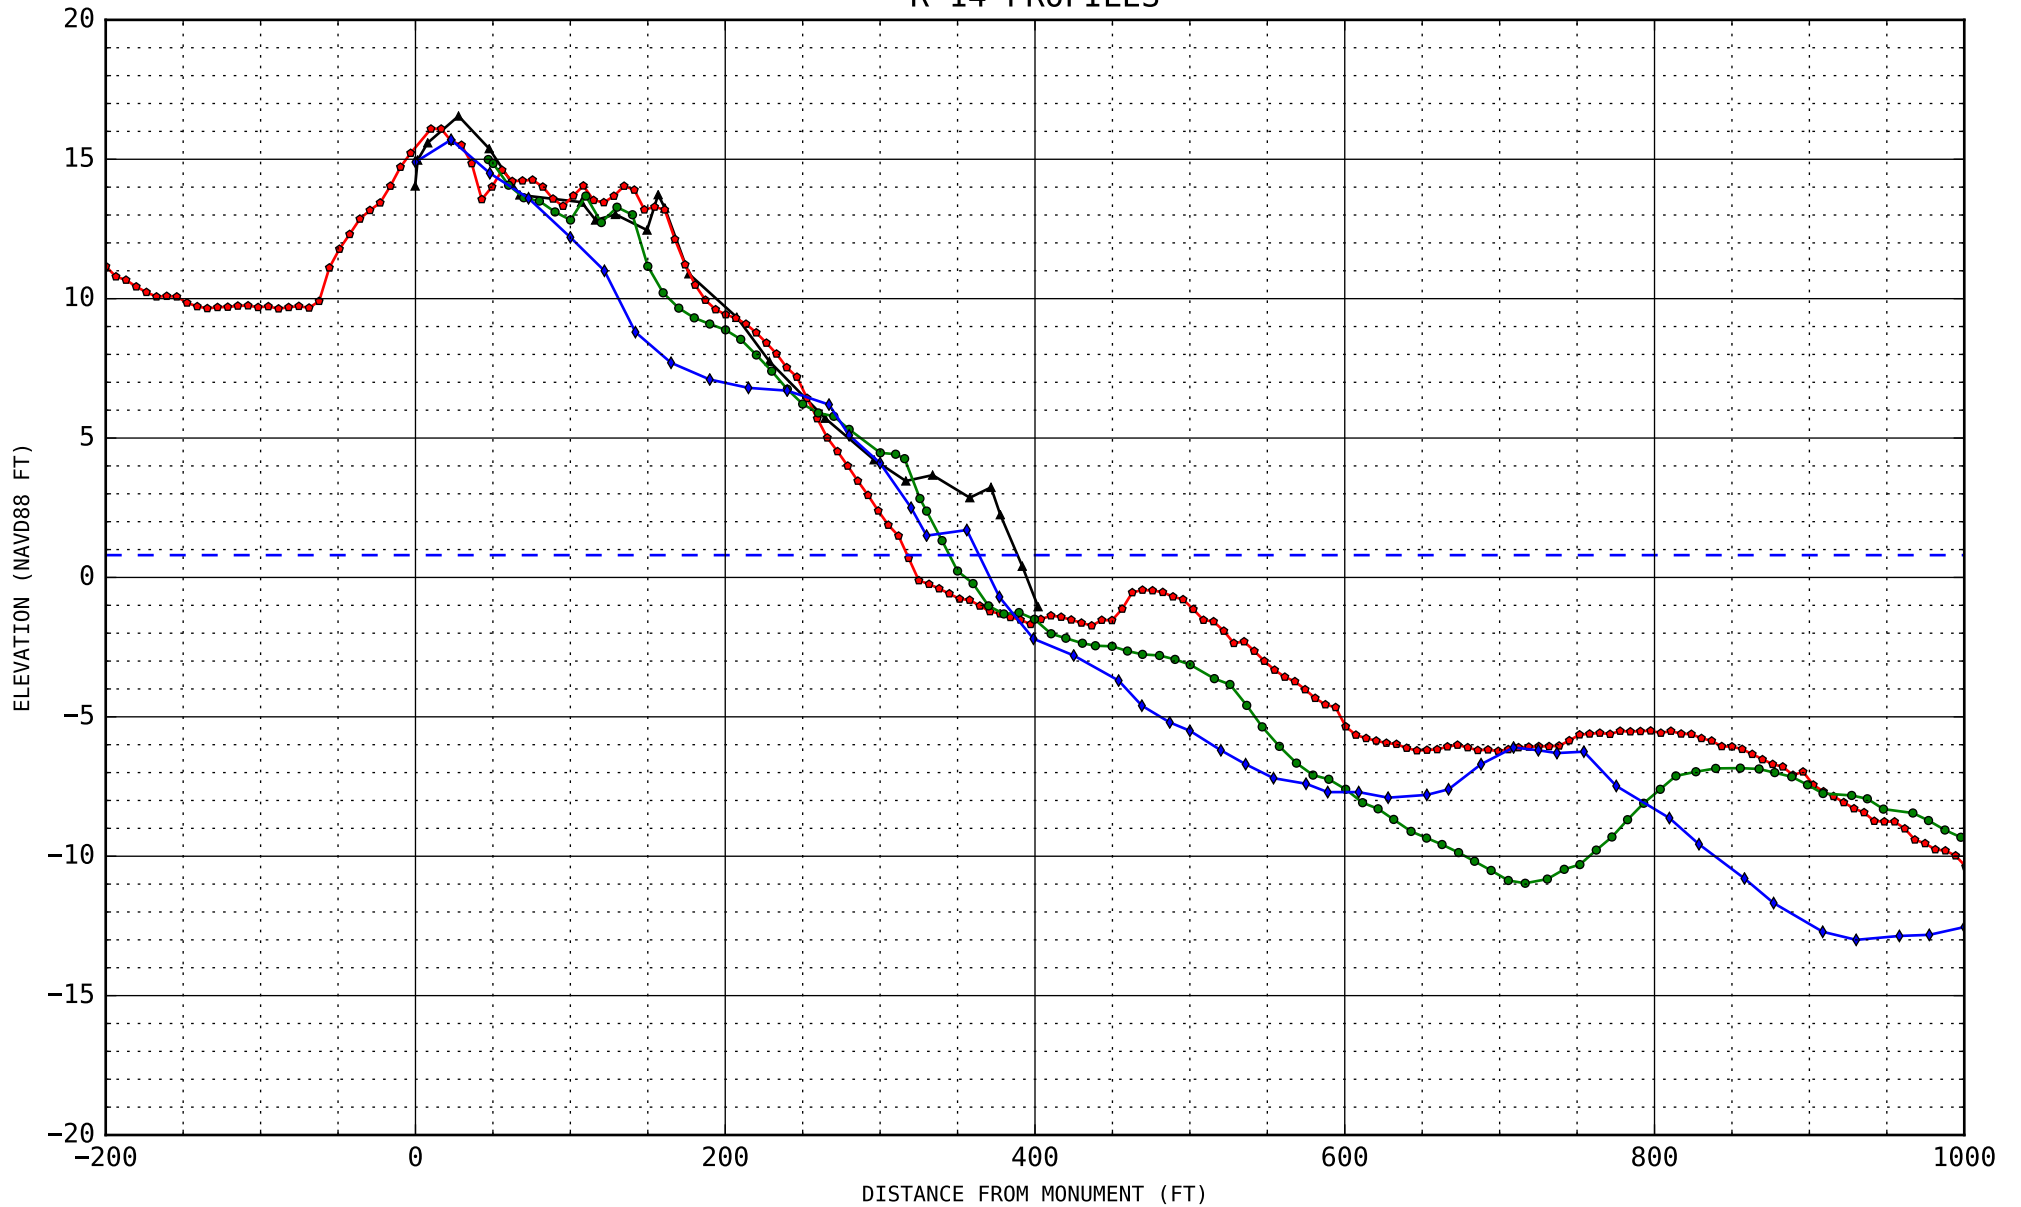
# R-14 PROFILES

- ▲ 2019-APR CONDITION BY DEP
- 2018-OCT MONITORING BY USACE-LIDAR
- 2013-SEP MONITORING BY USACE
- ◆ 2007-FEB MONITORING BY MAE
- - - MHW CONTOUR (0.8 FT)

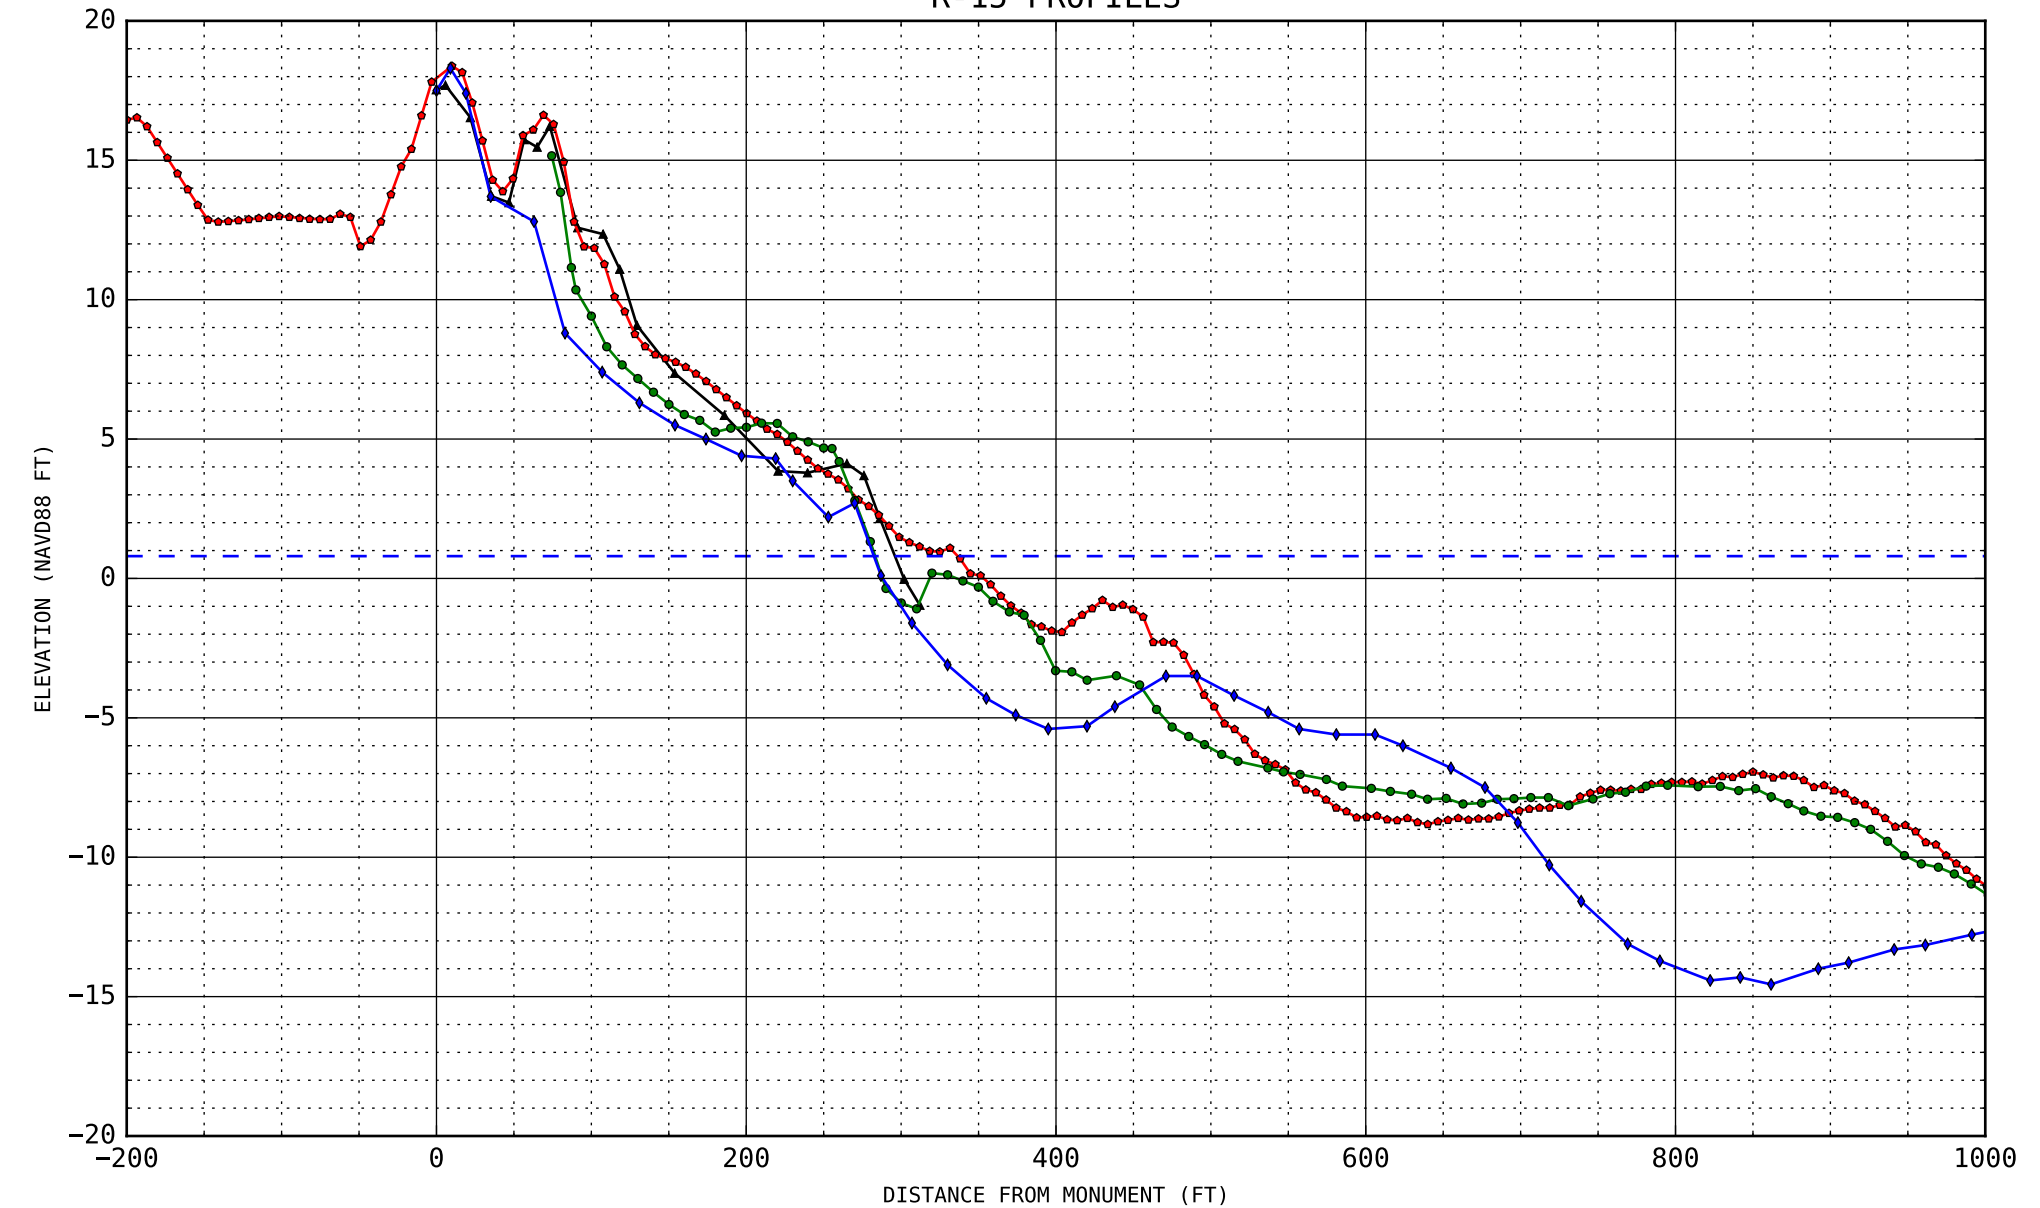
# R-15 PROFILES

- ▲ 2019-APR CONDITION BY DEP
- 2018-OCT MONITORING BY USACE-LIDAR
- 2013-SEP MONITORING BY USACE
- ◆ 2007-FEB MONITORING BY MAE
- - - MHW CONTOUR (0.8 FT)

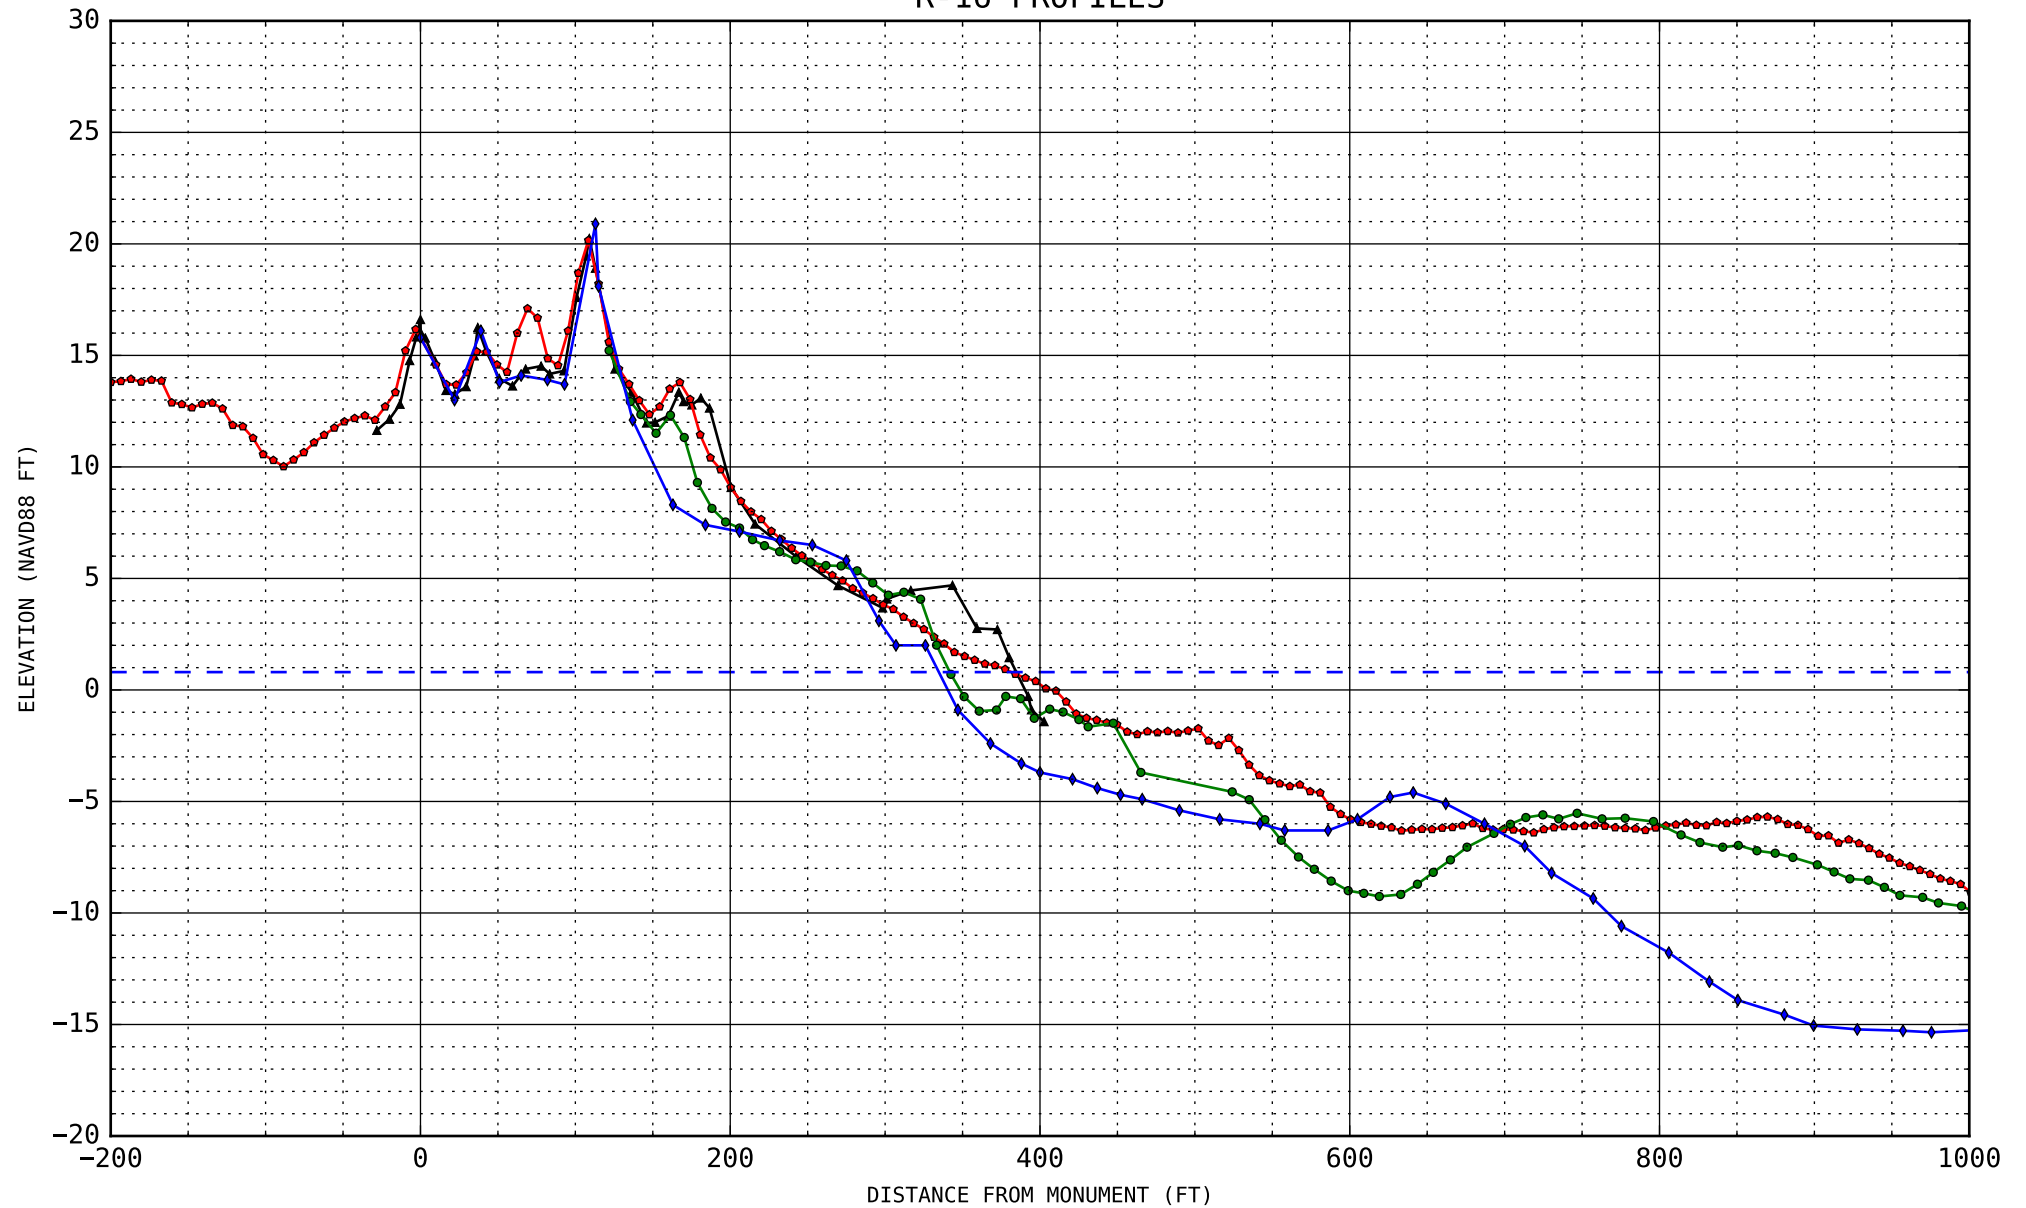
# R-16 PROFILES

- ▲ 2019-APR CONDITION BY DEP
- 2018-OCT MONITORING BY USACE-LIDAR
- 2013-SEP MONITORING BY USACE
- ◆ 2007-FEB MONITORING BY MAE
- - - MHW CONTOUR (0.8 FT)
