# R-1 PROFILES

WALTON  
PROGRAM SUPPORT GIS  
DIVISION OF WATER RESOURCE MANAGEMENT  
FLORIDA DEPARTMENT OF ENVIRONMENTAL PROTECTION

RANGE: R-1  
EST DATE: NOV1980  
SURVEY DATE: 04APR19  
AZIMUTH: 190.0

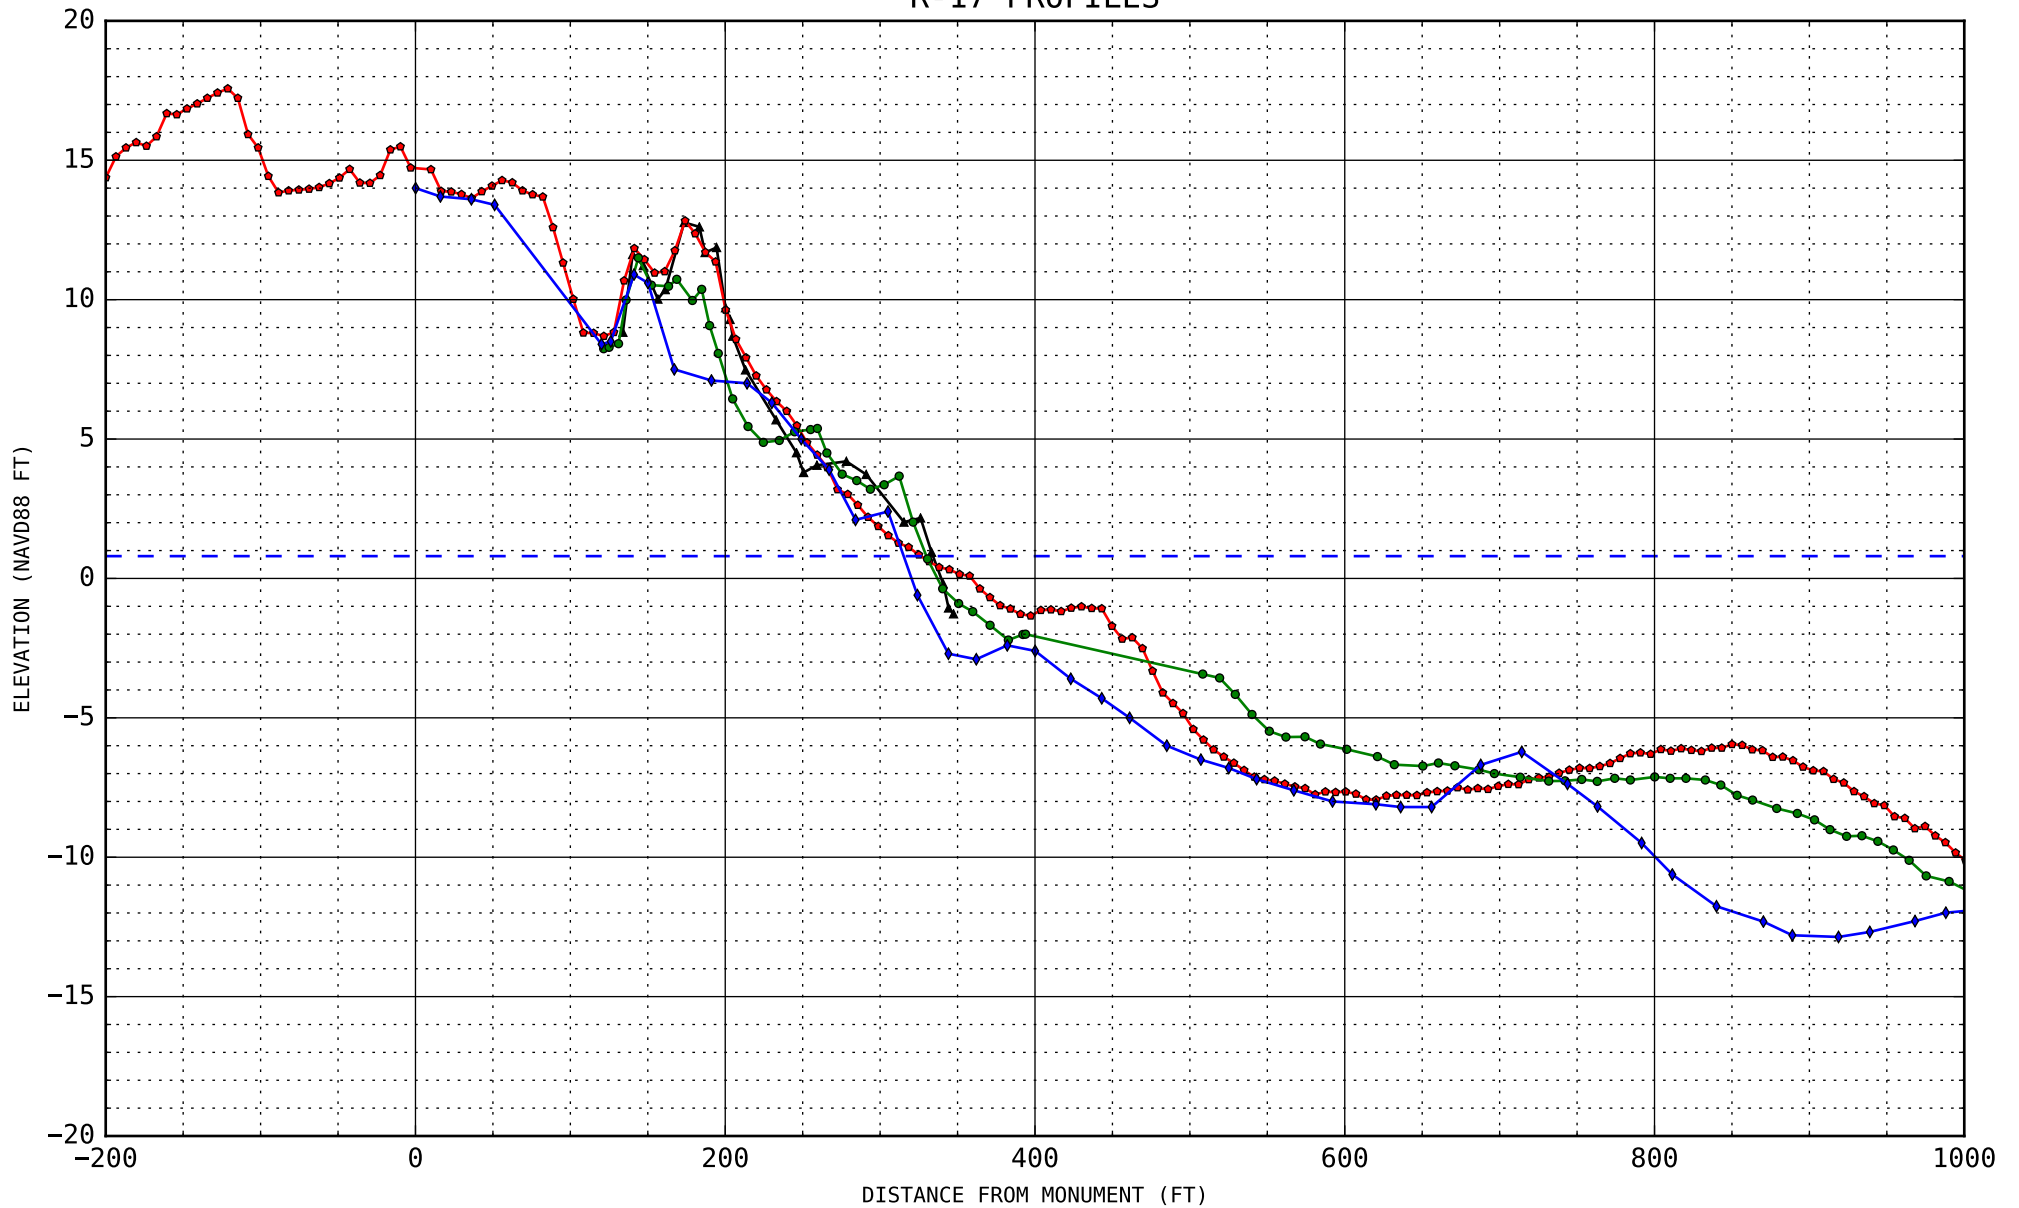
# R-17 PROFILES

- ▲ 2019-APR CONDITION BY DEP
- 2018-OCT MONITORING BY USACE-LIDAR
- 2013-SEP MONITORING BY USACE
- ◆ 2007-FEB MONITORING BY MAE
- - - MHW CONTOUR (0.8 FT)

RANGE: R-17  
 EST DATE: NOV1980  
 SURVEY DATE: 16APR19  
 AZIMUTH: 190.0

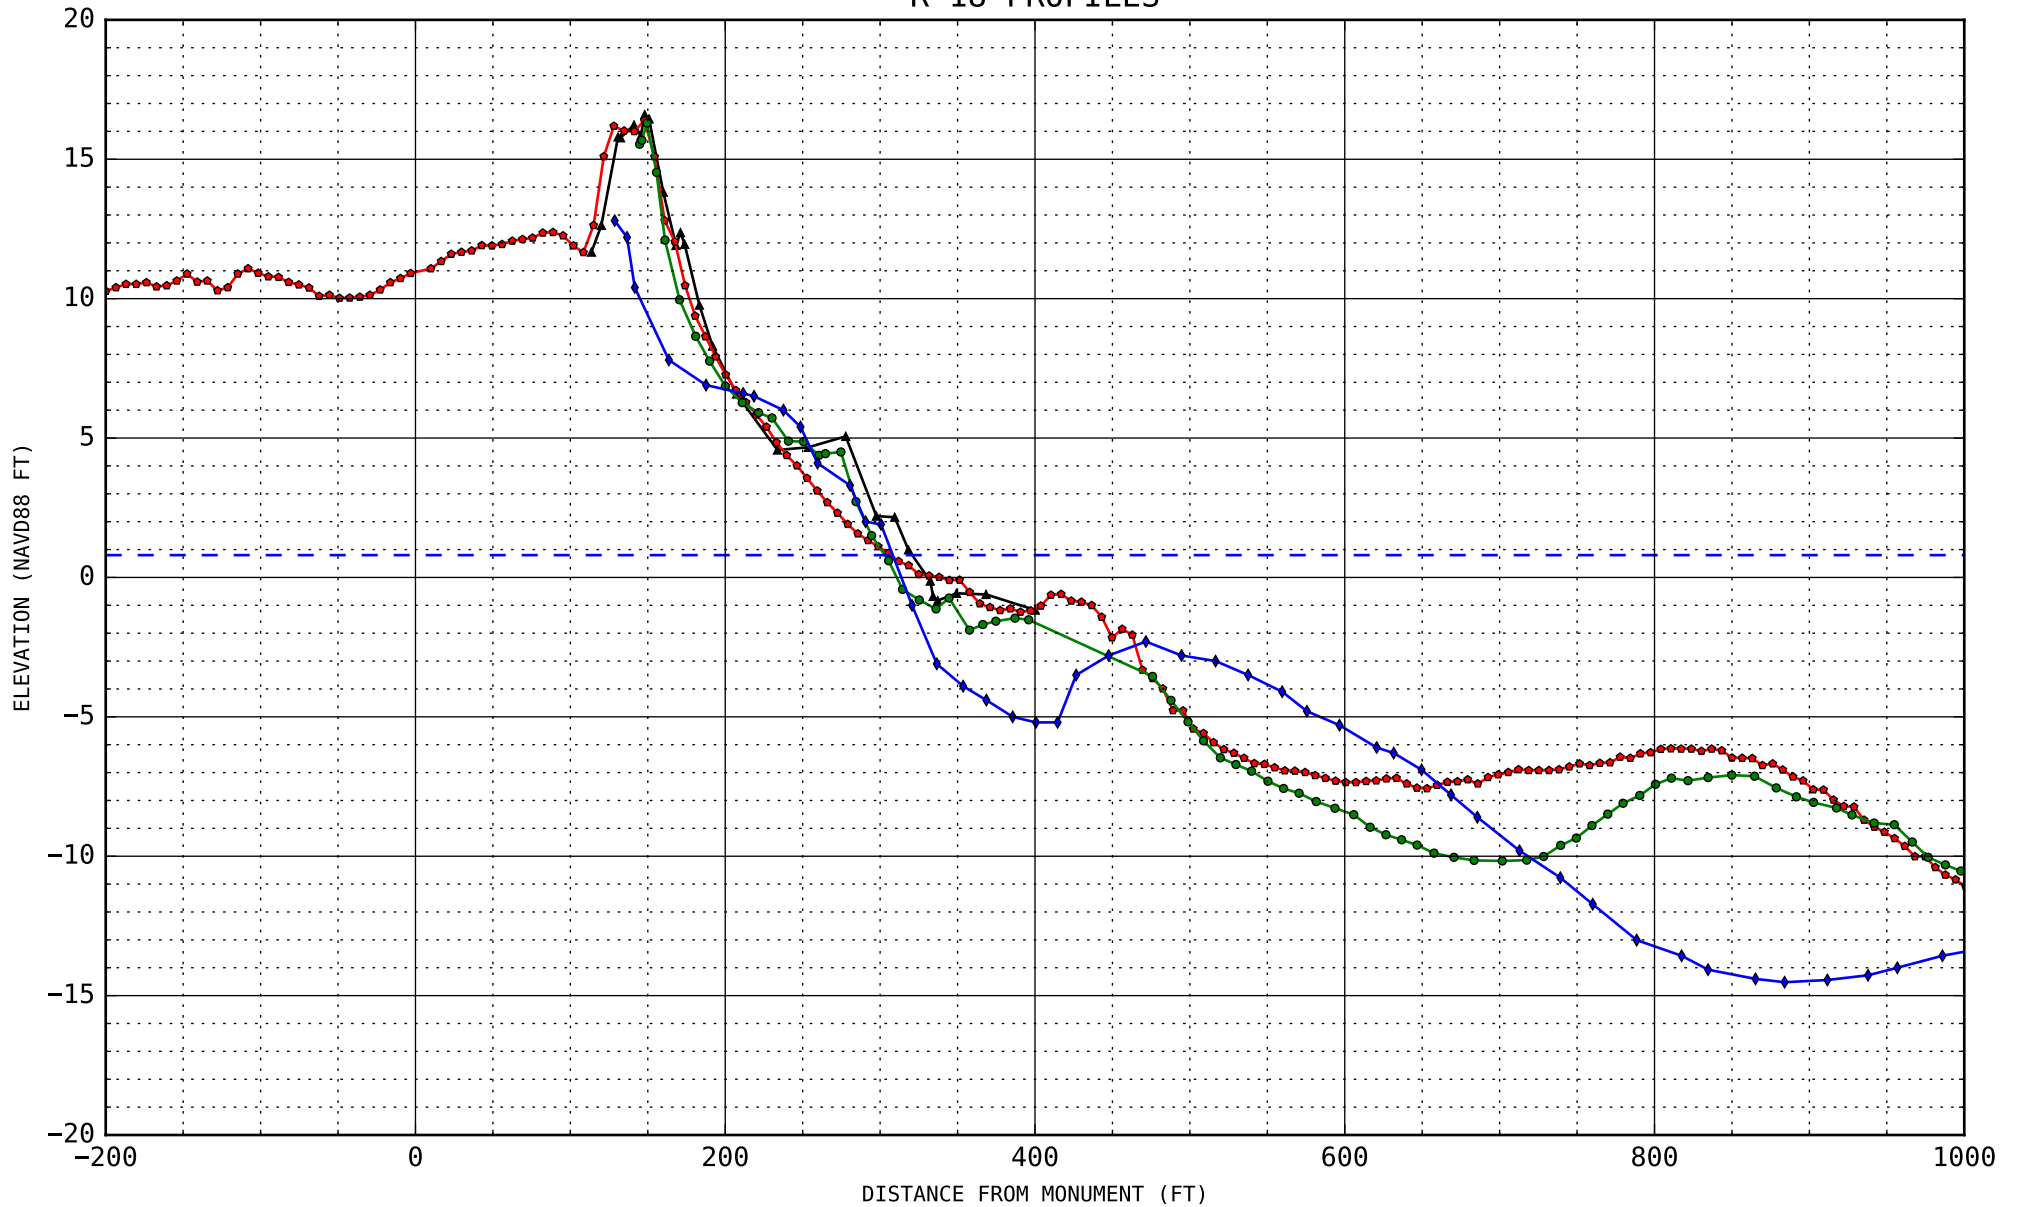
# R-18 PROFILES

- ▲ 2019-APR CONDITION BY DEP
- 2018-OCT MONITORING BY USACE-LIDAR
- 2013-SEP MONITORING BY USACE
- ◆ 2007-FEB MONITORING BY MAE
- - - MHW CONTOUR (0.8 FT)

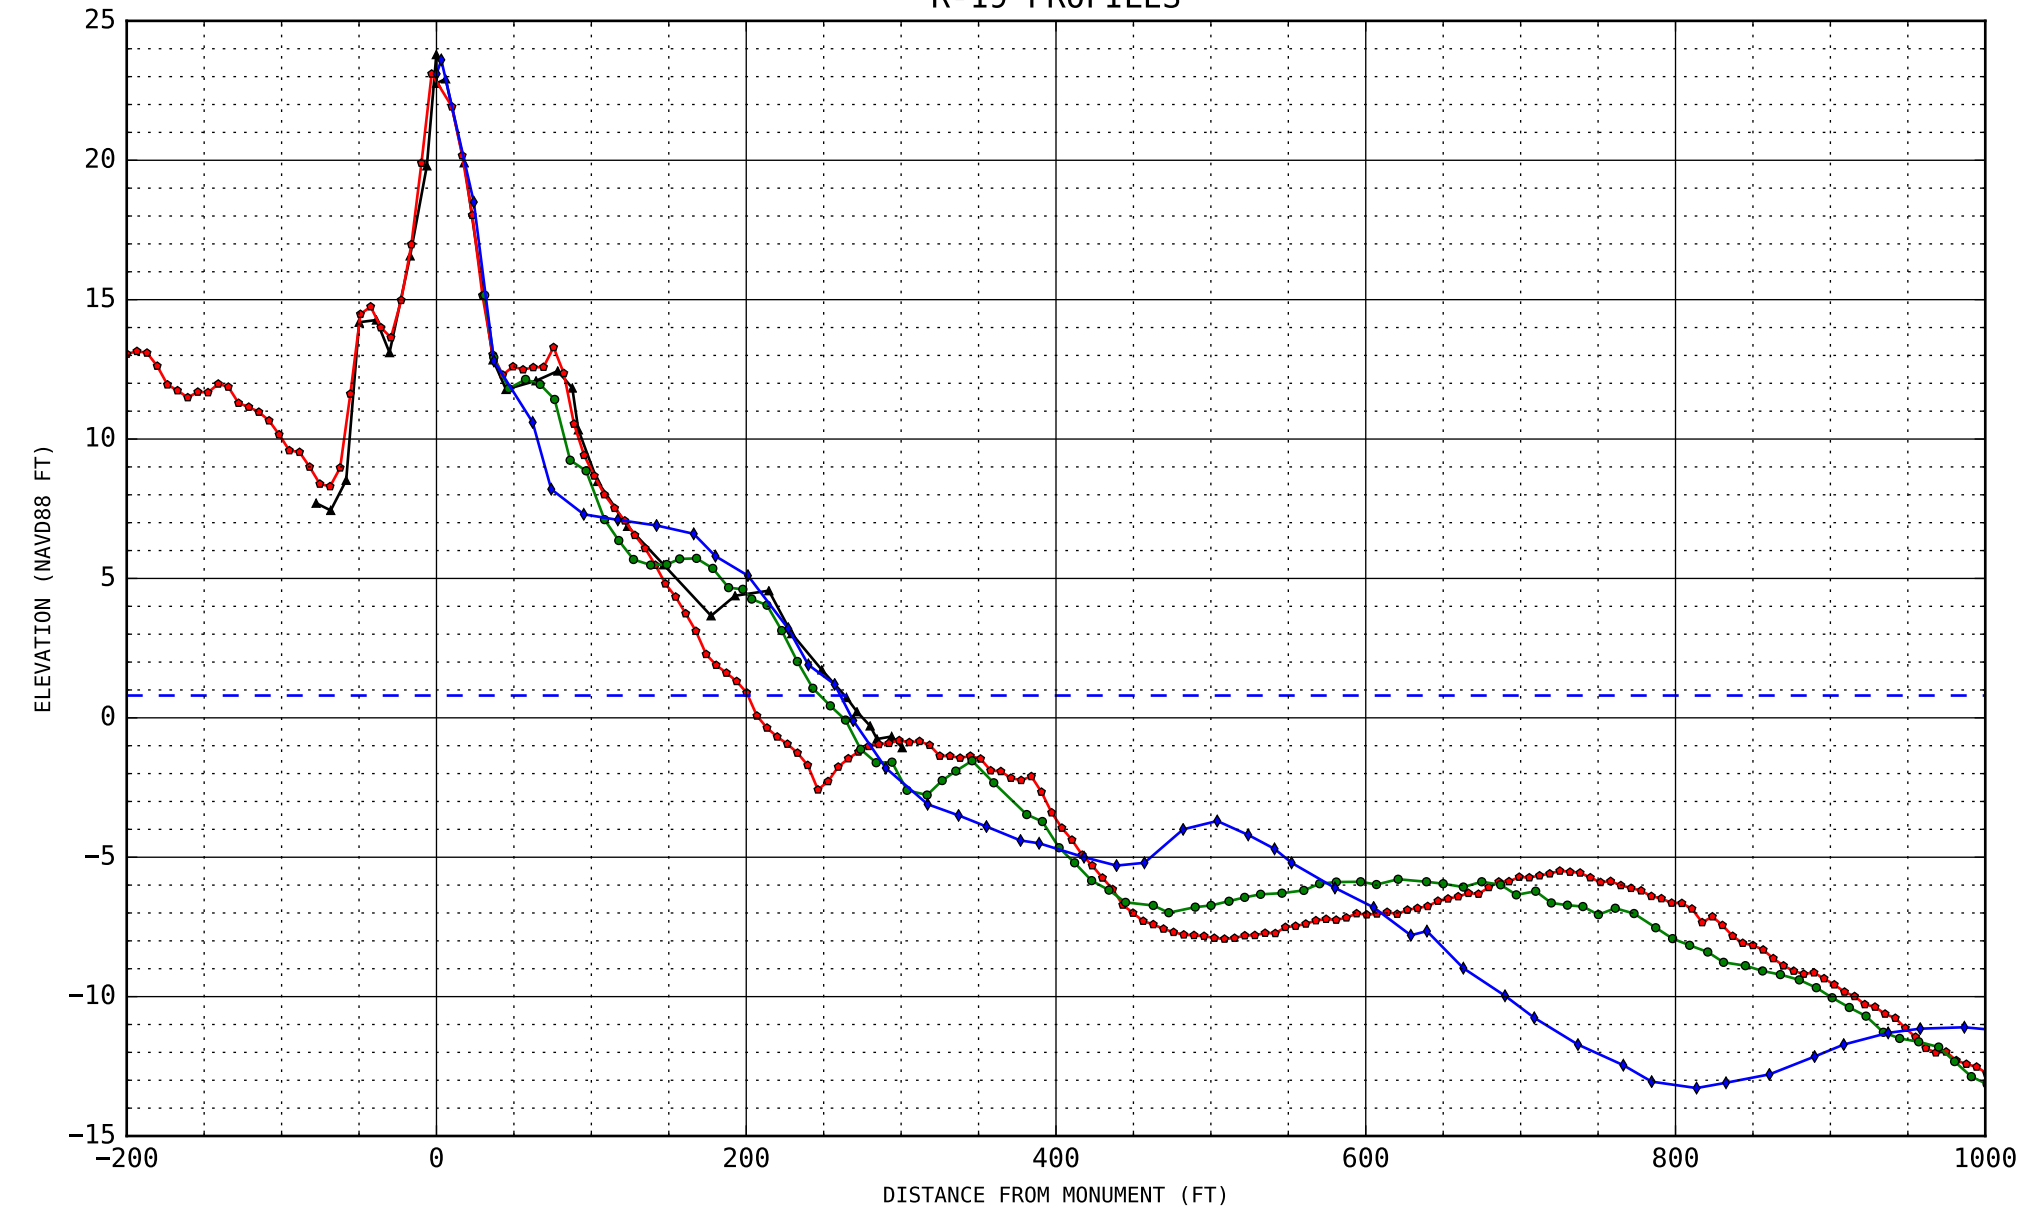
# R-19 PROFILES

- ▲ 2019-APR CONDITION BY DEP
- 2018-OCT MONITORING BY USACE-LIDAR
- 2013-SEP MONITORING BY USACE
- ◆ 2007-FEB MONITORING BY MAE
- - - MHW CONTOUR (0.8 FT)

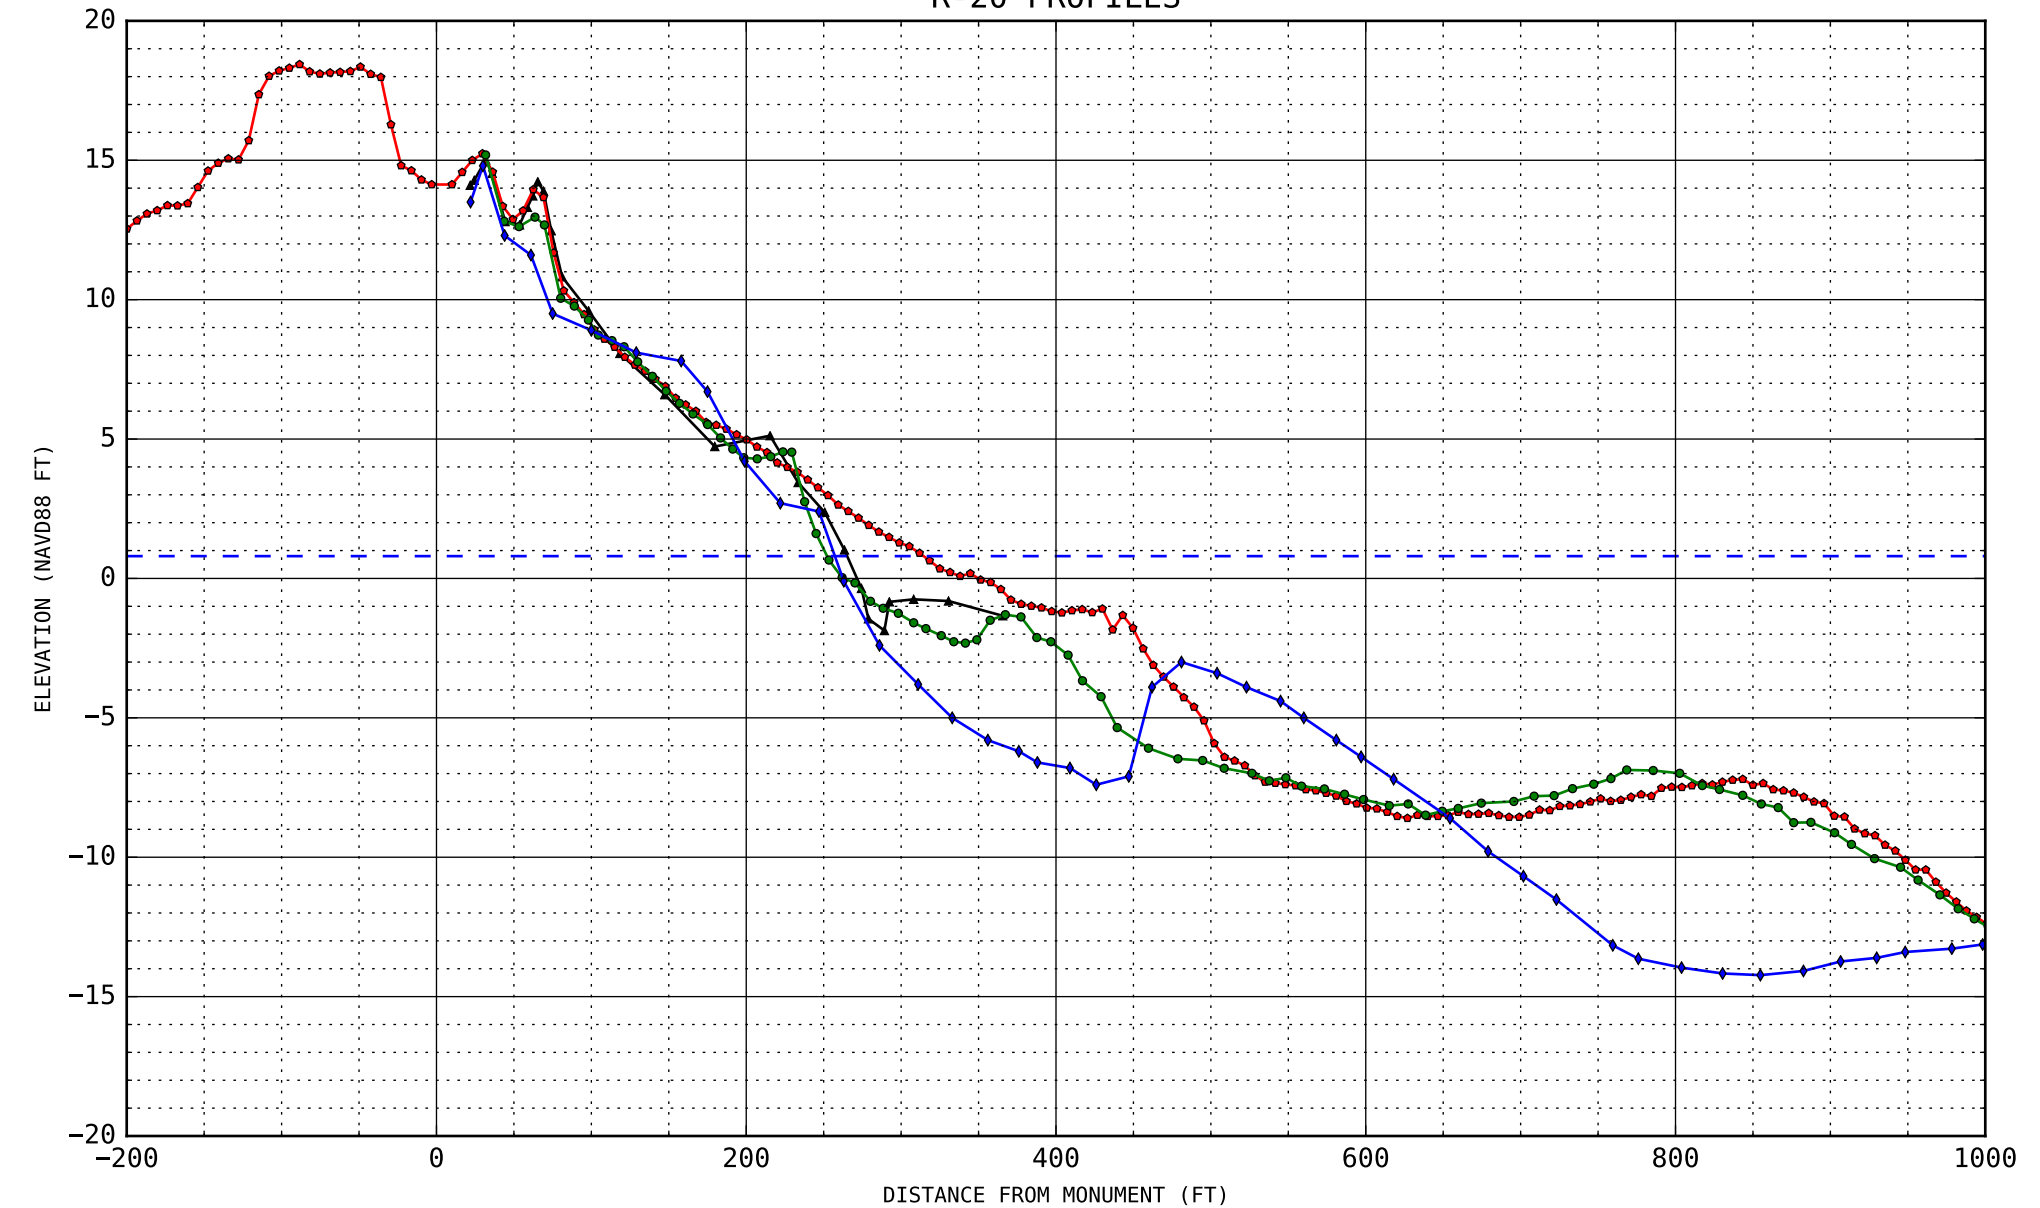
# R-20 PROFILES

- ▲ 2019-APR CONDITION BY DEP
- 2018-OCT MONITORING BY USACE-LIDAR
- 2013-SEP MONITORING BY USACE
- ◆ 2007-FEB MONITORING BY MAE
- - - MHW CONTOUR (0.8 FT)

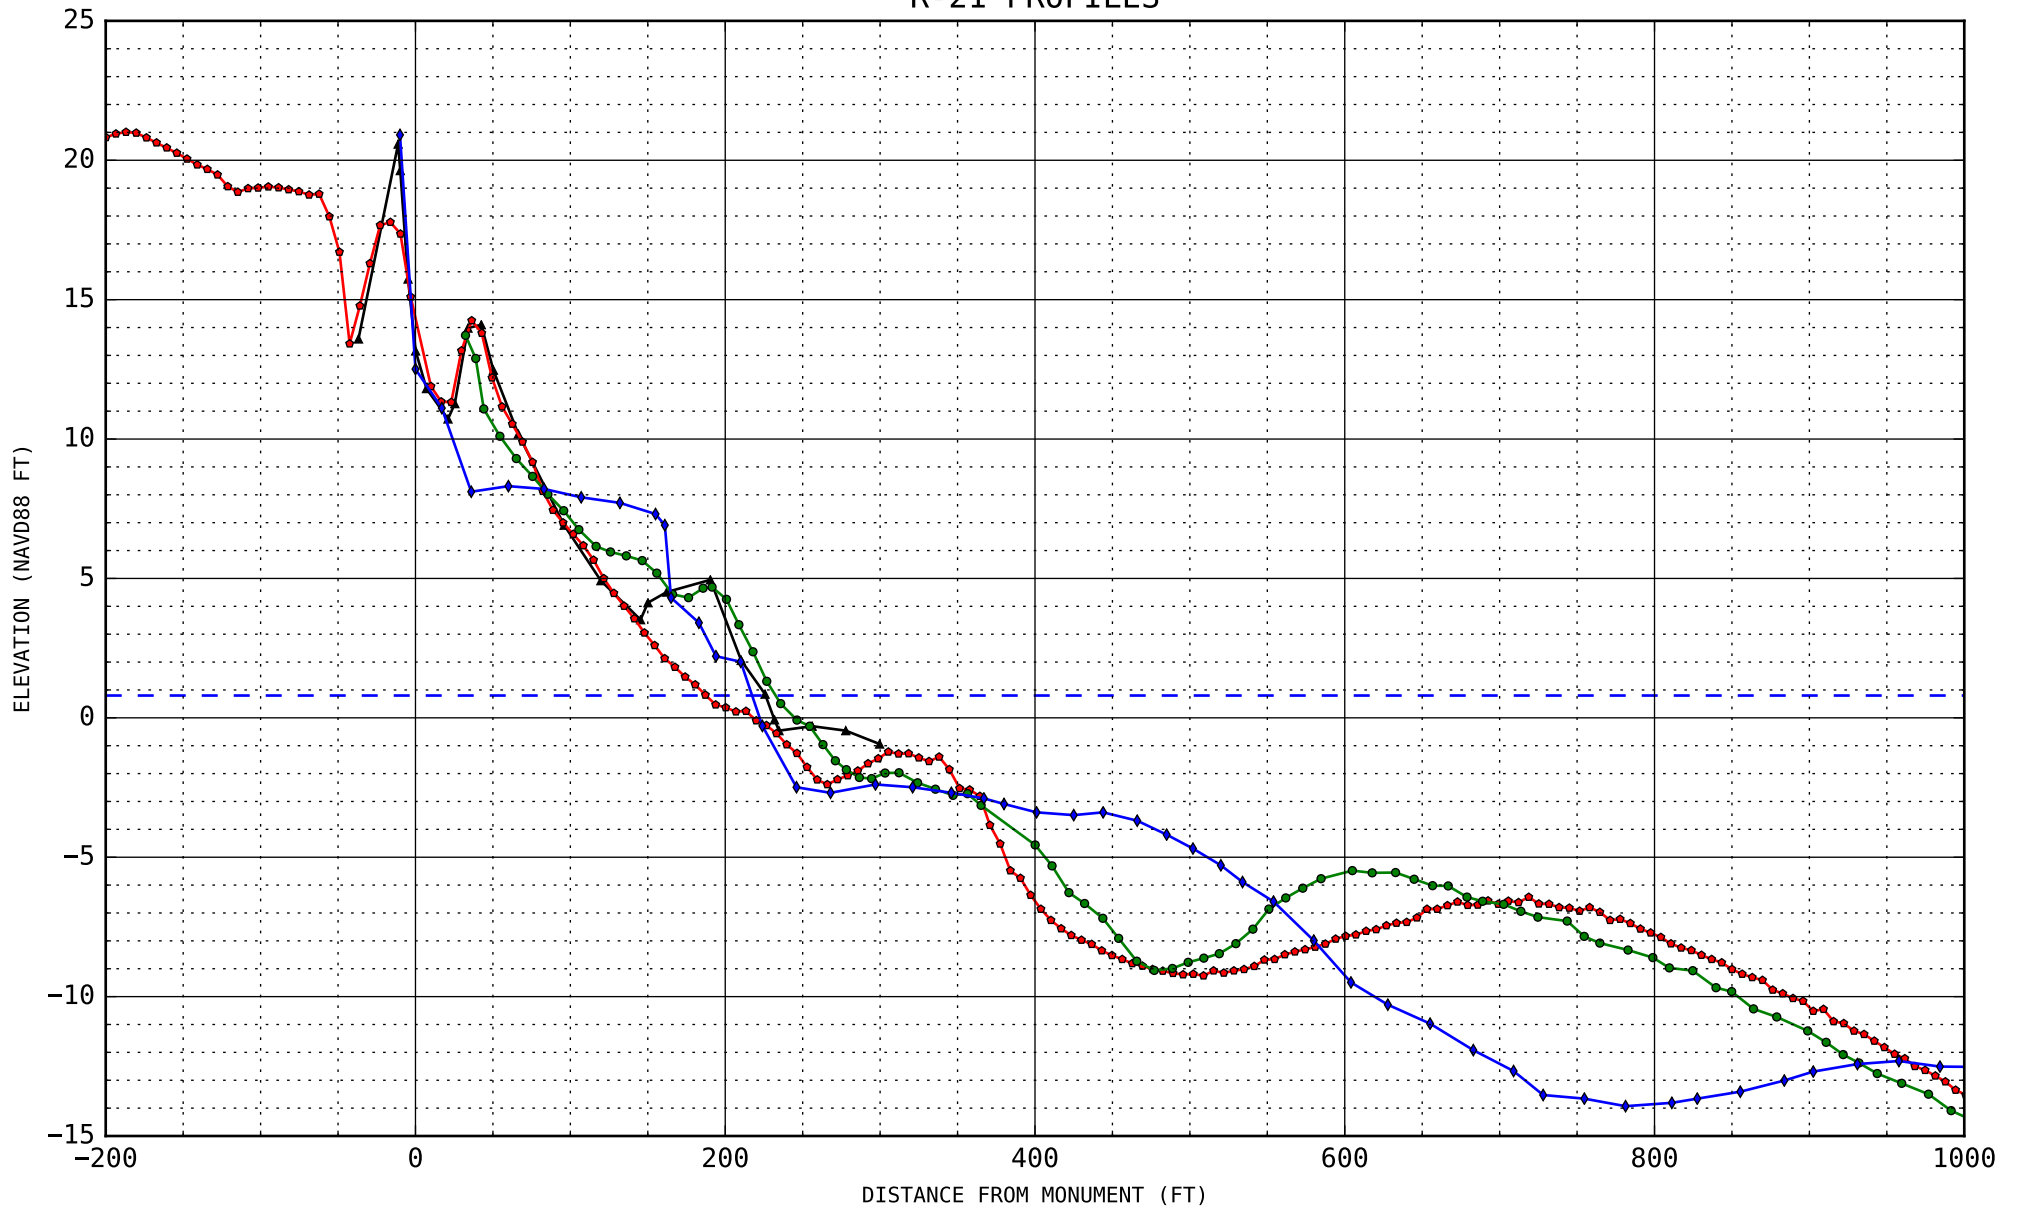
# R-21 PROFILES

- ▲ 2019-APR CONDITION BY DEP
- 2018-OCT MONITORING BY USACE-LIDAR
- 2013-SEP MONITORING BY USACE
- ◆ 2007-FEB MONITORING BY MAE
- - - MHW CONTOUR (0.8 FT)

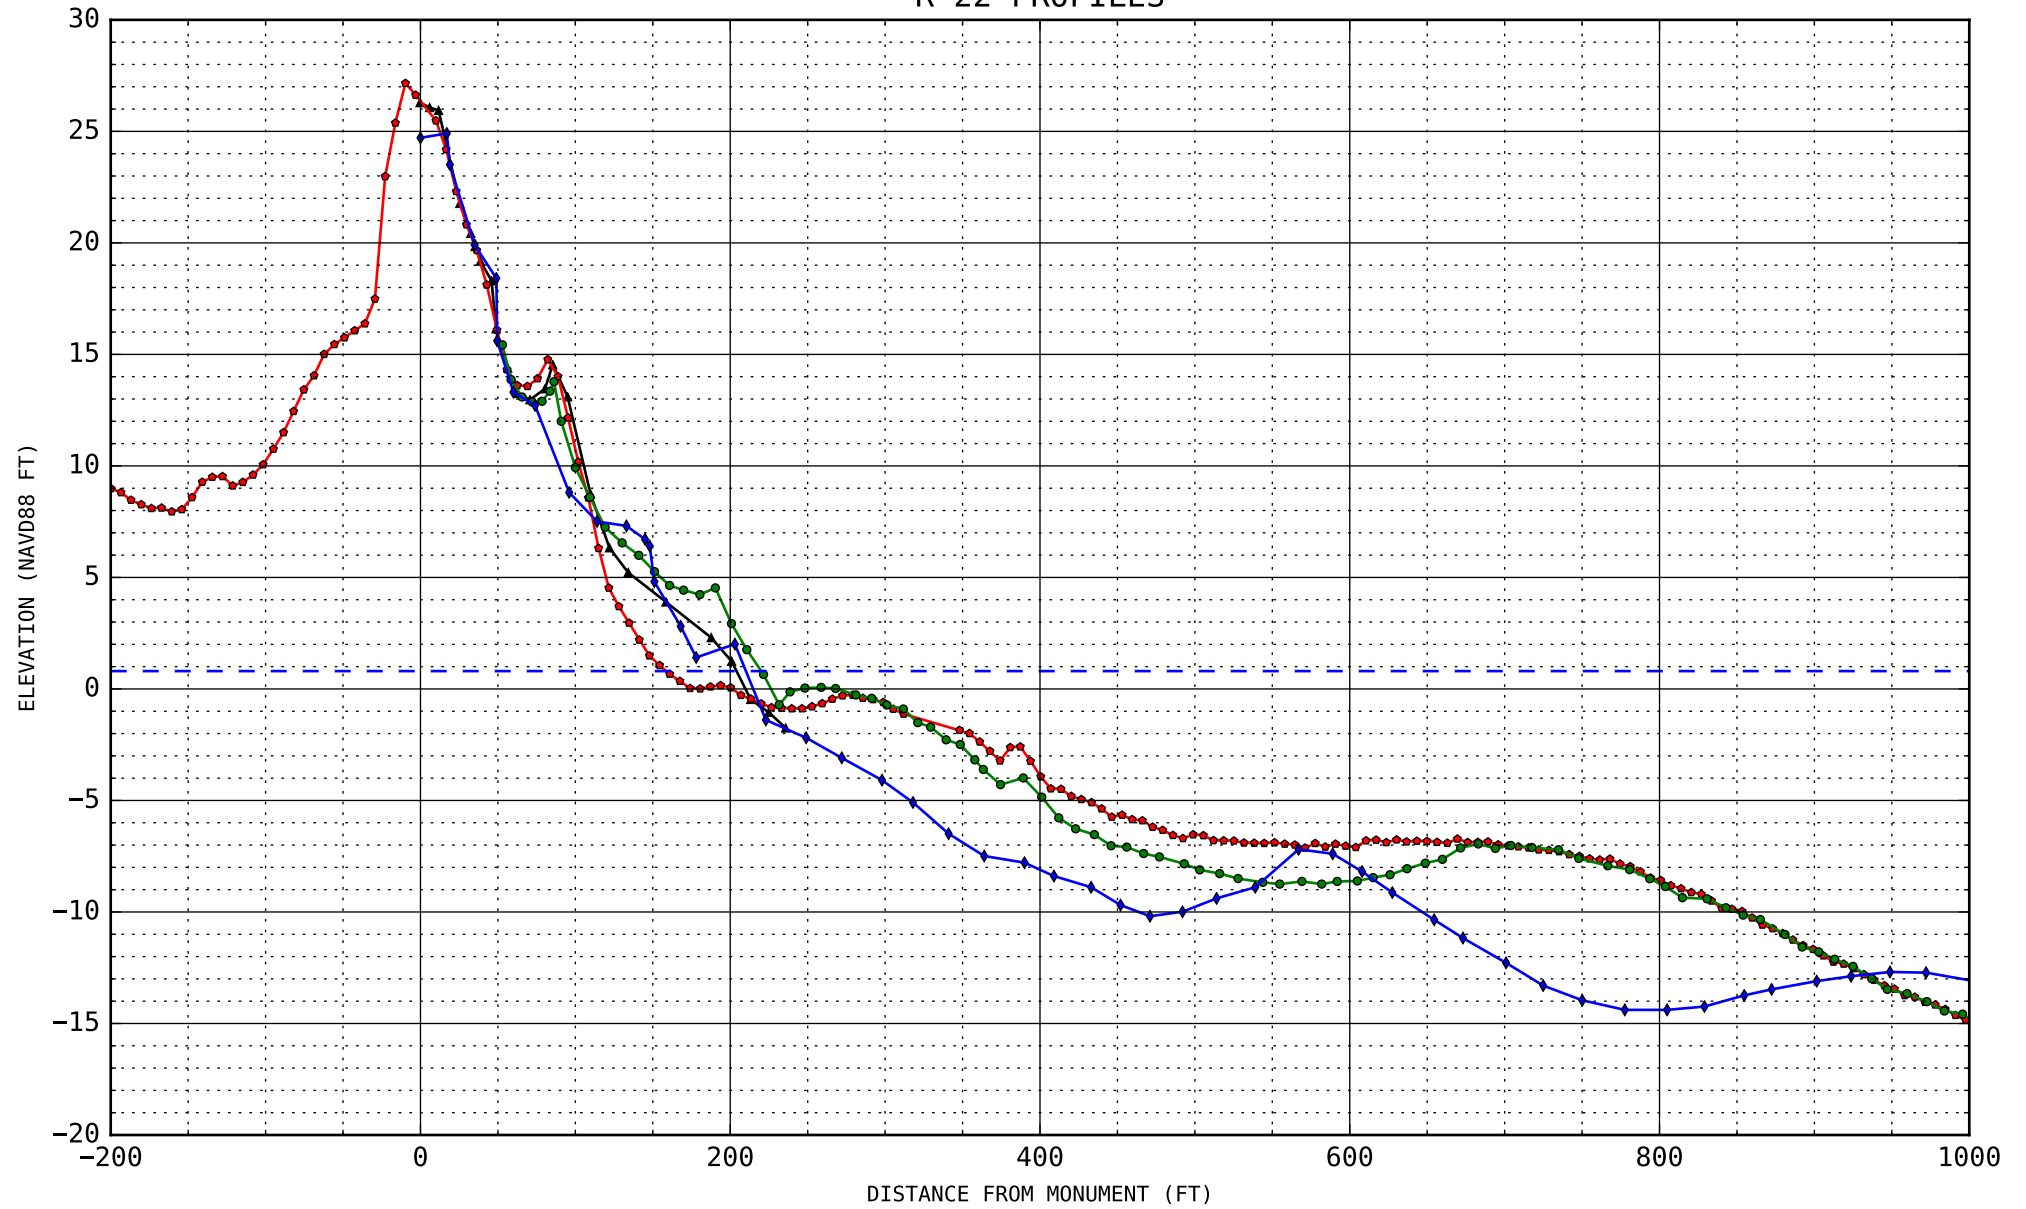
# R-22 PROFILES

- ▲ 2019-APR CONDITION BY DEP
- 2018-OCT MONITORING BY USACE-LIDAR
- 2013-SEP MONITORING BY USACE
- ◆ 2007-FEB MONITORING BY MAE
- - - MHW CONTOUR (0.8 FT)

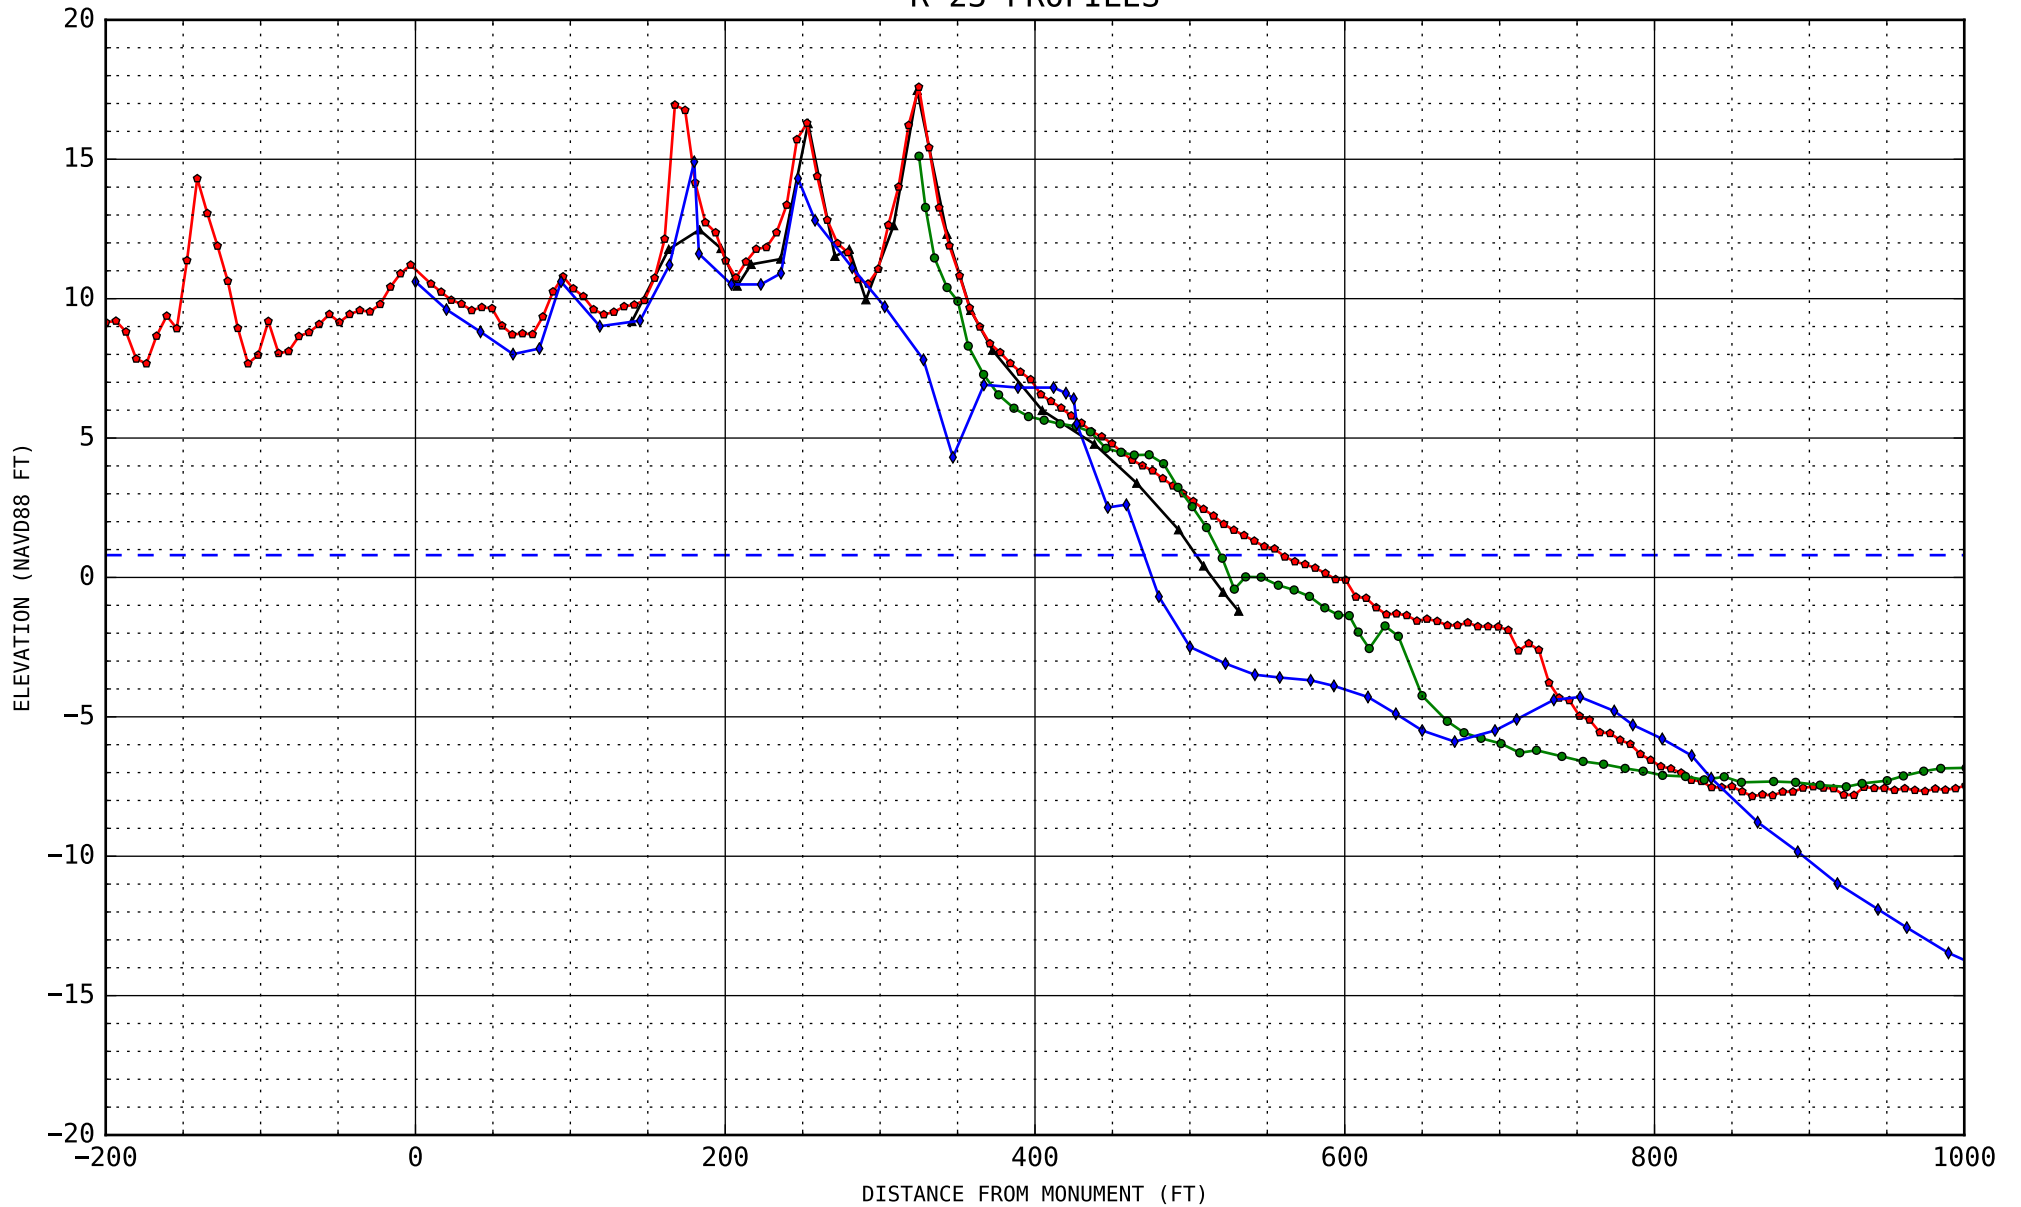
# R-23 PROFILES

- ▲ 2019-APR CONDITION BY DEP
- 2018-OCT MONITORING BY USACE-LIDAR
- 2013-SEP MONITORING BY USACE
- ◆ 2007-FEB MONITORING BY MAE
- - - MHW CONTOUR (0.8 FT)

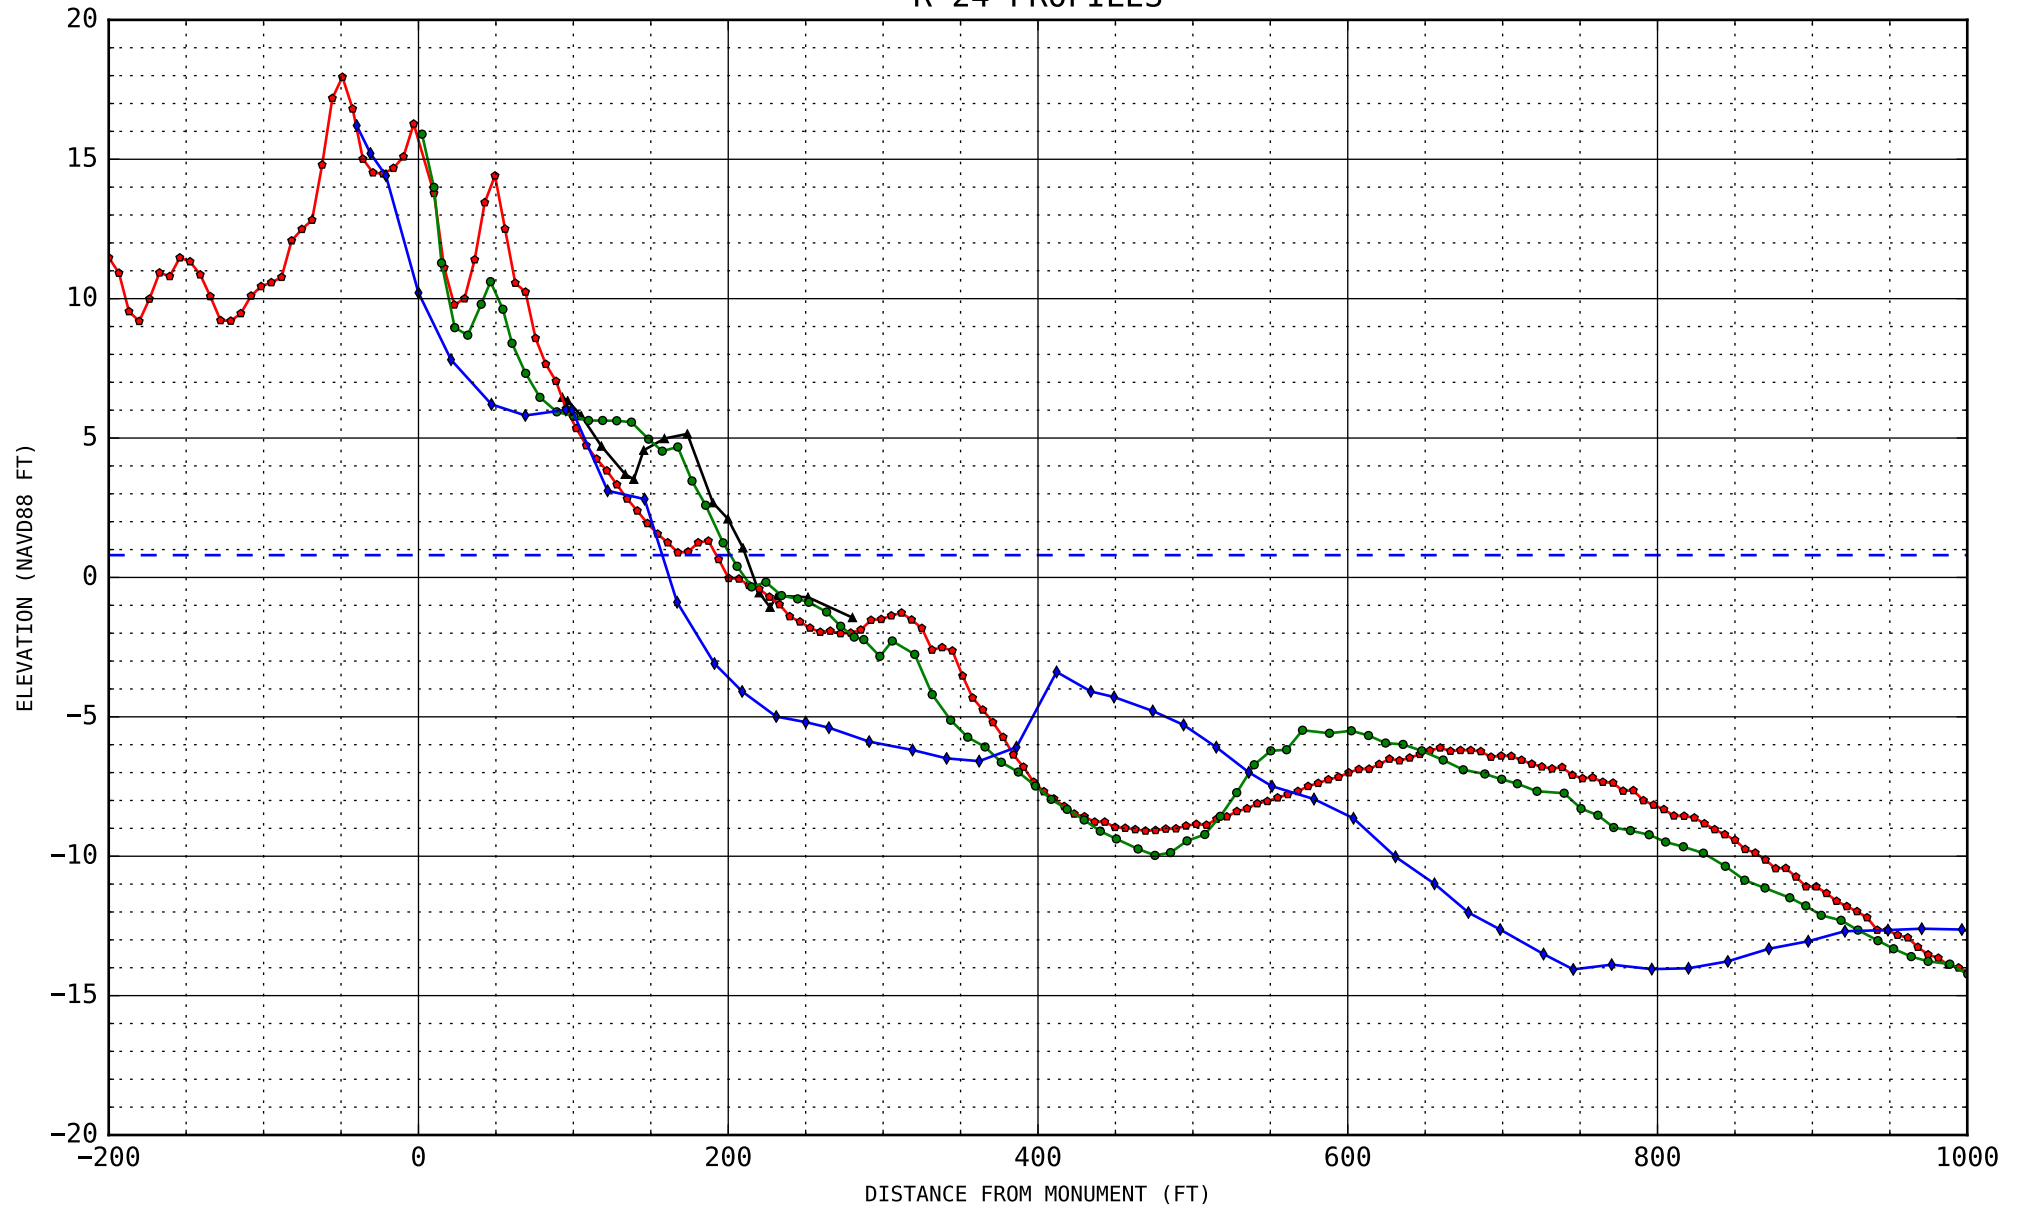
# R-24 PROFILES

- ▲ 2019-APR CONDITION BY DEP
- 2018-OCT MONITORING BY USACE-LIDAR
- 2013-SEP MONITORING BY USACE
- ◆ 2007-FEB MONITORING BY MAE
- - - MHW CONTOUR (0.8 FT)

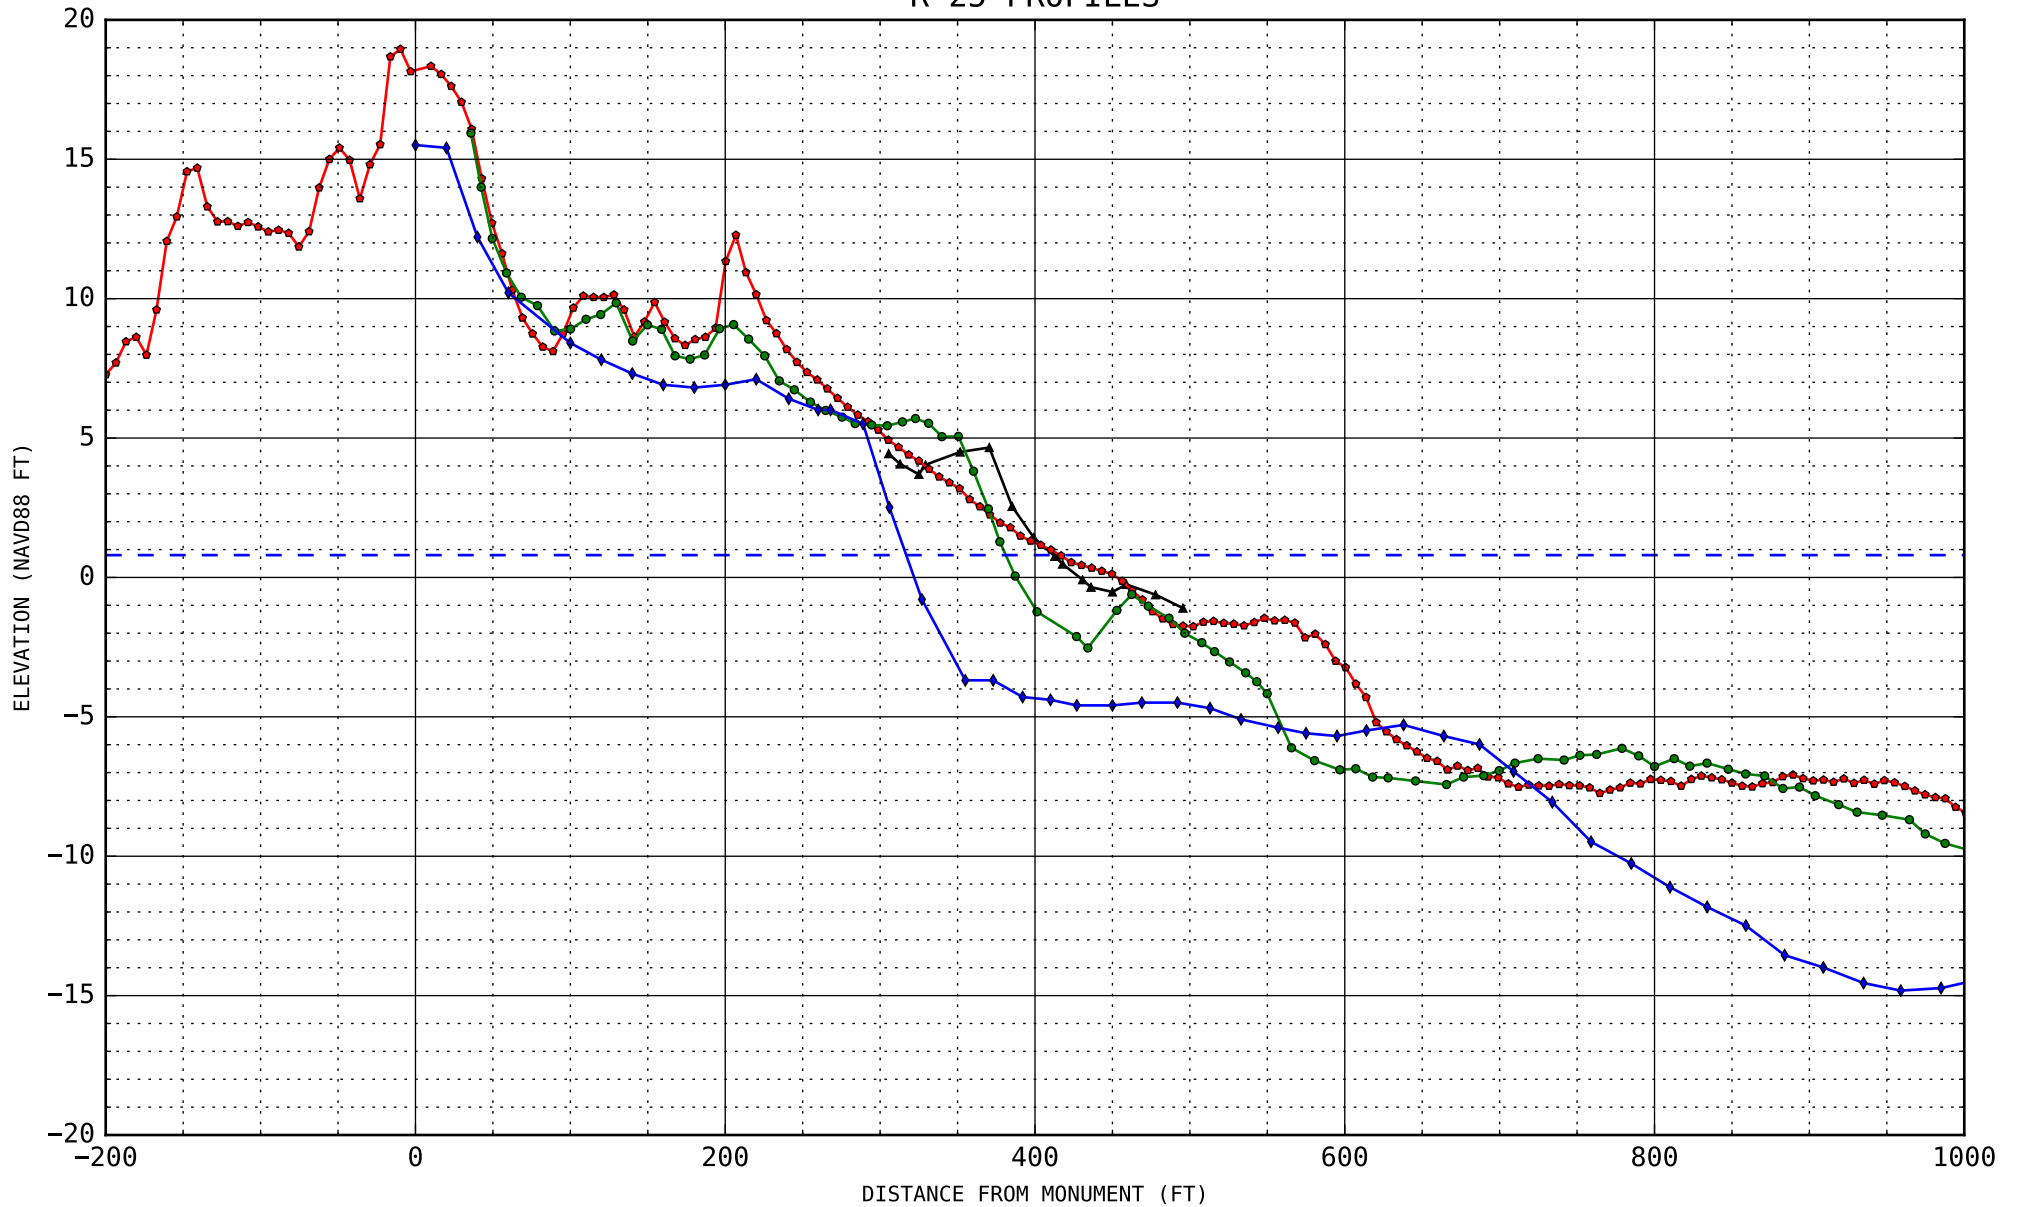
# R-25 PROFILES

- ▲ 2019-APR CONDITION BY DEP
- 2018-OCT MONITORING BY USACE-LIDAR
- 2013-SEP MONITORING BY USACE
- ◆ 2007-FEB MONITORING BY MAE
- - - MHW CONTOUR (0.8 FT)

RANGE: R-25  
EST DATE: NOV1980  
SURVEY DATE: 16APR19  
AZIMUTH: 190.0
