# R-1 PROFILES

WALTON  
PROGRAM SUPPORT GIS  
DIVISION OF WATER RESOURCE MANAGEMENT  
FLORIDA DEPARTMENT OF ENVIRONMENTAL PROTECTION

RANGE: R-1  
EST DATE: NOV1980  
SURVEY DATE: 04APR19  
AZIMUTH: 190.0

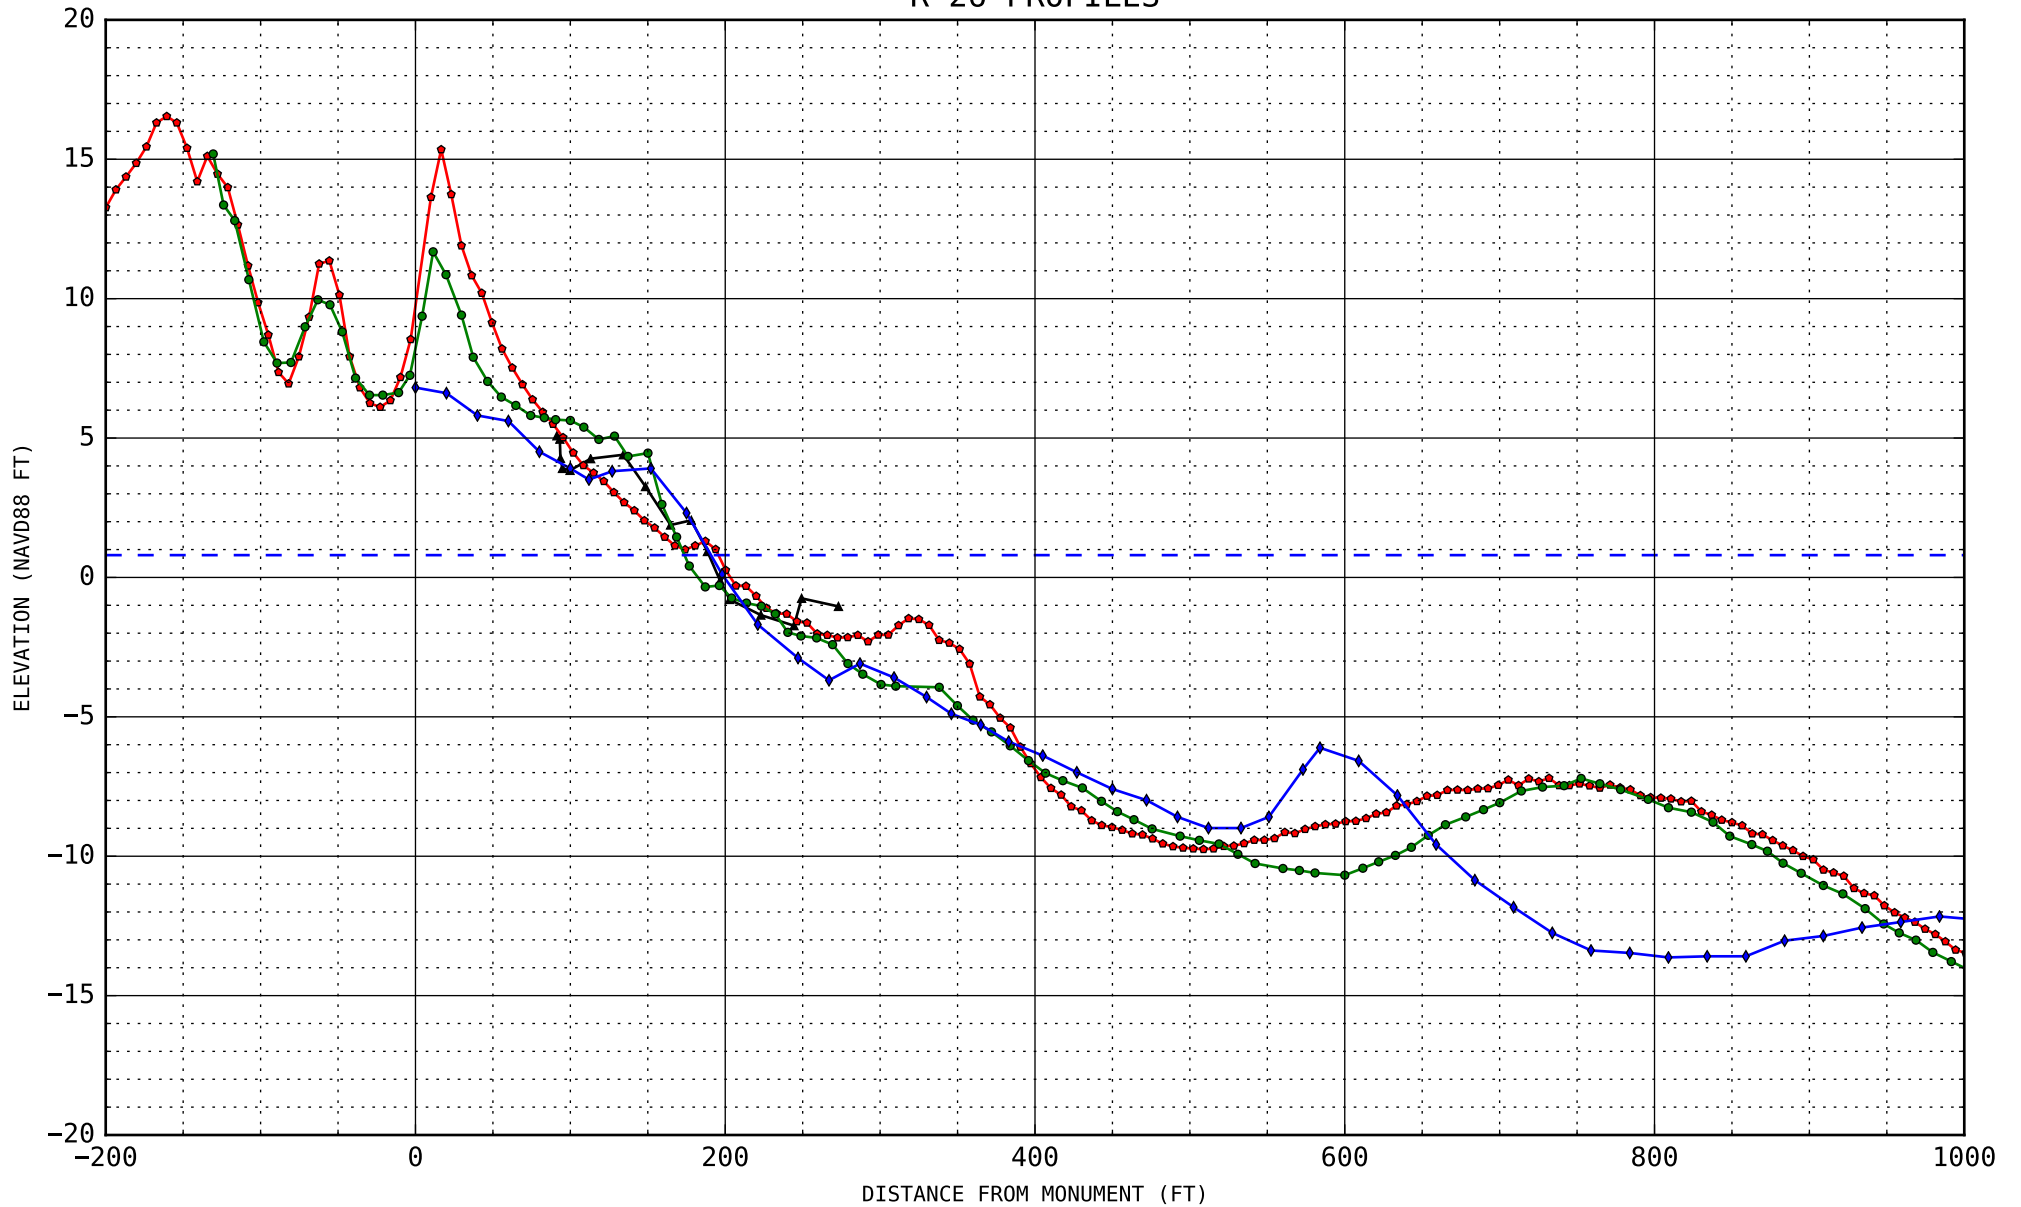
# R-26 PROFILES

- ▲ 2019-APR CONDITION BY DEP
- 2018-OCT MONITORING BY USACE-LIDAR
- 2013-SEP MONITORING BY USACE
- ◆ 2007-FEB MONITORING BY MAE
- - - MHW CONTOUR (0.8 FT)

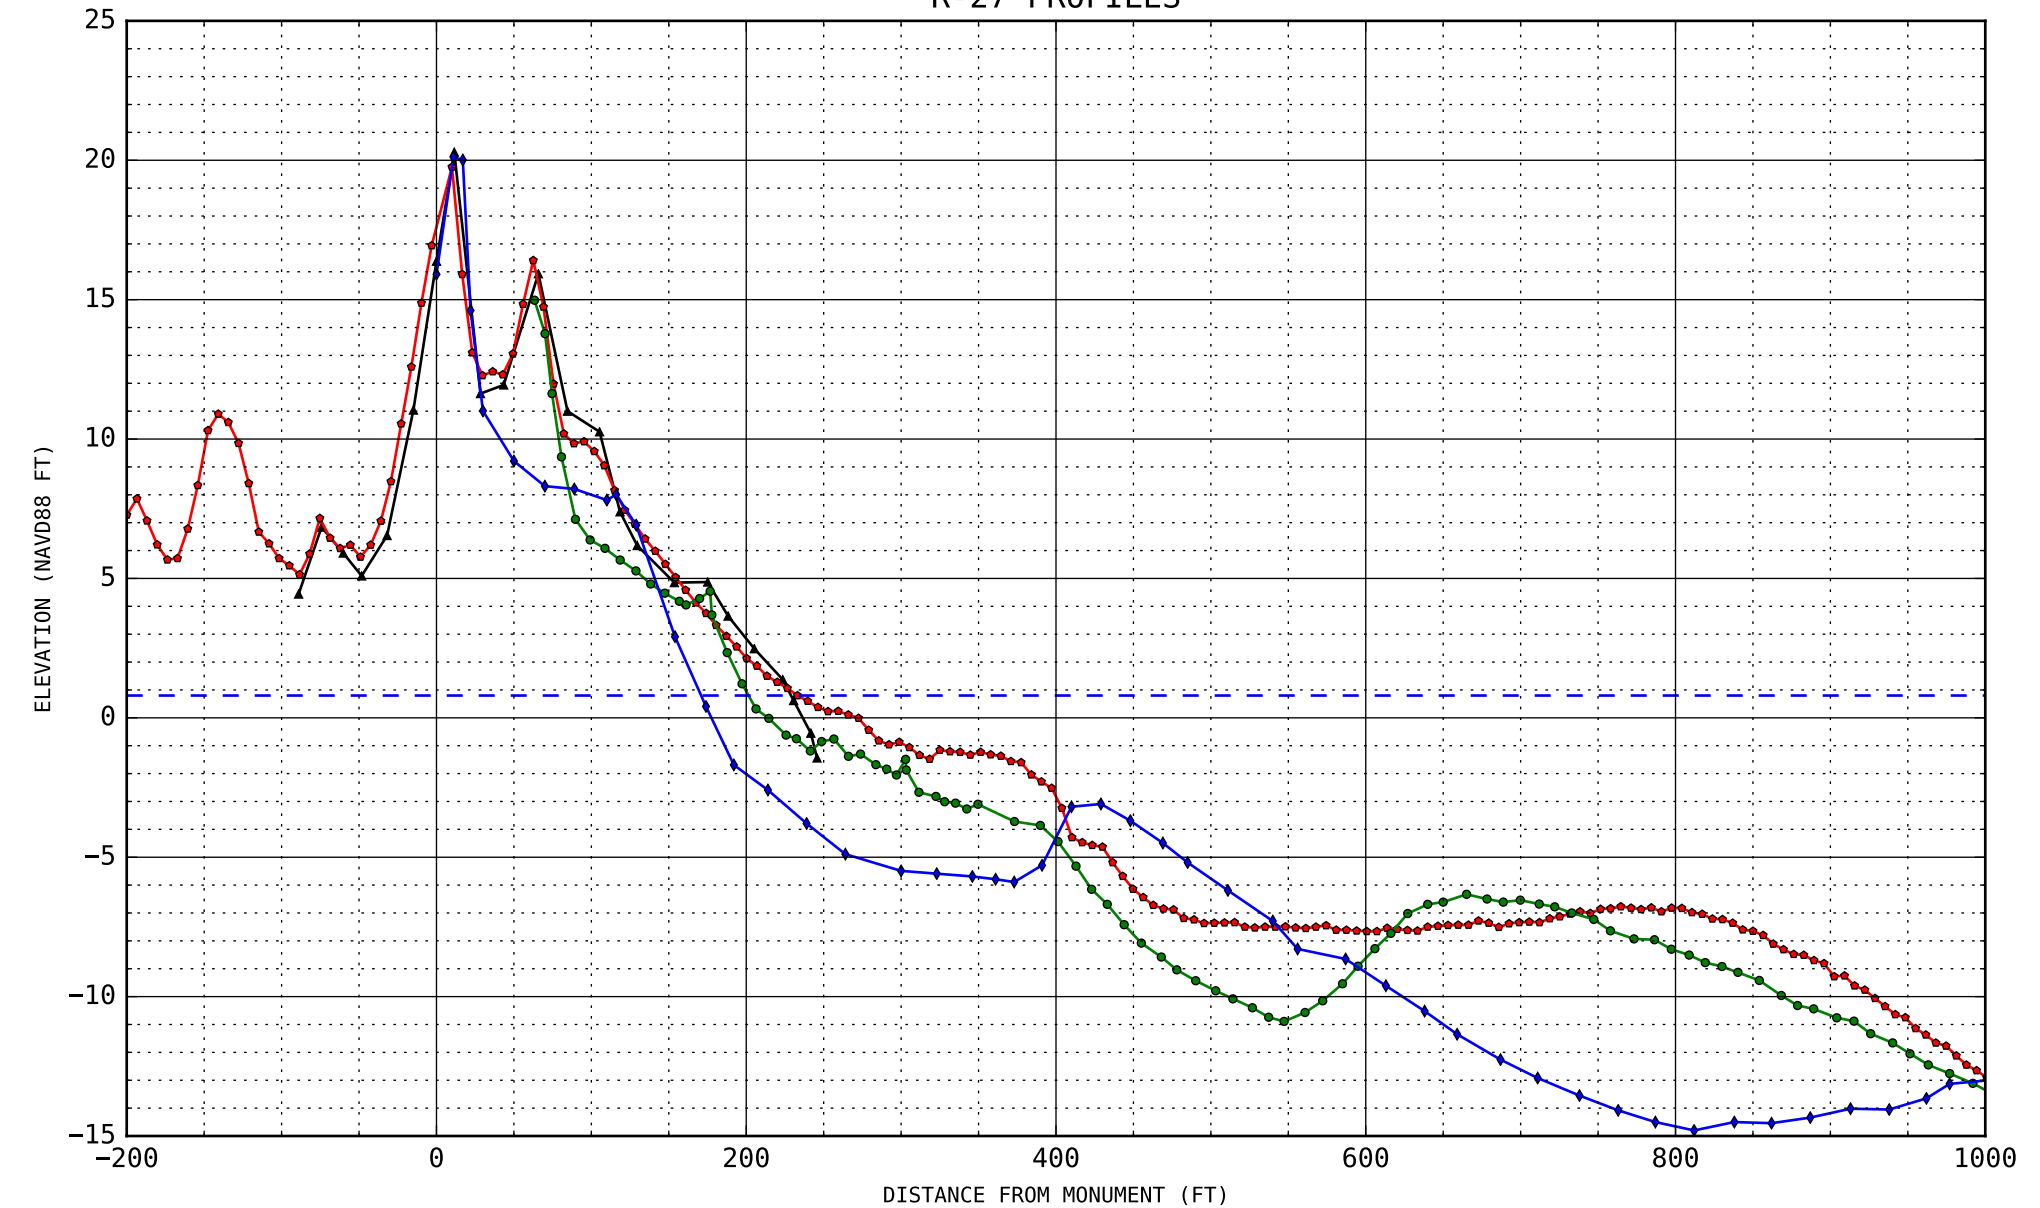
# R-27 PROFILES

- ▲ 2019-APR CONDITION BY DEP
- 2018-OCT MONITORING BY USACE-LIDAR
- 2013-SEP MONITORING BY USACE
- ◆ 2007-FEB MONITORING BY MAE
- - - MHW CONTOUR (0.8 FT)

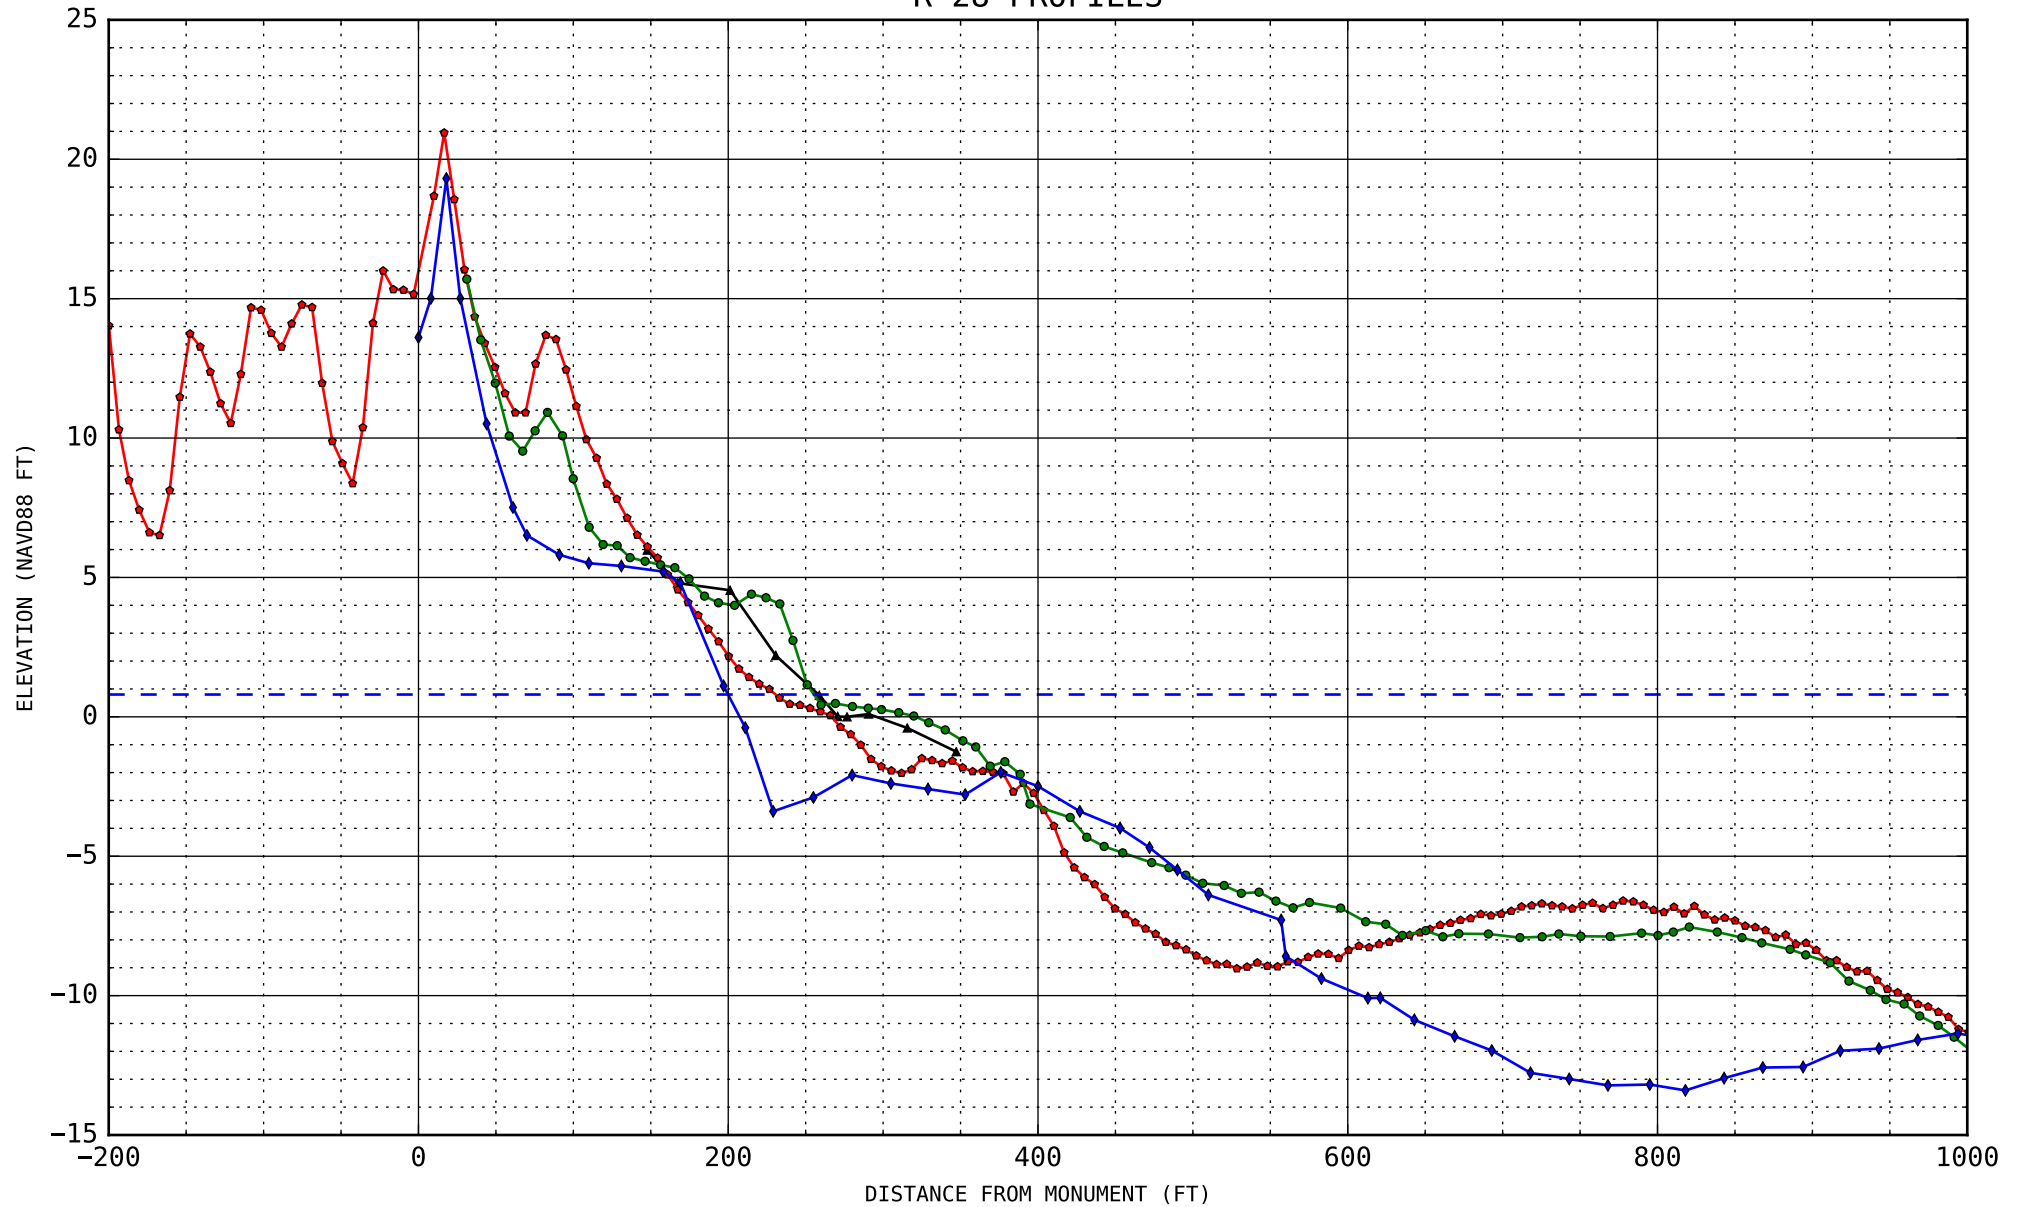
# R-28 PROFILES

- ▲ 2019-APR CONDITION BY DEP
- 2018-OCT MONITORING BY USACE-LIDAR
- 2013-SEP MONITORING BY USACE
- ◆ 2007-FEB MONITORING BY MAE
- - - MHW CONTOUR (0.8 FT)

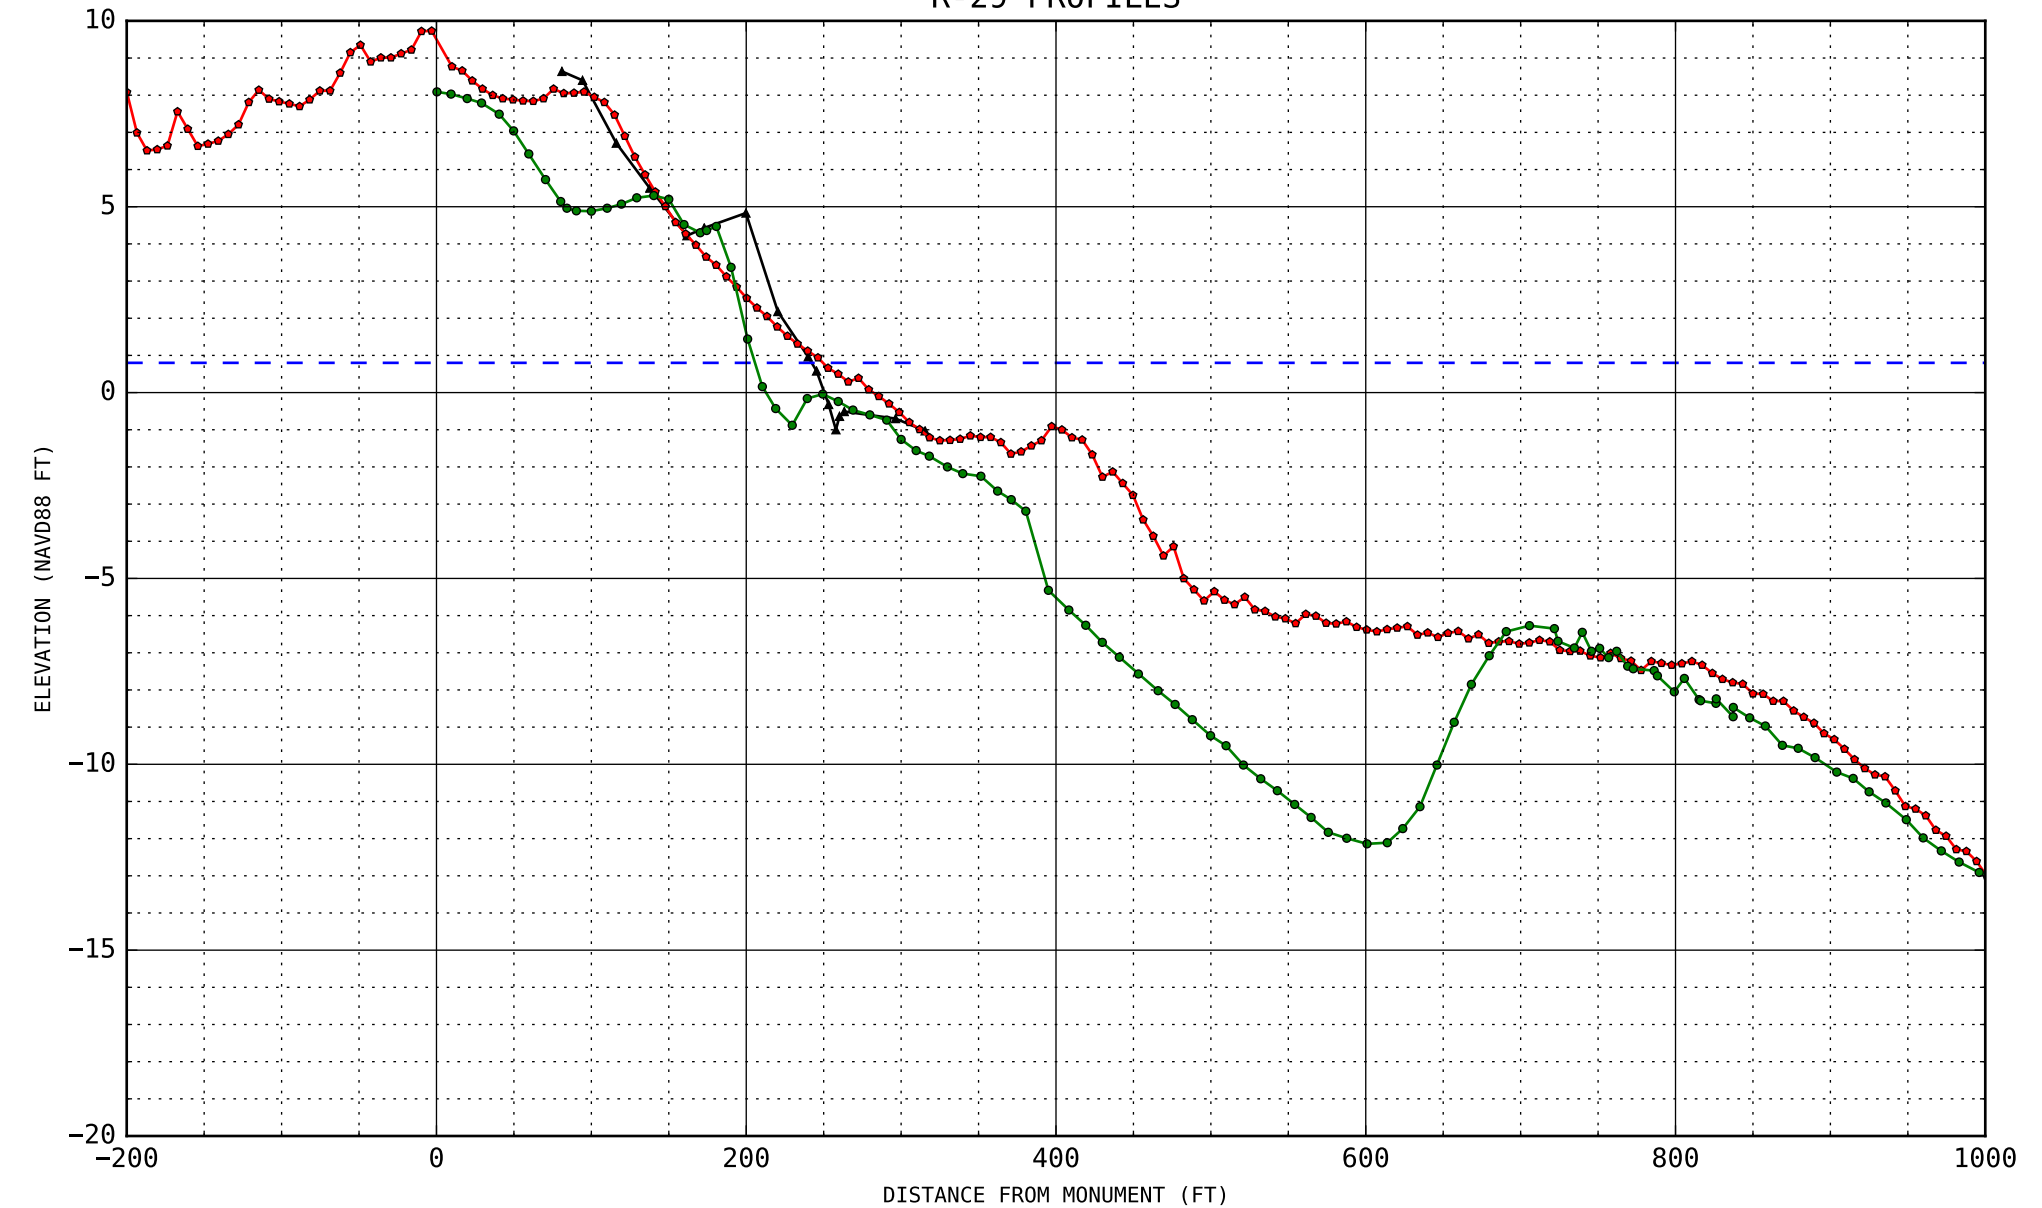
# R-29 PROFILES

- ▲ 2019-APR CONDITION BY DEP
- 2018-OCT MONITORING BY USACE-LIDAR
- 2013-SEP MONITORING BY USACE
- - - MHW CONTOUR (0.8 FT)

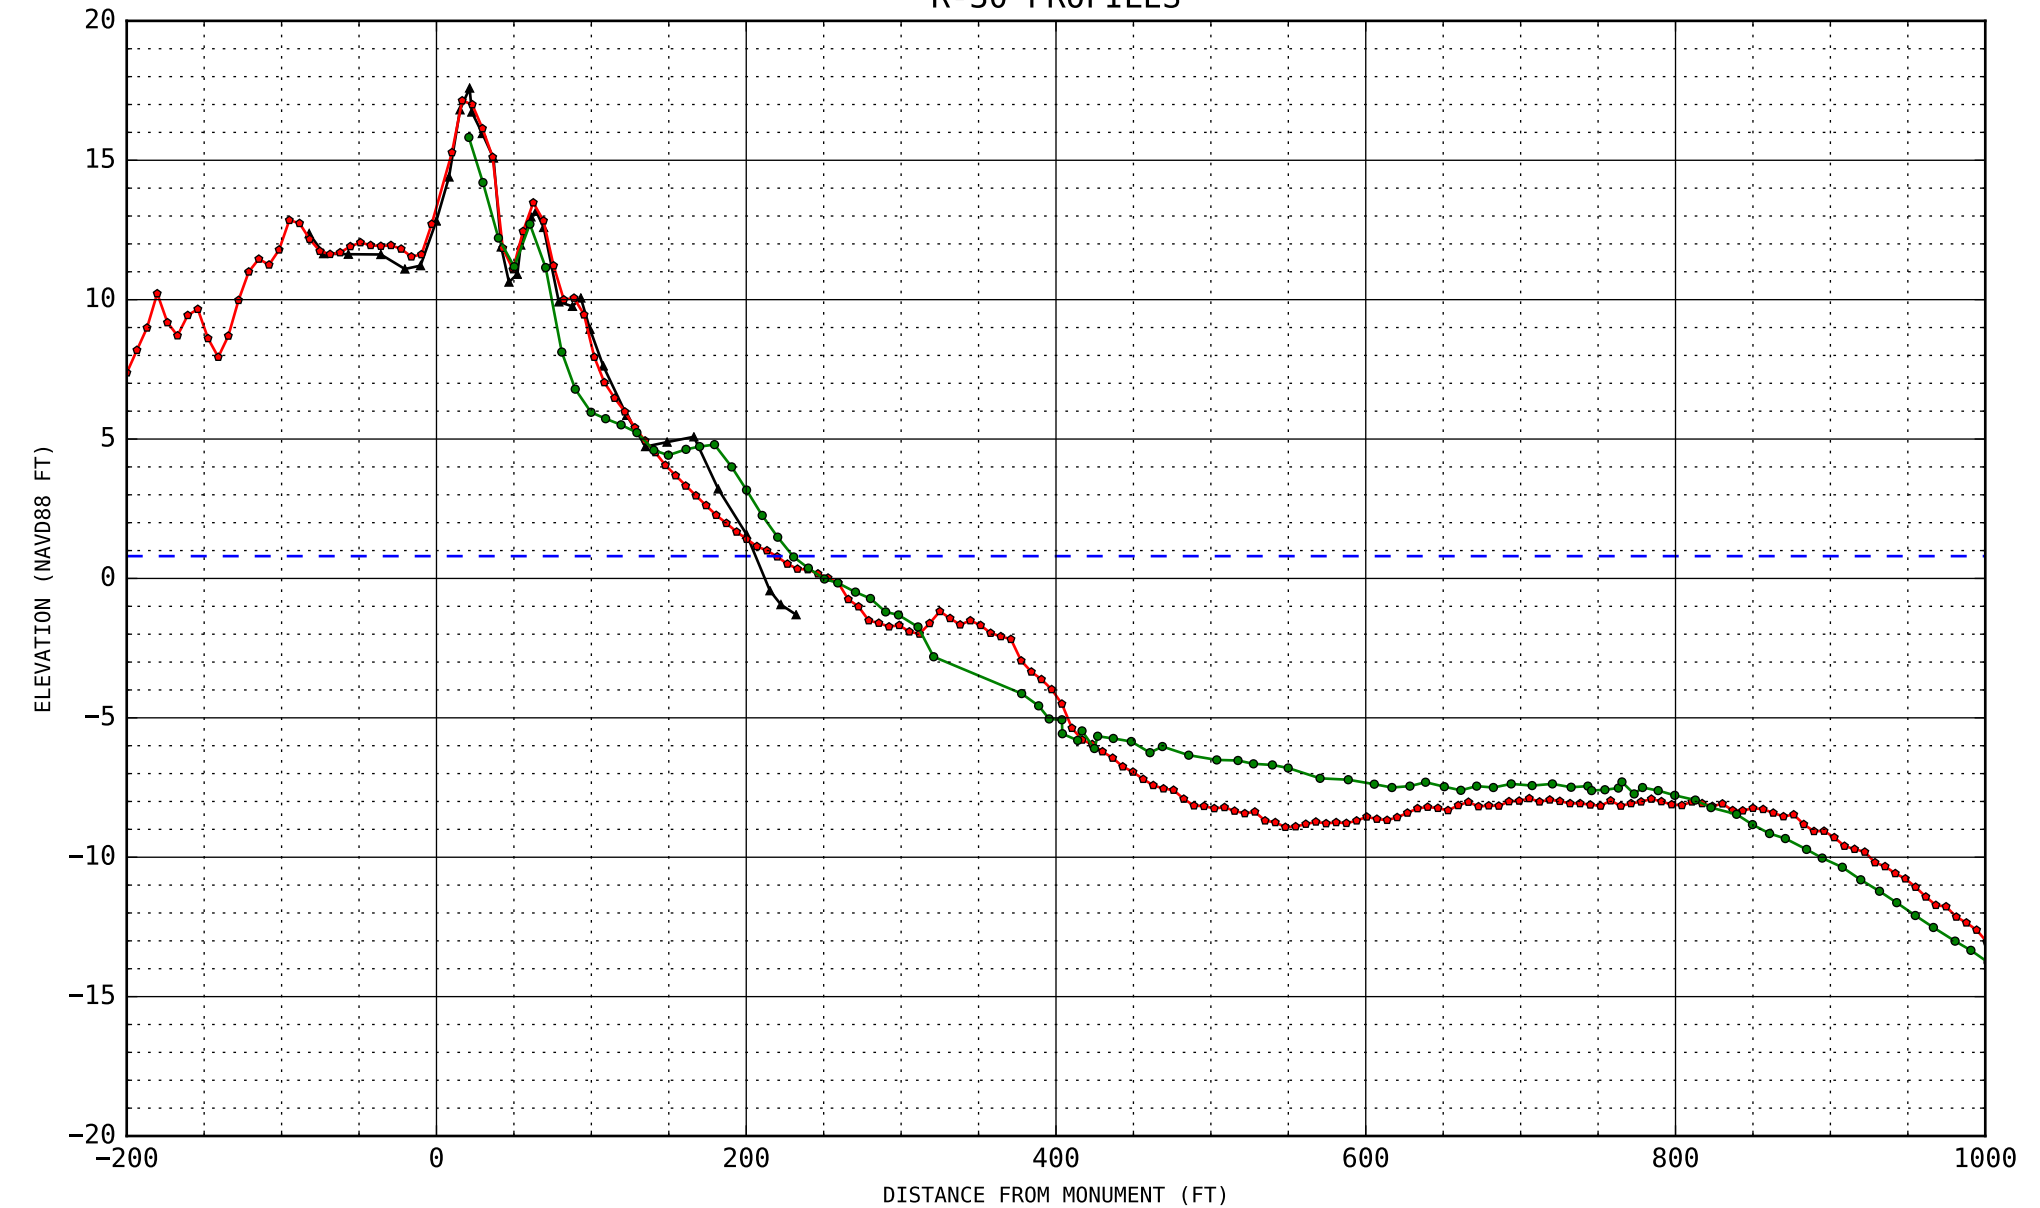
# R-30 PROFILES

- ▲ 2019-APR CONDITION BY DEP
- 2018-OCT MONITORING BY USACE-LIDAR
- 2013-SEP MONITORING BY USACE
- - - MHW CONTOUR (0.8 FT)

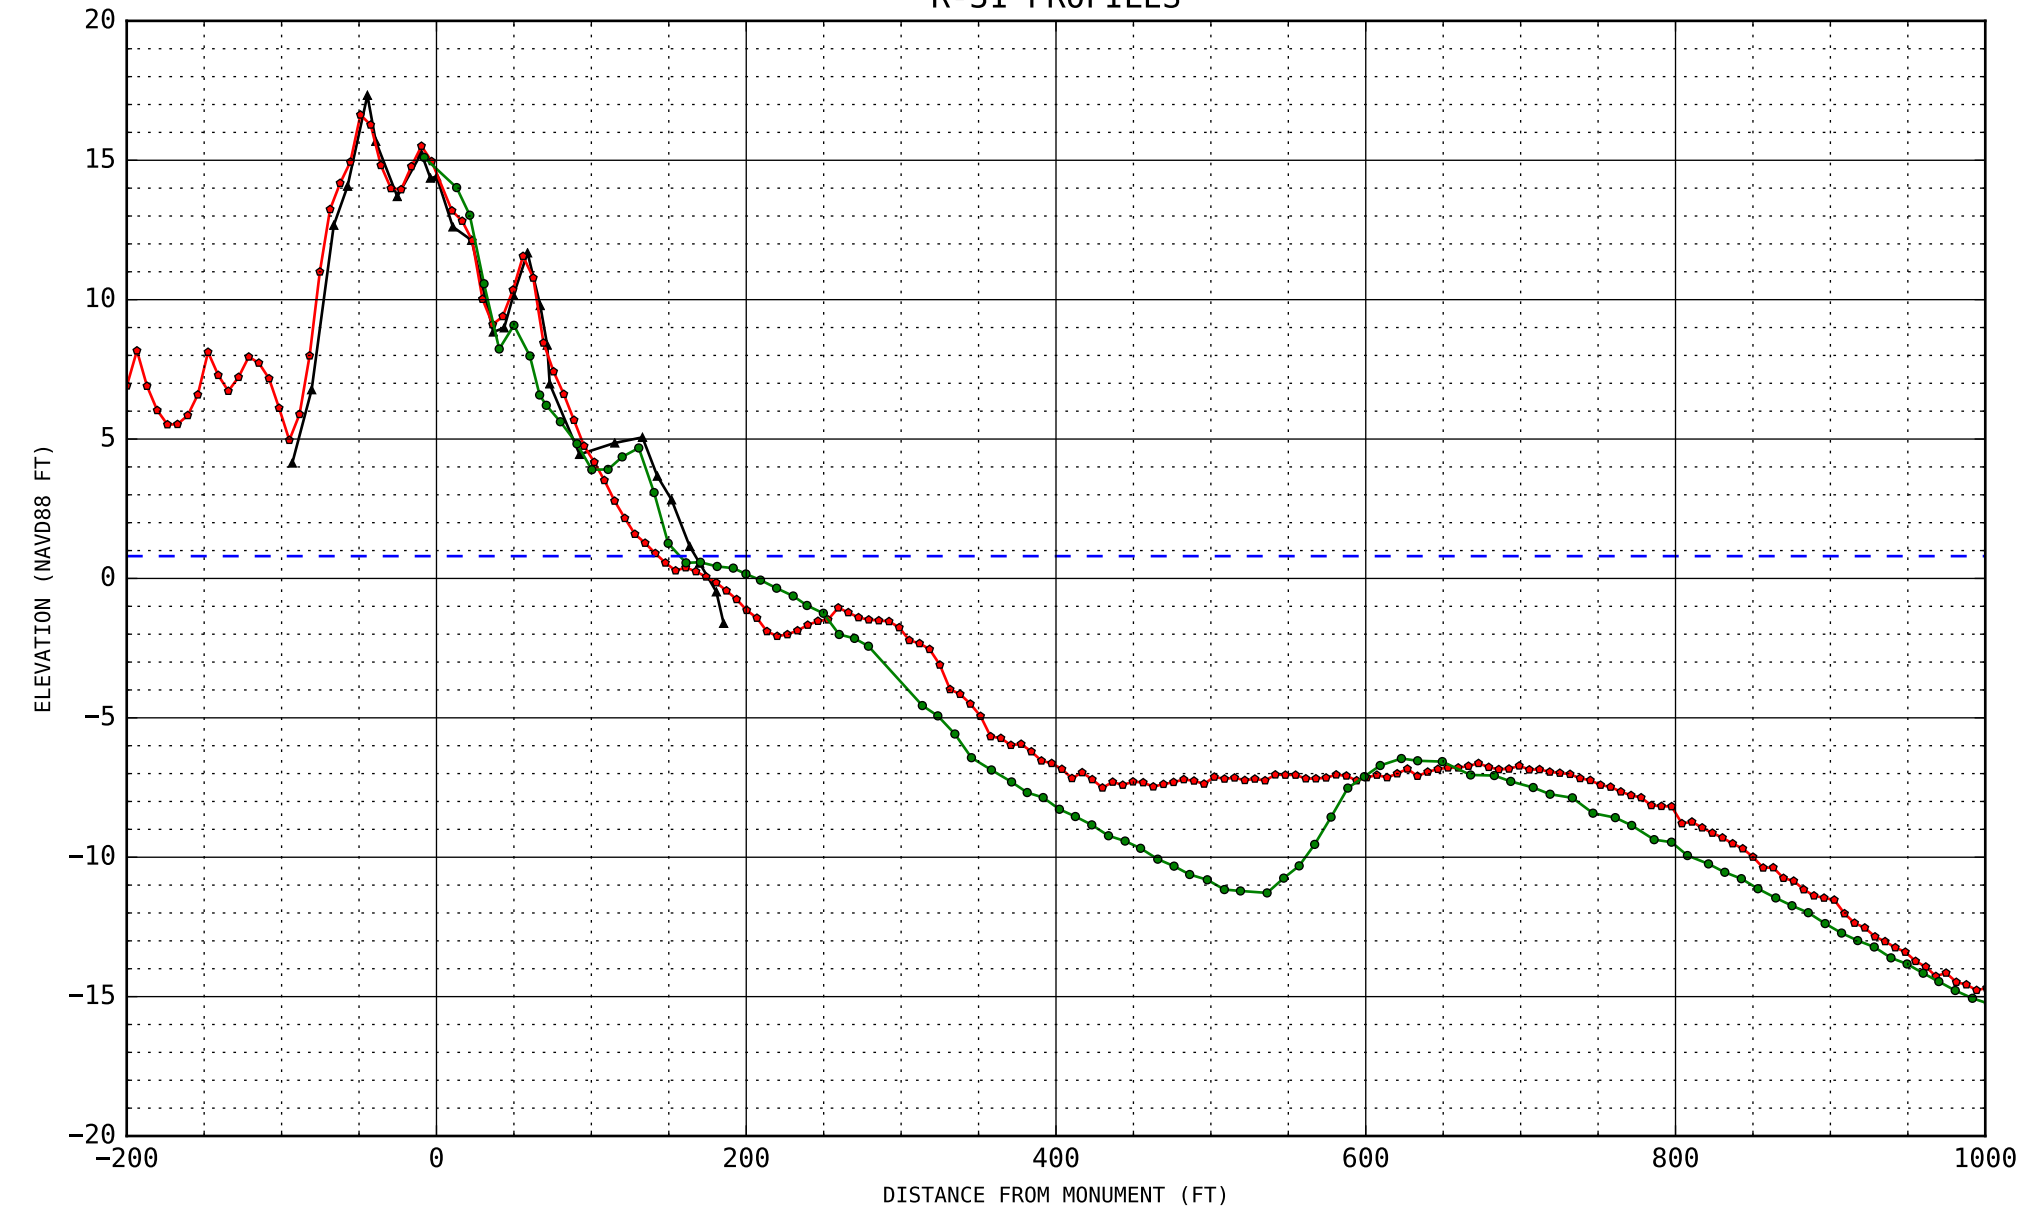
# R-31 PROFILES

- ▲ 2019-APR CONDITION BY DEP
- 2018-OCT MONITORING BY USACE-LIDAR
- 2013-SEP MONITORING BY USACE
- - - MHW CONTOUR (0.8 FT)

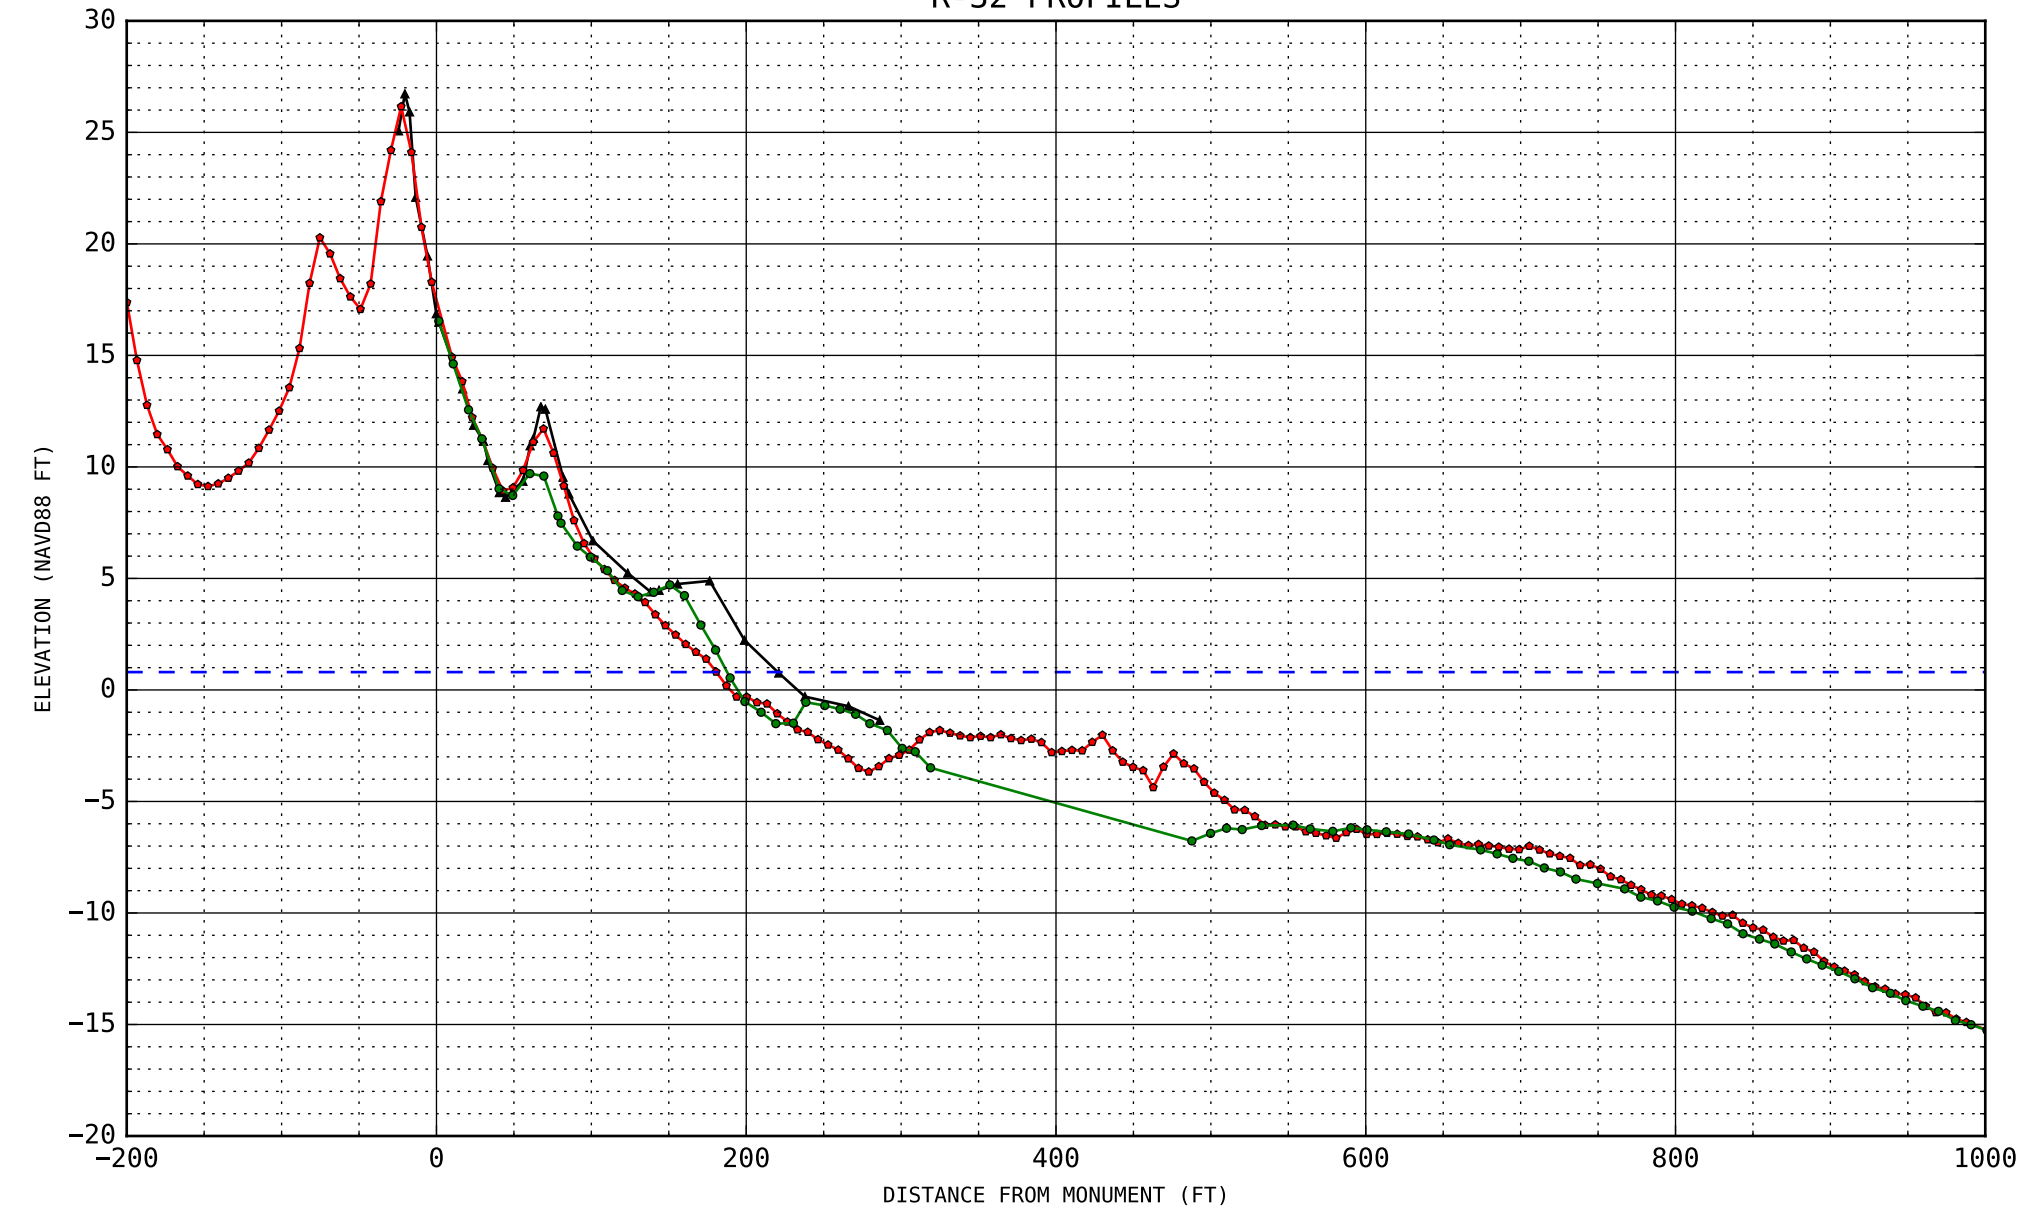
# R-32 PROFILES

- ▲ 2019-APR CONDITION BY DEP
- 2018-OCT MONITORING BY USACE-LIDAR
- 2013-SEP MONITORING BY USACE
- - - MHW CONTOUR (0.8 FT)

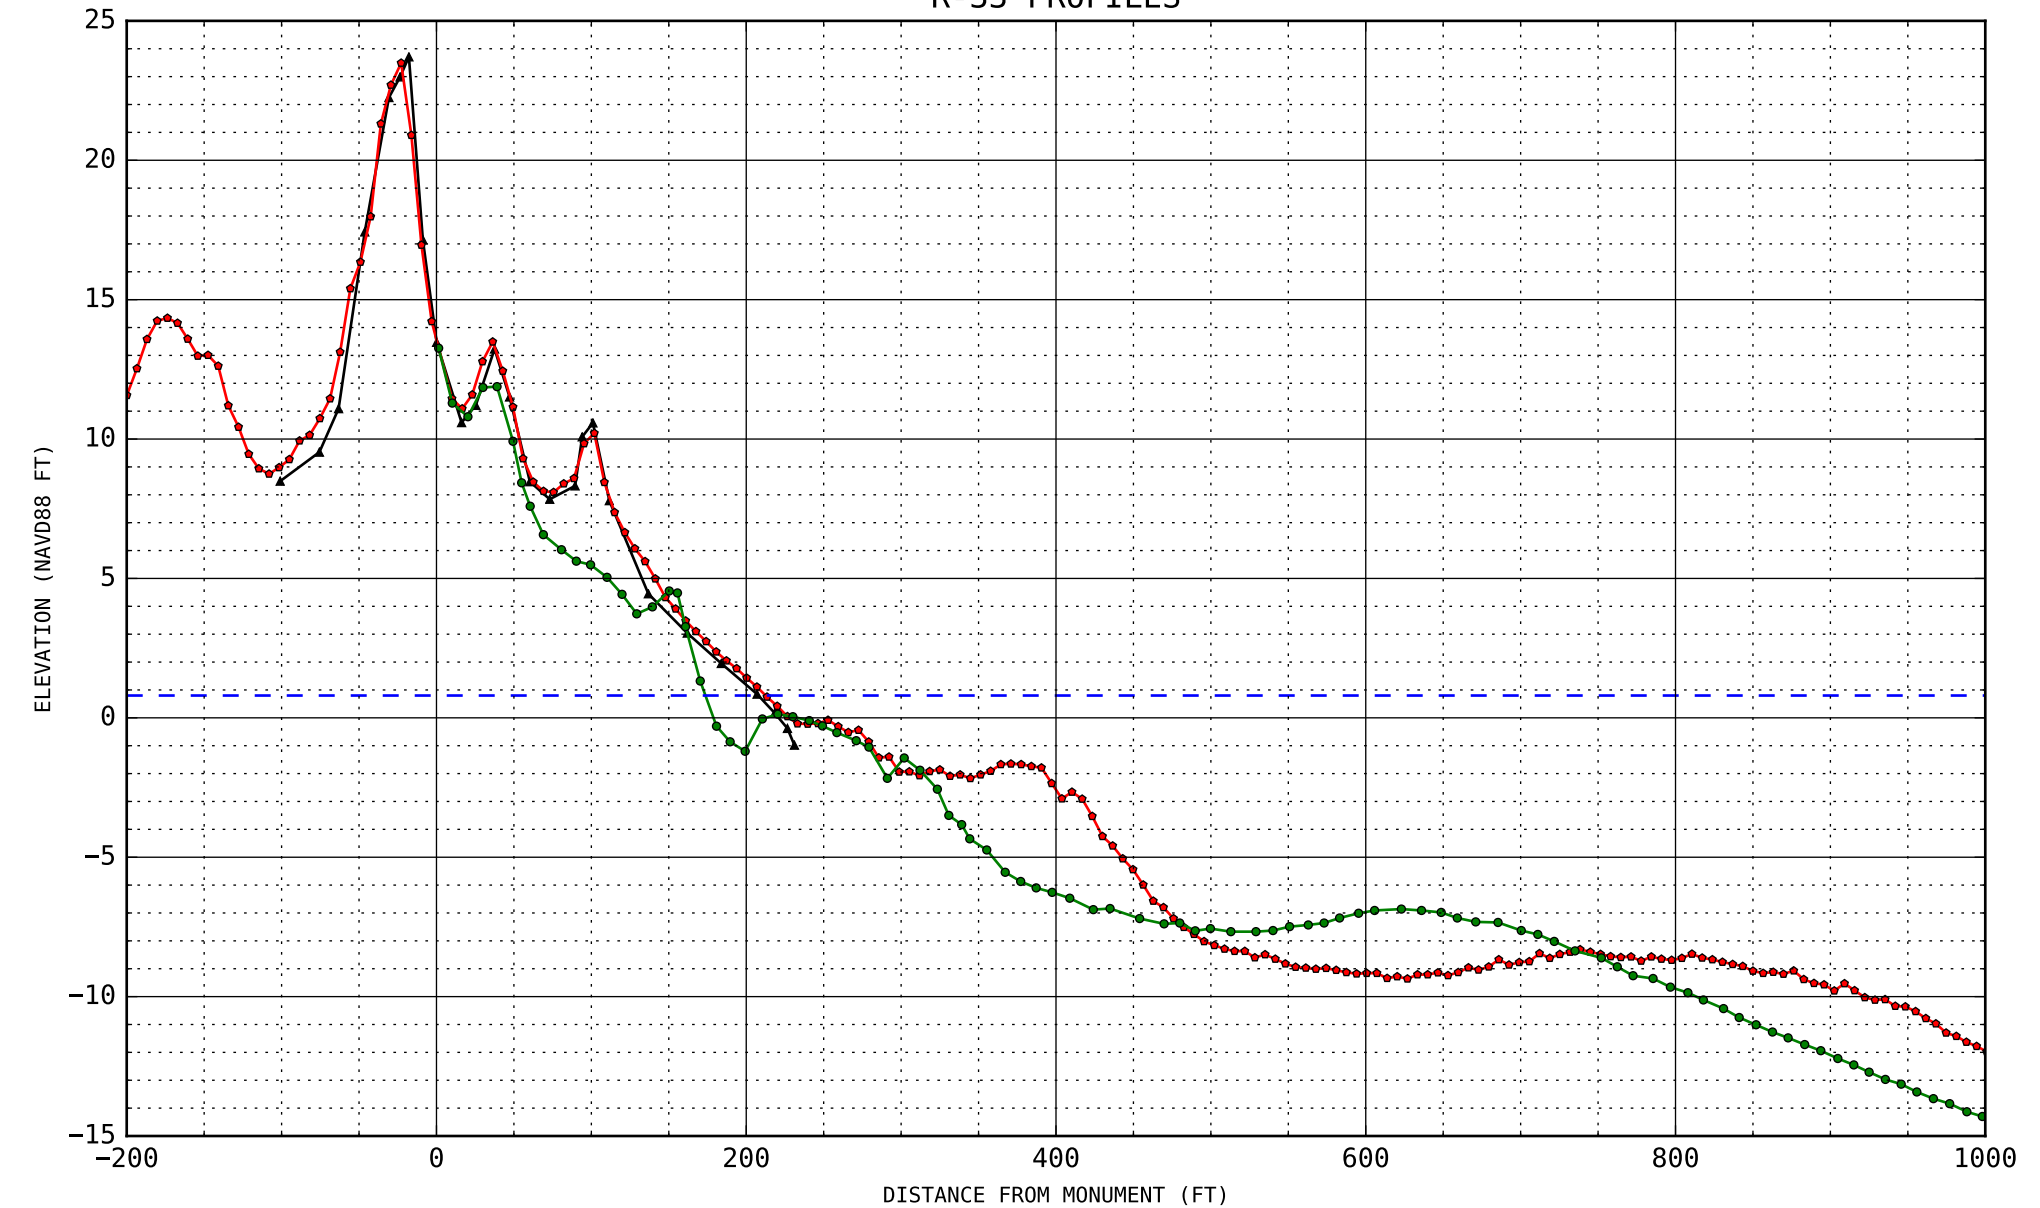
# R-33 PROFILES

- ▲ 2019-APR CONDITION BY DEP
- 2018-OCT MONITORING BY USACE-LIDAR
- 2013-SEP MONITORING BY USACE
- - - MHW CONTOUR (0.8 FT)

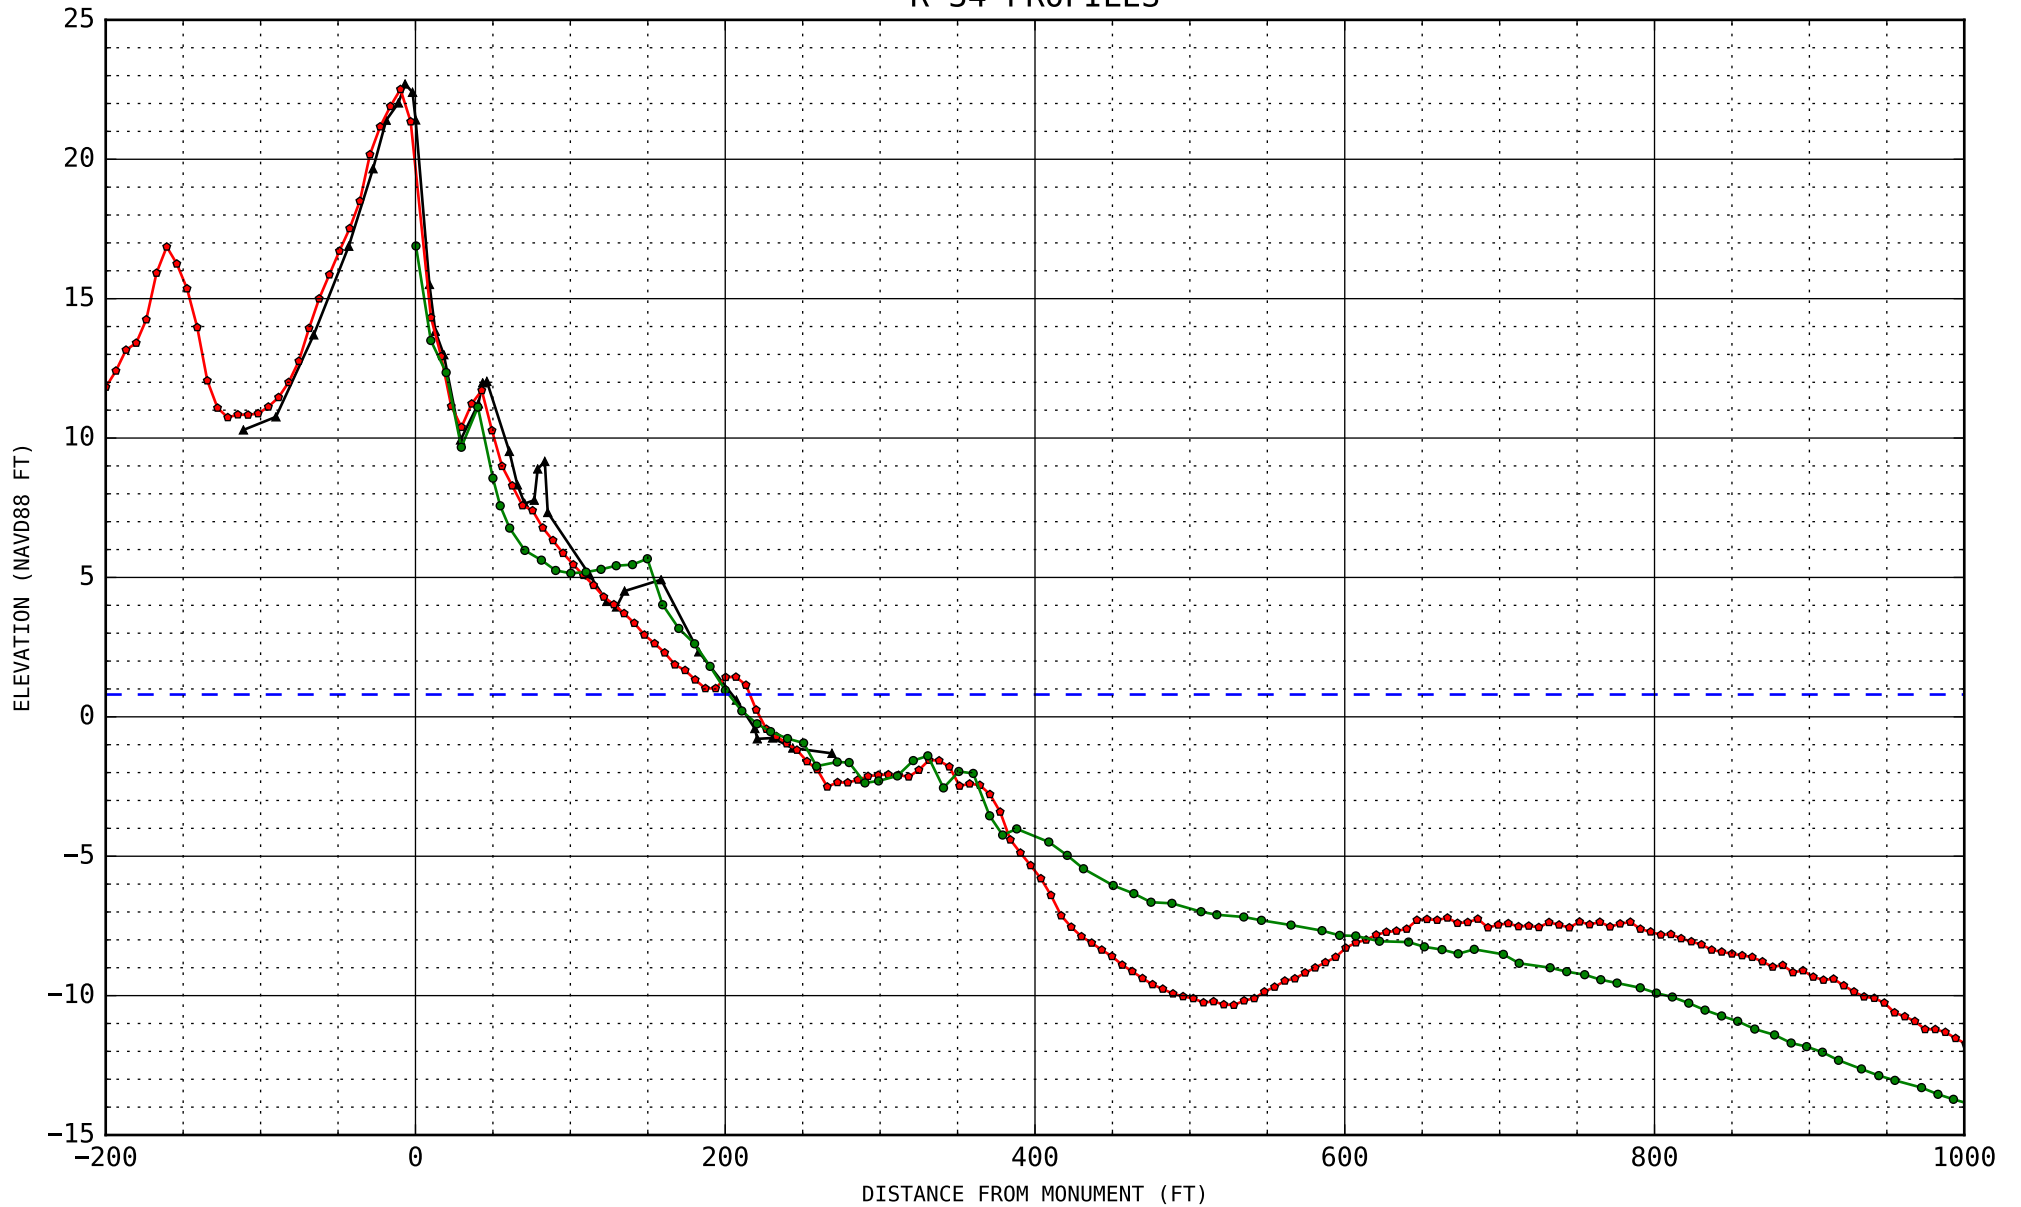
# R-34 PROFILES

- ▲ 2019-APR CONDITION BY DEP
- 2018-OCT MONITORING BY USACE-LIDAR
- 2013-SEP MONITORING BY USACE
- - - MHW CONTOUR (0.8 FT)

RANGE: R-34  
EST DATE: OCT1995  
SURVEY DATE: 16APR19  
AZIMUTH: 190.0
