# R-1 PROFILES

WALTON  
PROGRAM SUPPORT GIS  
DIVISION OF WATER RESOURCE MANAGEMENT  
FLORIDA DEPARTMENT OF ENVIRONMENTAL PROTECTION

RANGE: R-1  
EST DATE: NOV1980  
SURVEY DATE: 04APR19  
AZIMUTH: 190.0

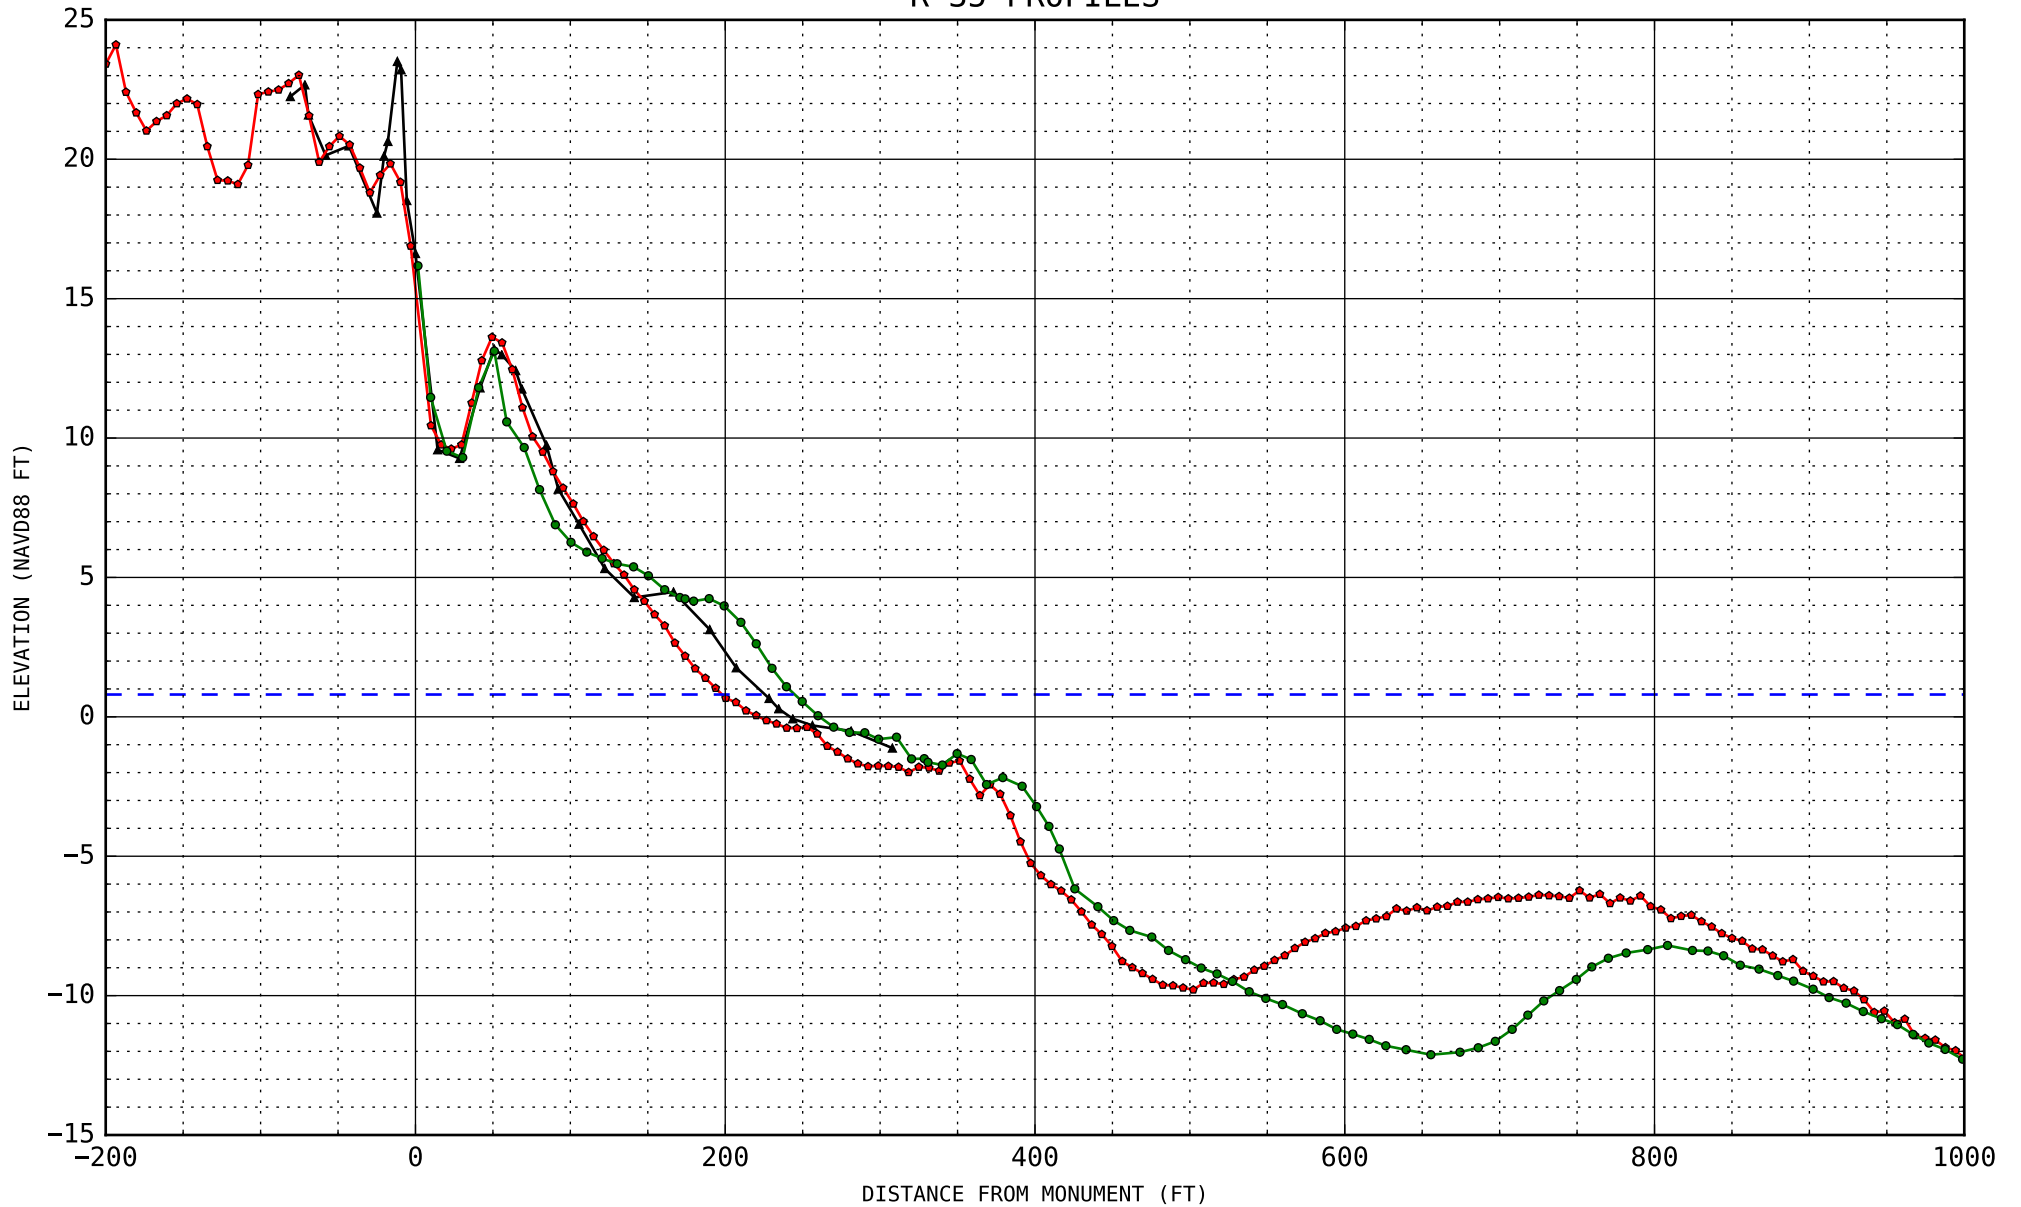
# R-35 PROFILES

- ▲ 2019-APR CONDITION BY DEP
- 2018-OCT MONITORING BY USACE-LIDAR
- 2013-SEP MONITORING BY USACE
- - - MHW CONTOUR (0.8 FT)

RANGE: R-35  
EST DATE: OCT1995  
SURVEY DATE: 16APR19  
AZIMUTH: 190.0

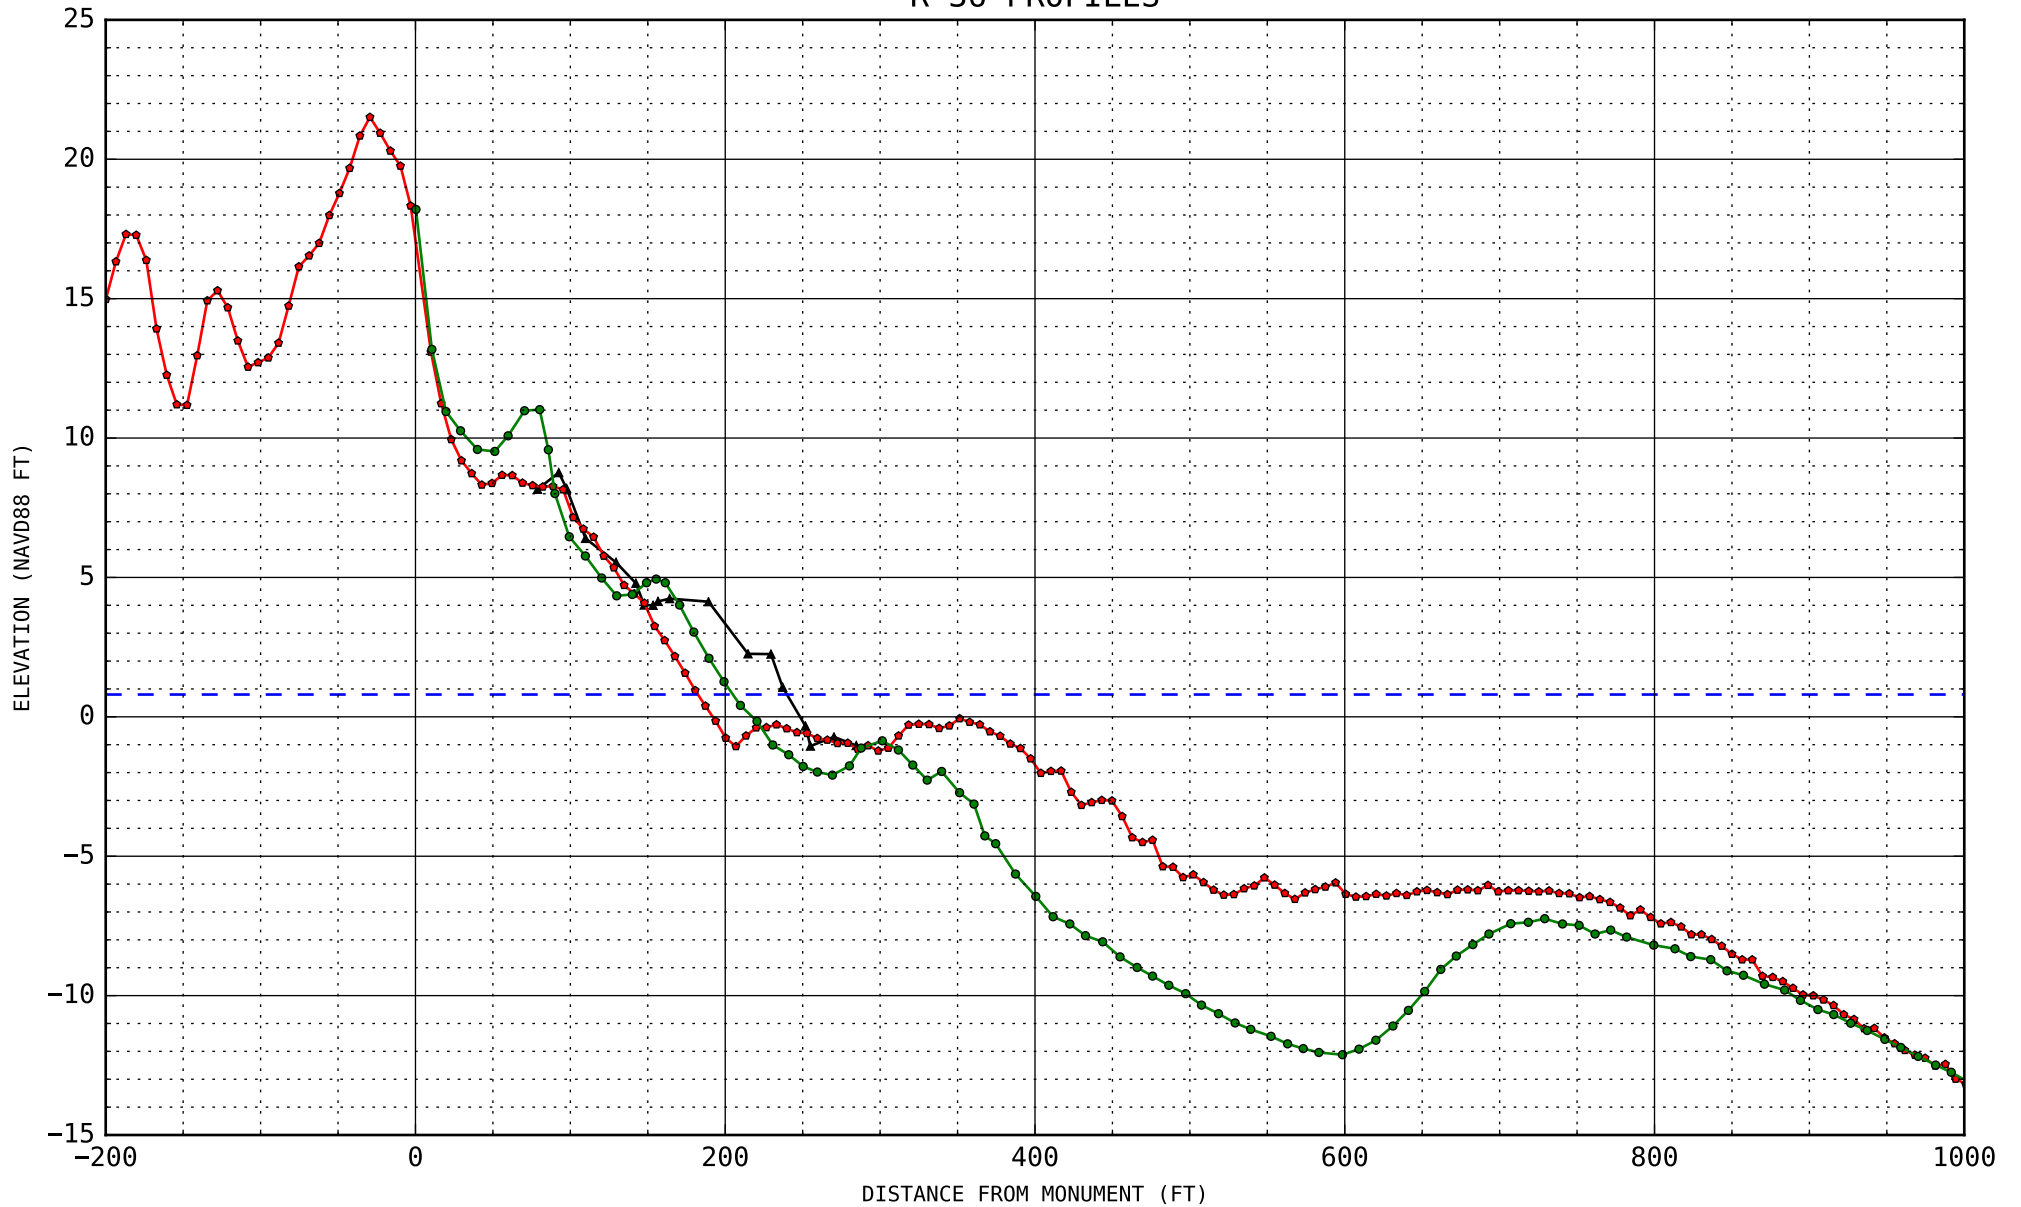
# R-36 PROFILES

- ▲ 2019-APR CONDITION BY DEP
- 2018-OCT MONITORING BY USACE-LIDAR
- 2013-SEP MONITORING BY USACE
- - - MHW CONTOUR (0.8 FT)

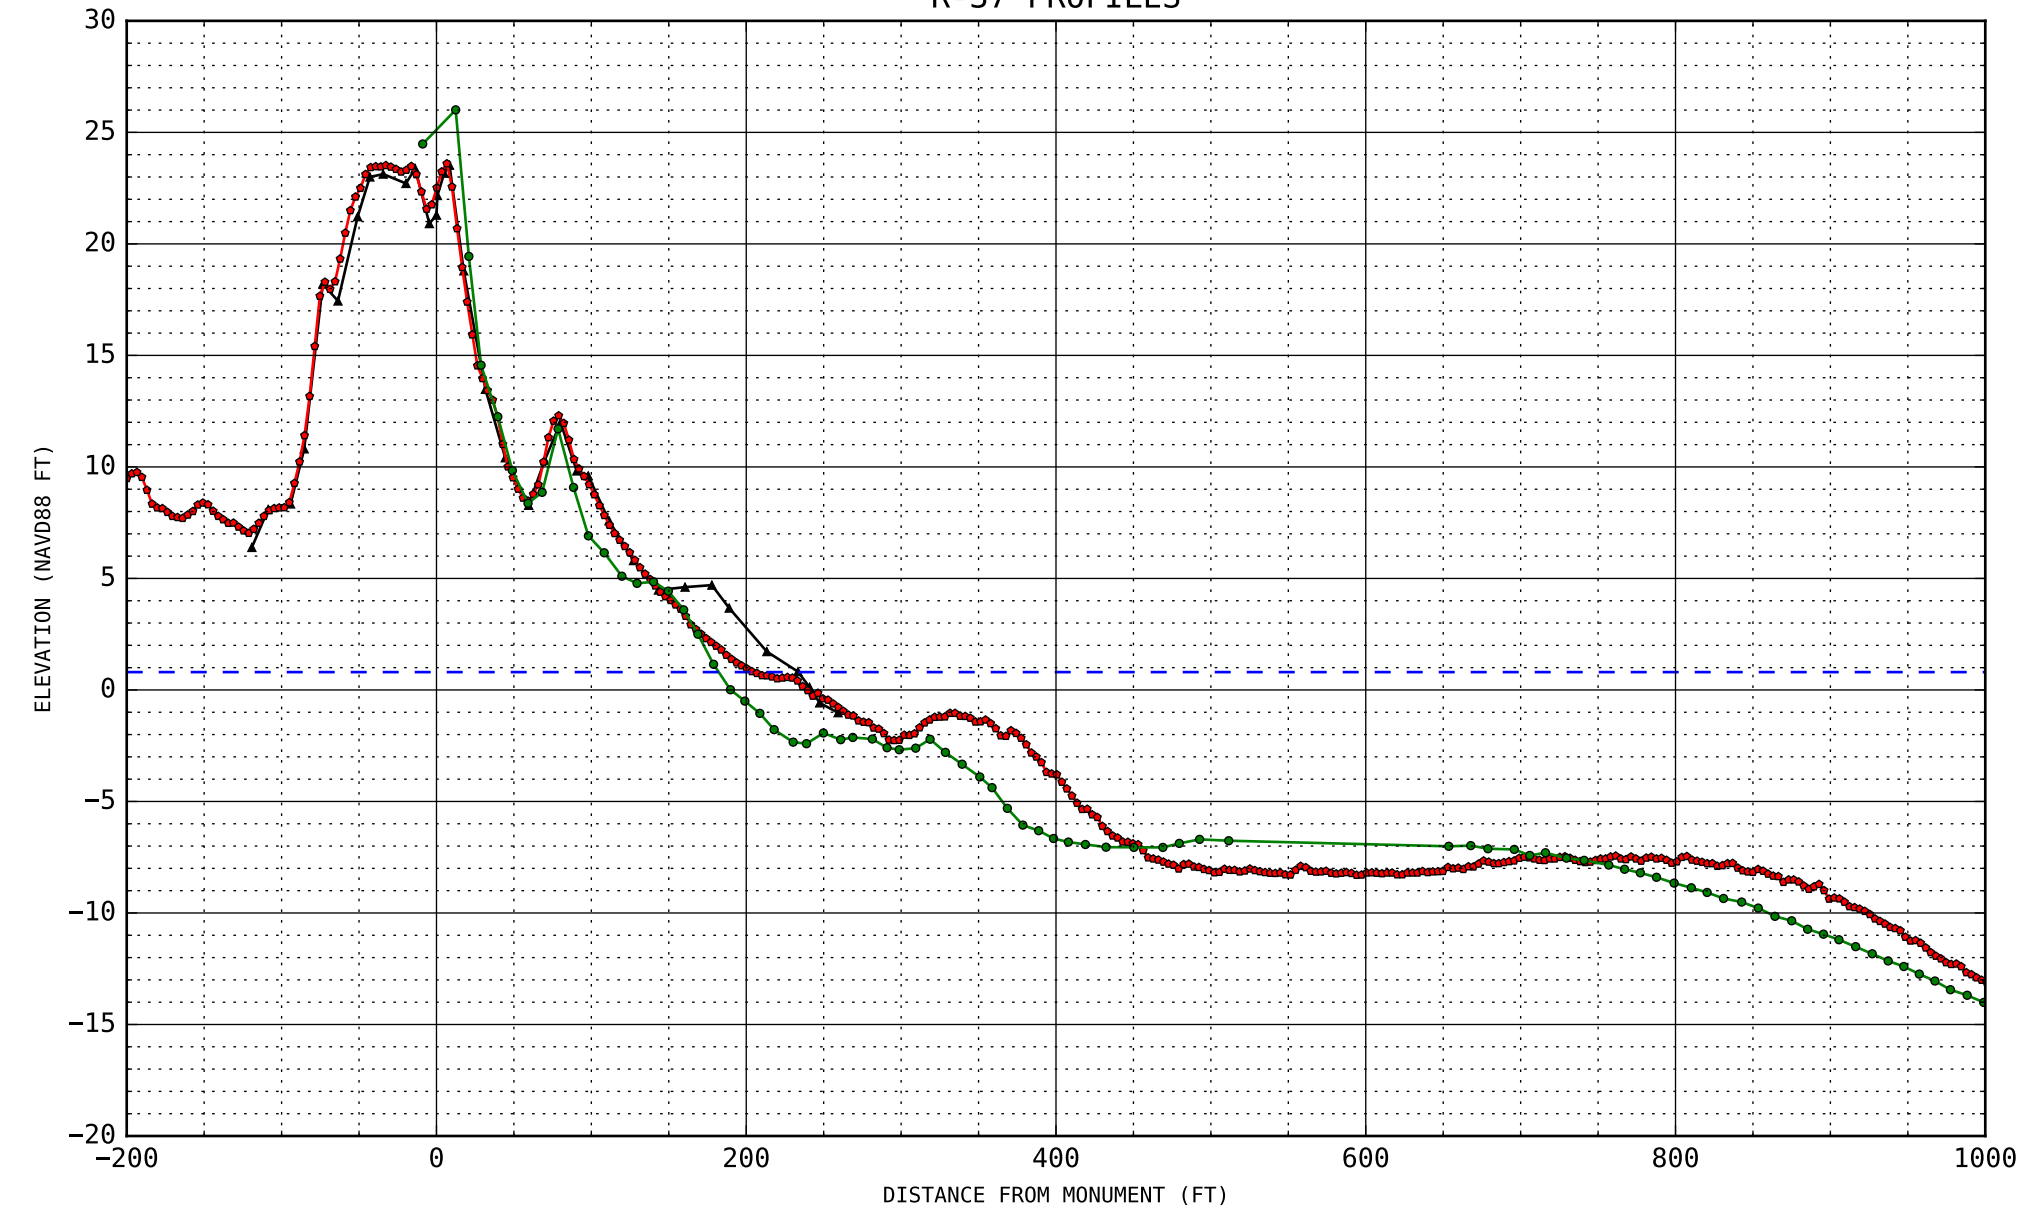
# R-37 PROFILES

- ▲ 2019-APR CONDITION BY DEP
- 2018-OCT MONITORING BY USACE-LIDAR
- 2013-SEP MONITORING BY USACE
- - - MHW CONTOUR (0.8 FT)

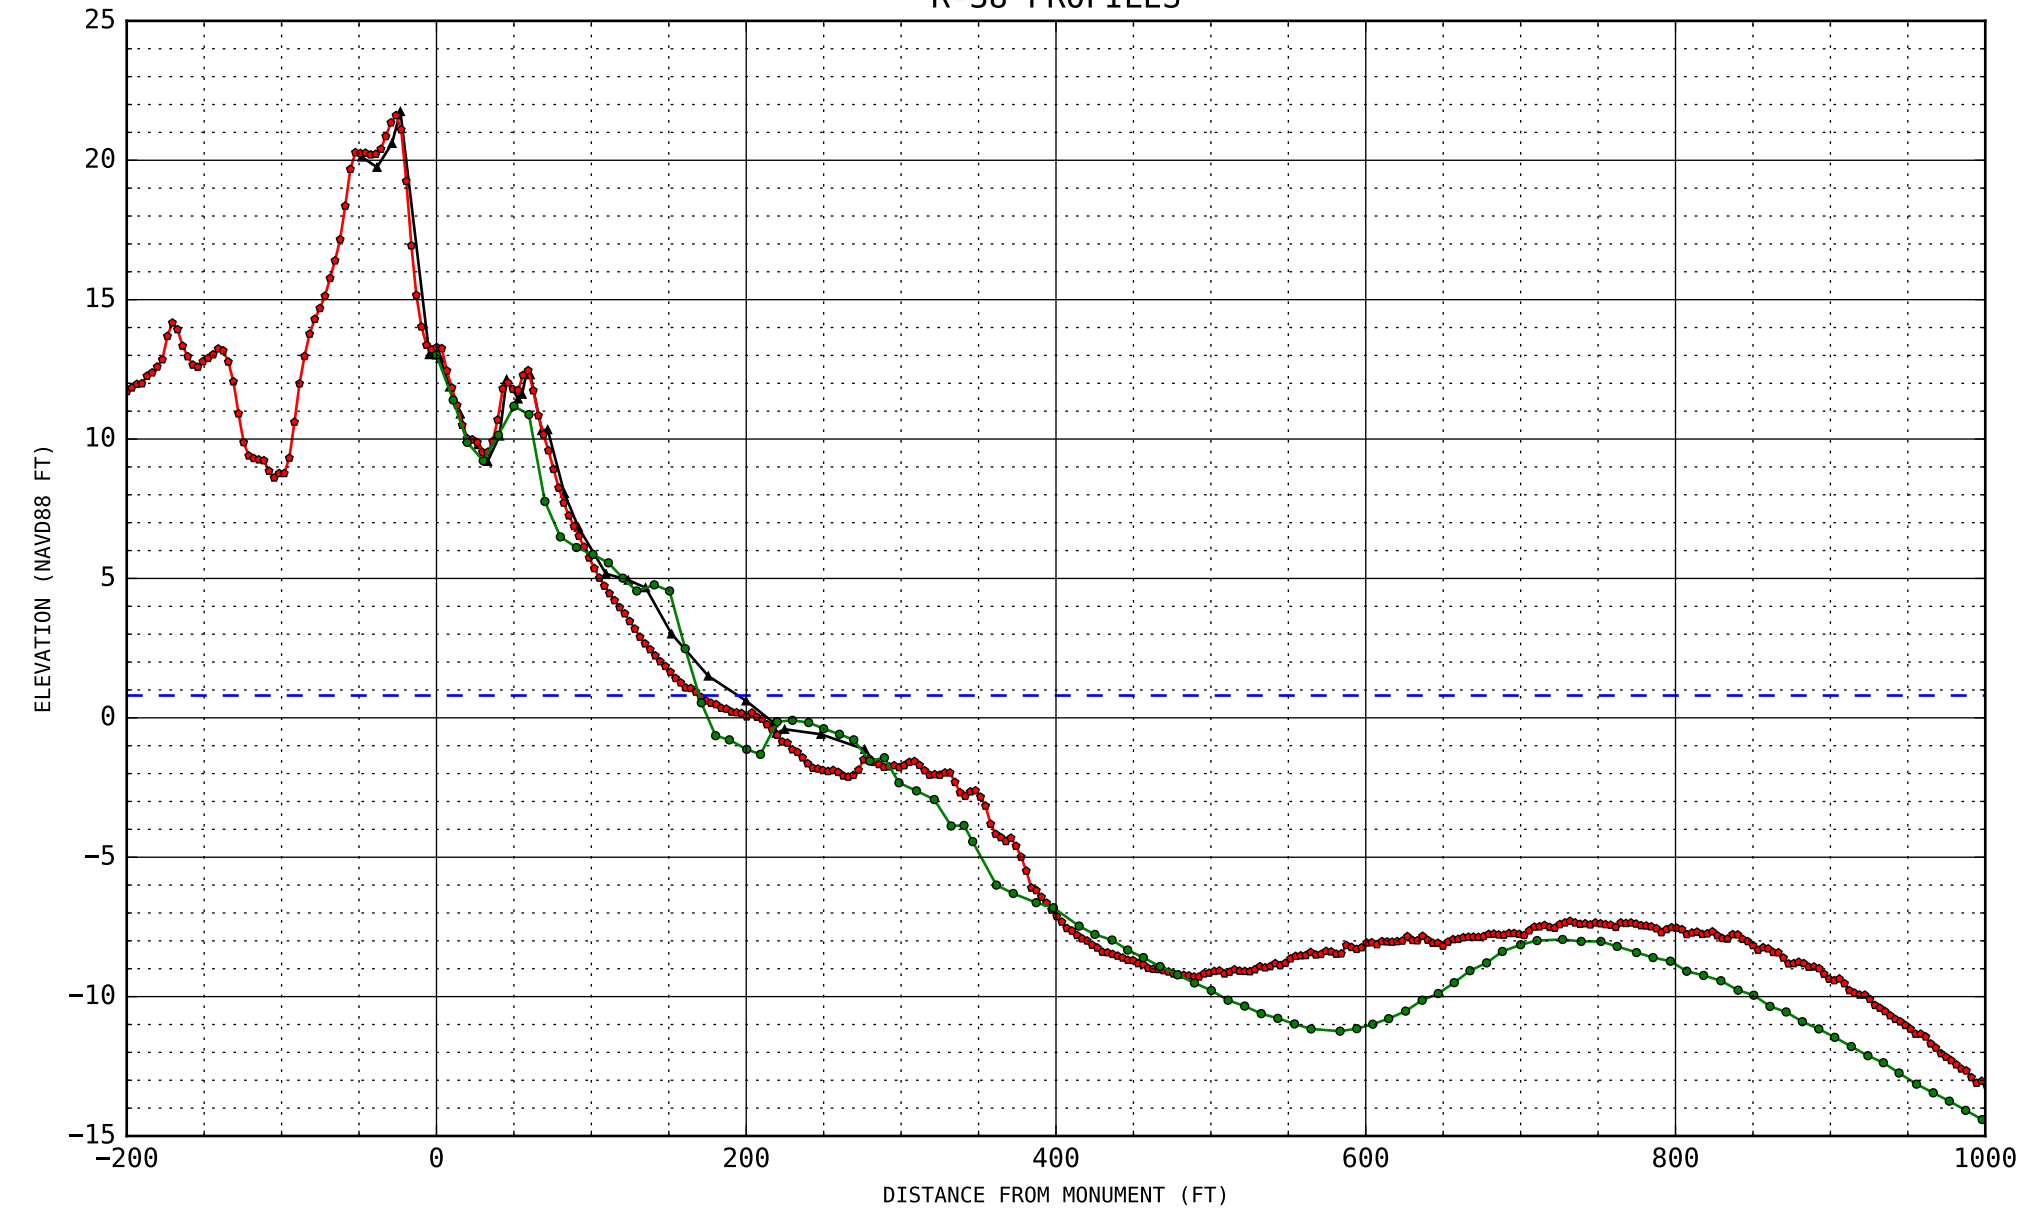
# R-38 PROFILES

- ▲ 2019-APR CONDITION BY DEP
- 2018-OCT MONITORING BY USACE-LIDAR
- 2013-SEP MONITORING BY USACE
- - - MHW CONTOUR (0.8 FT)

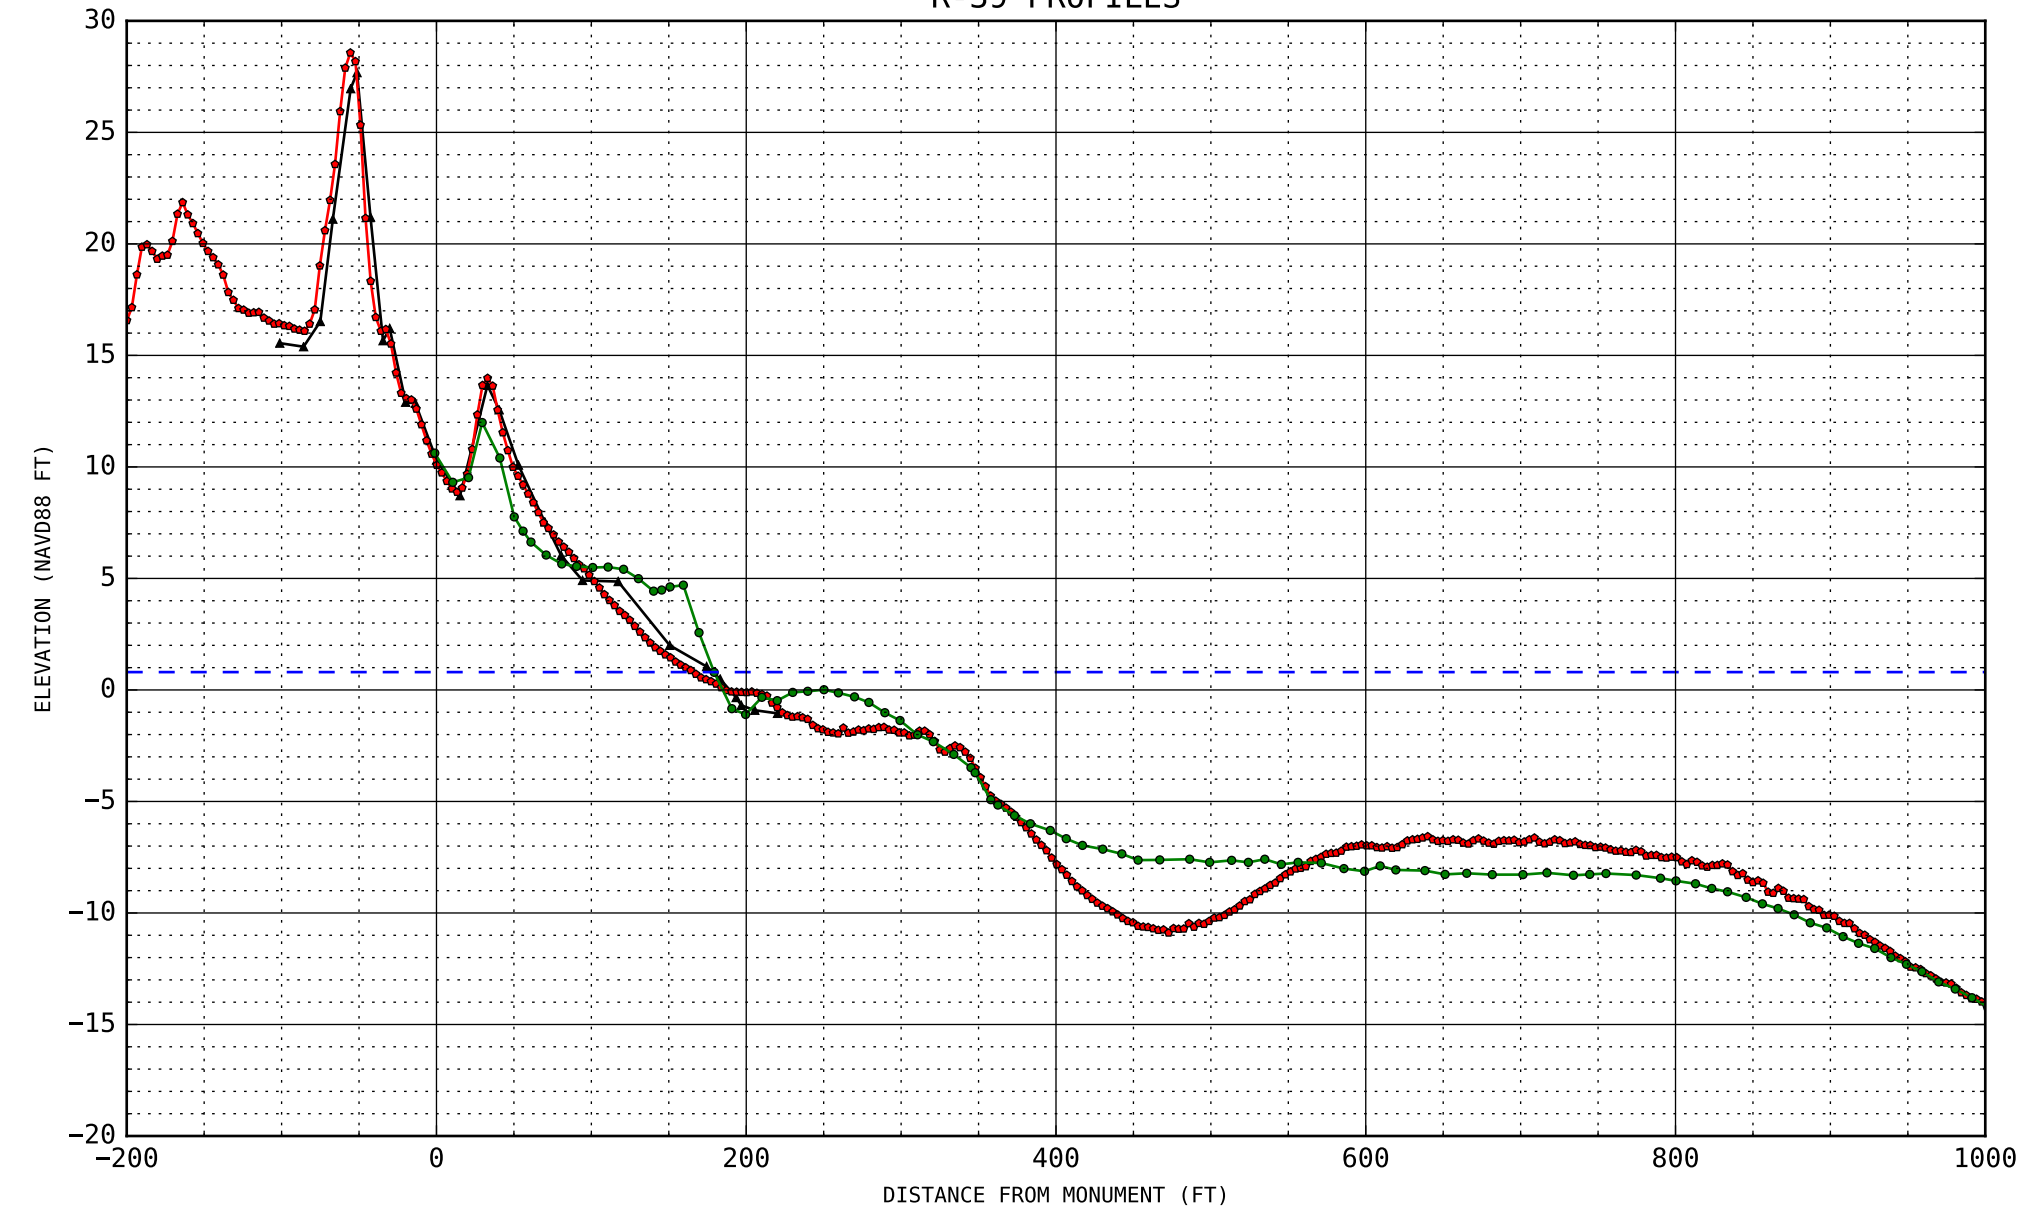
# R-39 PROFILES

- ▲ 2019-APR CONDITION BY DEP
- 2018-OCT MONITORING BY USACE-LIDAR
- 2013-SEP MONITORING BY USACE
- - - MHW CONTOUR (0.8 FT)

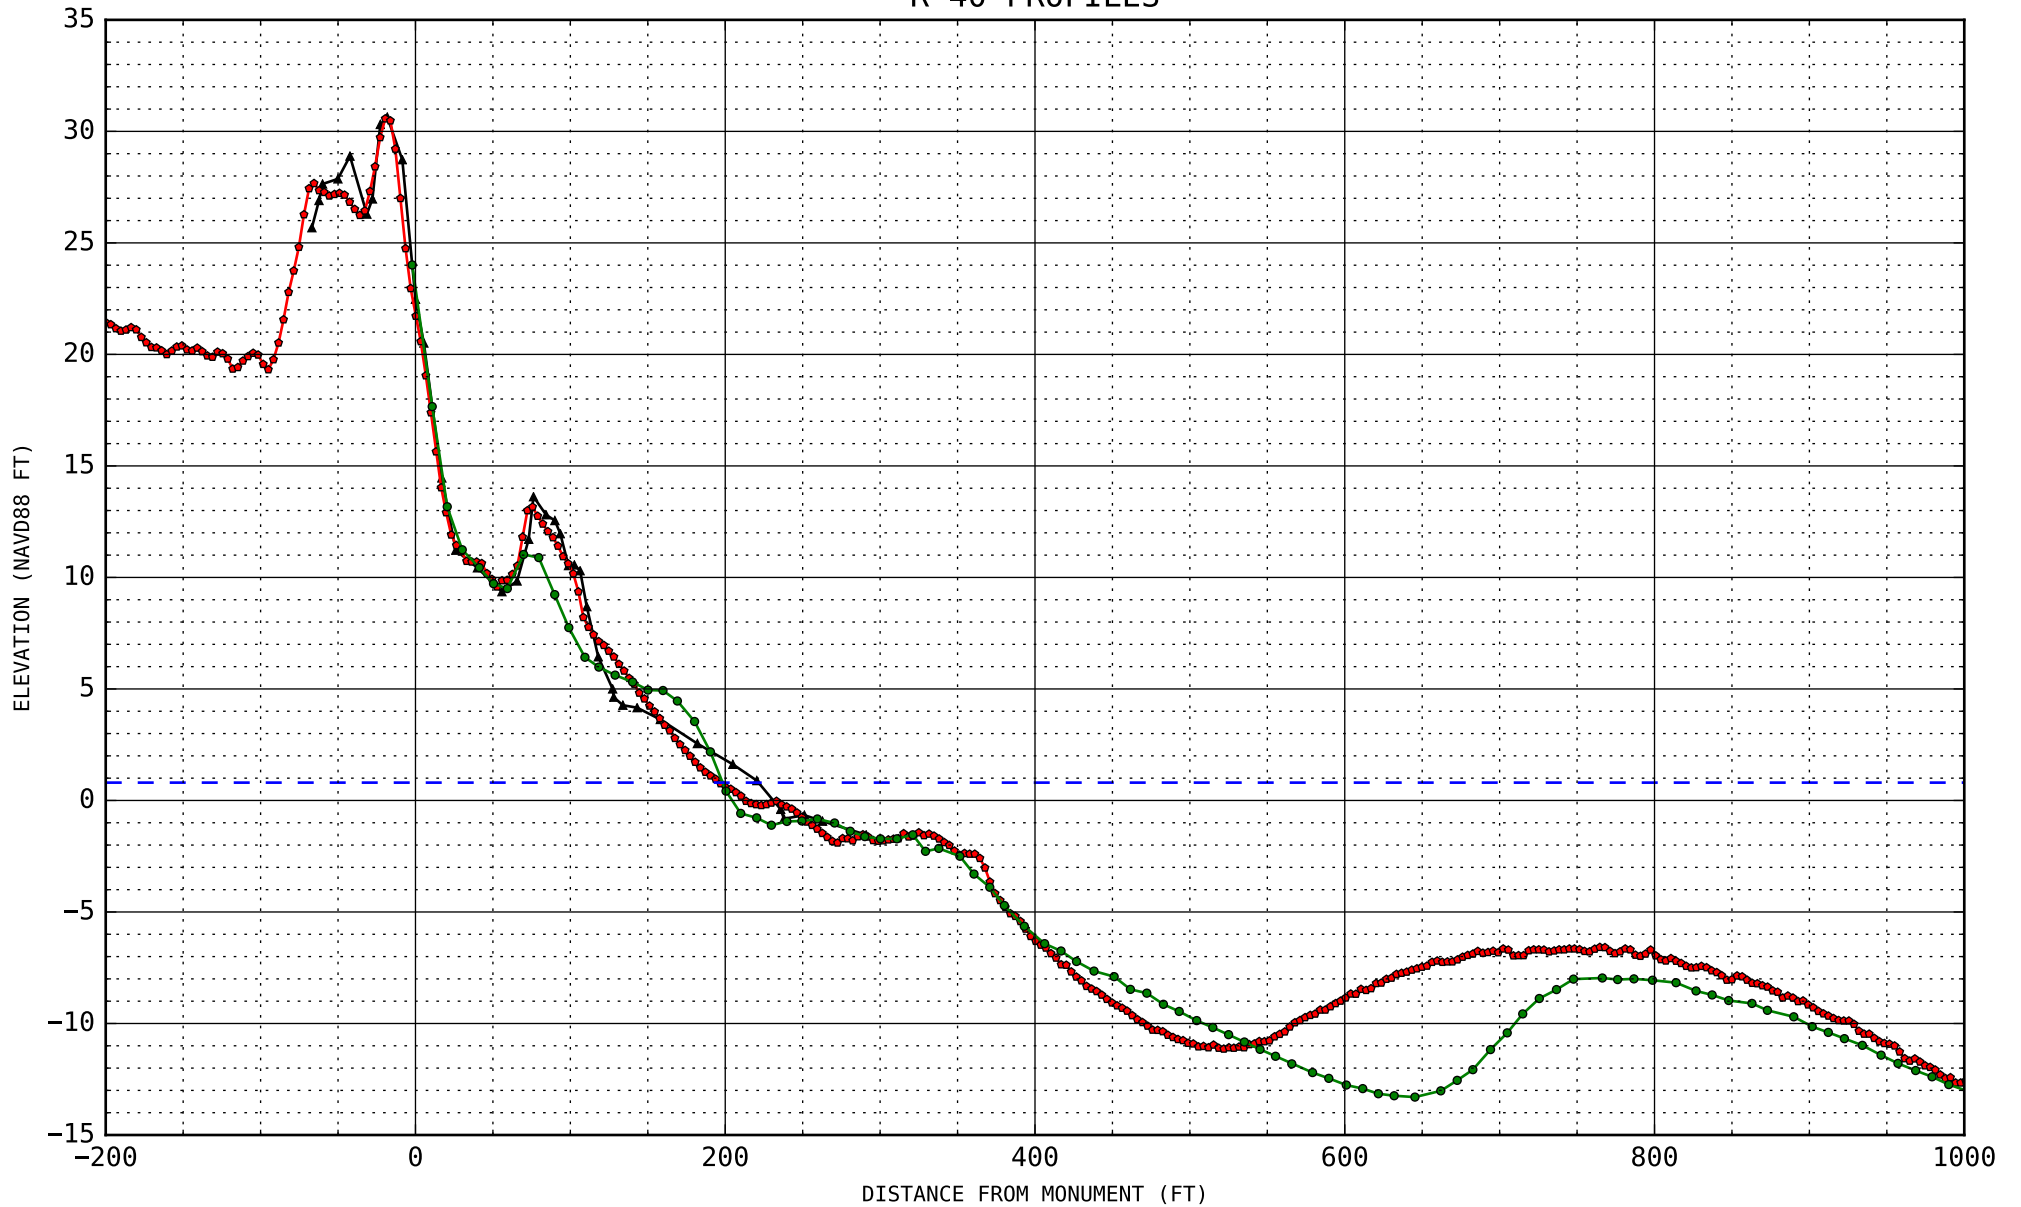
# R-40 PROFILES

- ▲ 2019-APR CONDITION BY DEP
- 2018-OCT MONITORING BY USACE-LIDAR
- 2013-SEP MONITORING BY USACE
- - - MHW CONTOUR (0.8 FT)

RANGE: R-40  
EST DATE: OCT1995  
SURVEY DATE: 16APR19  
AZIMUTH: 190.0

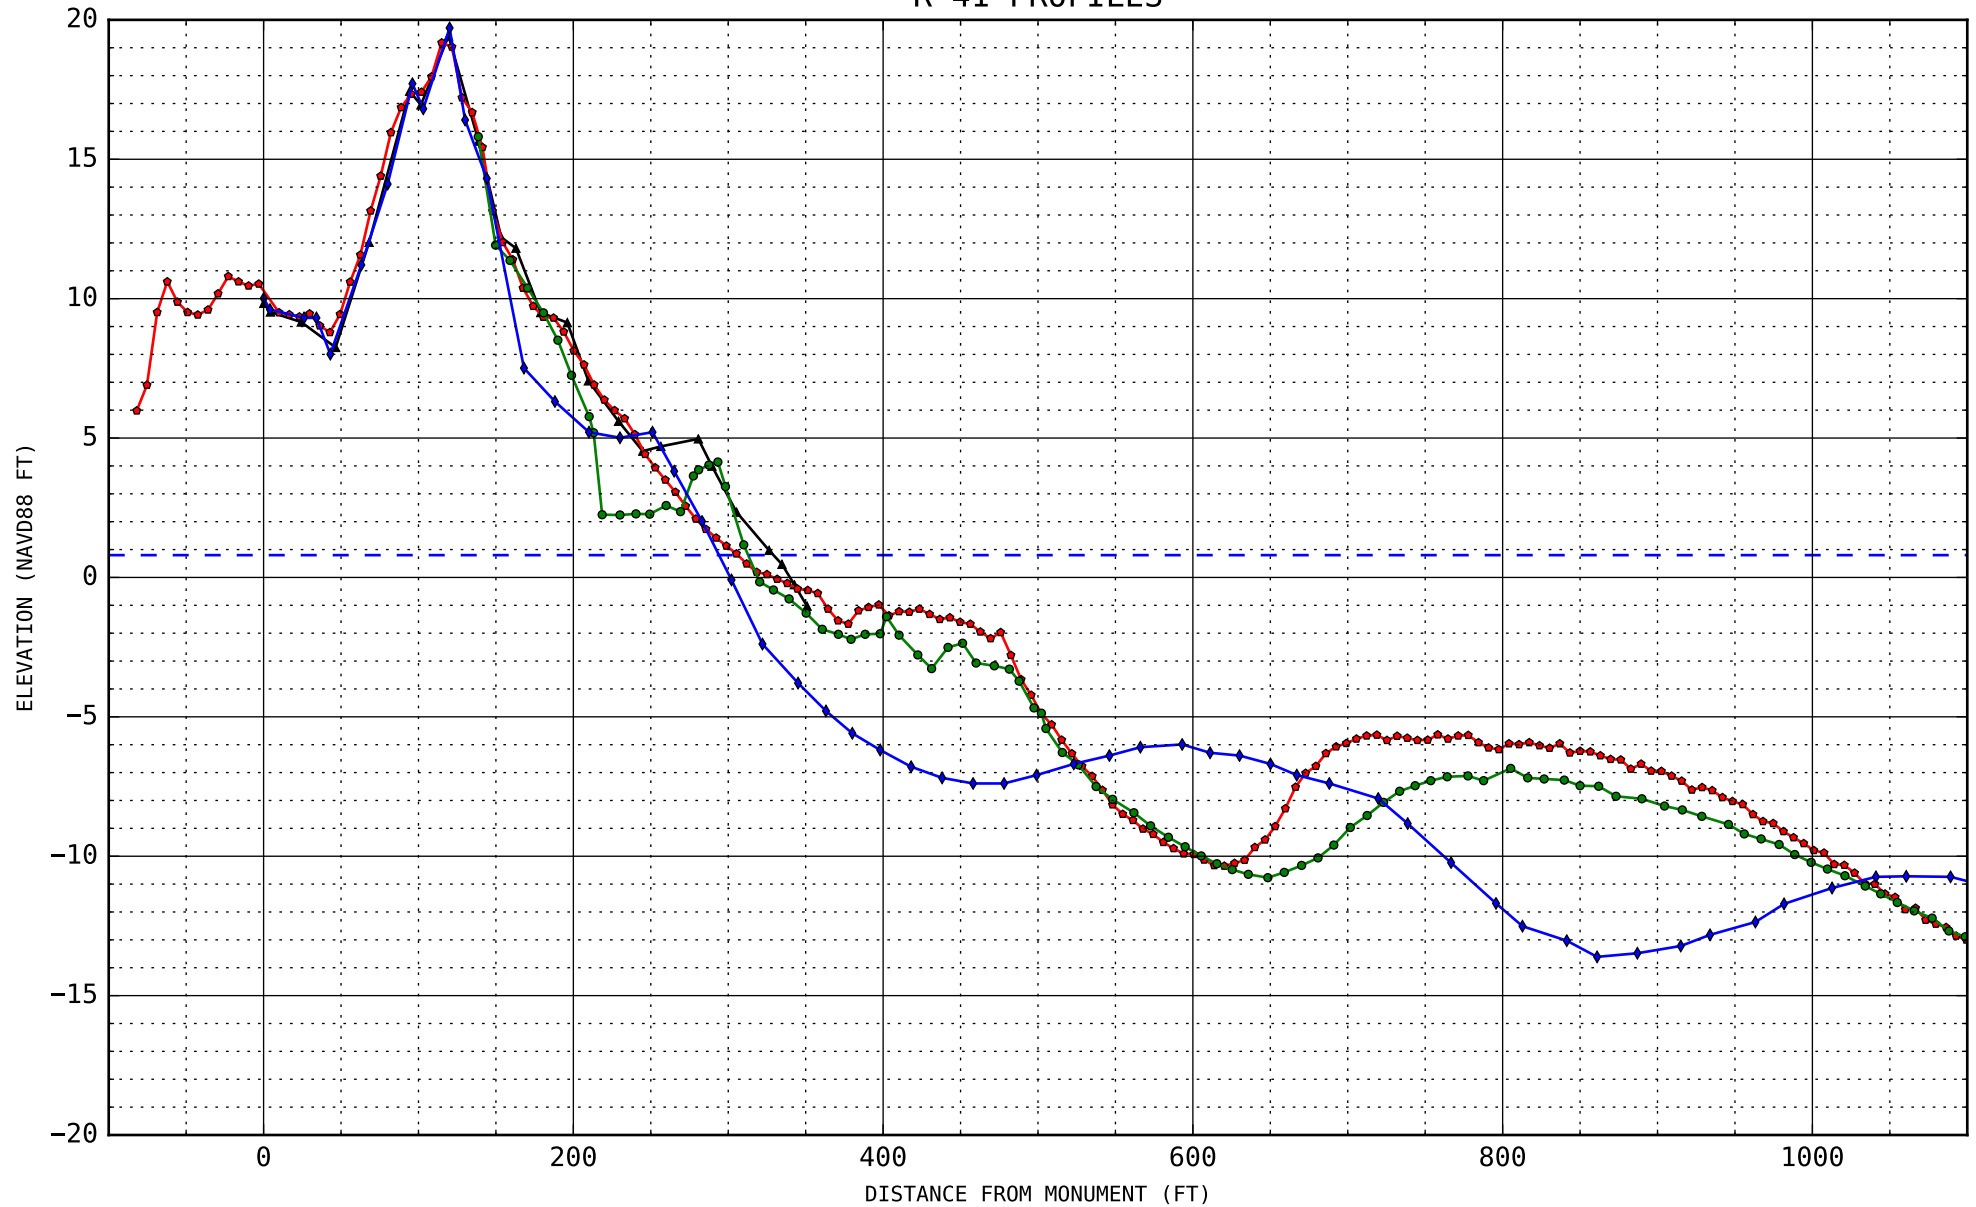
# R-41 PROFILES

- ▲ 2019-APR CONDITION BY DEP
- 2018-OCT MONITORING BY USACE-LIDAR
- 2013-SEP MONITORING BY USACE
- ◆ 2007-FEB MONITORING BY MAE
- - - MHW CONTOUR (0.8 FT)

RANGE: R-41  
EST DATE: OCT1995  
SURVEY DATE: 16APR19  
AZIMUTH: 195.0

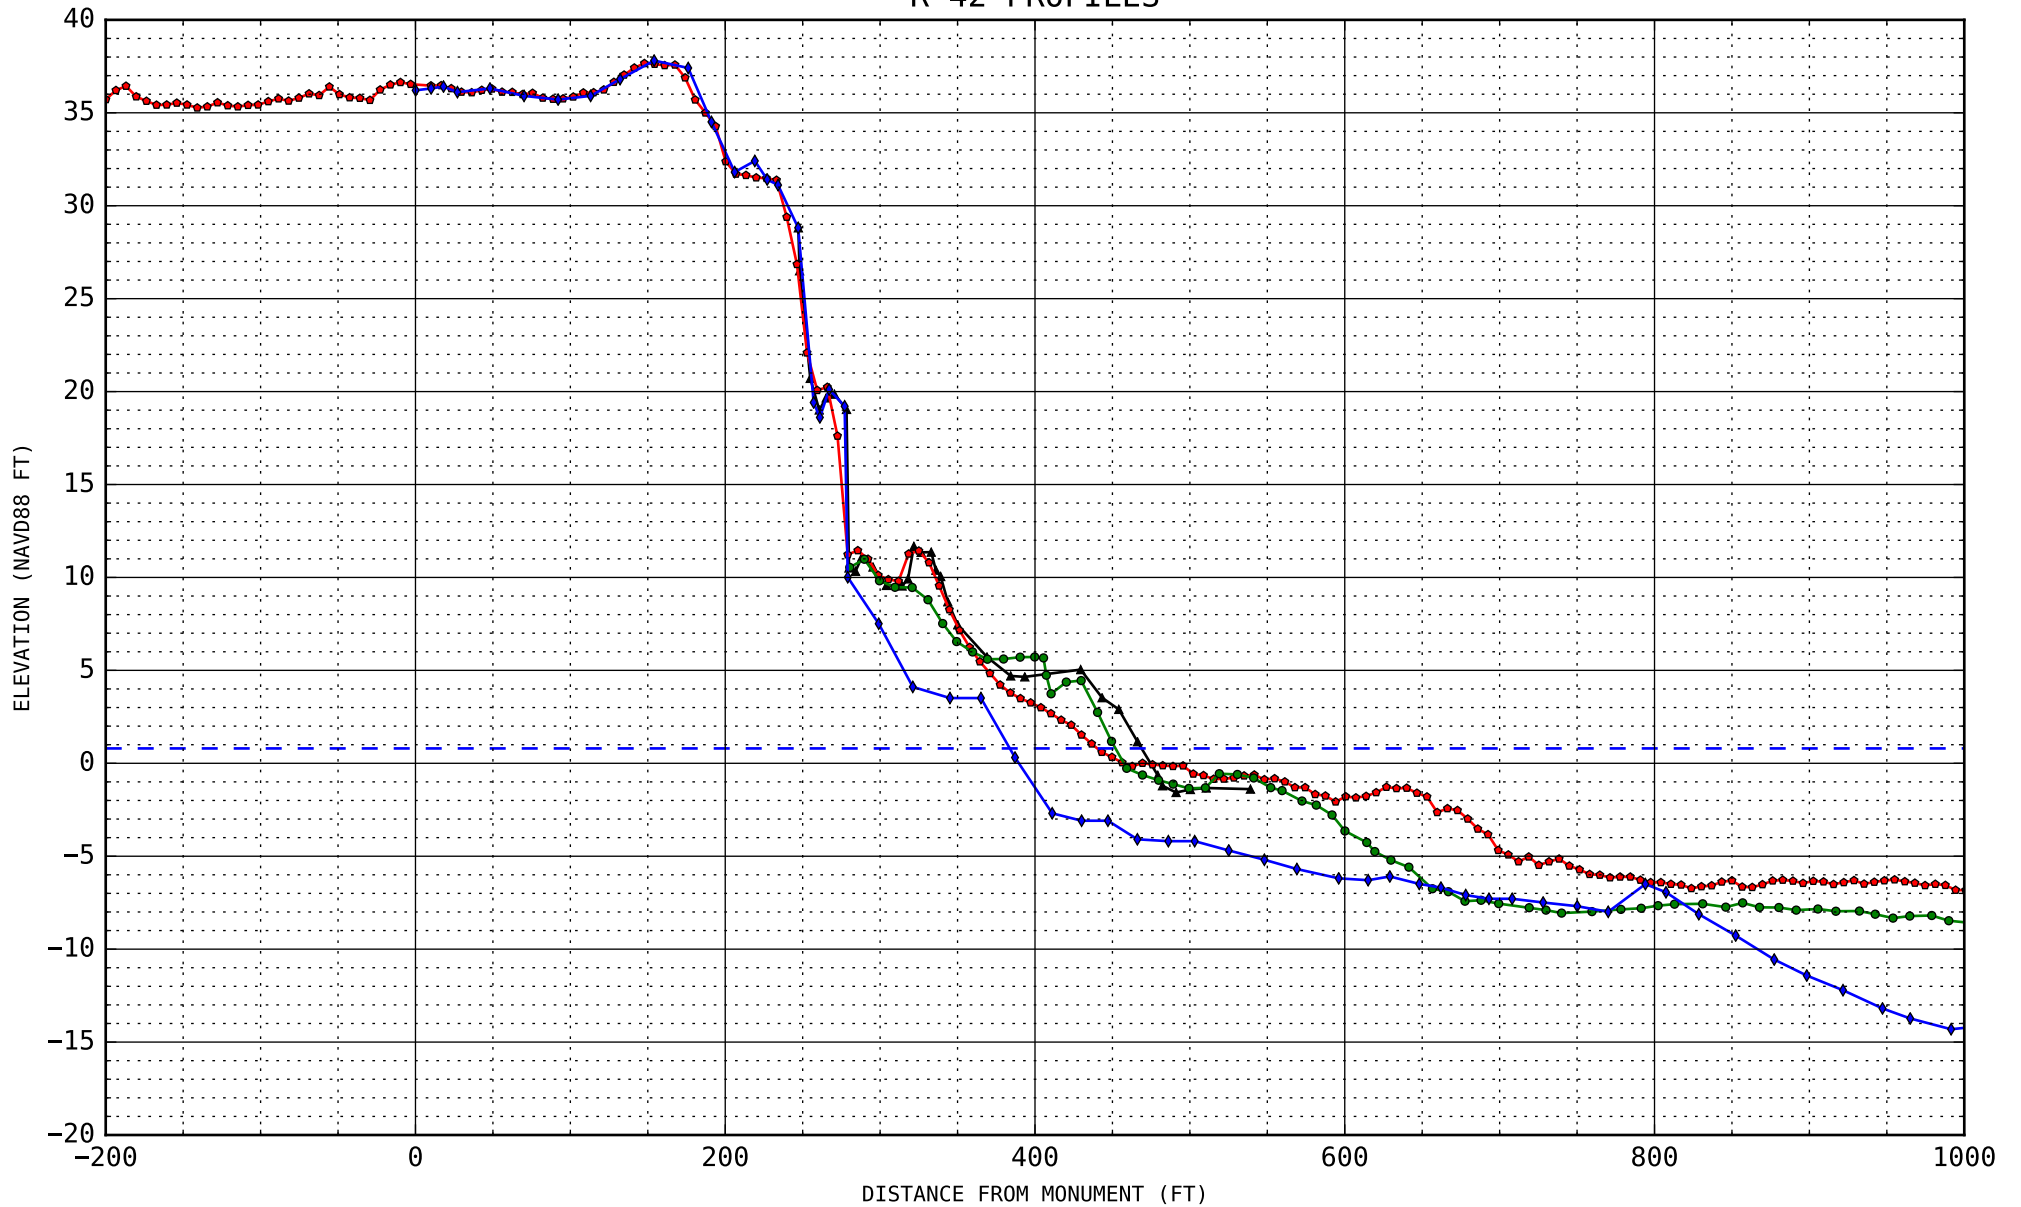
# R-42 PROFILES

- ▲ 2019-APR CONDITION BY DEP
- 2018-OCT MONITORING BY USACE-LIDAR
- 2013-SEP MONITORING BY USACE
- ◆ 2007-FEB MONITORING BY MAE
- - - MHW CONTOUR (0.8 FT)

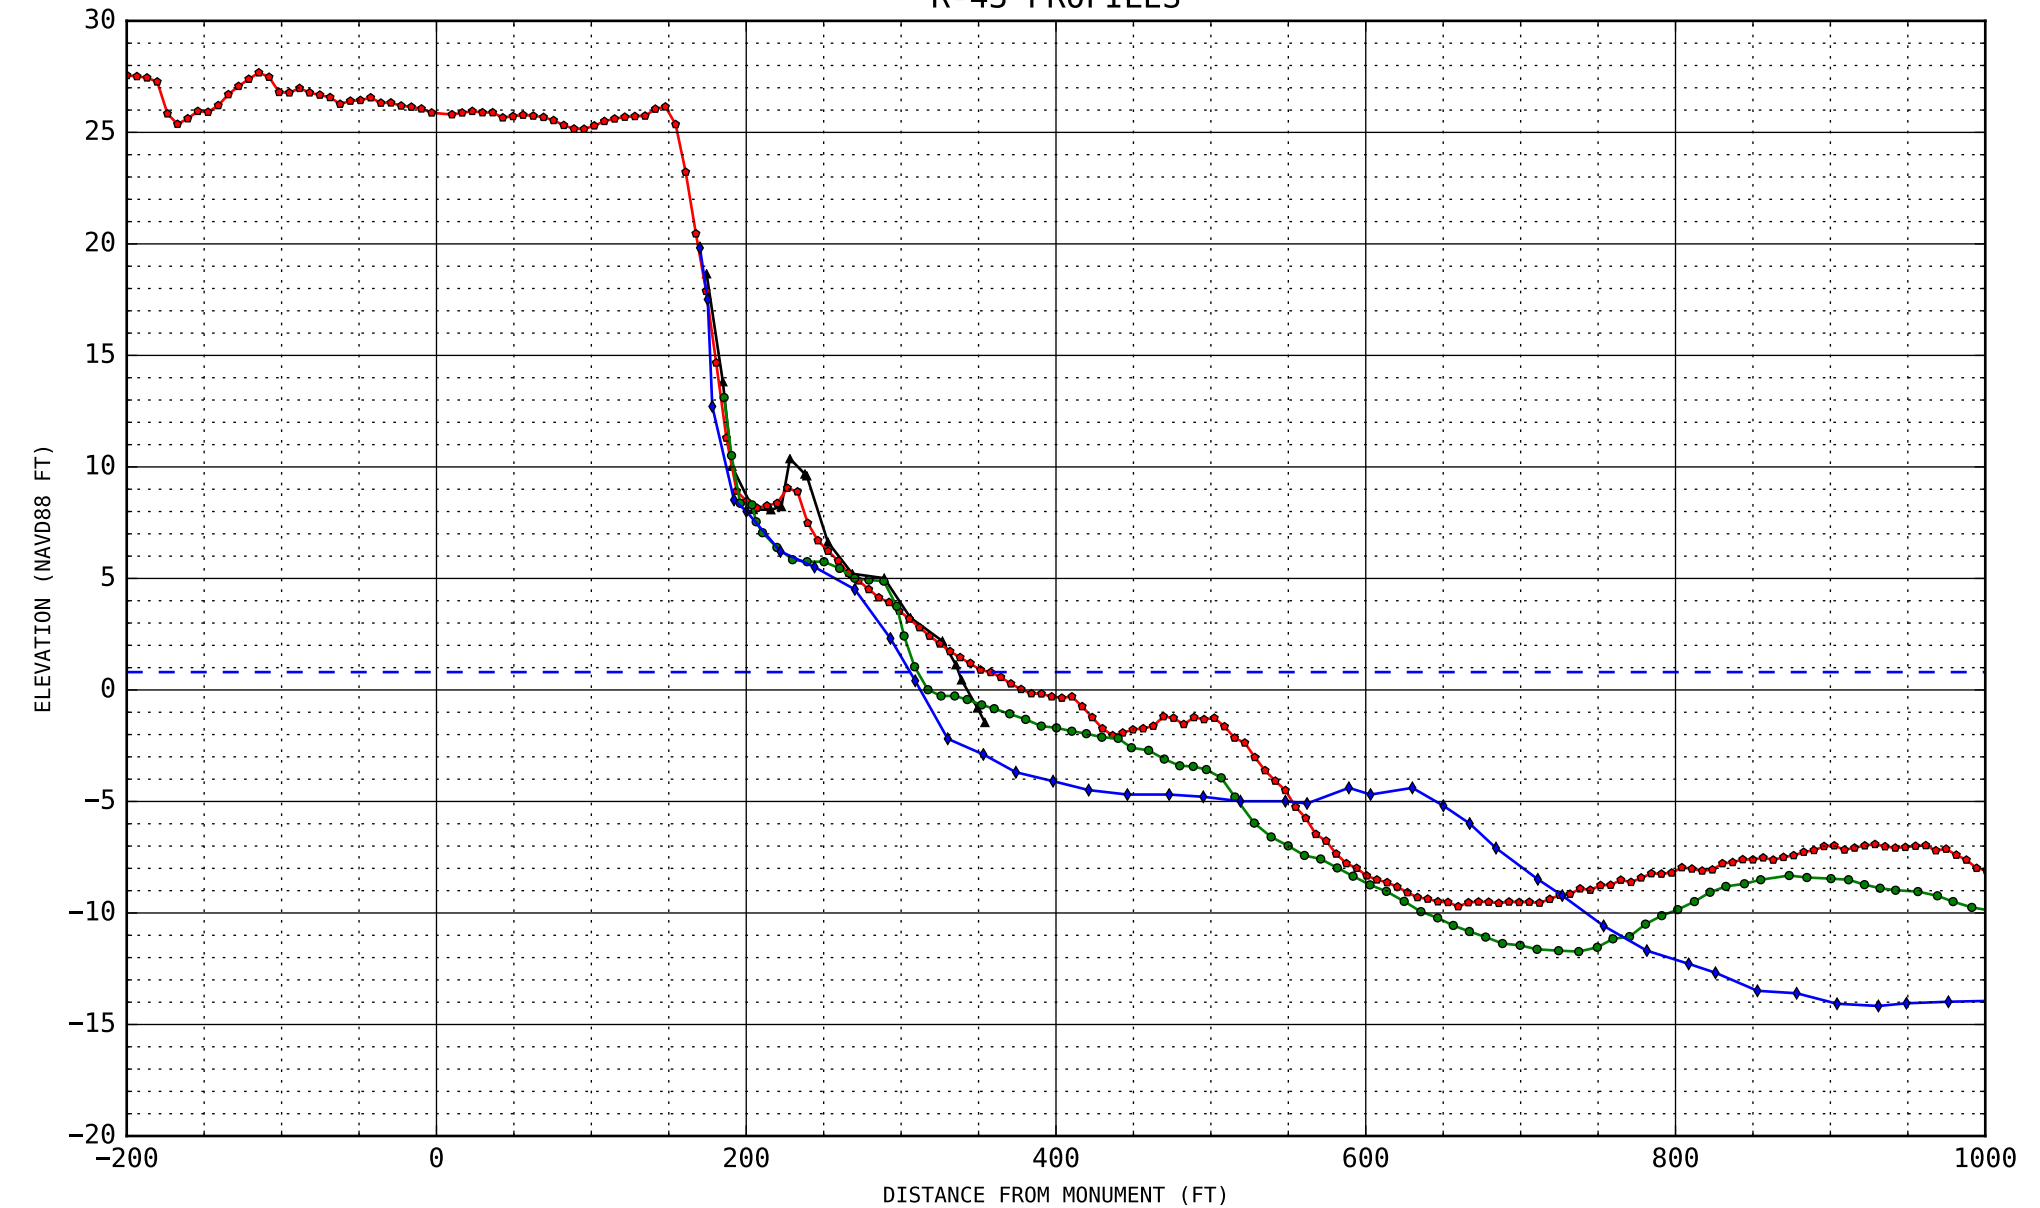
# R-43 PROFILES

- ▲ 2019-APR CONDITION BY DEP
- 2018-OCT MONITORING BY USACE-LIDAR
- 2013-SEP MONITORING BY USACE
- ◆ 2007-FEB MONITORING BY MAE
- - - MHW CONTOUR (0.8 FT)
