# R-1 PROFILES

WALTON  
PROGRAM SUPPORT GIS  
DIVISION OF WATER RESOURCE MANAGEMENT  
FLORIDA DEPARTMENT OF ENVIRONMENTAL PROTECTION

RANGE: R-1  
EST DATE: NOV1980  
SURVEY DATE: 04APR19  
AZIMUTH: 190.0

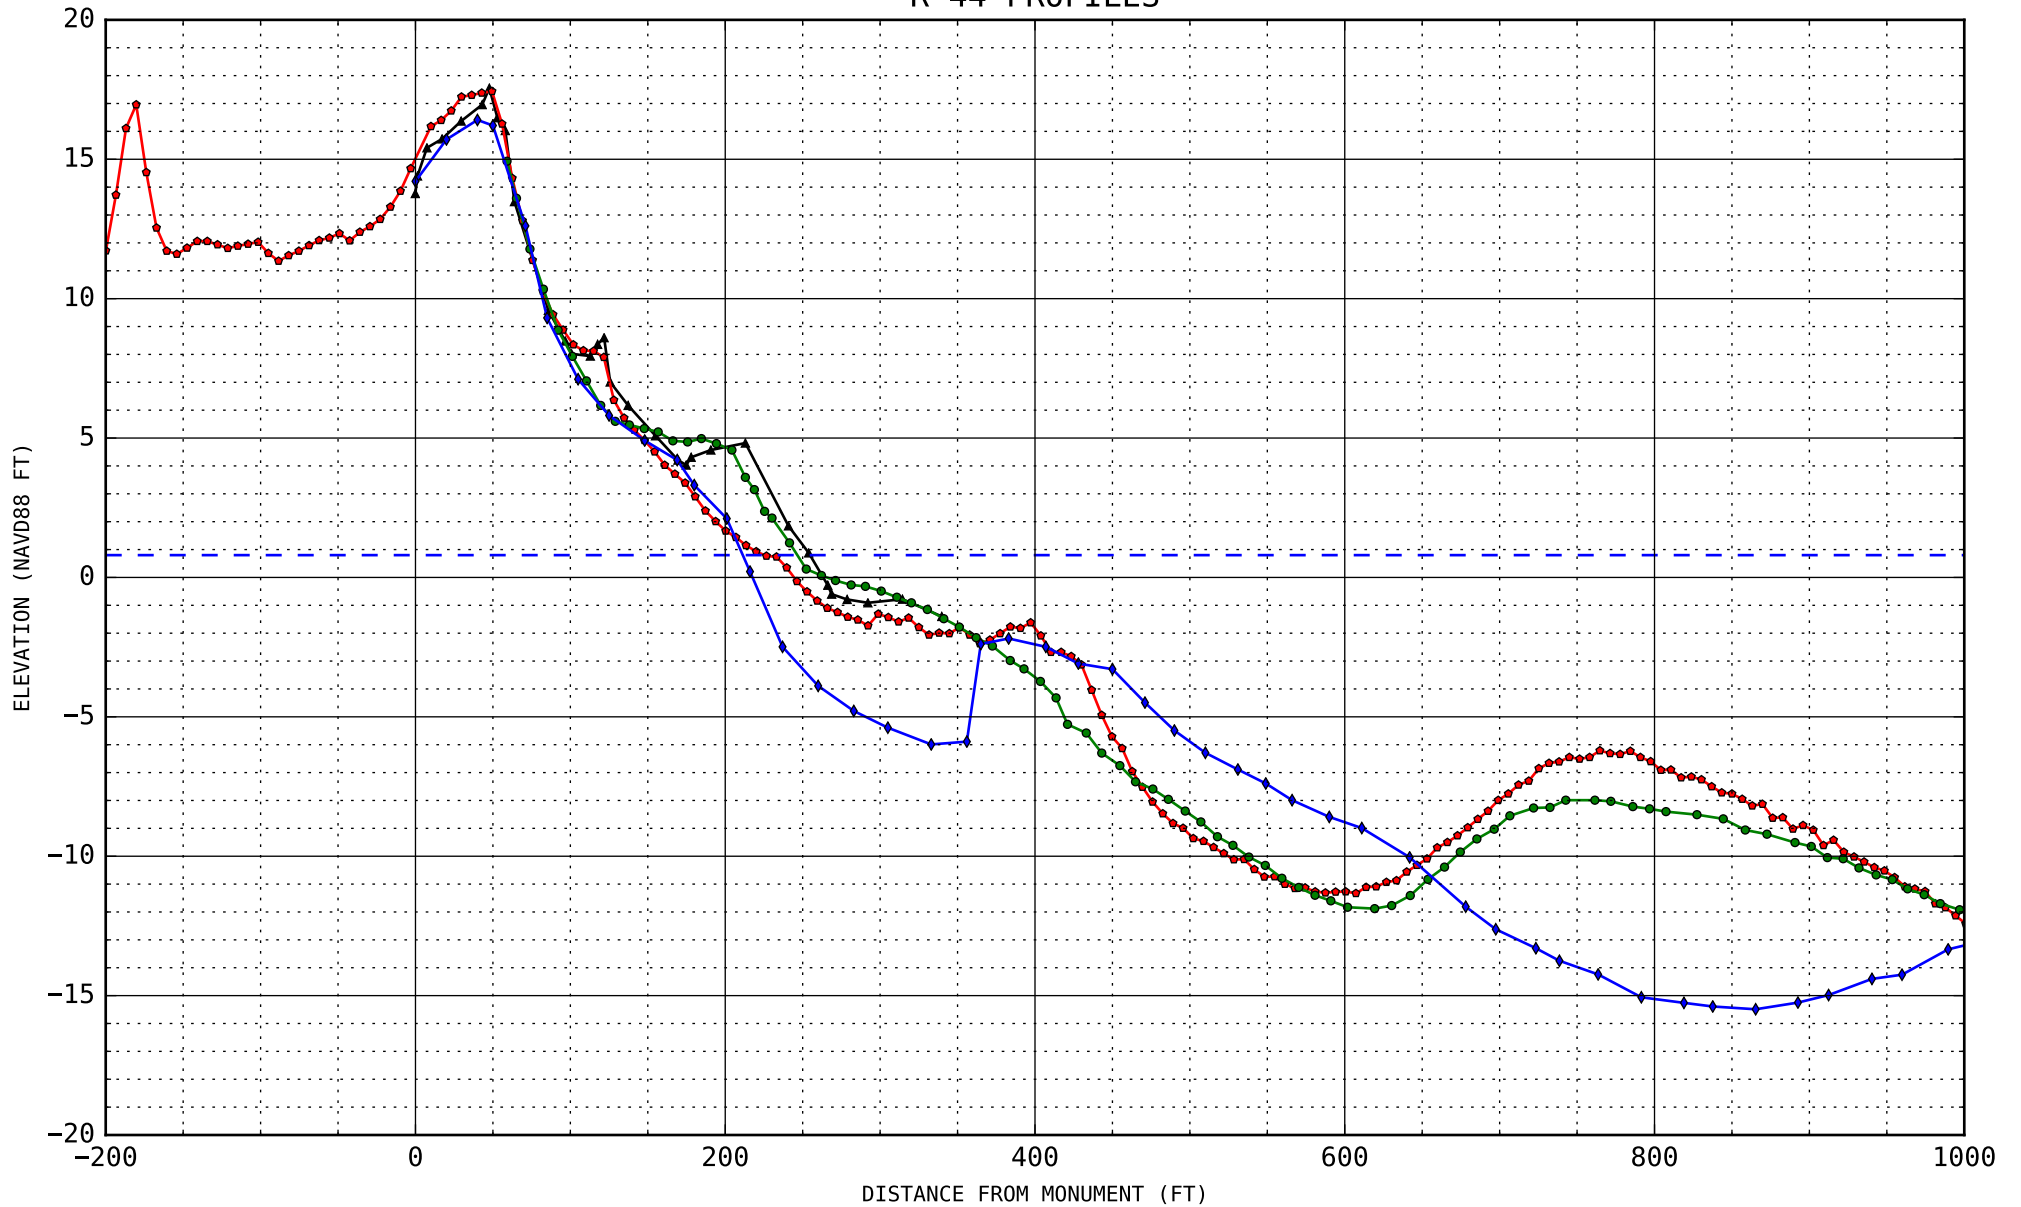
# R-44 PROFILES

- ▲ 2019-APR CONDITION BY DEP
- 2018-OCT MONITORING BY USACE-LIDAR
- 2013-SEP MONITORING BY USACE
- ◆ 2007-FEB MONITORING BY MAE
- - - MHW CONTOUR (0.8 FT)

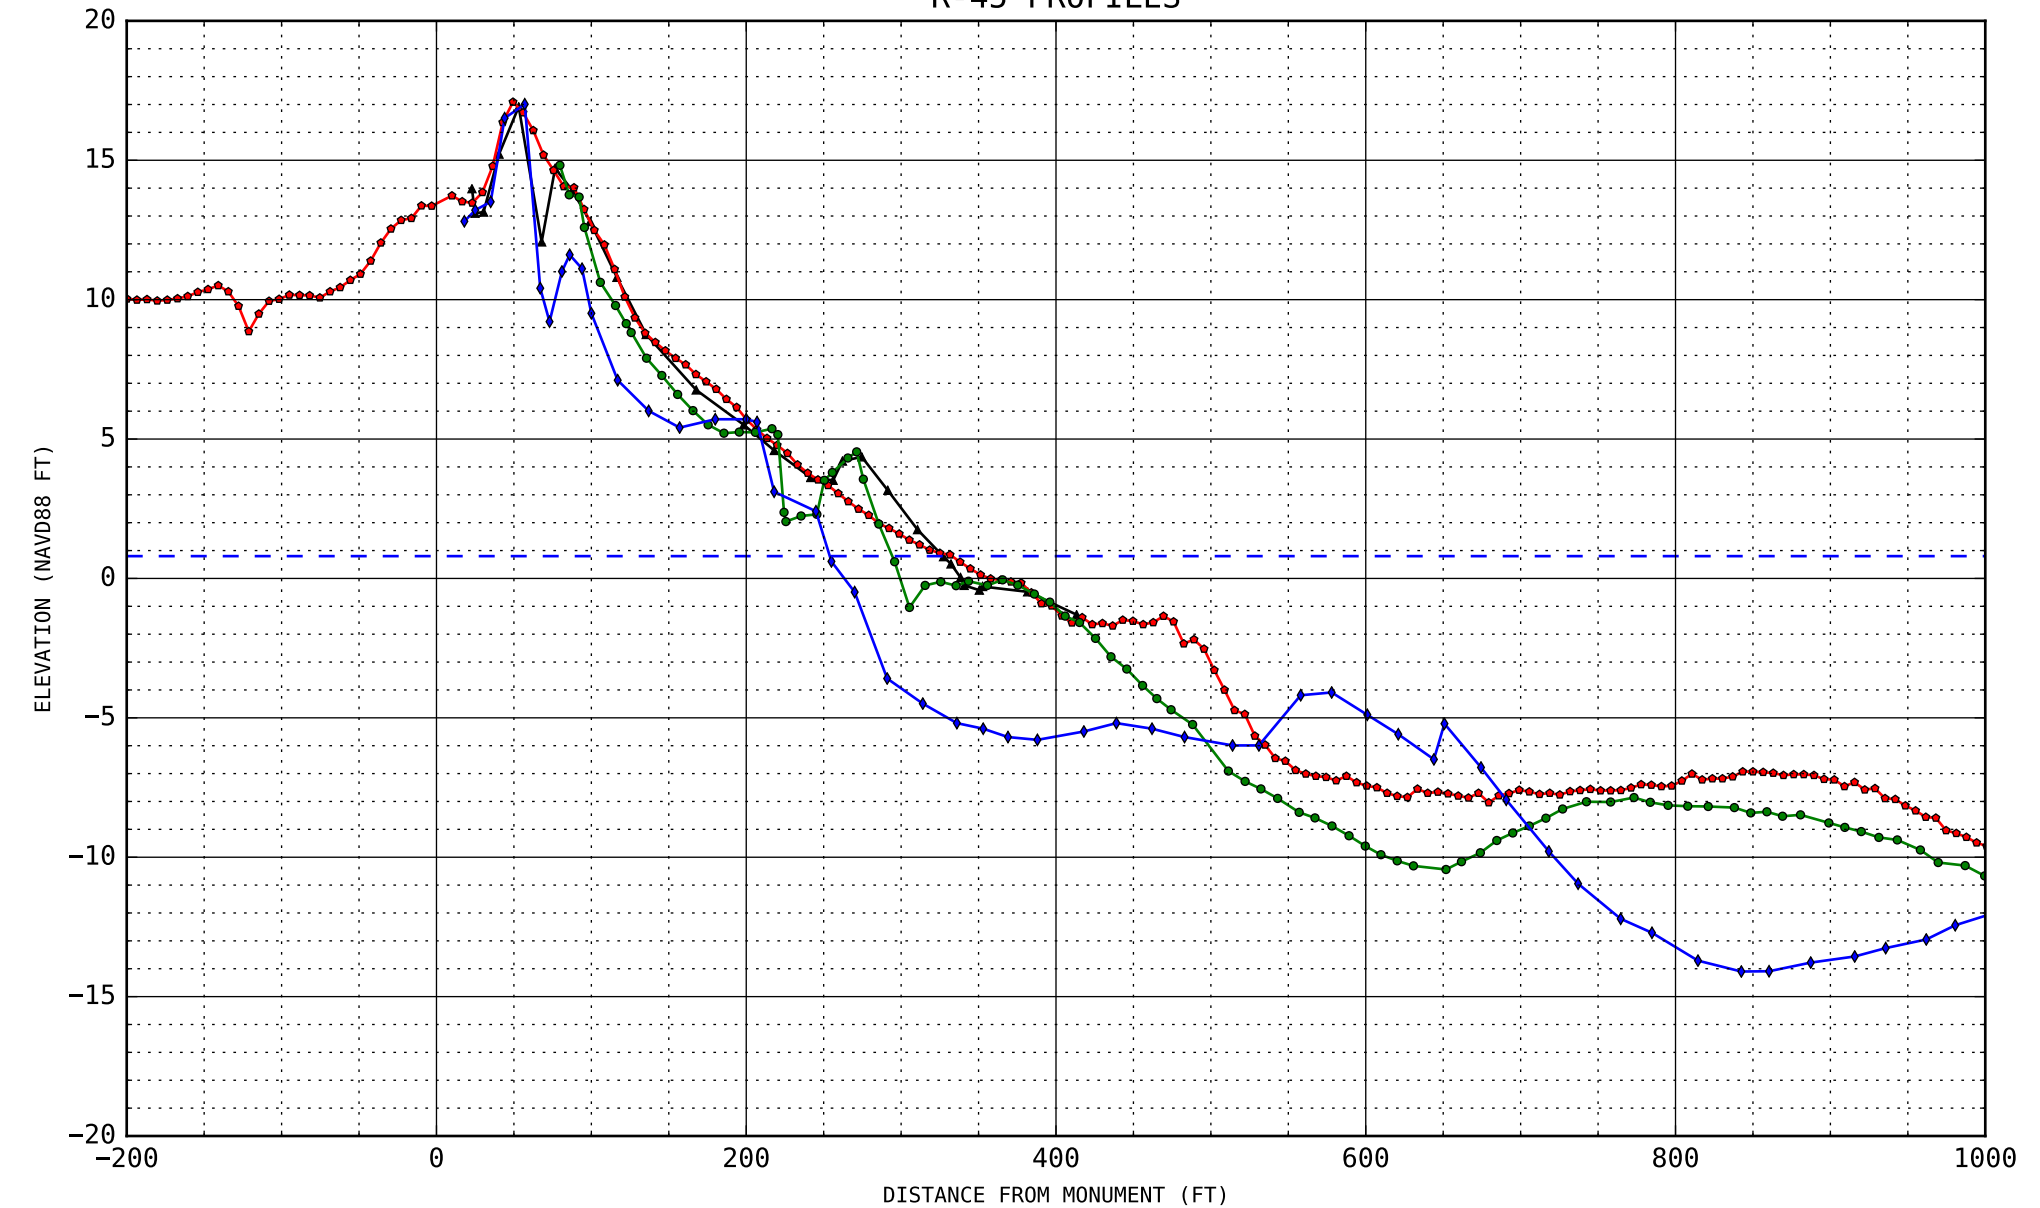
# R-45 PROFILES

- ▲ 2019-APR CONDITION BY DEP
- 2018-OCT MONITORING BY USACE-LIDAR
- 2013-SEP MONITORING BY USACE
- ◆ 2007-FEB MONITORING BY MAE
- - - MHW CONTOUR (0.8 FT)

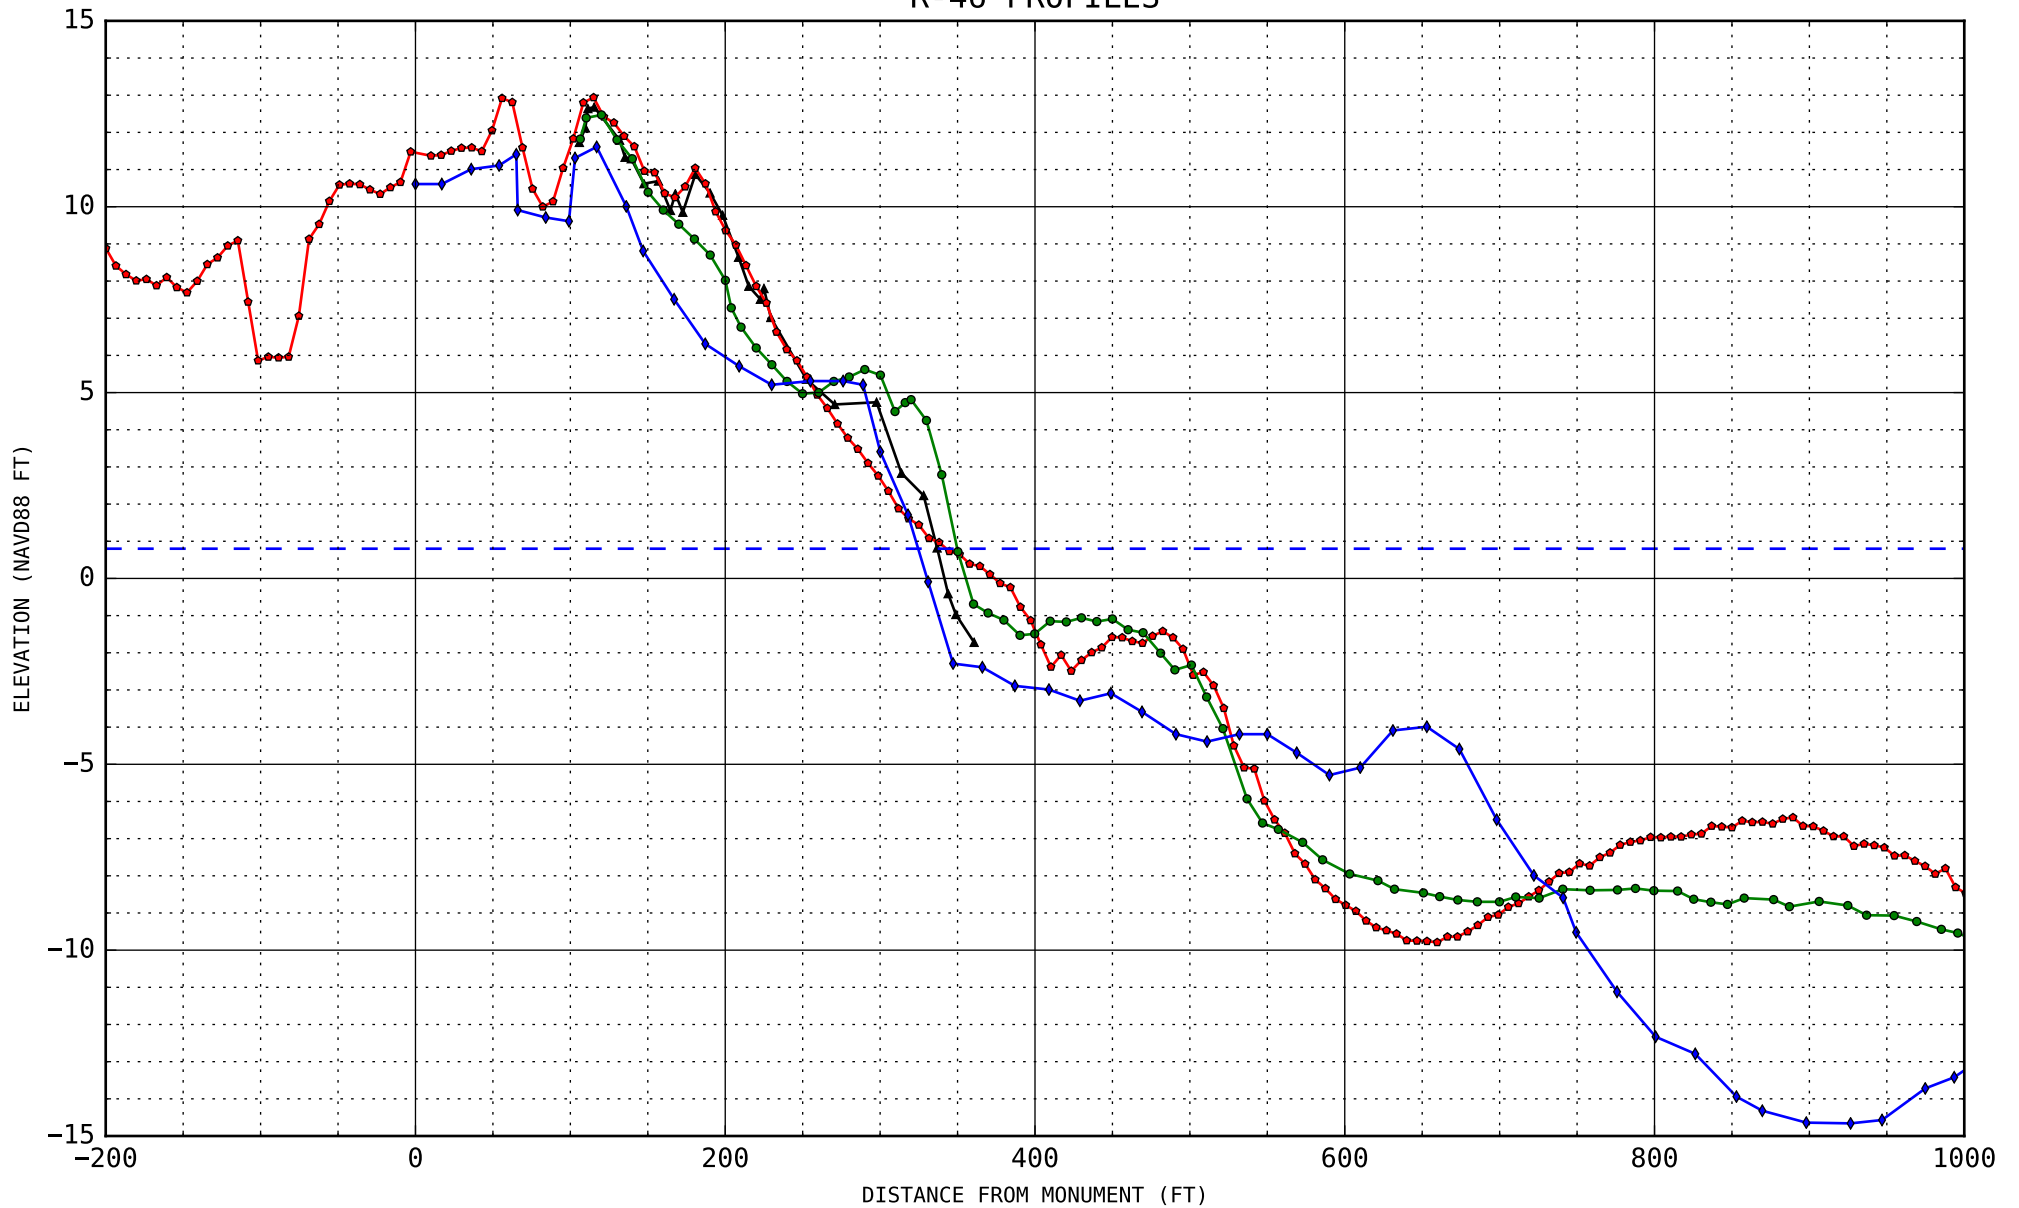
# R-46 PROFILES

- ▲ 2019-APR CONDITION BY DEP
- 2018-OCT MONITORING BY USACE-LIDAR
- 2013-SEP MONITORING BY USACE
- ◆ 2007-FEB MONITORING BY MAE
- - - MHW CONTOUR (0.8 FT)

RANGE: R-46  
EST DATE: NOV1980  
SURVEY DATE: 16APR19  
AZIMUTH: 195.0

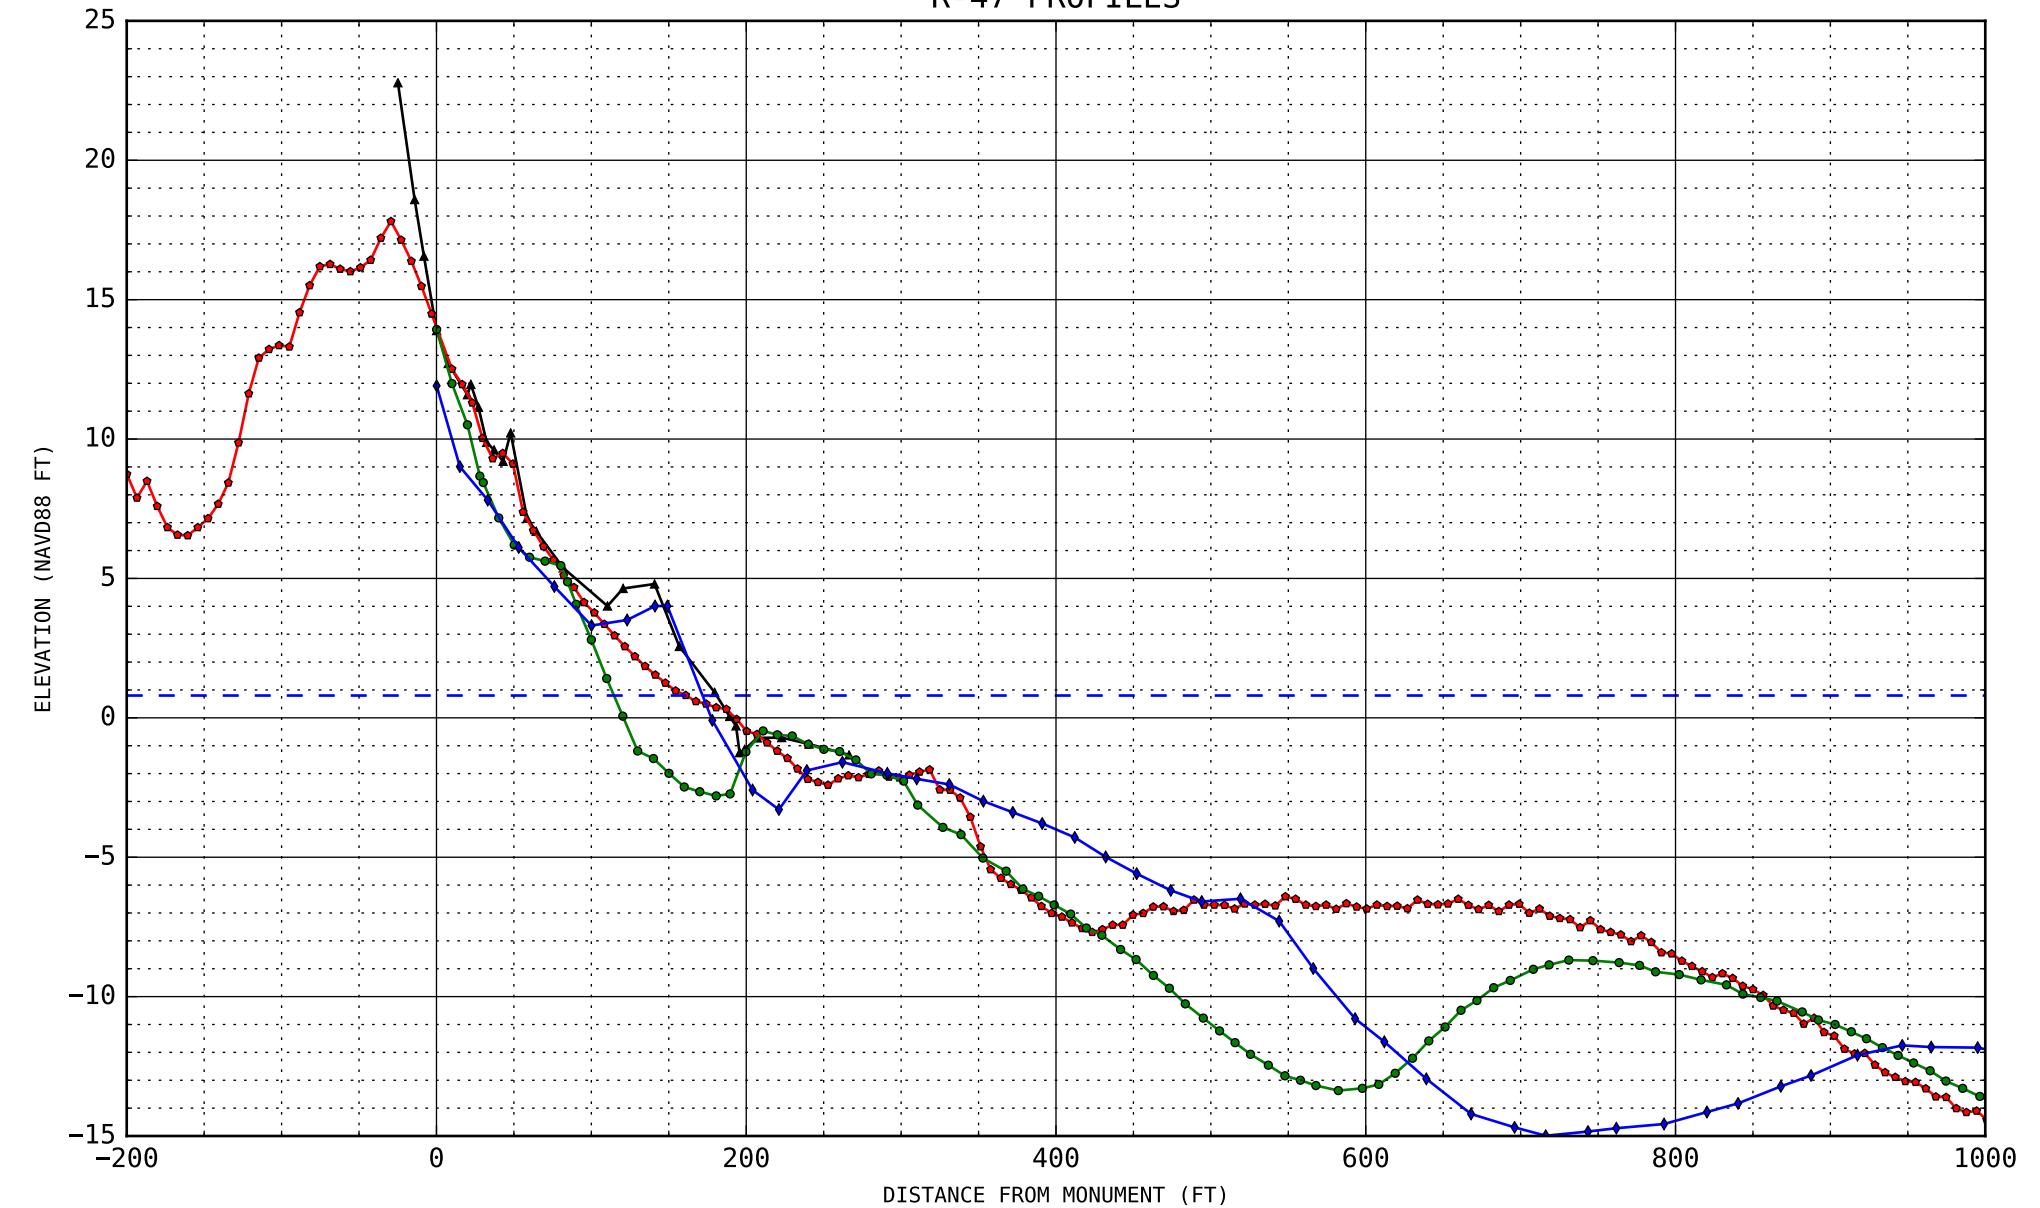
# R-47 PROFILES

- ▲ 2019-APR CONDITION BY DEP
- 2018-OCT MONITORING BY USACE-LIDAR
- 2013-SEP MONITORING BY USACE
- ◆ 2007-FEB MONITORING BY MAE
- - - MHW CONTOUR (0.8 FT)

RANGE: R-47  
EST DATE: NOV1980  
SURVEY DATE: 17APR19  
AZIMUTH: 195.0

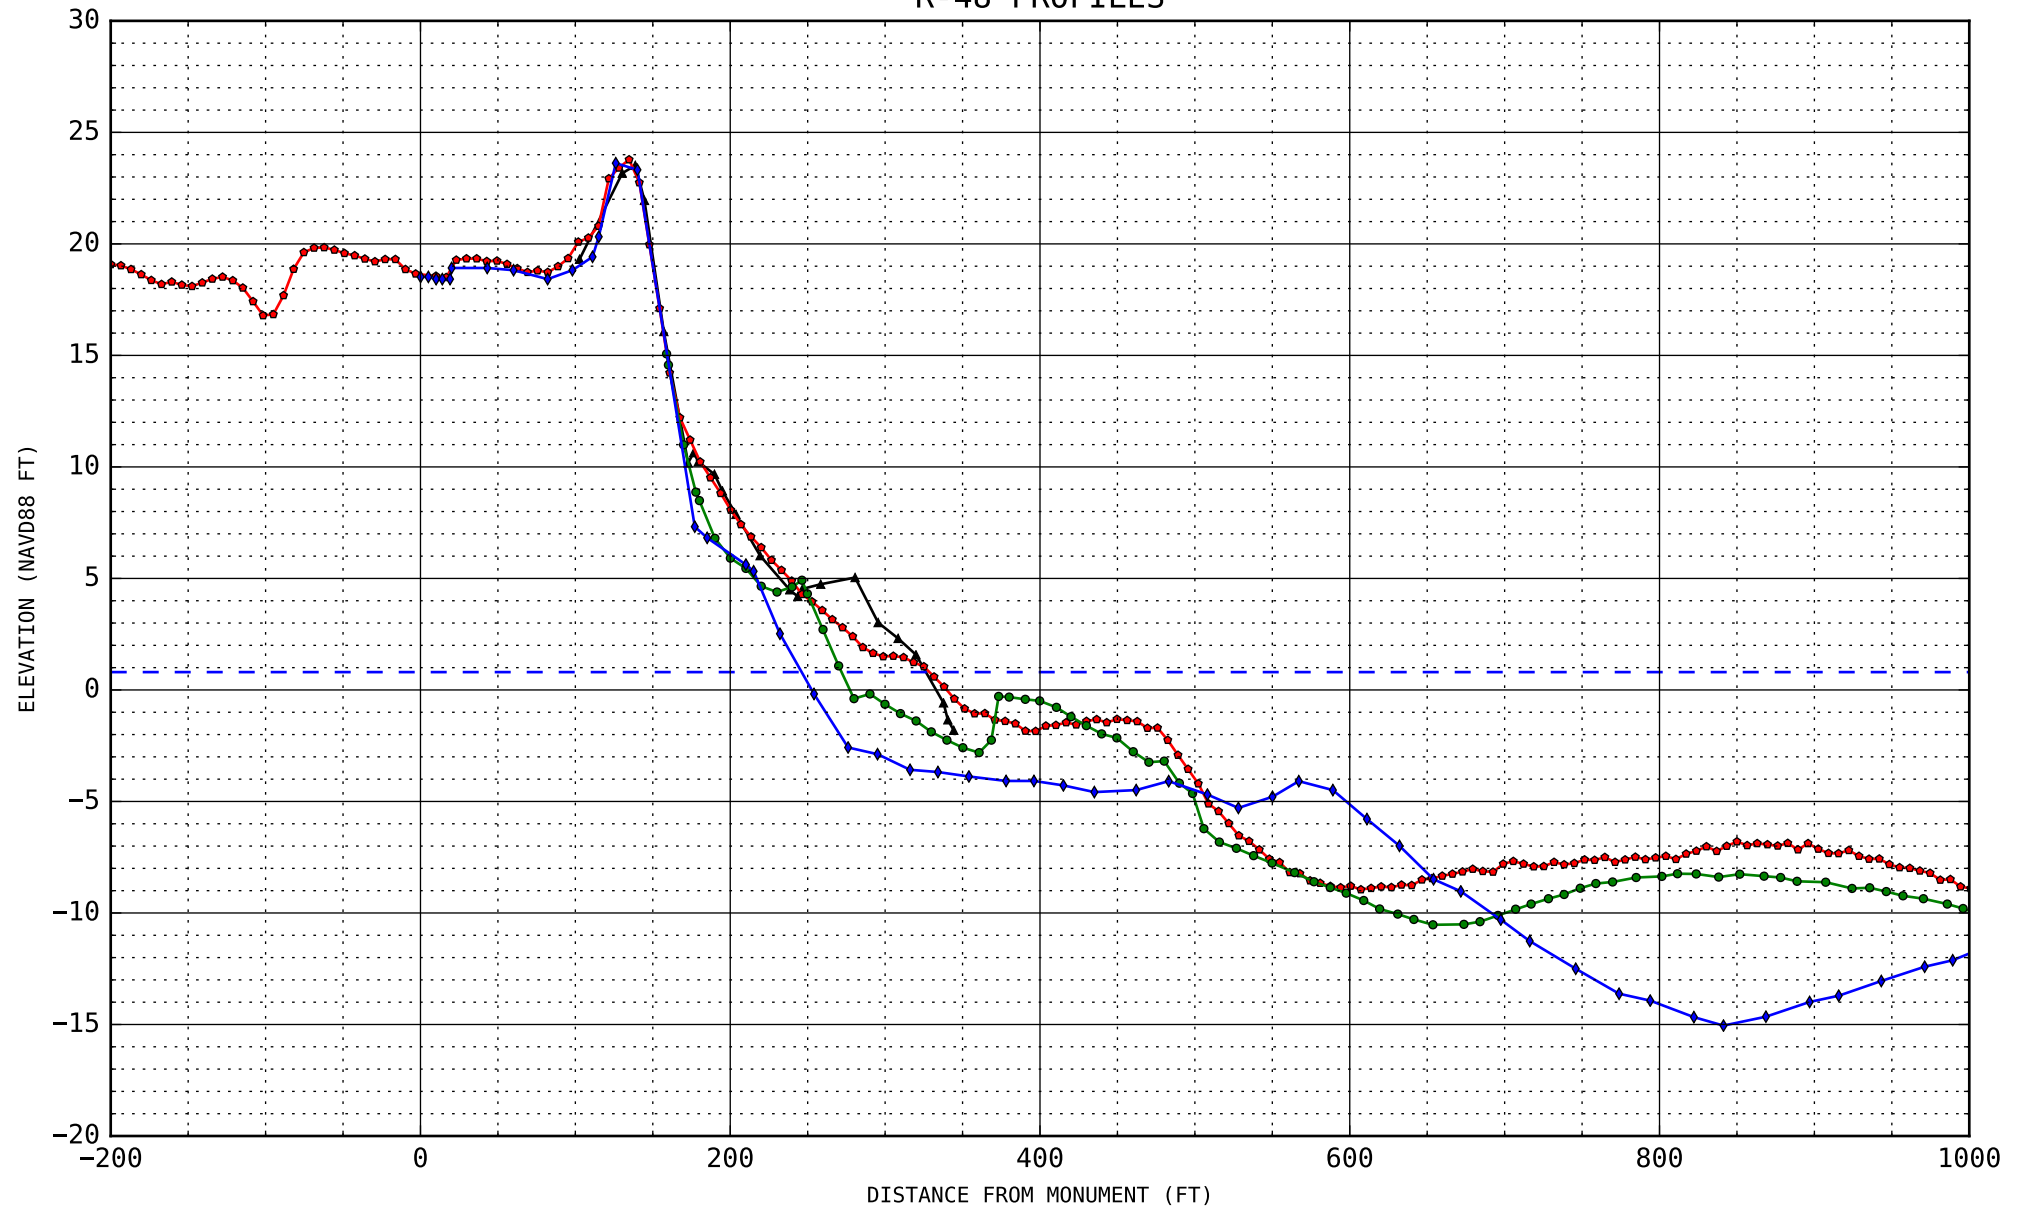
# R-48 PROFILES

- ▲ 2019-APR CONDITION BY DEP
- 2018-OCT MONITORING BY USACE-LIDAR
- 2013-SEP MONITORING BY USACE
- ◆ 2007-FEB MONITORING BY MAE
- - - MHW CONTOUR (0.8 FT)

RANGE: R-48  
 EST DATE: OCT1995  
 SURVEY DATE: 17APR19  
 AZIMUTH: 195.0

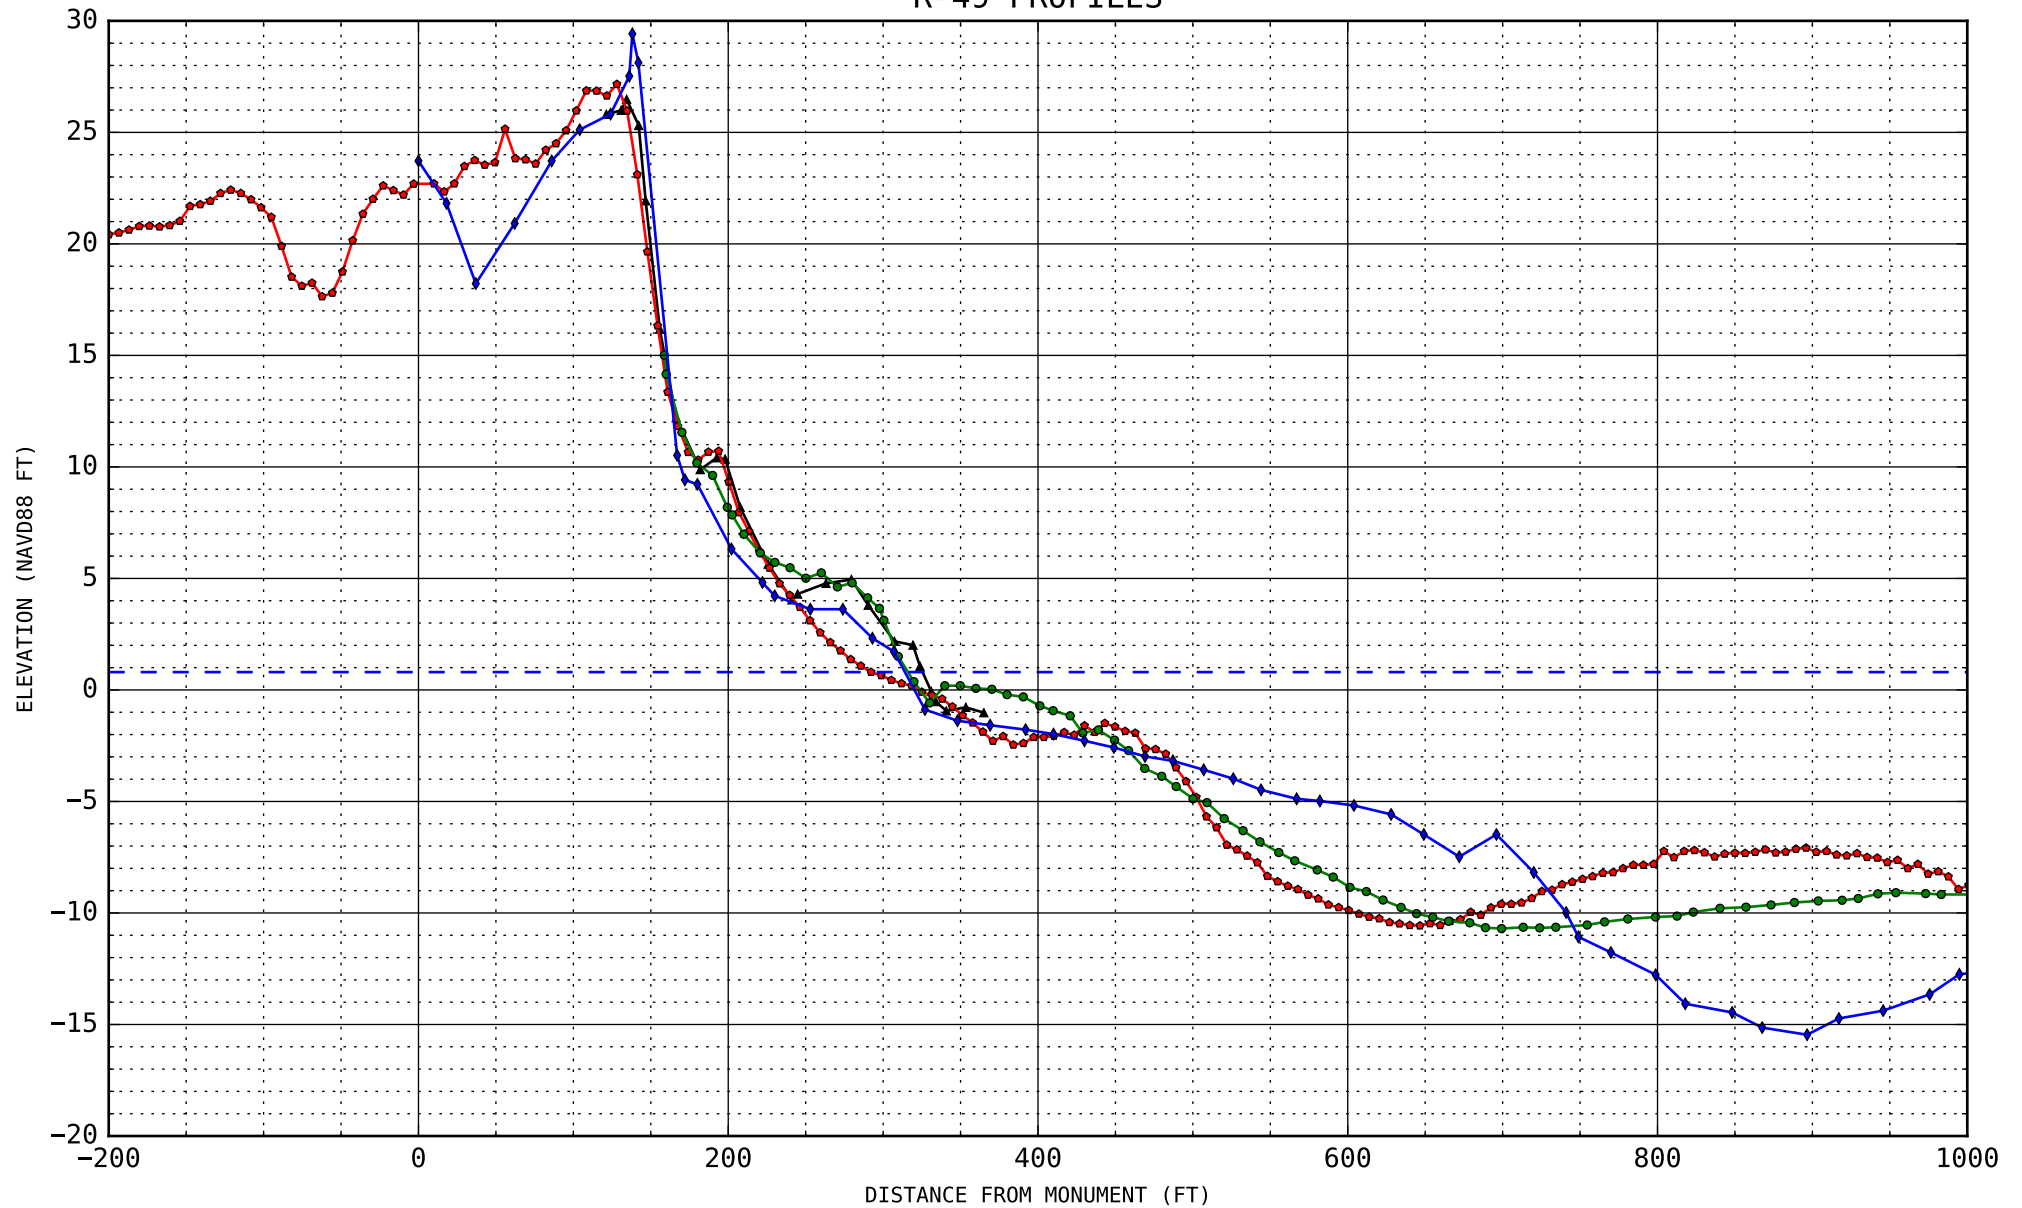
# R-49 PROFILES

- ▲ 2019-APR CONDITION BY DEP
- 2018-OCT MONITORING BY USACE-LIDAR
- 2013-SEP MONITORING BY USACE
- ◆ 2007-FEB MONITORING BY MAE
- - - MHW CONTOUR (0.8 FT)

RANGE: R-49  
EST DATE: OCT1995  
SURVEY DATE: 17APR19  
AZIMUTH: 195.0

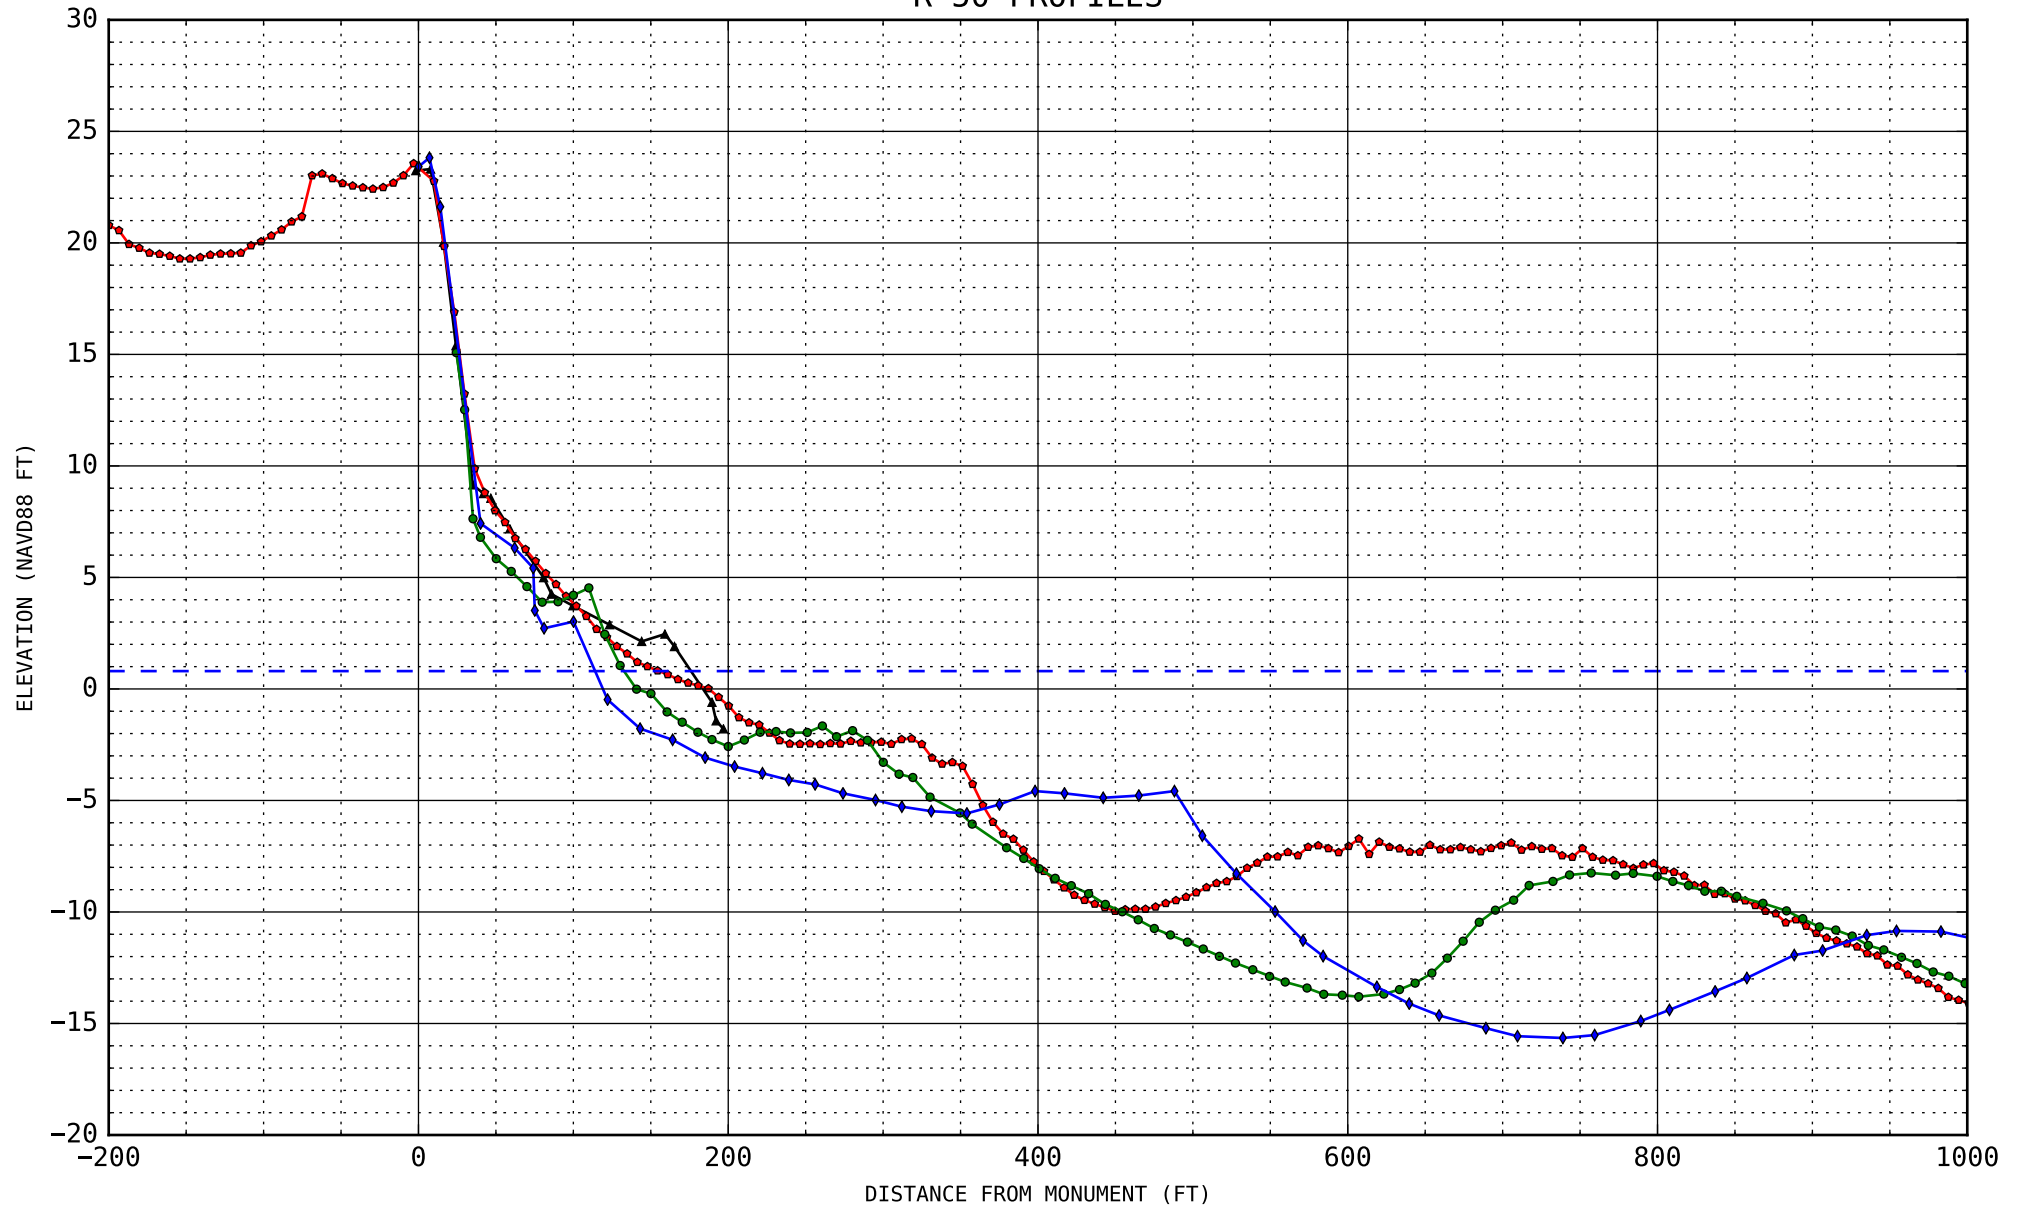
# R-50 PROFILES

- ▲ 2019-APR CONDITION BY DEP
- 2018-OCT MONITORING BY USACE-LIDAR
- 2013-SEP MONITORING BY USACE
- ◆ 2007-FEB MONITORING BY MAE
- - - MHW CONTOUR (0.8 FT)

RANGE: R-50  
EST DATE: JUN1973  
SURVEY DATE: 17APR19  
AZIMUTH: 195.0

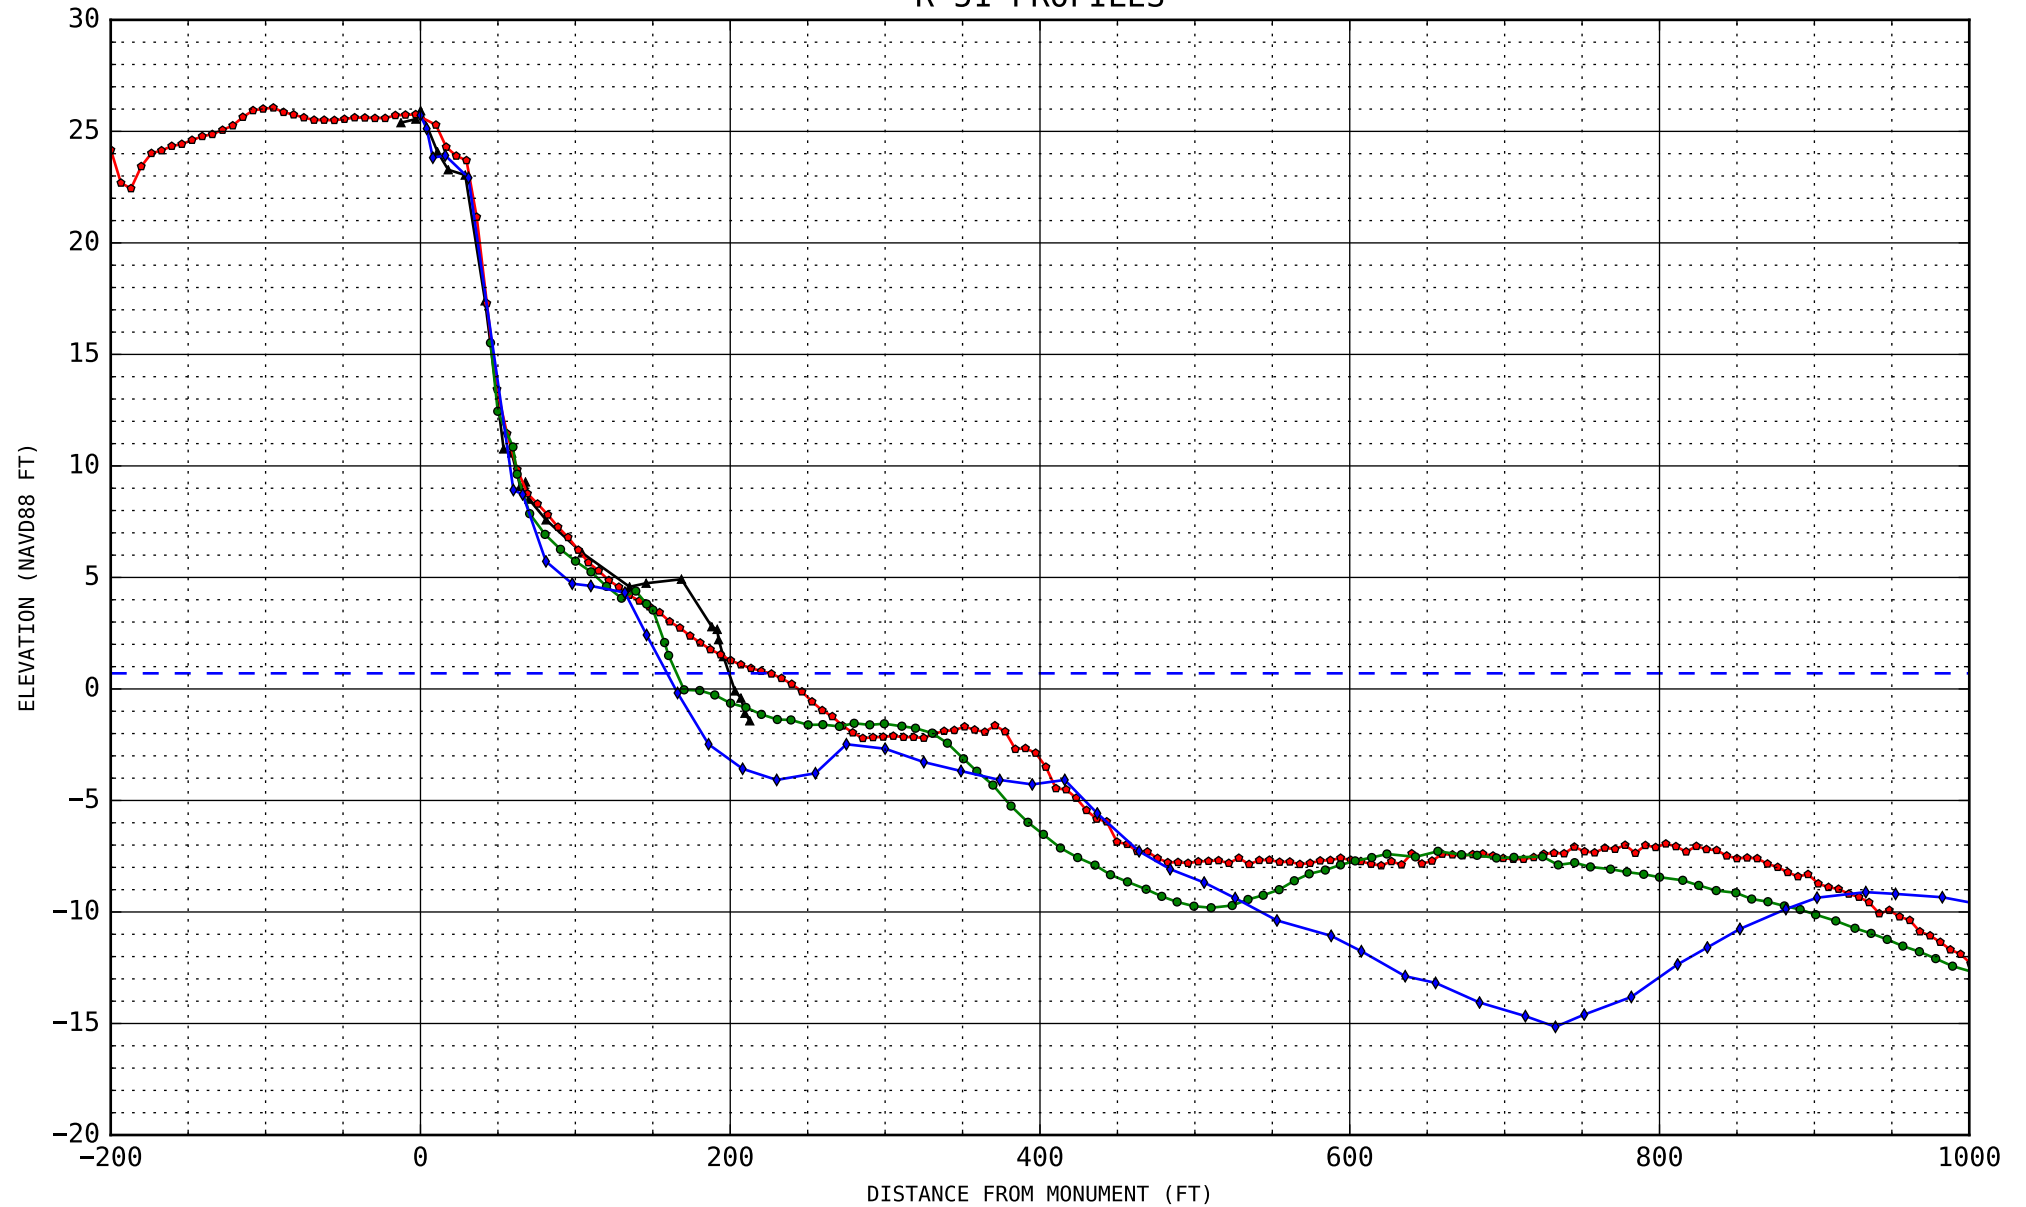
# R-51 PROFILES

- ▲ 2019-APR CONDITION BY DEP
- 2018-OCT MONITORING BY USACE-LIDAR
- 2013-SEP MONITORING BY USACE
- ◆ 2007-FEB MONITORING BY MAE
- - - MHW CONTOUR (0.7 FT)

RANGE: R-51  
EST DATE: OCT1995  
SURVEY DATE: 17APR19  
AZIMUTH: 200.0

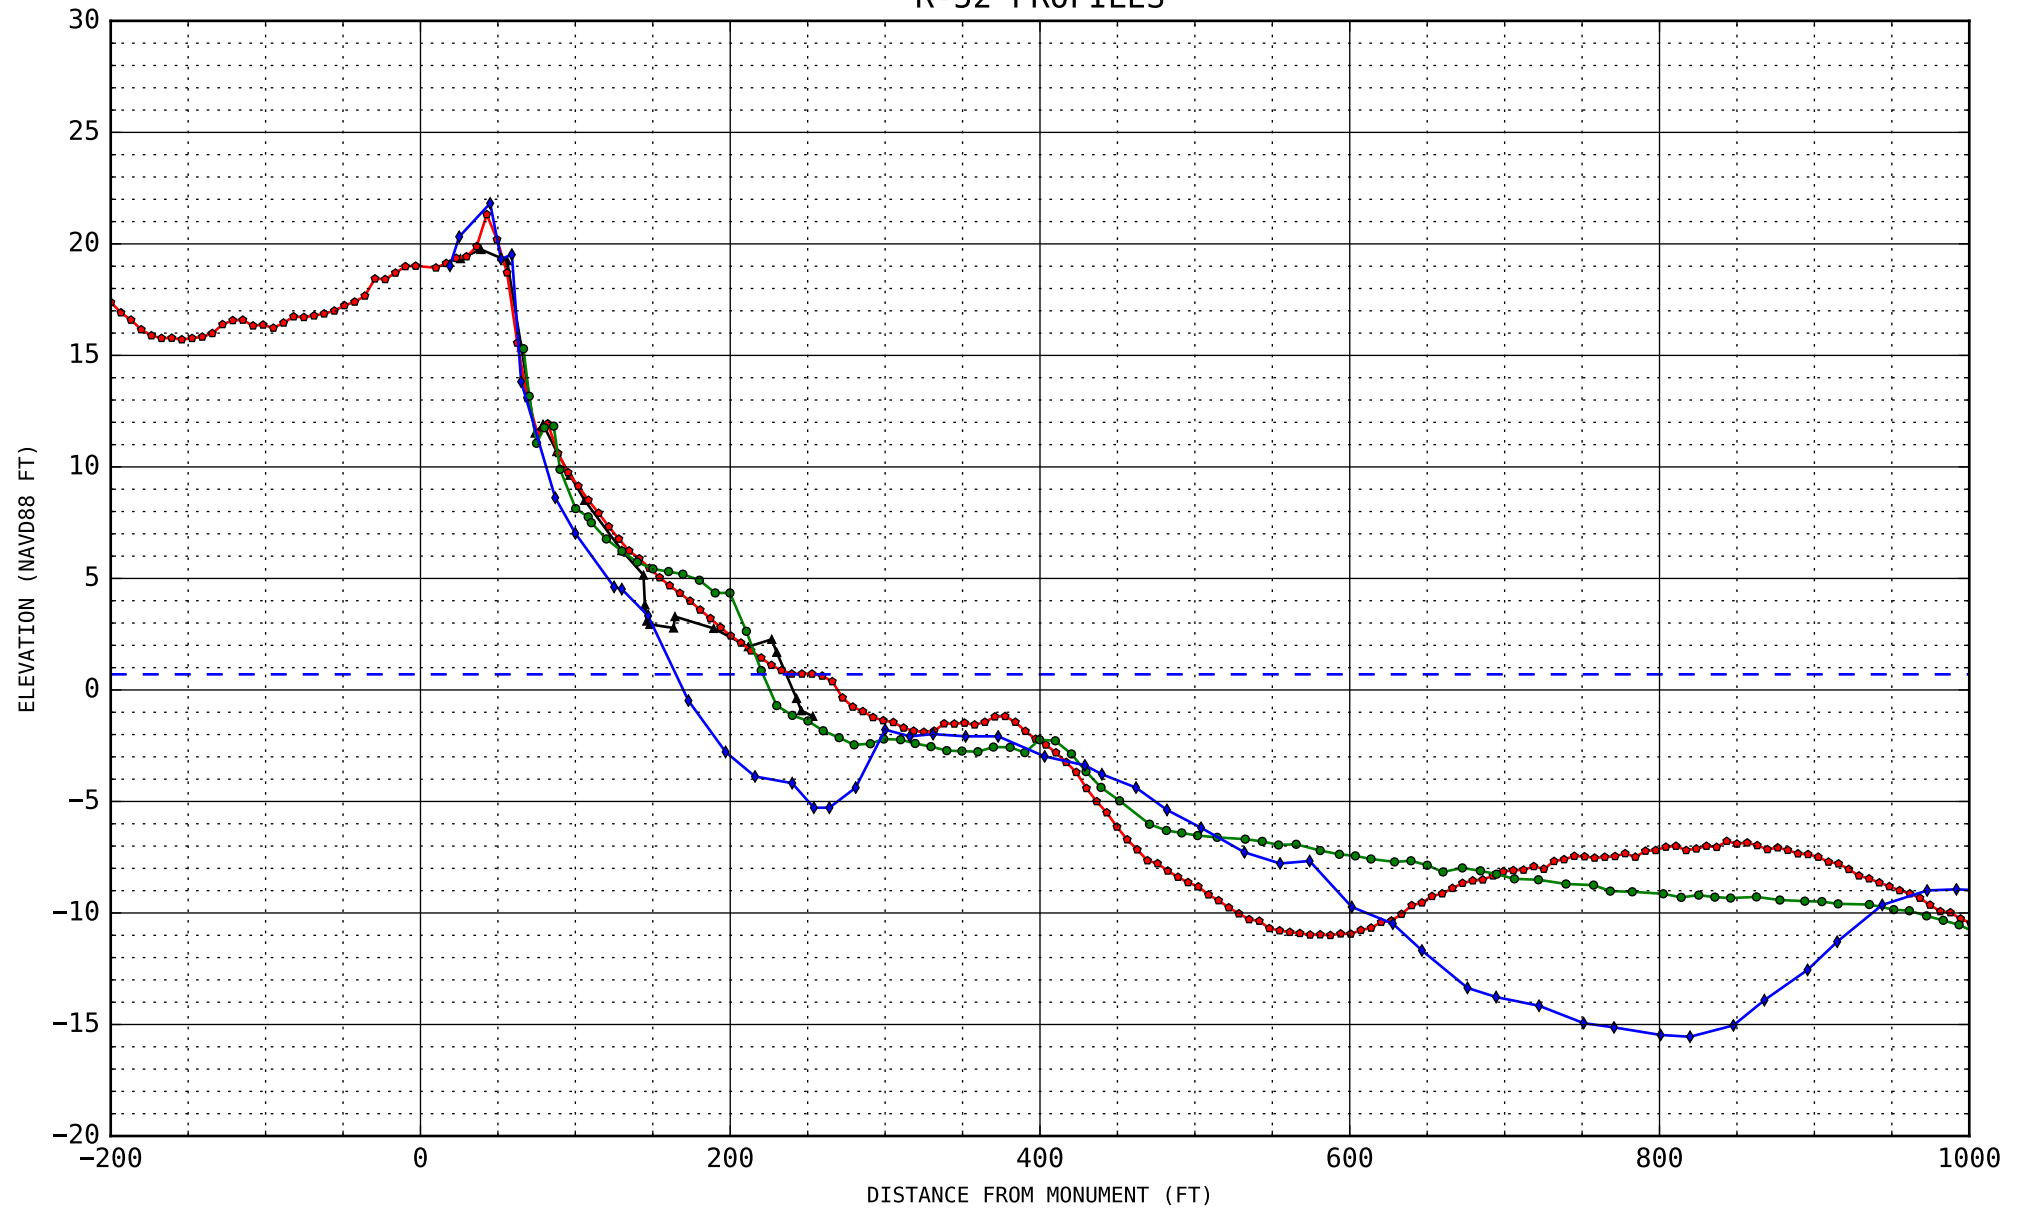
# R-52 PROFILES

- ▲ 2019-APR CONDITION BY DEP
- 2018-OCT MONITORING BY USACE-LIDAR
- 2013-SEP MONITORING BY USACE
- ◆ 2007-FEB MONITORING BY MAE
- - - MHW CONTOUR (0.7 FT)

RANGE: R-52  
EST DATE: OCT1995  
SURVEY DATE: 17APR19  
AZIMUTH: 200.0
