# R-1 PROFILES

WALTON  
PROGRAM SUPPORT GIS  
DIVISION OF WATER RESOURCE MANAGEMENT  
FLORIDA DEPARTMENT OF ENVIRONMENTAL PROTECTION

RANGE: R-1  
EST DATE: NOV1980  
SURVEY DATE: 04APR19  
AZIMUTH: 190.0

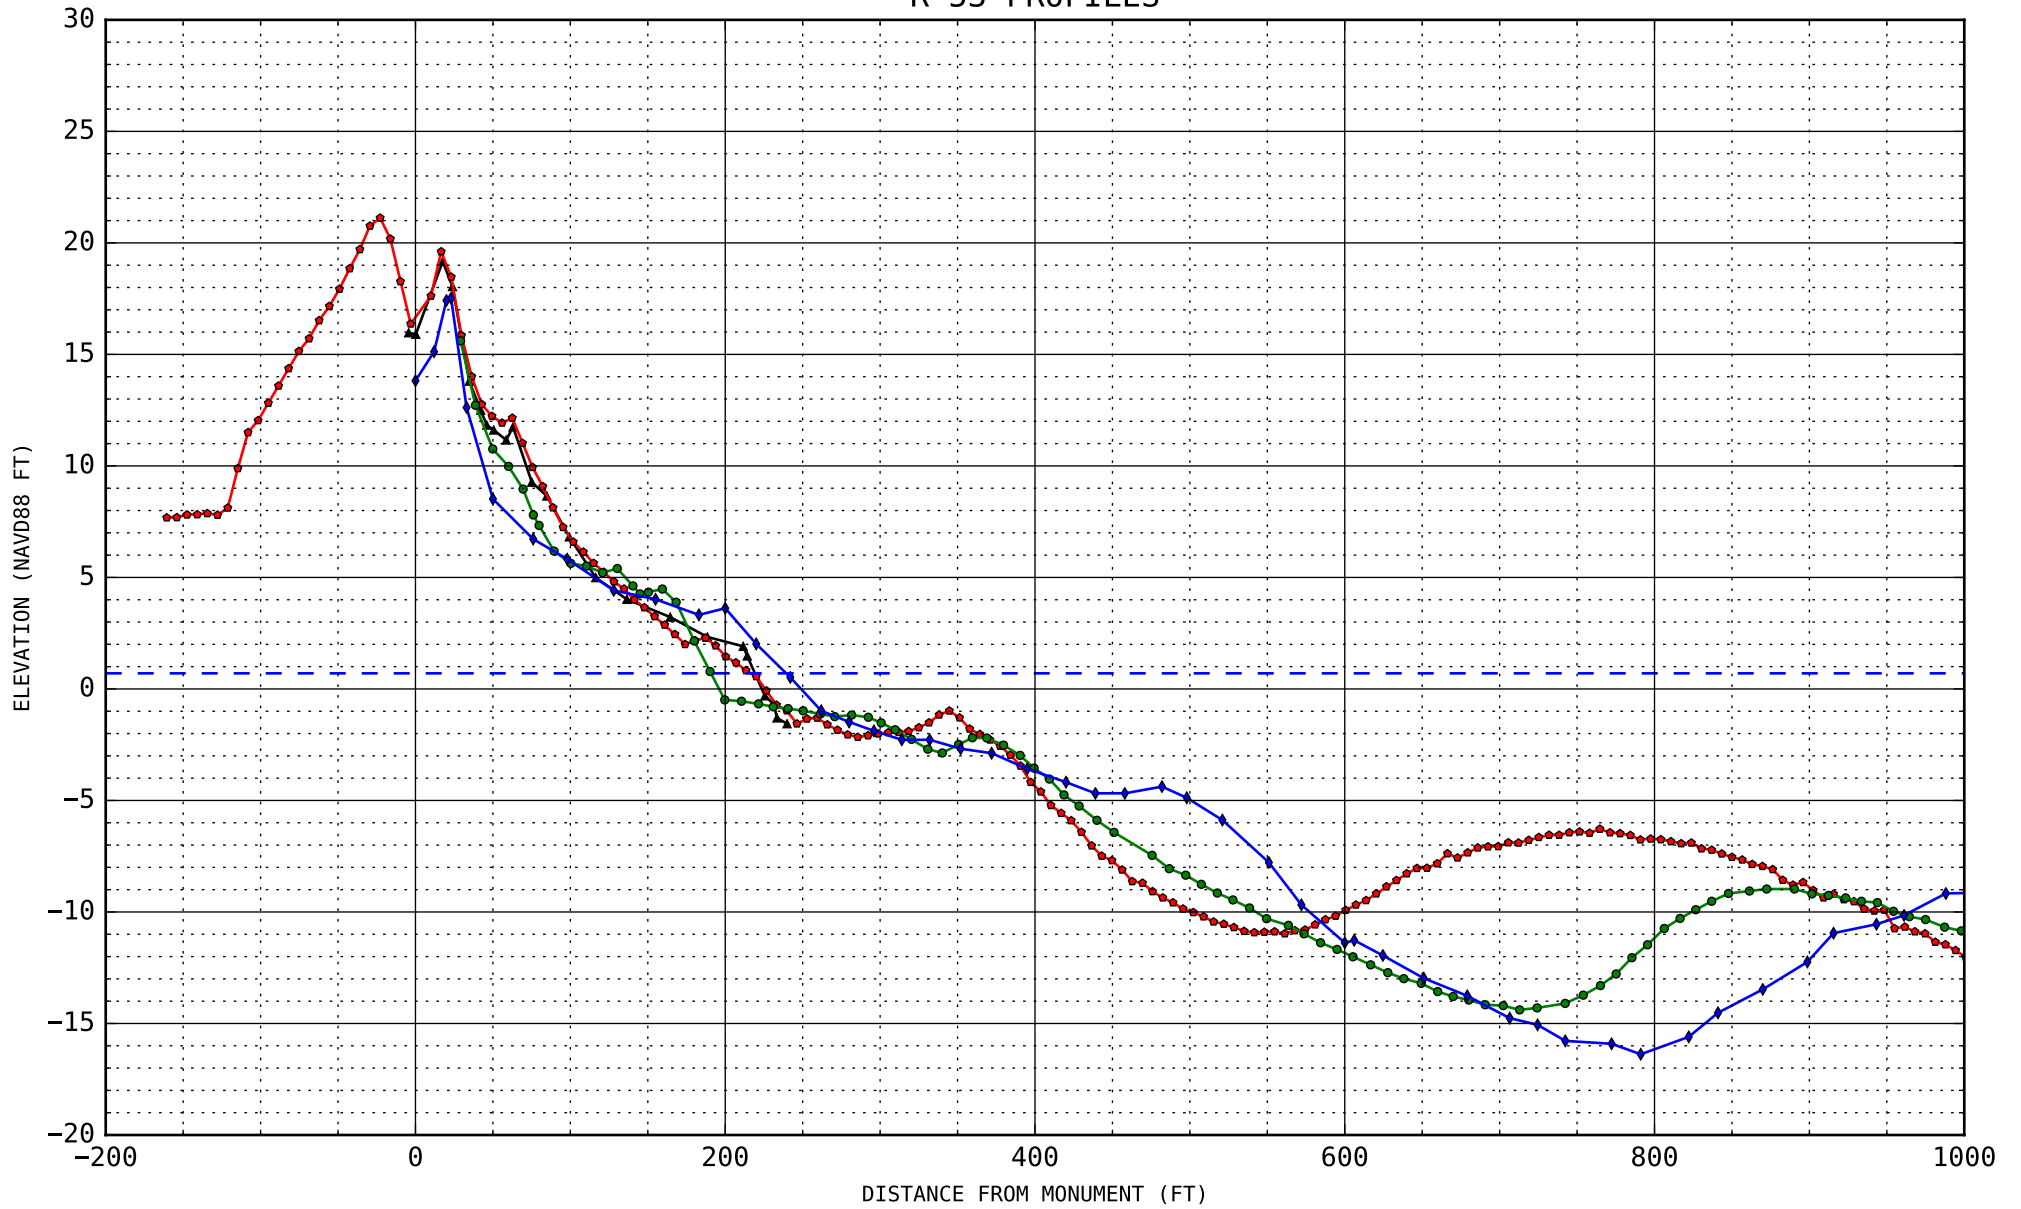
# R-53 PROFILES

- ▲ 2019-APR CONDITION BY DEP
- 2018-OCT MONITORING BY USACE-LIDAR
- 2013-SEP MONITORING BY USACE
- ◆ 2007-FEB MONITORING BY MAE
- - - MHW CONTOUR (0.7 FT)

RANGE: R-53  
EST DATE: OCT1995  
SURVEY DATE: 17APR19  
AZIMUTH: 200.0

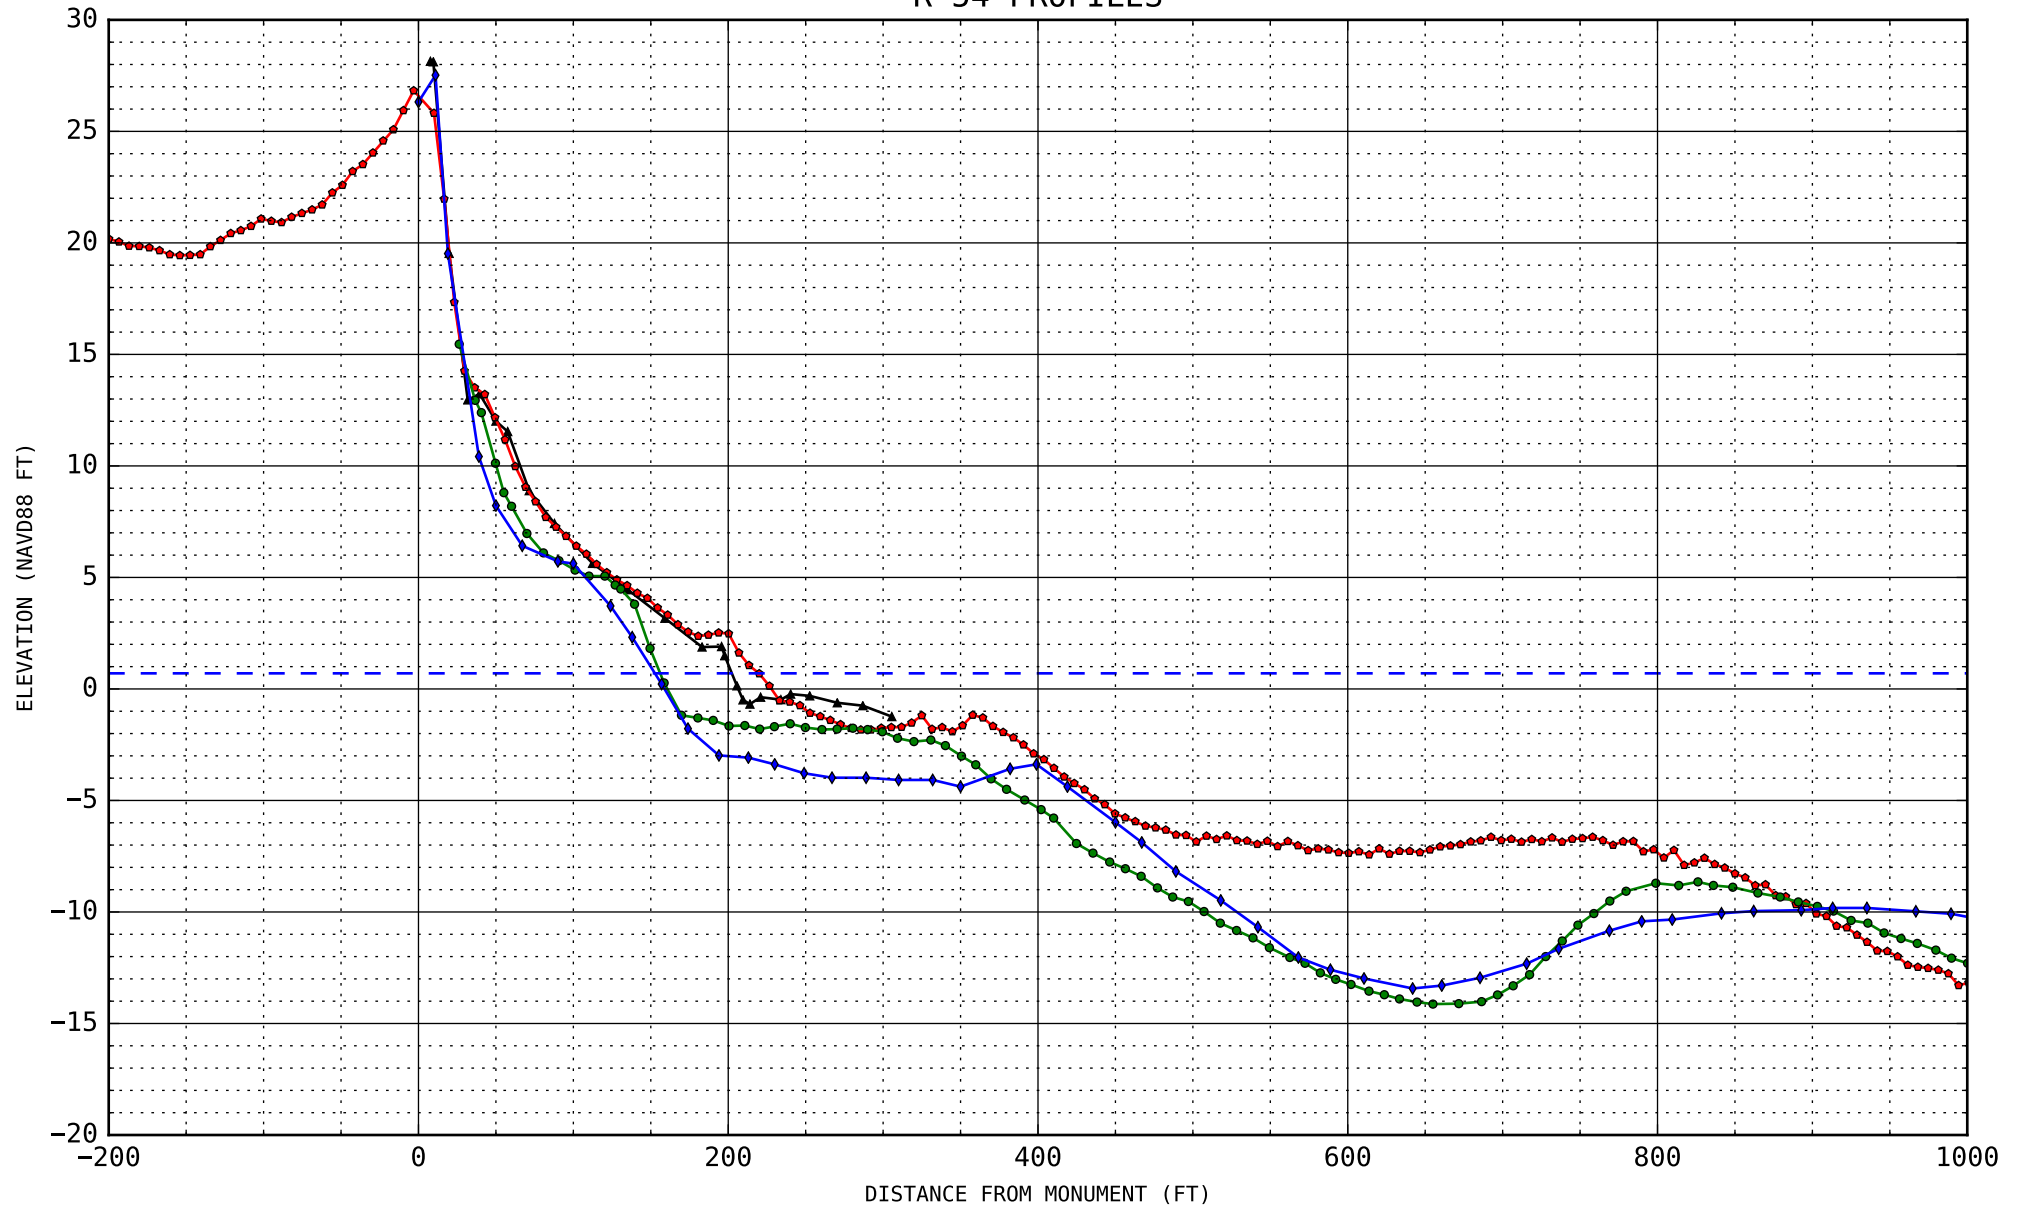
# R-54 PROFILES

- ▲ 2019-APR CONDITION BY DEP
- 2018-OCT MONITORING BY USACE-LIDAR
- 2013-SEP MONITORING BY USACE
- ◆ 2007-FEB MONITORING BY MAE
- - - MHW CONTOUR (0.7 FT)

RANGE: R-54  
EST DATE: OCT1995  
SURVEY DATE: 17APR19  
AZIMUTH: 200.0

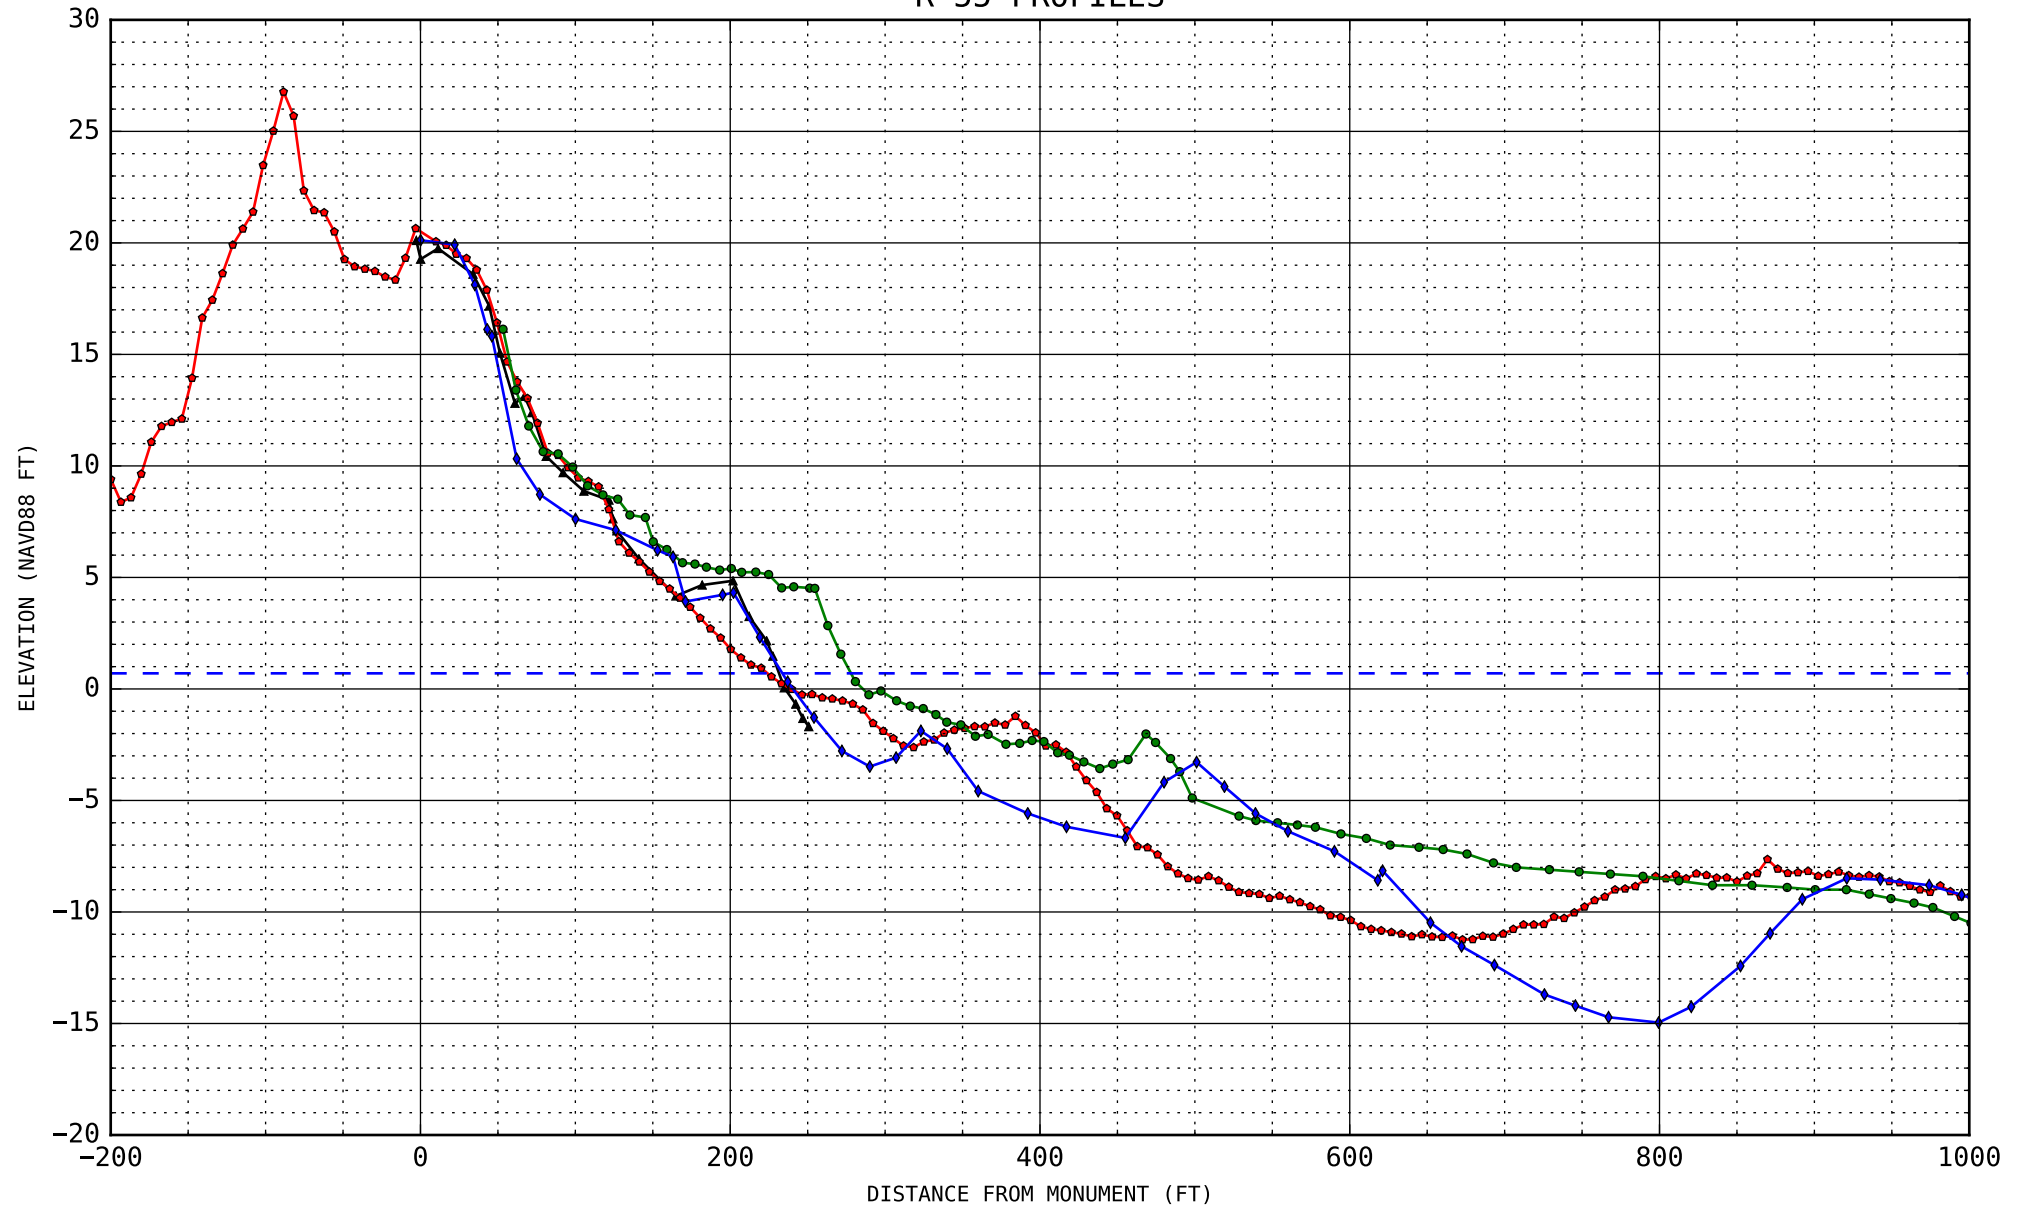
# R-55 PROFILES

- ▲ 2019-APR CONDITION BY DEP
- 2018-OCT MONITORING BY USACE-LIDAR
- 2013-SEP MONITORING BY USACE
- ◆ 2007-FEB MONITORING BY MAE
- - - MHW CONTOUR (0.7 FT)

RANGE: R-55  
EST DATE: NOV1980  
SURVEY DATE: 17APR19  
AZIMUTH: 200.0

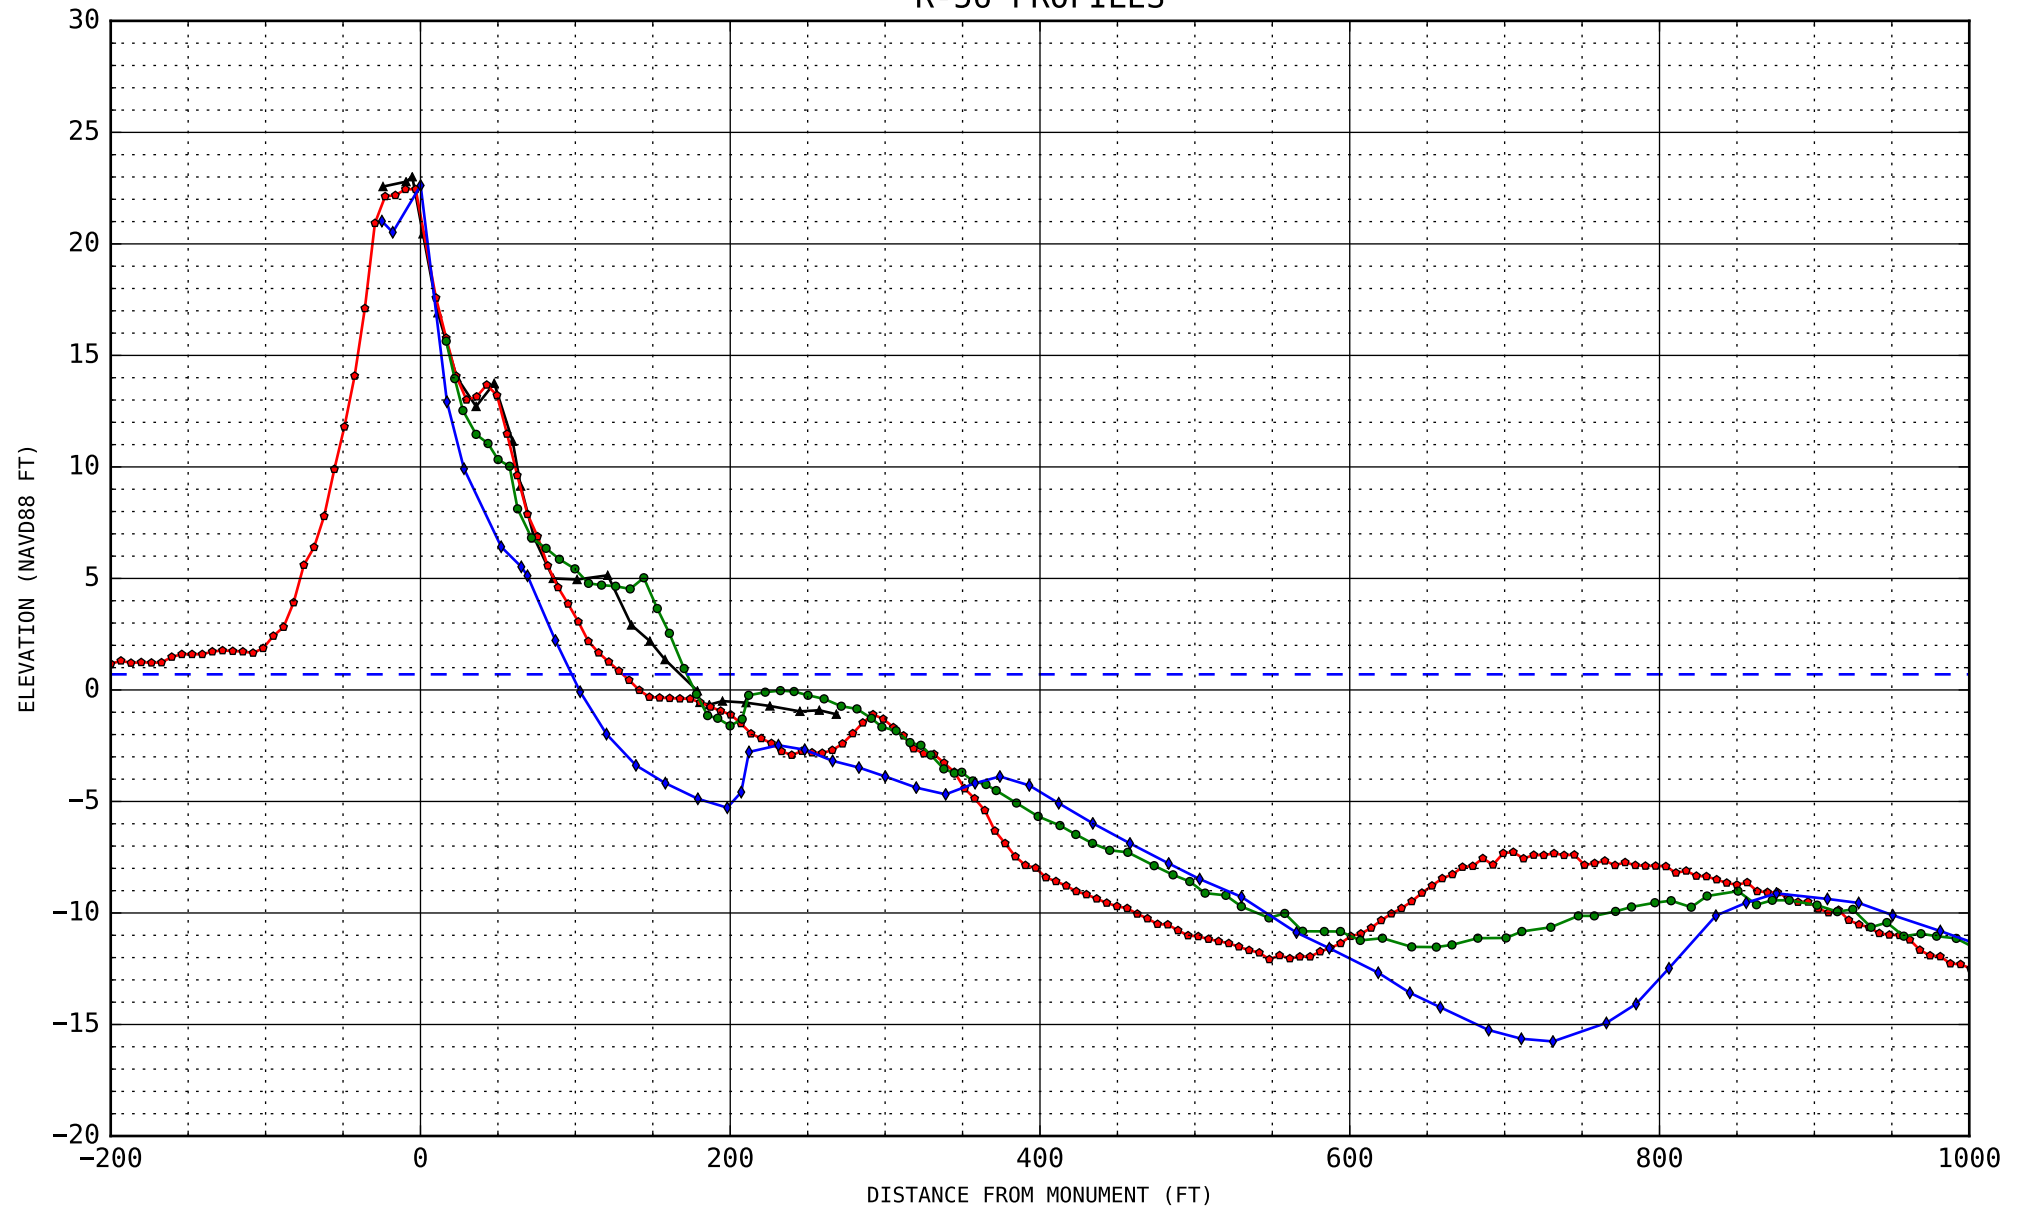
# R-56 PROFILES

- ▲ 2019-APR CONDITION BY DEP
- 2018-OCT MONITORING BY USACE-LIDAR
- 2013-SEP MONITORING BY USACE
- ◆ 2007-FEB MONITORING BY MAE
- - - MHW CONTOUR (0.7 FT)

RANGE: R-56  
EST DATE: OCT1995  
SURVEY DATE: 17APR19  
AZIMUTH: 200.0

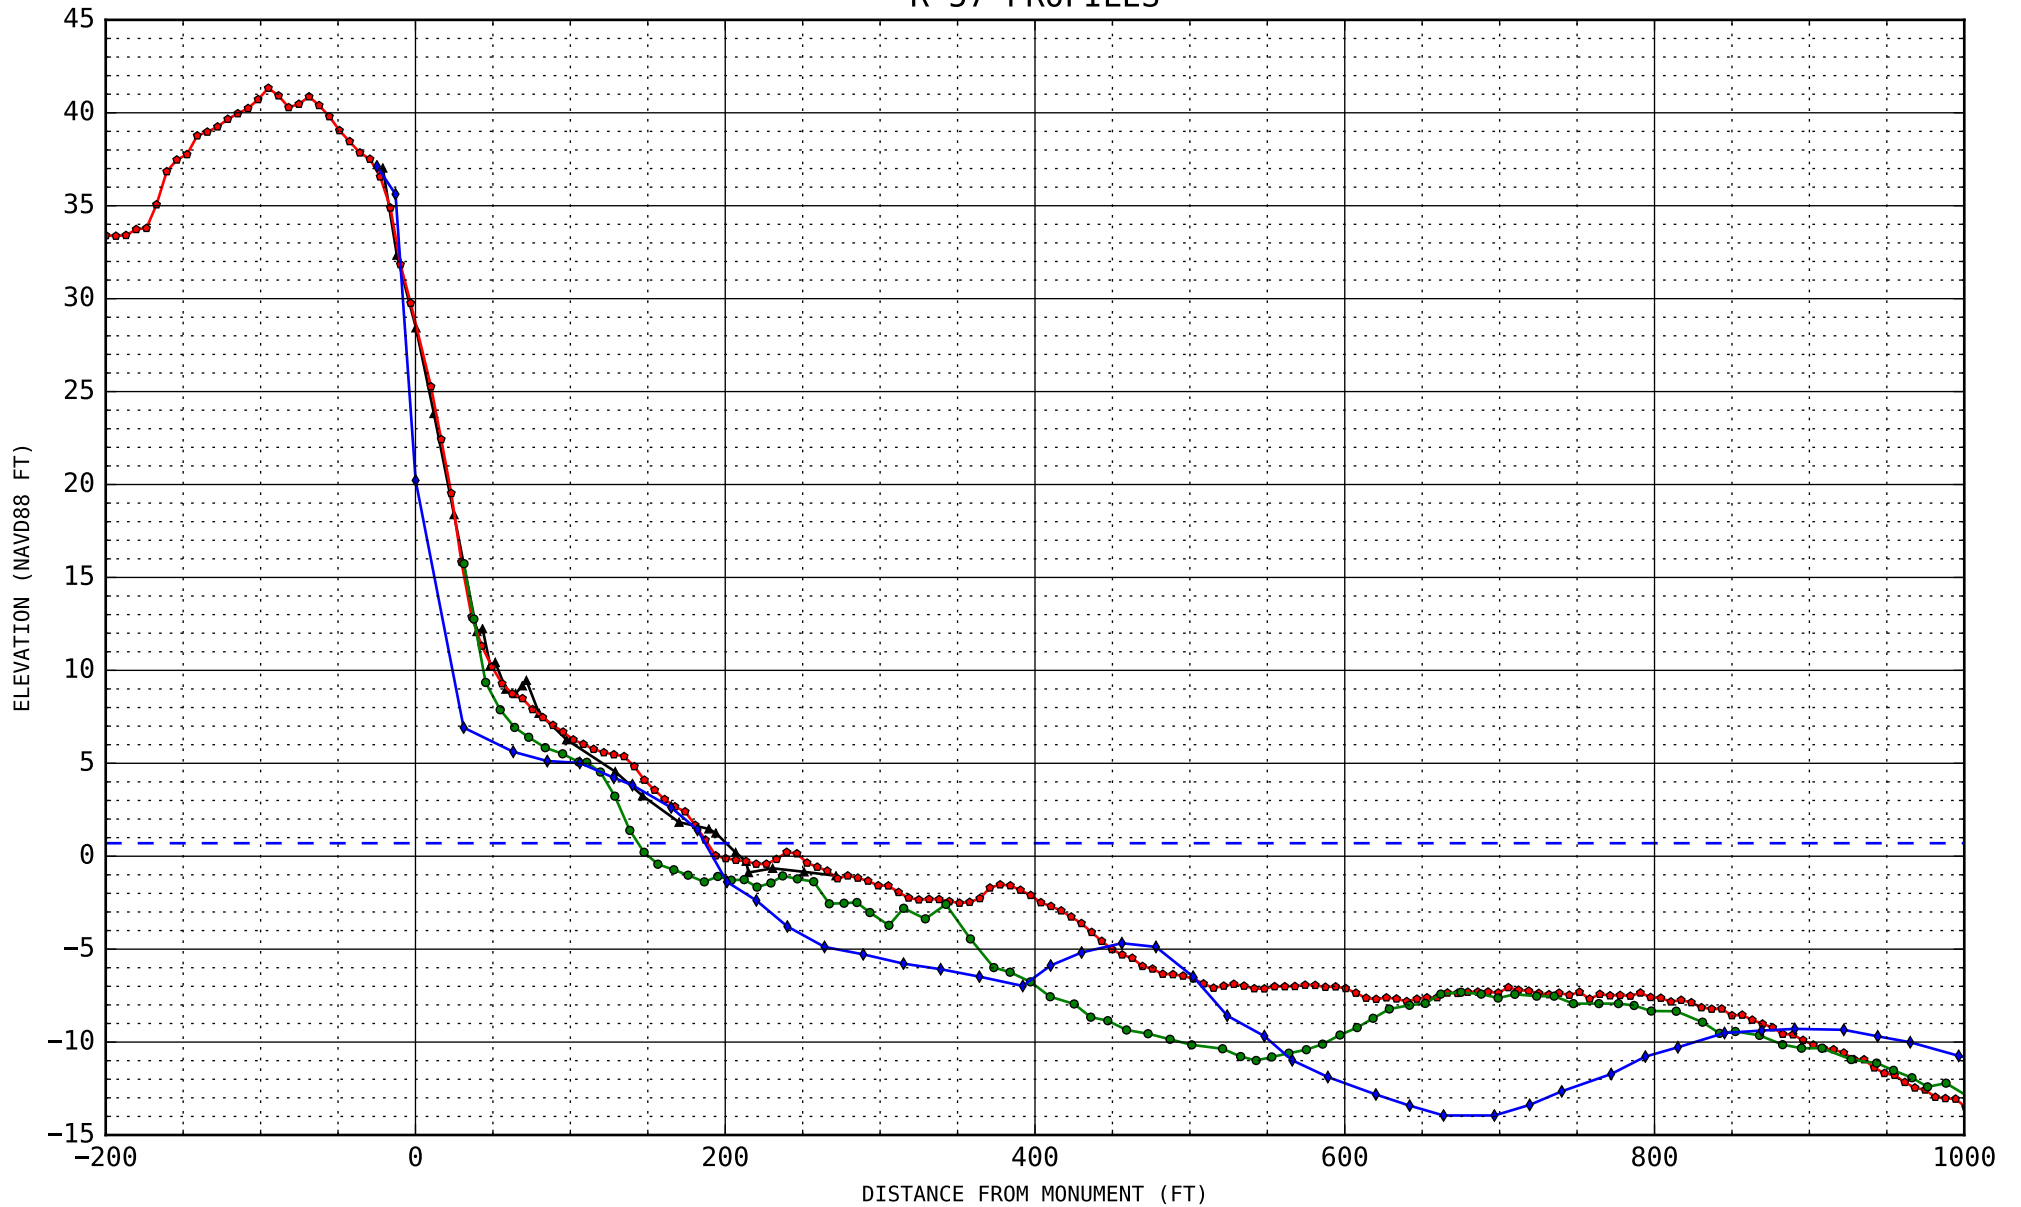
# R-57 PROFILES

- ▲ 2019-APR CONDITION BY DEP
- 2018-OCT MONITORING BY USACE-LIDAR
- 2013-SEP MONITORING BY USACE
- ◆ 2007-FEB MONITORING BY MAE
- - - MHW CONTOUR (0.7 FT)

RANGE: R-57  
EST DATE: JUN1973  
SURVEY DATE: 17APR19  
AZIMUTH: 200.0

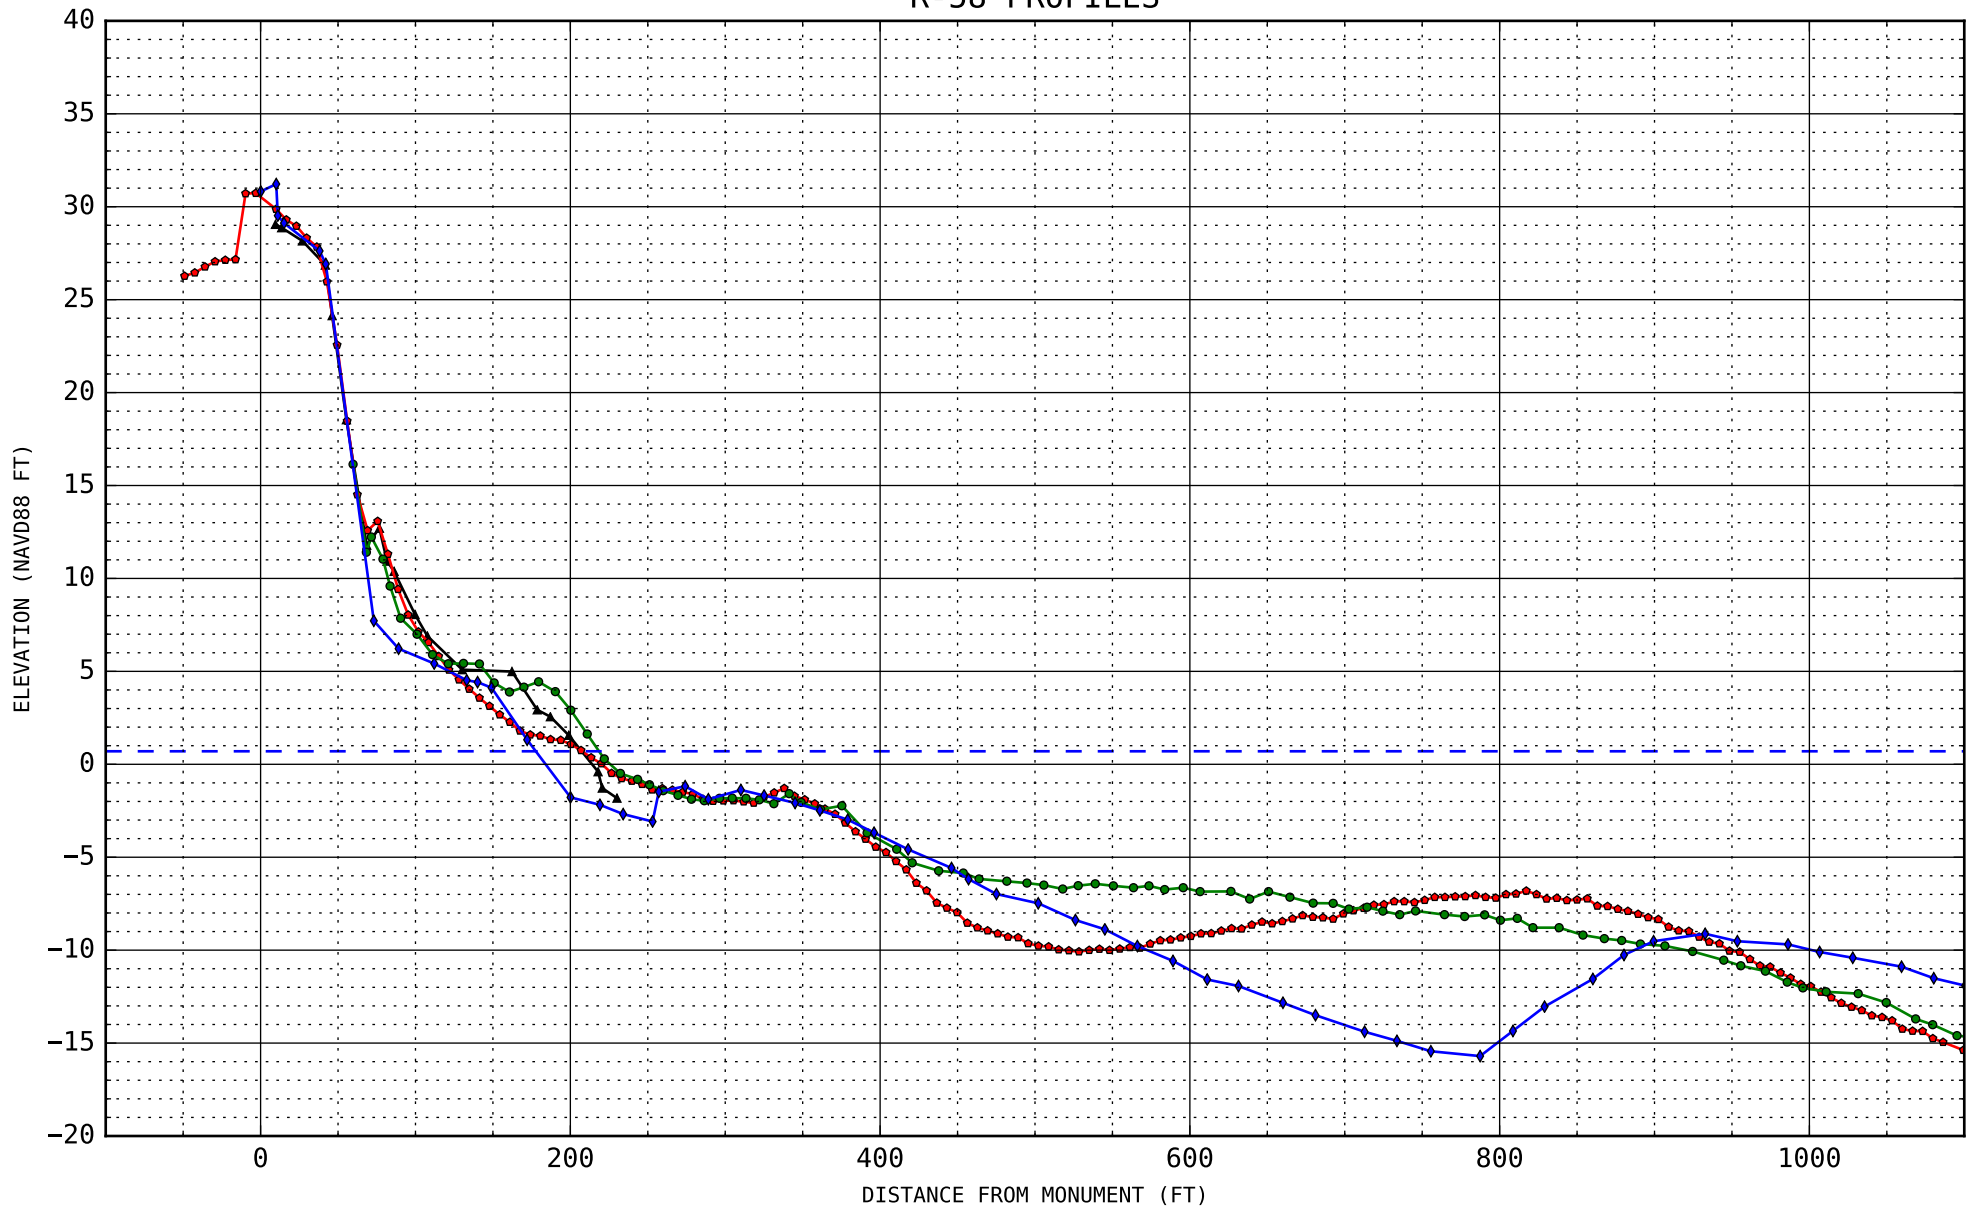
# R-58 PROFILES

- ▲ 2019-APR CONDITION BY DEP
- 2018-OCT MONITORING BY USACE-LIDAR
- 2013-SEP MONITORING BY USACE
- ◆ 2007-FEB MONITORING BY MAE
- - - MHW CONTOUR (0.7 FT)

RANGE: R-58  
EST DATE: M&E1997  
SURVEY DATE: 17APR19  
AZIMUTH: 200.0

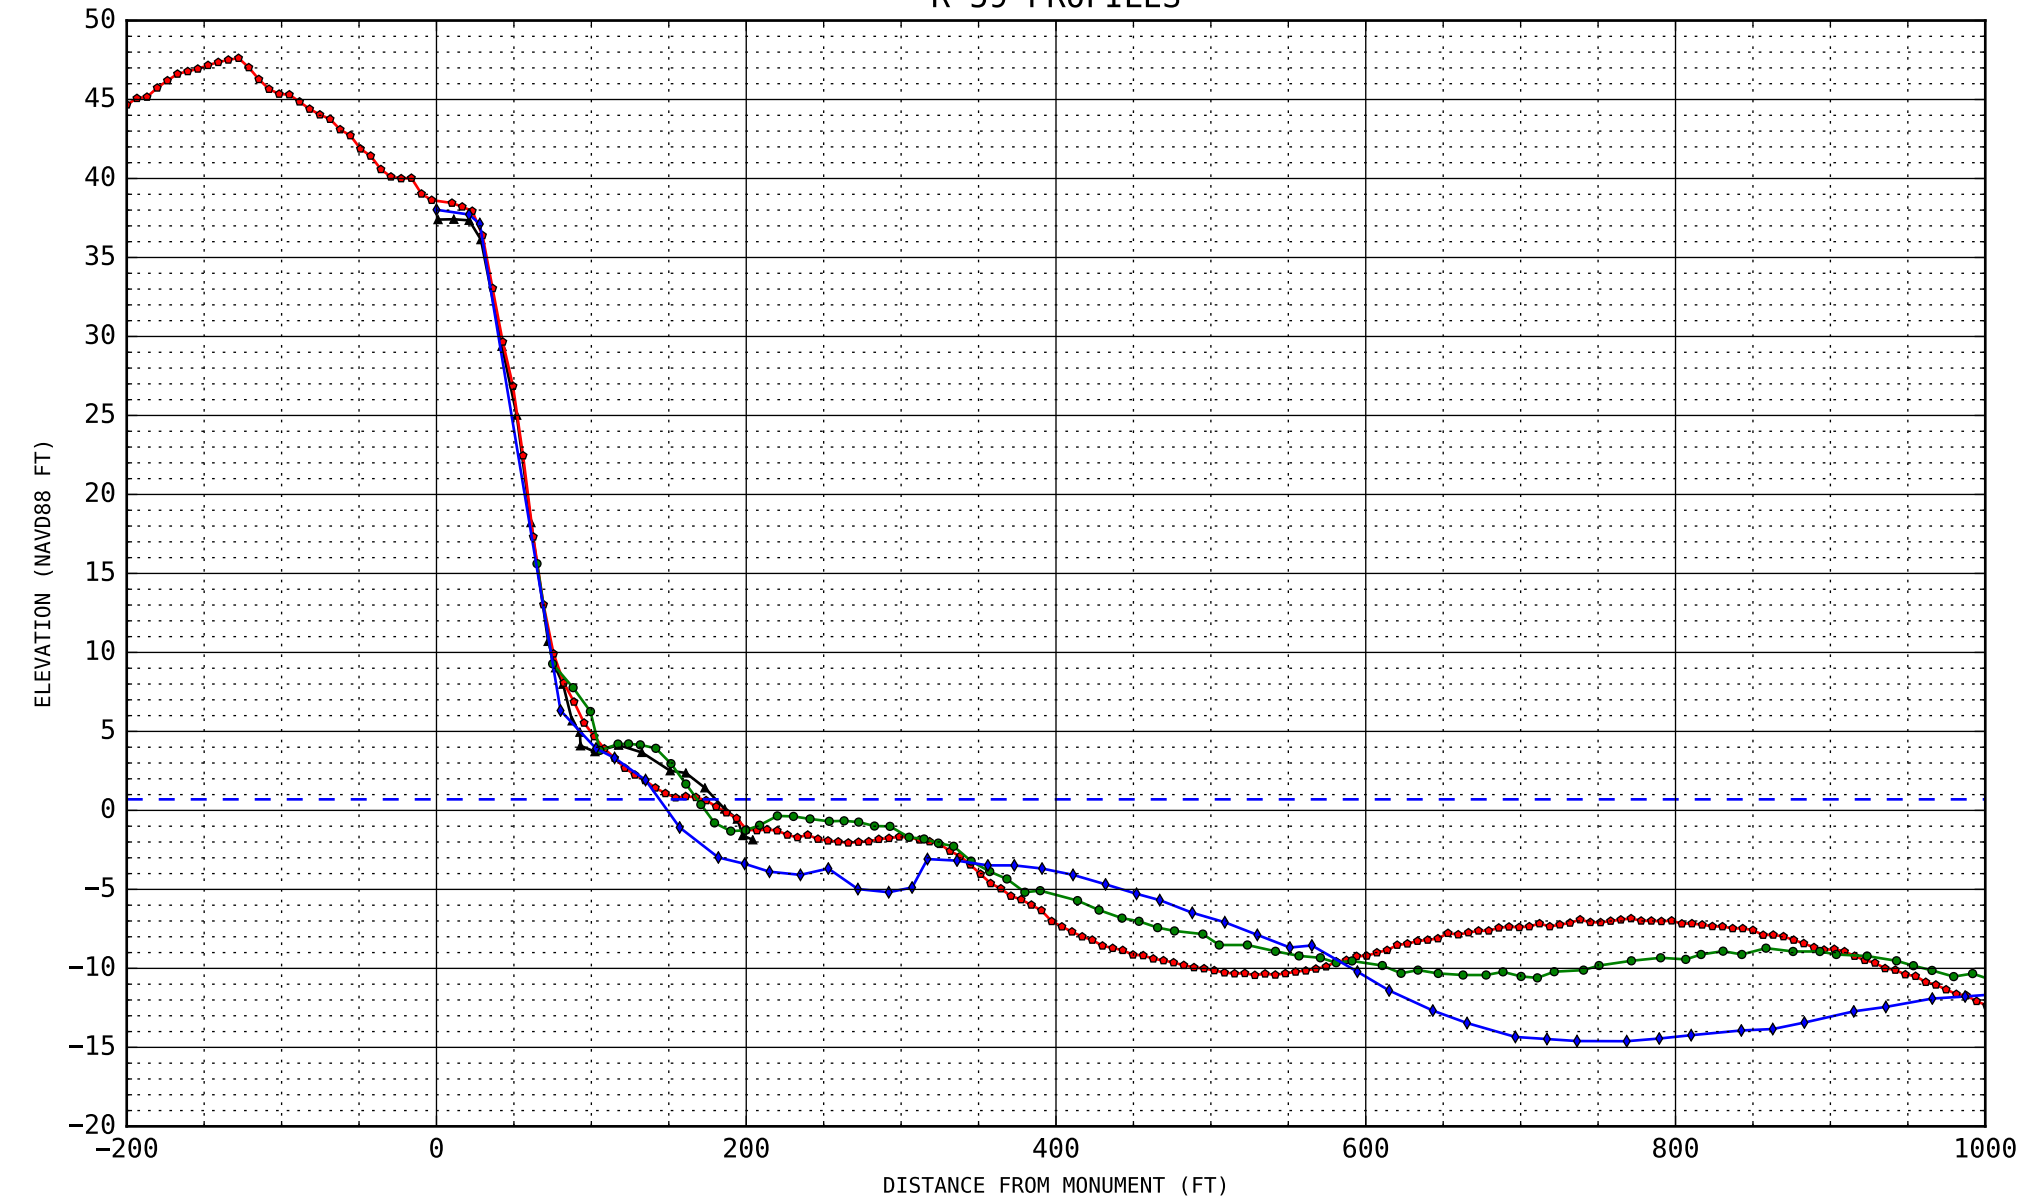
# R-59 PROFILES

- ▲ 2019-APR CONDITION BY DEP
- 2018-OCT MONITORING BY USACE-LIDAR
- 2013-SEP MONITORING BY USACE
- ◆ 2007-FEB MONITORING BY MAE
- - - MHW CONTOUR (0.7 FT)

RANGE: R-59  
EST DATE: OCT1995  
SURVEY DATE: 17APR19  
AZIMUTH: 200.0

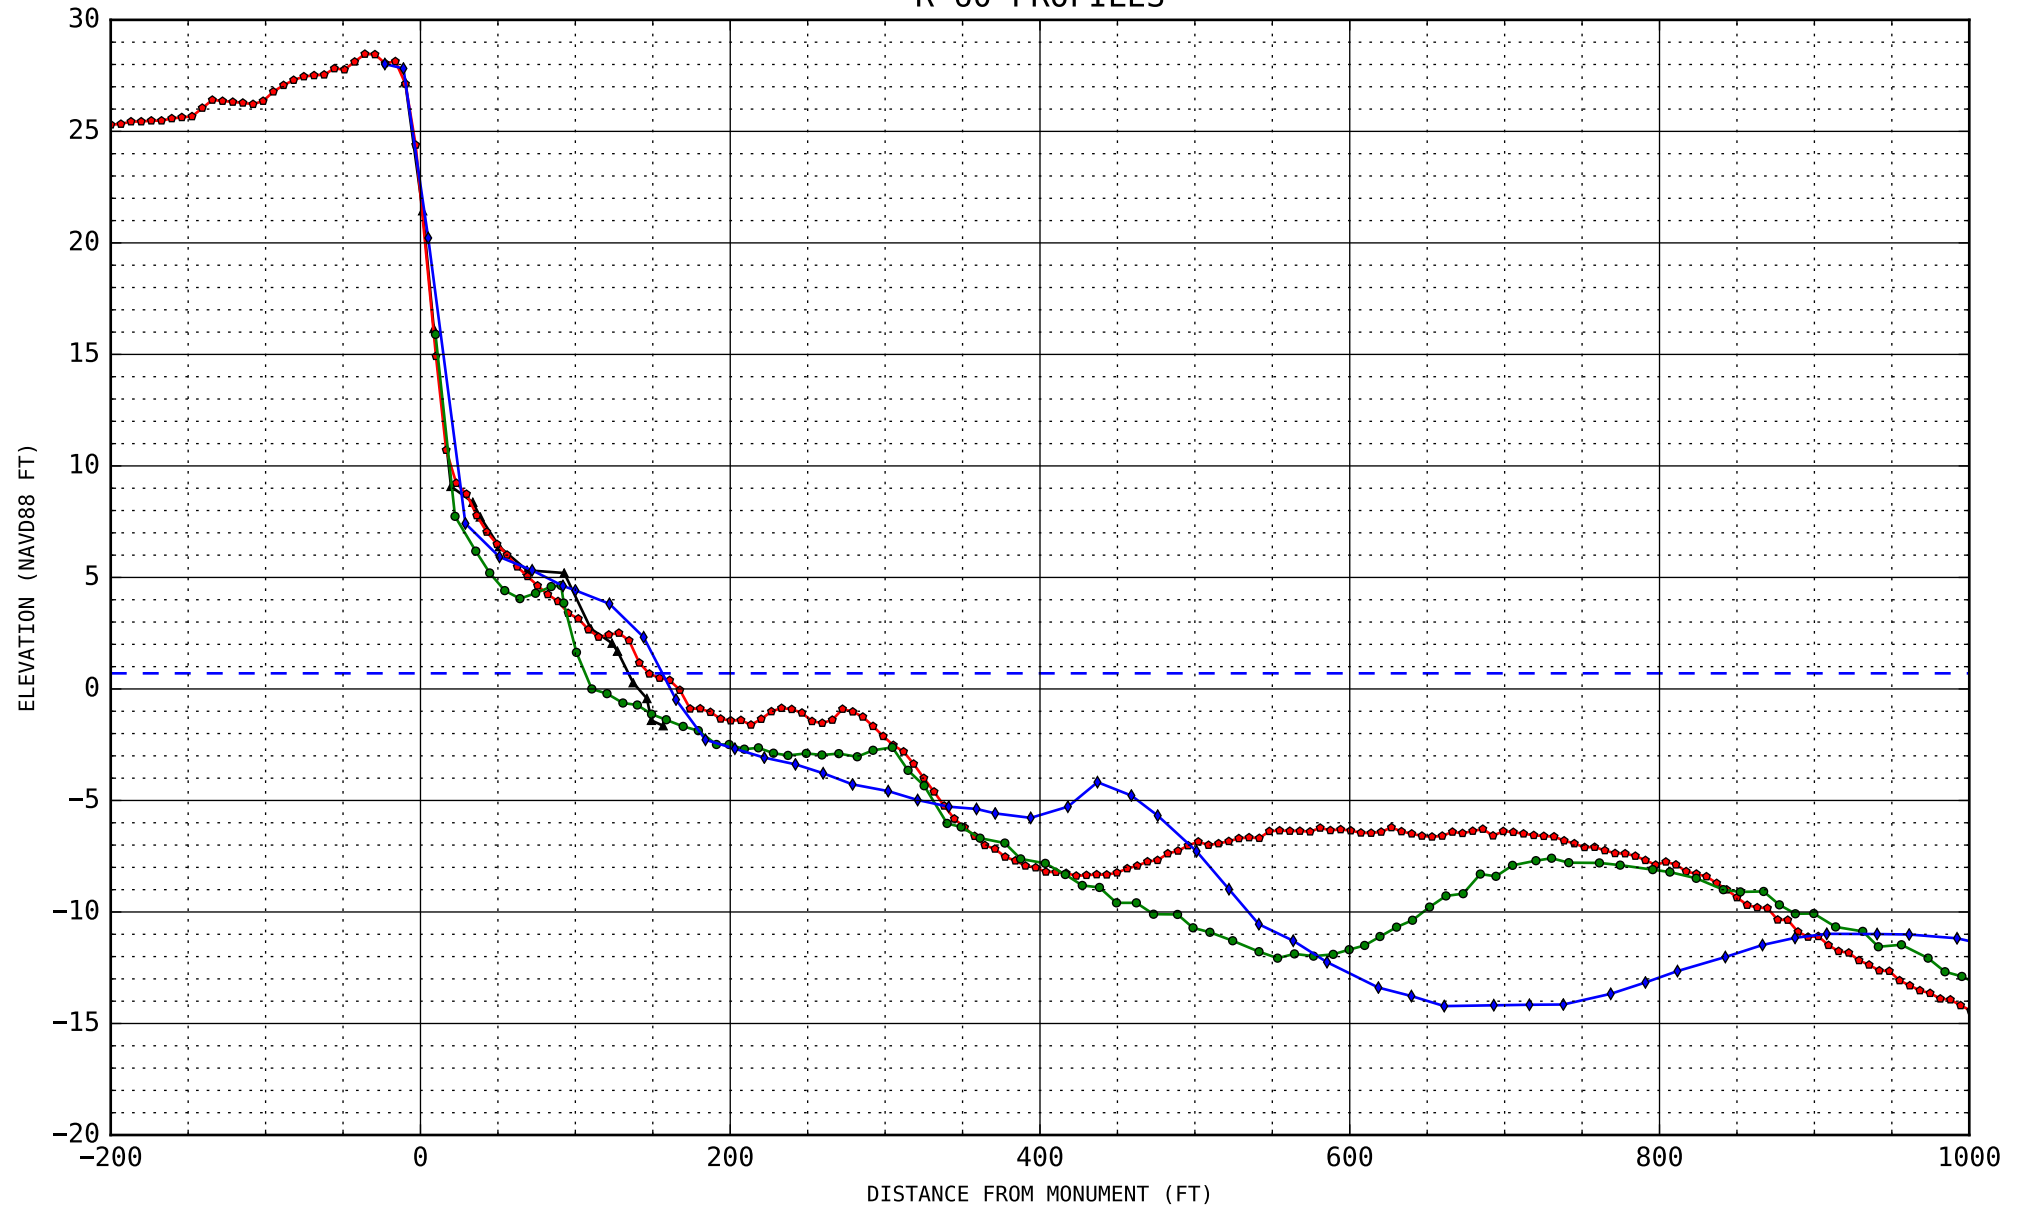
# R-60 PROFILES

- ▲ 2019-APR CONDITION BY DEP
- 2018-OCT MONITORING BY USACE-LIDAR
- 2013-SEP MONITORING BY USACE
- ◆ 2007-FEB MONITORING BY MAE
- - - MHW CONTOUR (0.7 FT)

RANGE: R-60  
EST DATE: JUN1973  
SURVEY DATE: 17APR19  
AZIMUTH: 200.0

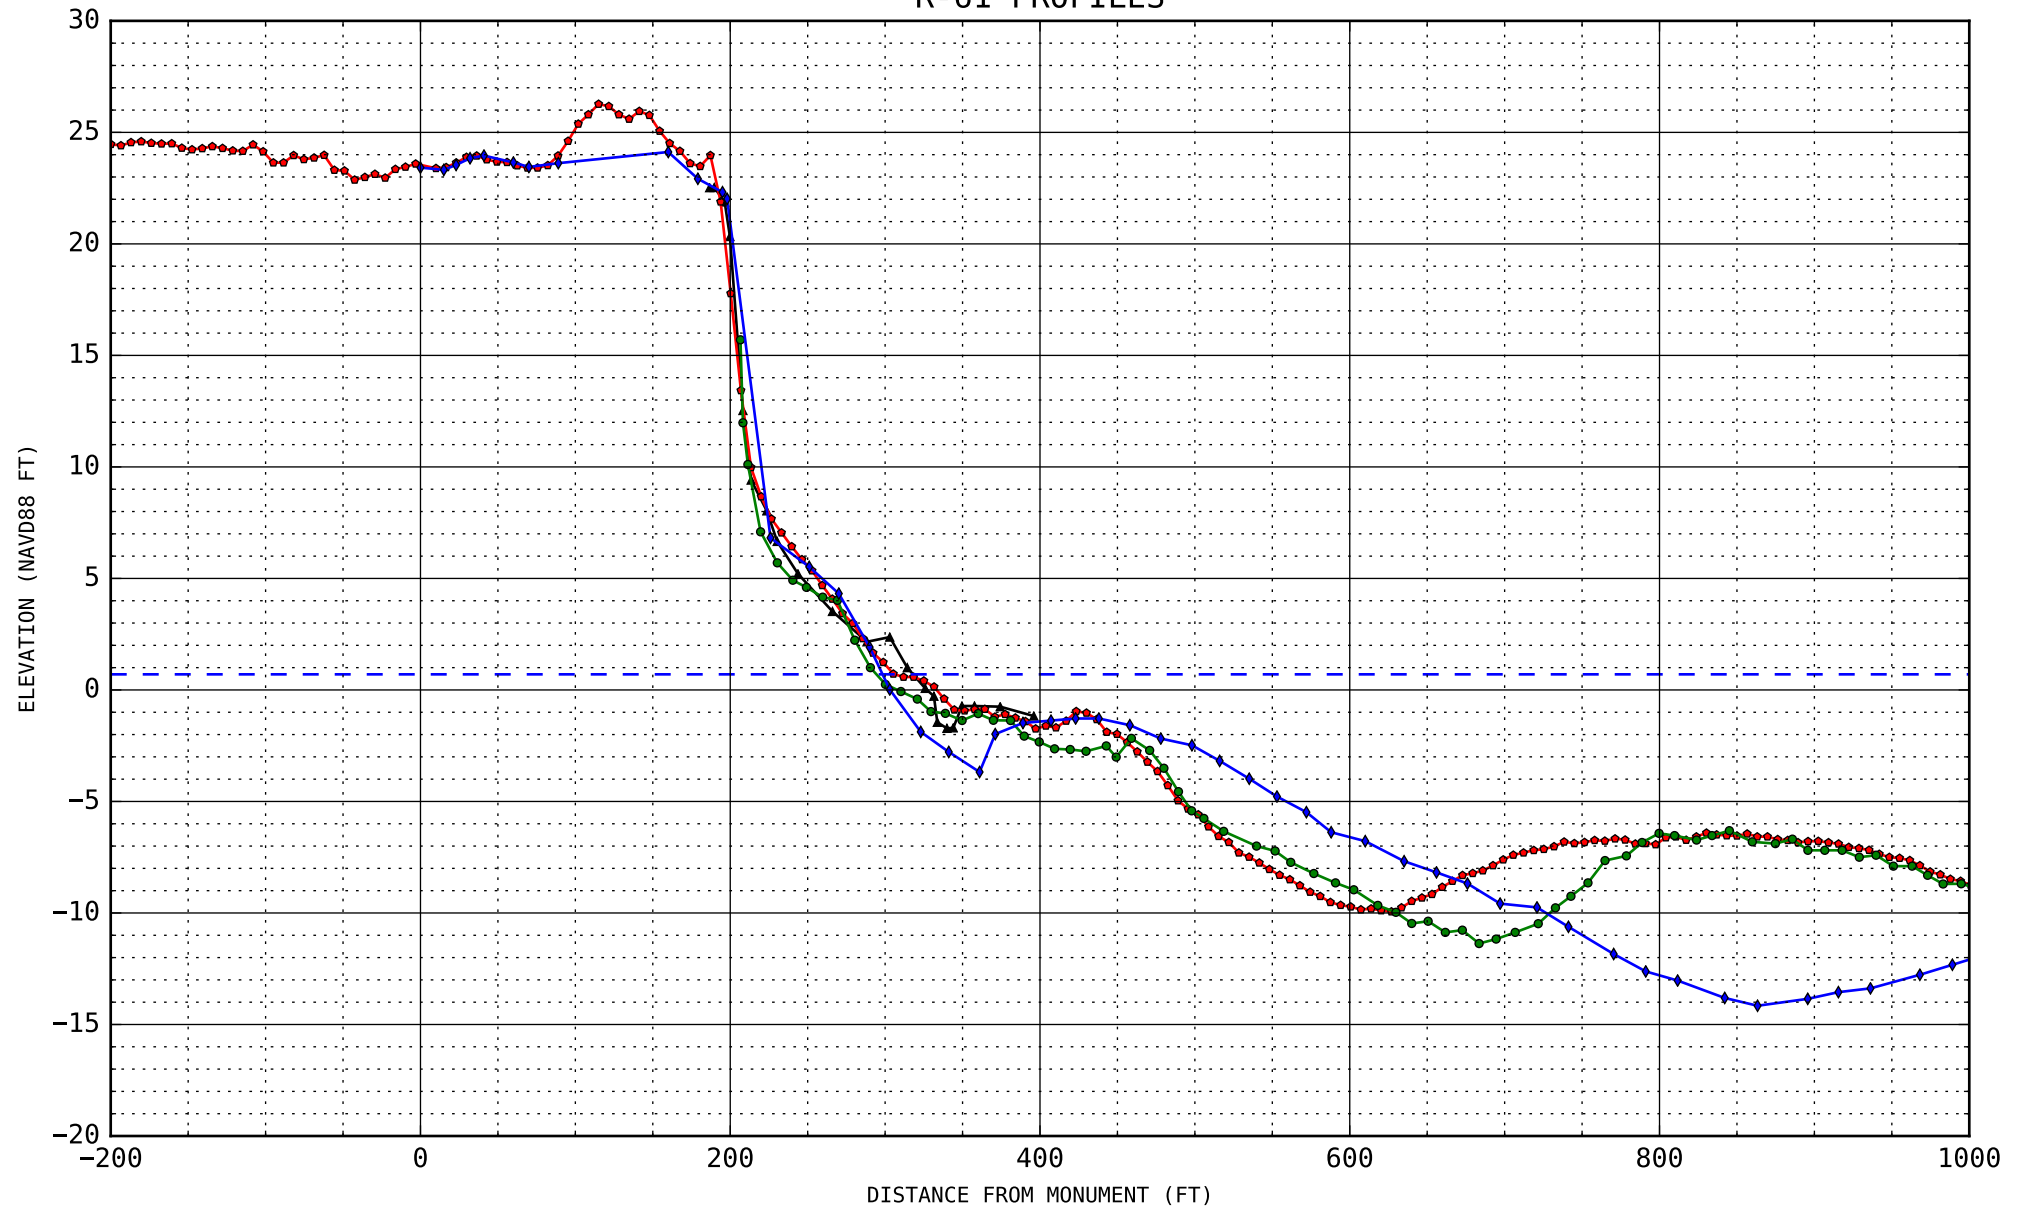
# R-61 PROFILES

- ▲ 2019-APR CONDITION BY DEP
- 2018-OCT MONITORING BY USACE-LIDAR
- 2013-SEP MONITORING BY USACE
- ◆ 2007-FEB MONITORING BY MAE
- - - MHW CONTOUR (0.7 FT)
