# R-1 PROFILES

WALTON  
PROGRAM SUPPORT GIS  
DIVISION OF WATER RESOURCE MANAGEMENT  
FLORIDA DEPARTMENT OF ENVIRONMENTAL PROTECTION

RANGE: R-1  
EST DATE: NOV1980  
SURVEY DATE: 04APR19  
AZIMUTH: 190.0

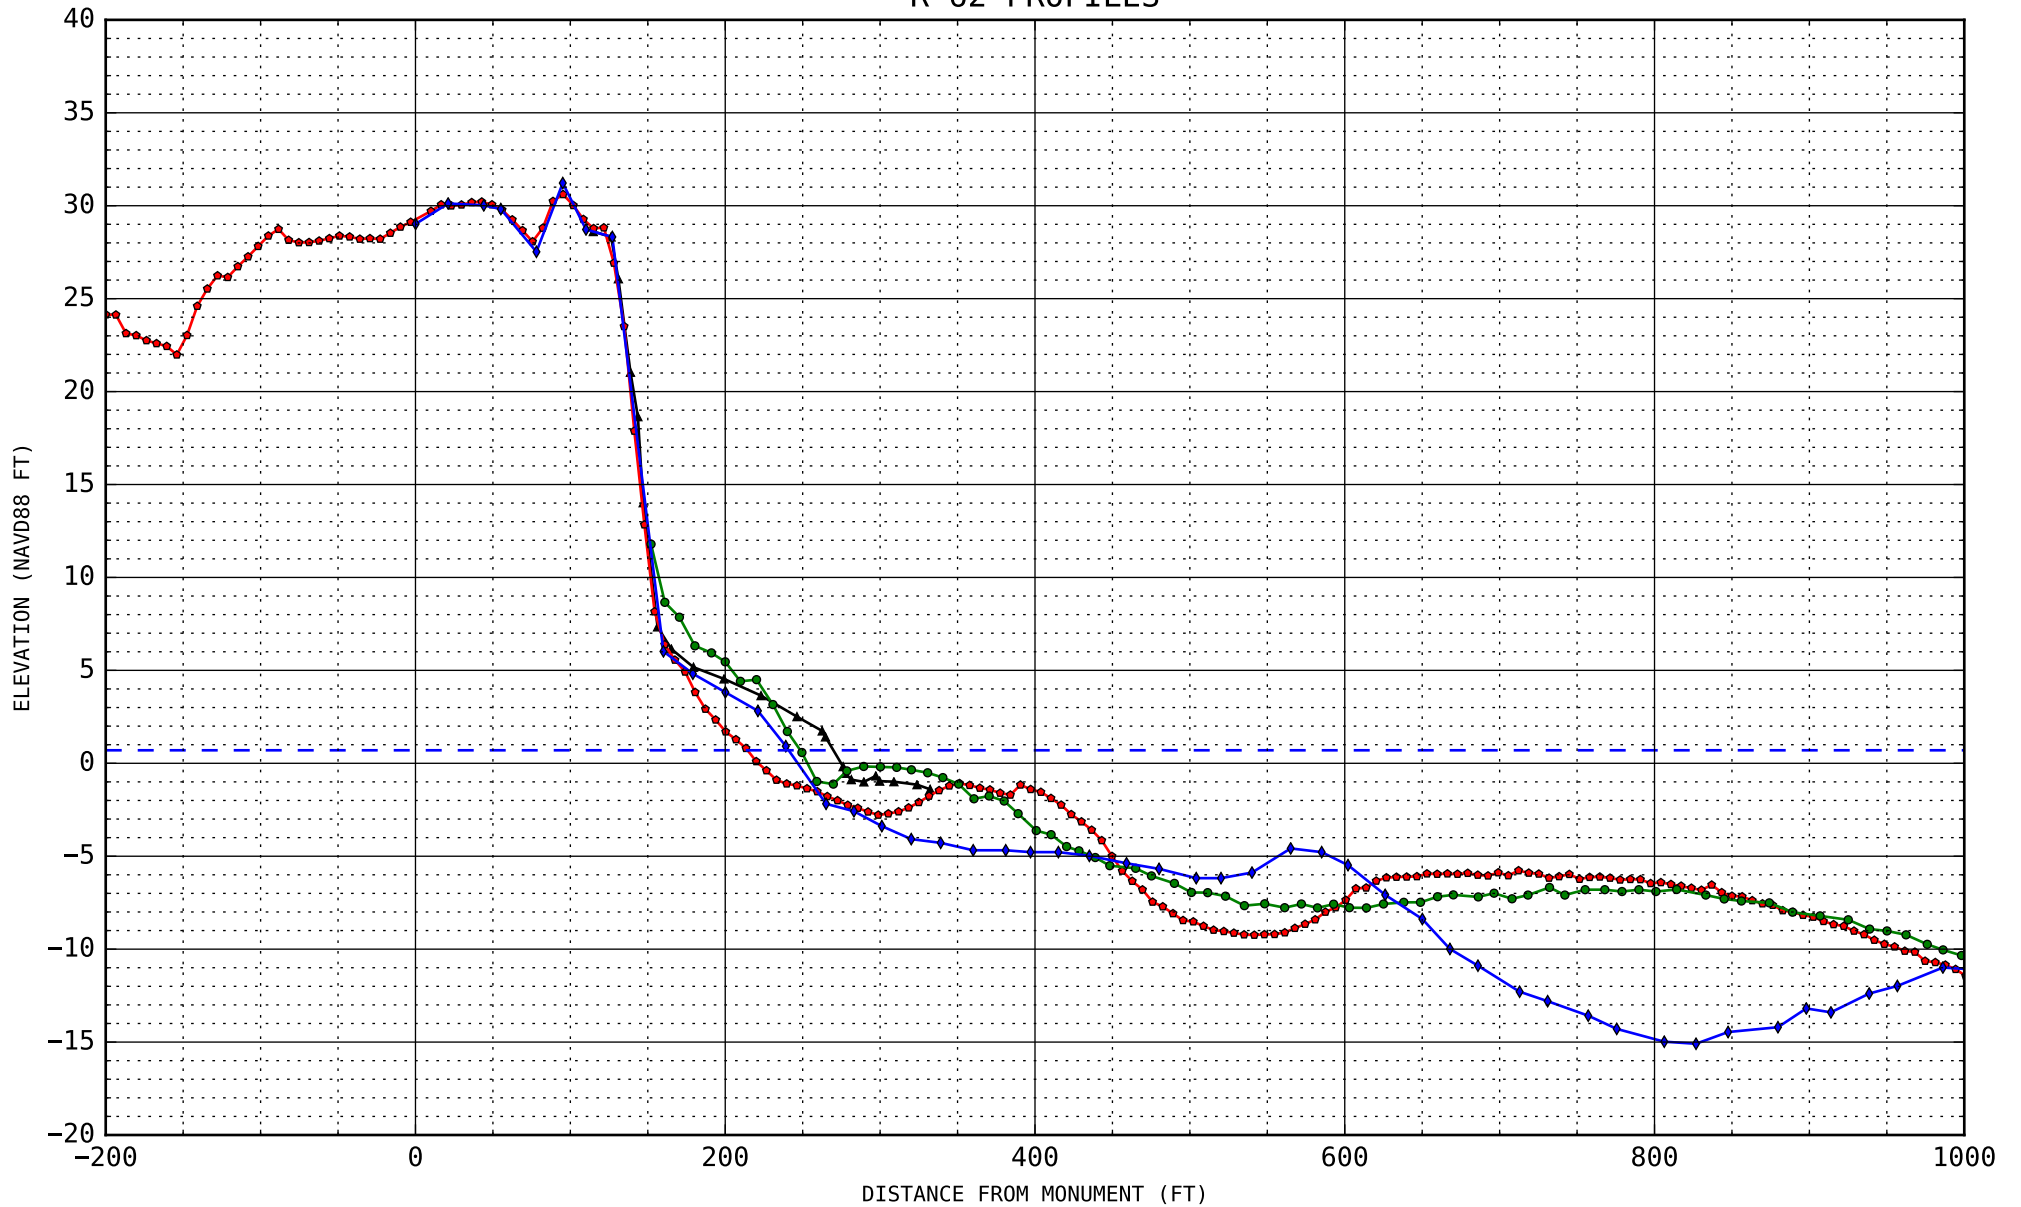
# R-62 PROFILES

- ▲ 2019-APR CONDITION BY DEP
- 2018-OCT MONITORING BY USACE-LIDAR
- 2013-SEP MONITORING BY USACE
- ◆ 2007-FEB MONITORING BY MAE
- - - MHW CONTOUR (0.7 FT)

RANGE: R-62  
EST DATE: OCT1995  
SURVEY DATE: 17APR19  
AZIMUTH: 200.0

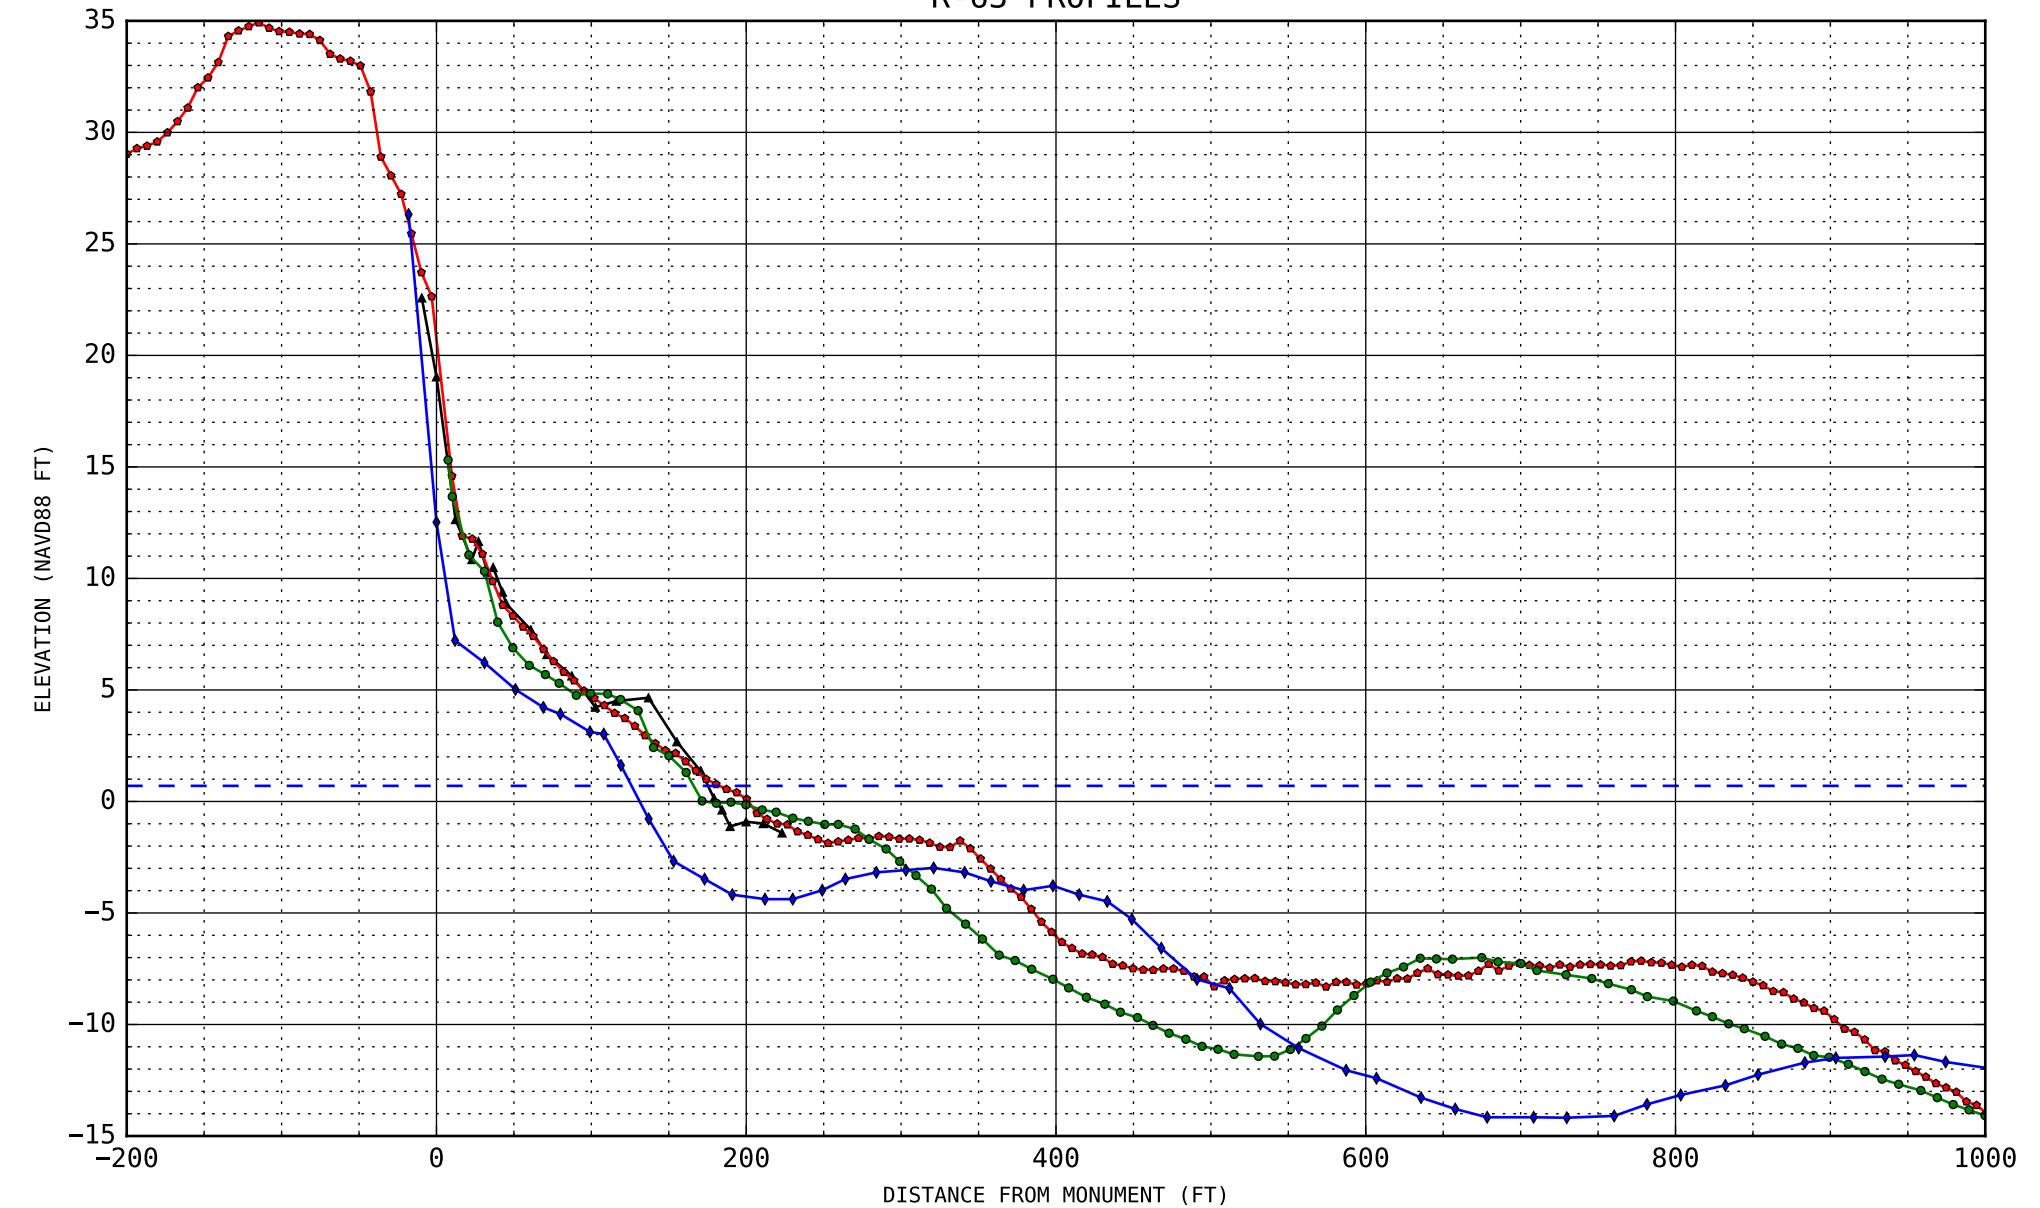
# R-63 PROFILES

- ▲ 2019-APR CONDITION BY DEP
- 2018-OCT MONITORING BY USACE-LIDAR
- 2013-SEP MONITORING BY USACE
- ◆ 2007-FEB MONITORING BY MAE
- - - MHW CONTOUR (0.7 FT)

RANGE: R-63  
EST DATE: JUN1973  
SURVEY DATE: 17APR19  
AZIMUTH: 195.0

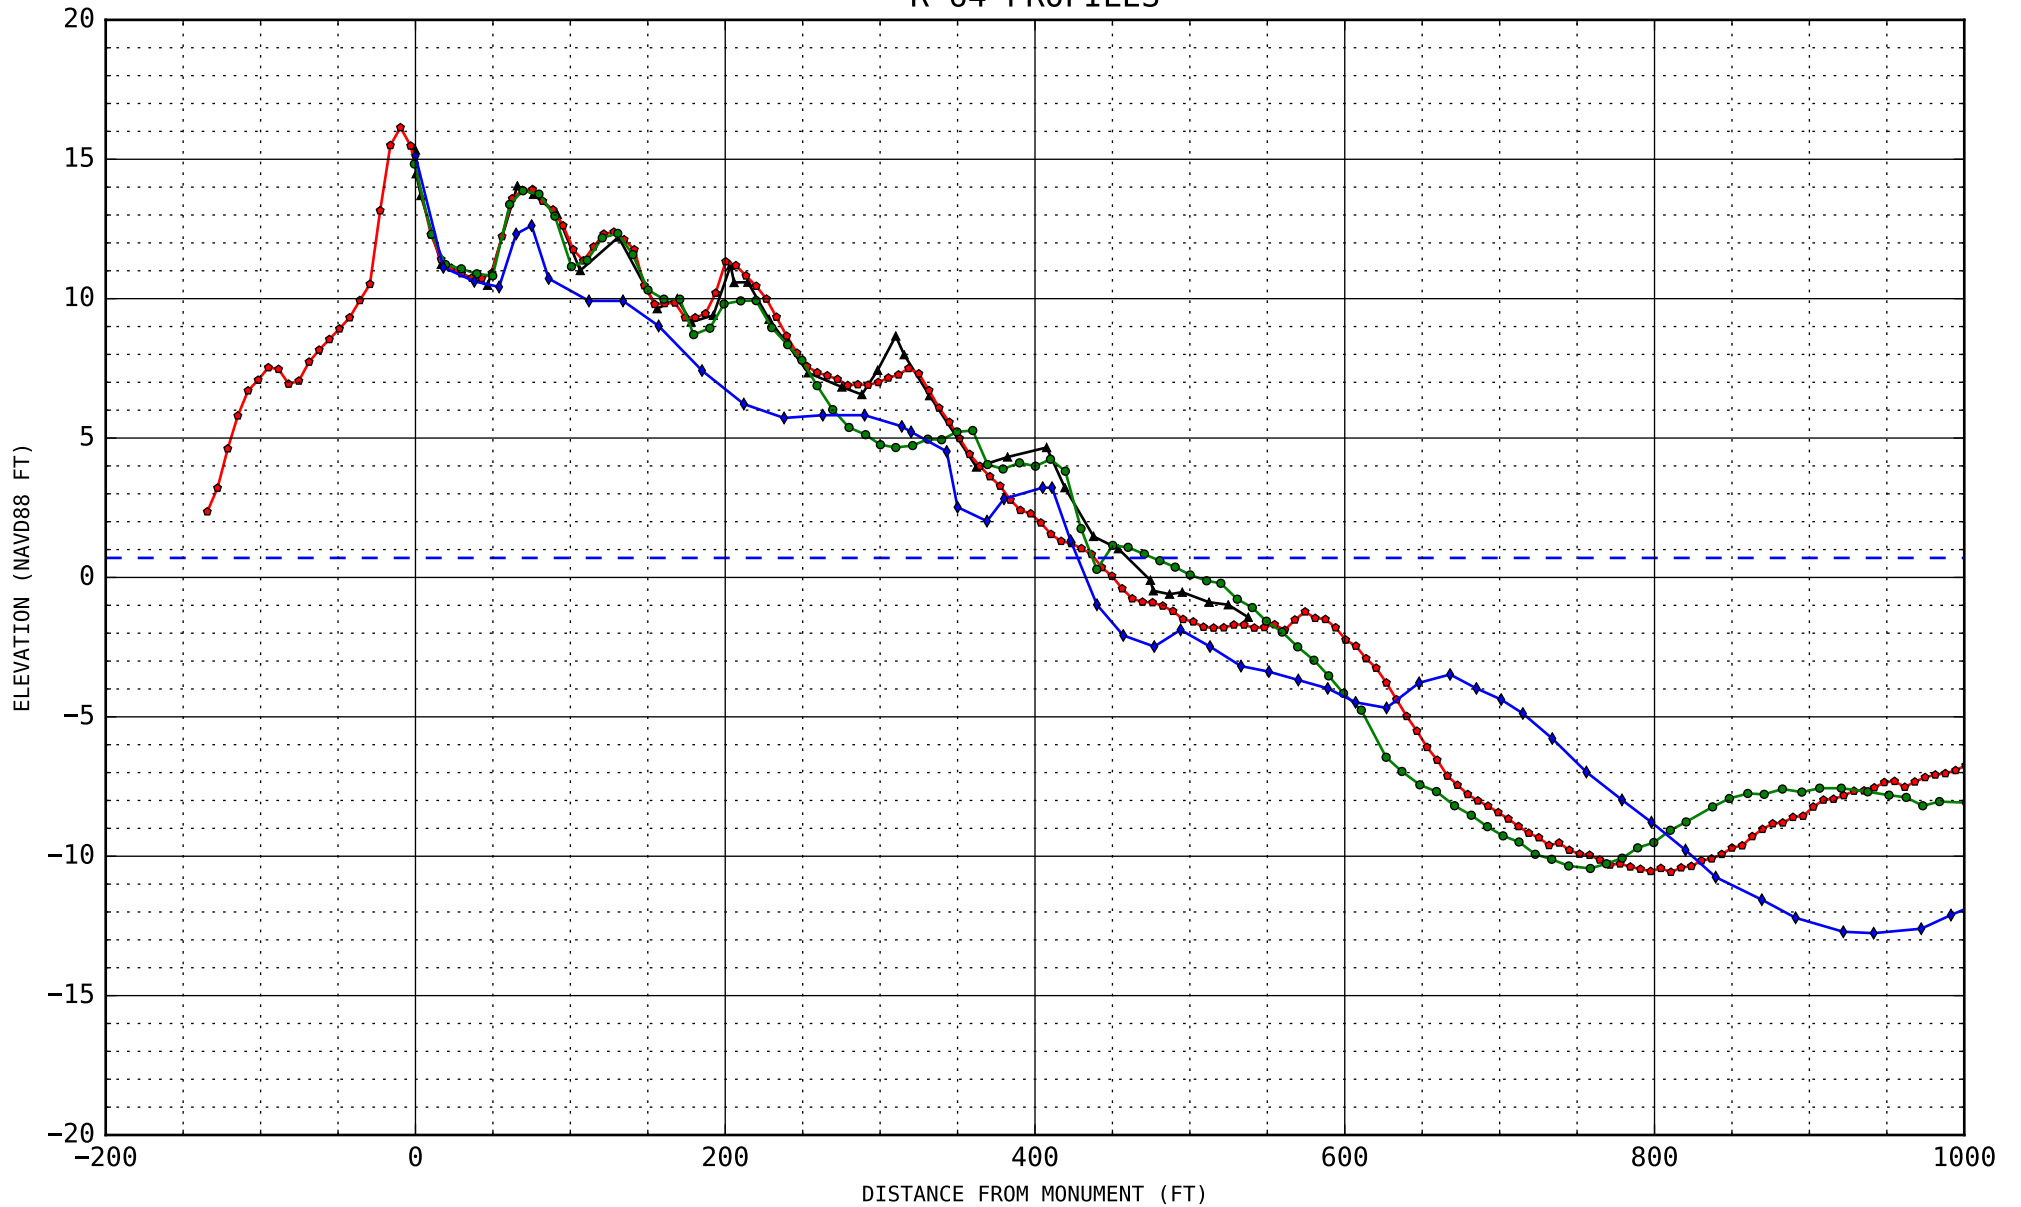
# R-64 PROFILES

- ▲ 2019-APR CONDITION BY DEP
- 2018-OCT MONITORING BY USACE-LIDAR
- 2013-SEP MONITORING BY USACE
- ◆ 2007-FEB MONITORING BY MAE
- - - MHW CONTOUR (0.7 FT)

RANGE: R-64  
EST DATE: NOV1980  
SURVEY DATE: 17APR19  
AZIMUTH: 200.0

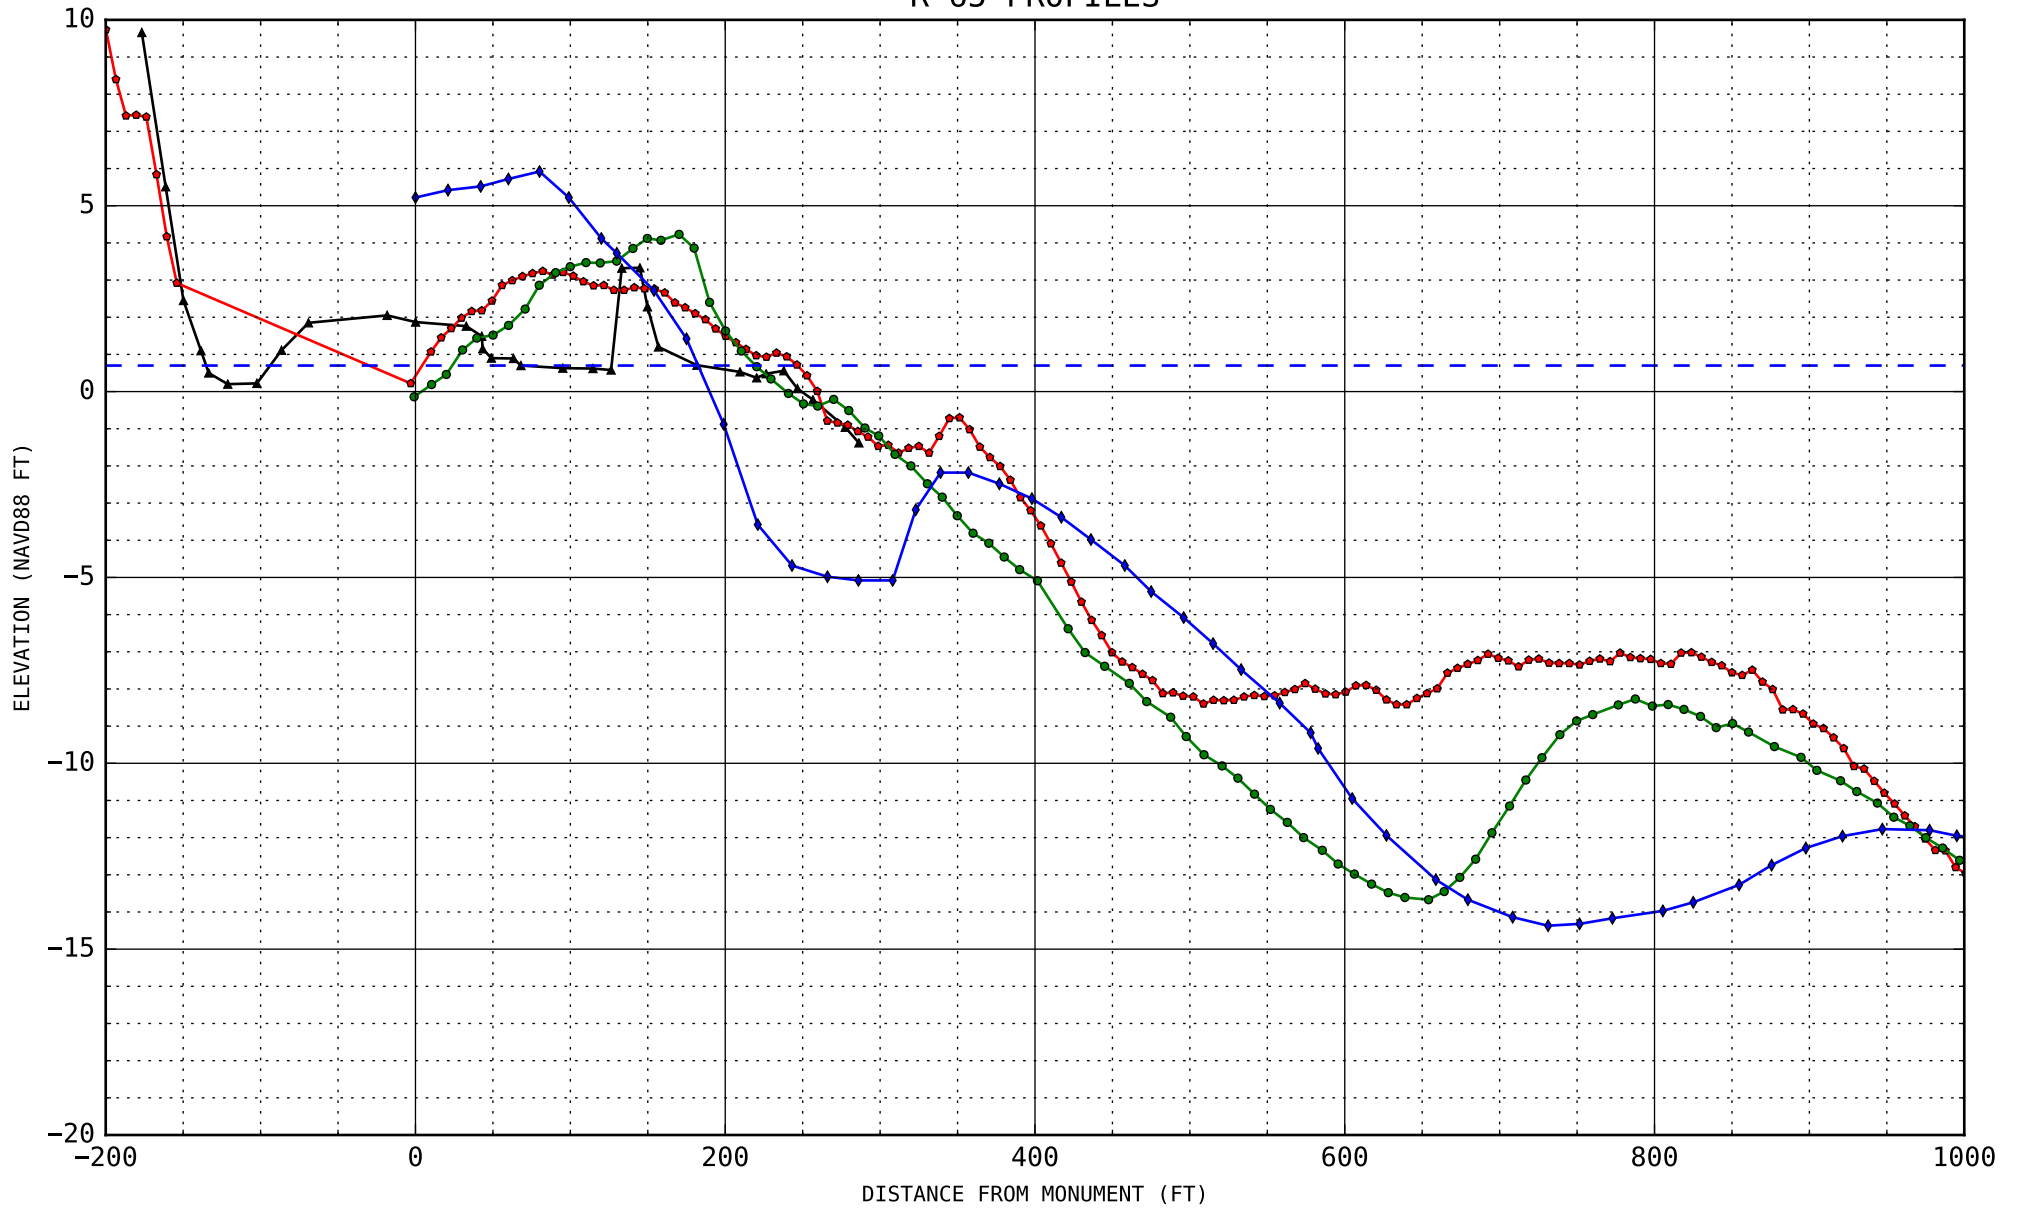
# R-65 PROFILES

- ▲ 2019-APR CONDITION BY DEP
- 2018-OCT MONITORING BY USACE-LIDAR
- 2013-SEP MONITORING BY USACE
- ◆ 2007-FEB MONITORING BY MAE
- - - MHW CONTOUR (0.7 FT)

RANGE: R-65  
EST DATE: OCT1995  
SURVEY DATE: 17APR19  
AZIMUTH: 200.0

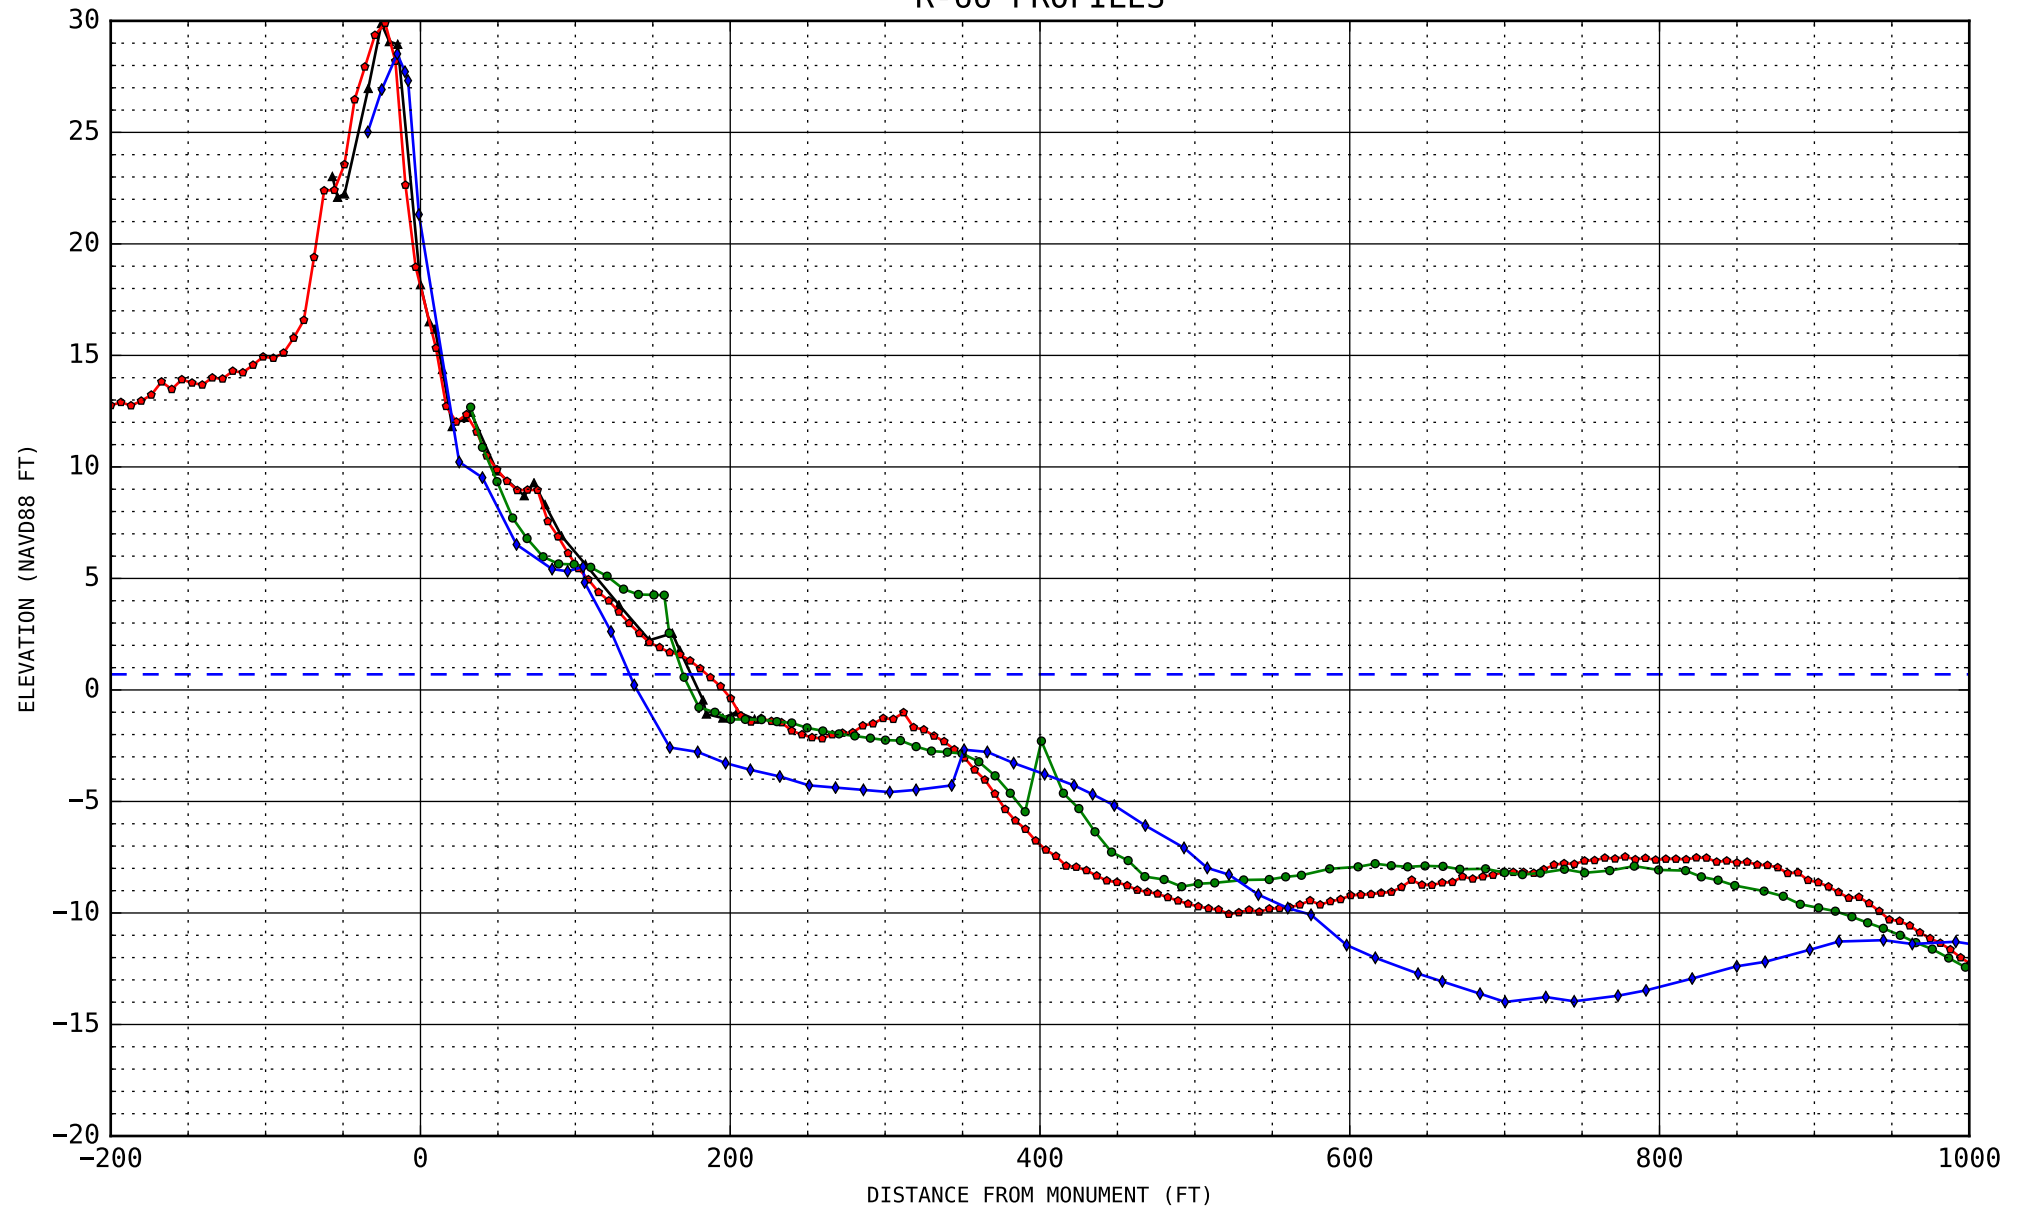
# R-66 PROFILES

- ▲ 2019-APR CONDITION BY DEP
- 2018-OCT MONITORING BY USACE-LIDAR
- 2013-SEP MONITORING BY USACE
- ◆ 2007-FEB MONITORING BY MAE
- - - MHW CONTOUR (0.7 FT)

RANGE: R-66  
EST DATE: JUN1973  
SURVEY DATE: 17APR19  
AZIMUTH: 200.0

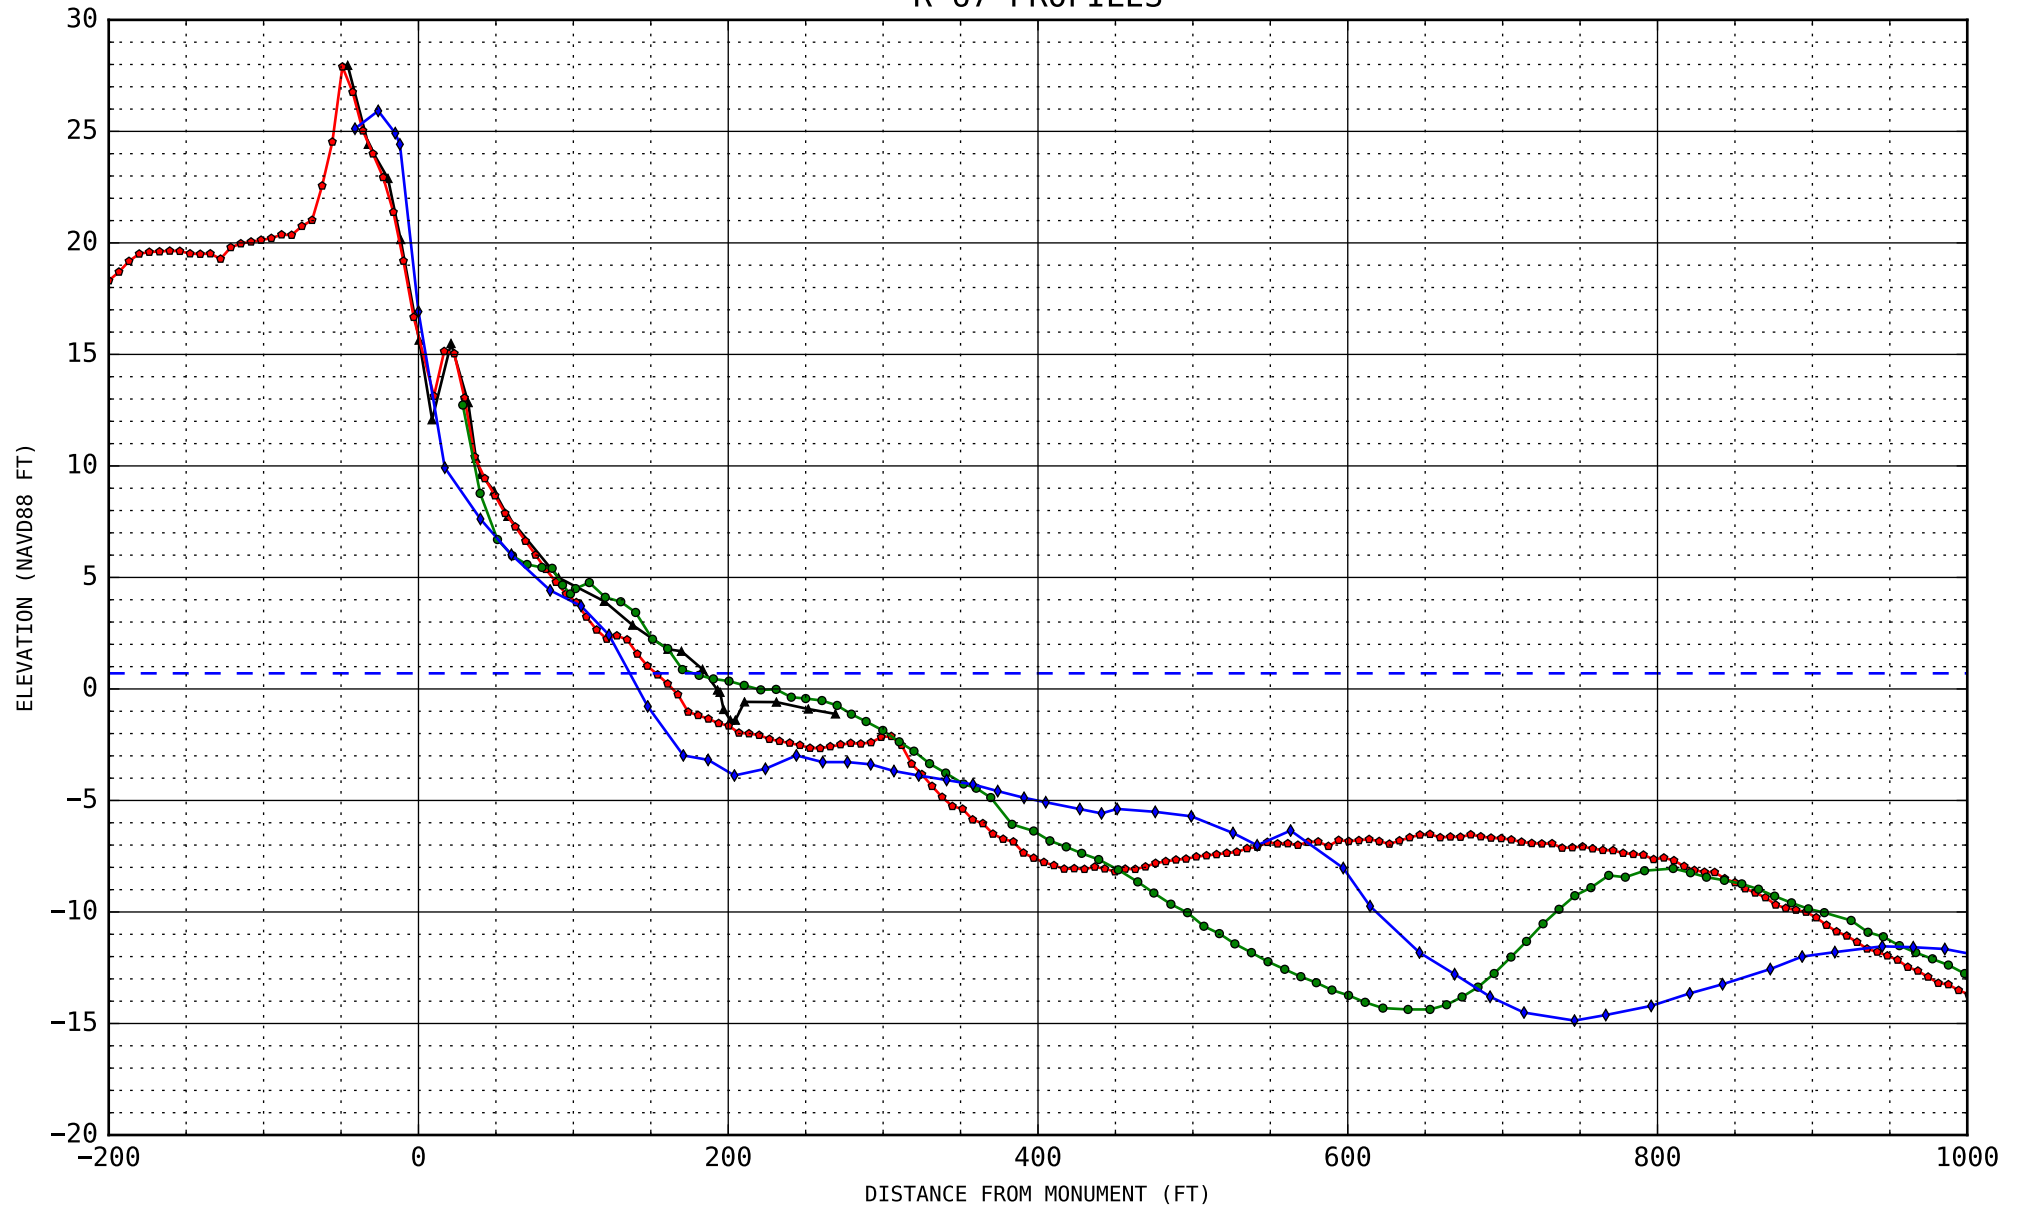
# R-67 PROFILES

- ▲ 2019-APR CONDITION BY DEP
- 2018-OCT MONITORING BY USACE-LIDAR
- 2013-SEP MONITORING BY USACE
- ◆ 2007-FEB MONITORING BY MAE
- - - MHW CONTOUR (0.7 FT)

RANGE: R-67  
EST DATE: OCT1995  
SURVEY DATE: 17APR19  
AZIMUTH: 200.0

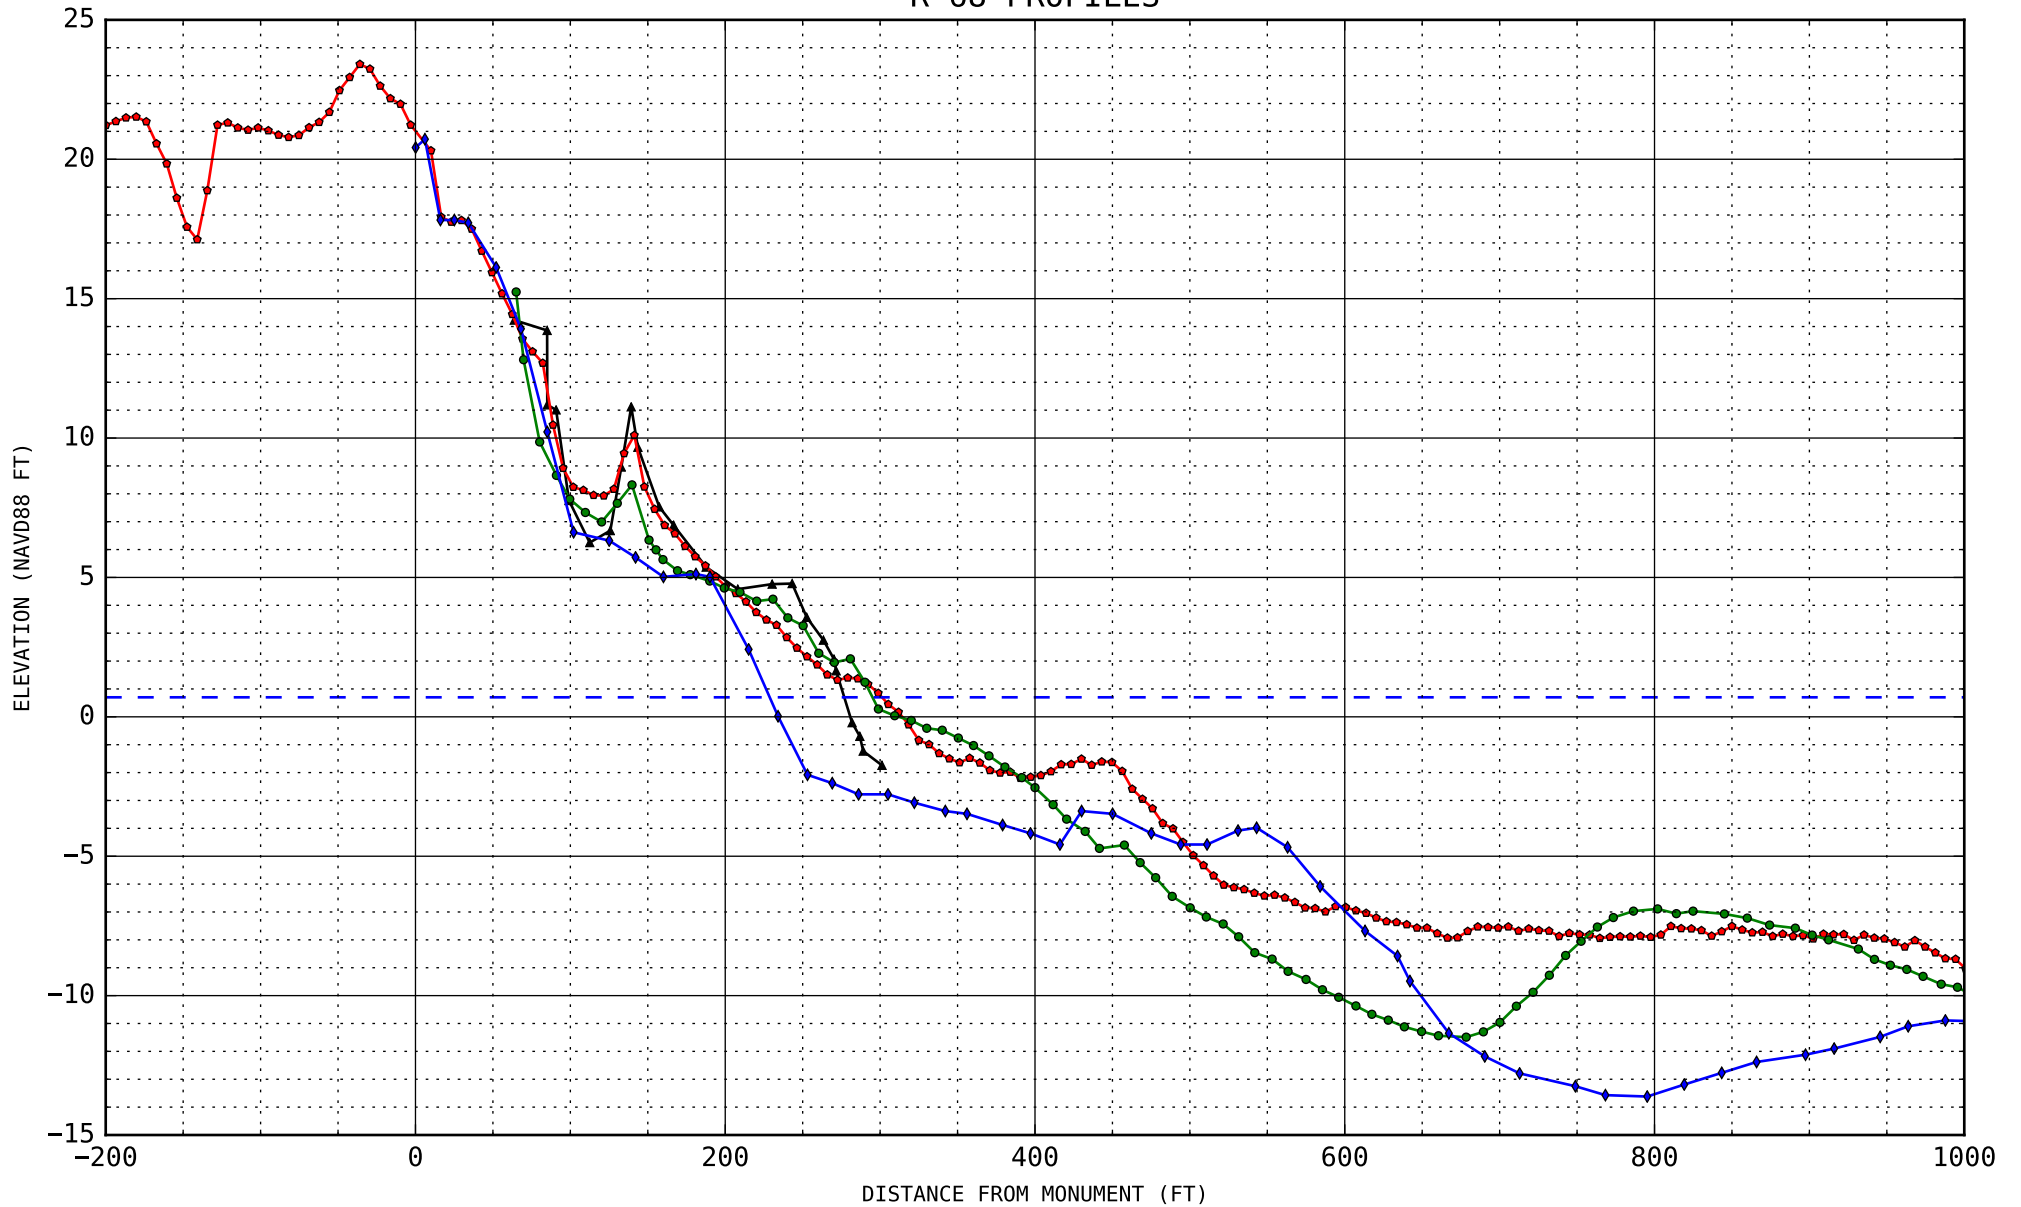
# R-68 PROFILES

- ▲ 2019-APR CONDITION BY DEP
- 2018-OCT MONITORING BY USACE-LIDAR
- 2013-SEP MONITORING BY USACE
- ◆ 2007-FEB MONITORING BY MAE
- - - MHW CONTOUR (0.7 FT)

RANGE: R-68  
EST DATE: OCT1994  
SURVEY DATE: 17APR19  
AZIMUTH: 200.0

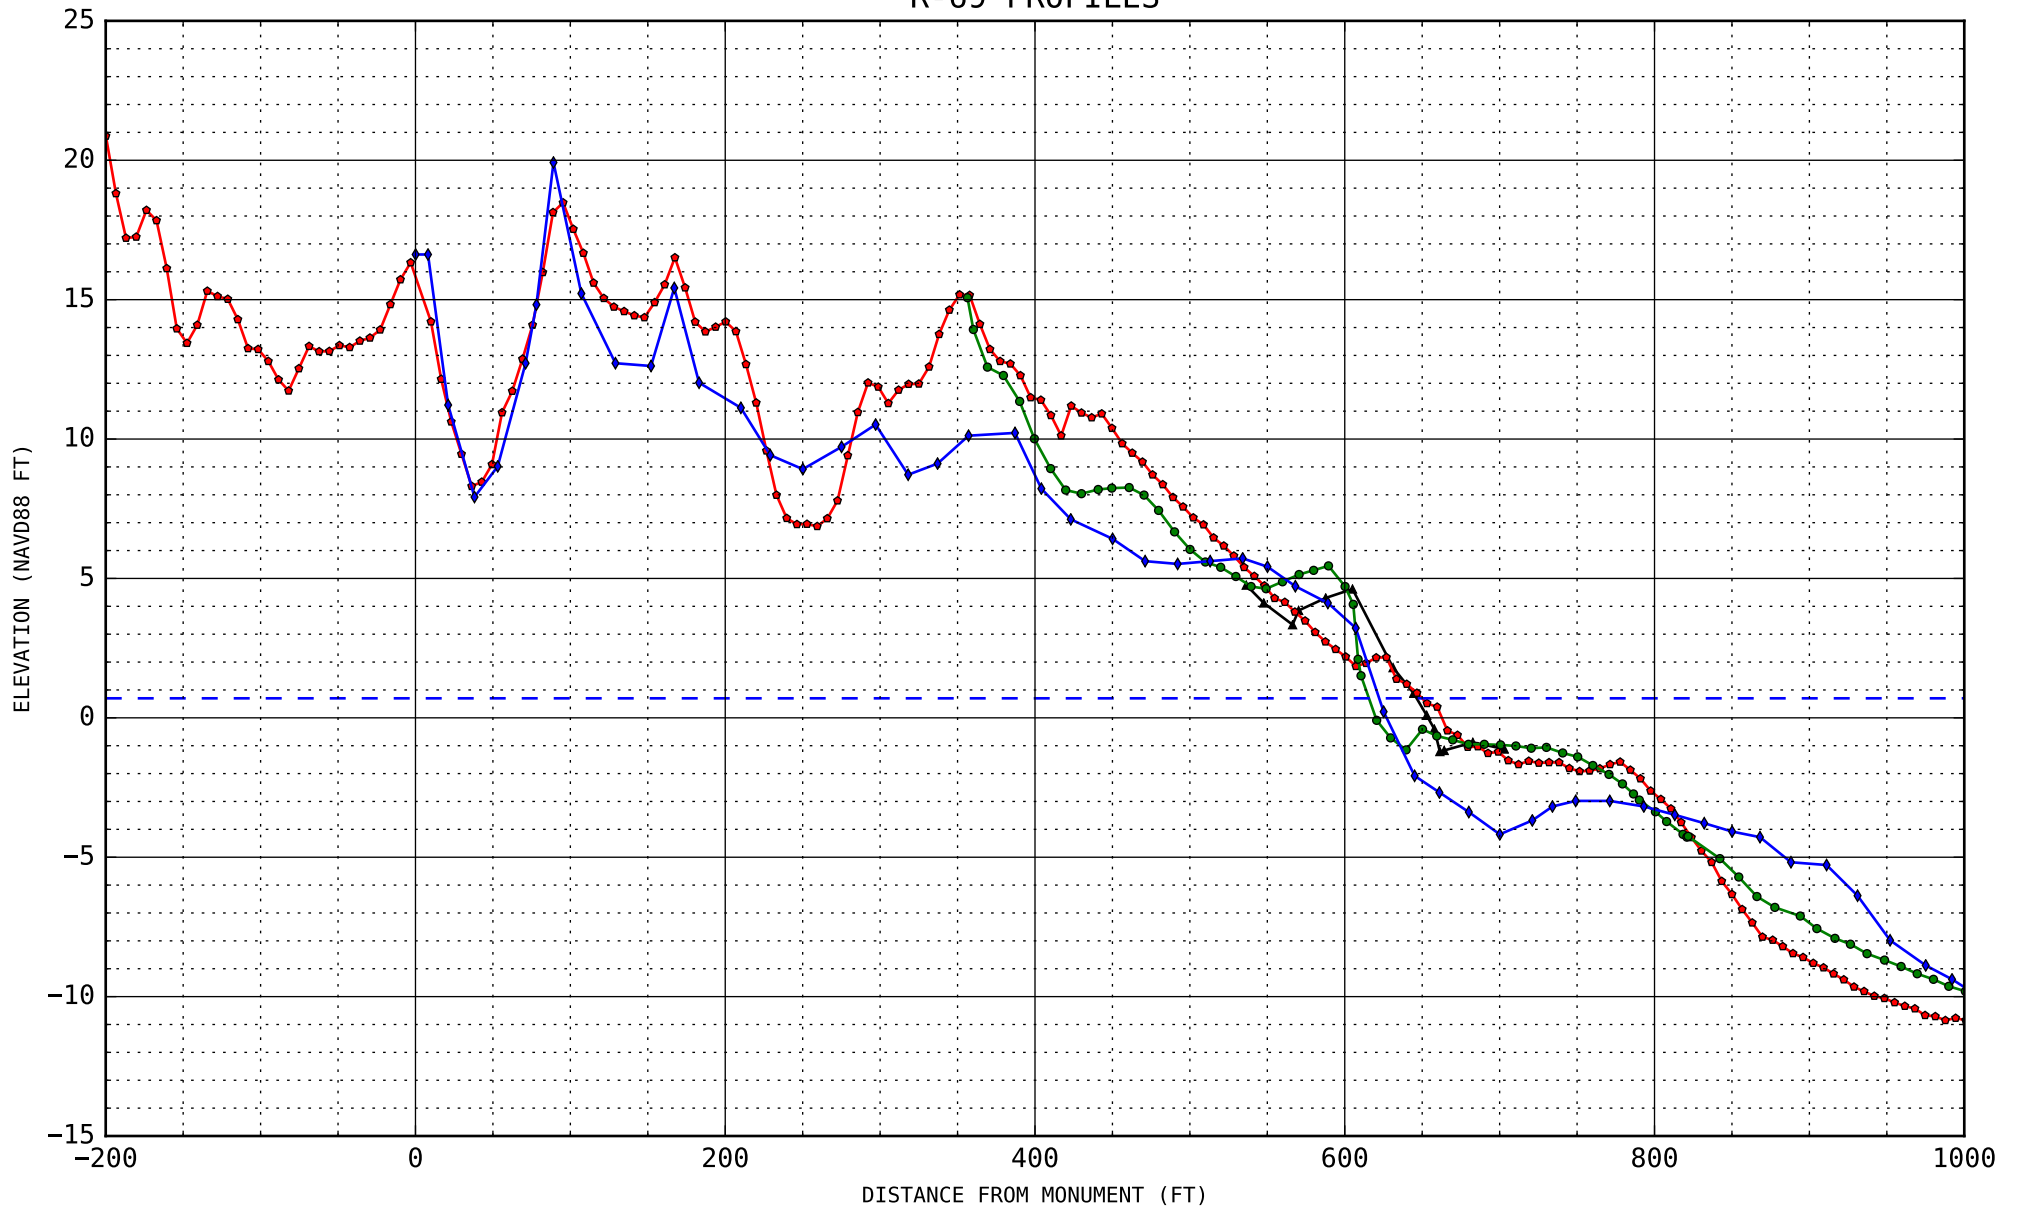
# R-69 PROFILES

- ▲ 2019-APR CONDITION BY DEP
- 2018-OCT MONITORING BY USACE-LIDAR
- 2013-SEP MONITORING BY USACE
- ◆ 2007-FEB MONITORING BY MAE
- - - MHW CONTOUR (0.7 FT)

RANGE: R-69  
 EST DATE: OCT1995  
 SURVEY DATE: 17APR19  
 AZIMUTH: 200.0

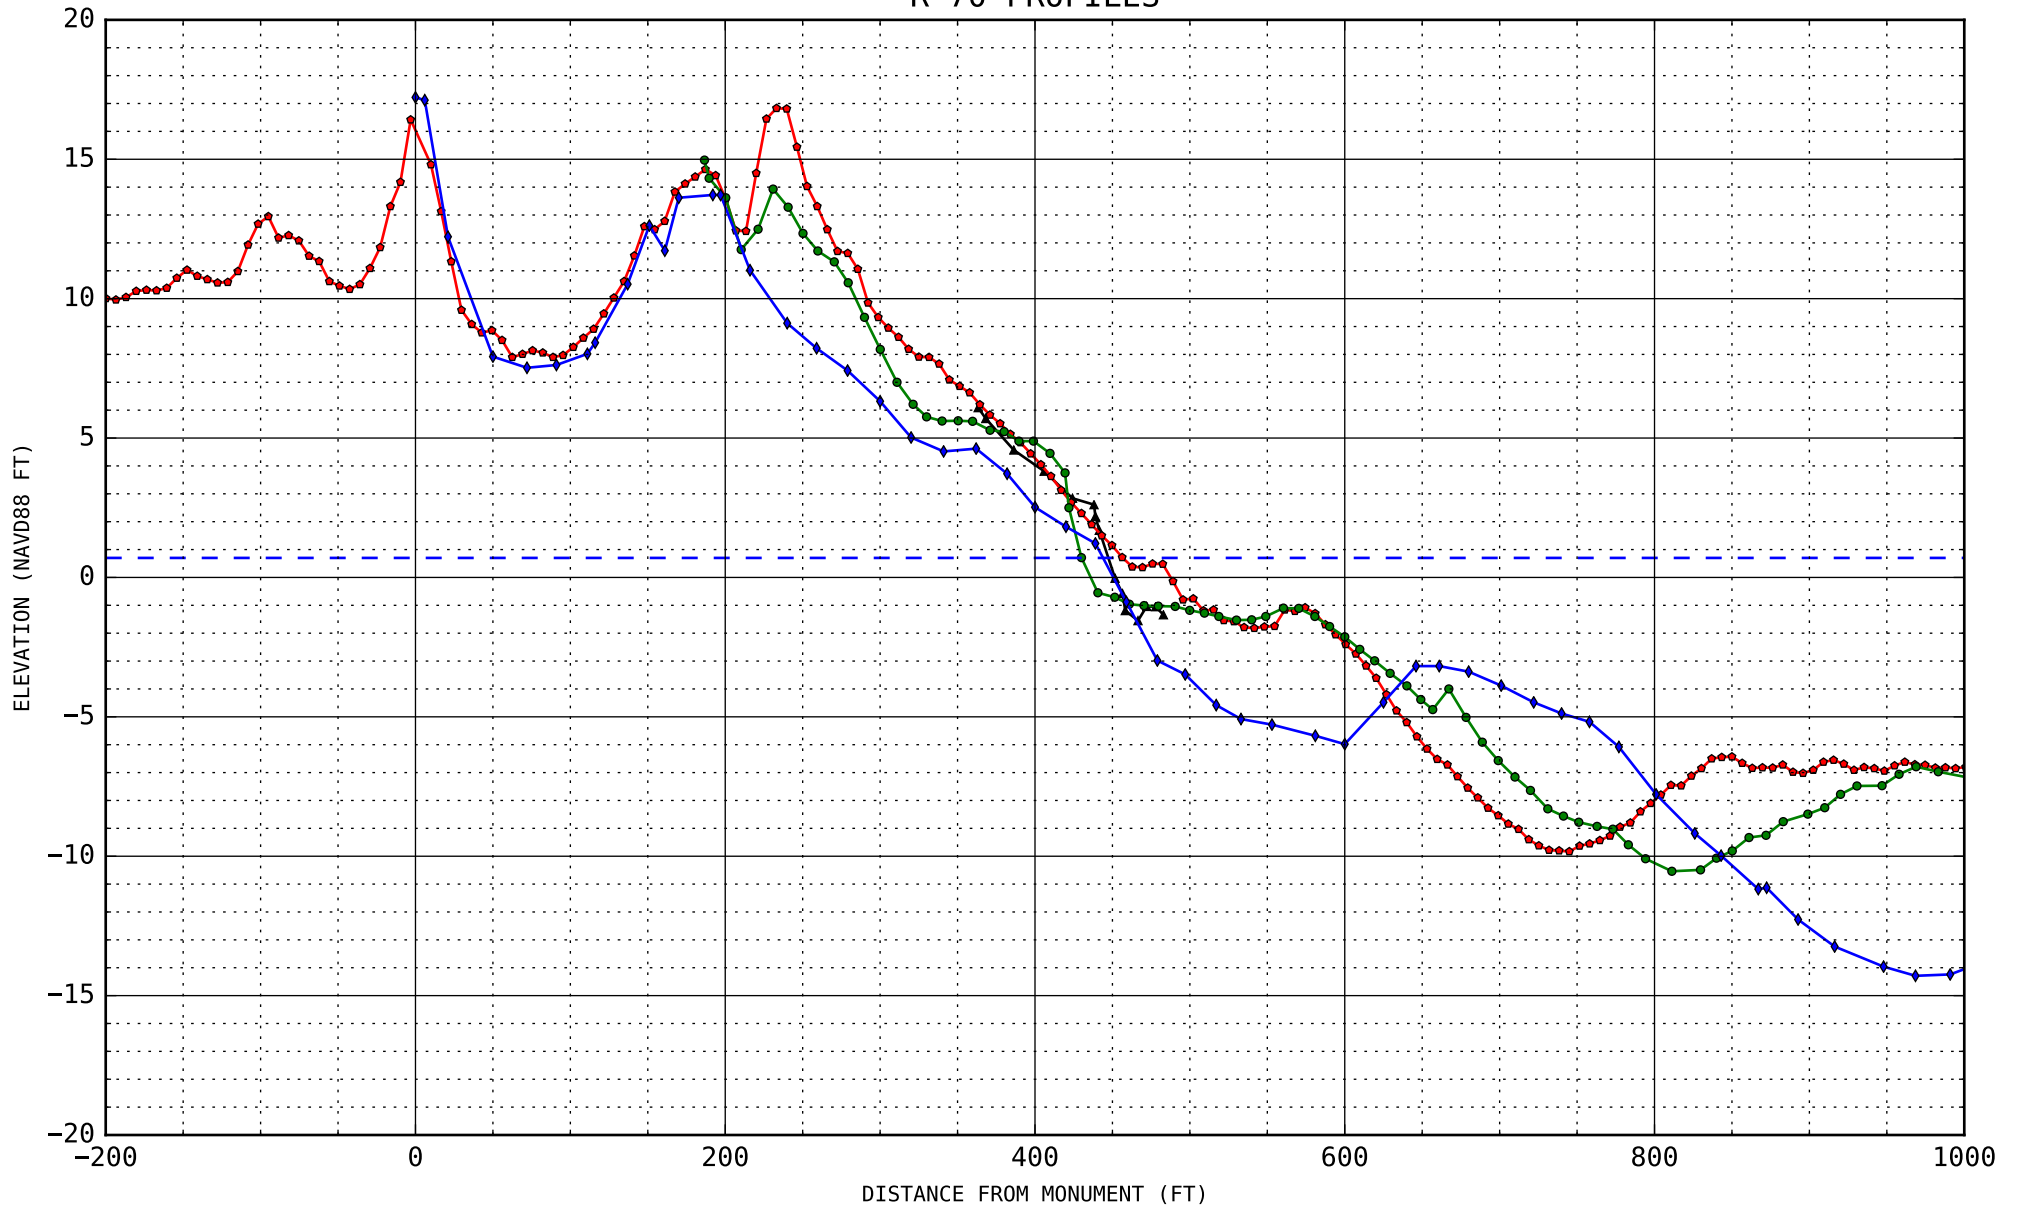
# R-70 PROFILES

- ▲ 2019-APR CONDITION BY DEP
- 2018-OCT MONITORING BY USACE-LIDAR
- 2013-SEP MONITORING BY USACE
- ◆ 2007-FEB MONITORING BY MAE
- - - MHW CONTOUR (0.7 FT)

RANGE: R-70  
 EST DATE: OCT1995  
 SURVEY DATE: 17APR19  
 AZIMUTH: 200.0
