# R-1 PROFILES

WALTON  
PROGRAM SUPPORT GIS  
DIVISION OF WATER RESOURCE MANAGEMENT  
FLORIDA DEPARTMENT OF ENVIRONMENTAL PROTECTION

RANGE: R-1  
EST DATE: NOV1980  
SURVEY DATE: 04APR19  
AZIMUTH: 190.0

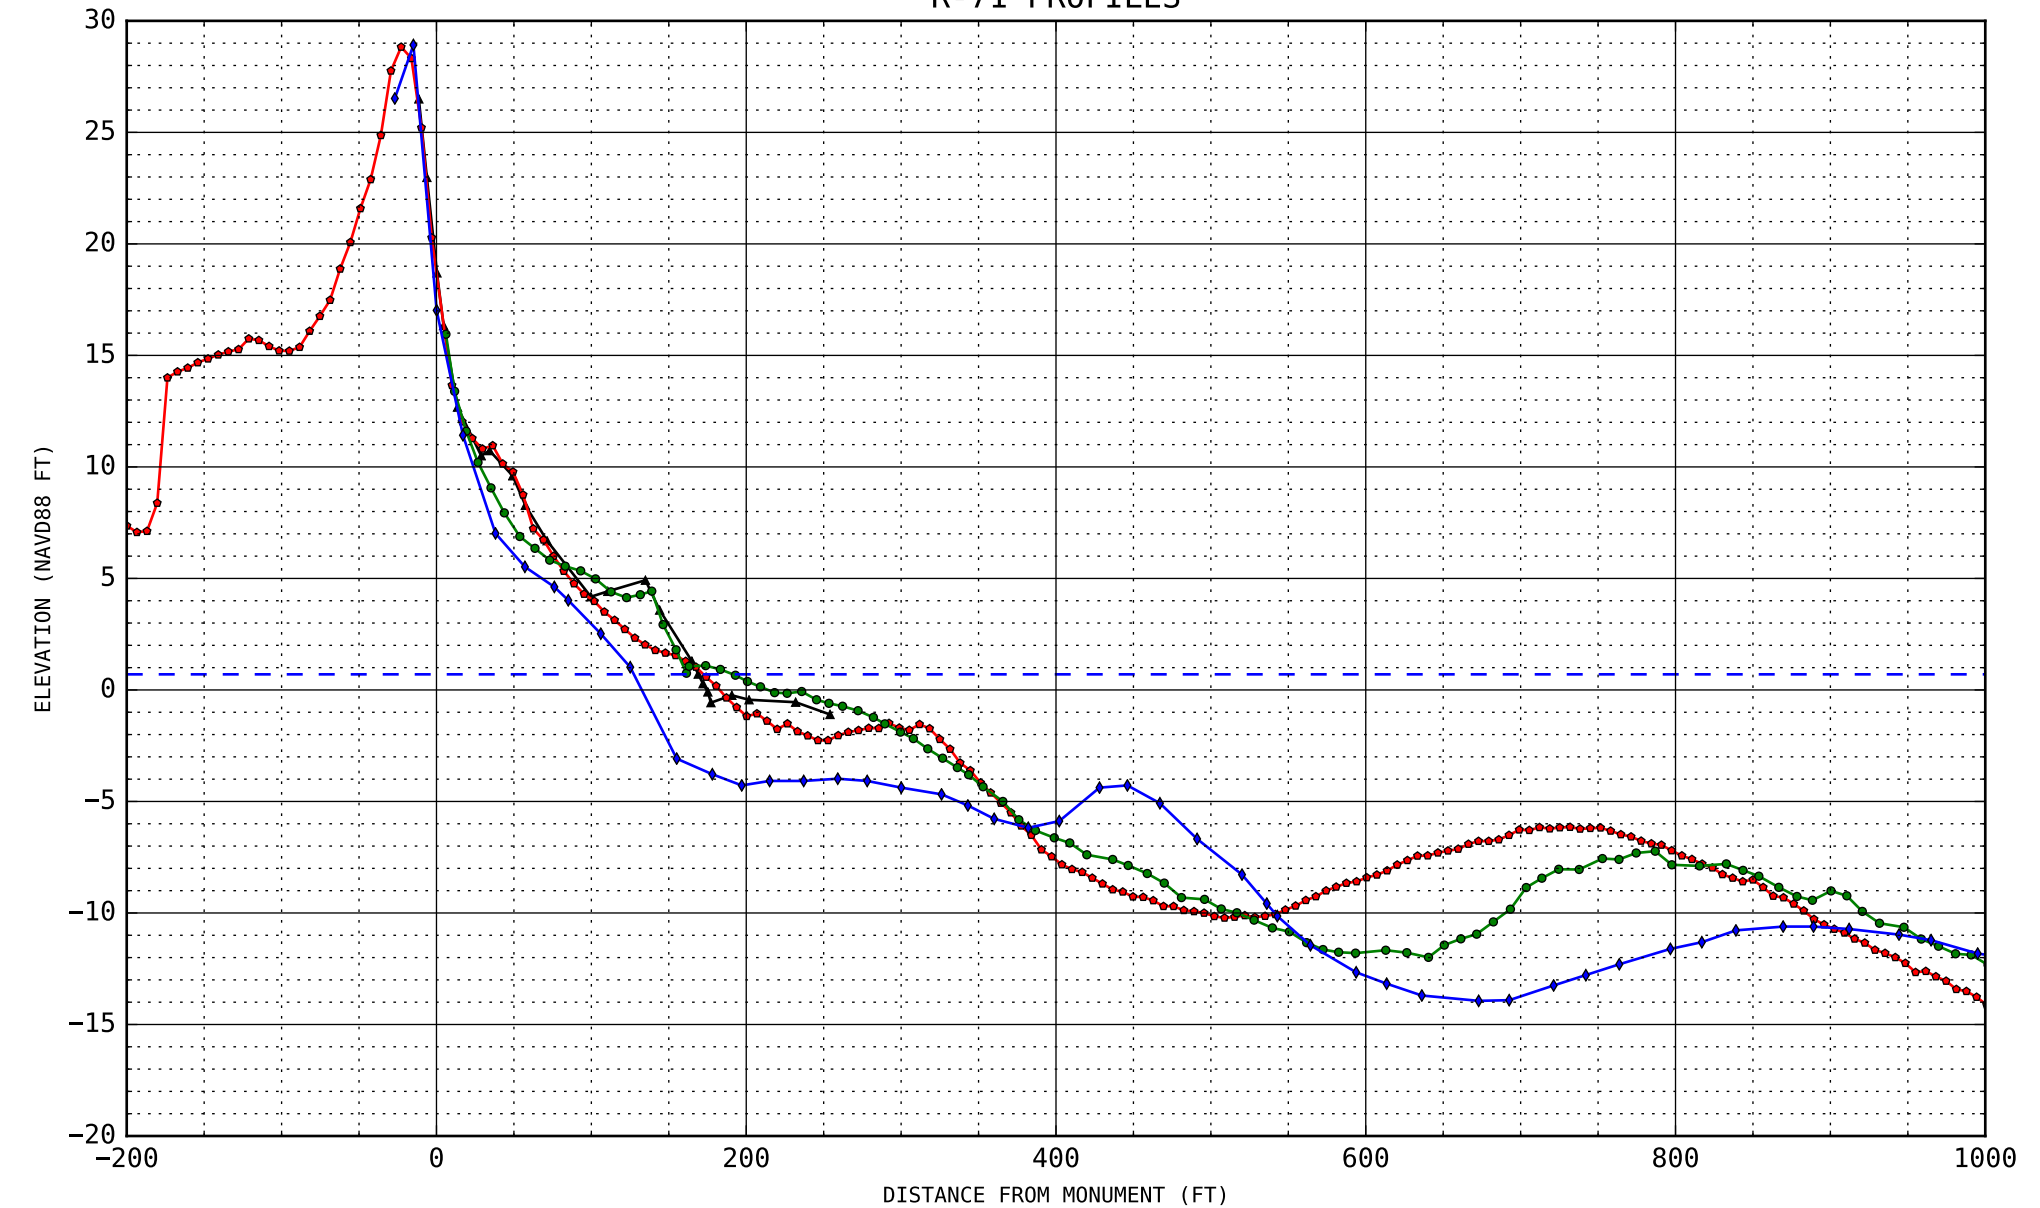
# R-71 PROFILES

- ▲ 2019-APR CONDITION BY DEP
- 2018-OCT MONITORING BY USACE-LIDAR
- 2013-SEP MONITORING BY USACE
- ◆ 2007-FEB MONITORING BY MAE
- - - MHW CONTOUR (0.7 FT)

RANGE: R-71  
EST DATE: OCT1995  
SURVEY DATE: 17APR19  
AZIMUTH: 200.0

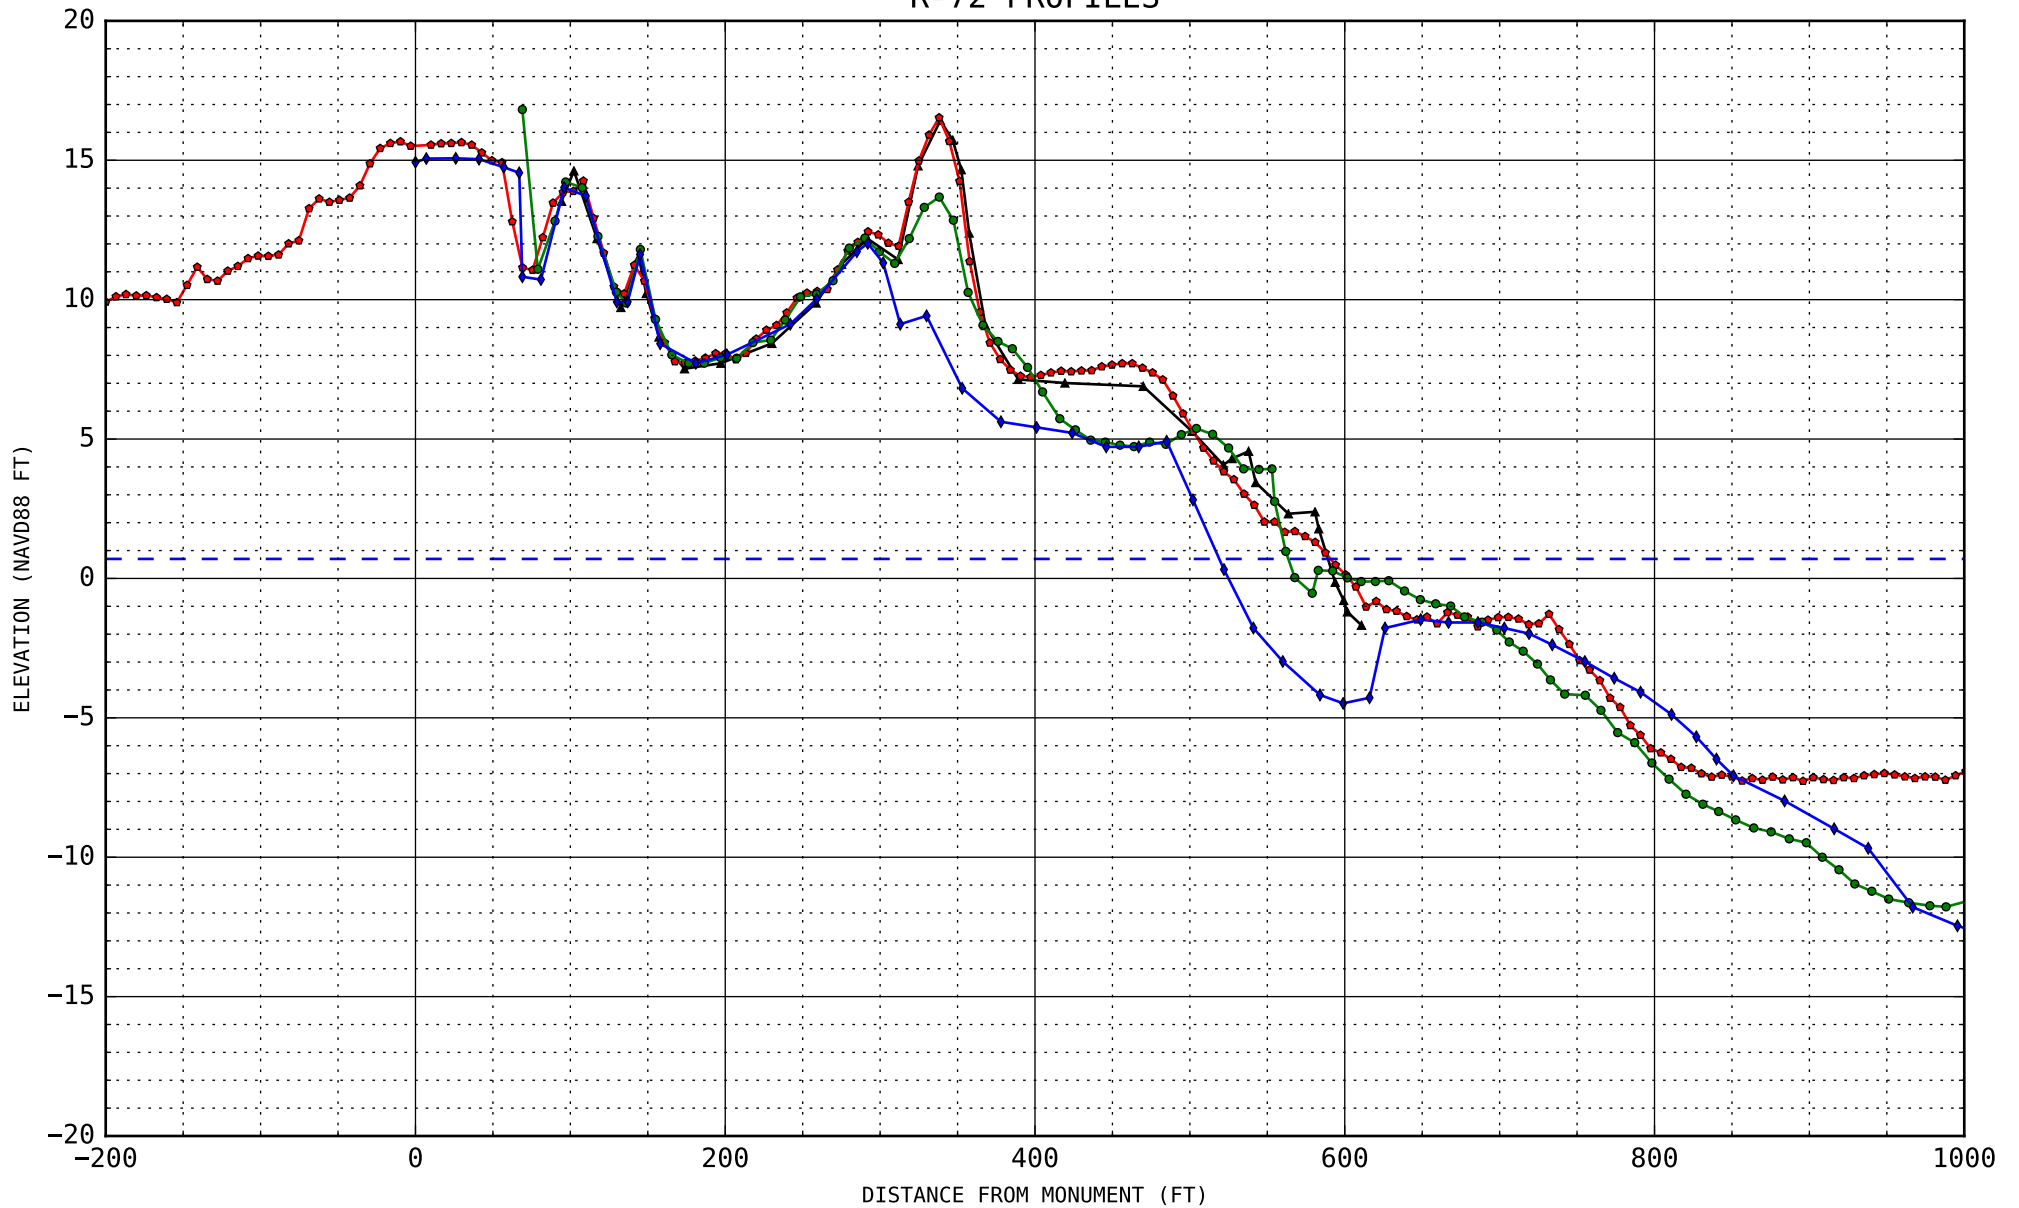
# R-72 PROFILES

- ▲ 2019-APR CONDITION BY DEP
- 2018-OCT MONITORING BY USACE-LIDAR
- 2013-SEP MONITORING BY USACE
- ◆ 2007-FEB MONITORING BY MAE
- - - MHW CONTOUR (0.7 FT)

RANGE: R-72  
EST DATE: AUG1976  
SURVEY DATE: 17APR19  
AZIMUTH: 200.0

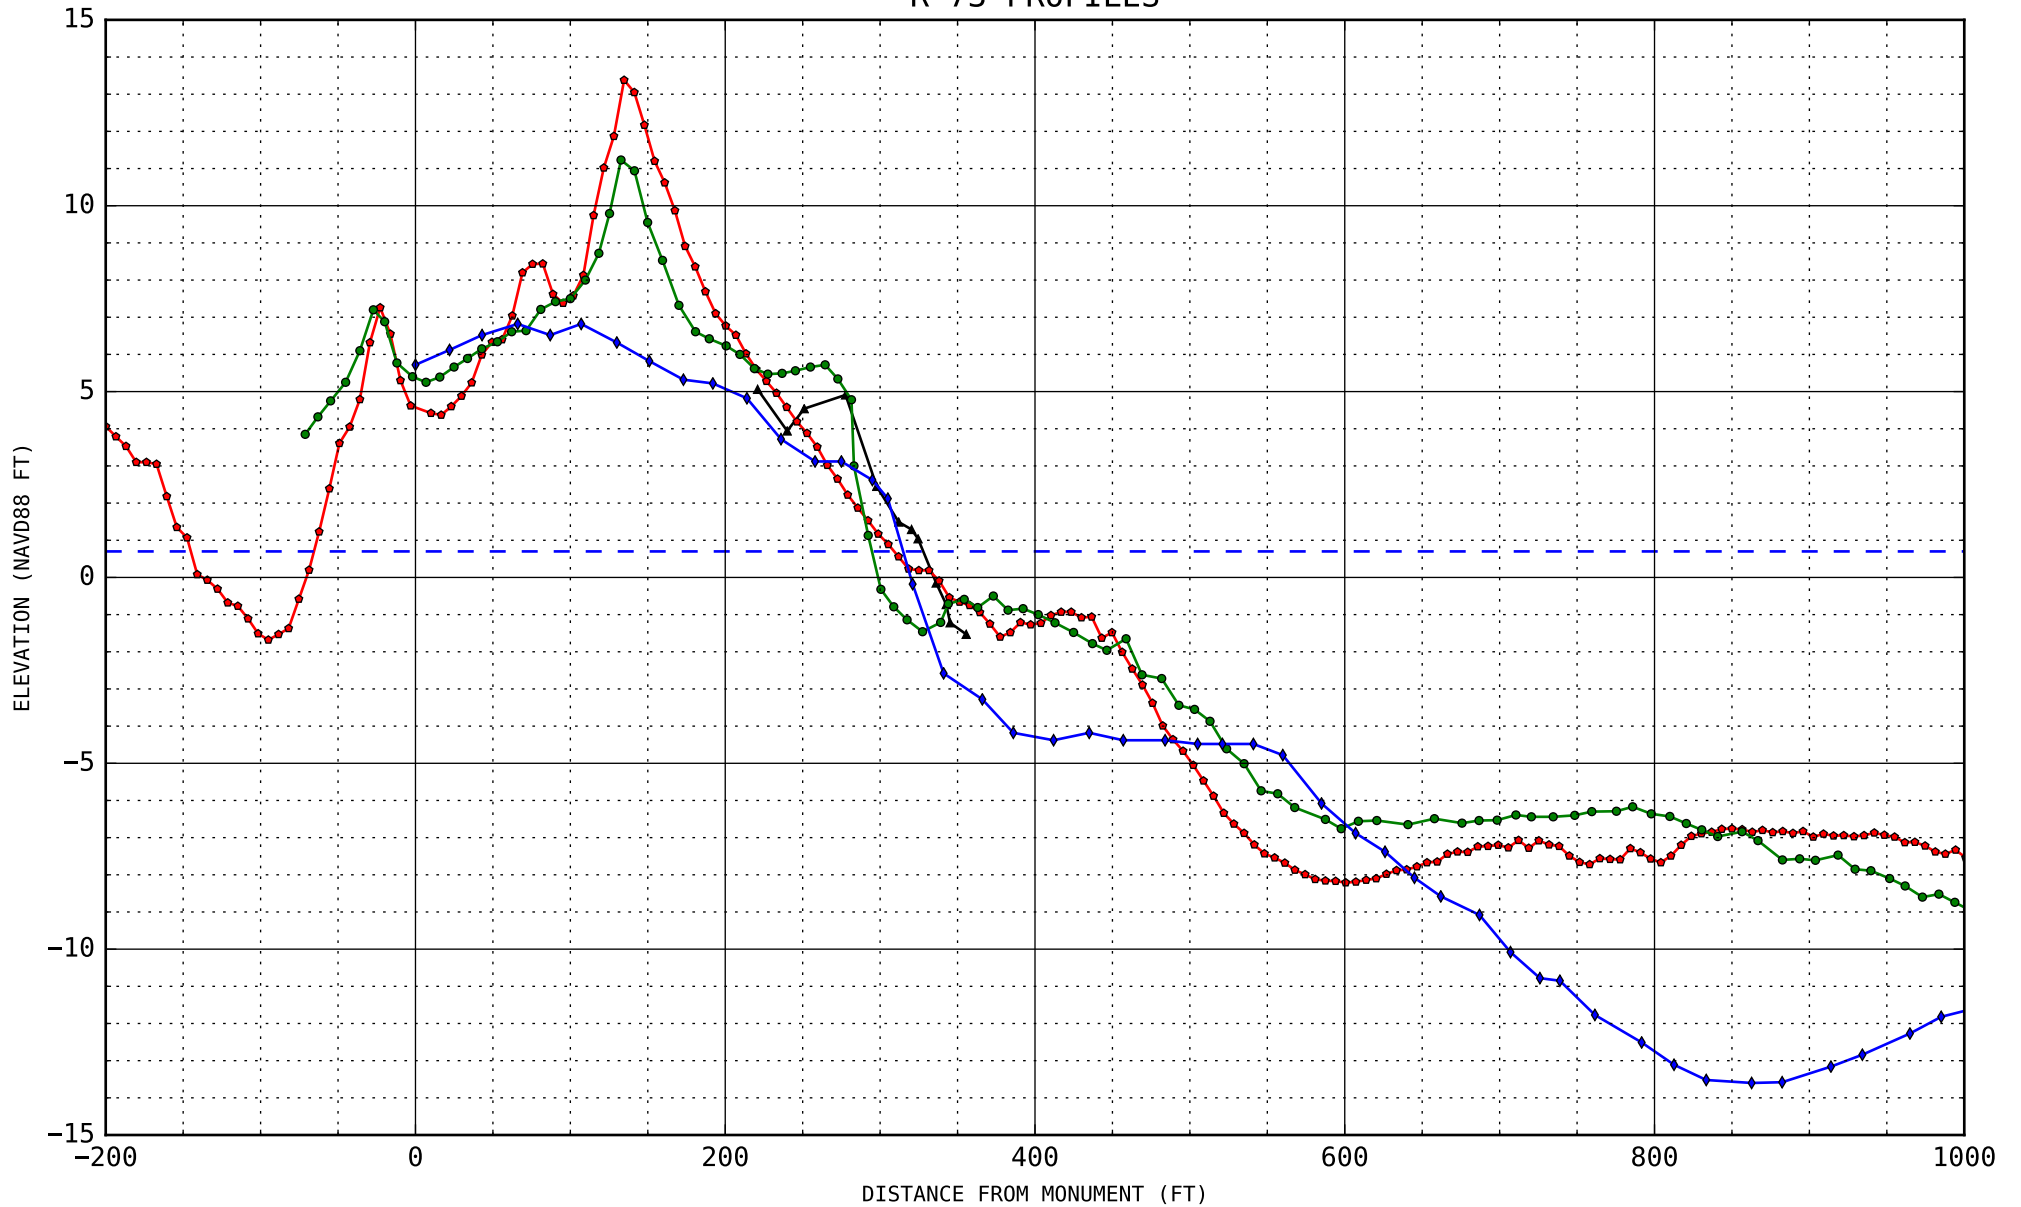
# R-73 PROFILES

- ▲ 2019-APR CONDITION BY DEP
- 2018-OCT MONITORING BY USACE-LIDAR
- 2013-SEP MONITORING BY USACE
- ◆ 2007-FEB MONITORING BY MAE
- - - MHW CONTOUR (0.7 FT)

RANGE: R-73  
EST DATE: M&E1997  
SURVEY DATE: 17APR19  
AZIMUTH: 190.0

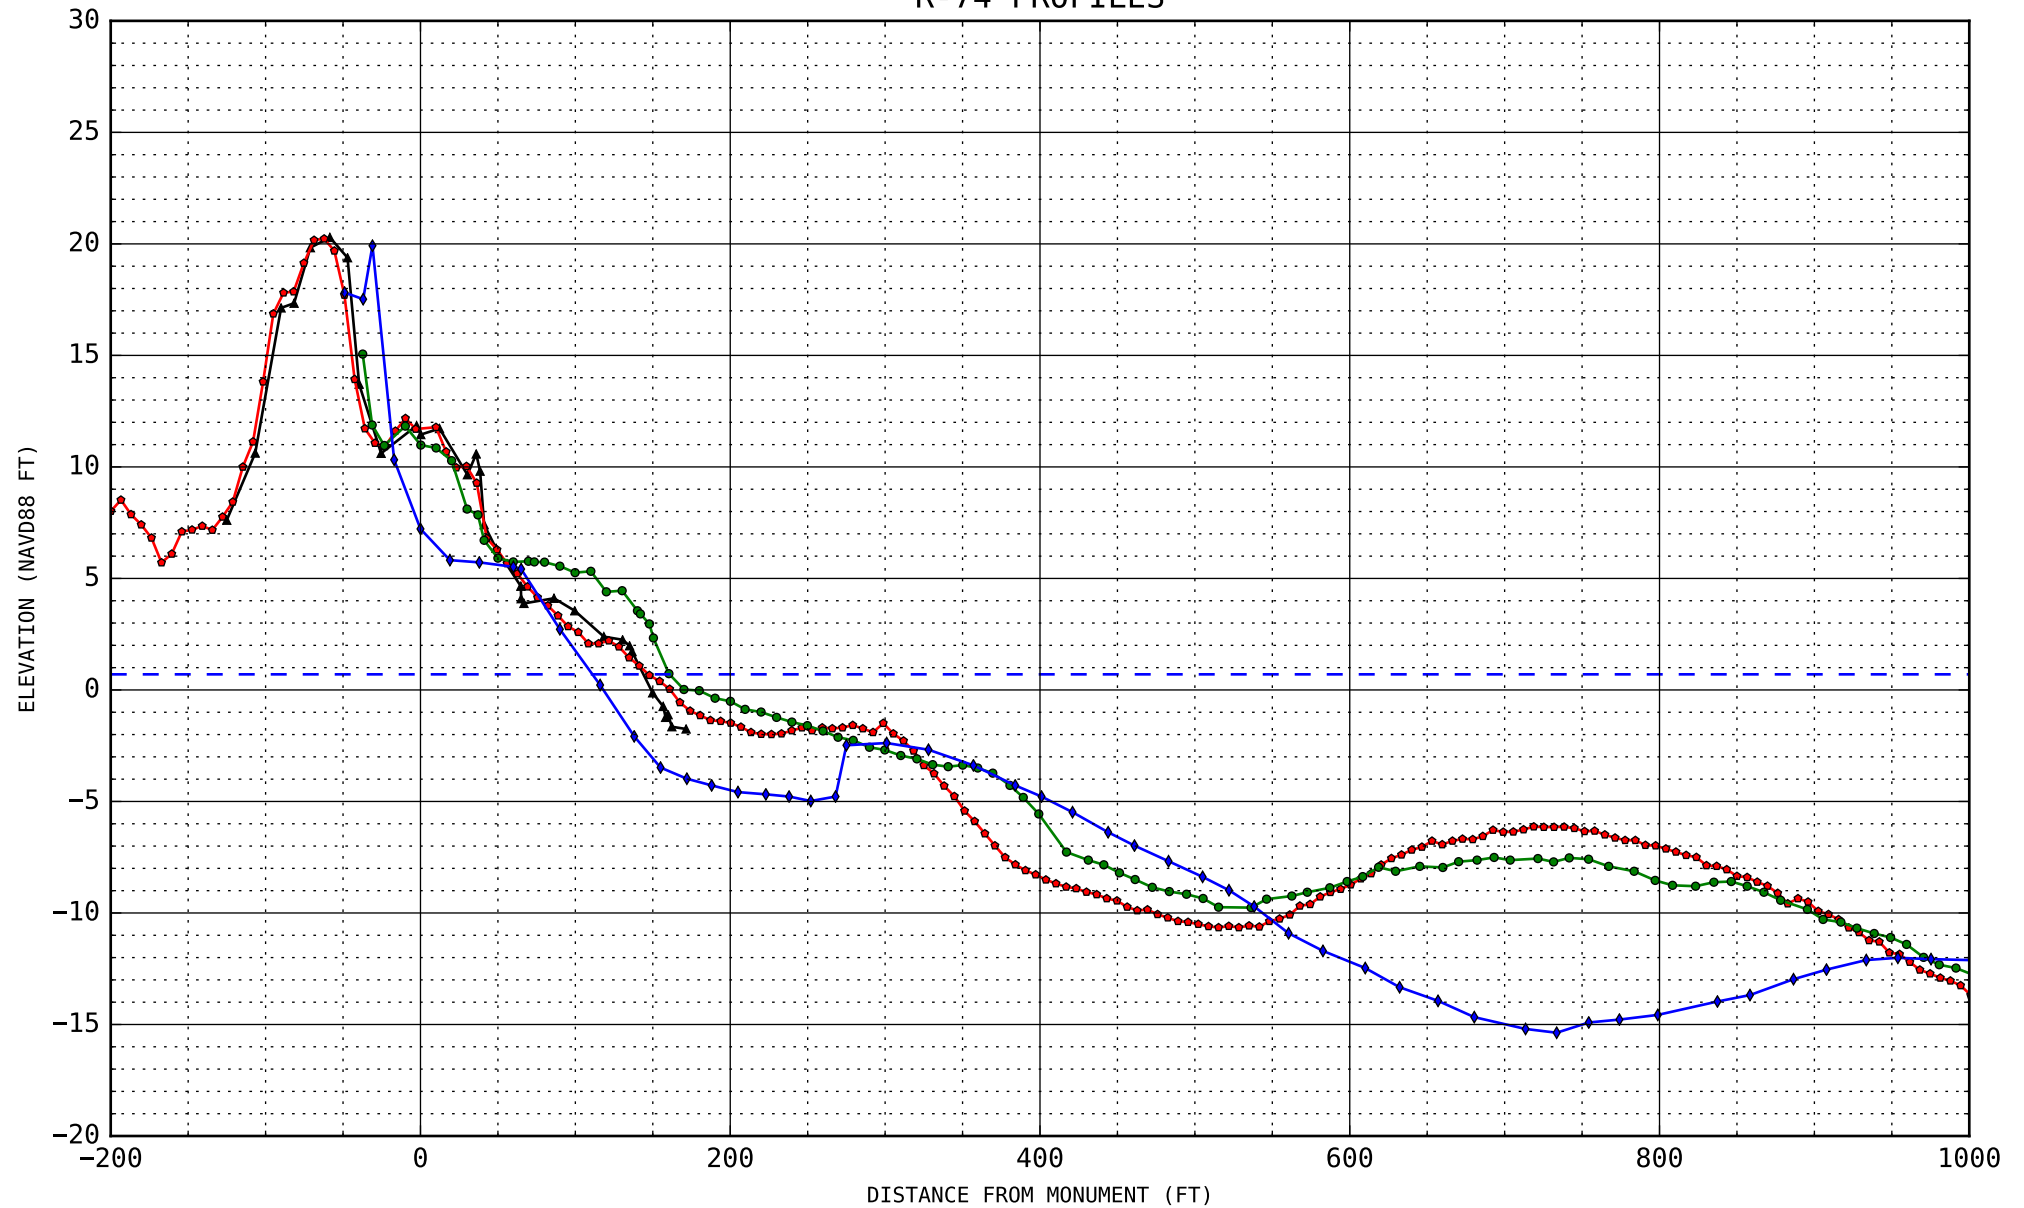
# R-74 PROFILES

- ▲ 2019-APR CONDITION BY DEP
- 2018-OCT MONITORING BY USACE-LIDAR
- 2013-SEP MONITORING BY USACE
- ◆ 2007-FEB MONITORING BY MAE
- - - MHW CONTOUR (0.7 FT)

RANGE: R-74  
EST DATE: M&E1997  
SURVEY DATE: 17APR19  
AZIMUTH: 190.0

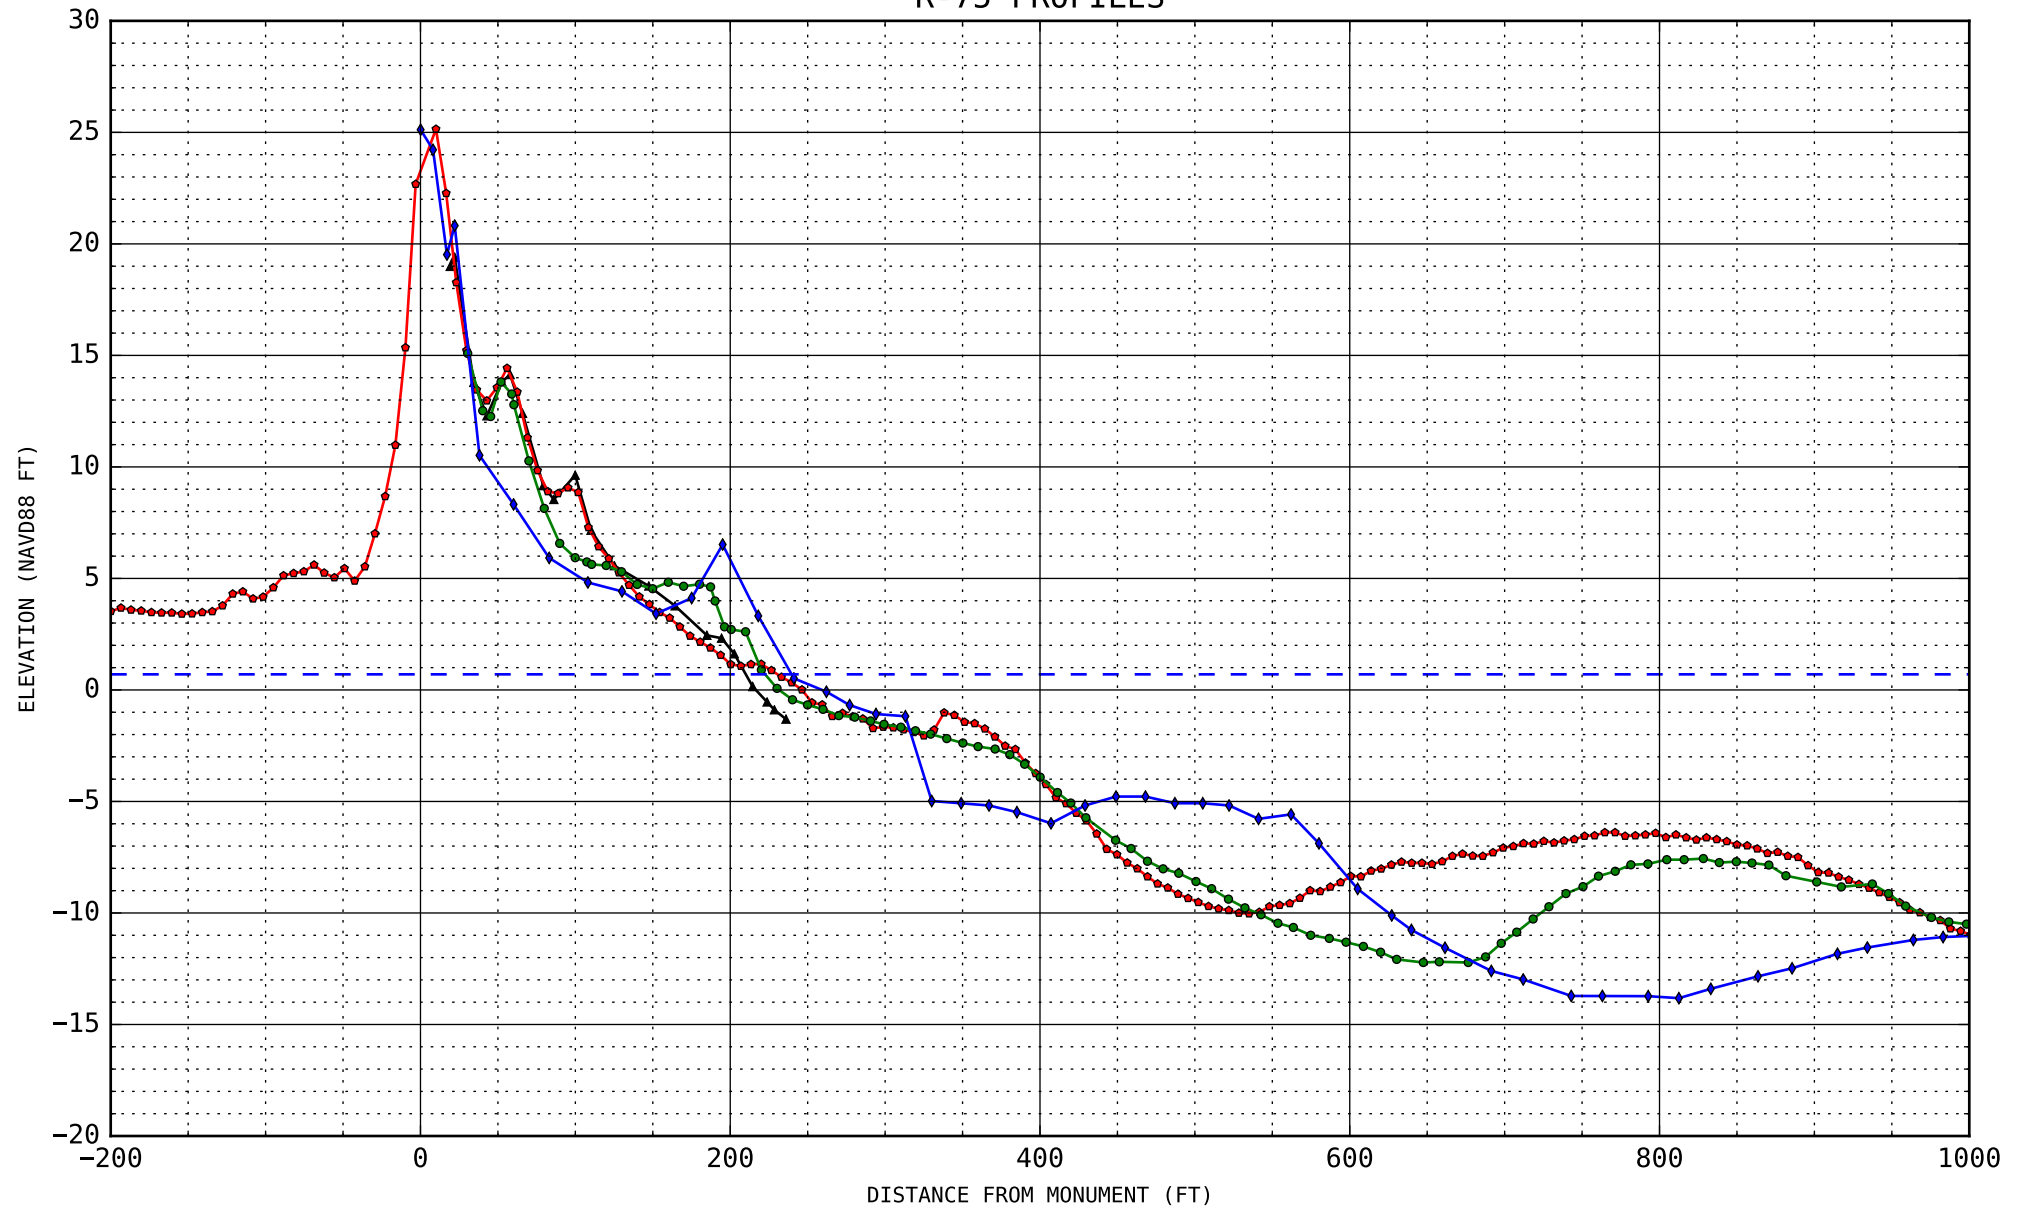
# R-75 PROFILES

- ▲ 2019-APR CONDITION BY DEP
- 2018-OCT MONITORING BY USACE-LIDAR
- 2013-SEP MONITORING BY USACE
- ◆ 2007-FEB MONITORING BY MAE
- - - MHW CONTOUR (0.7 FT)

RANGE: R-75  
EST DATE: OCT1995  
SURVEY DATE: 17APR19  
AZIMUTH: 190.0

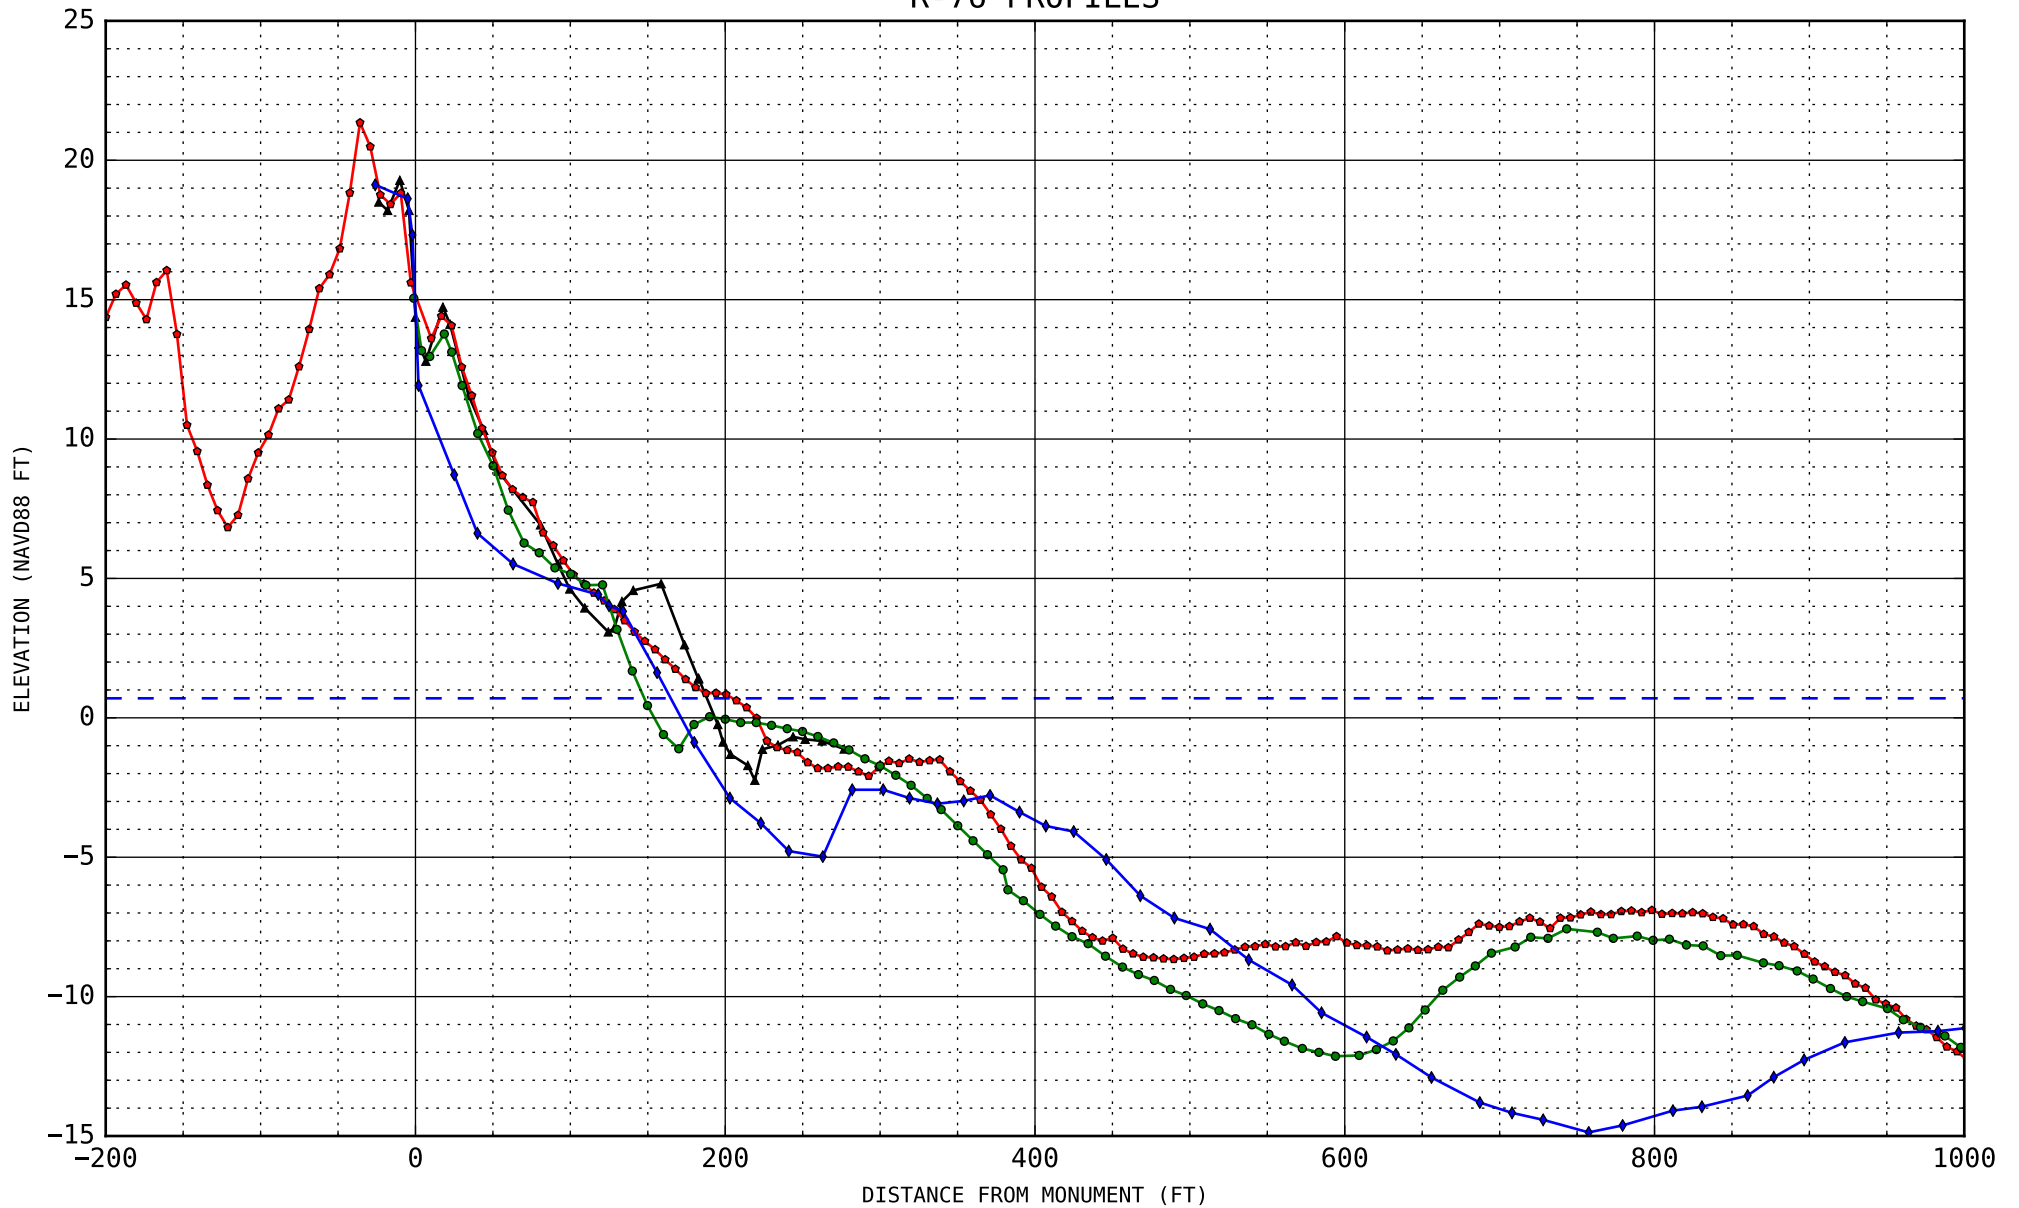
# R-76 PROFILES

- ▲ 2019-APR CONDITION BY DEP
- 2018-OCT MONITORING BY USACE-LIDAR
- 2013-SEP MONITORING BY USACE
- ◆ 2007-FEB MONITORING BY MAE
- - - MHW CONTOUR (0.7 FT)

RANGE: R-76  
EST DATE: NOV1980  
SURVEY DATE: 17APR19  
AZIMUTH: 205.0

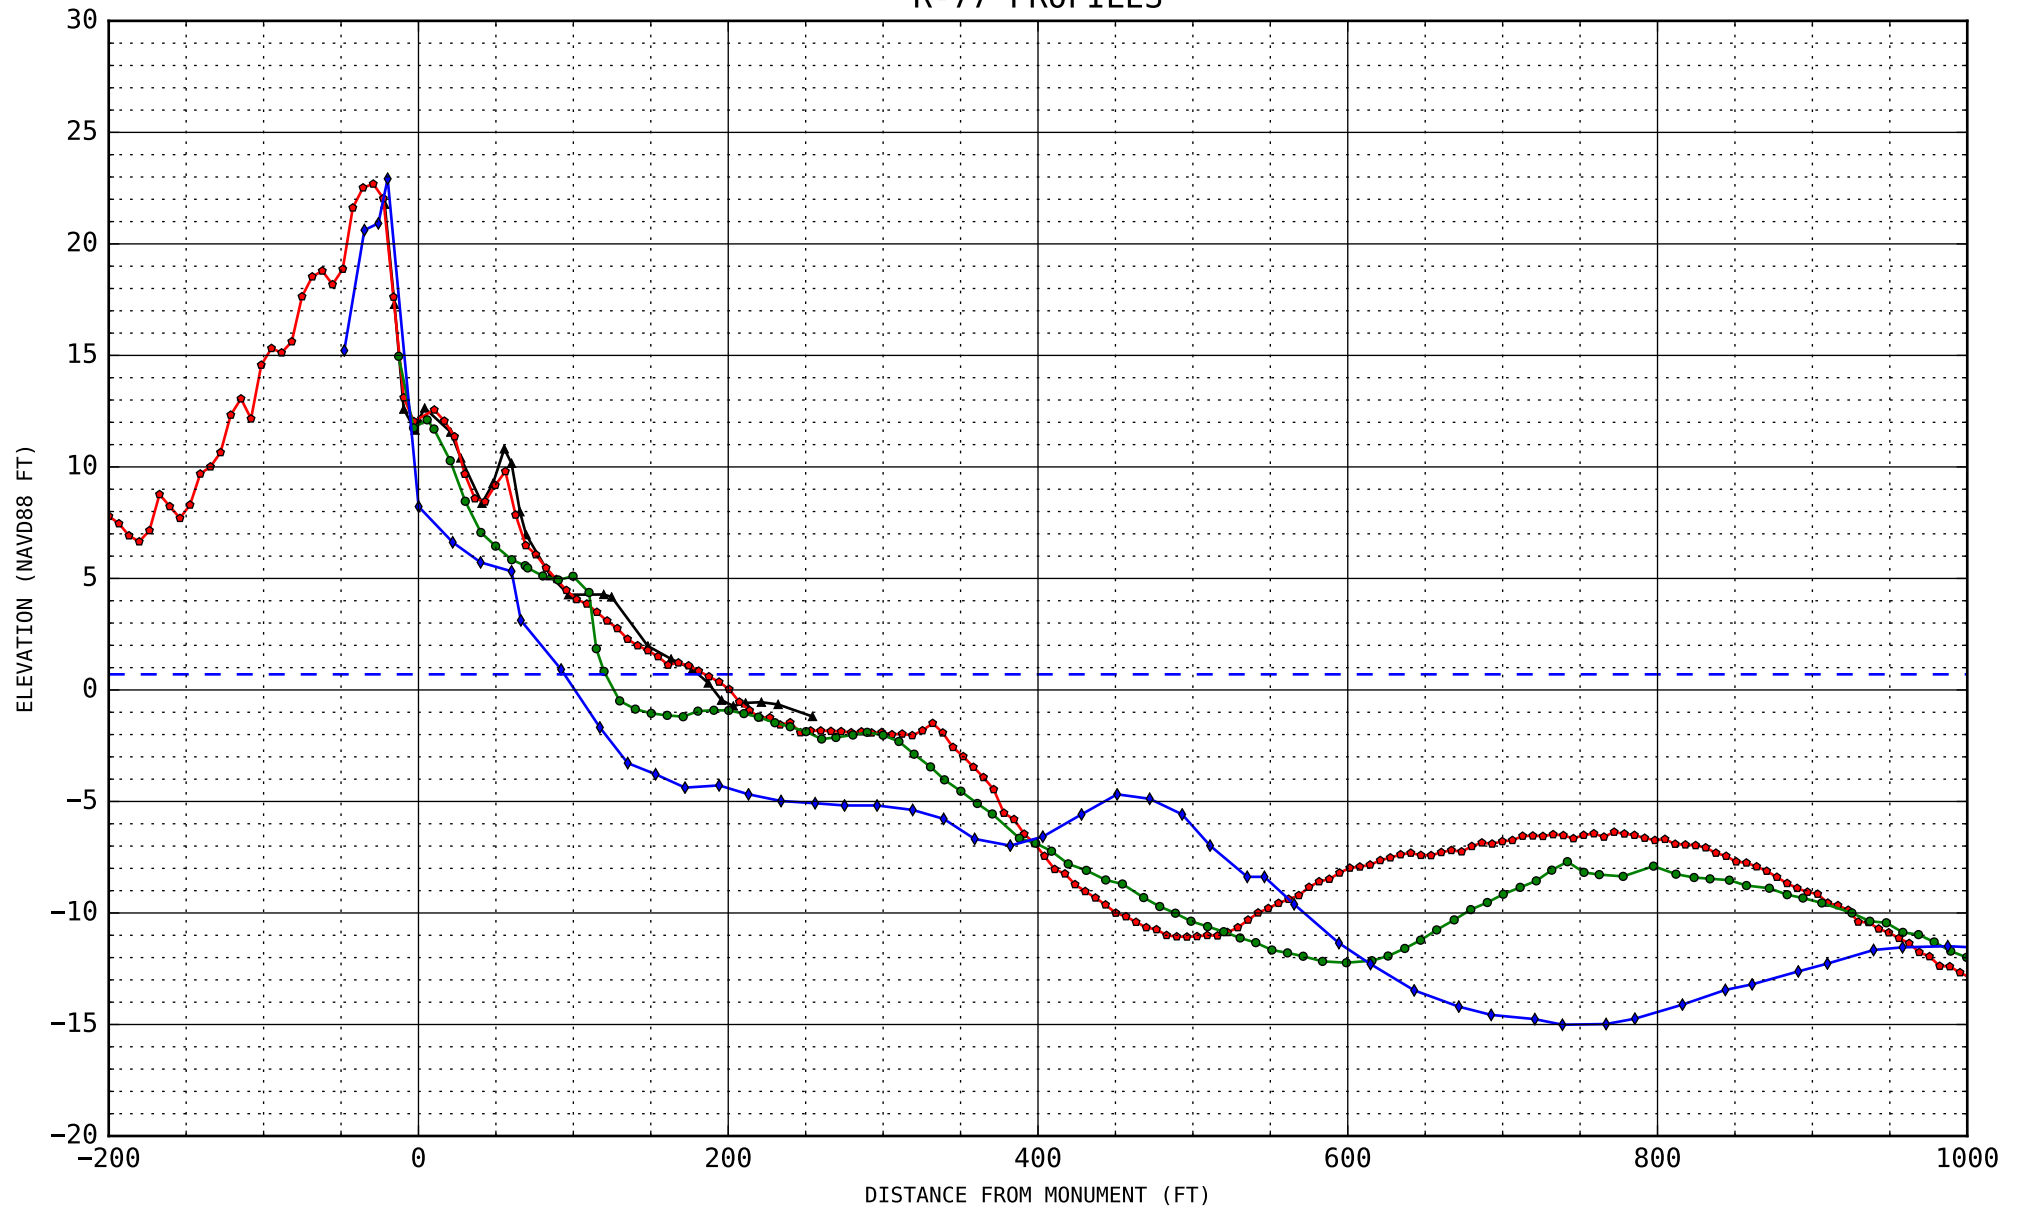
# R-77 PROFILES

- ▲ 2019-APR CONDITION BY DEP
- 2018-OCT MONITORING BY USACE-LIDAR
- 2013-SEP MONITORING BY USACE
- ◆ 2007-FEB MONITORING BY MAE
- - - MHW CONTOUR (0.7 FT)

RANGE: R-77  
EST DATE: M&E1997  
SURVEY DATE: 17APR19  
AZIMUTH: 205.0

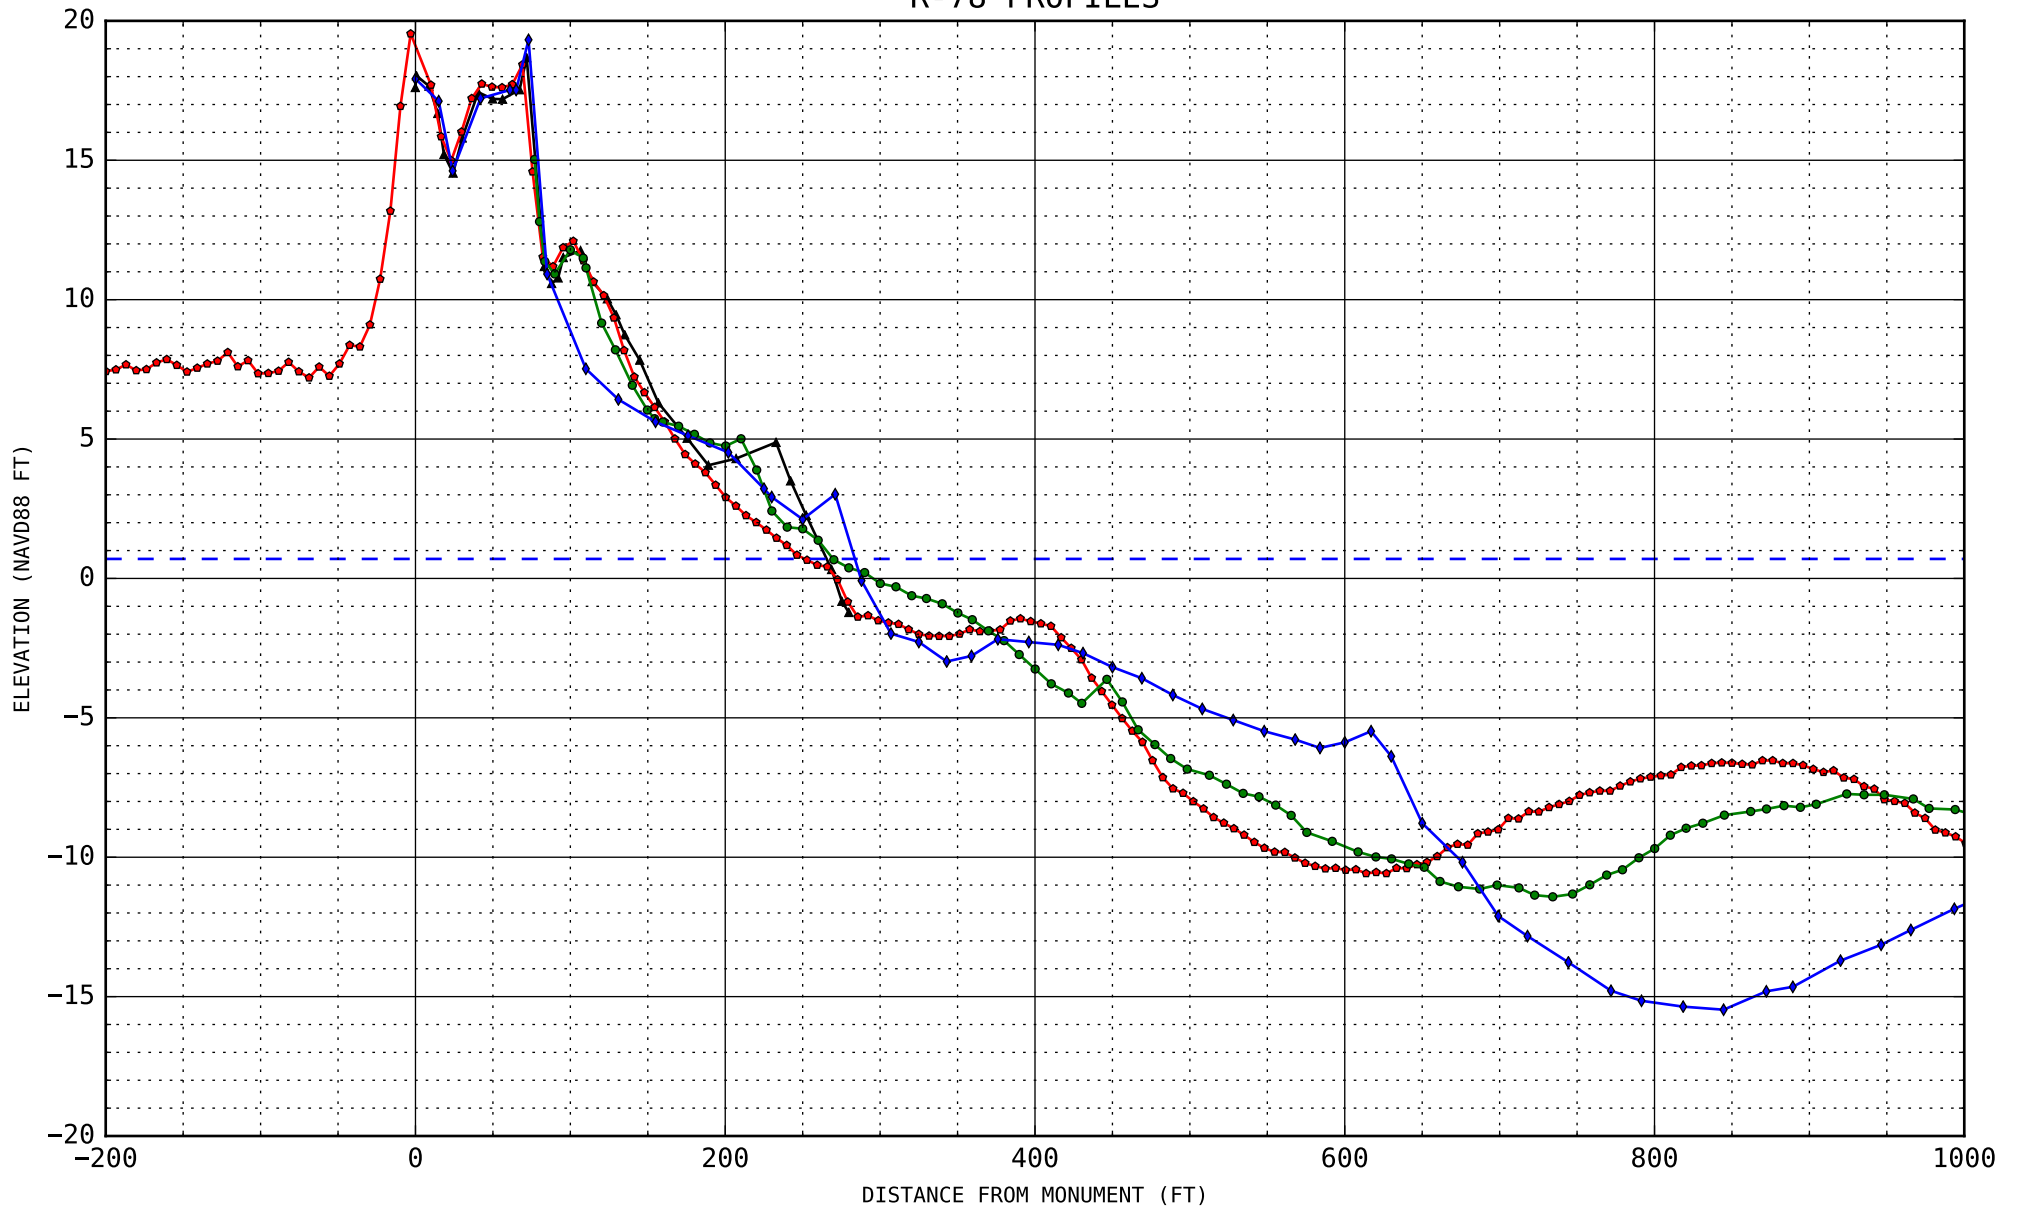
# R-78 PROFILES

- ▲ 2019-APR CONDITION BY DEP
- 2018-OCT MONITORING BY USACE-LIDAR
- 2013-SEP MONITORING BY USACE
- ◆ 2007-FEB MONITORING BY MAE
- - - MHW CONTOUR (0.7 FT)

RANGE: R-78  
EST DATE: OCT1995  
SURVEY DATE: 18APR19  
AZIMUTH: 202.0

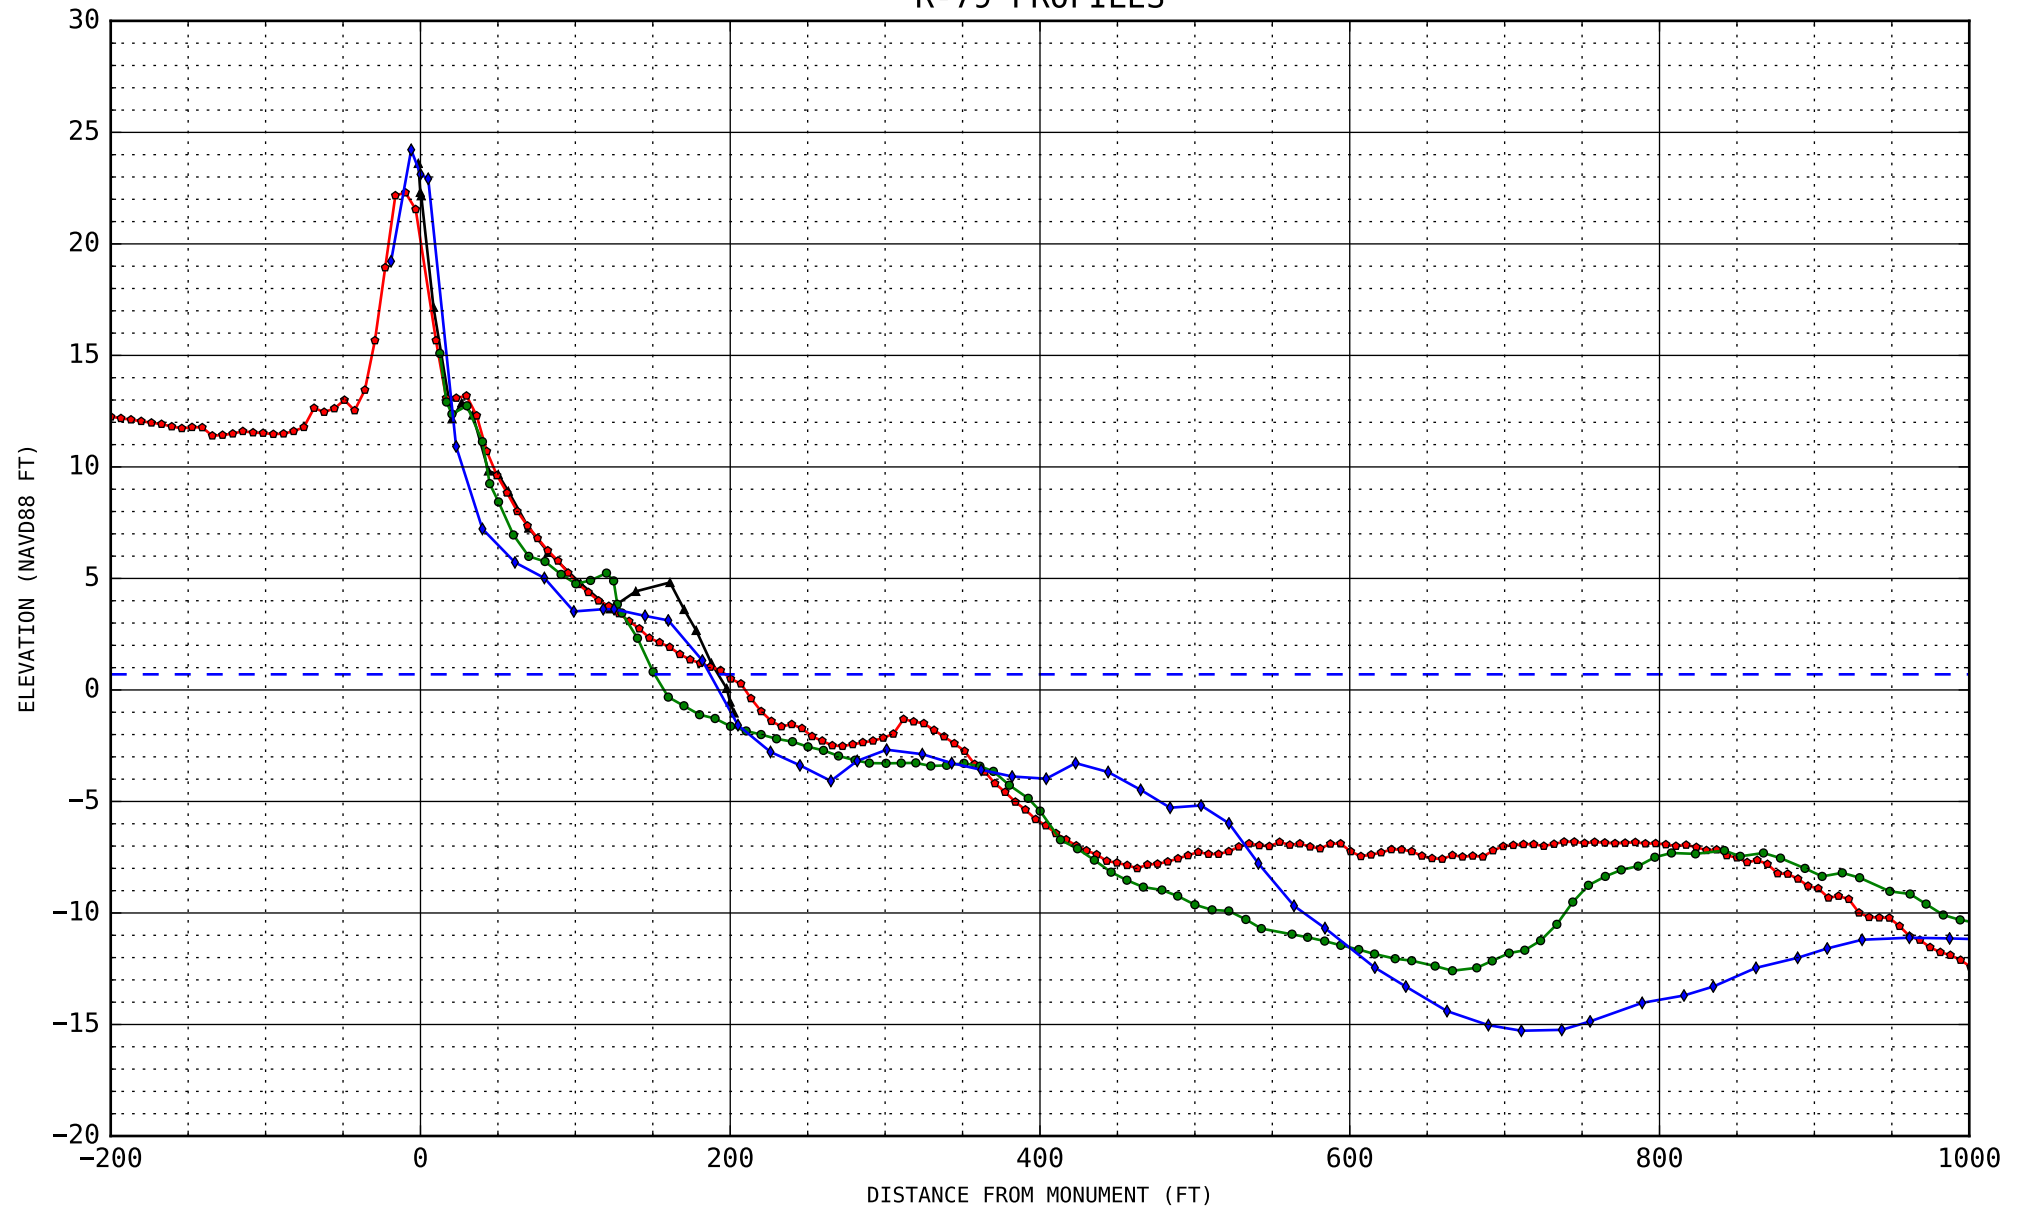
# R-79 PROFILES

- ▲ 2019-APR CONDITION BY DEP
- 2018-OCT MONITORING BY USACE-LIDAR
- 2013-SEP MONITORING BY USACE
- ◆ 2007-FEB MONITORING BY MAE
- - - MHW CONTOUR (0.7 FT)

RANGE: R-79  
EST DATE: OCT1995  
SURVEY DATE: 18APR19  
AZIMUTH: 202.0
