# R-1 PROFILES

WALTON  
PROGRAM SUPPORT GIS  
DIVISION OF WATER RESOURCE MANAGEMENT  
FLORIDA DEPARTMENT OF ENVIRONMENTAL PROTECTION

RANGE: R-1  
EST DATE: NOV1980  
SURVEY DATE: 04APR19  
AZIMUTH: 190.0

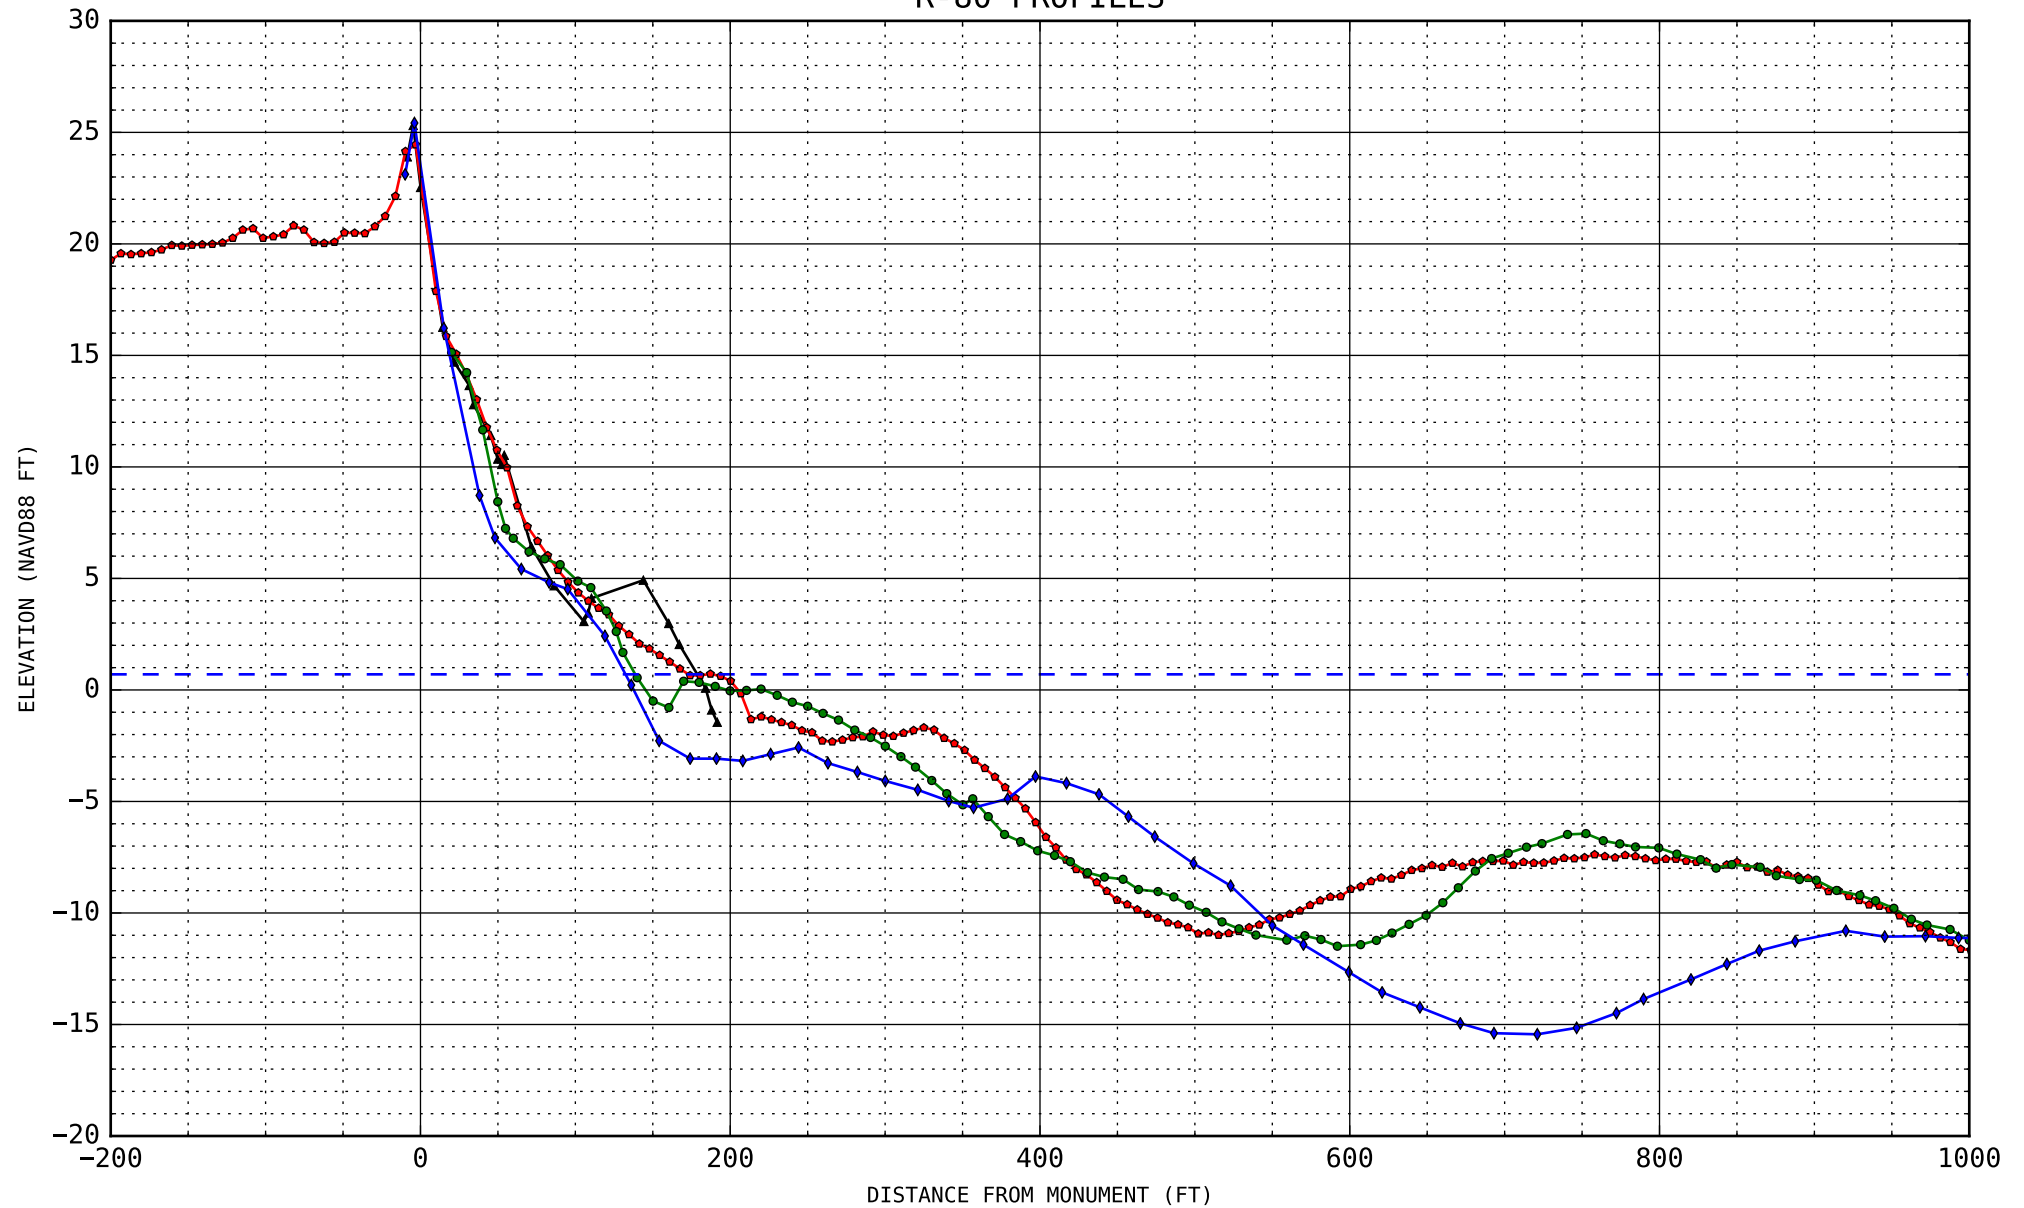
# R-80 PROFILES

- ▲ 2019-APR CONDITION BY DEP
- 2018-OCT MONITORING BY USACE-LIDAR
- 2013-SEP MONITORING BY USACE
- ◆ 2007-FEB MONITORING BY MAE
- - - MHW CONTOUR (0.7 FT)

RANGE: R-80  
EST DATE: OCT1994  
SURVEY DATE: 18APR19  
AZIMUTH: 202.0

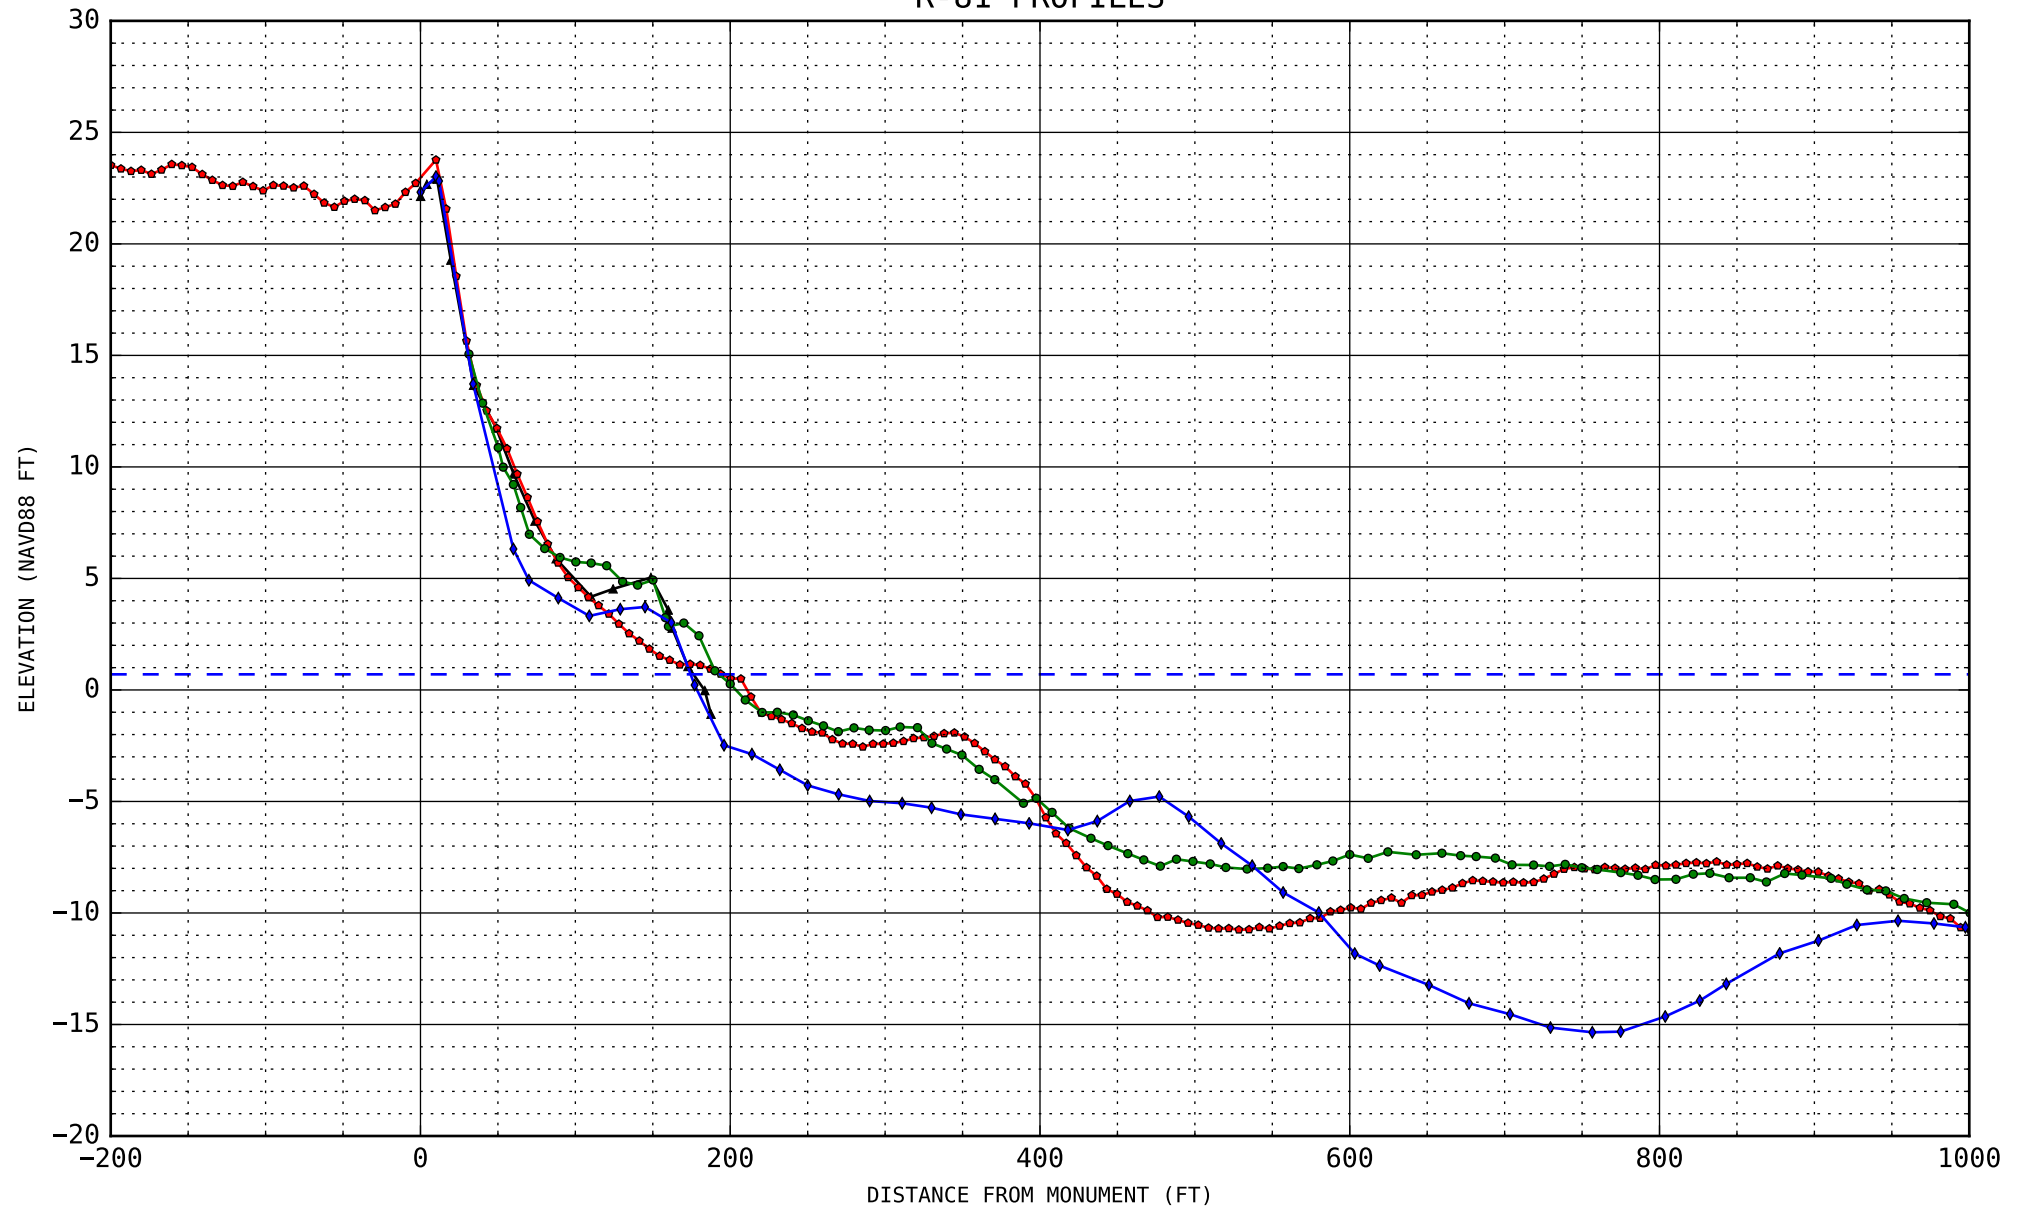
# R-81 PROFILES

- ▲ 2019-APR CONDITION BY DEP
- 2018-OCT MONITORING BY USACE-LIDAR
- 2013-SEP MONITORING BY USACE
- ◆ 2007-FEB MONITORING BY MAE
- - - MHW CONTOUR (0.7 FT)

RANGE: R-81  
EST DATE: M&E1997  
SURVEY DATE: 18APR19  
AZIMUTH: 202.0

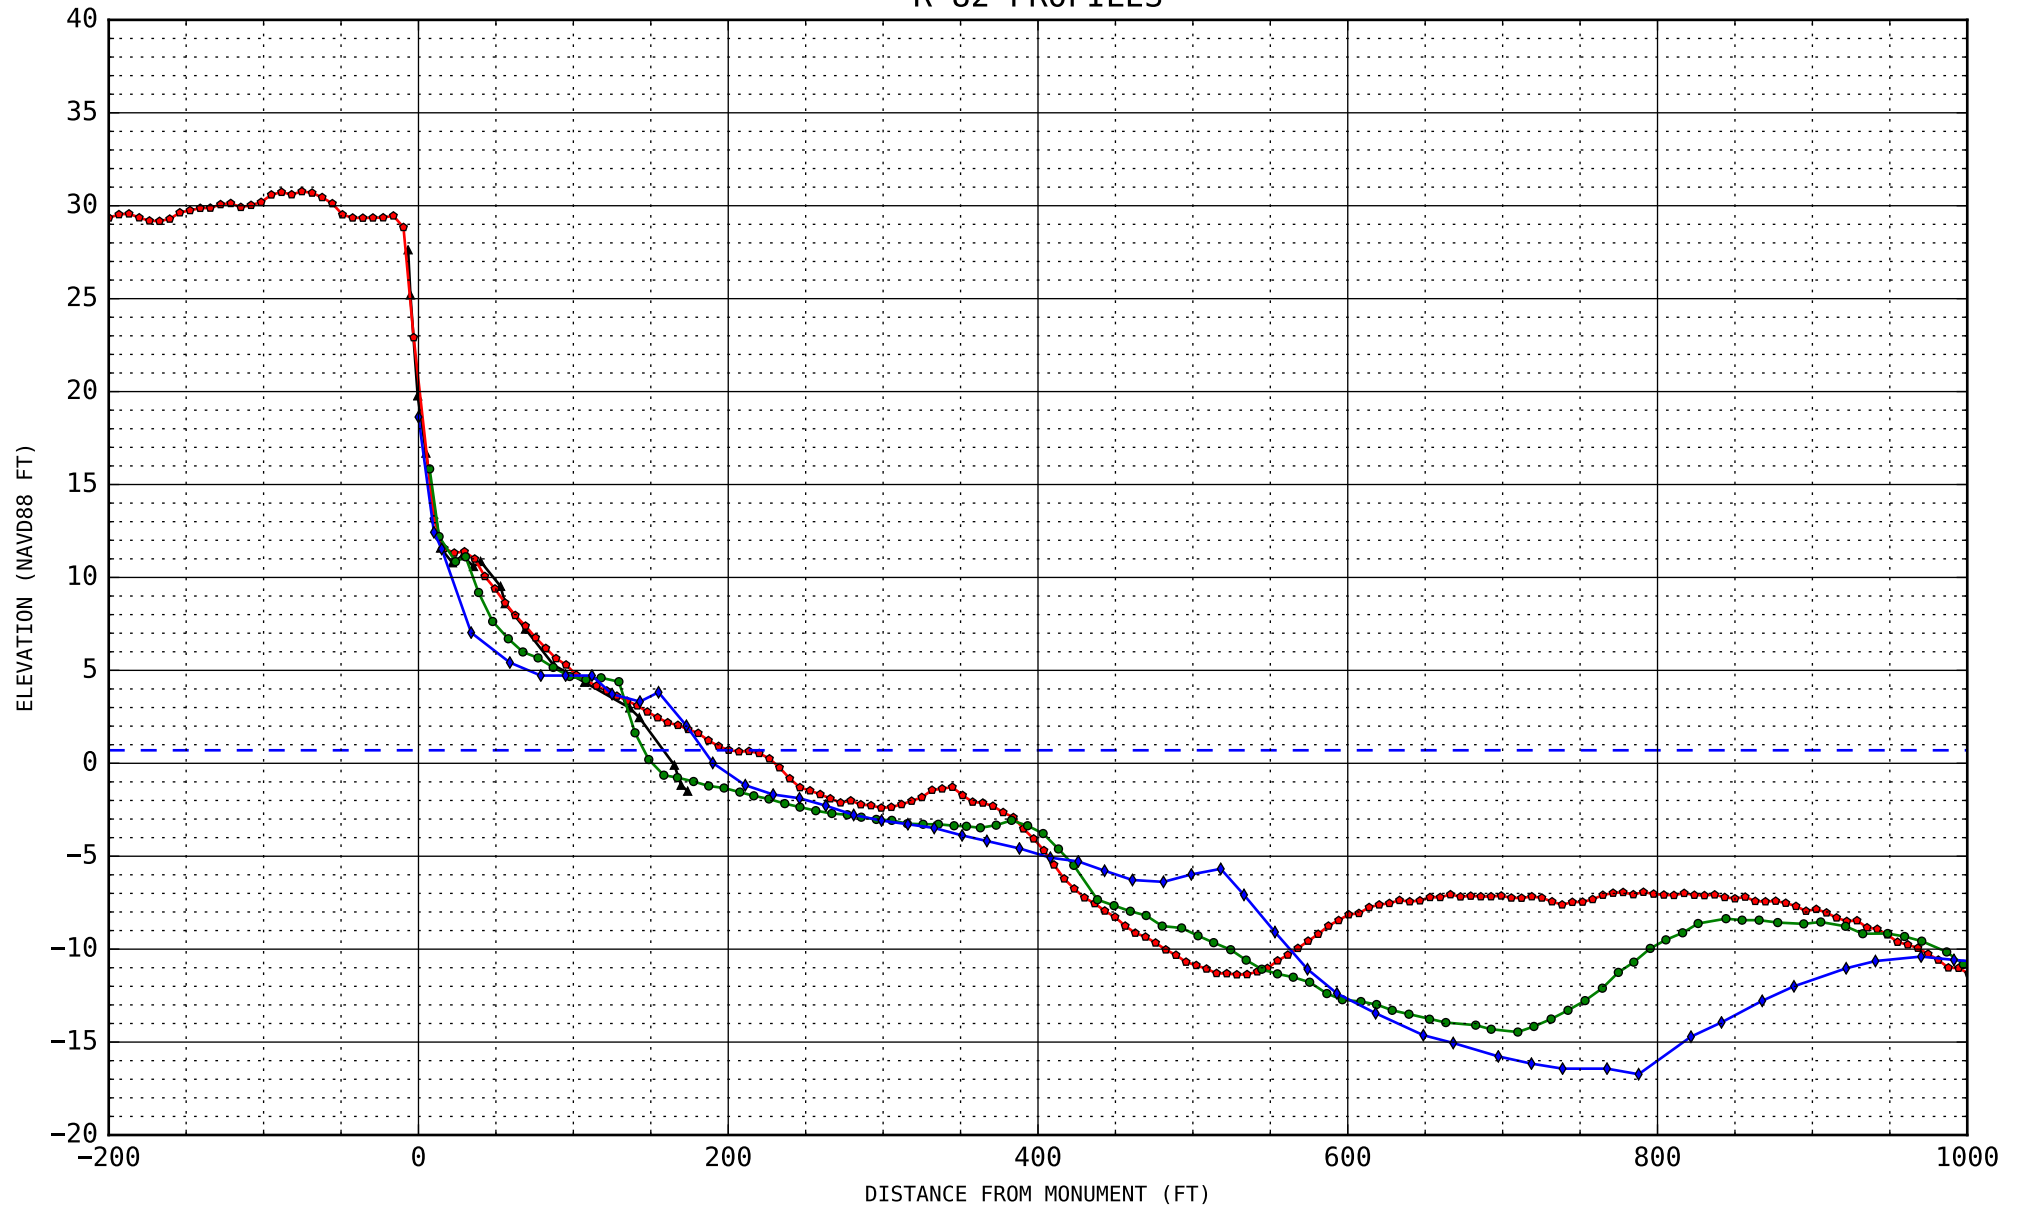
# R-82 PROFILES

- ▲ 2019-APR CONDITION BY DEP
- 2018-OCT MONITORING BY USACE-LIDAR
- 2013-SEP MONITORING BY USACE
- ◆ 2007-FEB MONITORING BY MAE
- - - MHW CONTOUR (0.7 FT)

RANGE: R-82  
EST DATE: OCT1995  
SURVEY DATE: 18APR19  
AZIMUTH: 202.0

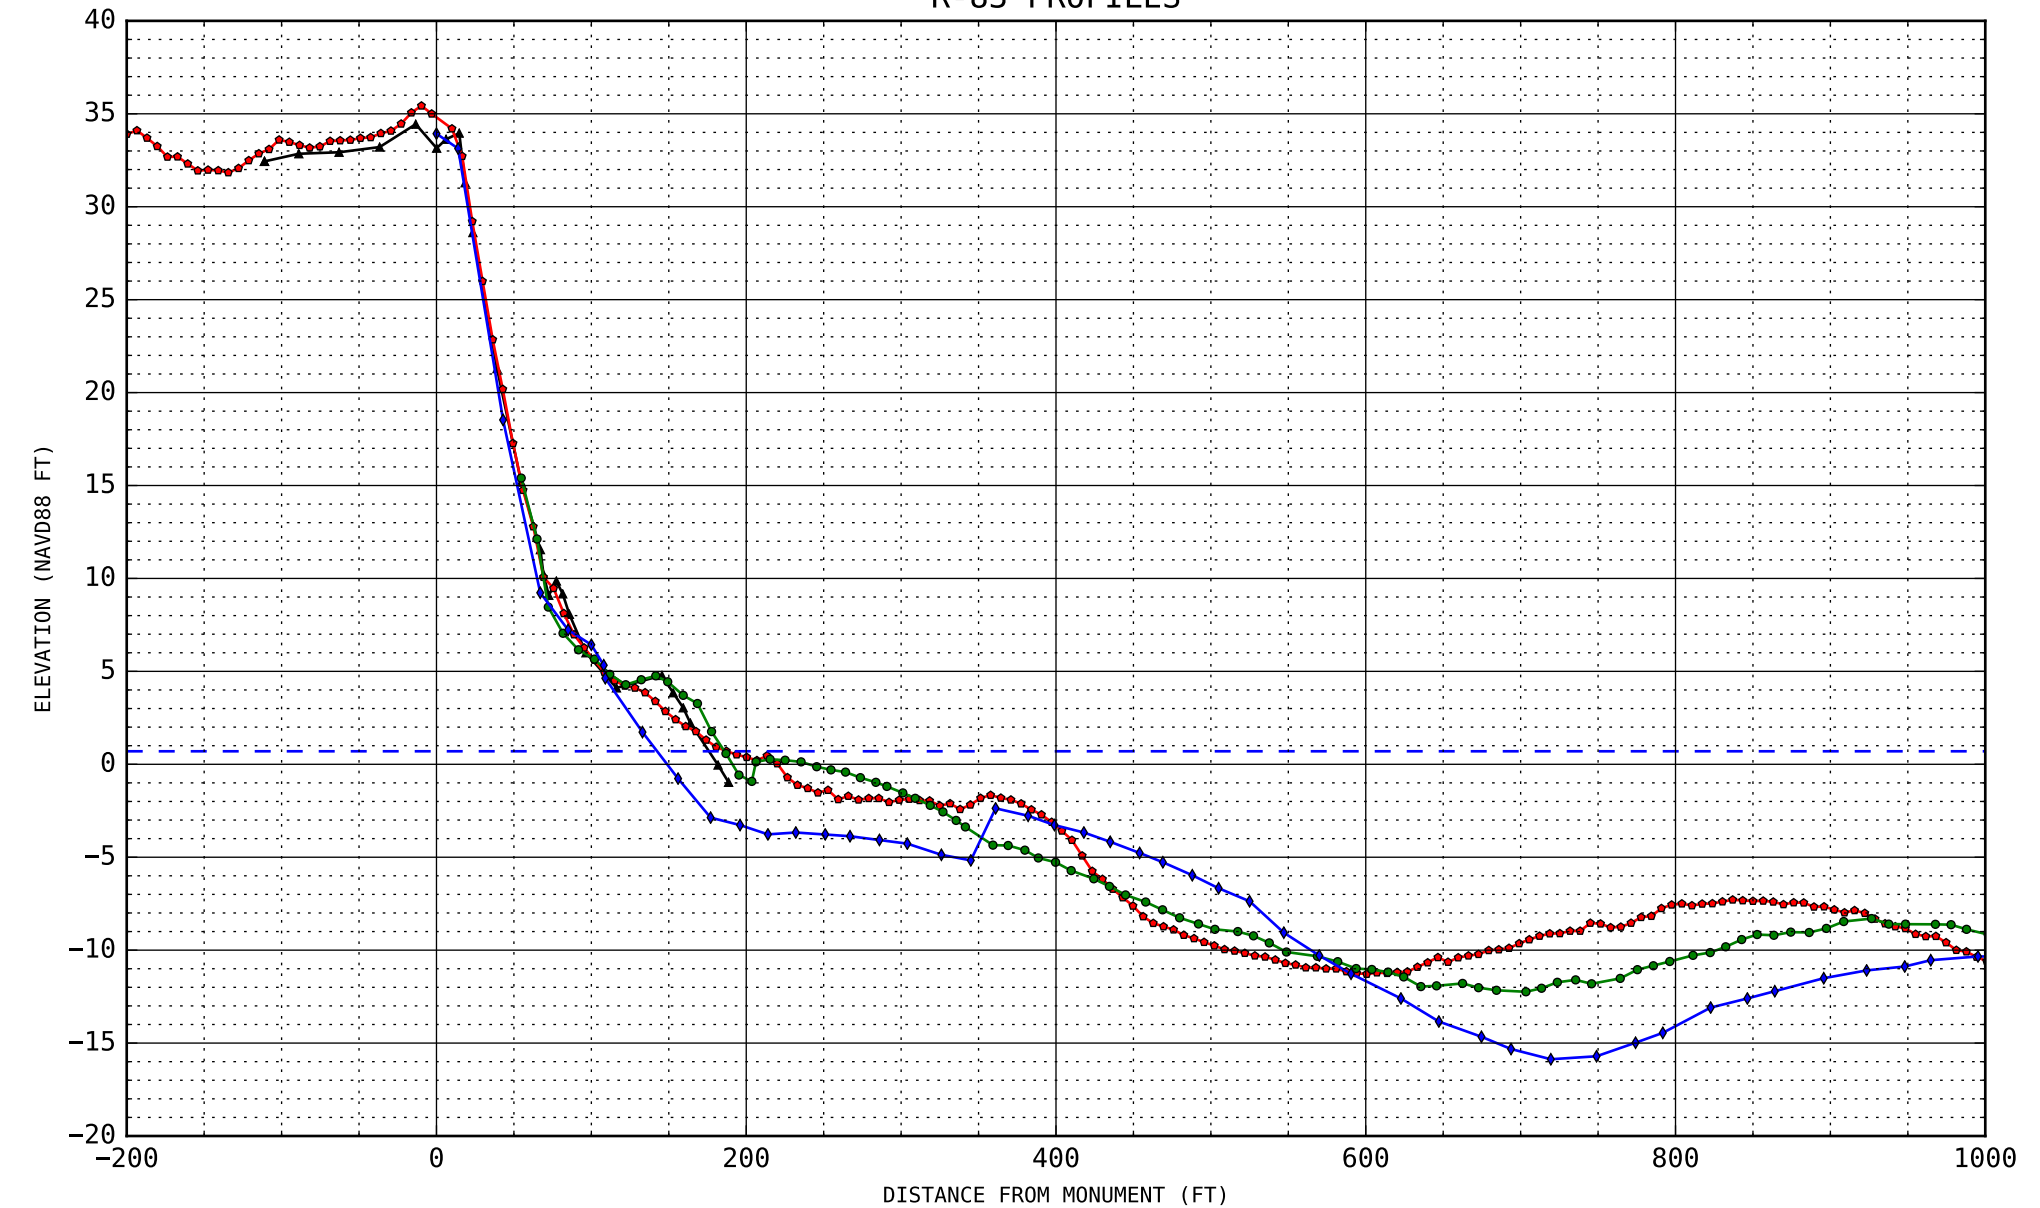
# R-83 PROFILES

- ▲ 2019-APR CONDITION BY DEP
- 2018-OCT MONITORING BY USACE-LIDAR
- 2013-SEP MONITORING BY USACE
- ◆ 2007-FEB MONITORING BY MAE
- - - MHW CONTOUR (0.7 FT)

RANGE: R-83  
EST DATE: NOV1980  
SURVEY DATE: 18APR19  
AZIMUTH: 202.0

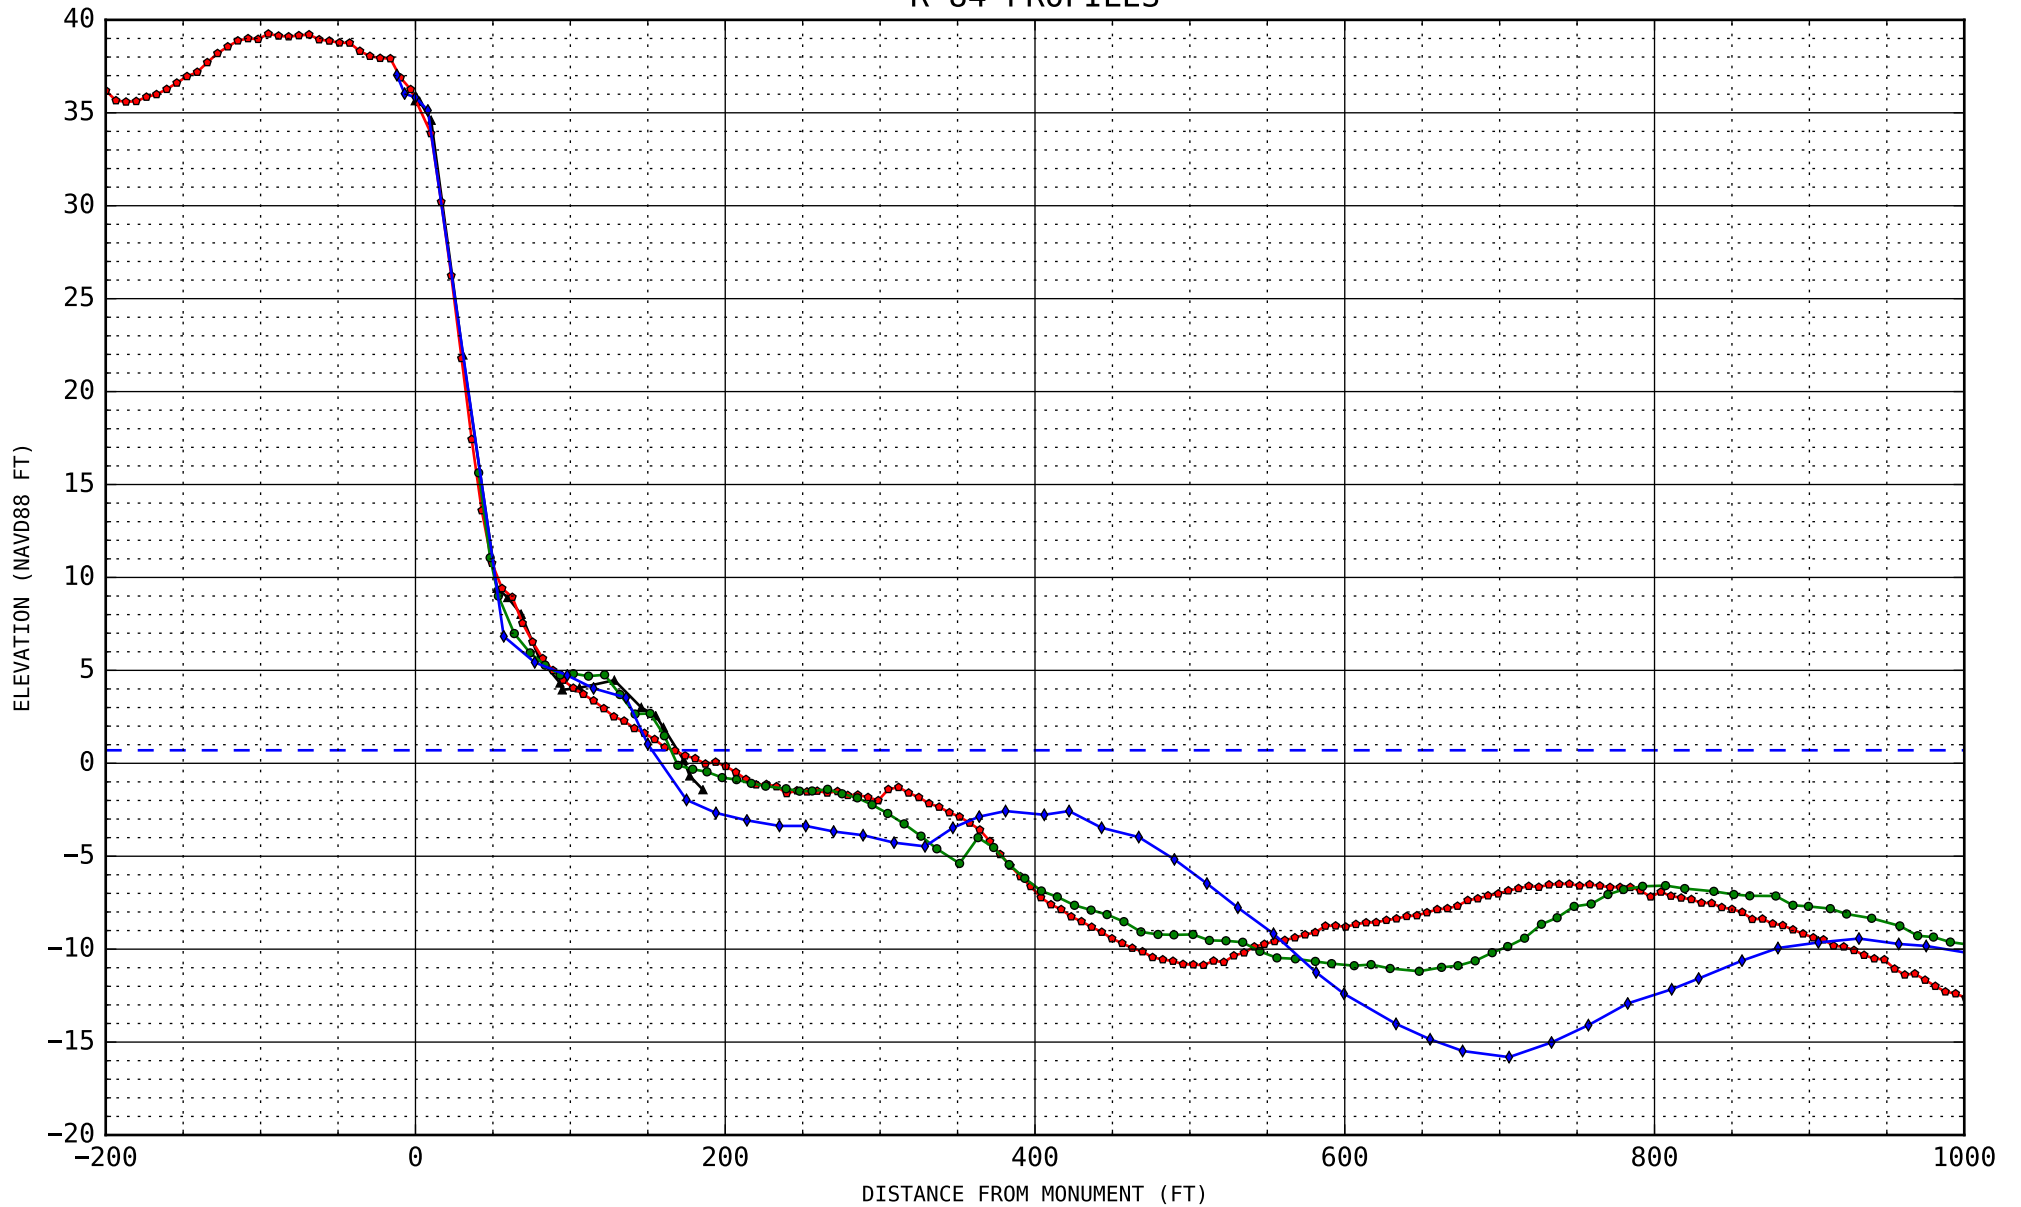
# R-84 PROFILES

- ▲ 2019-APR CONDITION BY DEP
- 2018-OCT MONITORING BY USACE-LIDAR
- 2013-SEP MONITORING BY USACE
- ◆ 2007-FEB MONITORING BY MAE
- - - MHW CONTOUR (0.7 FT)

RANGE: R-84  
EST DATE: JUN1973  
SURVEY DATE: 18APR19  
AZIMUTH: 202.0

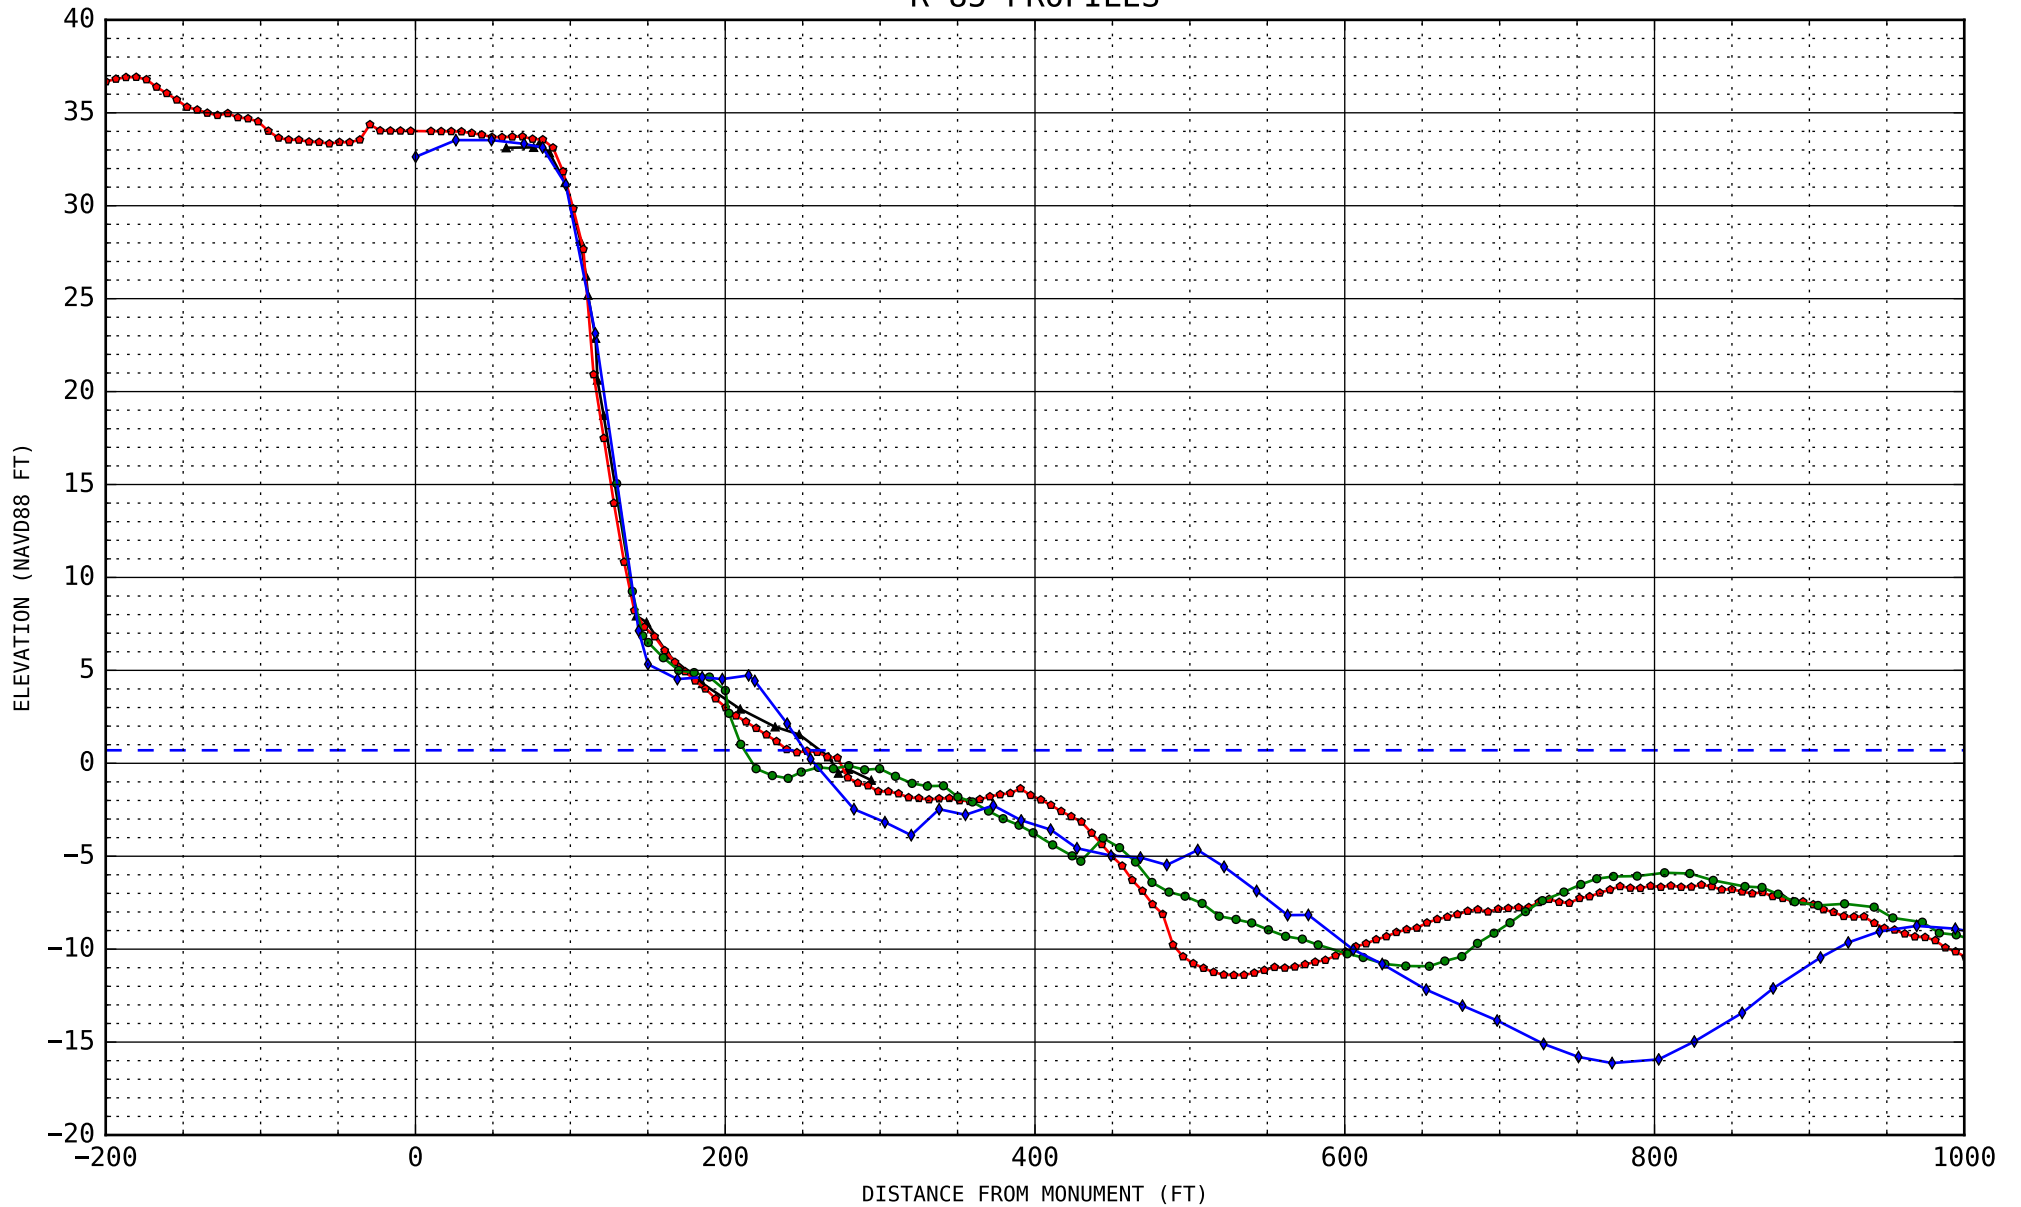
# R-85 PROFILES

- ▲ 2019-APR CONDITION BY DEP
- 2018-OCT MONITORING BY USACE-LIDAR
- 2013-SEP MONITORING BY USACE
- ◆ 2007-FEB MONITORING BY MAE
- - - MHW CONTOUR (0.7 FT)

RANGE: R-85  
EST DATE: OCT1995  
SURVEY DATE: 18APR19  
AZIMUTH: 202.0

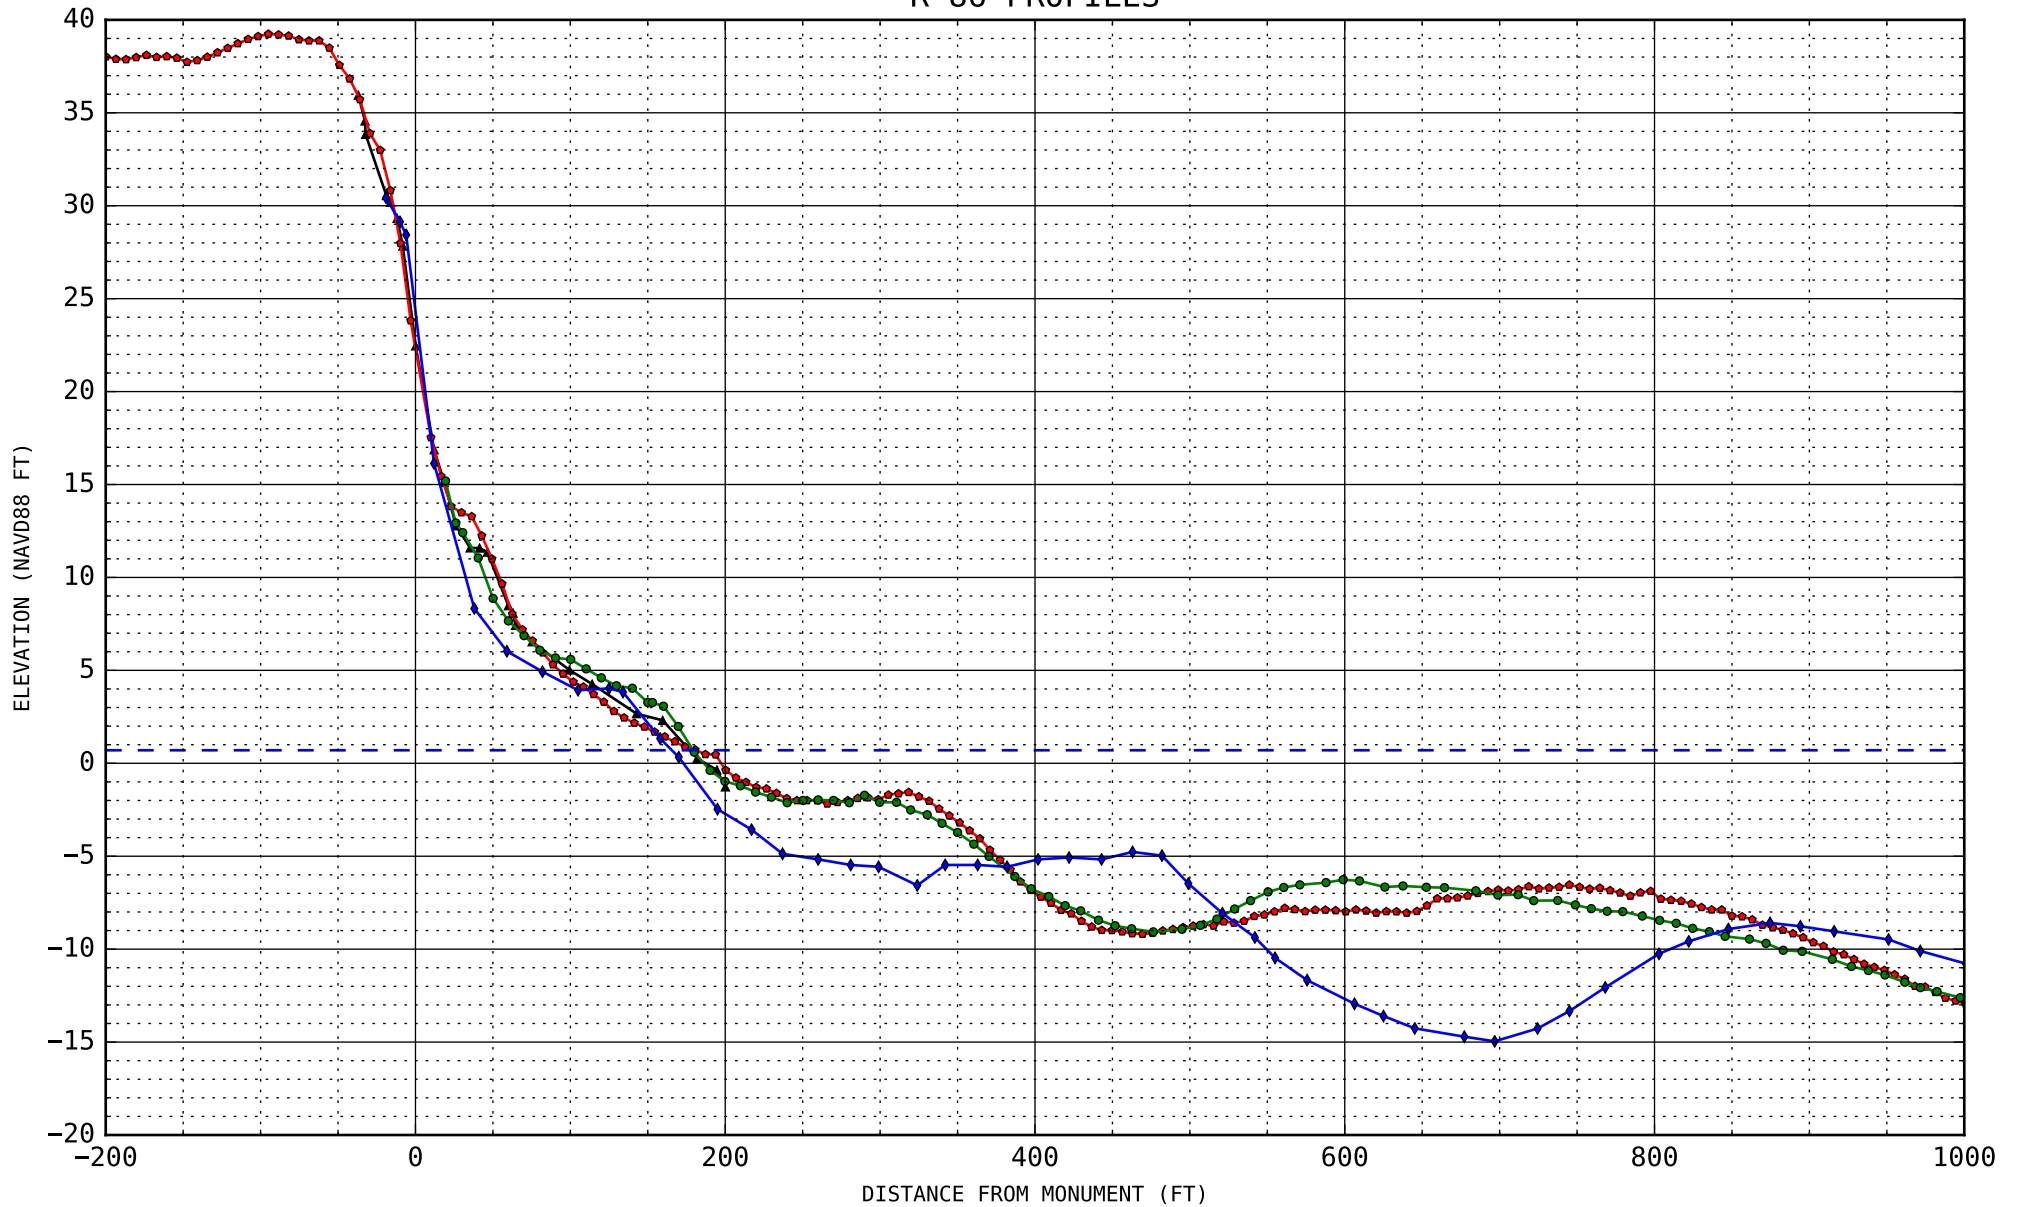
# R-86 PROFILES

- ▲ 2019-APR CONDITION BY DEP
- 2018-OCT MONITORING BY USACE-LIDAR
- 2013-SEP MONITORING BY USACE
- ◆ 2007-FEB MONITORING BY MAE
- - - MHW CONTOUR (0.7 FT)

RANGE: R-86  
EST DATE: JUN1973  
SURVEY DATE: 18APR19  
AZIMUTH: 202.0

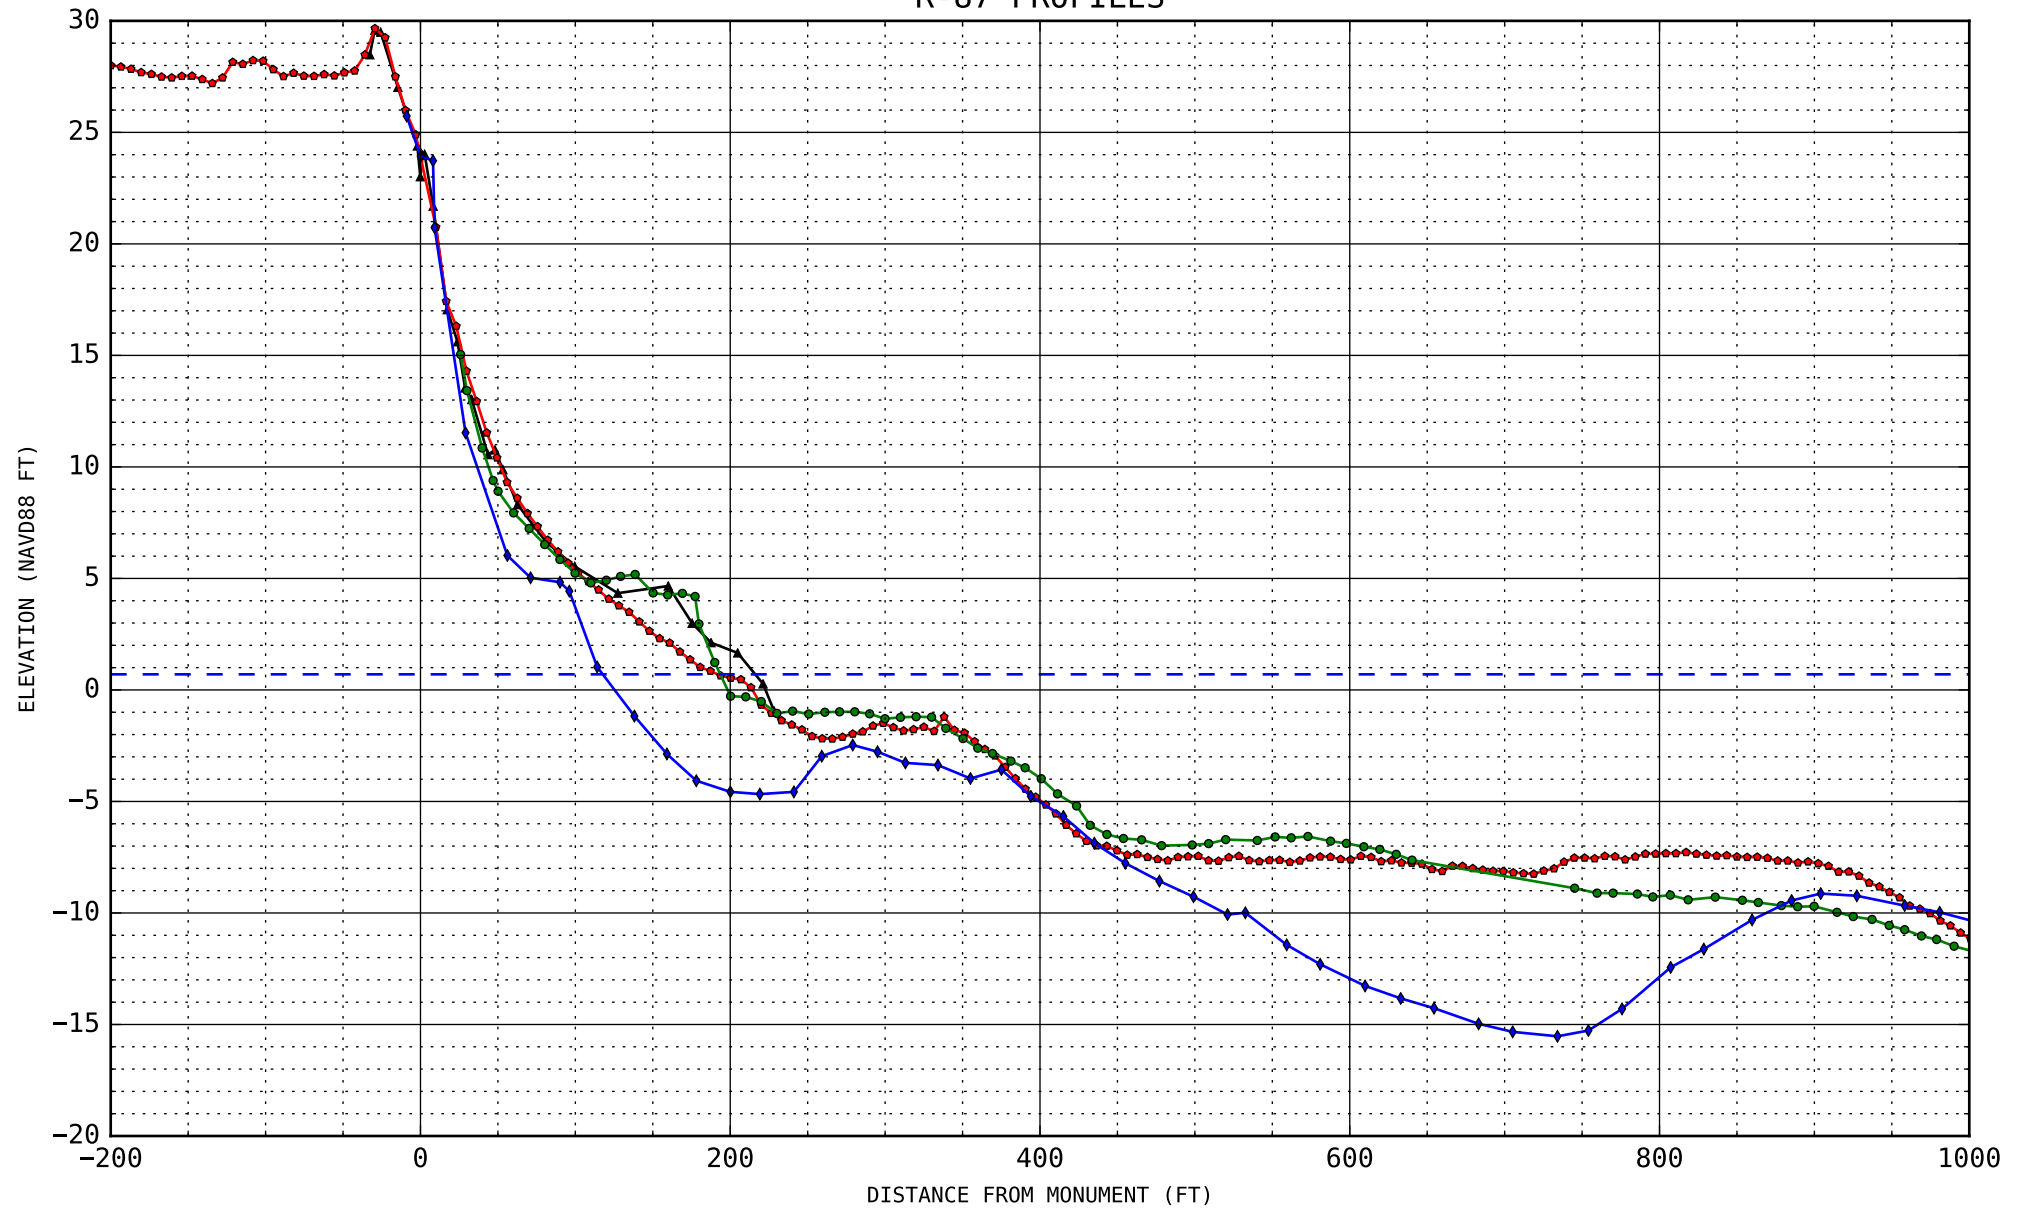
# R-87 PROFILES

- ▲ 2019-APR CONDITION BY DEP
- 2018-OCT MONITORING BY USACE-LIDAR
- 2013-SEP MONITORING BY USACE
- ◆ 2007-FEB MONITORING BY MAE
- - - MHW CONTOUR (0.7 FT)

RANGE: R-87  
 EST DATE: JUN1973  
 SURVEY DATE: 18APR19  
 AZIMUTH: 202.0

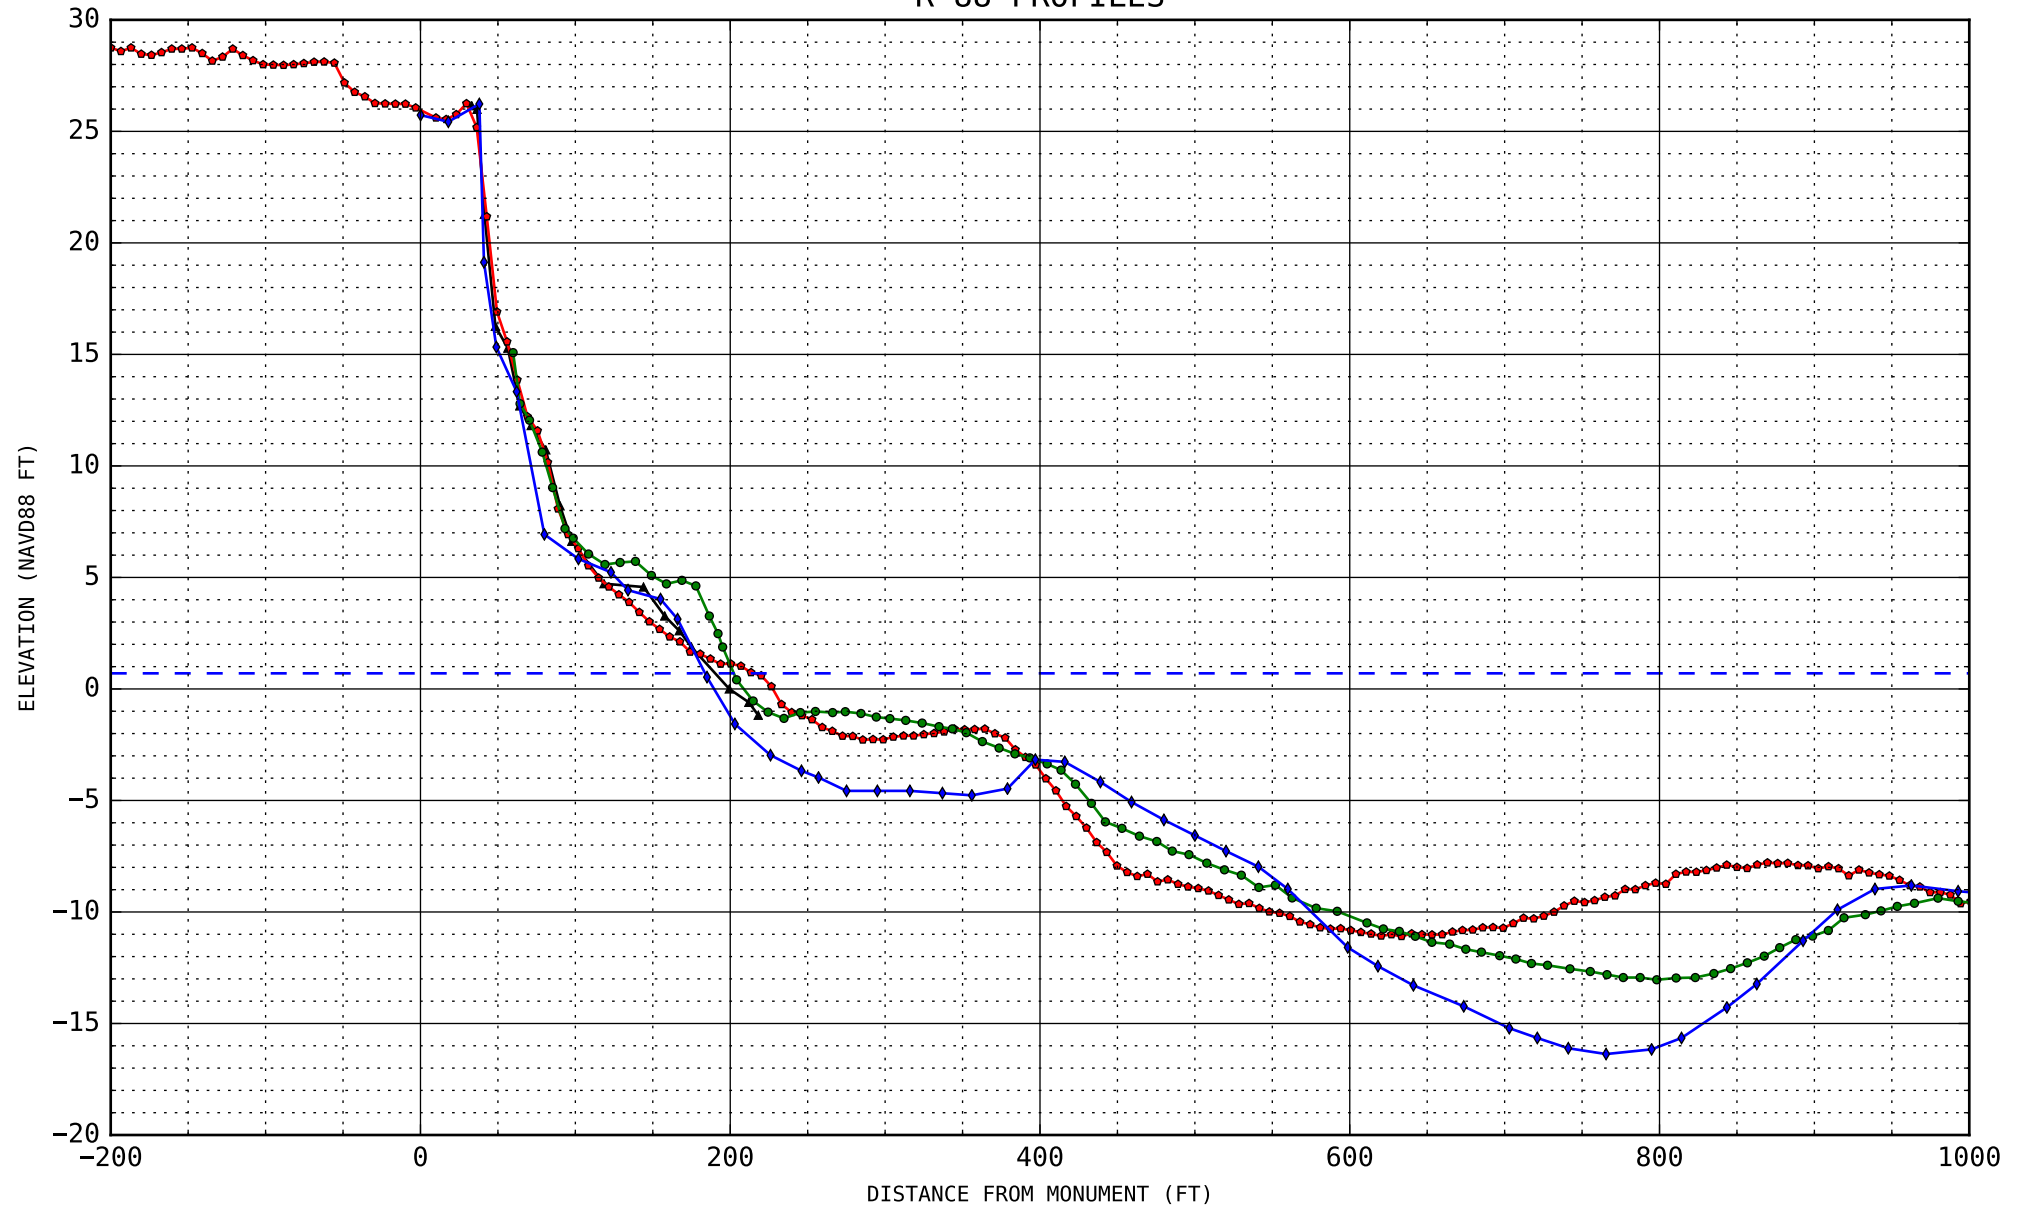
# R-88 PROFILES

- ▲ 2019-APR CONDITION BY DEP
- 2018-OCT MONITORING BY USACE-LIDAR
- 2013-SEP MONITORING BY USACE
- ◆ 2007-FEB MONITORING BY MAE
- - - MHW CONTOUR (0.7 FT)

RANGE: R-88  
EST DATE: OCT1995  
SURVEY DATE: 18APR19  
AZIMUTH: 202.0
